Summary of Oceanographic and Water-Quality Measurements Offshore of Matanzas Inlet, Florida, 2018

Open-File Report 2021-1014

By Marinna A. Martini, Ellyn T. Montgomery, Steven E. Suttles, and
John C. Warner

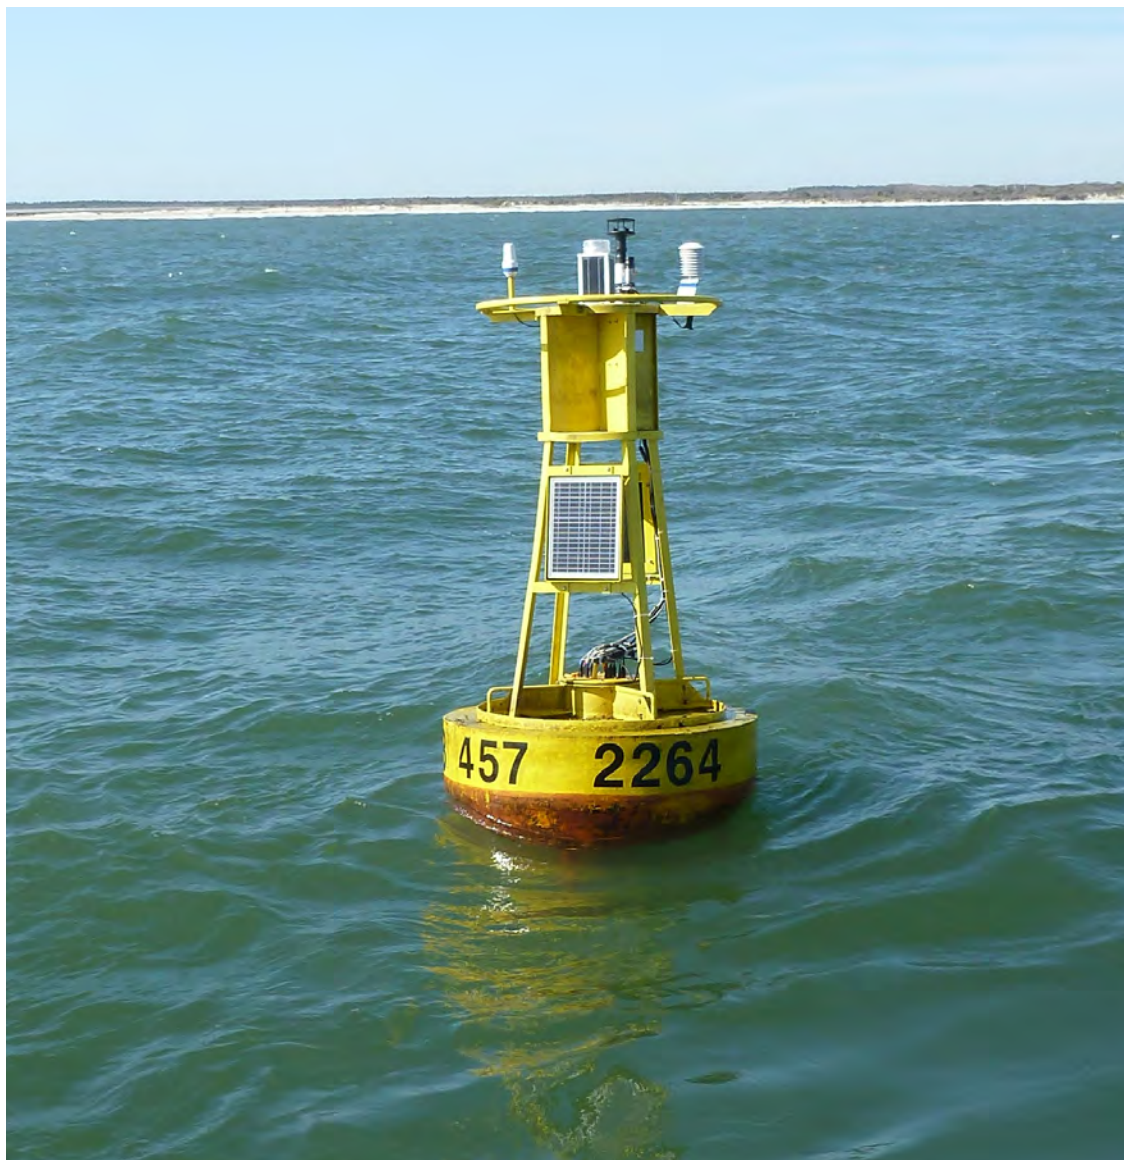
Figure 4. Surface buoy with meteorological sensors deployed at the deep site off Matanzas Inlet, Florida. Photograph by Ellyn Montgomery, U.S. Geological Survey.

G2000) was 1.5 m diameter foam with a 2.1 m high tower and 0.8 m high base (fig. 4). A smaller surface top-hat buoy, similar to a small navigation buoy was used at the shallow site.

The larger buoy at the deeper site supported meteorological measurement of local atmospheric conditions during the study (fig. 4), and both buoys measured near-surface water temperature and salinity. The processed time-series data that are reported here are presented in six categories: (1) currents

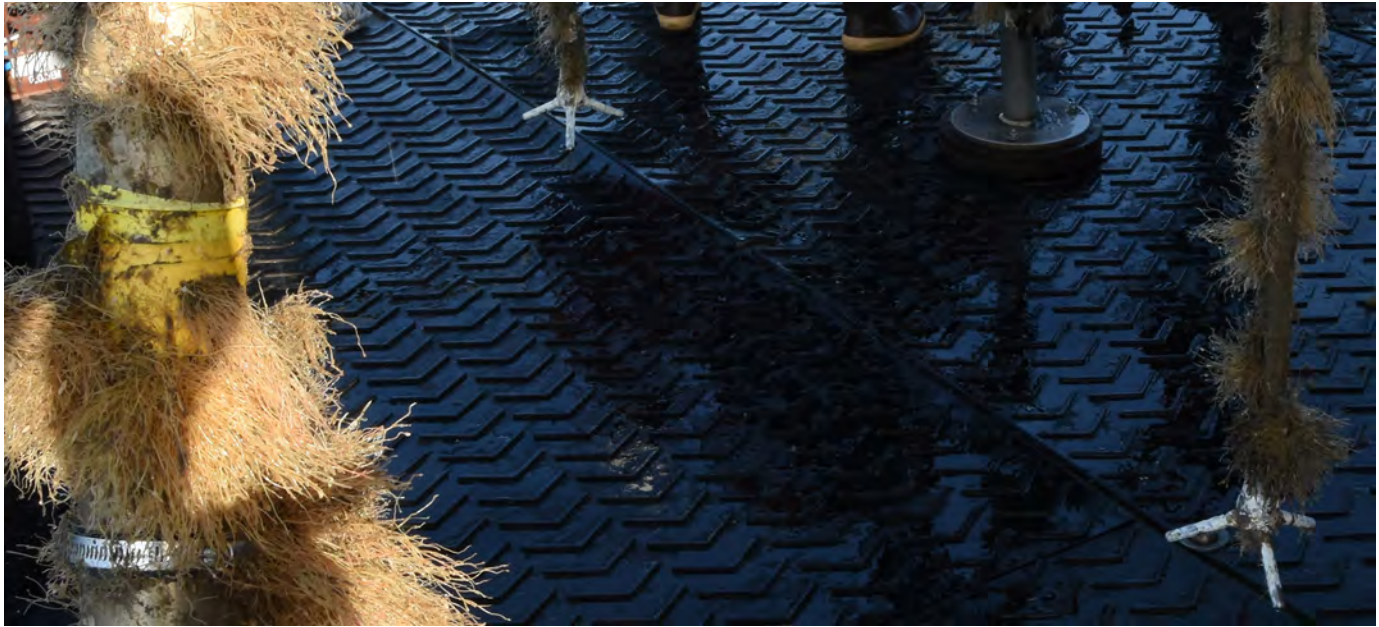
Figure 5. Biofouling on the quadpod shown compared to minimal fouling on sensors coated with zinc oxide paste (white). Photograph by Dann Blackwood, U.S. Geological Survey.

Time-series data quantifying currents, waves, acoustic and optical backscatter, sonar images, and meteorological conditions were collected to estimate how sediment dynamics near a natural inlet respond to periodic storms. The overall data return for the experiment exceeded 80 percent. The most common cause of data loss was instrument or sensor failures, most notably the TRDI-V at the shallow site. The other significant cause of data loss was fouling of the conductivity and temperature sensors on the MicroCATs and backscatter sensors. There was heavy barnacle and encrusting biofouling on the aluminum quadpods and the instrument housings, but the zinc oxide paste effectively prevented the encrusting organisms from attaching to the transducers (fig. 5).
