Geomorphic Survey of North Fork Eagle Creek, New Mexico, 2019

Open-File Report 2022–1041

By Alexander P. Graziano and Shaleene B. Chavarria

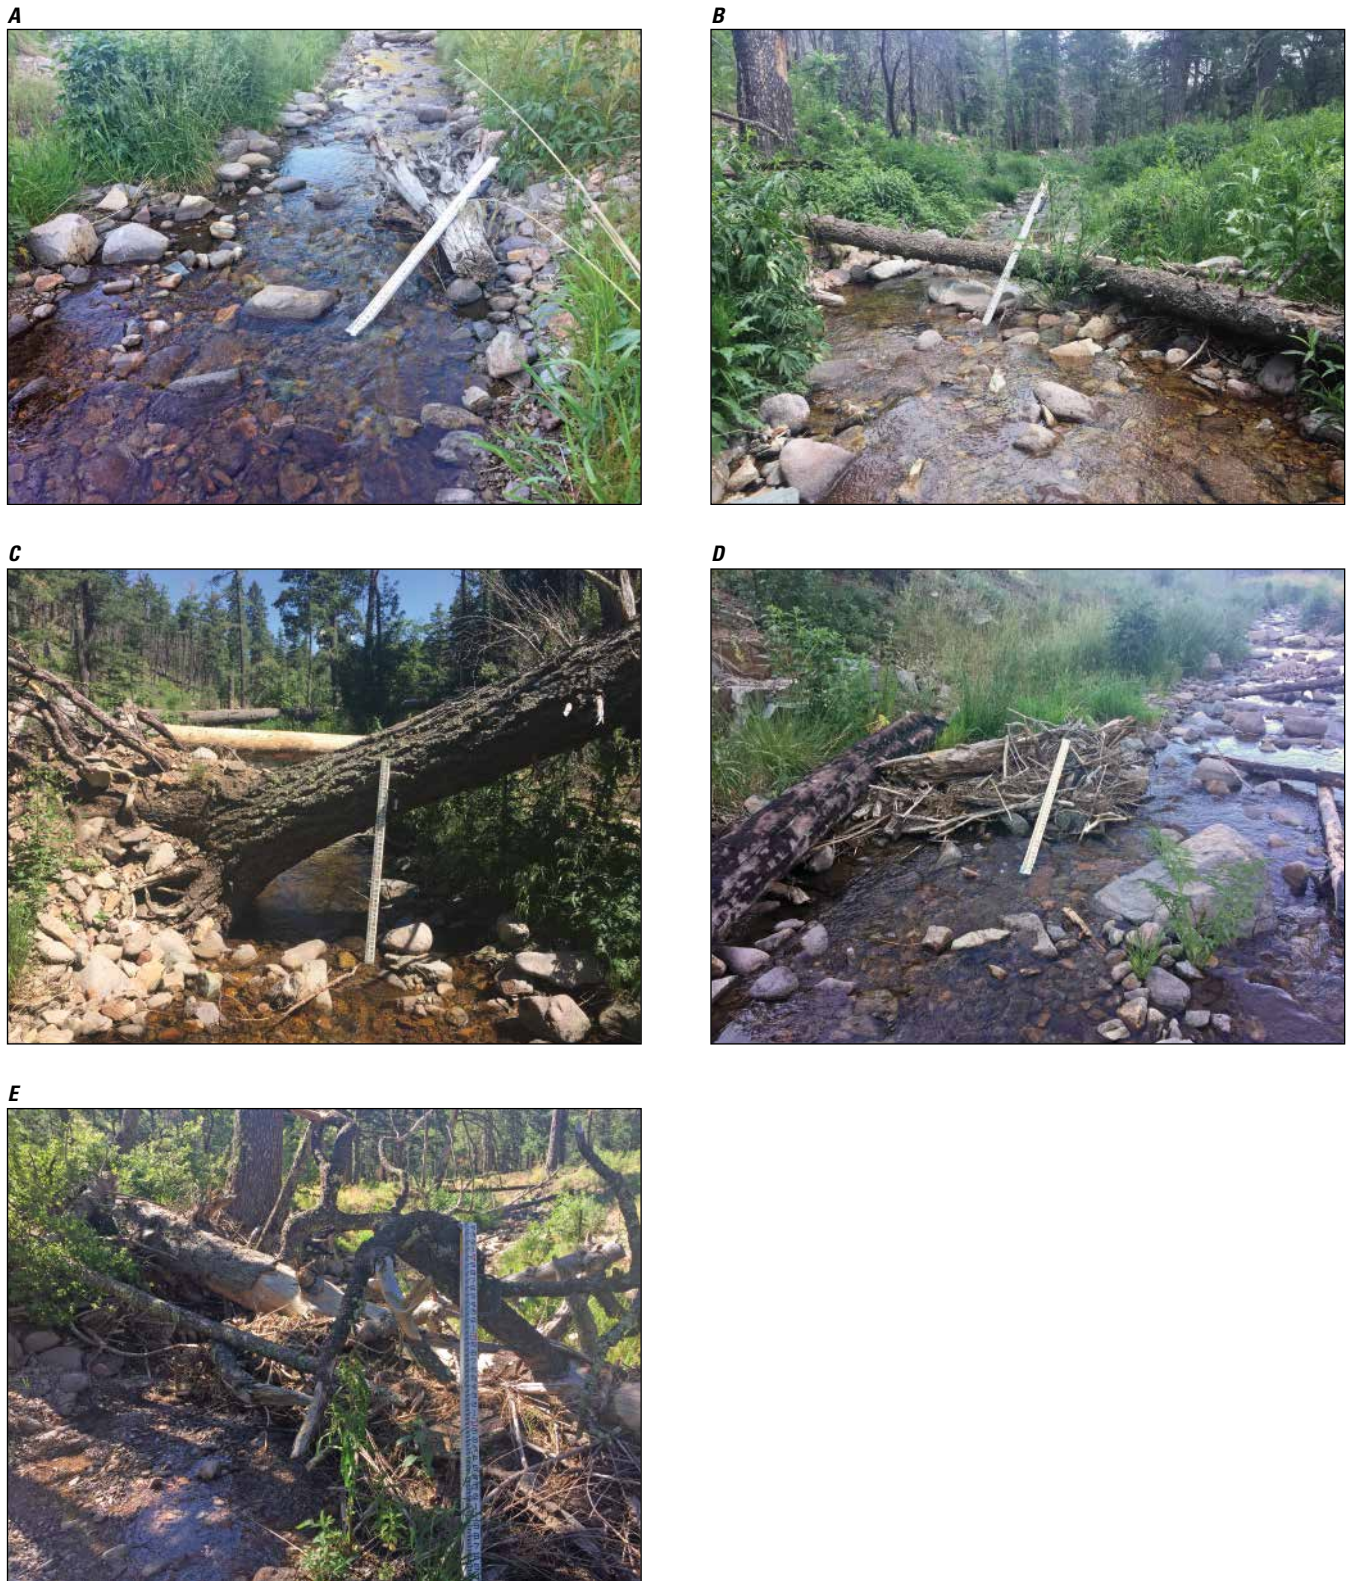
Example photographs of different woody debris accumulations identified during the 2019 survey are presented in figure 9, and the locations of the examples are shown in figure 8. Figure 9A depicts a type of debris deposit that was commonly seen during the 2019 survey, that being a debris deposit made up of woody debris loosely scattered on the side of the channel rather than in the middle.

Figure 9B and C shows examples of potential debris jams. In figure 9B, a log crosses the channel without causing any jamming in the channel, but the log is low and may become an active debris jam at moderately higher flows. The potential debris jam depicted in figure 9B was found upstream from cross section 1, before the first road crossing. Figure 9C, found upstream from cross section 5, depicts a less common type of potential debris jam, with potential geomorphic implications. It was one of the seven potential debris jams that was presumed to have newly formed between 2017 and 2018. This potential debris jam was unique in that it was a potential debris jam that appeared to have contributed to visible geomorphic change in the channel; specifically, where the tree uprooted on the left bank, the left bank collapsed, and the channel became constricted. It was also unique because it can be said with certainty that it was not woody debris that was mobilized and deposited by streamflow. Further, because the tree was large (between 2 and 3 ft in diameter) and it appeared to be firmly anchored by its root structure, it is likely that it will remain in place unless there is a substantial increase in streamflow or it is removed by artificial means. Therefore, it is likely well suited to become the key member of an active debris jam and to continue to be a driver of geomorphic change in the location where it was found during the 2018 survey.

Figure 9D and E depicts active debris jams with characteristics that were common to most of the active debris jams identified in the study reach in 2019. Specifically, the active debris jam in figure 9D, found upstream from cross section 6, contained small woody debris packed tightly against LWD key members, mostly on the upstream side. Also, like in most other active debris jams identified in 2019, the key members do not appear to be firmly anchored; therefore, the active debris jam could be easily mobilized and transported by high flows. Figure 9E (downstream from cross section 7) depicts an active debris jam that appeared to be the largest (by volume) found in the study reach in 2019 and that was also identified in 2018. This active debris jam is located downstream from cross section 7 and does not appear to have changed from 2018 to 2019, possibly because flows were not substantial enough to move debris.

Figure 9. Examples of woody debris accumulations identified in the study reach on North Fork Eagle Creek, Eagle Creek Basin, south-central New Mexico, 2019. All photographs are oriented downstream. For scale, a survey rod that is 4.46 feet in length (with graduation at feet, tenths of feet, and hundredths of feet) was included in each photograph. Locations of examples are shown in [figure 8](#). *A*, Debris deposit. *B*, Potential debris jam. *C*, Potential debris jam. *D*, Active debris jam. *E*, Active debris jam.

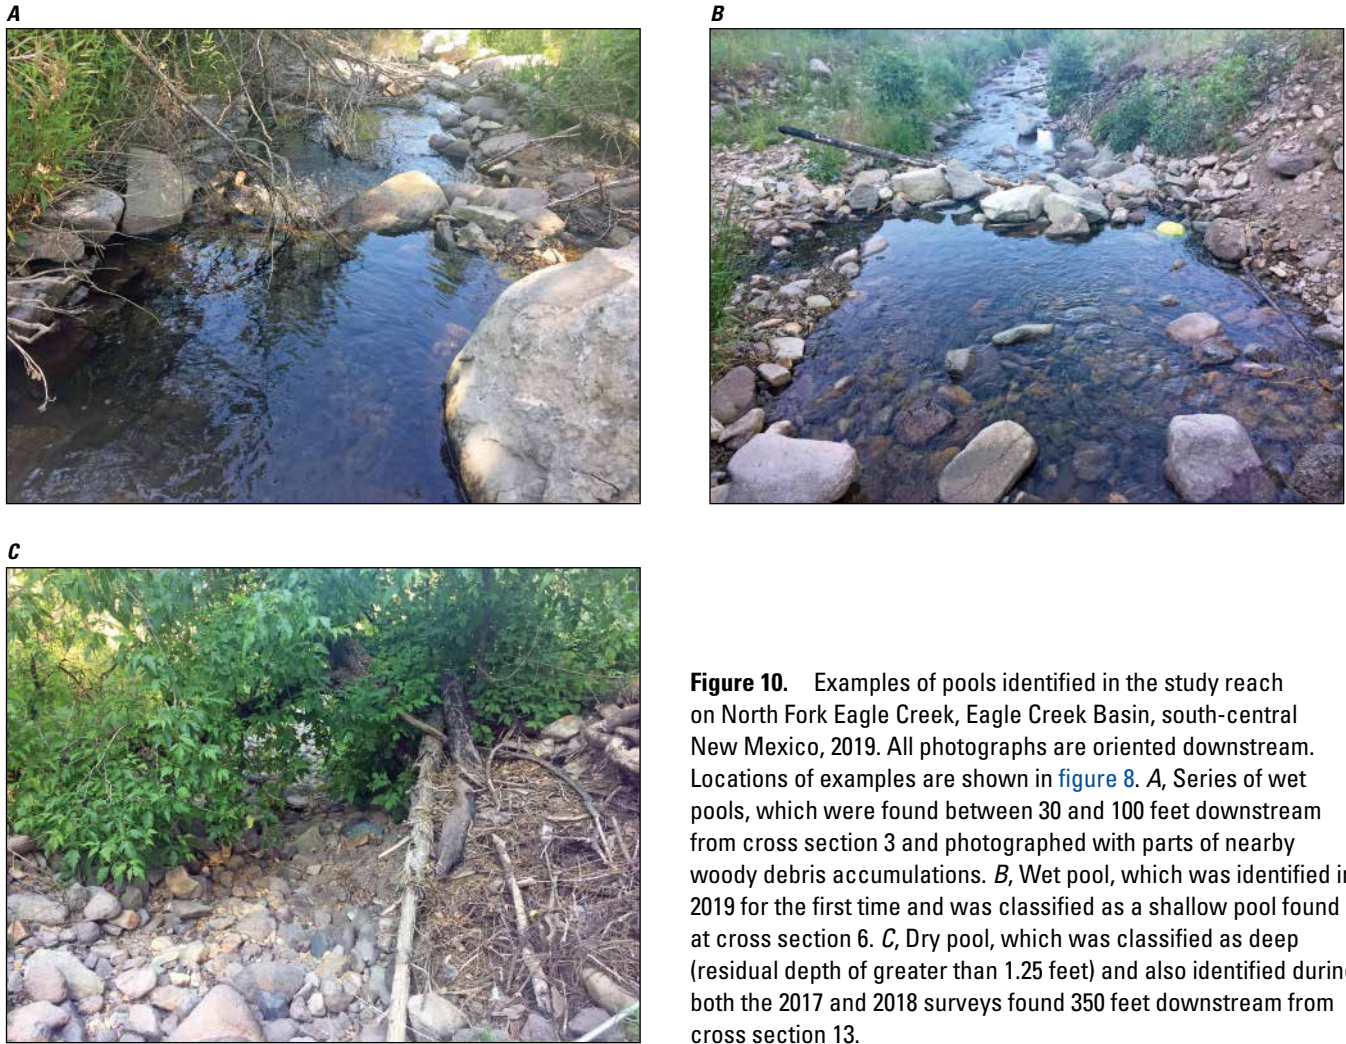
Figure 10. Examples of pools identified in the study reach on North Fork Eagle Creek, Eagle Creek Basin, south-central New Mexico, 2019. All photographs are oriented downstream. Locations of examples are shown in figure 8. *A*, Series of wet pools, which were found between 30 and 100 feet downstream from cross section 3 and photographed with parts of nearby woody debris accumulations. *B*, Wet pool, which was identified in 2019 for the first time and was classified as a shallow pool found at cross section 6. *C*, Dry pool, which was classified as deep (residual depth of greater than 1.25 feet) and also identified during both the 2017 and 2018 surveys found 350 feet downstream from cross section 13.

Example photographs presented in figure 10 depict various characteristics of pools identified in the study reach during the 2019 survey (locations of the examples are shown in fig. 8). Figure 10A depicts two pools classified as intermediate with respect to residual depth (table 5) that were located about 50 ft downstream from cross section 3; these pools were also present during the 2018 survey. Figure 10B (at cross section 6) shows a new pool that was found in 2019 and classified as a shallow pool. Figure 10C depicts a dry pool that was collocated with an active debris jam that may have influenced its

formation. The pool depicted in [figure 10C](#) was found about 350 ft downstream from cross section 13 and classified as a deep pool.
