Monitoring of Wave, Current, and Sediment Dynamics Along the Fog Point Living Shoreline, Glenn Martin National Wildlife Refuge, Maryland

Open-File Report 2024–1004

By Hongqing Wang, Qin Chen, William D. Capurso, Lukasz M. Niemoczynski, Nan Wang, Ling Zhu, Gregg A. Snedden, Matt Whitbeck, Carol A. Wilson, and Michael Brownley

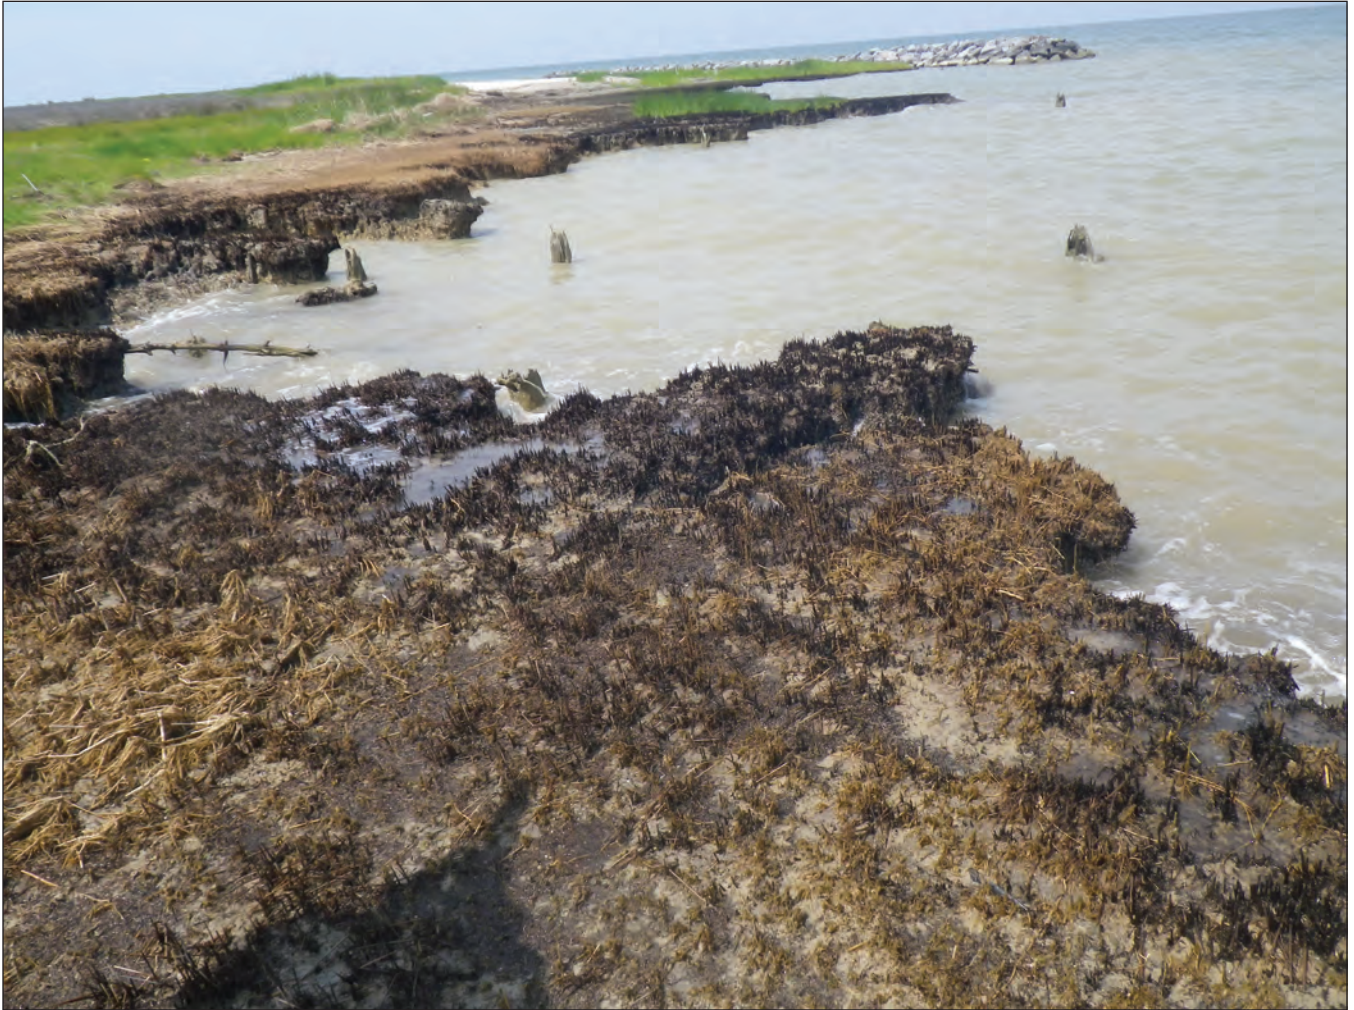
Figure 2. Degraded low marsh at low tide during the site visit on July 11, 2017, in the Fog Point Living Shoreline Restoration Project study area. The breakwater and healthy low marsh *Spartina alterniflora* can be seen in the far background. The four tree stumps in the middle of the photograph are indicative of landward migration of this coastal wetland. Brown and dark colors indicate the death of large areas of low marsh *S. alterniflora* (dead roots) caused by long-term sea level rise and wave action, resulting in the collapse of the low marsh and formation of shoreline scarps in the embayment area. Photograph by Hongqing Wang, U.S. Geological Survey.

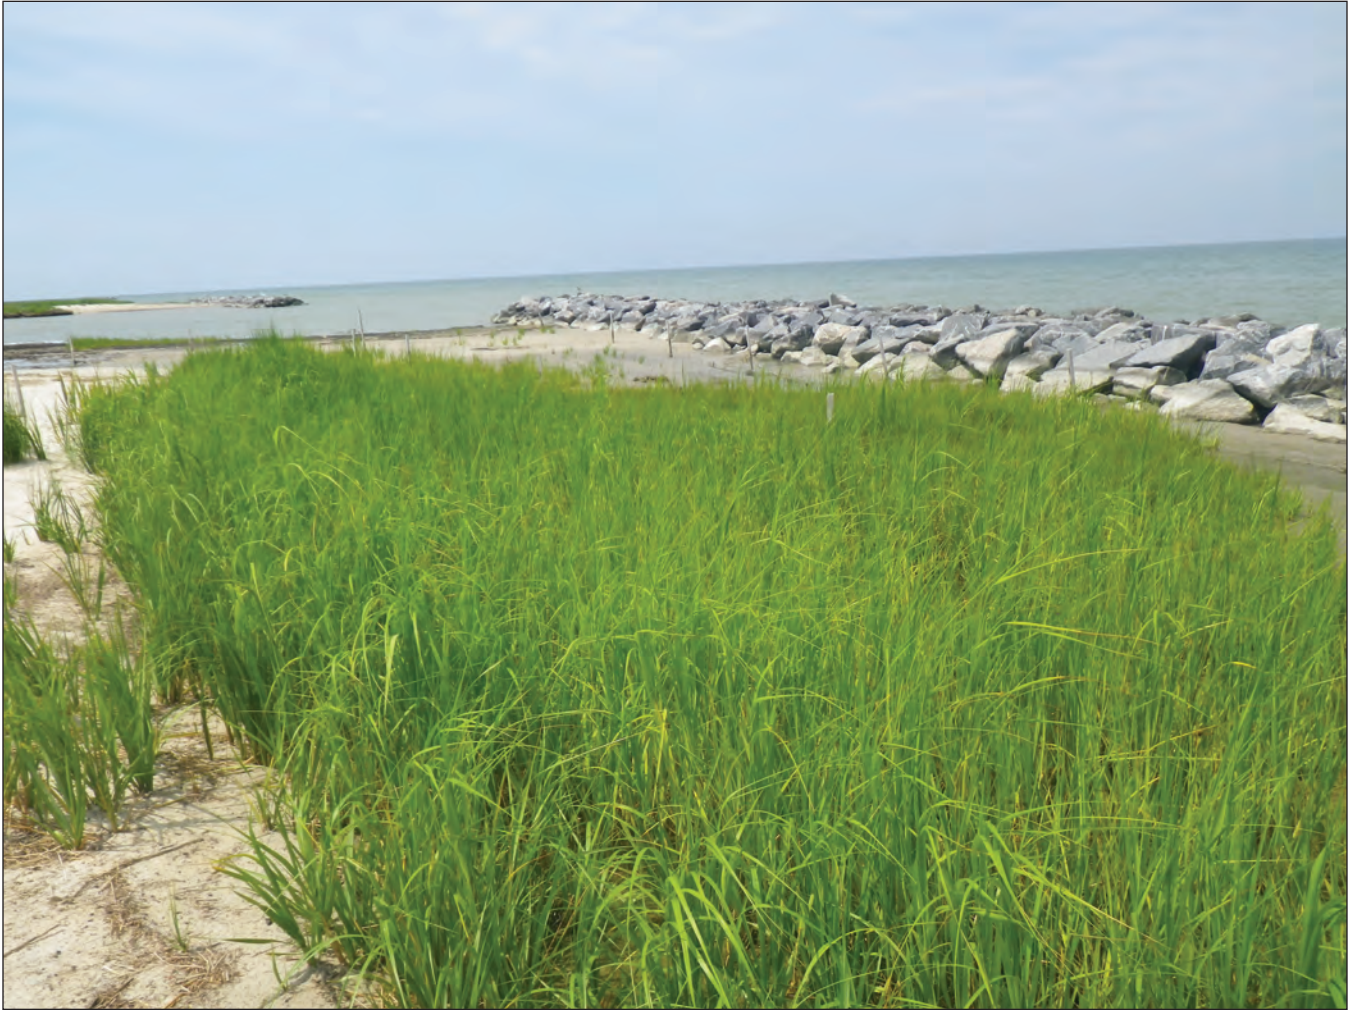
Figure 3. Salt marsh plants (*Spartina alterniflora*) growing behind the breakwater at the Fog Point Living Shoreline Restoration Project study area on July 11, 2017, nearly 1 year after breakwater construction. Photograph by Hongqing Wang, U.S. Geological Survey.

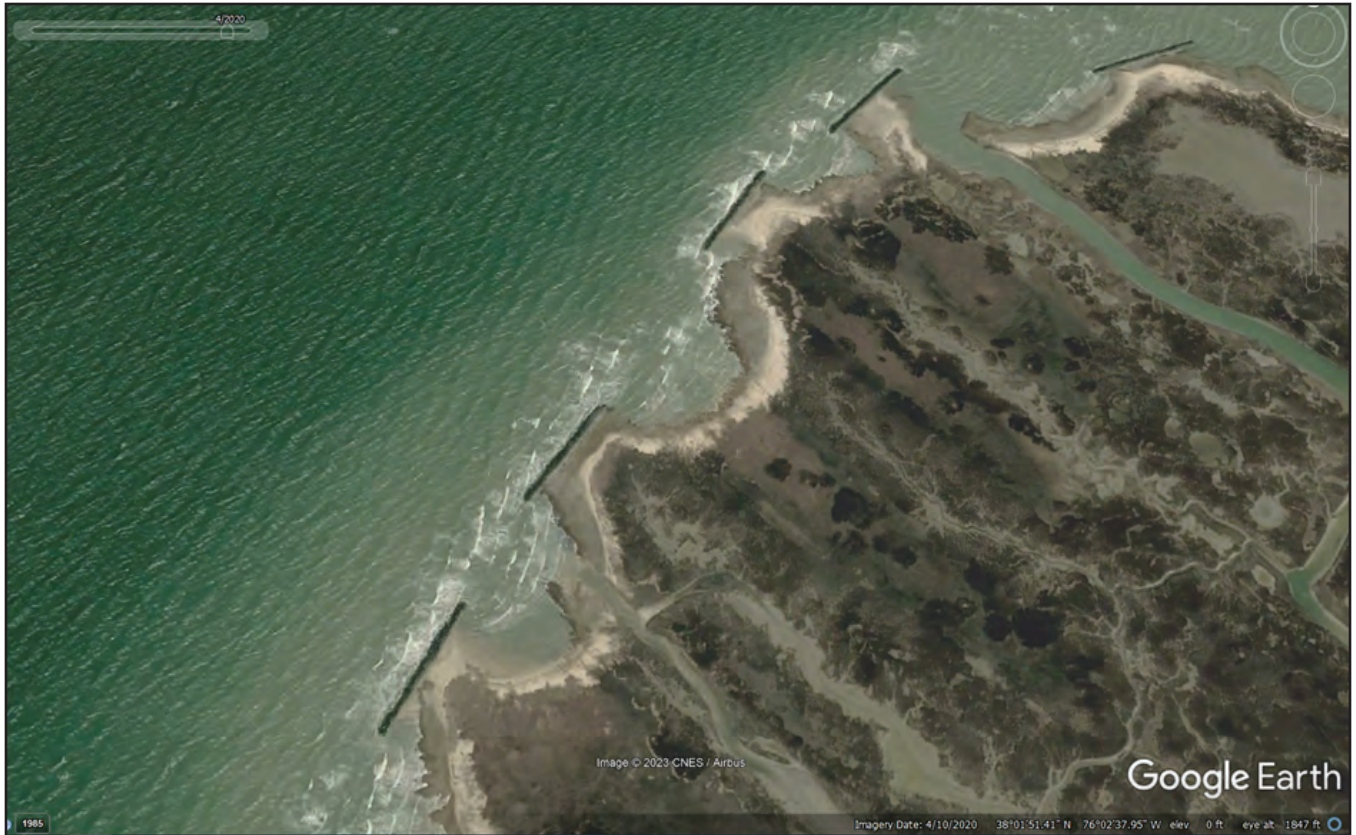
Figure 4. The “headland - breakwater - embayment” pattern in the Fog Point Living Shoreline Restoration Project study area within Glenn Martin National Wildlife Refuge in Maryland’s Chesapeake Bay.

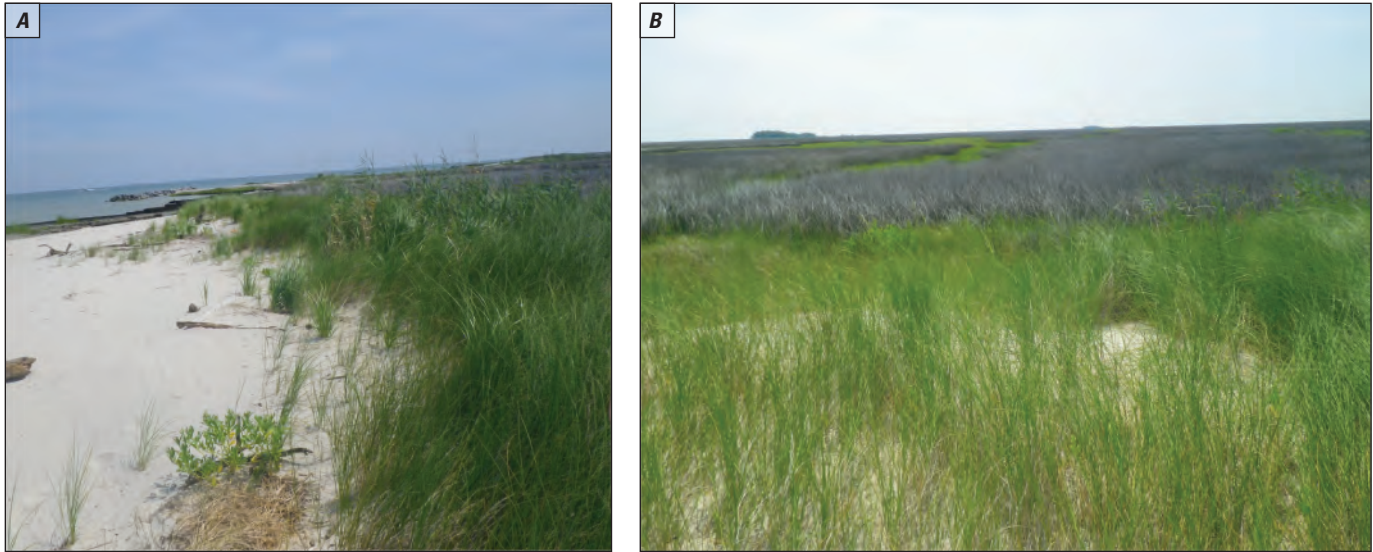
Figure 5. *A*, The sandy berm between low marsh (*Spartina alterniflora*) near the shoreline and high marsh (*S. patens* and *Distichlis spicata*) and *B*, the high marsh inside the sandy berm (sand dunes) and landward interior of the marsh area in the Fog Point Living Shoreline Project study area, July 2017. In photograph *B*, *S. patens* are green, and *Juncus roemerianus* are gray; an area of upland forest can be seen on the left side in the background within the Glenn Martin National Wildlife Refuge. Photographs by Hongqing Wang, U.S. Geological Survey.

The area and shape of the sandy berm were dictated by mean high tide, storm surge high water levels, and aggressive waves (Hardaway and Byrne, 1999) when debris of plants were brought to the upper berm line (fig. 5). The Fog Point Living Shoreline Restoration Project construction was completed in fall 2016.

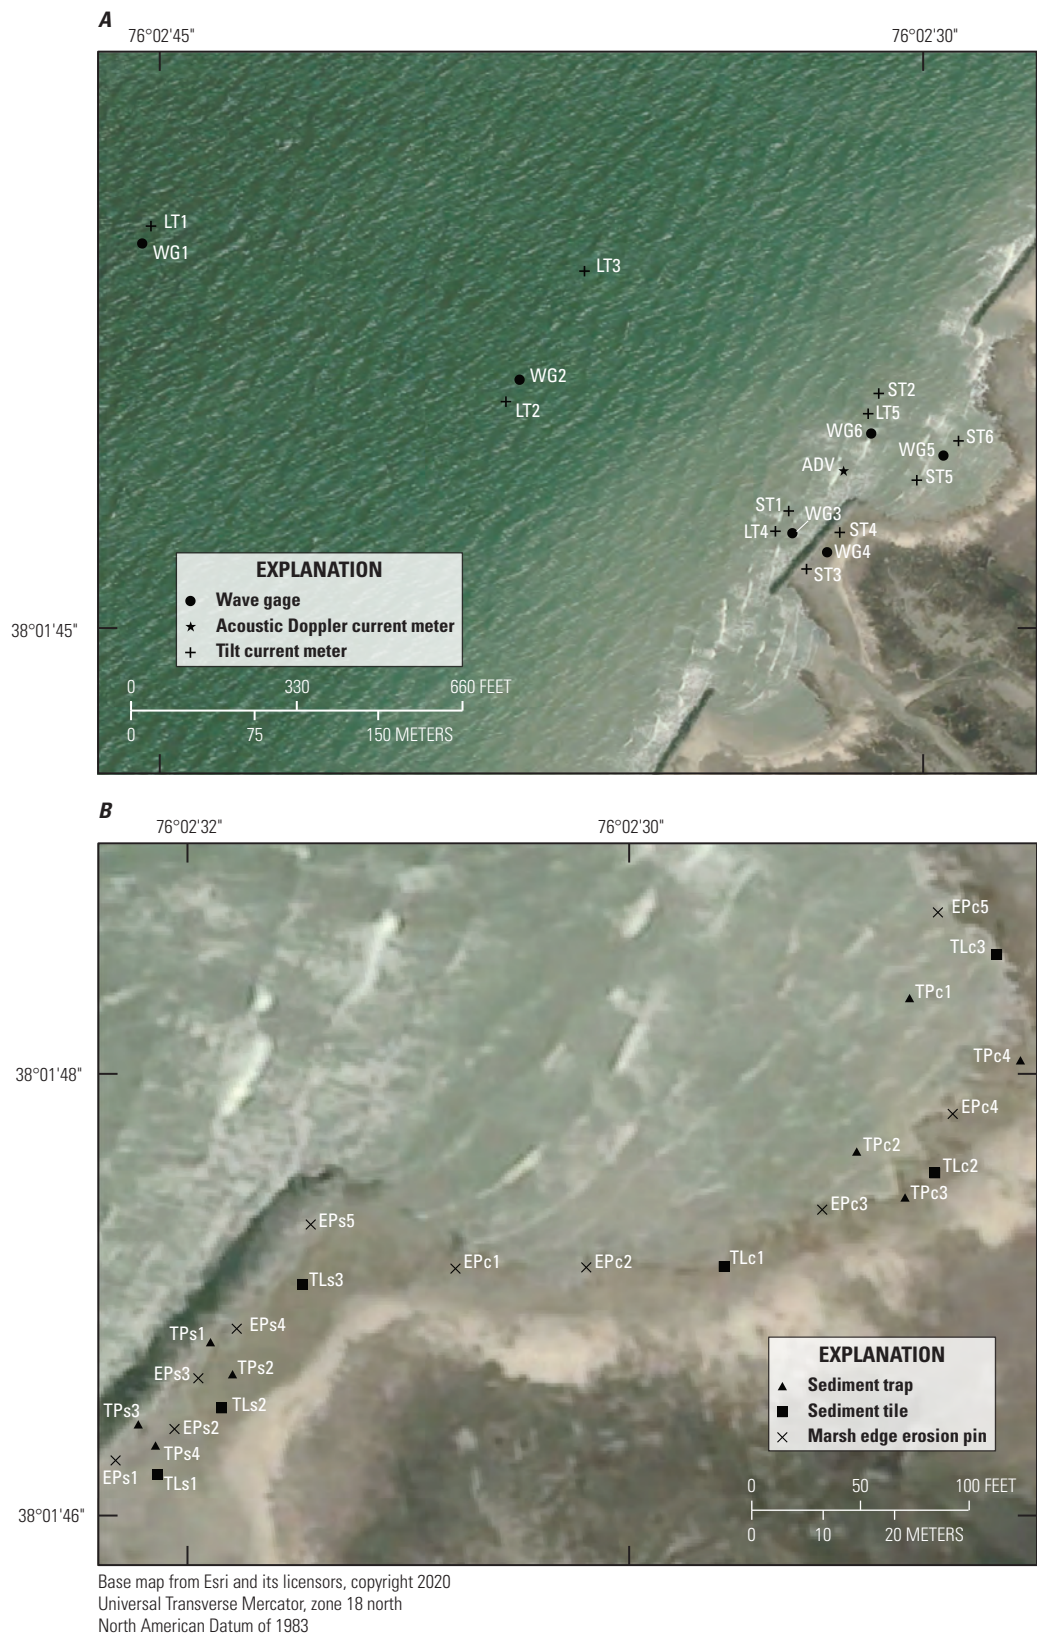
Figure 6. Locations of *A*, wave gages, tilt current meters, and an acoustic Doppler current meter and *B*, sediment tiles, sediment traps, and marsh edge erosion pins in the Fog Point Living Shoreline Project study area in the Glenn Martin National Wildlife Refuge, Maryland.

To measure sediment accumulation, six sites were selected in the study area: three behind the breakwater and three in the embayment (fig. 6B). At each site, three replicates of ceramic tiles (15.24 centimeters [cm] x 15.24 cm) were placed. Additionally, eight sediment pin/trap sets were installed, with four located behind the breakwater and four in the embayment (fig. 6B). To quantify lateral marsh erosion, 10 marsh edge erosion pins (1.25-inch PVC pipes) were placed vertically behind the shoreline along the study area to measure any horizontal movement of the marsh edge during the monitoring period. Among these pins, five were placed behind the breakwater and five along the embayment (fig. 6B). Examples of equipment installation are shown in figure 7.

During August 2021, sediment tiles behind the breakwater were retrieved, but sediment tiles in the embayment area were lost. Of the eight sediment traps, only the four behind the breakwater and one in the embayment (TPc2 on [fig. 6B](#)) were found. The vertical movement of the traps was measured onsite, and water and sediment inside the traps were transferred to 500-milliliter (mL) bottles and shipped to Louisiana State University for laboratory analysis of sediment mass and grain size distribution. The erosion pins along the marsh edge in the embayment area were all lost, but all erosion pins protected by the breakwater survived; the distances from marsh edge to the pins were measured to determine marsh horizontal accretion or deposition at these pin locations from deployment (February 12, 2020) to retrieval (August 25, 2021).

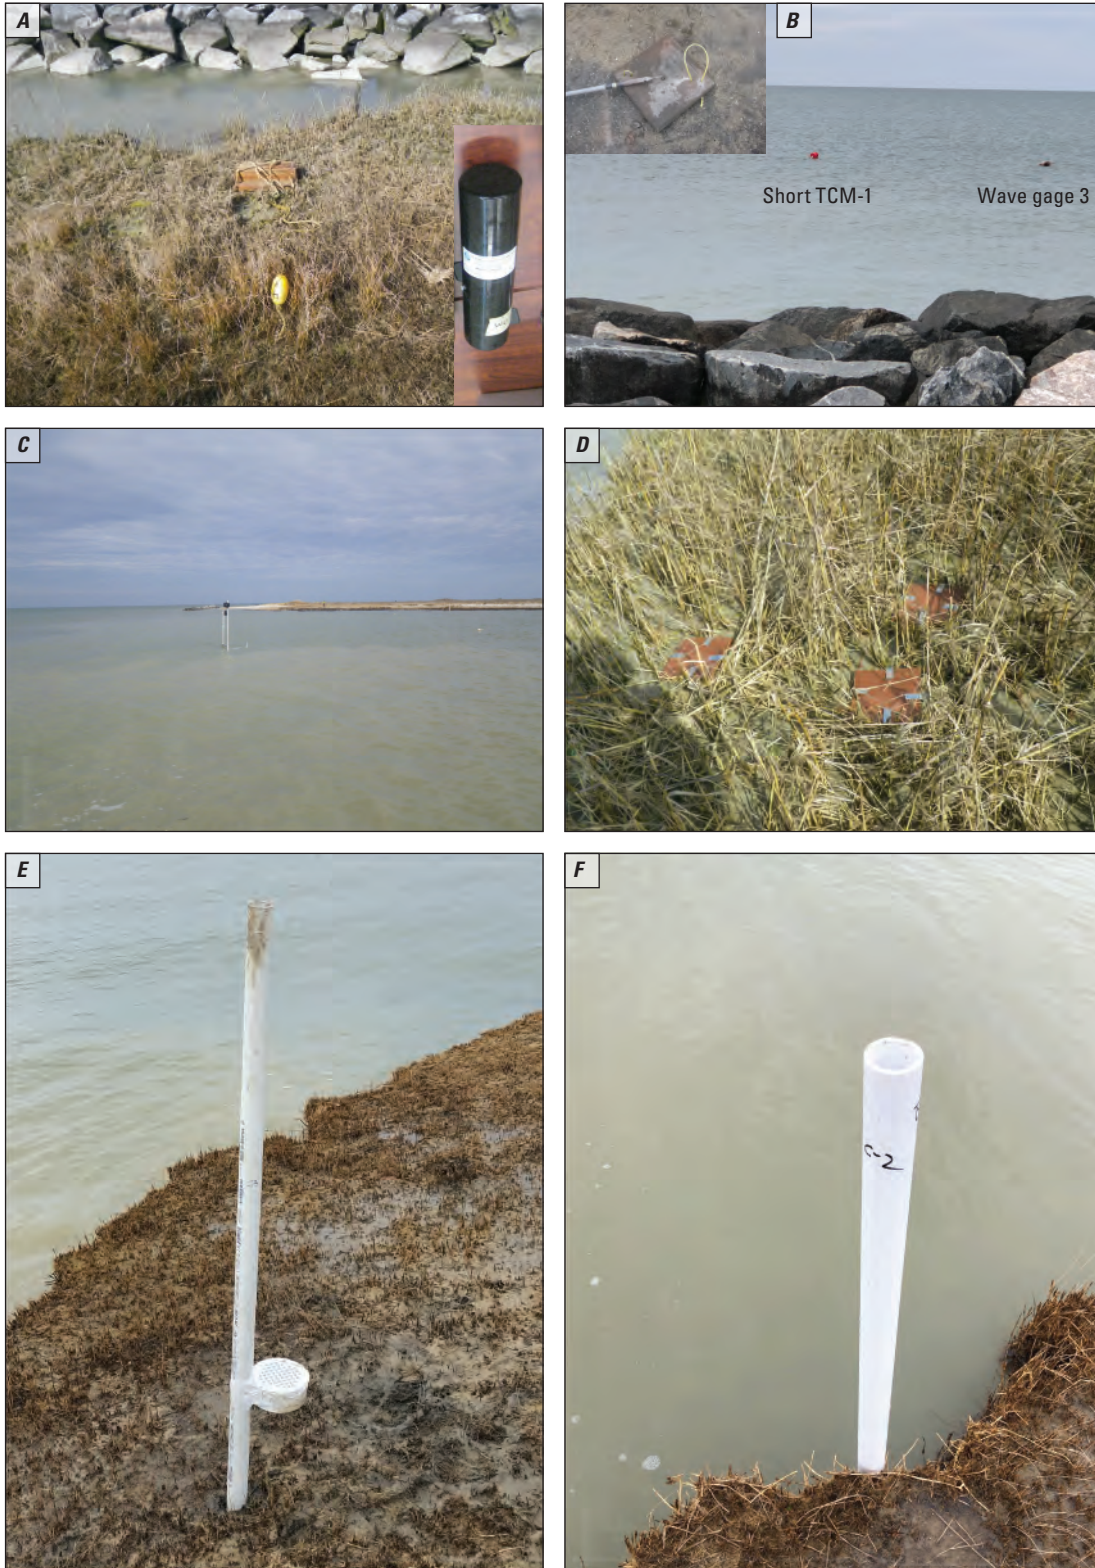
Figure 7. Examples of field deployment of *A*, wave gages, *B*, tilt current meters, *C*, an acoustic Doppler current meter with two GoPro cameras on top of the tripod, *D*, sediment tiles, *E*, sediment traps, and *F*, marsh edge erosion pins along the Fog Point living shoreline in the Glenn Martin National Wildlife Refuge, February 2020. Photographs by Hongqing Wang, U.S. Geological Survey, and Qin Chen, Northeastern University.

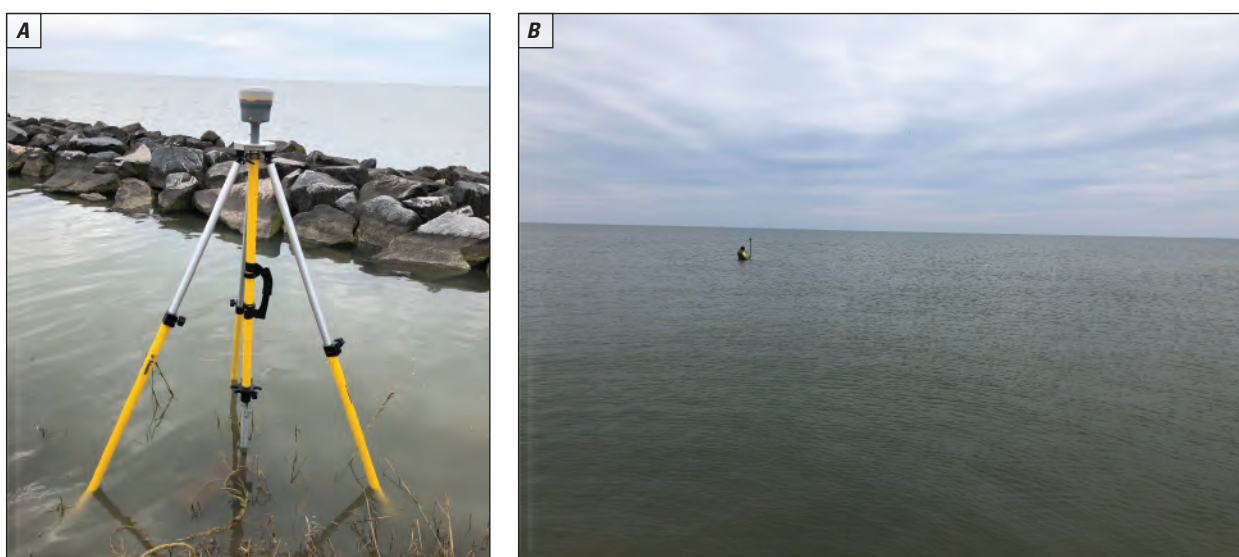
Figure 8. A Global Positioning System being used to measure *A*, the elevation of the wave gage (WG4) behind the breakwater and *B*, wave gages (WG5, WG6) in the embayment (and nearby tilt current meters) in the Fog Point Living Shoreline Project study area, February 2020. Photographs by Hongqing Wang, U.S. Geological Survey.

The coordinates and elevations of WGs, TCMs, ADV, sediment trap/pin sets, sediment tiles, and marsh erosion pins were measured by using a survey-grade Global Positioning System during the deployment (fig. 8). An elevation survey was conducted by using a static Global Navigation Satellite System with a horizontal accuracy of ± 0.015 m (0.05 ft) and a vertical accuracy of ± 0.03 m (0.10 ft).

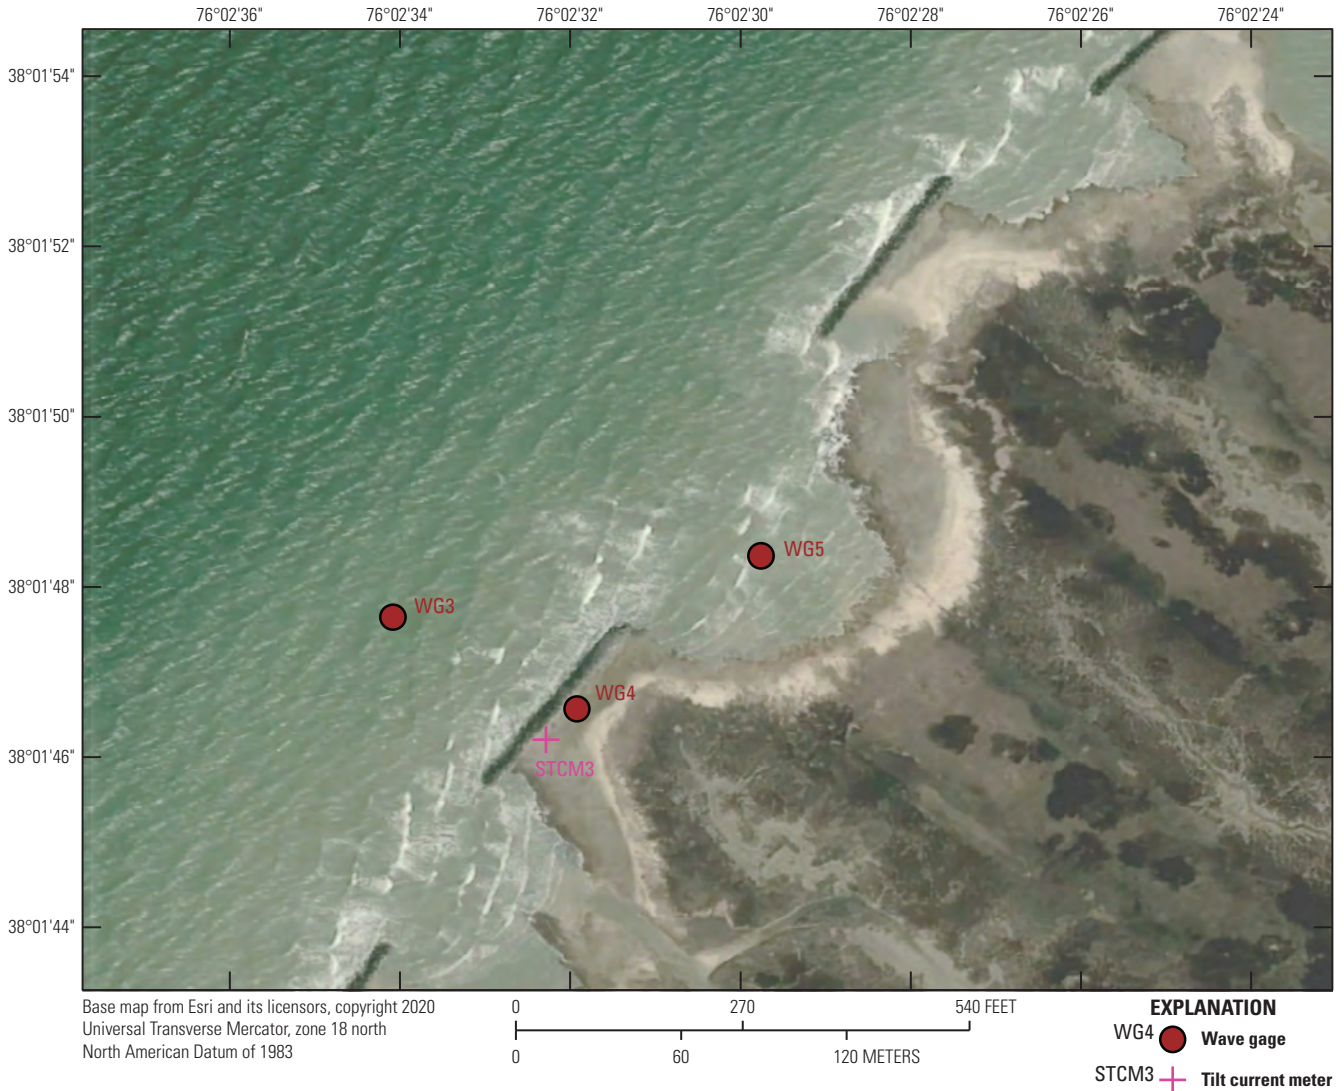
Figure 9. Locations of the retrieved three wave gages and one tilt current meter along the Fog Point living shoreline in the Glenn Martin National Wildlife Refuge, Maryland, 2020.

A site visit to retrieve instruments and conduct additional measurements was originally scheduled for May 2020. However, travel was restricted owing to the COVID-19 pandemic. Local fishermen were asked to help with the sensor retrievals. Only two wave gages were retrieved in the summer of 2020. During August 2021, the remaining sensors were retrieved, and onsite measurements were made. On August 25, 2021, other WGs and current meters, including the ADV, were retrieved, and onsite measurements were made. One additional WG and one TCM were found and retrieved, but other WGs and current meters were lost. The ADV was completely damaged by storms and other disturbances over this 18-month period in the water. The locations where the WGs and the current meter were retrieved are shown in [figure 9](#).

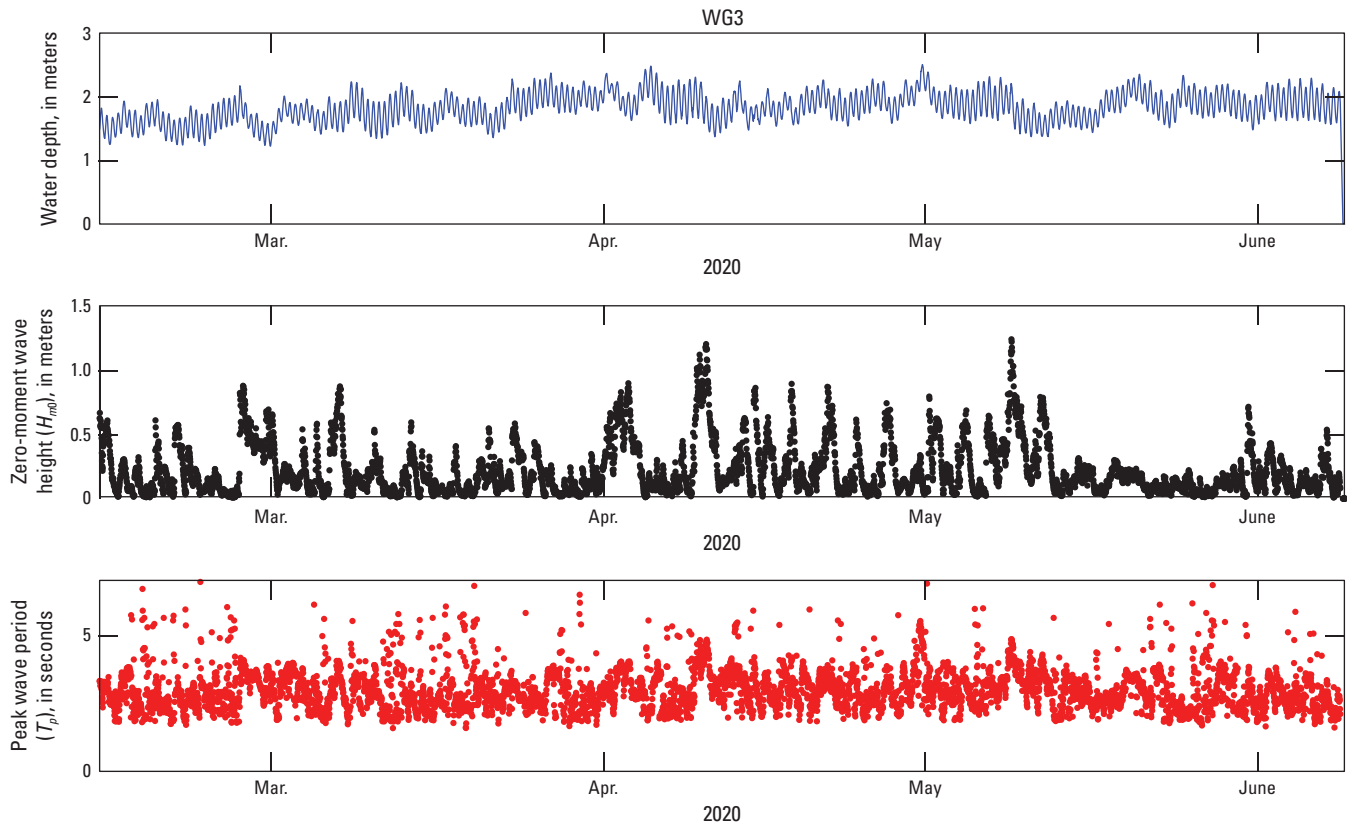
Figure 10. Time series of measured water depth, zero-moment wave height (H_{m0}), and peak wave period (T_p) at wave gage WG3, February–June 2020, Fog Point Living Shoreline Project study area in the Glenn Martin National Wildlife Refuge, Maryland.

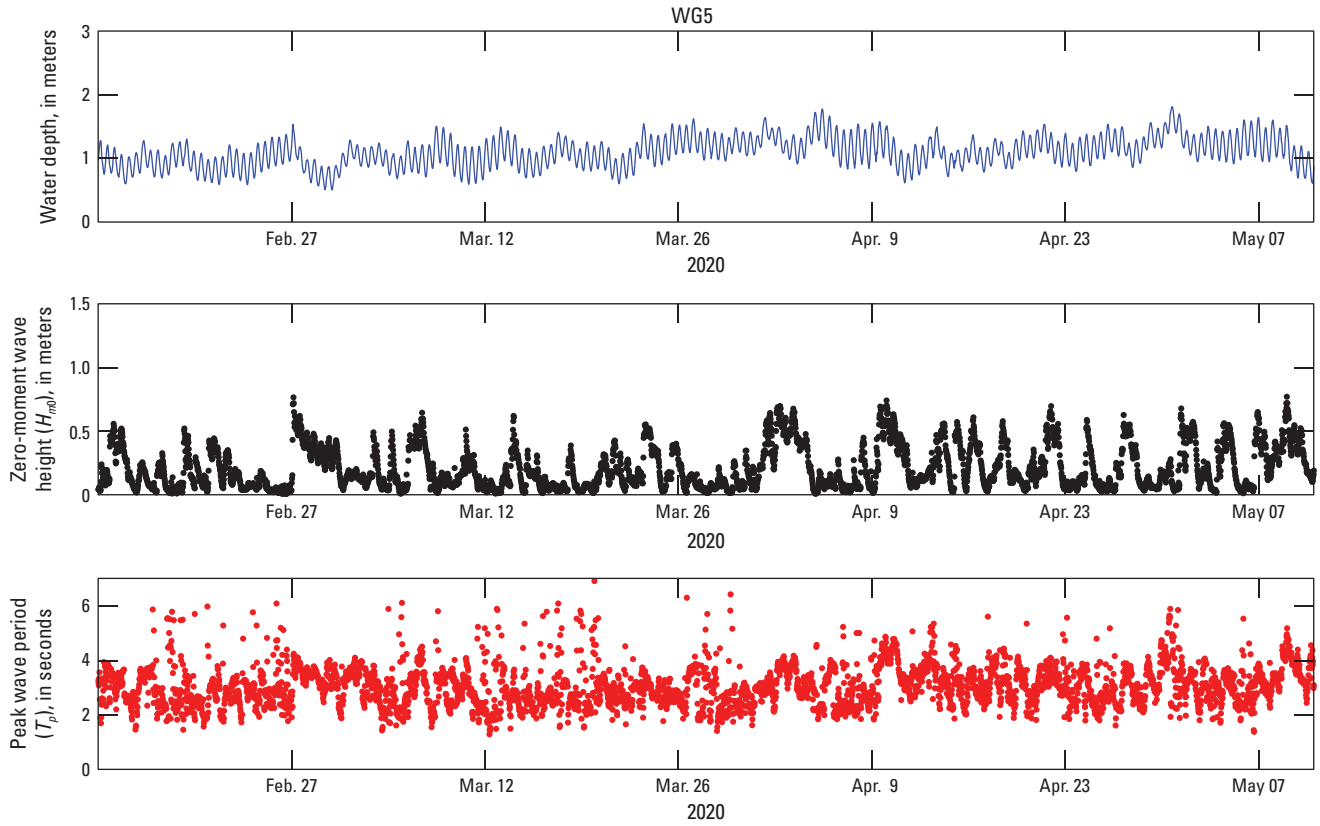
Figure 12. Time series of measured water depth, zero-moment wave height (H_{m0}), and peak wave period (T_p) at wave gage WG5, February–June 2020, Fog Point Living Shoreline Project study area in the Glenn Martin National Wildlife Refuge, Maryland. The data were removed after May 11, 2020, because the data were inaccurate.

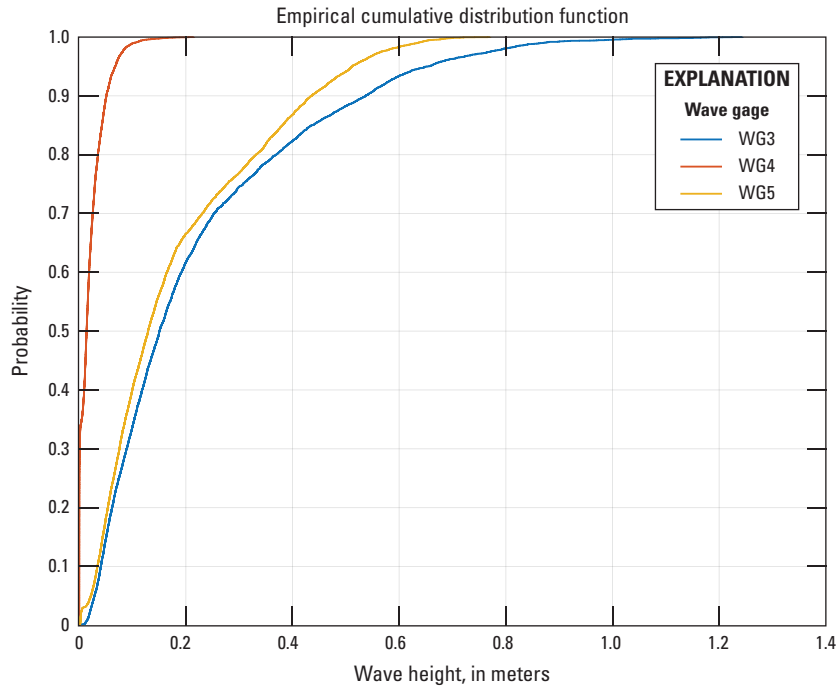
Figure 13. Cumulative distribution of wave height at three wave gages in the Fog Point Living Shoreline Project study area in the Glenn Martin National Wildlife Refuge, Maryland.

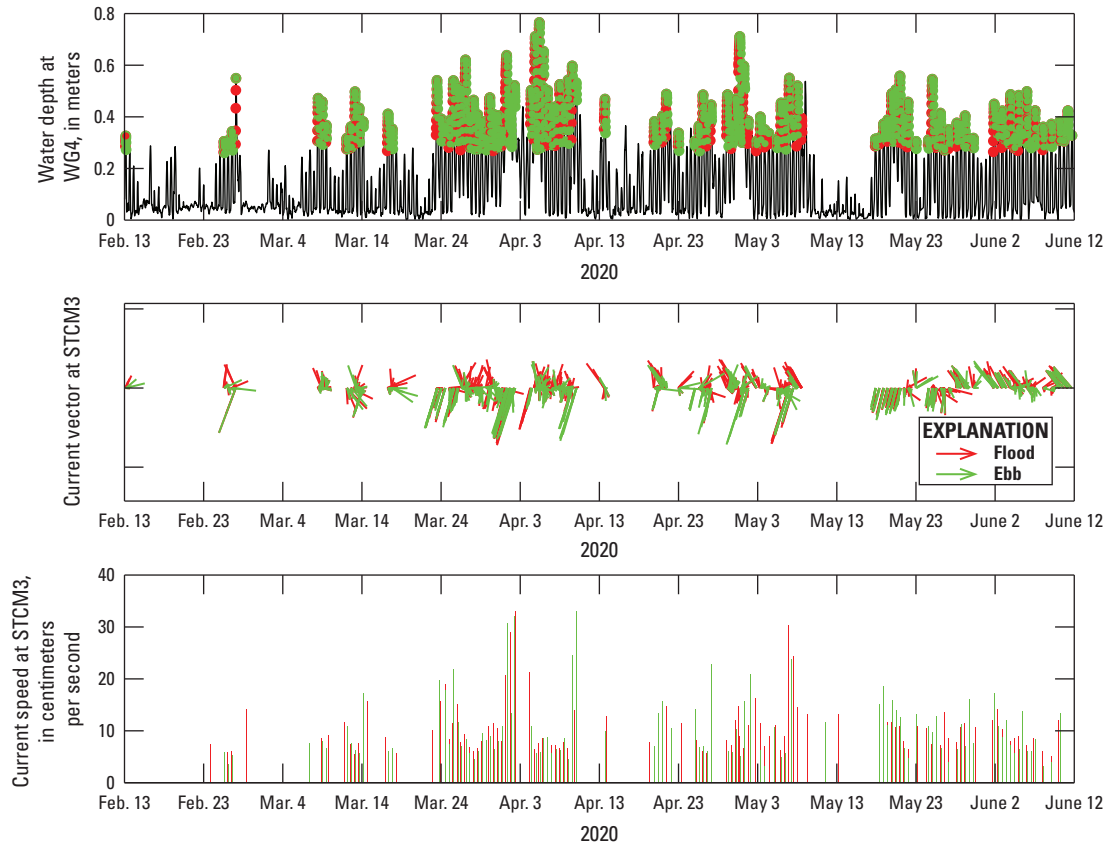
Figure 15. Time series of water depth measured at WG4 and current vectors and current speed measured at STCM3, February–June 2020, Fog Point Living Shoreline Project study area in the Glenn Martin National Wildlife Refuge, Maryland. The current speed was calculated by averaging the measured speed over the duration of flood or ebb tides. The length of the current vector shows the current speed (legend arrows = 10 centimeters per second).

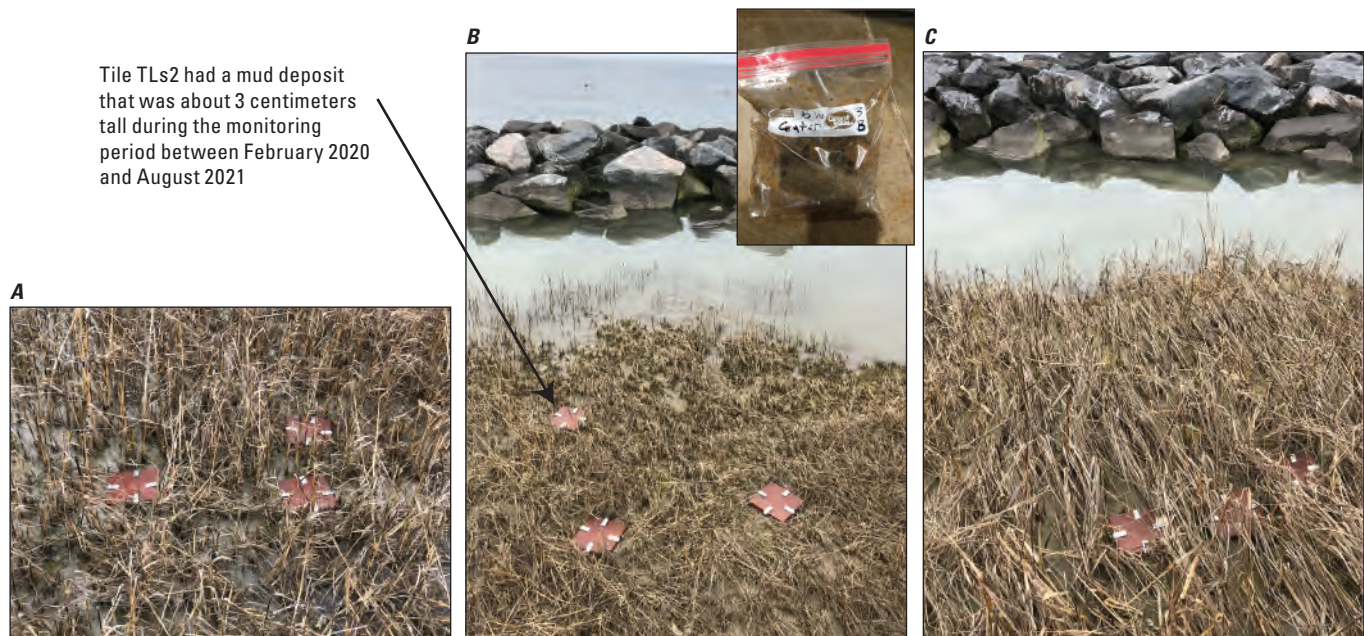
Sediment tiles S1, S2, and S3 behind the breakwater

Tile TLs2 had a mud deposit that was about 3 centimeters tall during the monitoring period between February 2020 and August 2021

Figure 16. Sediment tiles deployed behind the breakwater with collected mud in the plastic bag in the middle photo, February 2020, Fog Point Living Shoreline Project study area in the Glenn Martin National Wildlife Refuge, Maryland. Photographs by Qin Chen, Northeastern University.

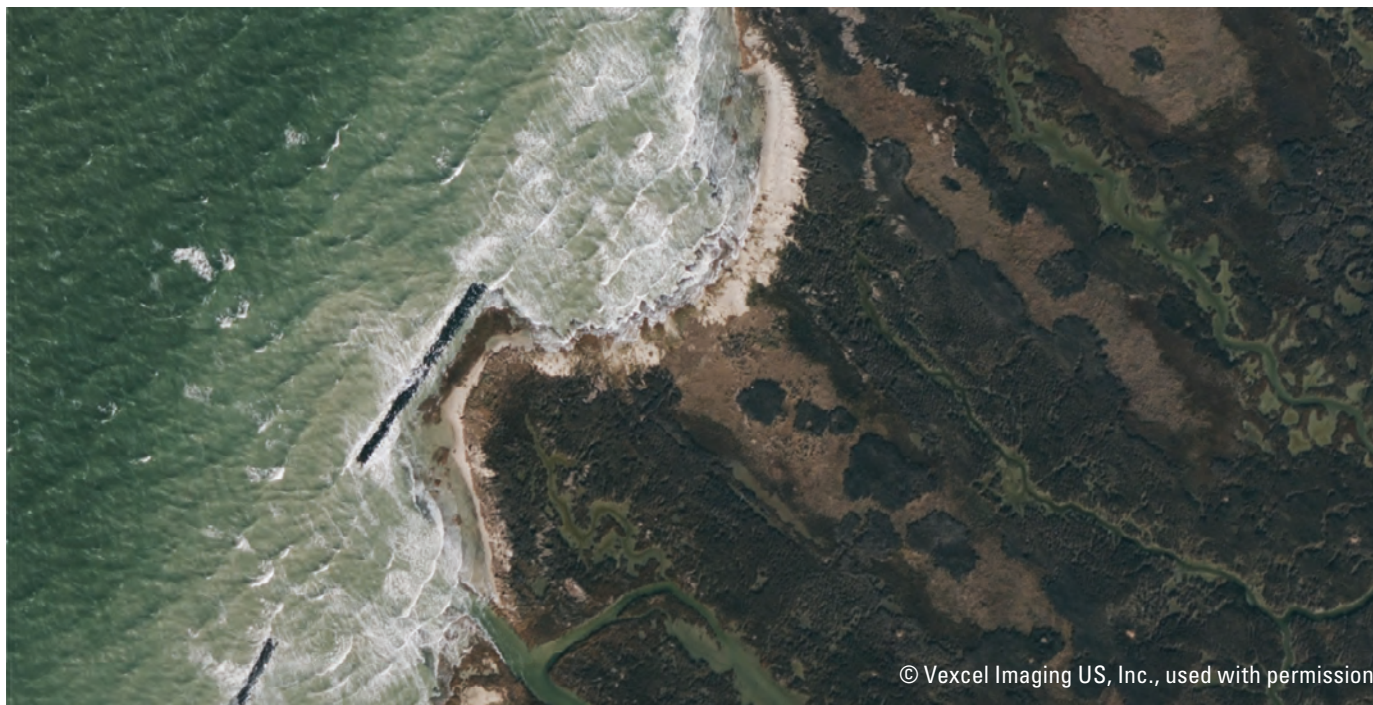
Figure 17. Wave overtopping at the breakwaters during November 23, 2020, storm surge (wave height was greater than 0.9 meter). Fringing low marsh *Spartina alterniflora* behind the structures was protected from wave impact. A low marsh zone in the embayment (gaps between segmented breakwaters) was inundated, however, and waves reached the sand berm line and high marsh (*S. patens*) zone. Image courtesy of Vexcel Imaging, used with permission.

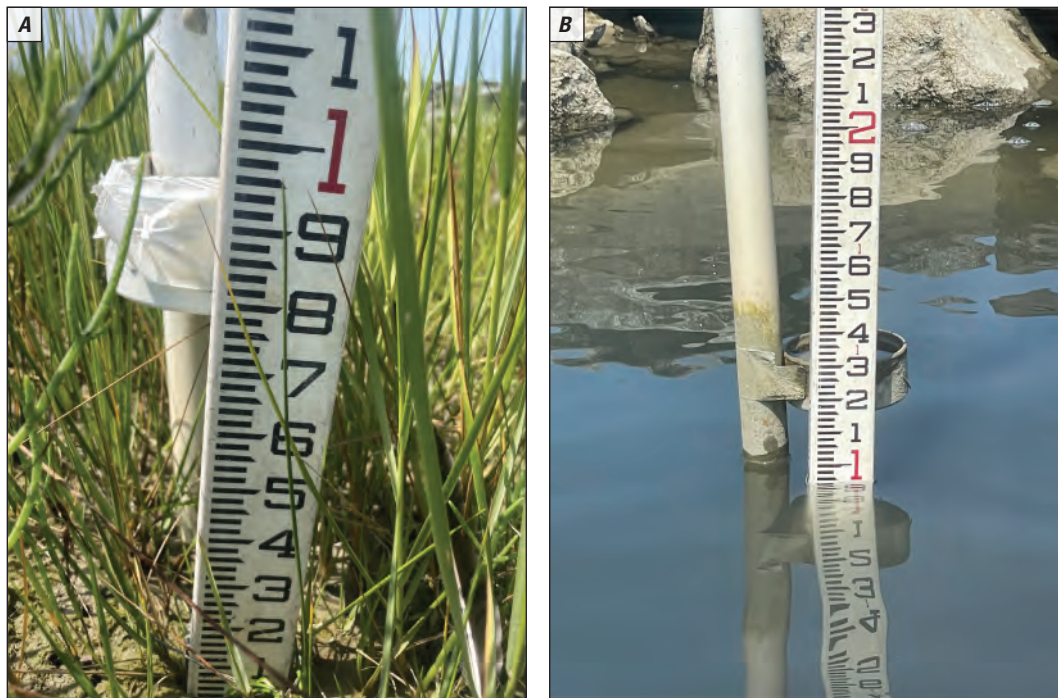
Figure 18. Vertical accretion or deposition measured with the sediment traps behind the breakwater at A, TPs4 (a high elevation location) and B, TPs3 (a low elevation location), August 2021, in the Fog Point Living Shoreline Restoration Project study area in the Glenn Martin National Wildlife Refuge, Maryland. Photographs by William D. Capurso, U.S. Geological Survey.

Sediment trap (fig. 6B)	Height from bottom at deployment (cm)	Height from bottom at retrieval (cm)	Height change (cm)
TPs1	30.48	33.04	2.56
TPs2	30.48	28.16	-2.32
TPs3	30.48	40.05	9.57
TPs4	30.48	28.77	-1.71
TPc2 (control)	30.48	59.25	28.77

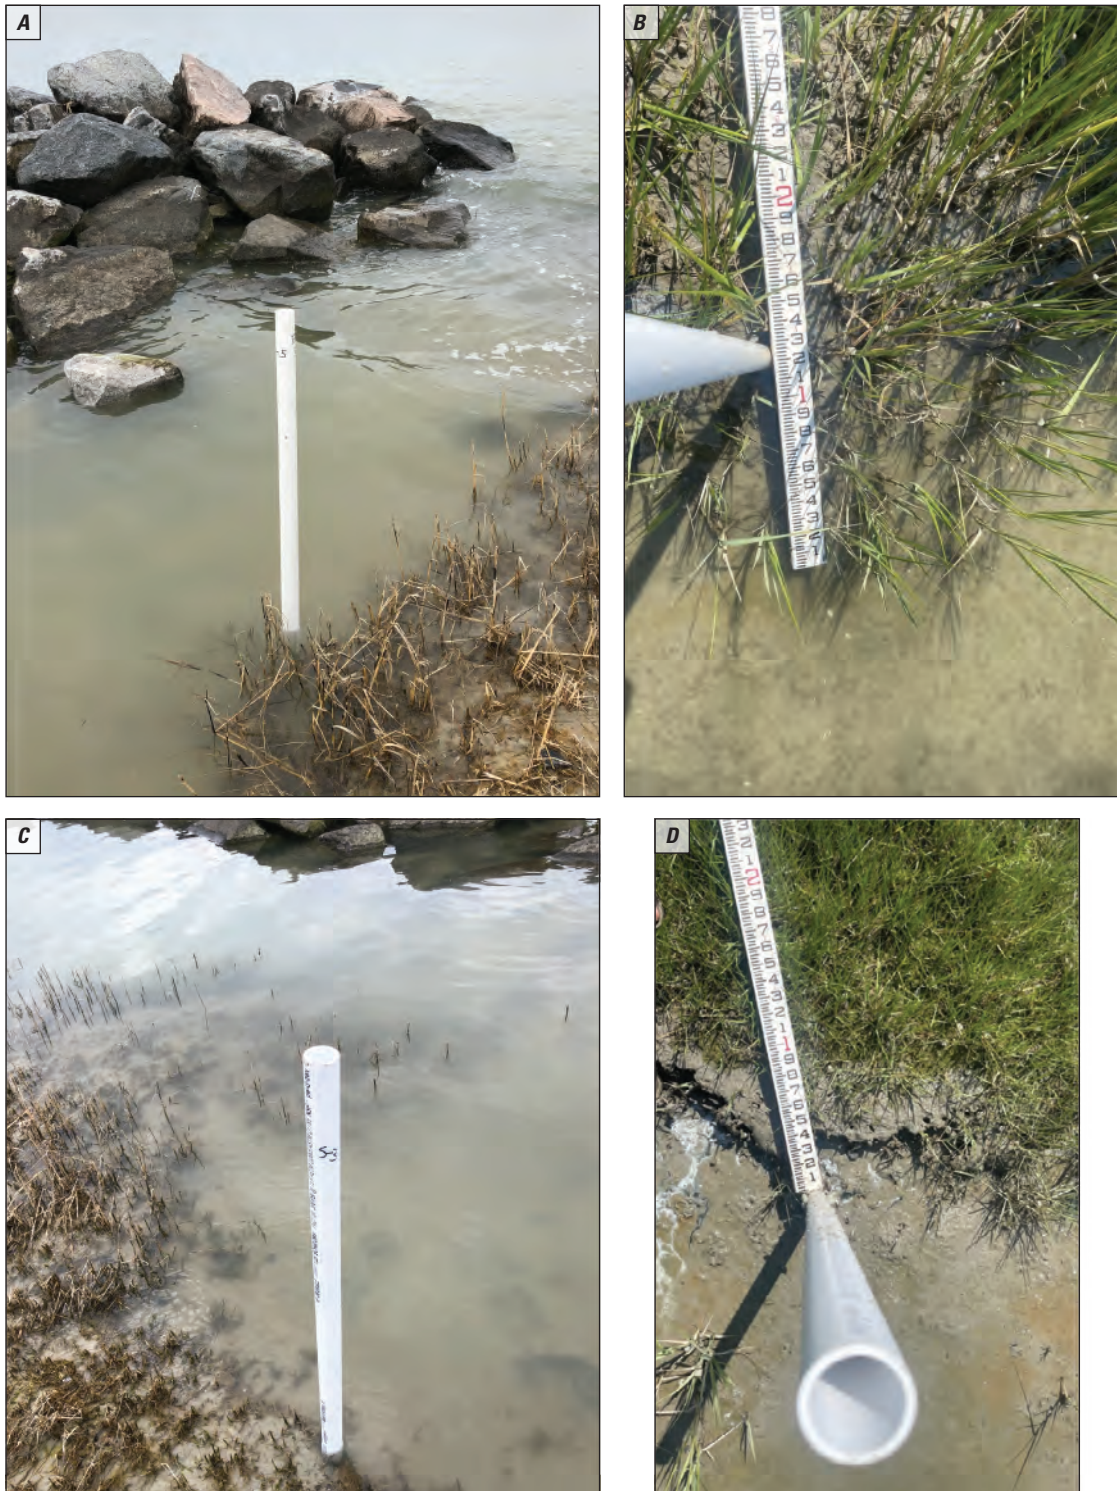
Figure 19. *A and B*, Lateral marsh accretion at Eps5 behind the breakwater during deployment in February 2020 and *C and D*, erosion at Eps3 behind the breakwater during retrieval in August 2021 at the Fog Point Living Shoreline Restoration Project site in the Glenn Martin National Wildlife Refuge, Maryland. Photograph *A* by Qin Chen, Northeastern University. Photographs *B* and *D* by William D. Capurso, U.S. Geological Survey. Photograph *C* by Hongqing Wang, U.S. Geological Survey.

Lateral edge erosion measurements were also made during retrieval by using the erosion pins as shown in figure 19. Marsh edge lateral accretion and erosion were observed at locations behind the breakwater during the monitoring period from February 2020 to August 2021. At EPs1 and EPs3 (fig. 6B), lateral erosion was measured as 7.42 cm, accretions ranged from 14.09 to 39.85 cm at EPs2, EPs4, and EPs5 (table 3).

Marsh edge erosion pin (fig. 6B)	Pin distance to marsh edge at deployment (cm)	Pin distance to marsh edge at retrieval (cm)	Final distance change (cm)
EPs1	0.20	7.62	7.42
EPs2	2.20	-11.89	-14.09
EPs3	0.20	7.62	7.42
EPs4	1.40	-24.99	-26.39
EPs5	4.80	-35.05	-39.85

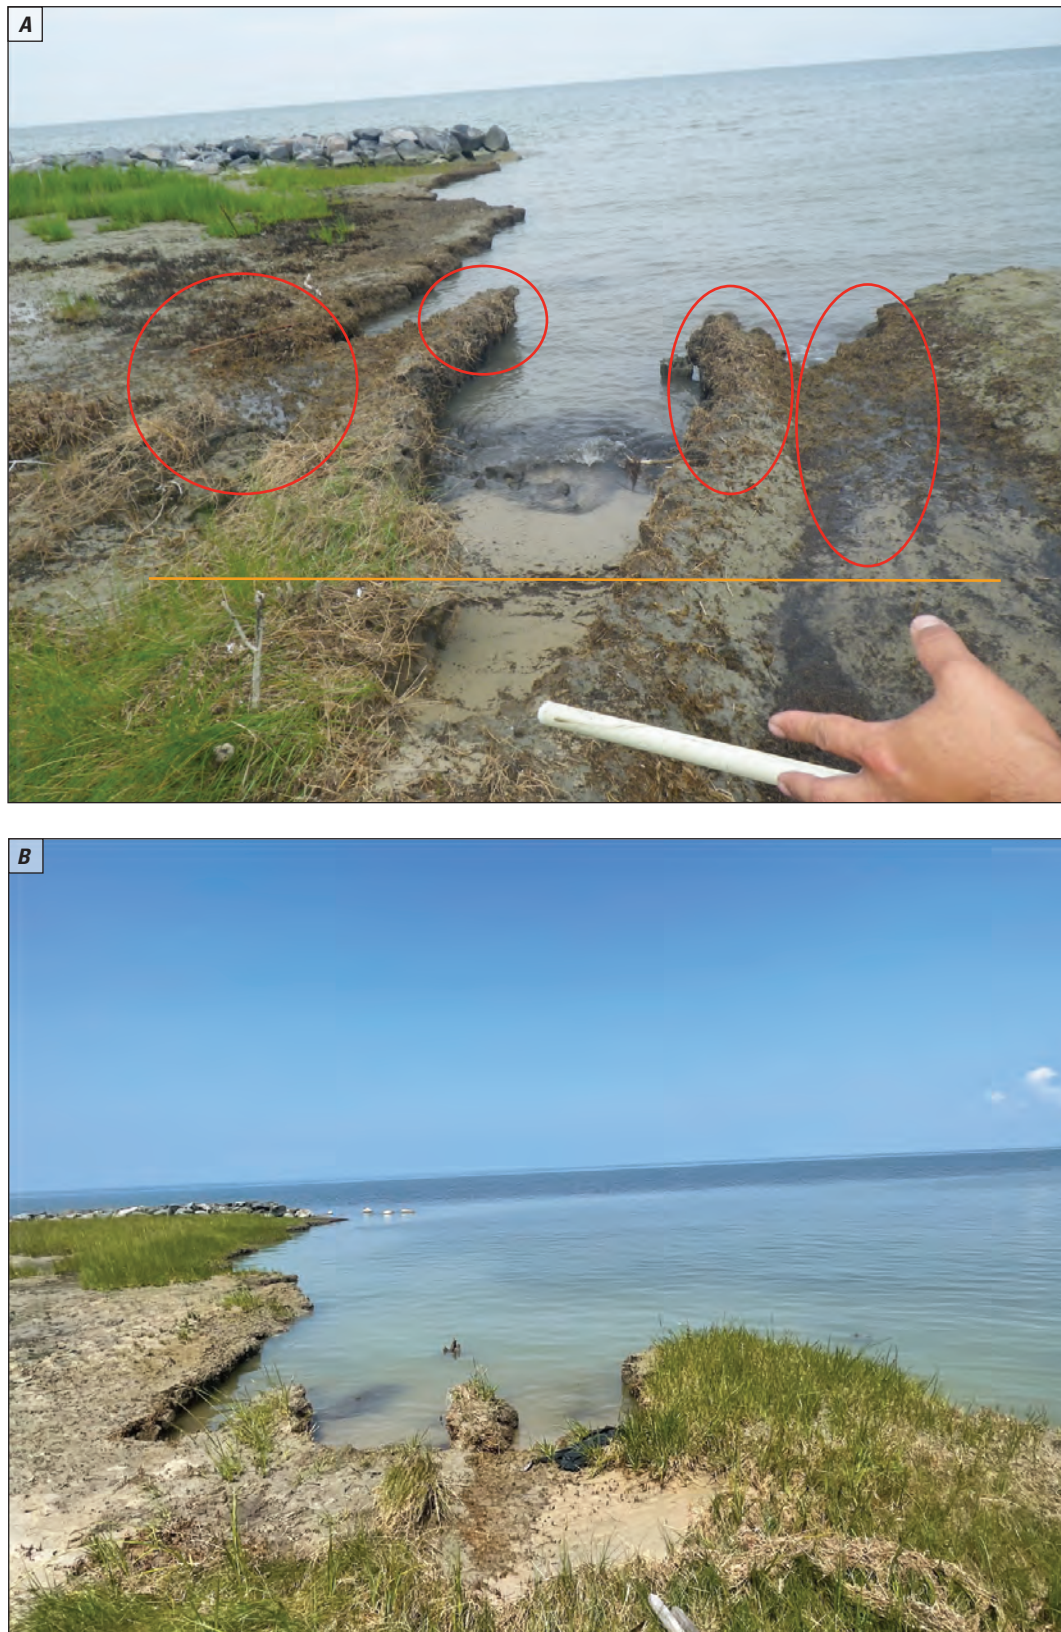
Figure 20. Increased marsh edge erosion in the embayment area along the Fog Point Living Shoreline Restoration Project area, *A*, on July 11, 2017, during a field visit and *B*, on August 25, 2021, during sensor retrieval. The low marshes in the red circles in photograph *A* were eroded by the time photograph *B* was taken. The orange line indicates the deepest new marsh cutting. Photograph *A* by Hongqing Wang, U.S. Geological Survey. Photograph *B* by William D. Capurso, U.S. Geological Survey.
