Monitoring of Wave, Current, and Sediment Dynamics Along the Fog Point Living Shoreline, Glenn Martin National Wildlife Refuge, Maryland

Open-File Report 2024–1004

By Hongqing Wang, Qin Chen, William D. Capurso, Lukasz M. Niemoczynski, Nan Wang, Ling Zhu, Gregg A. Snedden, Matt Whitbeck, Carol A. Wilson, and Michael Brownley

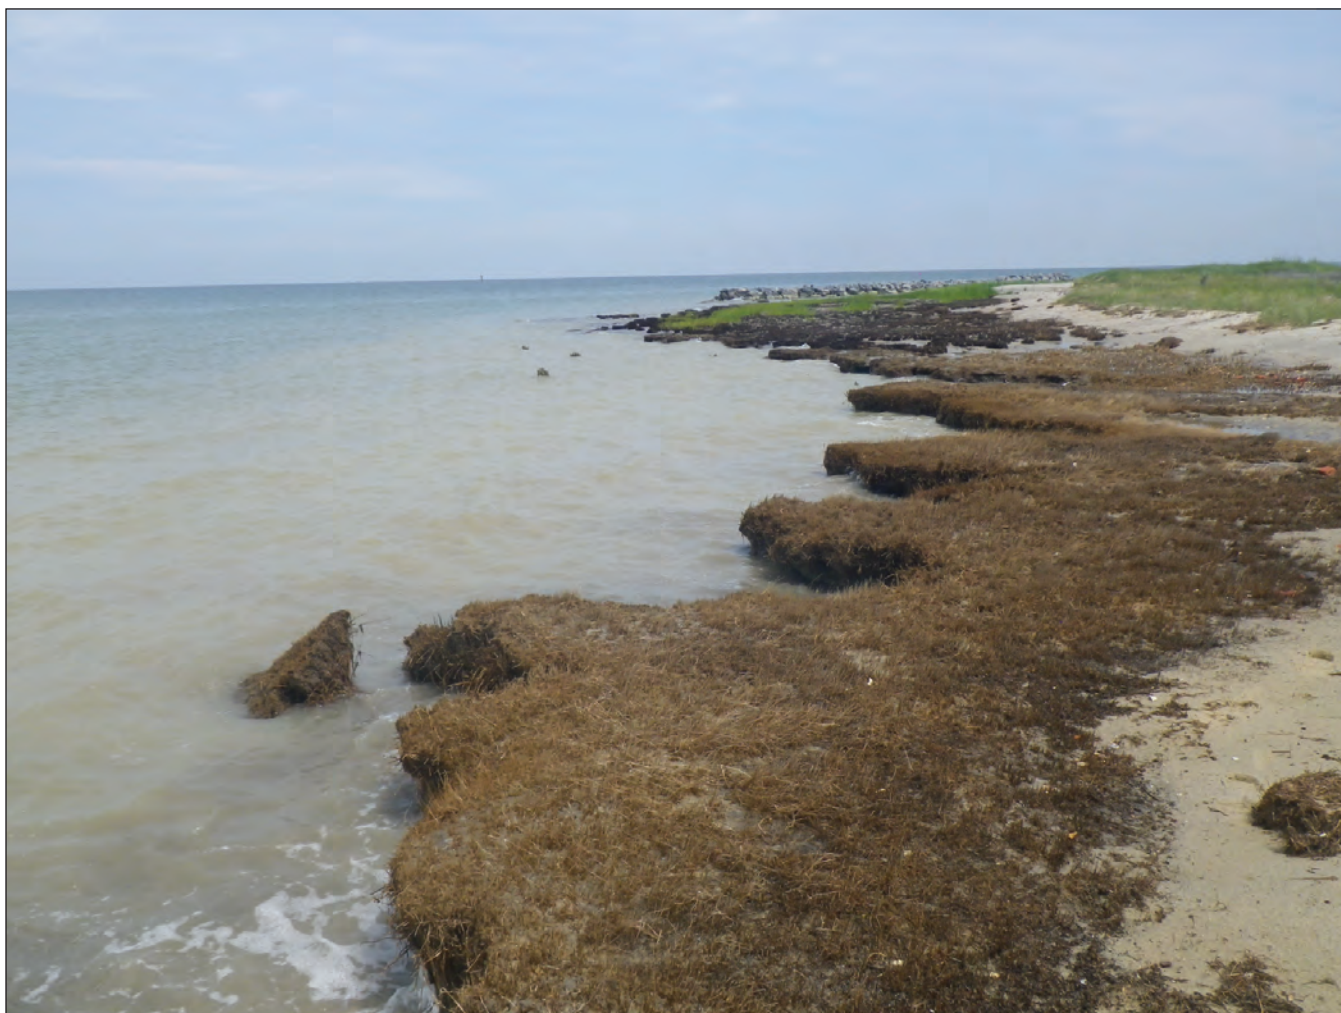
Figure 21. Wave-cut gullies along the low marsh edge in the embayment area of the Fog Point Living Shoreline Restoration Project site, July 2017. Photograph by Hongqing Wang, U.S. Geological Survey.

SLR and sustained or repetitive wave action are two long-term processes that cause shorelines to recede (Hardaway and Byrne, 1999; McLoughlin and others, 2015). The effects of SLR and wave action are noticeable in the Fog Point project area. A preliminary analysis of imagery from 1998 to 2015 showed that sand beach bands and high marsh lines had receded by approximately 43 m, with an annual shoreline retreat rate of 2.53 m/yr. Multiple wave-cut gullies (V-shaped notches) with varying lengths and widths were observed along the low marsh in the embayment area (figs. 21, 22). Wave-cut

gullies are sub-triangular incisions that are common along deteriorating marsh scarps (Schwimmer and Pizzuto, 2000; Priestas and Fagherazzi, 2011; Priestas and others, 2015). At the study site, gullies tended to form along the shoreline with dead vegetation. During normal and stormy conditions, waves incised the marsh platform, causing erosions at gully heads and ends and marsh collapse at gully ends (Fagherazzi and others, 2013). Wave shoaling by wave crest compression is hypothesized to concentrate wave energy at gully heads, leading to accelerated marsh incision (Priestas and Fagherazzi, 2011; Leonardi and others, 2016). Jagged marsh boundaries may be indicative of relatively low wave energy and high marsh strength, whereas the converse can result in a more uniform morphology (Leonardi and Fagherazzi, 2015). The occurrence of wave gullies is a sign of accelerated marsh deterioration (Priestas and Fagherazzi, 2011). Furthermore, once gullies are formed, shoreline erosion tends to increase, because erosion rates increase with boundary sinuosity at a small spatial scale (tens of meters) (Priestas and others, 2015).

Priestas and Fagherazzi (2011) reported that the formation of wave gullies requires areas of cohesive mud substrate along the scarped edges and waves with heights greater than 20–30 cm to impact the scarp with enough force to remove material. Wave gullies do not form in marsh shorelines with very shallow offshore slopes because of wave energy dissipation by depth-limited wave breaking, even with large offshore waves, nor do they form in scarped edges without sufficient wave power (Priestas and Fagherazzi, 2011; Priestas and others, 2015). Furthermore, Priestas and Fagherazzi (2011) reported that the size and spacing of wave gullies could be related to the strength of the eroding material relative to the wave power. Waves exert significant force on the scarp and can cause marsh erosion when the water elevation equals the marsh platform elevation, a condition conducive to increased dynamic wave pressure (Tonelli and others, 2010). However, it is important to also consider the findings of Priestas and others (2023), which demonstrate that maximum impact pressures can occur under optimal (plunging) wave-breaking conditions,

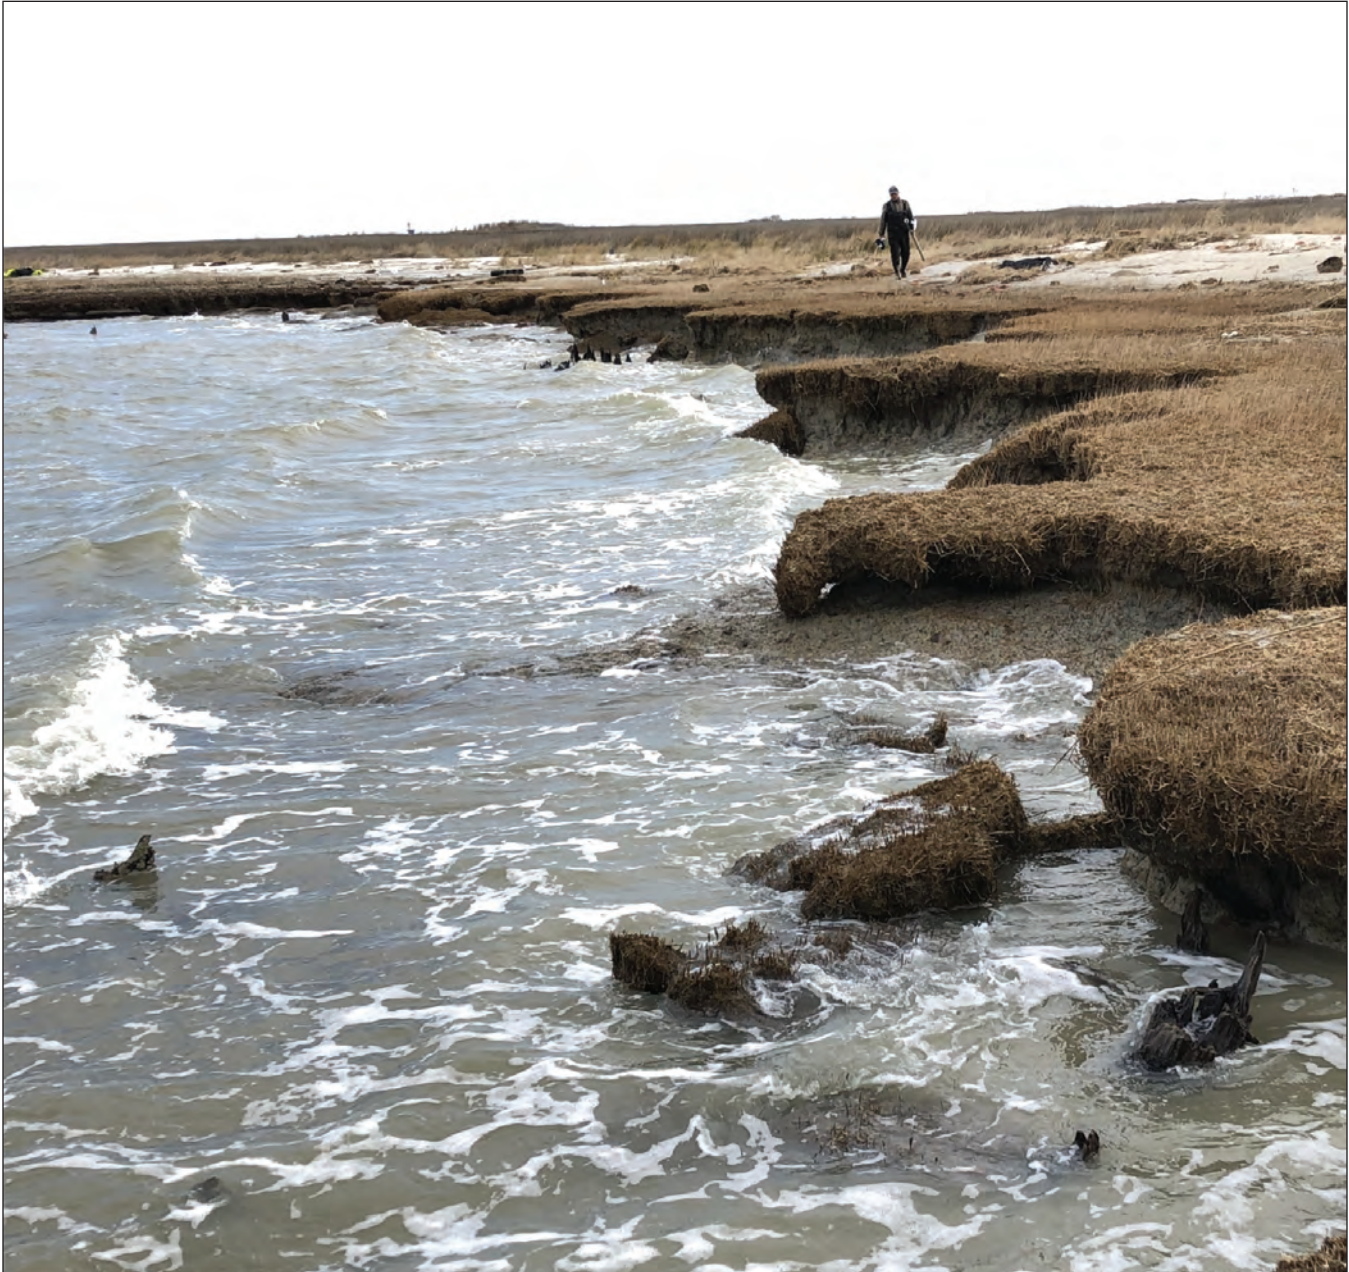
Figure 22. Scarps and undercuts at marsh edge in the embayment along the Fog Point Living Shoreline Restoration Project study area under low tide condition during field deployment on February 13, 2020. Photograph by Hongqing Wang, U.S. Geological Survey.
