Evaluation of Alternative Coatings for U.S. Geological Survey Water-Quality Samplers

Open-File Report 2025-1016

By Alyssa M. Thornton

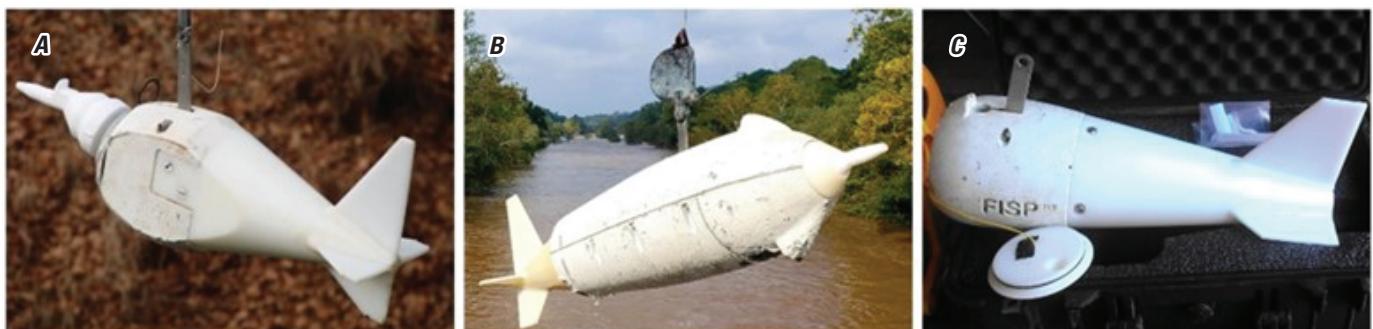
Figure 1. Photographs showing, A, DH-95, B, D-96, and, C, DH-2 water-quality samplers displaying moderate coating wear such as dents, abrasions, discoloration, and coating peeling. Photograph A taken by Ken Hyer, U.S. Geological Survey (USGS), on December 10, 2007. Photograph B taken by Jimmy Webber, USGS, on September 20, 2018. Photograph C taken by Jimmy Webber, USGS, on June 05, 2013.

DH-95 samplers (fig. 1A) were used for the study as the Virginia and West Virginia Water Science Center had five samplers readily available for use. The following four coating options were selected for testing: Plasti Dip, powder coating, Raptor, and DuraCoat; a fifth option was bare metal. Factors considered when evaluating the optimal coating material were (1) total cost, preparation time, and ease of coating application and coating maintenance; (2) the potential for sample contamination due to product content; and (3) the durability of the coating over time in both controlled and field-use settings. Each sampler underwent the following steps to test these factors:

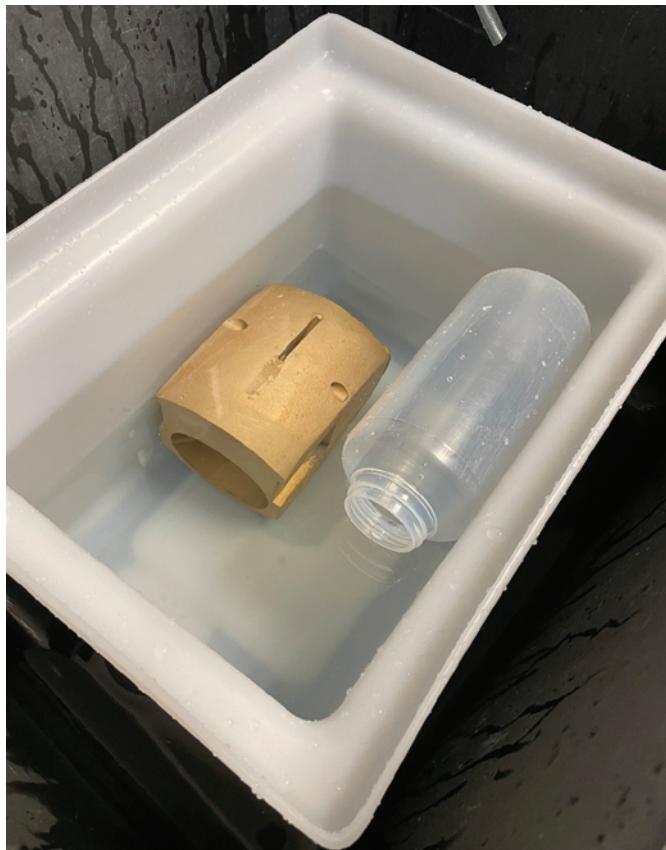
Figure 2. Photograph showing blank water-quality sample processing from a wash basin using a bare sampler. Photograph taken by Alyssa Thornton, U.S. Geological Survey, on December 2, 2020.

3. Set of three consecutive equipment blanks from wash basin with sampler body.—The next three blank sample sets were processed from the wash basin with the DH-95 coated (one bare) sampler soaking (fig. 2). For the first blank sample, the sampler had been soaking for 10 minutes. The subsequent blank samples were processed after the sampler soaked for 20 minutes and then at 30 minutes. The 10-minute soaking interval was chosen to provide adequate soaking time for the samplers to yield sufficient leaching or contamination potential.

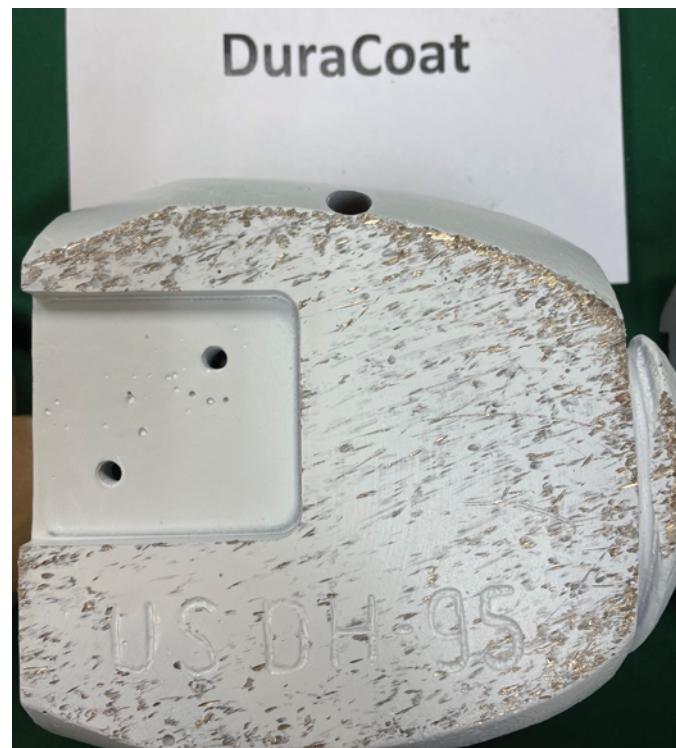
Figure 3. Photograph showing damage to the side of the DuraCoat sampler (fins removed) following the controlled wear test. Photograph taken by Alyssa Thornton, U.S. Geological Survey, on December 2, 2020.

Before starting the wear test, the tail section was removed from the samplers. A rope was tied around the sampler, feeding it through the hole where the sampler bottle was loaded. Samplers were set on a concrete surface, and a 40-ft track was measured and marked. Each sampler was pulled at a consistent rate of approximately 2 feet per second (ft/s) along the 40-ft concrete track twice on each side, subjecting each to abrasion. Photographs were taken after each pass to document the progressive damage (fig. 3).

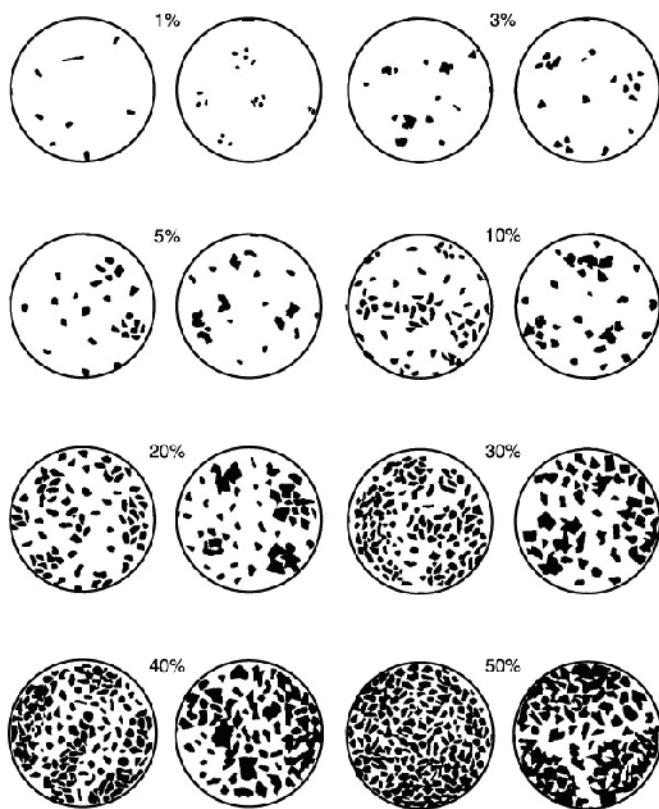
Figure 4. Image showing the visual percentage estimator used for damage evaluation (Shipboard Scientific Party, 2002, fig. 9).

Sampler wear was examined after the controlled wear test and the field-testing period. Descriptions of how each sampler exhibited wear-and-tear were recorded and approximate quantifications of the amount of wear observed were estimated using a visual percentage estimator (fig. 4).

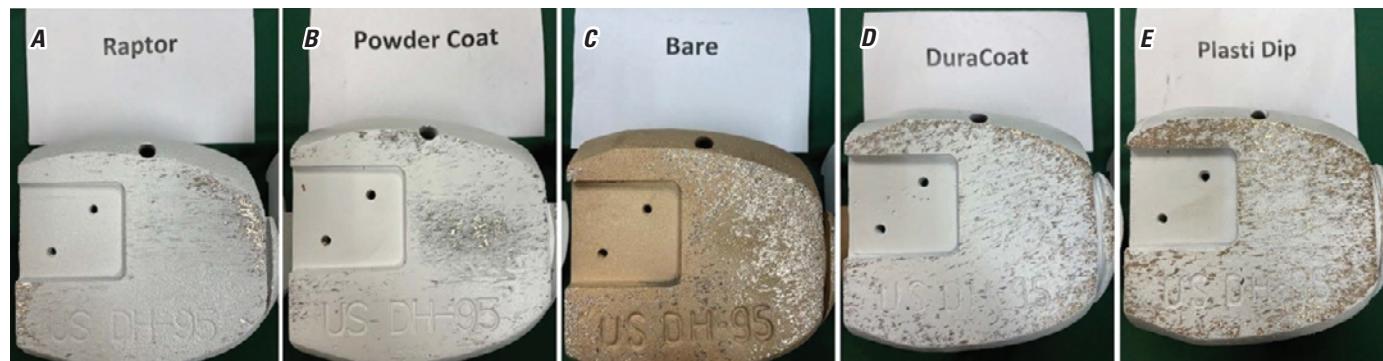
Figure 5. Photographs showing the damage to the sides of water-quality samplers after the controlled wear test. Photographs taken by Alyssa Thornton, U.S. Geological Survey, on December 2, 2020. A, Raptor. B, Powder coat. C, Bare. D, DuraCoat. E, Plasti Dip.

Results of the controlled wear test showed that samplers are more susceptible to wear by abrasive damage as opposed to strike damage. Substantially more damage was observed on the sides of the samplers that endured the abrasive action of dragging than the bottom of the samplers that endured the drop test. Wear characteristics were similar across the samplers, all displaying scratches and some flaking (fig. 5).

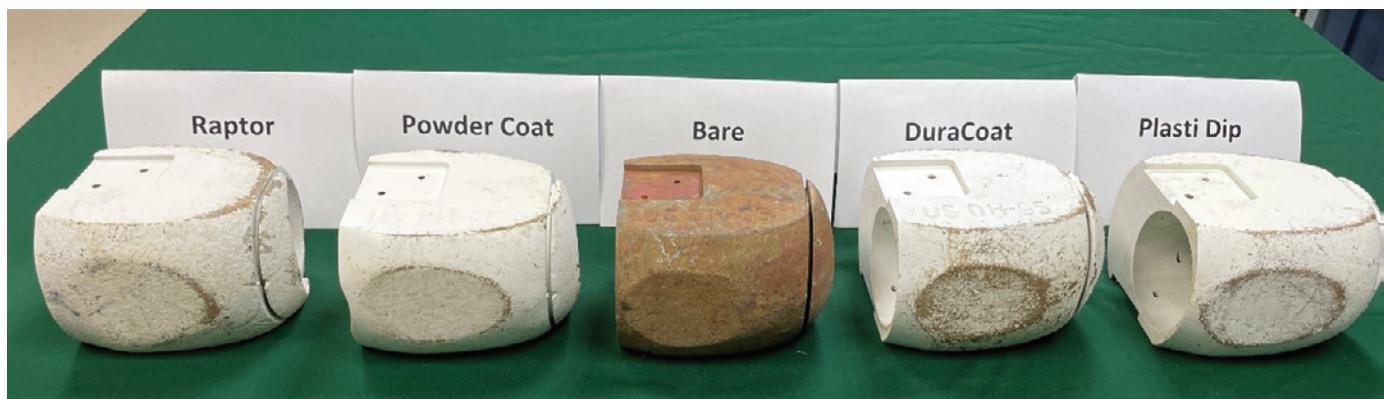
Figure 6. Photograph showing the damage to water-quality samplers after field use. Photograph taken by Alyssa Thornton, U.S. Geological Survey, on June 1, 2022.

to assess, as there was a greater variety of damage characteristics beyond previously observed scratches and flaking, which included chipping, gouging, dents, peeling, and staining. The percentage of damage also was more challenging to evaluate for each sampler as it was not even on the surfaces. The damage typically was more concentrated around the edges of the sampler sides, the ring around the sampler base surface, and the front lip of the sampler surrounding where the sampler bottle is inserted. These more heavily damaged points on the samplers correlate with specific in-field wear actions, such as the sampler contacting or dragging against the bridge when moving between stations, the sampler being set on a bridge or road surface before and after sample collection, the sampler contacting a rocky stream bed during sample collection, and the sampler being struck with in-stream debris during collection (fig. 6).
