# **Using High-Resolution Geospatial Imagery and Data To Document the Evolution of the Wilderness Breach That Was Created by Hurricane Sandy in 2012 at Fire Island National Seashore, New York**

Open-File Report 2025–1020

By Gary B. Fisher

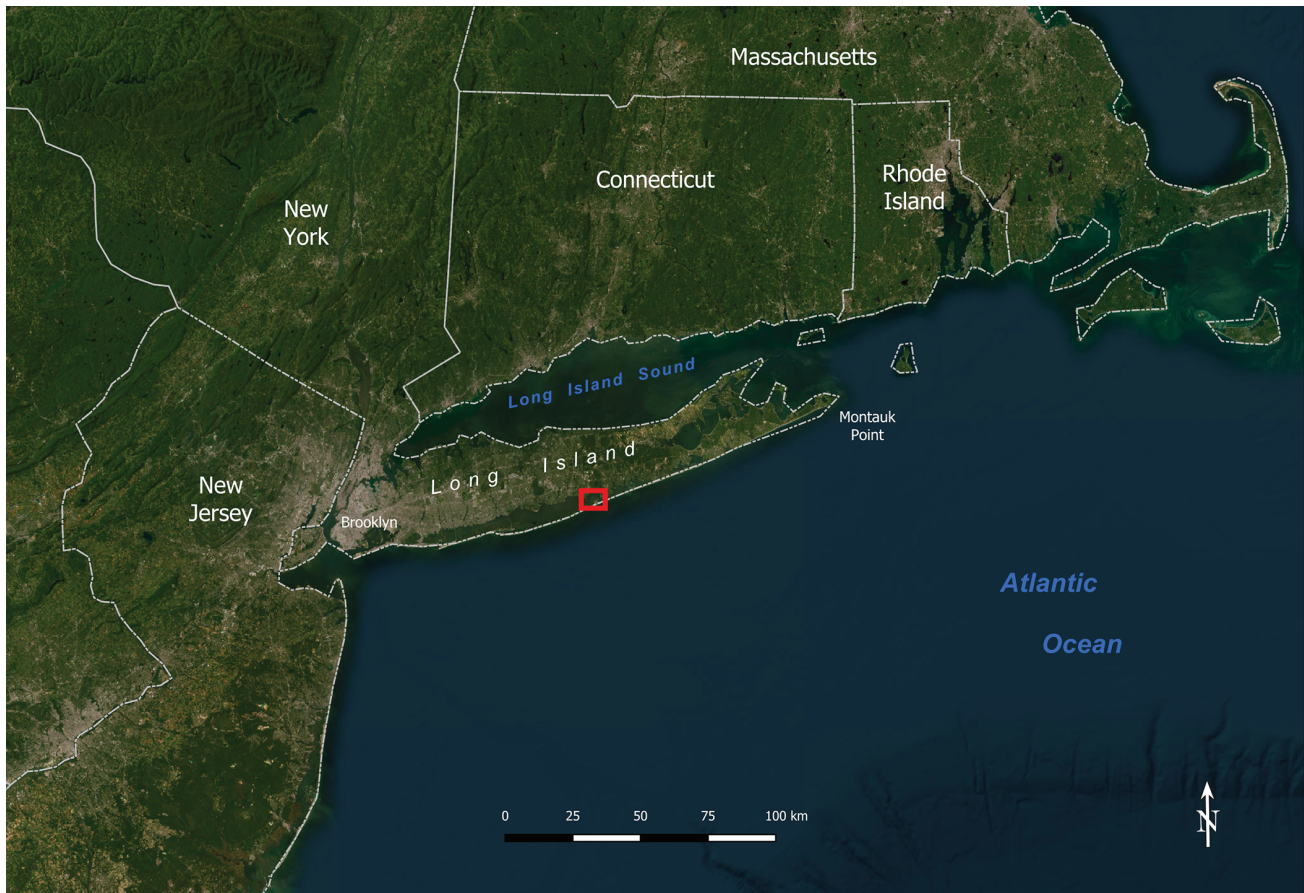
**Figure 1.** Landsat satellite image showing the location of the study area on Fire Island, which parallels the south shore of Long Island, New York. The red box indicates the study area where an inlet, the Wilderness Breach, formed on October 29, 2012, after Hurricane Sandy passed nearby. The scale bar is in kilometers (km).

Fire Island is a 48-kilometer-long barrier island, paralleling the south shore of Long Island, New York, extending from Fire Island Inlet eastward to Moriches Inlet (figs. 1, 2). The coastline is shaped by the interaction of ocean wave erosion and the predominantly westward lateral movement of sediment along the coast from Montauk Point on the eastern headlands of Long Island to Breezy Point Tip on the western end of the island. The central area of Fire Island is a dynamic location, with changes occurring daily as the shoreline is continually shaped and reworked by the lateral current of the Atlantic Ocean.

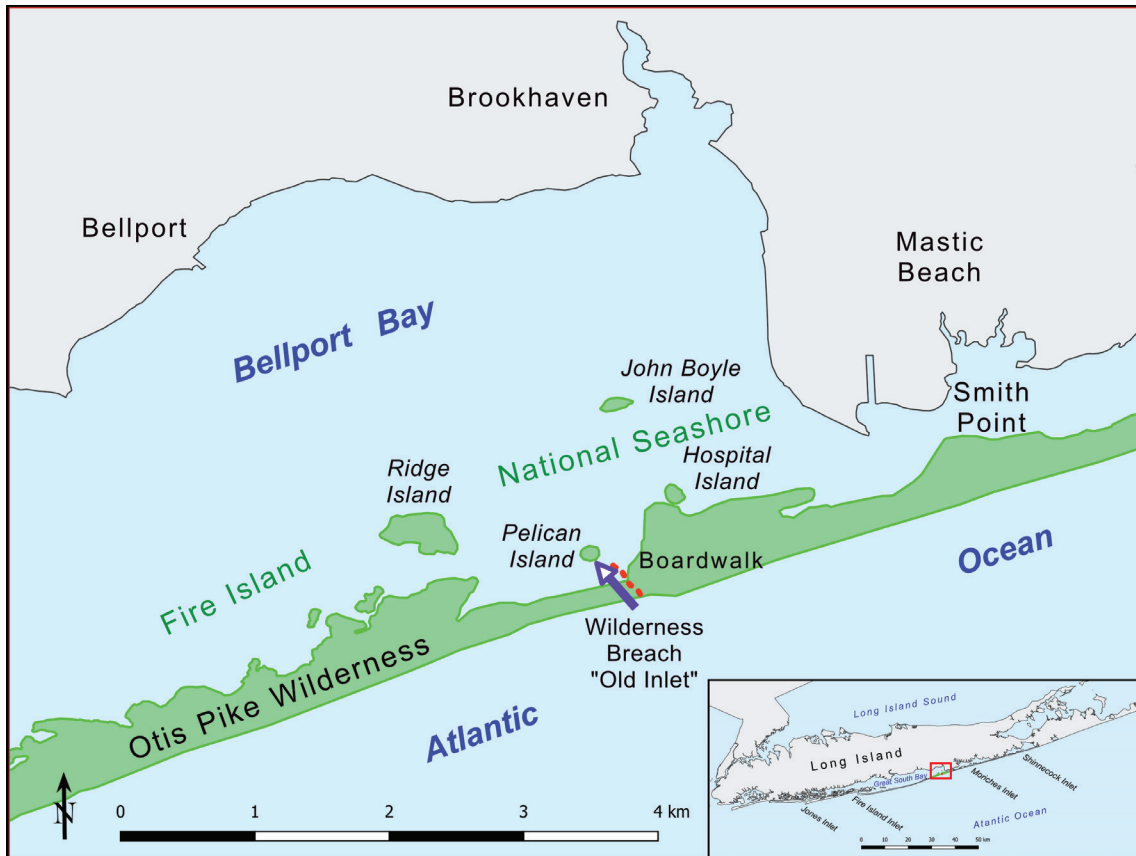
**Figure 2.** Location map of the study area near the Wilderness Breach on Fire Island, New York. The inset map shows the location of Fire Island parallel to the south shore of Long Island and a red box indicating the study site. The scale bar is in kilometers (km).

When the Wilderness Breach opened in 2012, sand and sediment were moved from the ocean beach into Great South Bay ([fig. 2](#)). Wave energy and currents reworked the sand into flood and ebb shoals, accumulating on the bay side (flood) and ocean side (ebb) of the breach (NPS, 2016b). During the 10-year existence of the breach, these shoals widened the island ([fig. 3](#)) and provided platforms for the growth of new salt marshes and other habitats that enhanced the resilience of the barrier island to future storms and sea-level rise. While localized erosion occurred immediately west of the inlet, the ebb shoal that formed on the ocean side remained relatively small and stable, indicating that the breach did not interrupt the sediment transport system. The flood shoal delta that formed on the bay side of the inlet quickly grew in size from 2013 through 2016 ([table 2](#)), with the front edge of the delta extending past Ridge Island

and John Boyle Island into Bellport Bay ([fig. 2](#)). It remained stable until late 2022 when the inlet closed, ending sediment transport into the bay. Between 2020 and December 2023, the area of the flood shoal delta decreased in size from 2,755,327 square meters (m<sup>2</sup>) to 1,291,971 m<sup>2</sup>. WorldView MSI was utilized to highlight the flood shoal delta on selected dates from 2013 through 2023 ([fig. 4](#)).

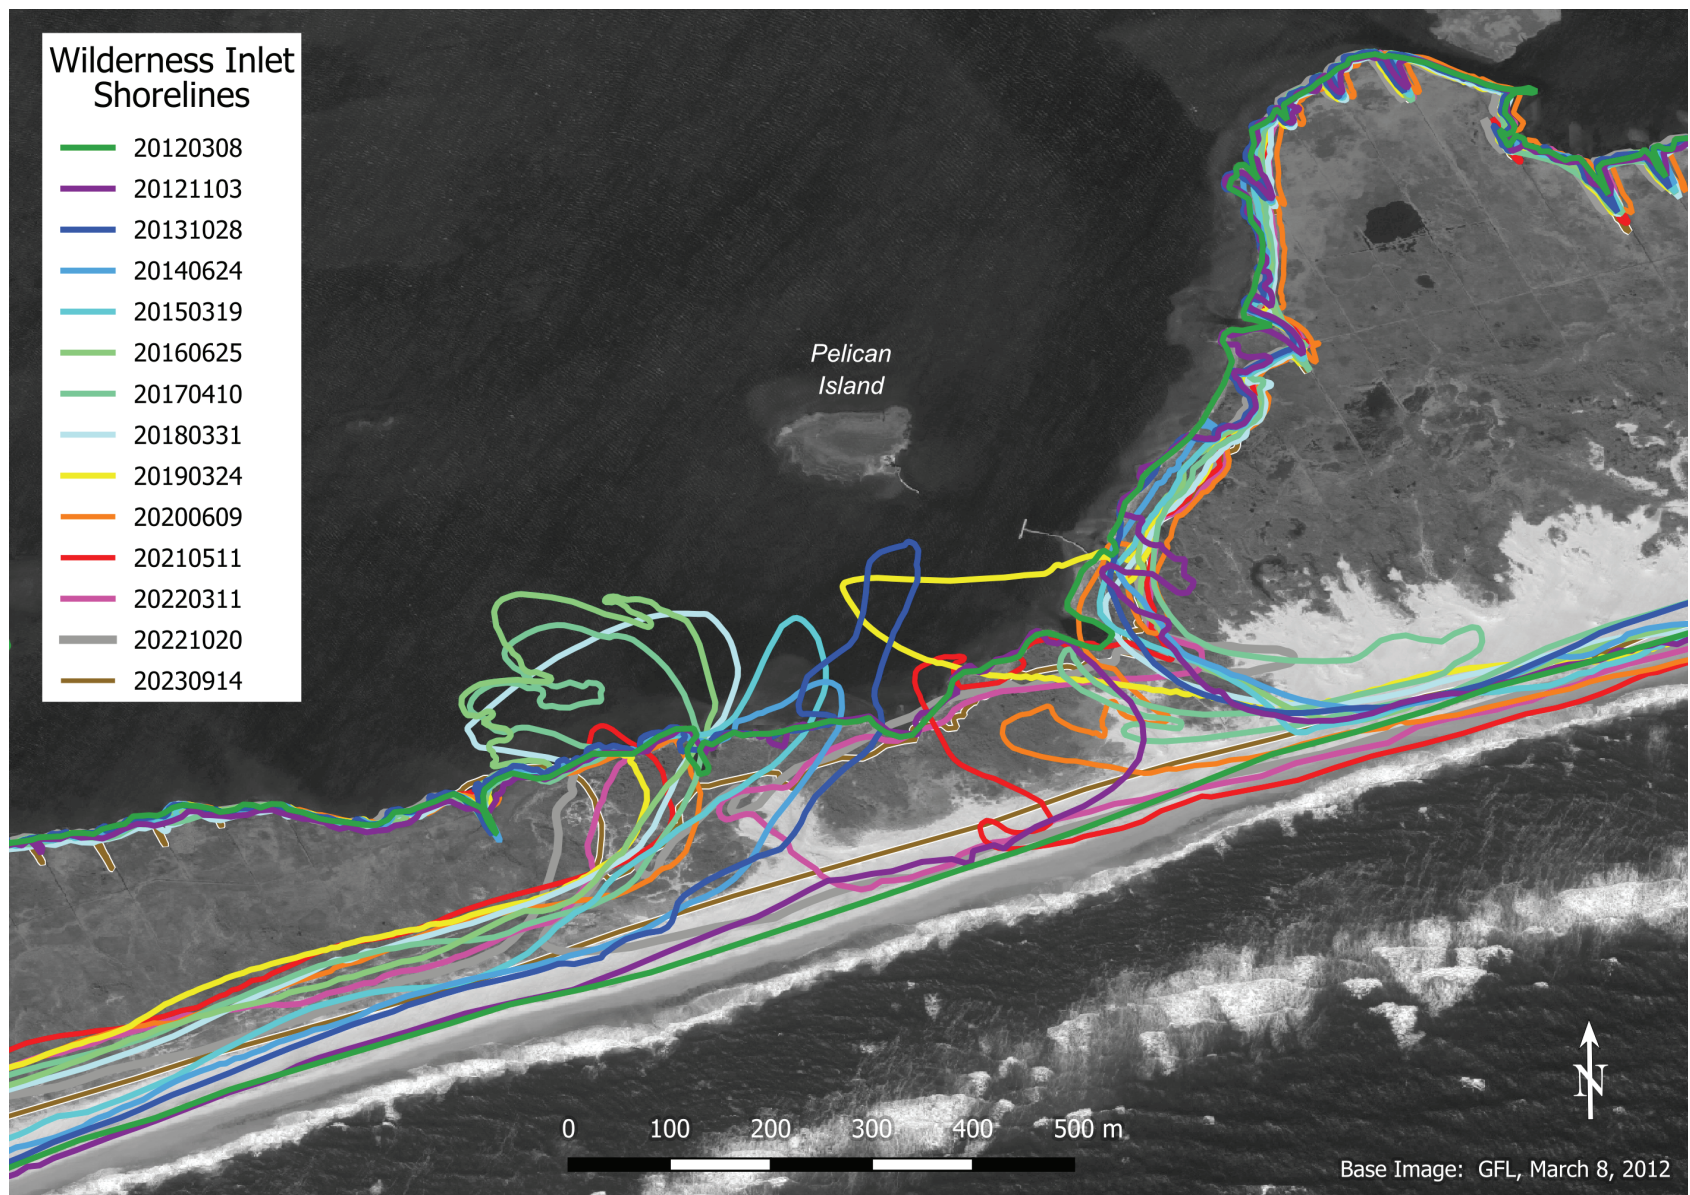
**Figure 3.** Satellite image map showing shorelines at the Wilderness Breach, Fire Island National Seashore, New York, 2012–2023. The image is from the Global Fiducials Library (<https://www.usgs.gov/global-fiducials-library-data-access-portal>), and it was collected on March 8, 2012. The scale bar is in meters (m).

WorldView-1 imagery collected over the Wilderness Breach site on November 03, 2012, shows the newly formed inlet measuring a maximum of 72 meters wide (table 1). In order to better understand and document the changes in the inlet, remote sensing data were assembled covering each year from 2012 through 2023. These images were used as a base to provide an annual data source for measuring breach shoreline change during the 10-year existence of the inlet (fig. 3). The shoreline in the breach area was digitized to create a vector line for each year that imagery was collected during the existence of the inlet (Fisher, 2025). The Wilderness Breach opened at the narrowest section of the central part of Fire Island where the low terrain and the absence of dunes provided an ideal path for hurricane overwash and breach formation. A boardwalk (fig. 2) that led from the ocean beach to the back bay near Pelican Island also provided a buffer to channel wave action across this section of the island. The lack of vegetation under the boardwalk

The widths of the inlet from 2012 through 2022 are listed in [table 1](#). The width of the inlet for each year was obtained by simply measuring a line on the imagery across the inlet at the narrowest section of the inlet. This technique provided a reliable measurement of the size of the inlet for each year as shown in the imagery. These data reveal that the inlet grew in width during the first 4 years, reaching a maximum width of 440 meters in 2016, when it stabilized. A series of storms in the 2013–2014 winter season affected the inlet (NPS, 2016b), forcing it to migrate to the west and deepening its channel. These changes can be observed in [figures 2.6](#) (October 28, 2013) and [2.7](#) (June 24, 2014) in [appendix 2](#).

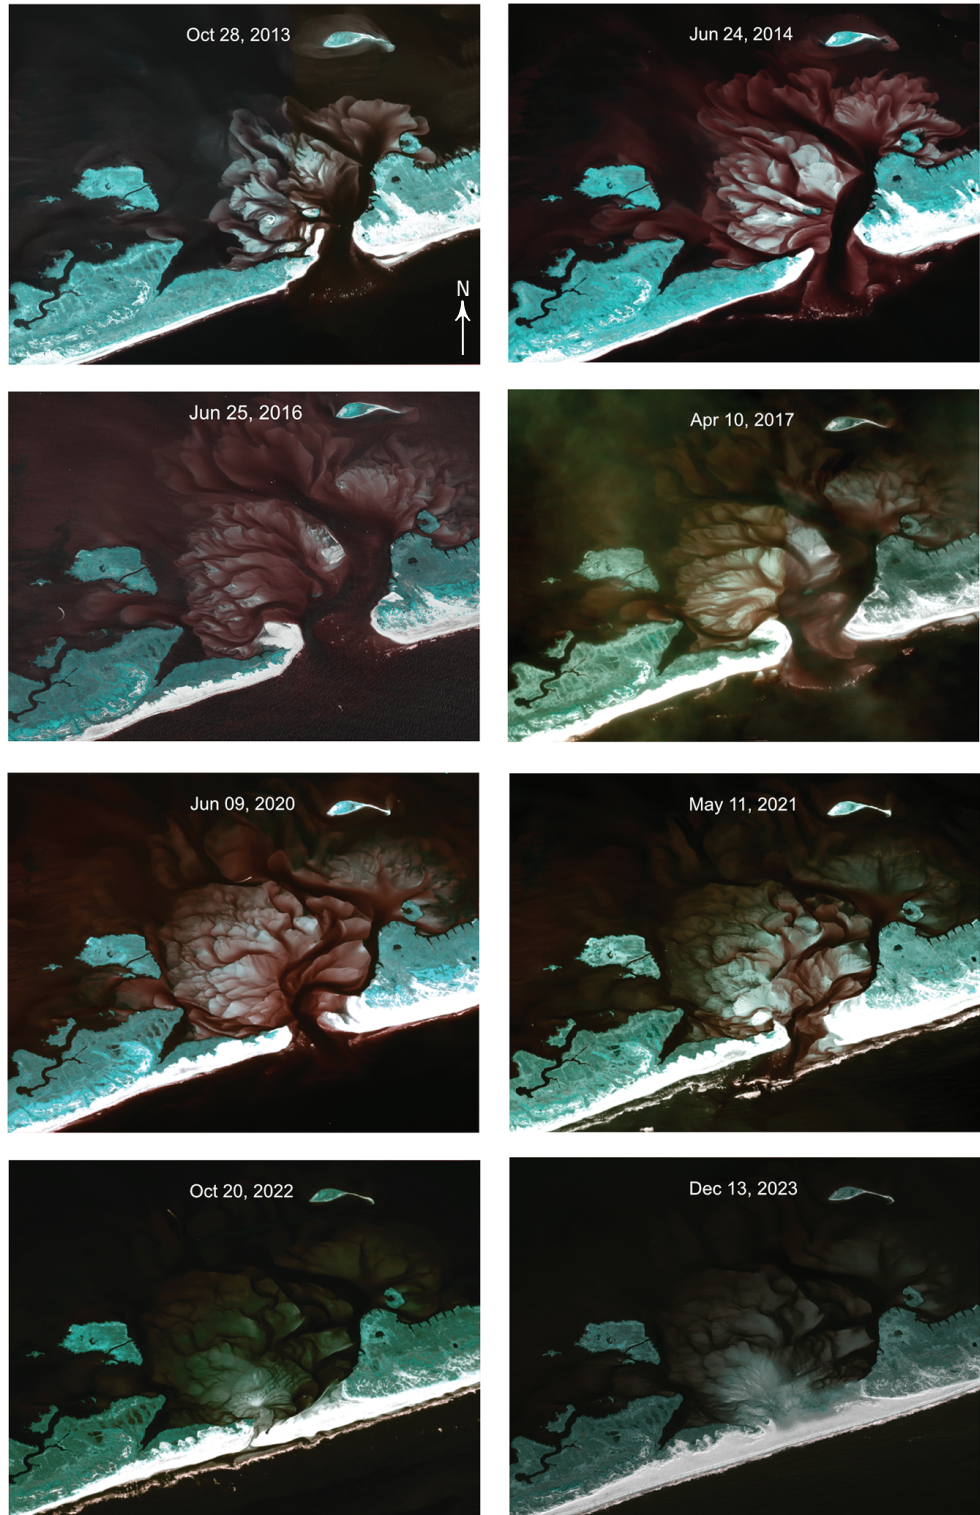
**Figure 4.** A collection of eight WorldView-2 multispectral images of the flood shoal delta at the Wilderness Breach, Fire Island National Seashore, New York. The images were collected on October 28, 2013; June 24, 2014; June 25, 2016; April 10, 2017; June 9, 2020; May 11, 2021; October 20, 2022; and December 13, 2023. The colors in the multispectral images represent differences in reflectance values of the material that is shown. The benefit of this imagery is being able to clearly see fine-grained material that has a brighter color against more compacted stable material that is highlighted in aqua. White represents a higher reflectance value in the imagery. The brighter white in the imagery represents coarser material such as fine-grained sand particles that do not hold together well and are susceptible to erosion. The light-green coloring represents a more stable landscape that has a healthy vegetation covering that holds the sediment together and will tolerate overwash better than the fine-grained beach material. The reddish-brown coloring represents submerged material that has accumulated in the shoal delta. This material is typically fine grained, loosely distributed, and very susceptible to erosion and movement during wave or tidal flow changes.

Analysis of the MSI data was done by using several modules (tools) available through the Orfeo ToolBox program. This program provided a method to manipulate the bands in the data through an extension in QGIS. This was done to highlight submerged topographic features and enhance the clarity of the data. This was performed by reordering the bands to highlight submerged features (bands 3-green, 2-blue, 1-coastal) and applying a contrast stretch to spread the values over a wider spectrum to enhance the dynamic range of the imagery. This results in a clearer image providing higher details of the submerged features in the flood shoal delta. This method proved to be robust for highlighting features normally obscured by the murky water in the bay.

Outlines for the flood shoal delta were obtained by using the “Line Segment Detection” module in the Orfeo ToolBox program. This application detects linear features in imagery by computing gradient and level lines to detect aligned points in a region. This provided a semi-automated method to digitize the outlines of the flood shoal delta for the dates of interest. The vector lines generated from this process were used to calculate the area of the flood shoal delta.

These images reveal that while the overall shape and morphology of the flood shoal delta remained constant, the area and extent of the feature changed over time in relation to the size of the inlet opening that provided sediment to allow this feature to grow or shrink in size. Once the Wilderness Breach began to close in 2022, the flood shoal delta correspondingly began to shrink.

[Multispectral images used to obtain the measurements are in [figure 4](#). GSD, ground sample distance]

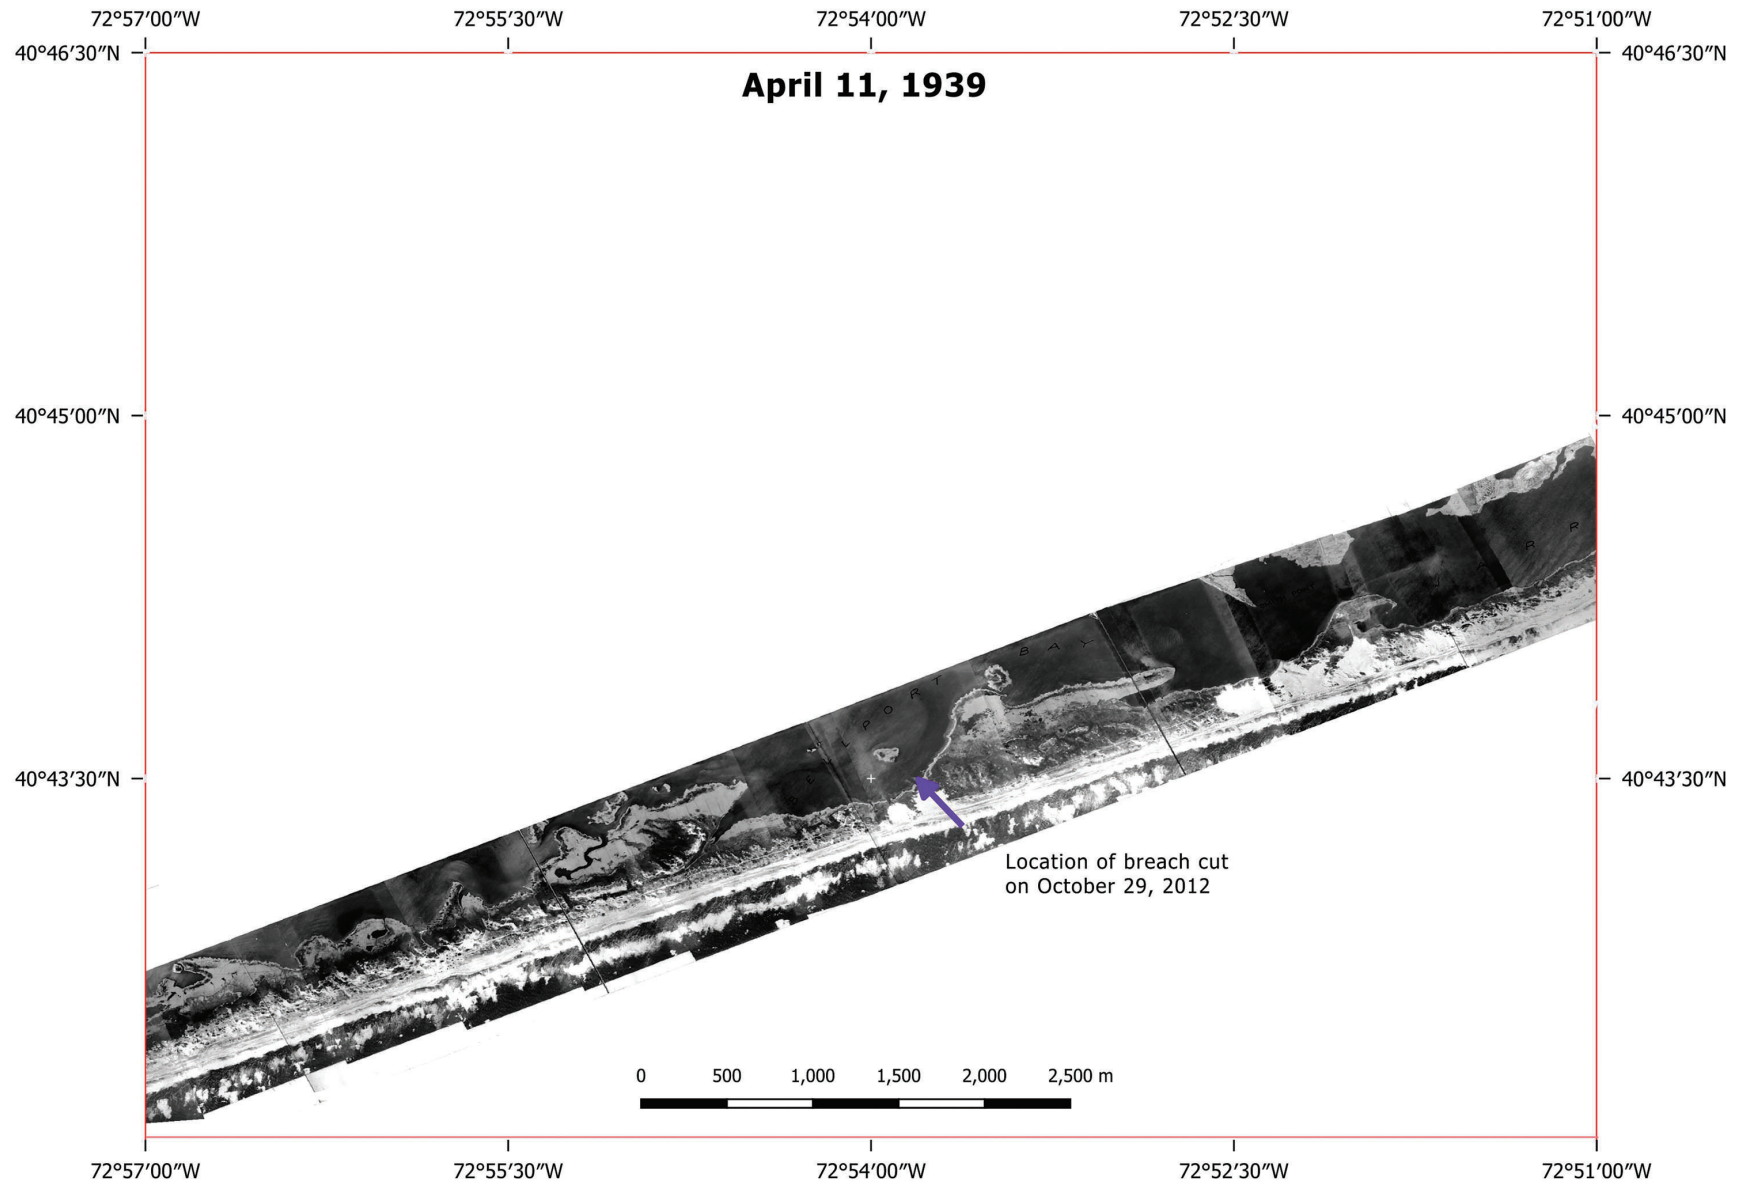
**Figure 2.1.** Aerial photography of part of Fire Island National Seashore, New York, collected by U.S. Army Air Corps, April 11, 1939, after a category 3 hurricane hit New York, Long Island, Fire Island, and New England on September 21, 1938. A blue arrow added to the black-and-white photomosaic indicates the location of the Wilderness Breach that cut Fire Island on October 29, 2012. The scale bar is in meters (m). The resolution is unknown.

Since the Wilderness Breach formed in 2012, a significant amount of remote sensing data has been collected over the breach. [Appendix 1](#) provides a list of some of the data that are available about this site, and [appendix 2](#) provides the images identified in [appendix 1](#). The U.S. Army Air Corps (predecessor of the U.S. Air Force) collected aerial photography over Fire Island on April 11, 1939. This imagery provides details on how the island looked prior to the changes at Smith Point, just east of the site where the Wilderness Breach occurred ([fig. 2.1](#) in [app. 2](#)).

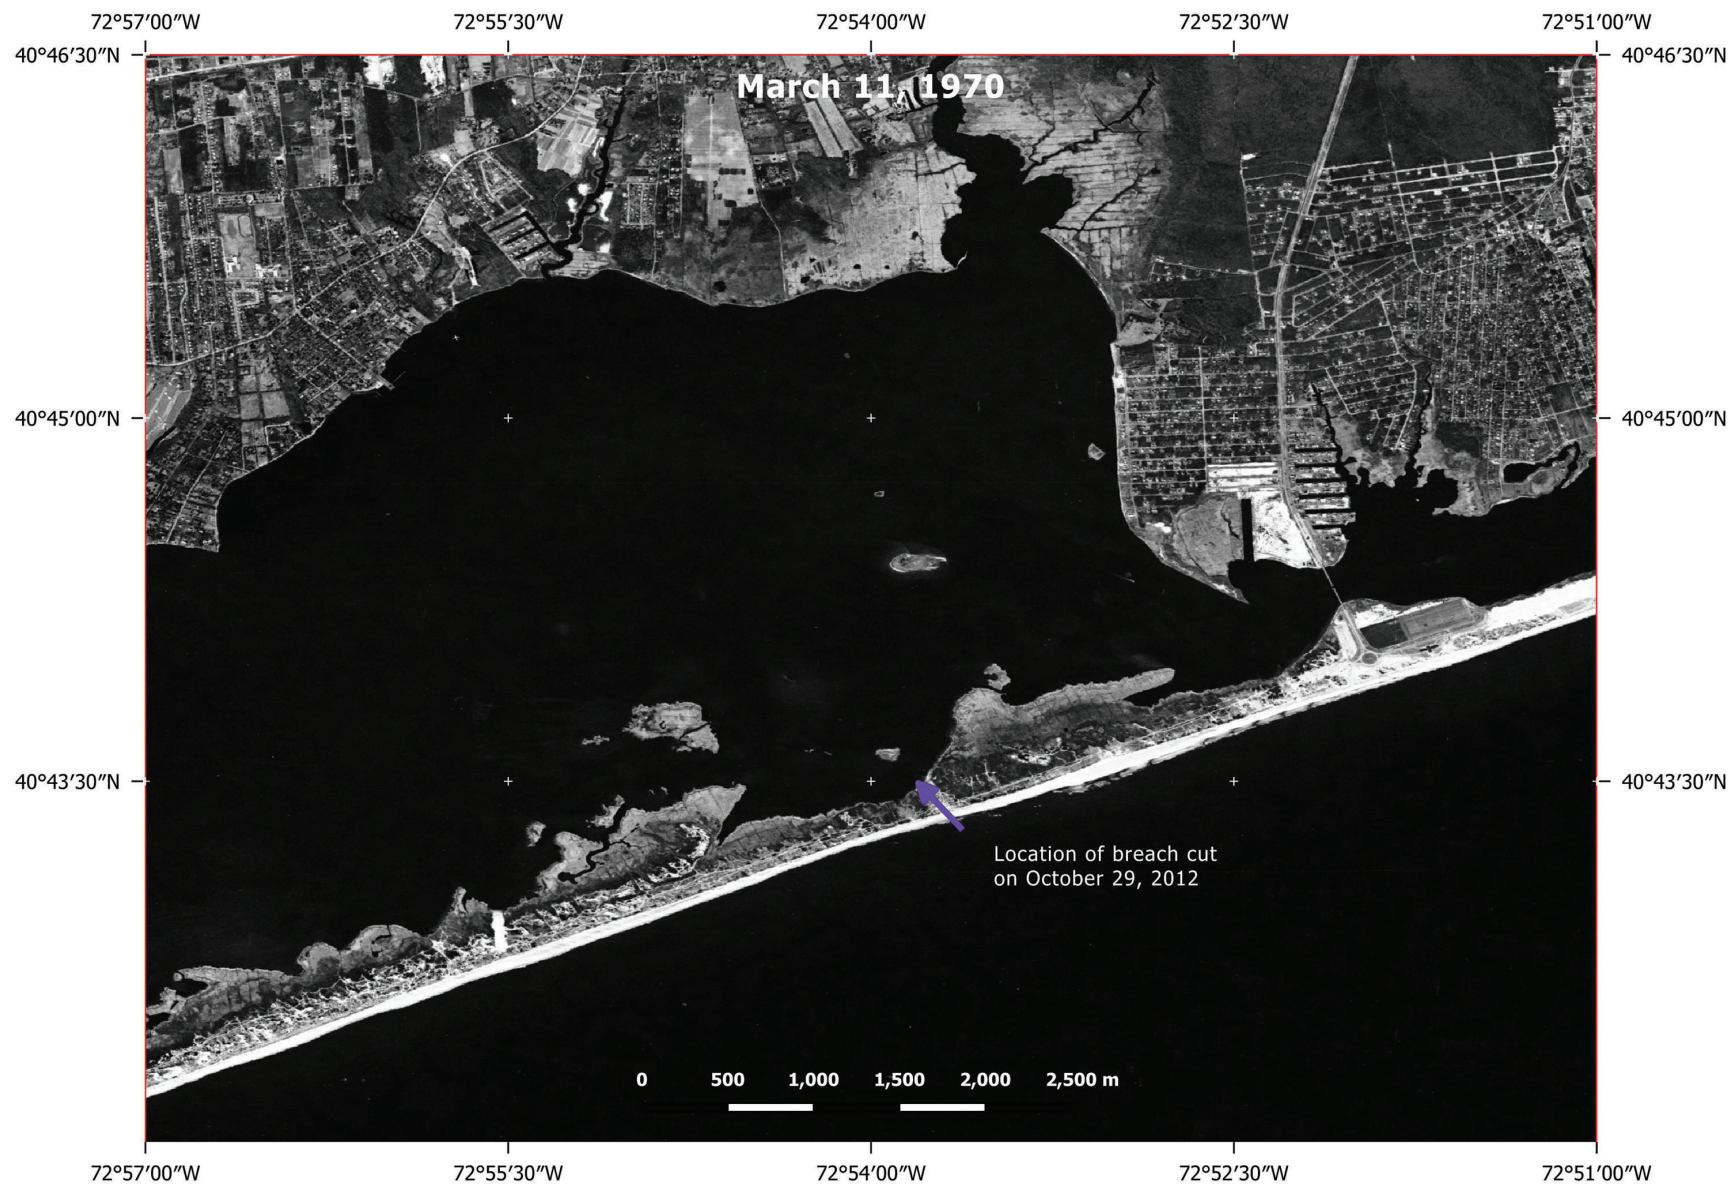
**Figure 2.2.** Declassified KH-4B (CORONA) satellite imagery of part of Fire Island National Seashore, New York, collected March 11, 1970. A blue arrow indicates the location of the Wilderness Breach that cut Fire Island on October 29, 2012. The scale bar is in meters (m). The resolution is 1.82 m ground sample distance (GSD).

Declassified CORONA and HEXAGON images shown in [figures 2.2 and 2.3](#) in [appendix 2](#) provide a detailed look at the study area during a period of relative stability on the island. The manmade changes at Smith Point are observed upcurrent from the location of the future breach.

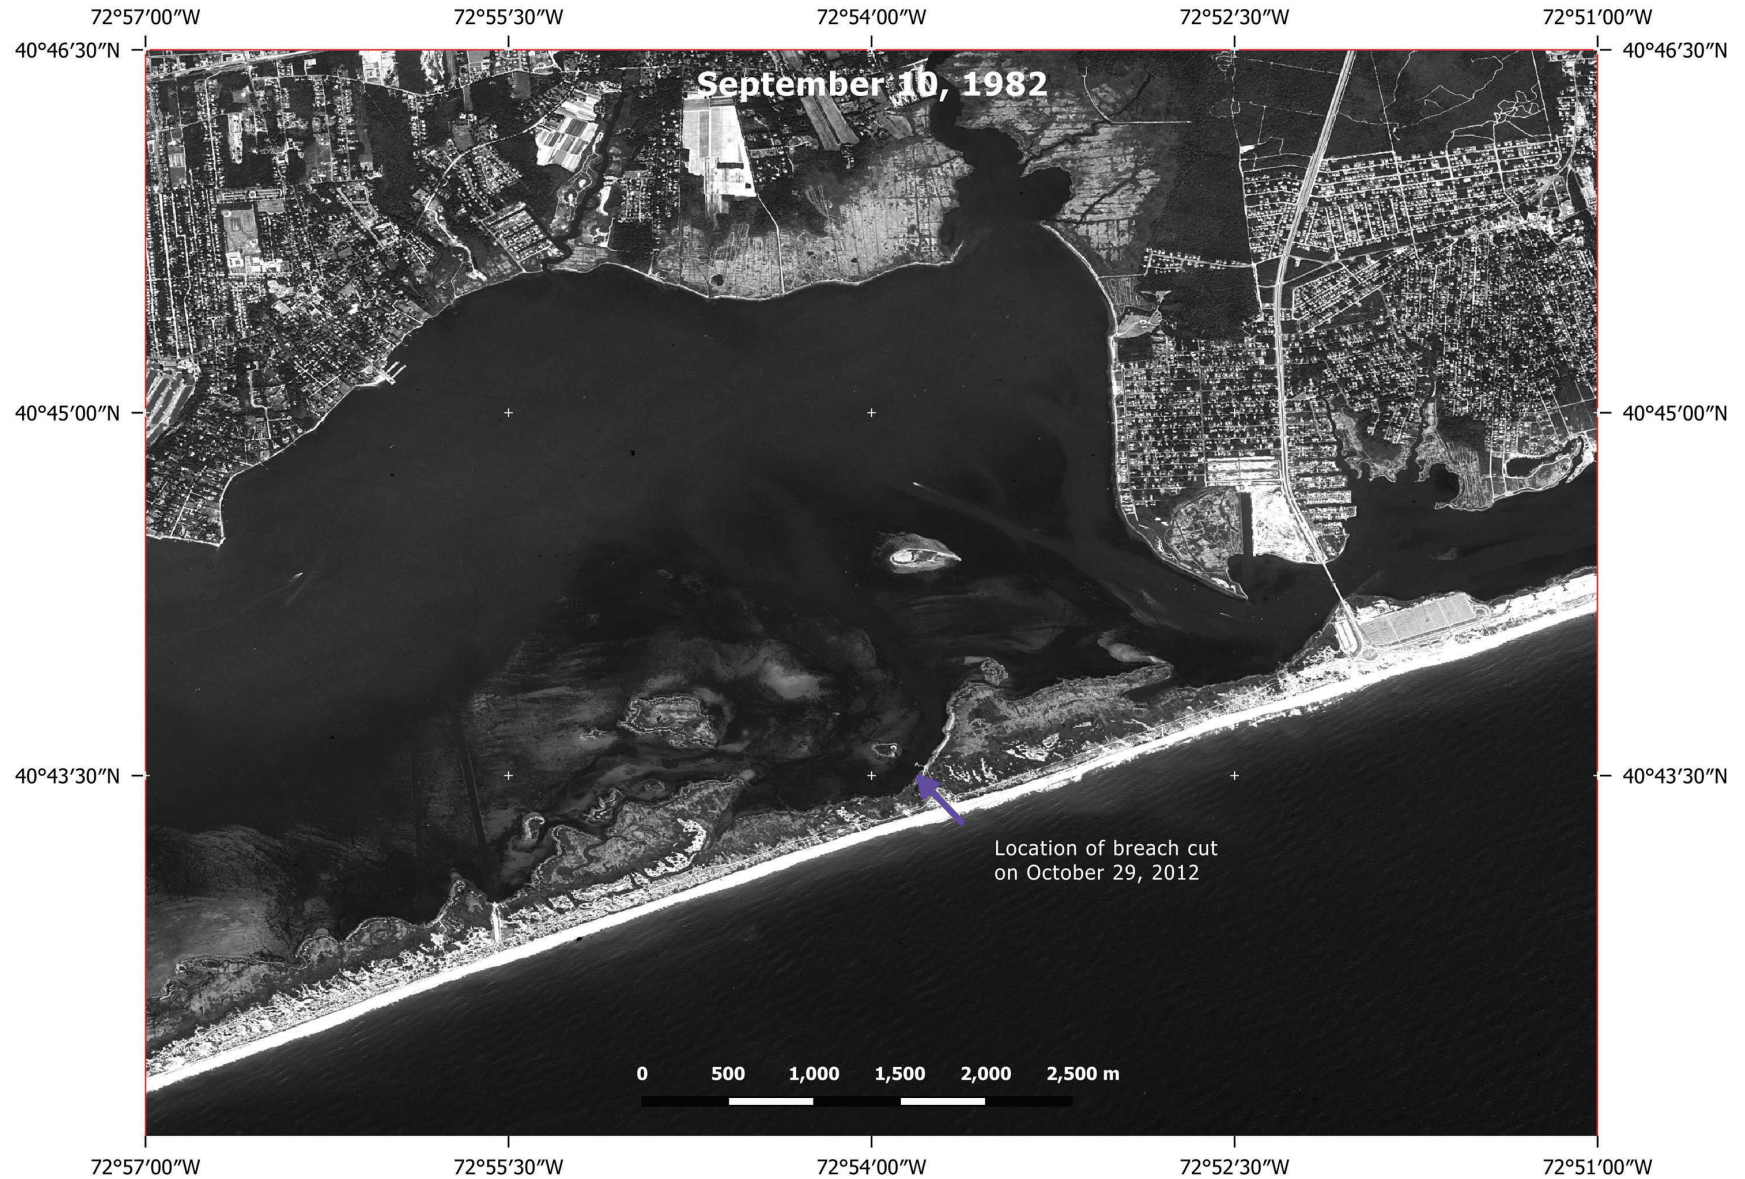
**Figure 2.3.** Declassified KH-9 (HEXAGON) satellite imagery of part of Fire Island National Seashore, New York, collected September 10, 1982. A blue arrow indicates the location of the Wilderness Breach that cut Fire Island on October 29, 2012. The scale bar is in meters (m). The resolution is 0.61 m ground sample distance (GSD).

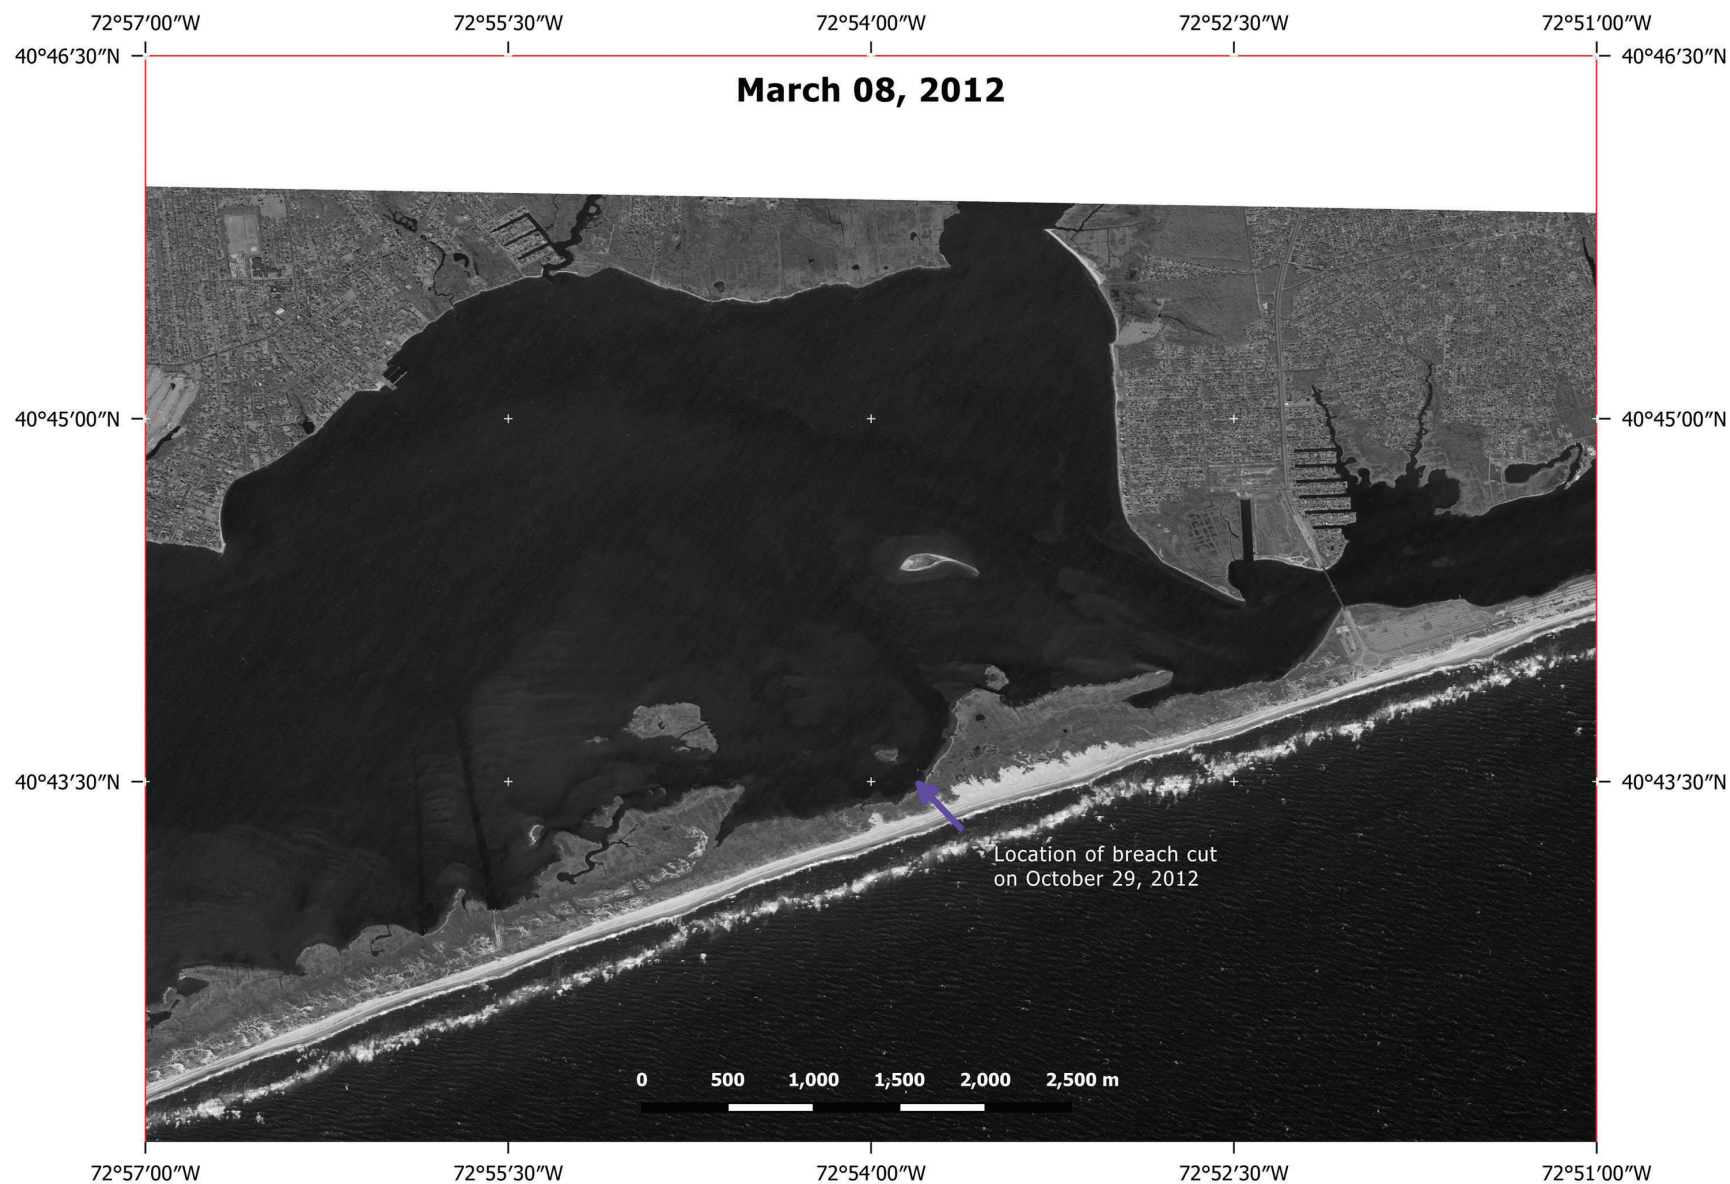
**Figure 2.4.** Global Fiducials Library panchromatic imagery of part of Fire Island National Seashore, New York, collected March 08, 2012, before Hurricane Sandy created the Wilderness Breach of Fire Island on October 29, 2012. A blue arrow indicates the location of the Wilderness Breach. The scale bar is in meters (m). The resolution is 1 m ground sample distance (GSD).

Analysis of imagery collected during the 14 years prior to November 2012 shows minimum change. The GFL image collected March 8, 2012, is [figure 2.4](#) of [appendix 2](#); it provides a detailed record of the conditions on Fire Island at the Otis Pike Fire Island High Dune Wilderness area prior to the breach being cut across the island in late 2012 during Hurricane Sandy.

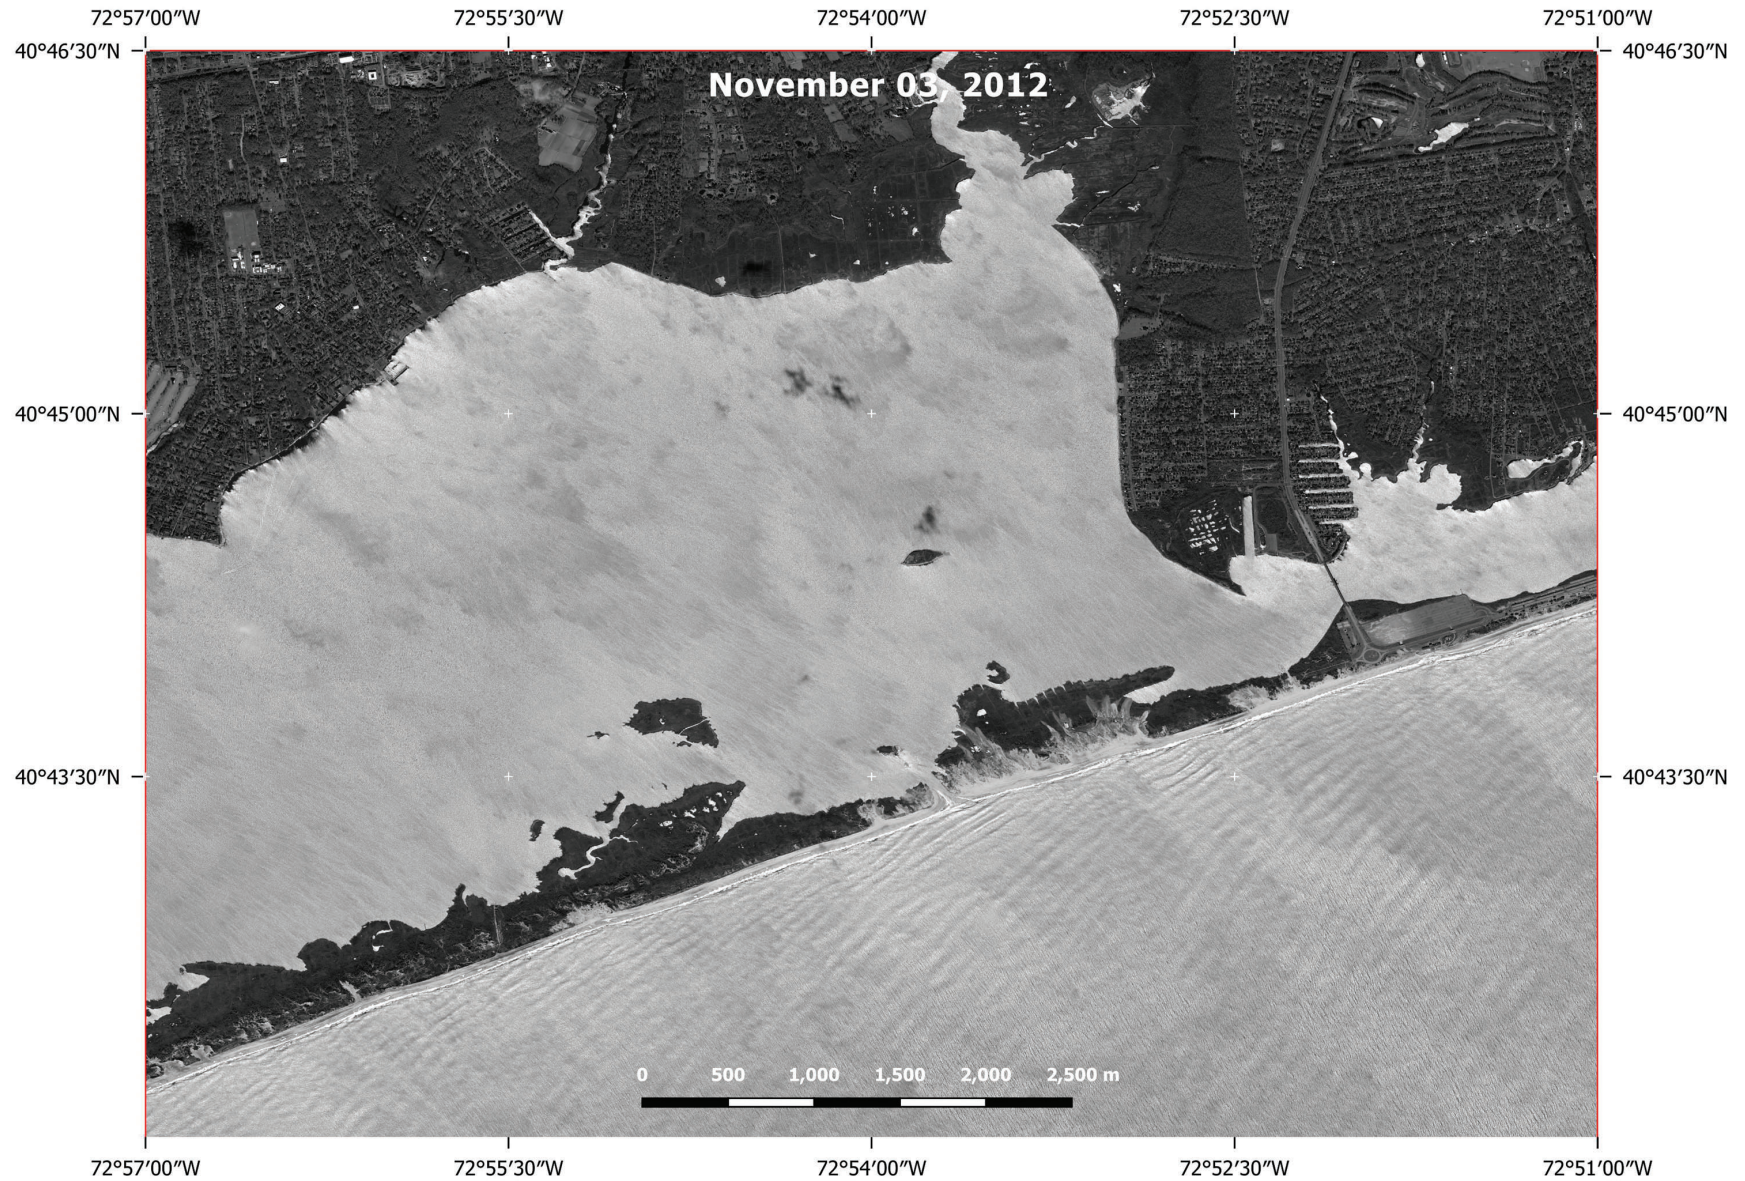
**Figure 2.5.** Maxar WorldView-1 panchromatic image of part of Fire Island National Seashore, New York, collected November 03, 2012, after Hurricane Sandy created the Wilderness Breach of Fire Island on October 29, 2012. The scale bar is in meters (m). The resolution is 52 centimeters ground sample distance (GSD).

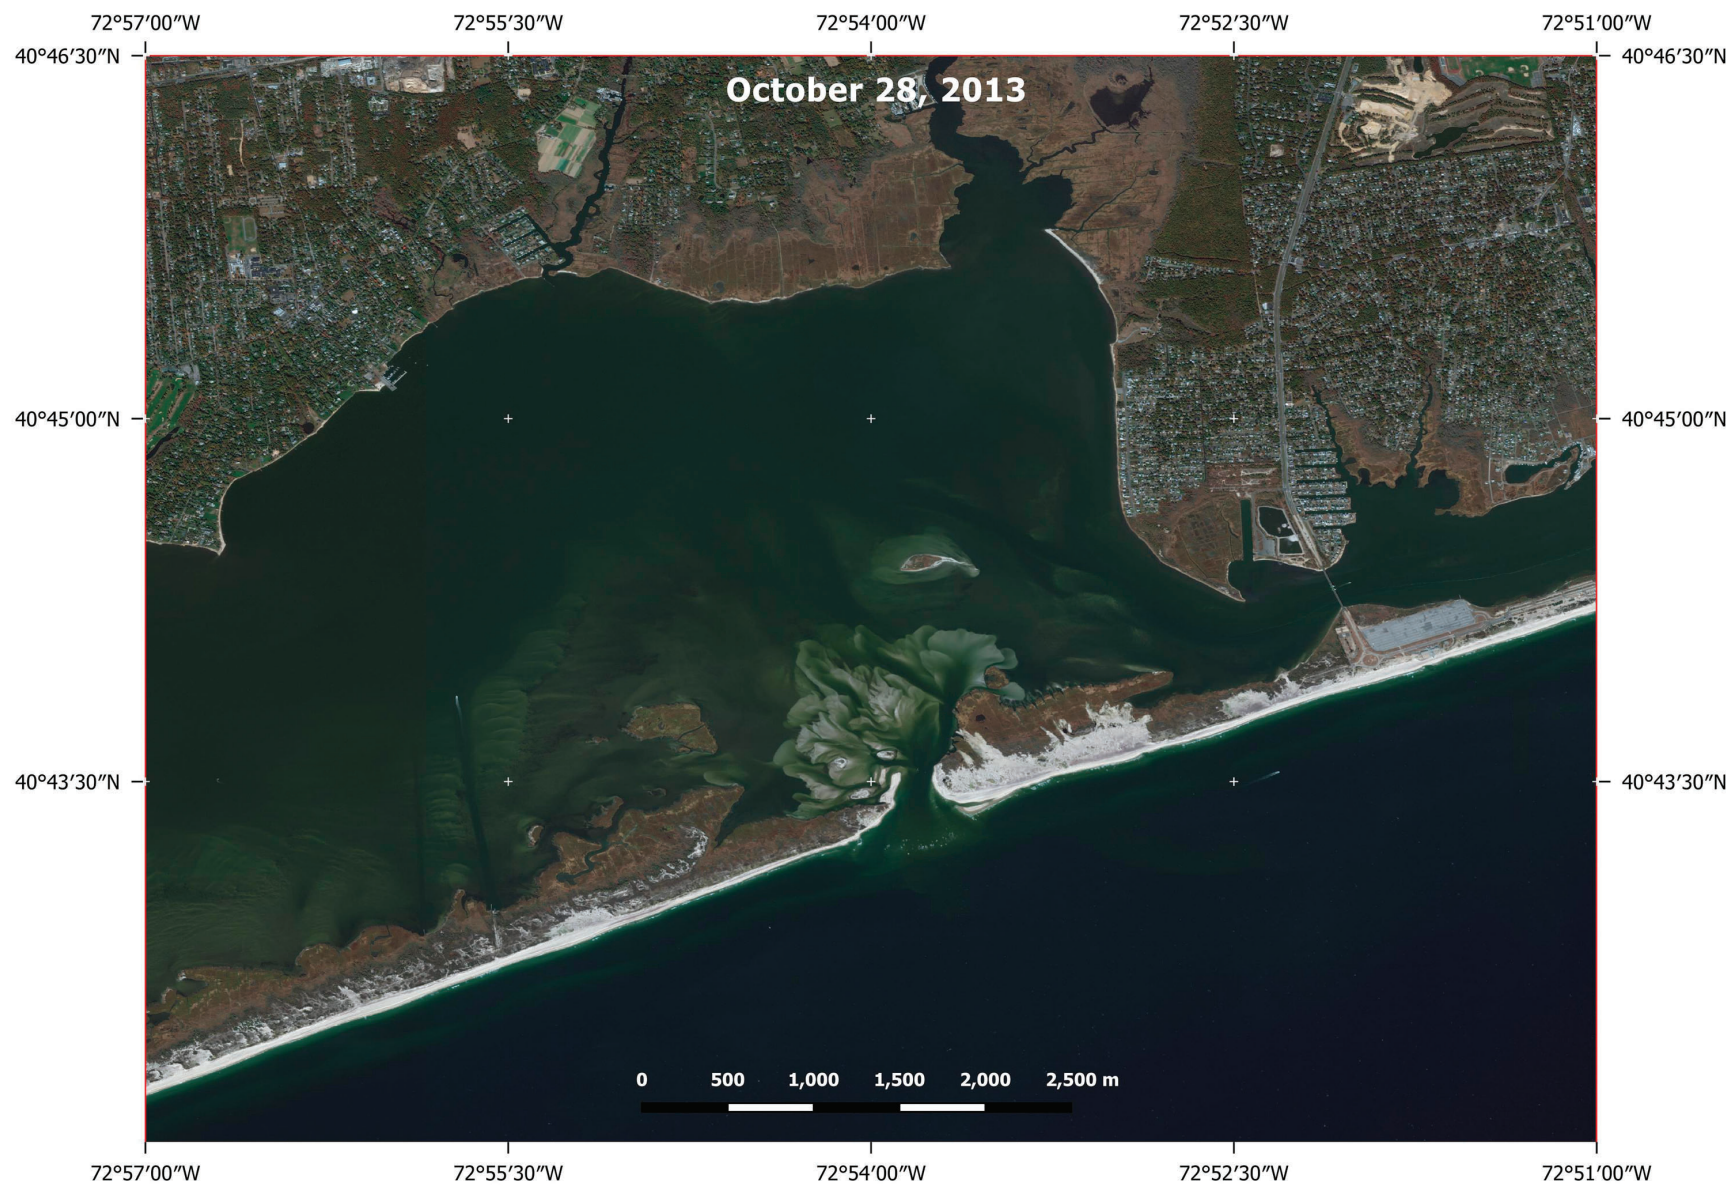
**Figure 2.6.** Maxar WorldView-2 ortho natural color image of part of Fire Island National Seashore, New York, collected October 28, 2013. The image shows the flood shoal delta north of the Wilderness Breach. The scale bar is in meters (m). The resolution is 59 centimeters ground sample distance (GSD).
