# **Using High-Resolution Geospatial Imagery and Data To Document the Evolution of the Wilderness Breach That Was Created by Hurricane Sandy in 2012 at Fire Island National Seashore, New York**

Open-File Report 2025–1020

By Gary B. Fisher

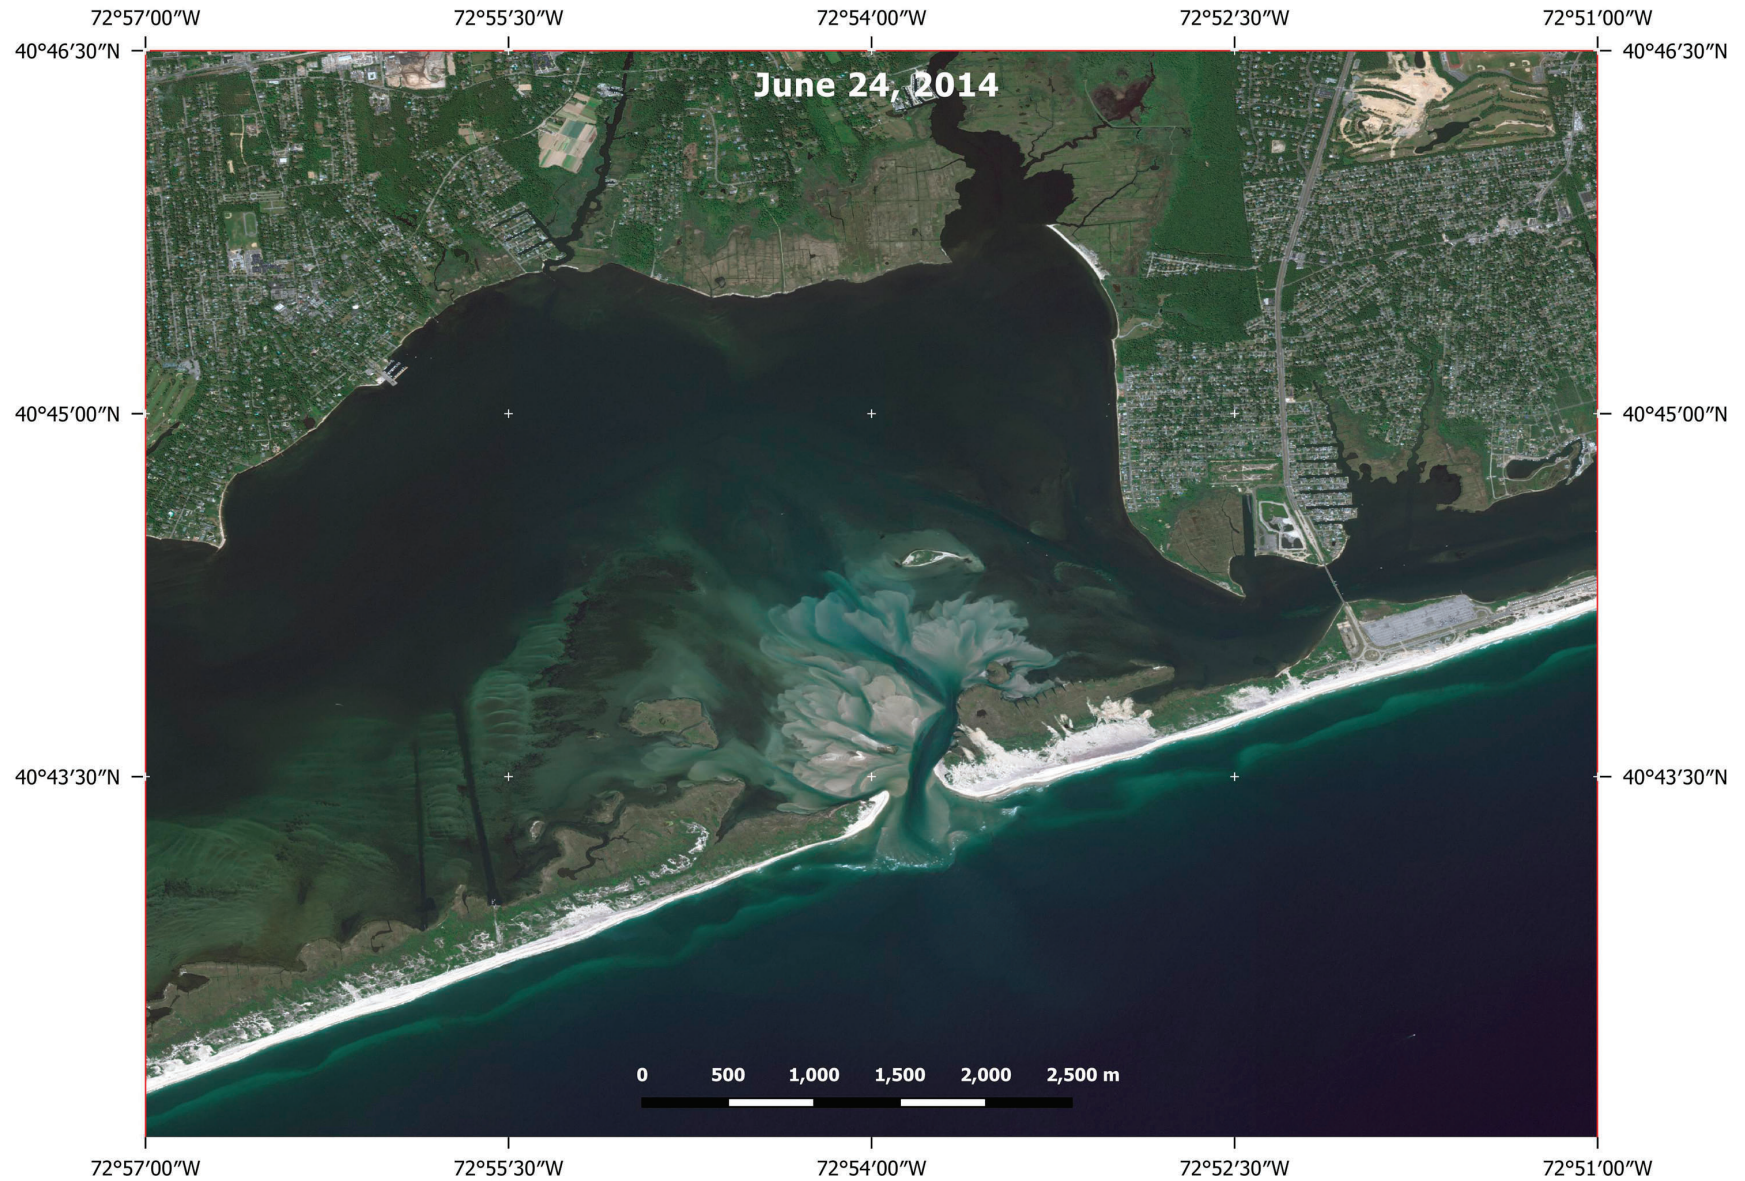
**Figure 2.7.** Maxar WorldView-2 ortho natural color image of part of Fire Island National Seashore, New York, collected June 24, 2014. The scale bar is in meters (m). The resolution is 57 centimeters ground sample distance (GSD).

The widths of the inlet from 2012 through 2022 are listed in [table 1](#). The width of the inlet for each year was obtained by simply measuring a line on the imagery across the inlet at the narrowest section of the inlet. This technique provided a reliable measurement of the size of the inlet for each year as shown in the imagery. These data reveal that the inlet grew in width during the first 4 years, reaching a maximum width of 440 meters in 2016, when it stabilized. A series of storms in the 2013–2014 winter season affected the inlet (NPS, 2016b), forcing it to migrate to the west and deepening its channel. These changes can be observed in [figures 2.6](#) (October 28, 2013) and [2.7](#) (June 24, 2014) in [appendix 2](#).

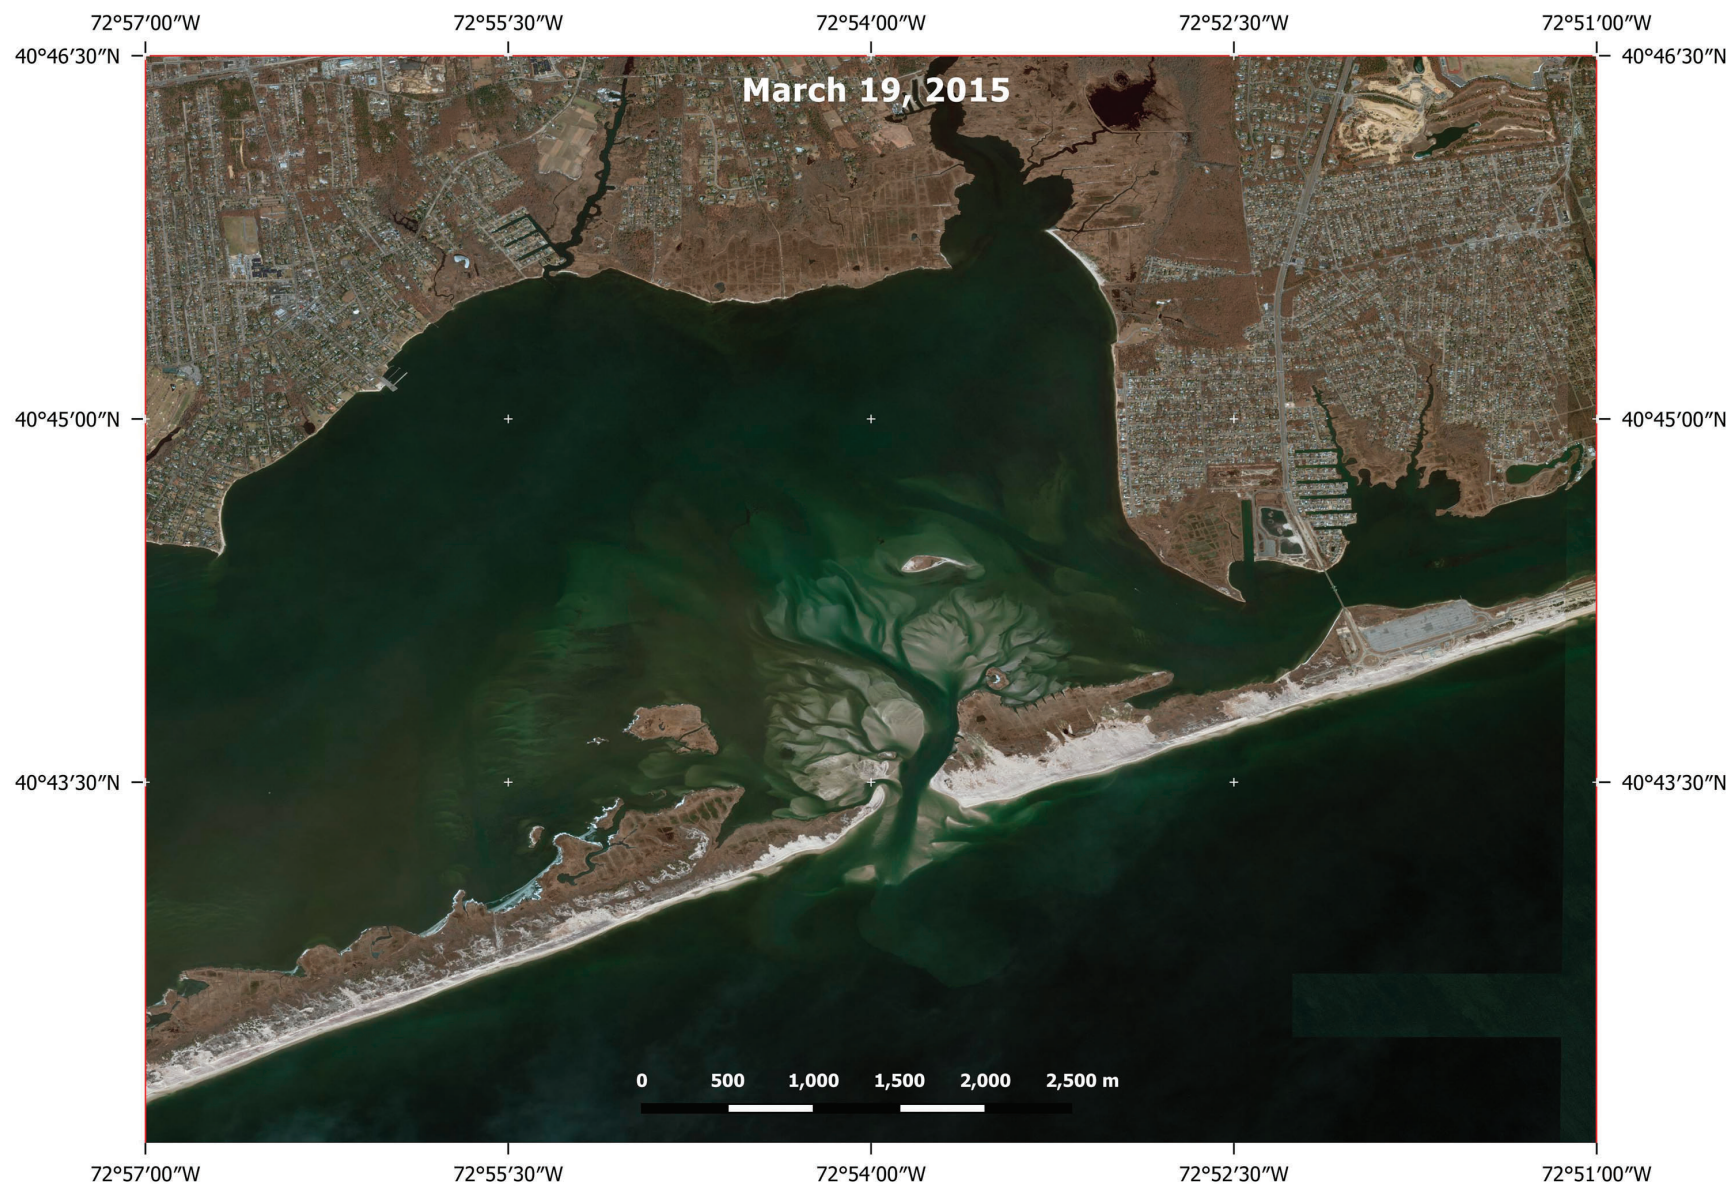
**Figure 2.8.** Maxar WorldView-2 ortho natural color image of part of Fire Island National Seashore, New York, collected March 19, 2015. The scale bar is in meters (m). The resolution is 53 centimeters ground sample distance (GSD).

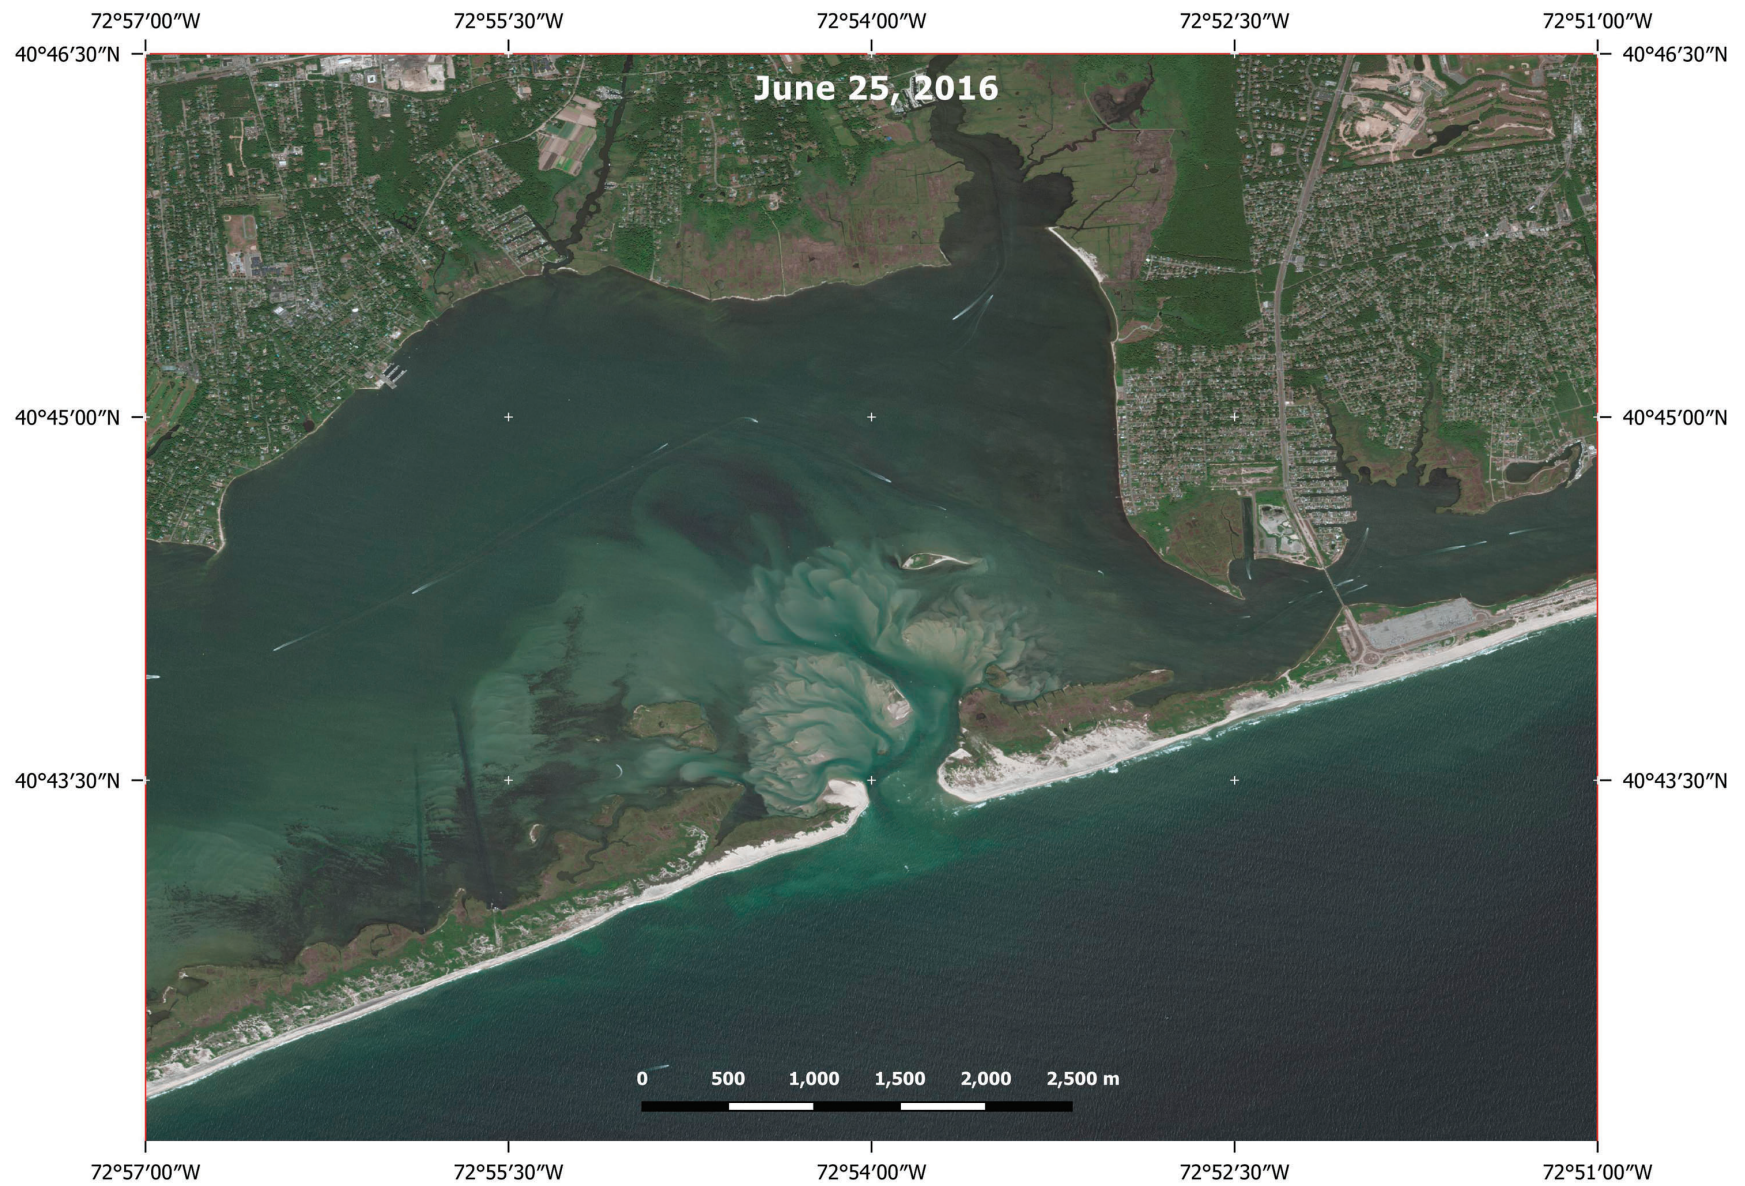
**Figure 2.9.** Maxar WorldView-2 ortho natural color image of part of Fire Island National Seashore, New York, collected June 25, 2016. The scale bar is in meters (m). The resolution is 51 centimeters ground sample distance (GSD).

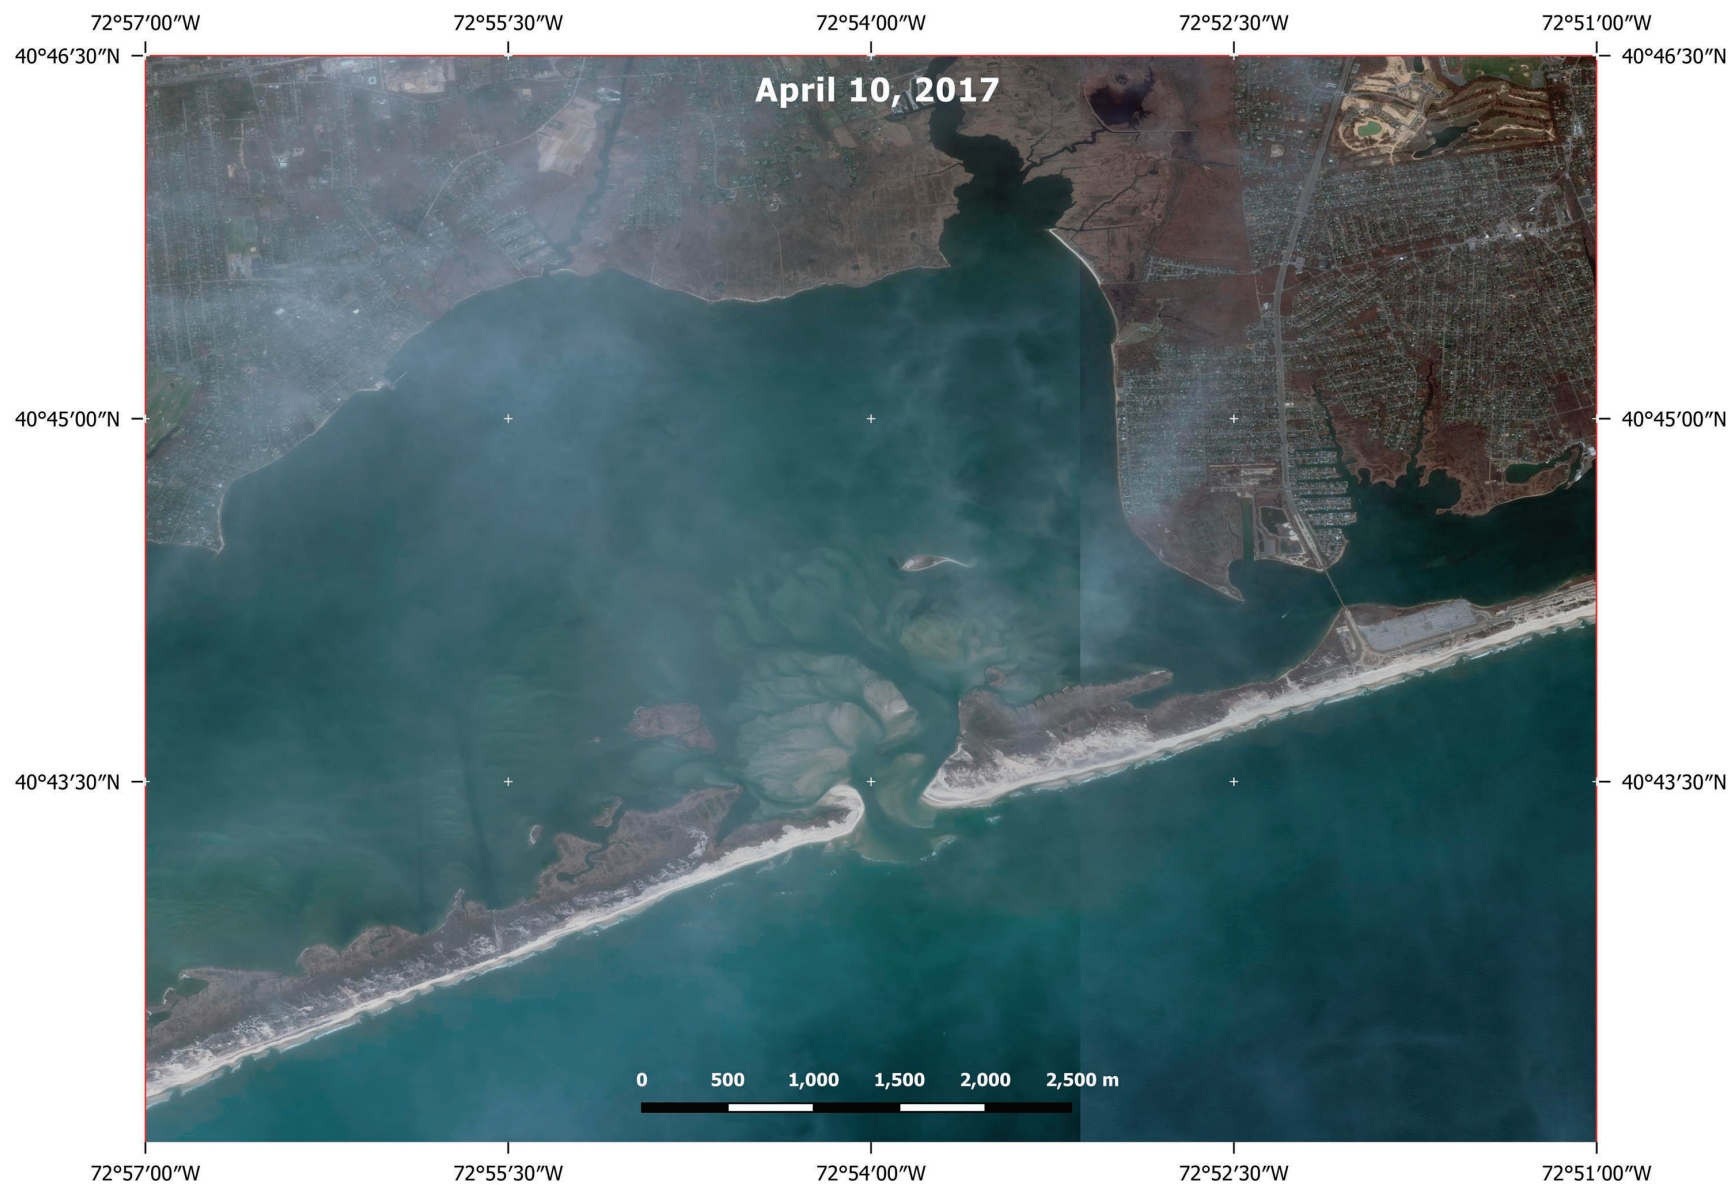
**Figure 2.10.** Maxar WorldView-2 ortho natural color image of part of Fire Island National Seashore, New York, collected April 10, 2017. The scale bar is in meters (m). The resolution is 55 centimeters ground sample distance (GSD).

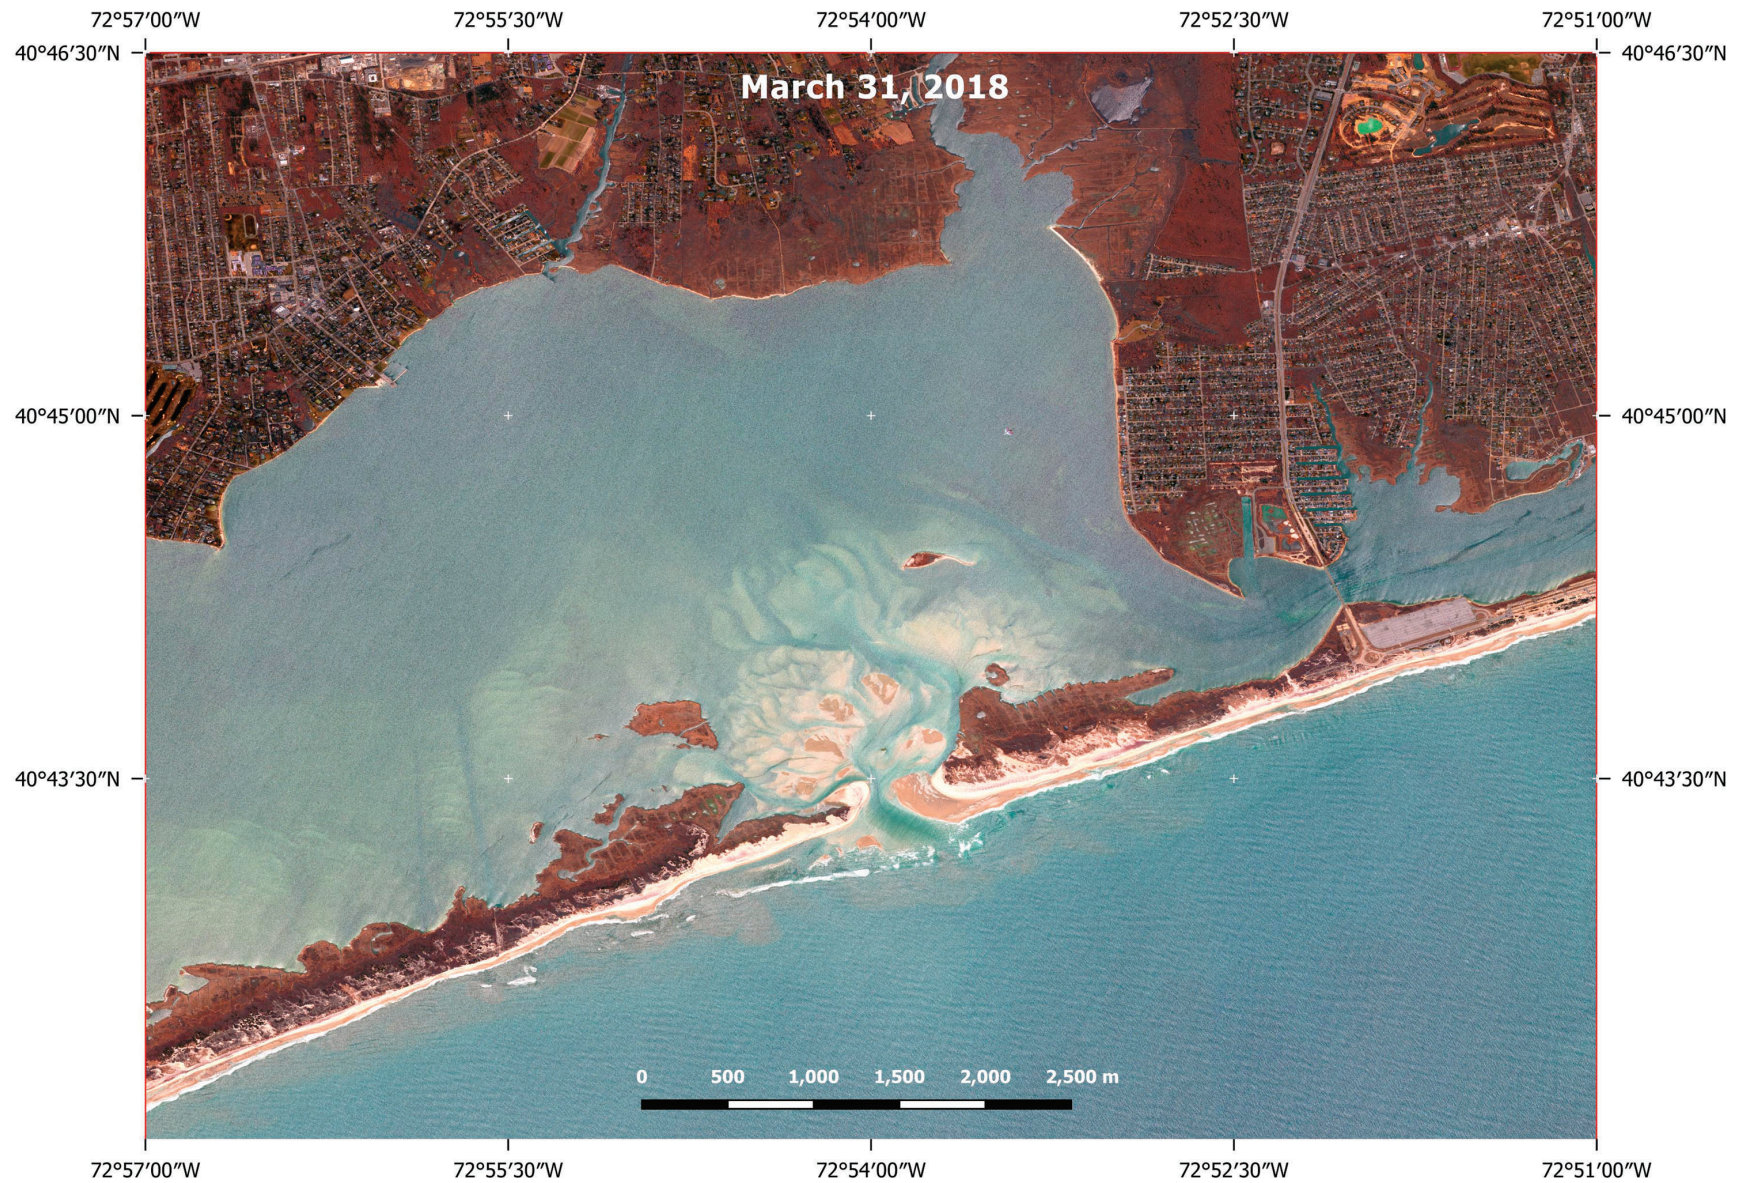
**Figure 2.11.** Maxar WorldView–3 visible near-infrared (VNIR) image of part of Fire Island National Seashore, New York, collected March 31, 2018. The scale bar is in meters (m). The resolution is 40 centimeters ground sample distance (GSD).

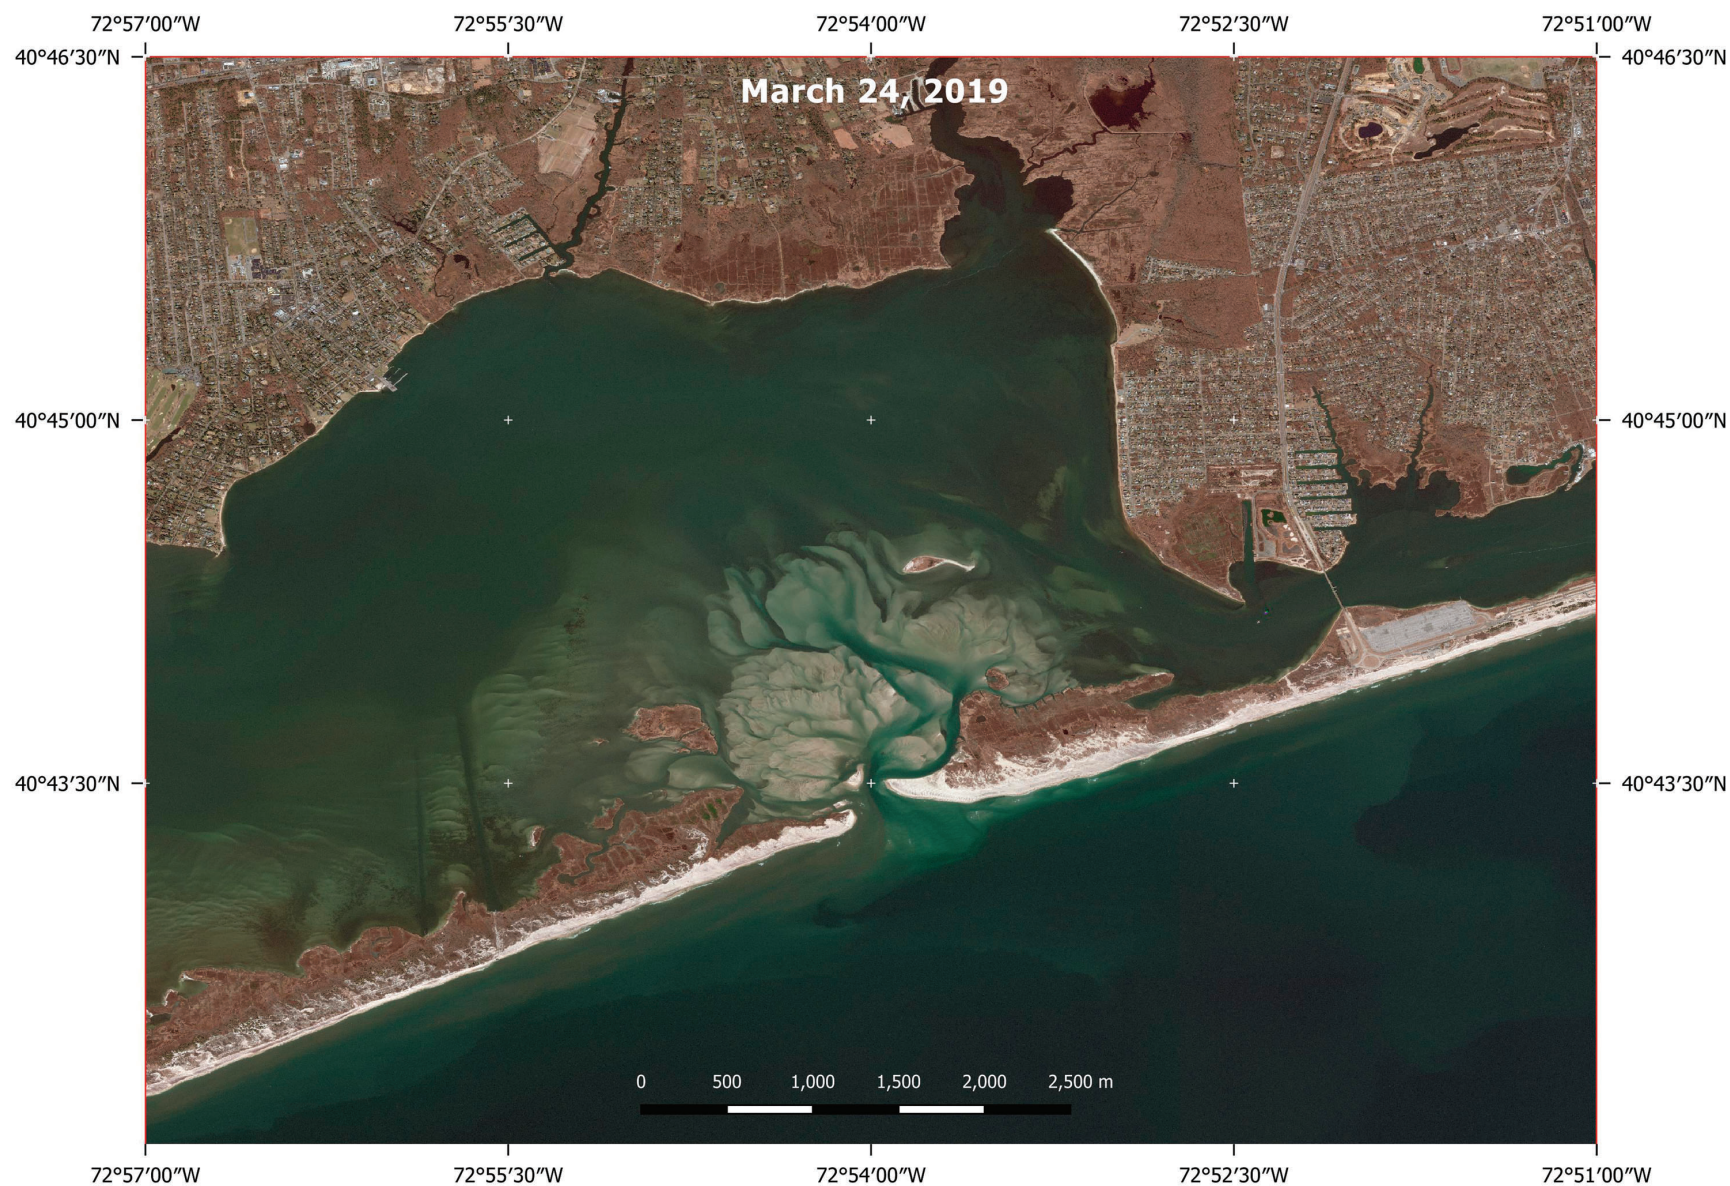
**Figure 2.12.** Maxar GeoEye-1 ortho natural color image of part of Fire Island National Seashore, New York, collected March 24, 2019. The scale bar is in meters (m). The resolution is 52 centimeters ground sample distance (GSD).

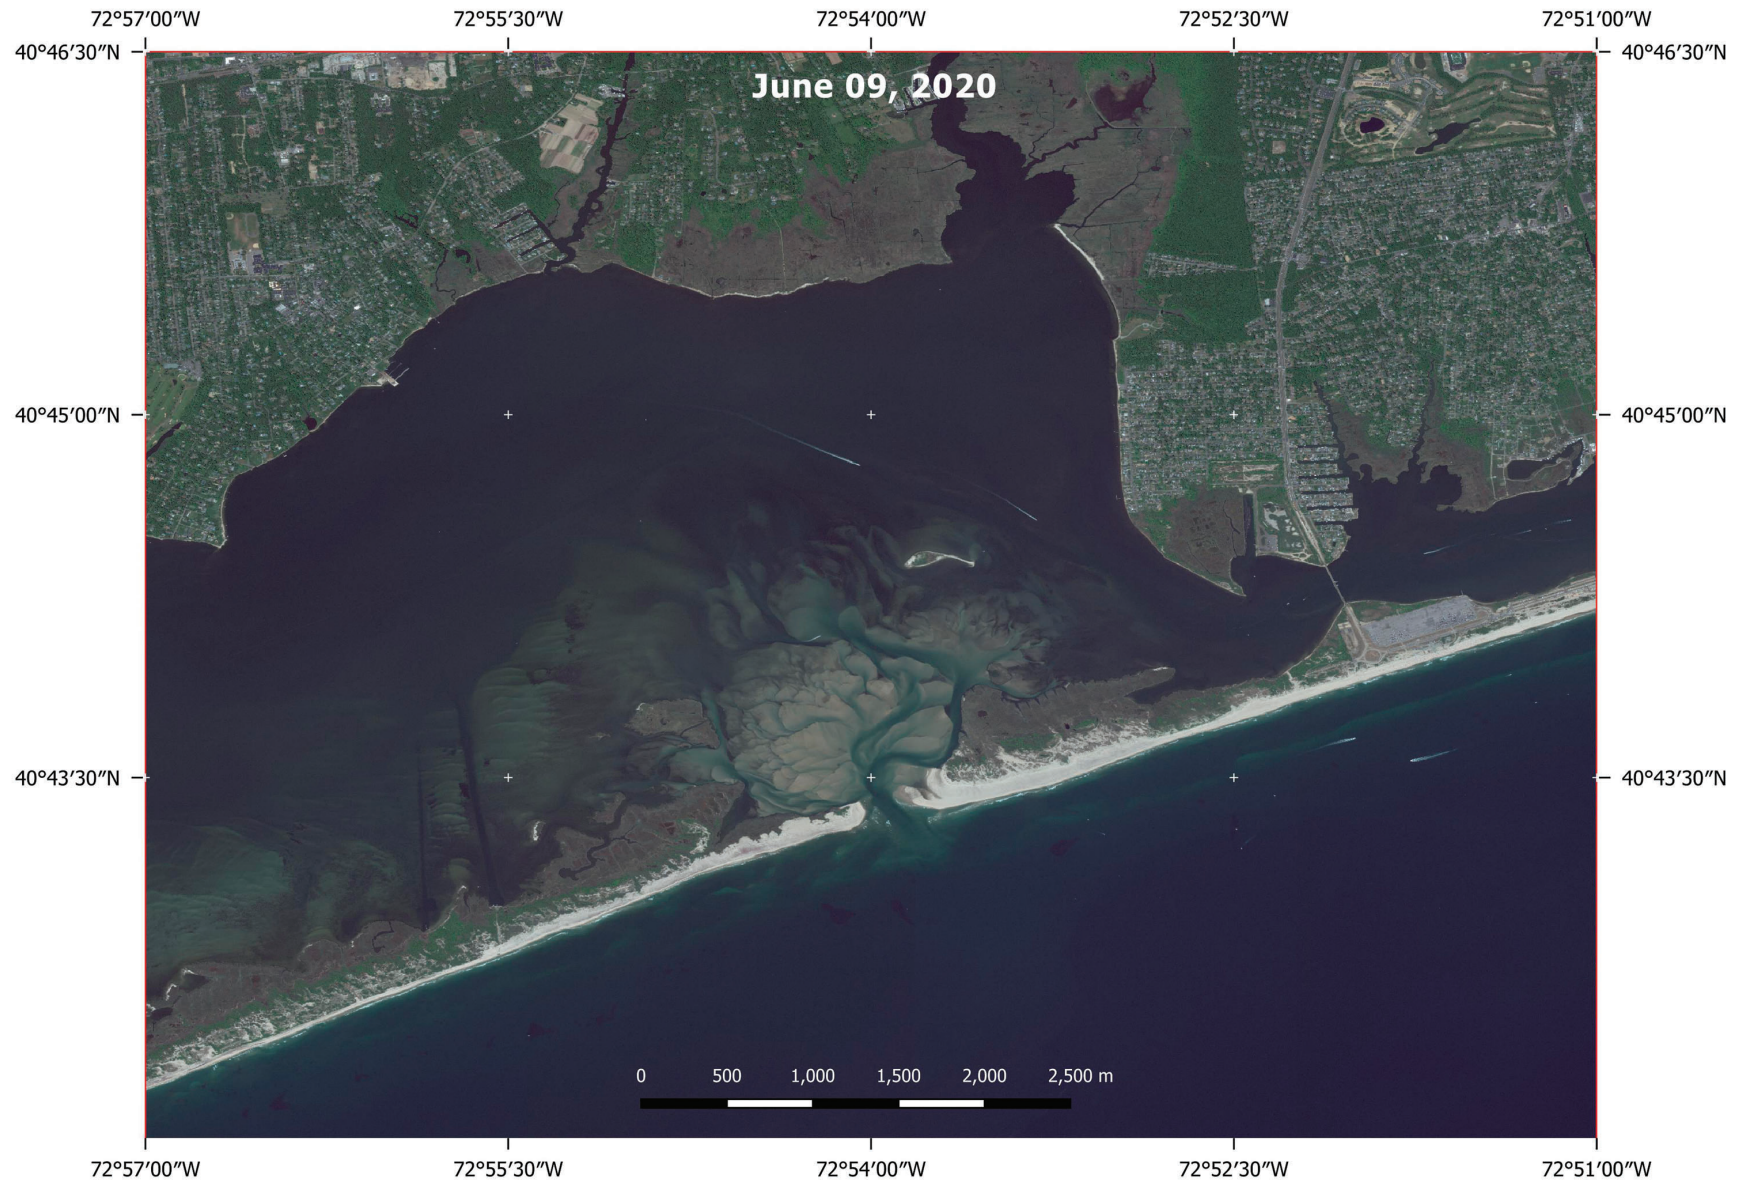
**Figure 2.13.** Maxar WorldView-2 ortho natural color image of part of Fire Island National Seashore, New York, collected June 09, 2020. The scale bar is in meters (m). The resolution is 59 centimeters ground sample distance (GSD).

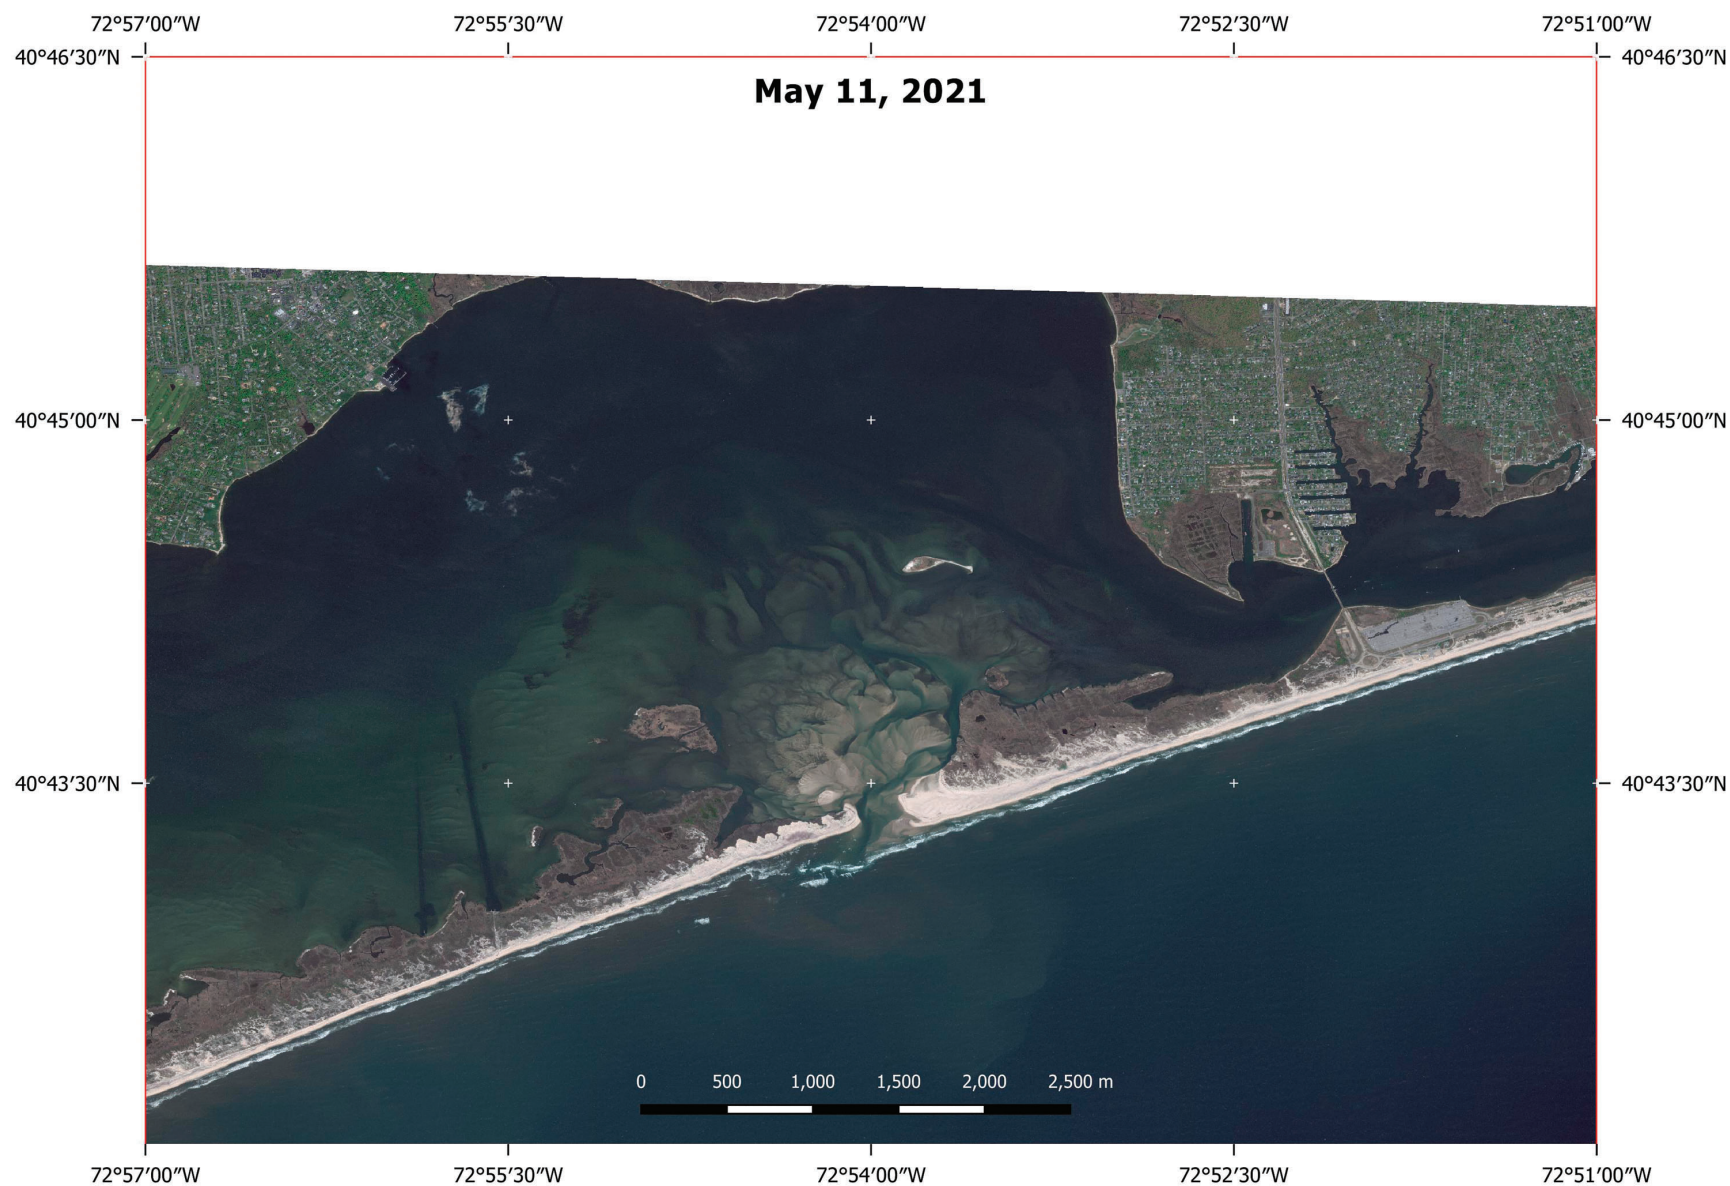
**Figure 2.14.** Maxar WorldView-2 ortho natural color image of part of Fire Island National Seashore, New York, collected May 11, 2021. The scale bar is in meters (m). The resolution is 49 centimeters ground sample distance (GSD).

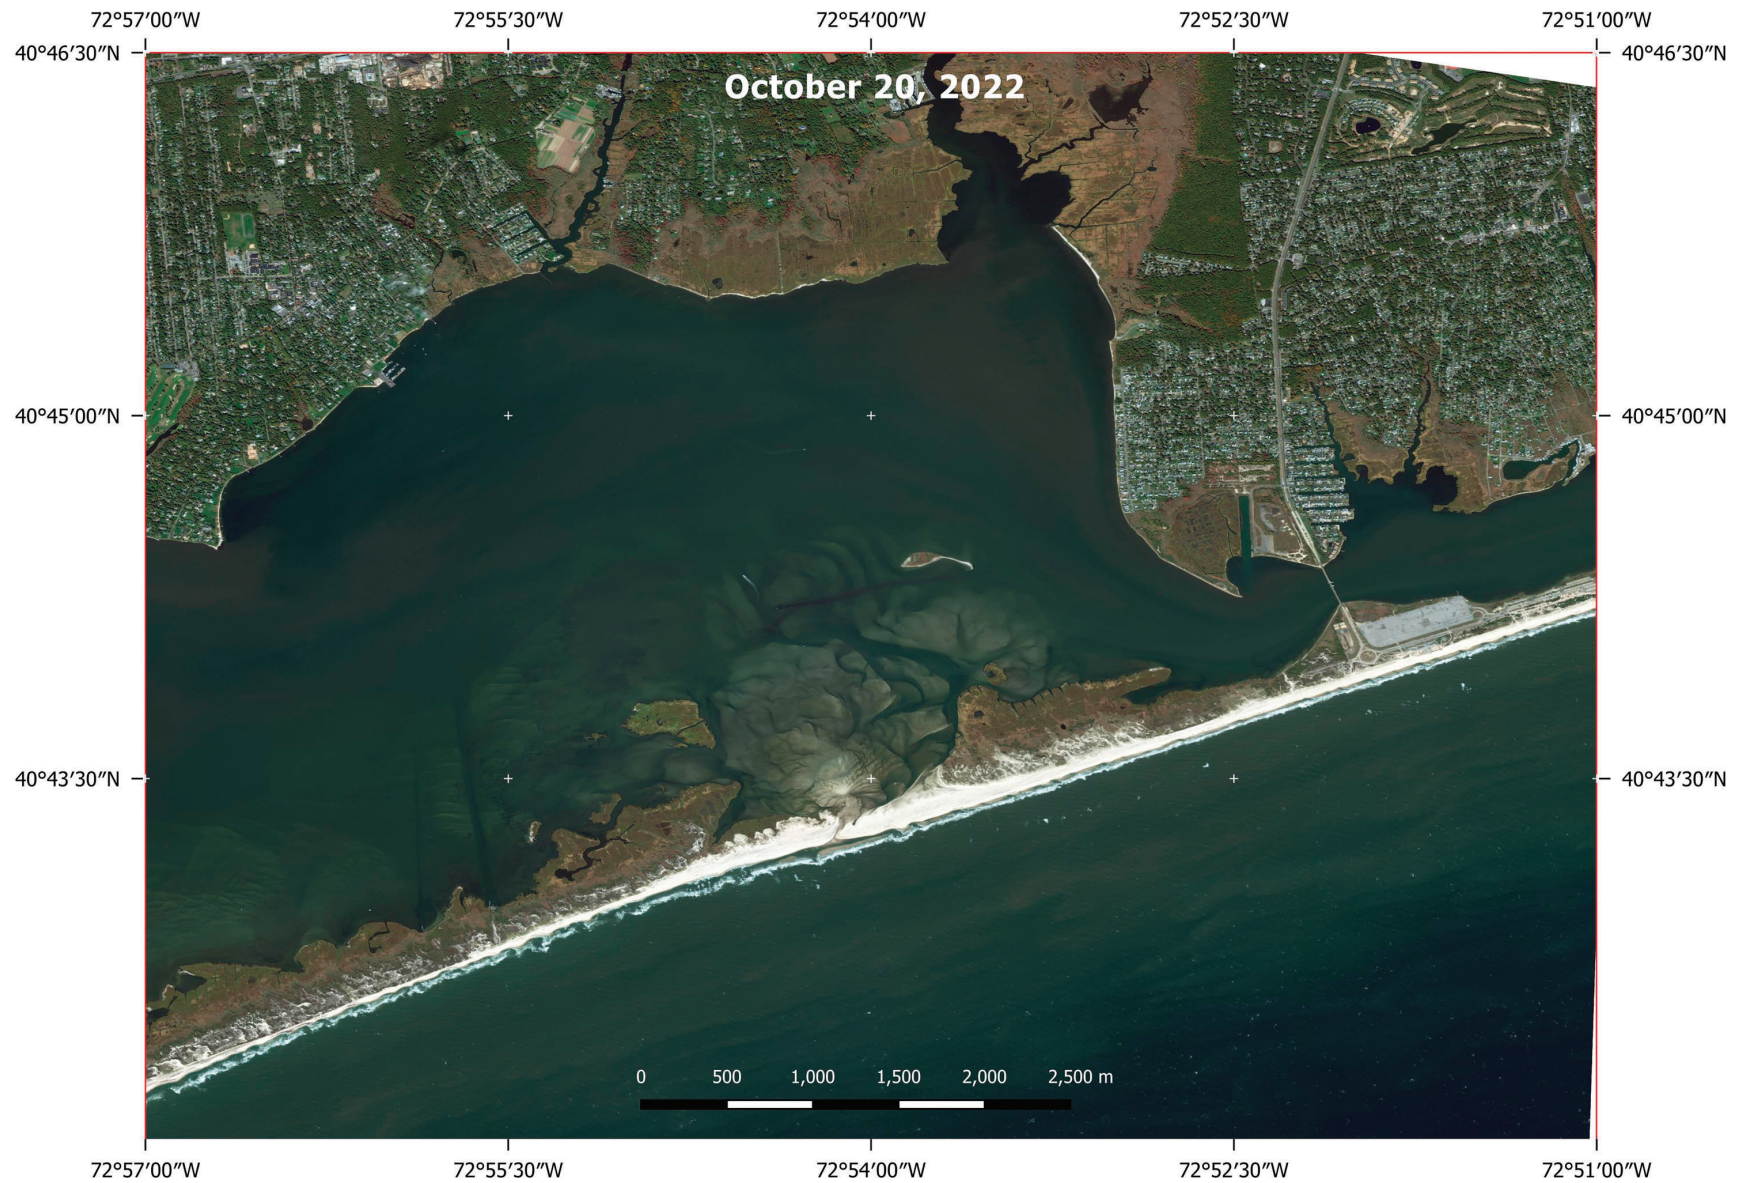
**Figure 2.15.** Maxar WorldView-2 ortho natural color image of part of Fire Island National Seashore, New York, collected October 20, 2022. The scale bar is in meters (m). The resolution is 64 centimeters ground sample distance (GSD).

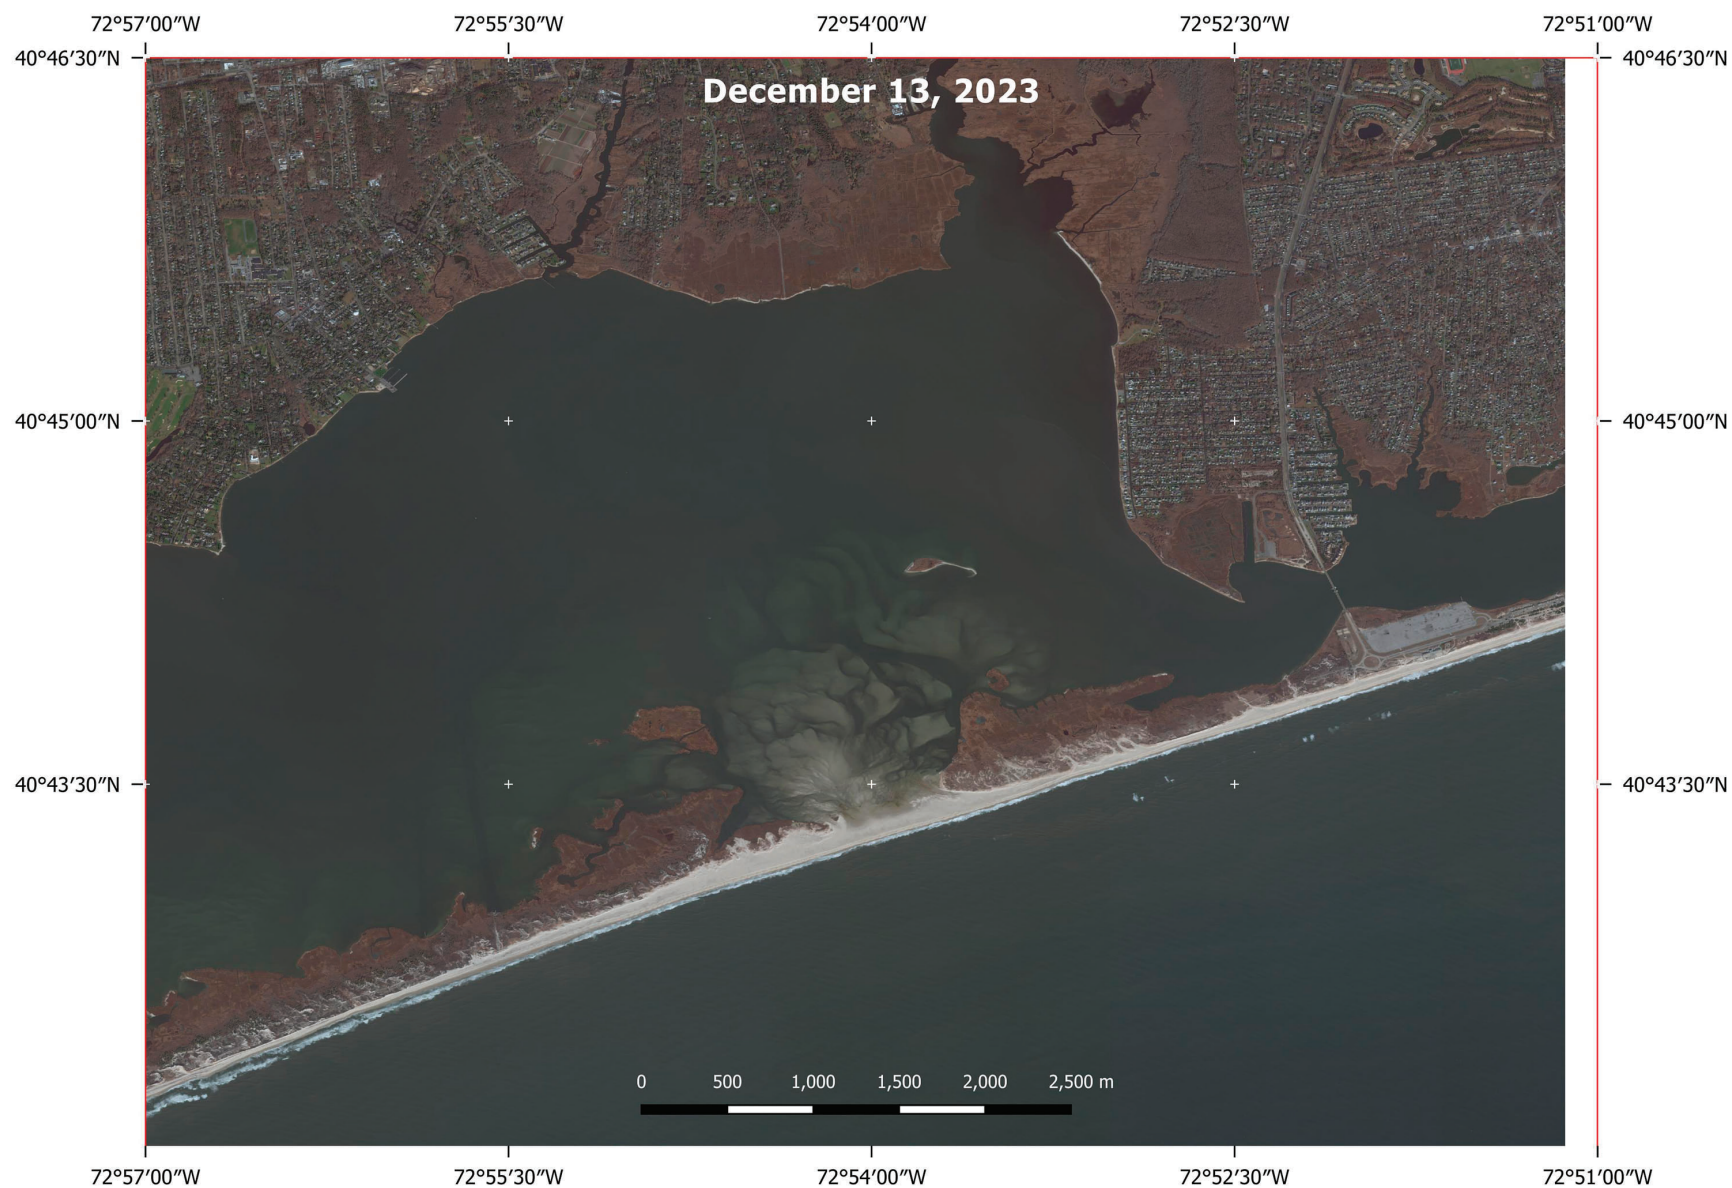
**Figure 2.16.** Maxar WorldView–2 ortho natural color image of part of Fire Island National Seashore, New York, collected December 13, 2023. The scale bar is in meters (m). The resolution is 57 centimeters ground sample distance (GSD). The Wilderness Breach had closed in late 2022.
