# **Using High-Resolution Geospatial Imagery and Data To Document the Evolution of the Wilderness Breach That Was Created by Hurricane Sandy in 2012 at Fire Island National Seashore, New York**

Open-File Report 2025–1020

By Gary B. Fisher

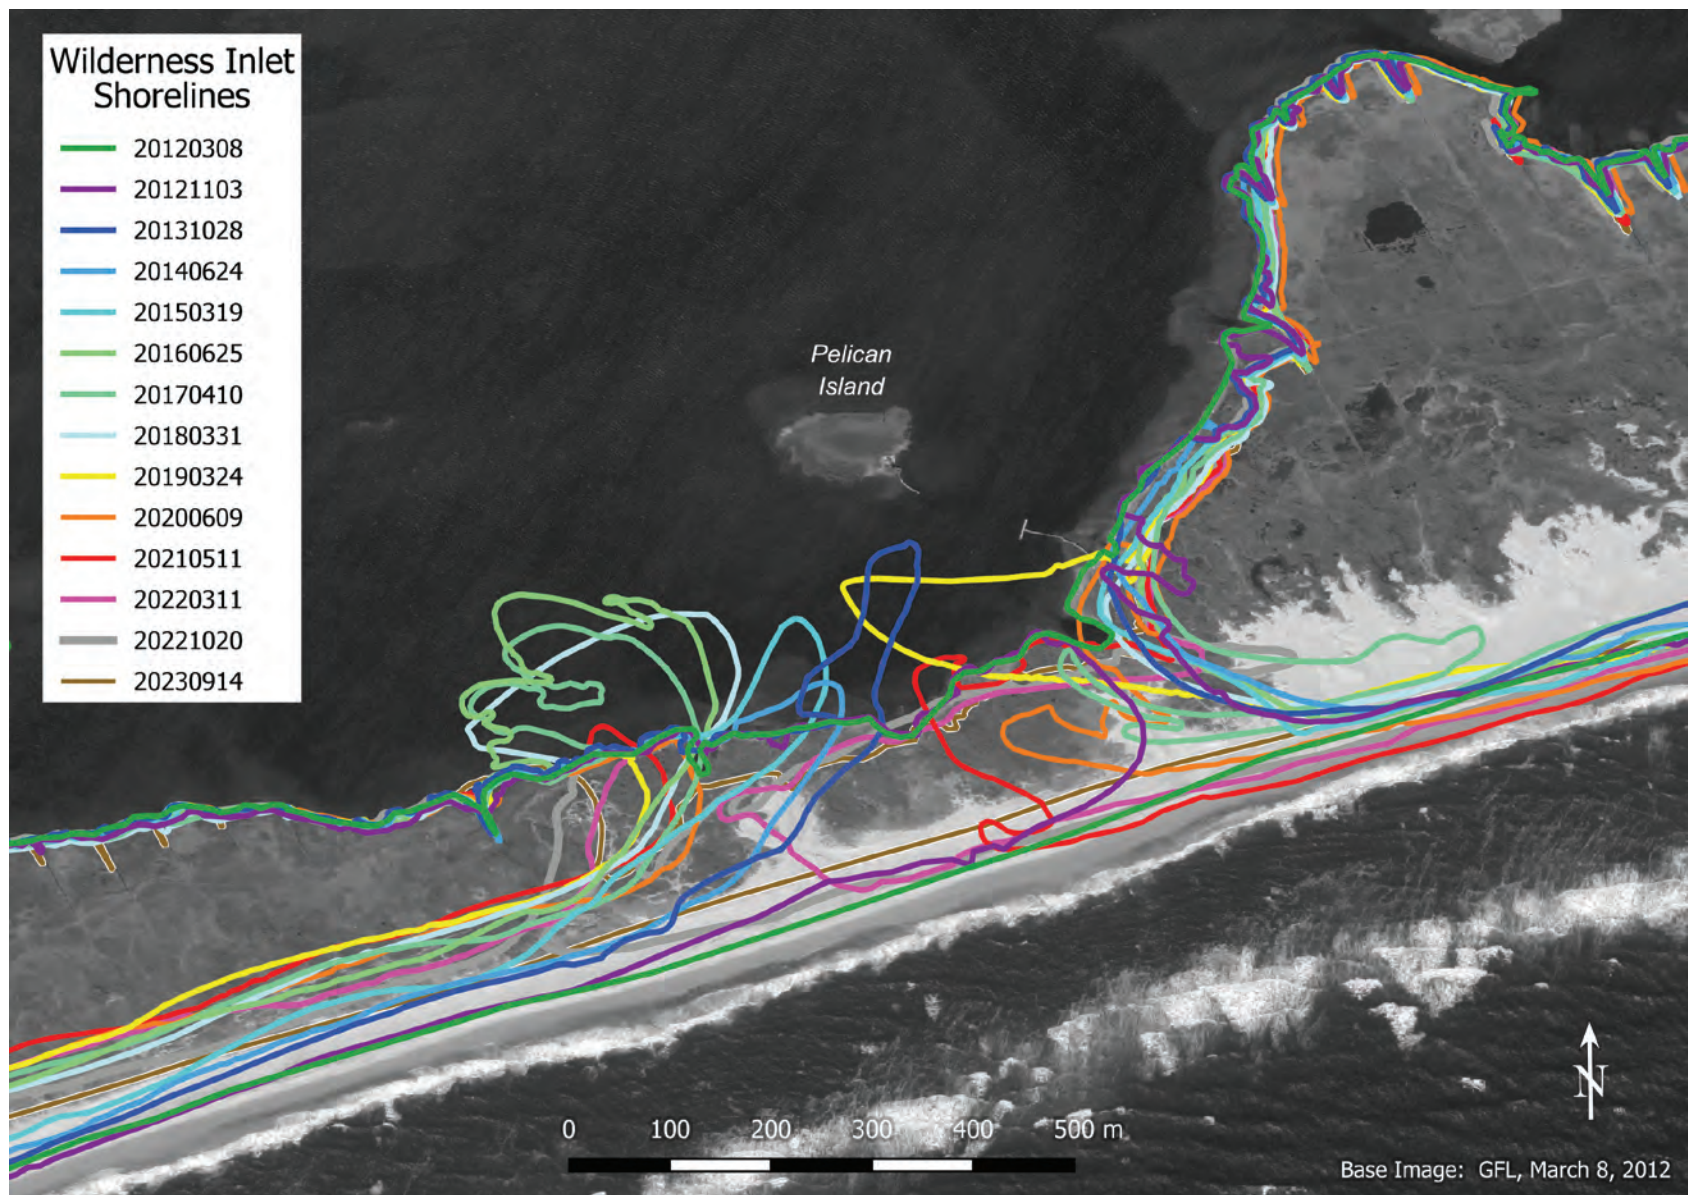
**Figure 3.** Satellite image map showing shorelines at the Wilderness Breach, Fire Island National Seashore, New York, 2012–2023. The image is from the Global Fiducials Library (<https://www.usgs.gov/global-fiducials-library-data-access-portal>), and it was collected on March 8, 2012. The scale bar is in meters (m).

The widths of the inlet from 2012 through 2022 are listed in [table 1](#). The width of the inlet for each year was obtained by simply measuring a line on the imagery across the inlet at the narrowest section of the inlet. This technique provided a reliable measurement of the size of the inlet for each year as shown in the imagery. These data reveal that the inlet grew in width during the first 4 years, reaching a maximum width of 440 meters in 2016, when it stabilized. A series of storms in the 2013–2014 winter season affected the inlet (NPS, 2016b), forcing it to migrate to the west and deepening its channel. These changes can be observed in [figures 2.6](#) (October 28, 2013) and [2.7](#) (June 24, 2014) in [appendix 2](#).

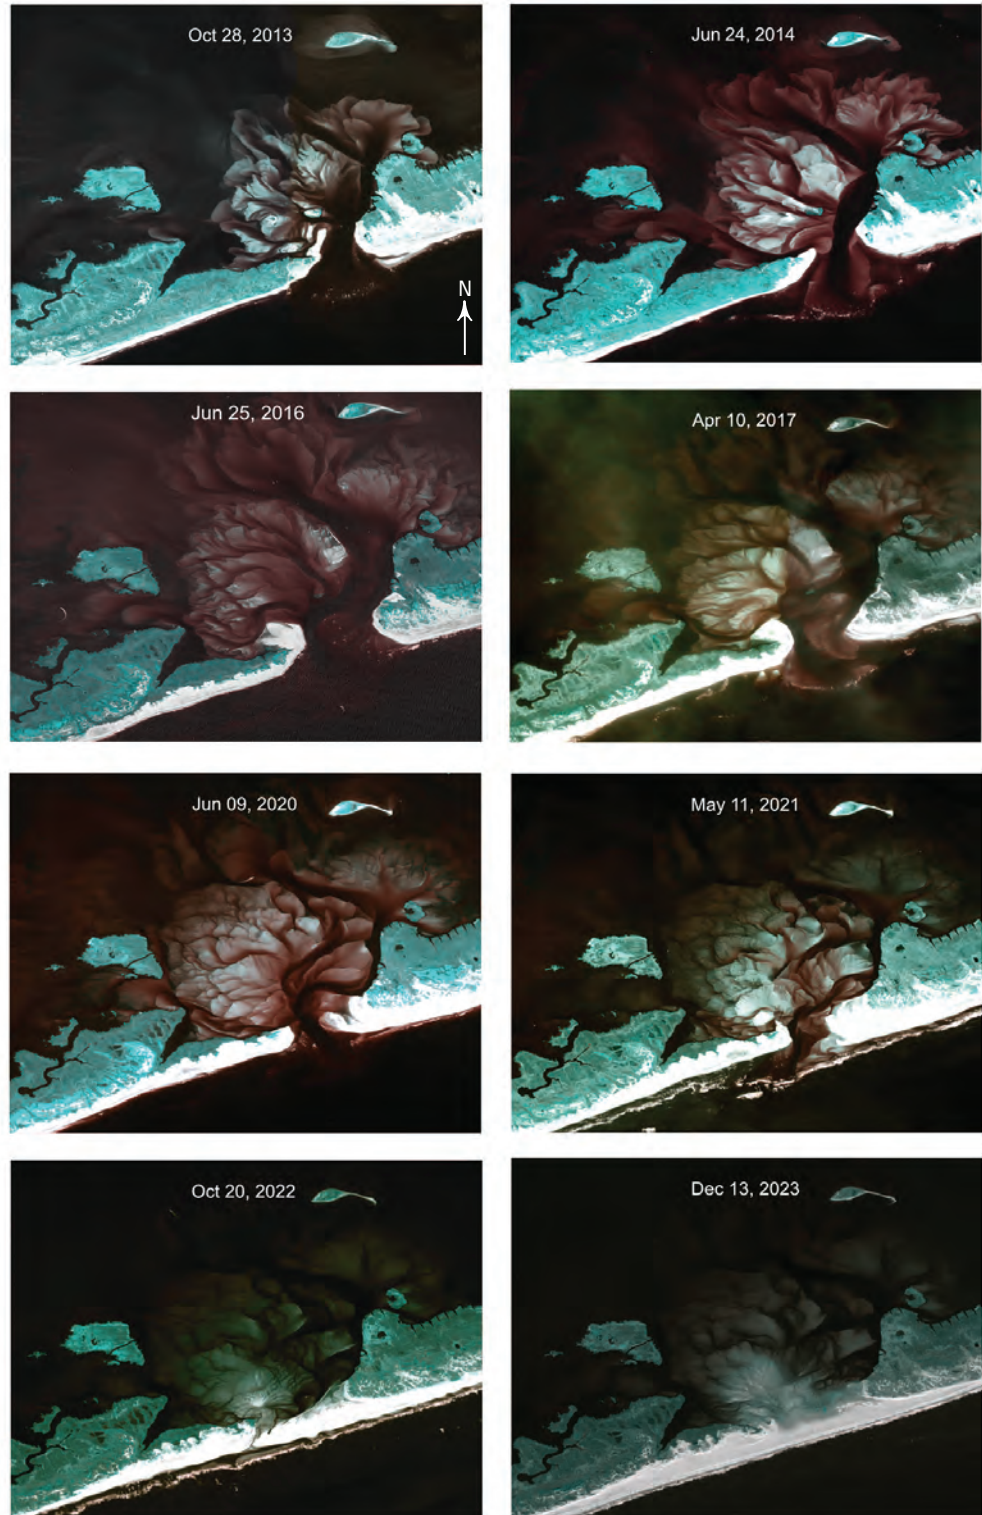
**Figure 4.** A collection of eight WorldView-2 multispectral images of the flood shoal delta at the Wilderness Breach, Fire Island National Seashore, New York. The images were collected on October 28, 2013; June 24, 2014; June 25, 2016; April 10, 2017; June 9, 2020; May 11, 2021; October 20, 2022; and December 13, 2023. The colors in the multispectral images represent differences in reflectance values of the material that is shown. The benefit of this imagery is being able to clearly see fine-grained material that has a brighter color against more compacted stable material that is highlighted in aqua. White represents a higher reflectance value in the imagery. The brighter white in the imagery represents coarser material such as fine-grained sand particles that do not hold together well and are susceptible to erosion. The light-green coloring represents a more stable landscape that has a healthy vegetation covering that holds the sediment together and will tolerate overwash better than the fine-grained beach material. The reddish-brown coloring represents submerged material that has accumulated in the shoal delta. This material is typically fine grained, loosely distributed, and very susceptible to erosion and movement during wave or tidal flow changes.

and John Boyle Island into Bellport Bay ([fig. 2](#)). It remained stable until late 2022 when the inlet closed, ending sediment transport into the bay. Between 2020 and December 2023, the area of the flood shoal delta decreased in size from 2,755,327 square meters (m<sup>2</sup>) to 1,291,971 m<sup>2</sup>. WorldView MSI was utilized to highlight the flood shoal delta on selected dates from 2013 through 2023 ([fig. 4](#)).

These images reveal that while the overall shape and morphology of the flood shoal delta remained constant, the area and extent of the feature changed over time in relation to the size of the inlet opening that provided sediment to allow this feature to grow or shrink in size. Once the Wilderness Breach began to close in 2022, the flood shoal delta correspondingly began to shrink.

[Multispectral images used to obtain the measurements are in [figure 4](#). GSD, ground sample distance]

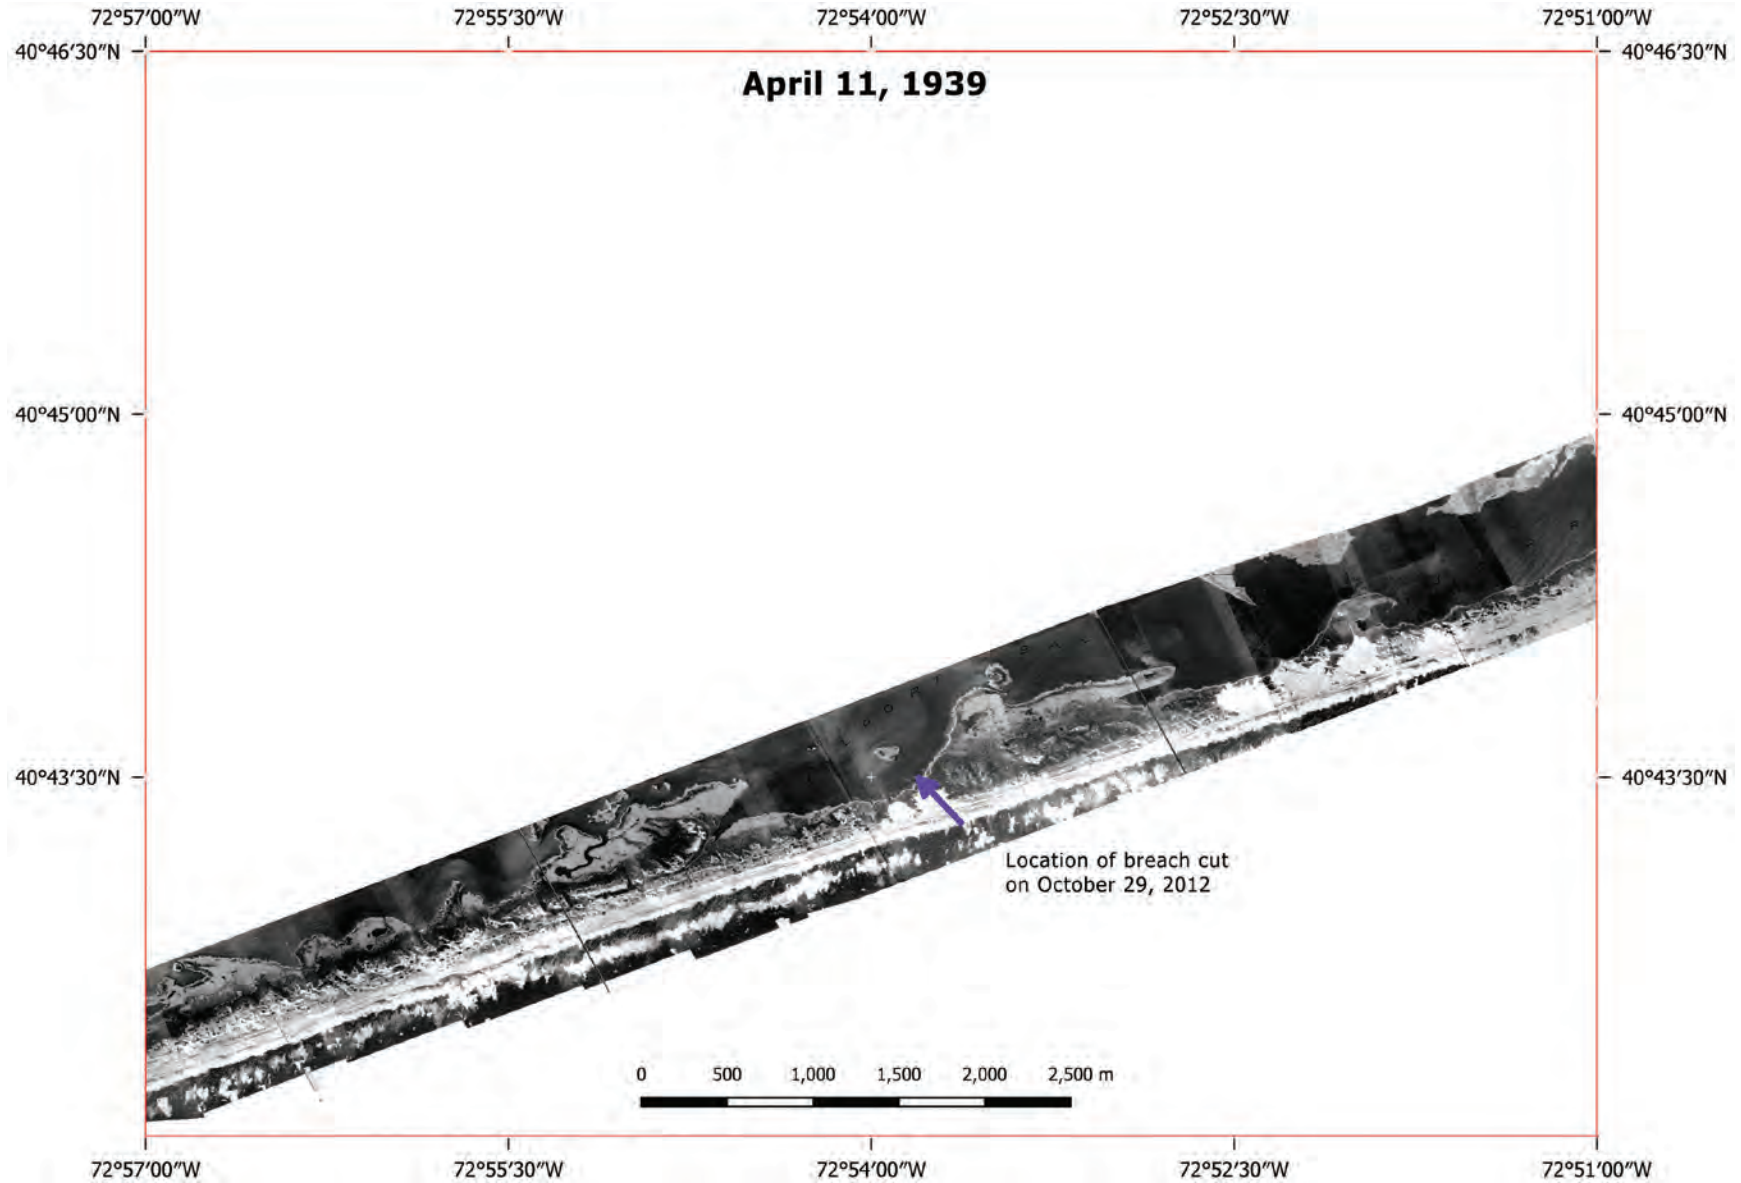
**Figure 2.1.** Aerial photography of part of Fire Island National Seashore, New York, collected by U.S. Army Air Corps, April 11, 1939, after a category 3 hurricane hit New York, Long Island, Fire Island, and New England on September 21, 1938. A blue arrow added to the black-and-white photomosaic indicates the location of the Wilderness Breach that cut Fire Island on October 29, 2012. The scale bar is in meters (m). The resolution is unknown.

Since the Wilderness Breach formed in 2012, a significant amount of remote sensing data has been collected over the breach. [Appendix 1](#) provides a list of some of the data that are available about this site, and [appendix 2](#) provides the images identified in [appendix 1](#). The U.S. Army Air Corps (predecessor of the U.S. Air Force) collected aerial photography over Fire Island on April 11, 1939. This imagery provides details on how the island looked prior to the changes at Smith Point, just east of the site where the Wilderness Breach occurred ([fig. 2.1](#) in [app. 2](#)).

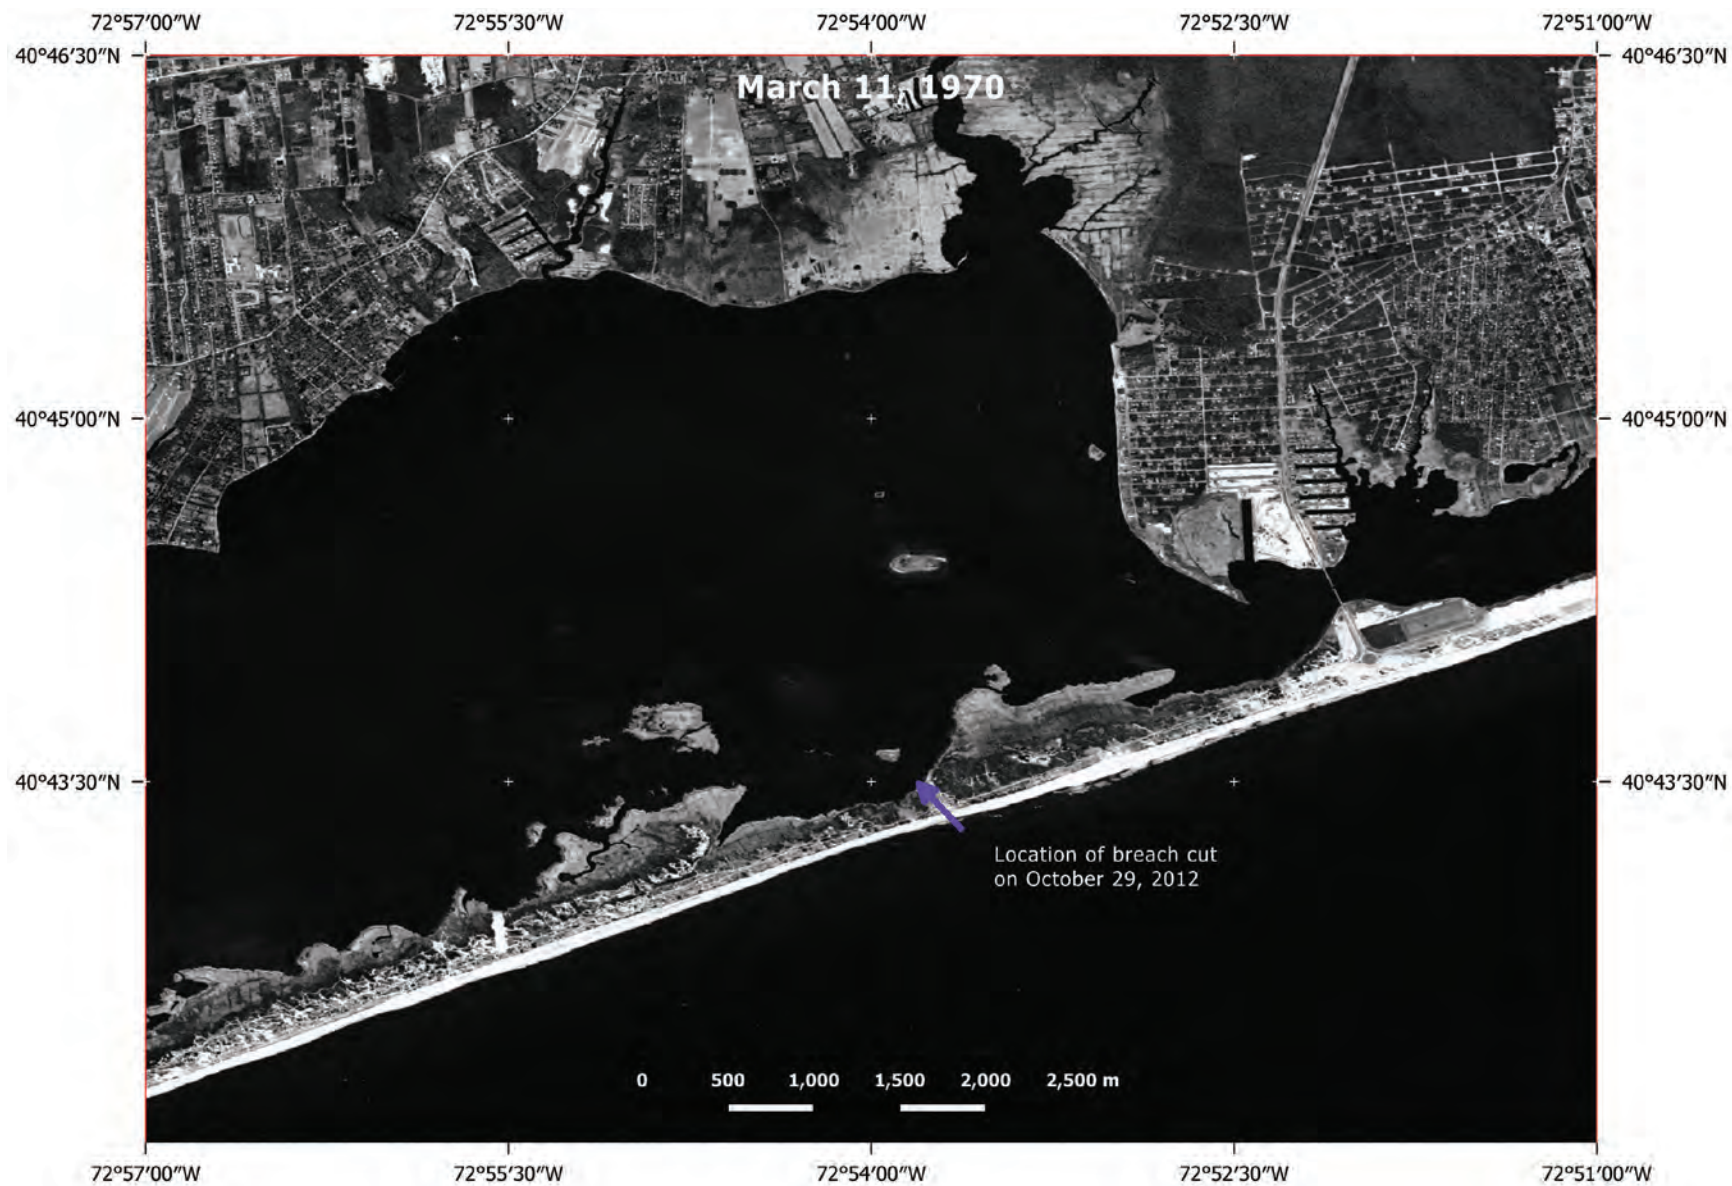
**Figure 2.2.** Declassified KH-4B (CORONA) satellite imagery of part of Fire Island National Seashore, New York, collected March 11, 1970. A blue arrow indicates the location of the Wilderness Breach that cut Fire Island on October 29, 2012. The scale bar is in meters (m). The resolution is 1.82 m ground sample distance (GSD).

Declassified CORONA and HEXAGON images shown in [figures 2.2](#) and [2.3](#) in [appendix 2](#) provide a detailed look at the study area during a period of relative stability on the island. The manmade changes at Smith Point are observed upcurrent from the location of the future breach.

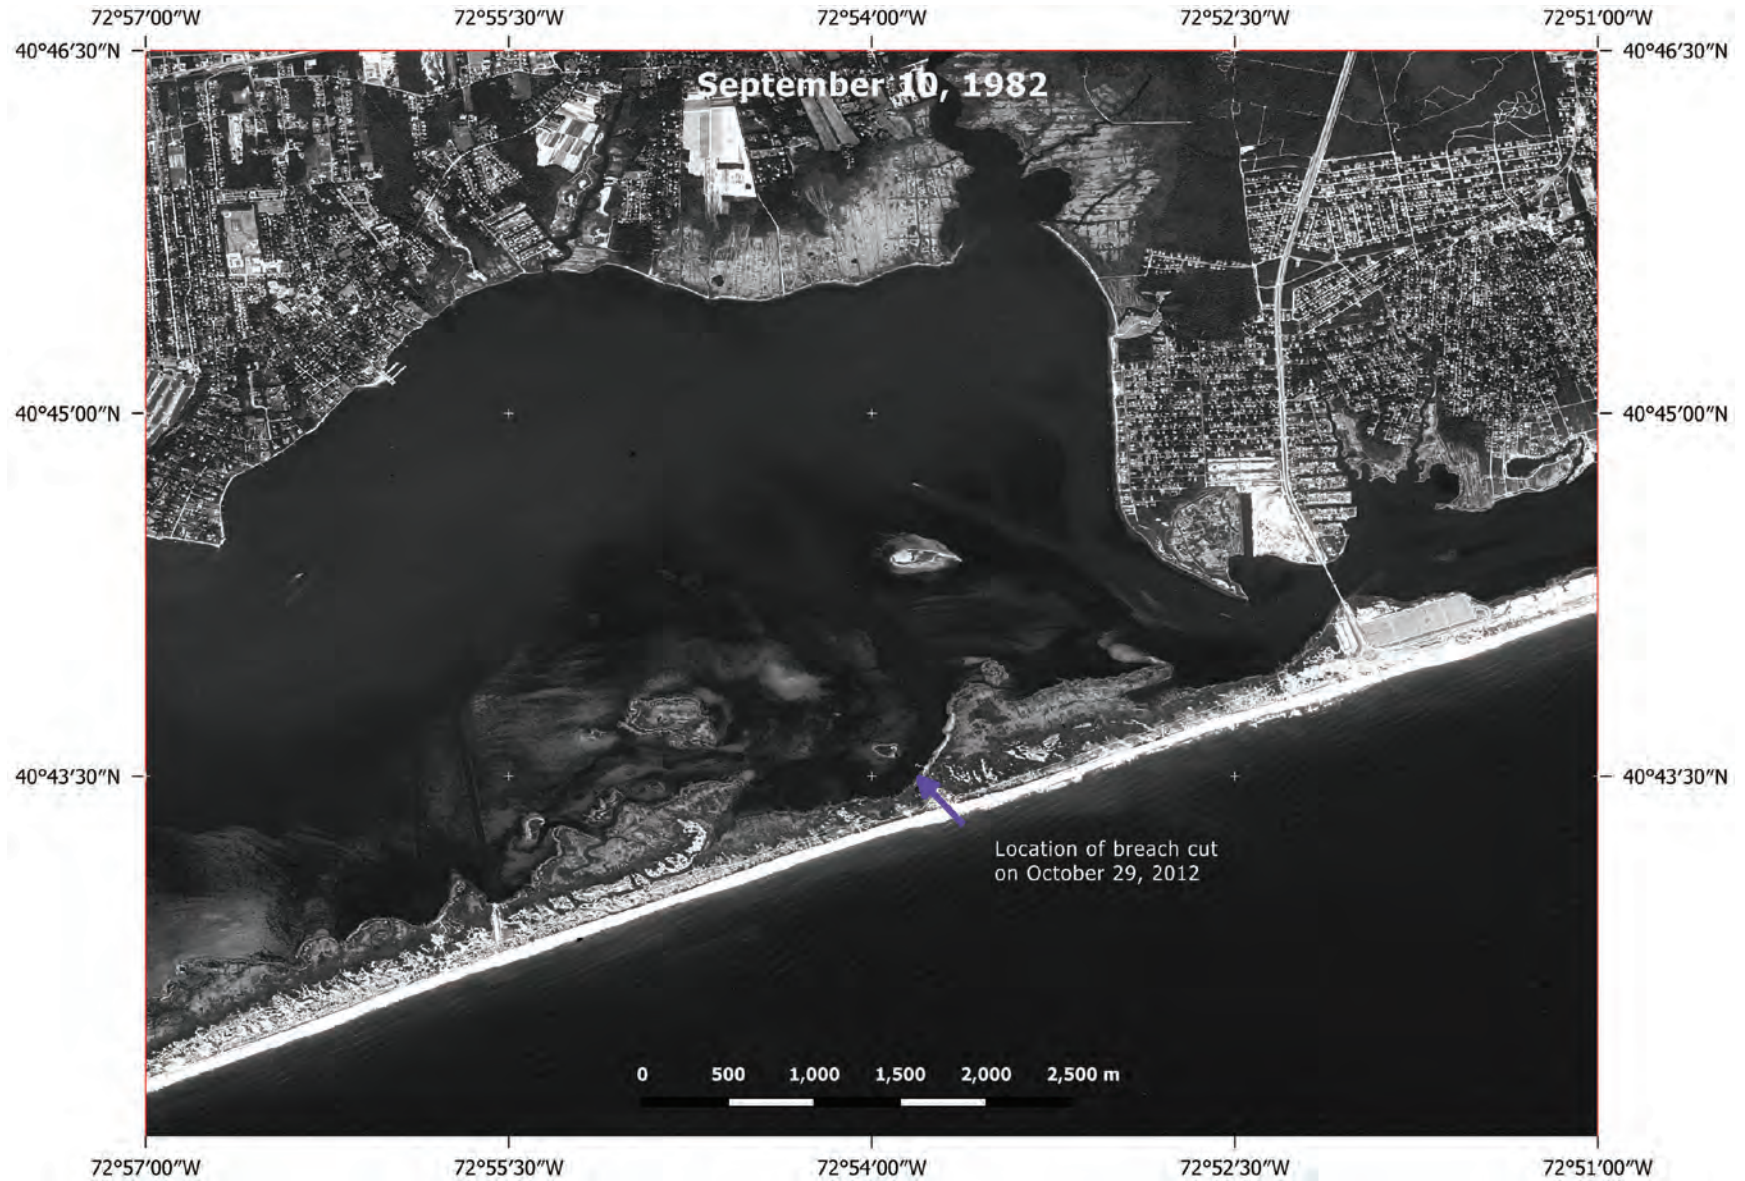
**Figure 2.3.** Declassified KH-9 (HEXAGON) satellite imagery of part of Fire Island National Seashore, New York, collected September 10, 1982. A blue arrow indicates the location of the Wilderness Breach that cut Fire Island on October 29, 2012. The scale bar is in meters (m). The resolution is 0.61 m ground sample distance (GSD).

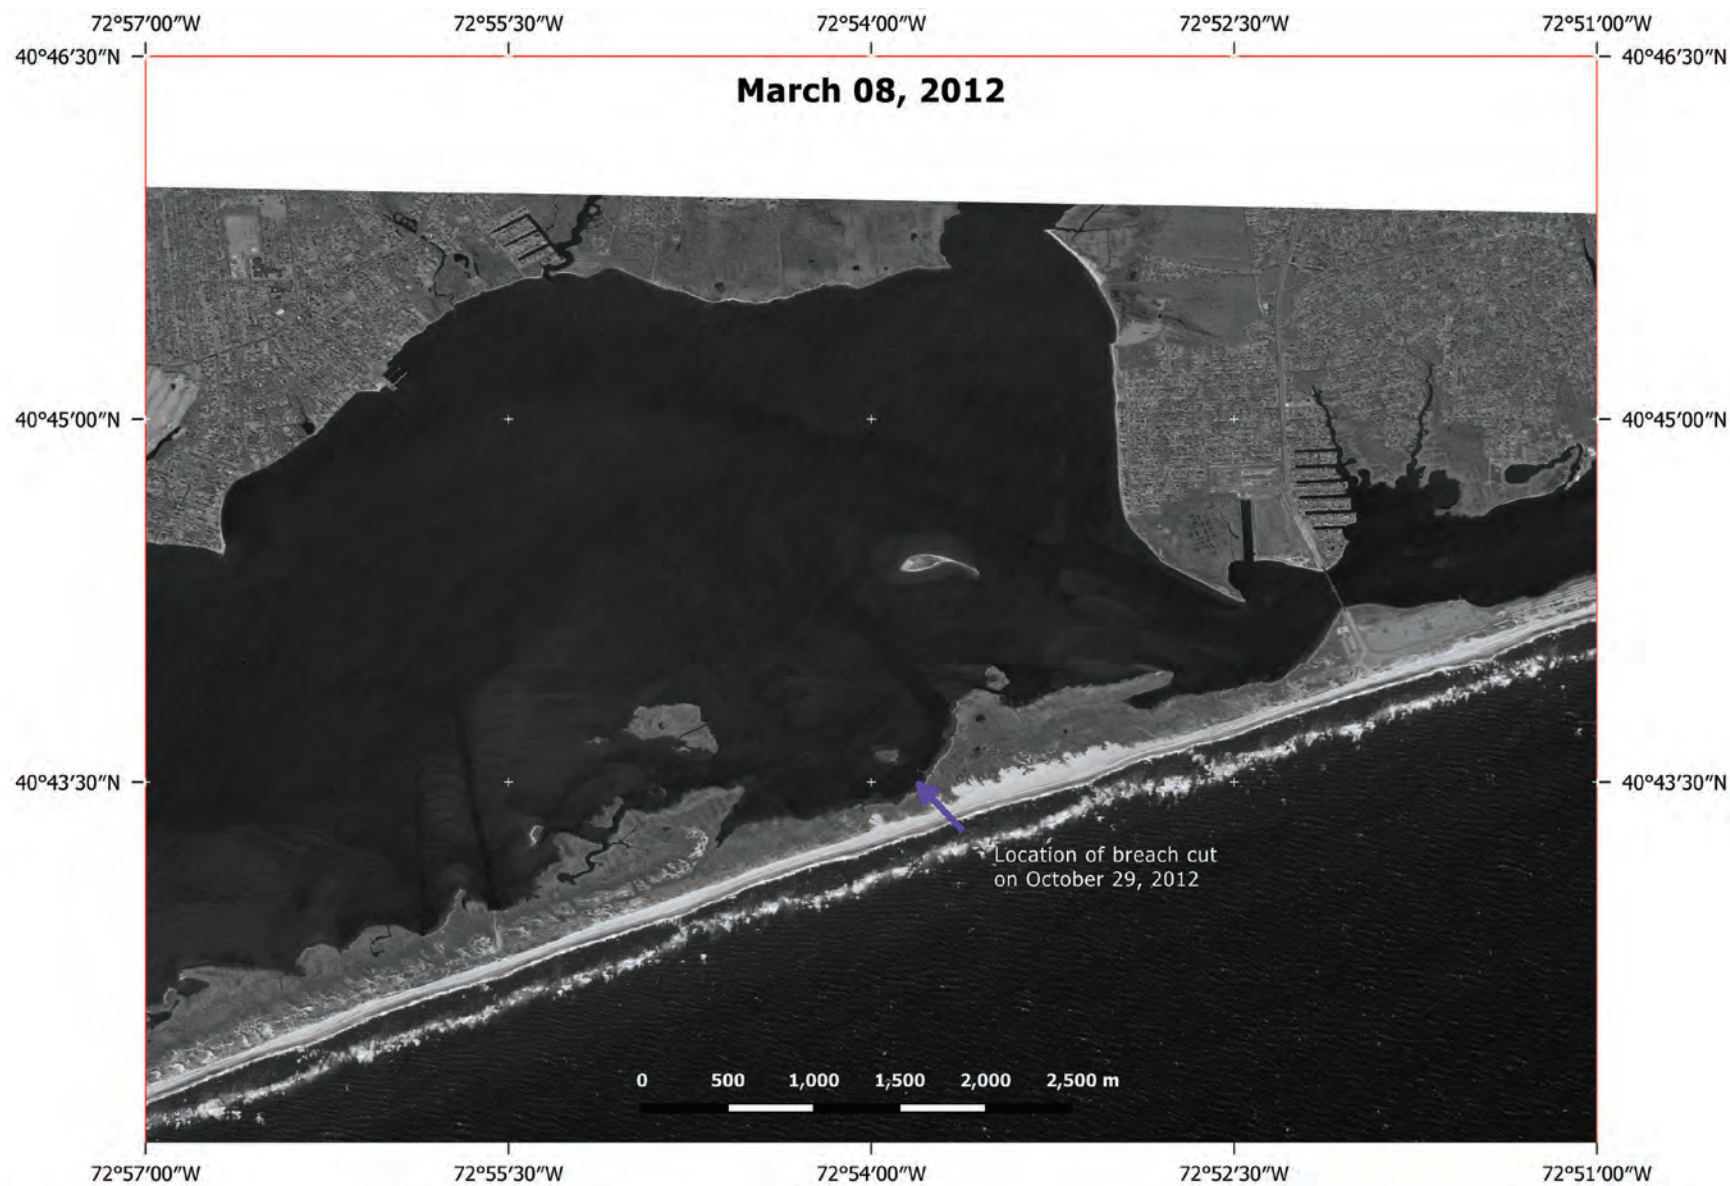
**Figure 2.4.** Global Fiducials Library panchromatic imagery of part of Fire Island National Seashore, New York, collected March 08, 2012, before Hurricane Sandy created the Wilderness Breach of Fire Island on October 29, 2012. A blue arrow indicates the location of the Wilderness Breach. The scale bar is in meters (m). The resolution is 1 m ground sample distance (GSD).

Analysis of imagery collected during the 14 years prior to November 2012 shows minimum change. The GFL image collected March 8, 2012, is [figure 2.4](#) of [appendix 2](#); it provides a detailed record of the conditions on Fire Island at the Otis Pike Fire Island High Dune Wilderness area prior to the breach being cut across the island in late 2012 during Hurricane Sandy.

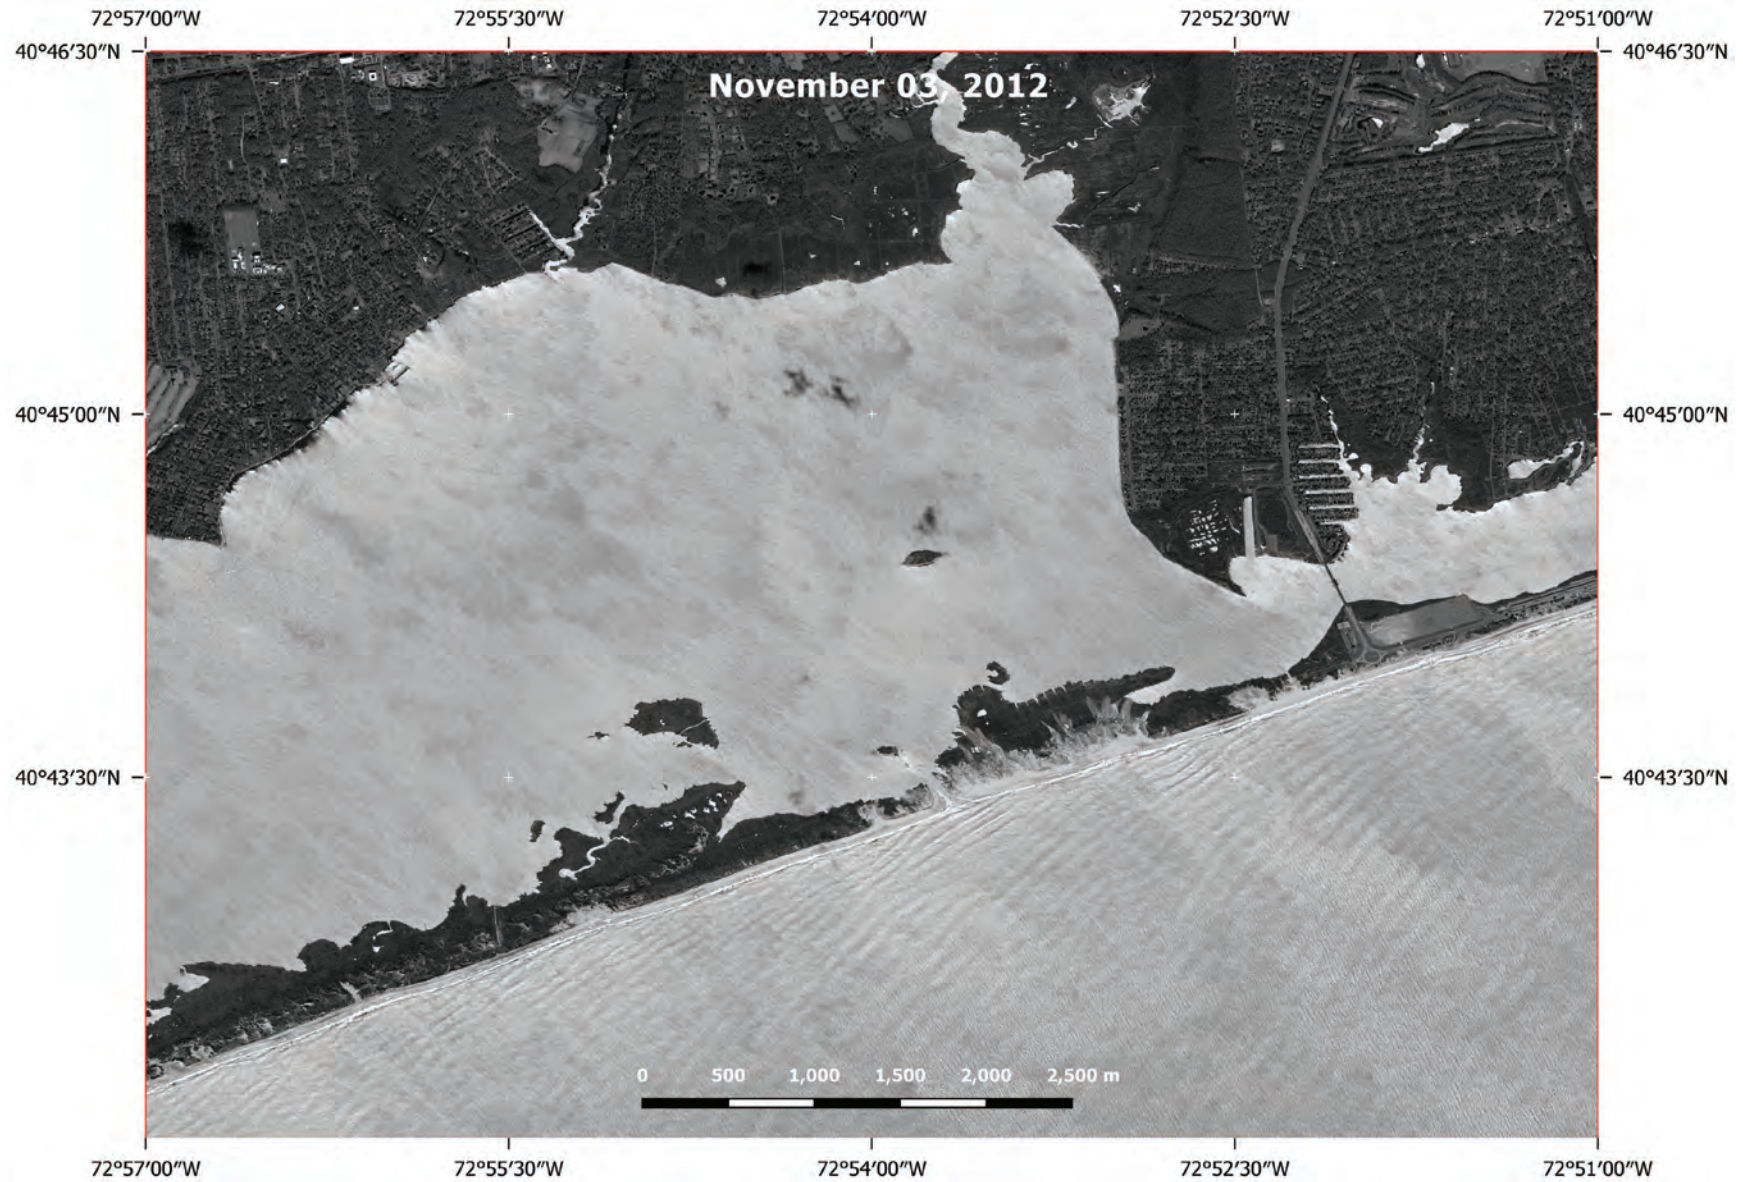
**Figure 2.5.** Maxar WorldView-1 panchromatic image of part of Fire Island National Seashore, New York, collected November 03, 2012, after Hurricane Sandy created the Wilderness Breach of Fire Island on October 29, 2012. The scale bar is in meters (m). The resolution is 52 centimeters ground sample distance (GSD).

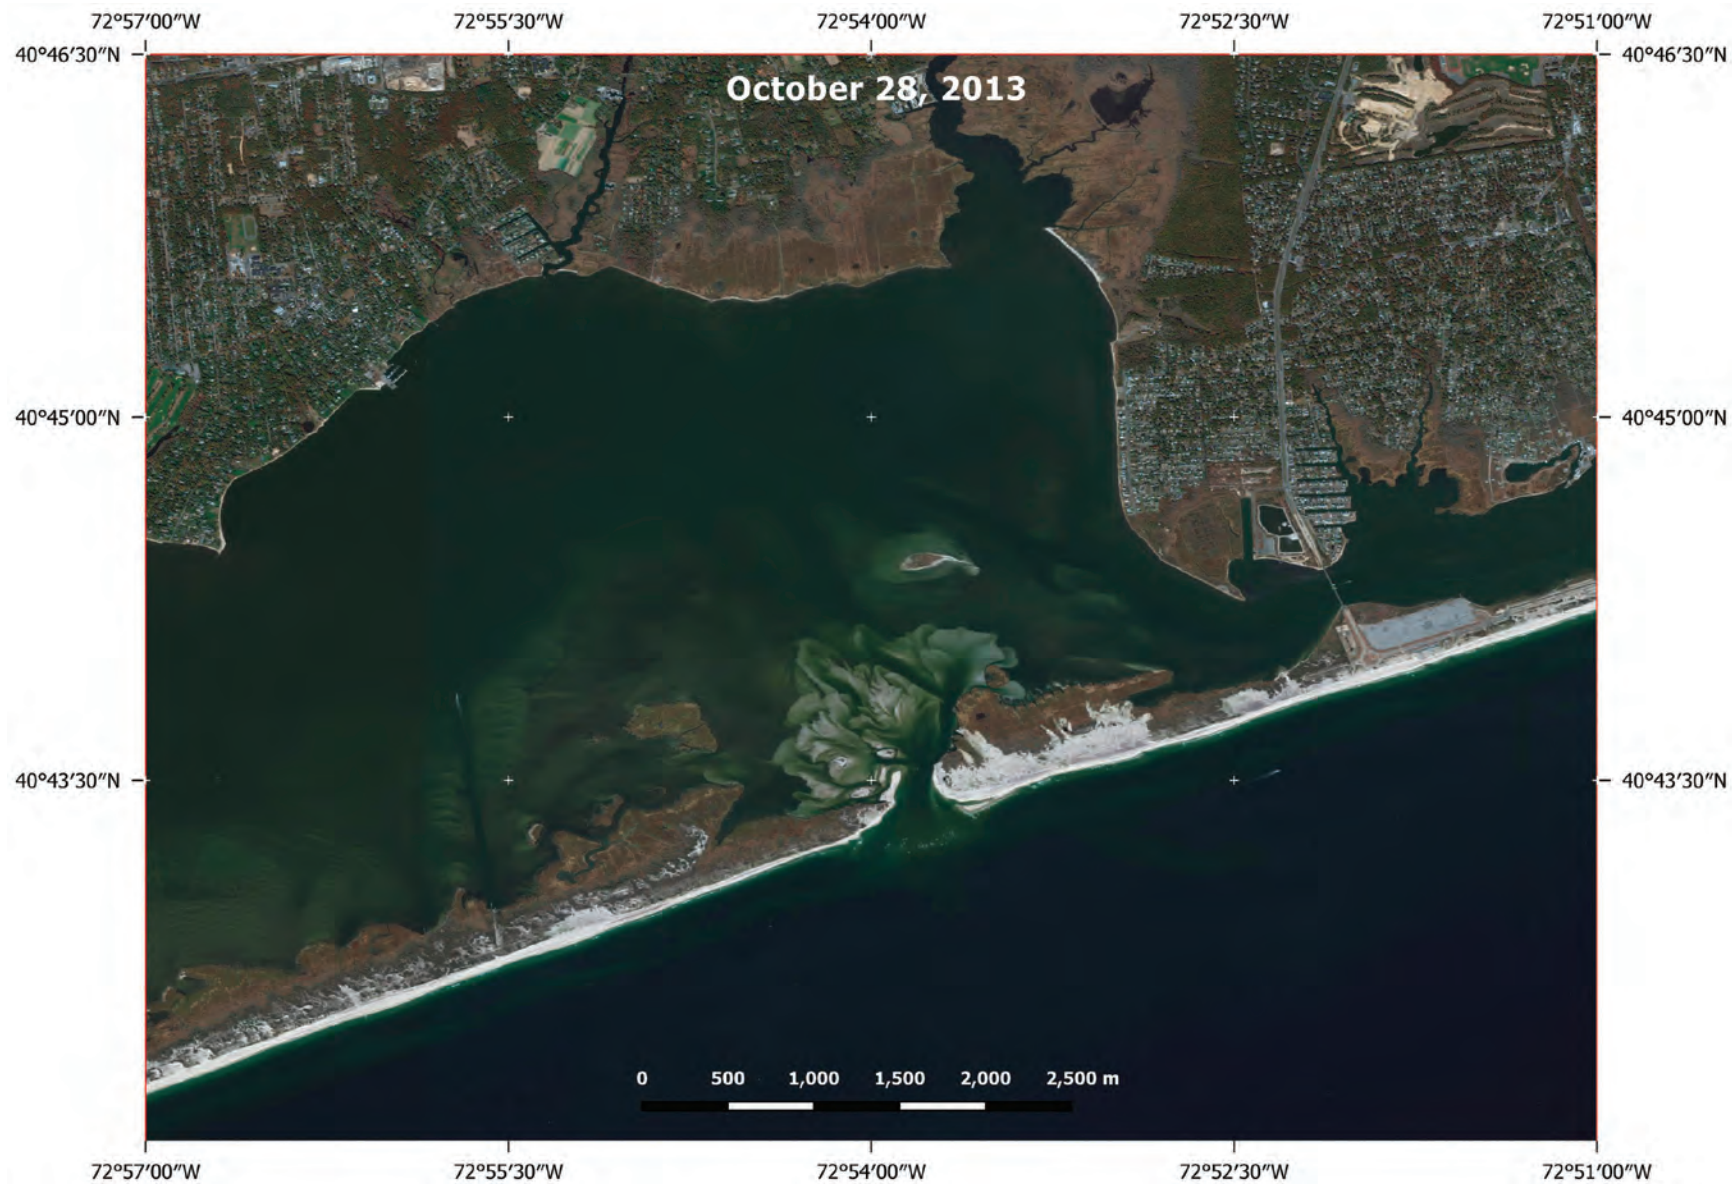
**Figure 2.6.** Maxar WorldView-2 ortho natural color image of part of Fire Island National Seashore, New York, collected October 28, 2013. The image shows the flood shoal delta north of the Wilderness Breach. The scale bar is in meters (m). The resolution is 59 centimeters ground sample distance (GSD).

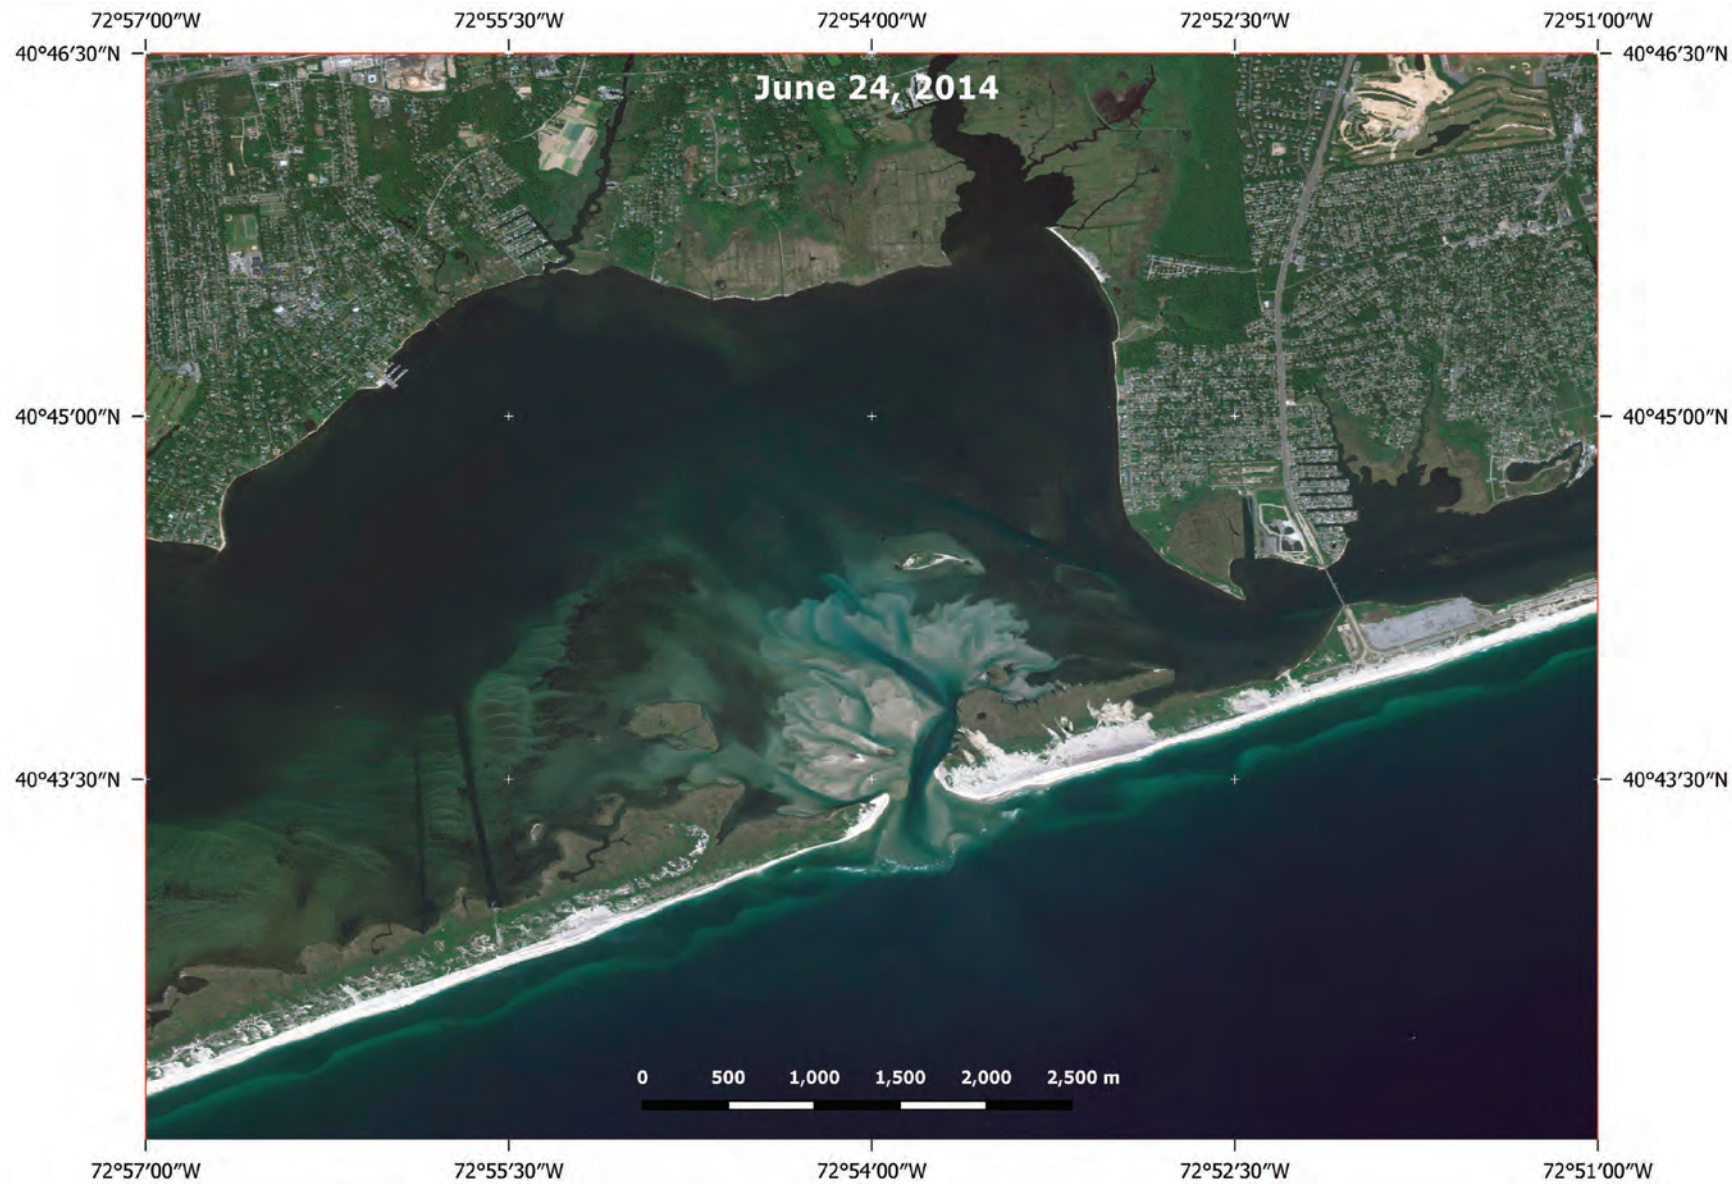
**Figure 2.7.** Maxar WorldView-2 ortho natural color image of part of Fire Island National Seashore, New York, collected June 24, 2014. The scale bar is in meters (m). The resolution is 57 centimeters ground sample distance (GSD).

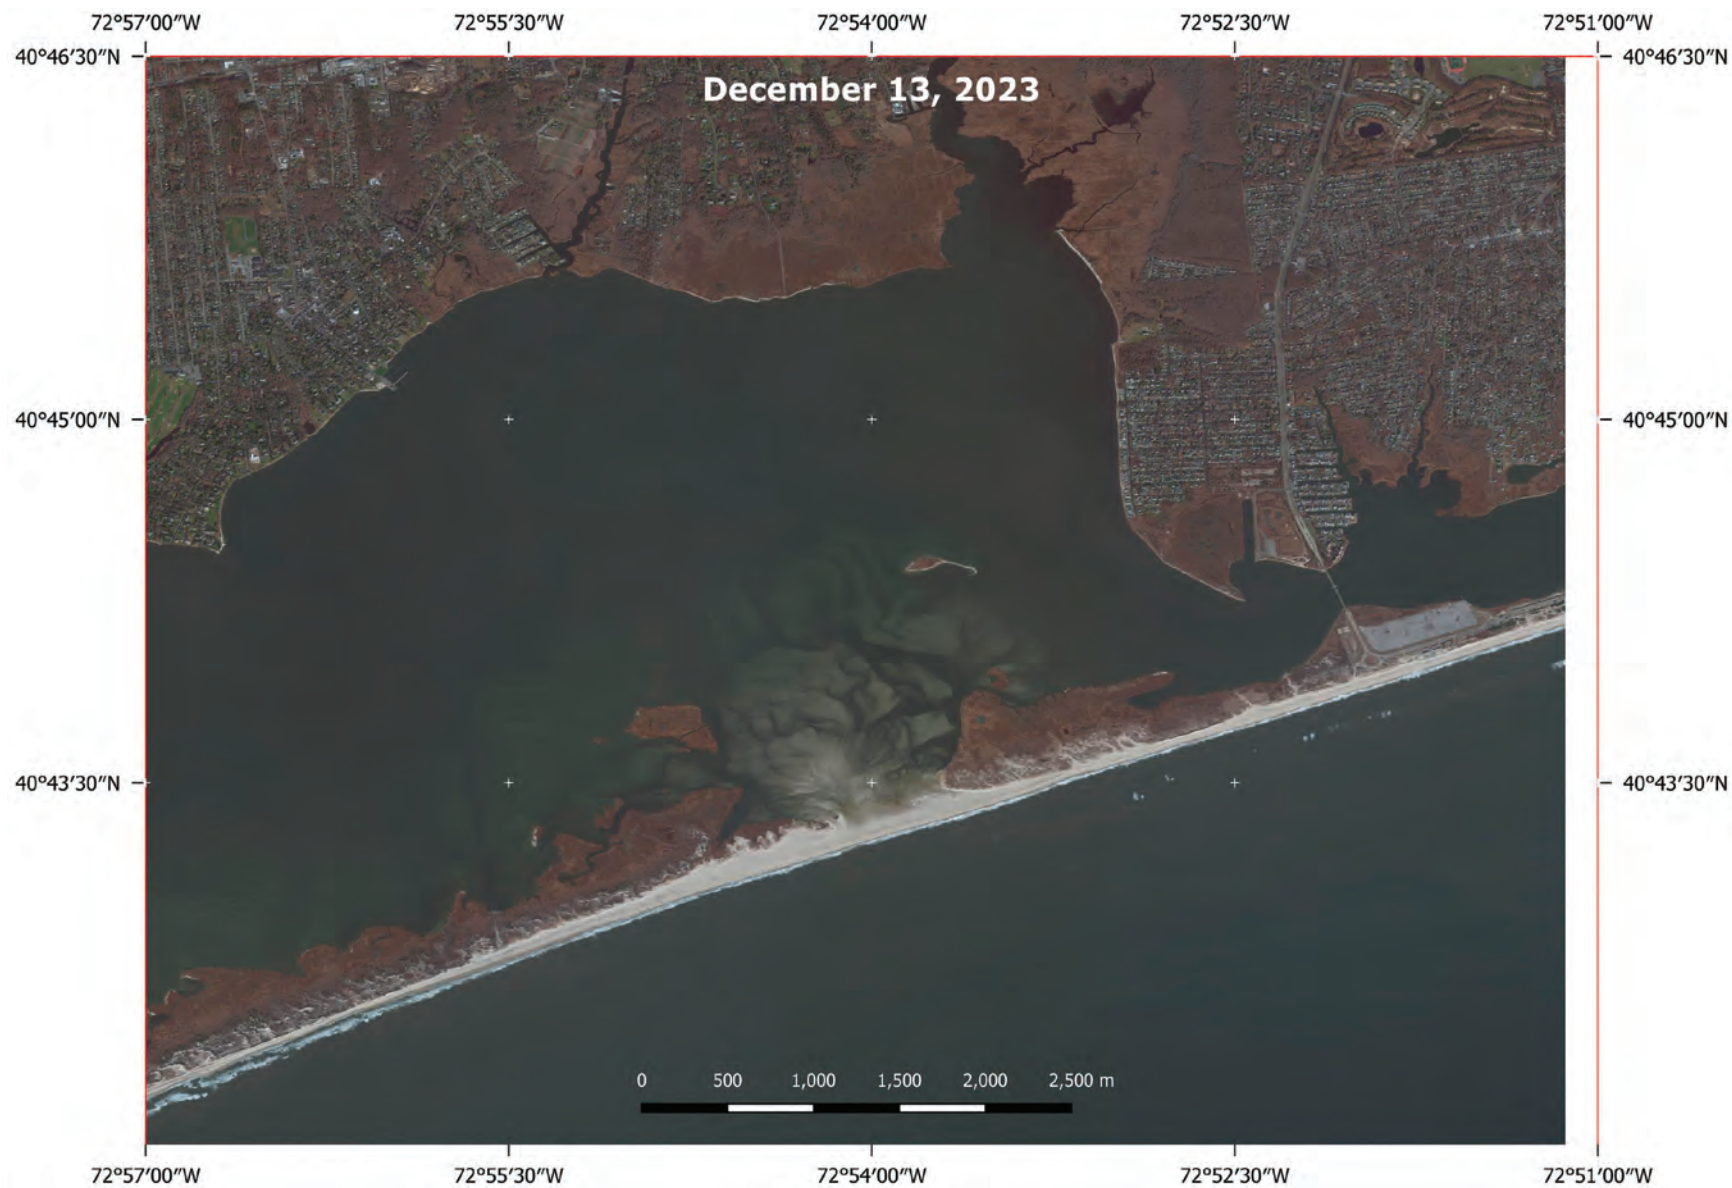
**Figure 2.16.** Maxar WorldView-2 ortho natural color image of part of Fire Island National Seashore, New York, collected December 13, 2023. The scale bar is in meters (m). The resolution is 57 centimeters ground sample distance (GSD). The Wilderness Breach had closed in late 2022.
