Preliminary Field Report of Landslide Hazards Following Hurricane Helene

Open-File Report 2025-1028

By Kate E. Allstadt, Sara K. McBride, Jonathan W. Godt, Stephen L. Slaughter, Kelli W. Baxstrom, Steven Sobieszczyk, and Anna Stull

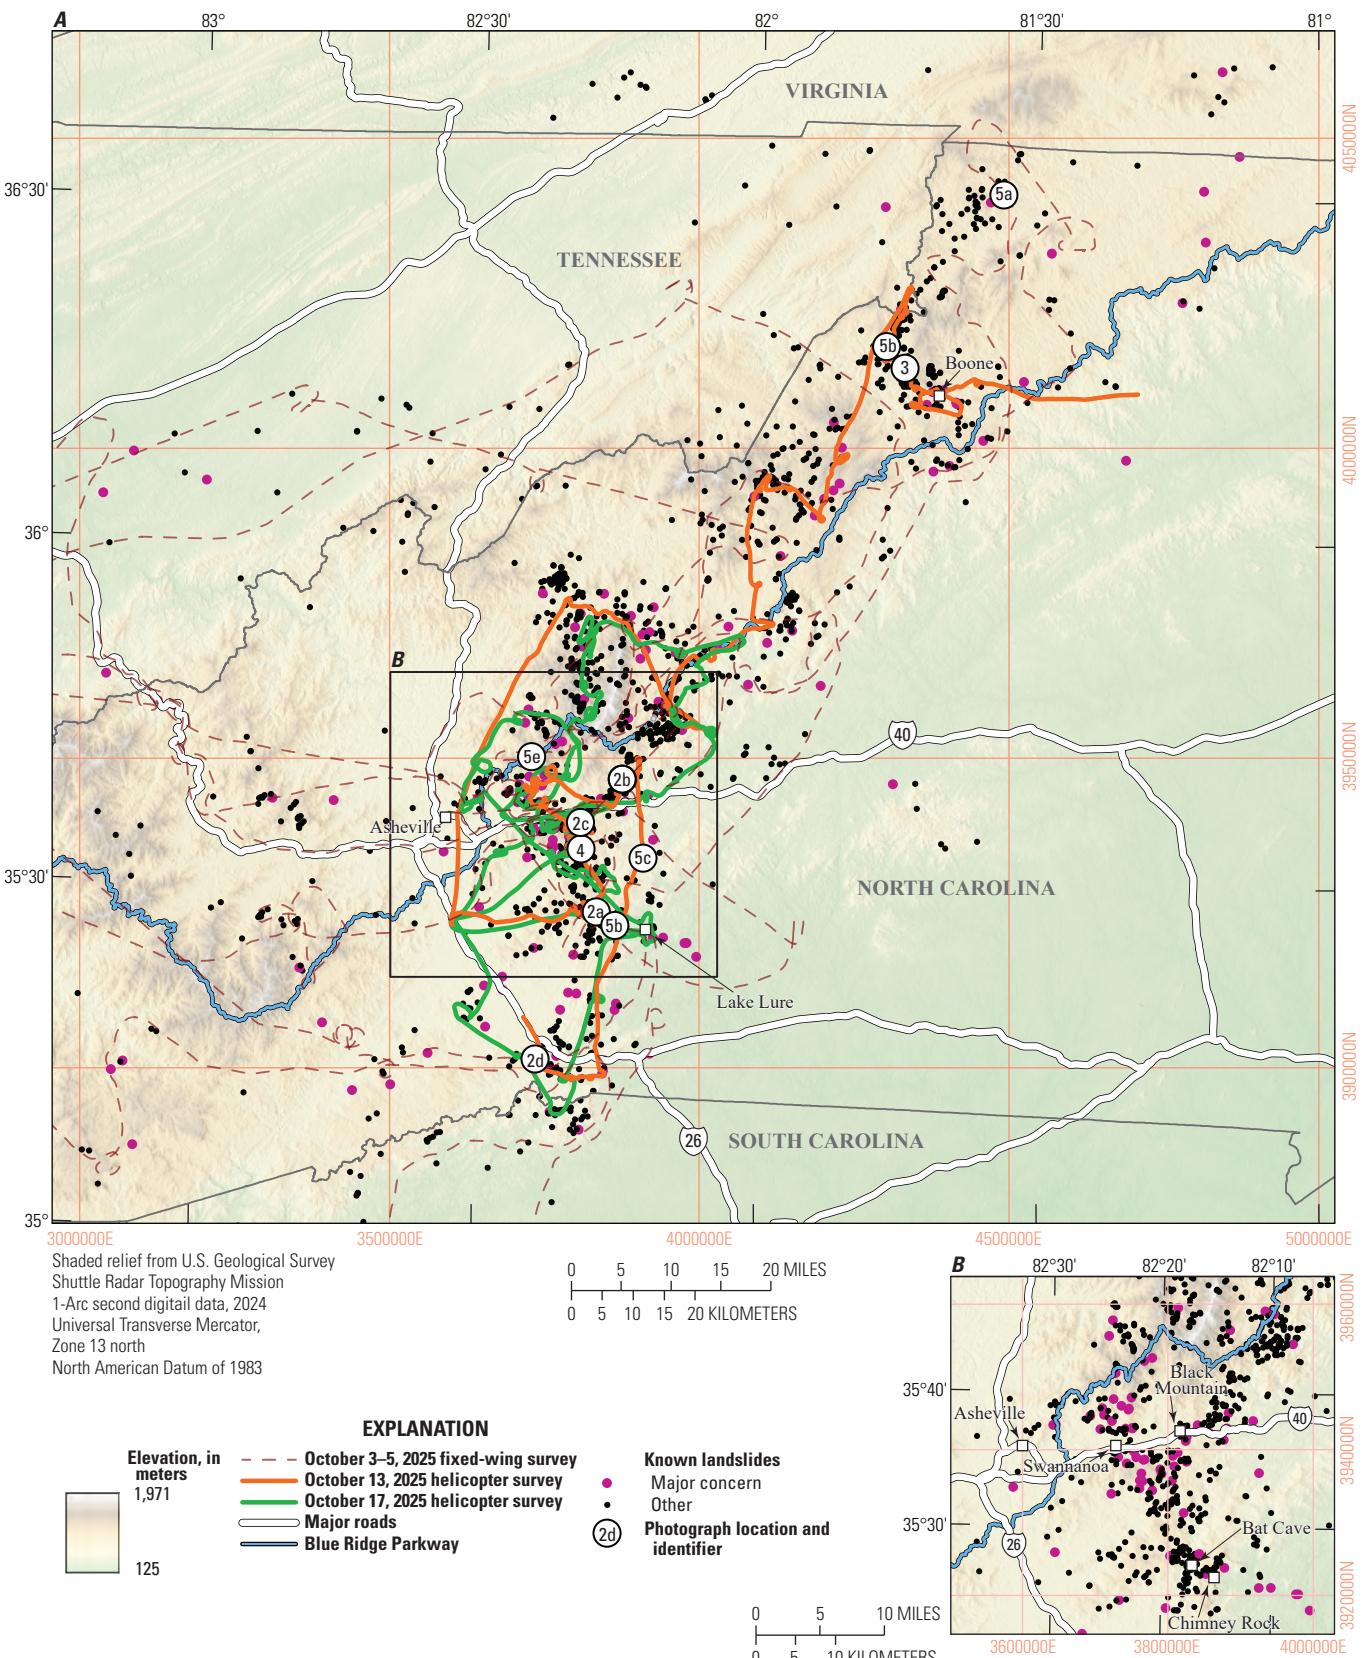
Figure 1. A–B, Elevation map showing an overview of landslides triggered by Hurricane Helene in western North Carolina, northern South Carolina, eastern Tennessee, and parts of southern Virginia. Landslide locations shown are those that were mapped by the U.S. Geological Survey and partner agencies by the end of the rapid response mapping effort on October 23, 2024. Known landslides labeled as “major concern” because of potential fatalities, injuries, rescue, or evacuation needs are indicated by pink points. Inventory is overlaid by aerial reconnaissance flight paths and photograph locations (refer to figs. 2–5).

Hurricane Helene’s intensive rainfall (combined with a prior frontal storm) caused a substantial number of slopes to fail, triggering landslides, mudflows, and (to a lesser extent) rock falls, affecting the whole region ([fig. 1](#)). Storms like Hurricane Helene that trigger thousands of landslides, which are typically also associated with tropical cyclones, reoccur about every 25 years in the southern Appalachian region (Wooten and others, 2016). As far as the authors are aware, the land movement triggered by rainfall from Hurricane Helene

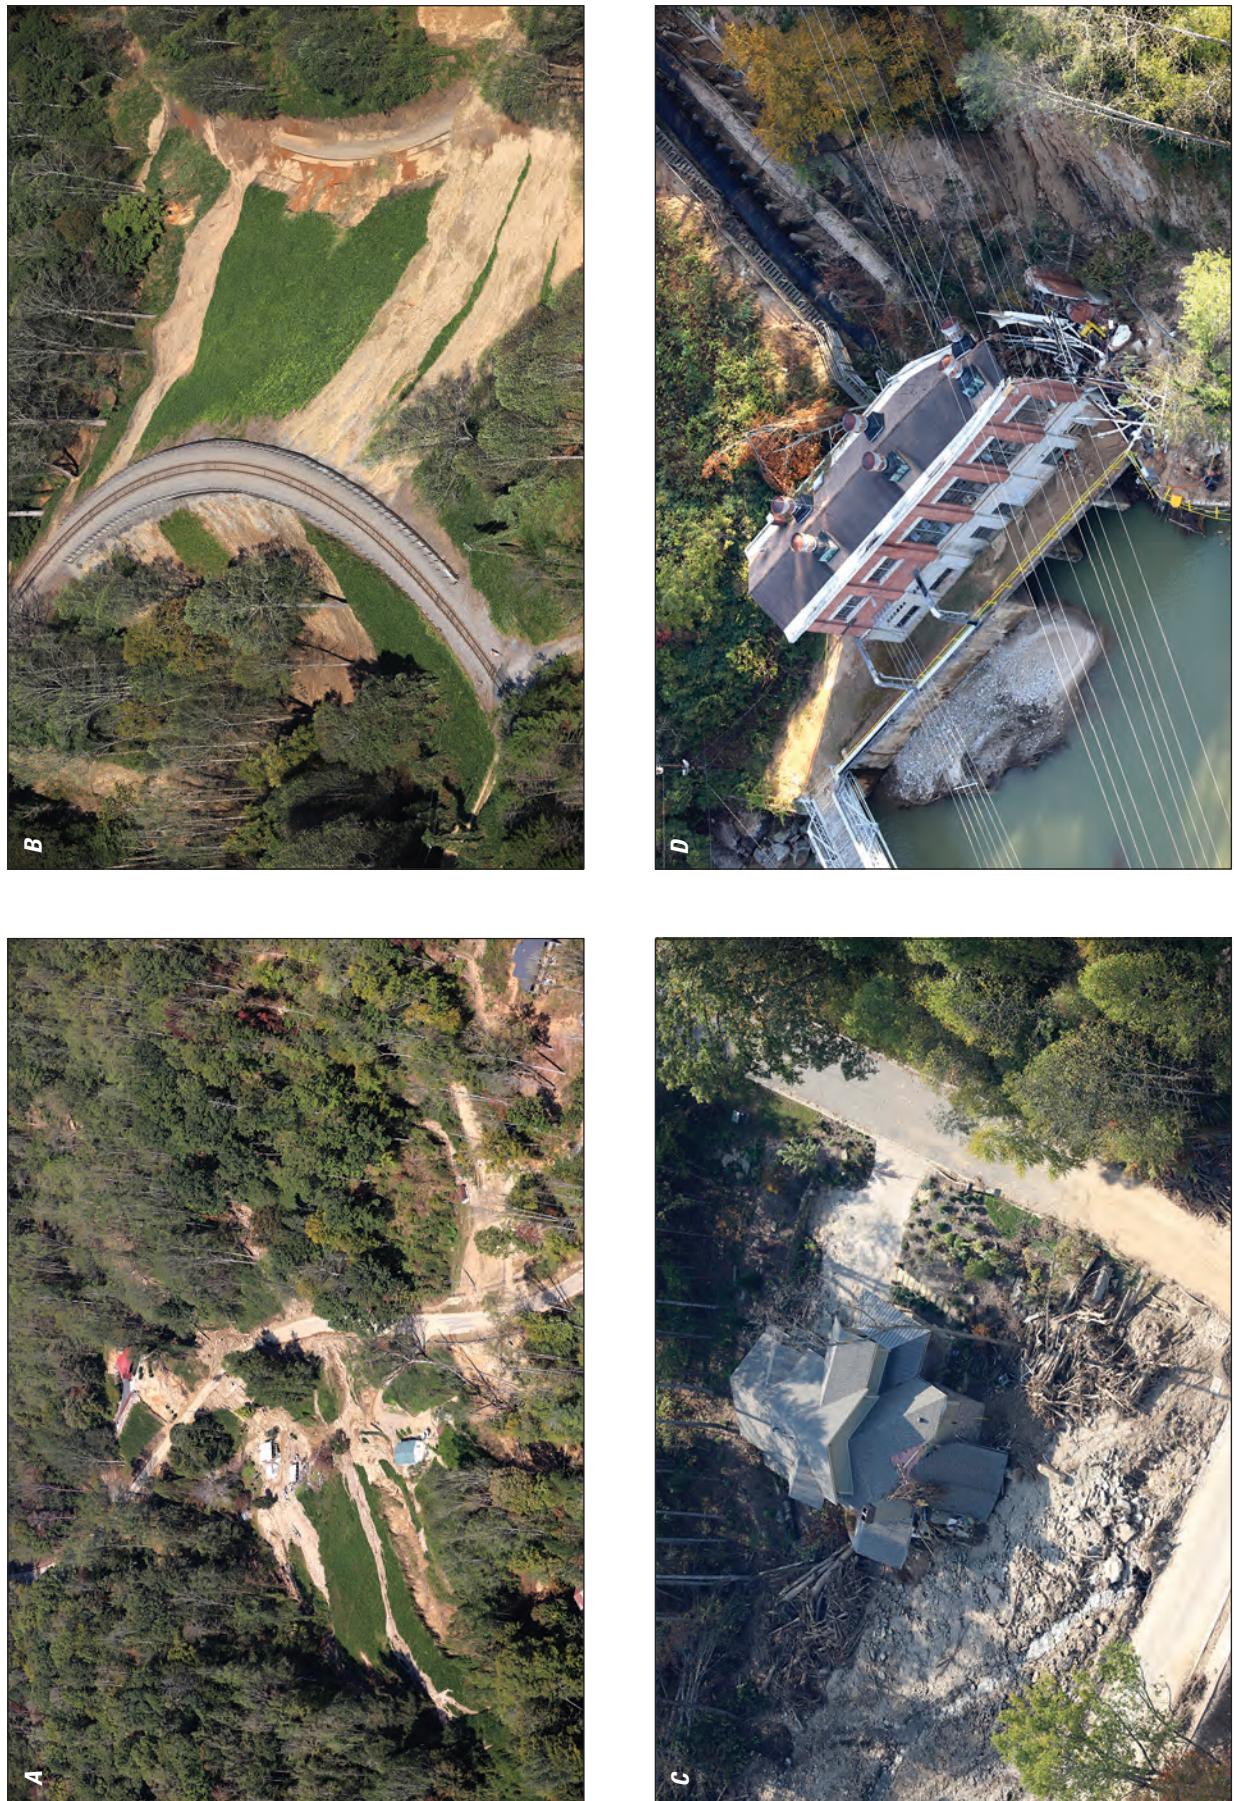
Figure 2. Photographs showing examples of homes and infrastructure affected by landslides and mudflows observed during reconnaissance flights in North Carolina. *A*, High concentration of impactful landslides in Bat Cave, 35.463° , -82.285° . *B*, Failures of engineered slope along railroad (left) inundating a lower-elevation section of track (right), 35.656° , -82.242° . *C*, House damaged by mudflow near Black Mountain, the road has been cleared of debris, 35.593° , -82.316° . *D*, Hydropower structure damaged by a landslide, 35.248° , -82.391° . Coordinates indicate the approximate location of the photographer (Photographs by S. Slaughter, U.S. Geological Survey).

Most of the landslides the field team observed (for example, [fig. 2A–D](#)) were relatively small but numerous and sometimes clustered in high concentrations ([fig. 2A](#)). Because of the density of structures in or near steep areas, sometimes even small landslides destroyed or damaged multiple structures ([figs. 2, 3](#)). Most damage was caused by the landslide runout, but some structures or roads were undercut by slope failures below the structures or roads. Landslides also indirectly affected communities by damaging or destroying roads and other infrastructure (for example, [fig. 2B, D](#)). The combined effects of landslides and flooding severed transportation connectivity across the region.

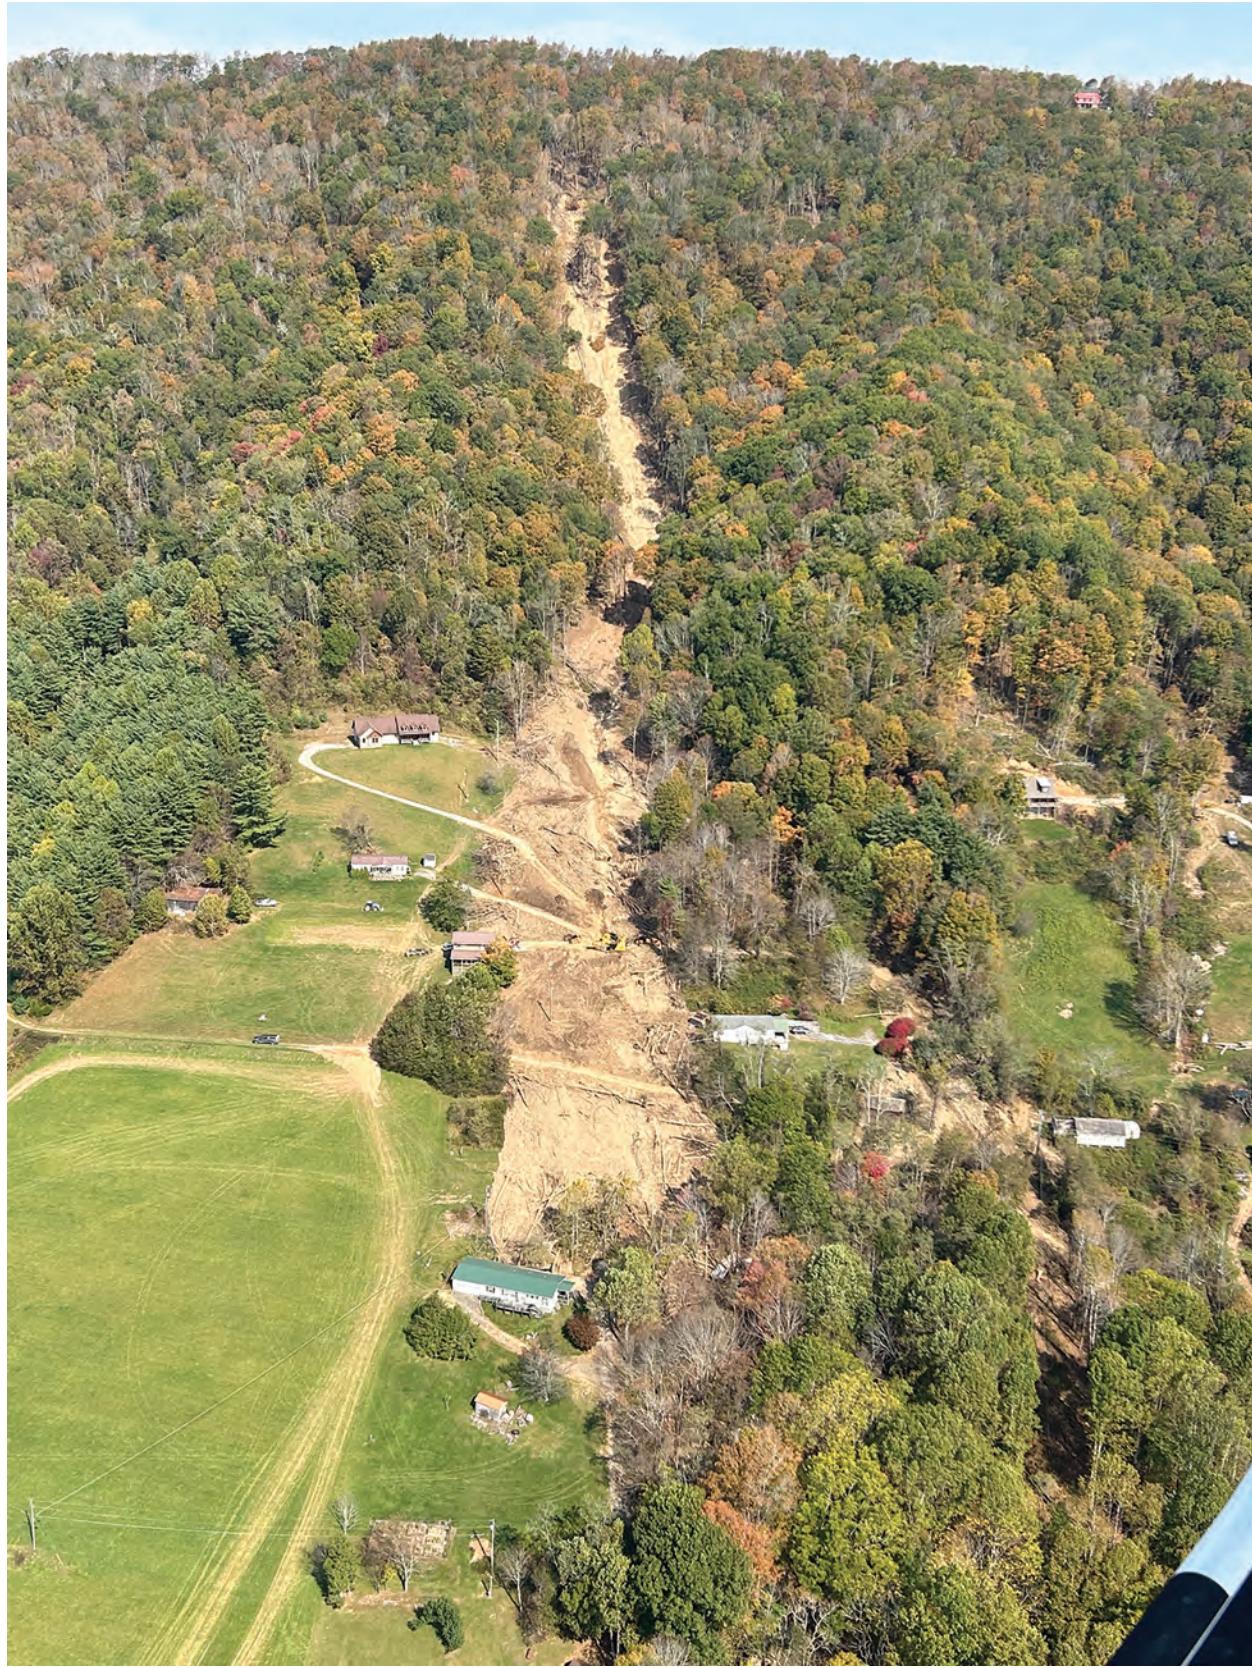
Figure 3. Photograph showing a landslide that transitioned into a mudflow that damaged structures near Boone, North Carolina. Approximate coordinates of the photographer were 36.259° , -81.744° (Photograph by J. Godt, U.S. Geological Survey).

The largest mudflows formed where many smaller landslides converged into channels and incorporated sufficient water and sediment to combine into massive, long runout mudflows. For example, one of the largest and deadliest mudflows originated from at least five coalescing landslide sources that traveled more than 1.5 miles along Flat Creek, where it destroyed a small community known as “Craigtown,” in Fairview, Buncombe County, North Carolina (fig. 4A, B). Thirteen residents were killed; 11 from the same family, and then two responders by a second surge (Medina, 2024). A similarly large mudflow occurred in Buck Creek near Marion, McDowell County, North Carolina, where landslides, many originating from near the Blue Ridge Parkway, coalesced into a large, destructive mudflow. The field team also visited another smaller but still damaging instance of this type of flow that occurred just on the other side of the ridge from Craigtown, where a mudflow damaged numerous structures at a conference and training center, filling several structures with mud and debris. An adjacent, smaller landslide impacted a cabin with six occupants, who were injured, but all survived.

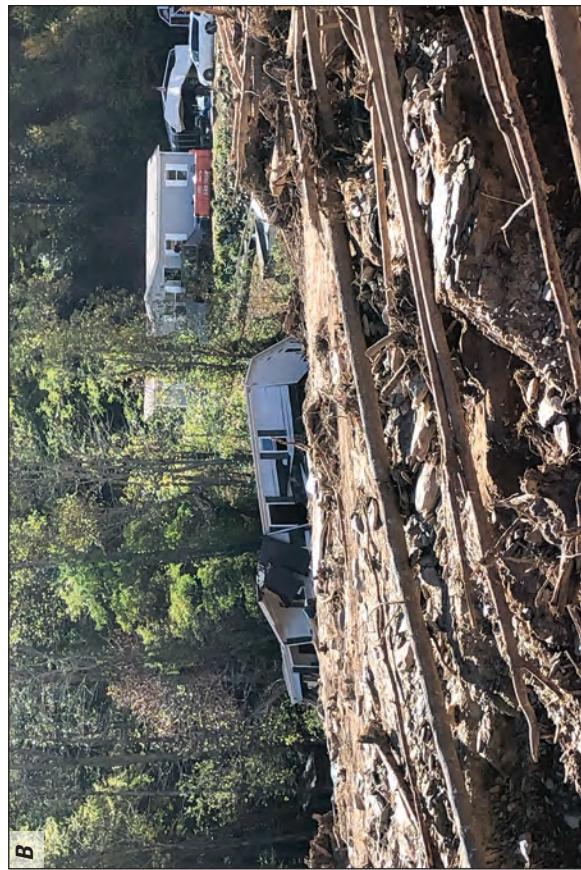
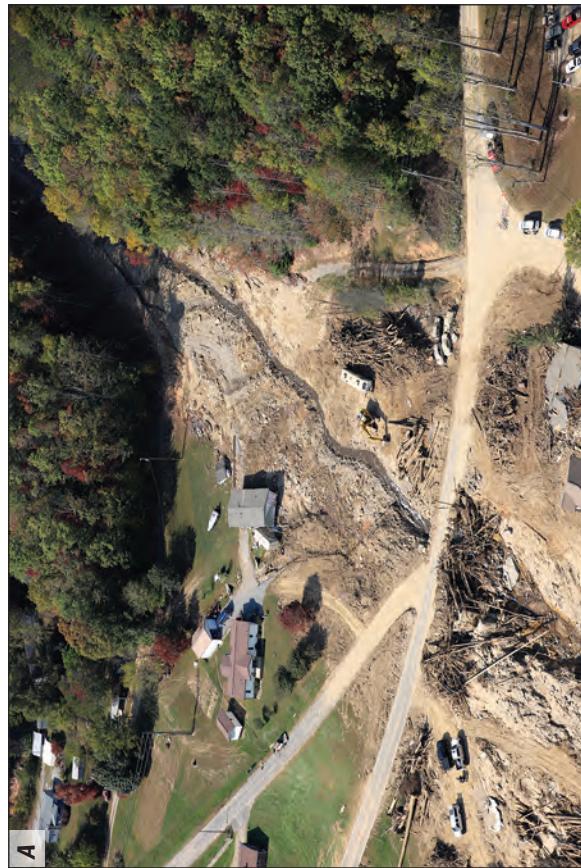
Figure 4. Photographs showing mudflow damage in a small community known as “Cragtown,” in Fairview, North Carolina, on the Flat Creek debris fan that caused 13 fatalities viewed from A, a helicopter and B, the ground. In A, a house was moved by a mudflow from its original location near the excavator in the image to the opposite side of Old Fort Road and can be observed near the bottom of the image. Approximate coordinates for both photographs were 35.558° , -82.317° (Photographs by S. Slaughter, U.S. Geological Survey).

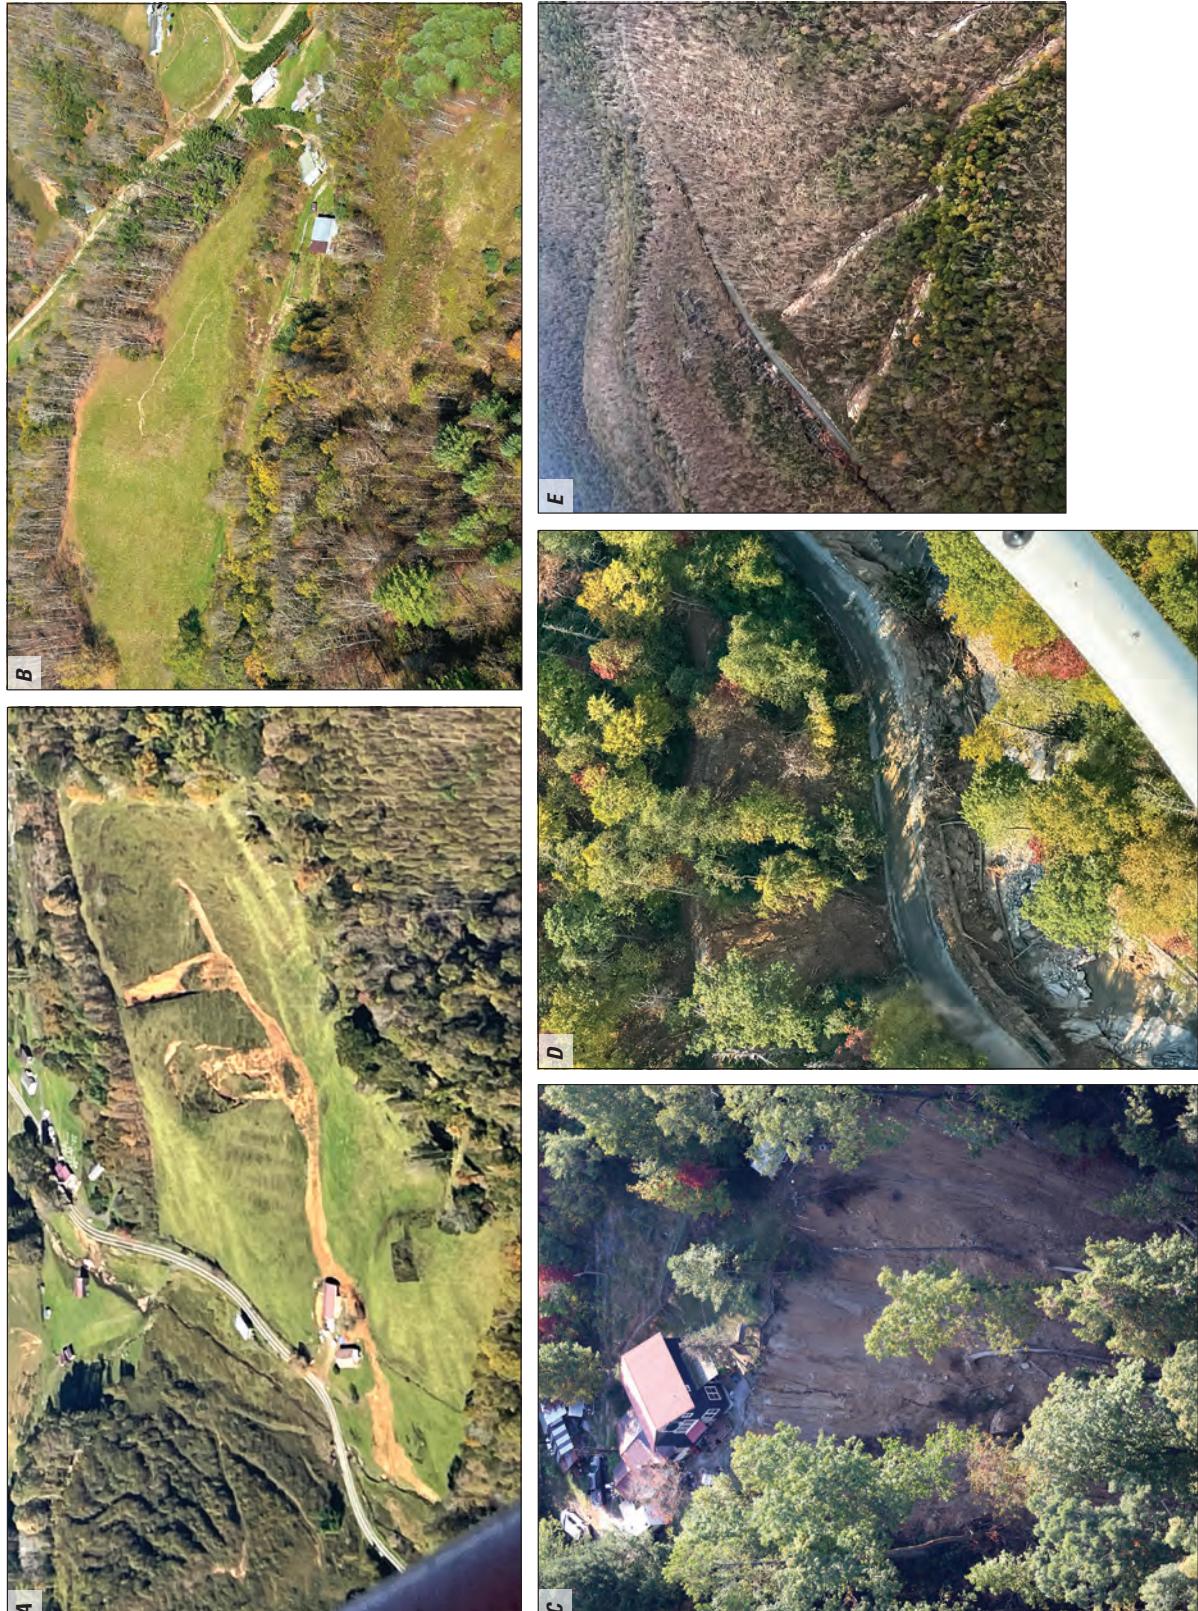
Figure 5. Photographs showing examples of ongoing landslide hazards in North Carolina. *A*, Destabilized material remaining in the landslide source area, 36.512° , -81.568° (Photograph by F. Rengers, U.S. Geological Survey); *B*, cracks indicating a landslide started to form, 36.290° , -81.777° (Photograph by J. Gott, U.S. Geological Survey); *C*, undercut slope resulting in destabilization of the structure and areas above, 35.542° , -82.204° (Photograph by S. Slaughter, U.S. Geological Survey); *D*, a road that was undercut and destabilized by flood erosion and prone to continued material failing from the slope above, 35.466° , -82.305° (Photograph by K. Allstadt, U.S. Geological Survey); *E*, Trees blowdown that may increase susceptibility to future debris flows due to loss of root strength, two mudflow source areas are visible to the left, 35.688° , -82.404° (Photograph by F. Rengers, U.S. Geological Survey). Coordinates indicate the approximate location of the photographer.

sliding on slopes destabilized during Hurricane Helene, but specific problem areas the field team highlighted include areas partially destabilized where some of the source material was not evacuated (fig. 5A) or where cracks opened in slopes either above landslide sources or where a landslide started to form but did not fail catastrophically (fig. 5B). Fresh cracks indicate the slope has already started moving and allows for easier destabilization by future water infiltration. The field team also noted that concentrated areas of blown down trees may increase the susceptibility of those areas to future debris flows either immediately where root balls were ripped out of the earth, or in future years, because roots helping stabilize the soil can rot or deteriorate (fig. 5E). Guidance on recognizing ongoing landslide hazards is provided in the “Safety Considerations” section.

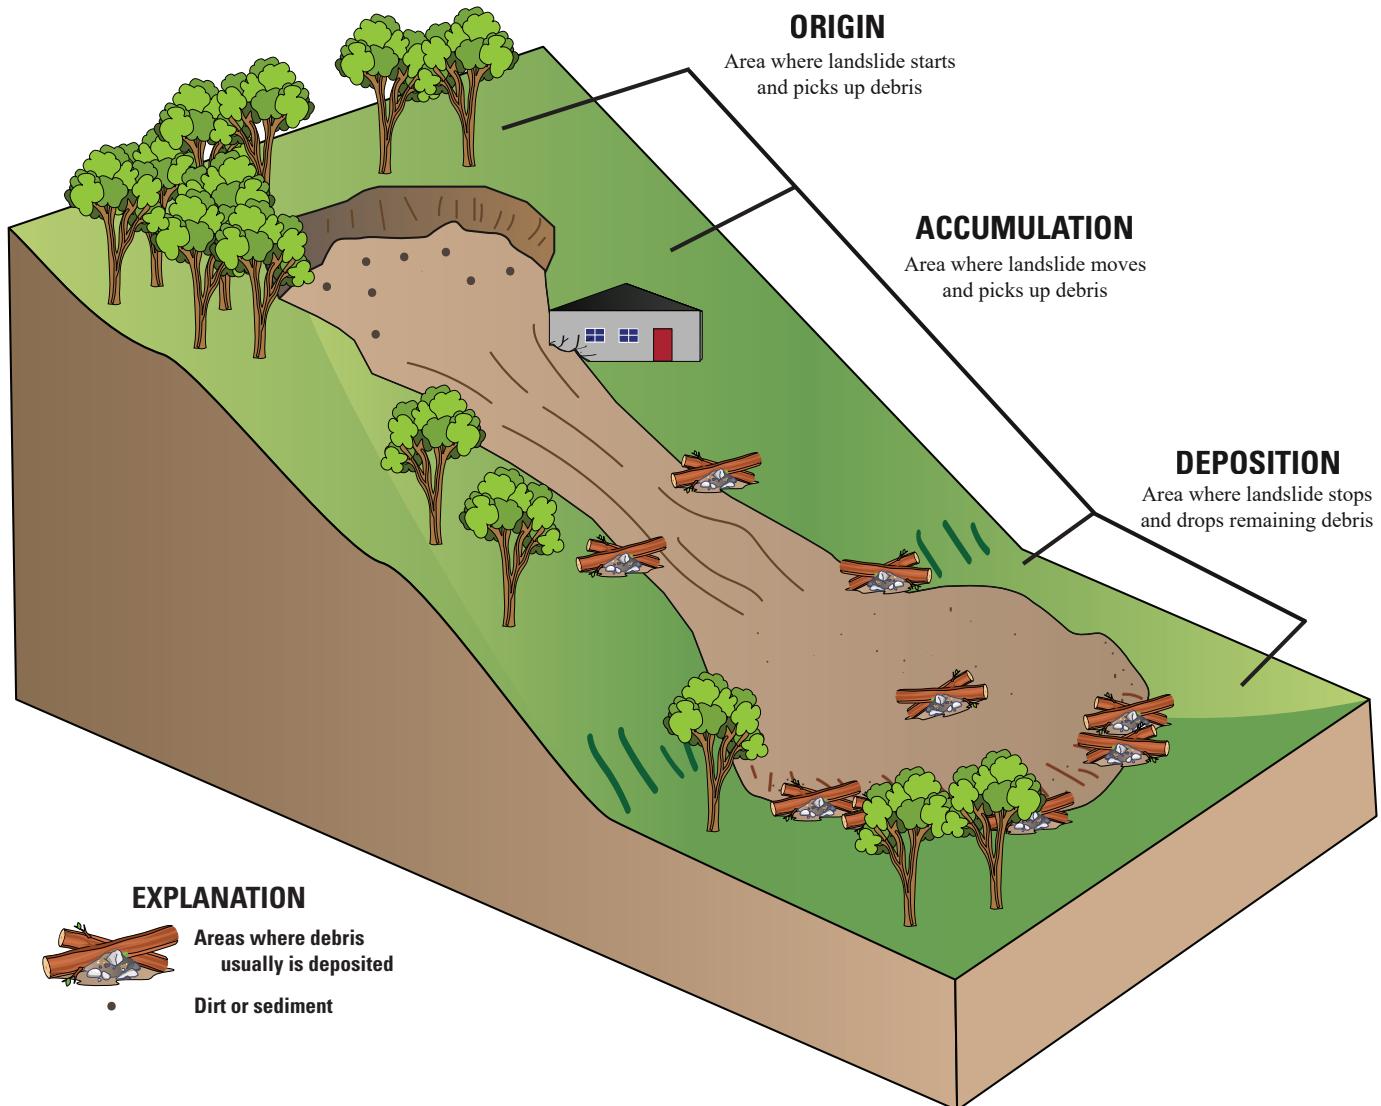
Figure 7. Schematic diagram showing areas where debris transported by a landslide may end up. This diagram was intended to illustrate areas on a landslide to focus recovery efforts for missing people.

Rapidly moving landslides are very powerful and can be compared to a bulldozer pushing trees, rocks, soil, and other material down a hill. Debris in the path of the landslide is picked up by the landslide and pushed downhill. Some debris picked up by the moving landslide may collect along the sides of the moving landslide, like debris piling up along either side of a bulldozer blade. When the landslide reaches the valley floor, it will lose speed and stop. The area at the bottom of a landslide can contain debris picked up by the moving landslide that is not deposited along the landslide margins.

- When a landslide strikes a structure, the contents of the structure can be incorporated into the landslide as debris.
- When a landslide strikes a vehicle, the entire vehicle can be incorporated into the landslide as debris.
- If a landslide stops in a flooded stream, the debris can be incorporated into the stream.
- Landslide movement can be rapid and can damage and destroy objects in its path.
