Colorado Yule Marble— Building Stone of the Lincoln Memorial

U.S. GEOLOGICAL SURVEY BULLETIN 2162

Prepared in cooperation with the
National Park Service

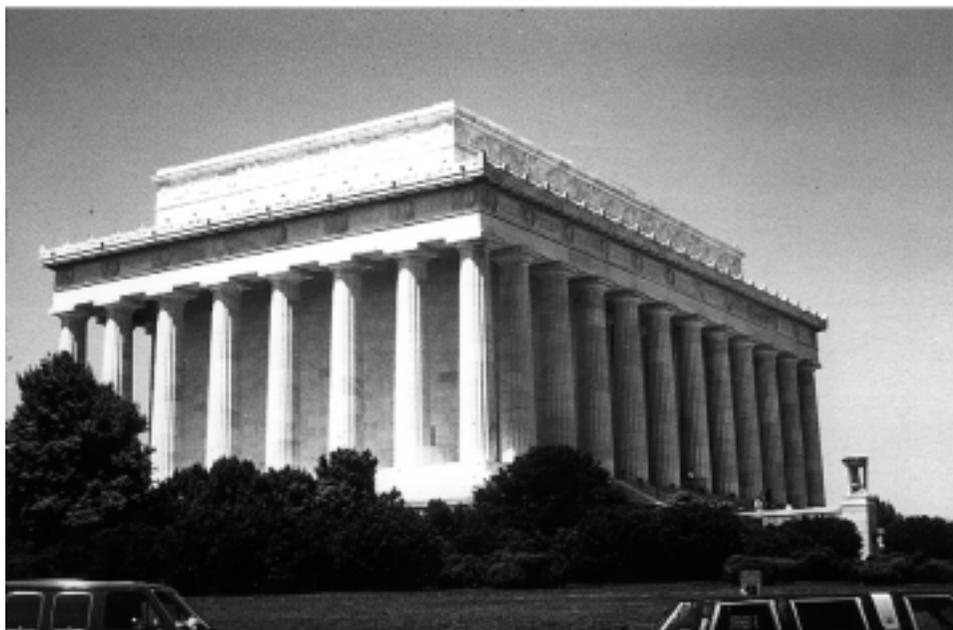
Figure 1. The Lincoln Memorial, Washington, D.C. (dedicated 1922). Photograph taken in 1990.

Praised as one of the purest marbles ever quarried, and cited as a rival to the Italian and Greek marbles of classic fame, the Colorado Yule marble was selected and used for the exterior stone of the Lincoln Memorial in Washington, D.C. Built between 1914 and 1922, the Lincoln Memorial (fig. 1) is one of the most visited and treasured memorials in Washington, D.C., and it serves as a symbolic focus for many historic gatherings. Some believe that the marble, selected for the monument at the urging of the architect Henry Bacon, is integral to the effect and feeling created by the memorial (Thomas, 1993).

The general condition of the Yule marble in the buildings in Denver is very similar to the condition of the marble at the Lincoln Memorial. When buildings made of Yule marble are viewed as a whole, they appear in good condition, and the stone is white and unblemished (figs. 1 and 21). Even from a close view, the marble is clear and nearly white, and the edges and surfaces appear to retain much of their original crispness. The inclusions are relatively subtle and show no appreciable difference in their weathering compared to the rest of the stone. There is little surficial blackening of the stone. However, I have no information about the cleaning or maintenance of the buildings in Denver.

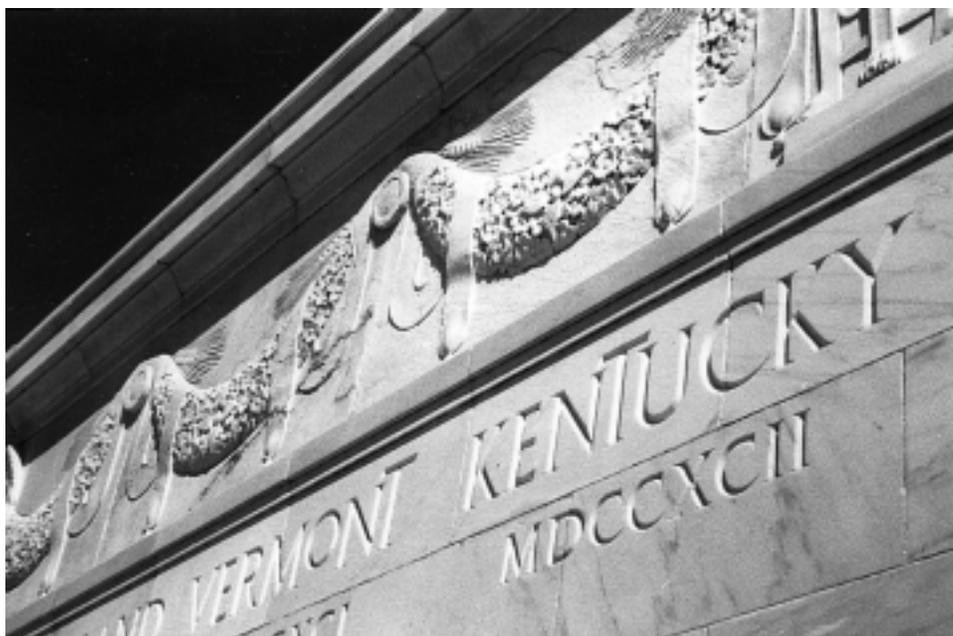
Figure 2. Colorado Yule marble in the penthouse wall of the Lincoln Memorial, Washington, D.C. Although the memorial gives an overall appearance of clear, white marble, some blocks (upper part of photograph) have a roughened, sugared surface, whereas adjacent blocks retain smooth surfaces and crisp edges (bottom of photograph).

One striking feature of the condition of the marble in the Lincoln Memorial is that while some blocks of stone appear to show little or no signs of deterioration at all, adjacent blocks show mild to severe deterioration (figs. 17 and 18). Stones that have withstood weathering are clear white and hard and retain crisp, well-defined edges on corners and carved features. In contrast, stones that have weathered poorly have pronounced surficial sugaring; they may show surficial cracks and a slight surficial discoloration; and in some cases, particularly where the stone has been carved, they appear to be badly crumbling. The presence of inclusions in a block of marble is not correlated with the degree of deterioration of the stone. This contrast in overall stone condition occurs in several places at the memorial but is most noticeable along the roof entablature and on the penthouse walls (figs. 2 and 17).

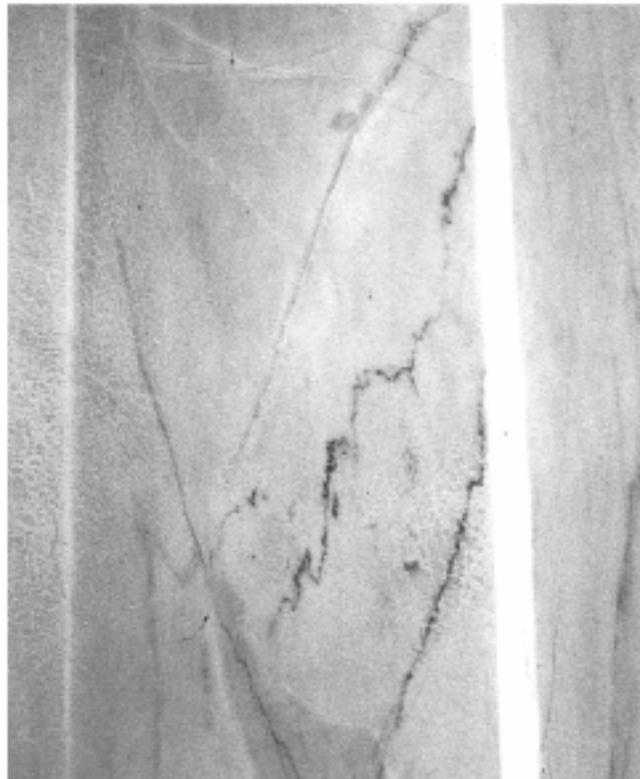
Figure 11. Weathered quartz inclusions in the Colorado Yule marble. *A*, Typical occurrence of large, fairly isolated quartz grains (in the Colorado National Bank, Denver, Colo.). *B*, Small quartz grains may be clustered, appearing as a vein in the marble (darker gray areas at the lower right of the photograph; in the Lincoln Memorial, Washington, D.C.).

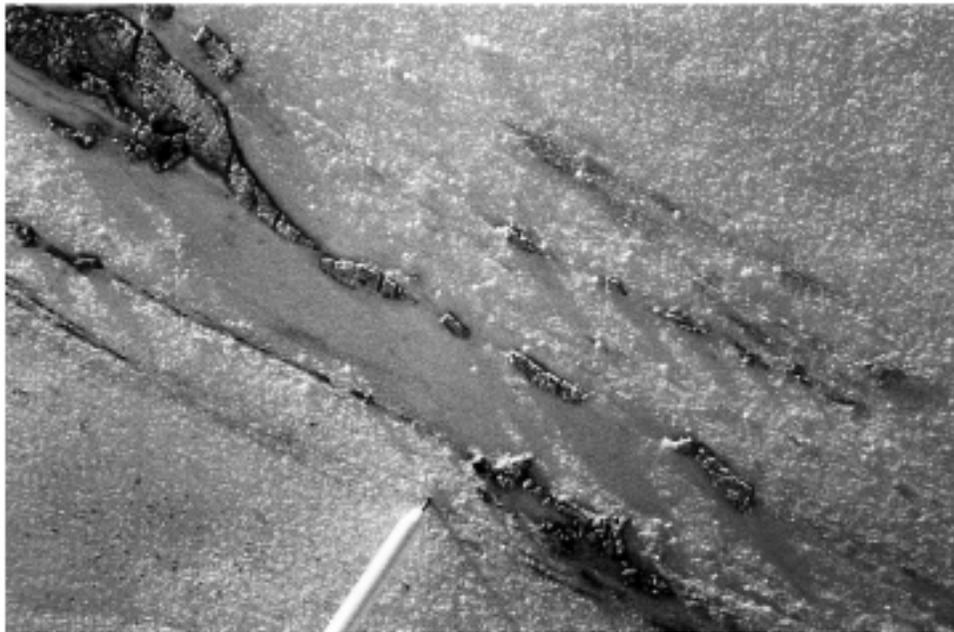
Figure 12. Large feldspar inclusions at the Lincoln Memorial (*A*) in a column shaft and (*B*) on the roof parapet; note how the feldspar stands above the surrounding calcite.

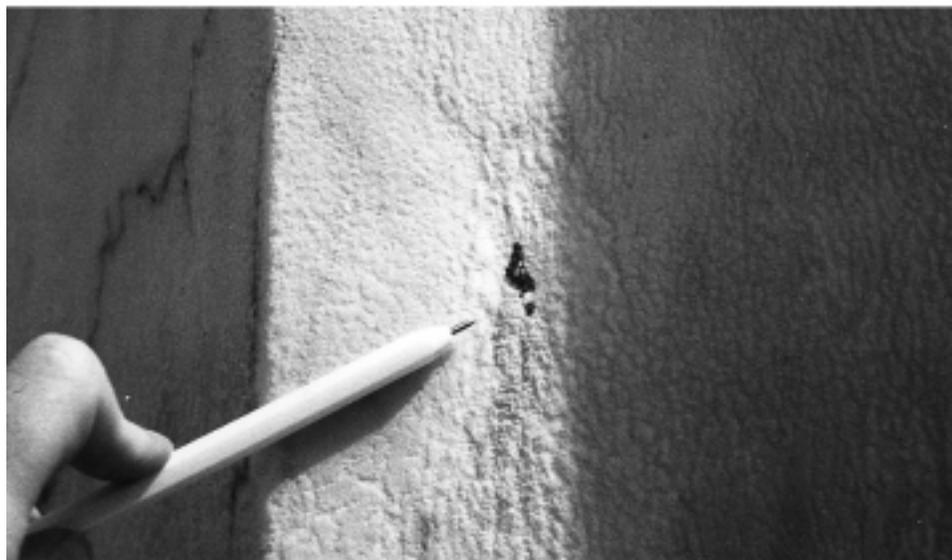
Figure 13. Sphalerite inclusion (dark grain) at the Lincoln Memorial occurs as an isolated grain with a rusty-brown surface. On weathered surfaces, sphalerite stands higher than the surrounding calcite.

Pyrite, sphene, apatite, rutile, zircon, and sphalerite all occur as minor inclusions in the marble. With the exception of pyrite, which ranges in size from about 20 to 160 micrometers, these inclusions are small (typically about 10 micrometers). Rutile, zircon, and apatite are minor inclusions visible in polished sections of the marble but not noticeable on weathered surfaces in buildings. Apatite is the most common of these minor inclusions; it occurs as part of the inclusion-rich clusters in the Colorado Golden Vein samples, along with quartz, mica, and occasional feldspar (fig. 9). Sphene, which is mostly noticeable in thin sections of the marble, also occurs in the clusters of quartz, mica, and feldspar in the Golden Vein samples (fig. 9). Typically, pyrite and sphalerite inclusions occur in small groups of a few isolated grains (fig. 13). The composition of the pyrite in the samples studied is variable but within the usual range for this sulfide (tables 7 and 8). At the Lincoln Memorial, where they have weathered, sphalerite and pyrite are quite noticeable compared to the surrounding white calcite. The exposed sphalerite surfaces have a reddish-brown rusty appearance (dark grain in fig. 13), the pyrite has a golden-metallic appearance, and both of these inclusions are raised compared to the surrounding calcite.

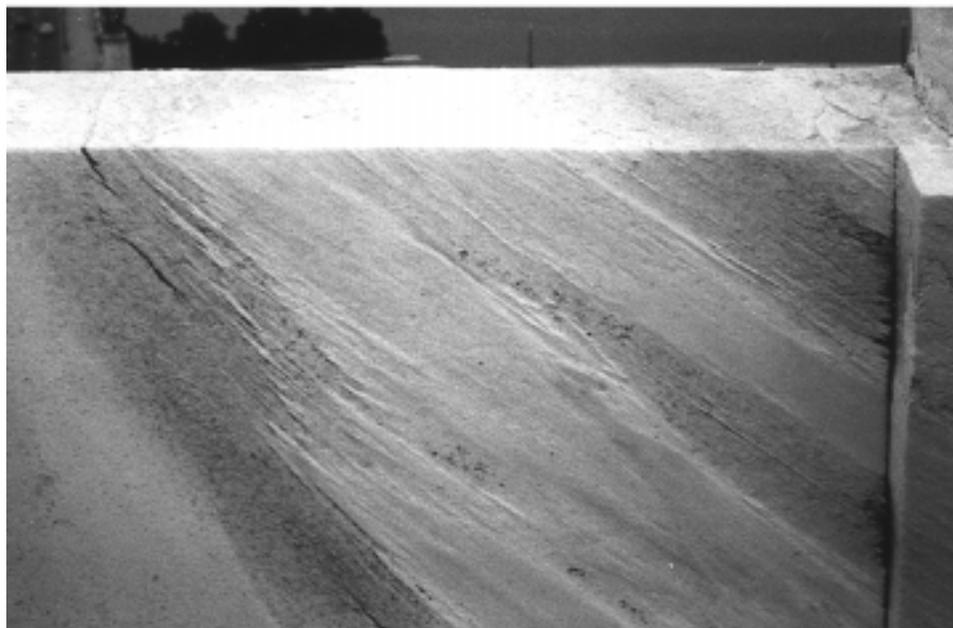
Figure 14. Differential wear on a cheneau piece along the roof at the Lincoln Memorial.

The marble in the Lincoln Memorial has deterioration features that are typical for marble used in buildings. Although some cracks exist in the marble of the Lincoln Memorial, few of the cracks resemble the “rifts” that were of such concern in the Cheesman Memorial (The Financial World, 1913; Bain, 1936a). On the upper areas of the Lincoln Memorial on the penthouse walls and along the entablature, in particular on the cheneau and antefixae, exposed surfaces of the marble have a sugary texture, and some stones show differential wear on the exposed surfaces, where the marble surface has weathered unevenly (fig. 14). Inclusions of quartz or feldspar, particularly in some of the stones around the roof entablature, stand higher than the surface of the calcite grains because they are more resistant to weathering (fig. 12B). The column shafts also show a differential weathering of inclusions or a localized pronounced

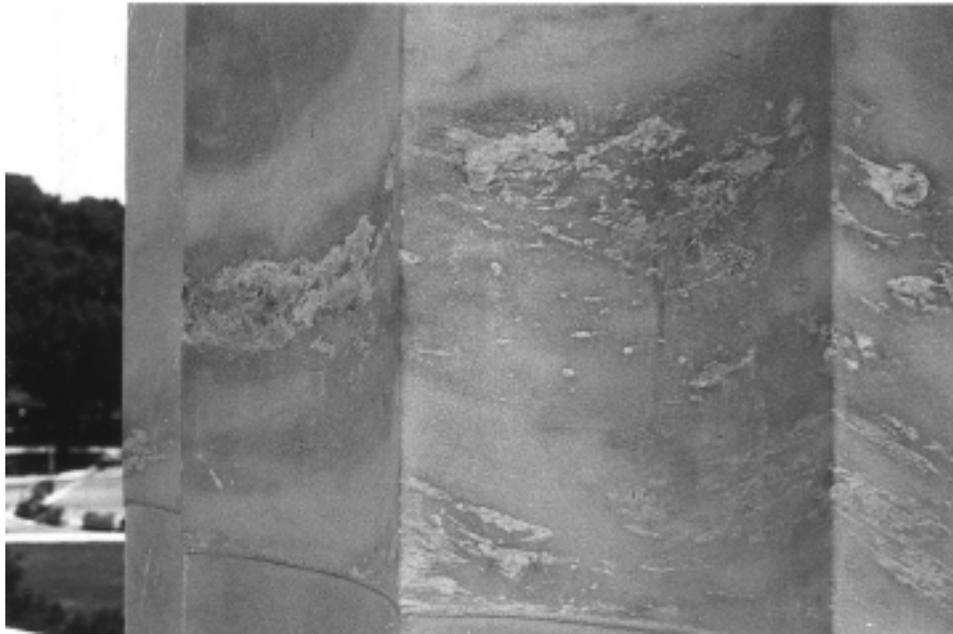
Figure 15. Chalky white inclusion on a column shaft at the Lincoln Memorial.

variation in stone quality, where there are chalky white areas in the marble (fig. 15).

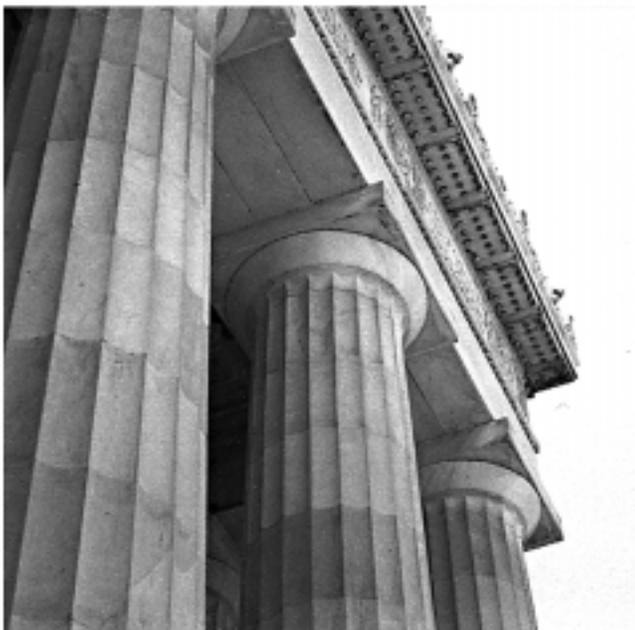
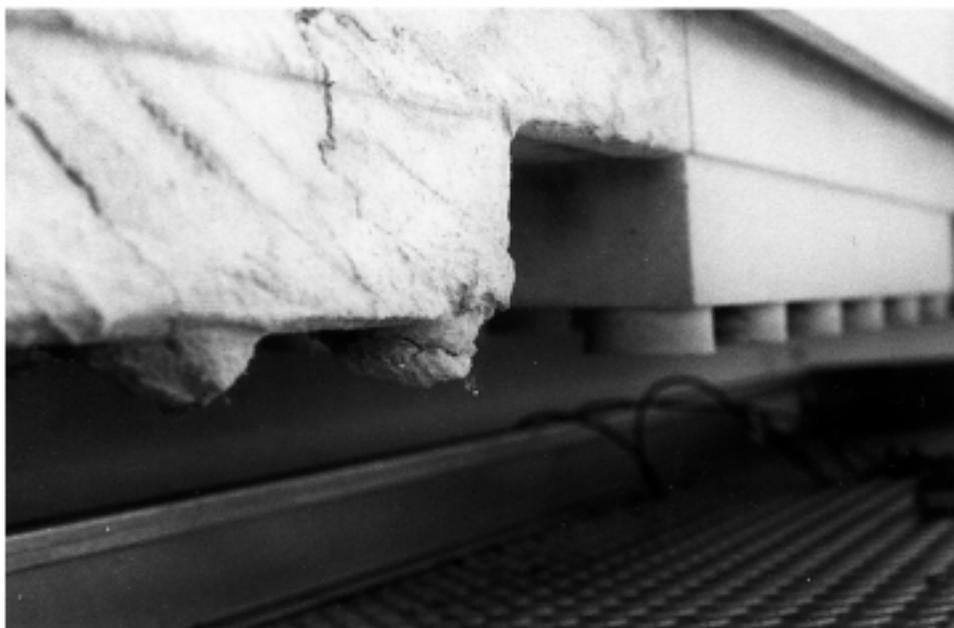
Figure 16. Blackened surficial alteration crusts accumulate on the underside of the roof entablature at the Lincoln Memorial. *A*, Black surficial alteration crusts accumulate in areas that are sheltered from washing and rain. *B*, Detail of the guttae under the roof entablature showing that many are disaggregating. A portion of black surficial alteration crust is still visible on the side of the crumbling gutta near the center of the photograph. The rest of the blackened surface on these guttae fell off when they were touched during examination of the area.

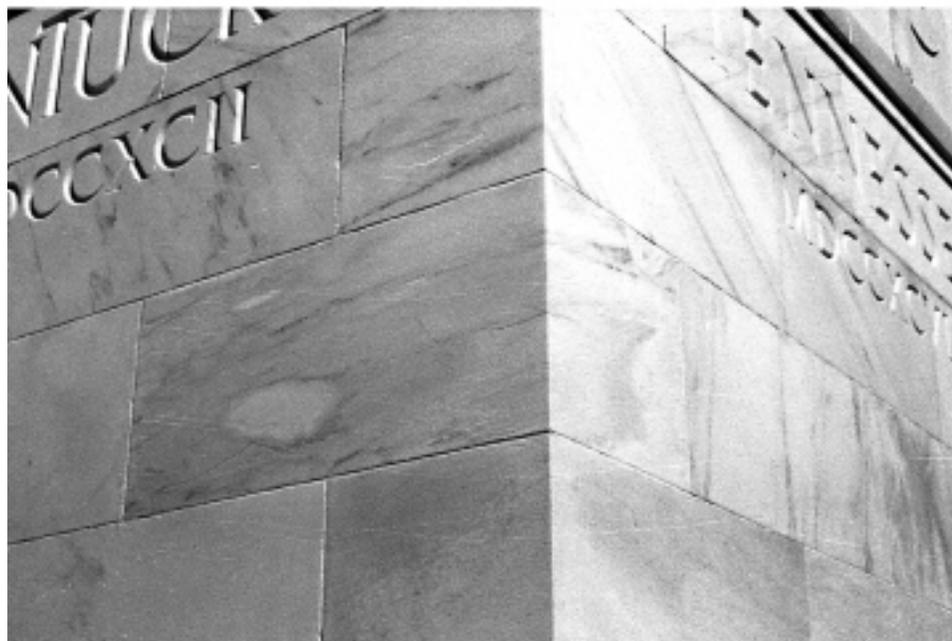
Figure 17. Orange surficial discoloration on the penthouse at the Lincoln Memorial looks darker gray in block at center of photograph. Note the difference in surficial integrity of the discolored stone compared with the other stones. However, orange discoloration and surficial roughness are not always correlated (see fig. 18).

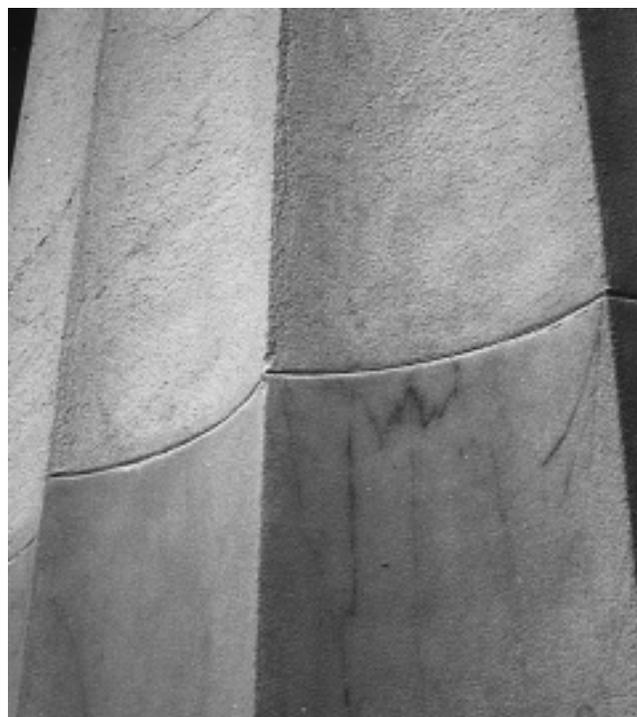
Figure 18. Close examination of a column shaft at the Lincoln Memorial shows a stone with a rough, sugared surface adjacent to a stone that has retained a smooth, nearly new appearing surface finish. The rough surface is not discolored.

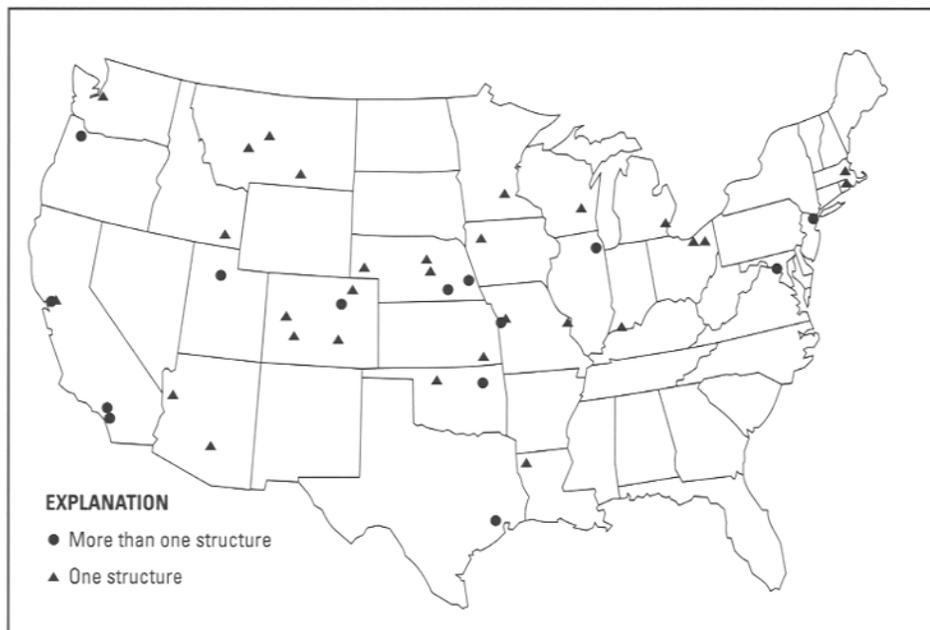
Figure 20. Locations in the United States where the Colorado Yule marble has been used for notable buildings and major structures.

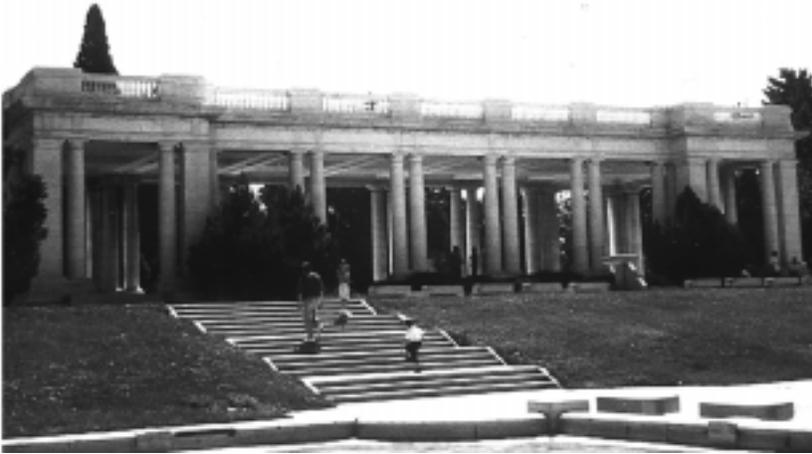
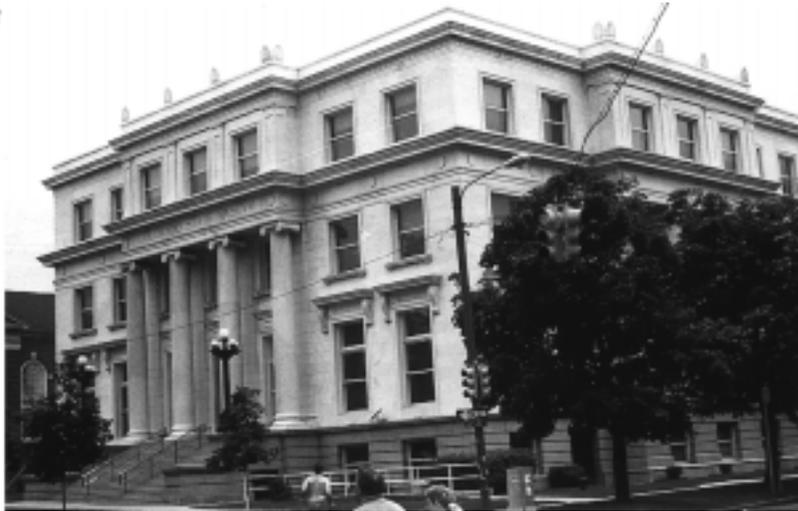
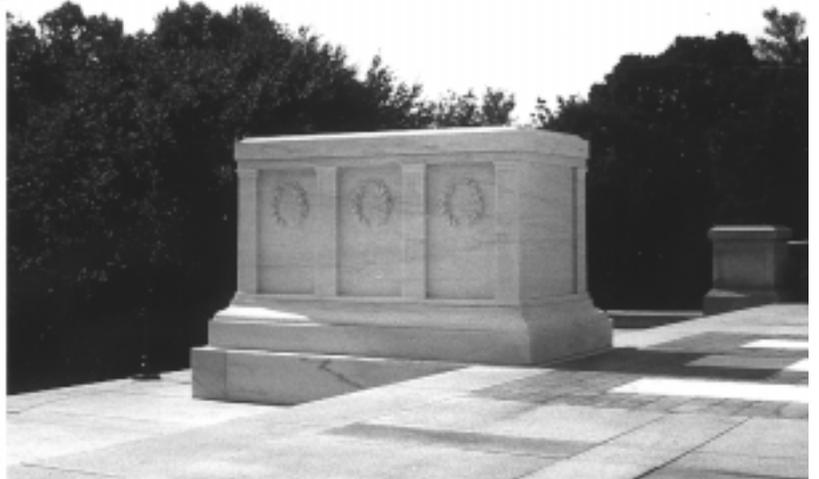
Figure 21. Structures with exterior Colorado Yule marble generally appear to be in very good condition. *A*, Cheesman Memorial, Denver, Colo. (built 1908). *B*, Colorado State Museum, Denver, Colo. (built 1916). *C*, Tomb of the Unknowns, Arlington, Va. (1931).

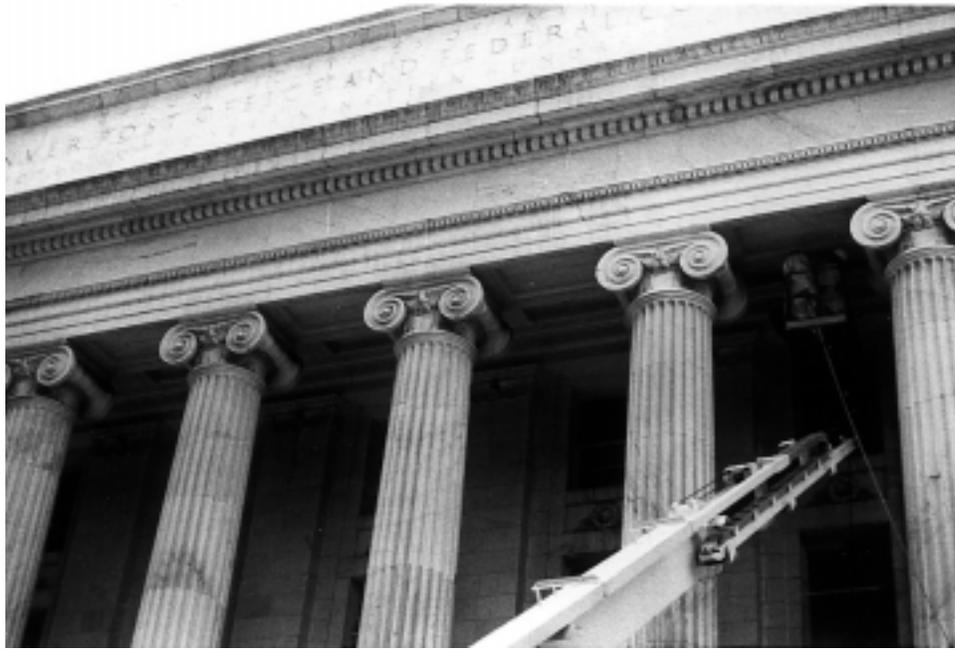
Figure 22. Cleaning at Denver Post Office in 1993. The workers had not yet removed the blackened surficial discoloration on the sides of the three column capitals on the left side of the photograph.

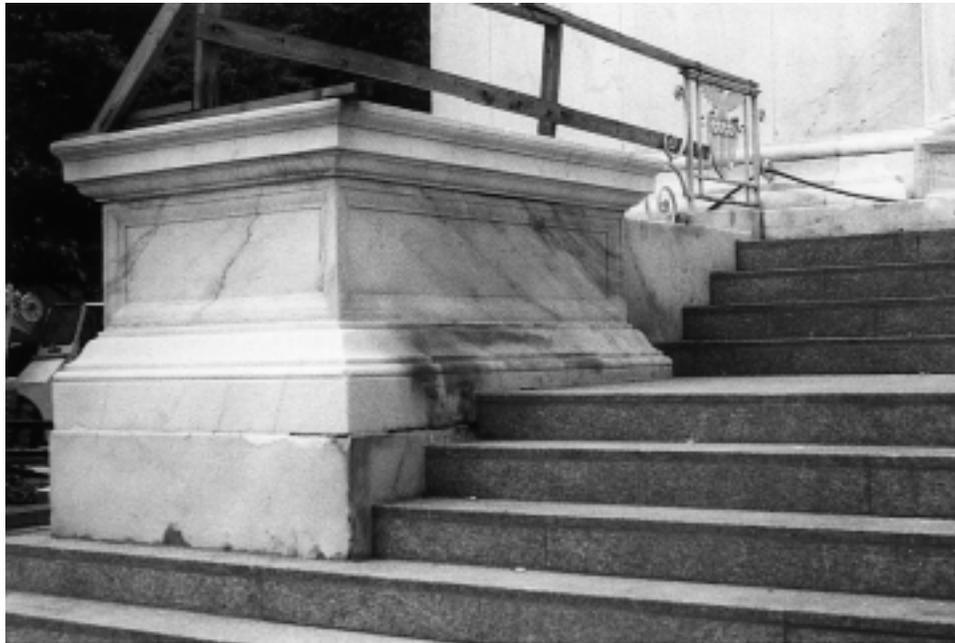
Figure 23. Reddish-orange stain at Denver Post Office (dark area at center of photograph) after several cleaning attempts in 1993.

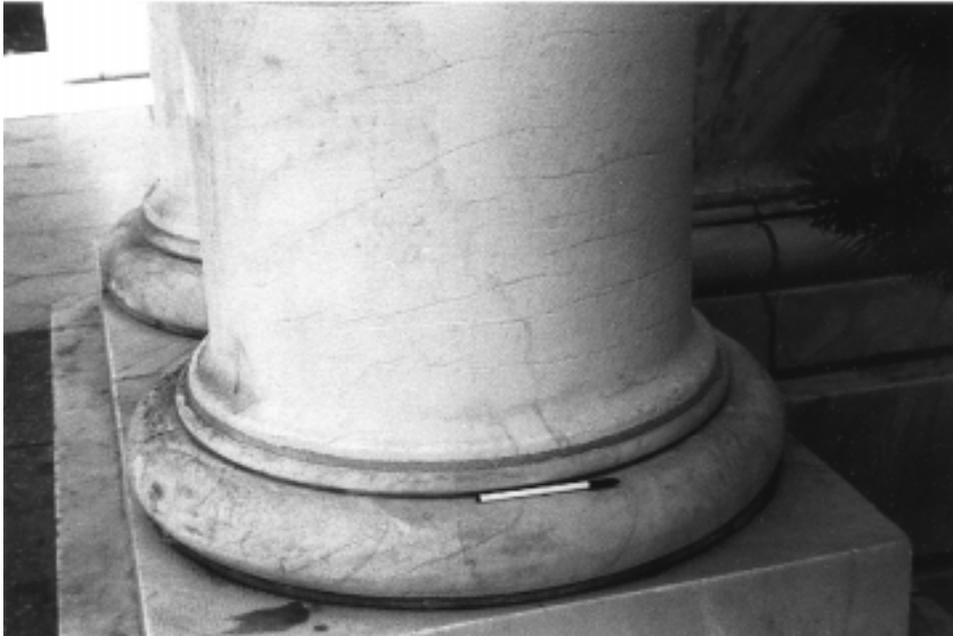
Figure 26. Rifts or surficial cracks in the marble at the Cheesman Memorial, Denver, Colo.

Because of reports of cracks (rifts) in two buildings where the Yule marble had been used in exterior work, in the Cheesman Memorial and the Post Office in Denver (The Financial World, 1913), a large portion of the testimony in a hearing held by the Lincoln Memorial Commission focused on the issue of the integrity of the marble (Lincoln Memorial Commission, 1913). To address concerns about the Yule
