# DEPARTMENT OF THE INTERIOR UNITED STATES GEOLOGICAL SURVEY

PROFESSIONAL PAPER 72

# **DENUDATION AND EROSION**

# SOUTHERN APPALACHIAN REGION

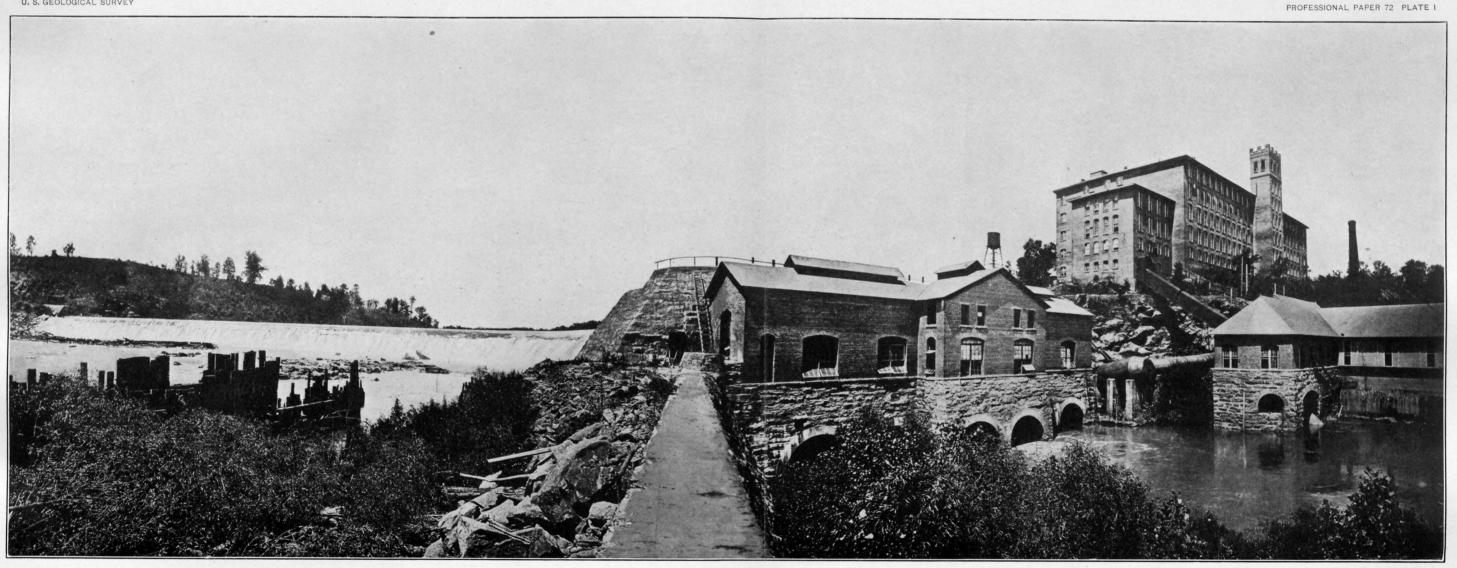
U. S. GEOLOGICAL SURVEY PROFESSIONAL PAPER 72 PLATE I

COLUMBUS POWER COMPANY'S PLANT ON CHATTAHOOCHEE RIVER AT COLUMBUS, GA. See page 14.

At one large plant storage basins that originally had capacity to hold the water accumulated by several days of ordinary stream flow have been so filled that they can not now hold even the flow of a single night. When the filling first began to cause serious trouble efforts were made to keep the material dredged out with centrifugal pumps, but the cost was soon found to be prohibitive. It has been necessary to maintain this dredging plant, however, in order to keep the channel to the wheel pits open.

channel down through the material and removes only enough for a channel way. The expense of dredging has been found to be prohibitive. The dredge merely keeps open the way to the wheel pits.

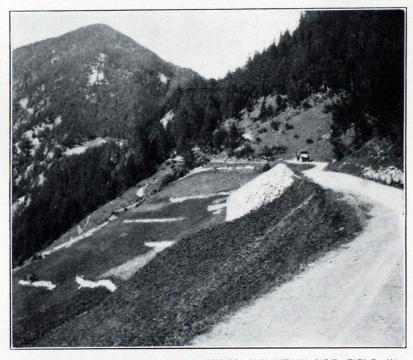
B. ROCK WALLS BUILT ON A STEEP MOUNTAIN-SIDE FIELD IN EUROPE TO KEEP THE SOIL FROM ERODING.
