Channel Widening and Flood-Plain Construction Along Cimarron River in Southwestern Kansas

GEOLOGICAL SURVEY PROFESSIONAL PAPER 352-D

By S. A. SCHUMM and R. W. LICHTY

EROSION AND SEDIMENTATION IN A SEMIARID ENVIRONMENT

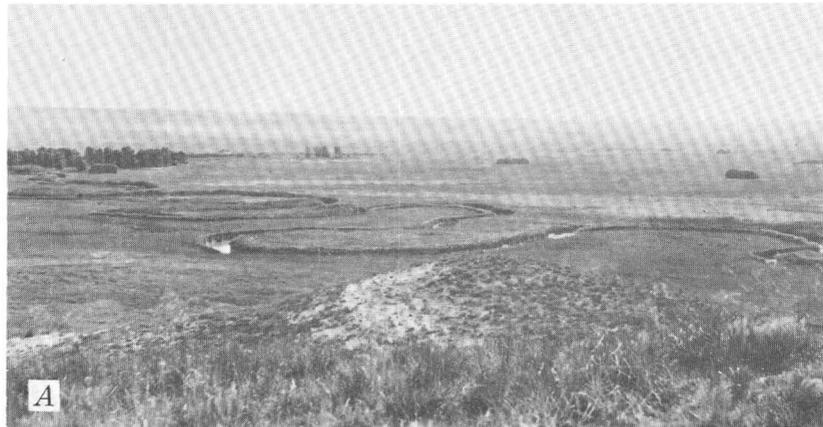
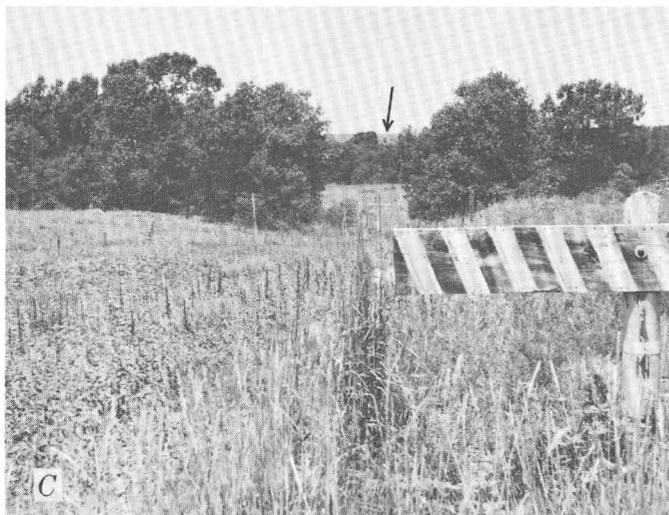
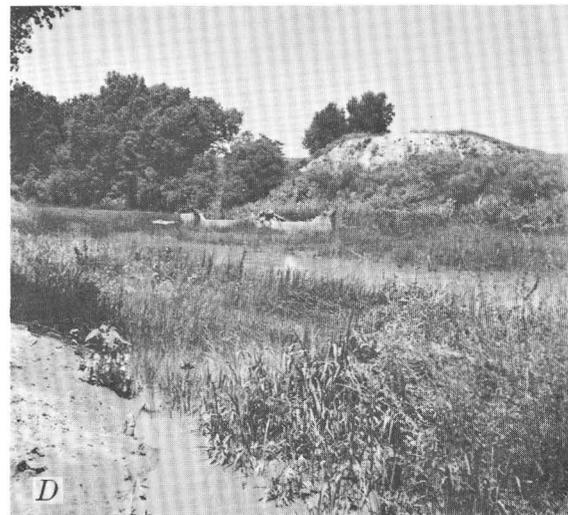
FIGURE 43.—Cimarron River in southwestern Kansas. *A*, Valley of Cimarron River in southeastern Meade County, Kans., prior to the flood of 1914. Photograph taken by W. D. Johnson in the 1890's. *B*, Cimarron River at old Highway 270 bridge north of Hugoton, Kans. (cross section 2, fig. 42), in 1943. Channel was about 700 feet wide. Arrow indicates position of windmill. Photograph taken by T. G. McLaughlin. *C*, Valley of Cimarron River at old Highway 270 bridge in 1960. Arrow indicates position of windmill shown in *B*. Trees in foreground are growing in abandoned channel shown at right end of profile *B-B'* (fig. 47). Present channel is beyond trees in background. *D*, Channel of Cimarron River at old Highway 270 bridge in 1960. Channel is 110 feet wide. Compare channel shown in this view with channel in 1943 shown in *B*.

of the century. Haworth (1897, p. 22) stated that "The Cimarron seems to have reached base-level and to have begun meandering across its flood plain. Beautiful ox-bow curves are frequent, and a sluggish nature is everywhere manifest during times of low water." (See fig. 43A.)

After the flood of 1942, a reversal of river activity occurred. Cross sections, when remeasured on aerial photographs taken in 1954, showed that the channel had become narrower (table 1). The narrowing was accomplished by flood-plain construction and, to a minor extent, by island formation. The channel width, as measured on the 1954 photographs, had decreased to an average of 550 feet (fig. 43*C*, 43*D*, 44*A*, *B*).

The major changes in width of the Cimarron River during the 46-year period 1914-60 can be grouped into 3 distinct periods: the period 1914-42 of channel widening and flood-plain destruction (figs. 43 and 44); the period 1943-54 of channel narrowing and flood-plain construction; and the period 1955-60 of relatively minor changes (figs. 43 and 44).

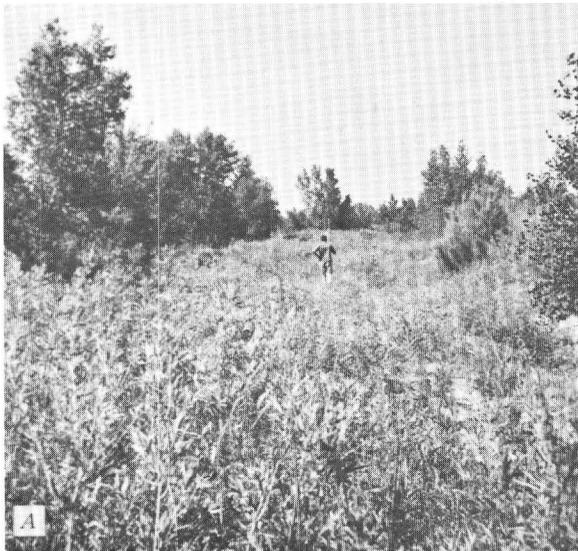
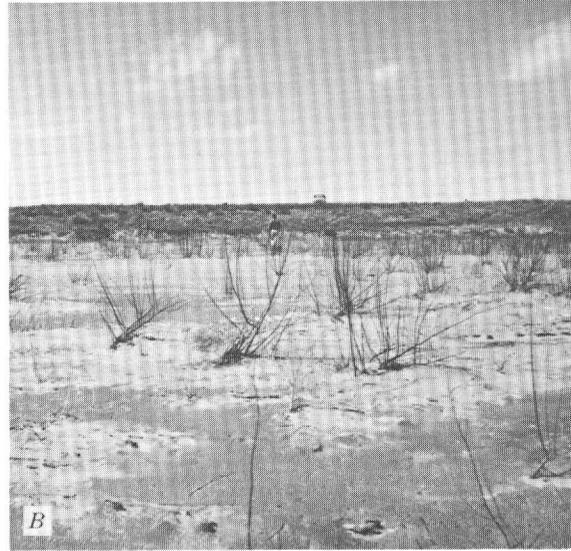
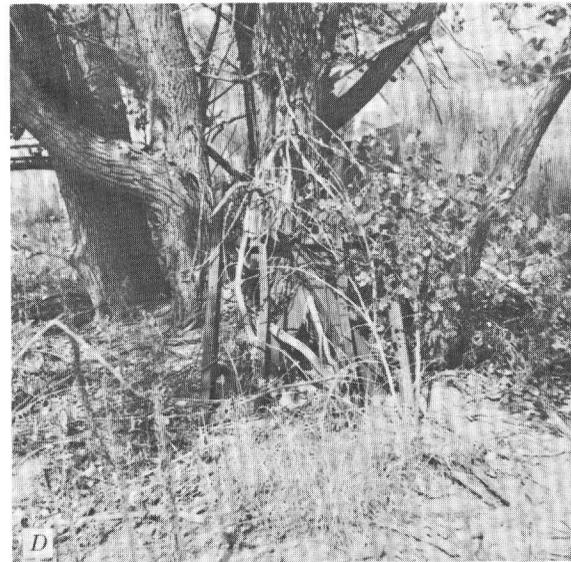
FIGURE 48.—Cimarron River in southwestern Kansas. *A*, Abandoned branch channel near State Highway 51 crossing north of Rolla, Kans., in 1960. On 1954 aerial photographs this channel contained no vegetation. *B*, One-year-old salt cedar saplings growing on mud-veneered part of channel shown at north side of profile *A-A'*, (fig. 47). Light-colored sediment is aeolian sand. *C*, Mud layers in flood-plain alluvium near bridge north of Moscow, Kans. Thin discontinuous mud layer just above thicker continuous layer in upper part of photograph is uppermost mud layer shown on figure 51. *D*, Partly buried automobile frame near country-road bridge north of Moscow, Kans. This frame is one of a group installed to aid bank stabilization. Trees growing to rear of frame are about 15 years old.

The formation of an island narrows the channel, but the presence of the island itself causes further narrowing. Depending on the orientation of the island in the channel, one or the other of the channels surrounding the island will be aggraded and abandoned (fig.

To examine these deposits in more detail, a vertical cut, which exposed 5 feet of the flood-plain alluvium, was made near the county road crossing north of Moscow. The base of the cut was at the level of the present channel. A diagrammatic sketch of this section is shown in figure 51. Six mud layers appear in this section (fig. 48C).

The flood plain is composed of sedimentary units deposited by overbank floods. A deposit of sand is overlain by a thin layer of fine sediment (the mud layer), which is deposited during the recession of the flood waters. A part of the sand above the uppermost mud layer (fig. 51) is composed of wind-blown sand trapped by vegetation on the flood-plain surface; undoubtedly, a part of the sand found between mud layers is aeolian, for the mud deposited in the channel in 1960 is now covered by a thin veneer of wind-blown sand (fig. 48B).
