# Channel and Hillslope Processes in a Semiarid Area New Mexico

GEOLOGICAL SURVEY PROFESSIONAL PAPER 352-G

By LUNA B. LEOPOLD, WILLIAM W. EMMETT, *and* ROBERT M. MYRICK  
EROSION AND SEDIMENTATION IN A SEMIARID ENVIRONMENT

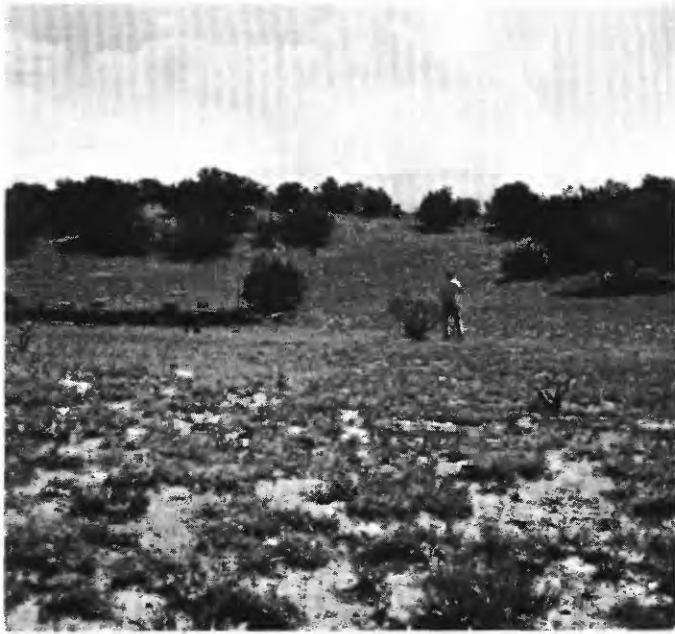
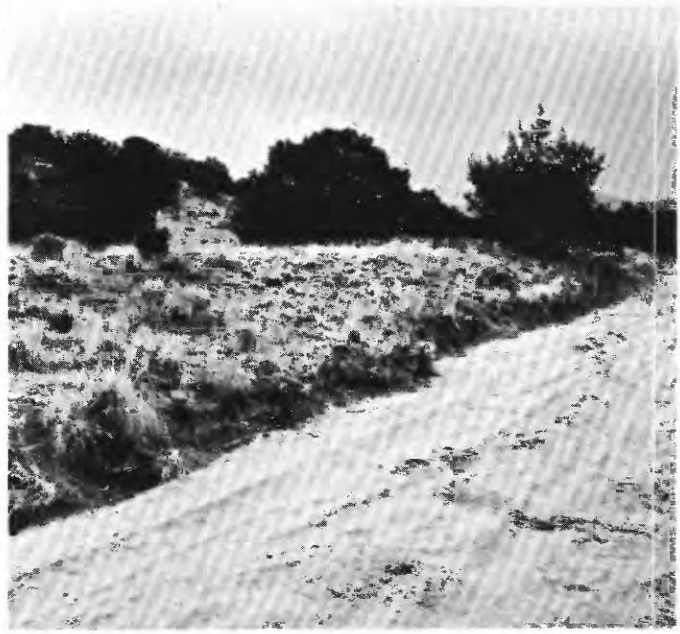
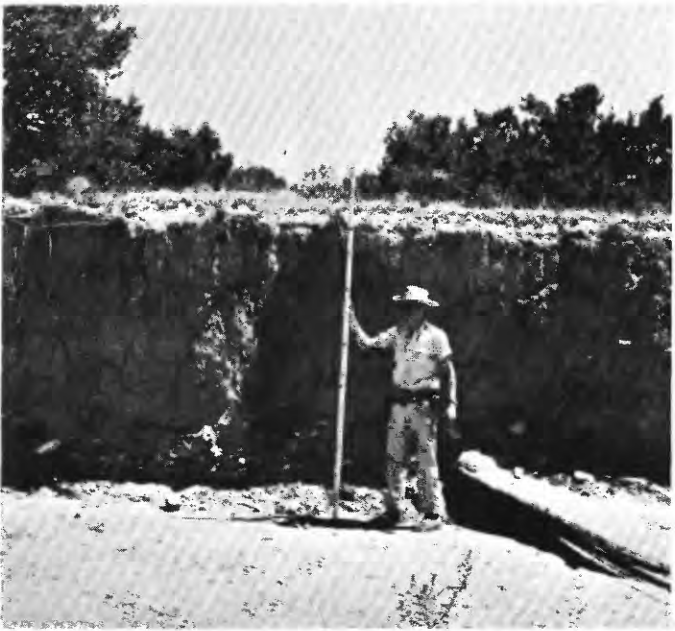
FIGURE 140.—Typical aspects of the valleys and the terraces. A, Drainage basin of Coyote C. Arroyo; the man is standing on a flat surface of alluvium or colluvium. B, Two terrace levels along Arroyo de los Frijoles; the lower terrace, about 18 inches above the channel bed, is in the foreground; at the tree near the channel edge, the upper terrace stands 5 feet above the present bed and grades smoothly to adjacent hills. C, Arroyo de los Frijoles; the channel is cutting into the upper terrace material that here stands 8 feet above the present bed elevation; the view is on the left bank just downstream from Fence Line Headcut; bedrock crops out in the channel bed at this place, dipping downstream.

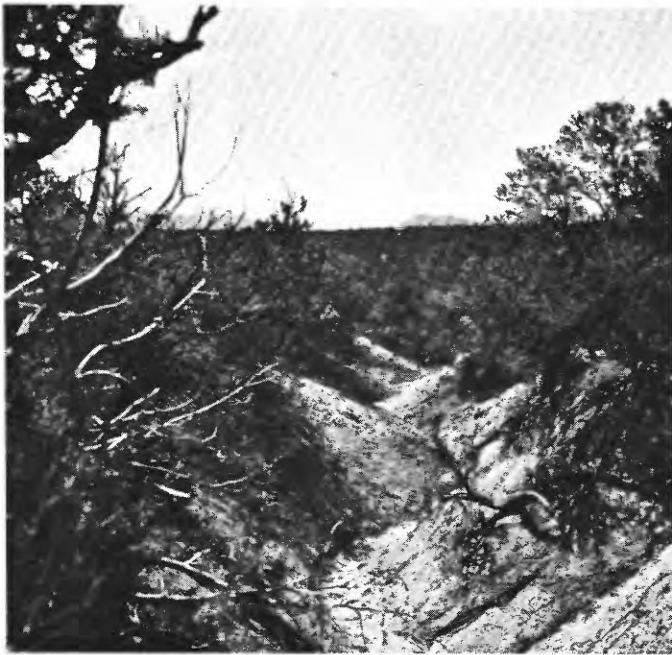
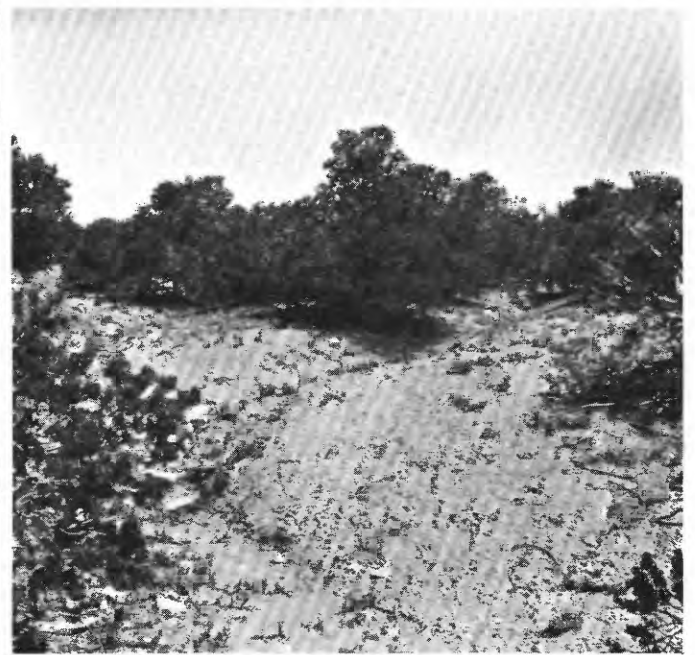
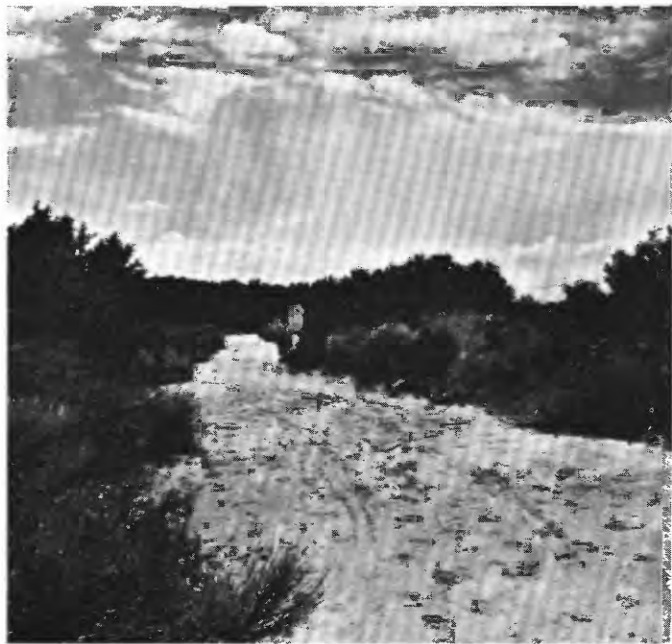
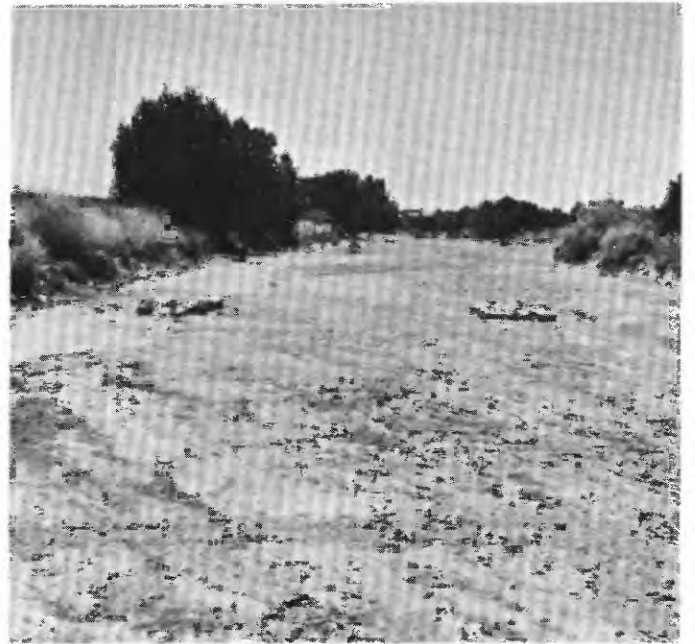
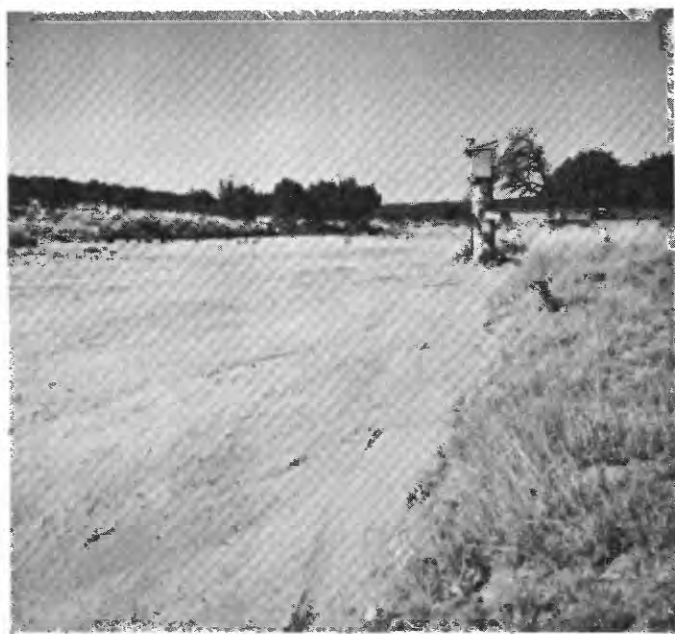
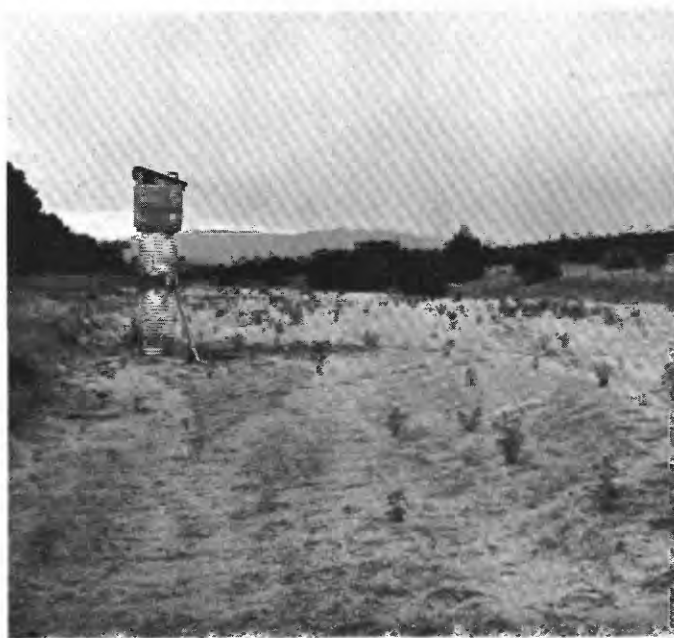
FIGURE 146 (Above and left).—Photographs illustrating several of the individual study areas. *A*, Slopewash Tributary; the area shown is along the mass-movement line (see fig. 144 for location). *B*, Slopewash Tributary; the area shown is within the erosion plot. *C*, North Frijoles Reach, Arroyo de los Frijoles; the view is downstream from above the gaging station. *D*, Locust Tree Reach, Arroyo de los

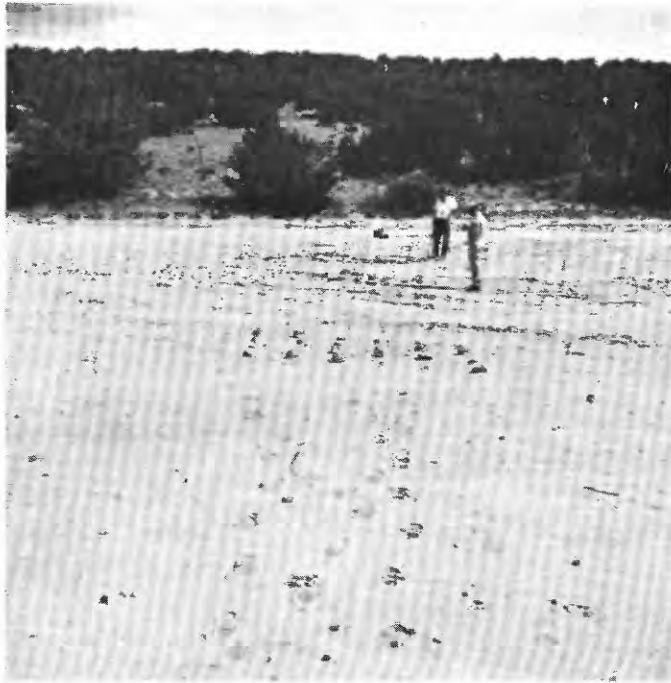
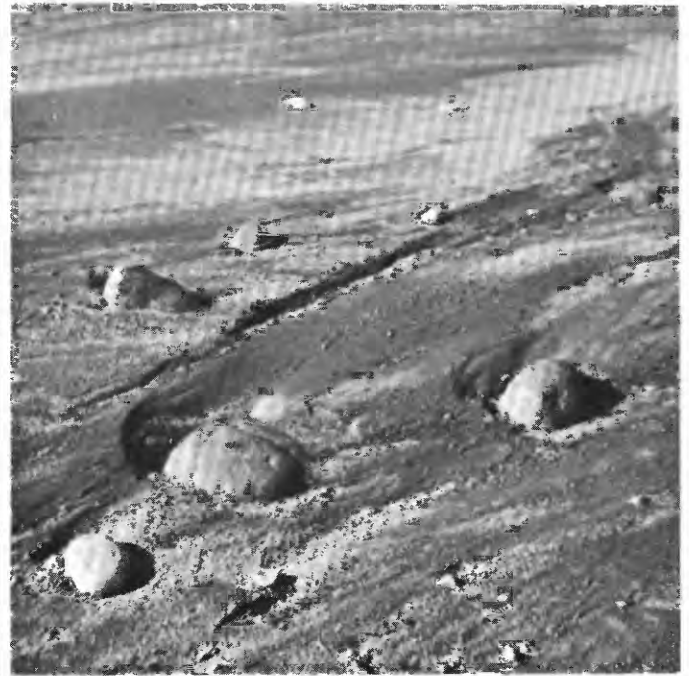
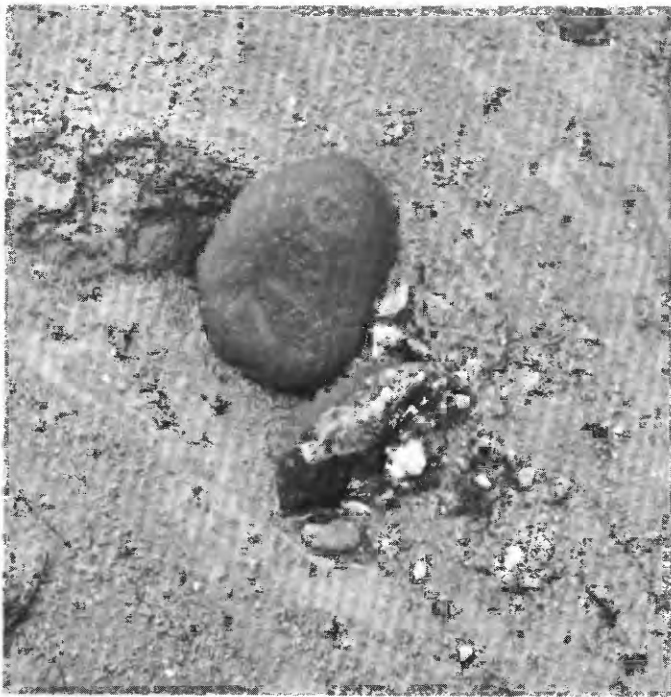
FIGURE 152.—The painted rock experiments and a naturally occurring accumulation of large particles. A, Main Project Reach, showing Latin Square position of painted rock groups in the sandy channel. B, Rocks moved from Main Project Reach during flood of August 4, 1960; note scour pits around each boulder. C, Detail of rock weighing 7,100 grams at Main Project Reach, partially buried by sand and organic debris during flow of August 4, 1960. D, Gravel bar at Sand Plug Reach, Arroyo de los Frijoles, looking upstream.

completely buried. Many particles are found partly buried (fig. 152) and the data on losses indicate that others become completely buried. Recoveries range from more than 90 percent in small flows to 2 percent for one exceptionally large flow. Apparently the losses have decreased since adoption of a water-base masonry paint, but even under optimum conditions losses of 10–30 percent during small flows and 30–50 percent during large flows are to be expected. The greatest losses occur in the smaller size classes.

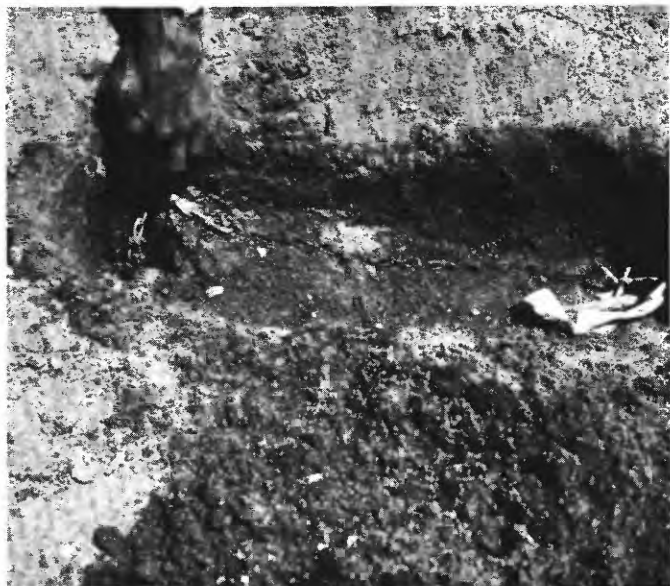
FIGURE 157.—Horizontal part of chain lying at depth of maximum scour, here about half a foot. Vertical part of chain disappears below man's hand.

Depths of scour and fill in channels are measured by chains set vertically in a dug hole in the streambed. At maximum depth of scour the chain is bent over by the flow and is usually covered by fill on the receding stage (Emmett and Leopold, 1964).

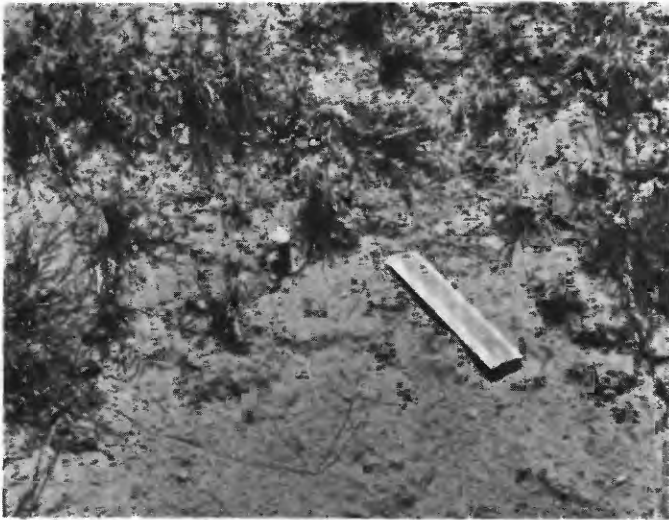
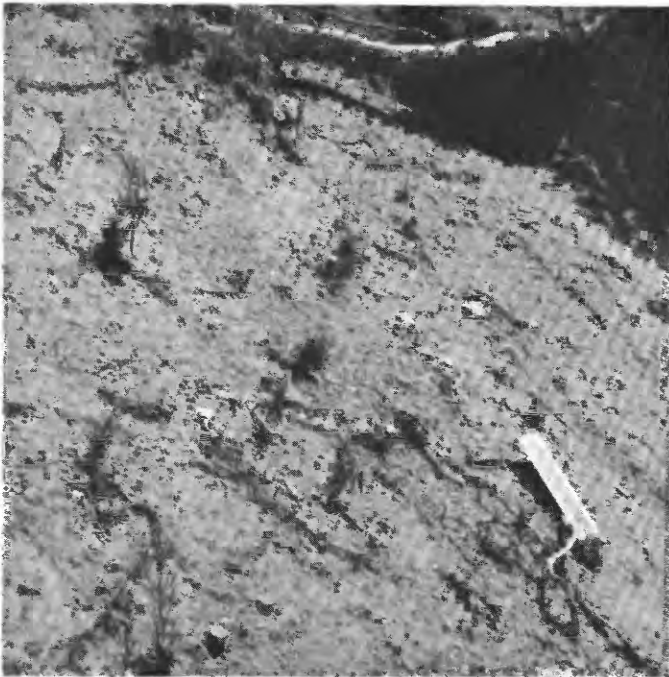
FIGURE 162.—Erosion pins consisting of 10-inch spike and washer. *A*, Erosion pins in grid system, Slopewash Tributary (scale is a 6-inch ruler). *B*, Erosion pins on slope-retreat line, Slopewash Tributary.

At the time of the installation, the nails (10-inch spikes) were slipped through a large washer and driven into the ground in a vertical position until the bottom of the washer was flush with the ground surface. Erosion undermines the washer, which then falls down a length of the pin. The pin protrudes above the washer at a distance equal to the erosion during the intervening period. While maximum erosion is marked by the washer, deposition may be recorded as the height of any material above the washer, a desirable feature in such places as a rill bottom where maximum and net erosion generally differ. Figure 162 shows typical erosion nails

on the erosion plot and on transects. Elevations of all nail heads were measured and resurveys show that the nails remain stable and are not being heaved by frost action.

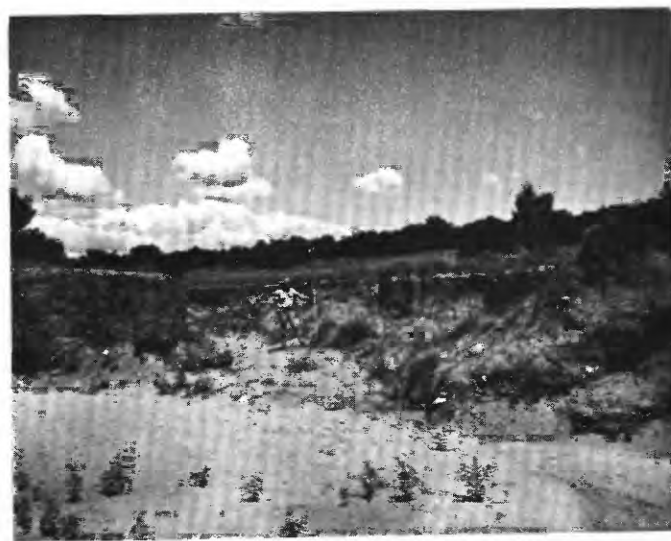
FIGURE 165.—Fence Line Headcut.

Fence Line Headcut is a tributary to the Arroyo de los Frijoles, entering on the left bank about 1,500 feet below the Main Project Reach. Figure 165 is a photograph of this headcut in 1964. In 1960 the headcut was staked with six iron pins, each 4 feet in length. The rate of enlargement of the headcut is determined by

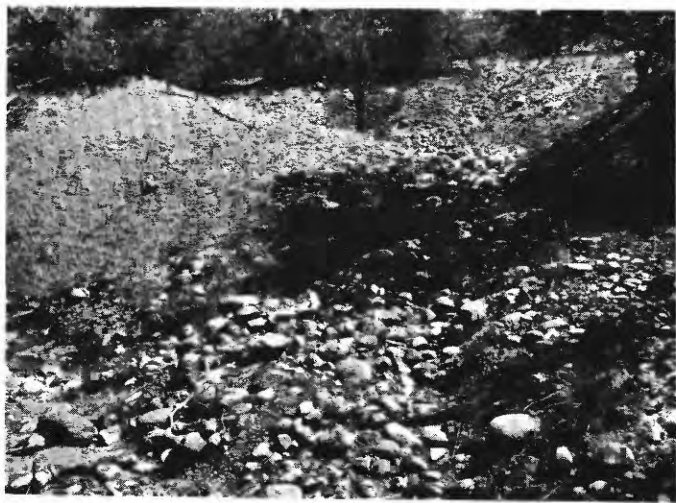
FIGURE 168.—Green Rock Gulch, a tributary to Slopewash Tributary. Rocks wash into this minor rill from the lag gravel covering some of the hillslopes seen in the background.
