Landslides Along the Columbia River Valley Northeastern Washington

GEOLOGICAL SURVEY PROFESSIONAL PAPER 367

By FRED O. JONES, DANIEL R. EMBODY, and WARREN L. PETERSON

*Descriptions of landslides and statistical
analyses of data on some 200 landslides in
Pleistocene sediments*

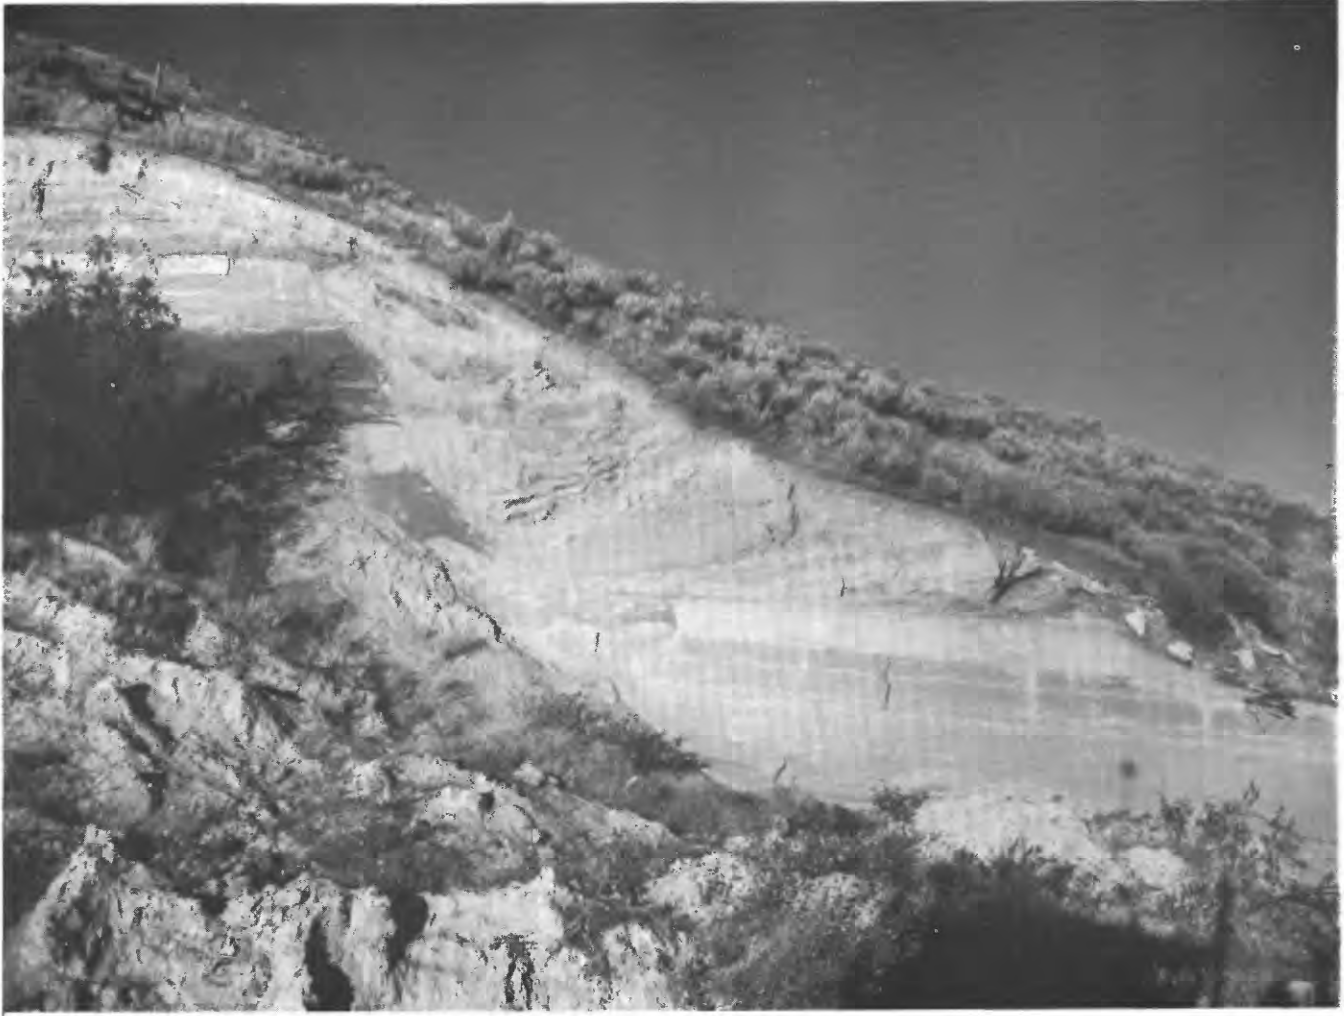
FIGURE 3.—An ancient slump-earthflow landslide exposed by recent sliding. Note that lower part of the surface of rupture follows a bedding plane. Fort Spokane area, lake mile 42.3 left bank.

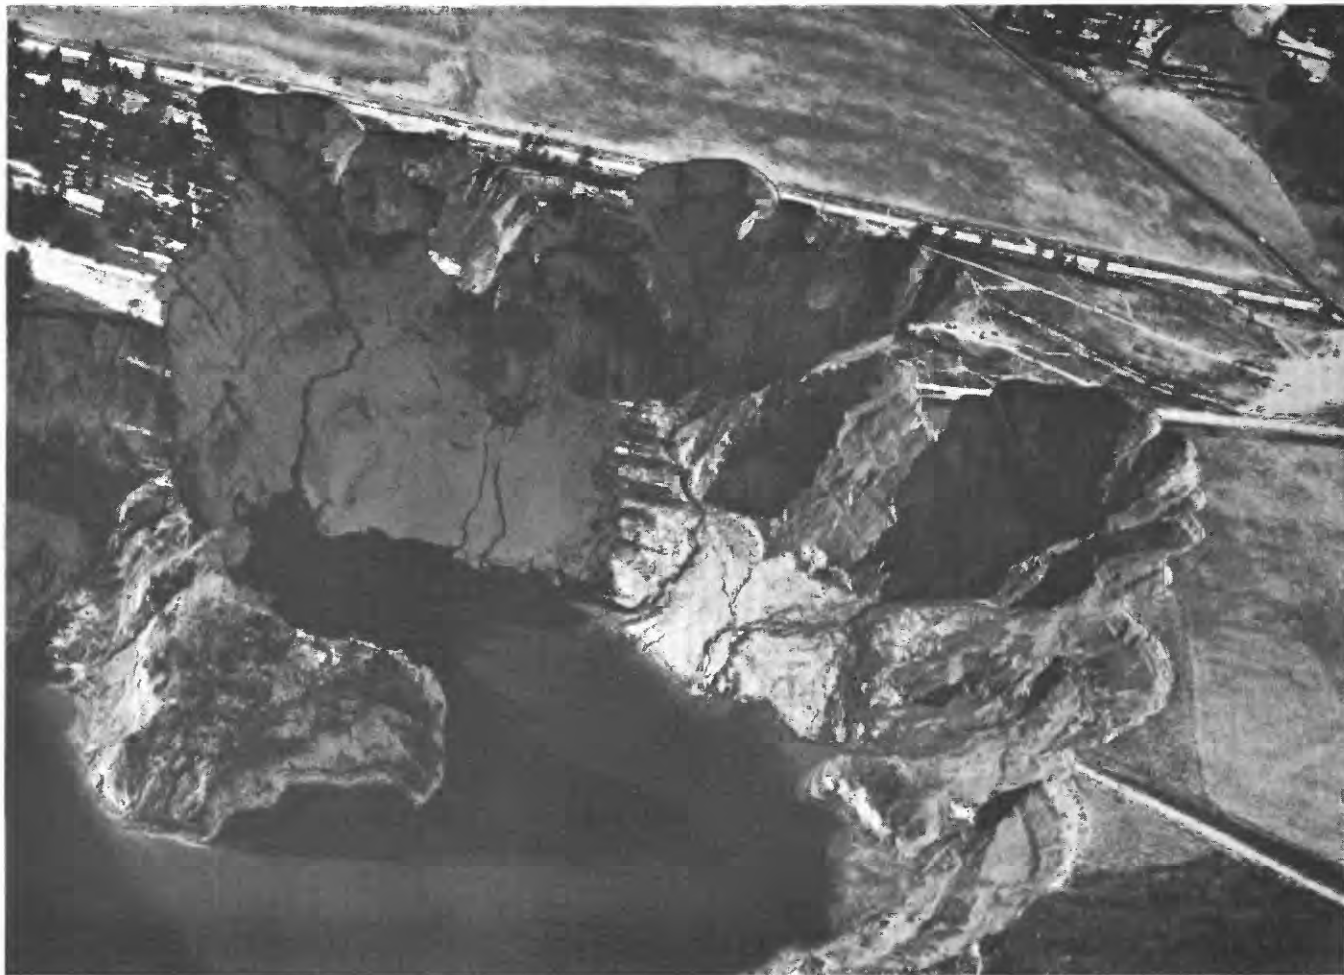
FIGURE 4.—Aerial view of a recent multiple-alcove landslide. See cross section in figure 5.

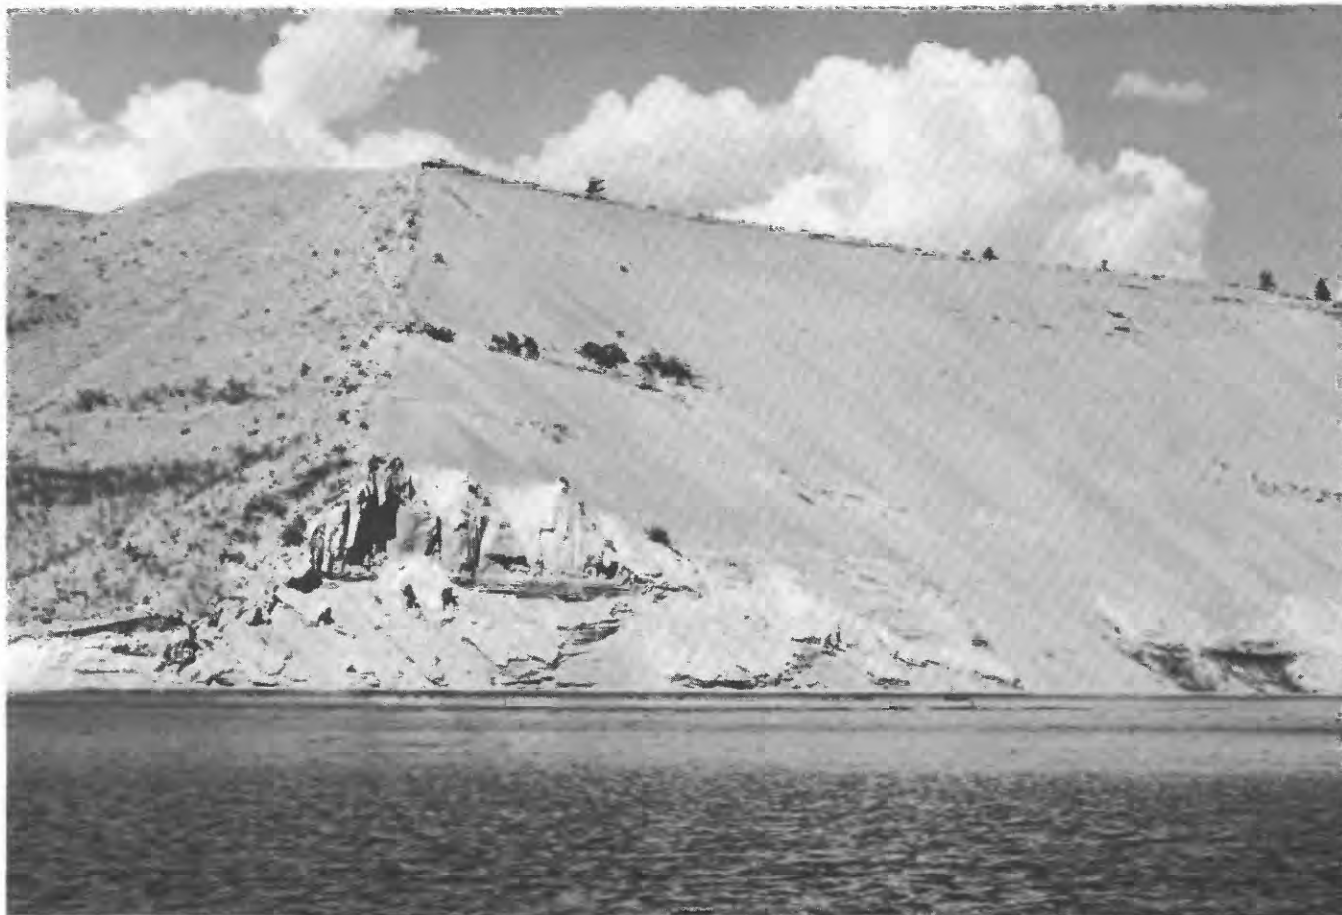
FIGURE 6.—Photograph of a typical slip-off slope landslide. See cross section in figure 7

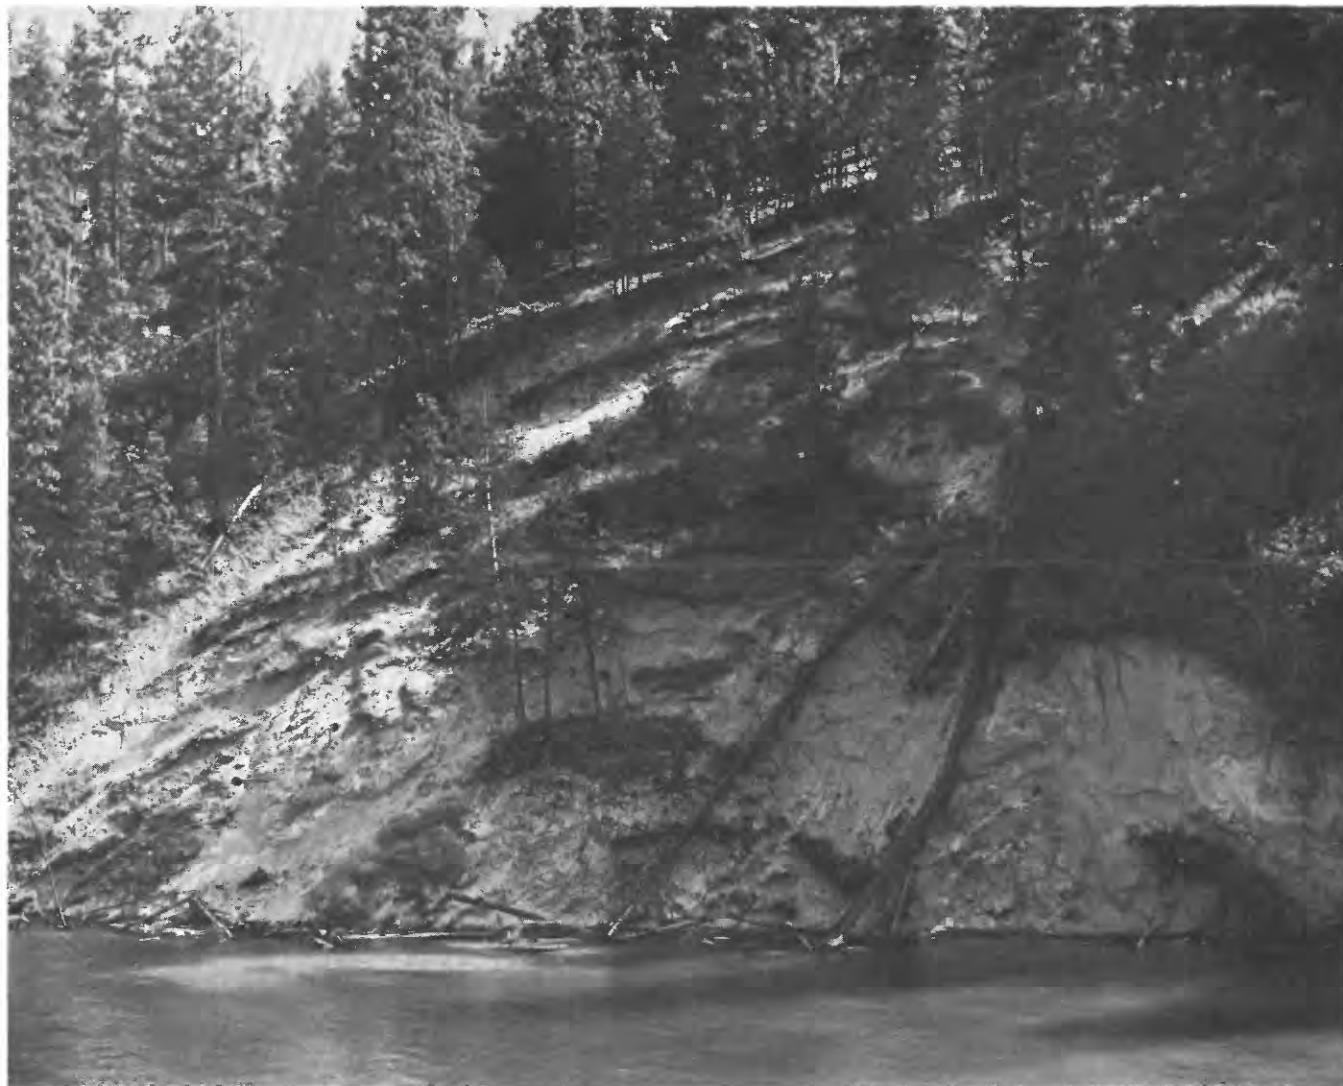
FIGURE 8.—Slip-off slope landslide in sand. Slide blocks show little or no backward rotation. Surface of rupture is at shallow depth beneath surface of the slide debris. Slide 268, Kettle Falls area.

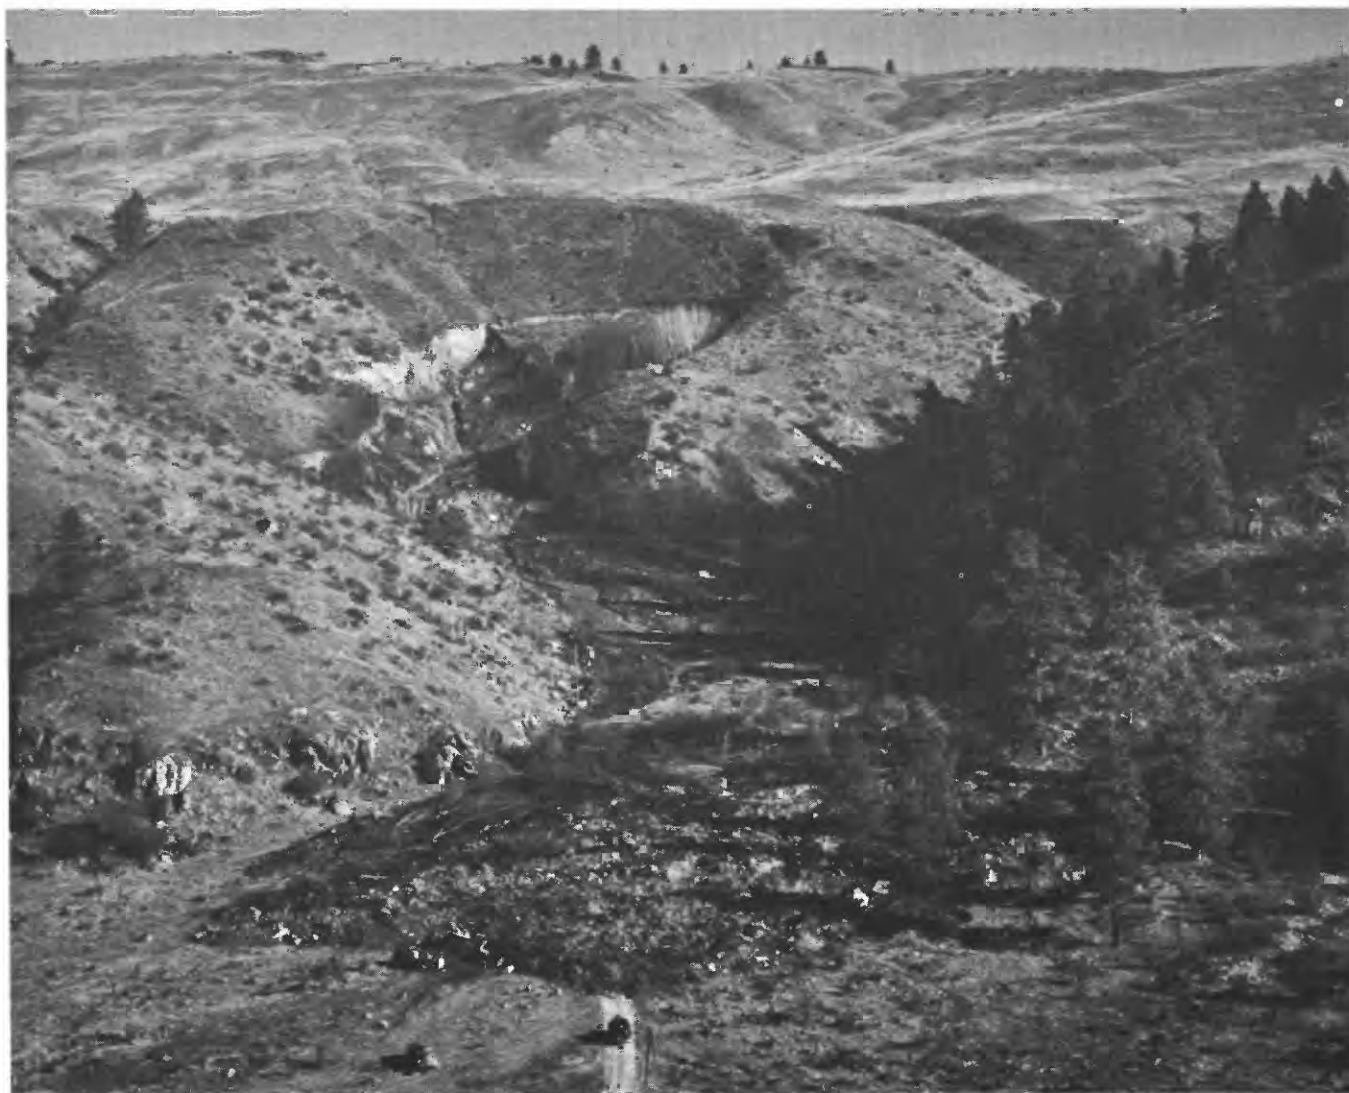
FIGURE 9.—Mudflow in Hopkins Canyon occurred on February 2, 1953, at about midnight; it lasted an estimated 7 minutes and destroyed a small house. The mudflow originated in the alcove in the background which before the mudflow was an area of seeps. A slump block which settled during or after the mudflow lies to the right of the alcove. This feature is analogous to the slump-earthflow landslide with slump block above and earthflow at the toe. In this instance, the earthflow was so mobile that a mudflow resulted. Slide 295, Nespelem River-Omak Lake valley area.

falls are common along the sides and upper part of the surface of rupture. Only two mudflows have been recorded in the area in recent years (figs. 9 and 18).

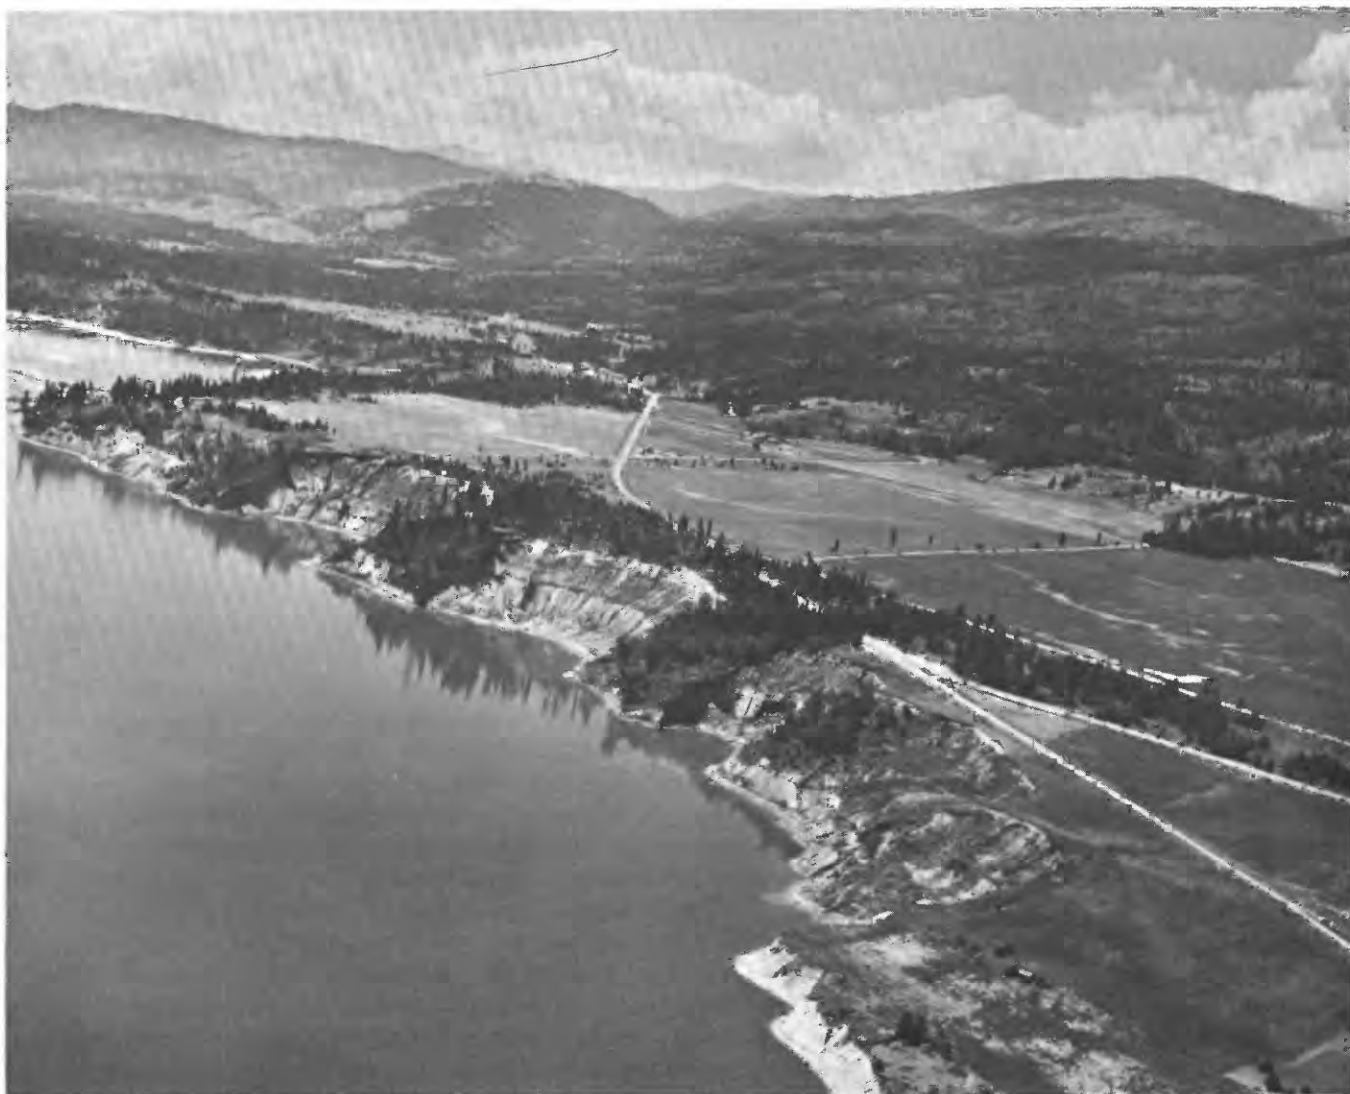
FIGURE 11.—Aerial oblique photograph of the Reed terrace taken on May 15, 1951, looking southwest. Scars of the two large landslides of 1944 are in the middle left. Vegetation-covered scars of ancient landslides at the lower right. The scar of slide 260 of March 1951, is between. Compare with figure 12. Franklin D. Roosevelt Lake on left.

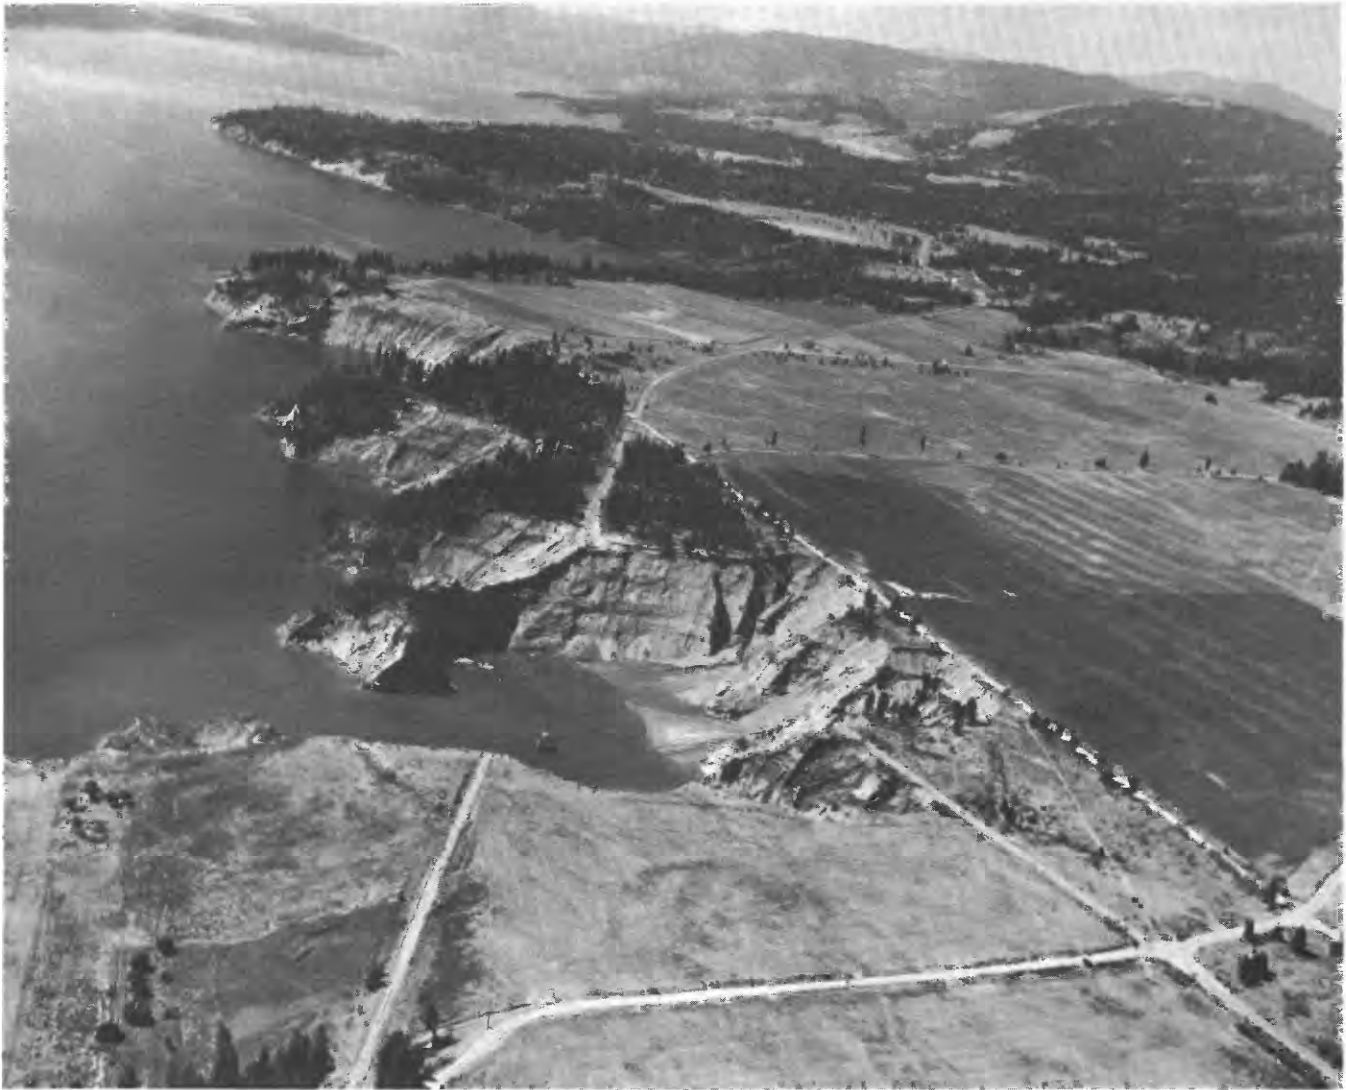
FIGURE 12.—Aerial oblique photograph of the Reed terrace looking south on August 1, 1952. The large landslide alcove in the foreground is the multiple-alcove landslide of April 10, 1952 (261). Compare this photograph with figures 4 and 11. The initial landslide slid through a narrow throat on April 10. How far into the terrace the initial failure cut is not known, but by April 13 repeated sliding had severed the middle road of the photograph (the Kettle Falls-Inchelium highway). The scarp advanced along three main lines corresponding to springs that issued high on the scarp until the scalloped form shown here was attained. Mudflows, and water issuing from the springs, built the fans into the slide basin in the later stages of scarp advance. See figure 4 for a more detailed view of this multiple-alcove slide and figure 11 for a view of the terrace before the occurrence of this slide. Franklin D. Roosevelt Lake on left.

The initial failure took place about 3:00 a.m., Thursday, April 10, 1952. Mr. Reed's house shook and lurched at this time. The landslide is at the north end of the Main terrace, the edge of it being just 2,000 feet from the Reed house. The initial slide occurred in a very narrow throat. Although the throat has been greatly widened by subsequent action, it is still narrow by comparison with the size of the slide (fig. 4). How far back the initial failure cut is not known, but by April 13 repeated sliding had severed the Kettle Falls-Inchelium highway (pl. 1; fig. 12) 2,000 feet from the original lakeshore.

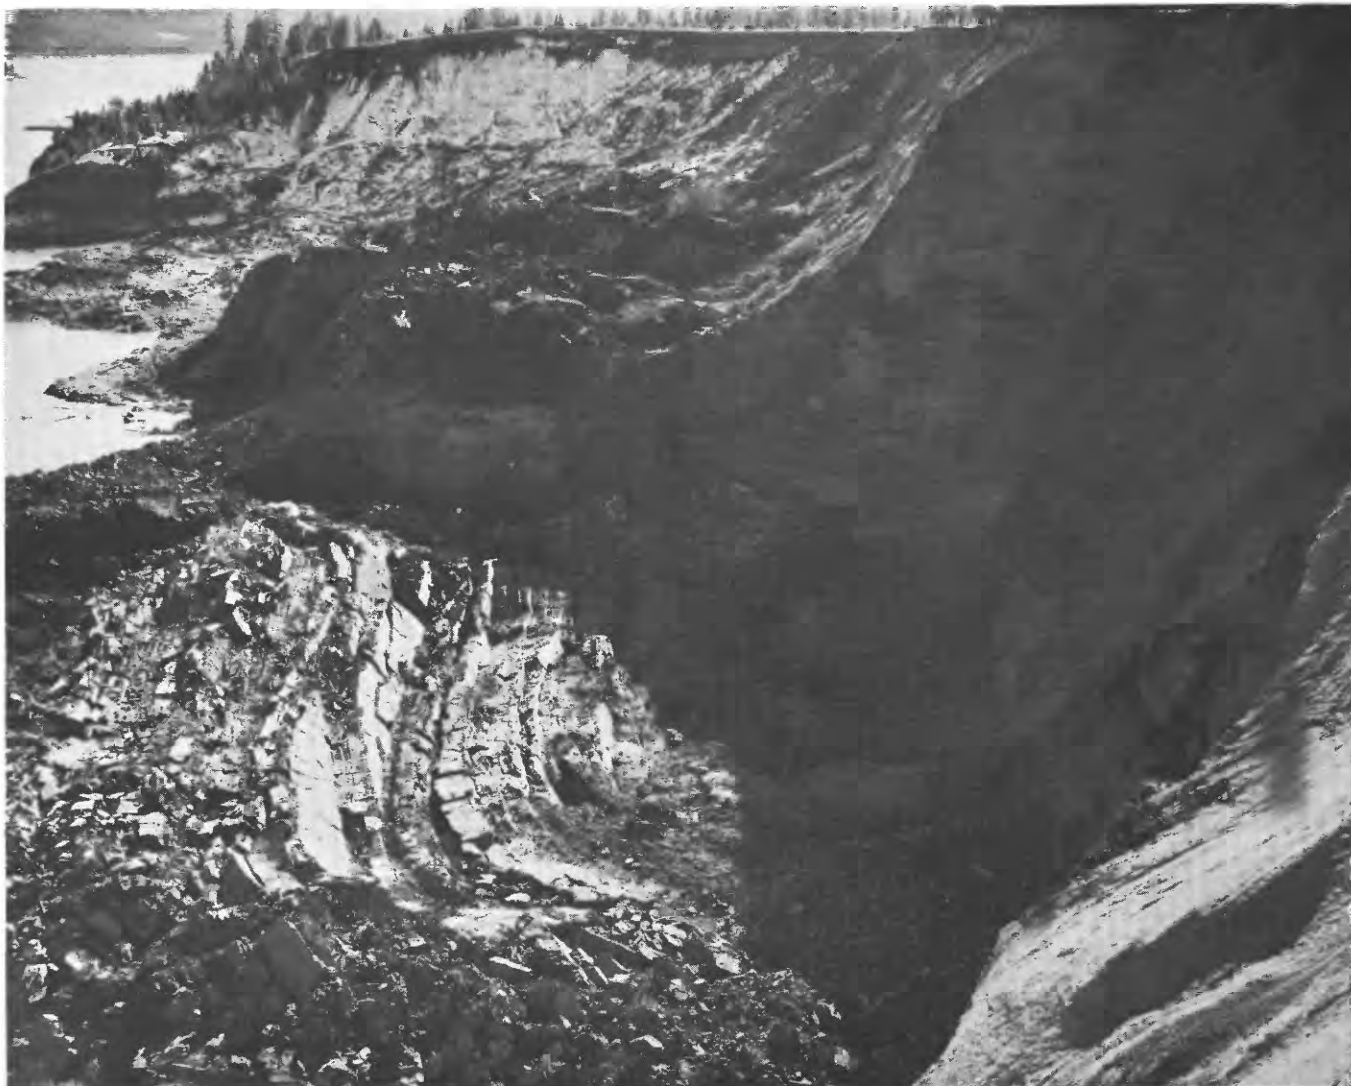
FIGURE 13.—Slump-earthflow landslide. Photograph taken about 2½ hours after landslide. Shows a large block rotated toward the scarp of the landslide which is typical of slump earthflows. Material is varved silt and clay. Slide 305, Reed terrace area.

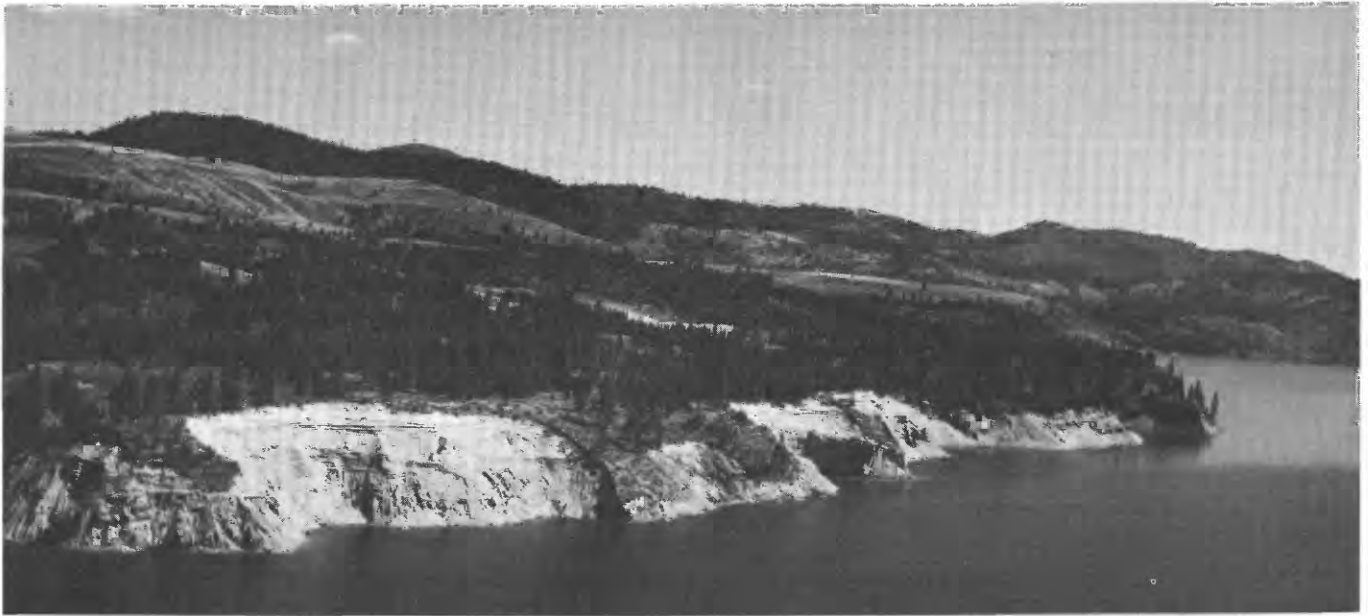
FIGURE 14.—Terrace of sand with some interbedded silt and clay. Most of terrace scarp has been cut away by a slump-earthflow landslides. Landslide debris disappeared below the surface of the lake. Cedonia area, lake mile 69 to 70 left bank.

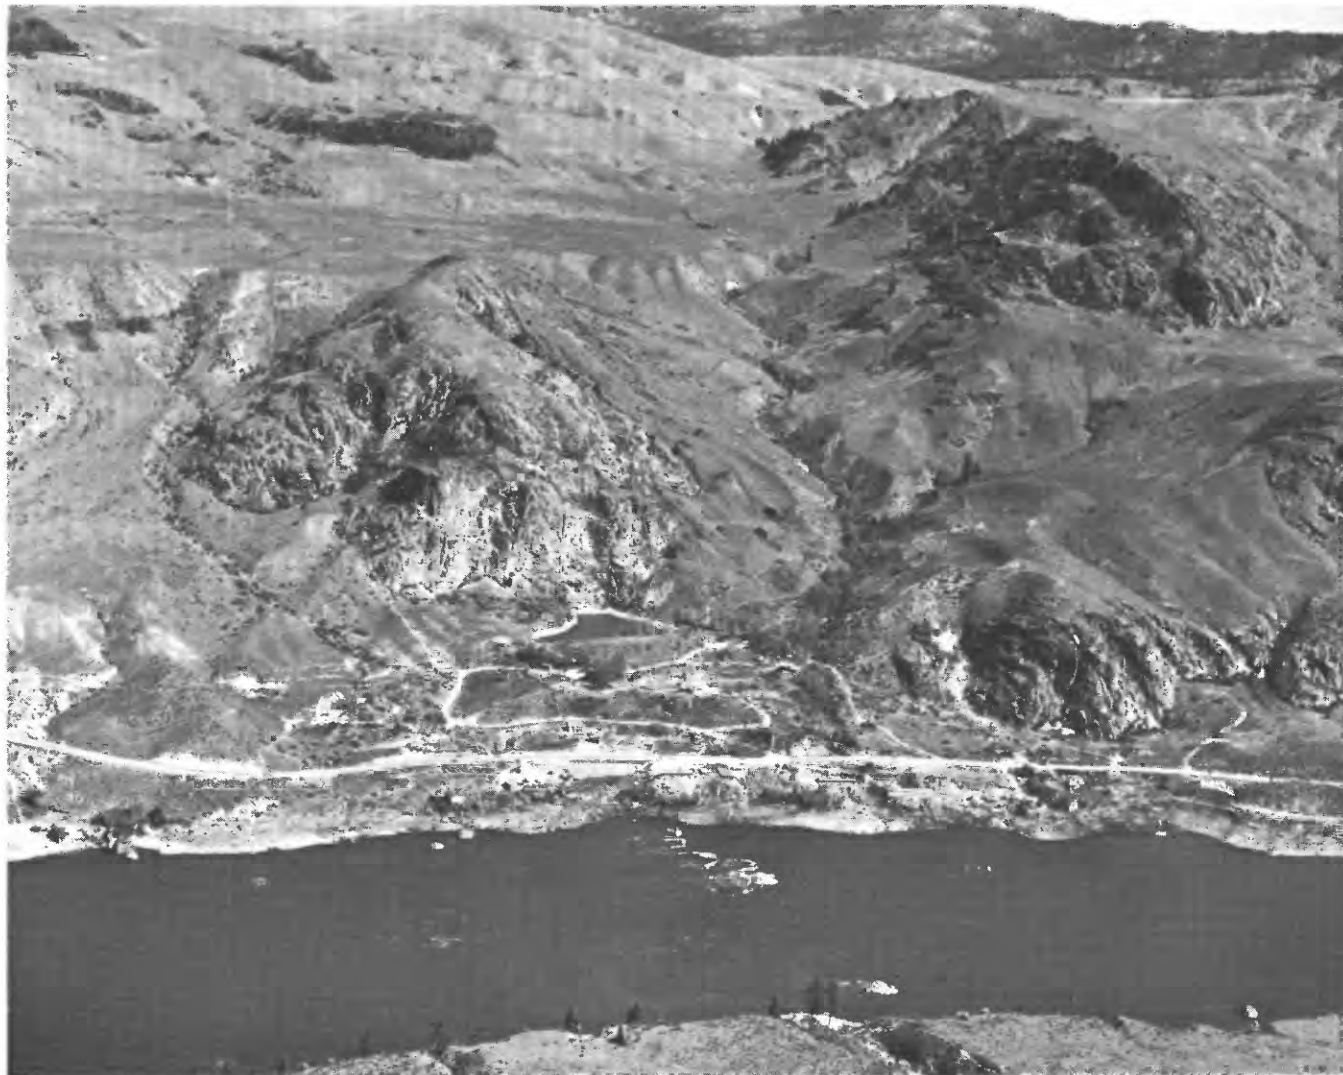
FIGURE 15.—Aerial photograph of Seatons landslide. Diagram showing major slide scarps shown in figure 16.

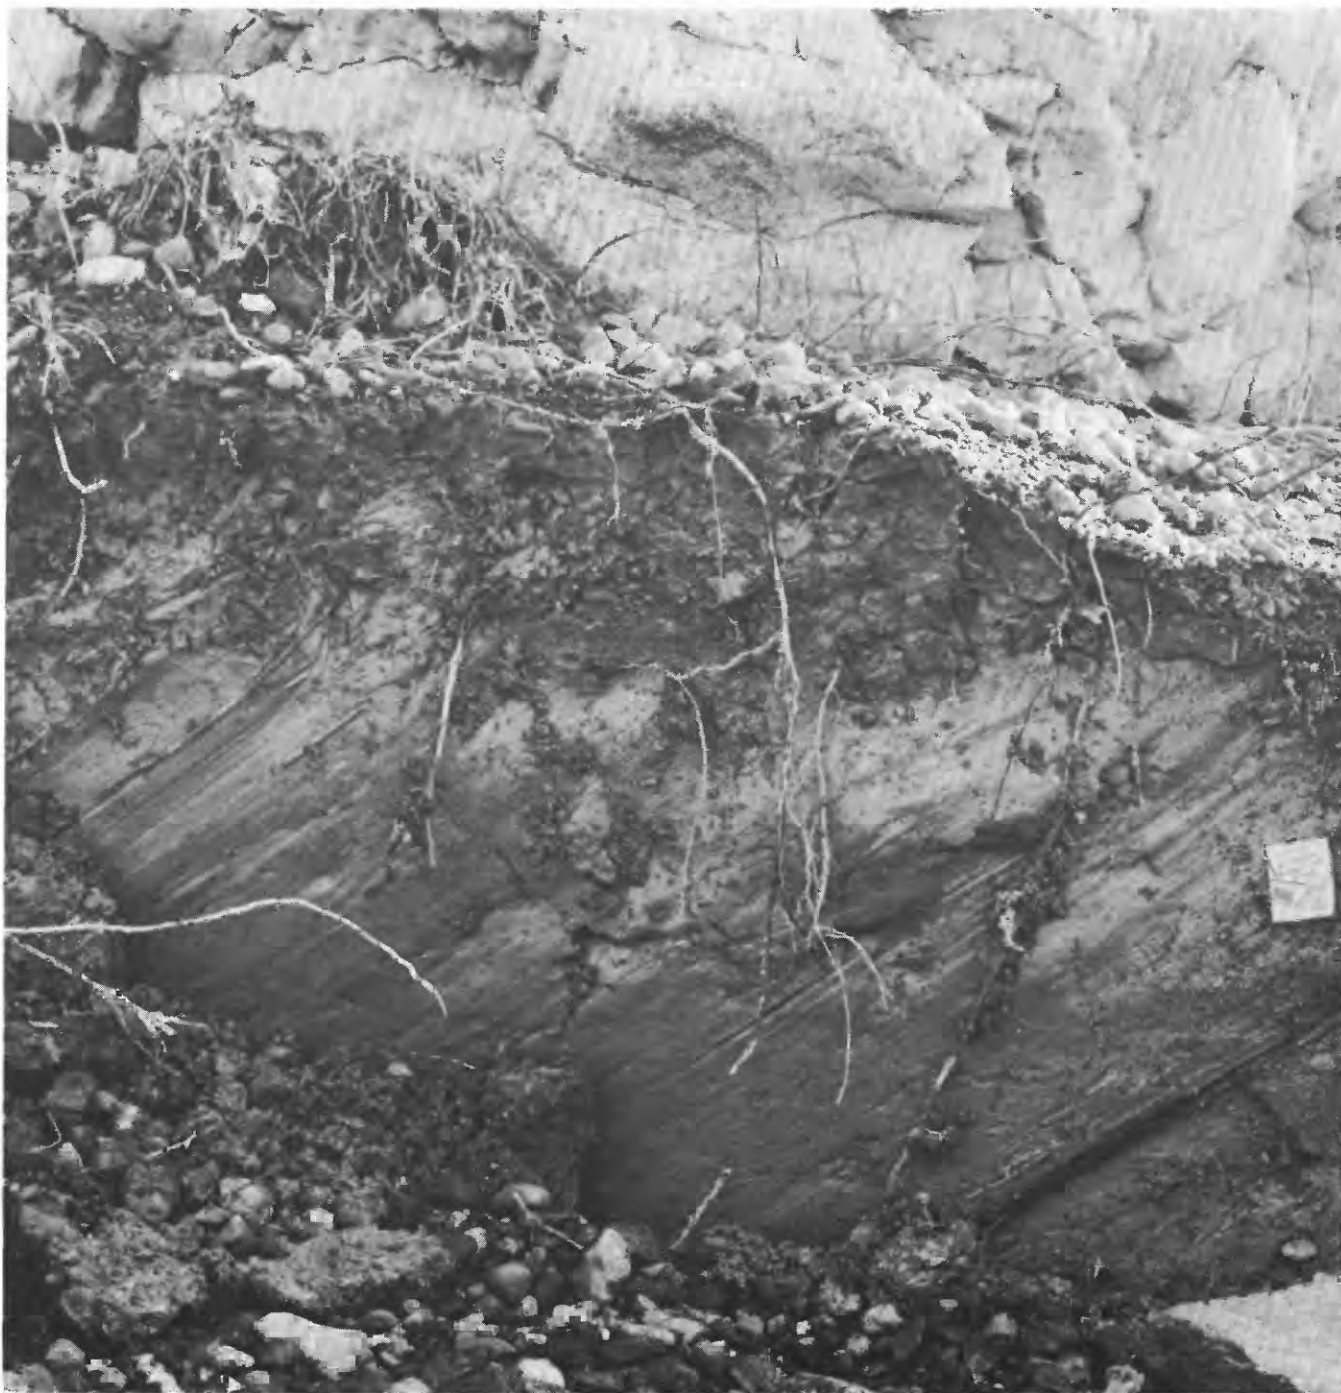
FIGURE 17.—Slickensides showing the upward and riverward (right) movement of the downstream side of the Seatons landslide. Striations are on the moved block which is composed of lacustrine silt and clay overlain by river gravel (rock at top of the photograph is a large boulder). Undisturbed material in the foreground. Photograph by H. W. Fuller for U.S. Bureau of Reclamation.

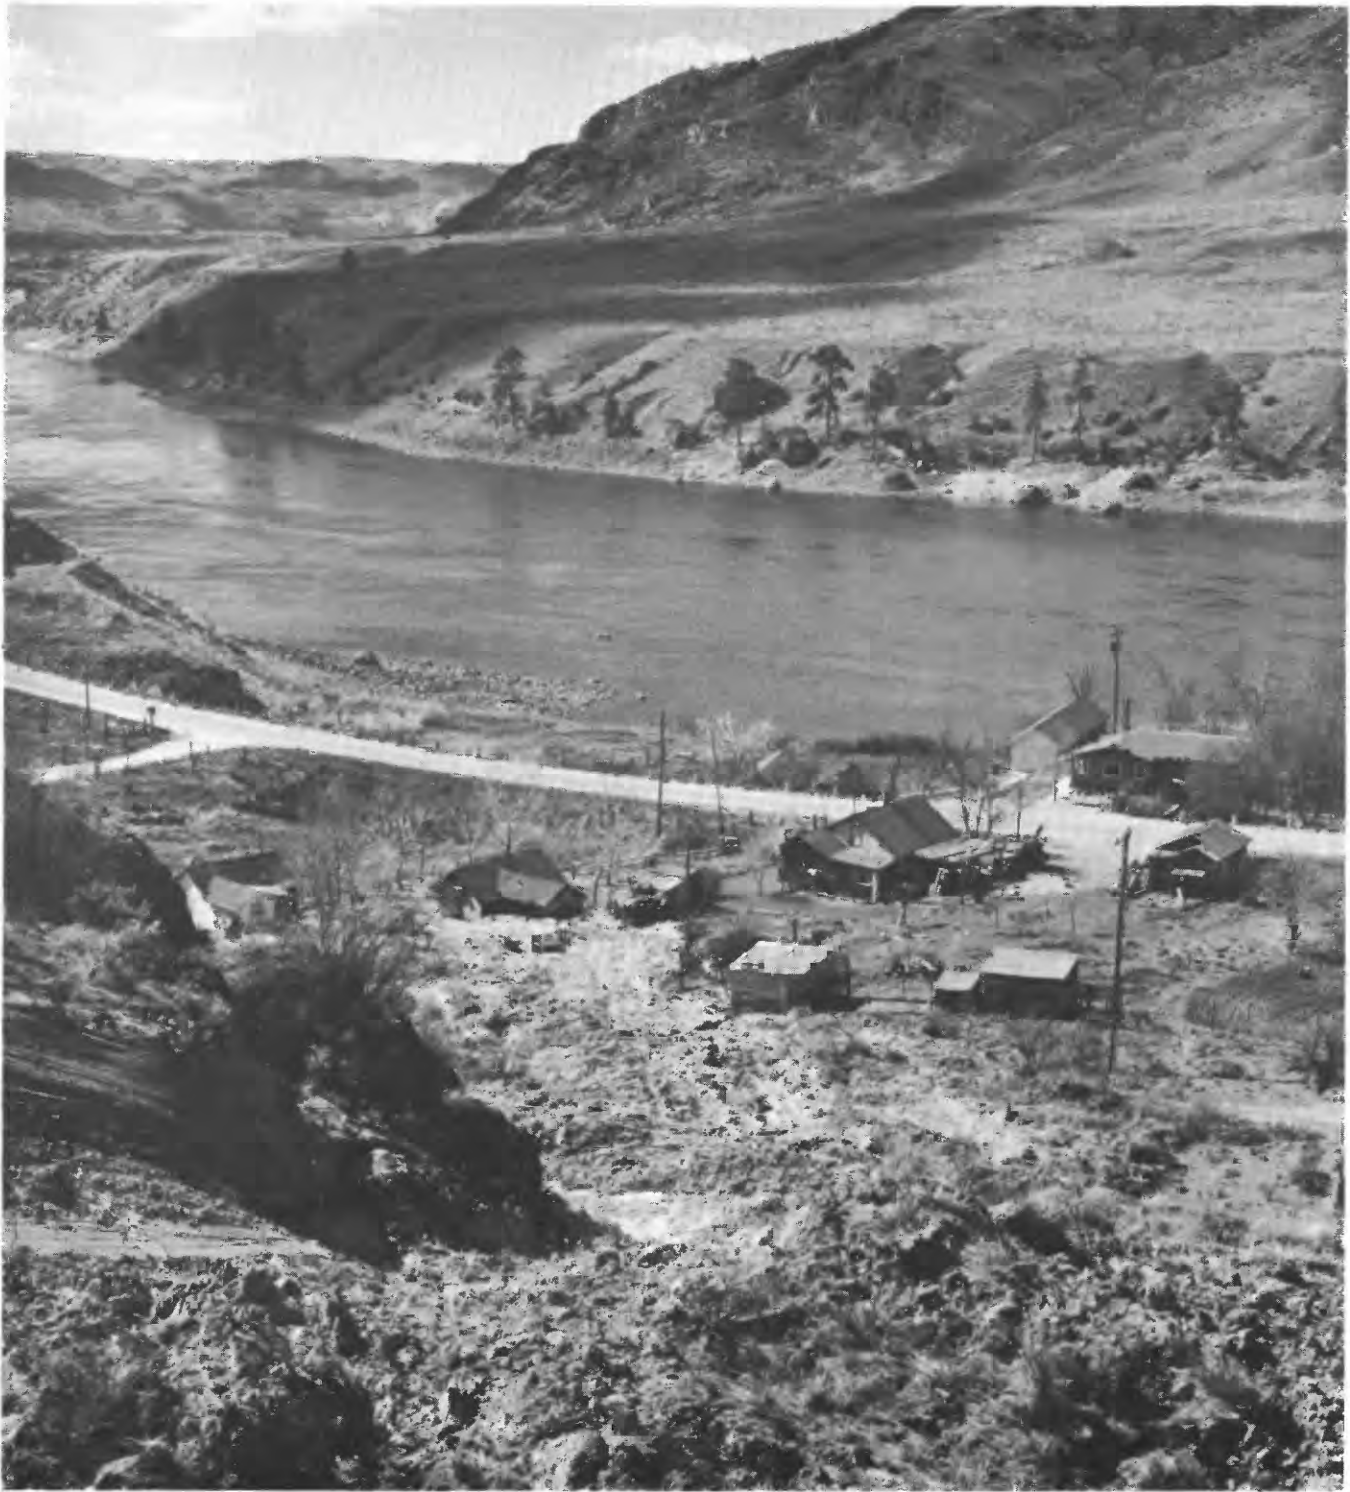
FIGURE 18.—Mudflow at Seatons Grove, in the foreground, occurred March 17, 1949, at 6:30 p.m. Several observers were almost trapped by the advancing mud. Striations at extreme left were formed as the mudflow crossed undisturbed material. Slide 320, Coulee Dam-Belvedere area, river mile 5.1 right bank.

On March 17, 1949, a mudflow occurred on the edge of the Seatons landslide (fig. 18). The materials of this mudflow were predominantly silt and clay that filled a steep-sided valley in granite. The mudflow was

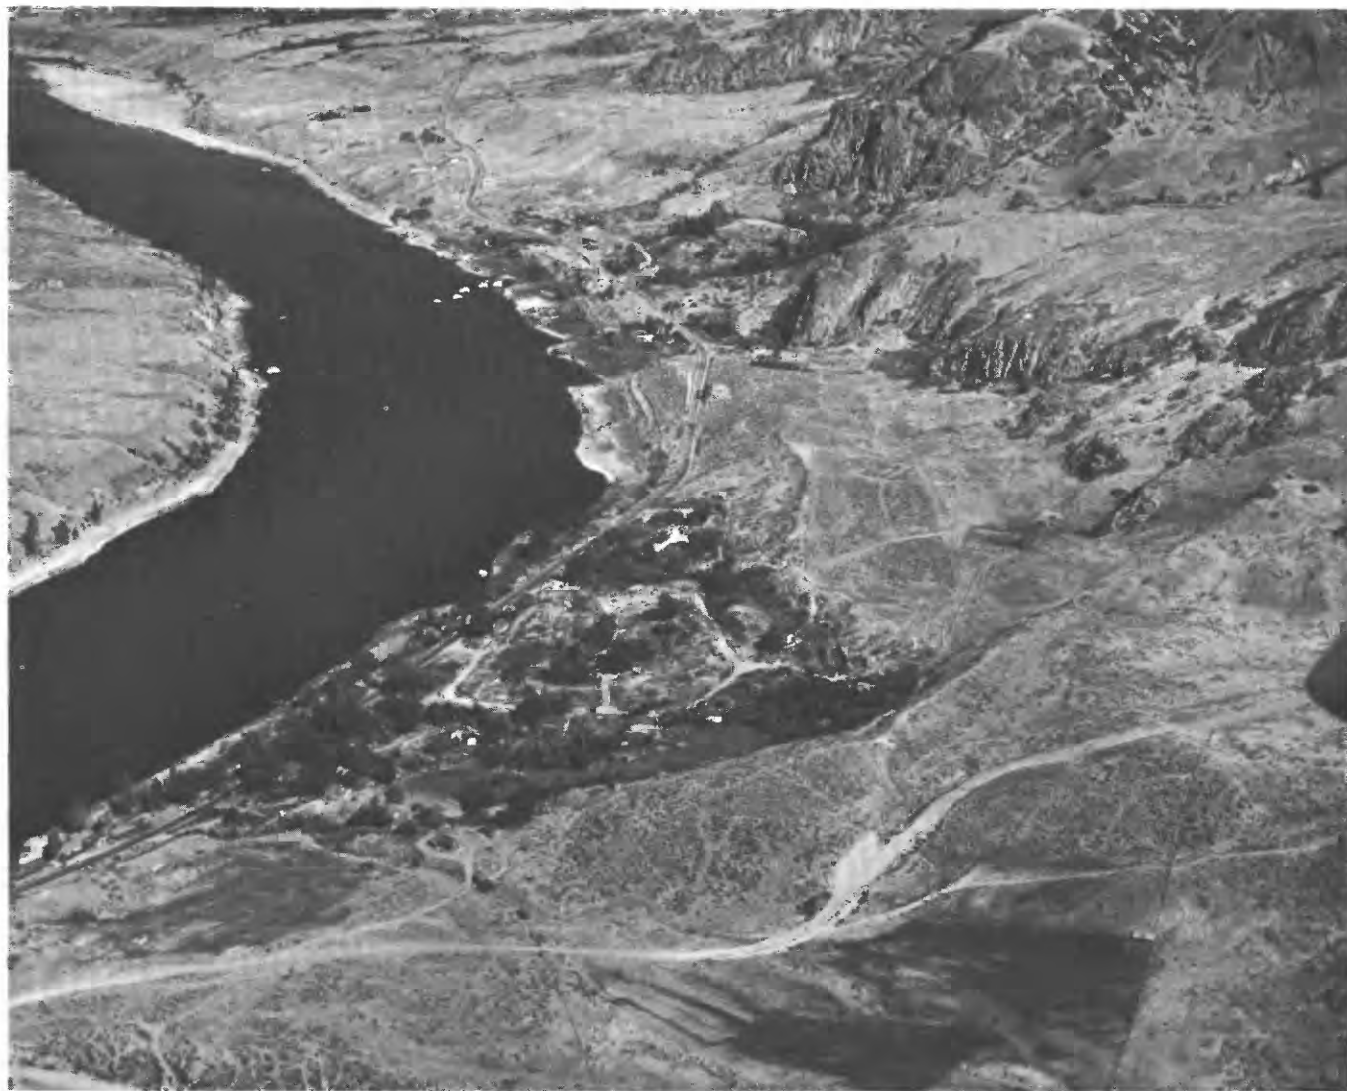
FIGURE 19.—Photograph showing the Koontzville landslide and its relationship to the Seatons landslide (see diagram, fig. 20).

The general setting is shown on figures 19 and 20. Old landslide materials extend from river level almost to the top of the terrace, or to an altitude of about 1,600 feet. Little or no landslide activity was noticed before the 1948 flood. There may have been some slight highway settlements or minor movements owing to irrigation and river-bank erosion below the highway, but no property damage from landslides was reported. In the fall of 1948 (about the time of the Seatons landslide movement) one resident of the area had trouble with water pipes parting and resorted to flexible hose connections to keep his water system operating. So far as is known, this marked the beginning of reactivation of the ancient slide. The slide has moved many times since. Movements are recorded on the following dates: December 23, 1951; November 10 or 11, 1952; November 27, 1952; and January 10, 1953.

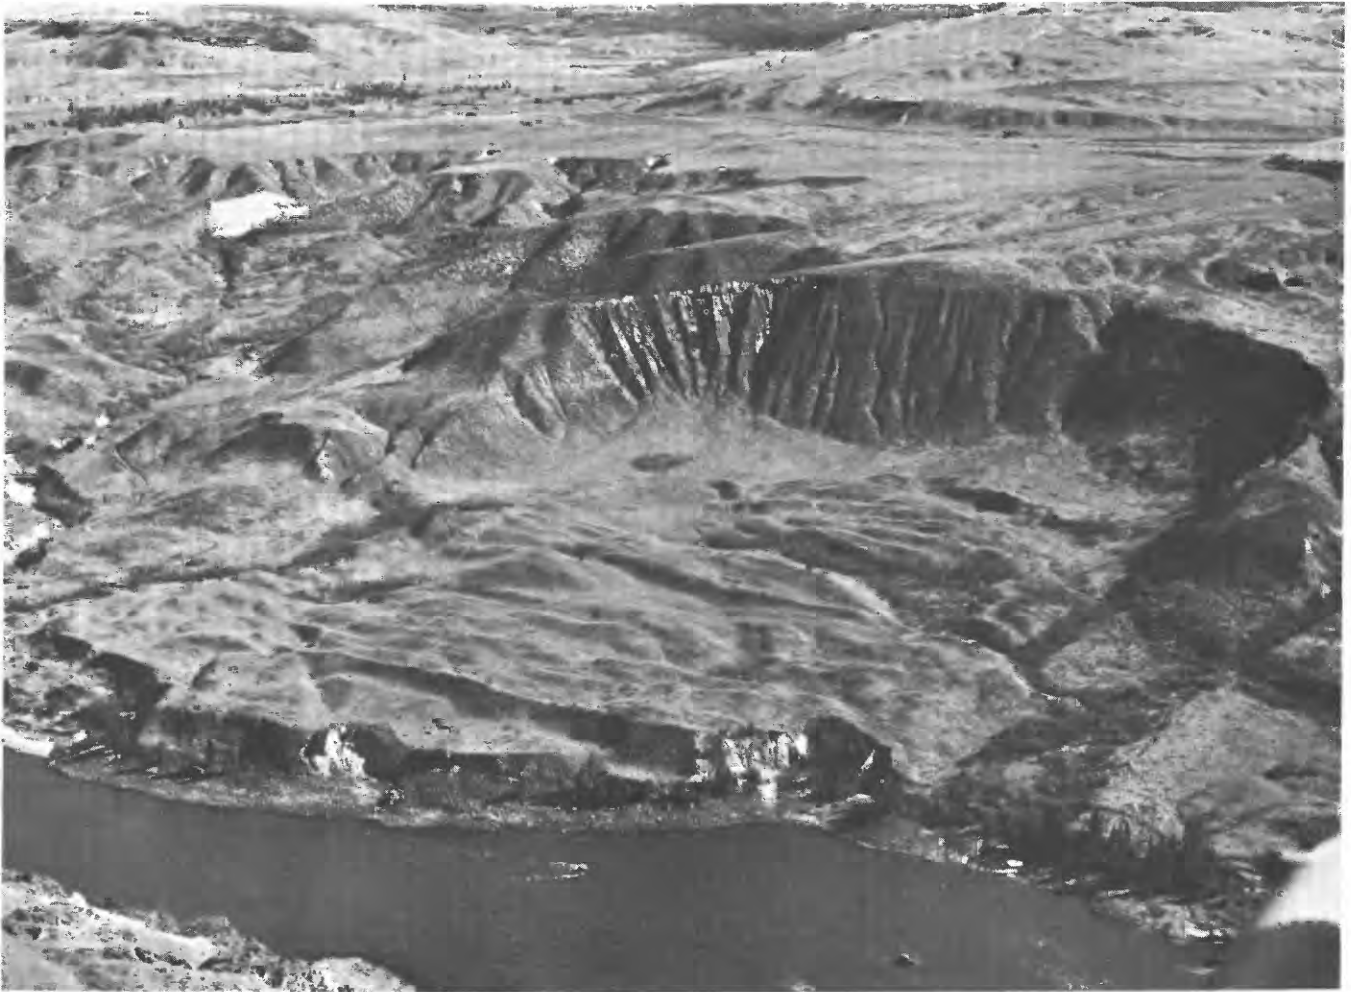
FIGURE 21.—Aerial photograph showing landslide in Bailey Basin. Columbia River in foreground. Note recent landslides at the river's edge. Landslide 13, Nespelem River area, river mile 11.86 right bank. Cross section shown in figure 22.
