Landslides Along the Columbia River Valley Northeastern Washington

GEOLOGICAL SURVEY PROFESSIONAL PAPER 367

By FRED O. JONES, DANIEL R. EMBODY, and WARREN L. PETERSON

*Descriptions of landslides and statistical
analyses of data on some 200 landslides in
Pleistocene sediments*

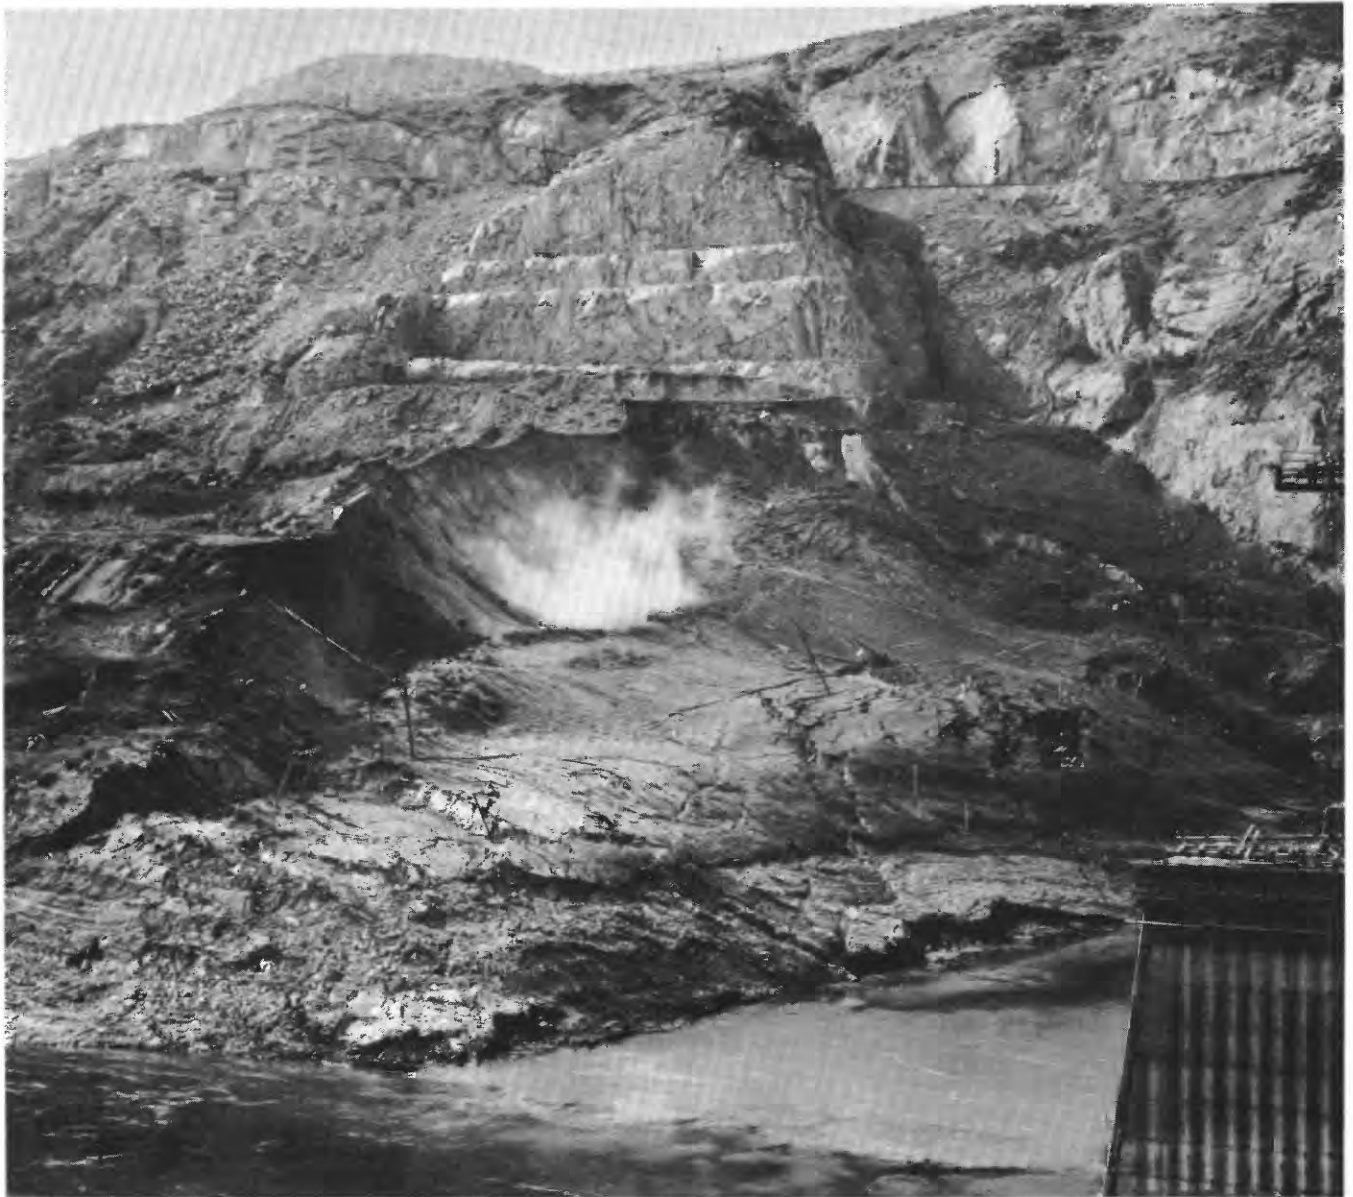
FIGURE 24.—Slump-earthflow landslide in lacustrine silt and clay. One of the many landslides that hindered the construction of Grand Coulee Dam. Located in what is now the pumping plant area at the left abutment of the dam. (Photograph by F. B. Pomeroy, Bureau of Reclamation.)

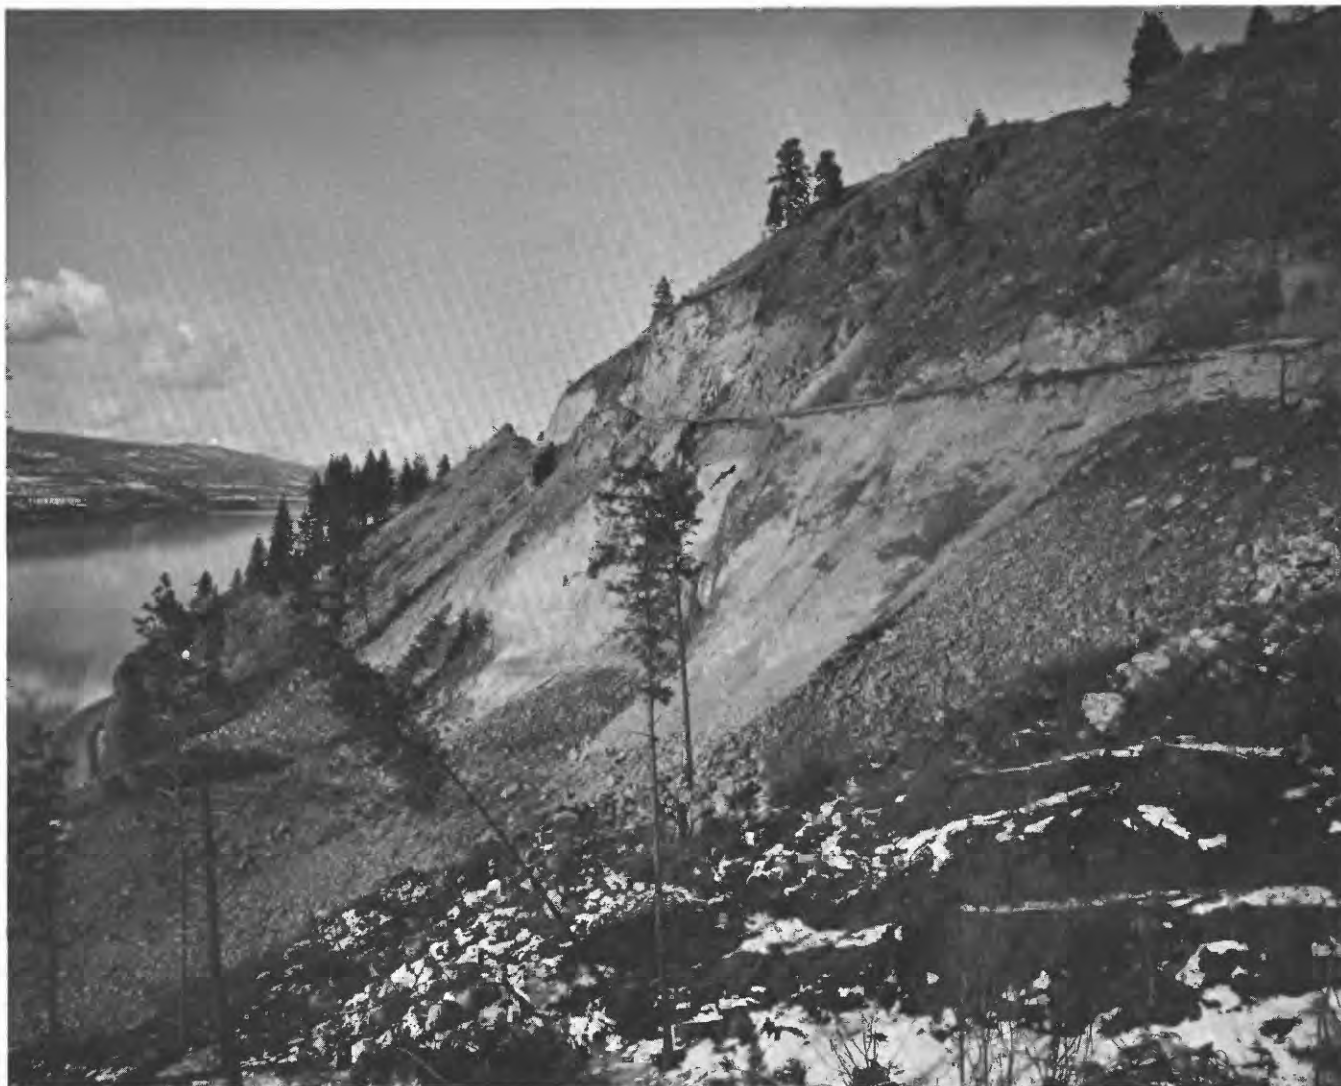
FIGURE 25.—Great Northern Railway slide near Marcus, Wash. This landslide occurred from 7 to 9 a.m., on February 23, 1951. It destroyed several hundred feet of railway track (roadbed shown at the crown of the slide). Repair of the roadbed cost \$230,374. Cost of removing slide debris from a highway shown at left side of the photograph was \$3,719. Photograph by courtesy of the Great Northern Railway Co.

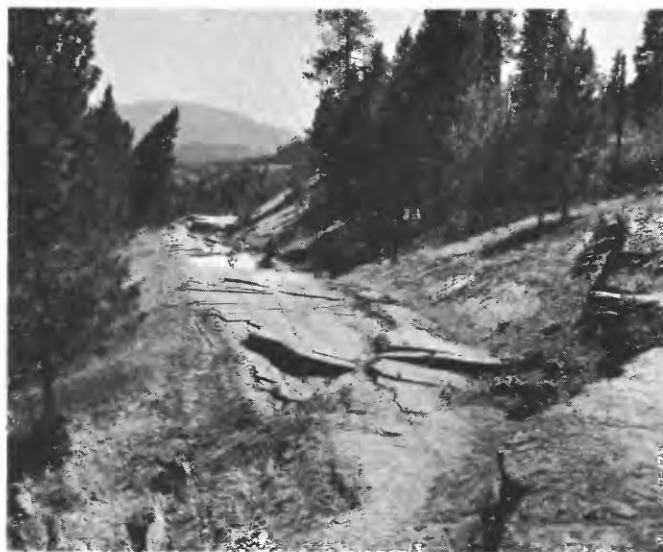
FIGURE 26.—Deadman Creek landslide. Slump-earthflow landslide that destroyed several hundred feet of Washington State Highway 3 in the Kettle River valley. Cost of relocation of the highway was \$112,000.

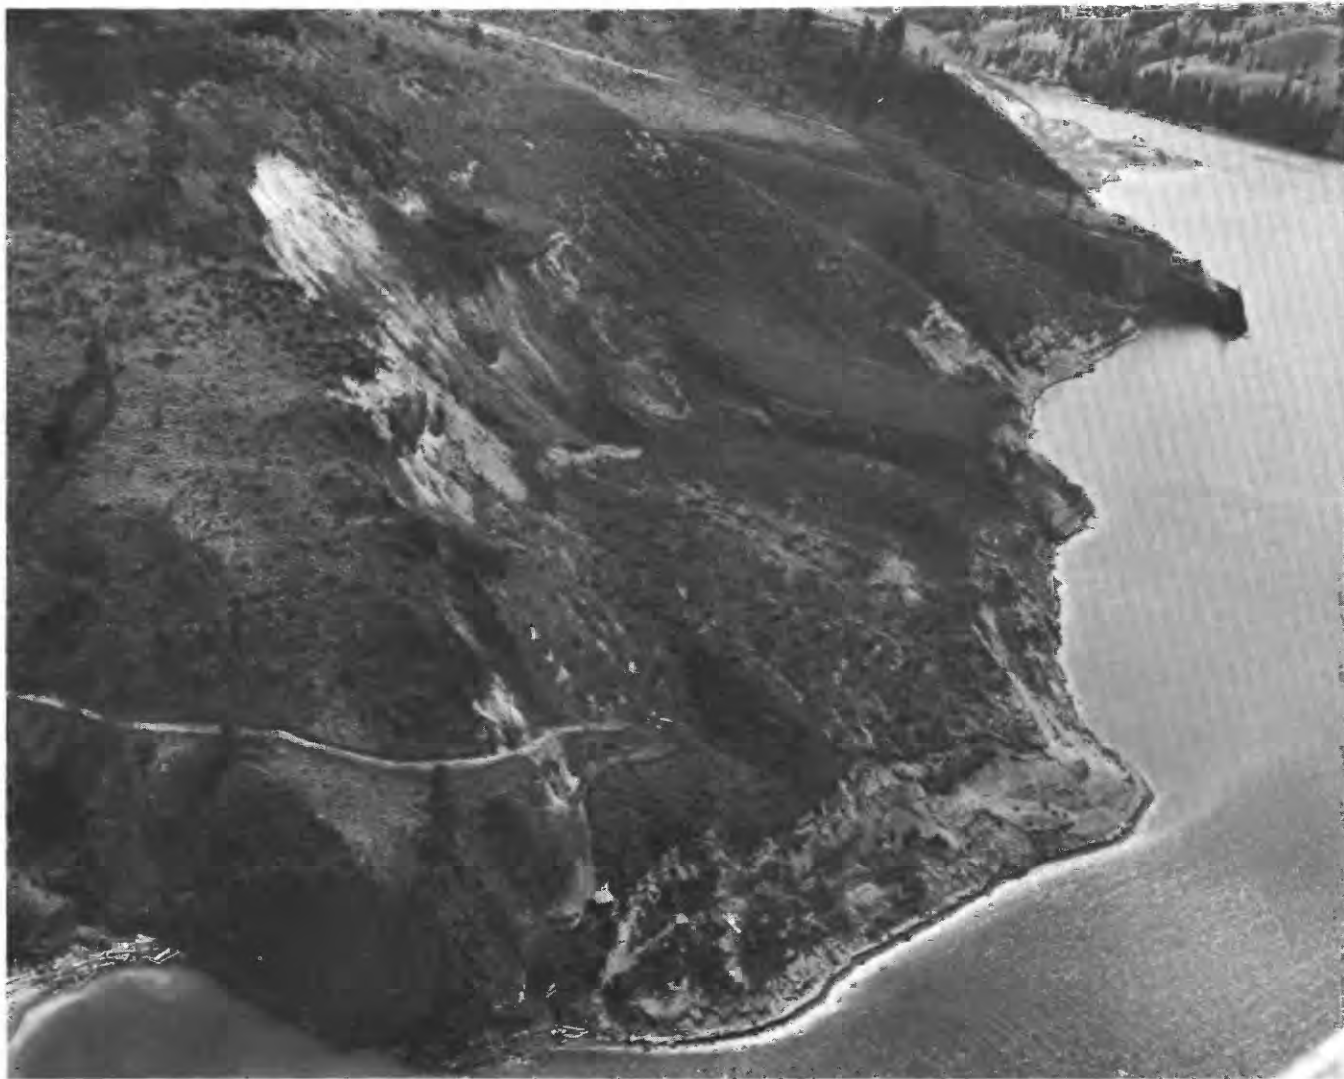
FIGURE 29.—Slump-earthflow landslide limited by bedrock. Basalt crops out at the crown of the slide. The distance into the slope that this slide cut was apparently limited by the bedrock surface. The slide is in lacustrine silt and clay with some interbedded sand. Initial movement was in August 1941, and minor movements occurred each year through 1953. Slide 63, Hawk Creek area, lake mile 37.2 left bank (Hawk Creek Bay 1,600 feet right bank).

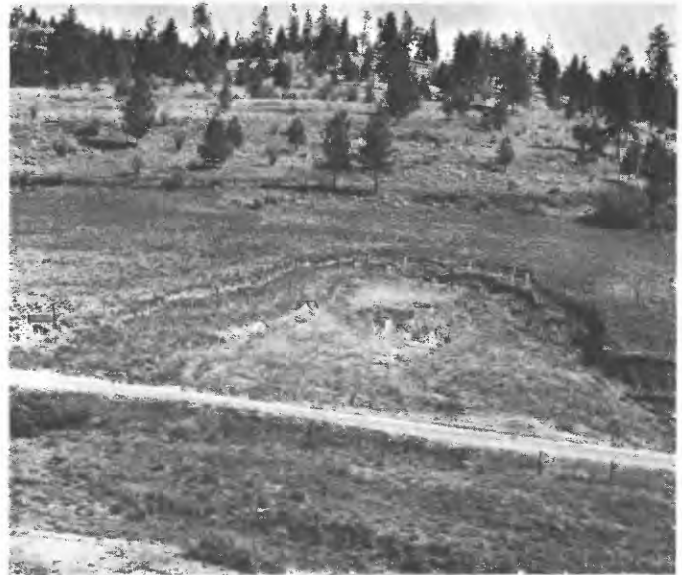
FIGURE 30.—Failure of an artificial slope. Landslide induced by a roadcut in lacustrine silt and clay (one-fourth mile southwest of Cedonia, Wash.). Toe of landslide was probably removed at intervals as it encroached on the road.

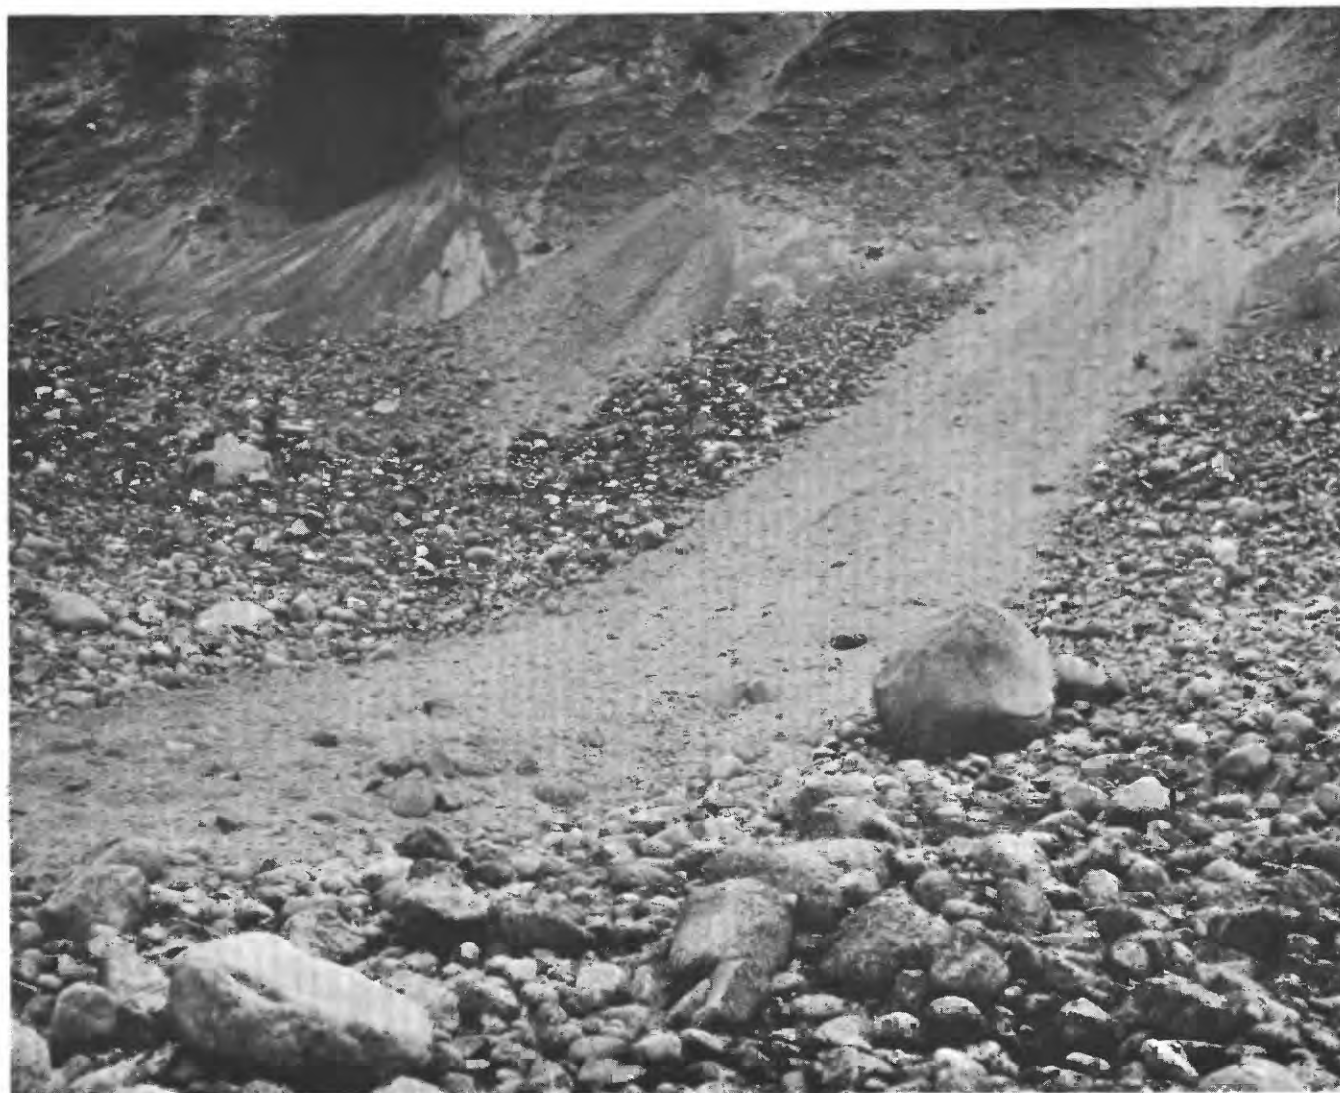
FIGURE 31.—Dry earthflow. It is believed that one or more blocks of dry lacustrine silt and clay fell at the same time from a high bluff in the background and disintegrated upon striking the base of the bluff, forming a solid-in-air density current which flowed downslope. Common alluvial cones at left of dry earthflow. Nespelem River area, river mile 9.7 right bank.

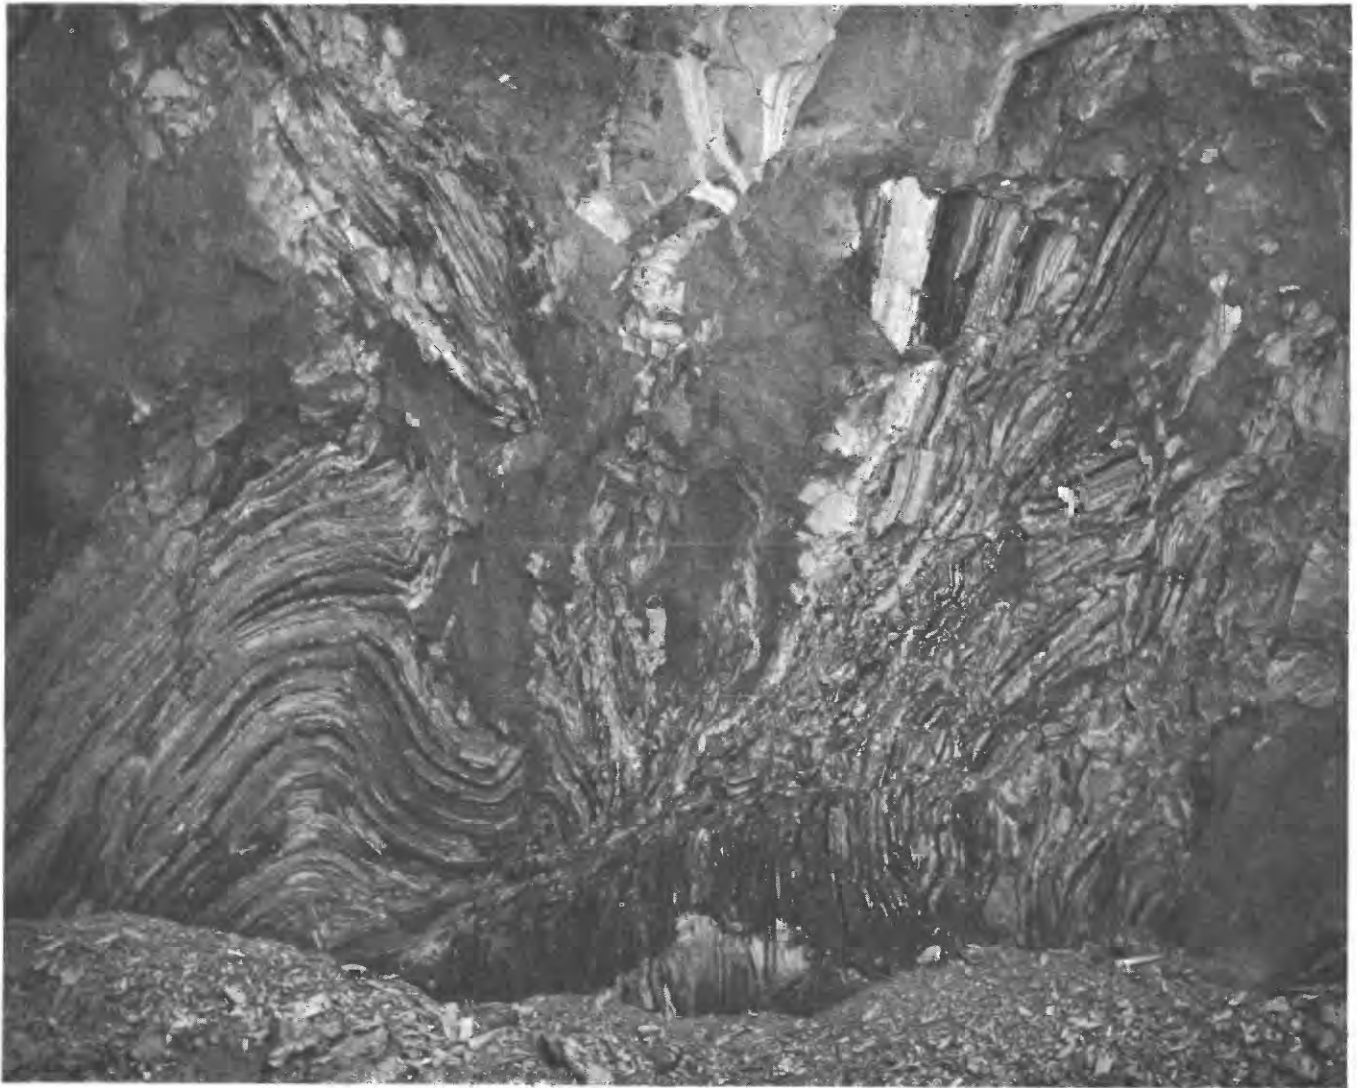
FIGURE 34.—Sediments included in material category 2 (disturbed or distorted silt and clay beds). This photograph shows varved silt and clay deformed by the thrust of glacial ice. Ninemile area.

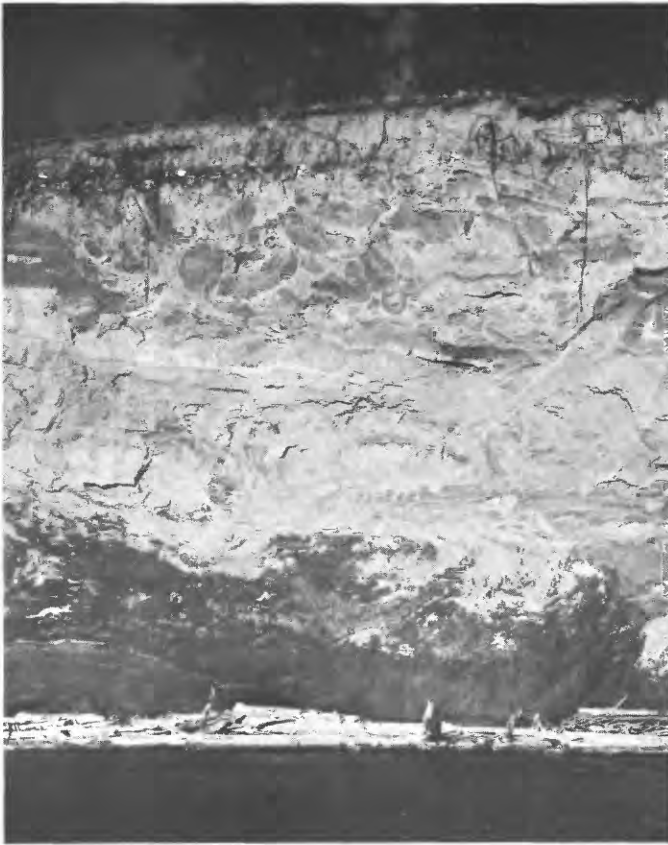
FIGURE 35.—Sediments included in material category 2. This photograph shows lacustrine silt and clay deformed by overriding glacial ice. Wilmont-Jerome area.

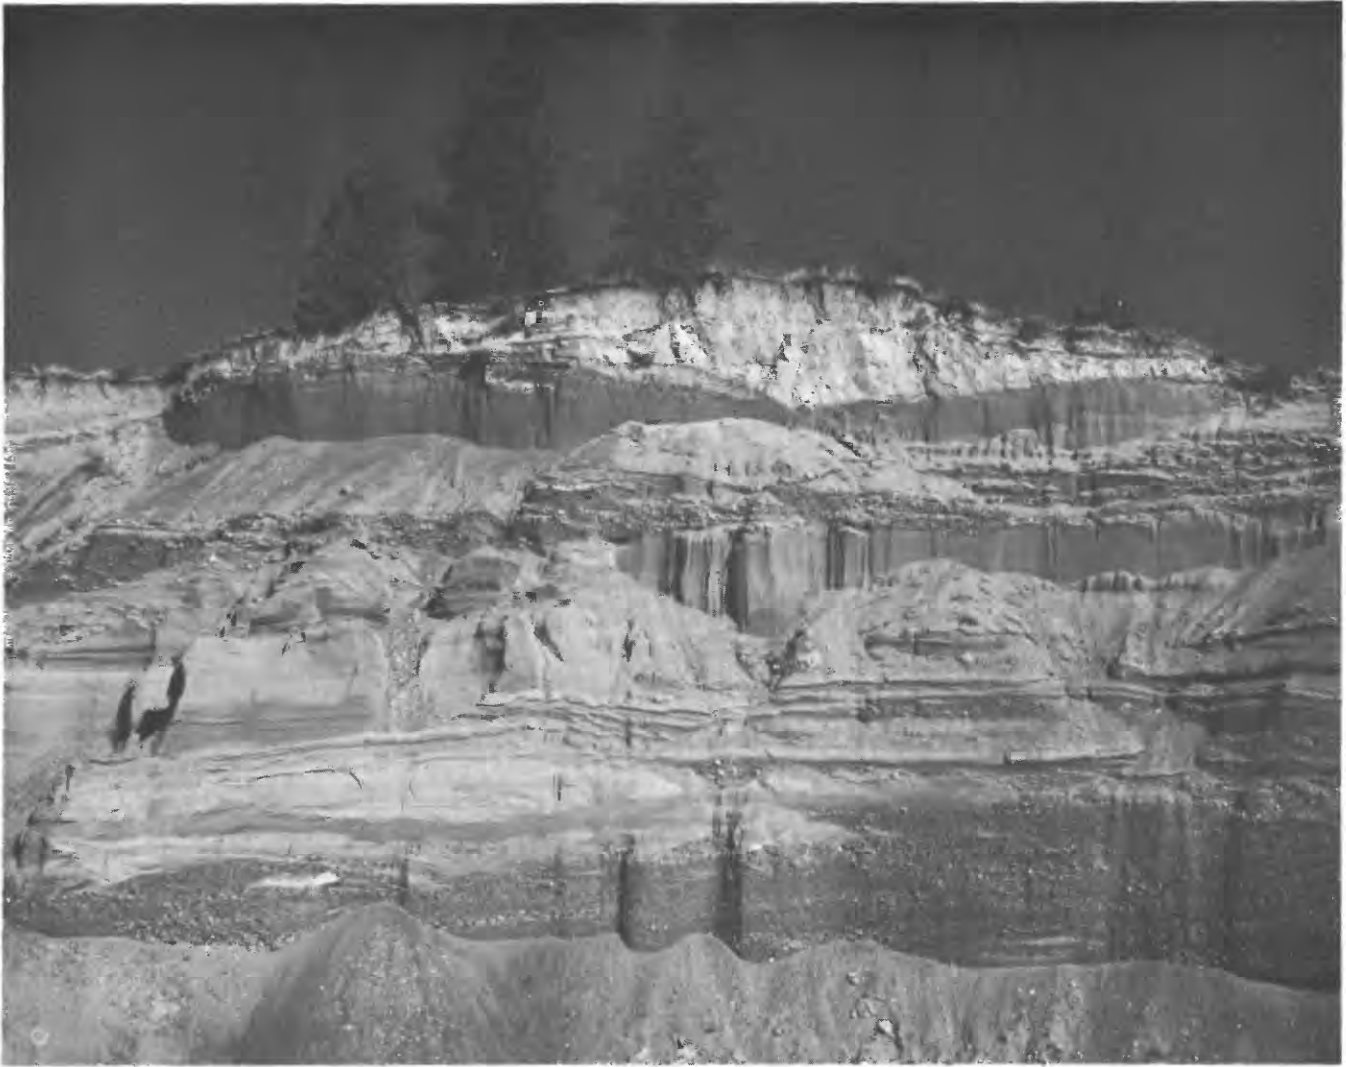
FIGURE 38.—Sediments included in material category 5 (sand and gravel). Cedonia area.

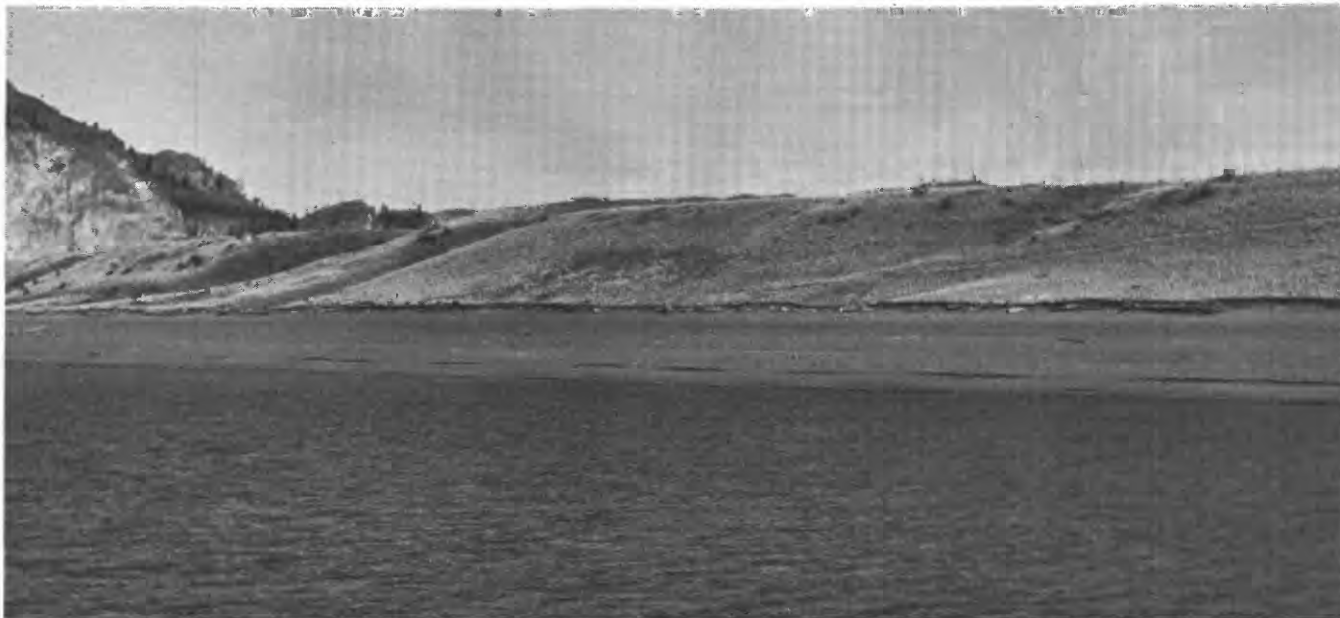
FIGURE 40.—A slope on sand judged to be very stable because of a discriminant function value of 0.0106. The lake is drawn down from its maximum level. Slope no. 43; lake mile 27.5 right bank; Hellgate-Whitestone area. See table 8 for classification data.

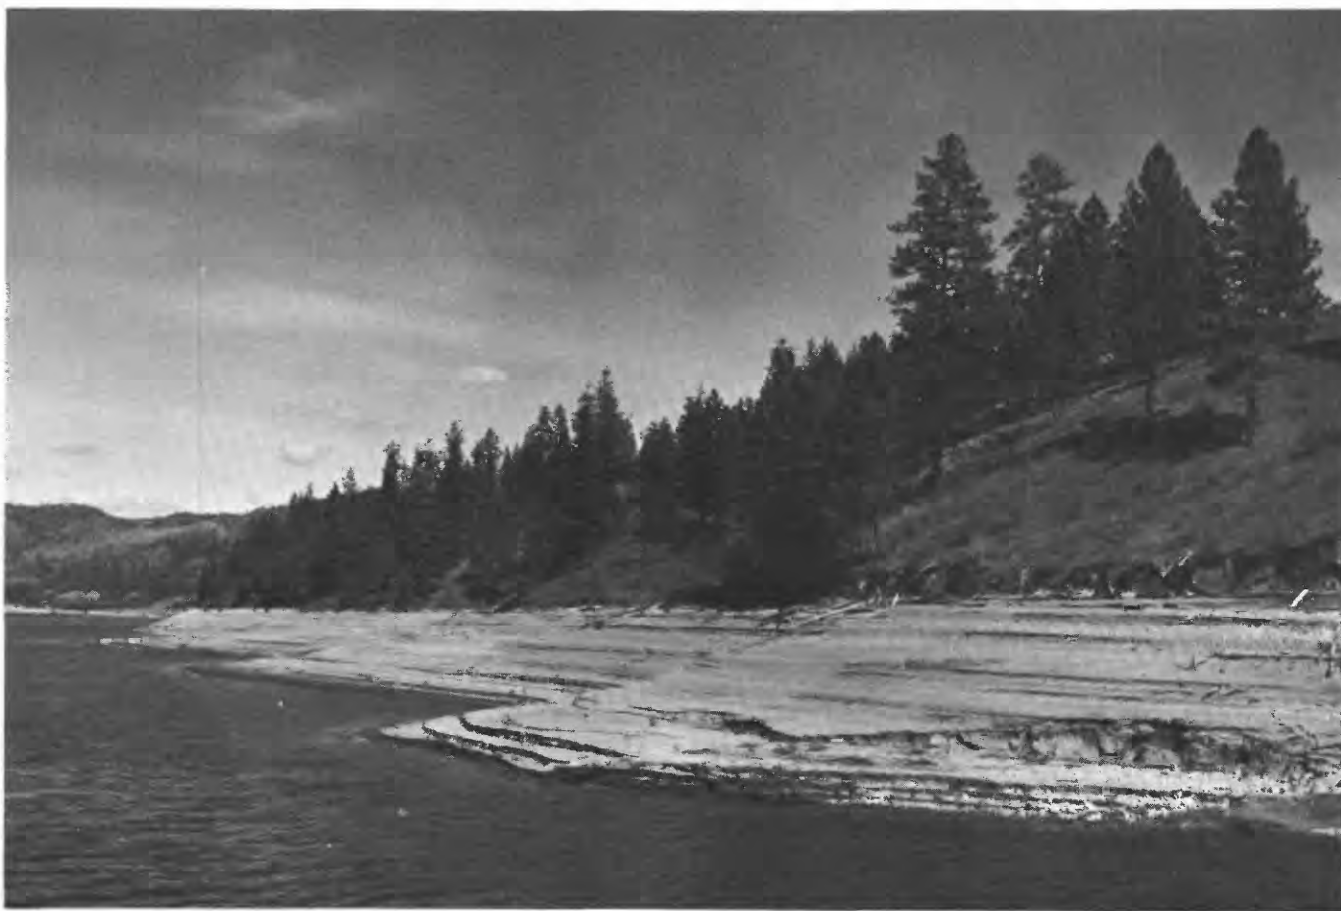
FIGURE 41.—A slope on interbedded silt, clay and sand judged to be relatively stable because of a discriminant function value of 0.0138. The lake is drawn down from its maximum level. Slope no. 131; lake mile 71.5 left bank; Cedonia area. See table 8 for classification data.

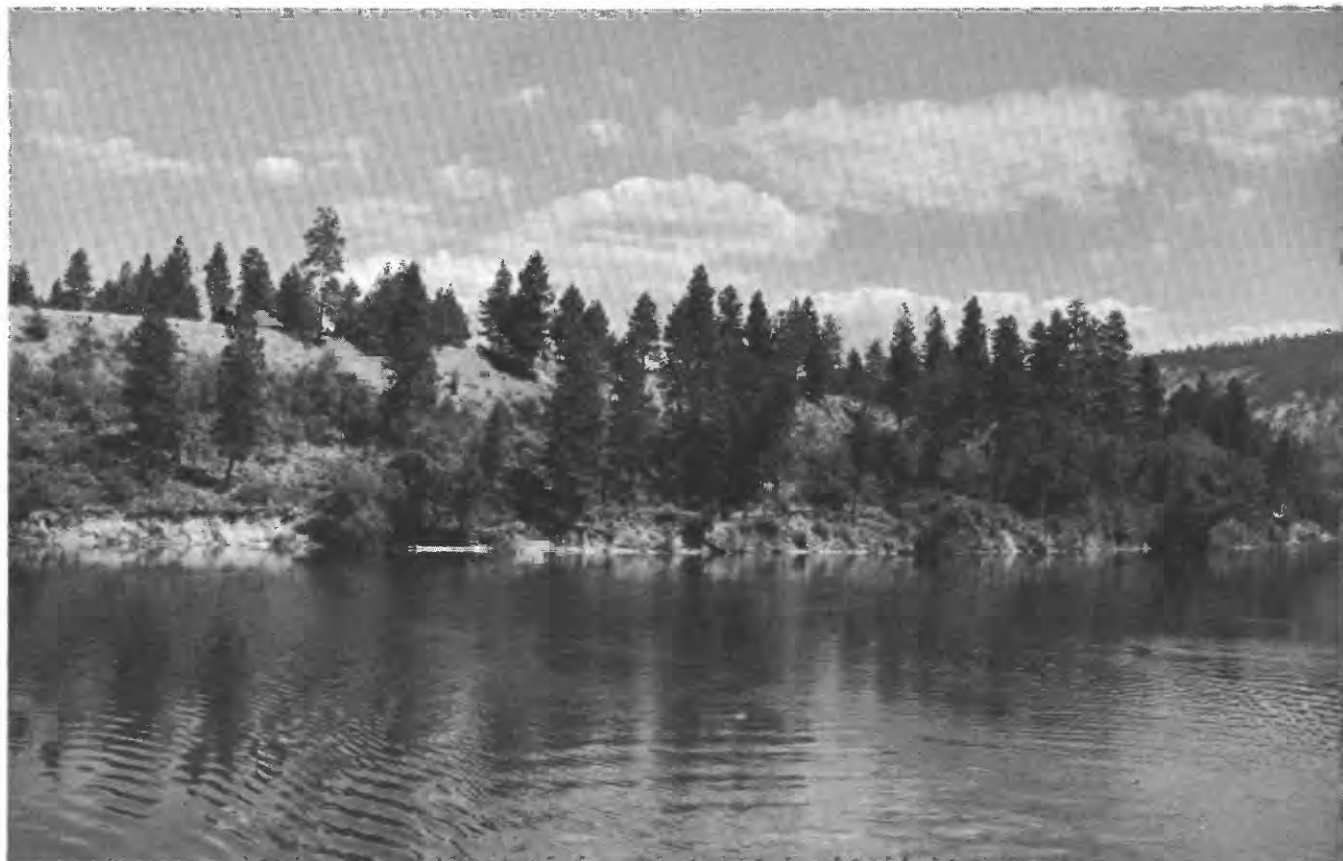
FIGURE 42.—A slope on silt and clay judged likely to be affected by landslides because of a discriminant function value of 0.0242. Slope 160; lake mile 107.0 right bank; Marcus-Evans area. See table 8 for classification data.
