The Hebgen Lake, Montana Earthquake of August 17, 1959

GEOLOGICAL SURVEY PROFESSIONAL PAPER 435

STRUCTURAL DAMAGE IN THE HEBGEN LAKE-WEST YELLOWSTONE AREA

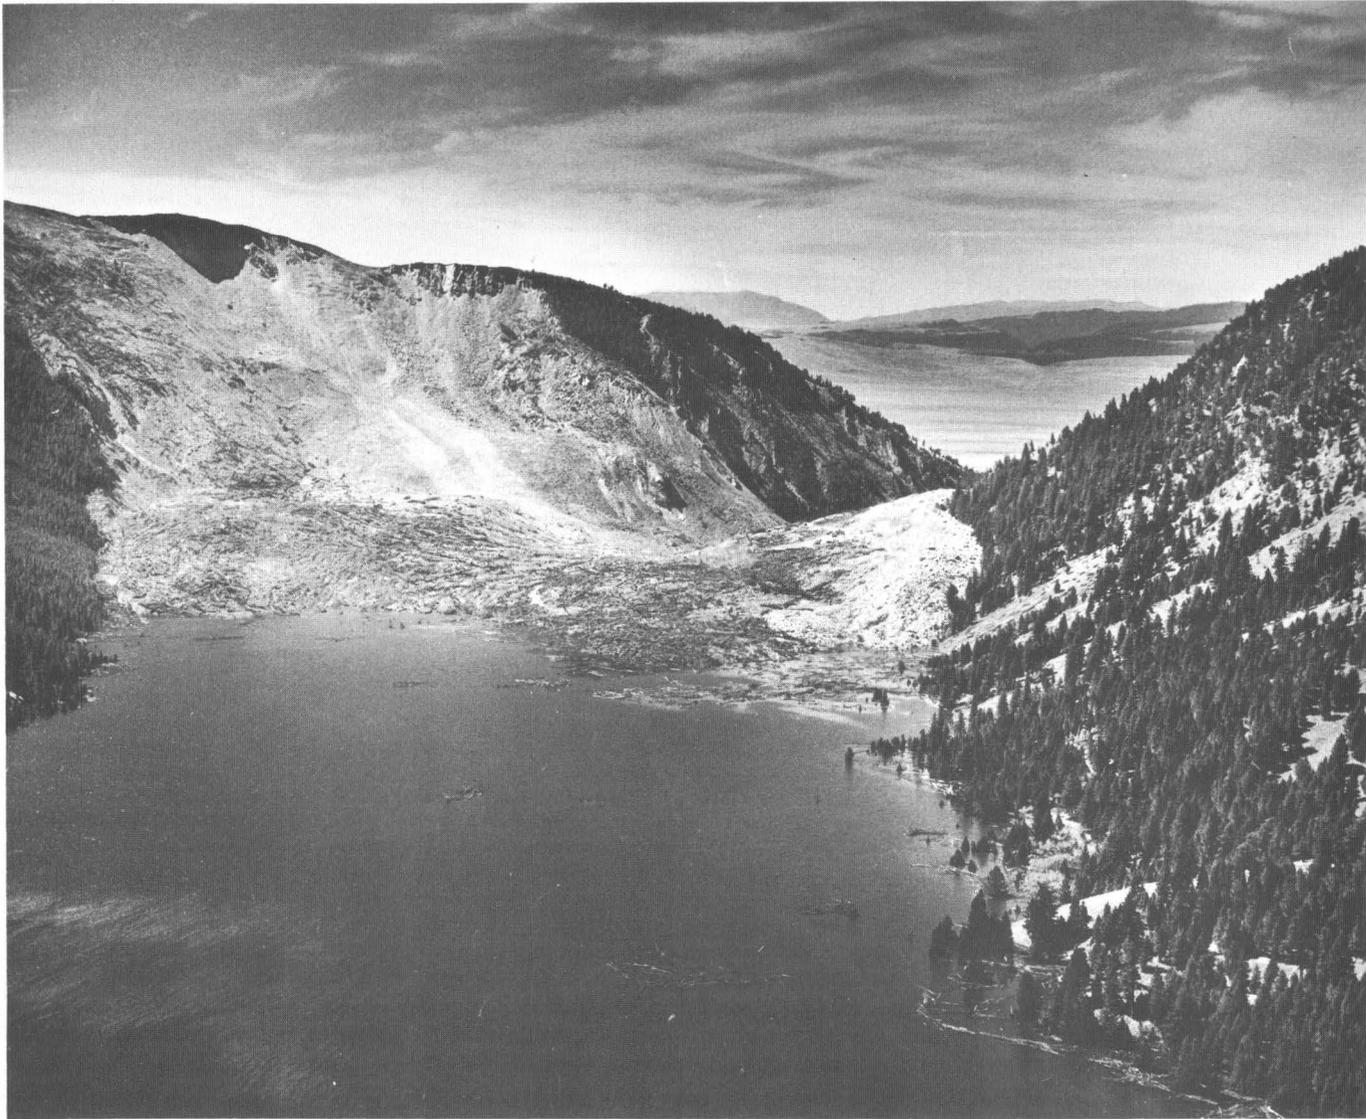
MADISON SLIDE AND EARTHQUAKE LAKE, AUGUST 21, 1959

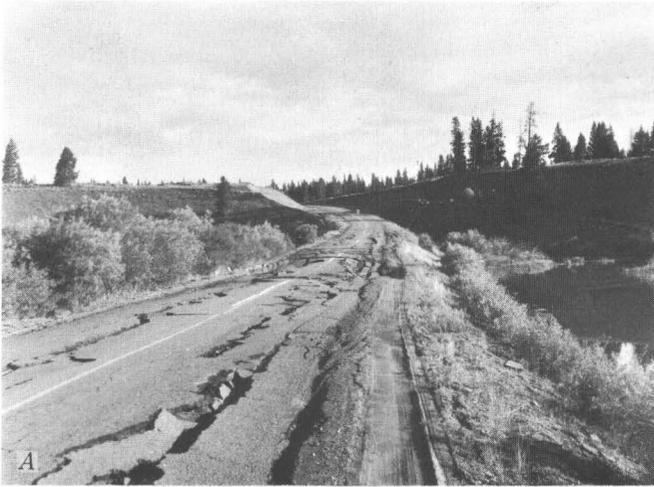
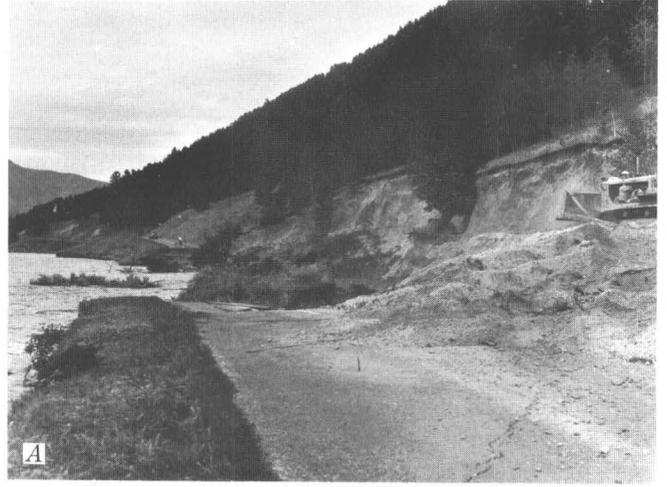
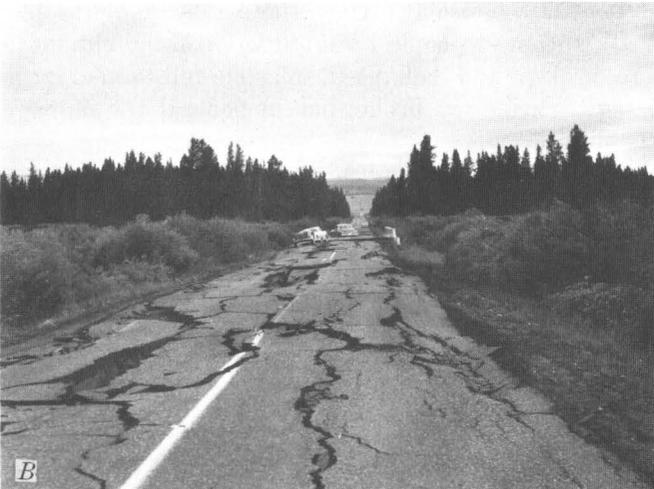
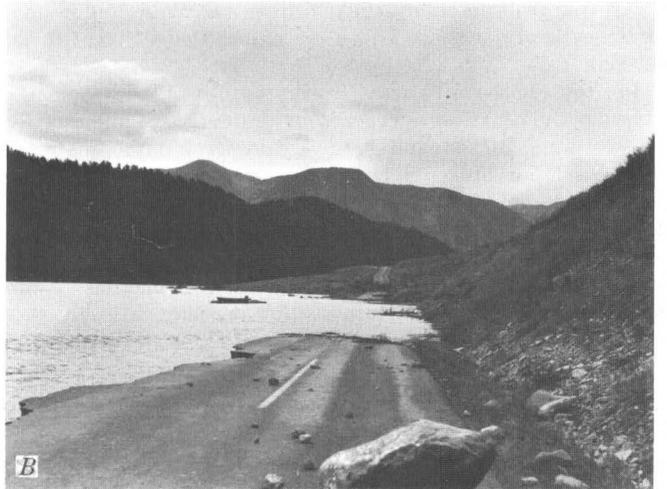
FIGURE 1.—Damage to highways in the epicentral area. *A*, Shattered remnants of asphalt-surfaced U.S. Highway 191 where it crosses the alluvial fill of the Madison River; *B*, disruption of U.S. Highway 191 near Cougar Creek.

Highways in the epicentral area were damaged extensively, chiefly due to compaction of the roadbed with resultant breakage and offset of the asphalt surface (fig. 1). All roads were broken by fractures, many of which were normal to the roadway. Offset along these fractures was mainly vertical and measurable in inches, but in several localities the offset of the paving due to slump of the roadbed created an impression of minor horizontal displacement. Near their junction, U.S. Highway 191 and State Highway 499 (SE $\frac{1}{4}$ sec. 16, T. 12 S., R. 5 E.) were displaced vertically as much as 5 feet by fault scarps. At three localities—(a) E $\frac{1}{2}$ sec. 31, T. 11 S., R. 4 E.; (b) W $\frac{1}{2}$ sec. 25, T. 11 S., R. 3 E.; and (c) center sec. 23, T. 11 S., R. 3 E.—landslips carried parts of State Highway 499 into Hebgen Lake (fig. 2). Near Kirkwood Ranch the road was inundated for about 100 yards (SE $\frac{1}{4}$ sec. 25, T. 11 S., R. 3 E.). Earthquake Lake, which formed behind the Madison Slide, submerged 3 miles of State Highway 499, and an additional mile of the route is buried by the slide (frontispiece; fig. 54).

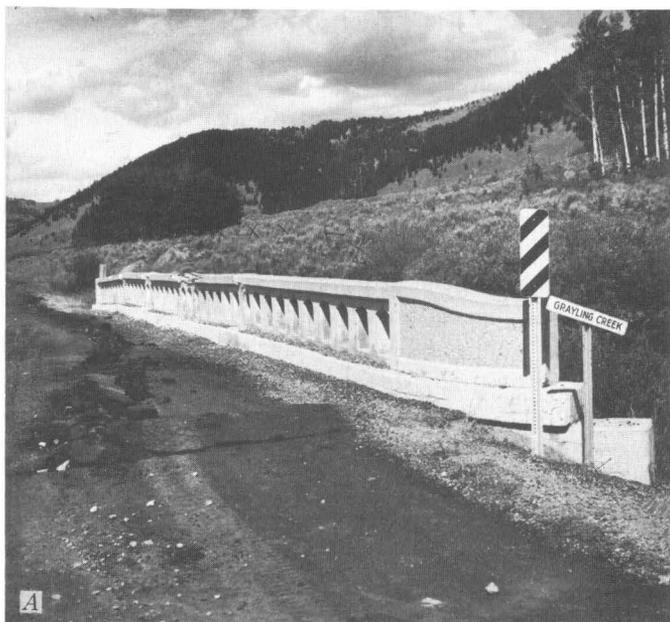
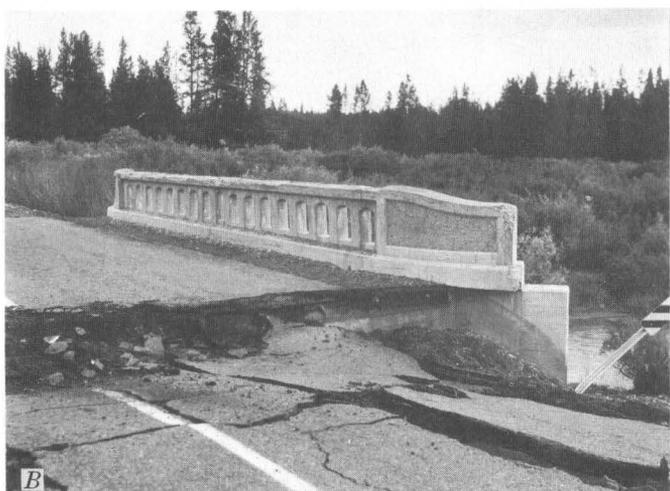
FIGURE 3.—Damage to bridges in epicentral area. *A*, Buckling of floor and separation of concrete guardrail on bridge across Grayling Creek; *B*, damage to road and bridge across Madison River.

Bridges remained intact, but concrete guardrails on many were broken and separated, chiefly between adjacent segments (fig. 3). Gaps of 2 to 3 inches appeared in the floors of some bridges along expansion joints. Abutments shifted slightly or stood free of adjacent fill, which was compacted by lateral oscillation of

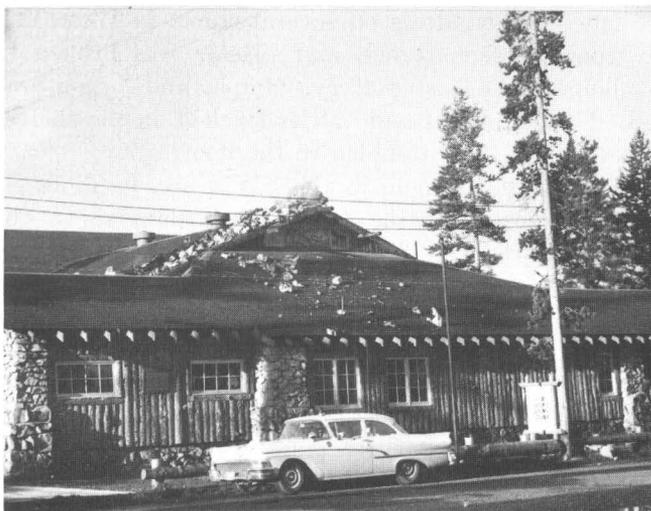
FIGURE 4.—Collapse of chimney at the Union Pacific Dining Lodge, West Yellowstone, Mont.

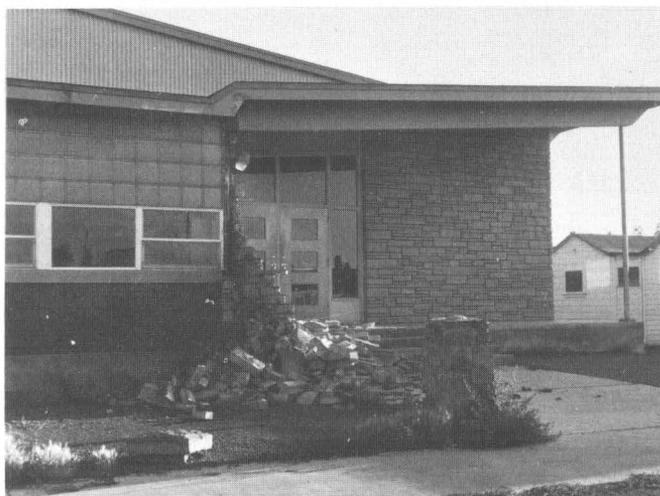
FIGURE 5.—Damage to elementary school at West Yellowstone, Mont. Decorative stone entryway has been shaken down.

In general, wooden structures were not as severely damaged as those built of masonry. The more rigid masonry buildings fractured, broke, or collapsed. Much of the damage to hotels, depots, and dwellings in both West Yellowstone and Yellowstone National Park resulted from falling chimneys. At Old Faithful Inn the main chimney fell through the roof, and the same thing happened at the Union Pacific Dining Lodge at West Yellowstone (fig. 4). Apparently many masonry walls fell because they were not adequately tied to interior walls of buildings. At the West Yellowstone School, the brick veneer along one entire wall fell, and so did the decorative stone wall flanking the main entryway (fig. 5).

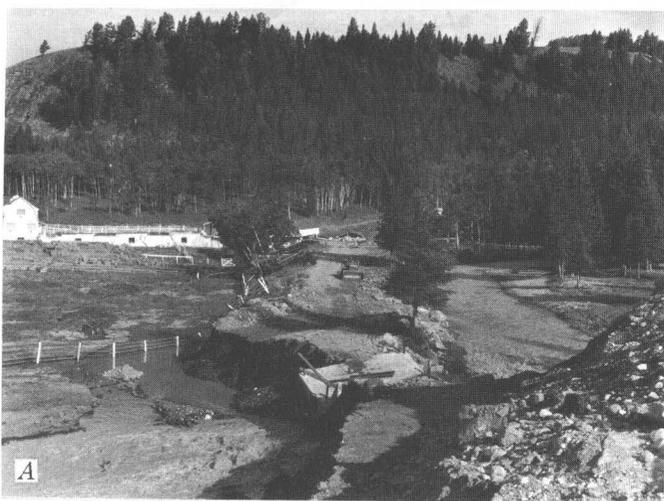
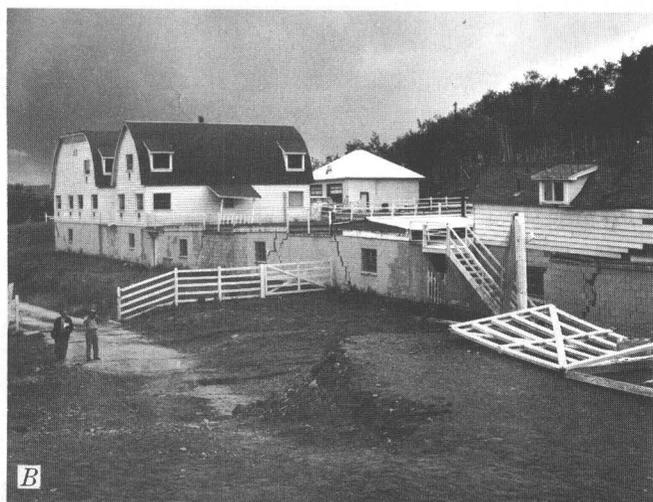
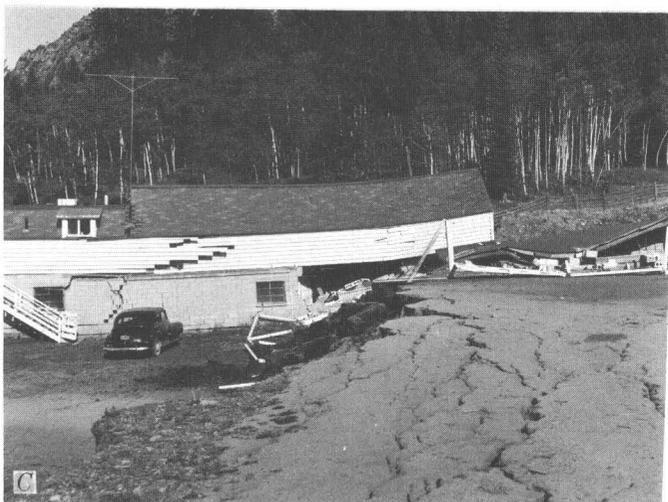
FIGURE 6.—Damage to Blarneystone Ranch (SW $\frac{1}{4}$ sec. 9, T. 12 S., R. 5 E.). *A*, Red Canyon fault scarp; block of ground on left (south) has dropped; collapsed culvert crosses Grayling Creek. *B*, The main group of buildings on the downdropped block; view is from the top of the fault scarp. *C*, Buildings astride the Red Canyon fault scarp; scarp extends from lower left edge of photograph toward center; left side dropped 10 to 12 feet. *D*, Damage to foundation of main dwelling.

Blarneystone Ranch, in the SW $\frac{1}{4}$ sec. 9, T. 12 S., R. 5 E., sustained the most severe damage in the epicentral area (fig. 6). The Red Canyon fault scarp cuts across the ranch and passes beneath the northern part of the main group of buildings (fig. 6A). The domestic quarters and storage sheds, which were astride the scarp, were completely demolished (fig. 6C); other buildings in the group were dropped 10 to 12 feet and consequently were severely shaken and

shattered (fig. 6B). Their foundations cracked and were locally displaced or caved (fig. 6D). Chimneys fell, and masonry supports for the entryway were cracked and tilted. The entire main dwelling was tilted northward toward the scarp, and no room inside was free from damage. Large pieces of furniture moved about or toppled. Pictures fell, as did large quantities of stored canned goods. Most doors were jammed, but surprisingly many of the large panes of window glass were undamaged.

time of the earthquake all livestock was on the down-thrown block. They ran amuck, and many received bad gashes as they ran into barbed wire fences. All barbed wire, which had been tautly drawn between steel fenceposts, was loosened and sagged. In places the wire appeared to have been stretched; elsewhere the steel fenceposts had been pulled from the ground. Access roads to the ranch were broken, and the culvert across Grayling Creek collapsed (fig. 6A).

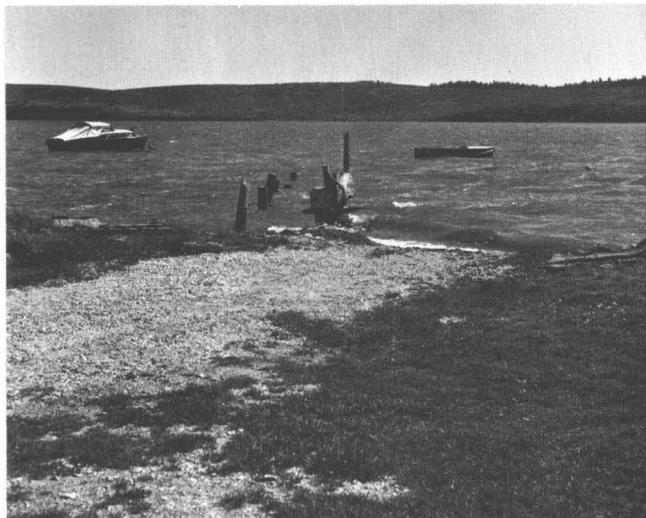
FIGURE 7.—Submerged dock at The Narrows Motel showing inundation of north shore of Hebgen Lake.

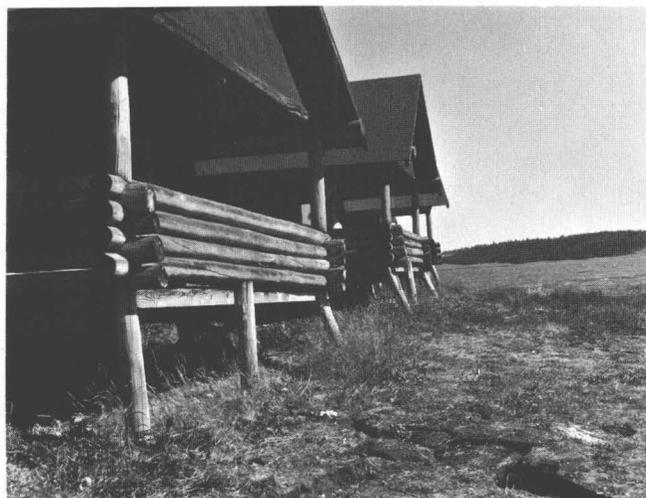
FIGURE 8.—Slump of ground toward lake with resultant tilting of foundation pillars, Lakeview Motel.

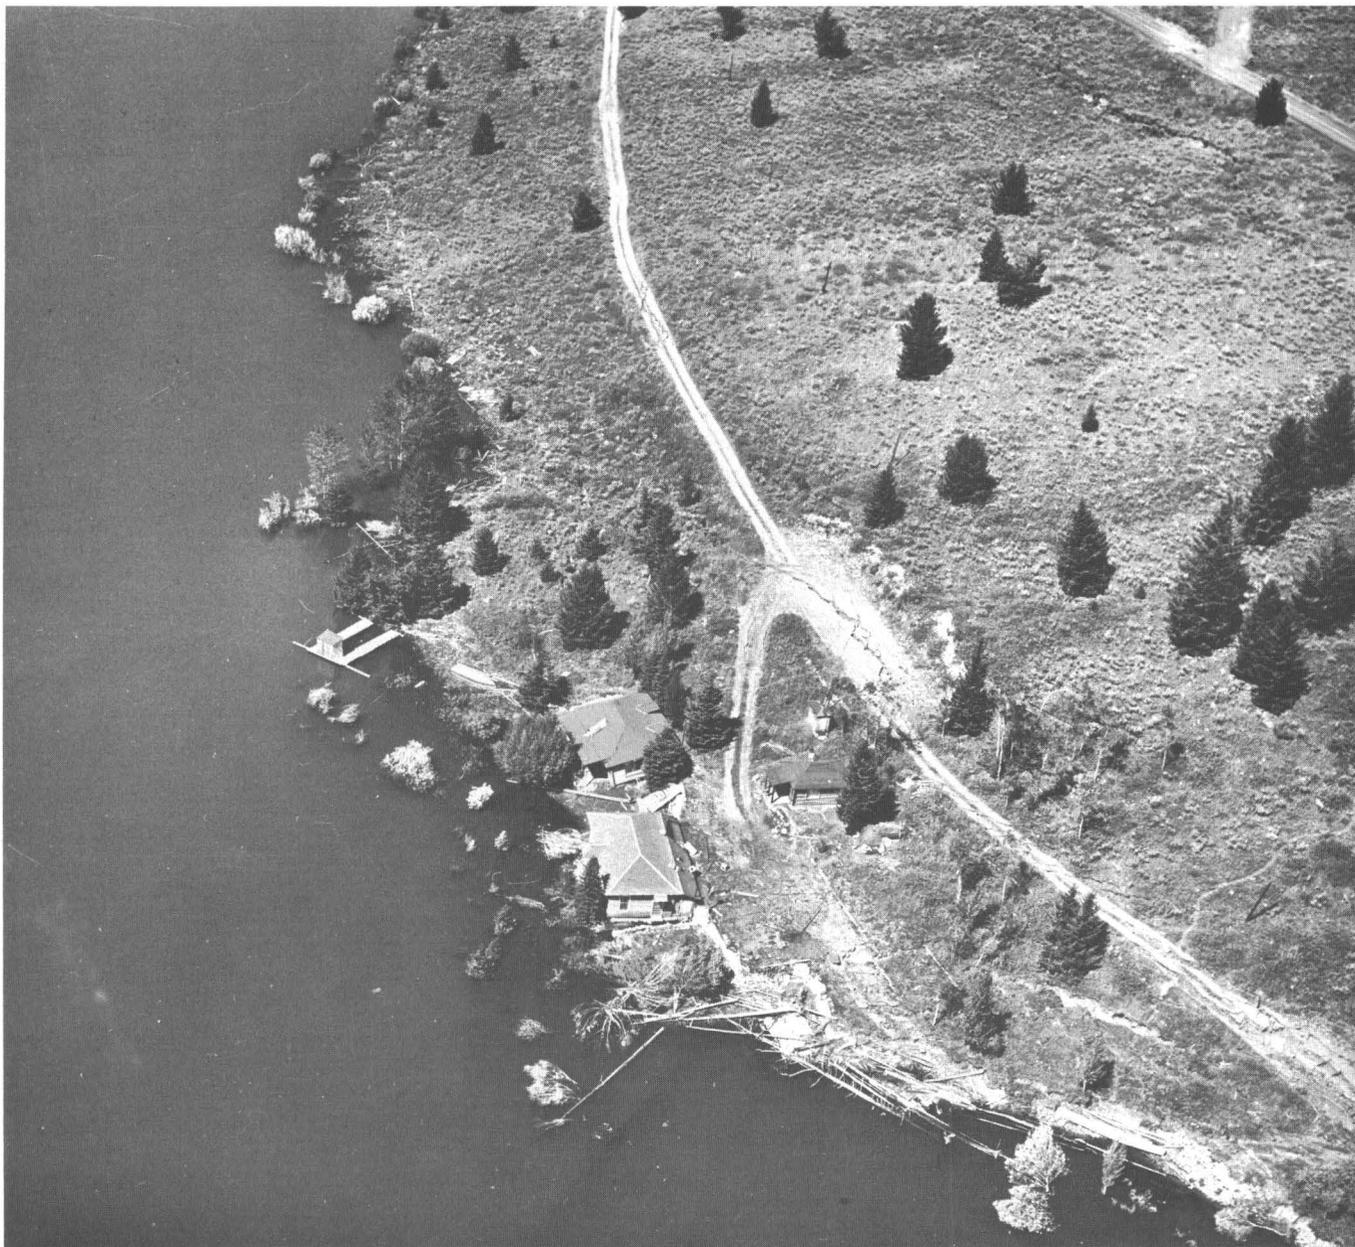
FIGURE 9.—Aerial view of Hilgard Lodge showing intense fracturing of ground and partial inundation of units. Main dwelling has floated away. Photograph by John R. Stacy.

At Hilgard Lodge, about a mile southeast of Hebgen Dam, the earthquake and the accompanying surges of the lake wreaked havoc (fig. 9). The main dwelling and a group of connected motel units were built on a broad sloping alluvial cone at the northeast edge of the lake—a sector of ground that dropped about 10 feet during the earthquake and was broken by many small scarps and gaping fissures. All the buildings were tilted and knocked askew, then lifted and dropped by a wave of water that moved toward the dam. Mrs. Miller, the owner, was asleep at the time of the quake. Suddenly aware that her house was sliding into the lake, she scrambled out with great difficulty and, dazed and shocked, stumbled across scarps and fissures in a rough sagebrush pasture to the Kirkwood Ranch, more than a mile away.

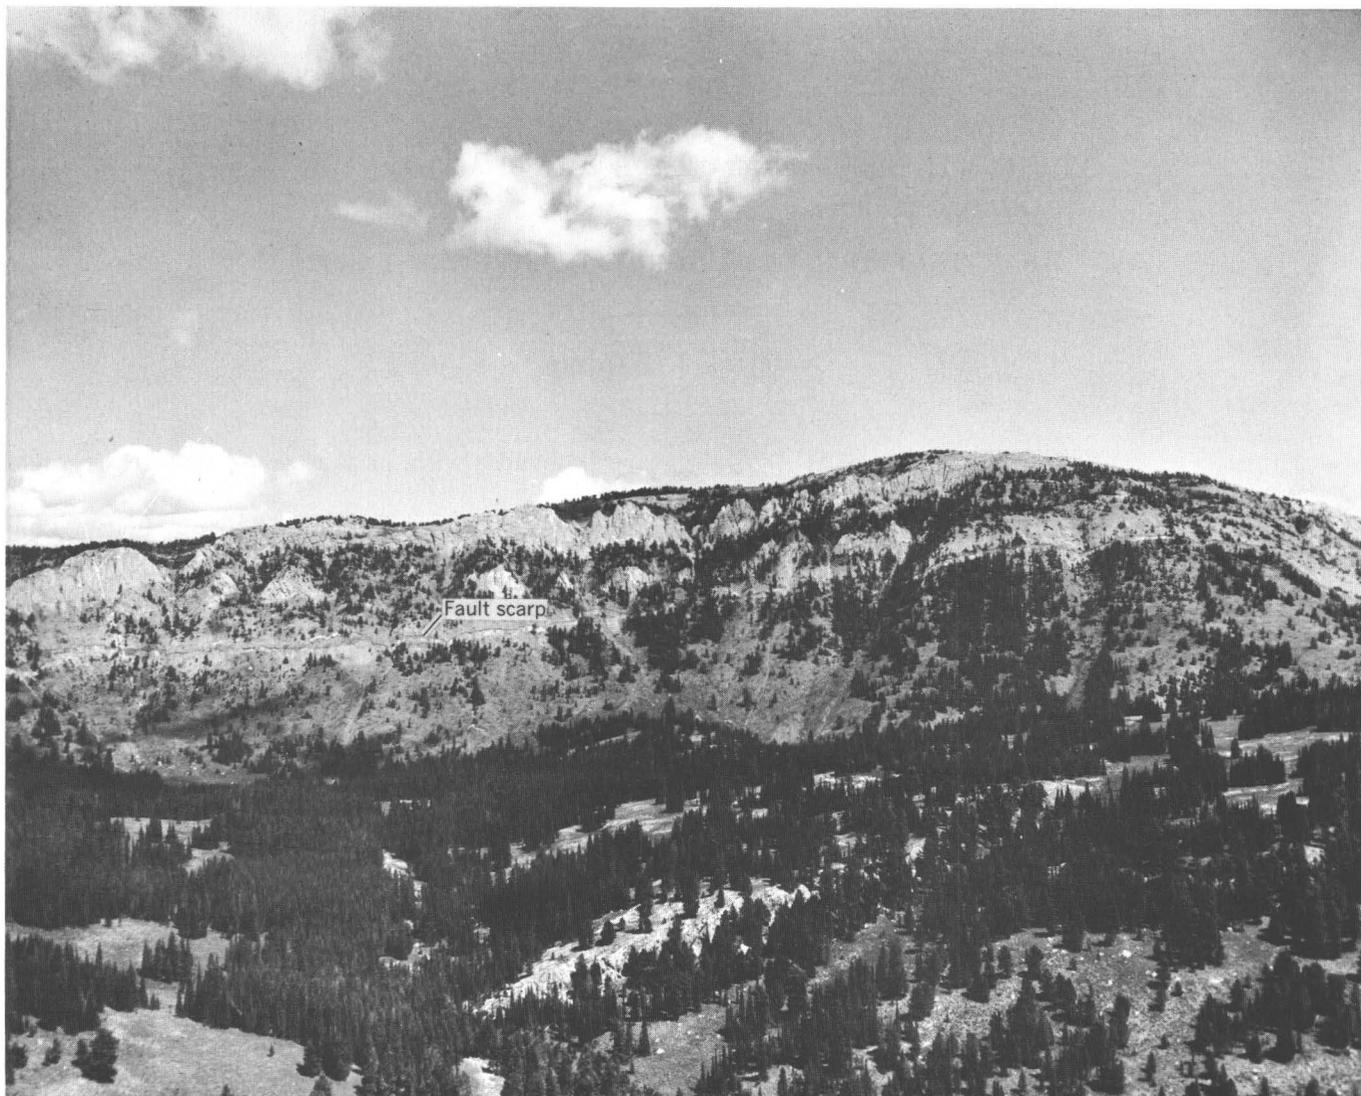
FIGURE 16.—The Red Canyon fault scarp as exposed along the south flank of Kirkwood Ridge. Several longitudinal step faults are shown near the left edge of the photograph.

The reactivated faults are expressed both as spectacular scarps as much as 20 feet high in unconsolidated material (fig. 16) and as gaping clefts which have little or no displacement. Commonly each scarp is paralleled by many smaller scarps. Most of these are in the unconsolidated material of the hanging wall, although a few cut the footwall.

Even as some subsidiary fractures cut the hanging wall, others cut the footwall. As shown in figure 23D, the resultant block (*m, e, n*) of the footwall has slid into and closed the gap. The scarps so formed face valleyward and are parallel. Downthrown segments form large elongate steps, and consequently, the fault group is known as a longitudinal step fault. A good example of a longitudinal step fault is along the south flank of Kirkwood Ridge in the $N1\frac{1}{2}$ sec. 21, T. 11 S., R. 4 E. (fig. 16).

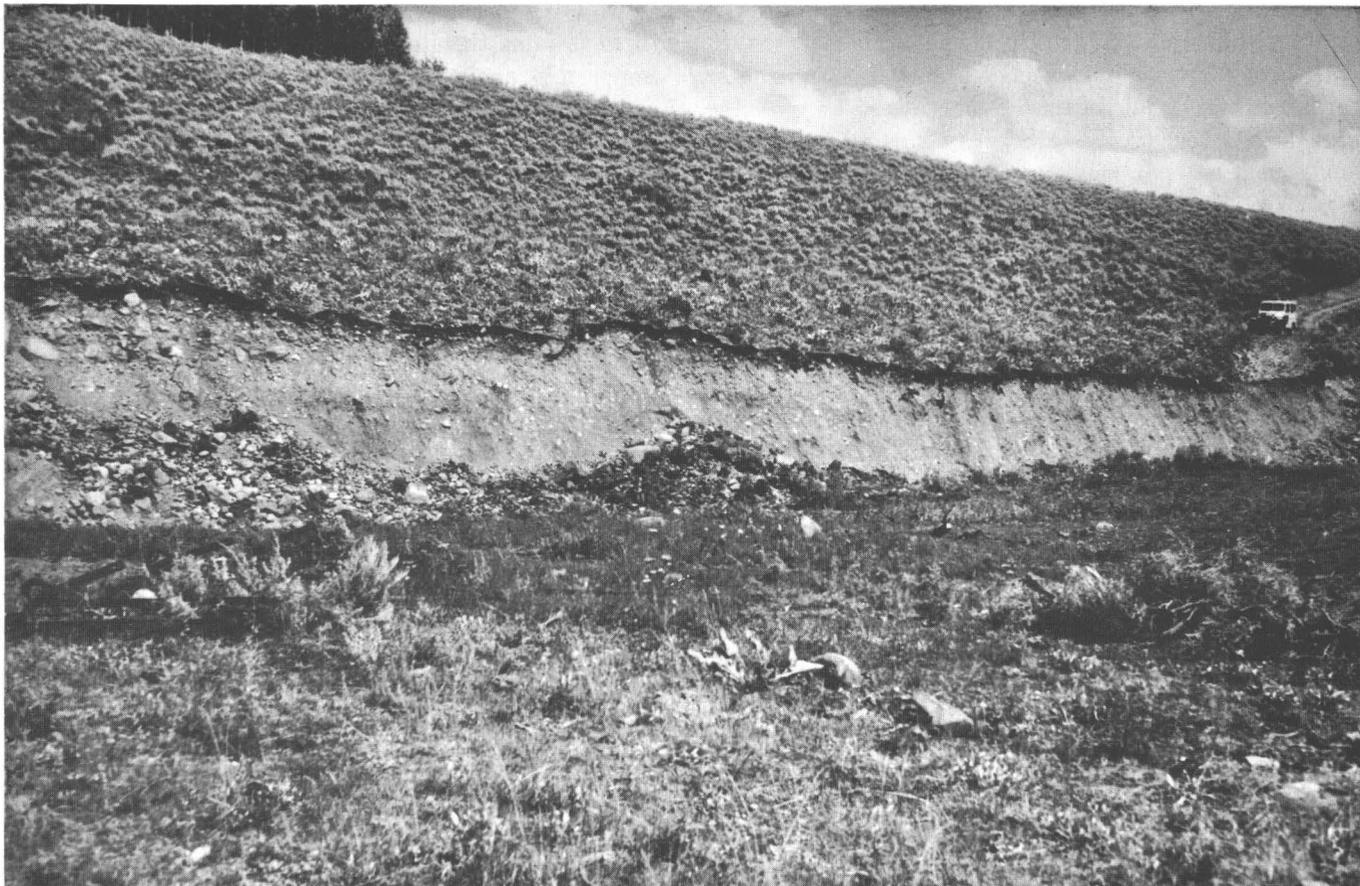
FIGURE 17.—Red Canyon fault scarp as exposed east of Blarneystone Ranch (SW $\frac{1}{4}$ sec. 9, T. 12 S., R. 5 E.), showing general nature of the unconsolidated material cut and offset. Rake of slickensides is 90° along the scarp in this locality. Area in center of picture is broad subsidence zone tilted toward fault scarp. Scarp height is about 14 feet; corrected surface displacement is about 10 feet.

interpreted as the eroded scarps of older movements. The scarps end to the northwest, and, near the junction of Highways 499 and 191, two scarps displace the roads; the southwestern scarp ends several hundred feet west of Highway 499, whereas the northeastern scarp continues to the northwest across a broad alluvial flat. The latter scarp increases in height gradually until it is about 14 feet high near Blarneystone Ranch (SW $\frac{1}{4}$ sec. 9, T. 12 S., R. 5 E.), where it dips southward, the south side is downthrown, and the rake of the slickensides on the scarp face is 90° (fig. 17).

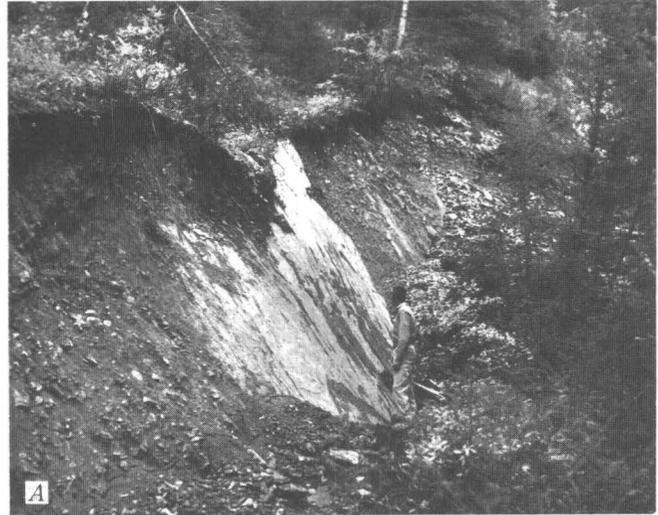
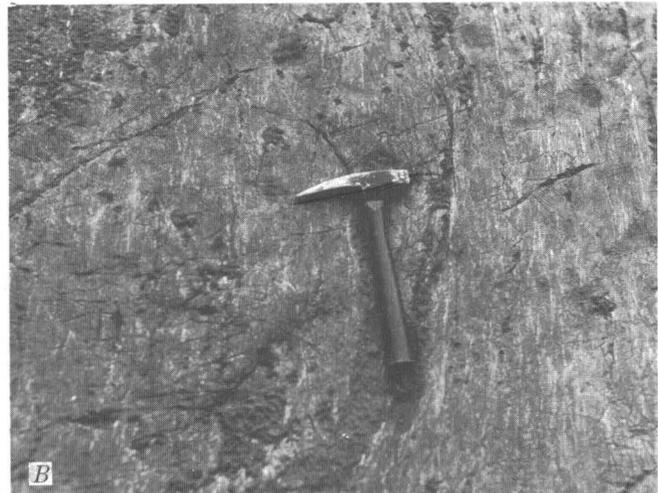
FIGURE 19.—Red Canyon fault scarp at contact between bedrock and colluvium. *A*, Footwall locally formed by steeply dipping strata; elsewhere footwall is at base of small prism of colluvium still attached to bedrock. *B*, Face of bedrock footwall striated by downward movement of the colluvium that forms the hanging wall.

In a few places the scarp is at the contact between the surficial debris and the bedrock which forms the footwall; at such places the bedrock surface is striated (fig. 19). Locally, where near bedrock, the fault scarp parallels the contact of colluvium and bedrock, and, consequently, this contact deviates from the regional linear trace of the scarp.

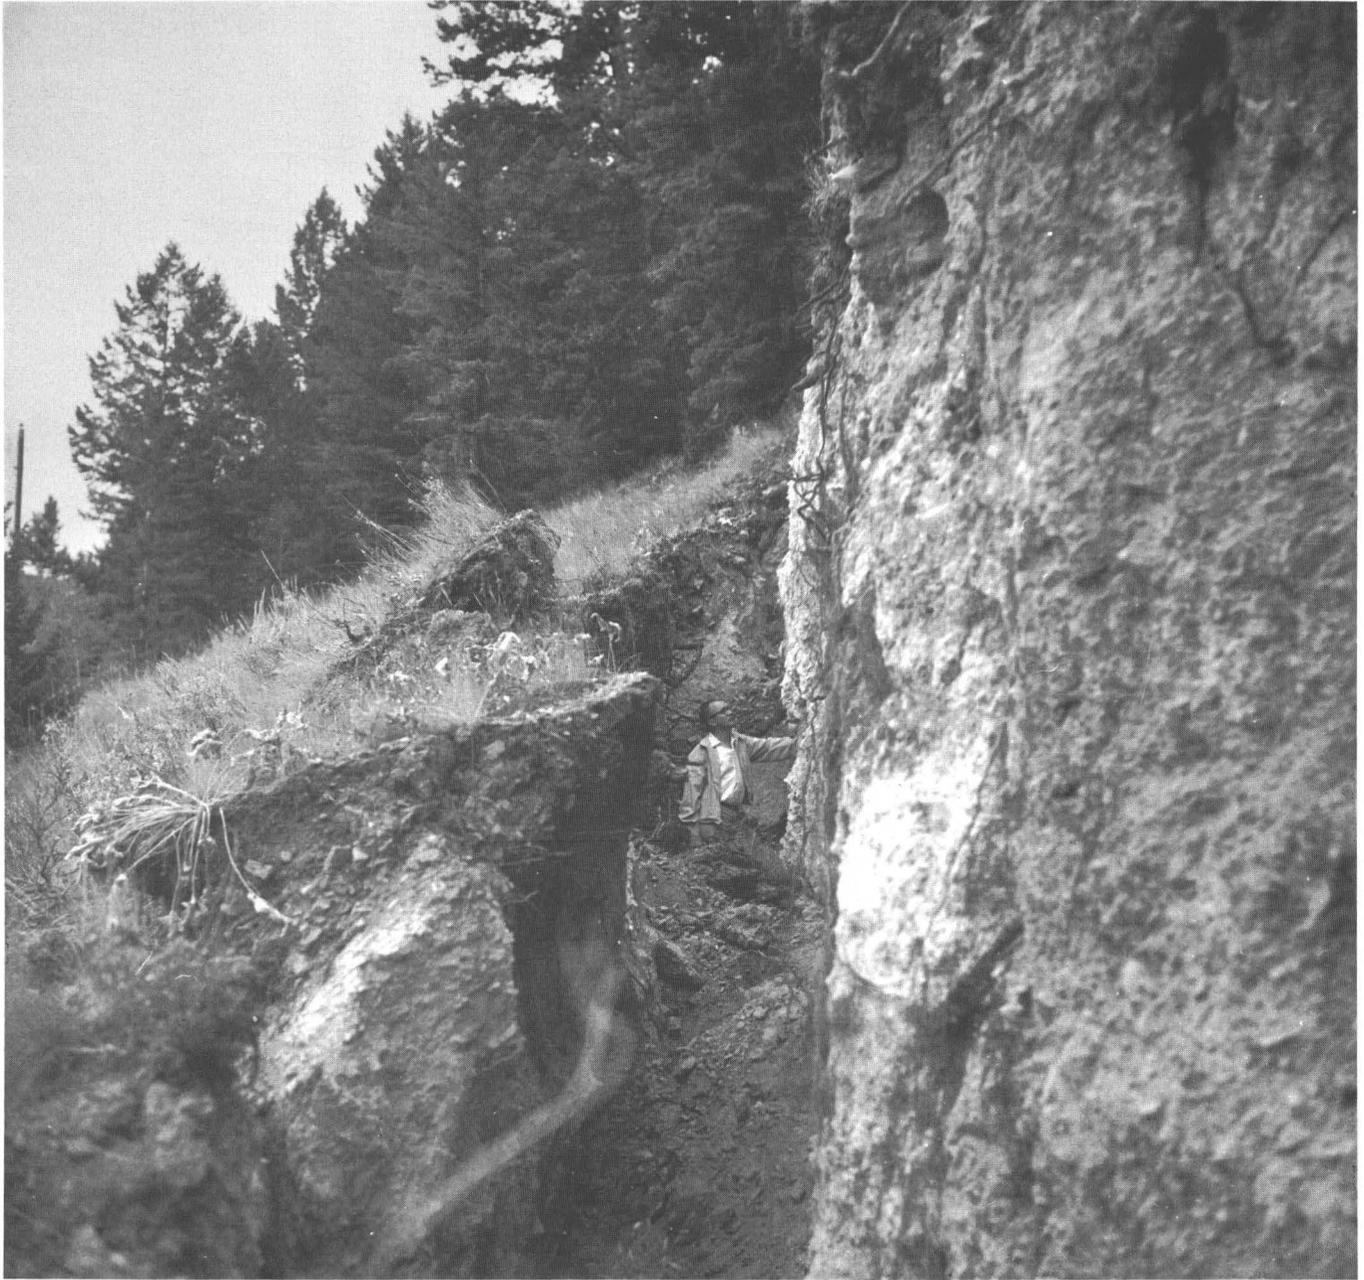
FIGURE 24.—Gap in a simple fault scarp as exposed along the trace of the Hebgen fault near Kirkwood Canyon.

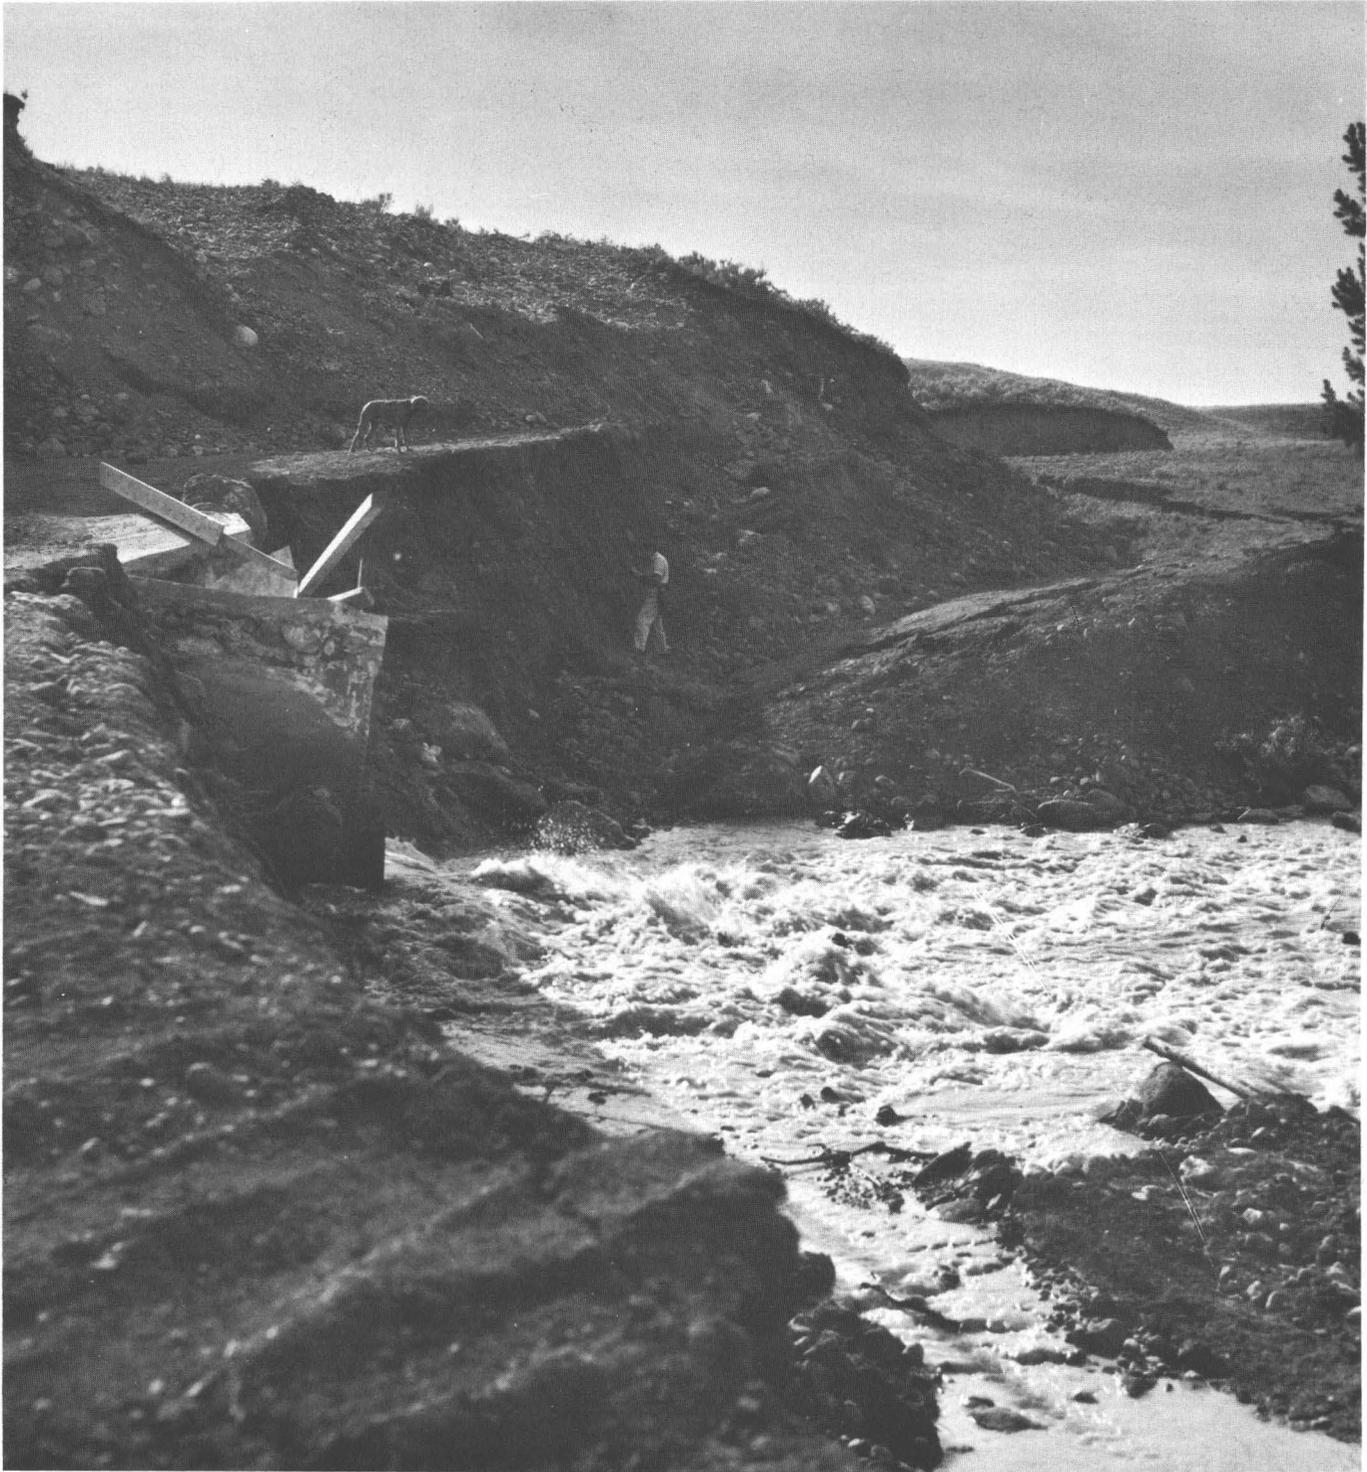
FIGURE 25.—Red Canyon fault scarp where it crosses Grayling Creek east of Blarneystone Ranch (SW $\frac{1}{4}$ sec. 9, T. 12 S., R. 5 E.). Rake of slickensides is vertical. Debris from footwall conceals scarp and partly fills gaps. Note inclination of subsidence zone behind man who is standing on downthrown part of road. Scarp height about 14 feet; corrected surface displacement about 10 feet.

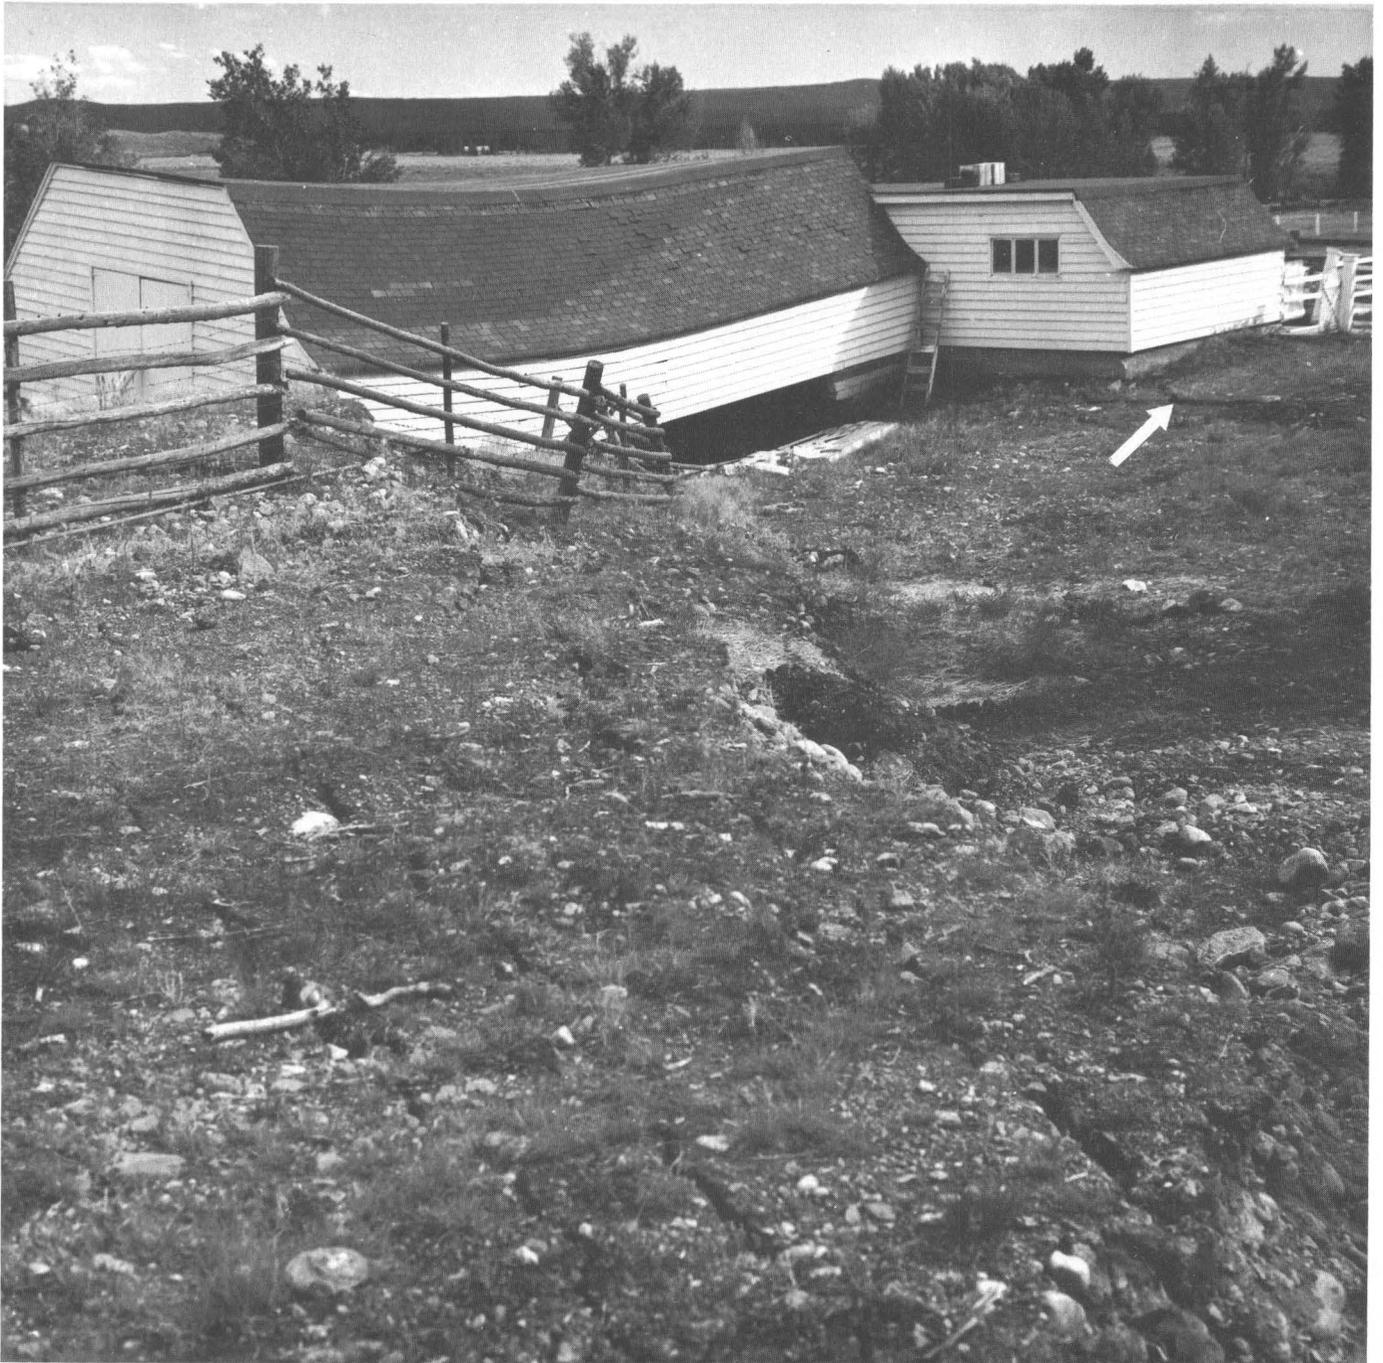
FIGURE 26.—Storage shed and domestic quarters of the Blarneystone Ranch astride a gravity graben. View is to southeast from position on footwall. Brow of main scarp trends obliquely across center of photograph; subsidiary scarp about 2 feet high and parallel to main scarp is shown by arrow. Note group of small parallel fractures cutting colluvium of footwall.

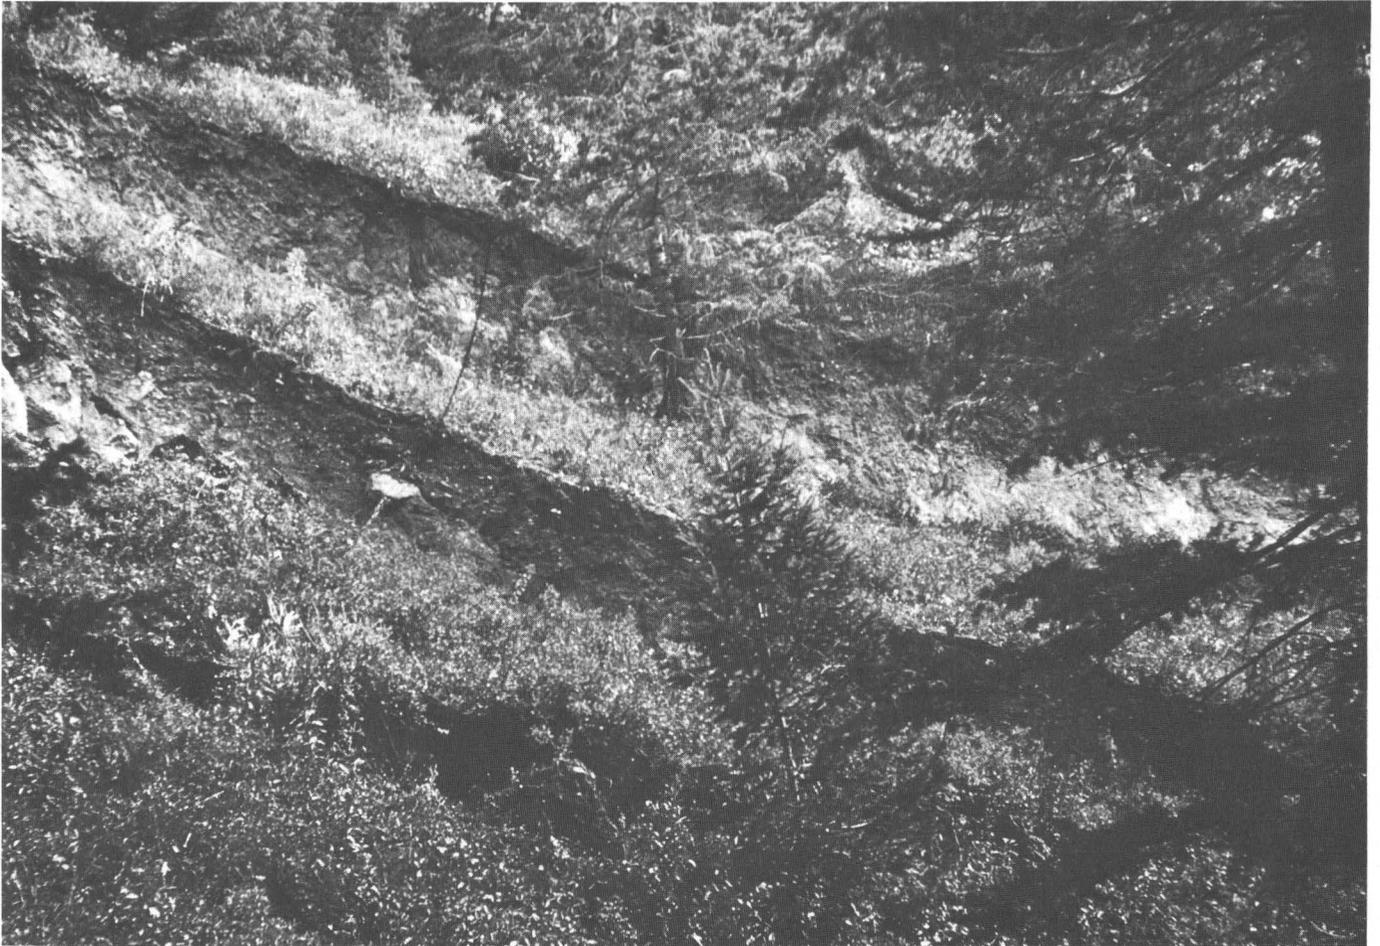
FIGURE 28.—Step faults along the Red Canyon fault scarp where it follows the south flank of Kirkwood Ridge.

hill slightly, and a series of scarps, all of which face valleyward, are formed (fig. 28). Commonly three or four minor scarps are below the main scarp, which can be recognized because of its continuity and height. Each splinter segment between the subsidiary scarps is about 50 feet wide, and each is broken without displacement by smaller fractures which parallel the flanking scarps. The whole fault group, although resembling the longitudinal step fault group, results from displacement of the hanging wall rather than

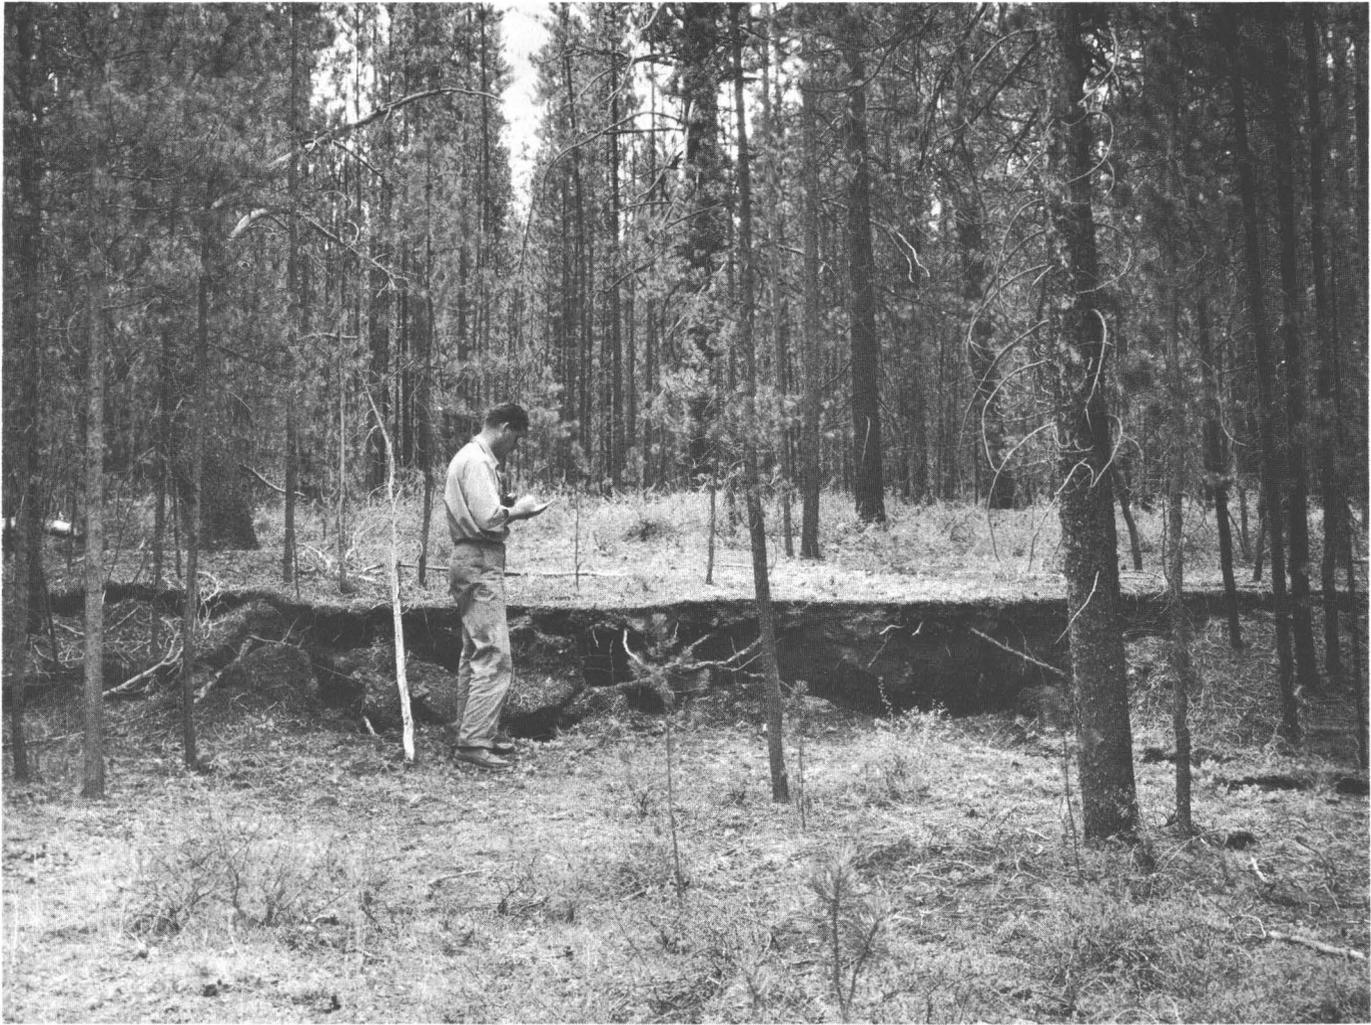
FIGURE 30.—New scarp in the sand plain. Dip of fault at surface is 85° back under scarp; opposite sides are tight together so that down-dropped block is slightly overhung by the relatively upthrown block. This is a refracted normal fault, not a reverse fault. (See fig. 39.) South of Madison Arm, 5.3 miles northwest of West Yellowstone.
