The Hebgen Lake, Montana Earthquake of August 17, 1959

GEOLOGICAL SURVEY PROFESSIONAL PAPER 435

STRUCTURAL DAMAGE IN THE HEBGEN LAKE-WEST YELLOWSTONE AREA

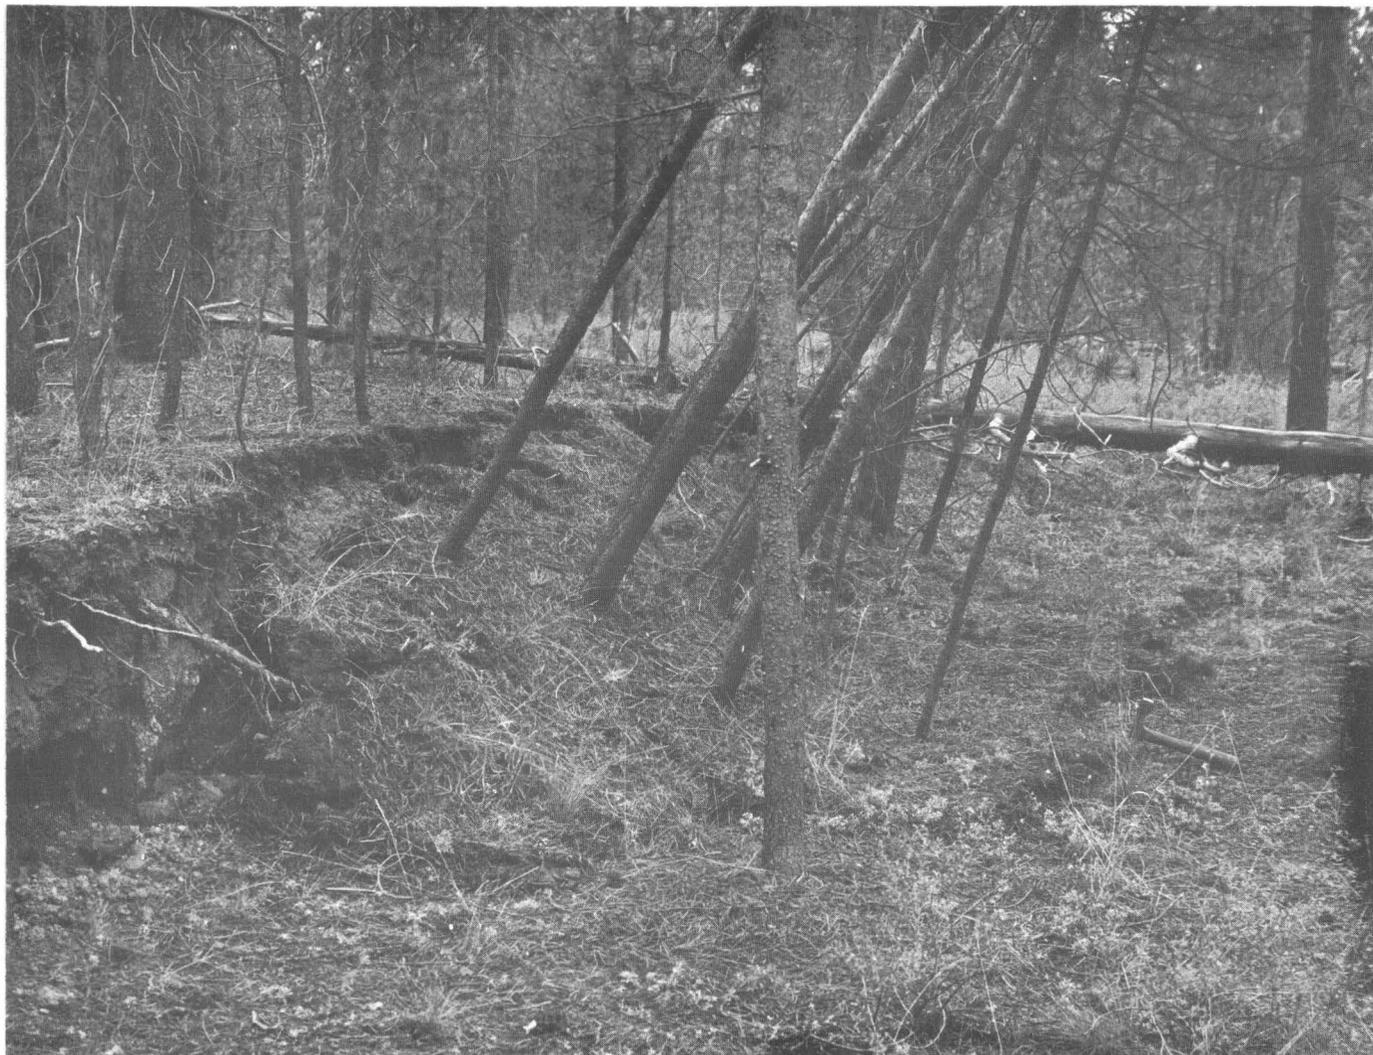
FIGURE 31.—New scarp and monocline in the sand plain. Fault (left) with tightly closed fissure gives way to an atypically steep and abrupt monocline (center) which gives way in turn to a gentle monocline. A mole-track thrust runs along the base of the monocline, past the head of the hammer. South of Madison Arm, 5.3 miles northwest of West Yellowstone. Photograph by John R. Stacy.

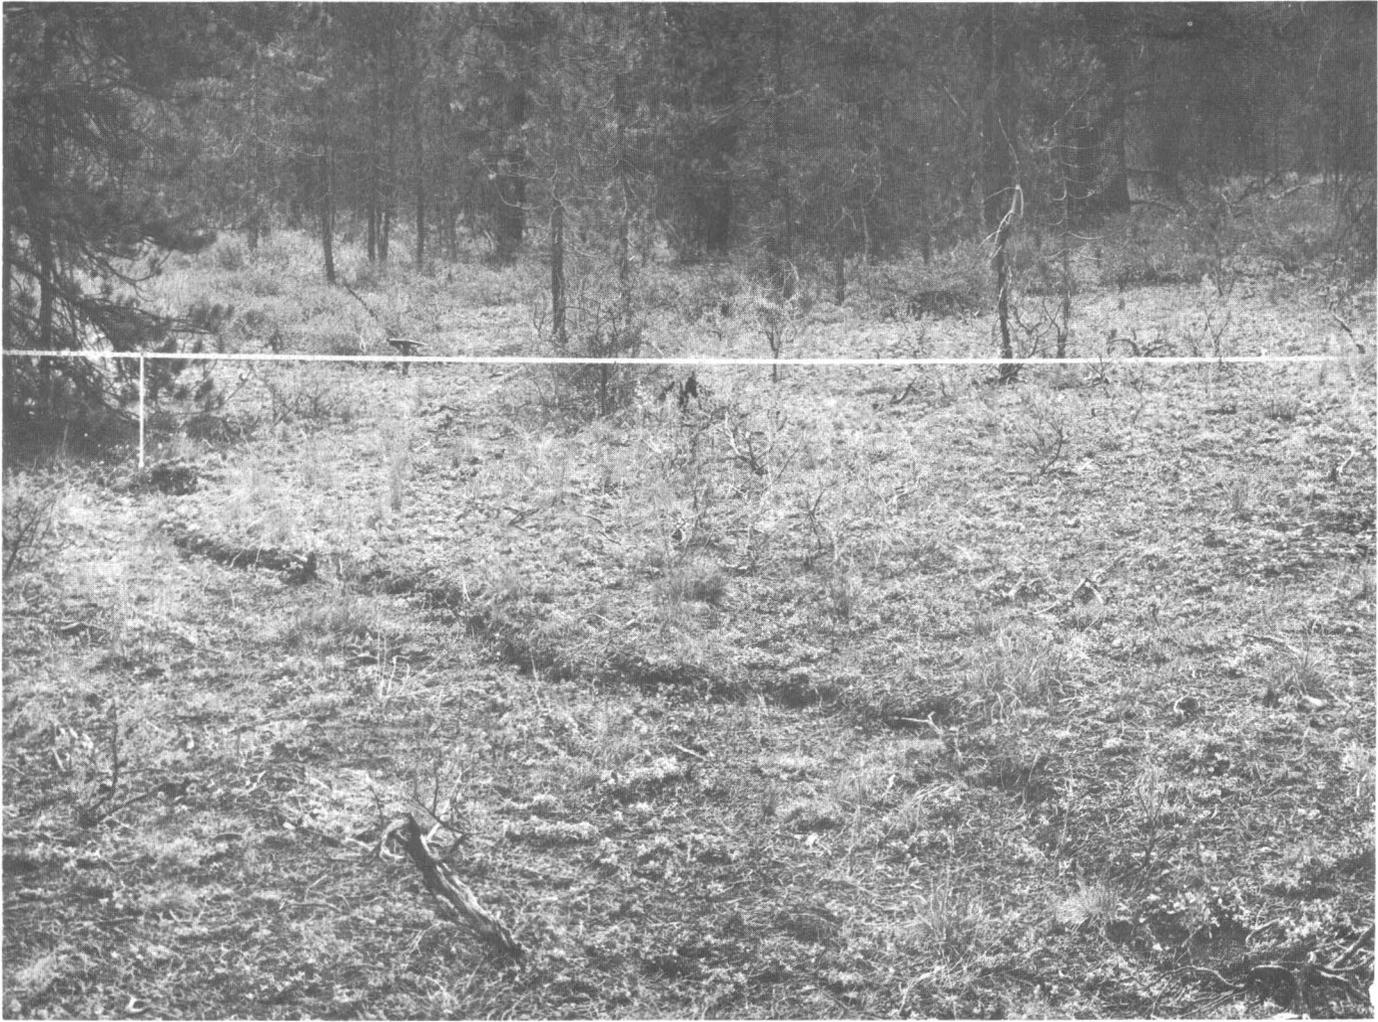
FIGURE 32.—Mole-track thrust at base of monocline formed during 1959 earthquake. White tapes indicate horizontal (17 feet) and vertical (1.5 feet) components of new monoclinal slope. South of Madison Arm, 5.3 miles northwest of West Yellowstone. Photograph by John R. Stacy.

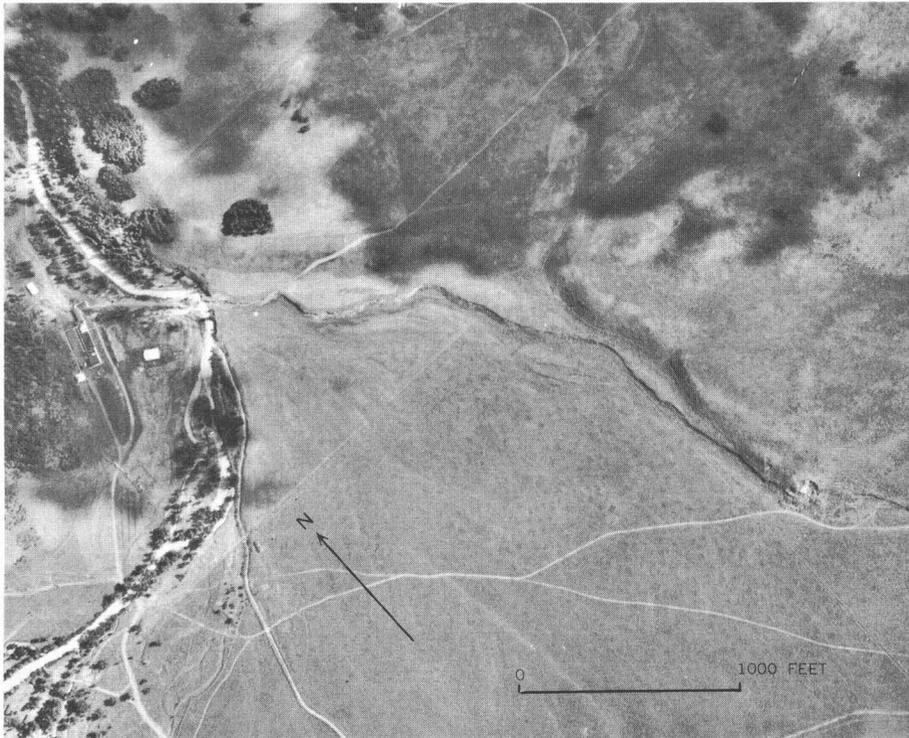
FIGURE 36.—Reactivated fault scarp at Grayling Creek. The 1959 scarp, about 10 feet high, is precisely superimposed upon an older fault scarp of similar height that shows best just southeast of Grayling Creek. (See also fig. 37.) A still older and greater displacement produced a moat within which Grayling Creek flowed for a time; the stream cut back the scarp then formed to produce the 60-foot erosional escarpment that parallels the younger structural scarps. Dark areas are cloud shadows. Vertical aerial photograph by U.S. Forest Service.

The new south-facing fault scarp in flat-lying unconsolidated material east of Grayling Creek near the Blarneystone Ranch is on a fault that has had two previous episodes of late Quaternary displacement. It precisely follows an older scarp of about the same height—10 feet (figs. 36, 37). An older and much higher—60 feet—scarp has been eroded back by Grayling Creek; possibly several episodes of faulting contributed to this height. Southeastward along strike the old fault scarps dwindle and give way to a low monocline that is apparently identical with those of the sand plain south of Hebgen Lake. As the monocline becomes lower and more gentle, the 1959 scarp-

its modern flood plain, parallel to and just above the prequake fault scarp (see figures 36 and 37), where it apparently flows along a slump moat of a branch of the fault. Tiny en echelon fissures, formed during the earthquake, were traced upstream for more than a quarter of a mile in the surficial deposits on the northwest side of the creek and may mark very slight quake shifting on this branch structure.

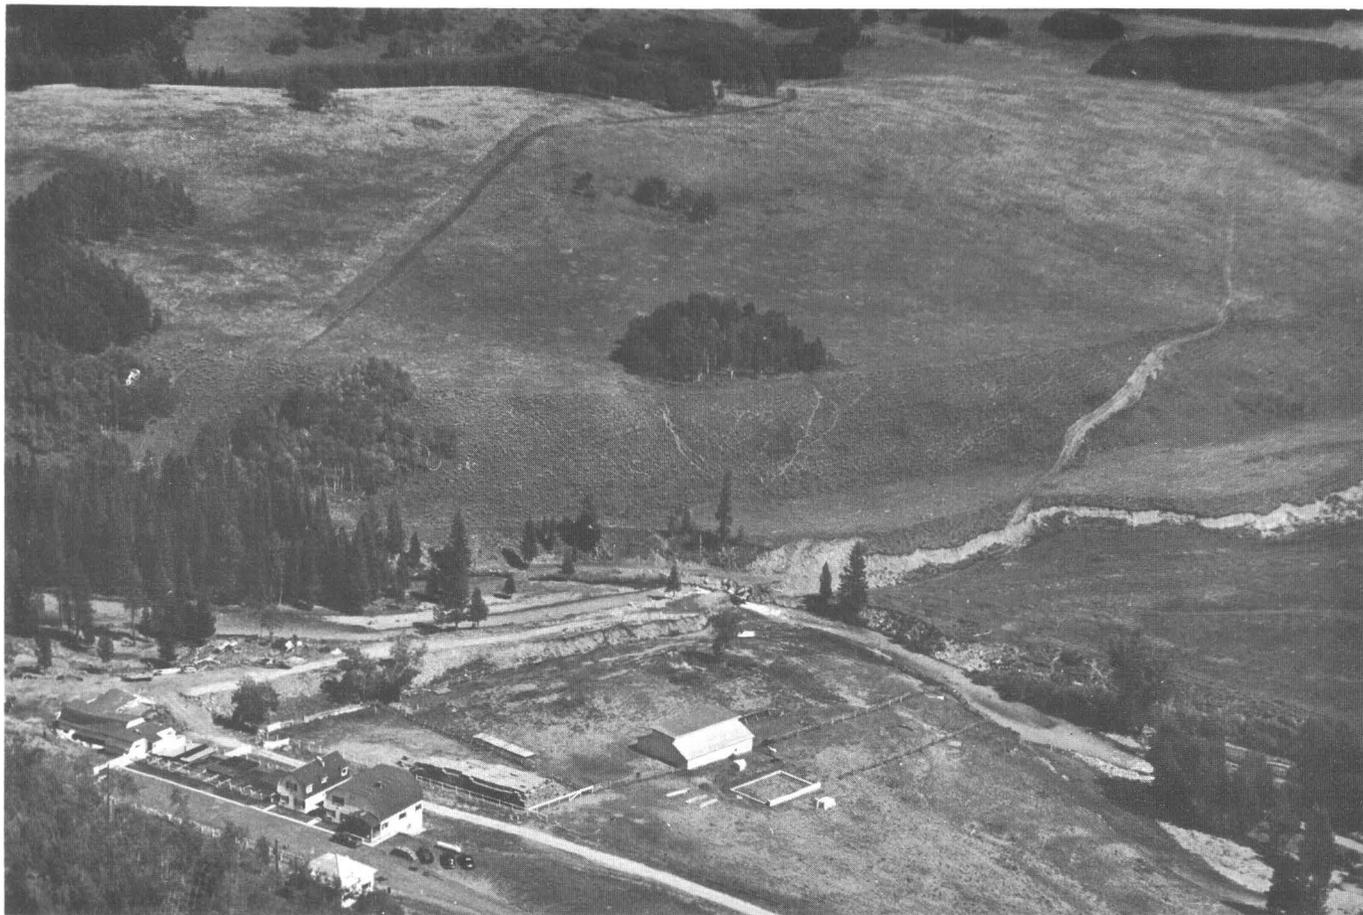
FIGURE 37.—Reactivated fault scarp at Grayling Creek. The new fault scarp is superimposed upon an older one of similar height. Behind this composite scarp is an escarpment eroded back by Grayling Creek from a larger older fault scarp on the same trace. View looking east across Blarneystone Ranch; see also figure 36. Photograph by John R. Stacy.

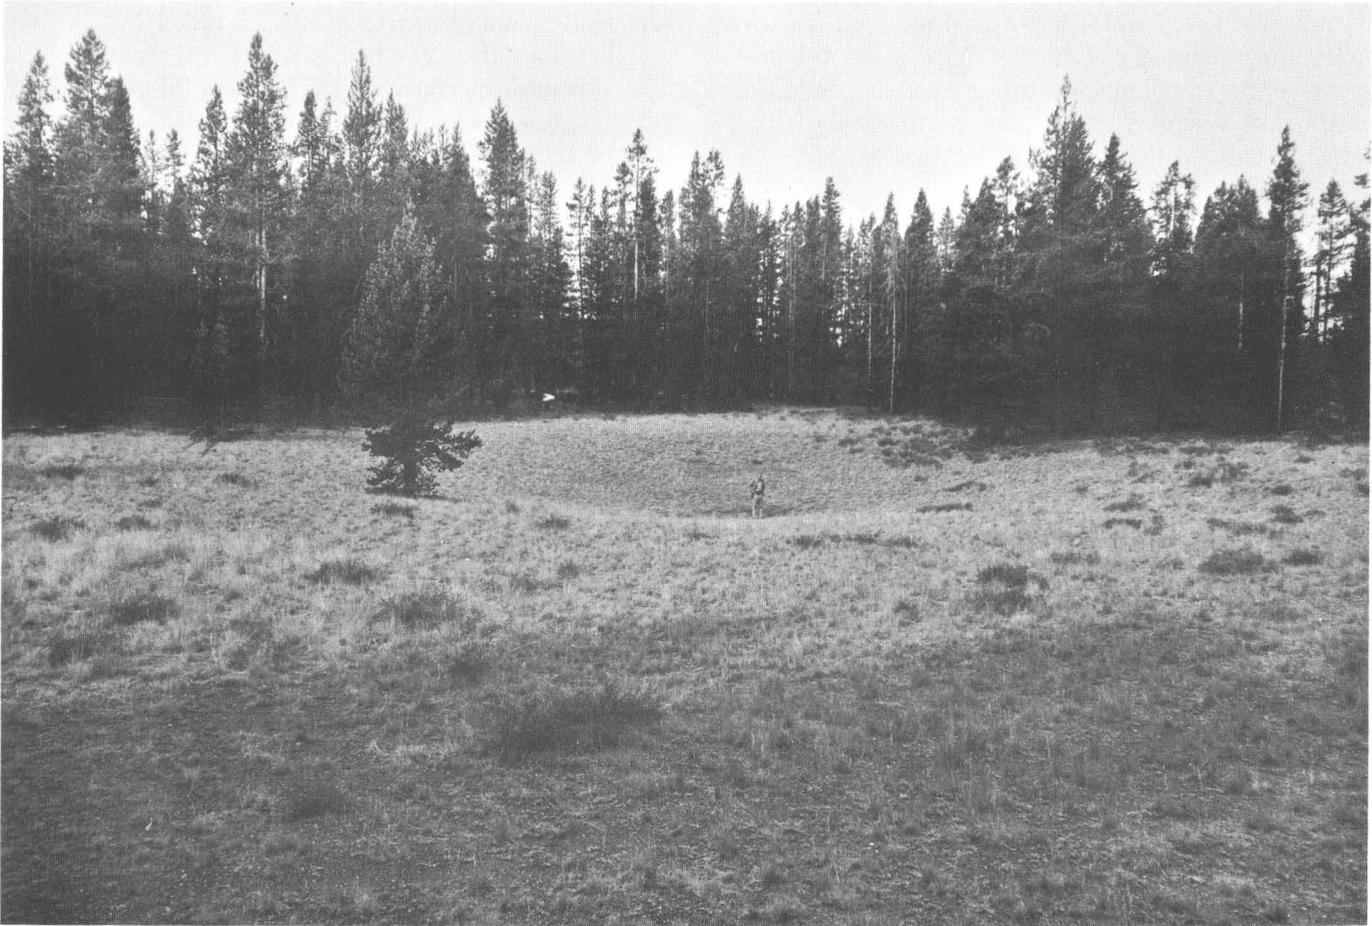
FIGURE 40.—Old conical depression in the sand plain. Depression is 130 feet across, nearly 10 feet deep, and probably was formed as a sand boil. Two miles north-northwest of West Yellowstone. Photograph by John R. Stacy.

Two more depressions occur near the west end of the monocline three-quarters of a mile southeast of those described above. One is a conspicuous circular, conical depression (fig. 40) 130 feet in diameter that has a closure of nearly 10 feet and a central plug 18 feet in diameter that subsided a few inches during the earthquake. The second depression is smaller, much shallower, and was not reactivated.

These conical depressions are collapse features that pock an undissected sand plain which slopes only very gently northward. They are interpreted as the result of collapse into the pits of giant sand boils formed during past earthquakes and are similar to those produced during the 1959 earthquake and described by F. A. Swenson (chapter N). The cylindrical central plugs that subsided during the 1959 earthquake probably represent the compaction of the sand in the throats of these short-lived sand-clogged artesian springs. Although no deposits from these postulated sand boils have been recognized, such deposits would be recognizable only by topographic form, as they would consist simply of detritus reworked from the sand plain. The large sand boils developed during the 1959 earthquake produced only thin veneers of sand and gravel despite the considerable size of the pits from which this material came; such veneers, formed of material identical with that beneath them, would not long be recognizable.

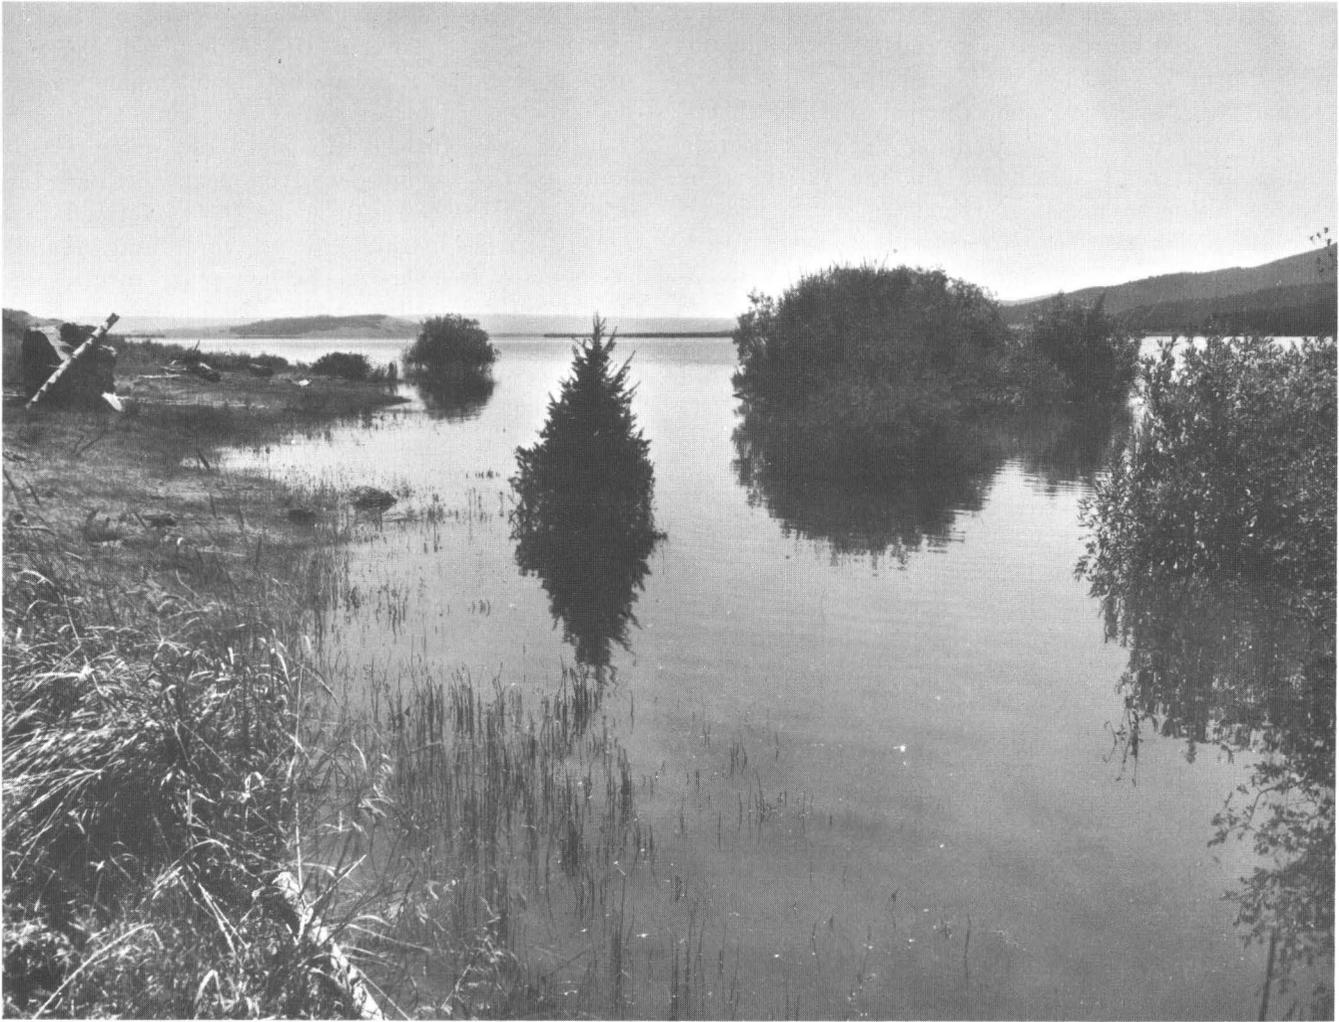
FIGURE 43.—Submerged land shrubs and trees in Hebgen Lake. Northeast shore of lake, near Kirkwood Creek. U.S. Forest Service photograph.

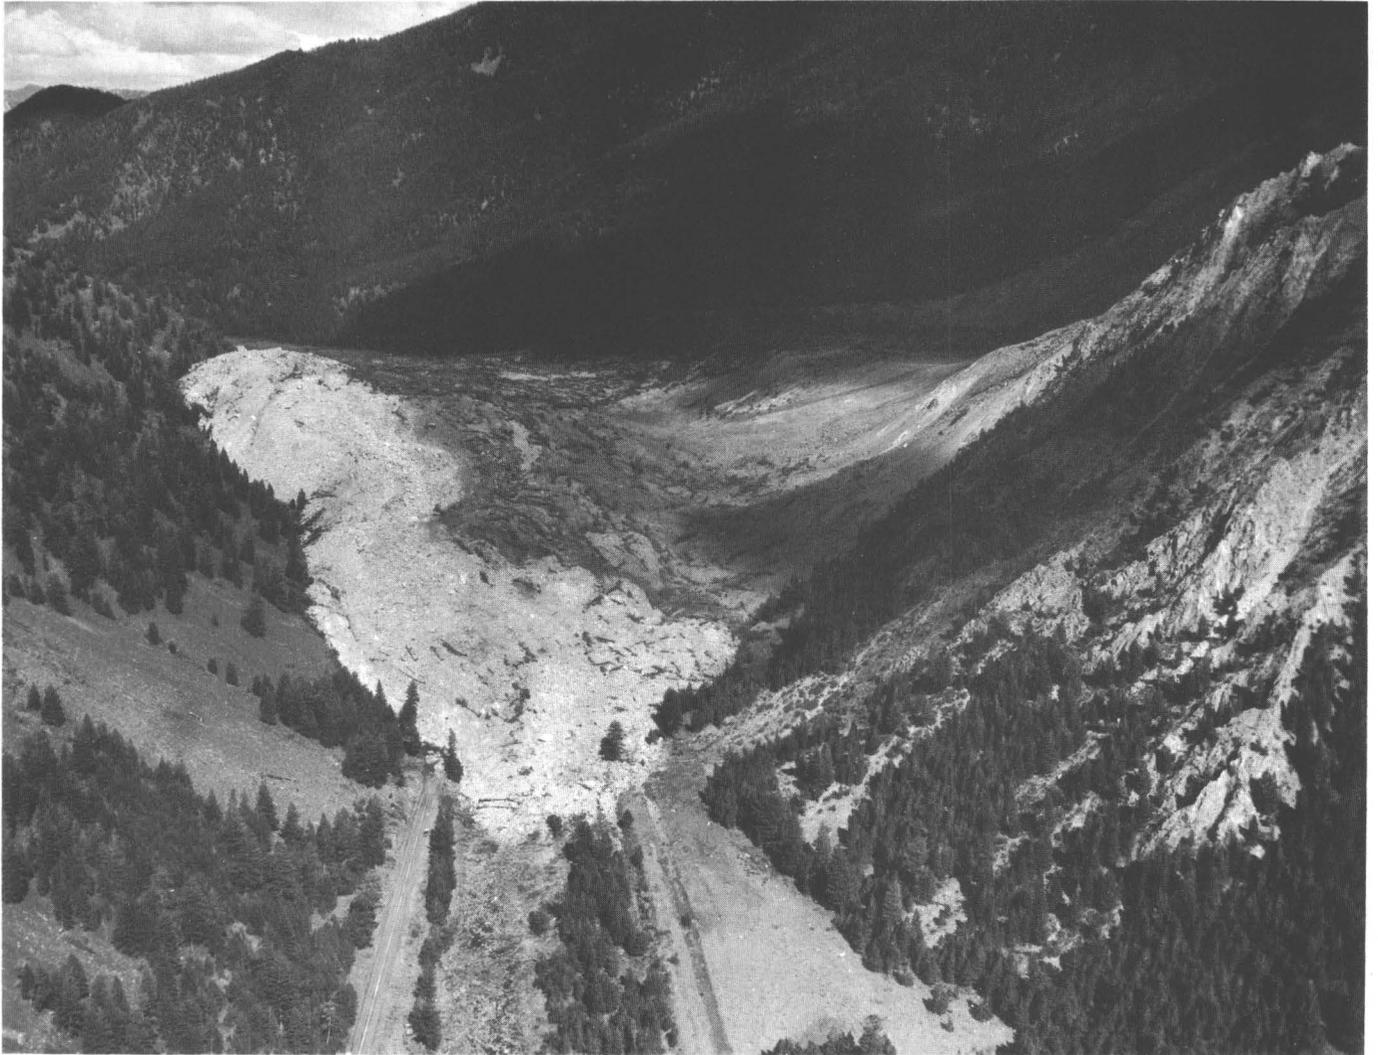
FIGURE 54.—Madison Slide, upstream view showing the west edge of the slide debris, blocked highway, and dry river bed below the slide. U.S. Forest Service photograph.

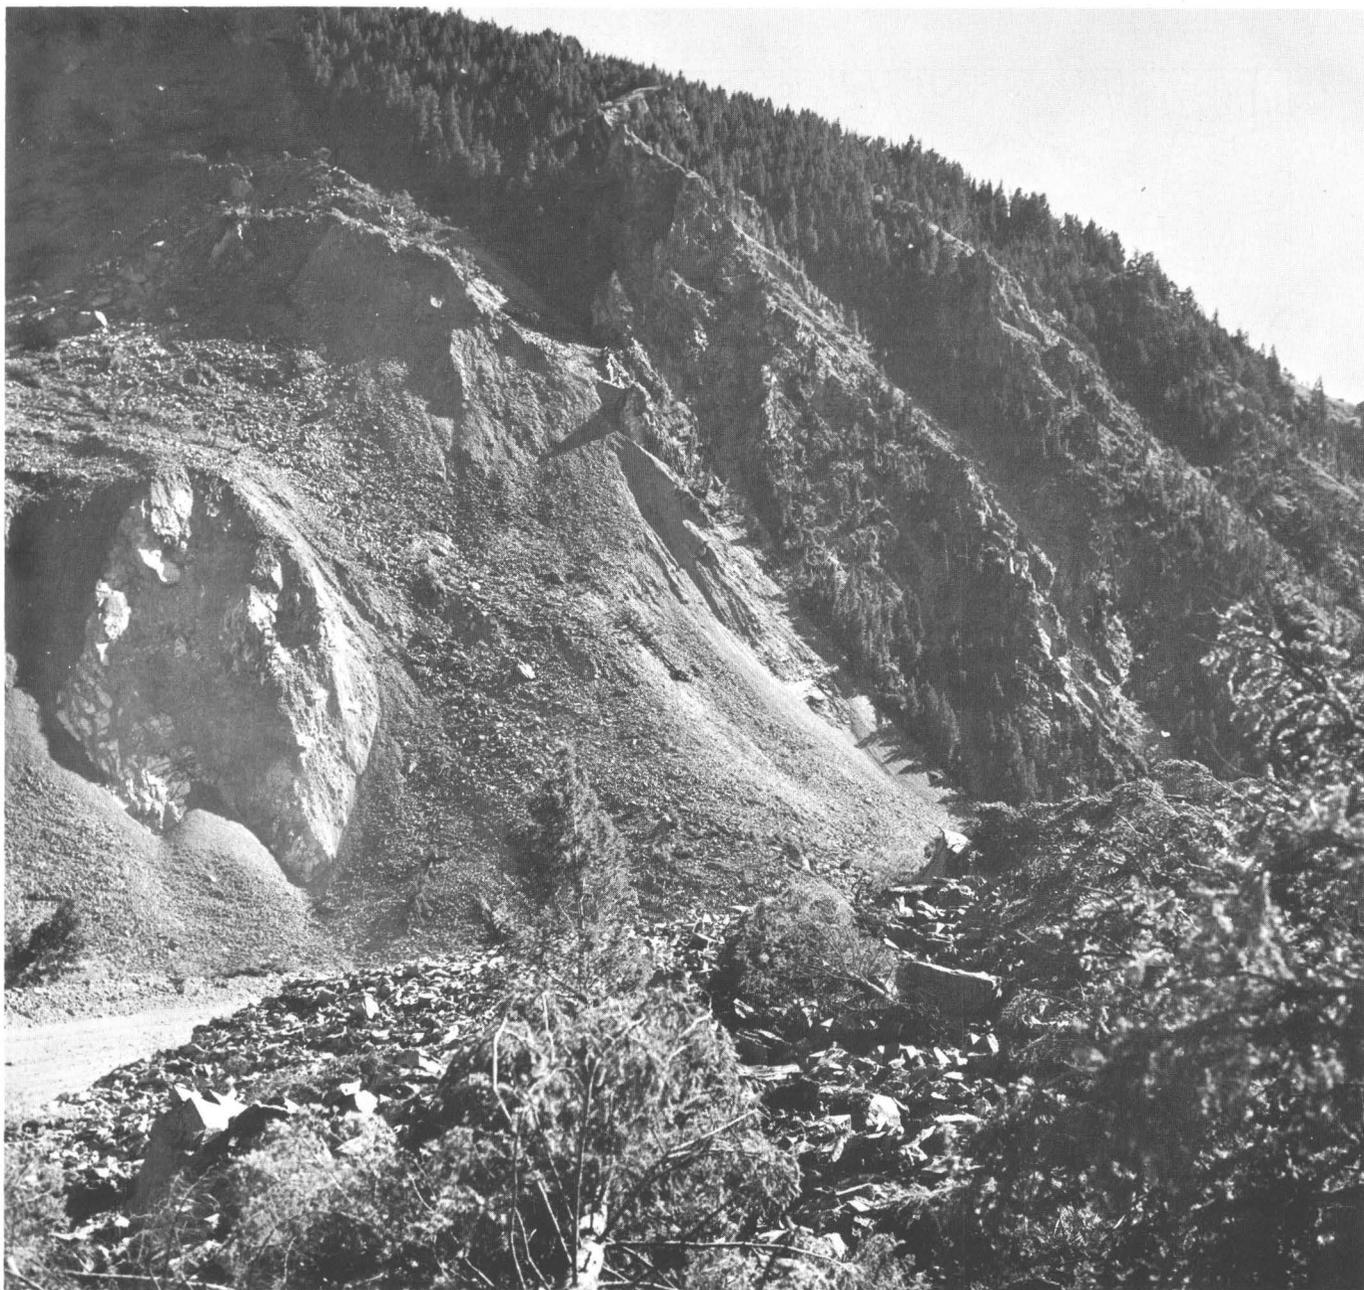
FIGURE 56.—West border of the Madison Slide scar showing dolomite spurs on stable slope. Part of the slide mass in foreground. Photograph by John R. Stacy.

The south wall of the canyon before the sliding consisted of two parts developed on contrasting types of bedrock. The western part, underlain by dolomite, was characterized by a series of craggy bedrock spurs 300 to 400 feet apart, separated by shallow but steep ravines with slopes approaching 45° (fig. 56). The slopes of the eastern and upper parts, underlain

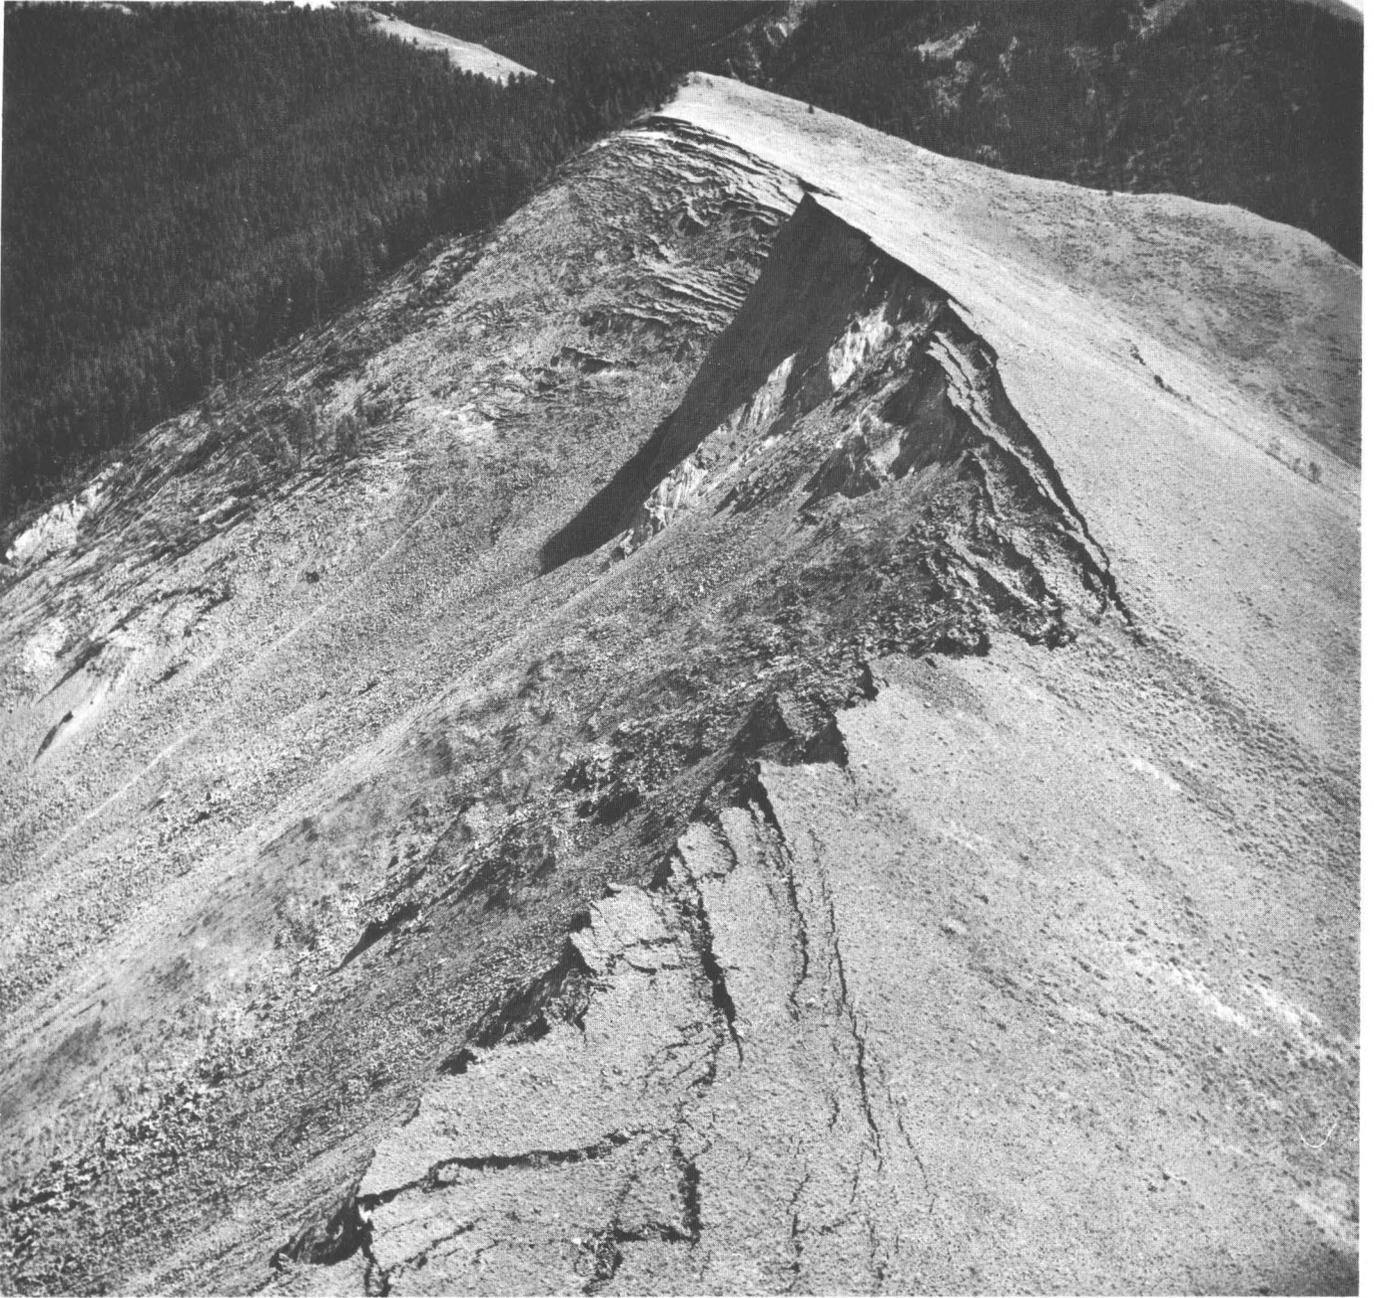
FIGURE 57.—View east along the crest of the Madison Slide scar. Highly sheared and weathered schist dipping steeply northward appears in the center; slump fractures in background and in foreground, those in foreground are parallel to schistosity in underlying rock. Photograph by John R. Stacy.

Northward-dipping foliation and shear zones in the schist and gneiss forming the rest of the south wall of the canyon contributed to the instability and movement of the rock. Most of this foliation and shearing resulted from movements associated with the Laramide faulting along the trend of the canyon and dips northward at angles ranging from 45° to 75° . In the upper part of the canyon wall west of the slide, however, foliation in the gneiss dips steeply southward and thus provides greater stability in that area. A prominent zone of greatly sheared and altered chloritic and sericitic schist 20 to 30 feet wide crosses the ridge obliquely somewhat west of the highest point on the slide scarp. The rock in this zone is par-

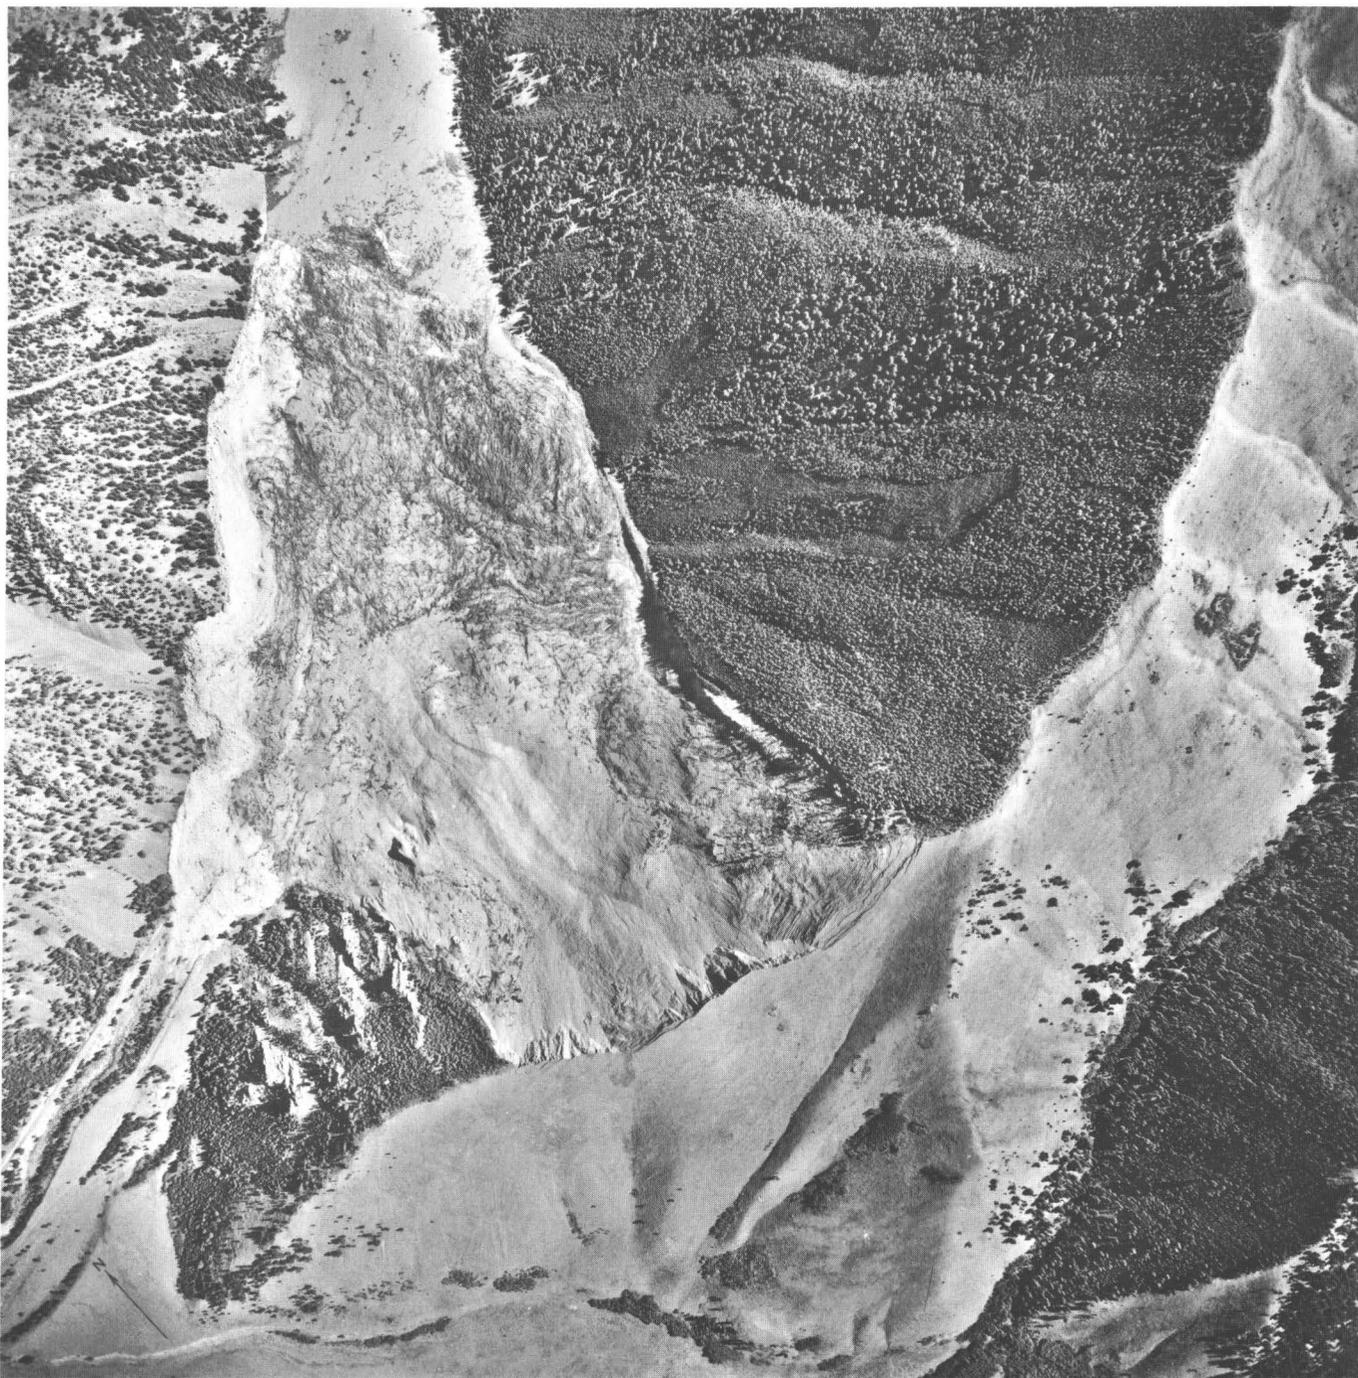
FIGURE 58.—Vertical aerial photograph of the Madison Slide. Recent scarp of Madison Range fault appears southwest of slide. U.S. Forest Service photograph, August 22, 1959.

feet long and 1,300 feet high slid northward into the canyon, spreading over an area of about 130 acres on the canyon floor and adjacent slopes (fig. 58). The farthest point on the toe of the slide mass reached just a mile from the crest of the scar. A dolomite spur 700 feet high and two smaller adjacent spurs were

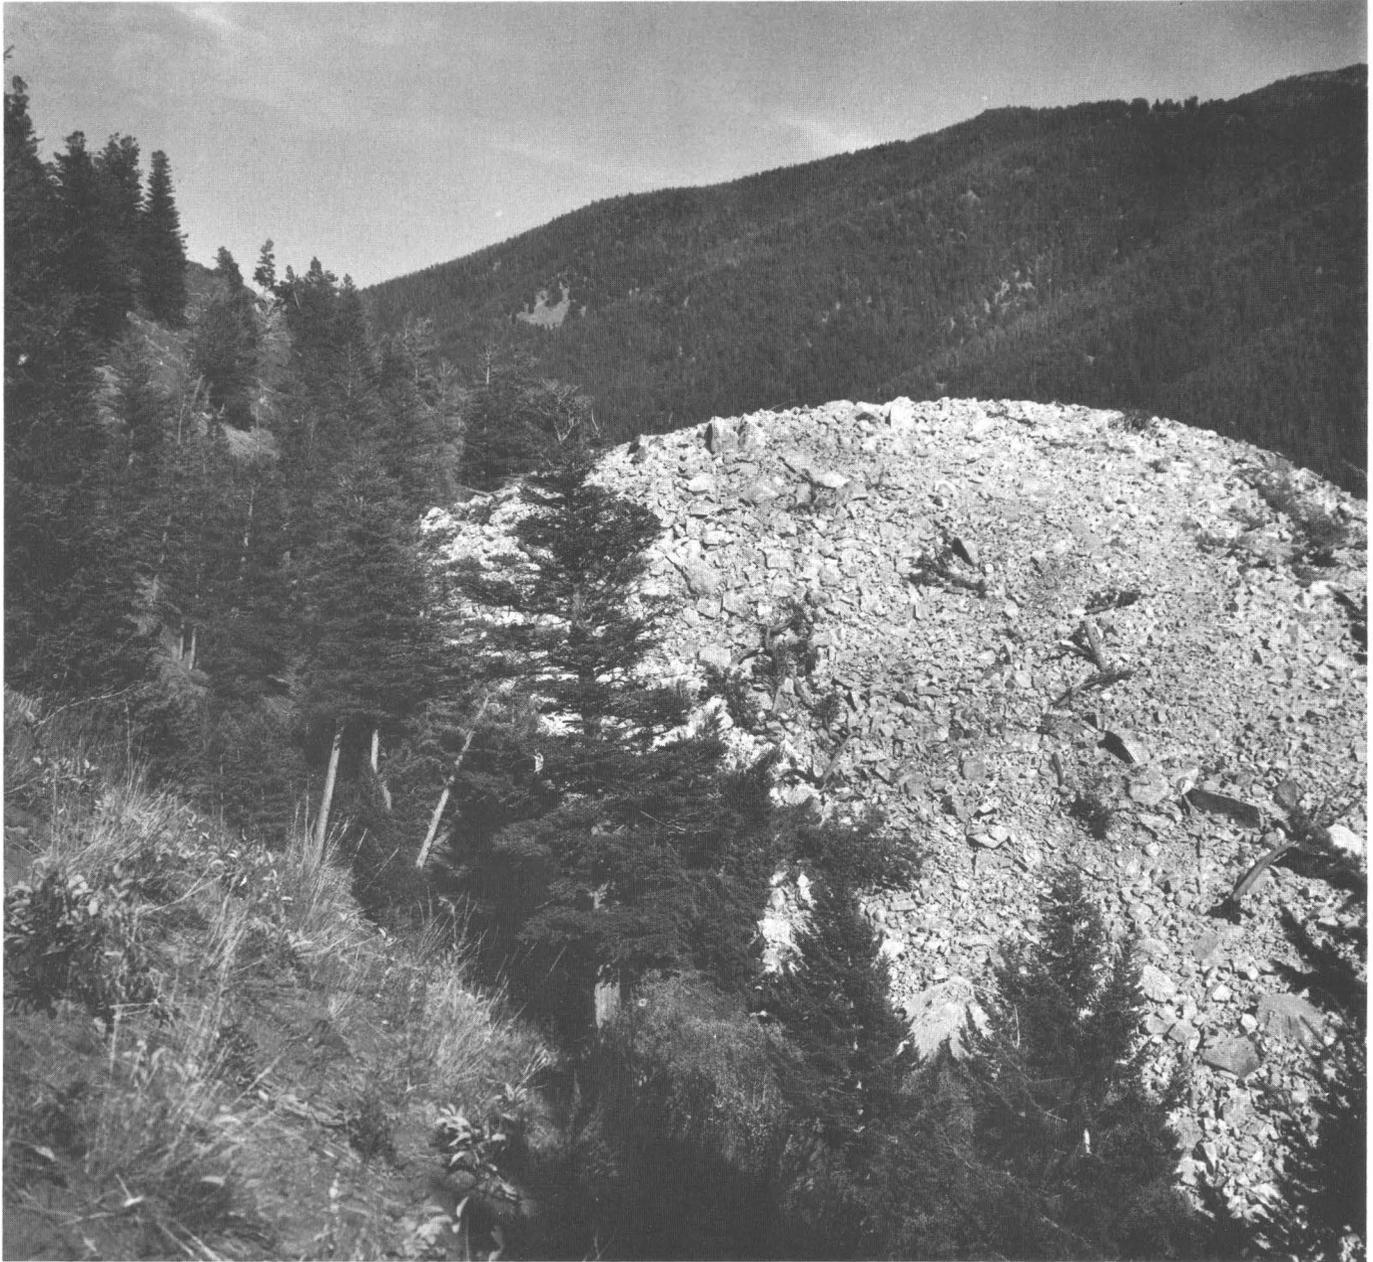
FIGURE 61.—Dolomite debris at highest point of slide mass against the north wall of the canyon, 430 feet above the riverbed. Photograph by John R. Stacy.

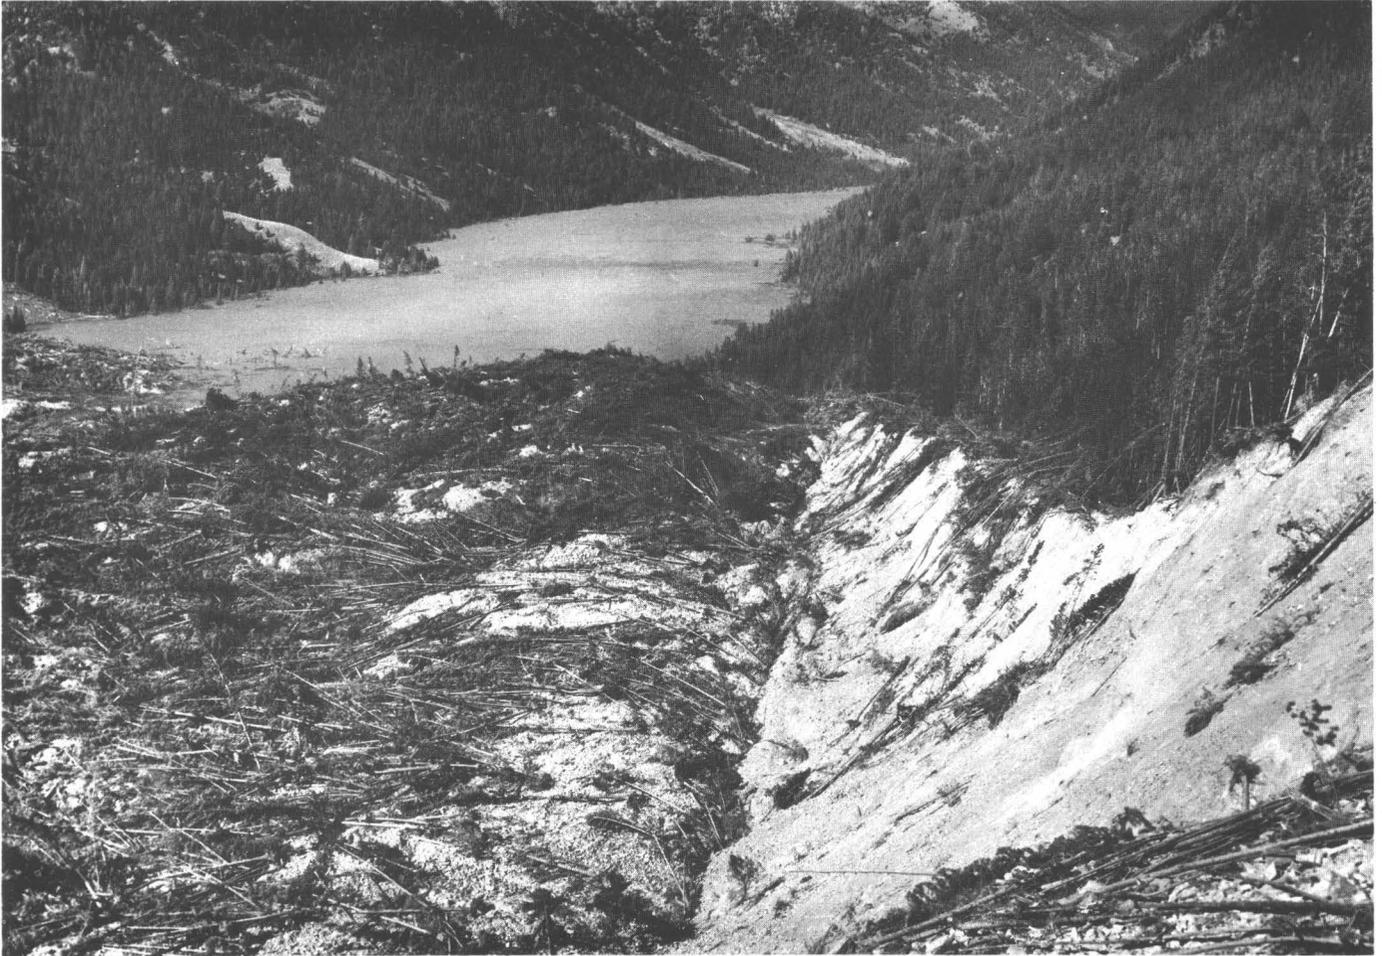
FIGURE 62.—Tree-covered southeastern part of the Madison Slide showing marginal ridge left by movement of the slide mass past it. Earthquake Lake in the background, August 28.

The eastern part of the slide mass traveled more slowly. Its edge is marked by marginal ridges that resulted from initial swelling and rising of the ground followed by sliding of all but the outer margin of the raised area (fig. 62). These ridges are 40 to 60 feet high, 100 feet or less wide, and 600 to 1,000 feet long. Their inner slopes are steep scarplike cuts in the slide material, whereas their outer slopes are less steep and retain their original forest cover, which was more or less disrupted in the process of raising the ridge. In some places the subsoil was so broken up and the outer slope so steepened that the trees and soil slid away to the bottom of the ridge. North- and northwest-trending pressure ridges developed between

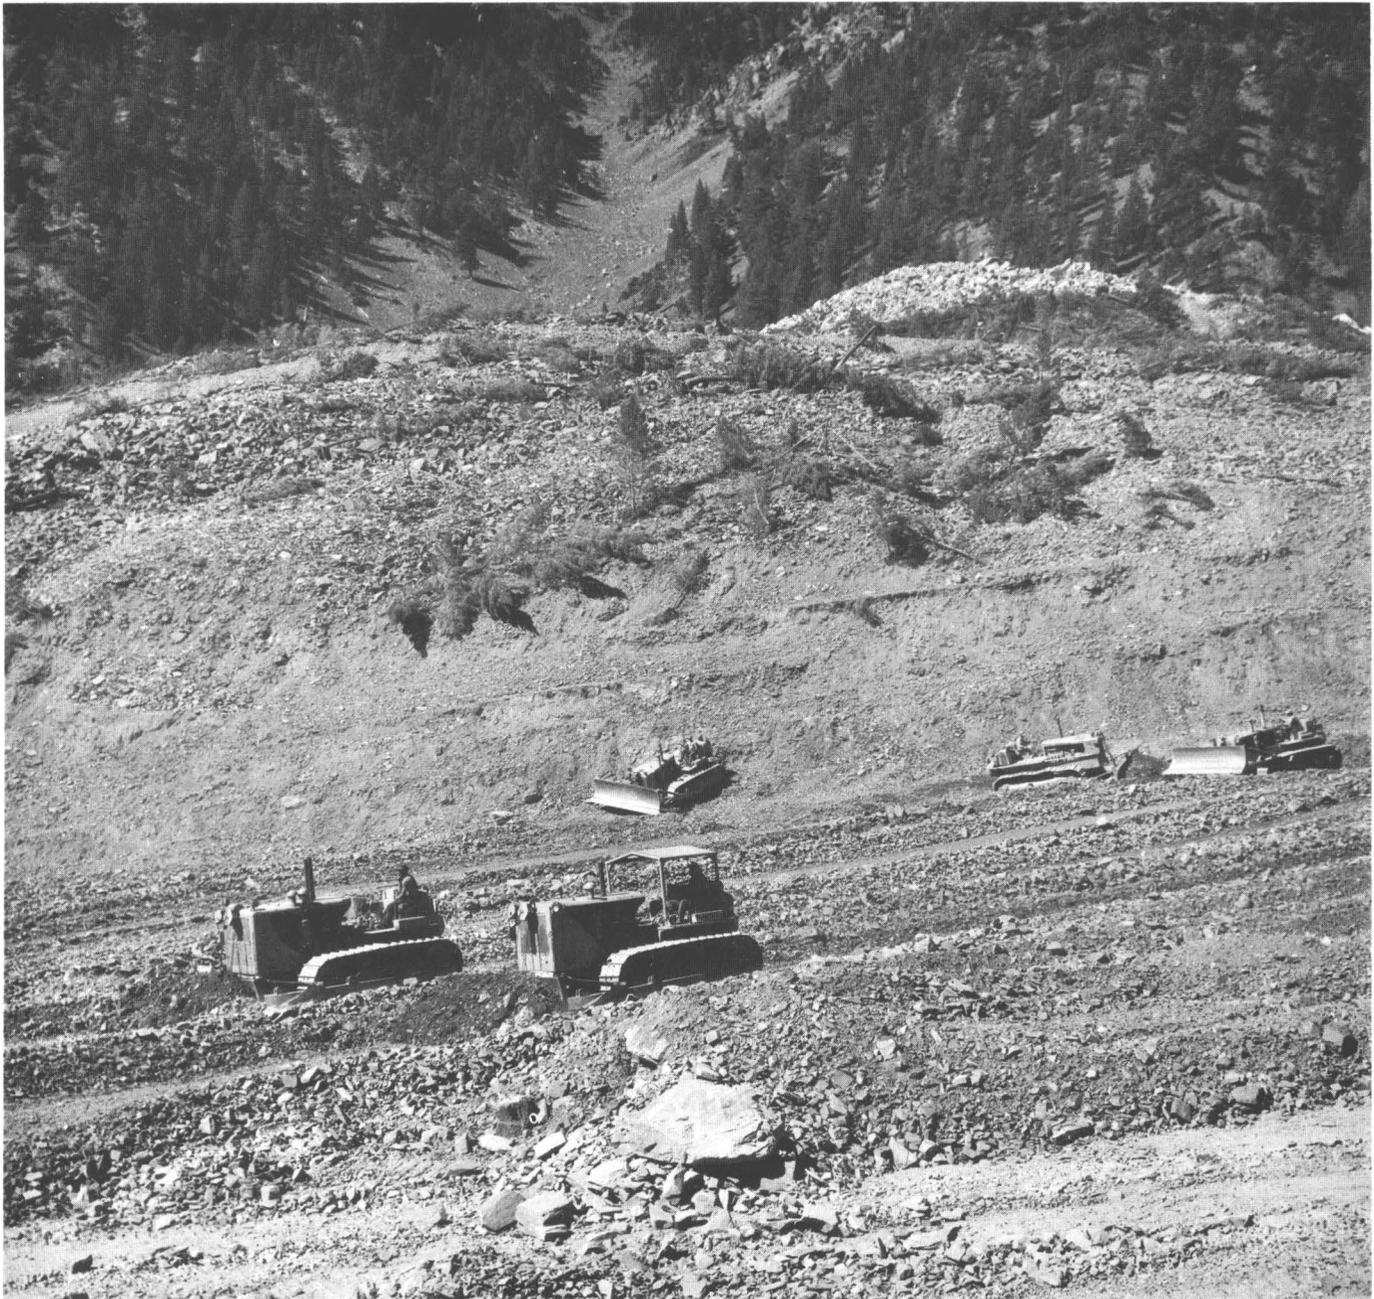
FIGURE 63.—Northern part of slide mass from trough in slide mass up dry gully on north side of canyon. Dolomite debris piled high against the side of the gully at upper right. Earth-moving equipment preparing spillway in foreground. Note the fineness of much of the slide debris beneath the surficial cover of blocks. Photograph by John R. Stacy.

Excavations made in preparing a spillway across the slide revealed that only the top few feet consists of coarse fragments without fine material, and that the upper part of the debris includes abundant smaller rock fragments as well as much sand, silt, and clay-sized material (fig. 63). Most of this represents decomposed rock in the original colluvium and weathered bedrock, but presumably some was produced by crushing and grinding in the mass as it descended. Ab-

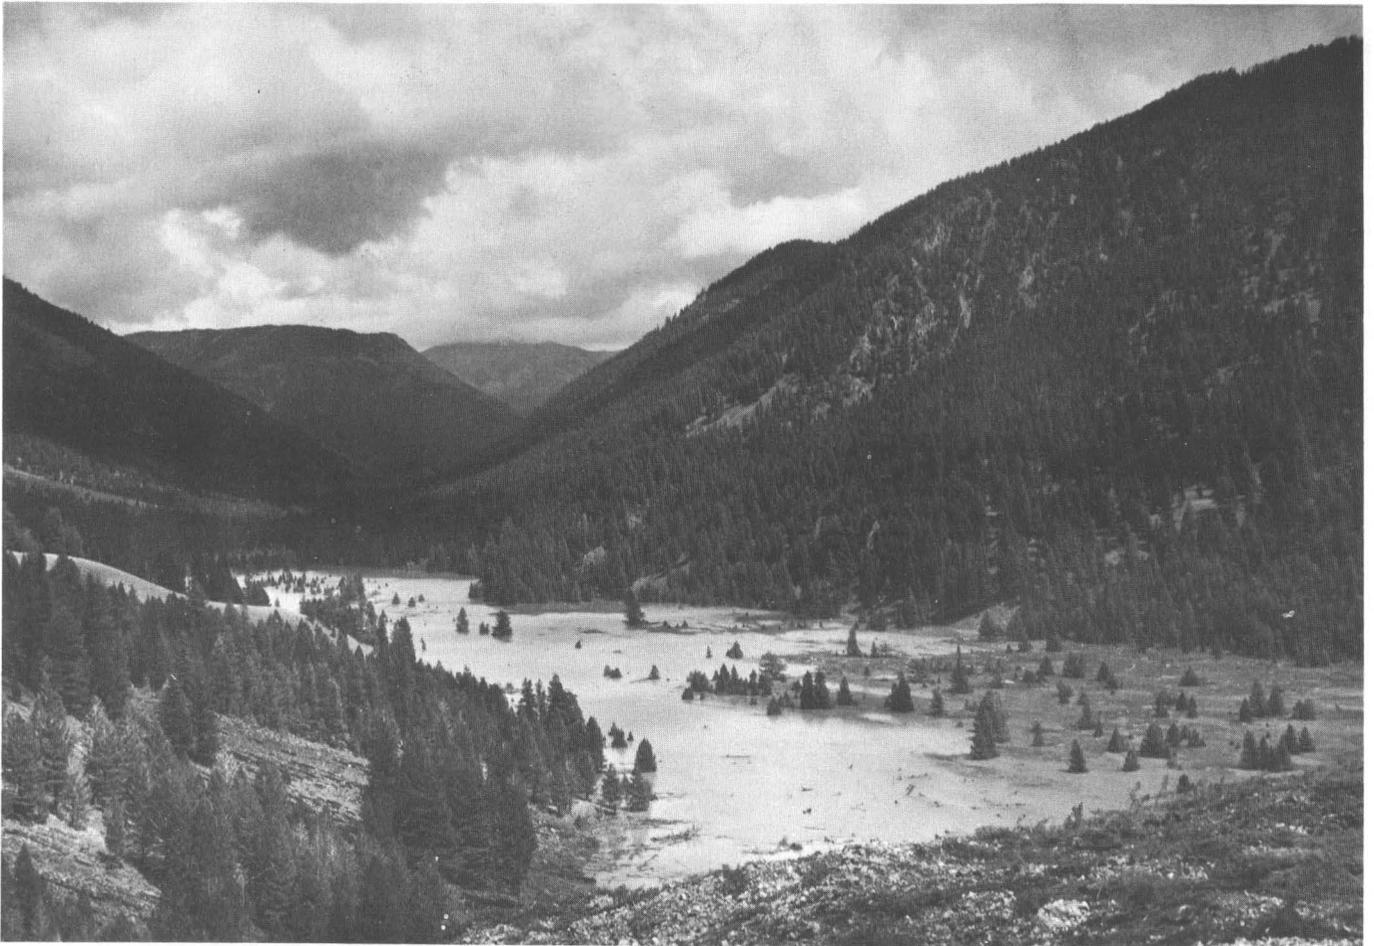
FIGURE 64.—Earthquake Lake seen from the upstream edge of the slide on August 20. Nearer trees in the water are in Rock Creek campground, submerged 20 to 40 feet.

of the Madison River formed a new lake that eventually reached the crest of the slide mass and extended upstream 6 miles, or almost to Hebgen Dam (frontispiece, fig. 64, and pl. 2). The level of the new lake rose very rapidly at first because of the small area of the new lake and the arrival of water from the first 3 or 4 surges in Hebgen Lake. By 6:30 on the morning after the earthquake, the water had risen 20 feet or more and had covered all the vehicles in Rock
