The Hebgen Lake, Montana Earthquake of August 17, 1959

GEOLOGICAL SURVEY PROFESSIONAL PAPER 435

STRUCTURAL DAMAGE IN THE HEBGEN LAKE-WEST YELLOWSTONE AREA

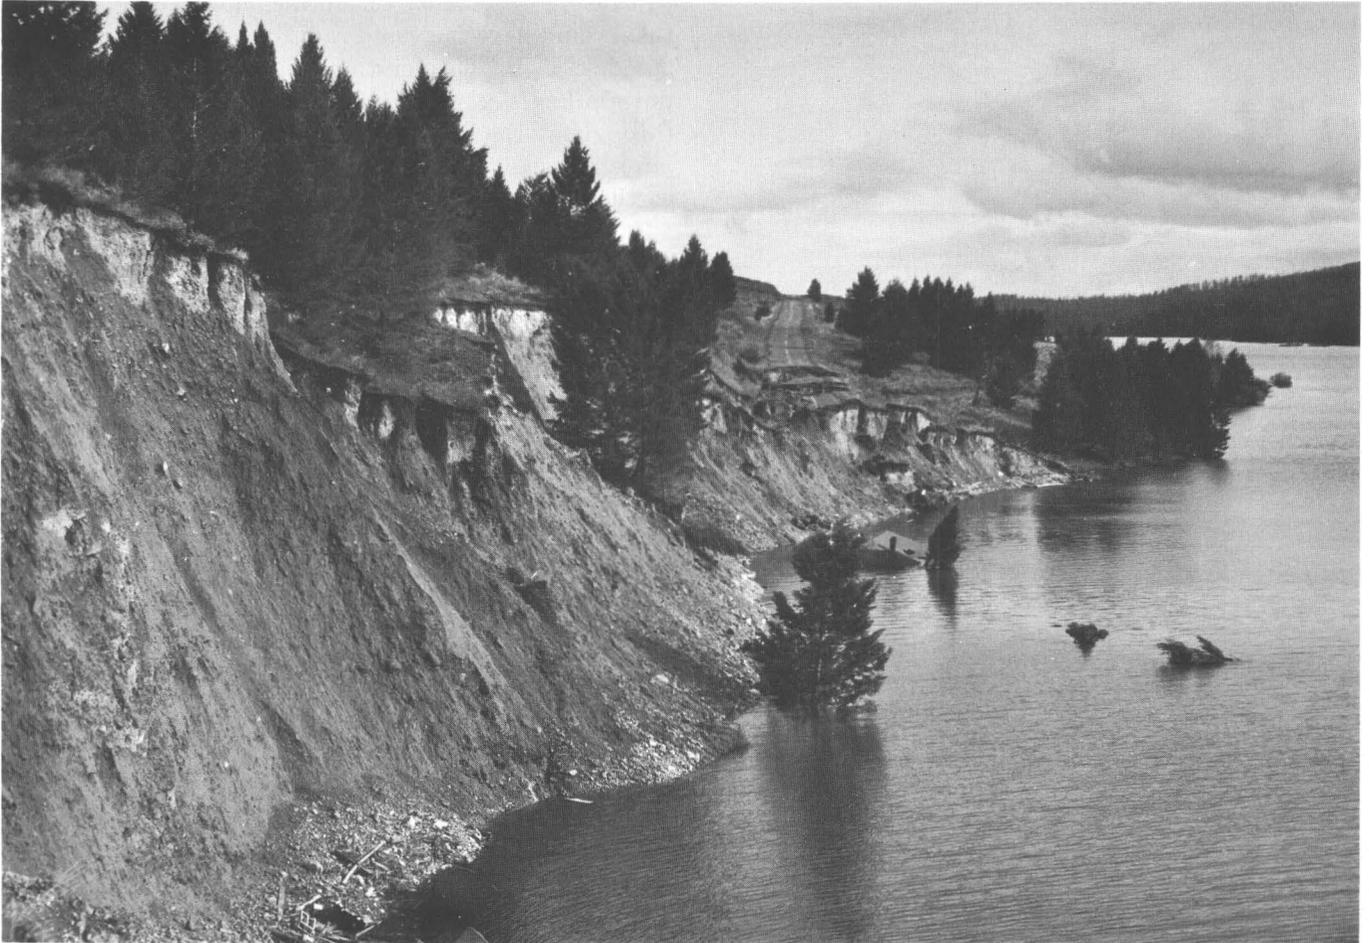
FIGURE 66.—Earthquake-induced landslide on the northeast shore of Hebgen Lake 0.6 mile from Hebgen Dam. Depth of water below the cut is indicated by the floating bungalow in the middle distance. Beyond is the tectonically submerged shore near Hilgard Lodge.

The concentration of landslides in this area is probably due to their proximity to the reactivated Hebgen fault and to the locus of maximum subsidence along the northeast shore of the lake. The slides occurred only in colluvial material on slopes steeper than 10° which extended below water level. Slopes as steep or steeper that were distant from the lake did not slide in spite of the fact that some of them were very close to the Hebgen fault. On the other hand, bottom soundings of the lower end of the lake, described by W. H. Jackson (chapter H), show accumulations of slide material as much as 20 feet thick in the submerged river channel 500 feet from the shore. This suggests that the presence of saturated material in the lower parts of these slopes was a major factor in their instability.

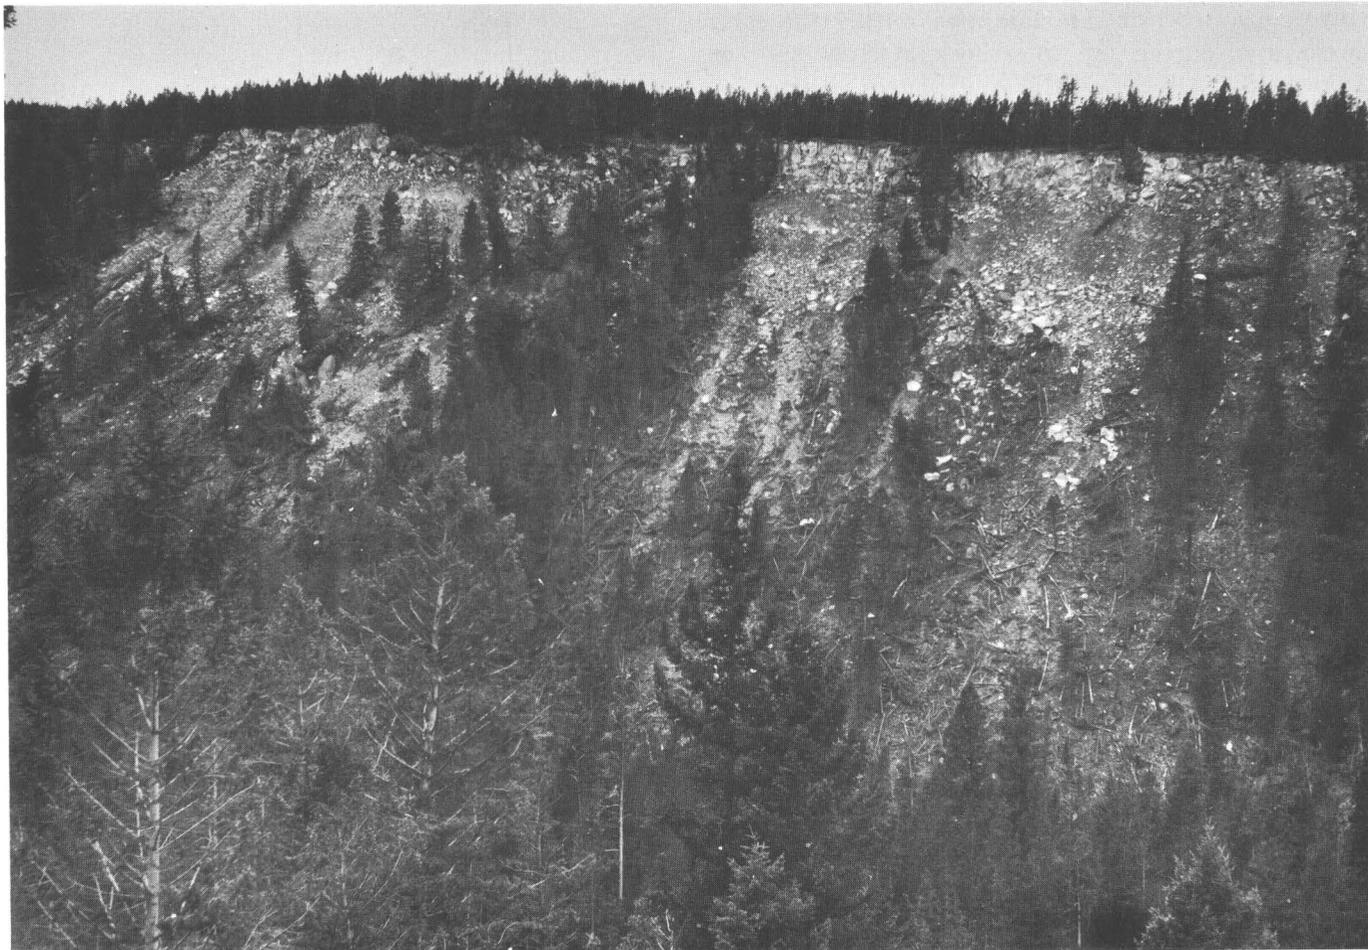
FIGURE 67.—Rhyolite cliffs, half a mile southwest of Wade Lake, from which blocks fell in large numbers, smashing trees on the slope beneath.

thick capped by well-consolidated rhyolite tuff 40 to 60 feet thick. This tuff, with a specific gravity considerably less than most rock, is broken by widely spaced joints into blocks several feet to 20 feet on a side and weathered to loosely held residual boulders on the cliff faces. These blocks fell in large numbers during the earthquake, smashing large trees on the slopes below and coming to rest in some places amid great piles of similar blocks which had preceded them in past centuries (fig. 67). At the north end of Cliff Lake, several blocks fell on a small campground; one, landing squarely on a tent with two occupants, accounted for the only fatalities other than those in the Madison slide.

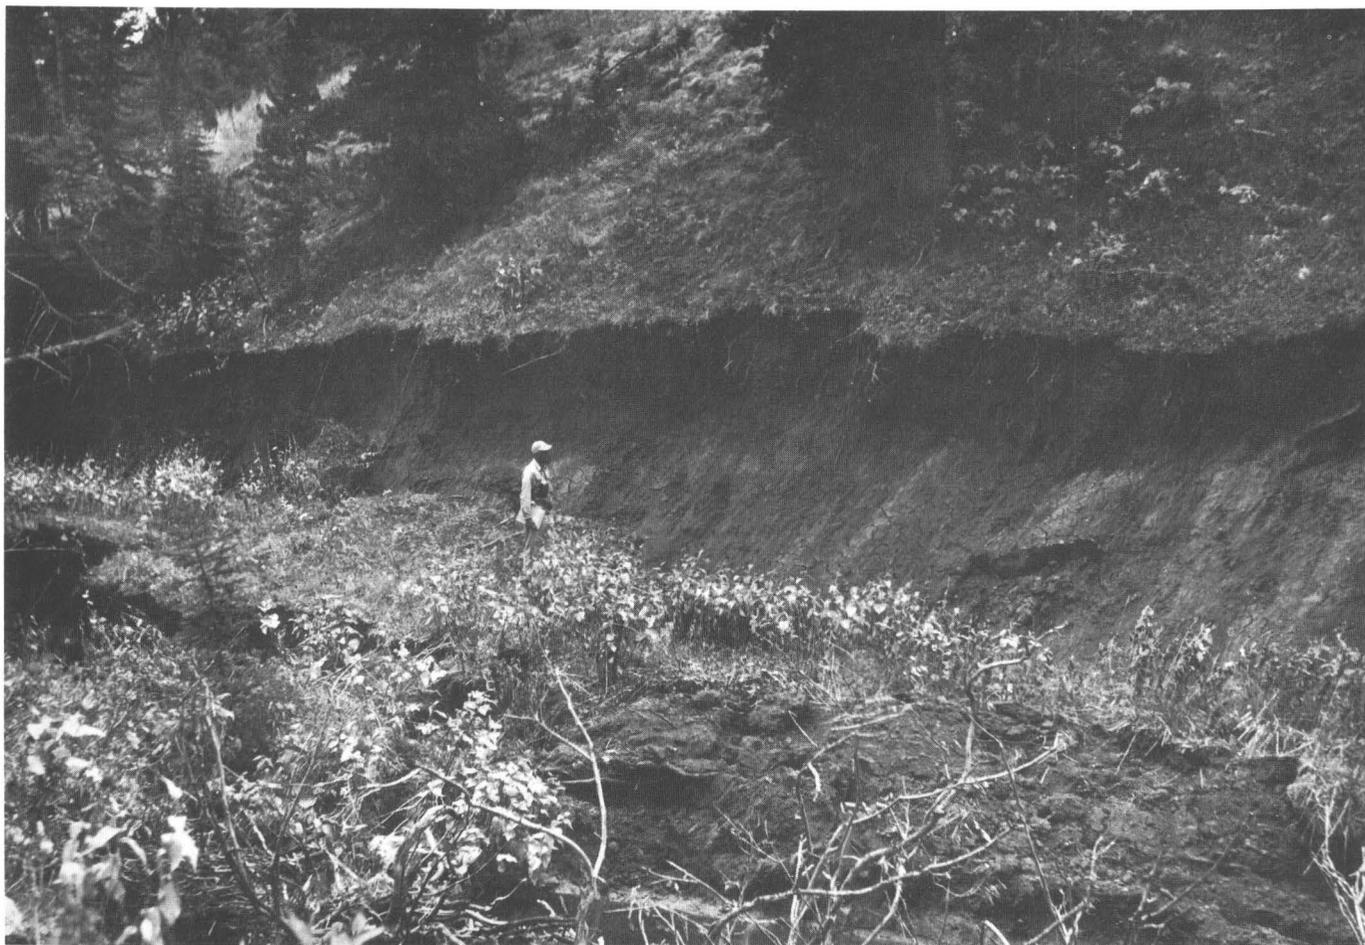
FIGURE 69.—Depressed margin at southwest side of the Kirkwood earthflow 700 feet from its head. The ground surface subsided 10 to 15 feet. Faint grooves on scarp plunge 10° SE (toward left).

surfaces that dip steeply under the flow and are seen as scarps 1 foot to 15 feet high (fig. 69). The scarps are commonly marked by grooves plunging 10° to 15° in the direction of flow and the surface of the flow is locally tilted or stepfaulted downward toward the scarps. The shear-scarp boundary along the southwest side of the flow is remarkably straight and continuous for a quarter of a mile, apparently guided by the steeply dipping beds in the adjacent valley wall.

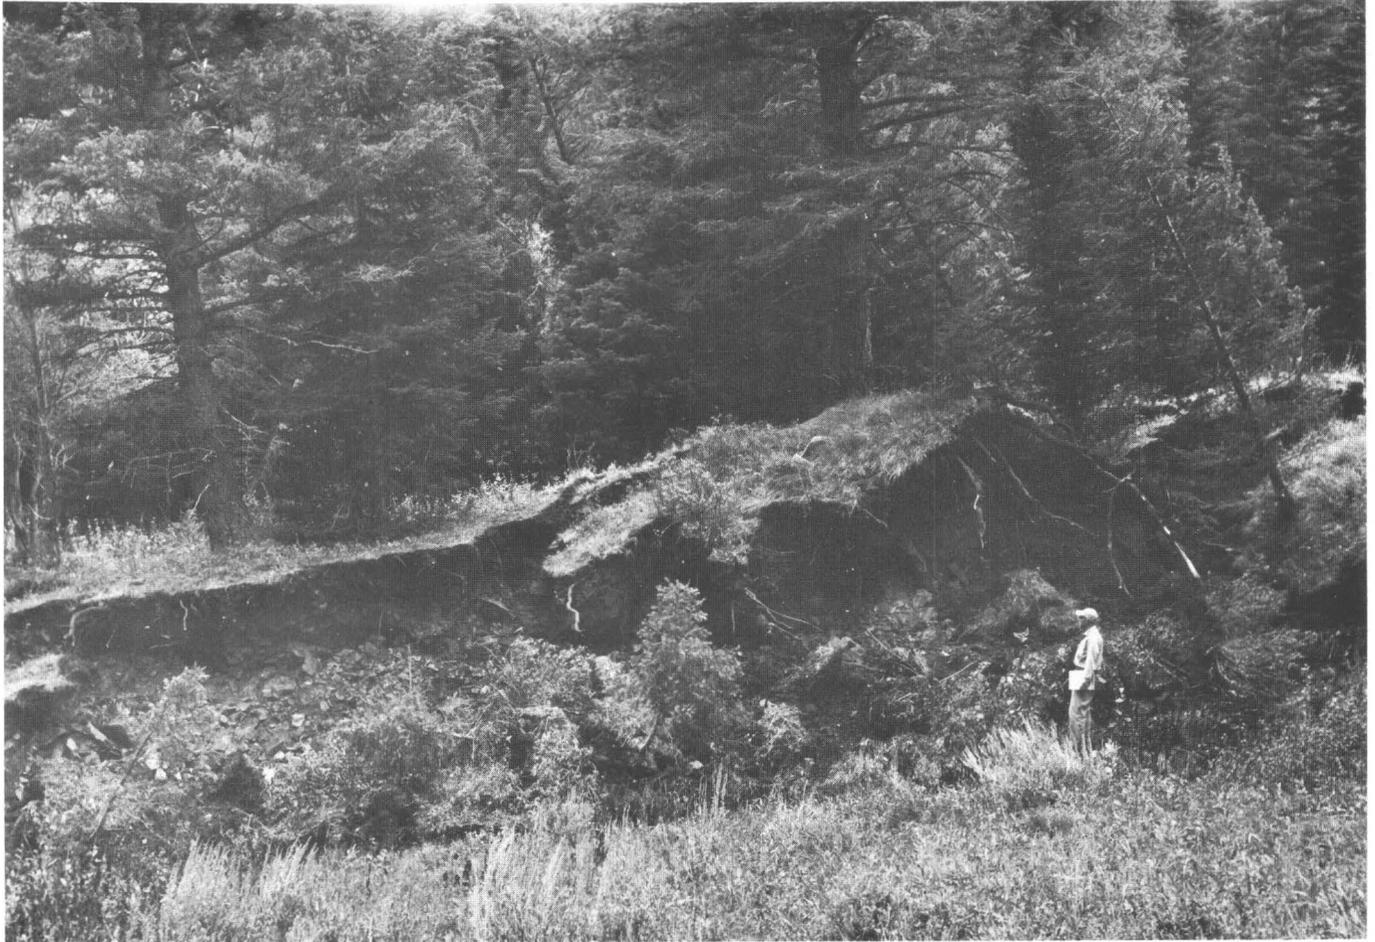
FIGURE 70.—Elevated margin of the Kirkwood earthflow about midway on the northeast side raised 15 feet. Man is standing on a trail whose continuation on the flow is displaced 100 feet to the left.

The margin for 1,000 feet along the northeast side and for a shorter distance along the southwest side of the flow is an elevated boundary along which the flow surface is raised as much as 18 feet above the adjacent ground (fig. 70). Such a margin developed in part where the ground surface at the edge of the flow was locally steeper than the overall gradient so that higher ground on the flow has been brought against lower ground at its margin. In part it also represents thickening and swelling of the flow mass.

That the middle part of the flow moved at least 100 feet was determined in three separate places. A trail crossing the elevated east margin 1,000 feet from the toe (fig. 70) was displaced at least 60 feet and probably nearly 100 feet, although the displaced part was partly obscured by slumping along the margin of the flow. A tree standing on the edge of the western marginal scarp at the northwest end of the pressure ridge lost branches, apparently broken off by a passing tree on the moving margin of the flow. The closest tree that would have been able to do this is 90 feet farther down the flow, indicating a movement of more than 90 feet at this point (fig. 71). Finally, a dry pond that was undisturbed when aerial photographs were taken of the earthflow area on August 22 had moved 100 to 125 feet relative to objects outside the flow by the time we visited the area (fig. 68).

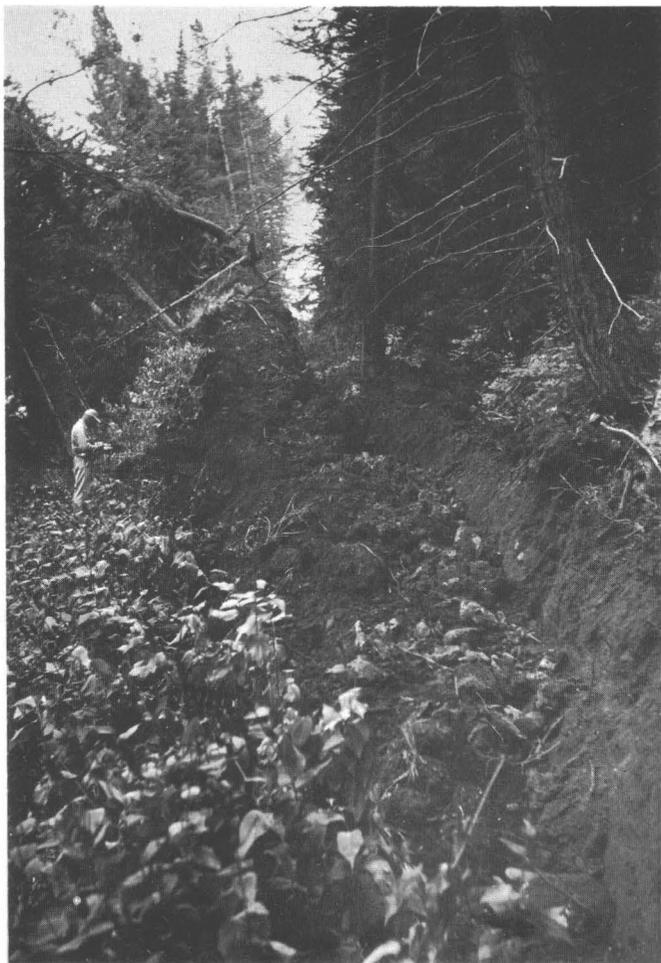
FIGURE 71.—Marginal pressure ridge at southwest side of Kirkwood earthflow 1,500 feet from its head. View is southeast along the boundary shear scarp at the northwest end of the ridge. Toppled tree at crest of ridge moved there from a point behind the camera, breaking branches from trees at the west side of the scarp before it fell.

A most remarkable boundary developed for 350 feet along the southwest edge of the flow where it impinged against the steep side of the valley (fig. 71). Here the flow encountered rising ground instead of level or falling ground and produced a pressure ridge along which the edge of the flow was raised 20 feet, tilting the forested surface from a 30° to a 75° slope and the trees on it to angles of 45° . The boundary shear surface of the flow was turned like a plowed furrow from its normal slope of 65° inward to 70° outward (fig. 72). Grooves on this surface plunge 5° to 10° backward toward the head of the flow and graphically record the raising of the ridge.

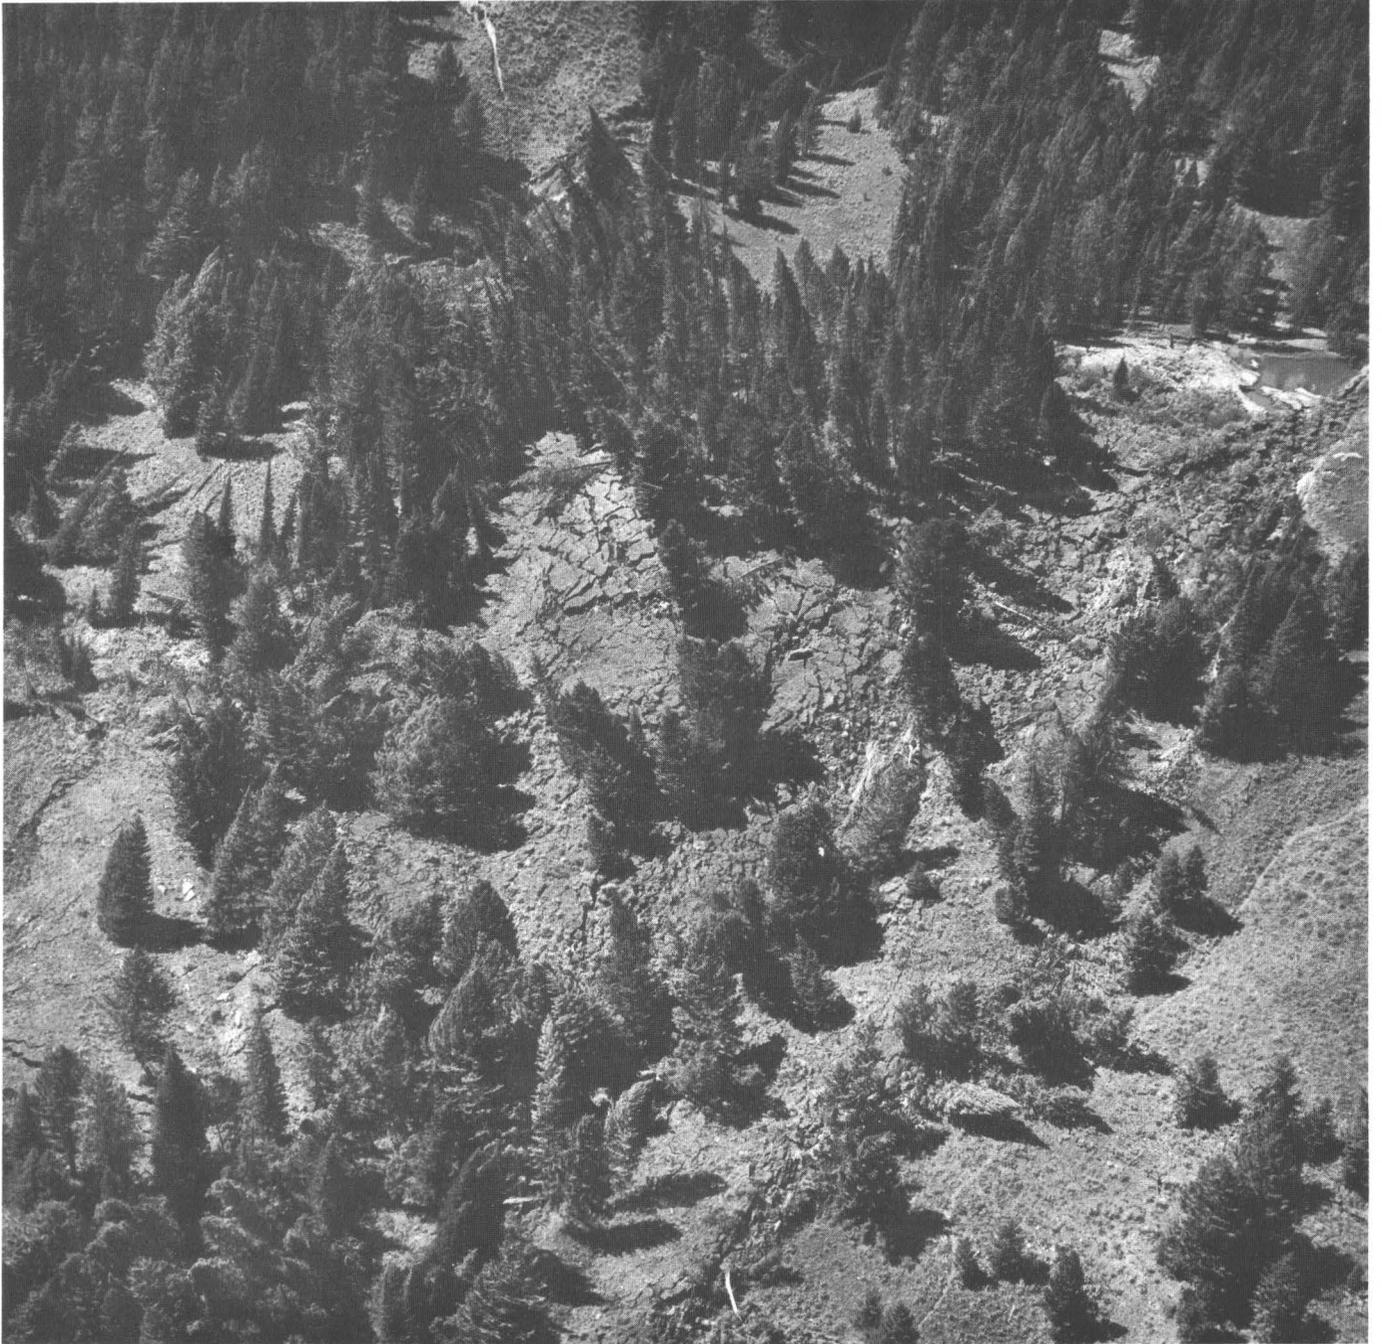
FIGURE 73.—Aerial view of the midsection of the Kirkwood earthflow where it went over a bedrock terrace. The elevated east margin is at lower center; crevassed ground and tilted trees are in center; and the depressed west margin is in the upper part of the picture. The new fault scarp appears at the top, and a nearly drained sag pond can be seen at the upper right. Photographed September 3. More trees were tilted and the sag pond had moved considerably by September 18. Photograph by John R. Stacy.

quent movement of the flow. Many transverse crevasses, similar to those in icefalls on glaciers, developed where the moving earth went over the edge of the terrace and low transverse pressure ridges formed just below them (fig. 73). An acre of large trees were uniformly tilted forward as they went over the edge of the terrace, and trees that formerly grew on the terrace face were tilted backward as they reached the level ground below (fig. 73).

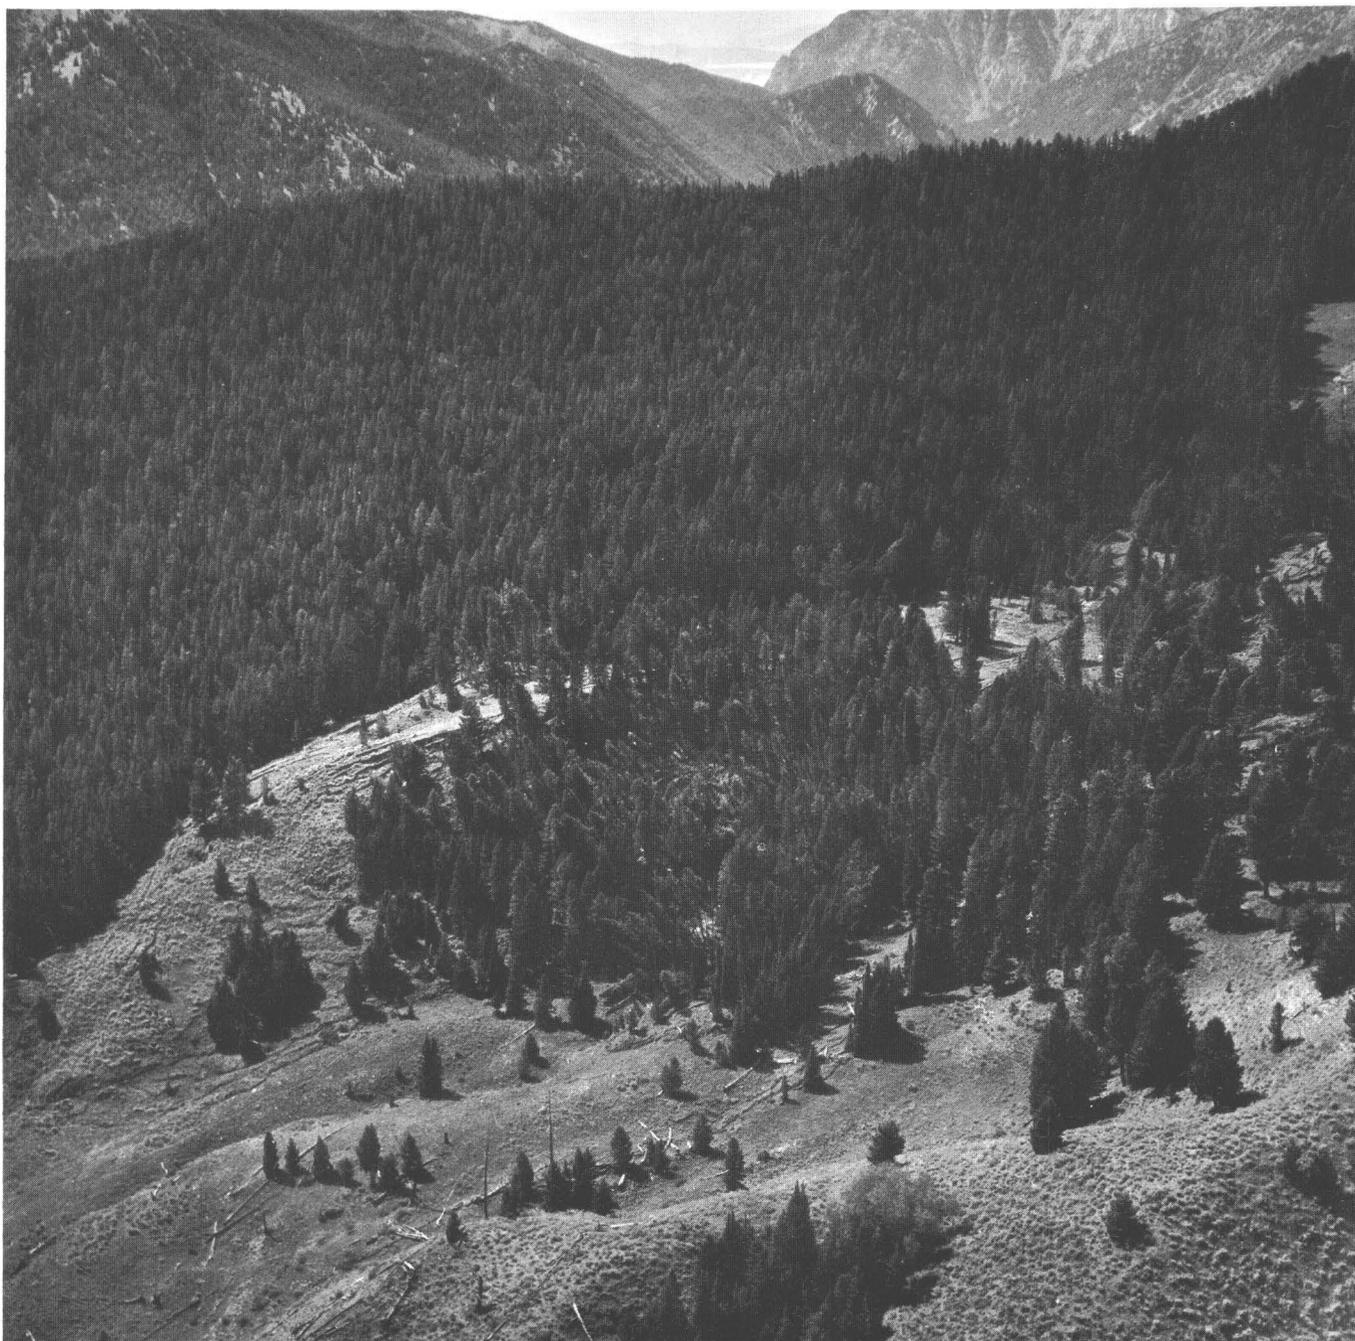
FIGURE 74.—Aerial view taken September 3 of the lower part of the flow as seen from the east. The high front of the flow is the partly wooded ridge in left center marked by crevasses and twisted trees. Many low pressure ridges are visible in the treeless area at left. Area at extreme right also shows in figure 73. Photograph by John R. Stacy.

The lower end of the flow is a bulbous ridge with a steep front 250 feet high marked by many large crevasses in its upper part and by pressure ridges and small underthrusts lower down along the toe of the flow. Many trees were uprooted and overturned in an area of deep crevassing on the east side of this ridge, and their roots were still parting with explosive sounds at intervals of half an hour or so while we were studying the flow (fig. 74). Trees along the toe toppled forward as the ground rose, but no large-scale overriding was evident.

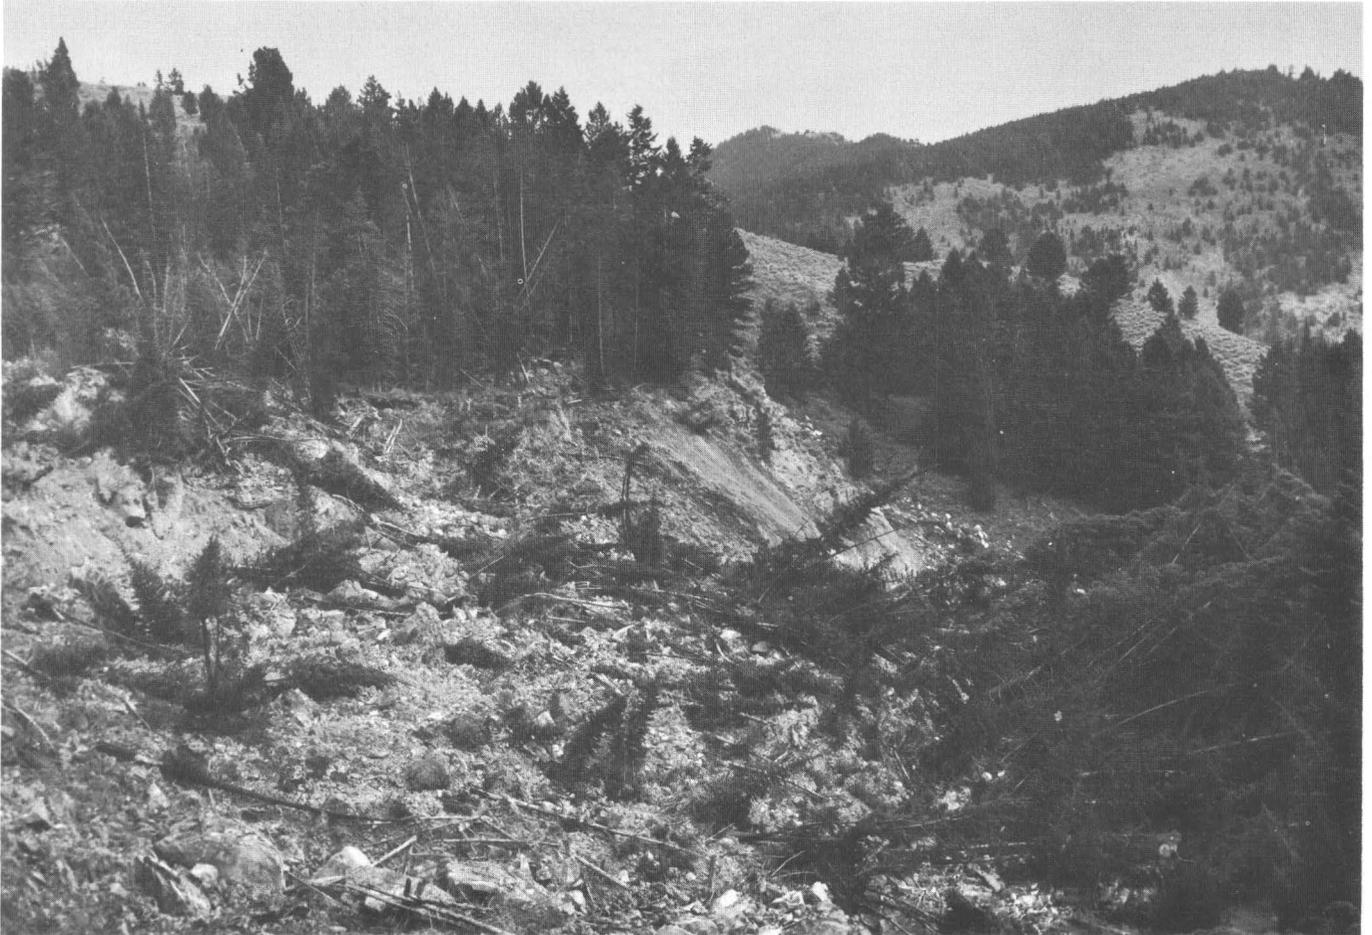
FIGURE 75.—Scarp area at the head of the Kirkwood earthflow. Shows maximum distension of the surface, toppled trees, soil destroyed, and much subsoil. View eastward from the west edge of the flow.

subsidence and horizontal displacement (fig. 75). Most of the bulk motion was apparently absorbed in raising and thickening the front of the flow and in forming the pressure ridges and underthrusts which are abundant along the toe. The toe itself did not override the ground in front of the flow to any great extent.

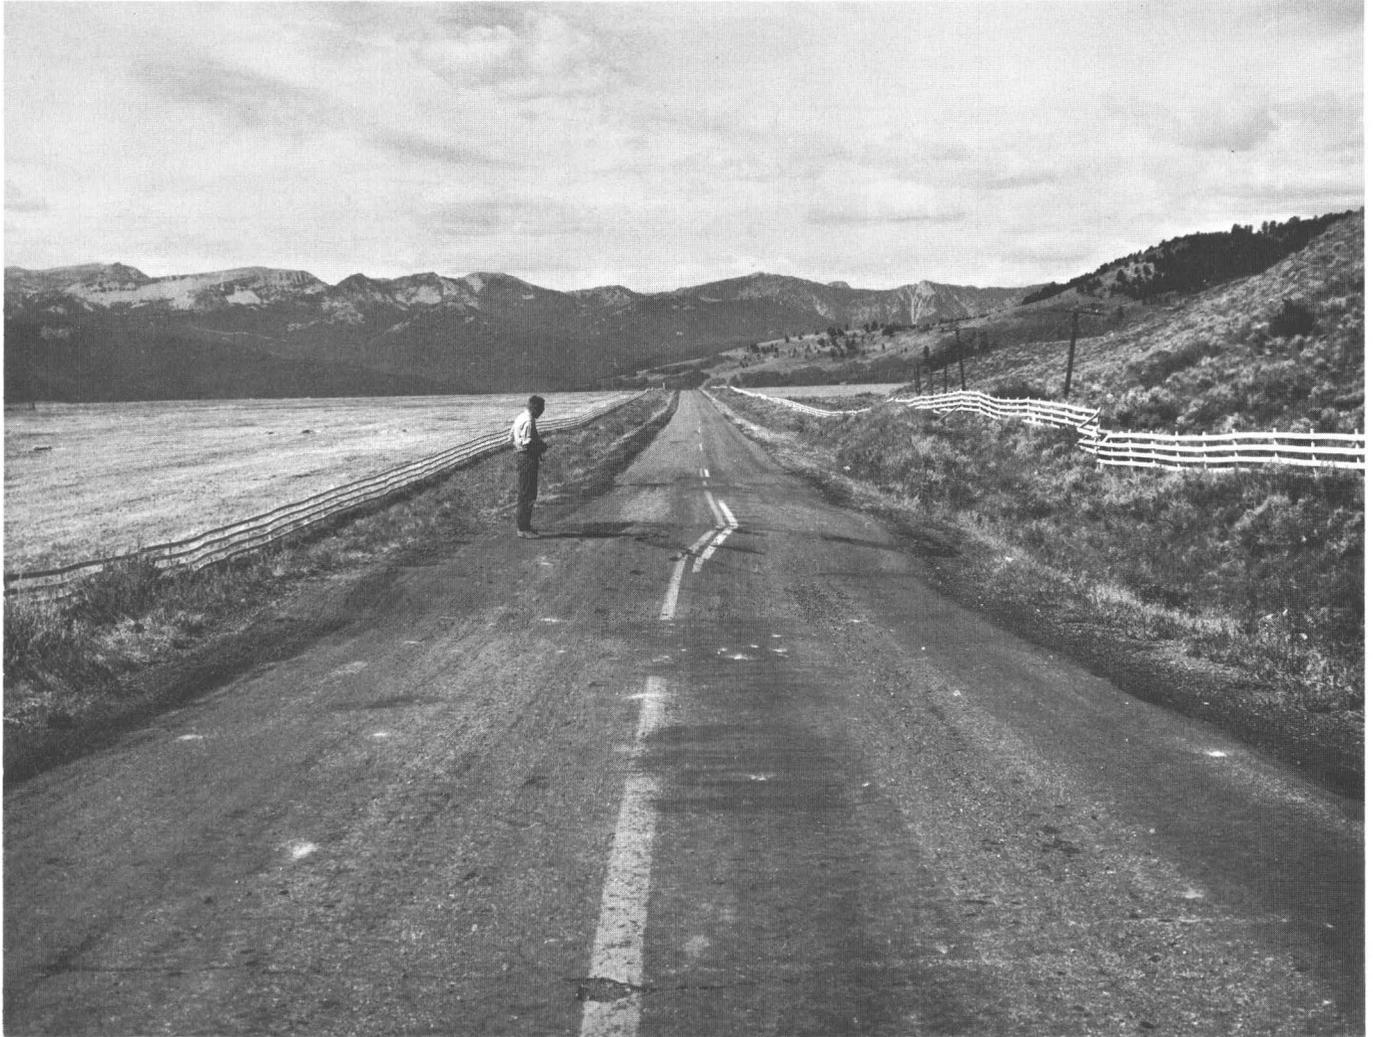
FIGURE 77.—Displaced pavement and fences along State Route 499 near Corey Spring. View west. Man is standing on crest of fold in pavement. Photograph by John R. Stacy.

Slump of an adjacent hillside caused a segment of Highway 499 to buckle and break in the E $\frac{1}{2}$ sec. 12, T. 12 S., R. 4 E. (fig. 77). About 1 $\frac{1}{2}$ miles to the southeast (NW $\frac{1}{4}$ sec. 17, T. 12 S., R. 5 E.), slight southward movement of a huge ancient earthflow bowed the centerline of Highway 499 as much as 2 feet out of line.

The highway was bent and offset by the fault as it went beneath the asphalt, but the road surface was not broken. The center line was displaced $3\frac{1}{2}$ feet, and a double bend was formed in 30 feet of road length (fig. 77).

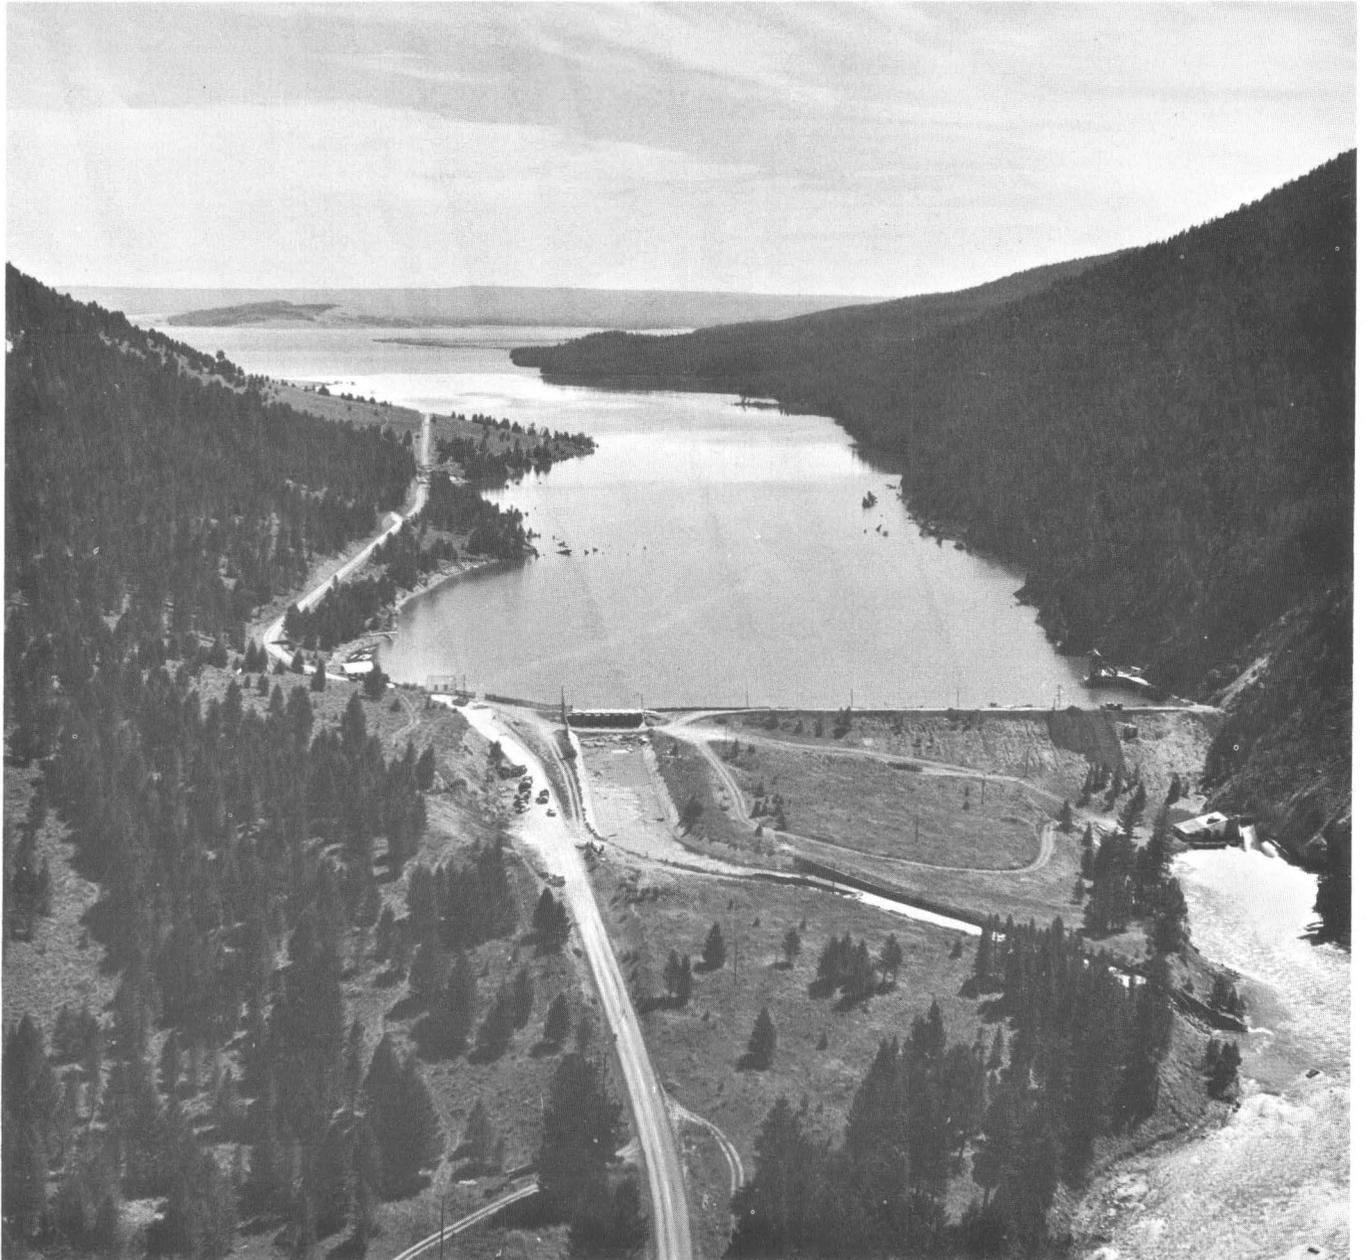
FIGURE 79.—Hebgen Dam, view upstream from a point 0.3 mile northwest of the dam. Repair is underway, but the exposed east end of the core wall, the damaged spillway, and the eroded downstream face can still be seen. The lake shore, except near the dam, is submerged, and trees have been carried into the water by landslides. Photograph by John R. Stacy.

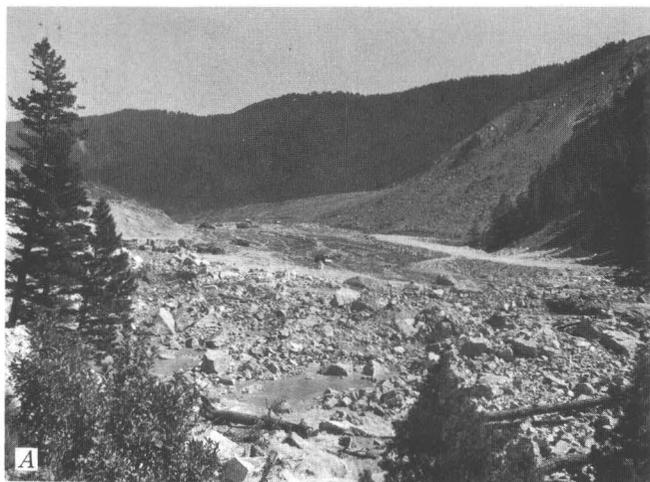
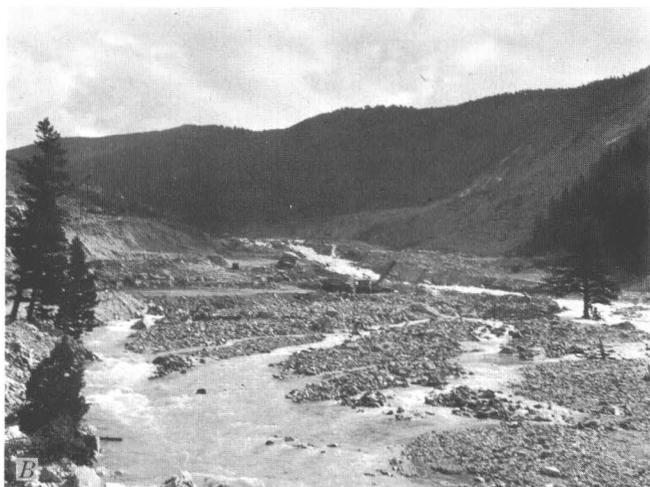
FIGURE 91.—Madison River, view upstream from the site of gage 1 to the landslide. *A*, September 10, 1959; *B*, September 14, 1959.

The movement of bed material continued (figs. 91, 92, 93), and by October 3 it was necessary to abandon gage 2. Sections of the channel at gage 1 on September 10 and 13 and at gage 2 on September 16 and October 3 are shown in figure 89. Profiles of the channel between the toe of the slide and gage 2 are shown in figure 90.

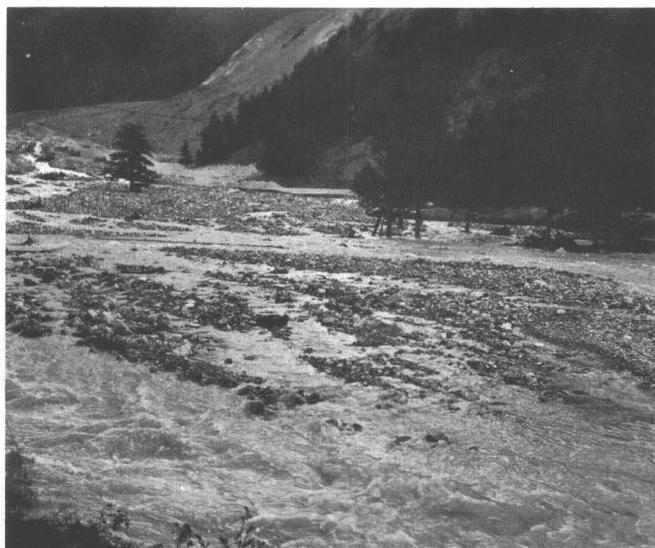
FIGURE 92.—The Madison River at the site of gage 1, September 14, 1959.

Aggradation in the channel at gage 1 averaged about $5\frac{1}{2}$ feet in depth by September 13, and, as the stage-discharge relation was changing so rapidly, it became necessary to abandon the station. By October 21 the channel at gage 1 had aggraded to an average depth of about 30 feet.

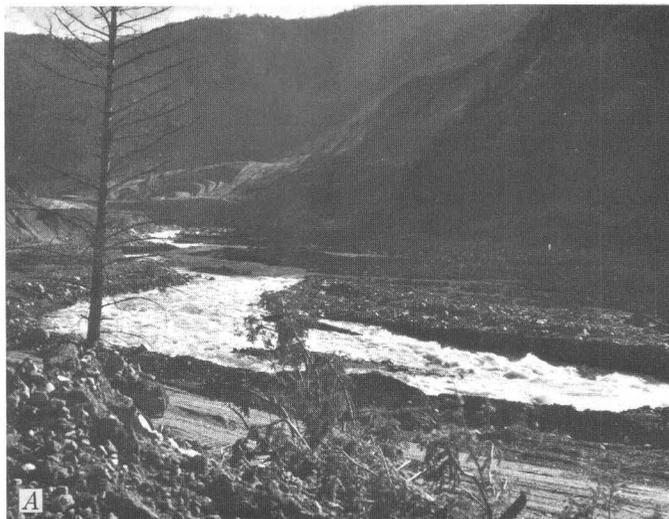
FIGURE 93.—Madison River below the landslide, October 28, 1959. The outlet channel across the slide dam at this time had been lowered about 50 feet from its original position, thus draining part of Earthquake Lake. A, View upstream from site of gage 1; B, view downstream from gage 2 showing erosion of bank and highway.

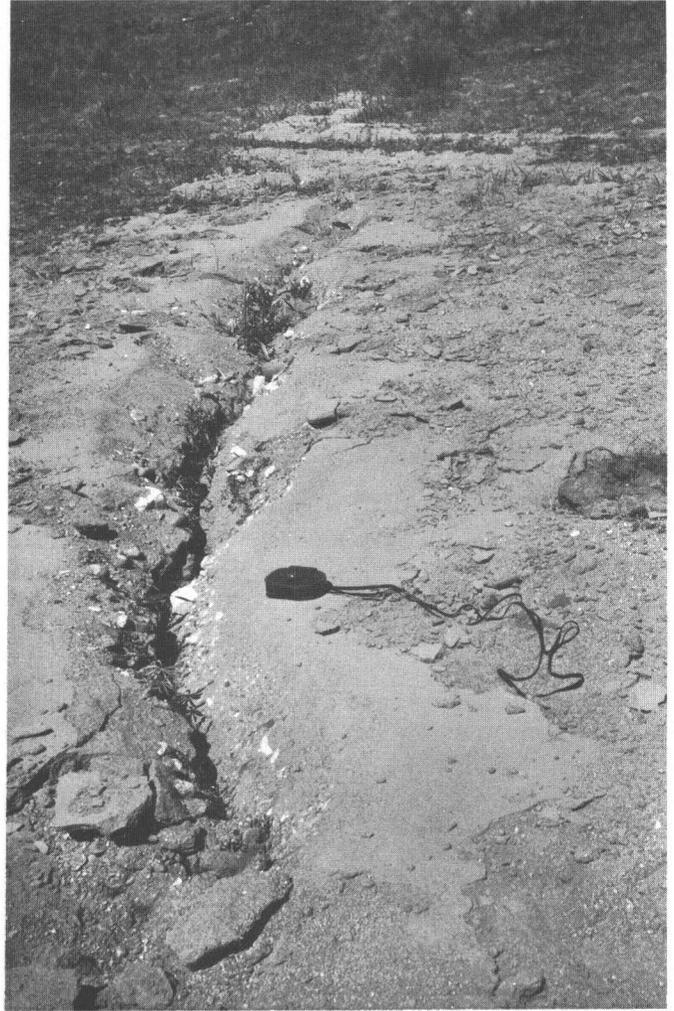
FIGURE 94.—Open cracks with ridges, about 6 inches high, of erupted fine-grained sand. The case is about 4 inches long.

Sand and water were ejected along the entire length of cracks in some areas (fig. 94), whereas discrete craters were formed along the cracks in other areas. There seems to be no pattern of distribution or alignment of the earth cracks in the Beaver Creek area.

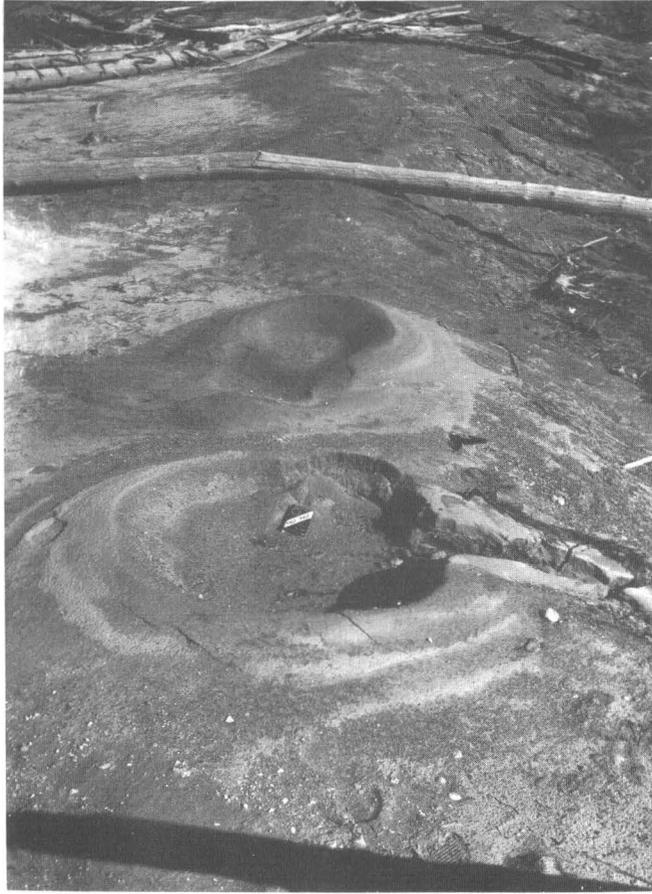
FIGURE 96.—Row of sand spouts with two principal craters on emergent floor of Hebgen Lake. The row of sand spouts is on trace of fault with downdropped block to the right. The fault displacement of about 2 feet is masked by the movement of saturated silt with the recession of the lake water. The craters were formed after the shore emerged and thus were not destroyed by lake waves. Tobacco can gives scale.

Two symmetrical sand spouts (fig. 96) were ob-

served on the emergent south shore of the Madison Arm of Hebgen Lake near the middle of sec. 6, T. 13 S., R. 5 E. They are the only ones that were found on a fault trace; all the others observed were on earth cracks having no discernible displacement. The ejected material consists of lake silt and fine-grained sand. The fact that these cones show no signs of wave erosion indicates that they were built after the Hebgen Lake shoreline emerged.

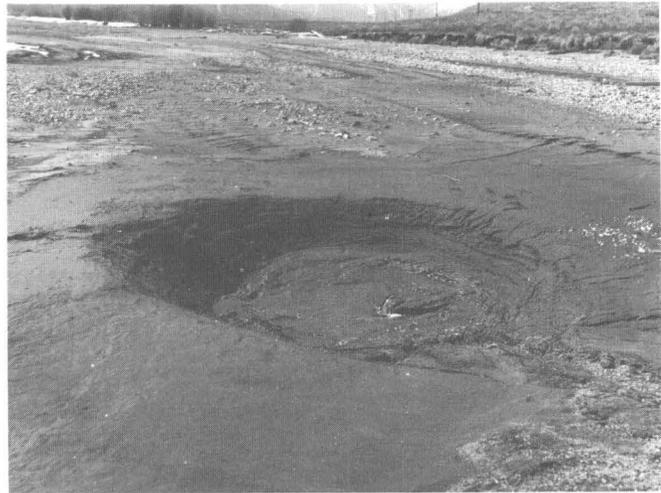
FIGURE 98.—Sublake sand-spout sinkhole on floor of Hebgen Lake in SW $\frac{1}{4}$ sec. 4, T. 12 S., R. 4 E. A shallow cone of erupted sediments can be seen around the crater. This feature is about 1,000 feet southeast of the sinkhole shown in figure 97. Crater is 10 feet in diameter and 3 feet deep.

On the strike of the large sinkhole, described above, and about 1,000 feet southeast of it, a large sand-spout sinkhole was visible (fig. 98). This feature was 10 feet in diameter and 3 feet deep with a broad shallow cone of erupted sediments. The flow of a small intermittent stream had discharged into the crater and eroded the cone of fine sediments to the gravelly lake bottom, but there was no visible evidence of surface flow from the crater. This sandspout sinkhole was formed under the lake and was exposed only when Hebgen Lake was lowered.

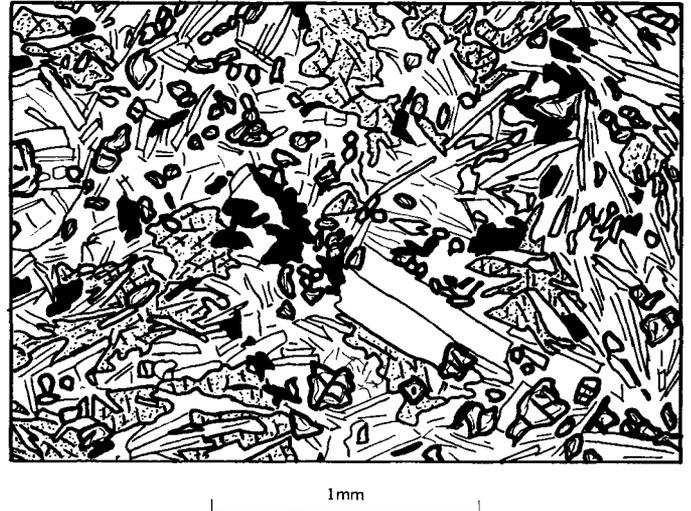
FIGURE 105.—Photomicrograph of olivine basalt. Laths and phenocrysts of labradorite are partly enclosed in subophitic plates of augite (stippled) and interstitial magnetite and ilmenite; granules of magnesian olivine, altered marginally to iddingsite, are strewn about the section. Northwest side of hill 6777, 3.5 miles west-northwest of West Yellowstone.

The only specimen of basalt from the Madison Range that was studied petrographically came from hill 6777. This is a light-gray rock; like many of the olivine basalts of the Yellowstone region, it is deceptively light colored because of its abundant near-white plagioclase. It has a diabasic texture, with big (0.5 mm) laths of labradorite, plates of augite, and granules of olivine ($-2V \approx 85^\circ$) that have been altered to iddingsite along cracks (fig. 105).

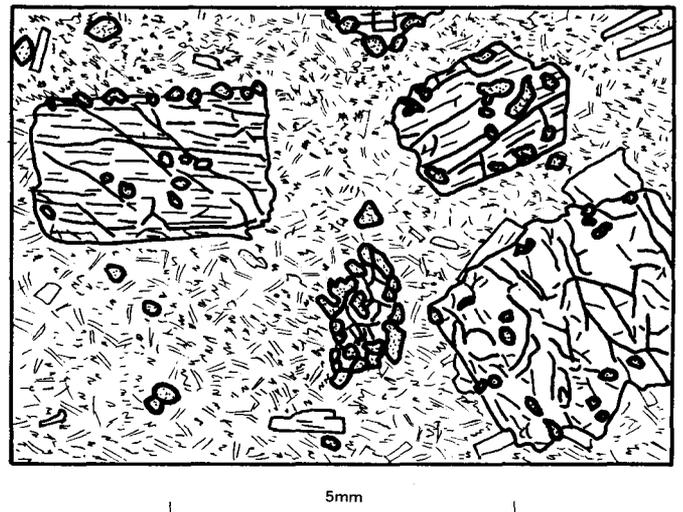
FIGURE 106.—Photomicrograph of olivine-augite andesite. Large phenocrysts of augite, enclosing, and partly rimmed by, granules of olivine (stippled; completely altered to iddingsite), lie in a fine-grained matrix of andesine laths, augite granules, clay, and magnetite. Northeast of peak 7307, 3 miles west-southwest of West Yellowstone.

grayish-red rock studded by very conspicuous stubby euhedral prisms 2 to 7 mm long of black augite, in which are enclosed granules of red iddingsite (fig. 106). There are fewer phenocrysts of normally zoned labradorite and numerous pseudomorphs of red iddingsite after small phenocrysts and granules of olivine. Much of the olivine is enclosed in, or is at the rim of, augite phenocrysts. The dark-red groundmass consists of andesine laths, augite granules, iddingsite granules, magnetite, and interstitial clay(?). Hamil-

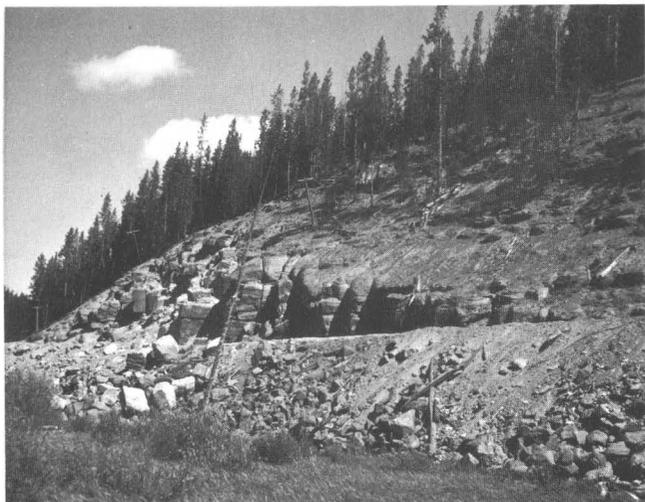
FIGURE 109.—Welded rhyolite tuff. The squashed-shard bedding in this thick unit is nearly horizontal. Railroad cut, 3 miles southwest of West Yellowstone.

ably represents only a single eruption. It is exposed almost continuously in river, road, and railway cuts for 6 miles along the river and dips mostly less than 2° , everywhere less than 5° (fig. 109). Most of the tuff is streaky slabby-weathering rock; less is massive. The rock is light gray with a purplish cast, and the streaks are nearly white where fresh, yellow where weathered. The matrix is of squashed and welded shards that have been thoroughly devitrified to hazes of fine quartz and feldspar and opaque dust. Phenocrysts are clear sanidine and subordinate oligoclase (An_{20}). Tiny fragments of clinopyroxene and red-altered olivine(?) are rare. Biotite and hornblende are lacking.
