The Hebgen Lake, Montana Earthquake of August 17, 1959

GEOLOGICAL SURVEY PROFESSIONAL PAPER 435

STRUCTURAL DAMAGE IN THE HEBGEN LAKE-WEST YELLOWSTONE AREA

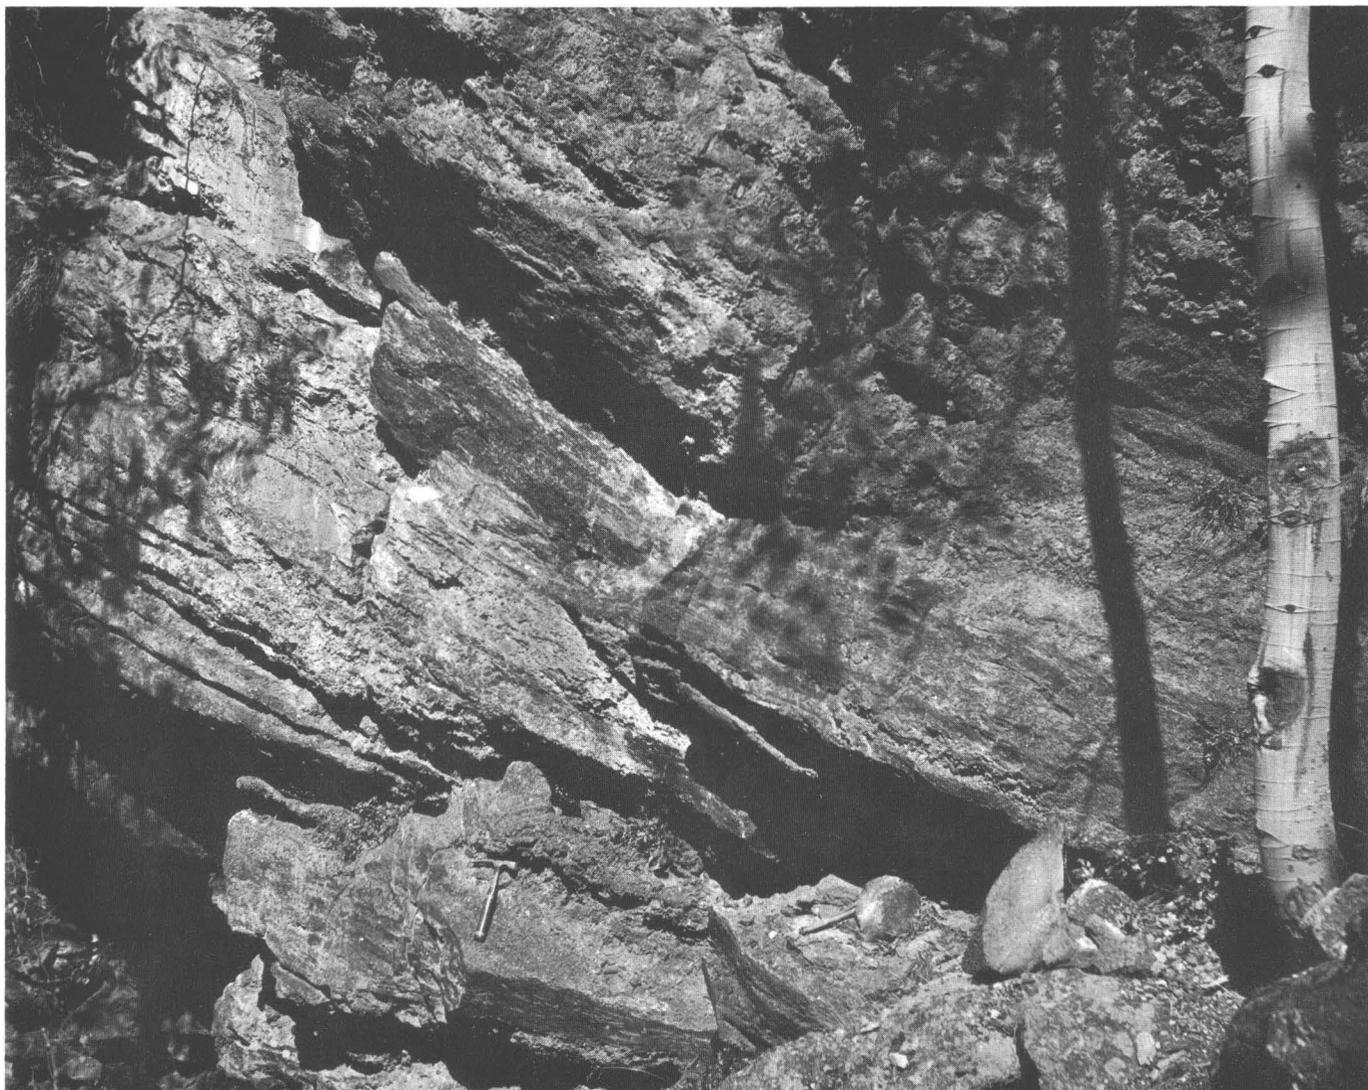
FIGURE 112.—Flow-layered spherulitic obsidian, part of a single huge block within the upper, agglomeratic part of a rhyolite flow. Layers vary from pure glass to nearly pure spherulites and dip back into the flow at this locality near the flow front. Five miles southwest of West Yellowstone.

brown, and, most commonly, pink, and 1 mm to 3 cm in diameter. They are generally clustered in layers parallel to the flow structures, and many blocks are composed of alternate spherulite and obsidian. Flow structures are widespread, but they are restricted to individual blocks and are chaotically oriented (fig. 112). Blocks of pumice, scoriaceous glass, brown obsidian, and light-gray lithoidal rhyolite are greatly subordinate to black obsidian.

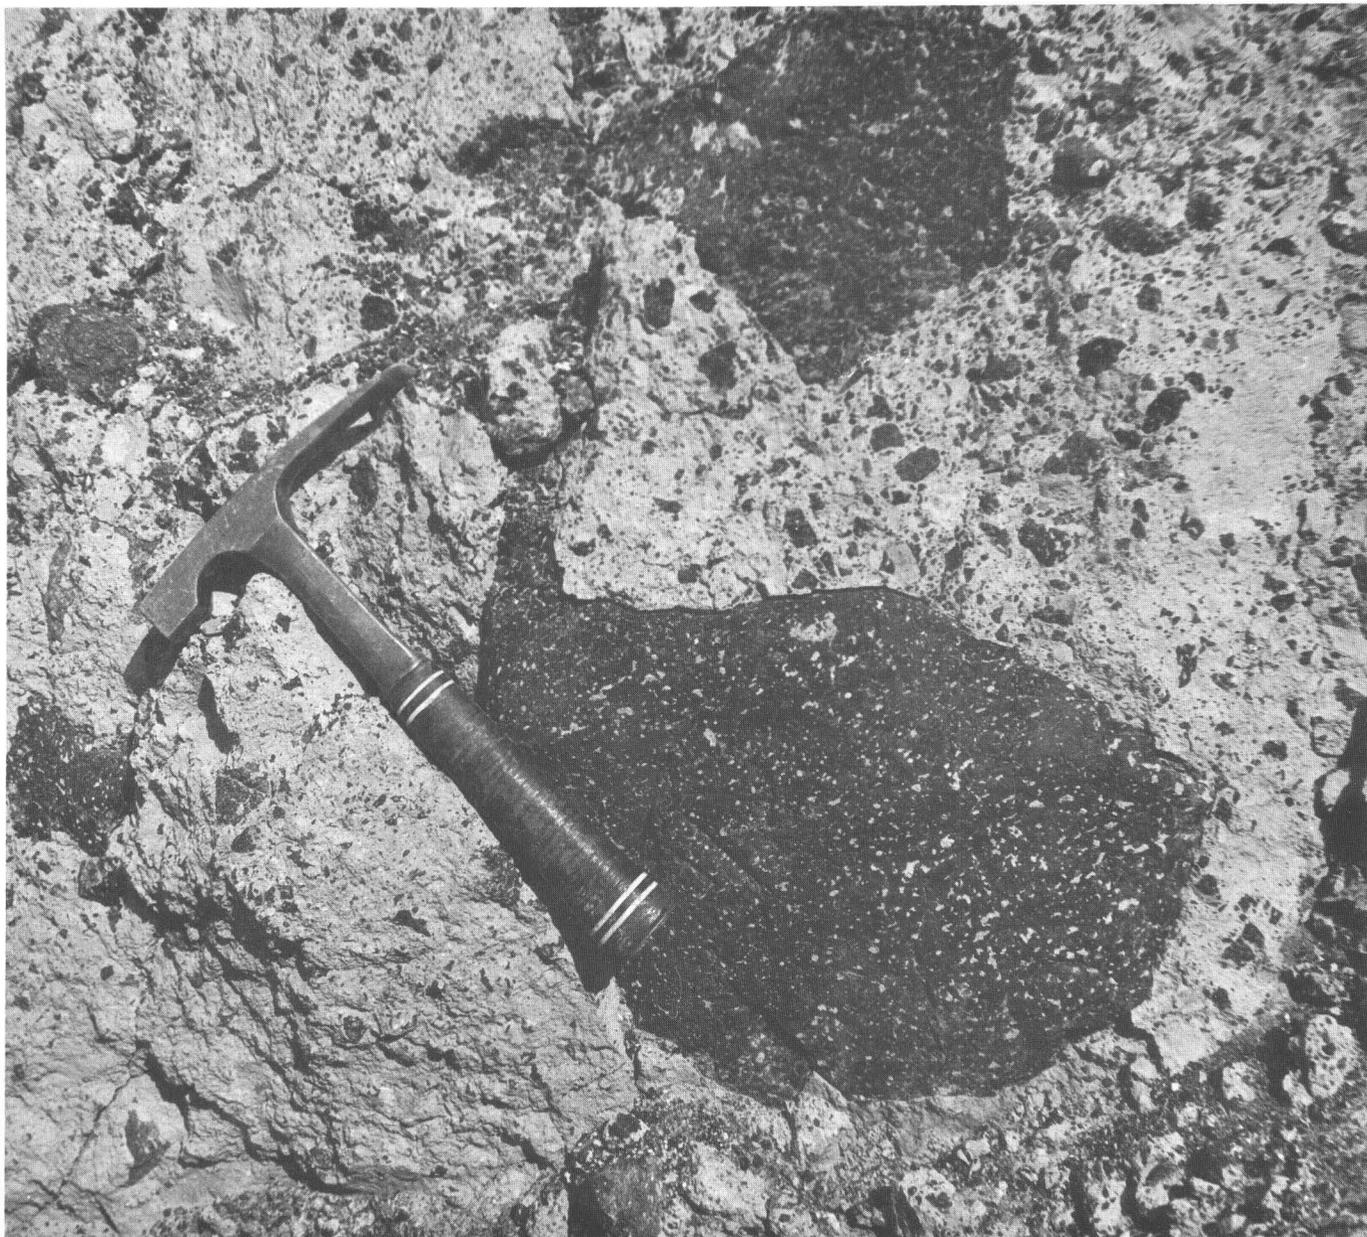
FIGURE 113.—Obsidian agglomerate at top of rhyolite flow. Blocks of porphyritic black obsidian are enclosed in cementlike welded shards. Near flow front, 5 miles southwest of West Yellowstone.

The matrix of the agglomerate is composed of shards, short fibers, and sandlike grains of clear glass that are rather evenly sized 0.02 to 0.2 mm and un-squashed and unconsolidated but generally cohesive where freshly excavated. Larger grains are ropy and pumiceous. Most is colorless, but some is very light gray or light yellowish gray. Small granules of black obsidian are mixed with the glass. Harder matrix, superficially resembling colored concrete, is uncommon (fig. 113). No welded tuff was seen.
