The Alaska Earthquake

March 27, 1964

Effects on Communities

GEOLOGICAL SURVEY PROFESSIONAL PAPER 542-G

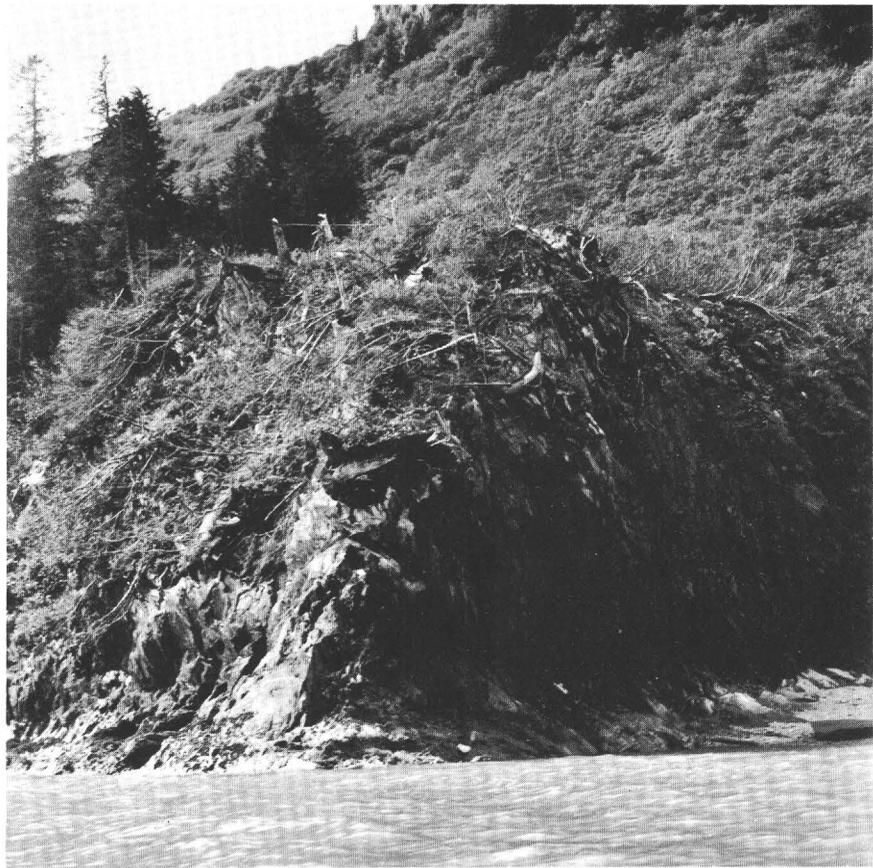
2.—Spur west of Shoup Bay in Port Valdez that was overtopped by a local wave traveling from right to left. Trees and branches are broken to an elevation of more than 100 feet above lower low water. Location shown in figure 1.

diameter spruce trees at elevations as high as 101 feet and deposited barnacle-covered boulders estimated to weigh 1,700 pounds 88 feet above the shoreline (figs. 2, 3, and 4). The waves that moved westward out of Port Valdez overtopped and destroyed the Valdez Narrows navigation light situated on top of a reinforced concrete pedestal 35 feet above lower low water (fig. 1).

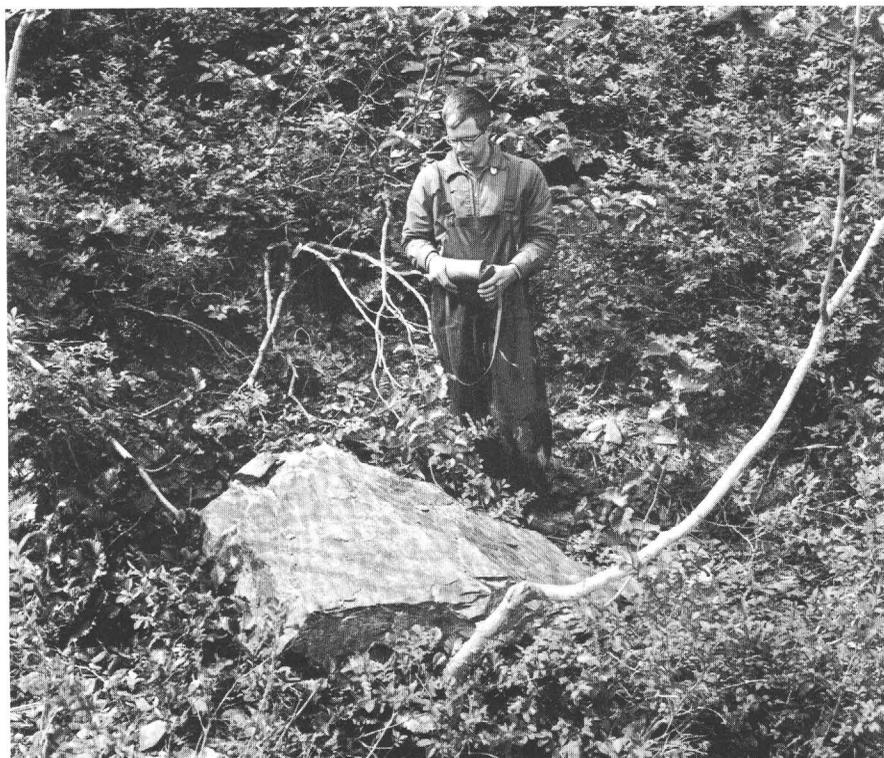
4 (right).—Boulder estimated to weigh 1,700 pounds thrown up 88 feet above the shoreline by a local wave at the place near Shoup Bay shown in figure 1.

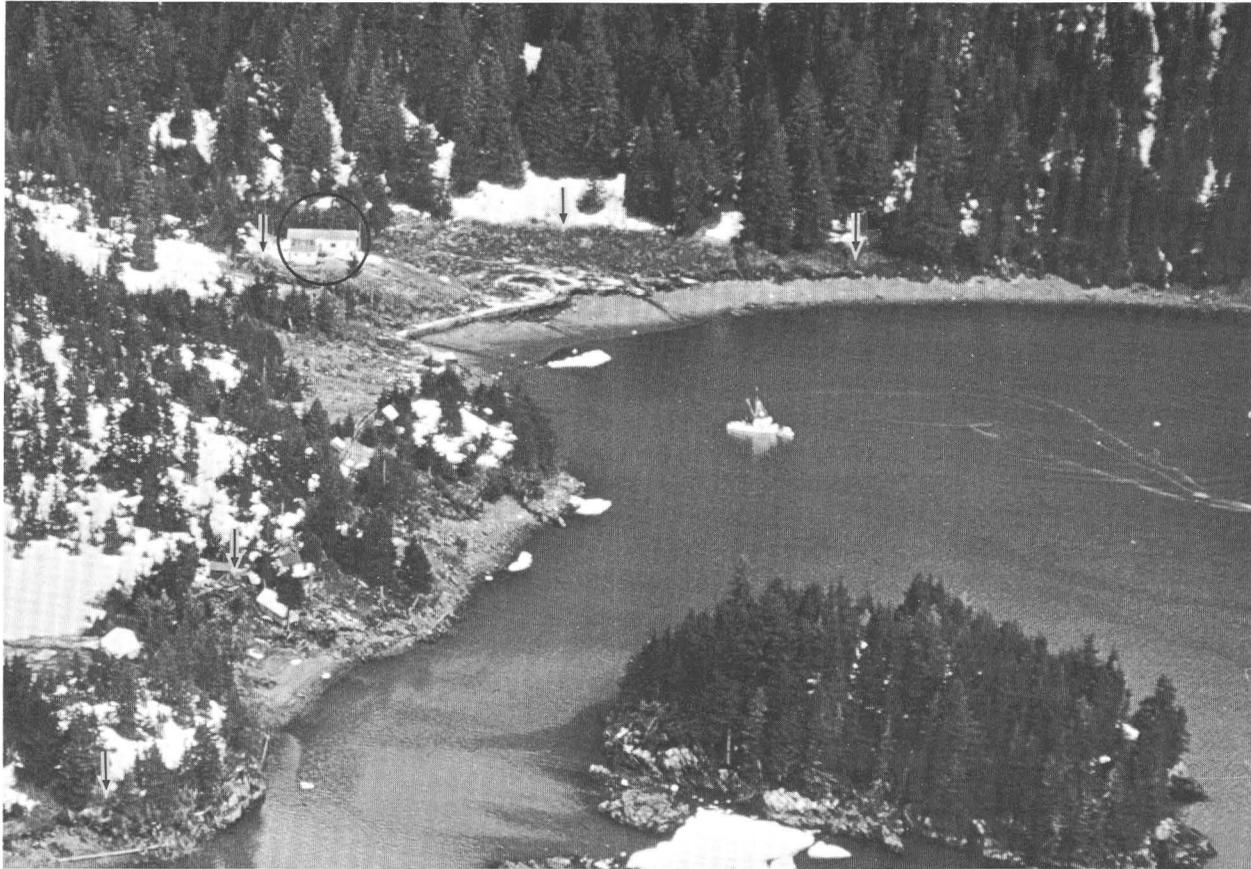
5.—Aerial view of the Chenega village site at the head of Chenega Cove. Lower limits of snow, as shown by arrows, indicate the approximate limits of wave runup; the schoolhouse is circled. Photograph taken March 29, 1964.

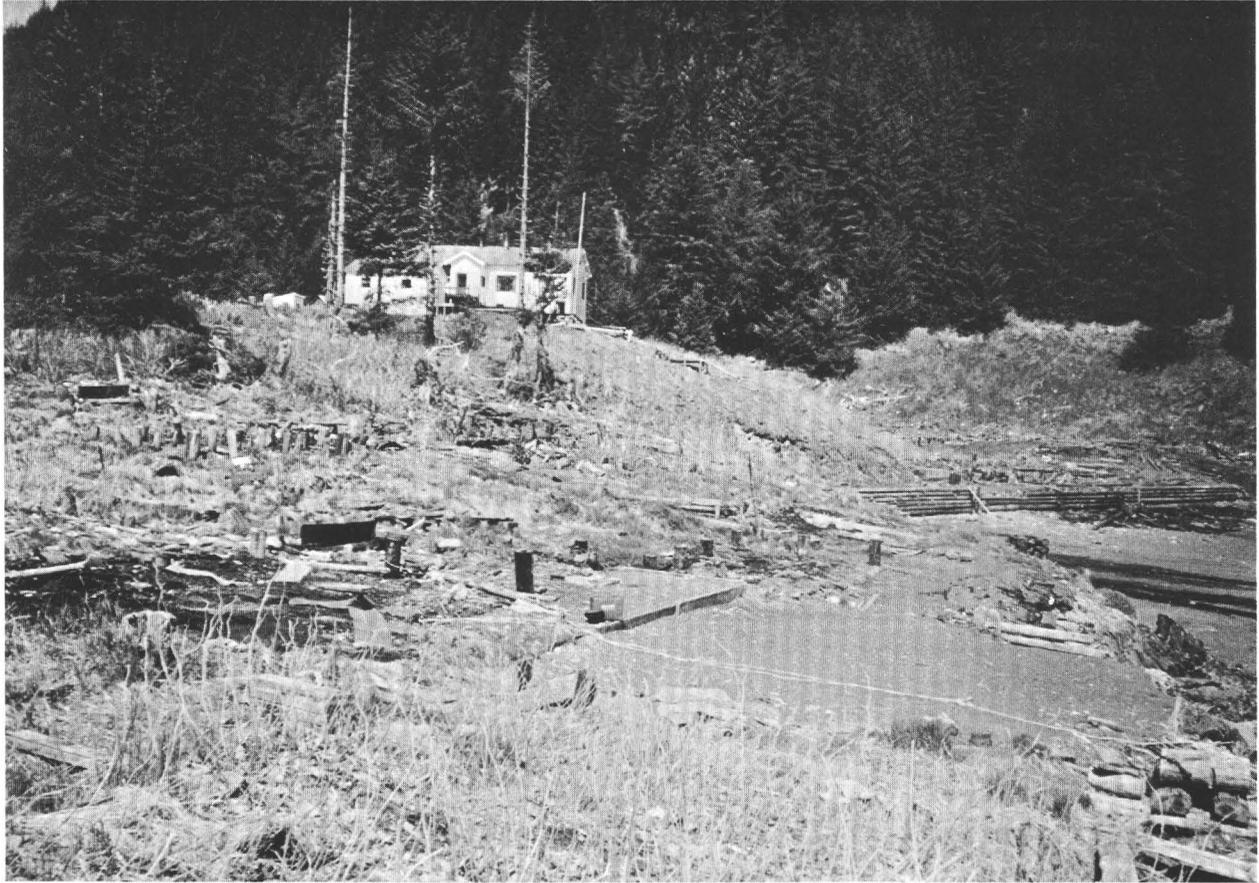
6.—Main part of the Chenega village site. Piling in ground marks the former locations of homes that were swept away by waves. Schoolhouse on high ground was undamaged.
