# The Alaska Earthquake

Geologic Effects of the  
March 1964 Earthquake  
And Associated Seismic  
Sea Waves on Kodiak  
And Nearby Islands  
Alaska

GEOLOGICAL SURVEY PROFESSIONAL PAPER 543-D

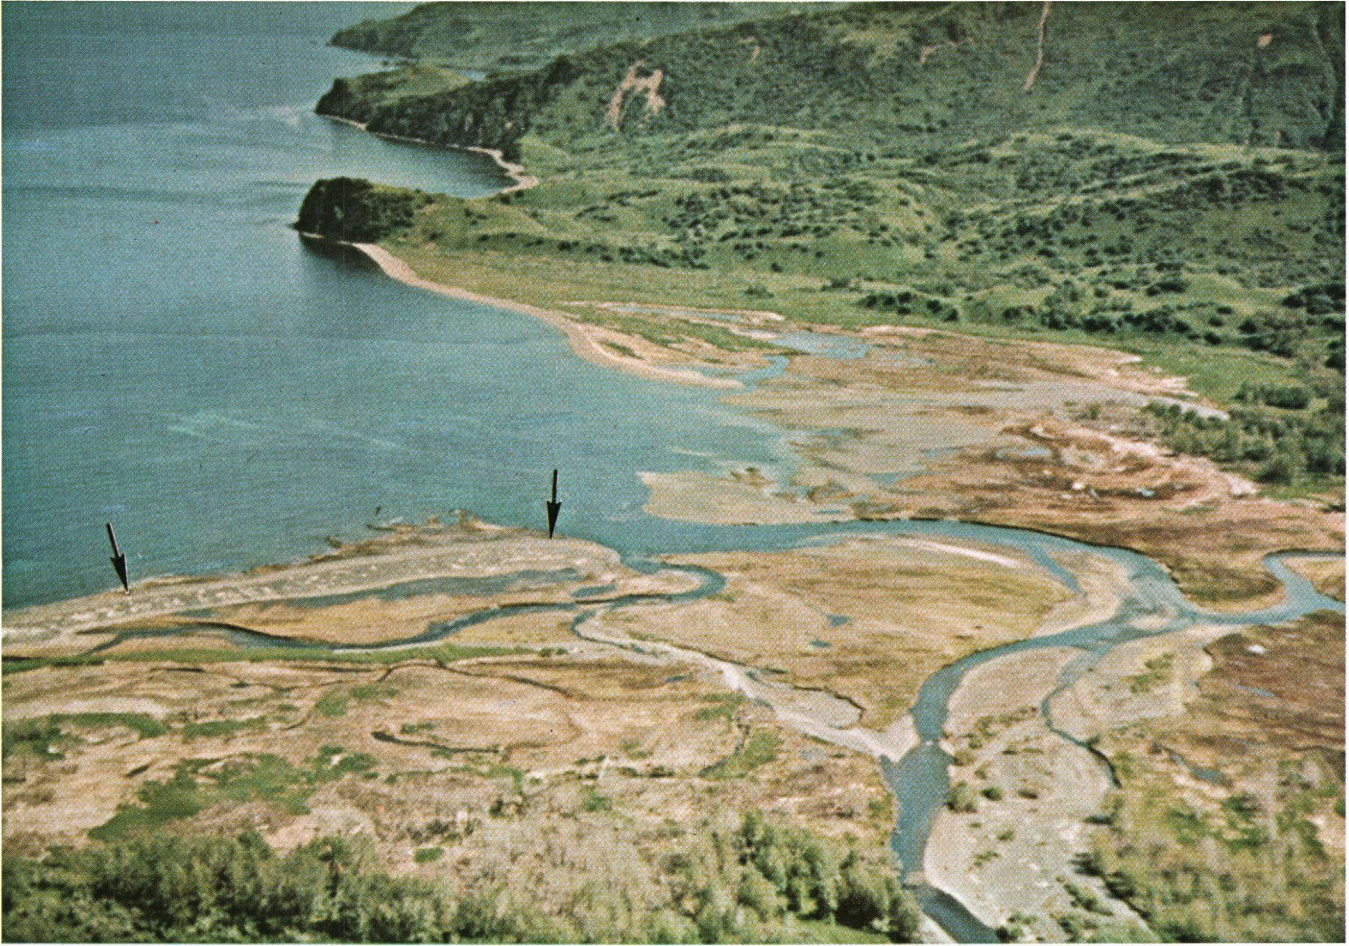
#### DROWNED STREAM ESTUARY AT EAGLE HARBOR ALONG SOUTH SHORE OF UGAK BAY

Extensive brown area of terrestrial vegetation has been killed by salt-water immersion after 4 feet of tectonic subsidence and an unknown amount of surficial subsidence. The gray ridge of beach gravel in the left part of view (arrows) has been eroded back and built up in adjustment to the new higher base level of deposition. The fact that the effects of inundation are scarcely visible along the steep bedrock shore in the background suggests that much of the subsidence at the estuary deposits was surficial rather than tectonic.

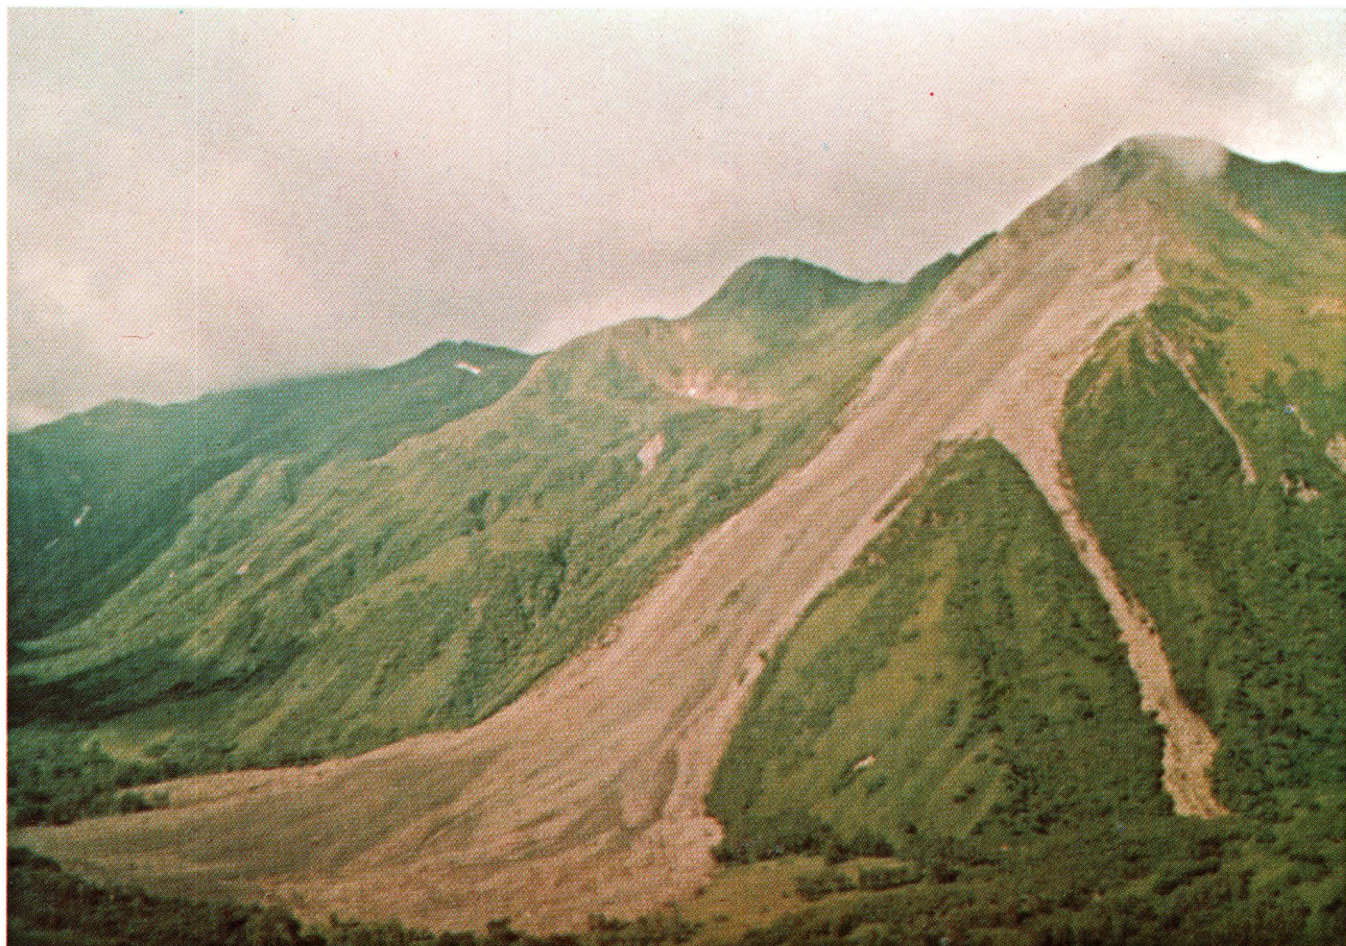
#### DEBRIS AVALANCHE ON THE PENINSULA BETWEEN UGAK AND KILIUDA BAYS

A slide of Tertiary rocks from the 1,500-foot-high peak at upper right flowed into the uninhabited valley below at about 300-foot altitude where it spread out as a debris lobe roughly 1,500 feet across. The narrow streak of light-colored debris in the lower right corner is part of the slide mass that overflowed the near flank of the landslide scar.

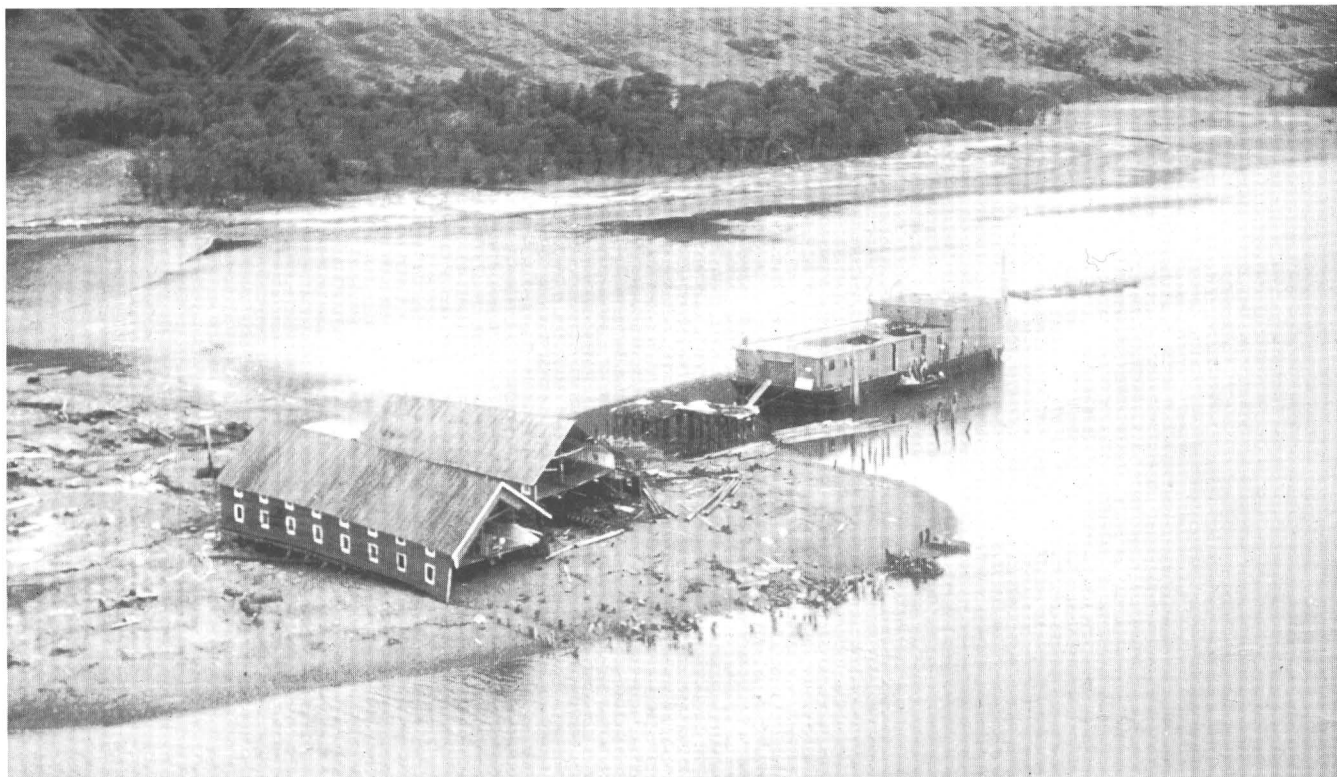
6. — The Kadiak Fisheries cannery site in Shearwater Bay along the north shore of Kiliuda Bay. Cannery buildings in the foreground were split during the earthquake and the seaward parts of the structures were later washed away by seismic sea waves. The former locations of the buildings and dock are outlined by timber pile foundations in the beach and water. The entire beach is now inundated at high tide as a result of about 4 feet of tectonic subsidence and 2-10 feet of surficial subsidence of the beach deposits. The barge behind the cusp is a floating cannery that replaces the destroyed facility on land. Location of cannery shown on figure 5.

posits throughout the islands. In these areas, structural damage resulted mainly from foundation failure attributable to partial liquefaction, differential settlement, and cracking of unconsolidated deposits and artificial fill. The sole structural failure reported in the area was the partial collapse of the main building of the Kadiak Fisheries cannery located on a beach cusp on Shearwater Bay along the north shore of Kiliuda Bay. The structure split in half when it was shifted off its piling foundation according to the cannery watchman, Mr. Sergei Pestrikoff. The piling was driven into beach gravel that was partially liquefied during the earthquake (fig. 6). The fallen section was later washed away by the seismic sea waves.

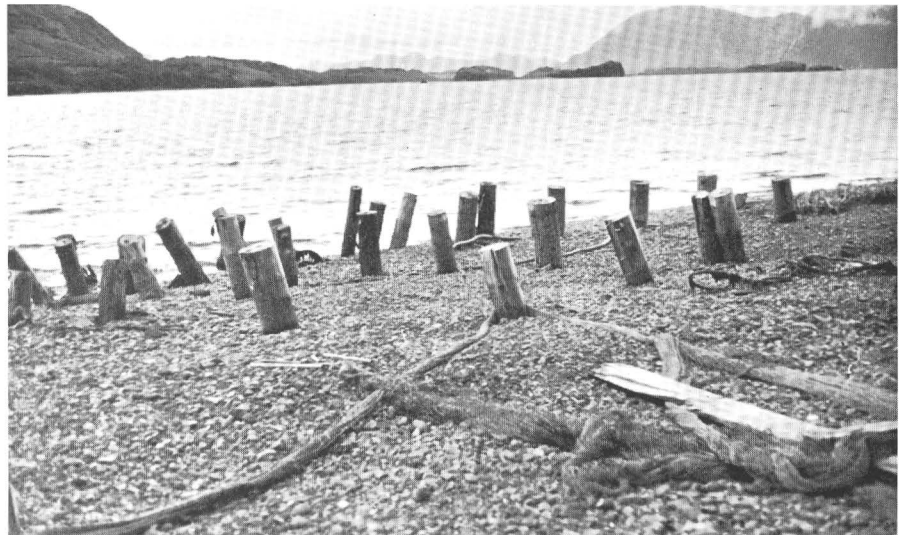
7. — Timber pile foundation at Kodiak Fisheries cannery site. Pronounced tilting of unbroken piling is indicative of lateral motion of the piling through 10–15 feet of beach gravel. Piling tops formerly level are now 7.8 feet lower at the seaward end of the cannery site than in the foreground owing to local settlement of the distal part of the beach culsp. Bent drift pins in the piling tops indicate that the cannery moved southward (away from the observer) off the piling.

ed subsidence was  $5\frac{1}{3}$  feet at the shipway piling to the right (north) of the cannery buildings. This subsidence, 2 feet more than that at a bedrock site 1 mile to the south, indicates surficial settlement of about 2 feet relative to bedrock. Furthermore, measurement of the difference in height of the tops of the piling that previously supported the destroyed part of the cannery indicates that an additional 7.8 feet of surficial settlement occurred towards the tip of the culsp (fig. 7).

The site is now submerged at high tides, and the facilities have been replaced by a floating cannery. Ground cracks as much as a foot wide reportedly crisscrossed the cusp after the earthquake. Mr. Edward Pestrikoff, the cannery watchman, saw cracks form in the ground during the earthquake and saw water ejected as high as 6 feet. Reduction of shear strength of the unconsolidated deposits through partial liquefaction is suggested by the manner in which the foundation pilings shown in figure 7 were tilted without being broken when the cannery building collapsed.

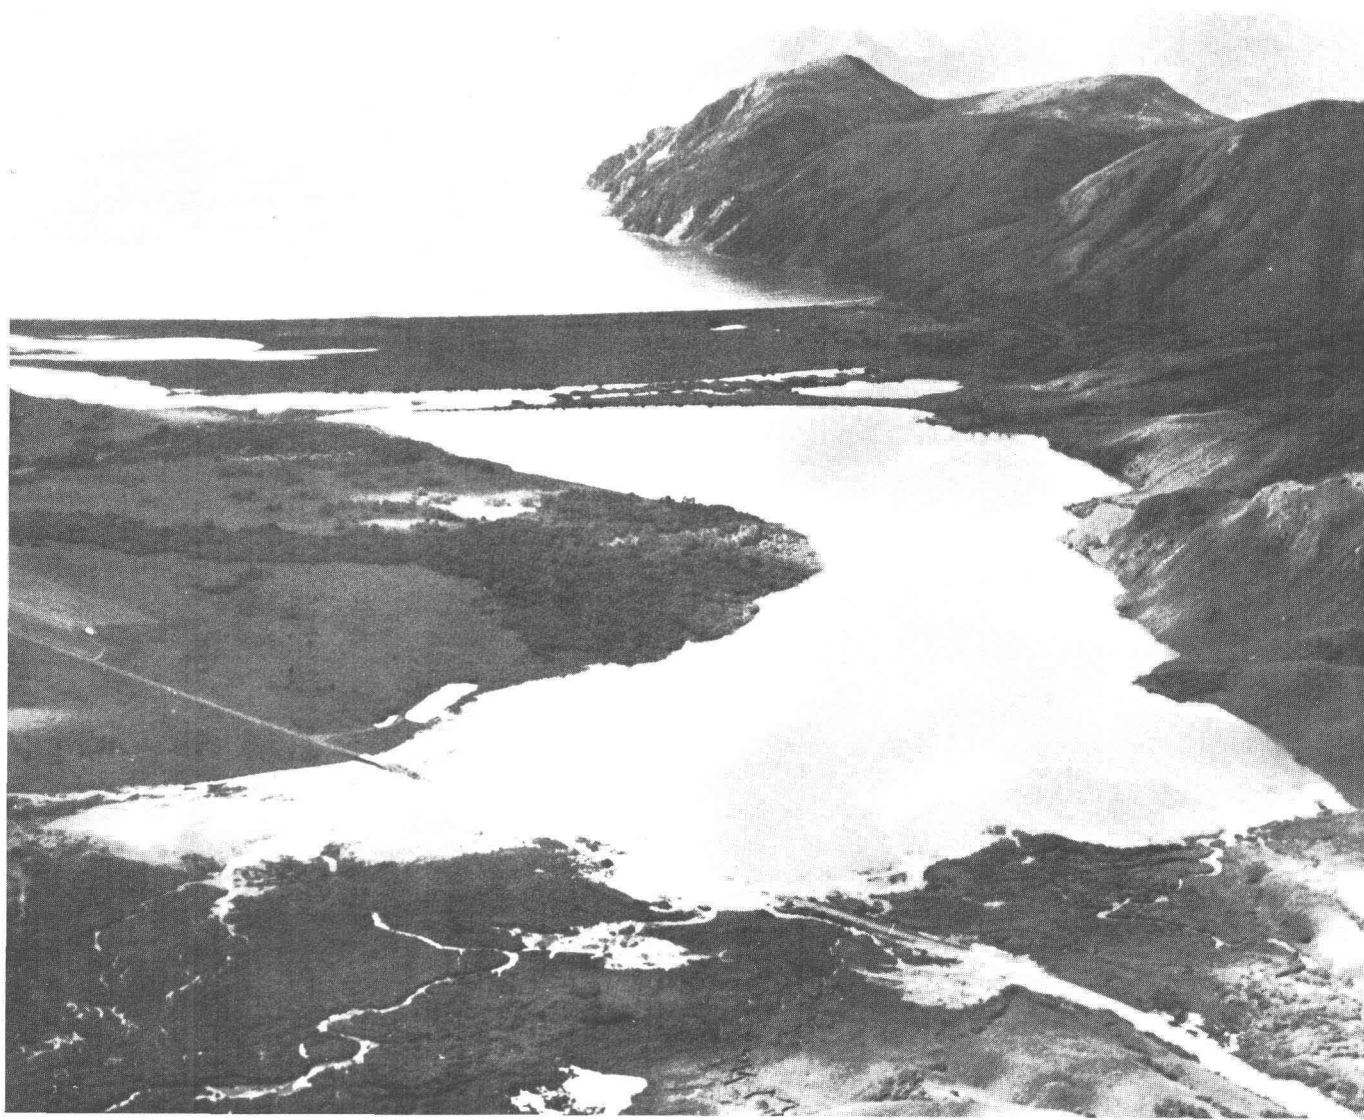
8. — Road near the head of Lake Rose Tead submerged by about 5 feet of surficial subsidence of inlet-stream deltaic deposits. Ugak Bay is visible in the background. Photograph by Alaska Department of Fish and Game.

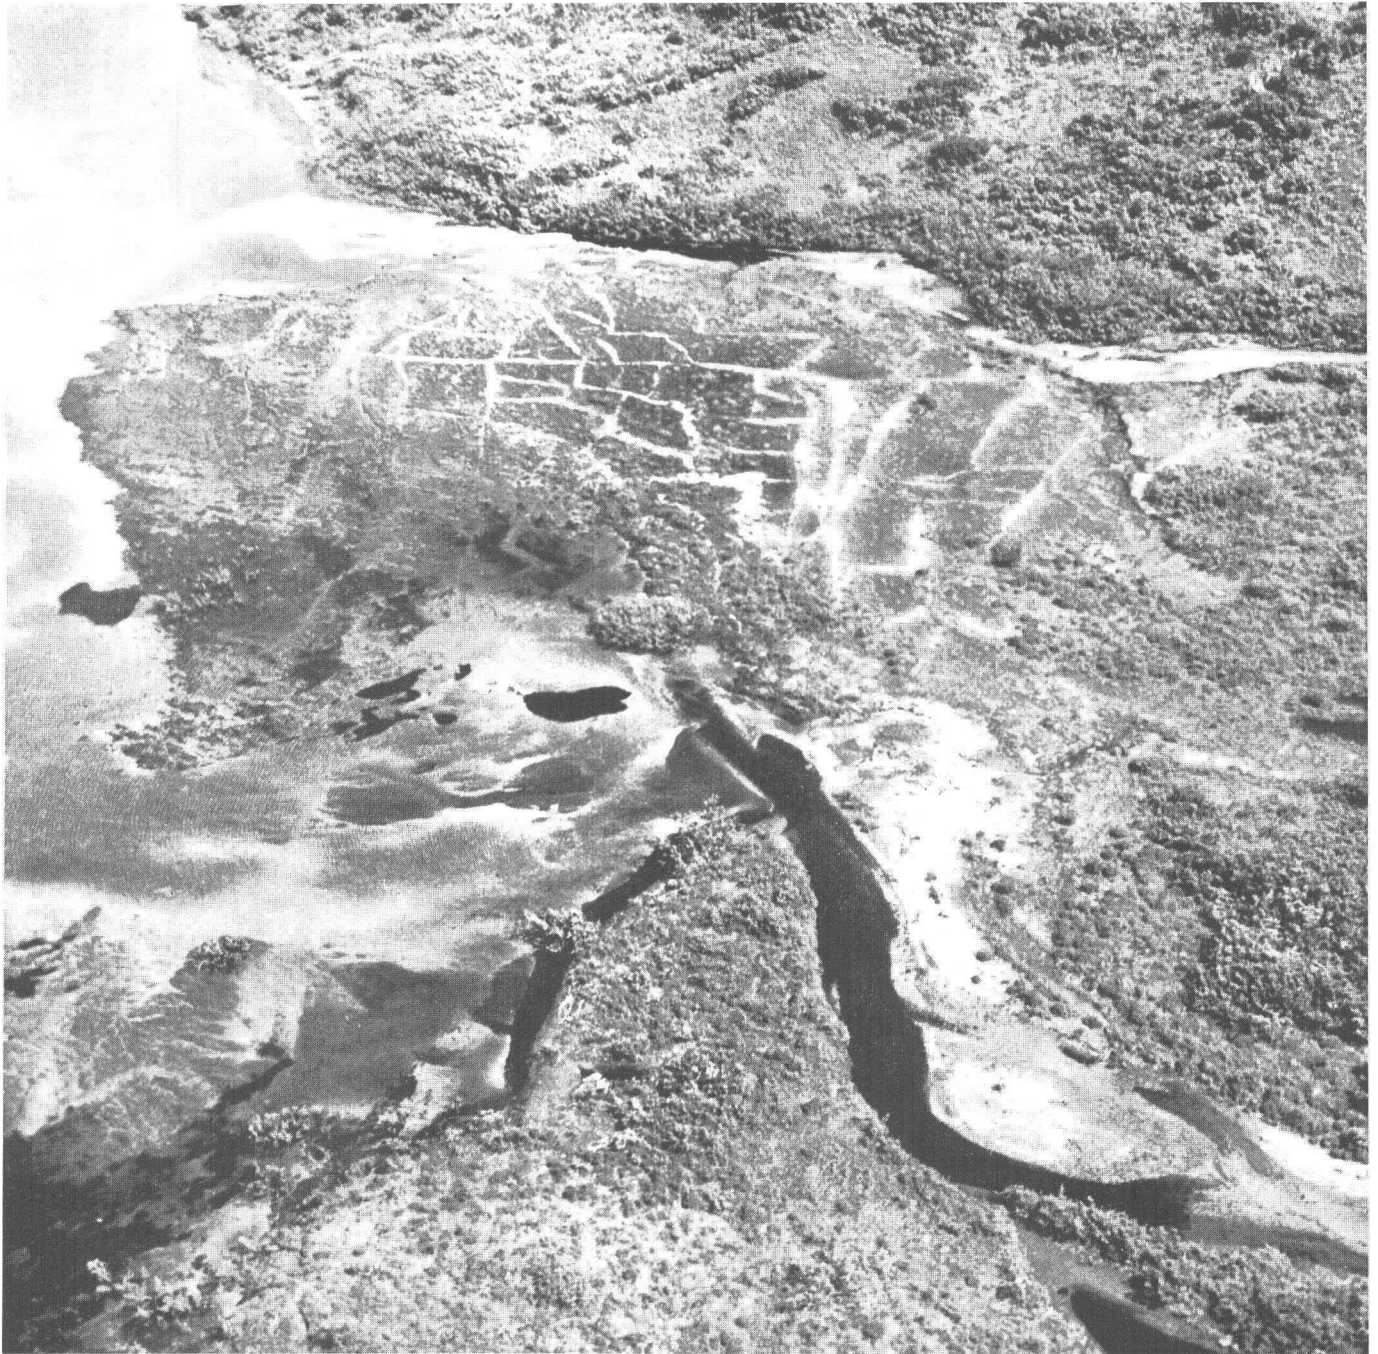
9.— Inlet delta at the head of Terror Lake showing inundation of slumped and cracked delta margin and linear cracks defined by light-colored pumiceous ejecta. Photograph by F. O. Jones.

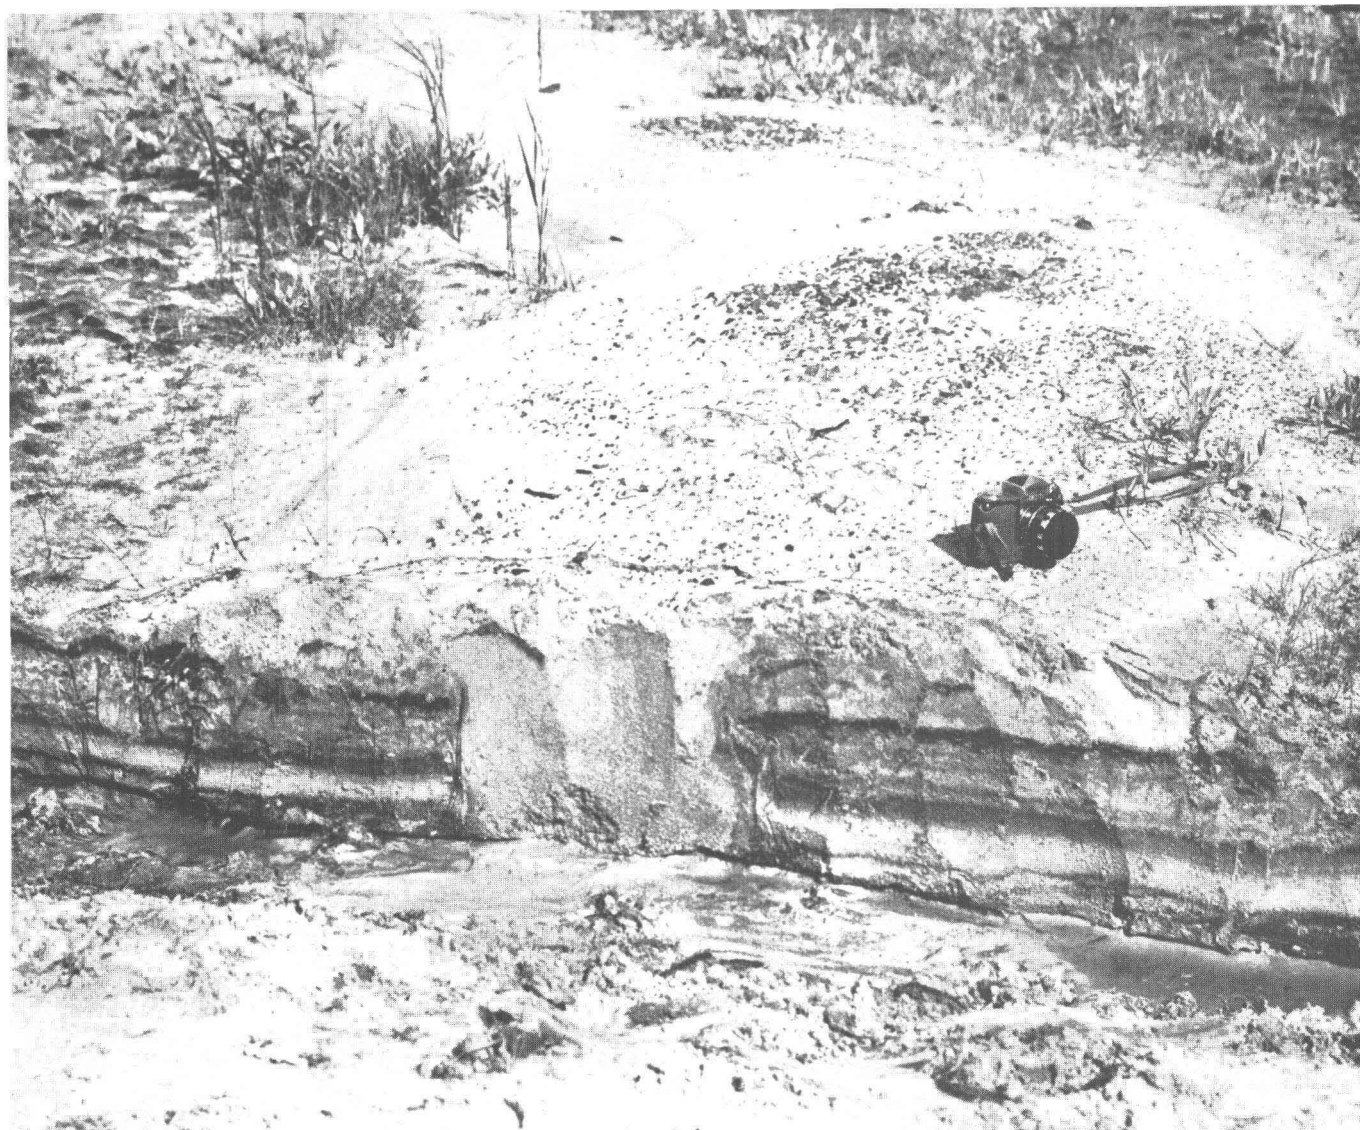
10.—Sectioned extension crack 1 foot wide at head of Terror Lake showing light-colored fine- to medium-grained pumiceous sand ejecta at surface and subsurface clastic dike. Photograph by F. O. Jones.

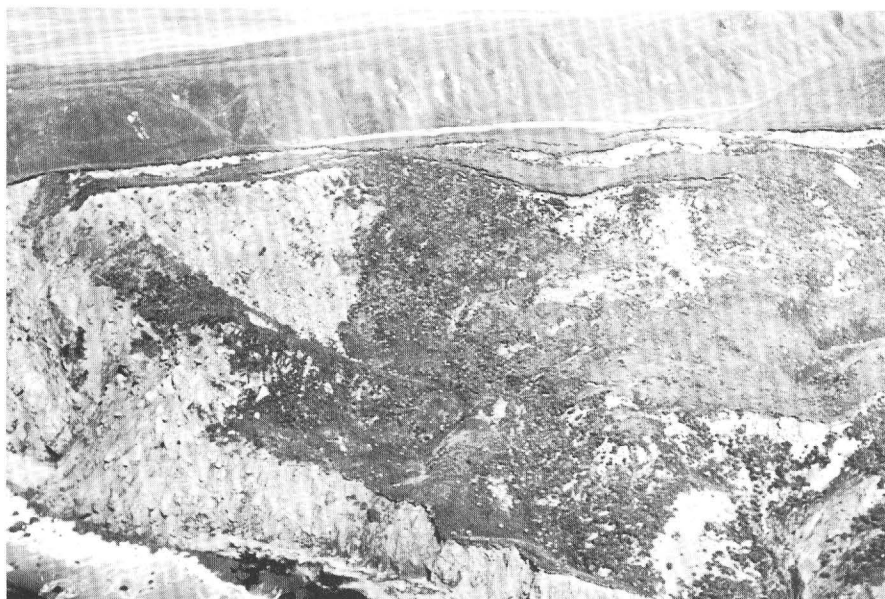
13. — Reactivated large debris slide in sedimentary rocks of middle Tertiary age along the south shore of Sitkinak Island. Note the characteristic steplike transverse scarps, displacing surface vegetation at head of the slide. A small rockfall covers part of the beach in lower left of photograph. Vertical height of slide mass is approximately 300 feet.

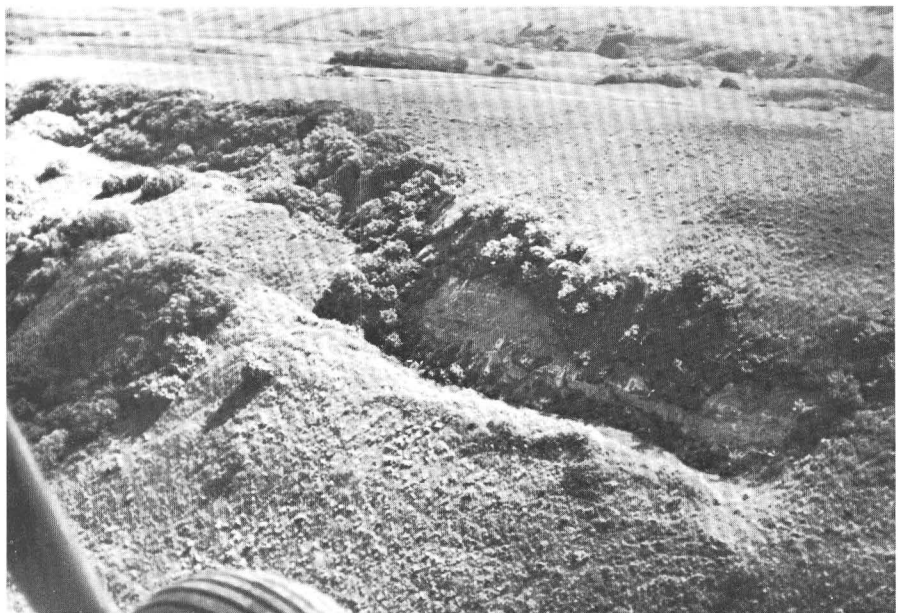
15. — Main scarp at the head of a large rotational slump in Tertiary deposits on Narrow Cape, Kodiak Island. The landslide is approximately 1,400 feet long and 125–150 feet high. The rock mass at the left slid 8–15 feet downslope along a surface of rupture, the main scarp of which trends diagonally across the photograph. Note the headward tilt of the original surface on the upper part of the slide mass and draping of the vegetation mat over the crown of the main slide.

The Narrow Cape landslide involved moderately dipping, poorly indurated sedimentary rocks of late Tertiary age. It occurred on slopes of  $15^{\circ}$ – $35^{\circ}$  along a structurally controlled northeast-trending linear valley that is incised 125–150 feet into a flat-lying erosion surface. The main scarp of the slide (fig. 15) broke at the top of the southeast valley wall along a distance of roughly 1,400 feet. The slide mass slumped down on the northwest side as much as 15 feet with headward tilting along a surface of rupture that intersected the surface on the valley floor 125–150 feet be-

low. Open tension cracks and shallow grabens are abundant on the erosion surface headward from the main scarp. The slide toe is characterized by transverse pressure ridges and small overthrusts in the surface mat of muskeg vegetation. The brush-covered hummocky topography of the lower part of the slide surface and the chaotic internal structure suggest that earlier gravity movement has taken place.

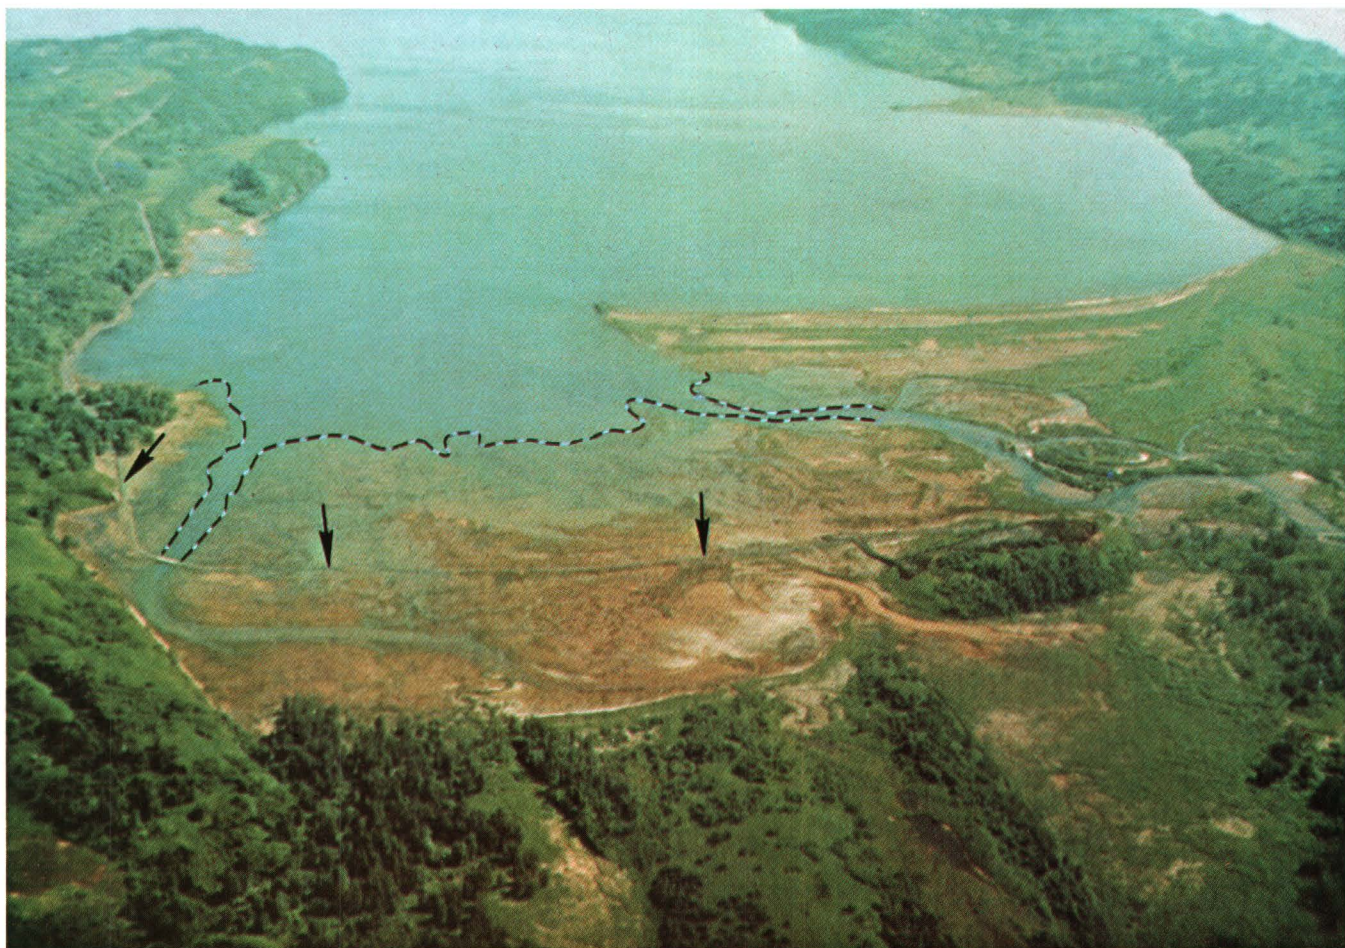
### SUBSIDENCE AT MIDDLE BAY

Extensive inundation at the head of Middle Bay resulting from 5 feet of tectonic subsidence and an unknown but substantial amount of surficial subsidence. Arrows indicate the approximate location of remnants of the Kodiak-Chiniak highway. Dashed line shows the approximate preearthquake mean high-water shoreline which has been shifted about half a mile landward.

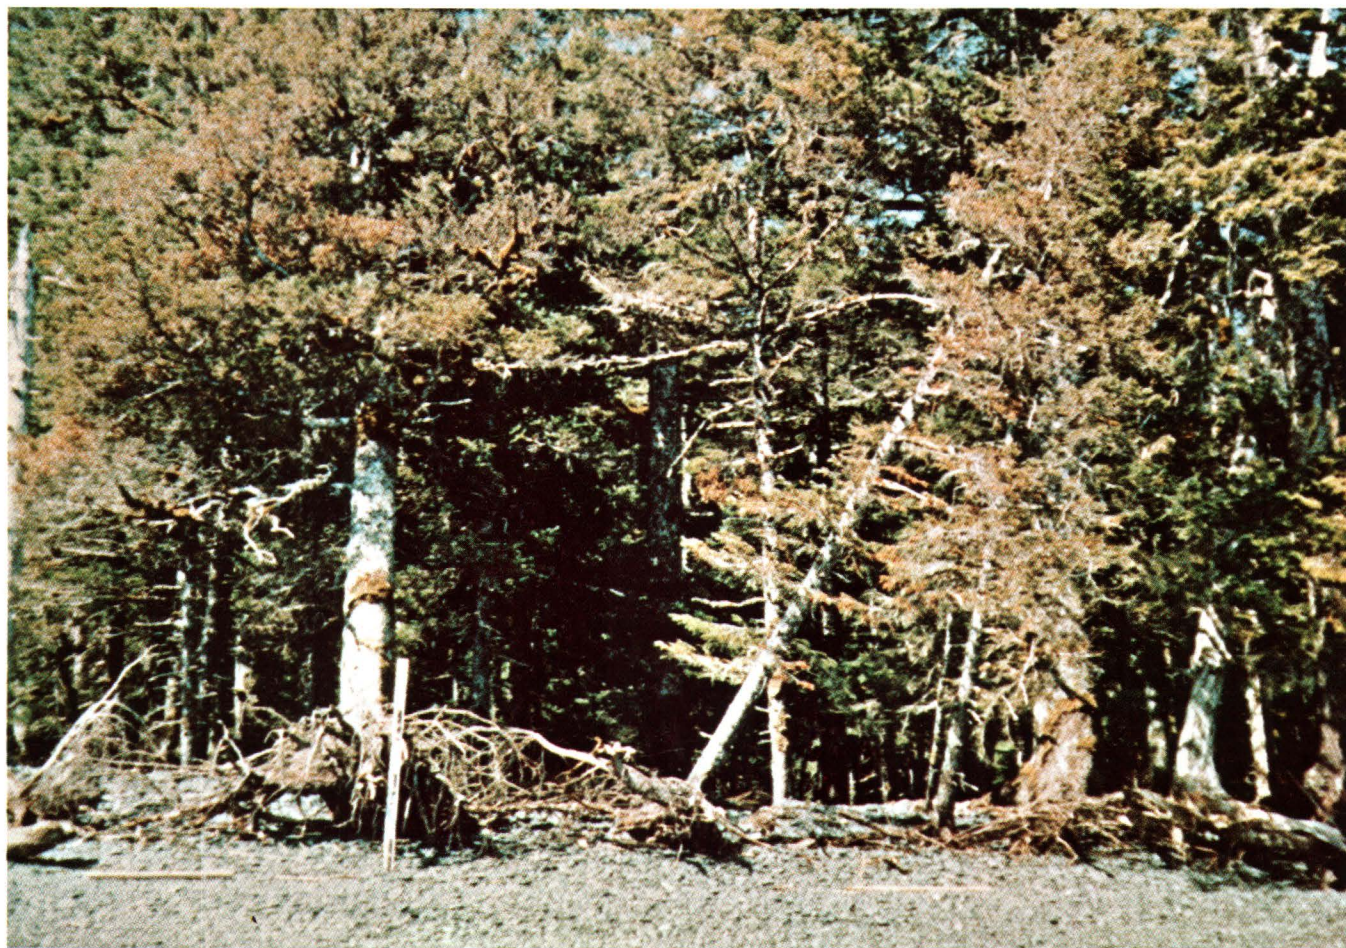
UNDERMINED TREES ON BARRIER BEACH IN IZHUT BAY, AFOGNAK ISLAND

Accelerated wave erosion in an area of about 5 feet of tectonic subsidence caused this damage. Foliage of trees along shore has turned brown from salt-water immersion of the roots.

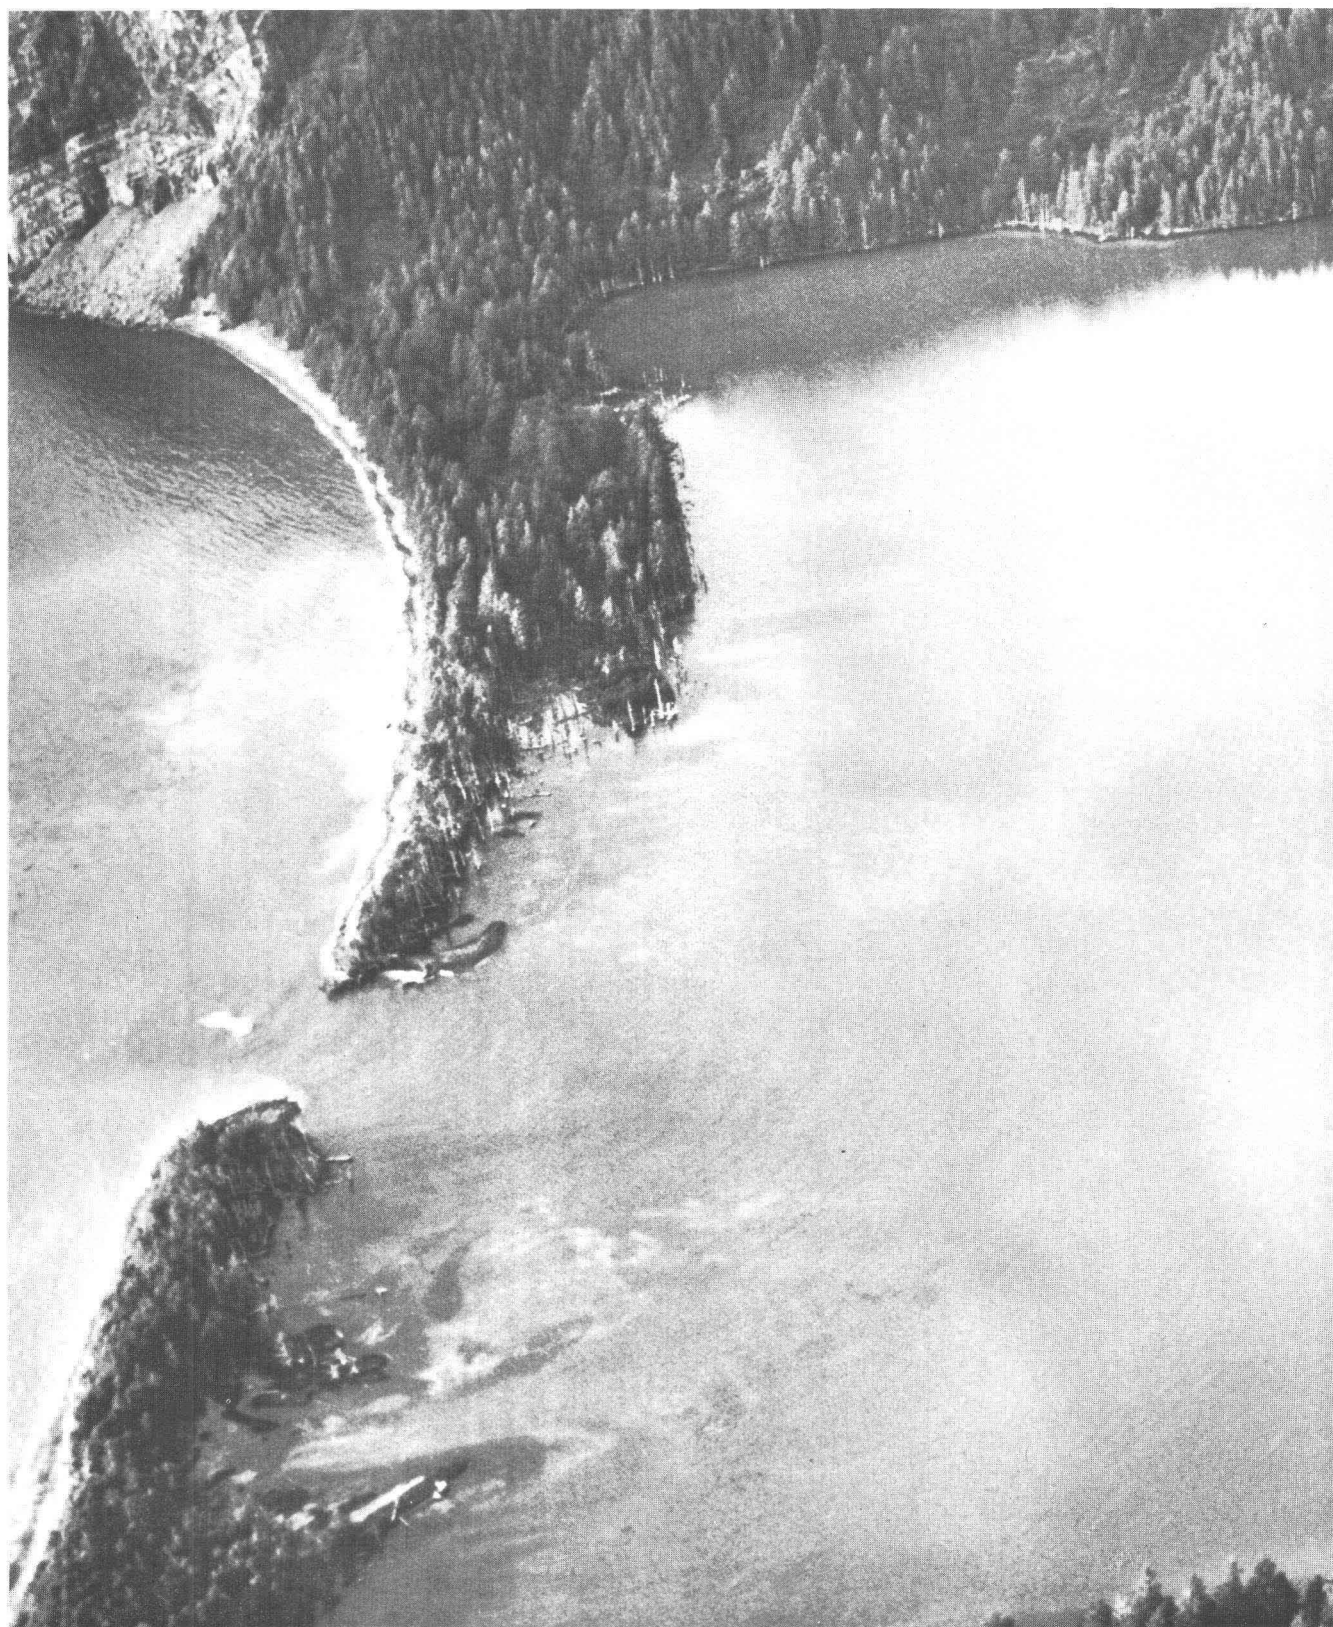
20. — Opening torn by seismic sea waves in the barrier beach of a large lake along the shore of Izhut Bay on Afognak Island. Channel scour and subsidence of at least 6 feet permit sea water to enter the basin at all stages of tide. Note partially submerged trees along inner margins of the beach spits, and small new rockslide along bluff in background. Photograph by Alaska Department of Fish and Game.

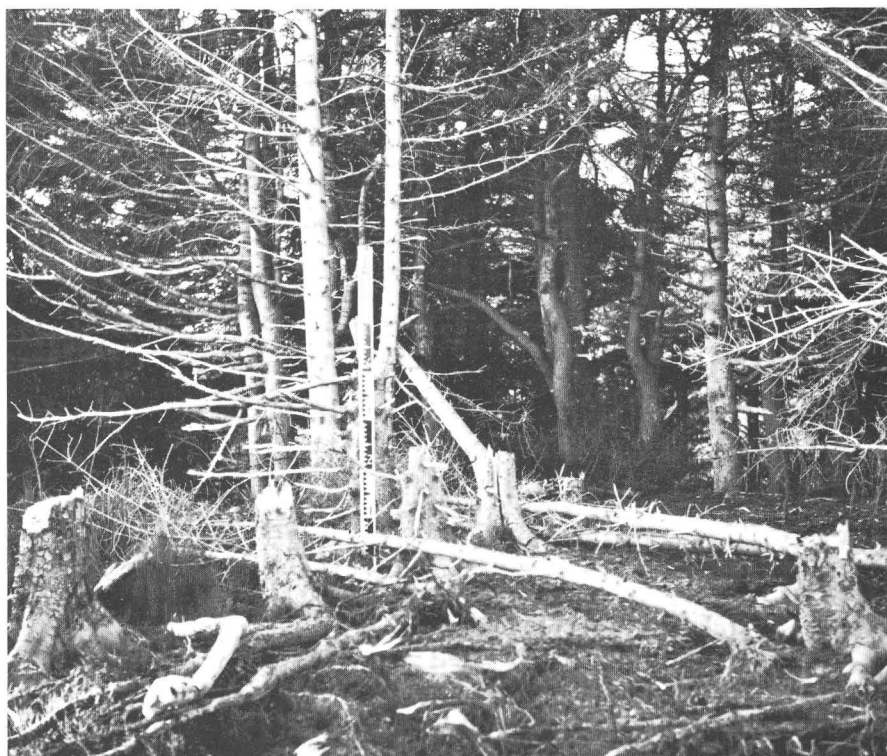
21.— Shoreline damage between Narrow Cape and Cape Chiniak caused by driftwood-laden seismic sea wave. Spruce trees as much as 8 inches in diameter were broken off at about 30 feet altitude. Limbs were broken and trunks scarred to a measured altitude of 42 feet above lower low water. Crowns of downed trees point in direction of water movement.

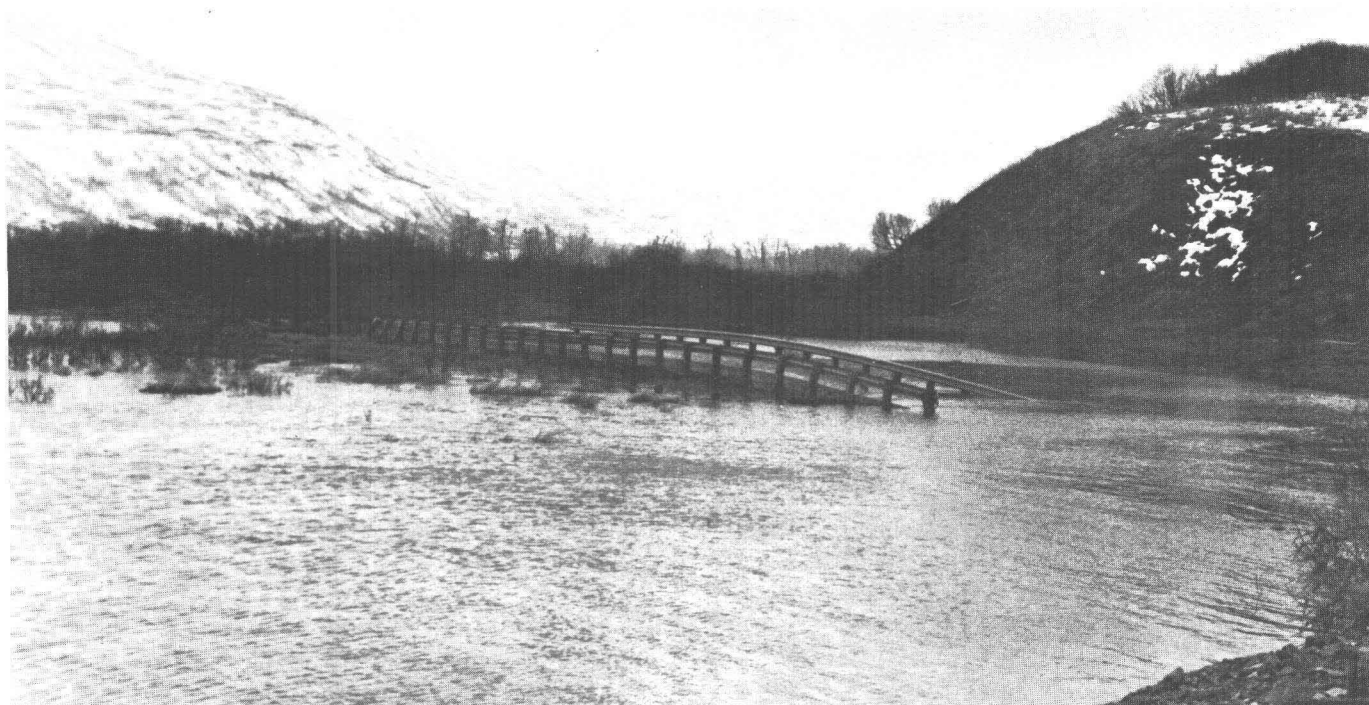
23. — Bridge at Womens Bay destroyed by seismic sea waves. Deck of bridge collapsed owing to destruction of piles. Compare with fig. 24. Photograph by U.S. Navy, March 30, 1964.

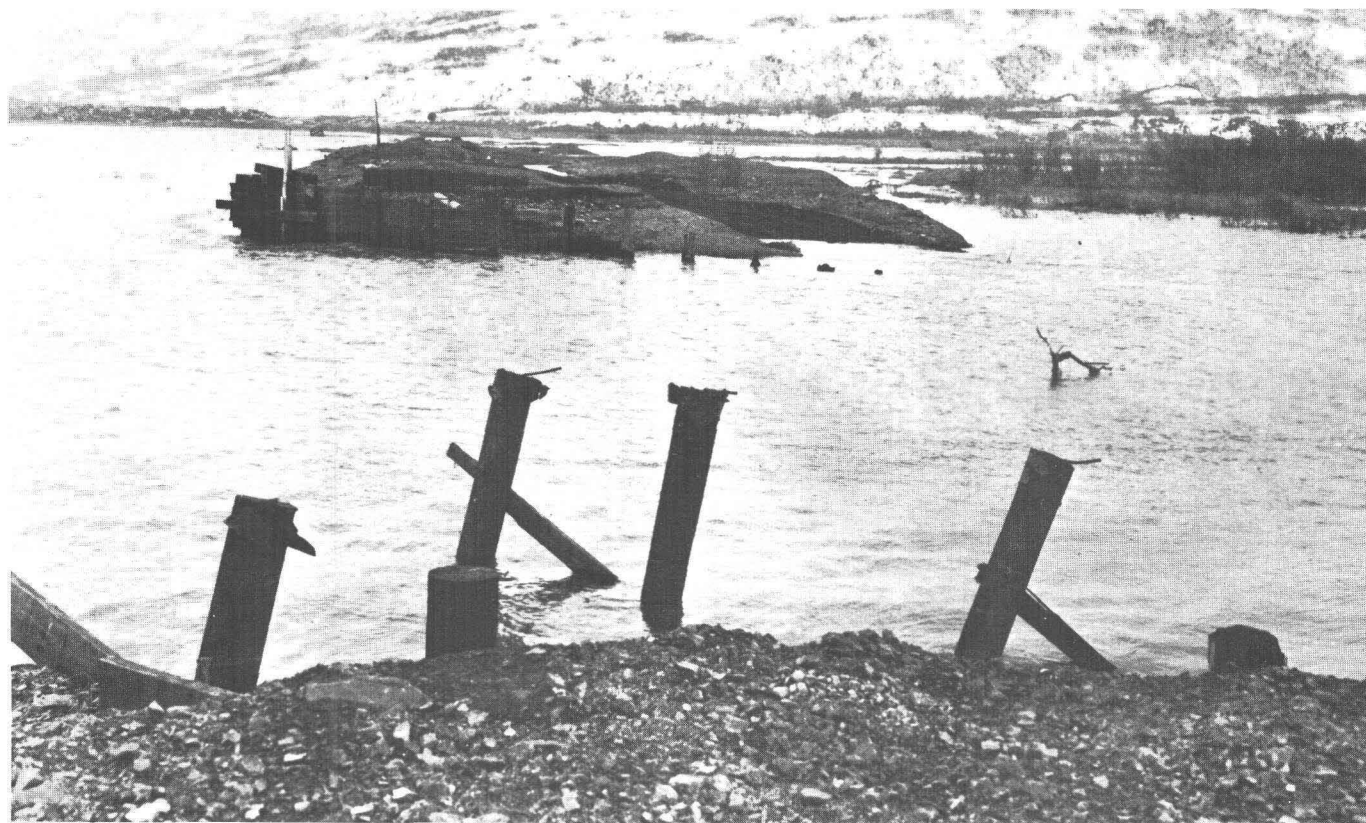
24. — Deck of highway bridge at Womens Bay washed away by seismic sea waves. Photograph by U.S. Navy, March 30, 1964.

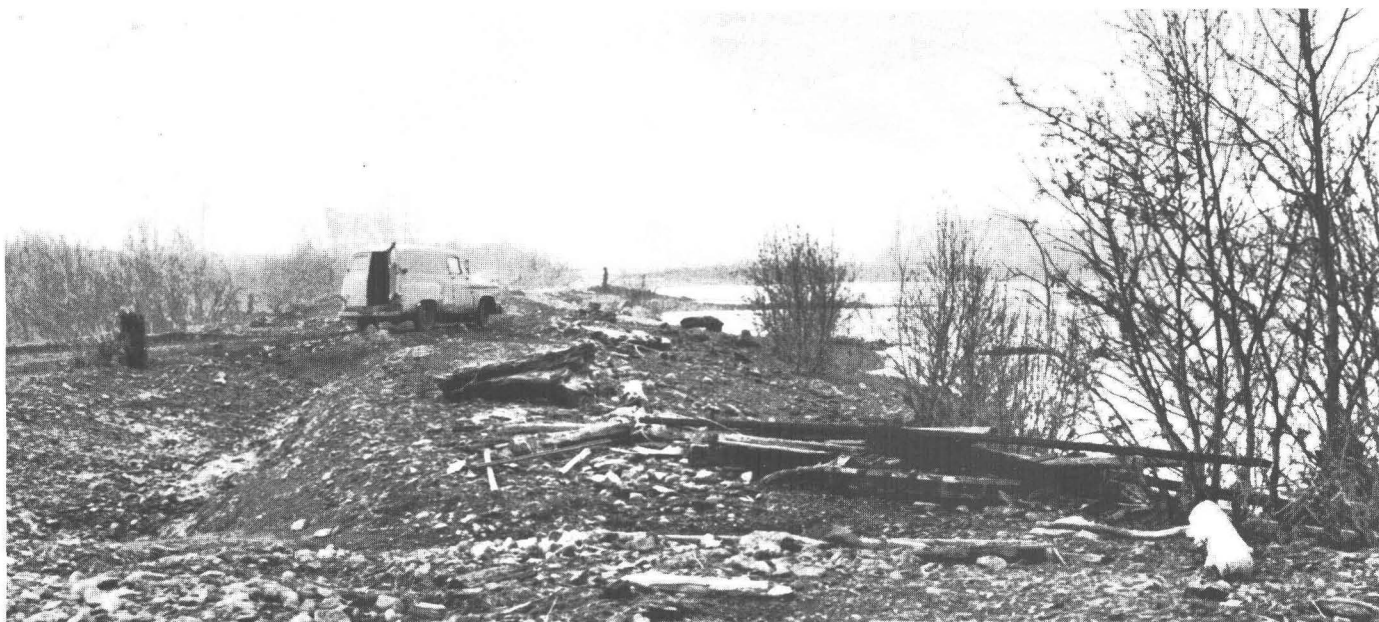
25. — Section of roadway along Chiniak highway at Womens Bay destroyed by seismic sea waves. Photograph by U.S. Navy, March 30, 1964.

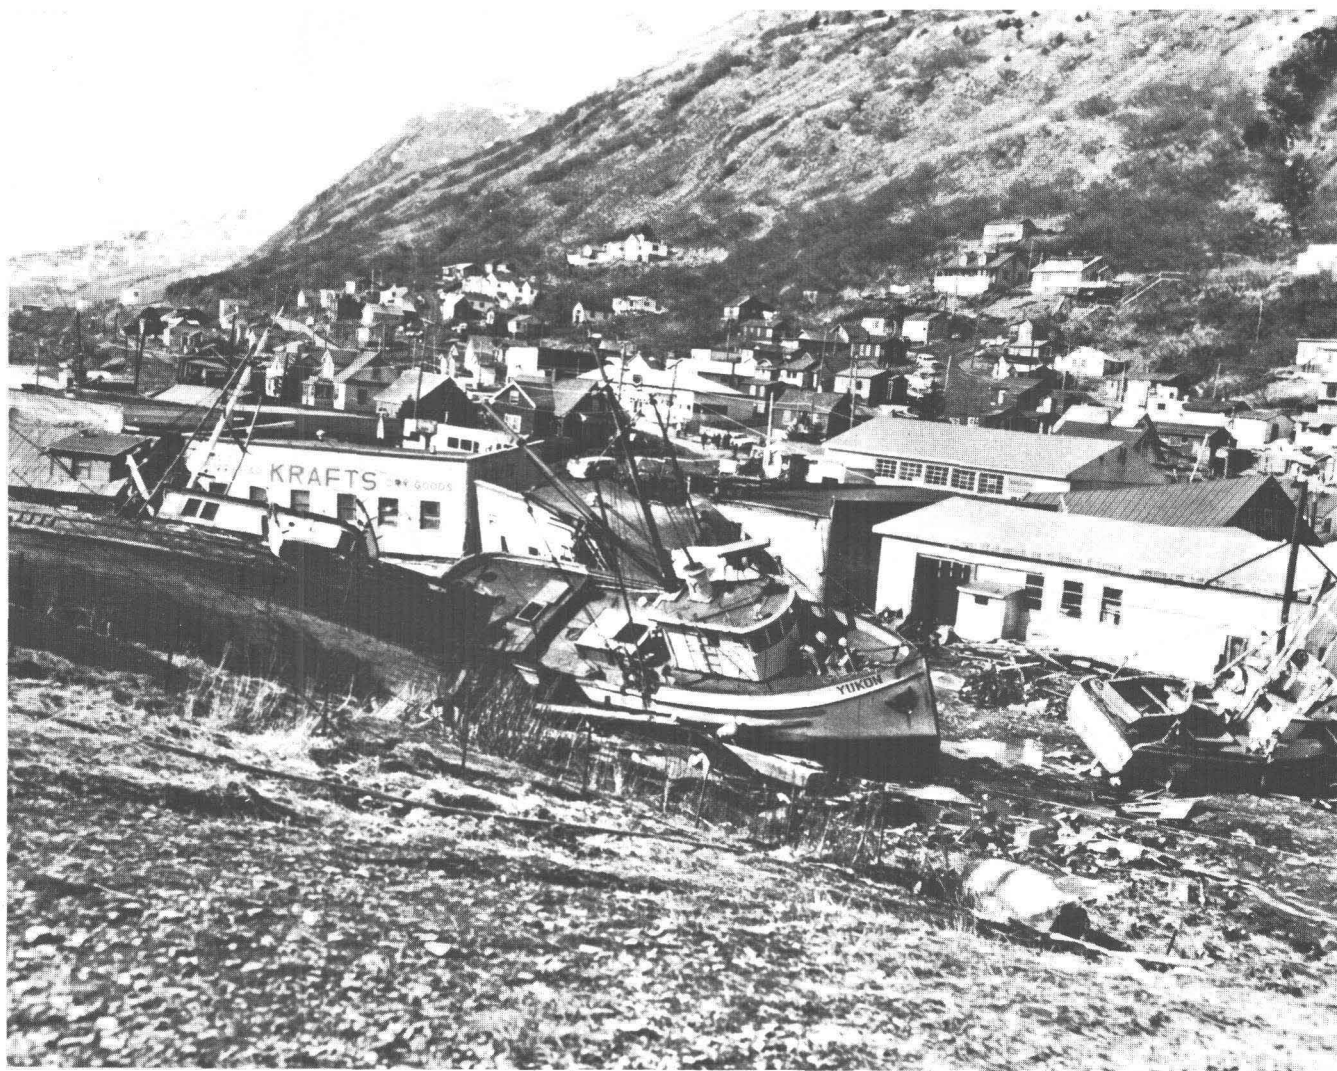
26. — Chaotic condition of the commercial section of the city of Kodiak following inundation by seismic sea waves. The small-boat harbor, which was in the left background, contained an estimated 160 crab and salmon fishing boats when the waves struck. Photograph by U.S. Navy, March 30, 1964.
