INTERIOR—GEOLOGICAL SURVEY, WASHINGTON, D.C.—1967—G67277

MAPS OF DISRUPTION ON OUTWASH DELTA OF TUSTUMENA LAKE, ALASKA

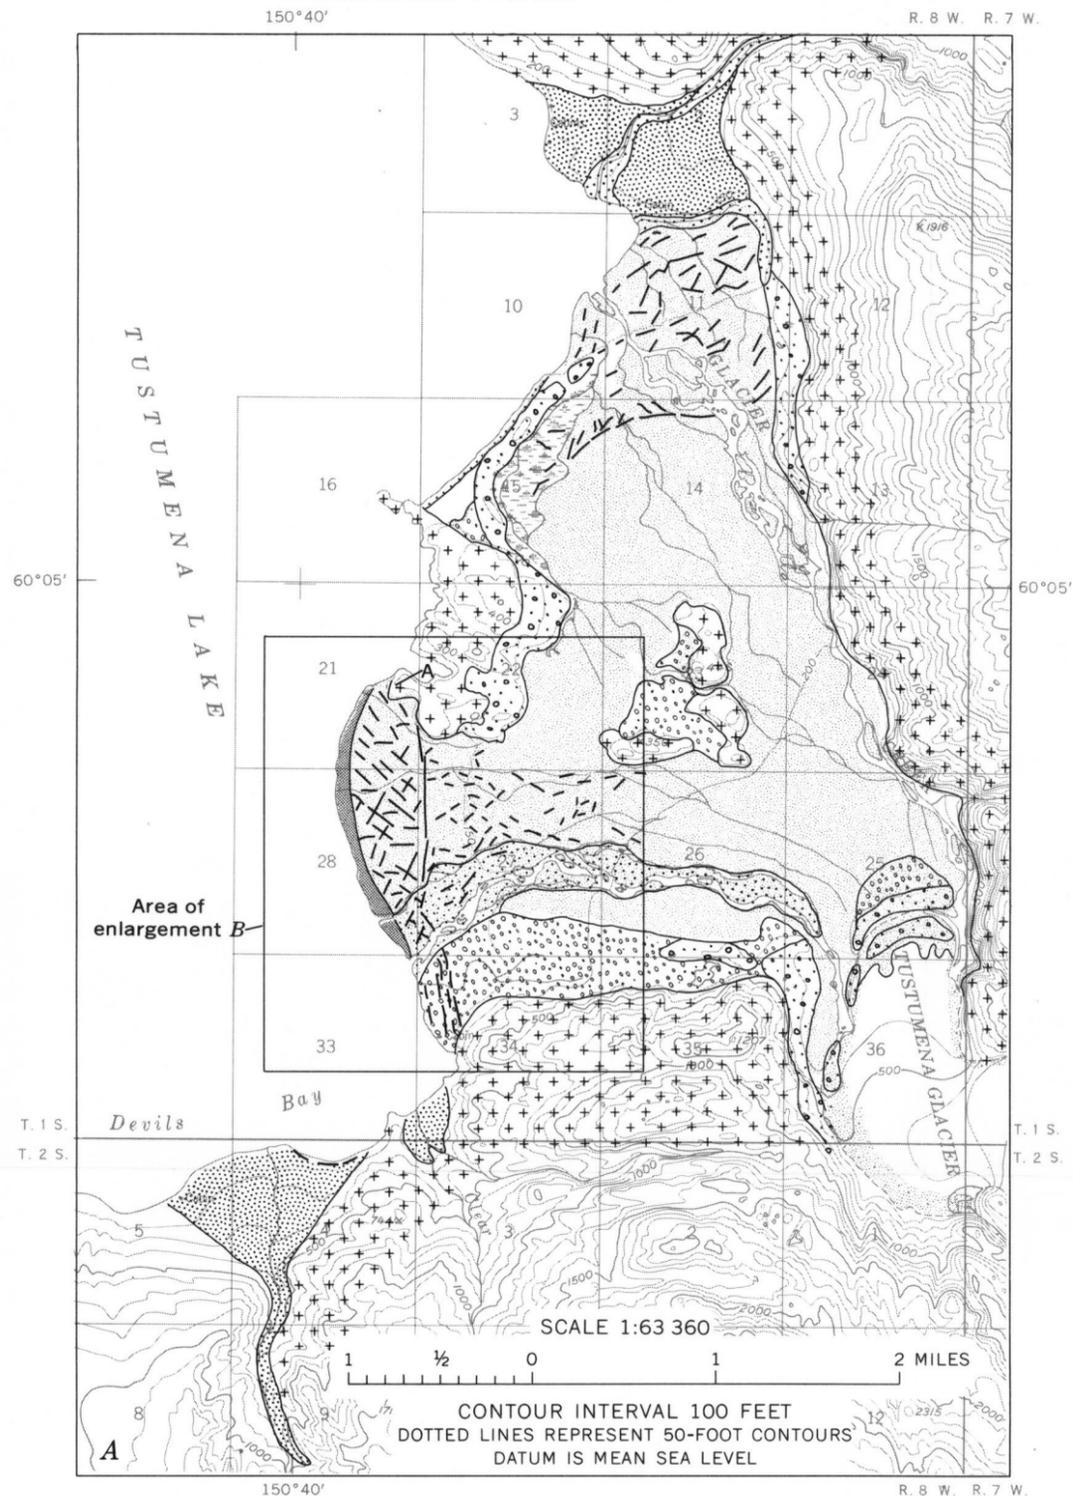
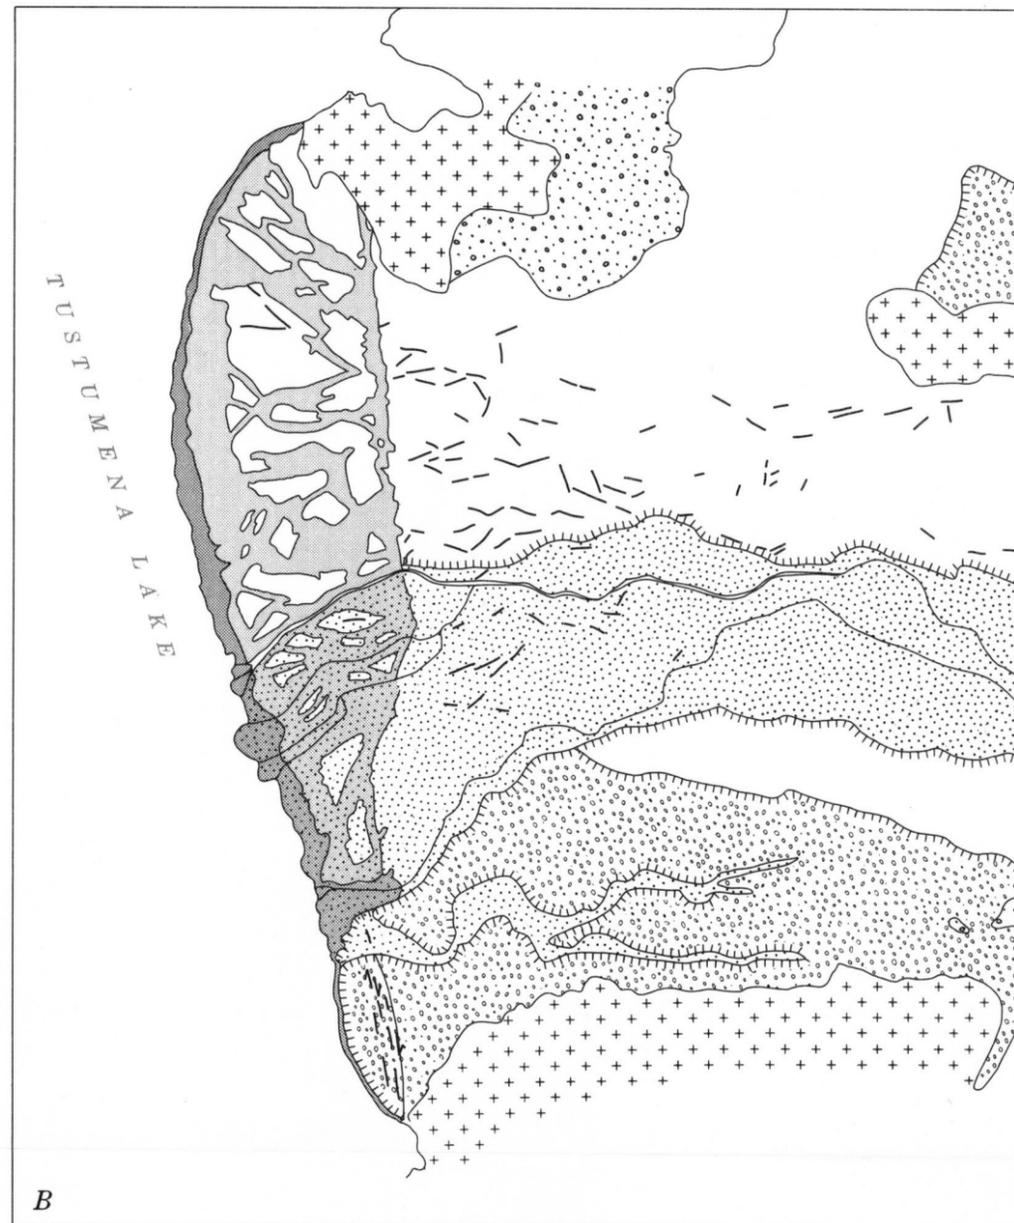
A
Letter indicates location of photograph

Enlargement (B) shows outwash delta front as sketched from aerial photographs taken a few days after the earthquake. (See fig. 16)
Location of Tustumena delta can be seen on plate 1
