The Alaska Earthquake

Effects of the
Alaska Earthquake of
March 27, 1964
On Shore Processes and
Beach Morphology

By KIRK W. STANLEY

GEOLOGICAL SURVEY PROFESSIONAL PAPER 543-J

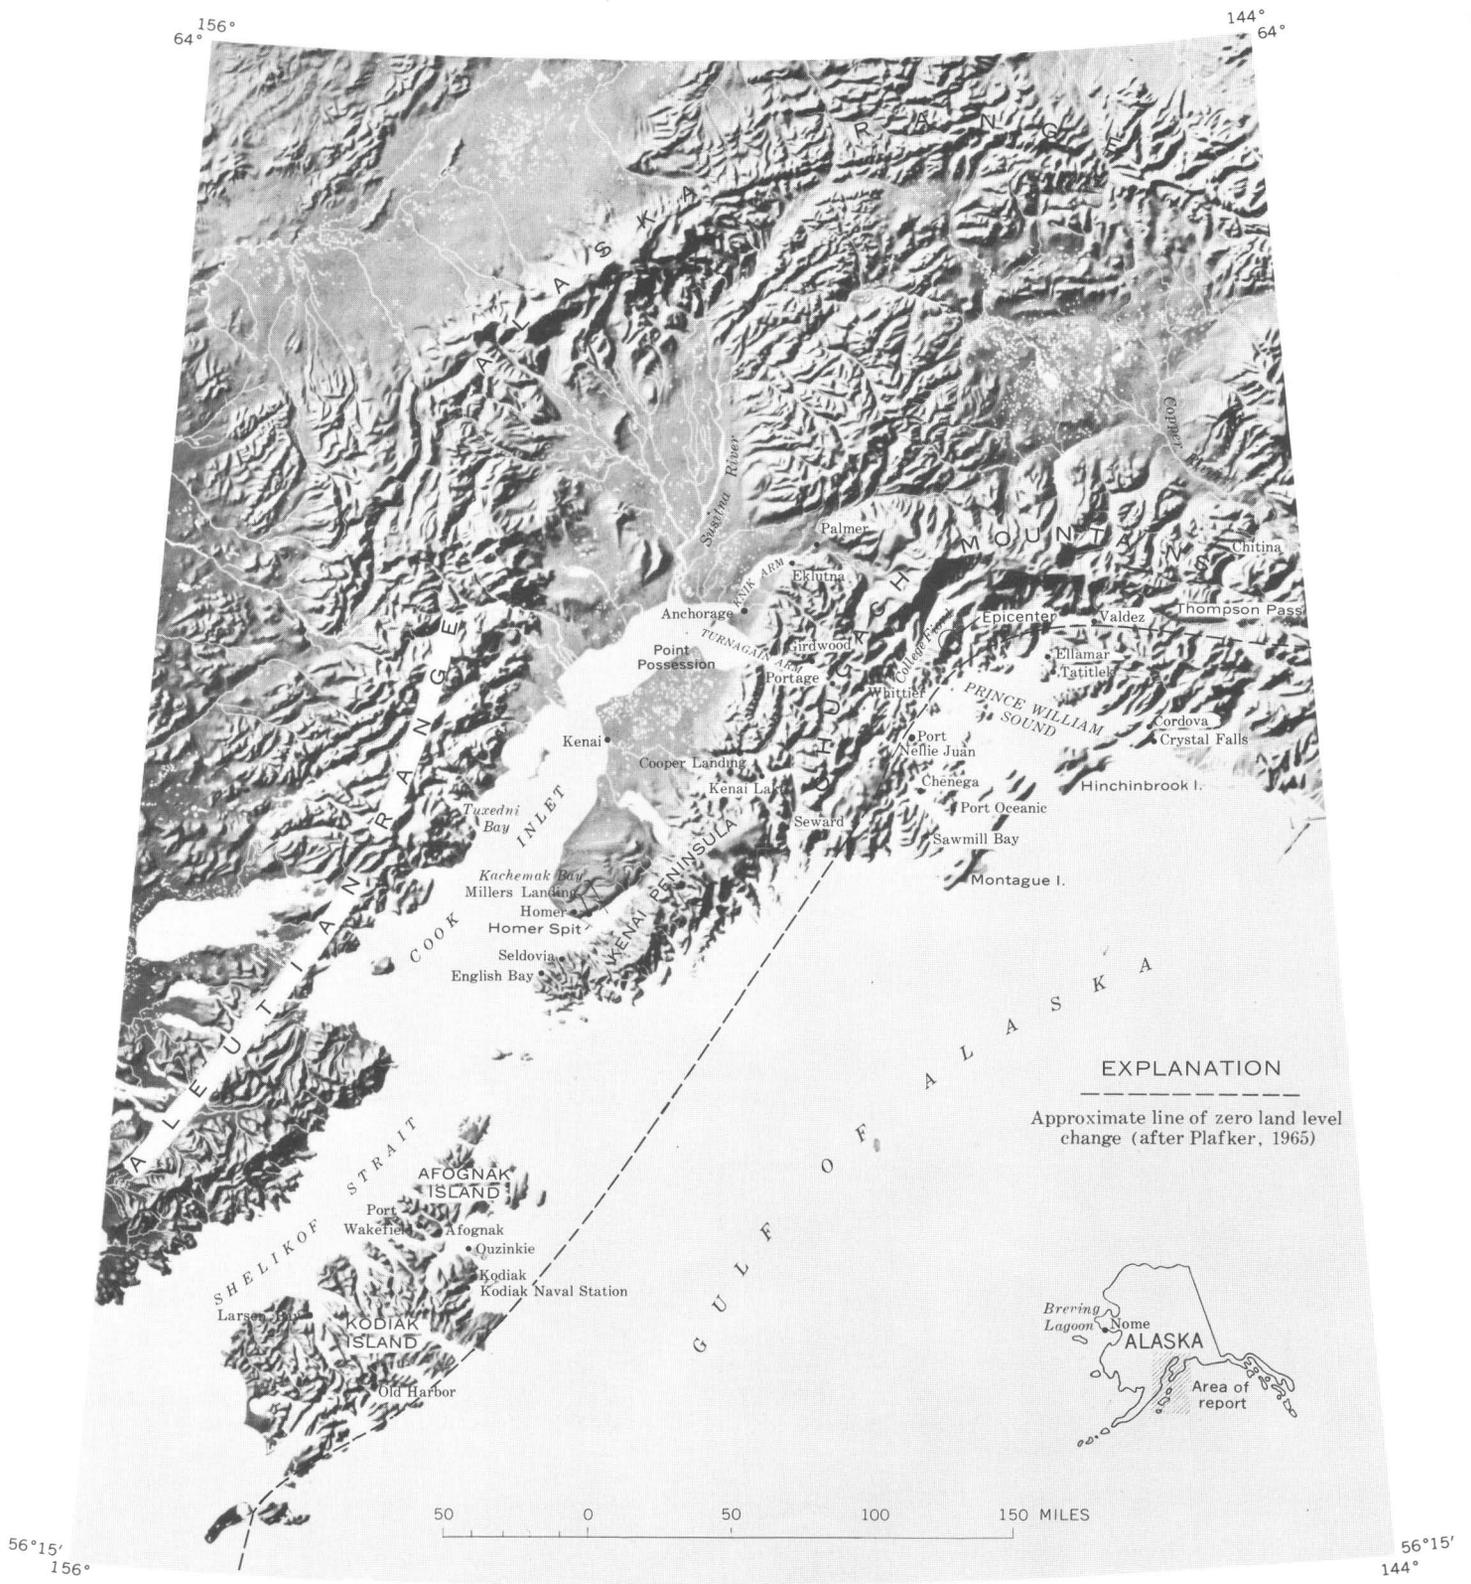
1.—South-central Alaska showing coastlines affected by the earthquake. Land to left of zero land-level change was generally lowered; land to right was raised.

The line of zero land movement, (fig. 1) trends southwest from the epicenter on Unakwik Inlet at the head of Prince William Sound, along the east shore of Kenai Peninsula, to Kodiak Island. West of this line the land subsided; to the east it was uplifted. Anomalous areas of submergence, particularly along deltas and at the heads of bays, occur in both regions and were caused by compaction and settlement of sediments. Compaction of sediments in the uplifted area reduced the overall upward change in some localities; compaction in the subsided areas accentuated submergence.

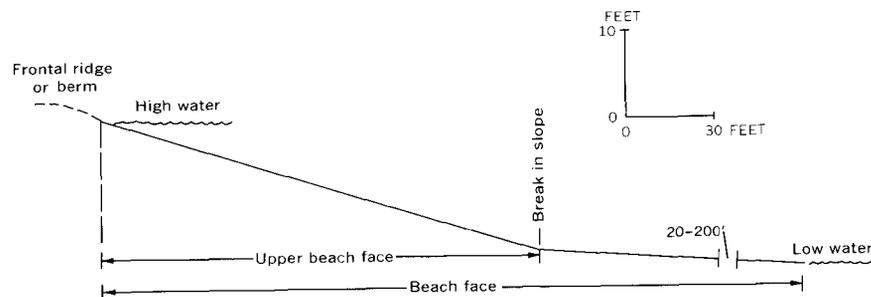
2.—Diagram illustrating beach features.

The beach face is the area between high and low water (fig. 2). It is an ever-changing feature, but normally the changes are subtle and become noticeable only during severe storms.

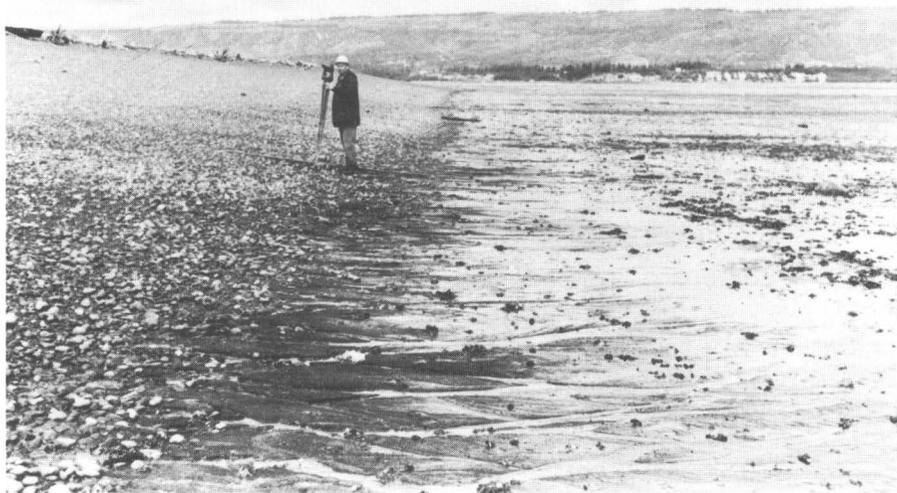
3.—Sharp break-in-slope between upper and lower beach faces extends from mid-foreground to midcenter of photograph, just to right of man. These features, here seen in Kachemak Bay at low tide, are common to many shingle beaches.

ent from 1:8 to 1:30 and are characterized by a break-in-slope 50–200 feet seaward of the high-water line. The break-in-slope marks the location where waves act longest at high tide (King, 1959). The beach face (fig. 2) shoreward of the break (termed the “upper beach face”) has a steeper gradient and coarser material than does the lower beach face. The break-in-slope shown in figure 3 is typical of those on many shingle beaches in Alaska.

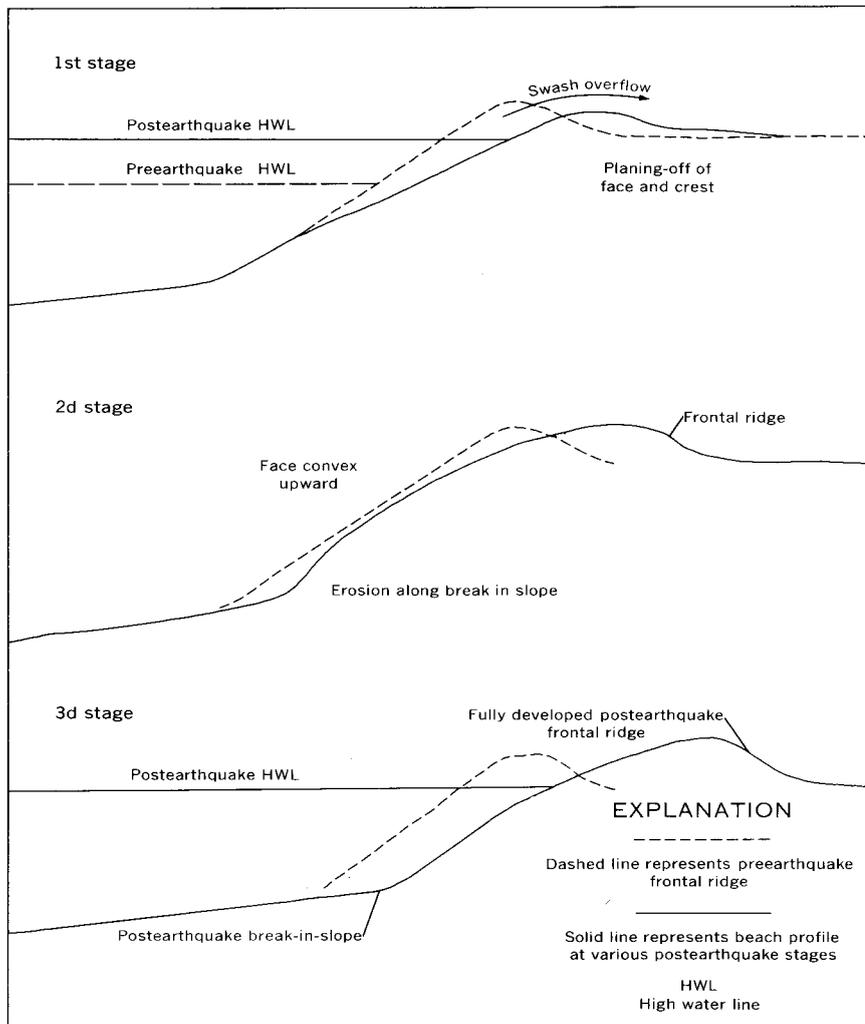
4.—Sketch of three stages that characterized the postearthquake changes of beach configuration in the submergent areas. Sketch is based on behavior of the beach on the Cook Inlet side of Homer Spit, but applies to many other beaches.

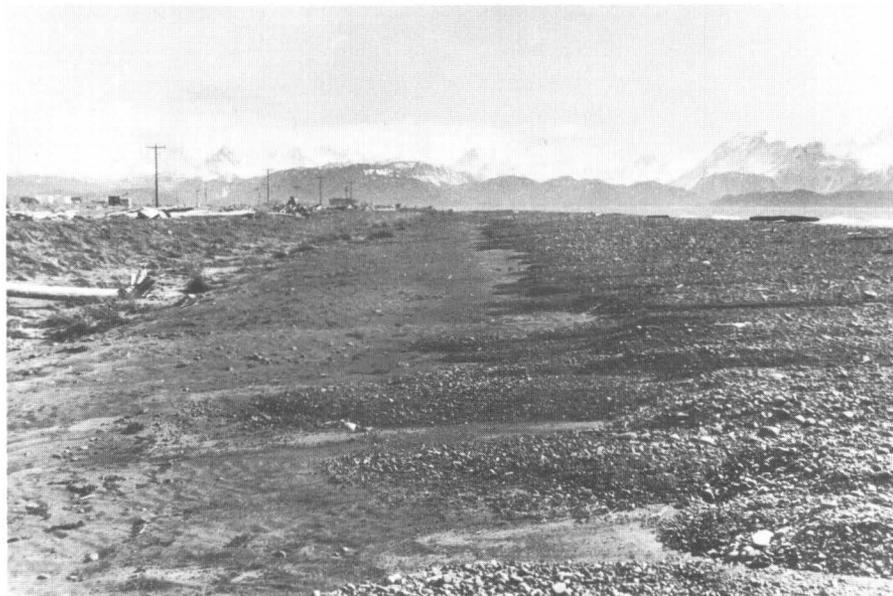
5.—Overflow of the crests of some beaches caused material to be carried and spread out along the backshore, left half of picture. Gradually the material accumulated into a new and higher frontal ridge. View along Homer Spit, looking southeast.

In some areas, such as along Homer Spit, subsidence caused waves to reach as much as 6 feet higher on the beach face than before the earthquake, and swashes overflowed the crest of the frontal ridge. Material along the upper beach face, which was formerly above all but the highest waves and swashes, was scoured and eroded. Part of the eroded material was carried by the swash across the crest of the frontal ridge and deposited along the landward slope (fig. 5).

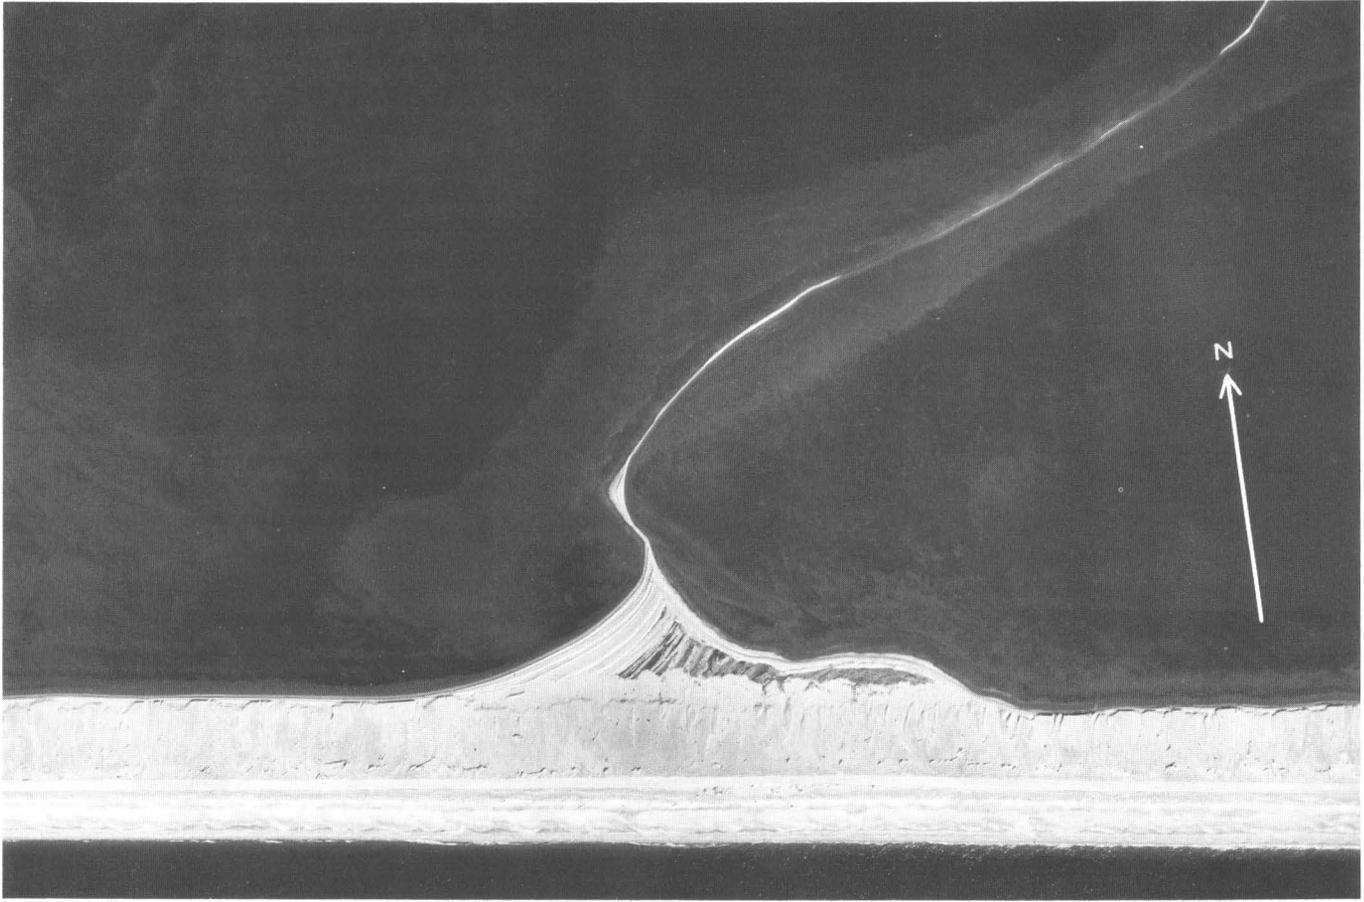
6.—Part of the barrier beach at Breving Lagoon, Seward Peninsula. Lagoon is north of (above) beach; Bering Sea is south of (below) beach. The lagoonward migration of the barrier beach is shown by superposition of the overflow upon the cusped spit. Most beaches in the earthquake-affected part of Alaska migrated landward only short distances because they were backed by land platforms that allowed overwash material to accumulate. Photograph by Alaska Highway Department.

for buildup of material, and landward migration of the beach ridge may continue indefinitely. This condition is exemplified by the barrier beach at Breving Lagoon, on the Seward Peninsula, far from the area where shorelines were affected by the earthquake (fig. 6). This barrier beach has a maximum width of 500 feet and is separated from the mainland by a shallow lagoon as much as a mile across. The beach is migrating landward, apparently because of storm-wave action and the resultant process of overflow. Material eroded by storm waves from the seaward side and transferred by overflow to the landward side of the barrier beach is carried into, and spread out on the floor of, the lagoon. Because the lagoon affords no platform on which overflow material can accumulate there can be no appreciable widening of the barrier beach, and therefore, the height of the beach cannot be increased. Hence under normal storm conditions the beach will continue to migrate landward; the landward migration is not dependent on a rise in sea level.

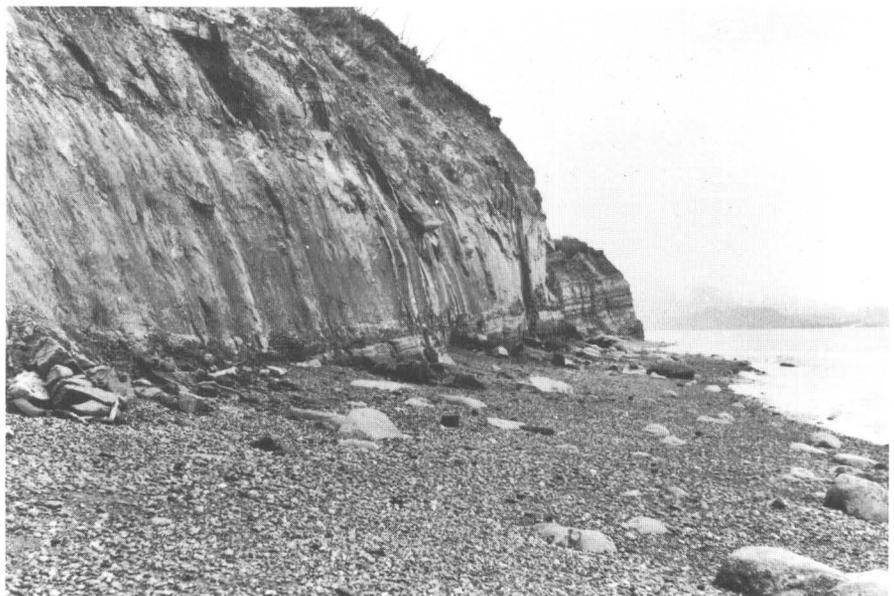
7.—Submergence caused the high-water line to shift to a higher elevation on this beach on the eastern shore of Cook Inlet. The establishment of a new high-water line caused undercutting and sloughing of bluffs. Note absence of beach ridges.

(fig. 7). Thus, the material, instead of accumulating higher on the beach (as it did along Homer Spit) was dissipated by wave action and was transported away from the site by the longshore drift. As the bluffs in such areas erode and recede, the beaches will eventually regain their preearthquake widths, and new beach ridges similar to those that existed before the earthquake should develop.

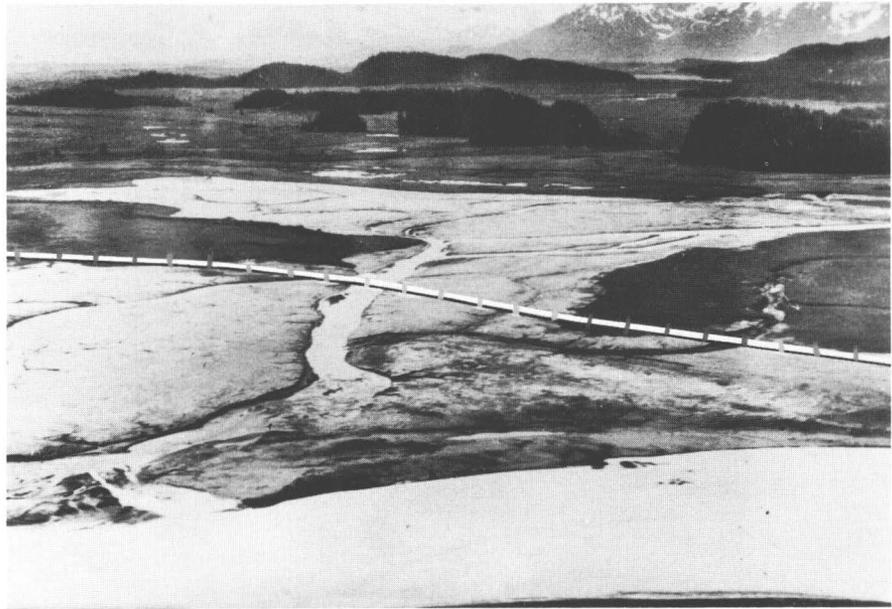
8.—Tectonic uplift created new lands permanently above high water, such as this area along the Copper River Delta. View at high tide, several months after the earthquake. The preearthquake high-water line is shown approximately by the dashed line. Photograph by U.S. Forest Service.

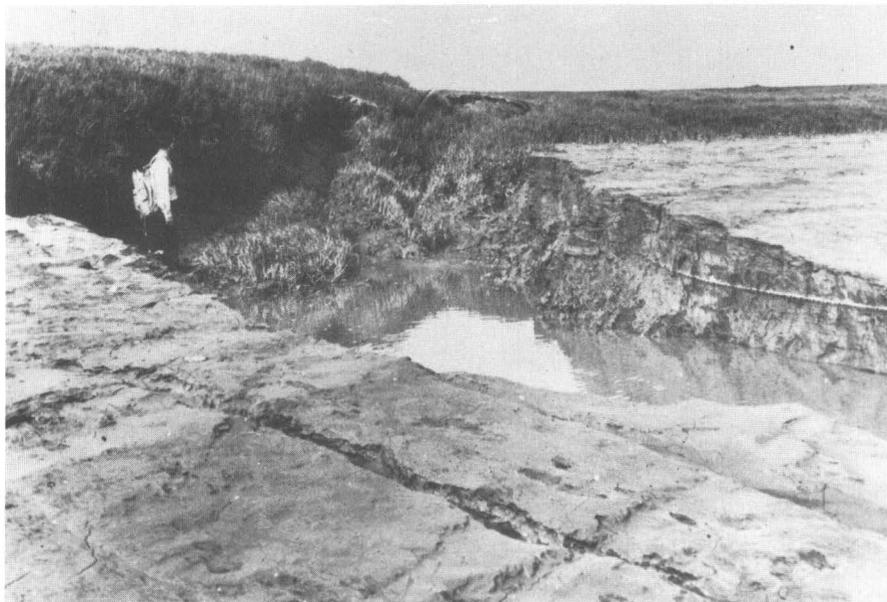
9.—Rapid gullying and sloughing caused by headward stream erosion along the uplifted coast on the Copper River Delta. Photograph by U.S. Forest Service.

Along appreciably uplifted shorelines composed of sand and silt, rapid gullying occurred at stream mouths (fig. 9). Along the Copper River Delta, an area of readily eroded sand and silt that was uplifted several feet, gullying commenced within hours after uplift (Reimnitz and Marshall, 1965). Rapid headward erosion produced small waterfalls 1–2 feet high.

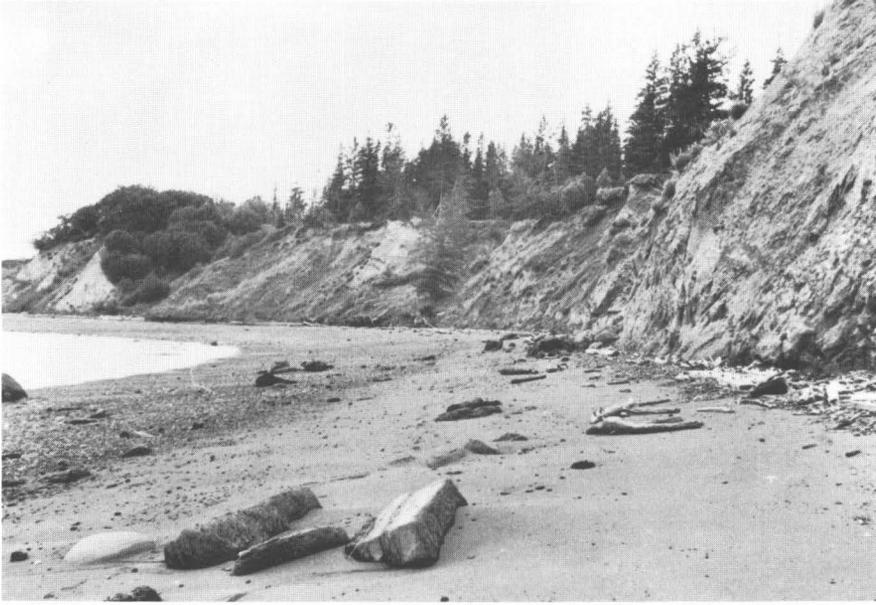
10.—Undercutting and sloughing of bluffs caused by tectonic subsidence, eastern shore of Cook Inlet. Driftwood along toe of bluff indicates the position of post-earthquake high-water line.

During the earthquake the shoreline subsided as much as $3\frac{1}{2}$ feet along the southern section near Homer and as much as 1 foot near Point Possession at the mouth of Turnagain Arm. Prior to submergence the width of beach between the high-water line and the toe of the bluff was generally less than 100 feet, and in some areas less than 20 feet. Submergence decreased these widths and, after the earthquake, storm waves, particularly along the southern section, acted directly upon the toes of the bluffs. Many beach ridges that had previously protected the toes of the bluffs were exposed to waves of even, moderate height (fig. 10).

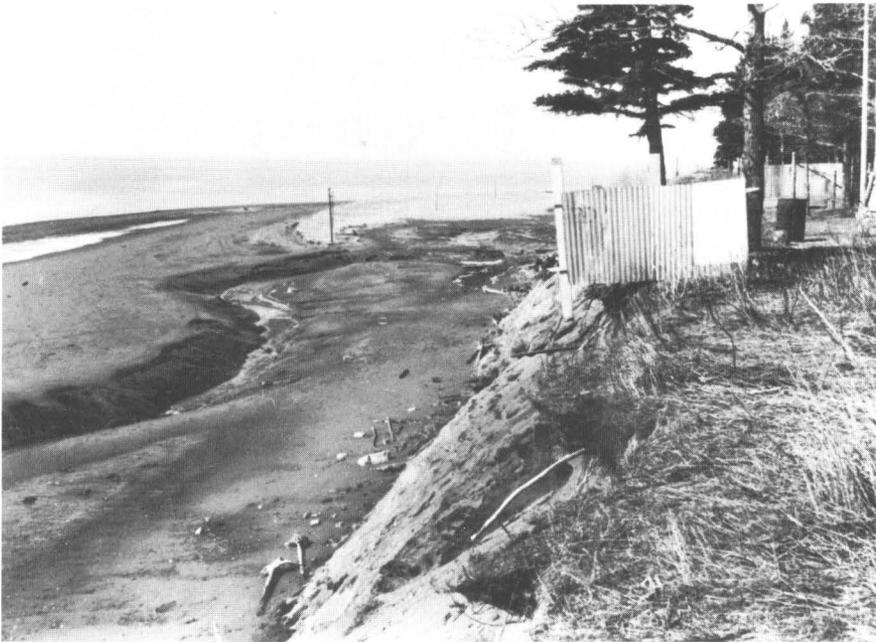
11.—Serious bluff erosion caused by subsidence along the waterfront of the town of Kenai. View looking northwestward, about 30 days after the earthquake.

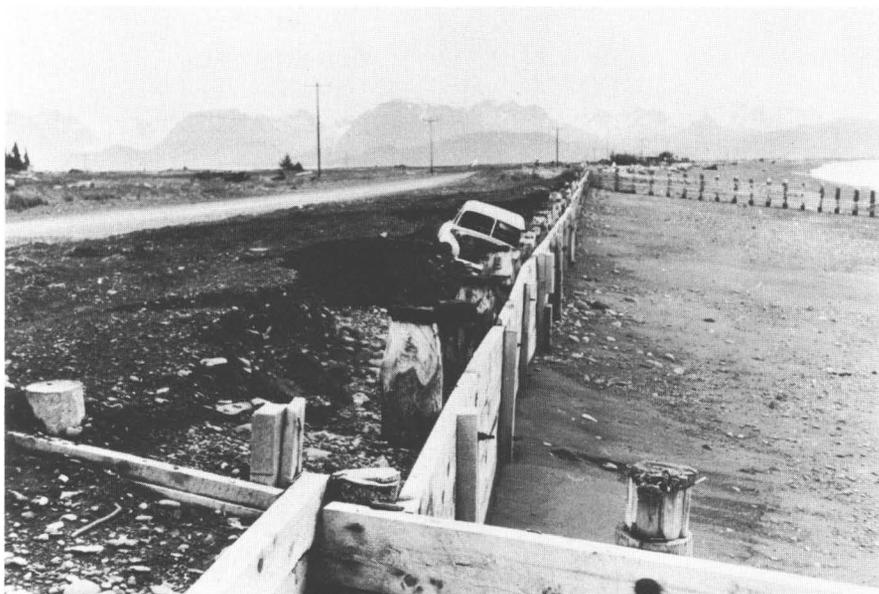
12.—Timber seawall and new groins along west side of Homer Spit as constructed 3½ months after earthquake-caused subsidence.

Except at Homer and a few small villages, no serious effort has been made to construct erosion-preventive works anywhere in the earthquake-affected area. Along the Cook Inlet side of Homer Spit, erosion on the lee side of the groin farthest downdrift became critical. Retreat of the beach was jeopardizing the spit highway. In July 1964, a seawall and two additional groins were constructed. Two hundred feet of the wall was constructed to a height of 1–2 feet above the high-water line, and one section was built 5 feet higher above the high-water line. Figure 12 shows the timber bulkhead and the additional groins a short time after construction. Figures 13 and 14 show the same area 6 and 16

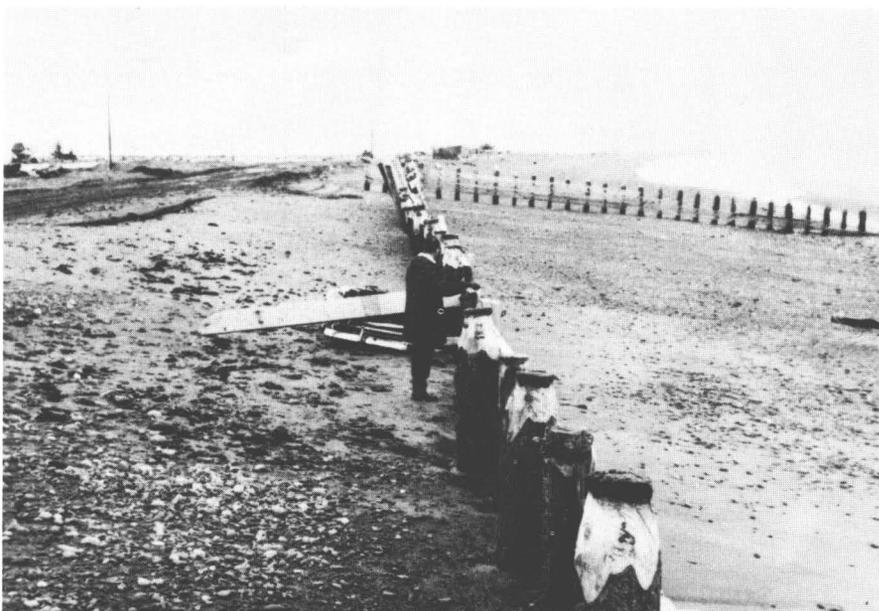
13.—Seawall shown in figure 12, approximately 6 months after construction.

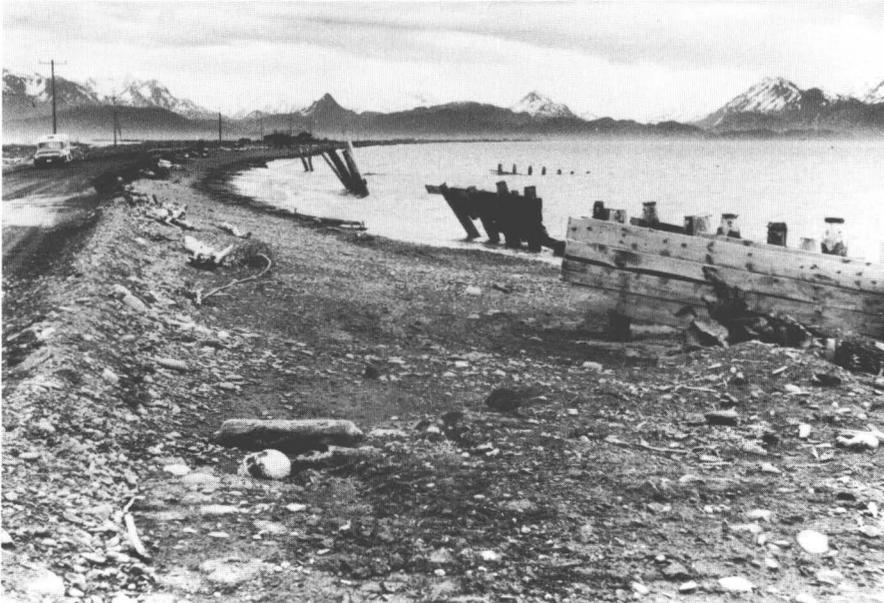
14.—Seawall shown in figure 12 some 16 months after construction. Note that the bulkhead and one of the groins were completely destroyed during this period owing to their excessive height.

months later, respectively. Sixteen months after construction, the high timber bulkhead between the fifth and sixth groin had been destroyed, as had the last groin (fig. 14). Similar high bulkheads were

constructed in other areas but most were destroyed within several months, or at most within a year, after the earthquake. Failure is attributed to the fact that the bulkheads were too high and were

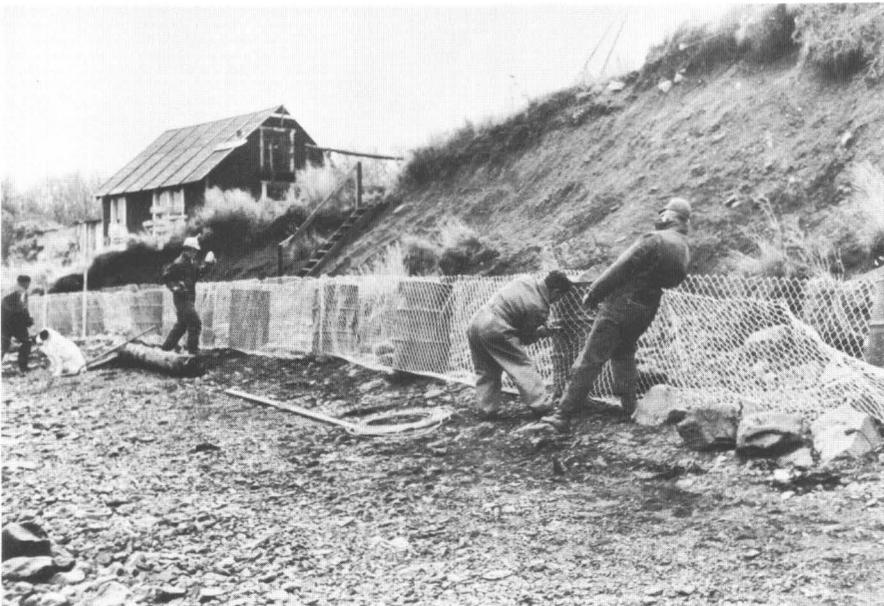
15.—Cobble-filled wire-mesh fence under construction at Larsen Bay, Kodiak Island, shortly after the earthquake and resultant subsidence of 2 feet. Most of the fence was destroyed by a storm before it could be completed.

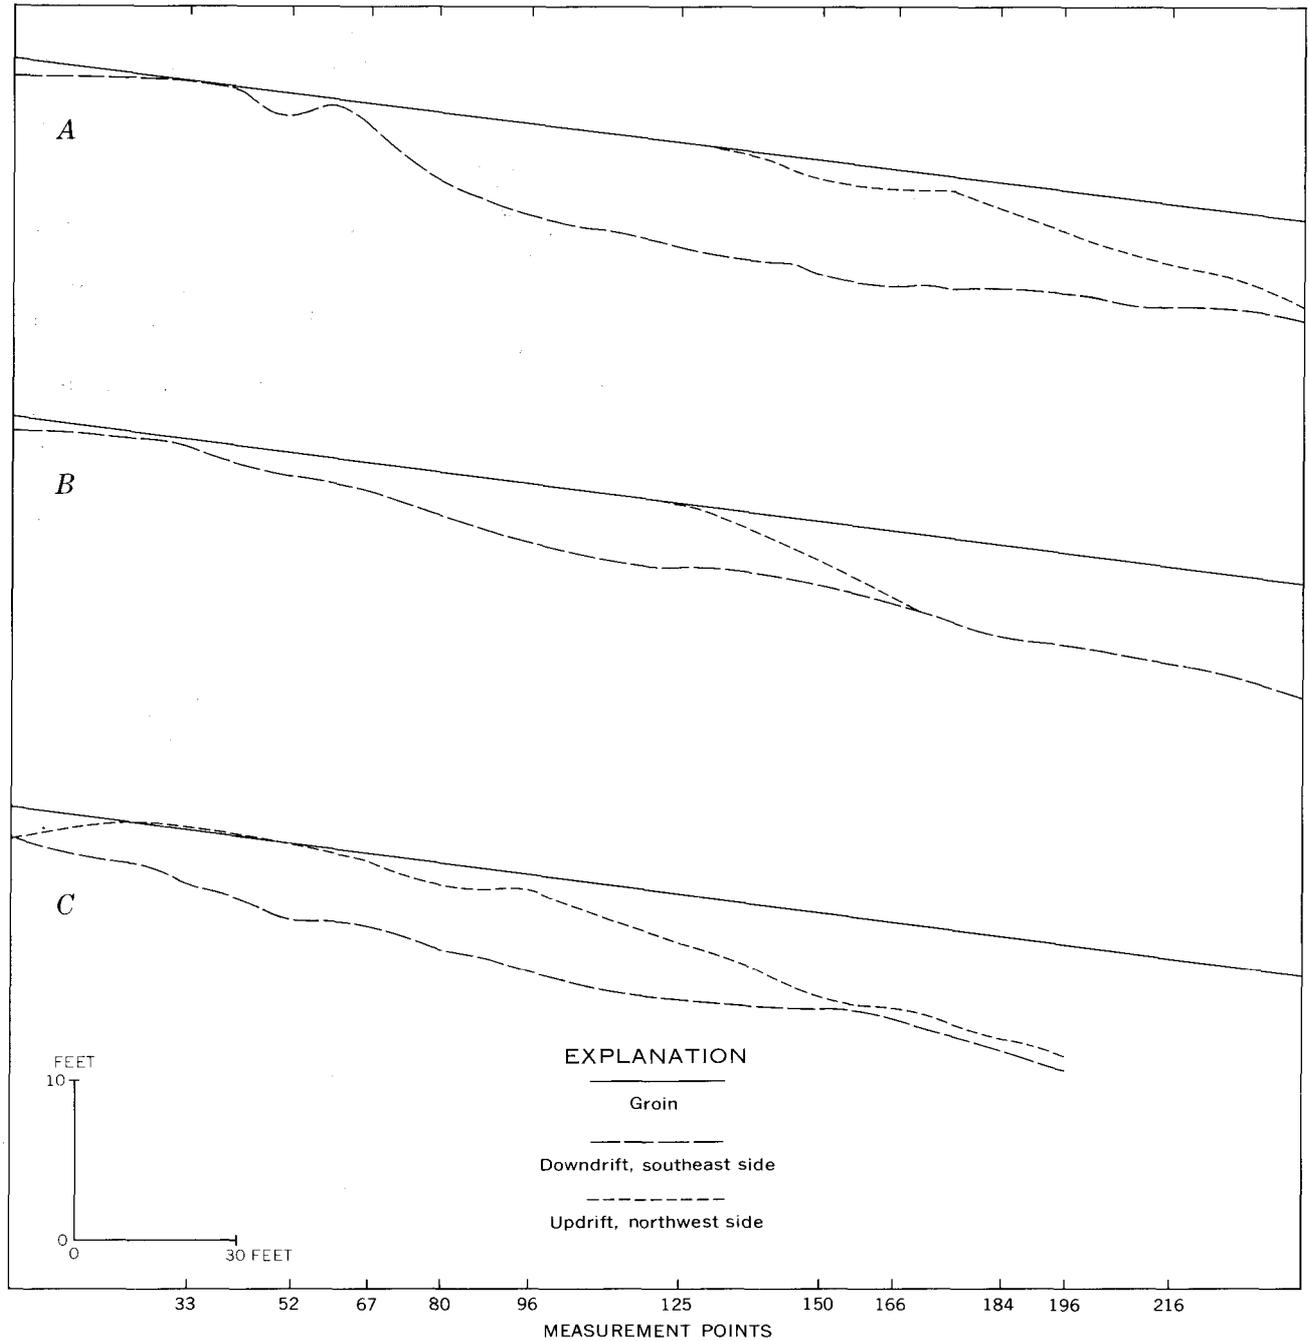
16.—Profiles of updrift and downdrift fill of groin at Homer Spit, measured (A) on March 2, 1964, a few weeks prior to the earthquake; (B) on August 28, 1964, 4 months after submergence; and (C) on September 30, 1965, 18 months after submergence. The change in configuration of the groin fill was caused by submergence and the resultant higher level of water on the fill. Note, however, that the gradient at 18 months approximates the preearthquake gradient.

in some areas, but no direct effect, such as the formation of new berms by the deposition of the material, was observed along beaches until several weeks after the earthquake. A good example of the effect of a delayed longshore drift is described by Stanley (in Waller, 1966a, p. D24). At Homer Spit the additional quantity of material that had entered the longshore drift in the source area, 2–6 miles west of the spit, did not reach the spit until about 30 days after the earthquake.
