The Alaska Earthquake

March 27, 1964

Effects of the Earthquake Of March 27, 1964, on Air and Water Transport, Communications, and Utilities Systems In South-Central Alaska

GEOLOGICAL SURVEY PROFESSIONAL PAPER 545-B

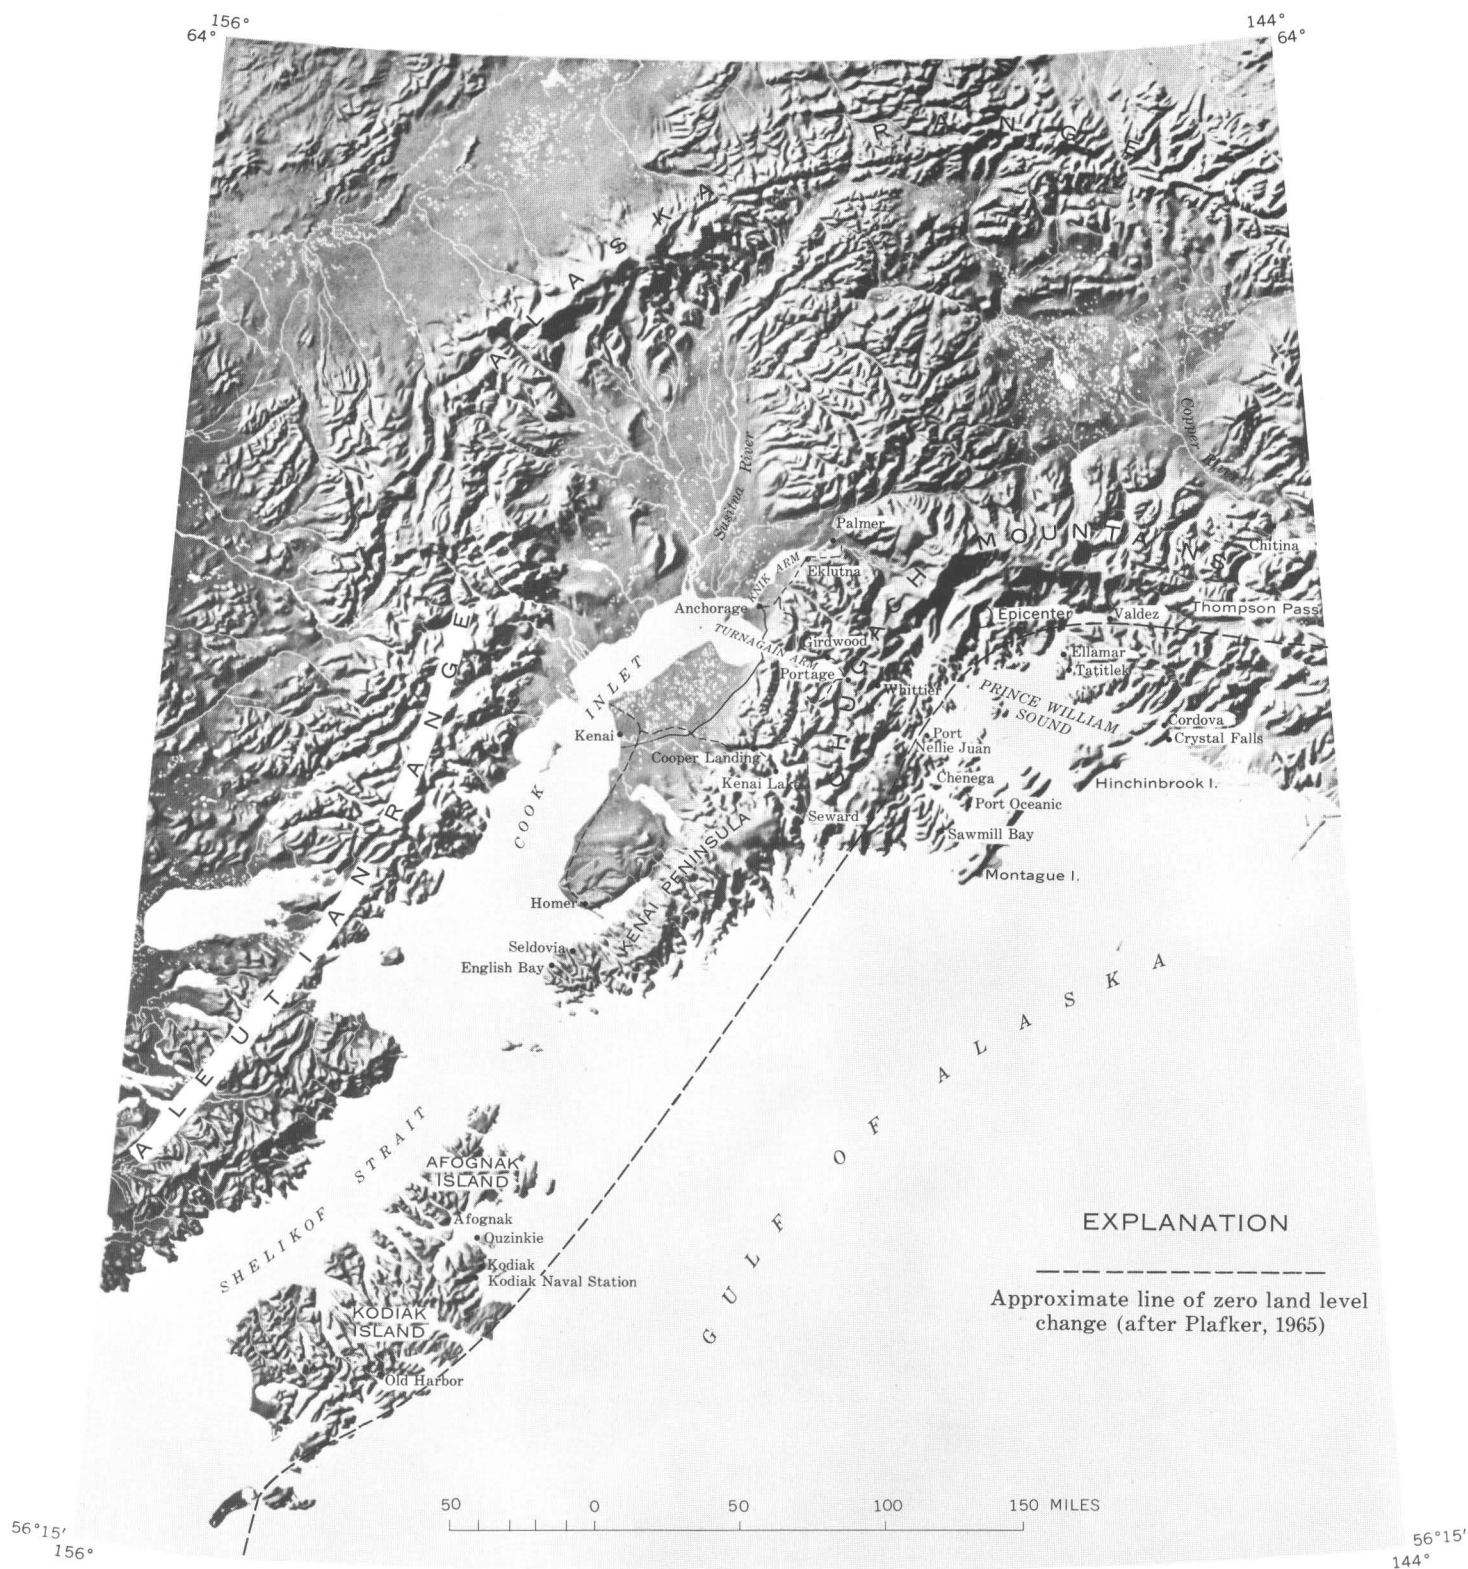
1.—South-central Alaska, showing main power (short-dashed) and gas-transmission (solid) lines and principal communities whose ports, airports, or utility systems were damaged by the earthquake. Land to left of zero land level change line was generally lowered; land to right of line was raised.

The tectonic uplift that affected most of the Prince William Sound area resulted in shoaling of waters that had been navigable before the earthquake (fig. 1); during the first weeks after the quake some small craft were grounded or damaged by hidden rocks or were stranded by low tides. At least one cannery in the area of uplift—the Crystal Falls cannery at Mountain Slough, not far from Cordova—became inaccessible to fishermen and was declared a total loss (Alaska Dept. Fish and Game, 1965).

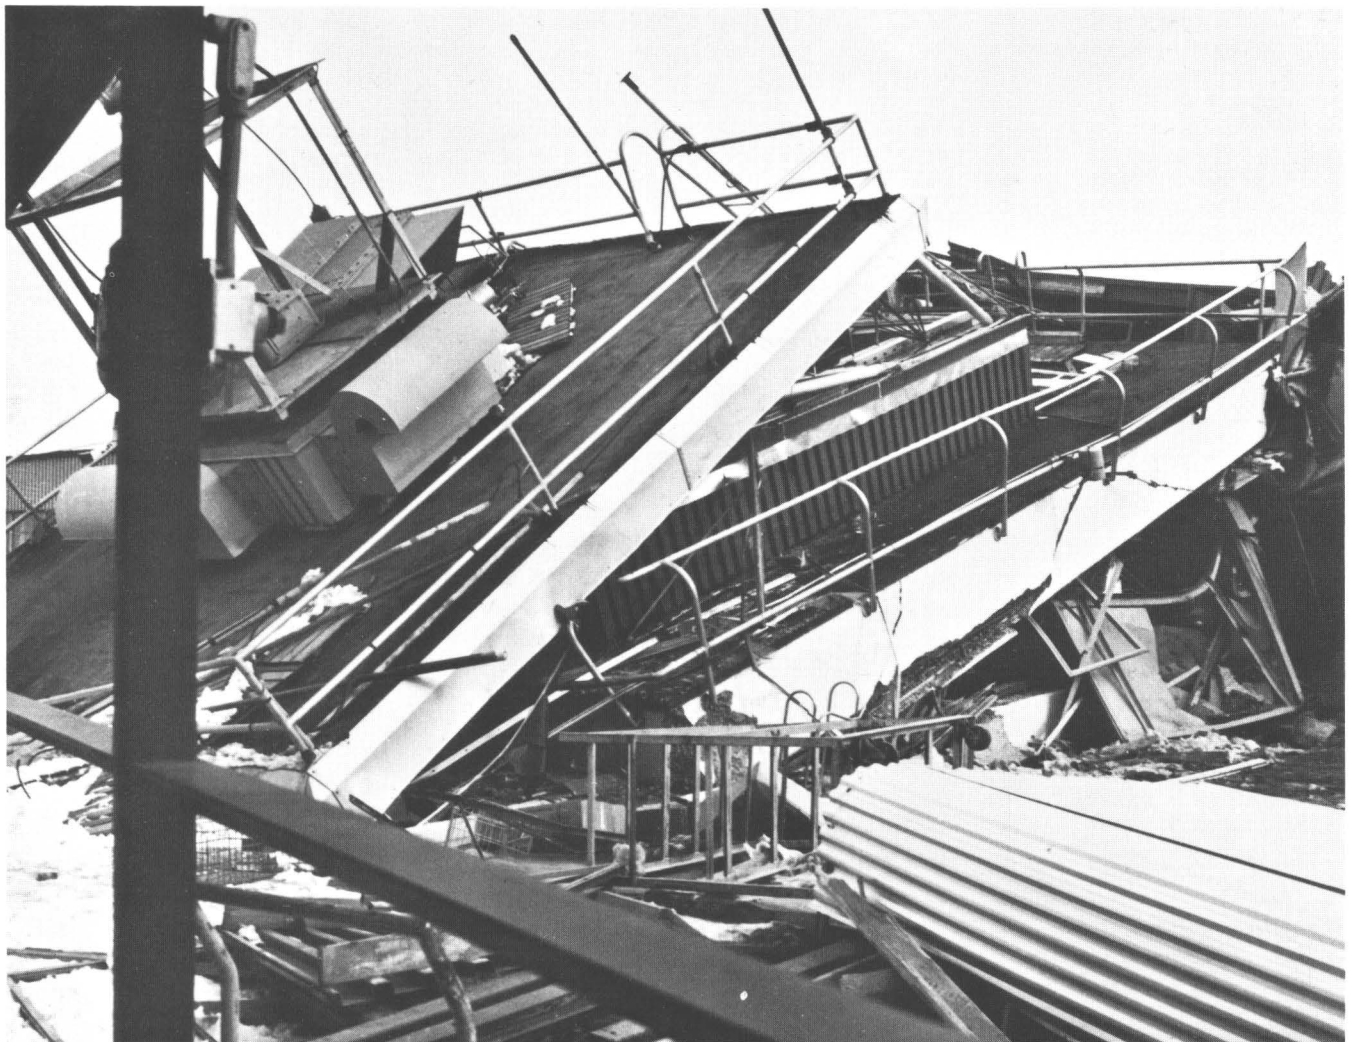
2.—Control tower at Anchorage International Airport, collapsed by earthquake shaking. Photograph by Federal Aviation Agency.

were damaged and their utilities disrupted by seismic shaking. The wrecked control tower at Anchorage International Airport was one of the greatest single losses, caused by vibration, that directly affected the aviation system (figs. 2, 3). Some subsidiary buildings, however, such as the military hospital at Elmendorf Air Base, sustained greater damages in terms of total repair costs. Many runways, aprons, and taxiways were cracked and made uneven by shaking and the resultant differential consolidation of alluvial materials or artificial fill. Hangars, seaplane ramps, and parts of the runways at Kodiak Naval Station were flooded by a series of seismic sea waves, and a few smaller airstrips were either destroyed by waves or were subjected to partial flooding by high tides due to regional subsidence. Despite all these difficulties, total damage to Alaska's air facilities amounted to only a few million dollars, as compared with more than \$100 million worth of damages to the water, rail, and highway systems. More significant than the relatively small dollar losses, perhaps, is the fact that nearly all air facilities were partly or wholly operational within a few hours after the earthquake. This made possible the enormous air transport of people, food, and supplies that were required at once.

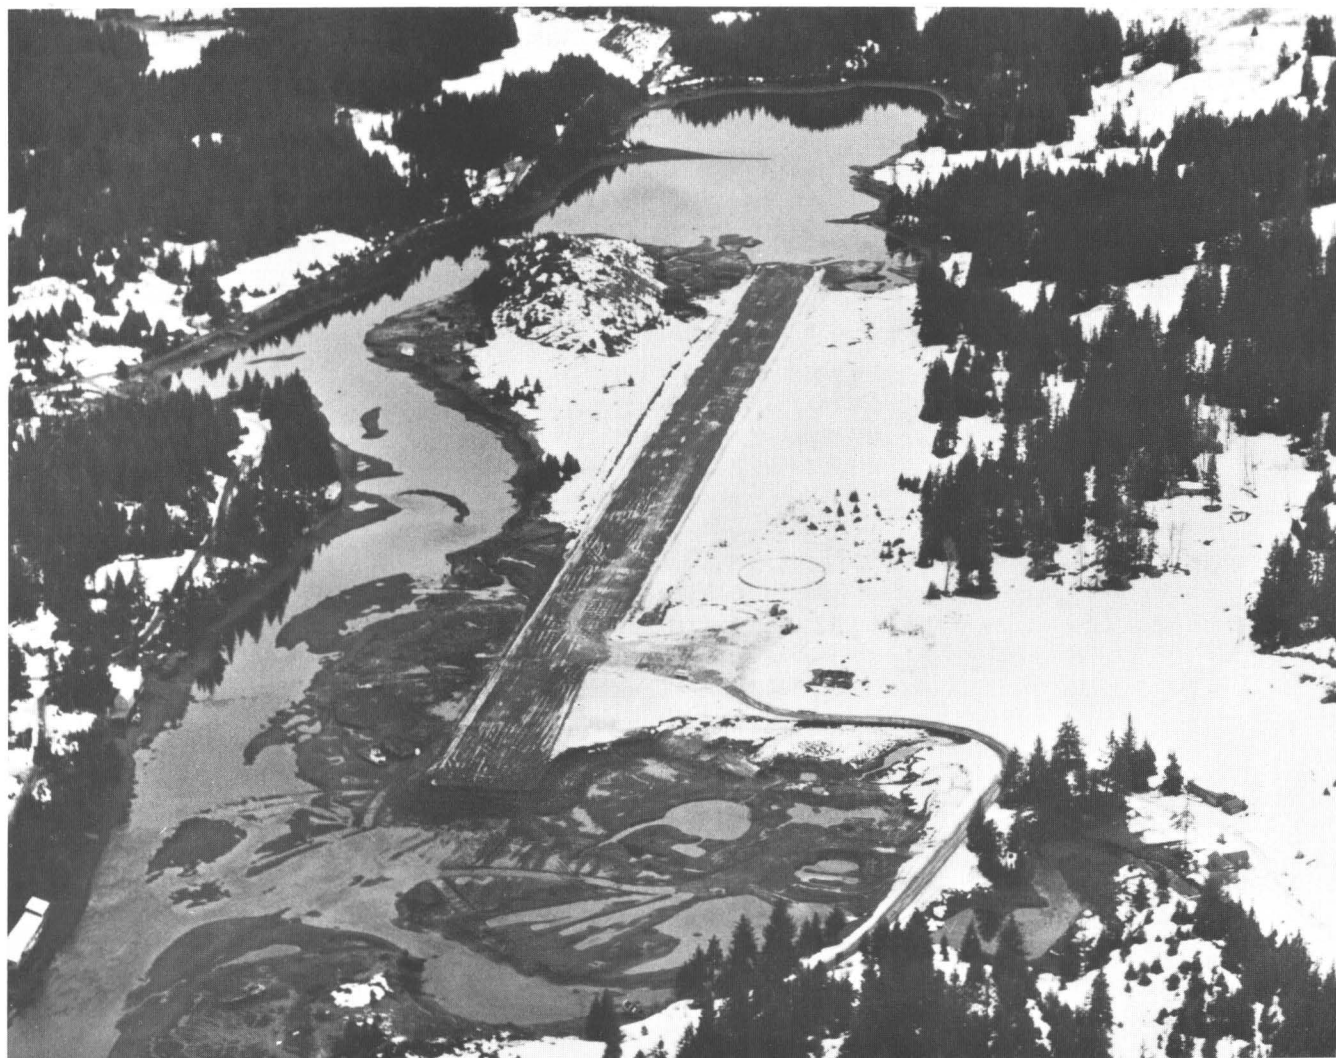
4.—Tectonic subsidence required raising of airstrip at Seldovia. U.S. Army photograph.

be built up as much as 4–5 feet, at an estimated cost of \$600,000, to raise the strip above tide level (fig. 4). Runways at Ninilchik, Kenai, Soldatna, and Hope sustained minor cracks. The airport at Homer was undamaged, but new construction work there was delayed, and made more costly, when the once-ample source of gravel on Homer Spit became difficult to obtain because of tectonic subsidence and consolidation of the spit materials. The only undamaged airstrip on the Kenai Peninsula was the one at Lawing.

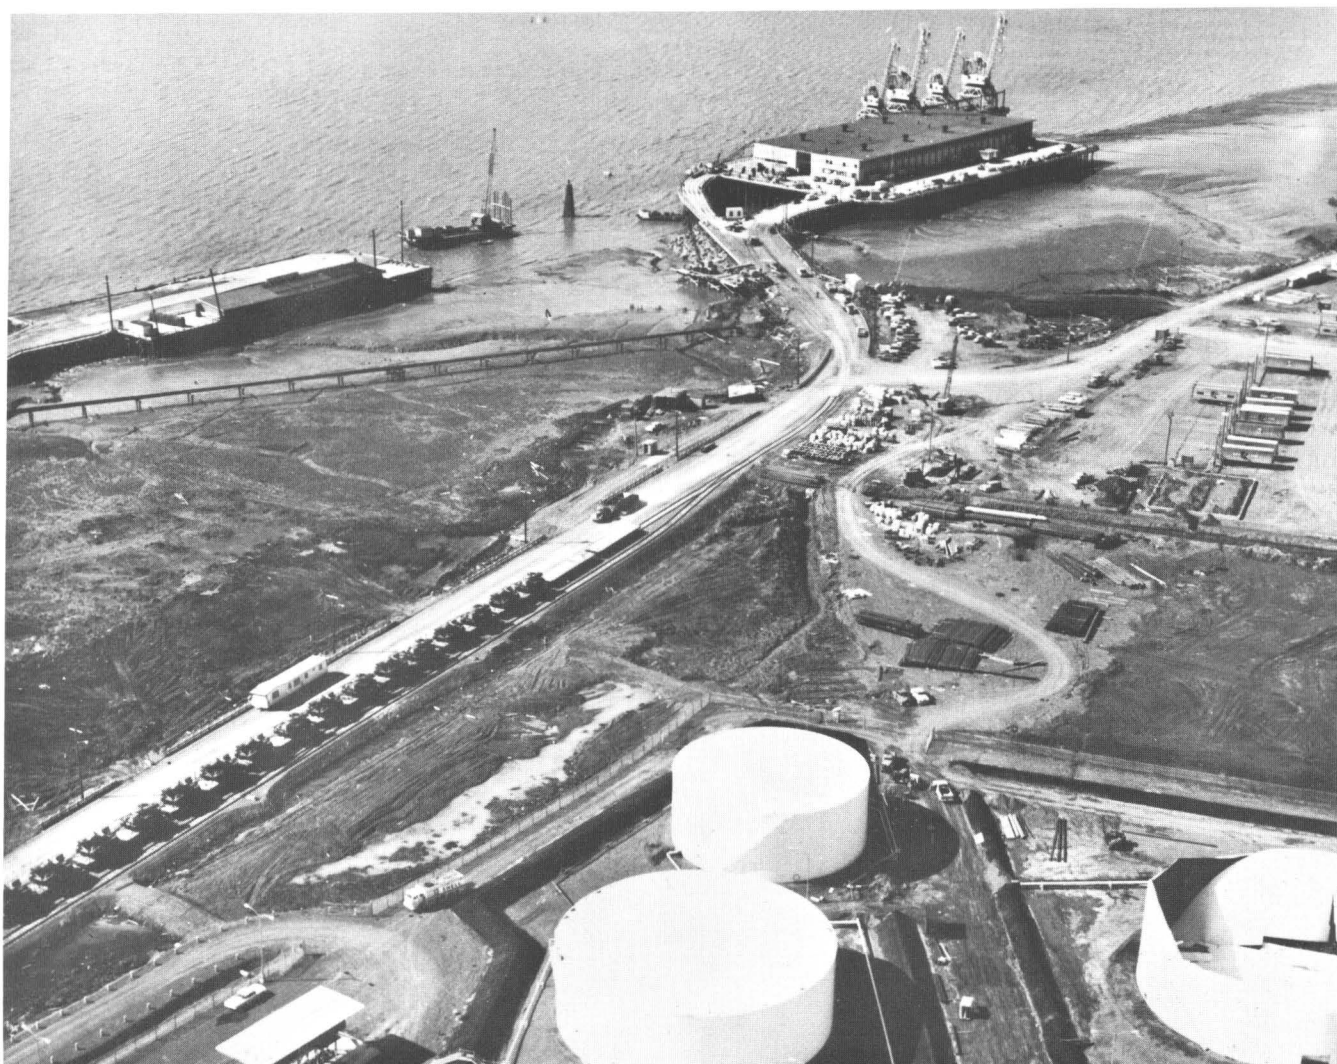
5.—Anchorage municipal wharf area shortly after the earthquake, at low tide. The main dock was only slightly damaged, but the older Army dock (upper left), was ruined. Vibration and ground fractures damaged some structures in the port area, including the petroleum tank (lower right). U.S. Army photograph.

The municipally owned Anchorage wharf is the largest port structure (fig. 5). It consists of two adjacent reinforced-concrete docks on concrete-filled tubular piles. The joint between the two docks was opened 4–12 inches; all four cranes were shaken off their tracks, and their undercarriages and counterweight arms were damaged. The steel-frame transit shed was cracked and twisted but only to a minor degree. Some steel piles broke at their caps; battered H-piles were sprung out of line when the main dock structure shifted its position (Berg and Stratta, 1964; Alaska Construction Consultant Committee, 1964).

The so-called old Army Dock (fig. 5), a timber structure that was already much deteriorated, was made unusable for offloading of private and military petroleum supplies; a temporary petroleum dock was built to replace the old Army Dock, but it was severely damaged by ice and did not last through the following winter. Petroleum pipelines and approach roads and rail lines were broken or twisted by settlement and vibration. A cement bin, 30 feet high and 30 feet in diameter, collapsed on its pedestal. The walls of several petroleum storage tanks developed bulges at ground level. Berg and Stratta (1964) suggested that the bulges may have been caused by an earthquake-induced swirling of the tank contents, which in turn induced large vertical forces acting over a small zone at the base of the cylinder.

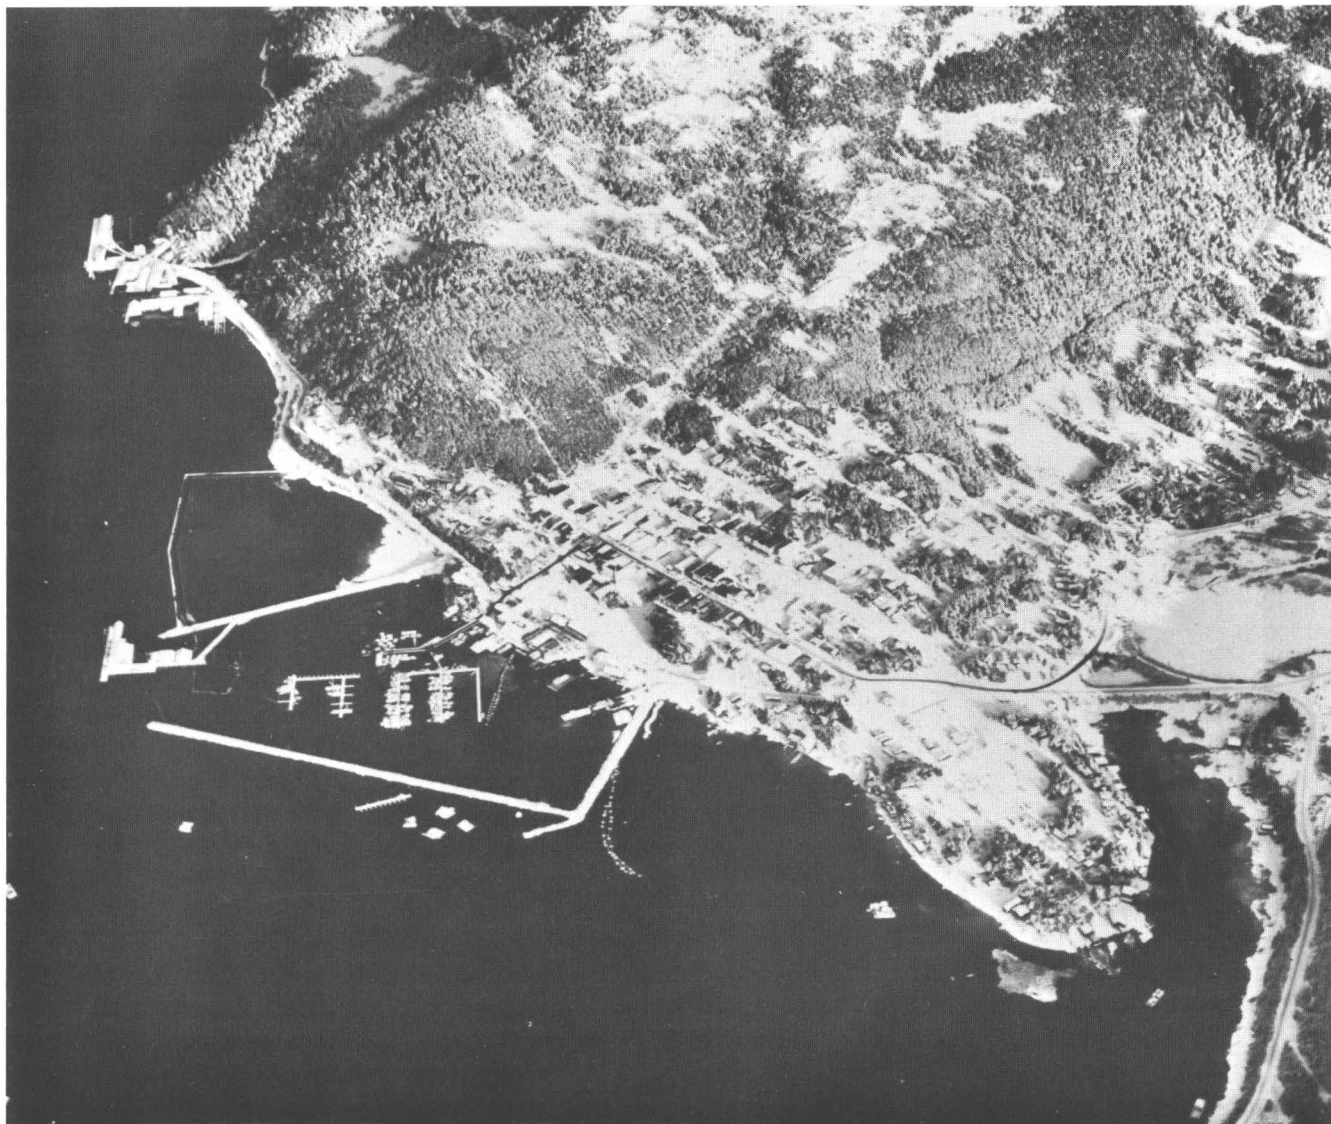
6.—Cordova harbor as it appeared in February 1965. Tectonic uplift left docks inaccessible to ships except at very high tides. Reconstruction involved dredging of harbor and rebuilding of docks and small-boat basin. U. S. Army photograph.

The Cordova area was raised about 6 feet by tectonic uplift, and the docks were thereby made inaccessible to ships except at very high tides. The deck of the main city dock was lifted and displaced by seismic sea waves and was battered by ships tied up to it. The ferry terminal dock was also damaged by waves, but these damages were insignificant

improvement of existing facilities rather than replacement of damaged facilities (Alaskan Construction Consultant Committee, 1964; Anchorage Daily Times, March 26, 1965). The Cordova canneries had to extend their docks an average of 110 feet to reach water depths equal to those which prevailed before the earthquake.

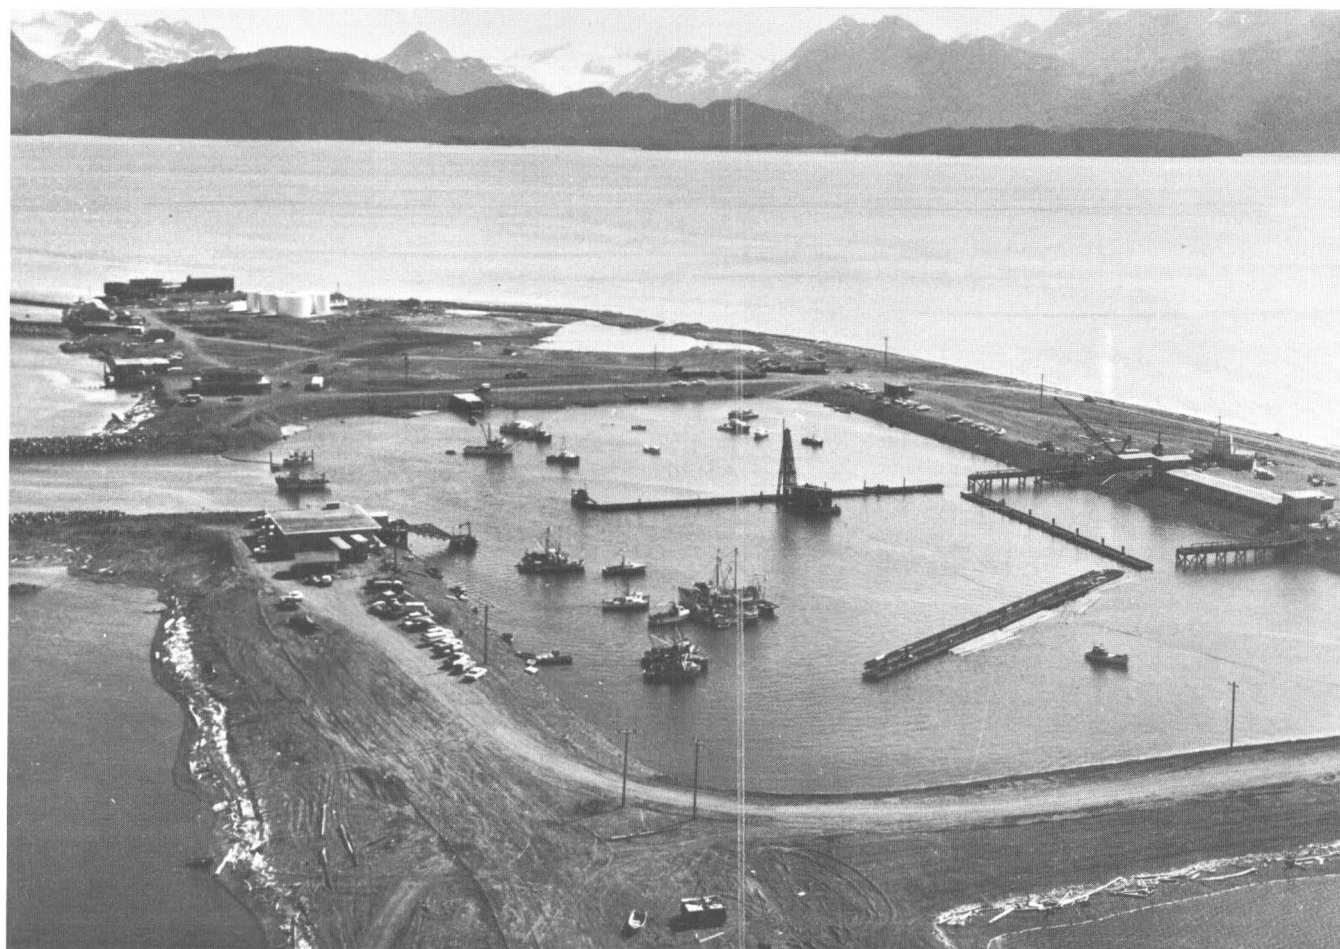
7.—New small-boat basin, excavated in end of Homer Spit. Former basin, on left side of the spit, was destroyed by a small offshore slide. The fact that the entire end of the spit is submerged by high tides because of tectonic subsidence and compaction necessitates dikes around new basin. U.S. Army photograph.

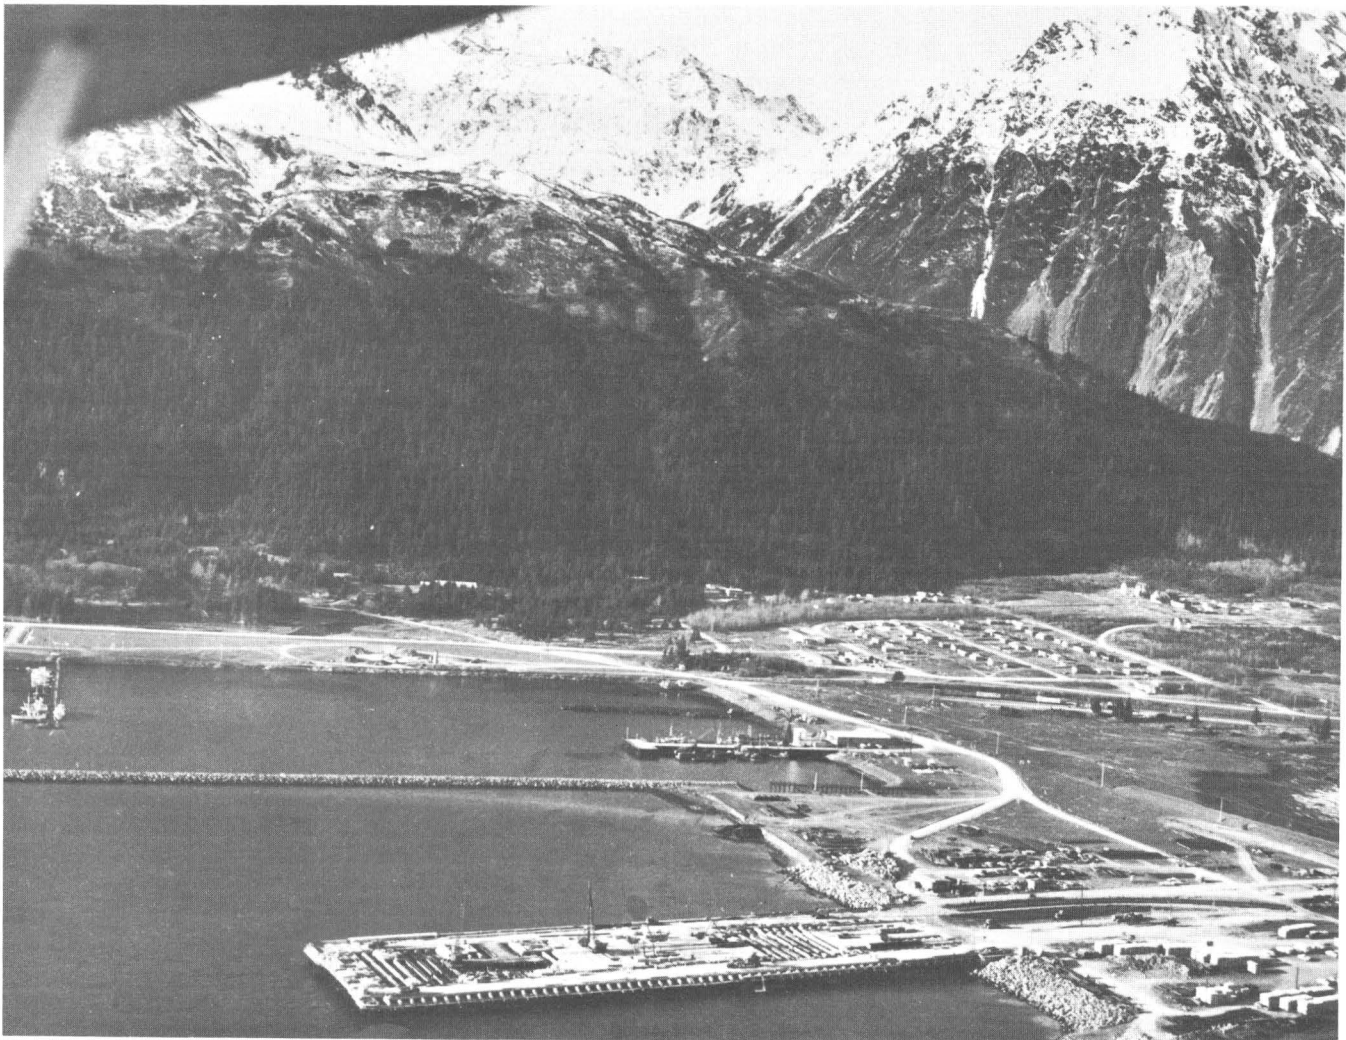
8.—Part of new small-boat basin and nearly completed railroad dock at Seward, November 1965. All former Seward waterfront facilities (to left of picture) were destroyed by submarine slides, waves, and fire. U.S. Army photograph.

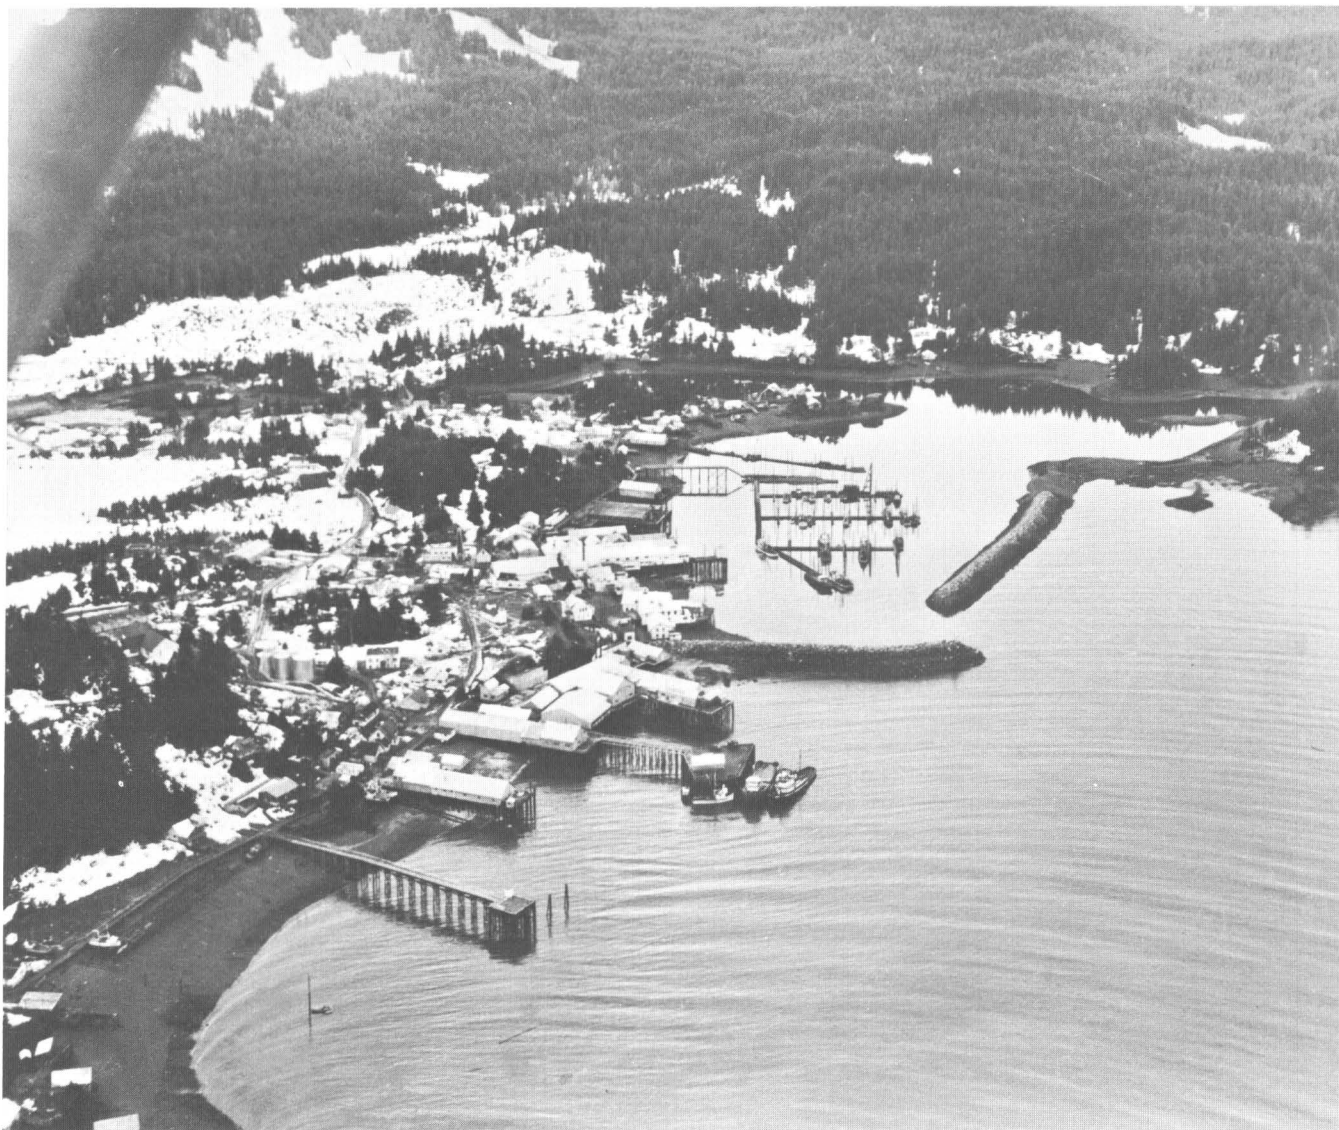
9.—Seldovia at low tide in March 1965, with raised breakwater and small-boat basin in use. Tectonic subsidence submerged boardwalk (curving structure at shore end of docks in foreground) at high tide. The boardwalk has been replaced on new fill. Urban renewal project will alter buildings and utilities to conform with higher water levels. U.S. Army photograph.

protected harbor between Seward and Anchorage that can accommodate ocean vessels (fig. 1). Tectonic subsidence lowered the area about 3.5 feet so that most harbor facilities, including the mile-long boardwalk on which the business section of the town is built, were awash at high tides. The Corps of Engineers built a new breakwater, raised the docks, and restored the small-

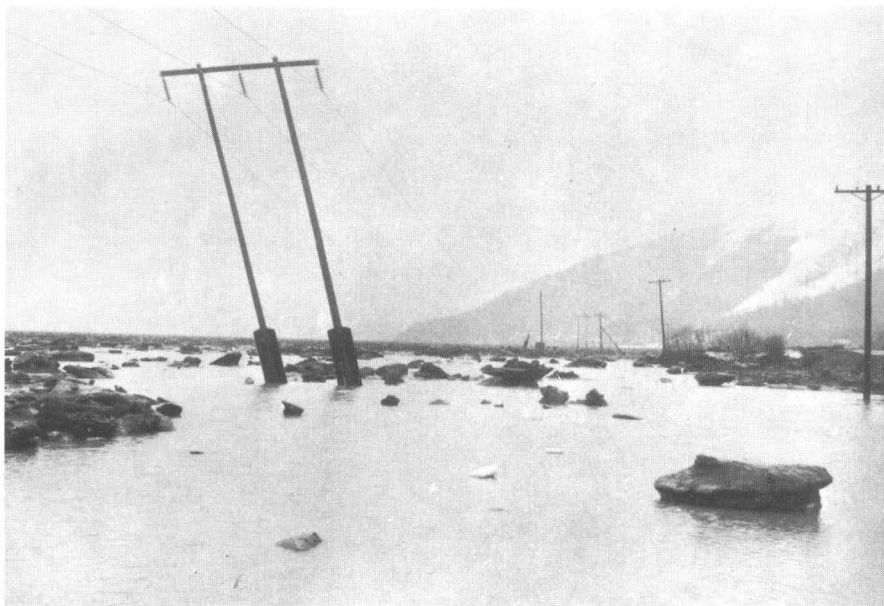
12.—Power and telephone poles along Turnagain Arm were tipped when the silt in which they were embedded was liquefied by earthquake vibrations. Photograph by Chugach Electric Association, Inc.

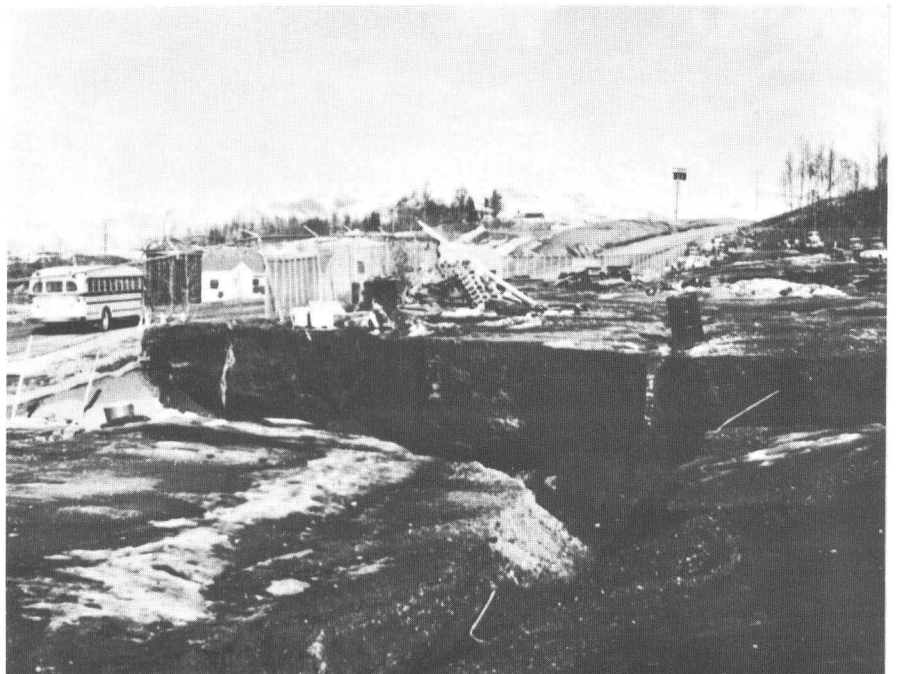
15.—Twelve-inch gas main, supplying fuel for municipal powerplant, was ruptured by landslide at Third Avenue and Post Road, Anchorage. Photograph by W. J. Stump.
