MAP OF GROUND CRACKING, FLOODING, AND AVALANCHES ON HUNTER FLATS, ALASKA,
THAT RESULTED FROM THE MARCH 27 EARTHQUAKE

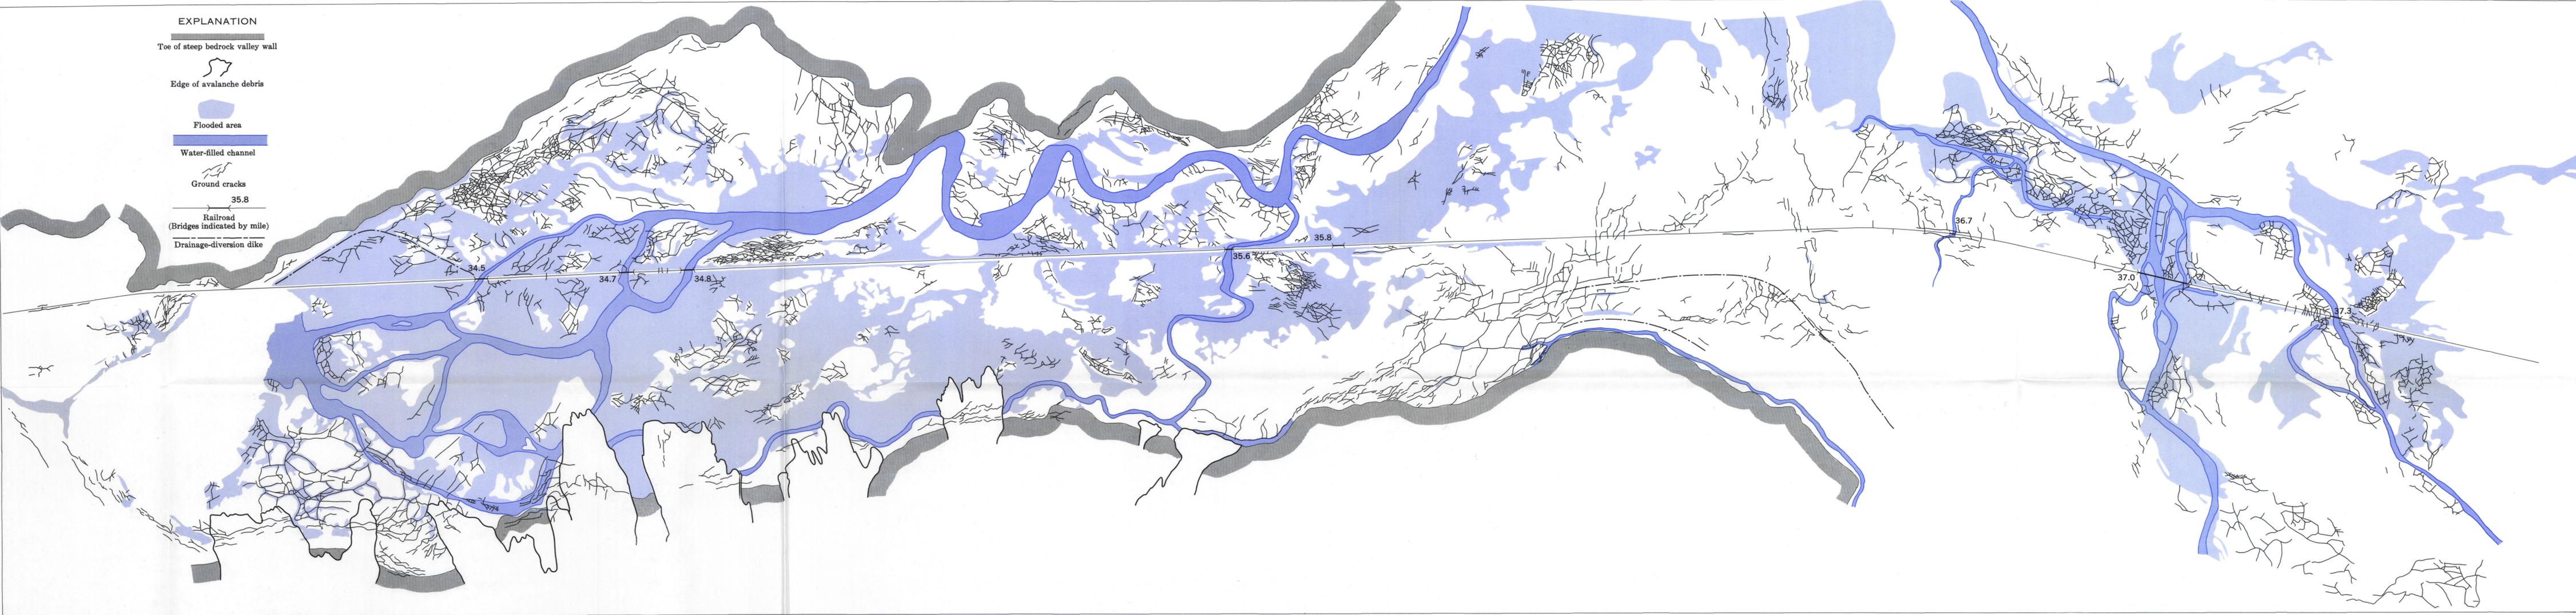
- Toe of steep bedrock valley wall
- Edge of avalanche debris
- Flooded area
- Water-filled channel
- Ground cracks
- 35.8
Railroad
(Bridges indicated by mile)
- Drainage-diversion dike
