Evapotranspiration and the Water Budget of Prairie Potholes in North Dakota

GEOLOGICAL SURVEY PROFESSIONAL PAPER 585-B

By JELMER B. SHJEFLO

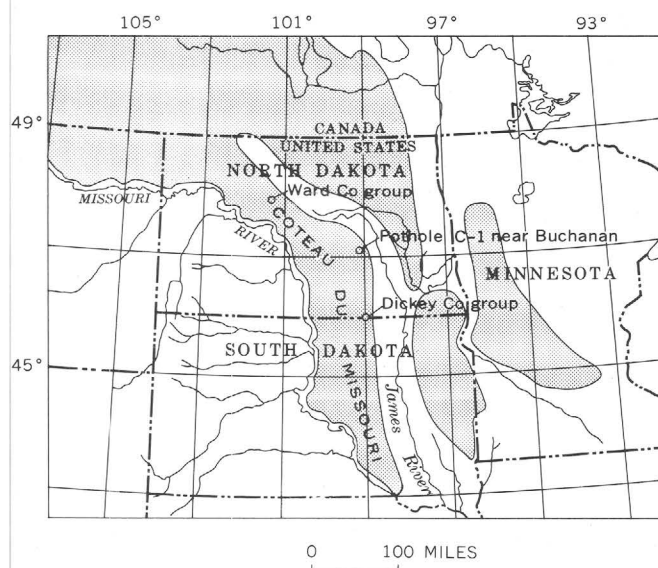
FIGURE 1.—Prairie-pothole region (shaded), showing the Coteau du Missouri and location of the pothole study areas.

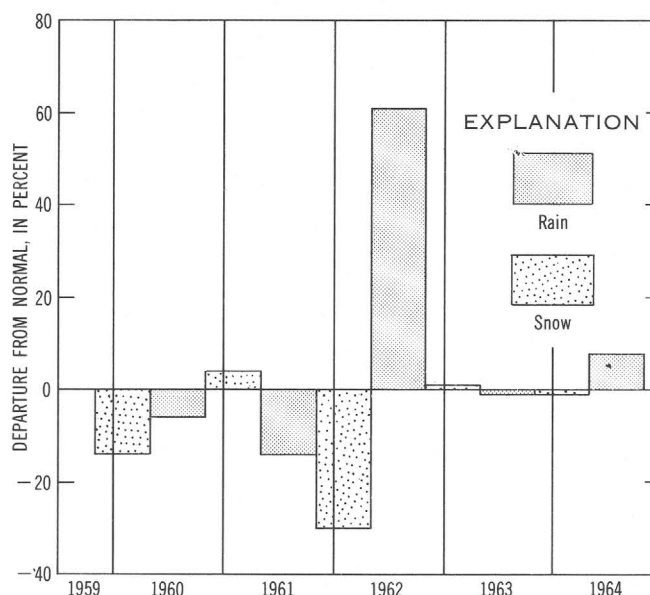
FIGURE 2.—Precipitation departures from normal during the study period, by 6-month periods. Data are from long-term weather records at Max, Jamestown, and Ashley.

In spite of the abnormal distribution of precipitation in 1962 when winter precipitation (mostly snow) was 30 percent deficient, runoff from snowmelt was four times greater than it was in either the succeeding or the preceding years when snowfall was above normal. This was partly because there was very little thawing during the winter of 1961–62 so that the snows accumulated, and partly because the accumulated snows melted rapidly in the spring while the ground was still frozen.

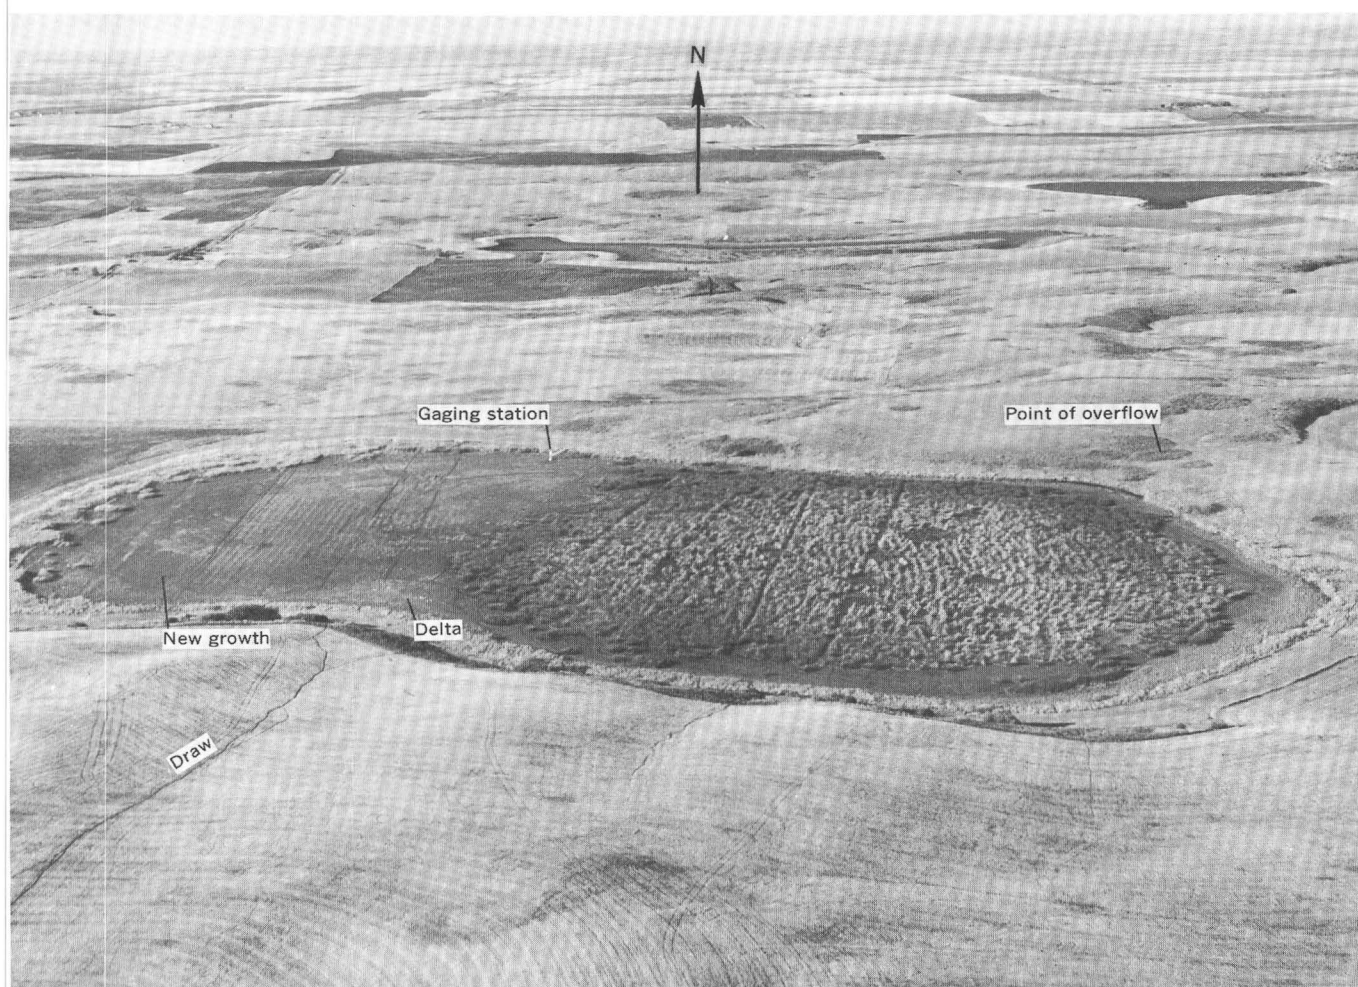
FIGURE 3.—Pothole 2 near Max, N. Dak., September 16, 1961, after it had been dry about 1 month. At low stages, the pothole covered about 30 acres, 18 of which were covered with hardstem bulrush. There was also a ring of cattail and whitetop around the edge. The remaining 12 acres, at the left, stayed clear of vegetation until the fall rains caused cattail seeds to germinate. New growth filled the clear area with plants several inches high before killing frosts occurred. Farming operations during the drought of 1929-39 are clearly indicated by the lines marking the ditches and furrows. There is little evidence of sedimentation, except for the delta on the near side, at the foot of the draw containing a cow trail. The gaging equipment is on the far side of the pothole, and the point of overflow (if any) is in the northeast corner. Photograph by W.P. Sebens, Executive Secretary, North Dakota State Soil Conservation Committee.

with plants several inches high. Pothole 2, shown in figure 3, underwent similar changes.

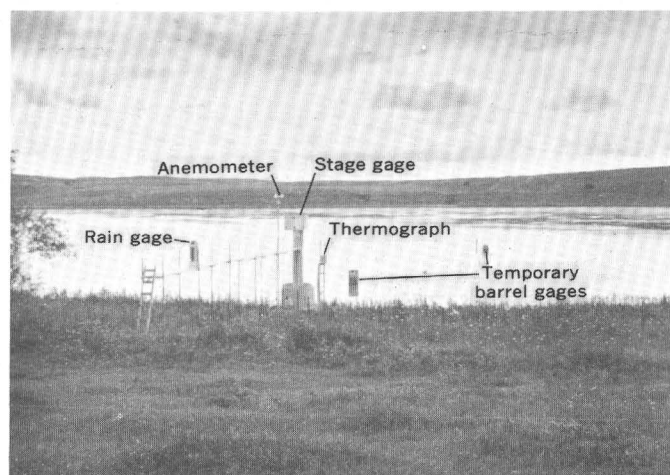
FIGURE 4.—Pothole 3 near Max, showing instruments. Photograph by Roger Pewé, September 13, 1965.

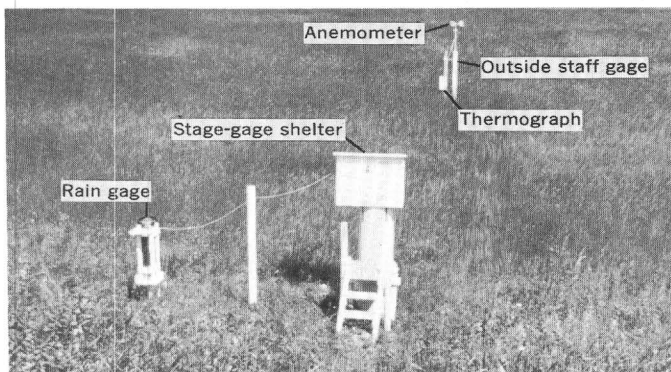
FIGURE 5.—Pothole 8 near Forbes, showing instruments. Photograph by Roger Pewé, September 15, 1965.

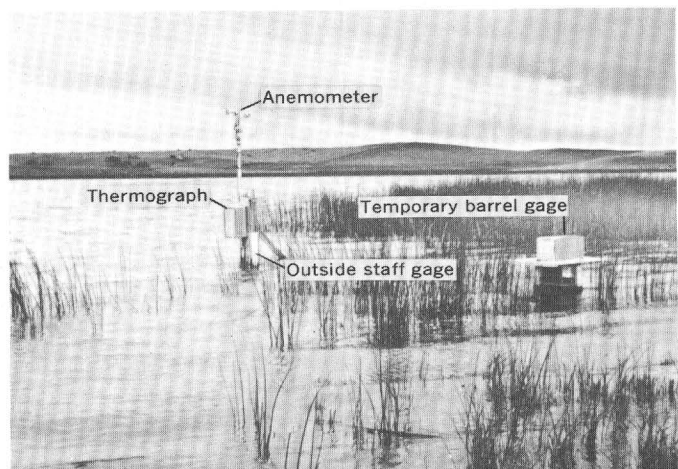
FIGURE 6.—Pothole C-1 near Buchanan, showing the temporary barrel gage, thermograph, anemometer, and staff gage. Photograph by Roger Pewé, September 14, 1965.

The temporary barrel-type stilling wells were economical and fairly satisfactory. Materials cost very little, and a gage could be installed in a few hours. Intake action was positive. Additional holes could be punched in the barrel just above the bed ice in the spring to admit runoff from snowmelt. The barrel gages were usually heaved about 0.2–0.3 foot by frost action, but they did not settle back during April and May as did the Ward County gages because they were so light in weight. Of course, the barrel could be damaged by ice in the spring, or submerged by runoff from a heavy rainstorm.

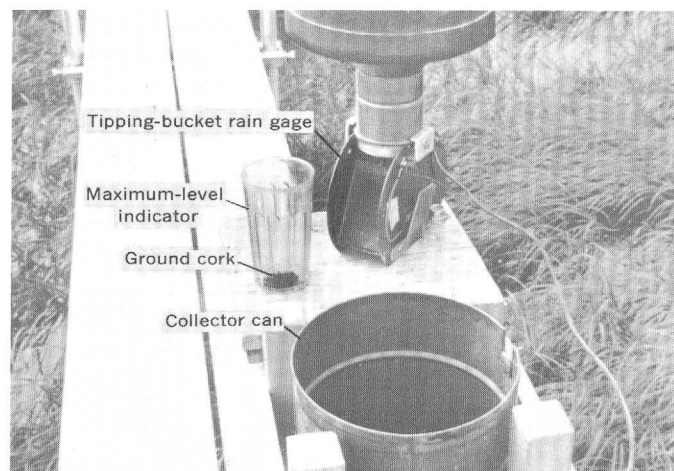
FIGURE 8.—Tipping-bucket rain gage with collector can. Photograph by Roger Pewé, September 13, 1965.

Precipitation was recorded at each of the permanent stilling wells by using a U.S. Weather Bureau standard 8-inch rain gage with a tipping-bucket attachment, as shown in figure 8. The tipping bucket was connected electrically to the auxiliary pen on the Stevens A35 water-stage recorder. The bucket tipped after each 0.1 inch of precipitation was collected and closed a switch that would advance a mechanical counter dial by 1 and cause the left margin pen to jog one step to the right or left. Five jogs to the right and five to the left complete a cycle and represent 1 inch of precipitation.

The tipping-bucket rain gages did not function properly during the first season. Some of the 8-inch collector cans and some of the tipping buckets leaked at the seams and had to be resoldered. The switch had to be carefully centered and adjusted to eliminate double and even triple counts. Multiple counts occurred, for instance, when the cup bounced after the bucket had tipped; on each bounce the electrical circuit was completed. Some of the bumper screws also required adjusting, for sometimes a bucket would tip after receiving only 0.06 or 0.07 inch of water, or would not tip until it had received 0.12 or 0.13 inch of water, or would not tip at all. During the following years, care was taken to level the gages after each field visit so that the buckets would tip properly.

An inherent shortcoming of the tipping-bucket rain gage is that rains of less than 0.1 inch cannot be detected, and many rains were of this magnitude. Thus, errors in several phases of the computations could have been prevented if a more accurate type of rain gage had been used. The weighing-type rain gages used in other phases of the study were entirely satisfactory. Alter type windshields recommended by the U.S. Weather Bureau were used in connection with the weighing rain gages, but no windshields were used on the tipping-bucket rain gages.

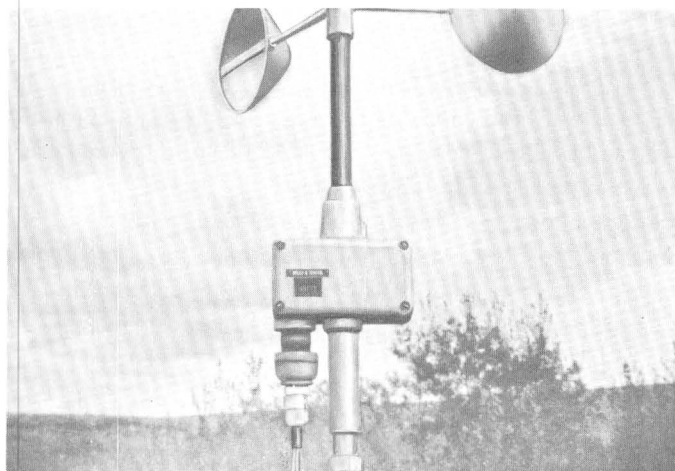
FIGURE 9.—Totalizing anemometer. Photograph by Roger Pewé, September 13, 1965.

Wind movement was measured by a totalizing anemometer, as shown in figure 9. The instrument has three cups, a mechanical counter, and a dial reading to the nearest one-tenth of a mile. The dial showed the total number of miles of wind movement that had passed the gage. At the end of each 10 miles of wind movement, a switch would close and cause a pen on the right margin of the record chart to make a pip. The anemometer was

The anemometers performed very well during the period. Occasionally one of the mechanical counters would become stuck and need replacing. Sometimes the counter could be repaired by replacing the "tenths" wheel. Sometimes the ball bearing at the lower end of the shaft would wear flat on one side and need replacing.

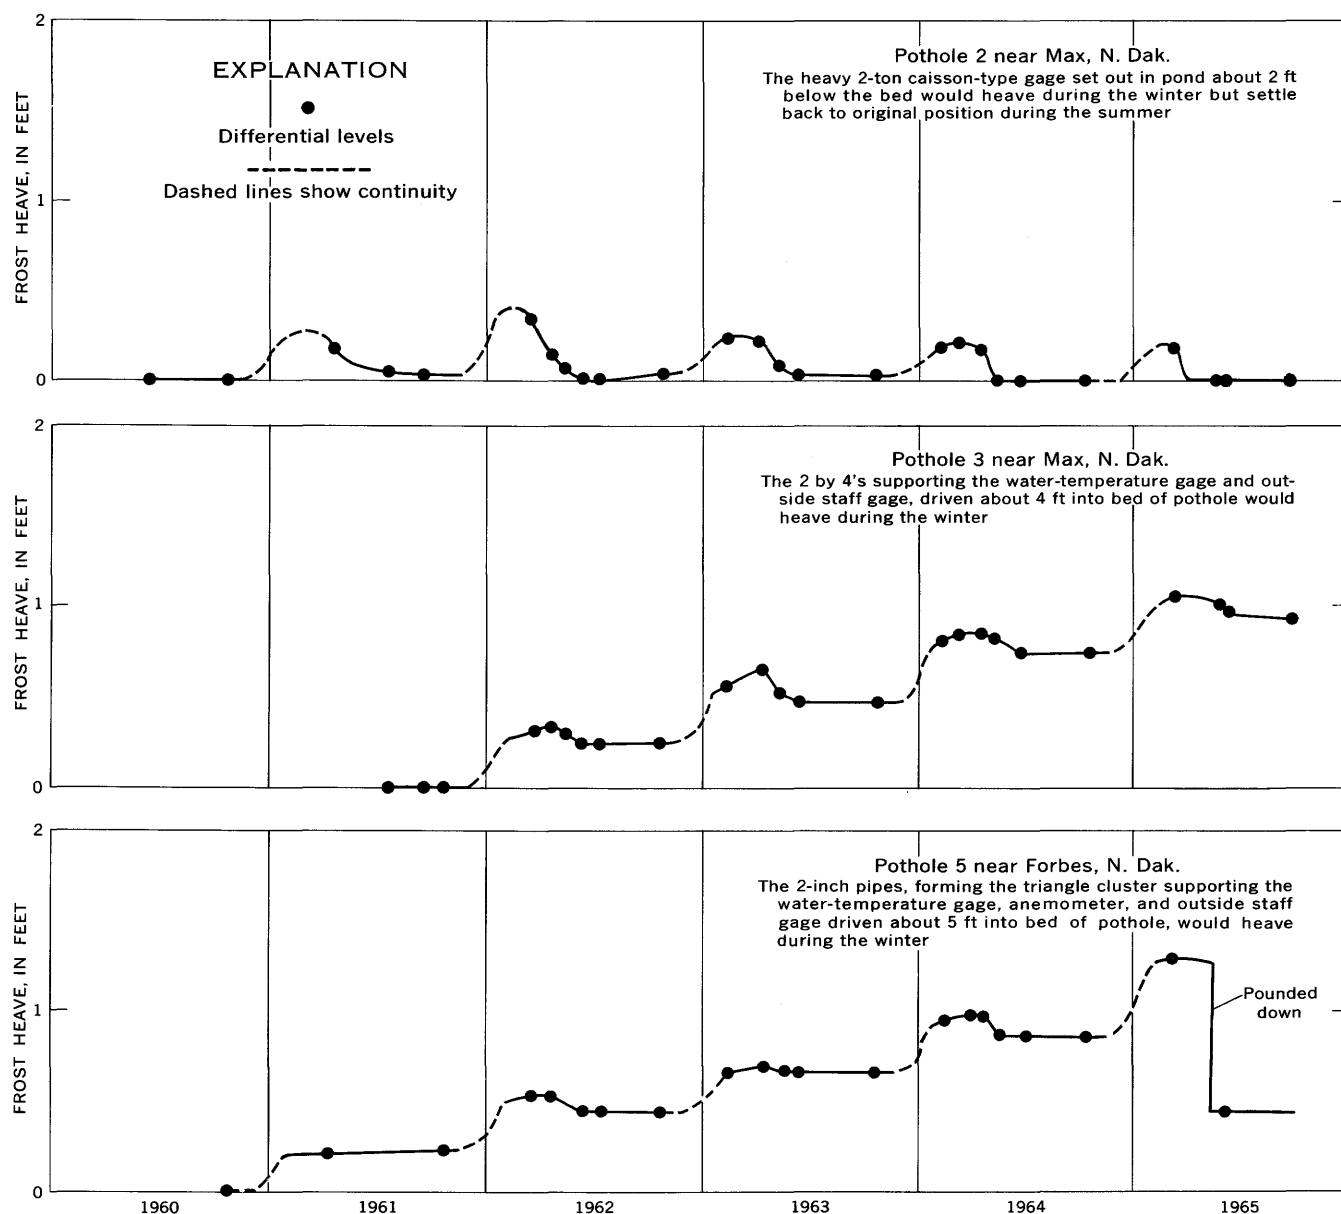
FIGURE 12.—Frost heave for gages of different construction.

Because the heavy gages settled back to their original positions and the deeply set 2-inch pipes beside them did not move appreciably, it became obvious that by placing an index pointer on the nearby pipe and obtaining the difference in elevation between the gage well and the pipe each week, the amount of settling of the gage well could be roughly observed, as shown in figure 13. These weekly measurements are plotted in figure 13 along with the results of the monthly differential leveling, and agreement is very good. These readings helped to define more closely the proper distribution of the datum corrections applicable during this period when rate of change was the greatest.

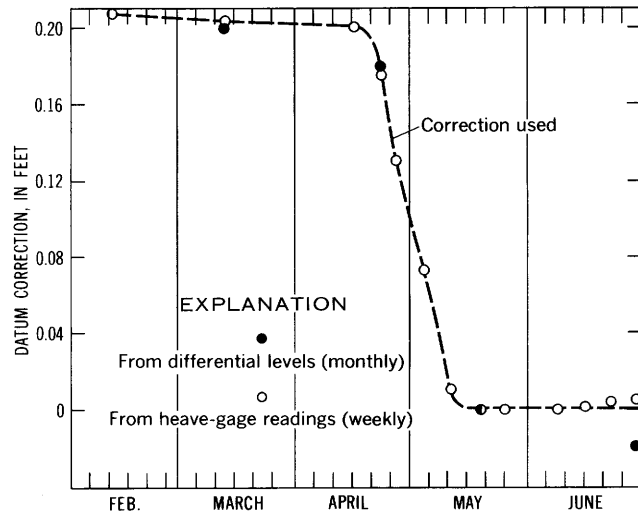
FIGURE 13.—Rate of settlement of the heavy 2-ton gage at pothole 2 during the spring of 1964.

To get more detailed information on the settling rate of these heavy gages, intensive leveling was attempted on May 6 and 7, 1963. An accurate gage-height record was needed to compute an N value during May because the settlement of the gage was greater than the water loss during certain periods, and these quantities had to be separated. The plan was to alternate level runs among the four gages in Ward County and measure the amount of settlement continuously for several days. The project was abandoned on the second day when the wind became so strong that the level rod could not be read accurately. A rain (0.16 in.) the first evening at pothole 4 also interfered because it eliminated May 6 and possibly May 7 from being used in the determination of N . The datum corrections found to be applicable as a result of this survey are shown in the following table.

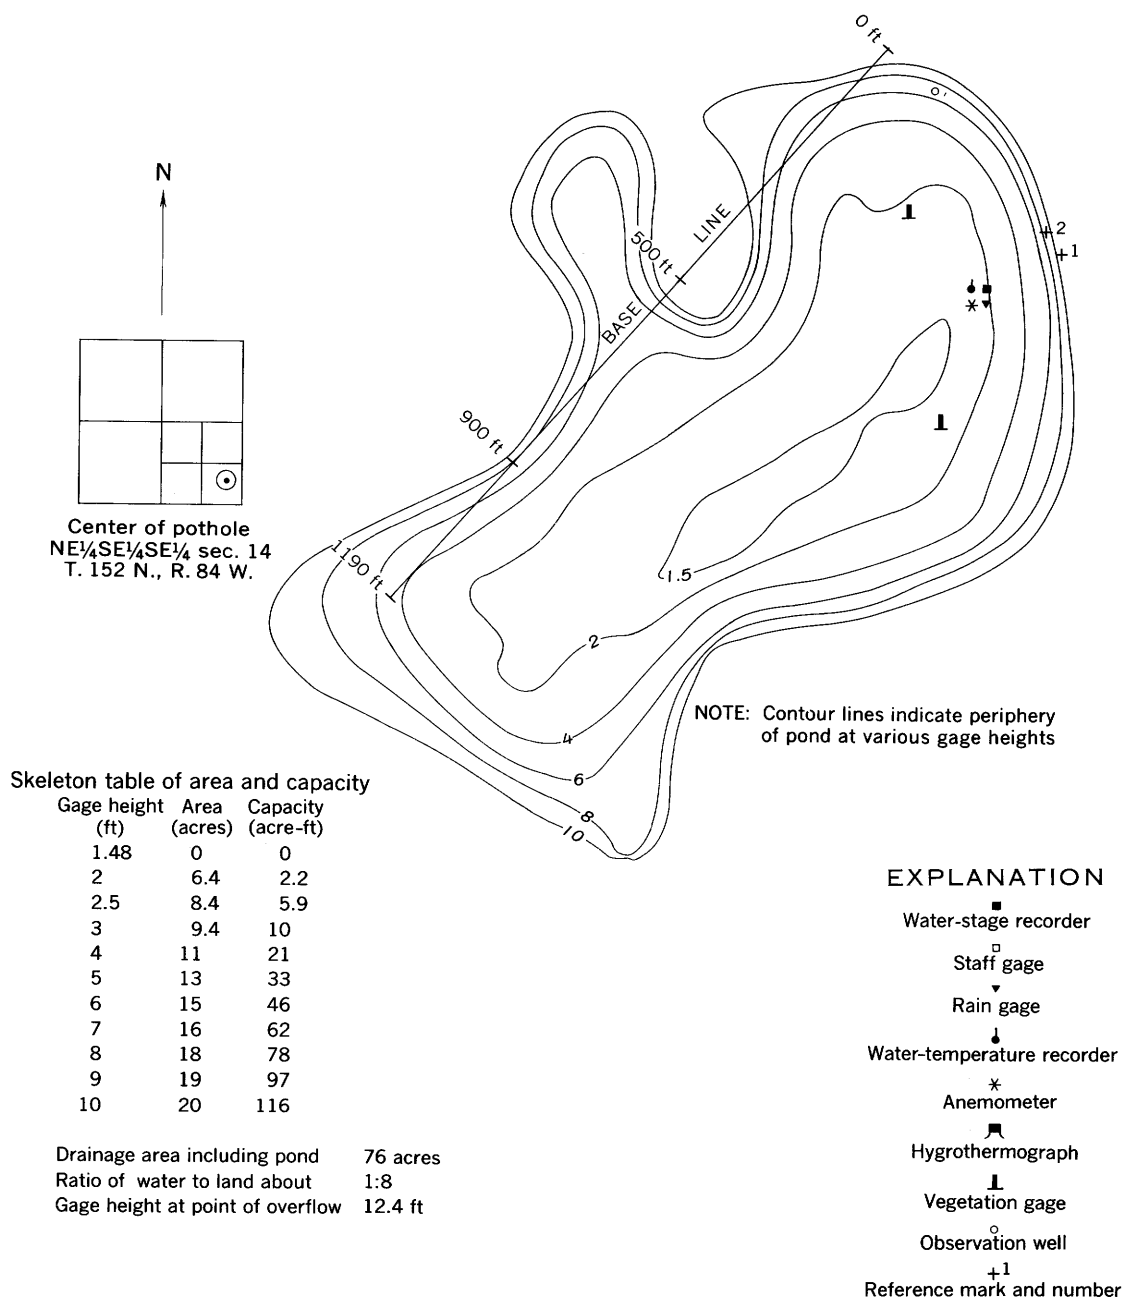
FIGURE 14.—Contour map for pothole 1 with skeleton table of area and capacity.

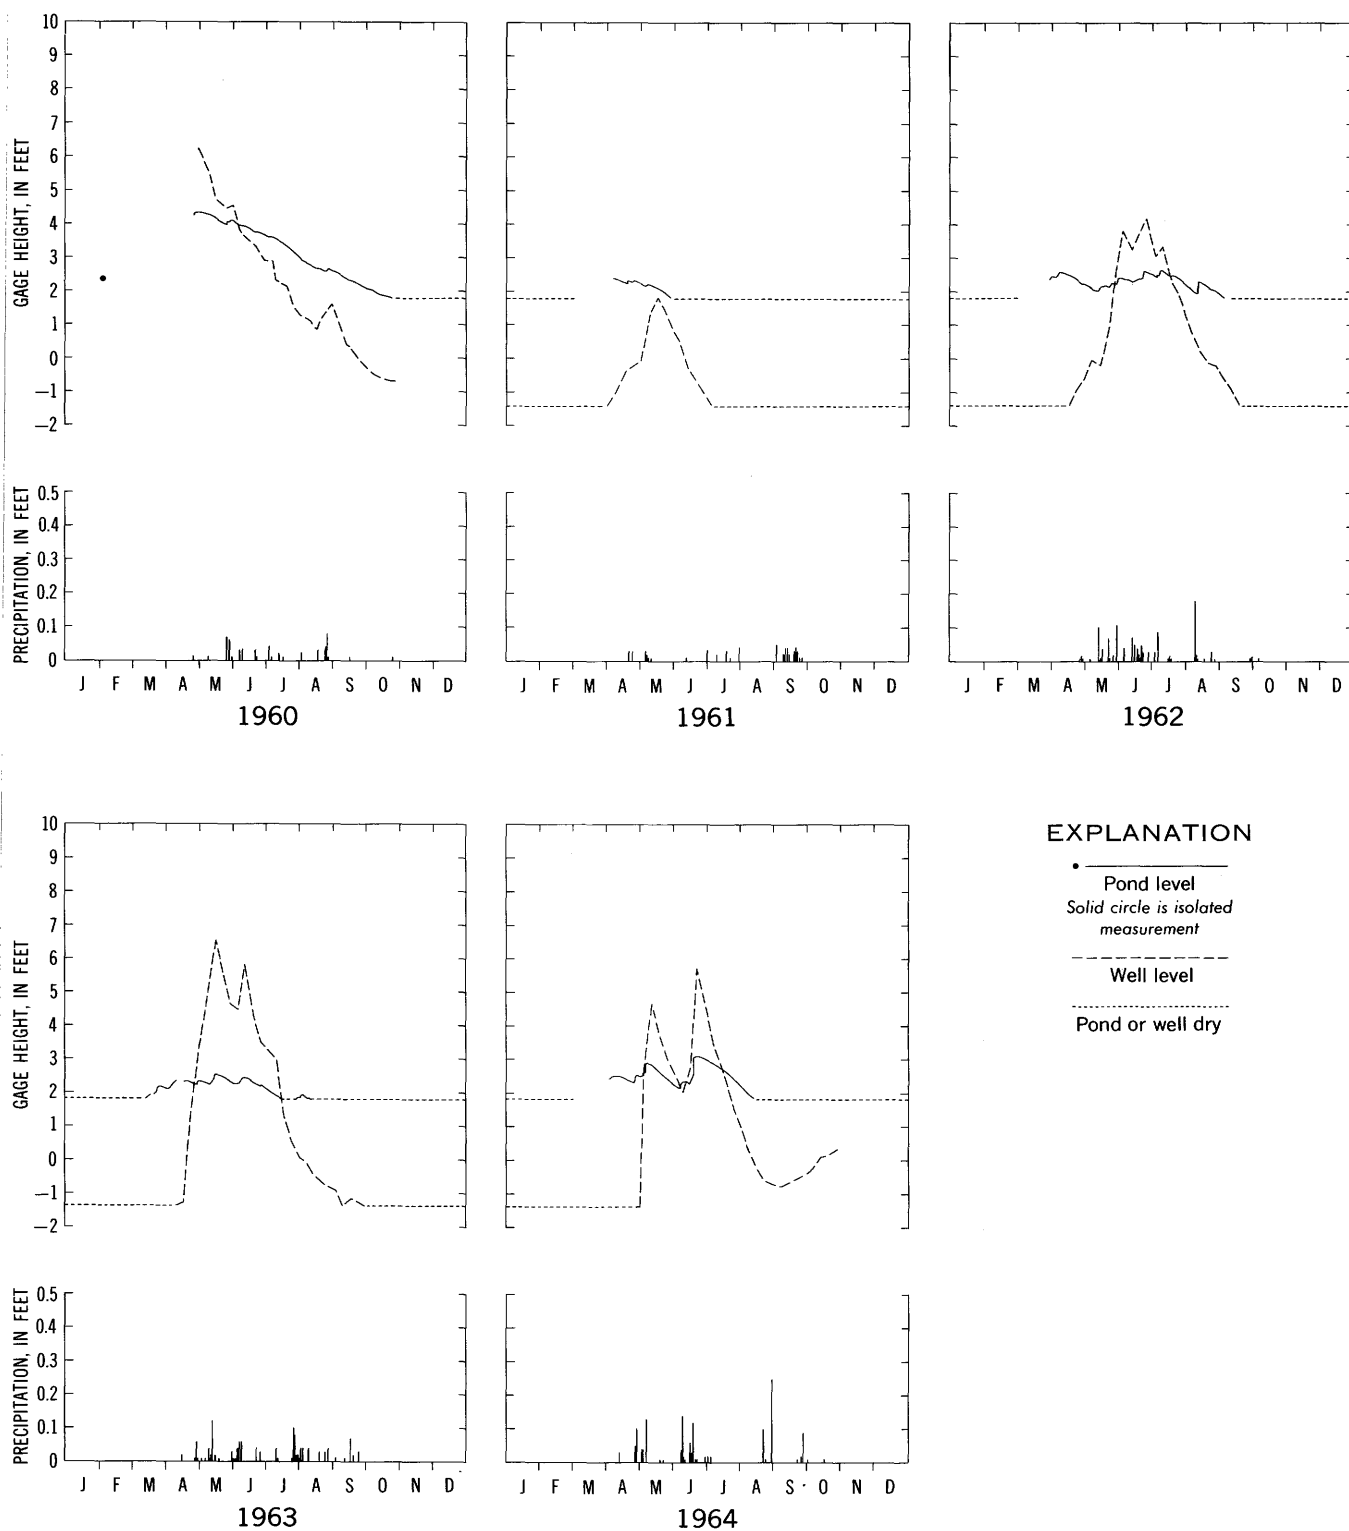
FIGURE 15.—Hydrographs for pothole 1, showing water levels in pond and observation well, and daily precipitation.

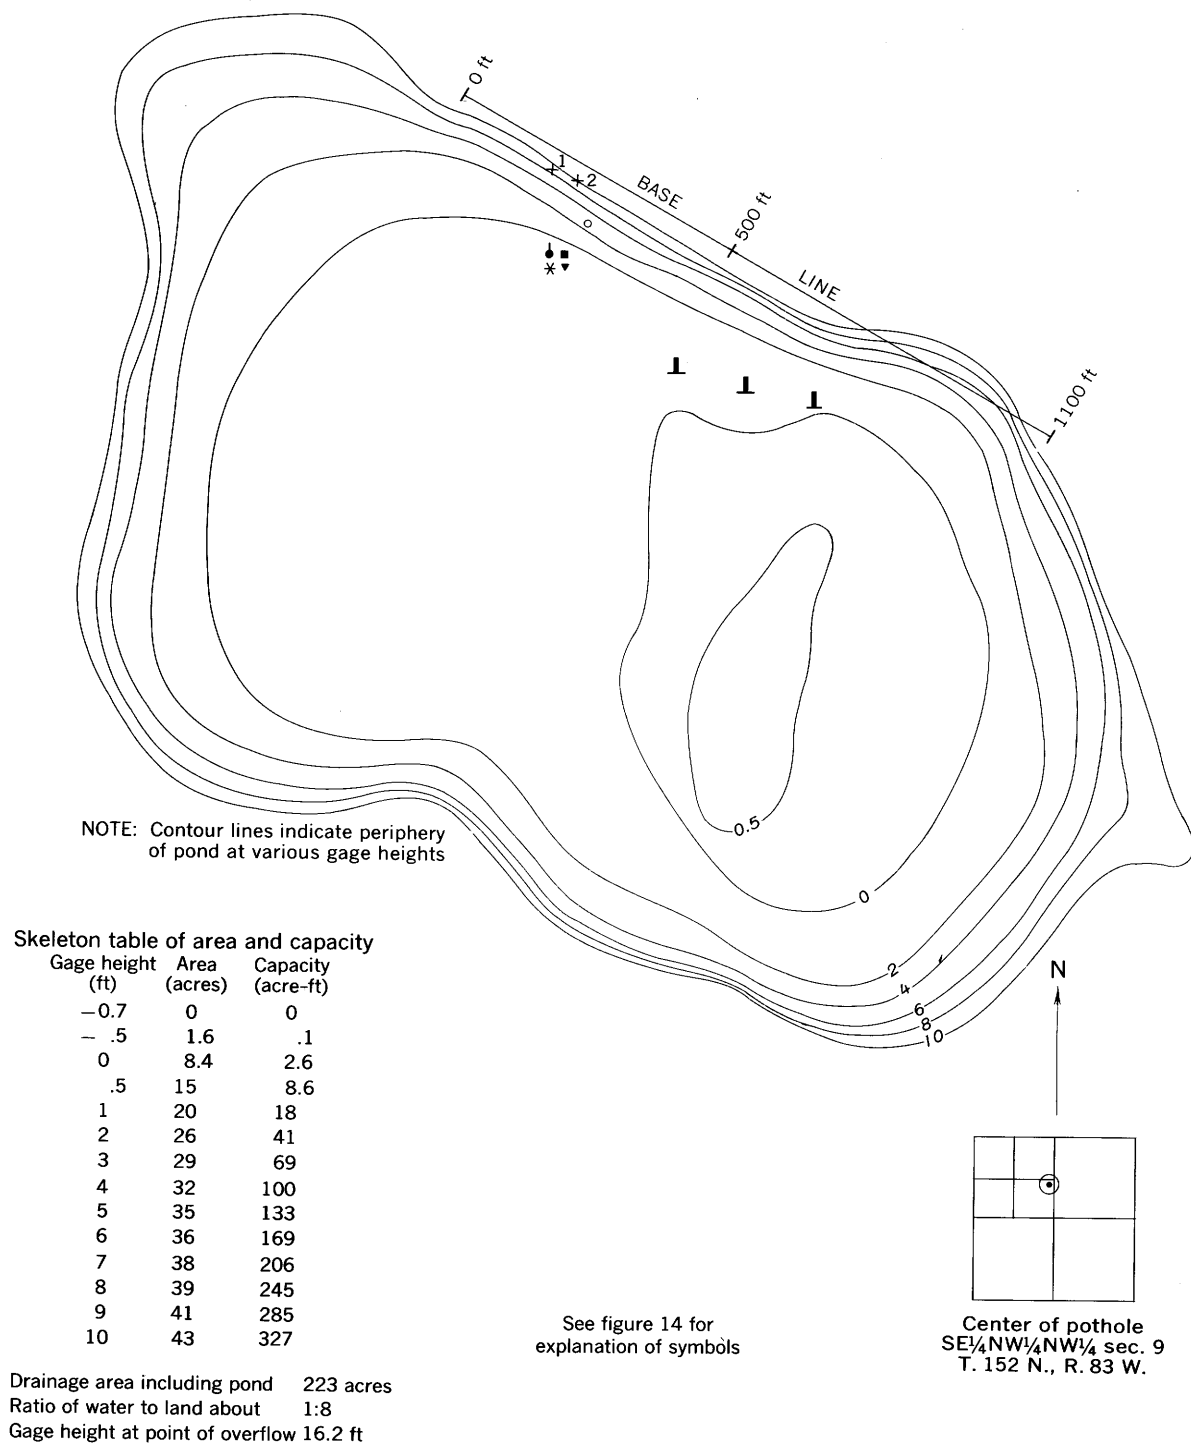
FIGURE 16.—Contour map for pothole 2 with skeleton table of area and capacity.

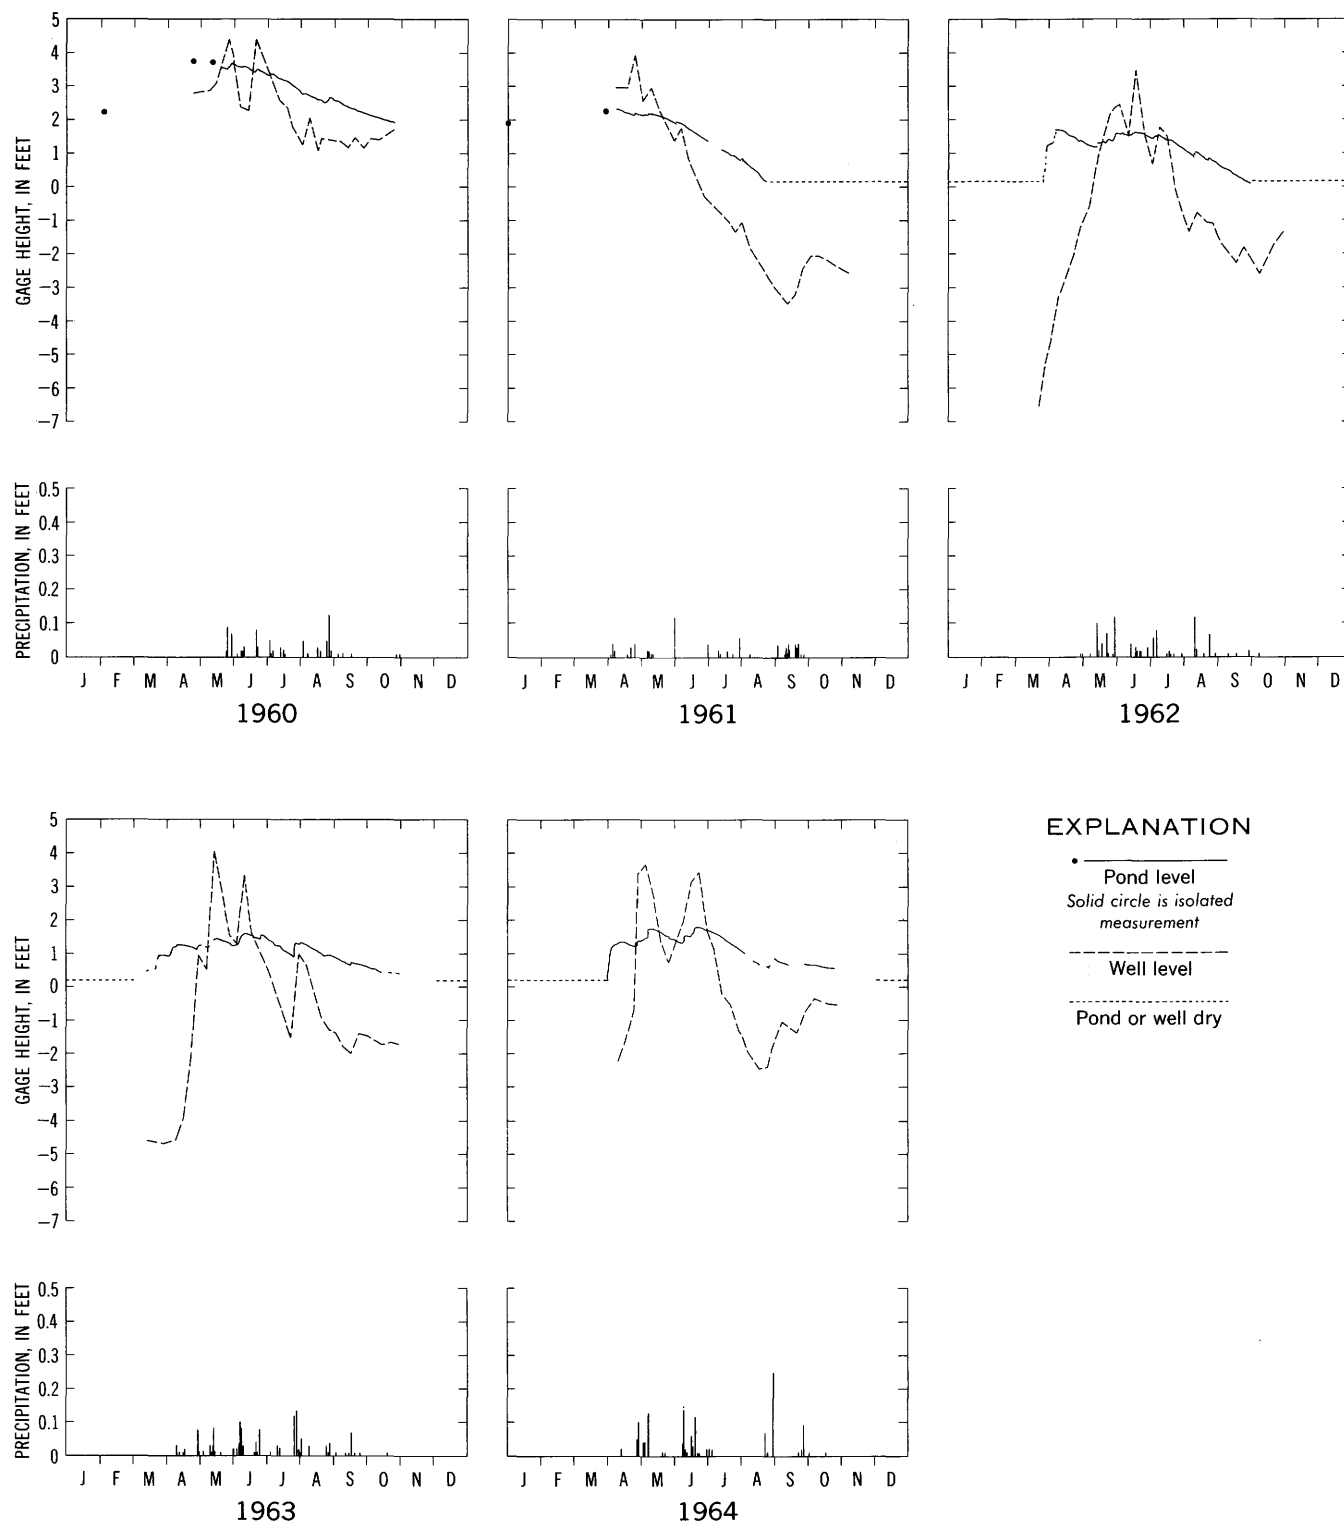
FIGURE 17.—Hydrographs for pothole 2, showing water levels in pond and observation well, and daily precipitation.

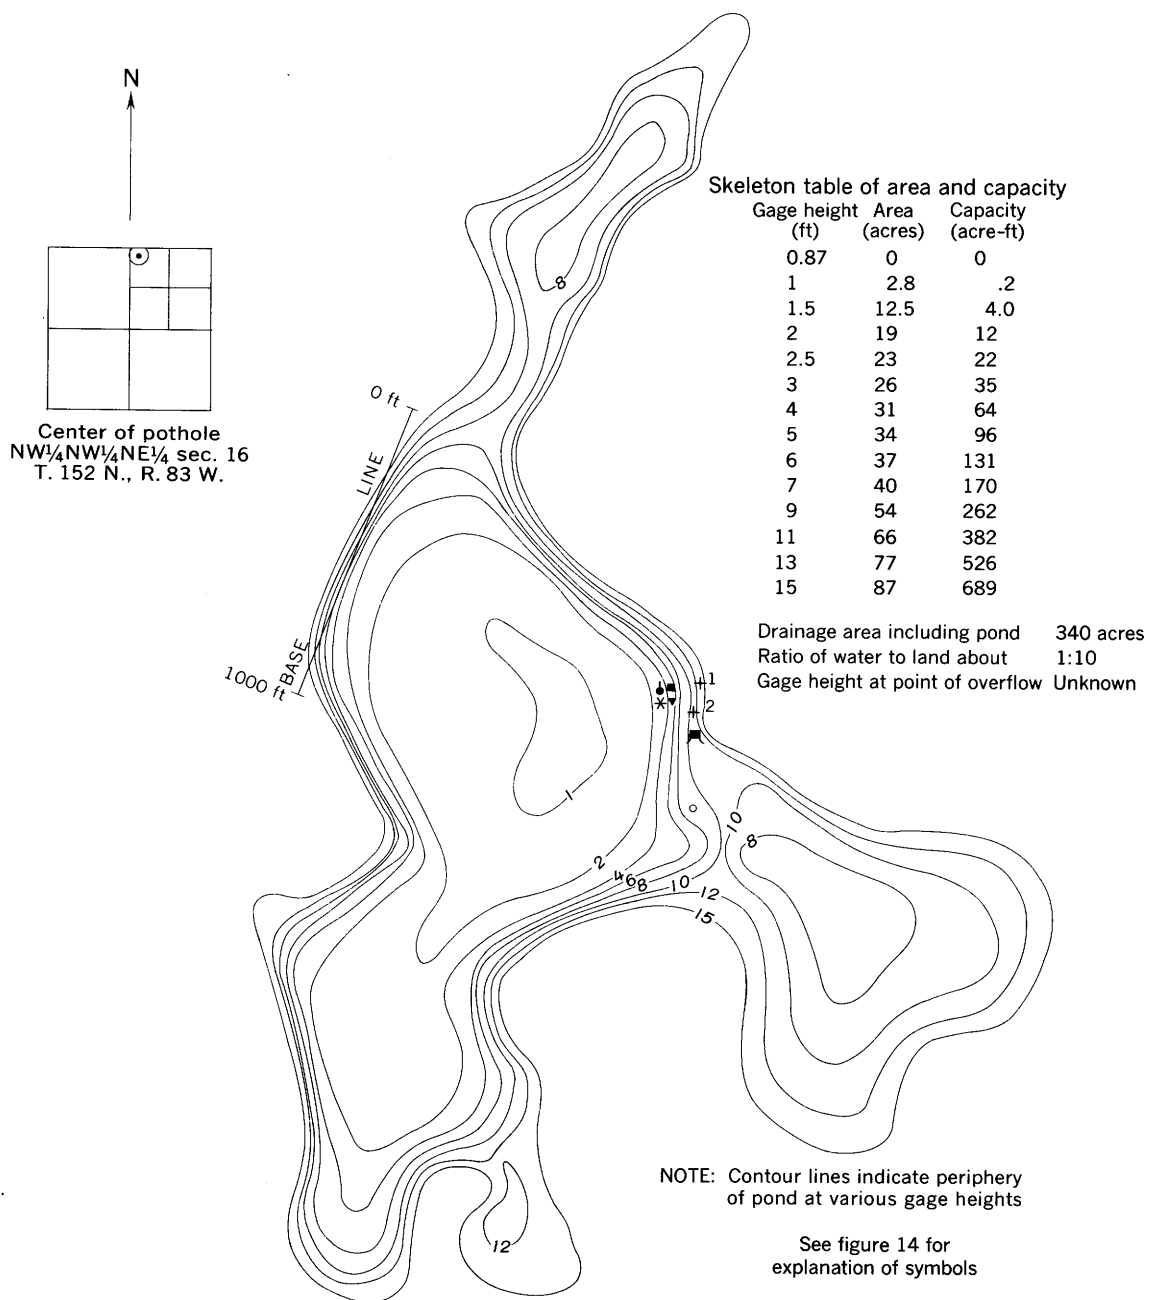
FIGURE 18.—Contour map for pothole 3 with skeleton table of area and capacity.

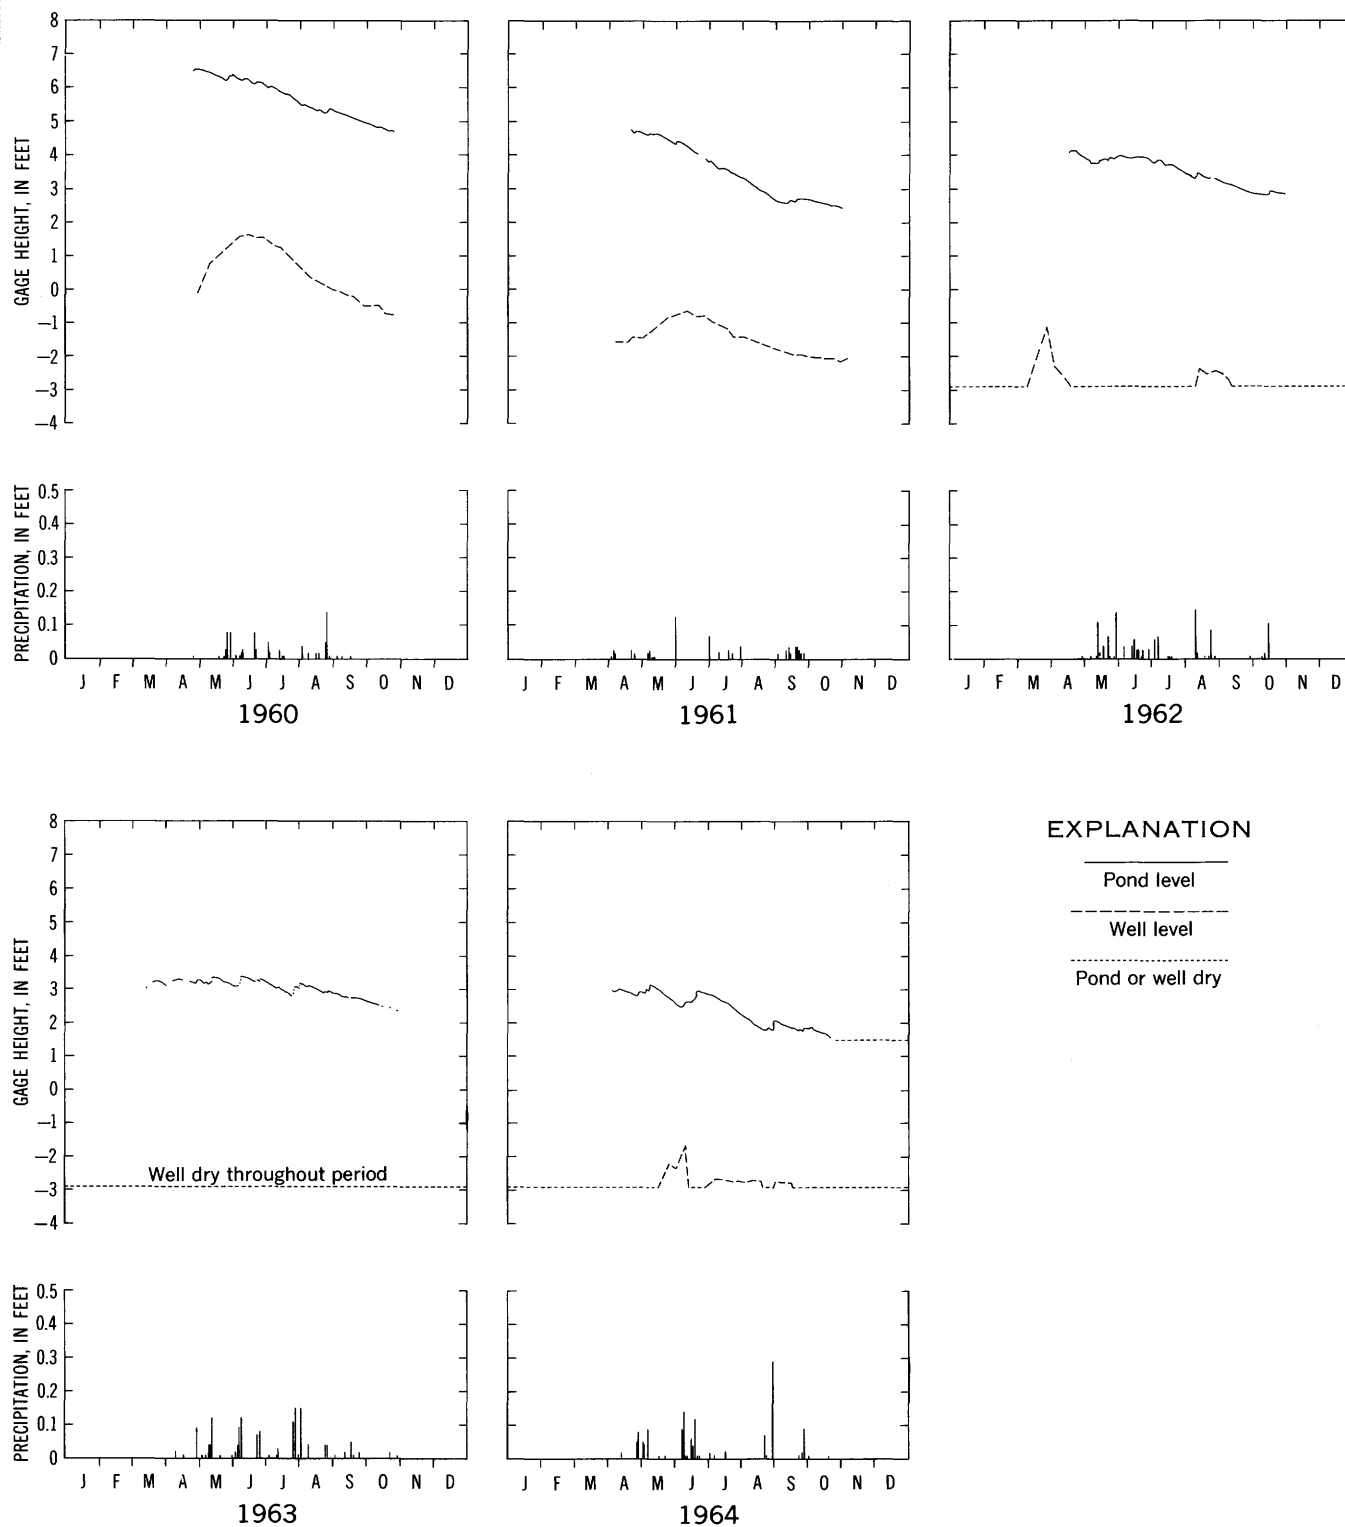
FIGURE 19.—Hydrographs for pothole 3, showing water levels in pond and observation well, and daily precipitation.

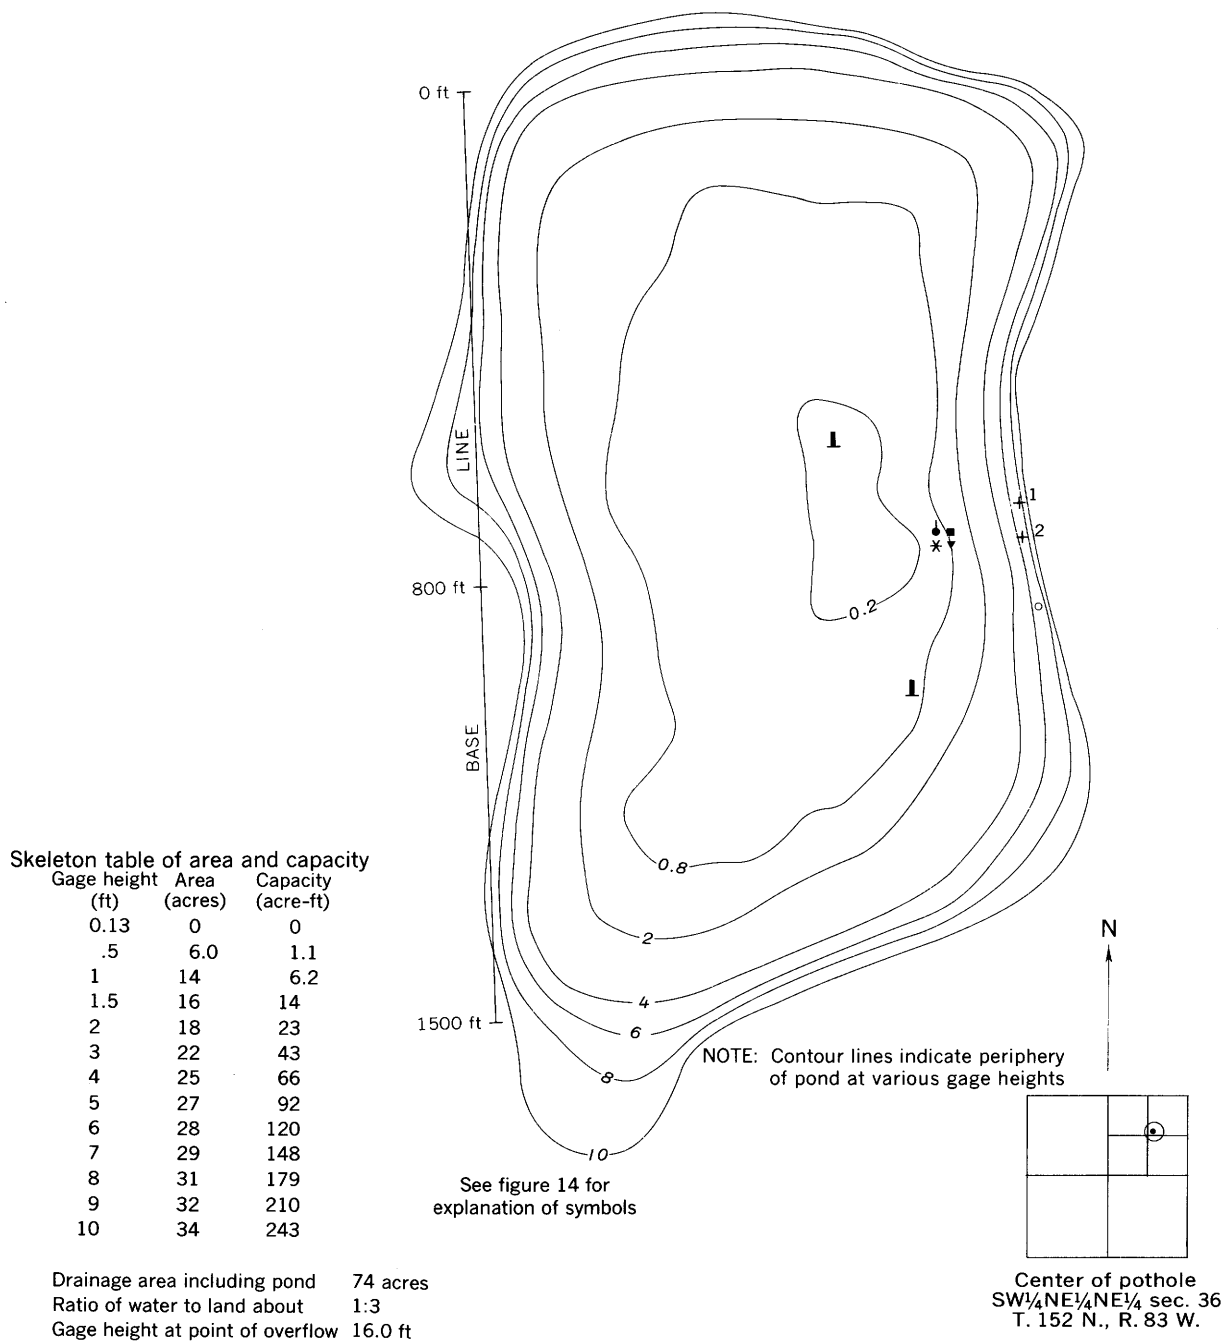
FIGURE 20.—Contour map for pothole 4 with skeleton table of area and capacity.

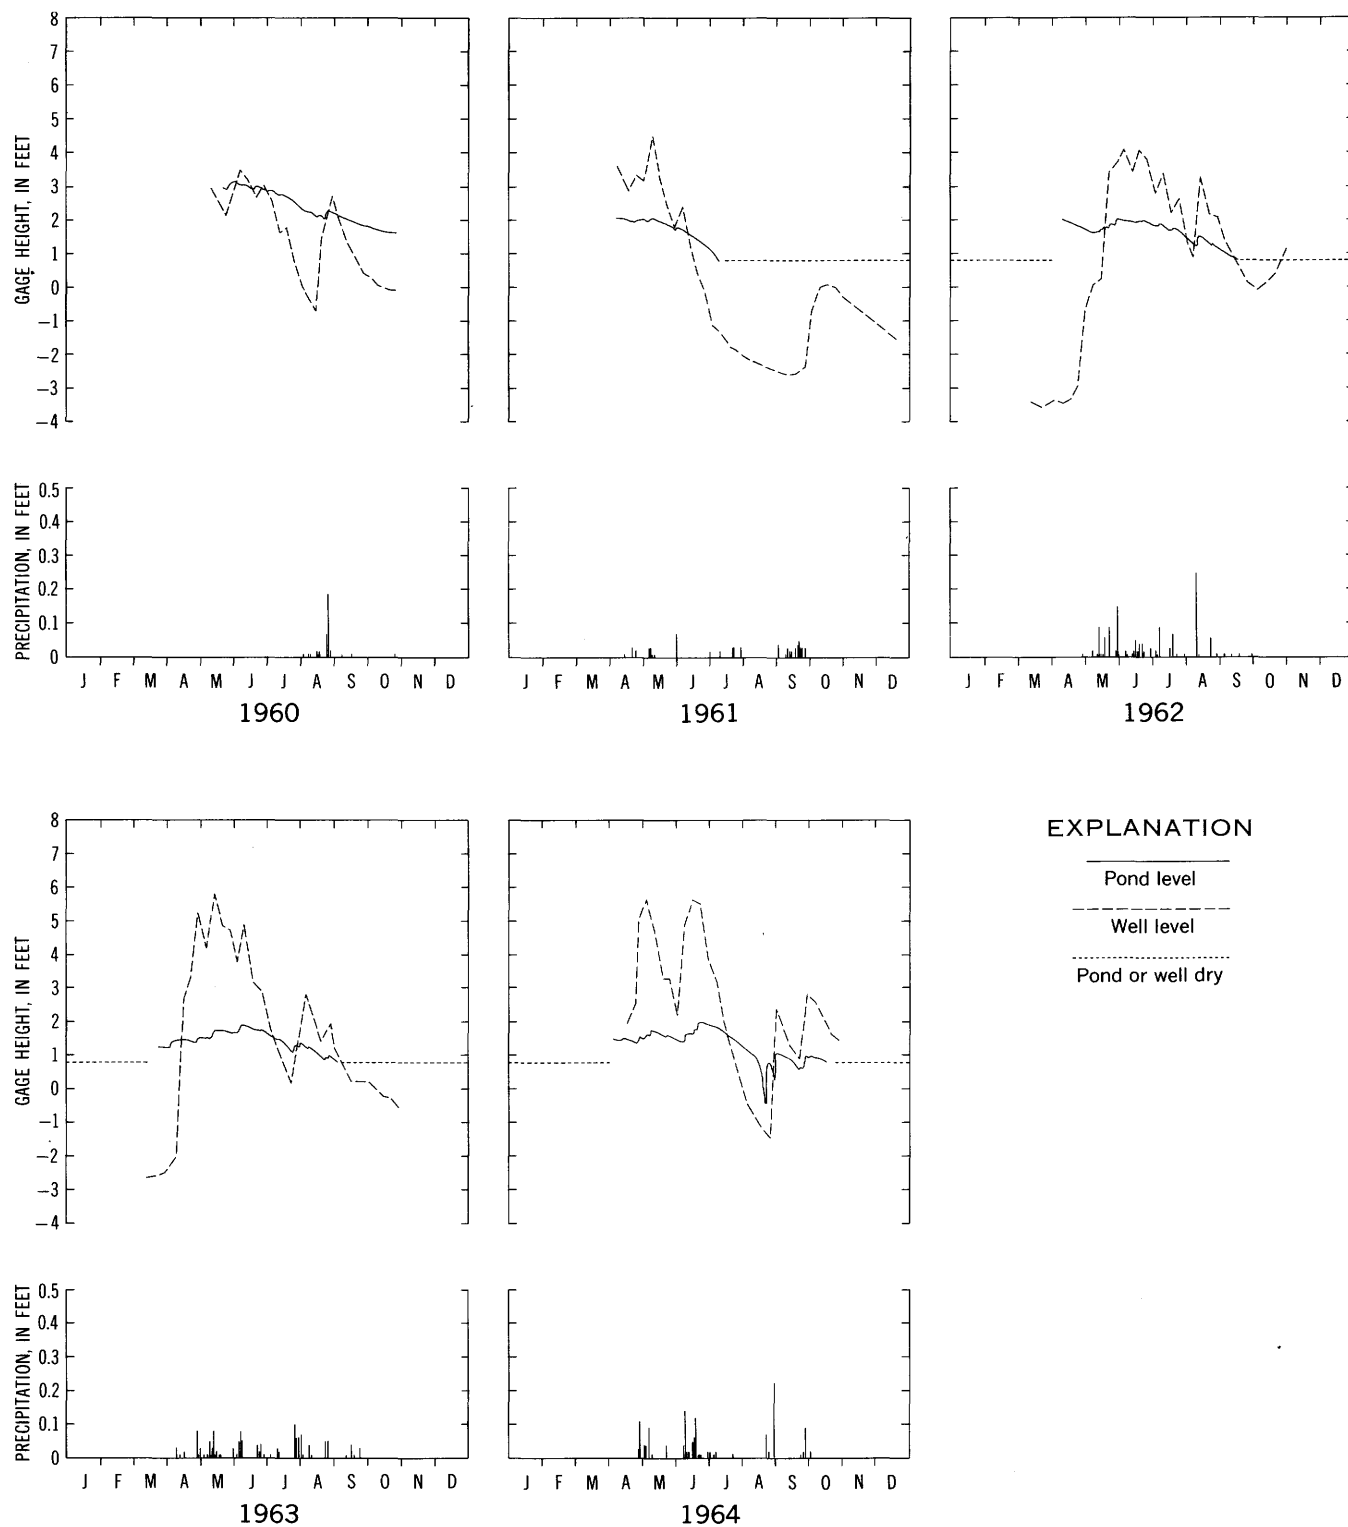
FIGURE 21.—Hydrographs for pothole 4, showing water levels in pond and observation well, and daily precipitation.
