Evapotranspiration and the Water Budget of Prairie Potholes in North Dakota

GEOLOGICAL SURVEY PROFESSIONAL PAPER 585-B

By JELMER B. SHJEFLO

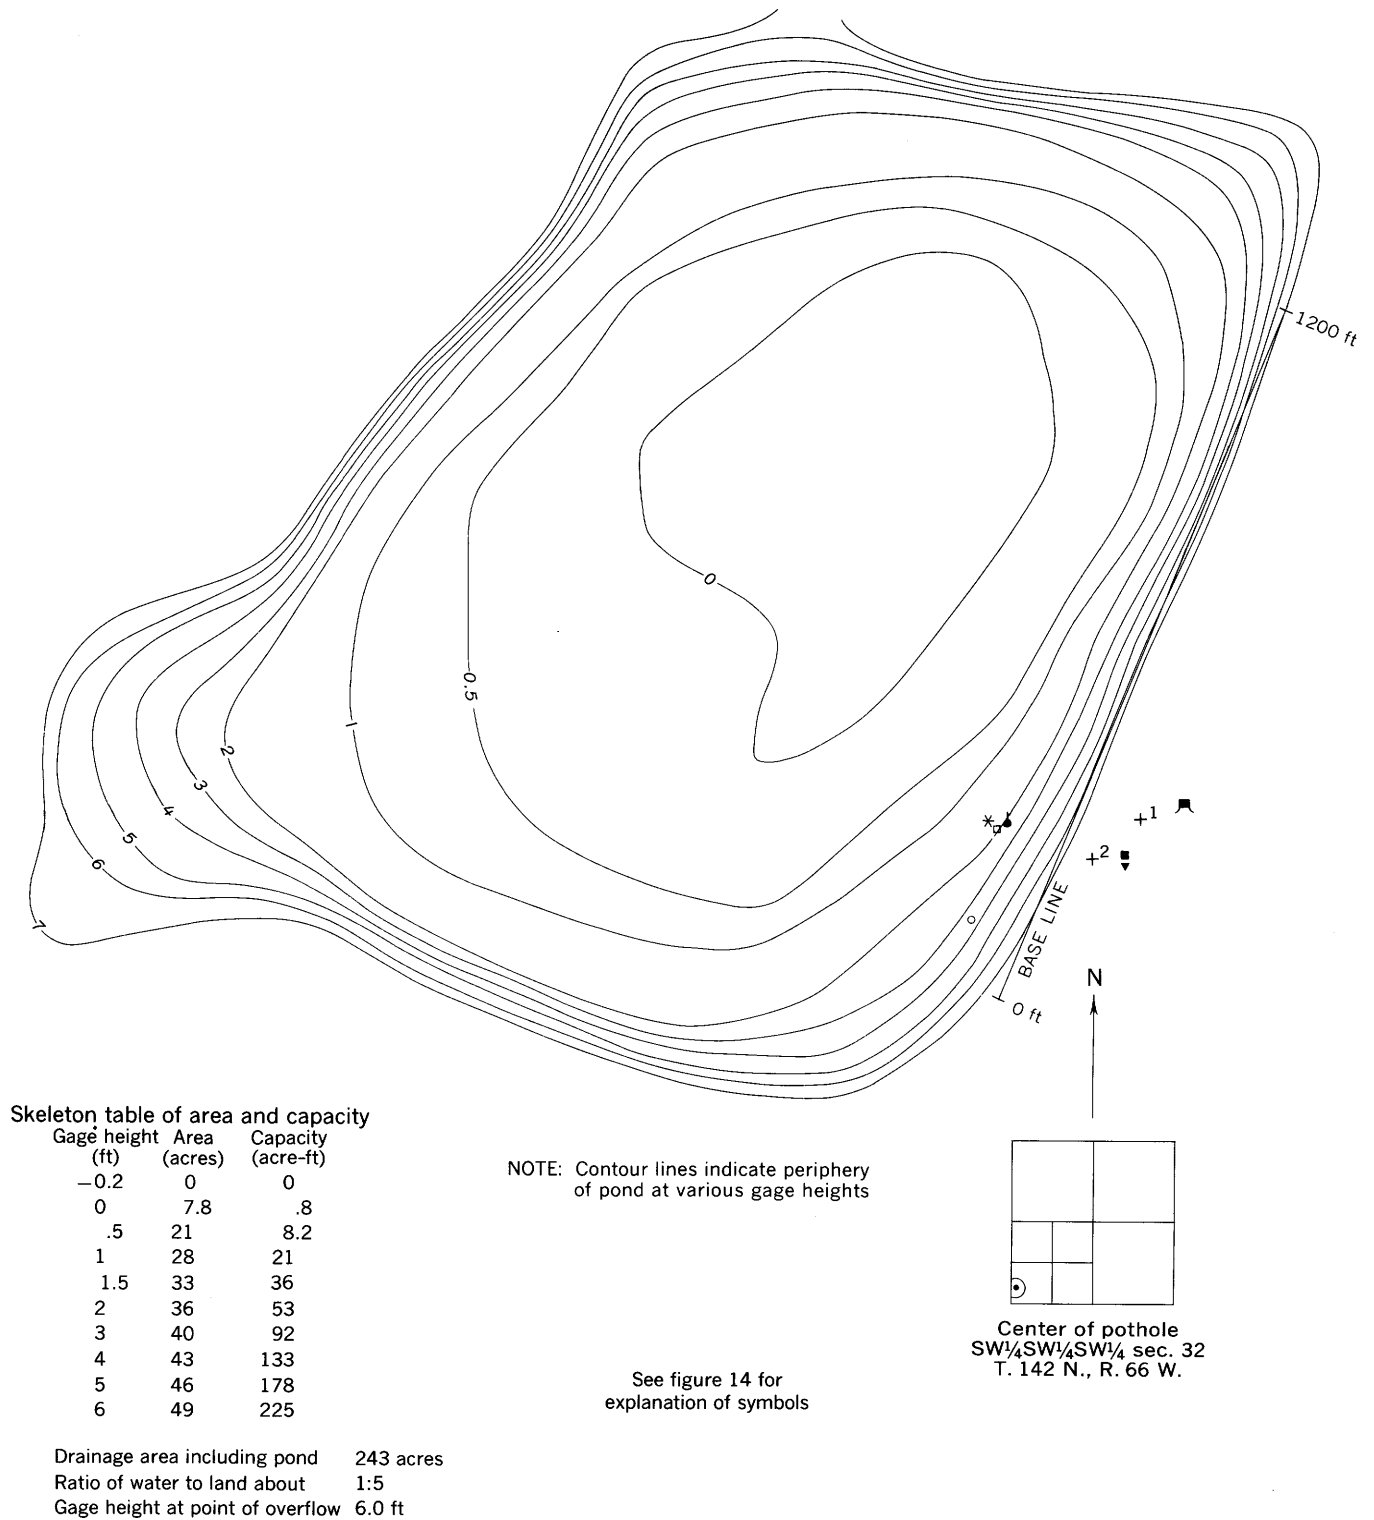
FIGURE 22.—Contour map for pothole C-1 with skeleton table of area and capacity.

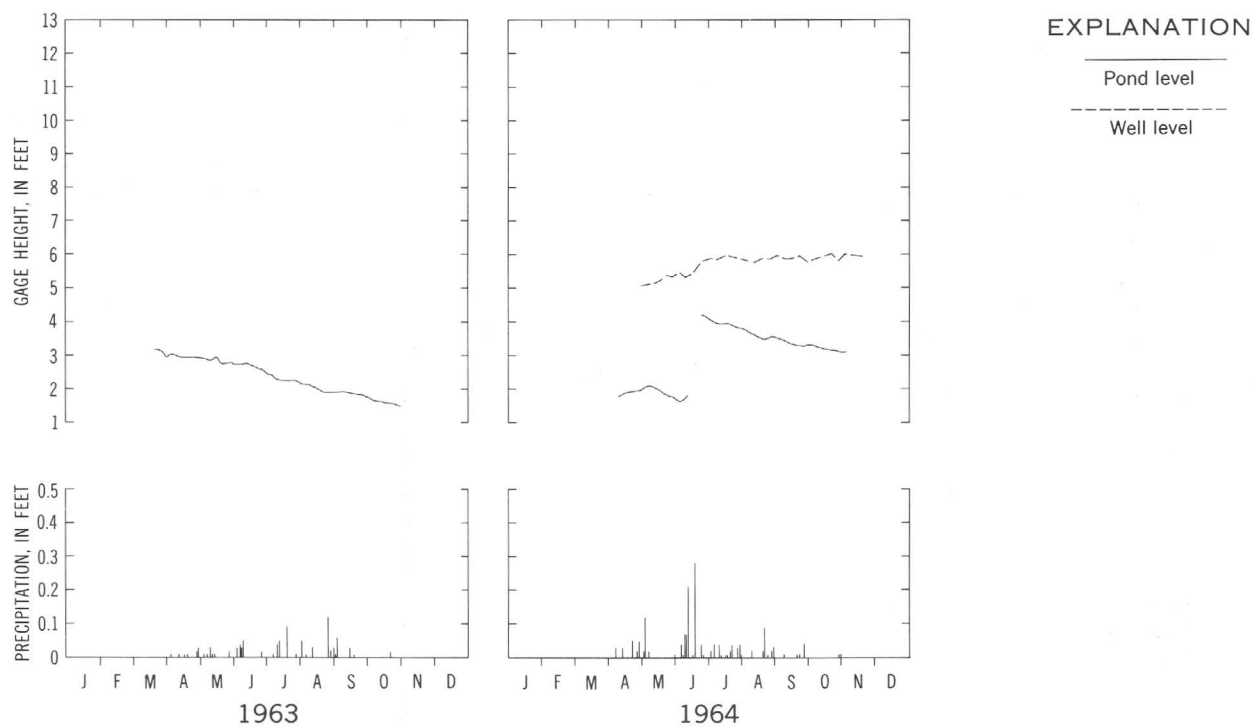
FIGURE 24.—Hydrographs for pothole C-1, showing water levels in pond and observation well, and daily precipitation.

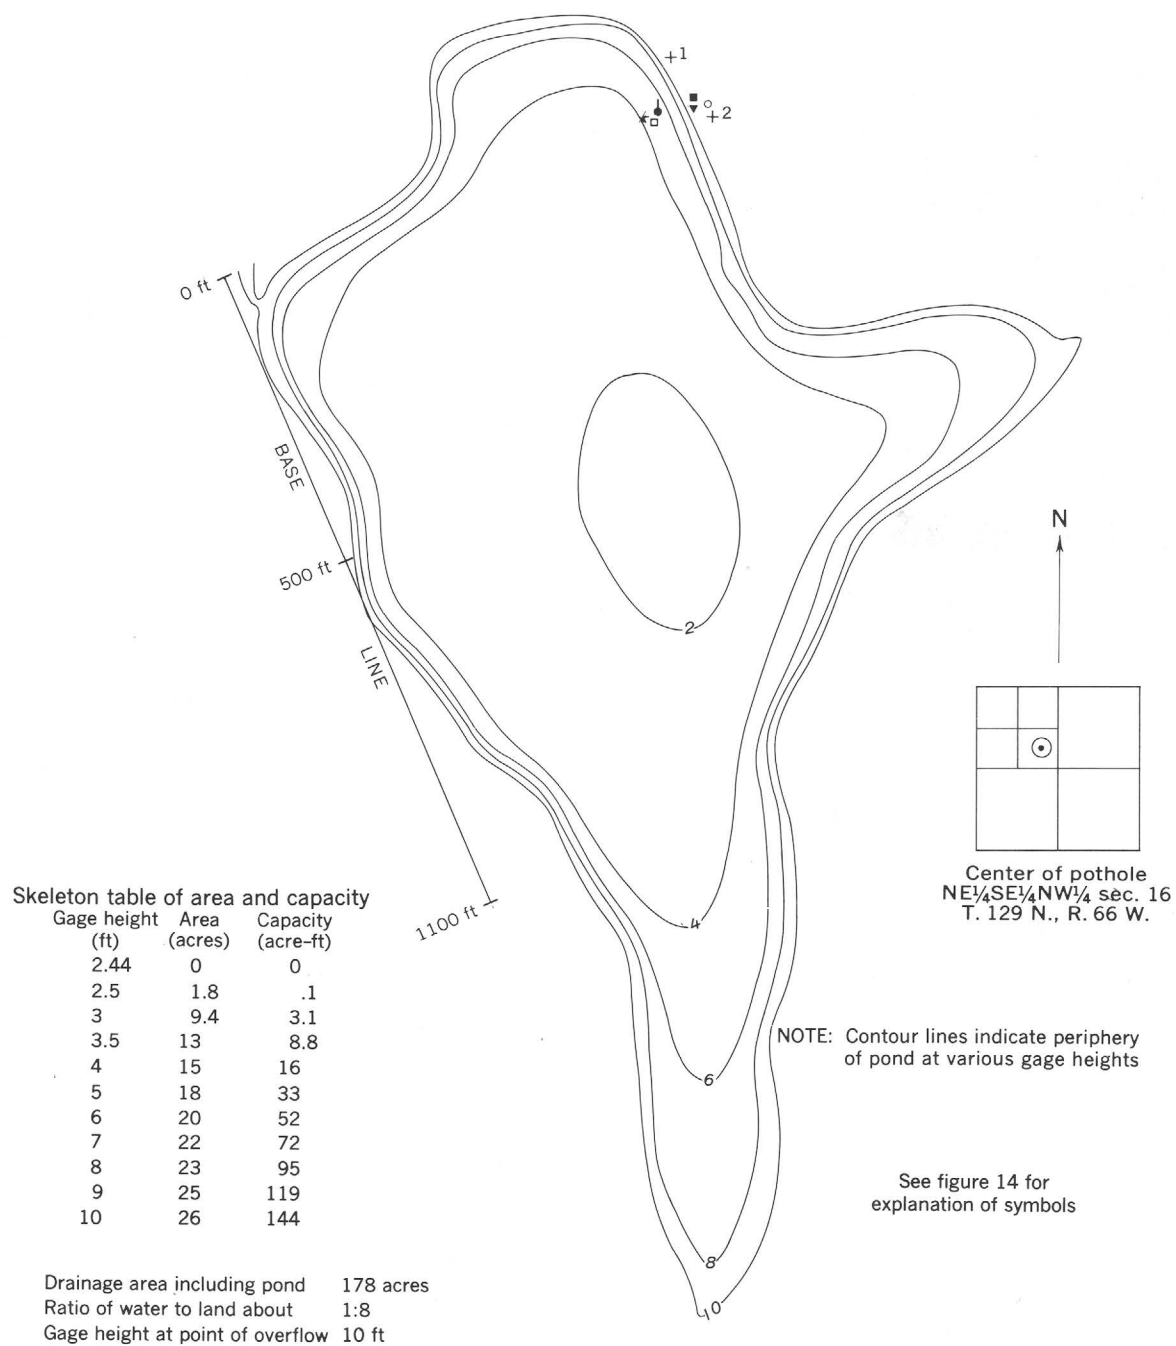
FIGURE 25.—Contour map for pothole 5 with skeleton table of area and capacity.

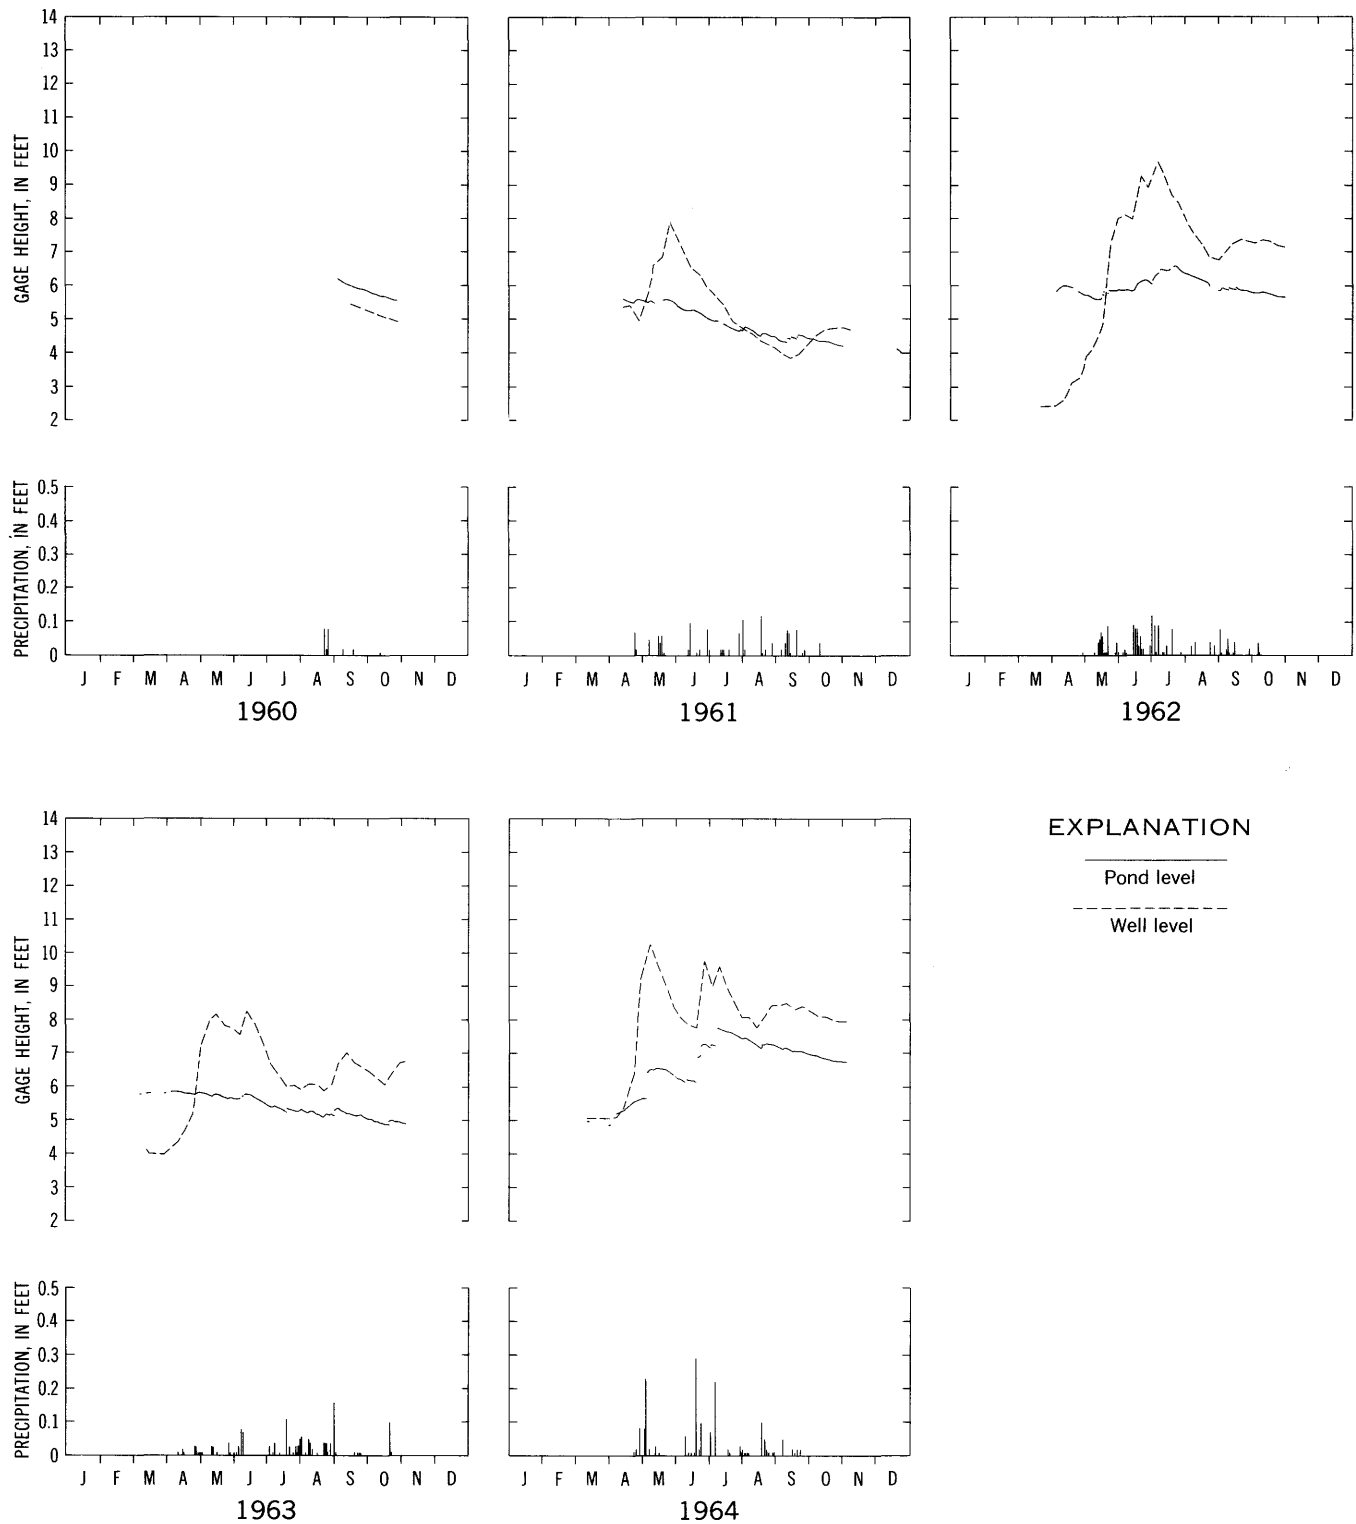
FIGURE 26.—Hydrographs for pothole 5, showing water levels in pond and observation well, and daily precipitation.

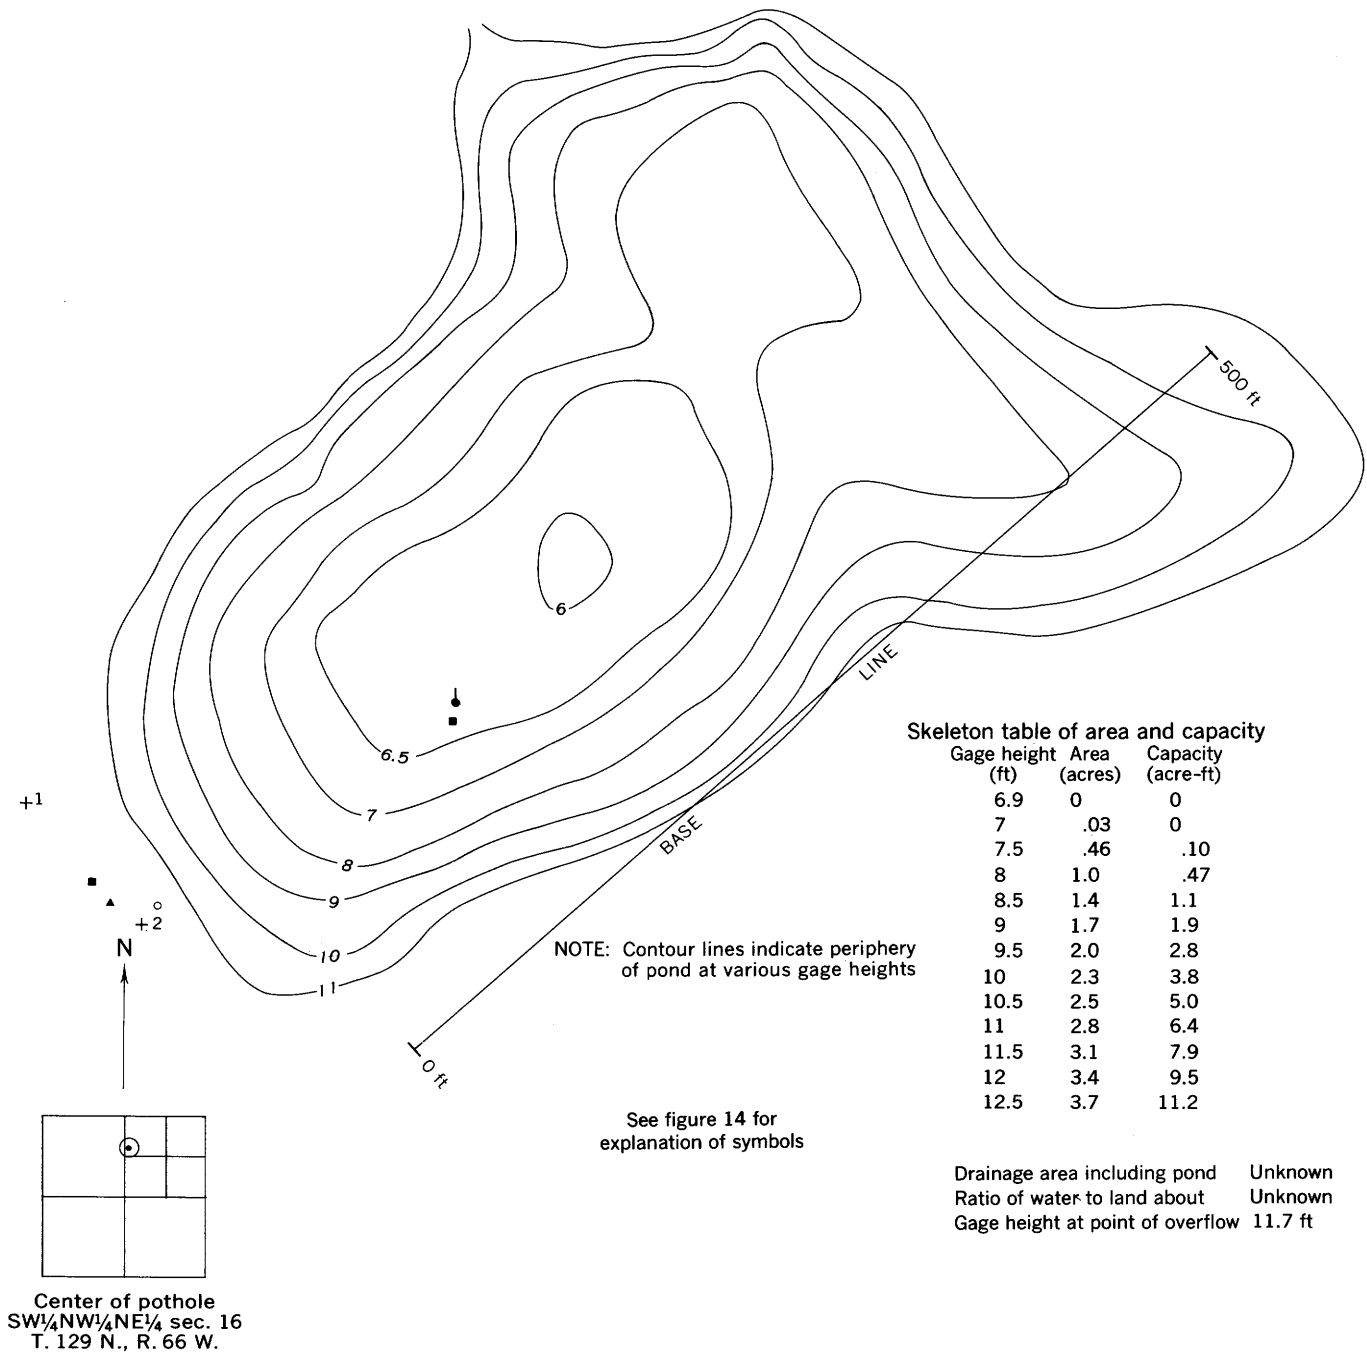
FIGURE 27.—Contour map for pothole 5A with skeleton table of area and capacity.

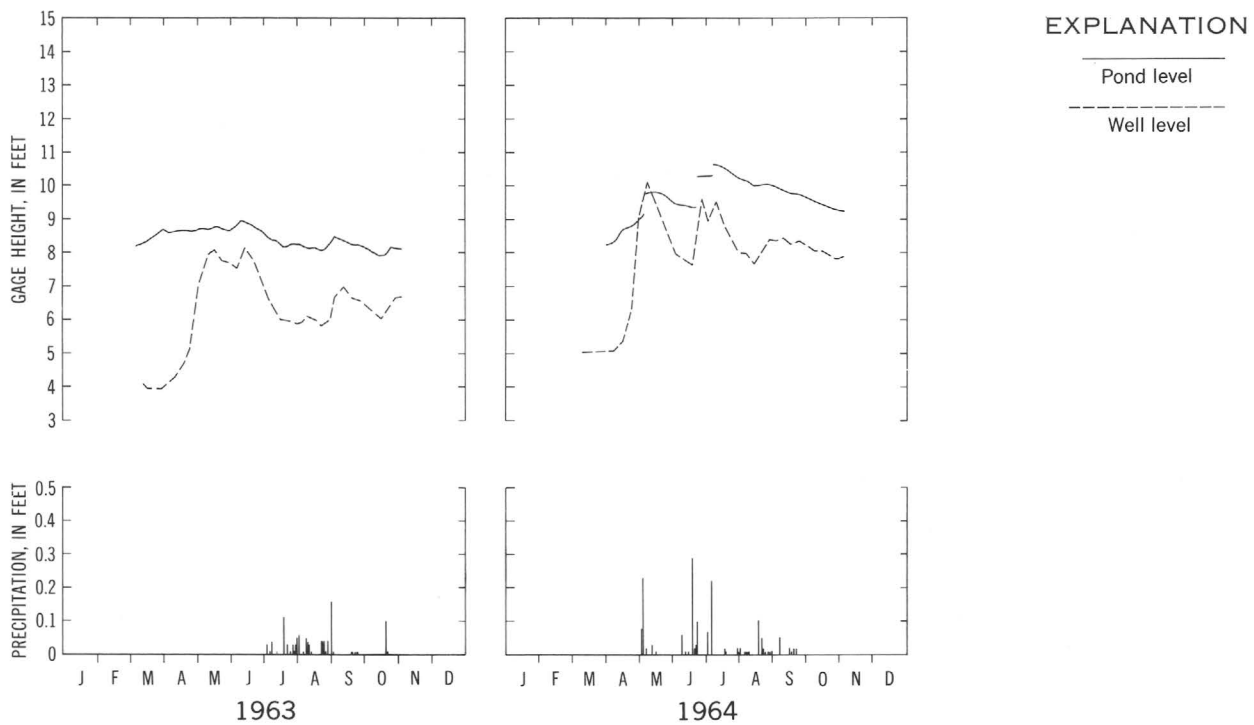
FIGURE 29.—Hydrographs for pothole 5A, showing water levels in pond and observation well, and daily production.

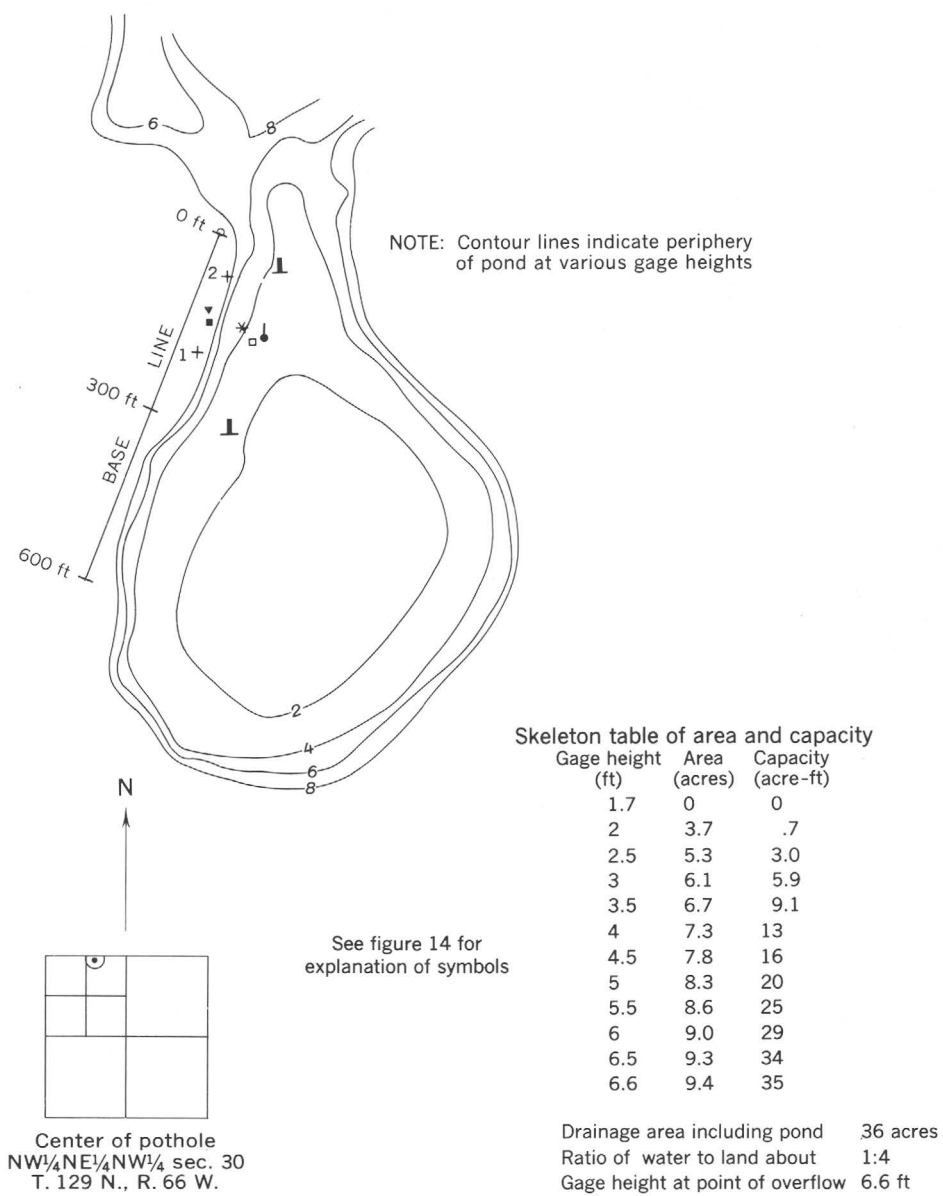
FIGURE 30.—Contour map for pothole 6 with skeleton table of area and capacity.

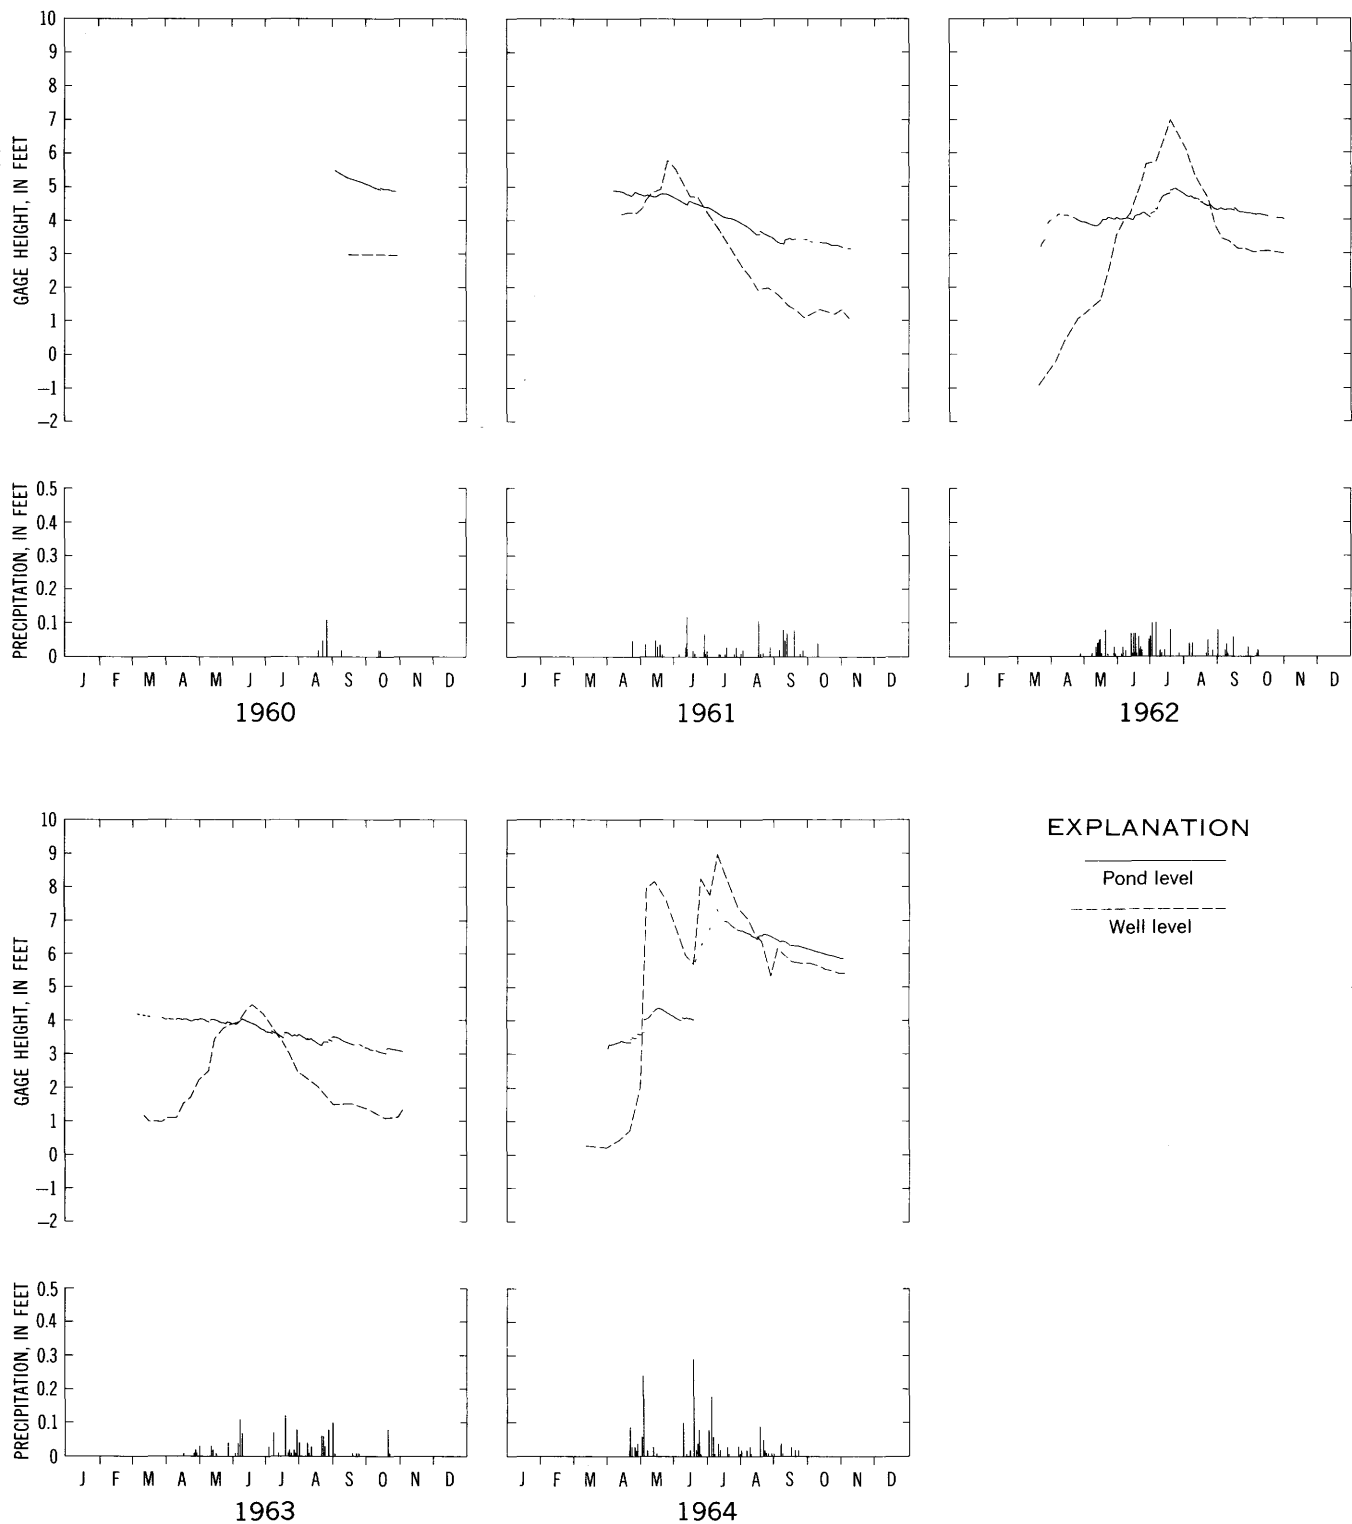
FIGURE 31.—Hydrographs for pothole 6, showing water levels in pond and observation well, and daily precipitation.

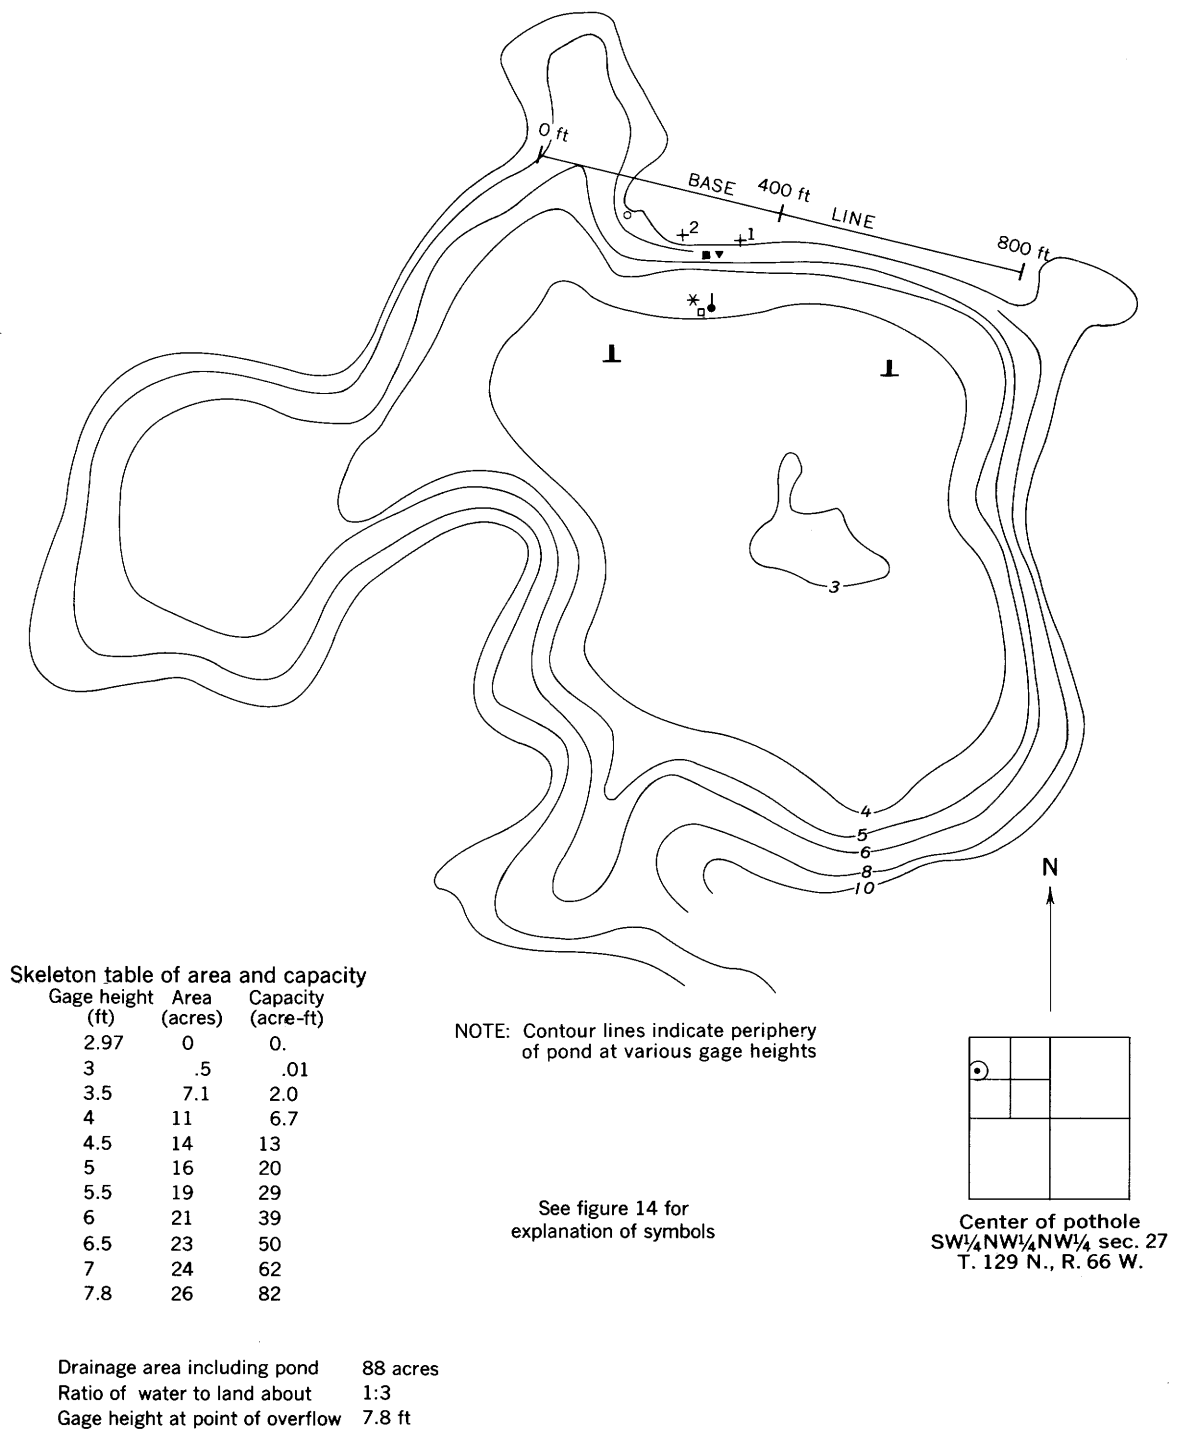
FIGURE 32.—Contour map for pothole 7 with skeleton table of area and capacity.

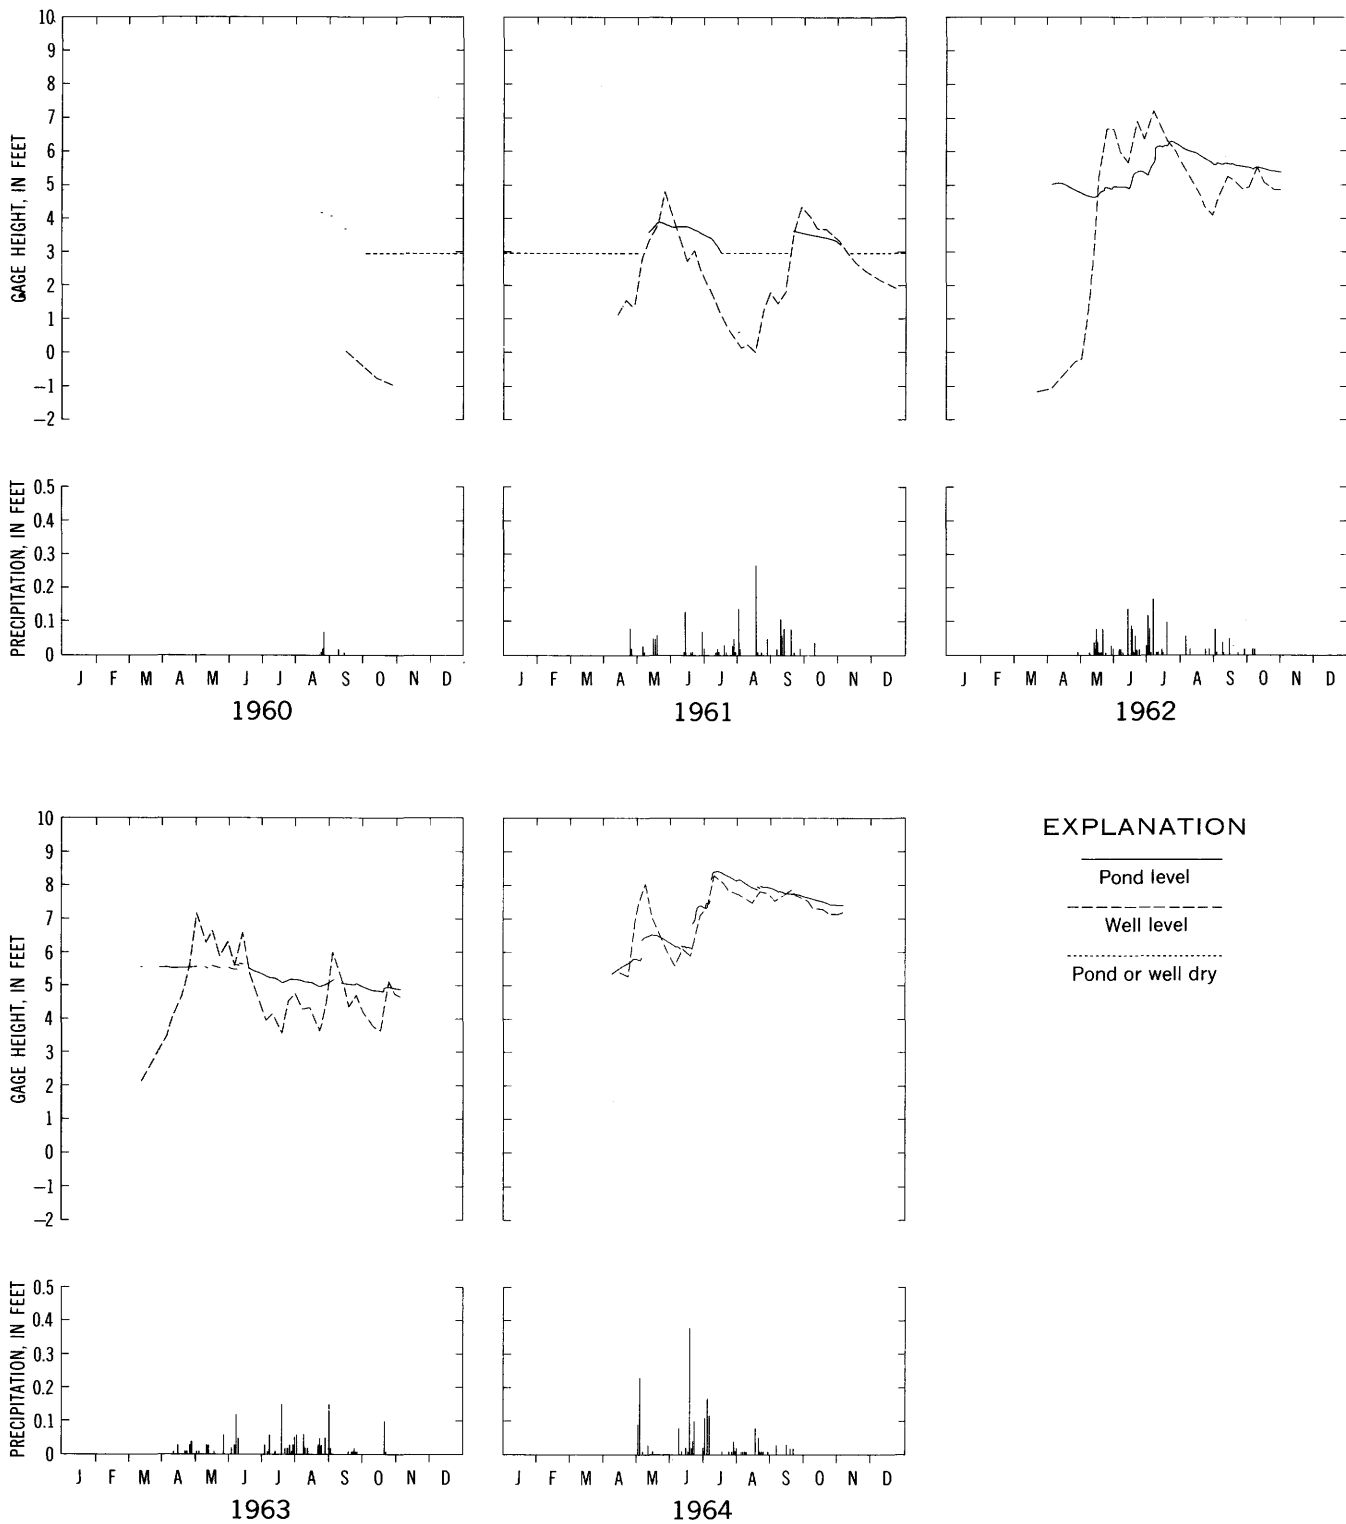
FIGURE 33.—Hydrographs for pothole 7, showing water levels in pond and observation well, and daily precipitation.

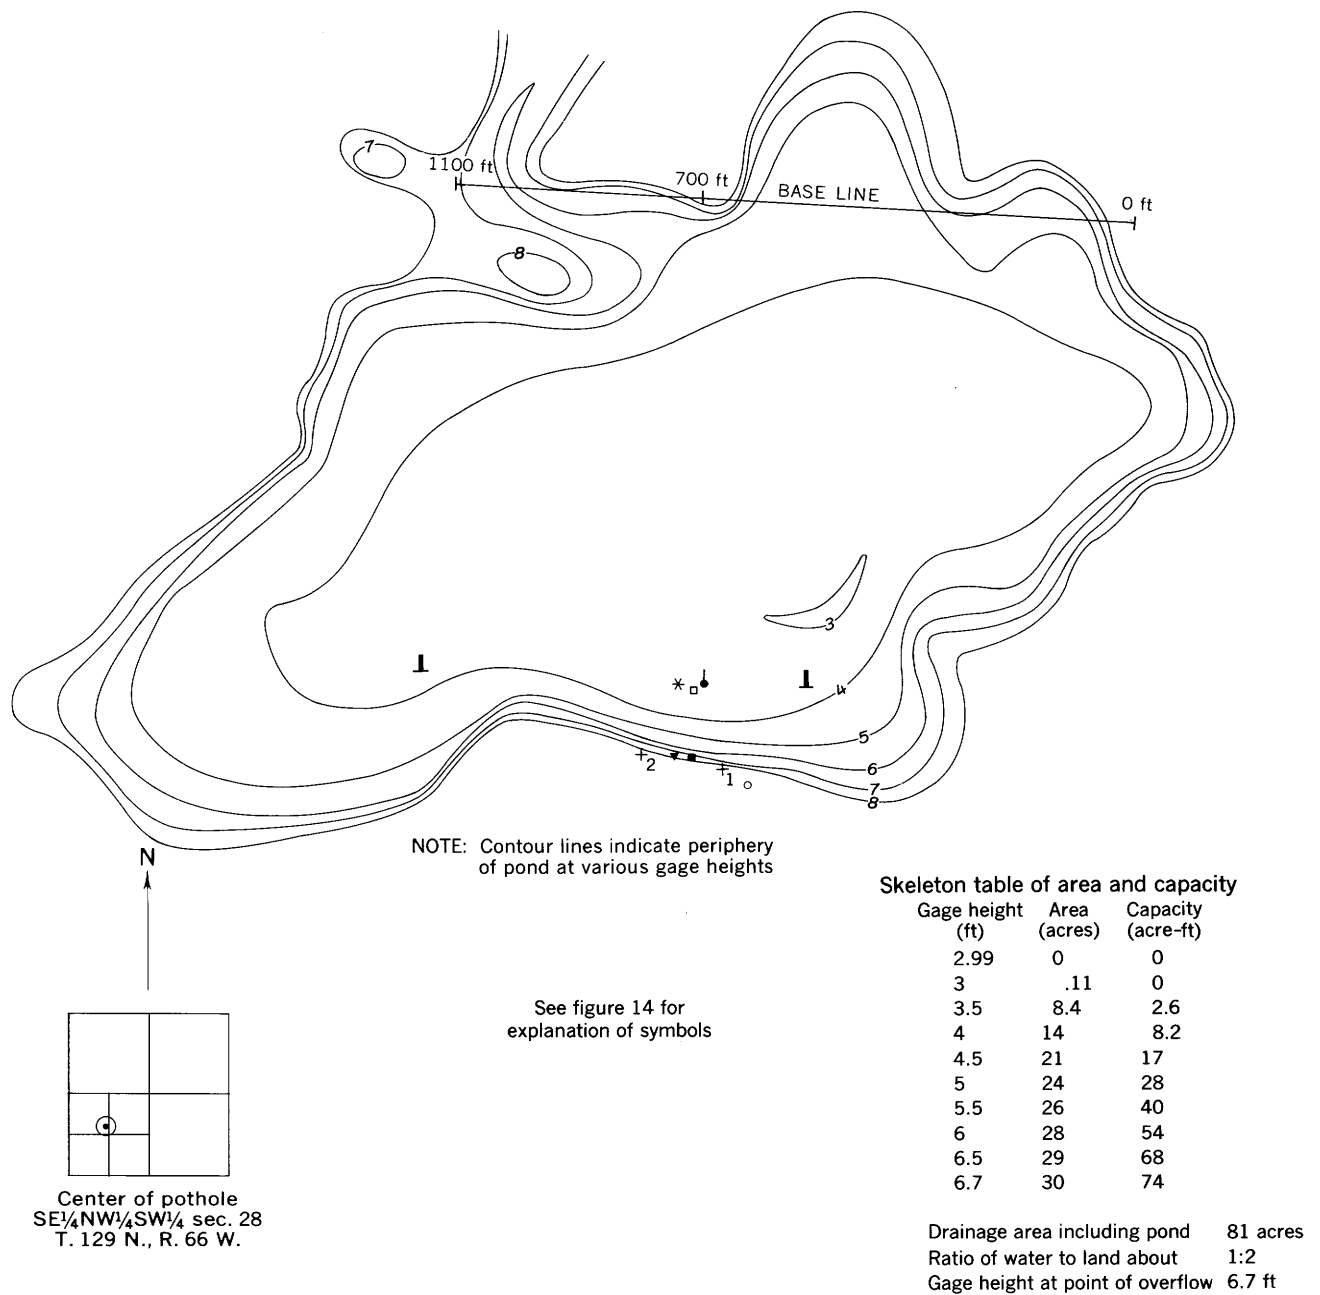
FIGURE 34.—Contour map for pothole 8 with skeleton table of area and capacity.

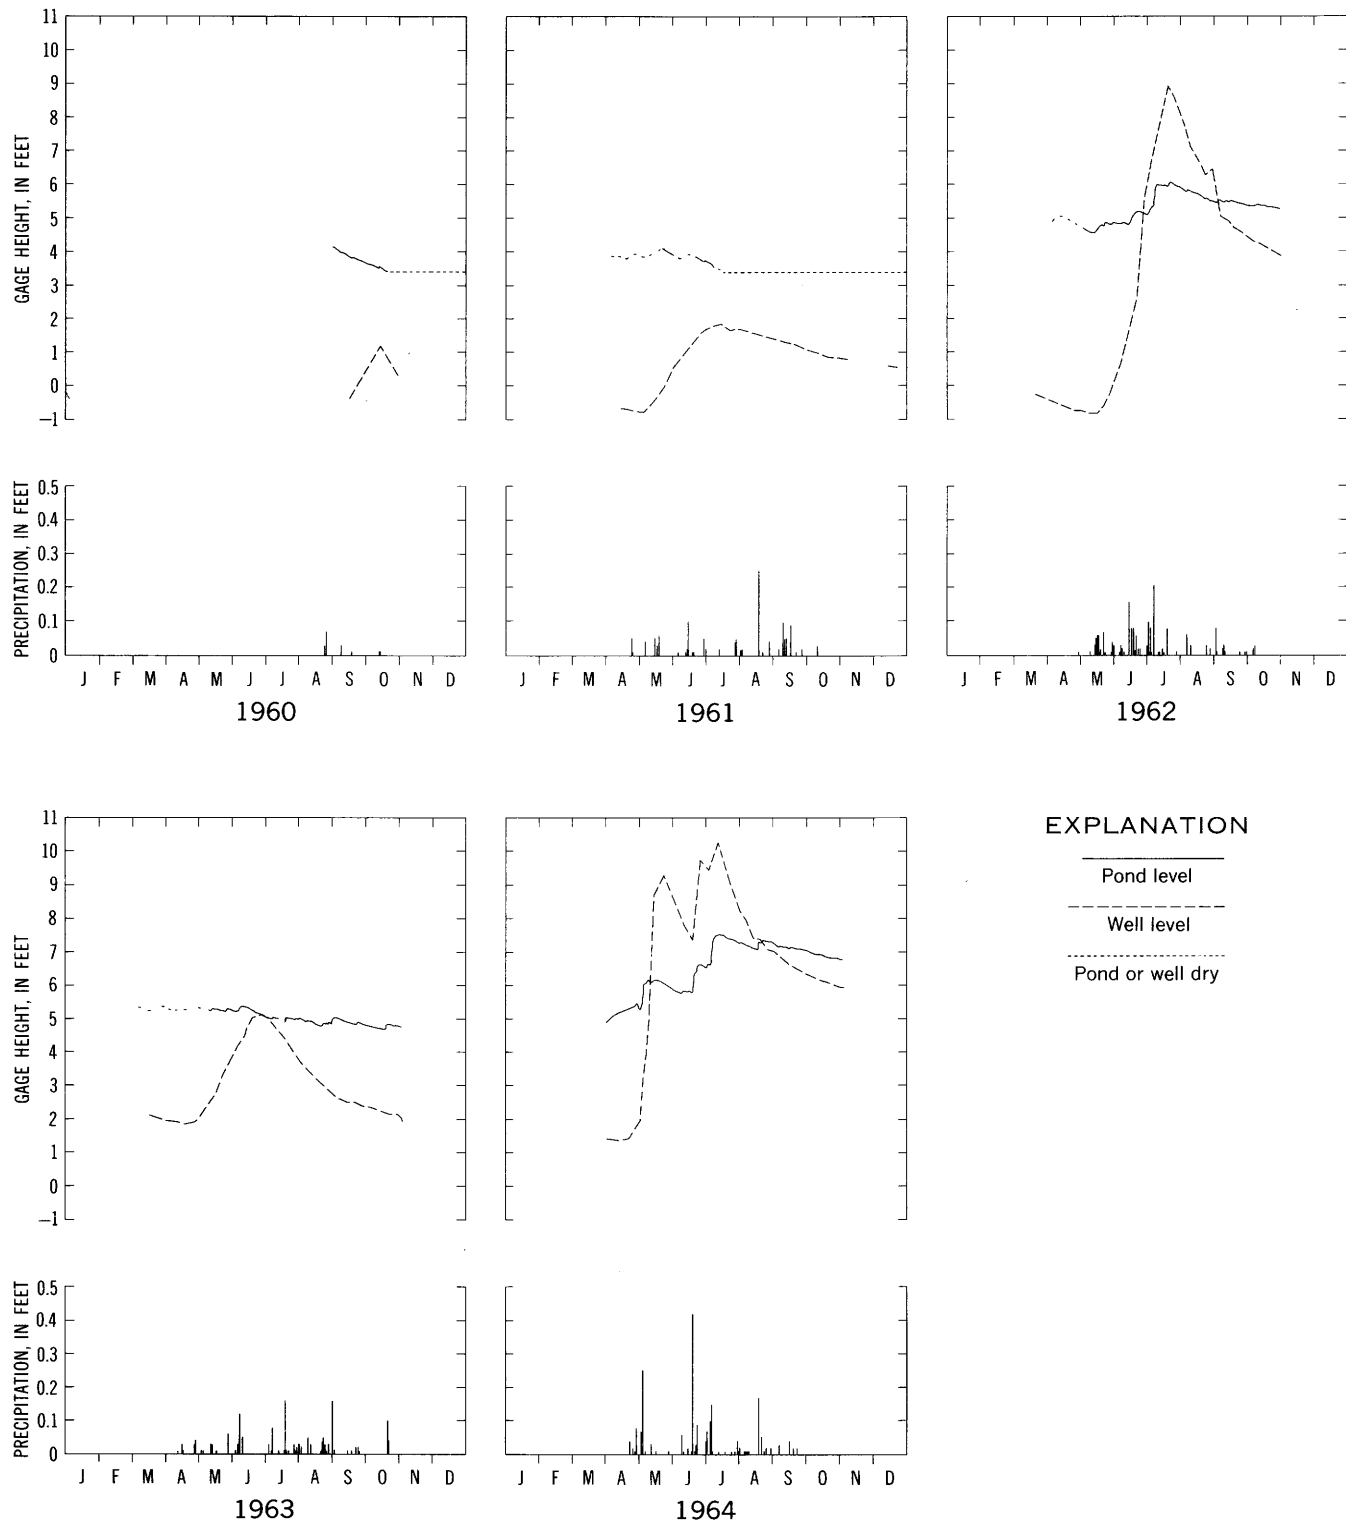
FIGURE 35.—Hydrographs for pothole 8, showing water levels in pond and observation well, and daily precipitation.

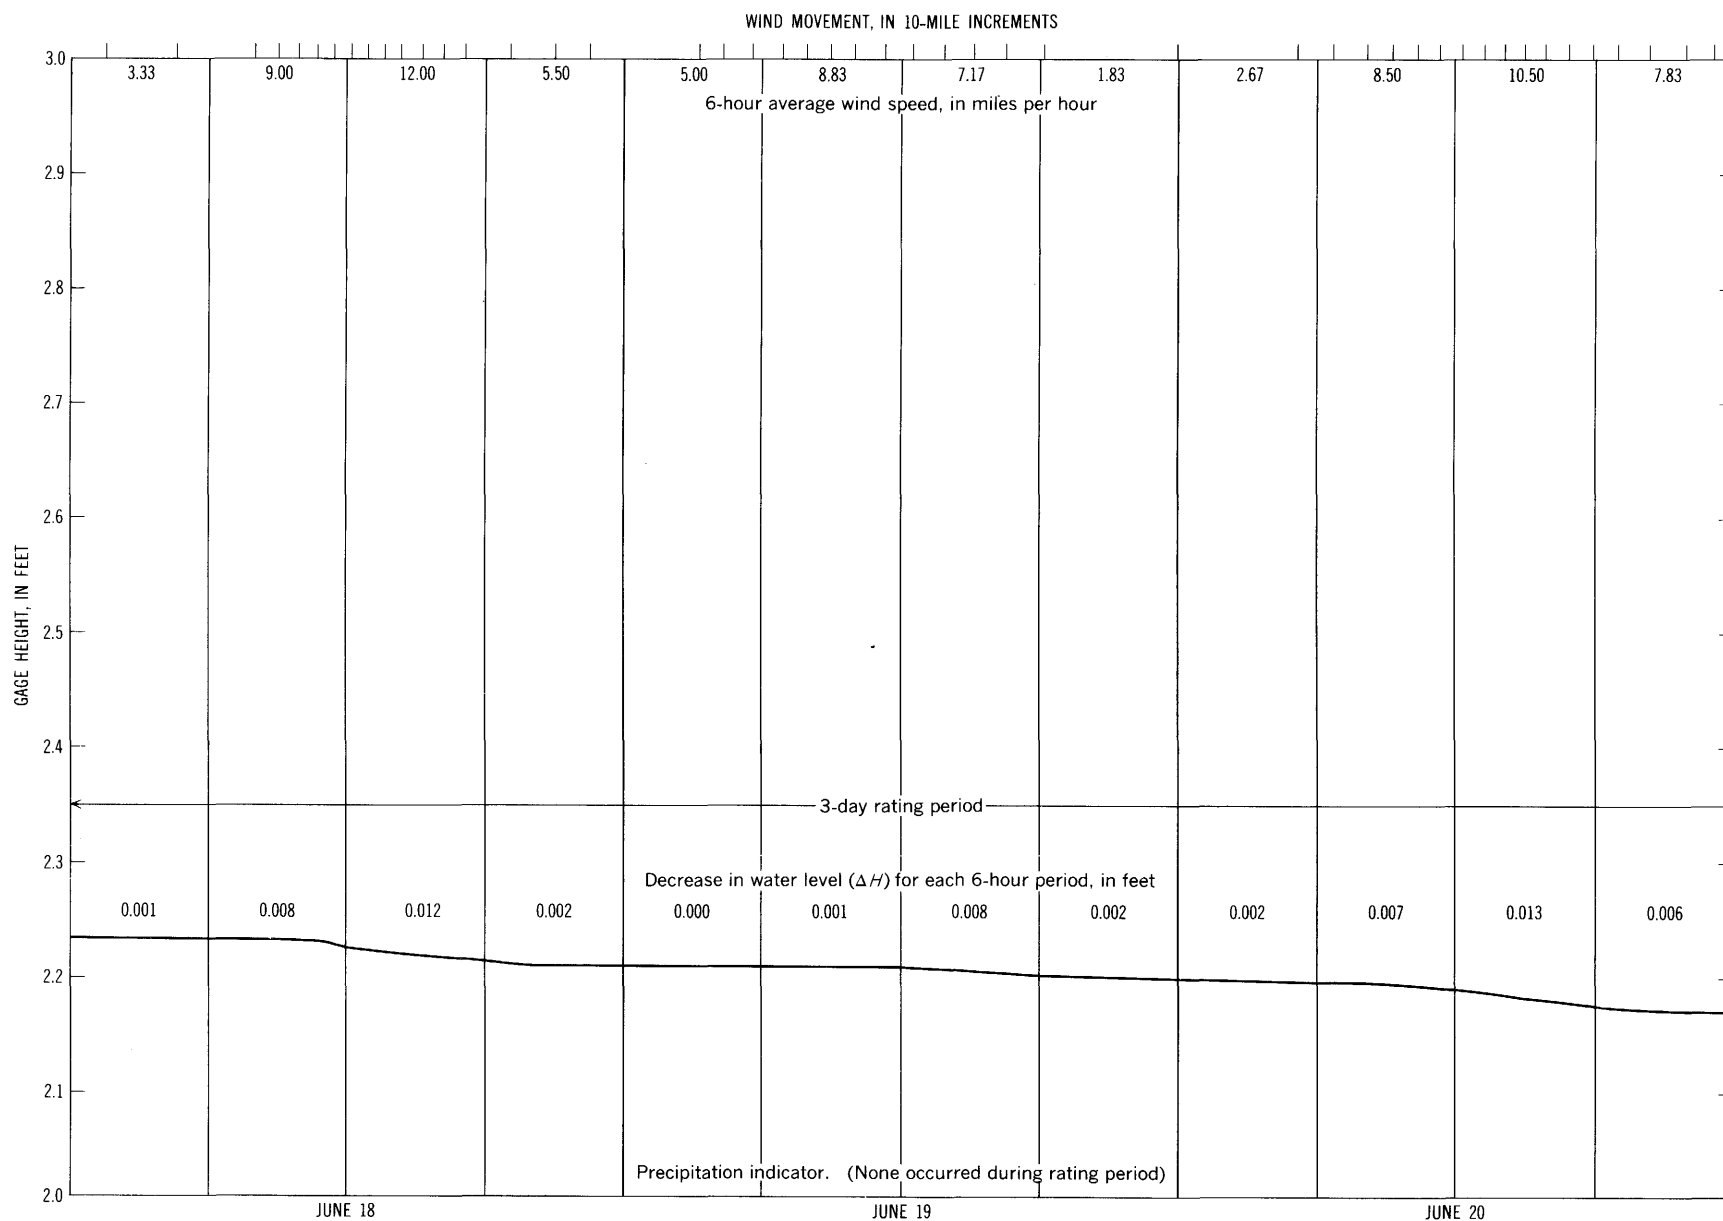
FIGURE 36.—Recorder chart for pothole 1 near Douglas, June 18–20, 1963, showing a 3-day rating period.

A suitable rating period would be one such as that of June 18–20, as shown in figure 36.
