Evapotranspiration and the Water Budget of Prairie Potholes in North Dakota

GEOLOGICAL SURVEY PROFESSIONAL PAPER 585-B

By JELMER B. SHJEFLO

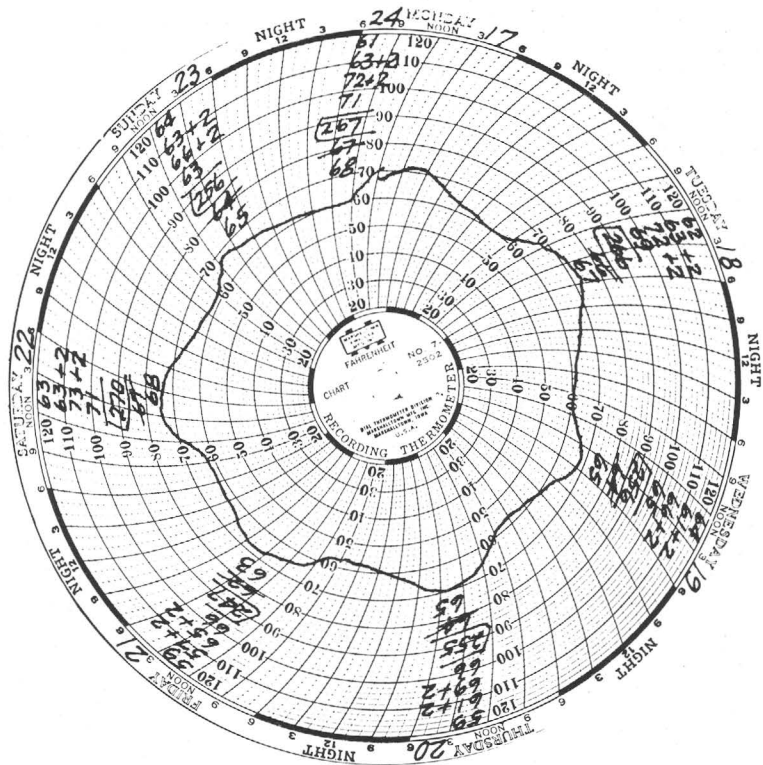
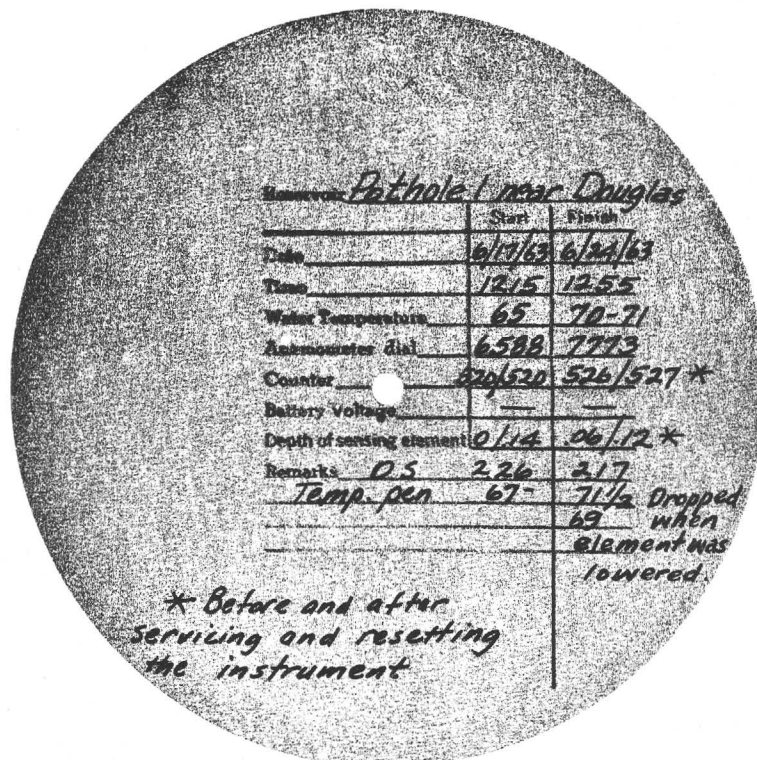
FIGURE 37.—Thermograph chart showing the diurnal fluctuation of water temperature.

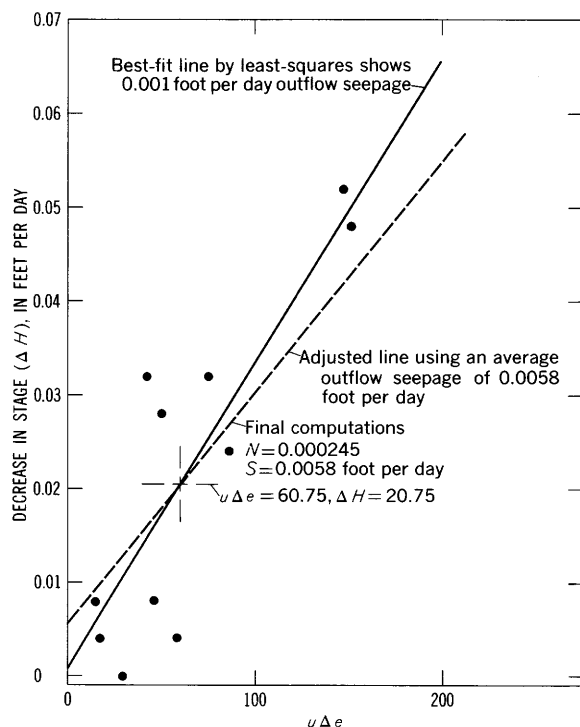
FIGURE 40.—Least-squares line showing intercept on Y-axis.

This computation was checked graphically by replacing the least-squares line with a line drawn from the average Y-intercept through the means of the plotted points, as shown in figure 40.

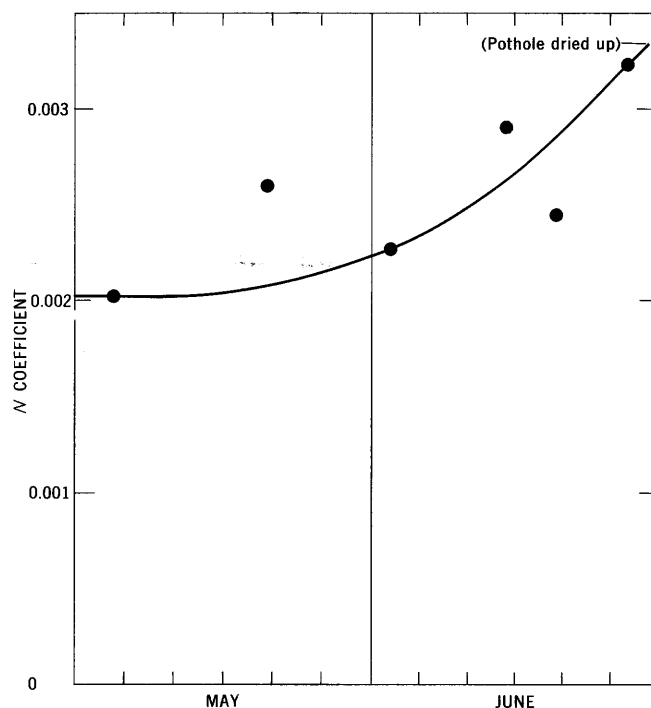
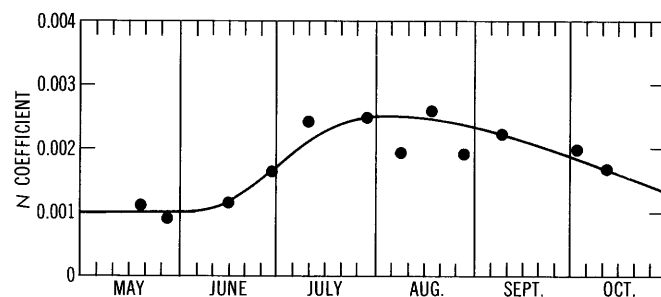
FIGURE 41.—A, Variation of the N coefficient with time for a vegetated pothole. B, Another example of how the N coefficient varies with time for a vegetated pothole.

The mass-transfer coefficients for the vegetated potholes were plotted with respect to time. Figure 41A shows the data that result from the sample computations illustrated in figures 36–40. As this N curve is not complete for the season, a complete curve is illustrated in figure 41B. This curve usually showed an increase in evapotranspiration from the middle of May to the end of July and a decrease from late August until some time in October when it became constant. N values for the vegetated potholes were picked from this curve at the middle of each computation period.

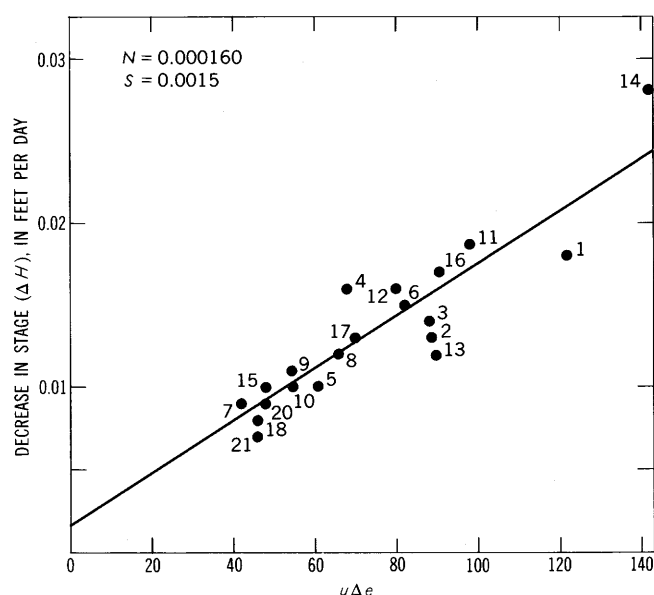
FIGURE 42.—*N* coefficient remaining constant for a clear pothole.

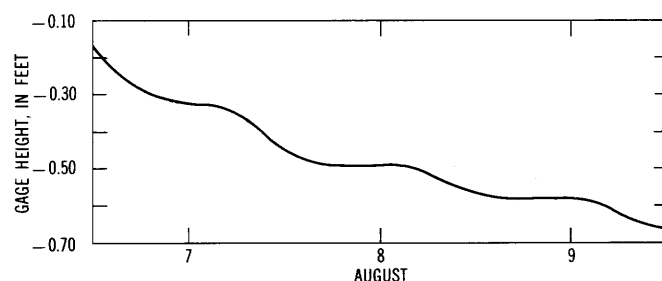
FIGURE 43.—Diurnal fluctuation of water level in gage well as pothole 2 dried up in 1962.

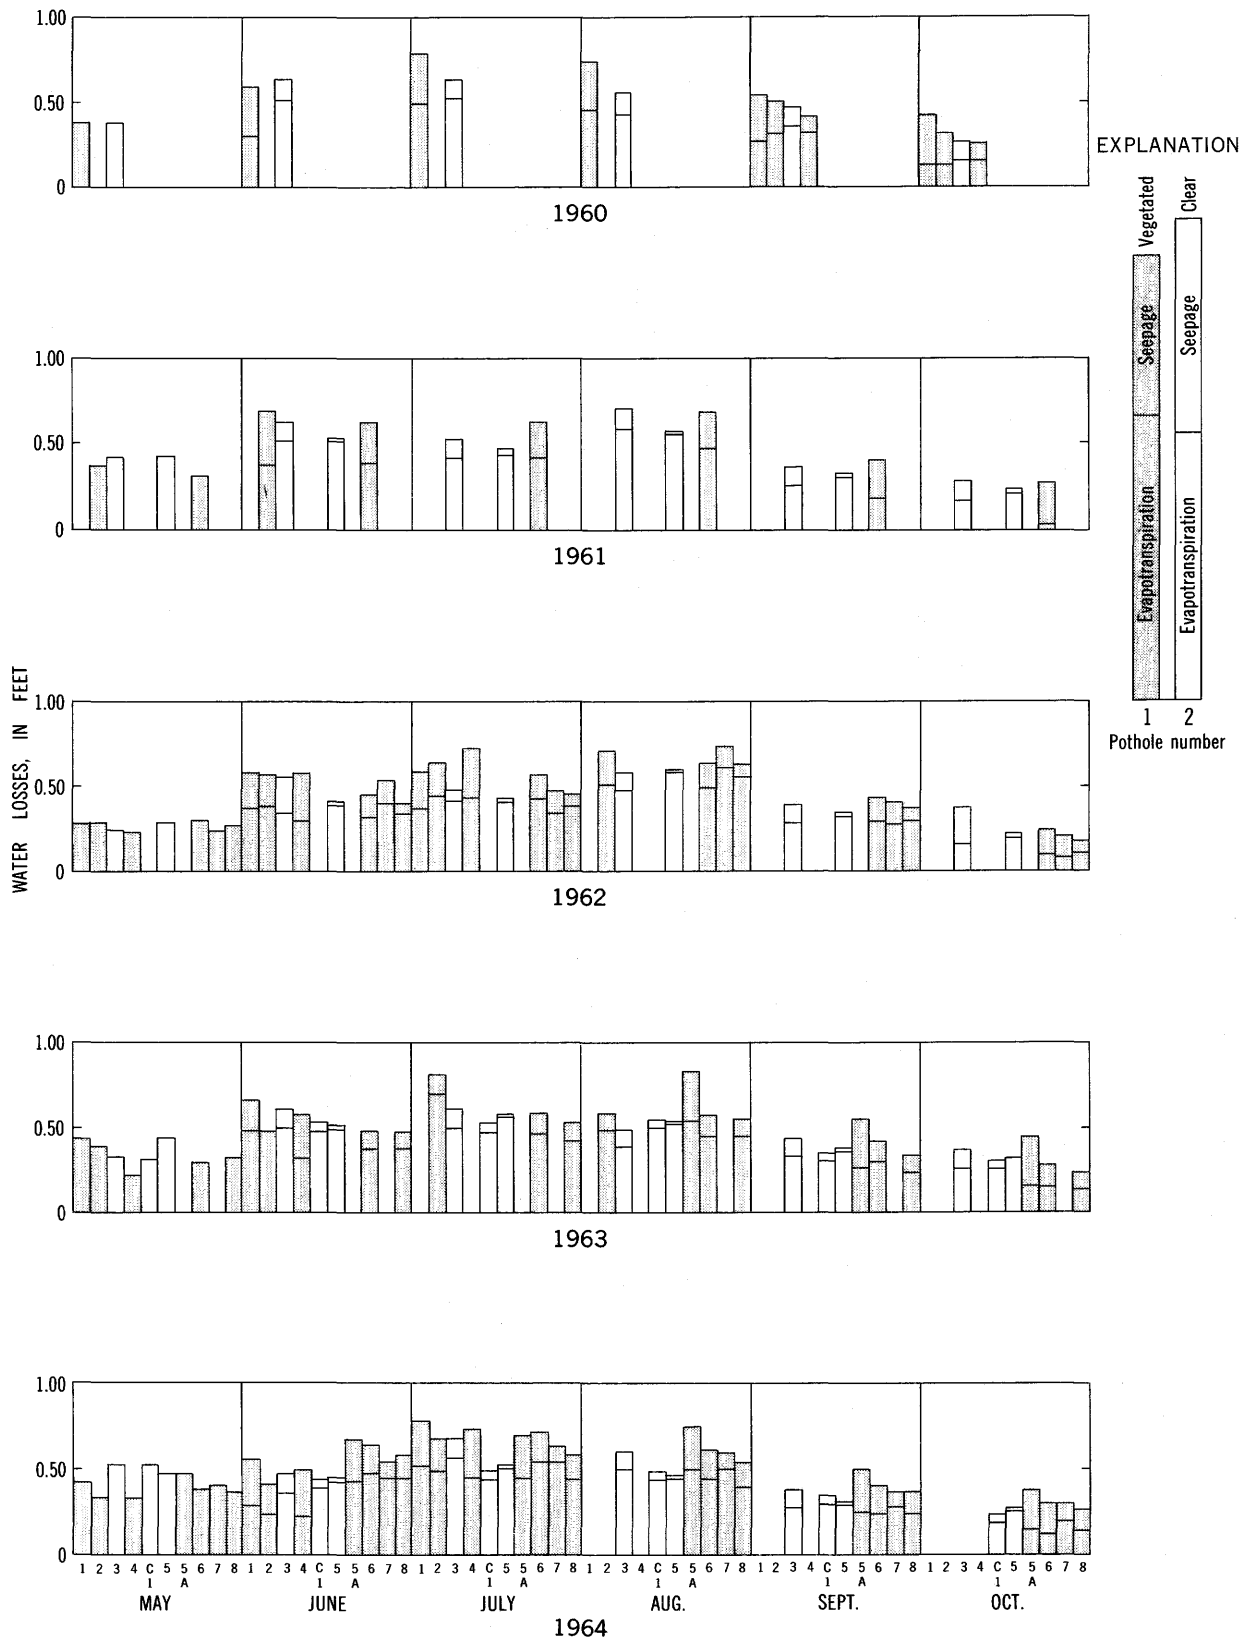
FIGURE 44.—Monthly evapotranspiration and seepage losses for each pothole, May to October 1960–64.

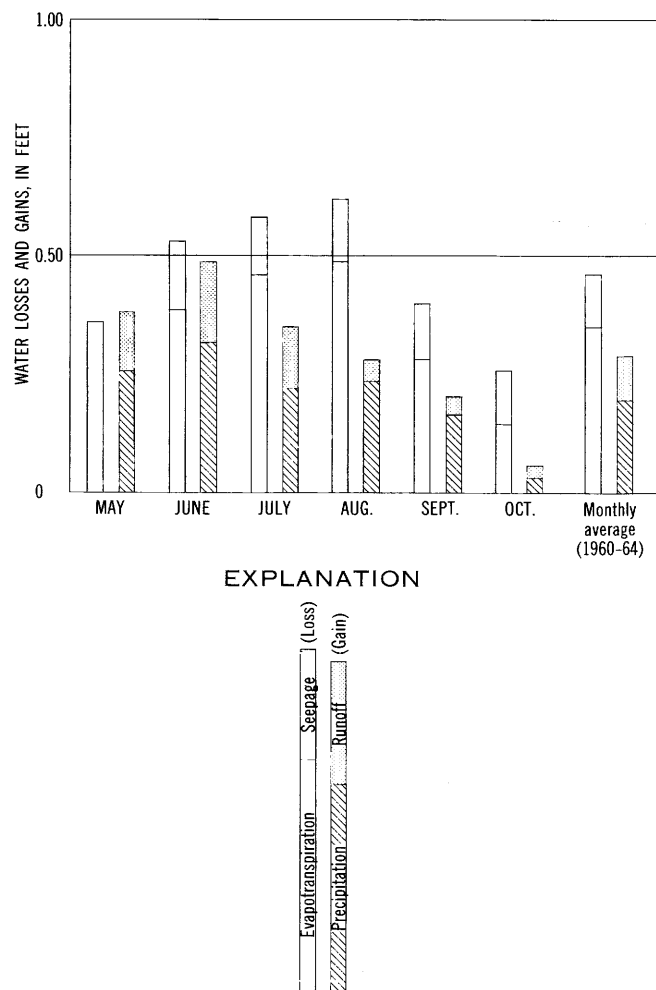
FIGURE 45.—Average monthly water losses and gains for all potholes, May to October 1960-64.
