A. Aerial photograph of part of the Hempstead subarea in the East Meadow Brook drainage area in 1938. Photograph from the National Archives and Records Service

D. Location map of Nassau County showing the East Meadow Brook drainage area, Hempstead subarea, the Mincola precipitation gage, and the sample area

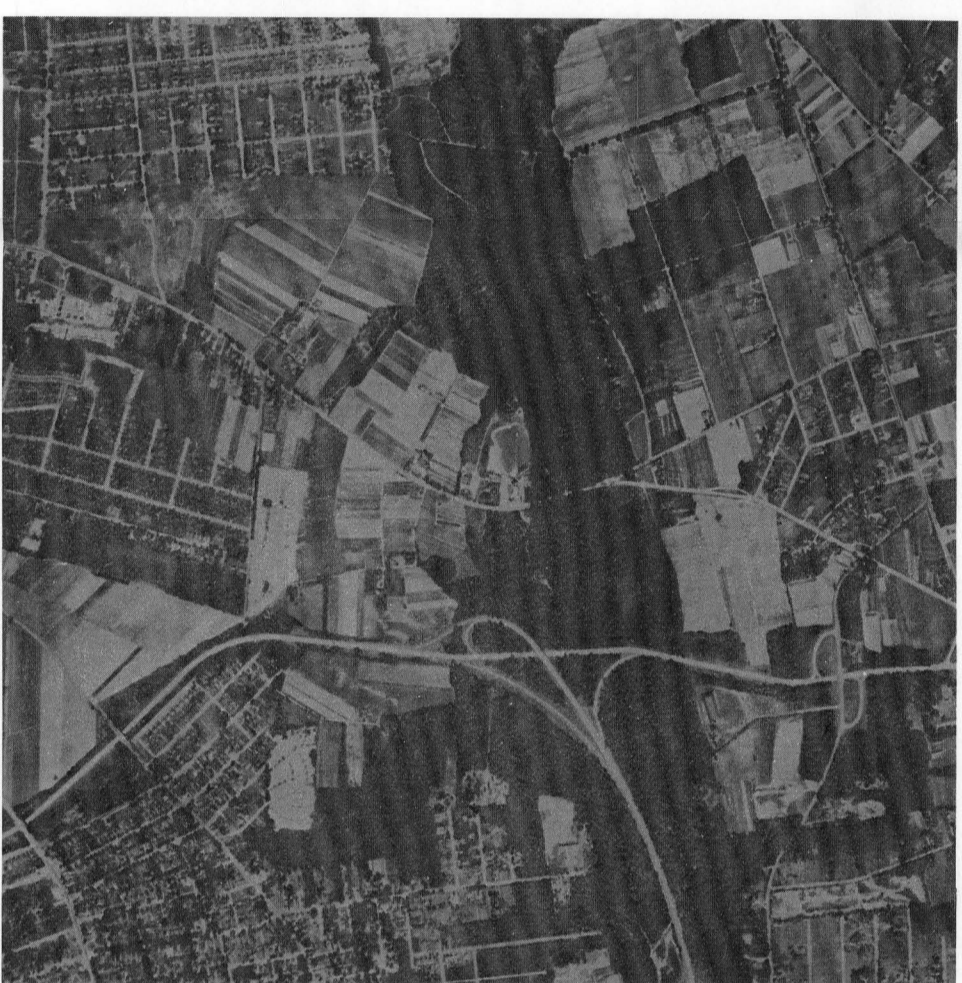
E. Aerial photograph of part of the Hempstead subarea in the East Meadow Brook drainage area in 1947. U.S. Department of Agriculture photograph

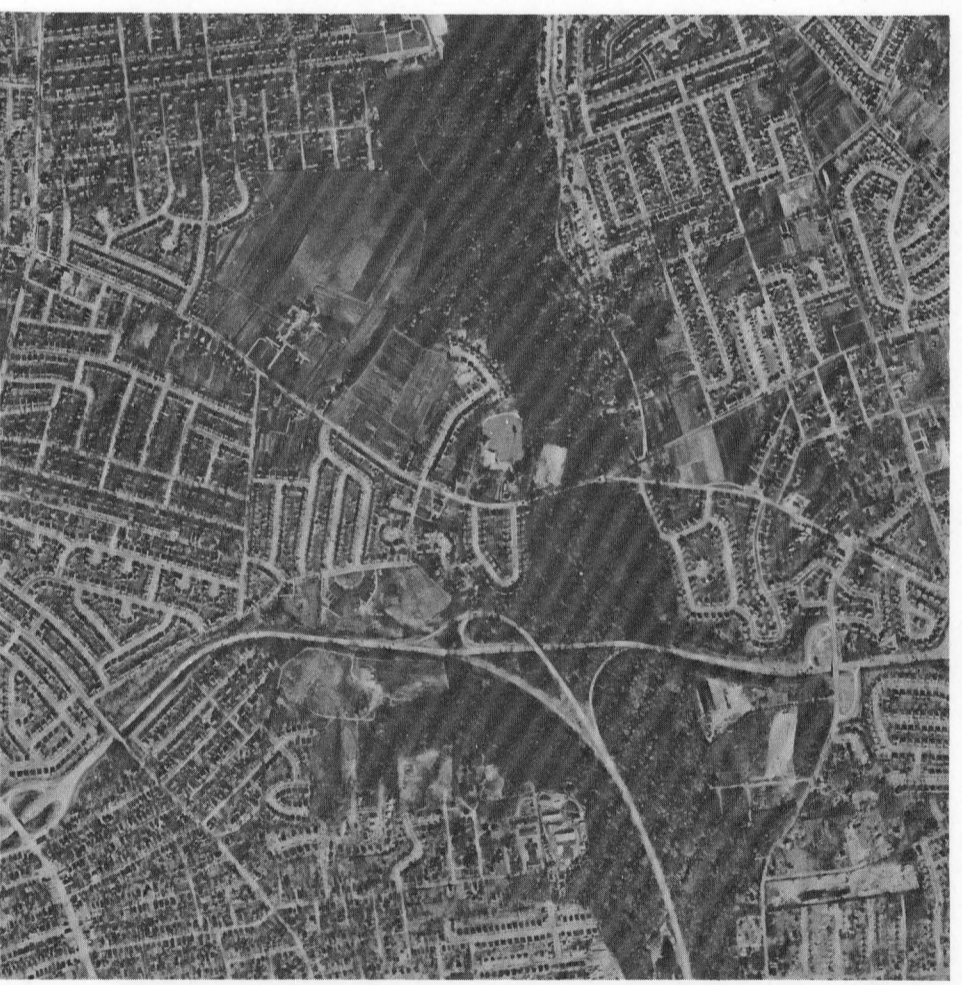
H. Aerial photograph of part of the Hempstead subarea in the East Meadow Brook drainage area in 1953. U.S. Geological Survey photograph

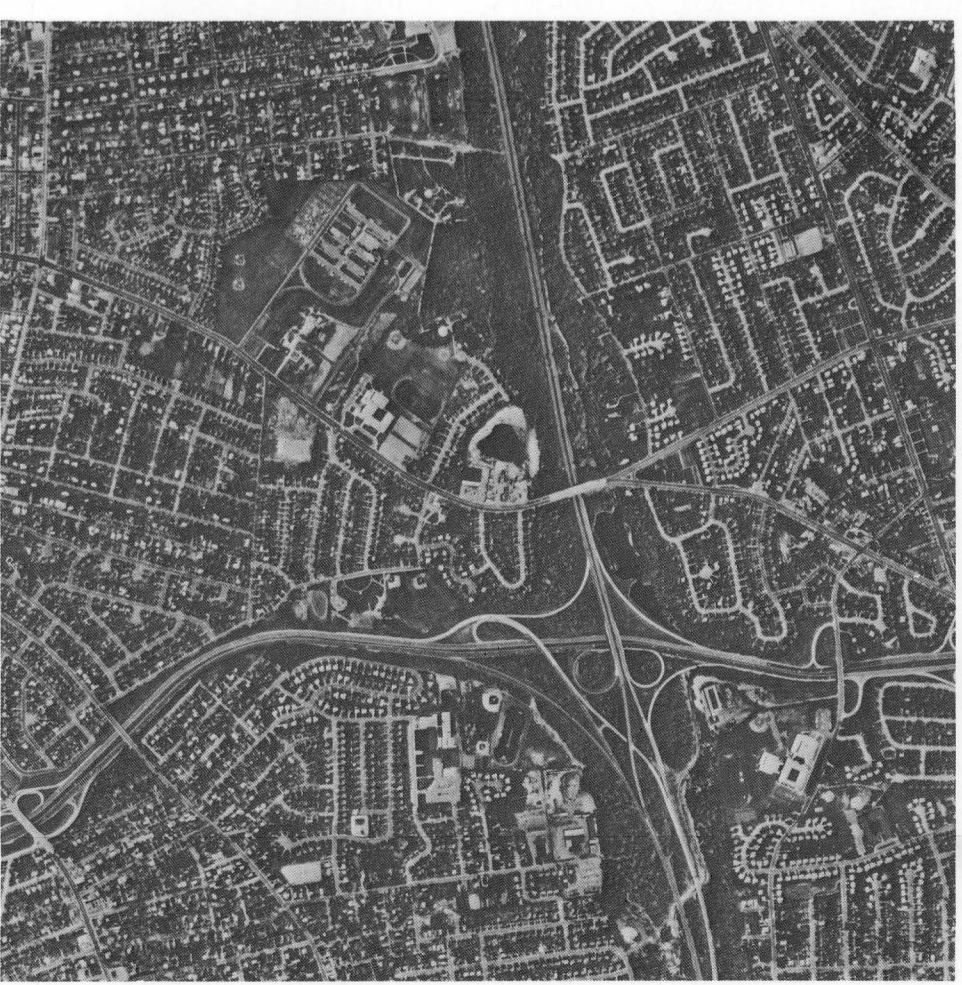
K. Aerial photograph of part of the Hempstead subarea in the East Meadow Brook drainage area in 1966. Photograph from Lockwood, Kessler, and Bartlett, Engineers

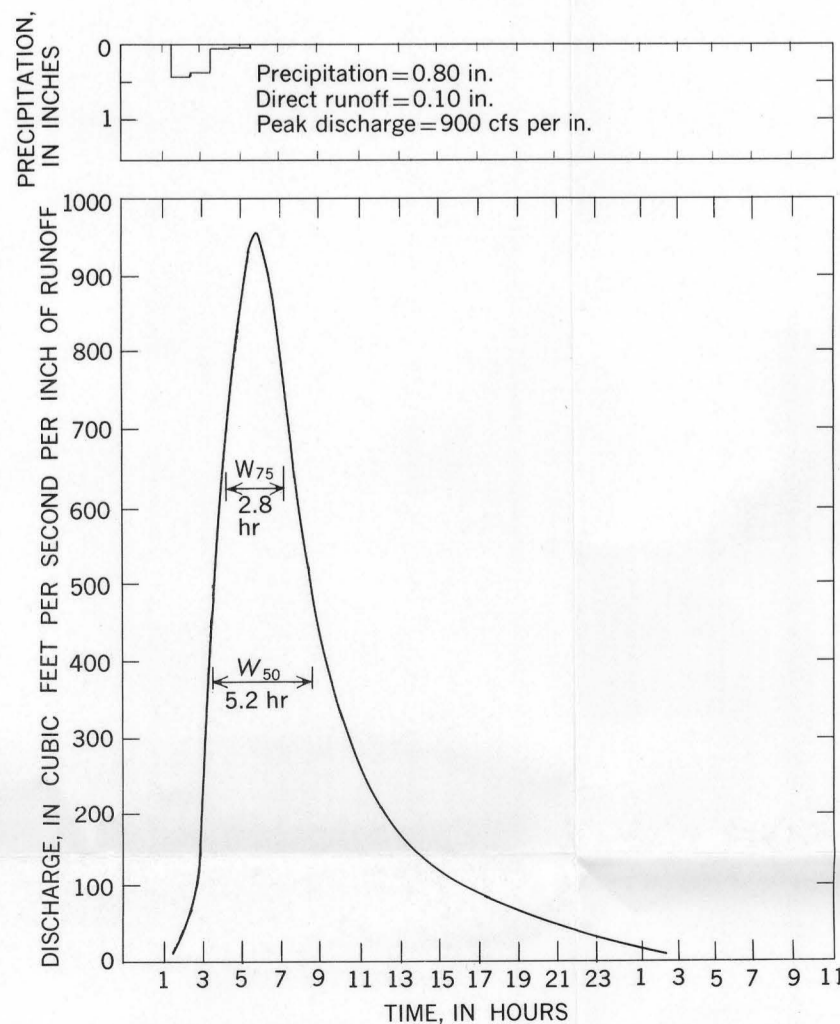
M. One-hour unit hydrograph of the storm on August 21, 1962, in the Hempstead subarea
