MAPS AND AERIAL PHOTOGRAPHS SHOWING CHANNEL CHANGES  
OF THE GILA RIVER NEAR PIMA, ARIZONA

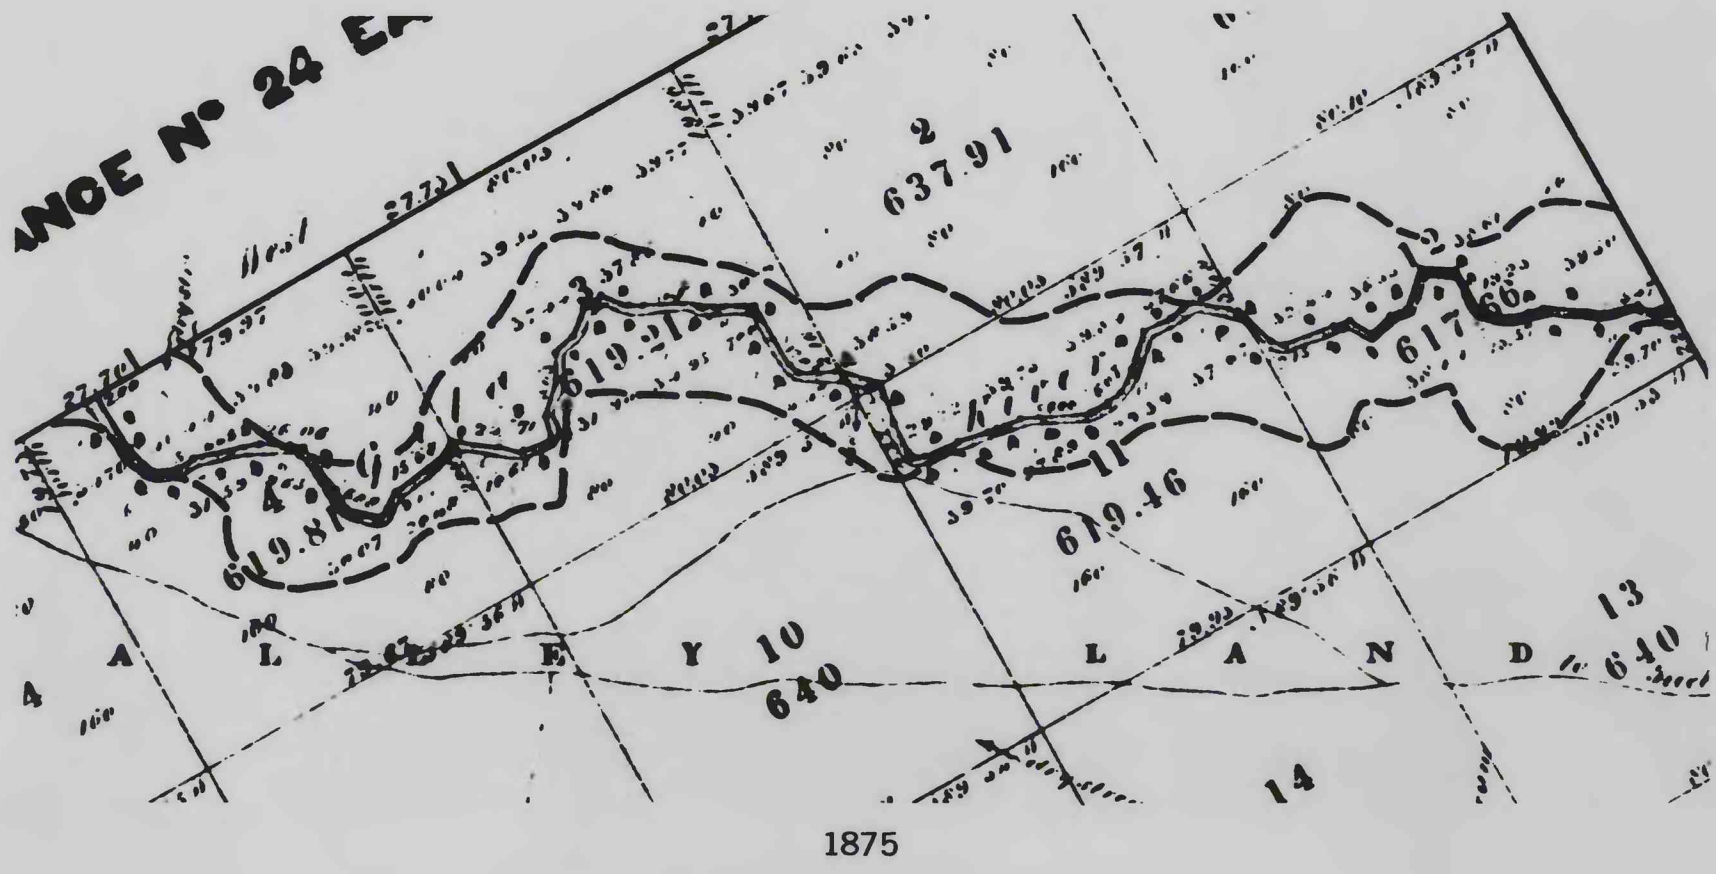
The major widening of the stream channel from 1903 to 1914 was caused mainly by the major winter floods of 1905 and 1906 (p. 3). The widening during 1959-66 was caused mainly by the flood of December 1965; further widening was caused by the flood of August 1967. The maps for 1875 and 1919 are from cadastral surveys and are in the files of the U.S. Bureau of Land Management, Phoenix. The map for 1903 is from a soil survey by Lapham and Neill (1904), and the map for 1915 is from the files of the U.S. Bureau of Indian Affairs, Phoenix. The aerial photographs are from the files of the U.S. Geological Survey, Tucson.
