PHOTOGRAPHS SHOWING DEVELOPMENT OF THE ALLUVIAL FAN AT THE MOUTH  
OF A TRIBUTARY TO THE GILA RIVER NEAR CALVA, ARIZONA

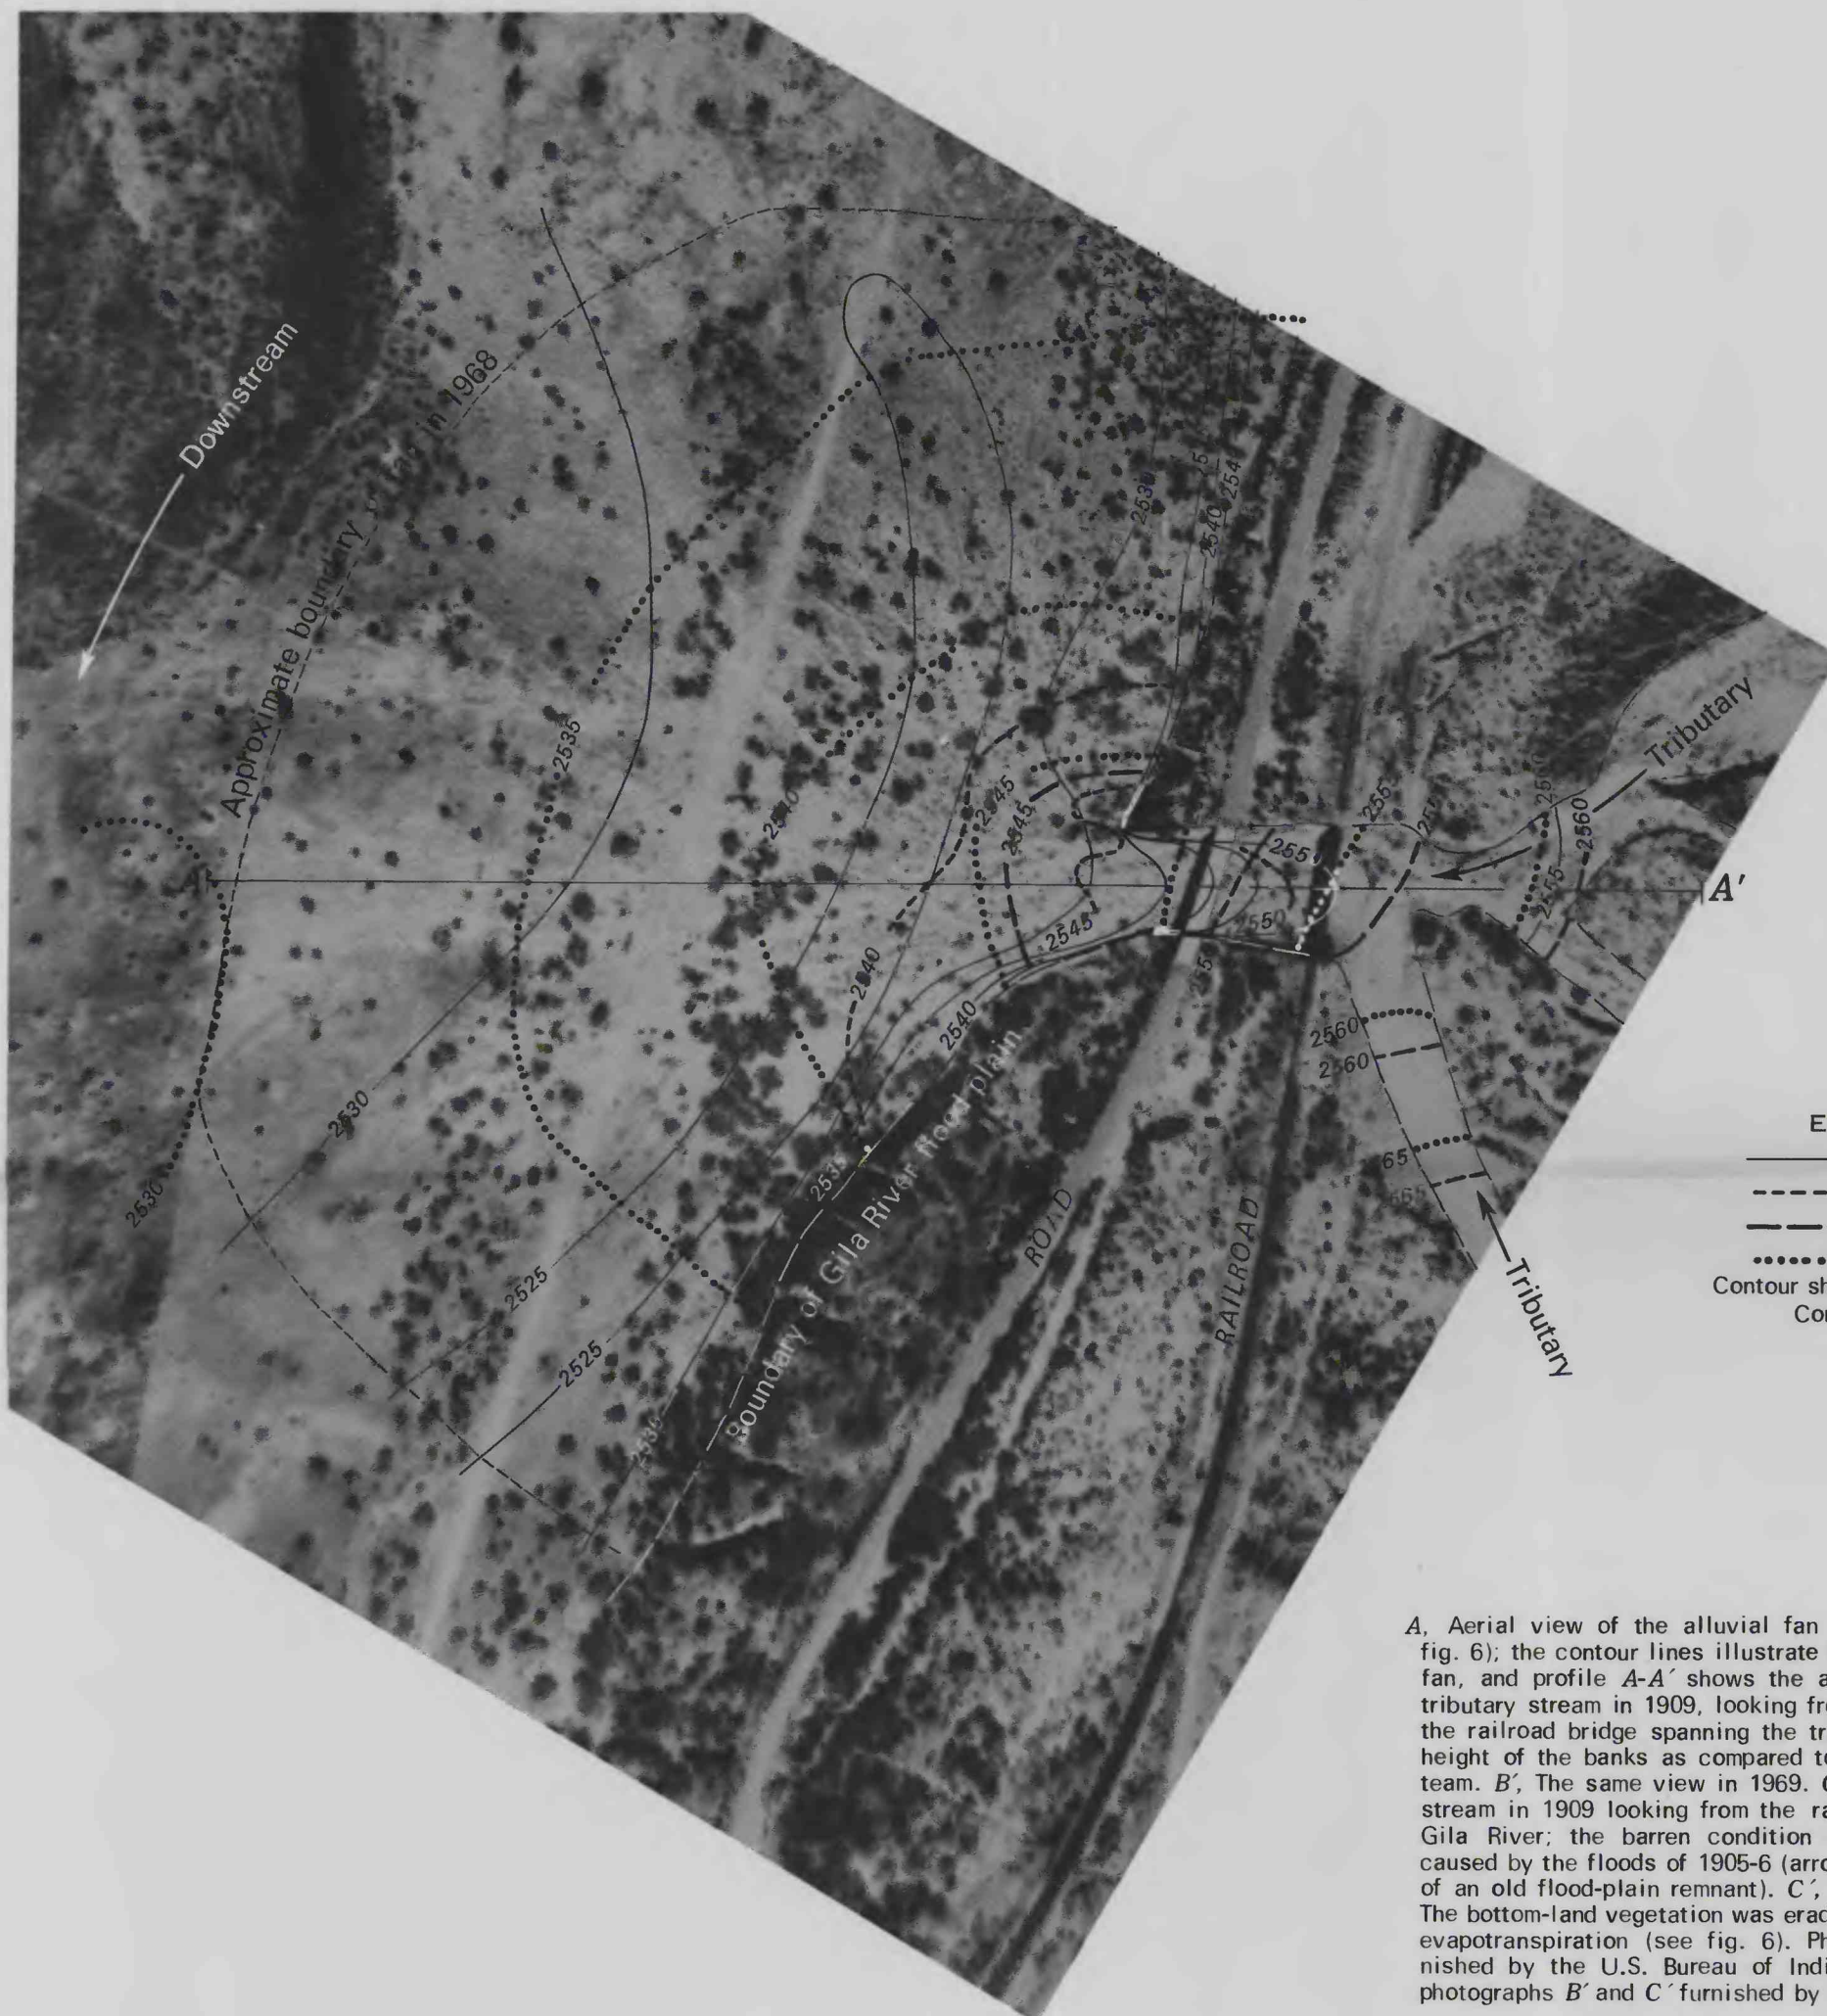
EXPLANATION  
 ——— 1914 ———  
 - - - 1947 - - -  
 - - - 1964 - - -  
 ..... 1968 .....  
 Contour shows rate of growth of fan  
 Contour interval 5 feet

A, Aerial view of the alluvial fan in 1964 (see pl. 1 and fig. 6); the contour lines illustrate the rate of growth of the fan, and profile A-A' shows the altitude. B, Mouth of the tributary stream in 1909, looking from the Gila River toward the railroad bridge spanning the tributary stream; note the height of the banks as compared to that of the wagon and team. B', The same view in 1969. C, Mouth of the tributary stream in 1909 looking from the railroad bridge toward the Gila River; the barren condition of the flood plain was caused by the floods of 1905-6 (arrow indicates the location of an old flood-plain remnant). C', The same view in 1969. The bottom-land vegetation was eradicated in 1966 to control evapotranspiration (see fig. 6). Photographs B and C furnished by the U.S. Bureau of Indian Affairs, Washington; photographs B' and C' furnished by Mr. R.M. Turner, Tucson.
