PHOTOGRAPHS AND PROFILES SHOWING HORIZONTAL AND VERTICAL CHANGES
IN THE GILA RIVER NEAR FORT THOMAS, ARIZONA

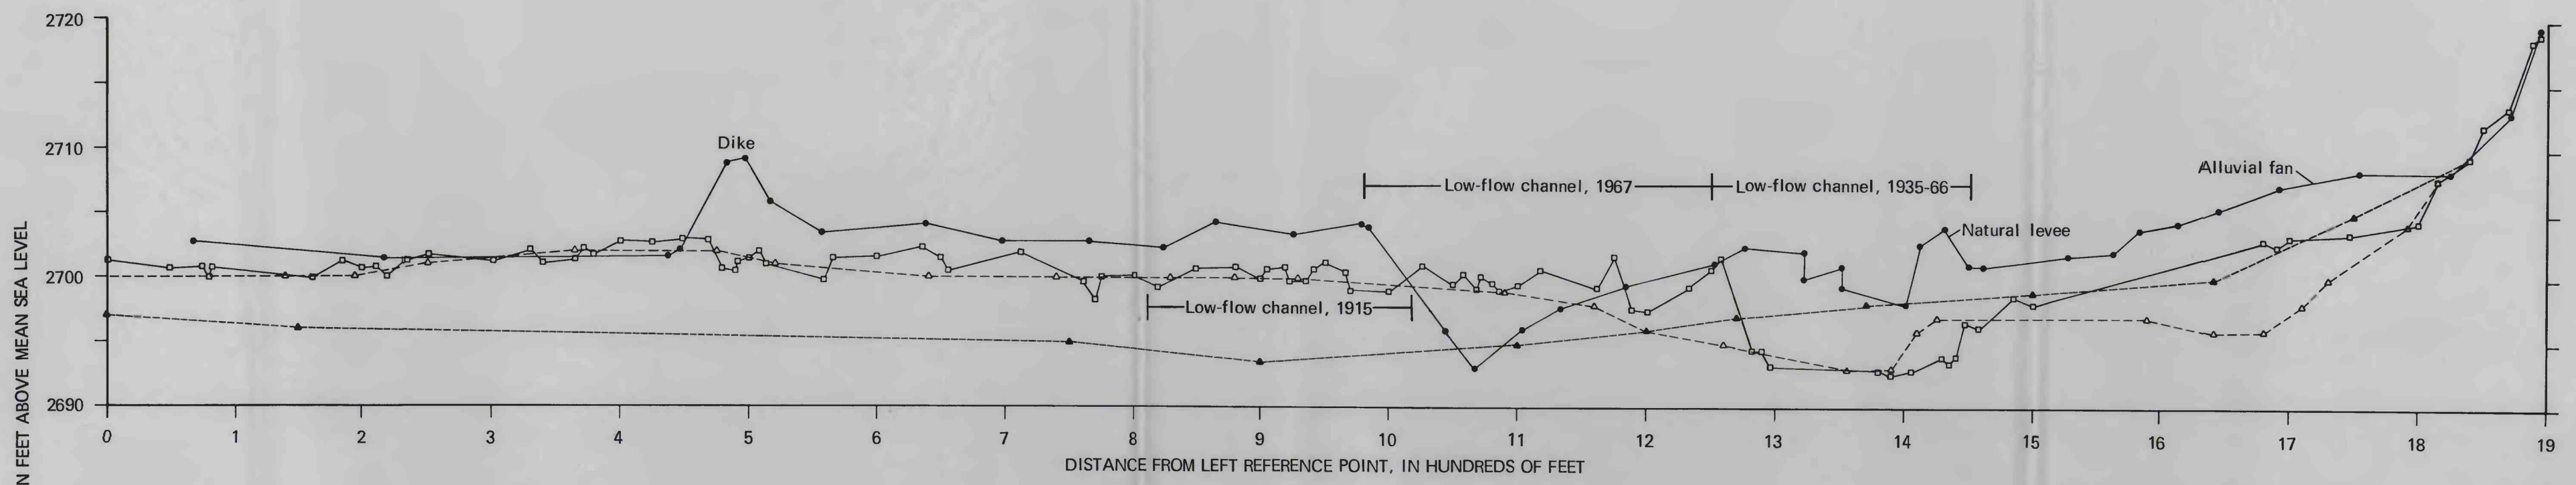
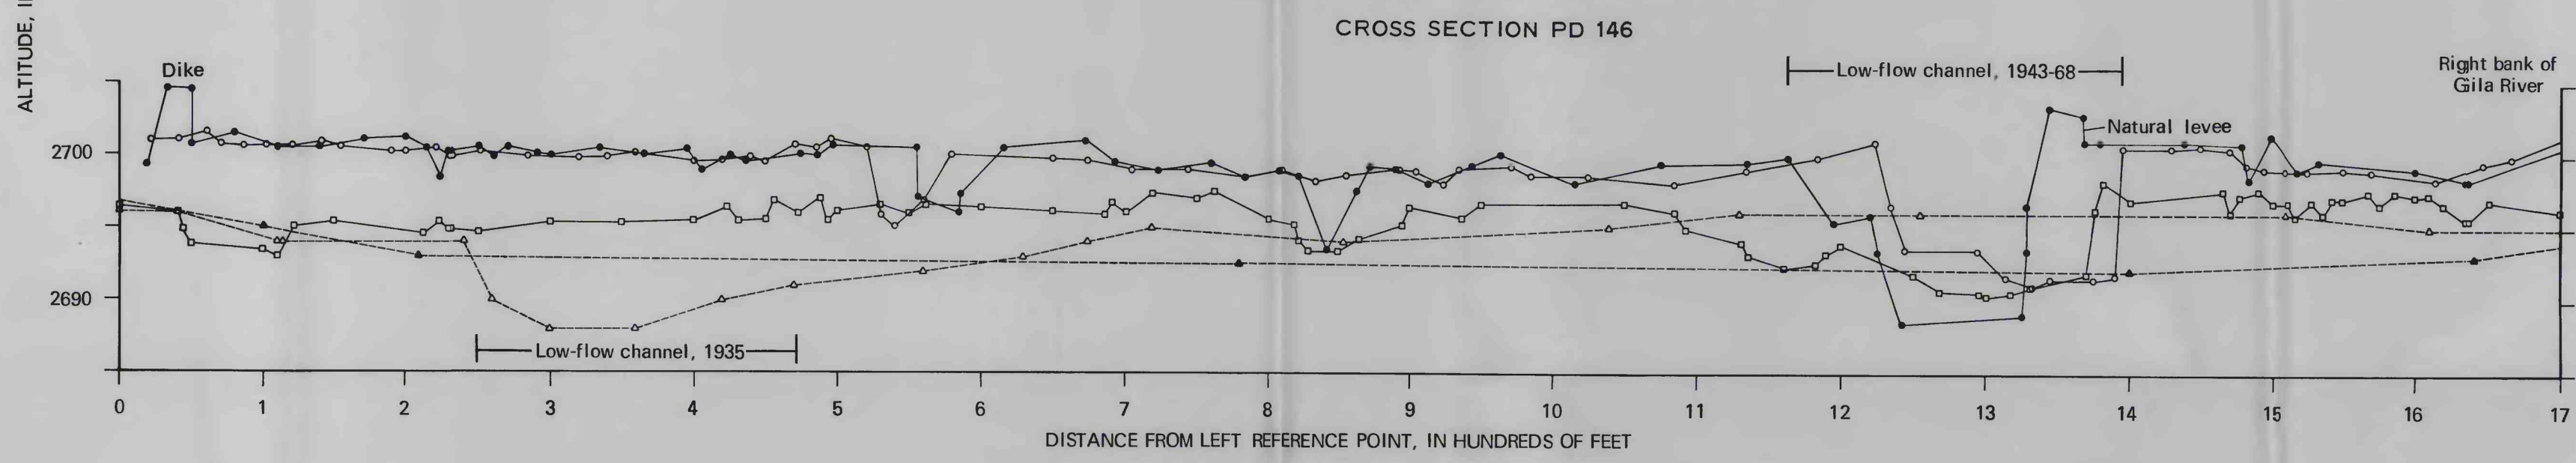
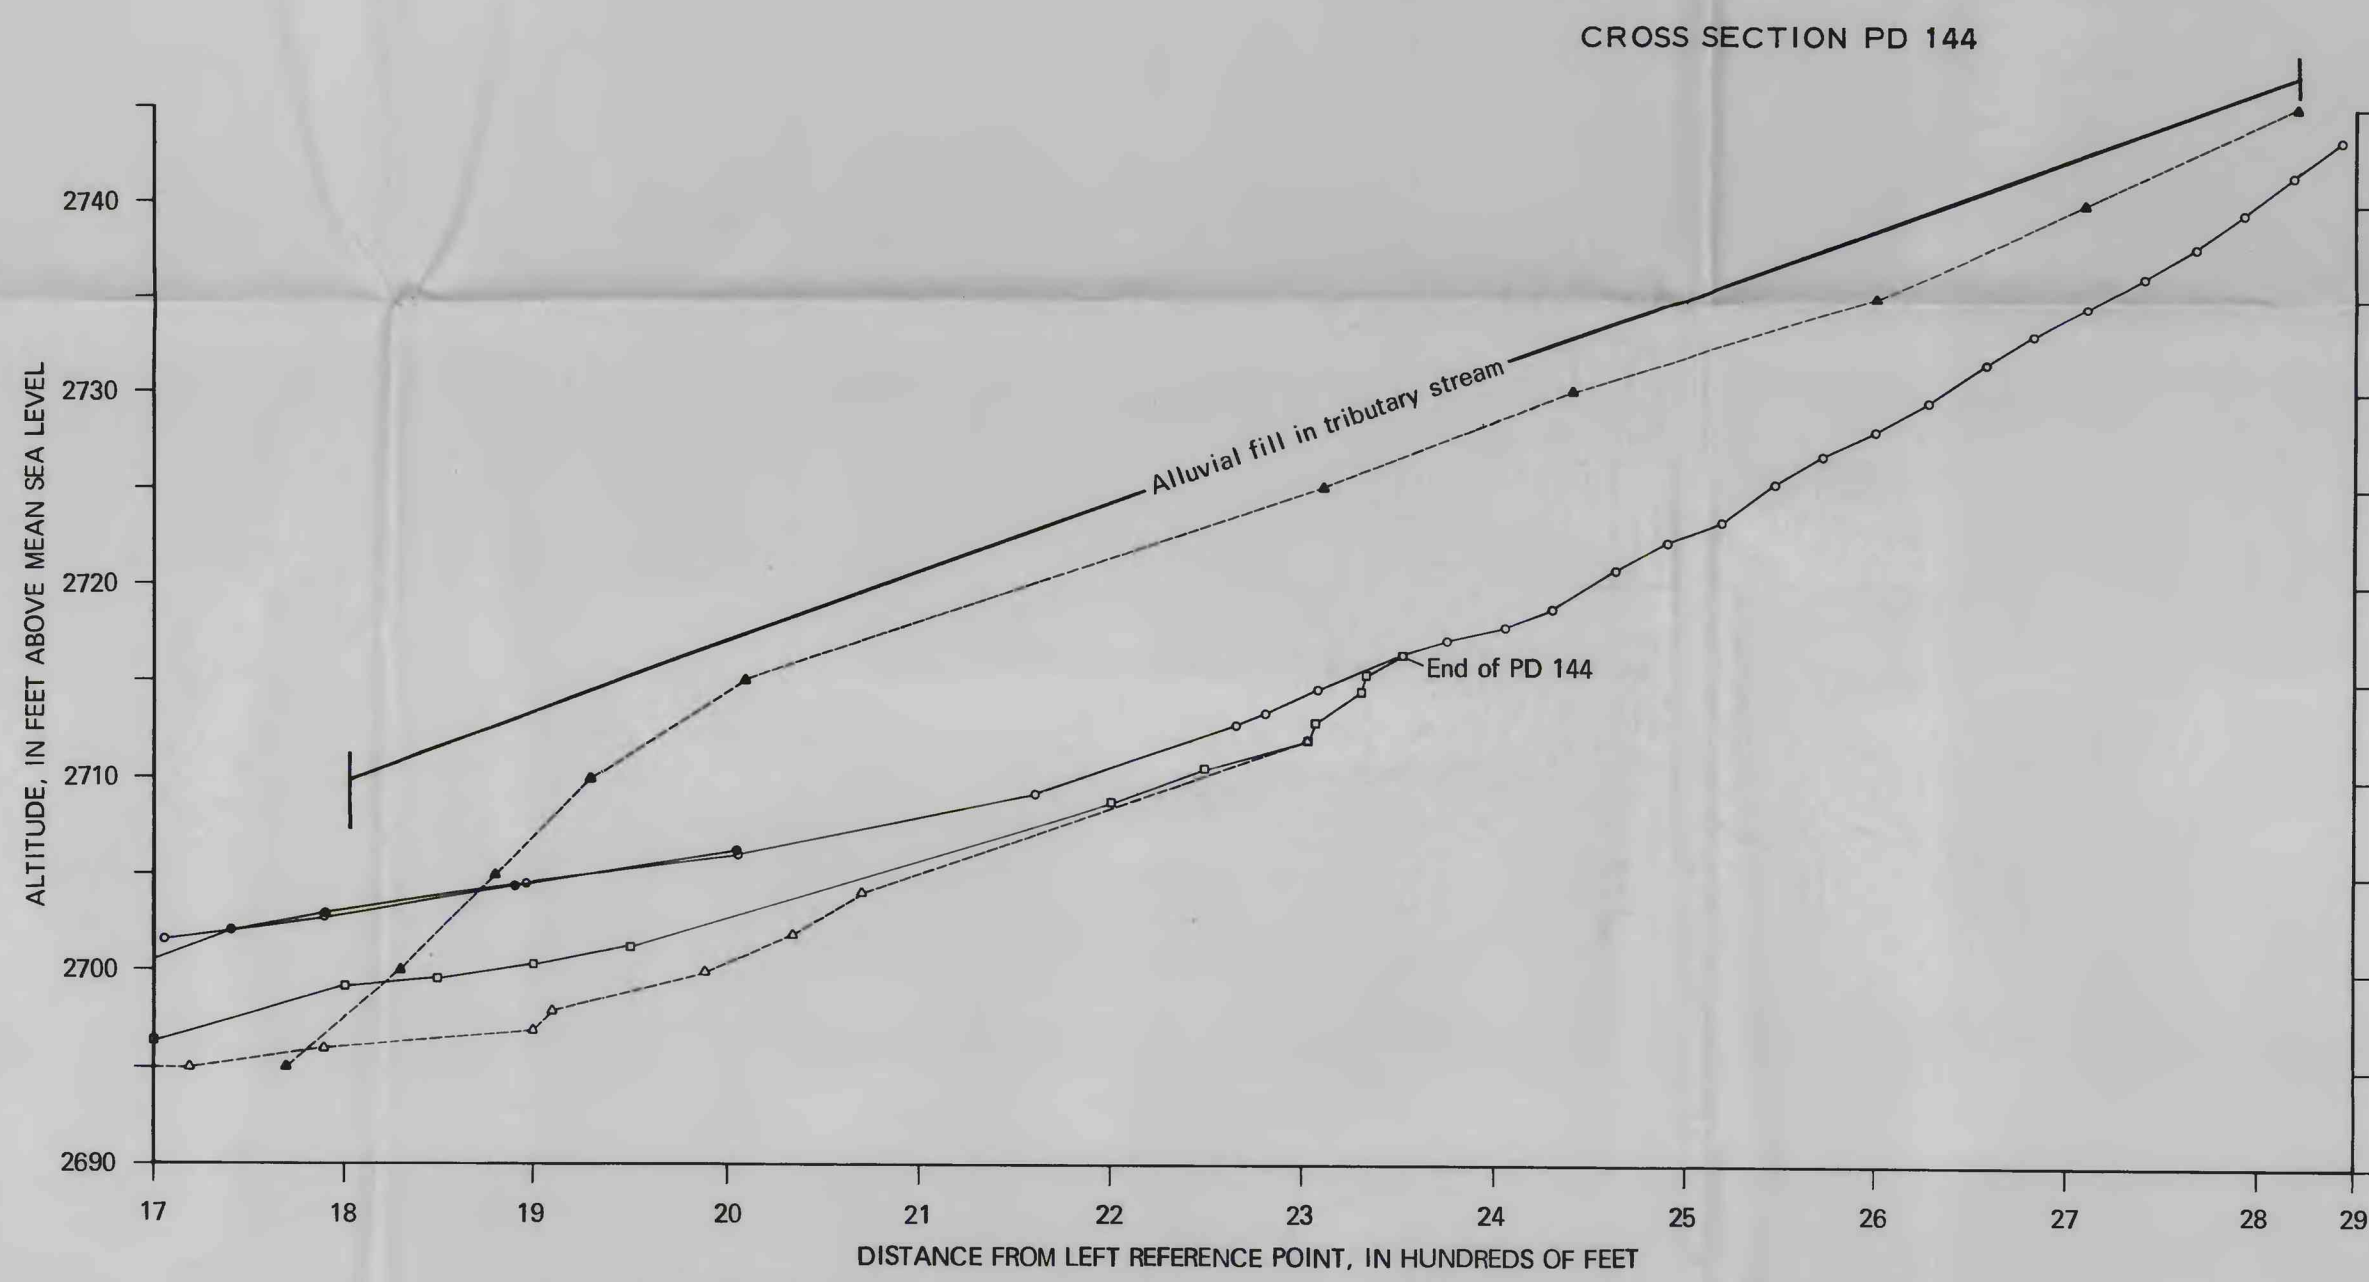
EXPLANATION
PROFILE DATA

- ▲ Scaled from 5-foot contour map made in 1915 by U.S. Bureau of Indian Affairs
- Scaled from 2-foot contour map made in 1935 by U.S. Soil Conservation Service
- Obtained by field survey in 1943 by Phelps Dodge Corp.
- Obtained by field survey in 1967 by U.S. Geological Survey
- Obtained by field survey in 1968 by U.S. Geological Survey

4. The changes in the transverse profiles shown in cross sections PD 144 and PD 146 are typical for the lower half of subreach B and for subreaches C and D (pl. 1). The scour along the right bank of the Gila River at the cross sections in 1915-35 probably occurred during the floods of 1915-16. A, The dog-leg bend in the river developed as a result of the two alluvial fans (shown by arrows) and the high flows that occurred in 1965-67. The cultivated fields were prepared by stripping the bottom land of natural vegetation, mostly salicoid, leveling the land, and building dikes to protect the cropland from moderate floods. The photographs are from the files of the U.S. Geological Survey, Tucson.
