PHOTOGRAPHS AND GRAPH SHOWING DEVELOPMENT OF THE ALLUVIAL FAN
AT THE MOUTH OF A TRIBUTARY TO THE GILA RIVER

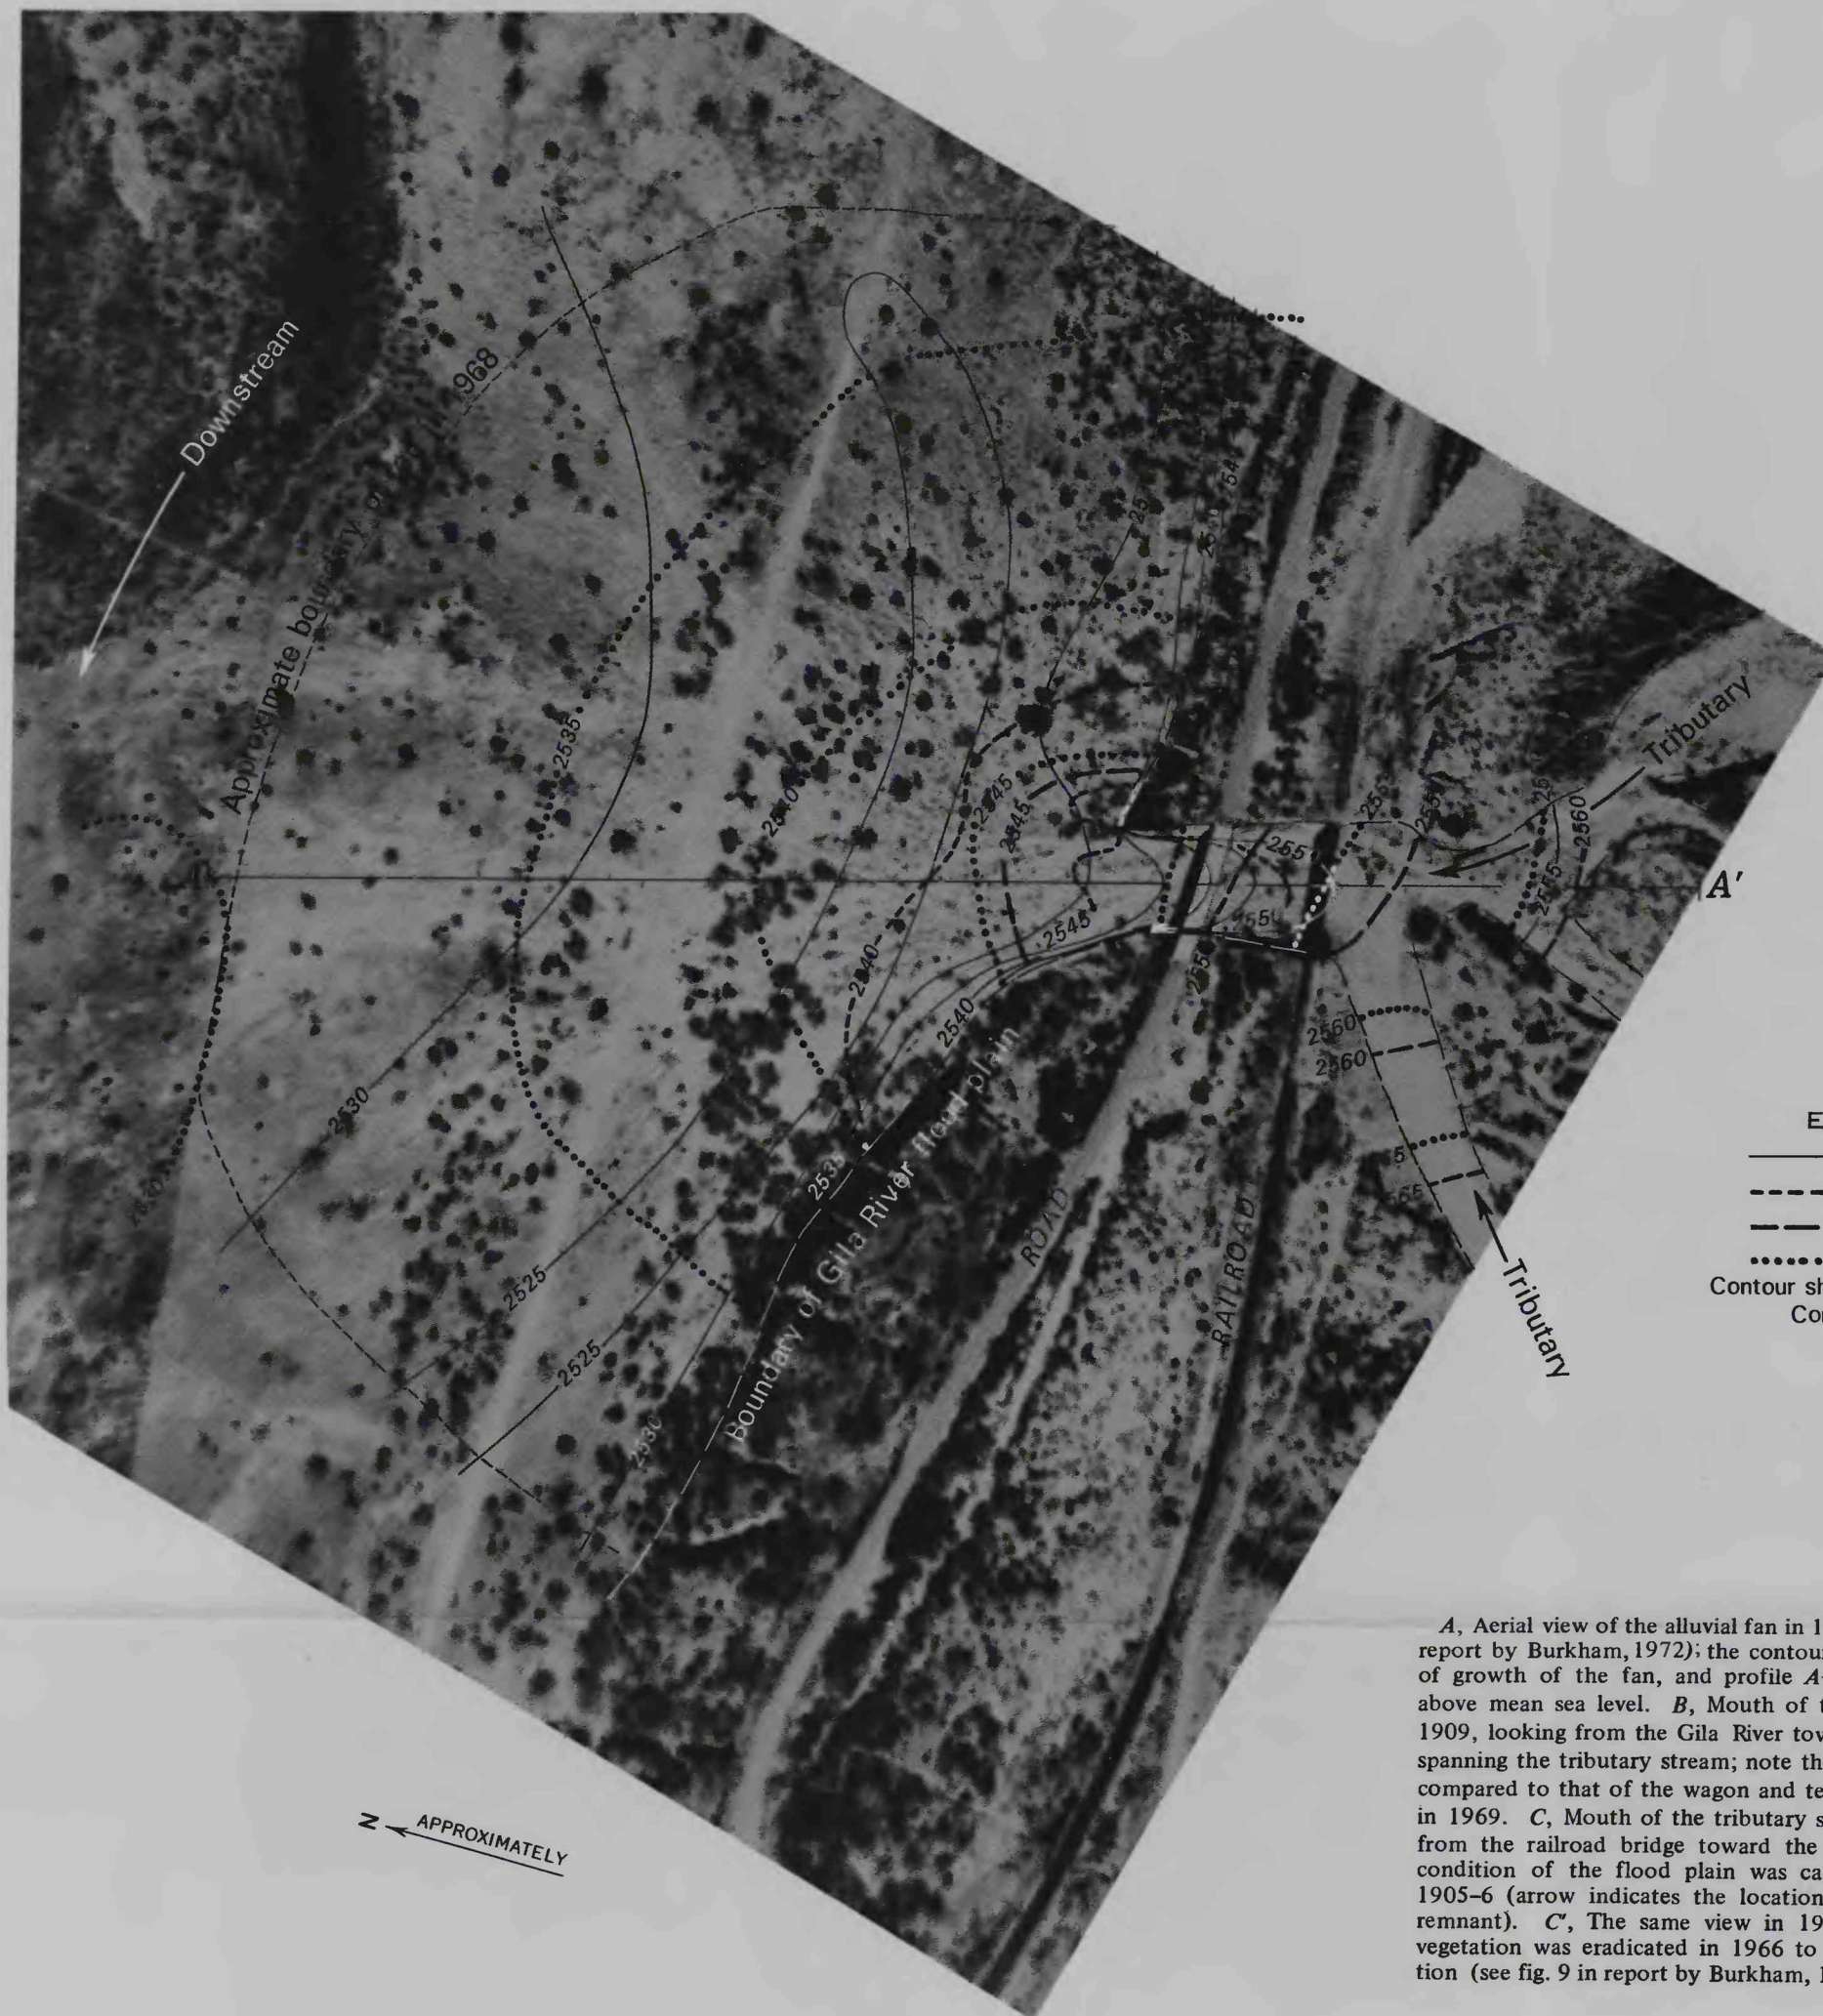
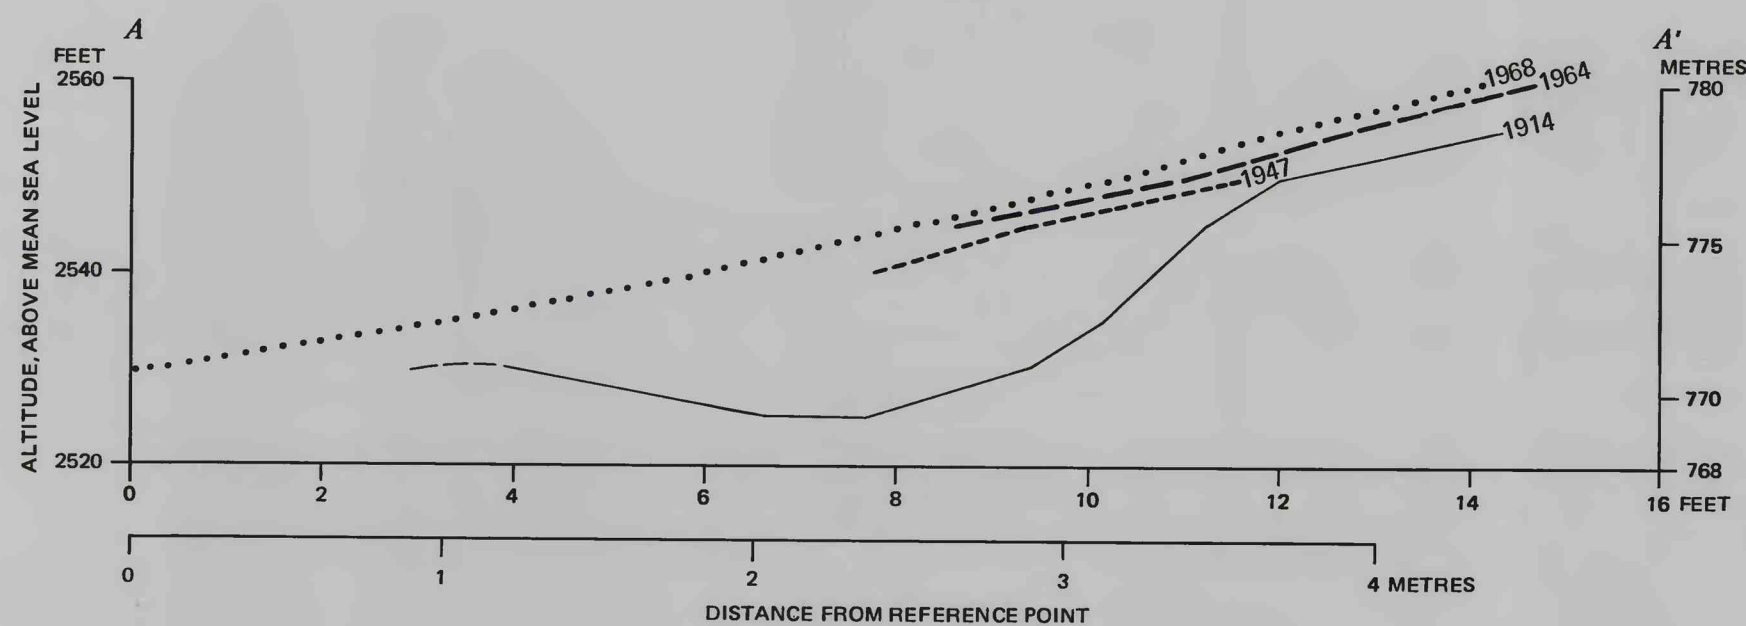
A

EXPLANATION
 ——— 1914 ———
 - - - - 1947 - - - -
 - - - - 1964 - - - -
 1968
 Contour shows rate of growth of fan
 Contour interval 5 feet

A. Aerial view of the alluvial fan in 1964 (see figs. 2 and 9 in report by Burkhani, 1972); the contour lines illustrate the rate of growth of the fan, and profile A-A' shows the altitude above mean sea level. B. Mouth of the tributary stream in 1909, looking from the Gila River toward the railroad bridge spanning the tributary stream; note the height of the banks as compared to that of the wagon and team. B', The same view in 1969. C. Mouth of the tributary stream in 1909, looking from the railroad bridge toward the Gila River; the barren condition of the flood plain was caused by the floods of 1905-6 (arrow indicates the location of an old flood-plain remnant). C', The same view in 1969. The bottom-land vegetation was eradicated in 1966 to control evapotranspiration (see fig. 9 in report by Burkhani, 1972).
