Geological, Geophysical, and Engineering Investigations of the Loveland Basin Landslide, Clear Creek County, Colorado, 1963-65

GEOLOGICAL SURVEY PROFESSIONAL PAPER 673-A, B, C, D, E, F, G

*A study using several methods of investigation
to define the geometry and behavior of a
landslide*

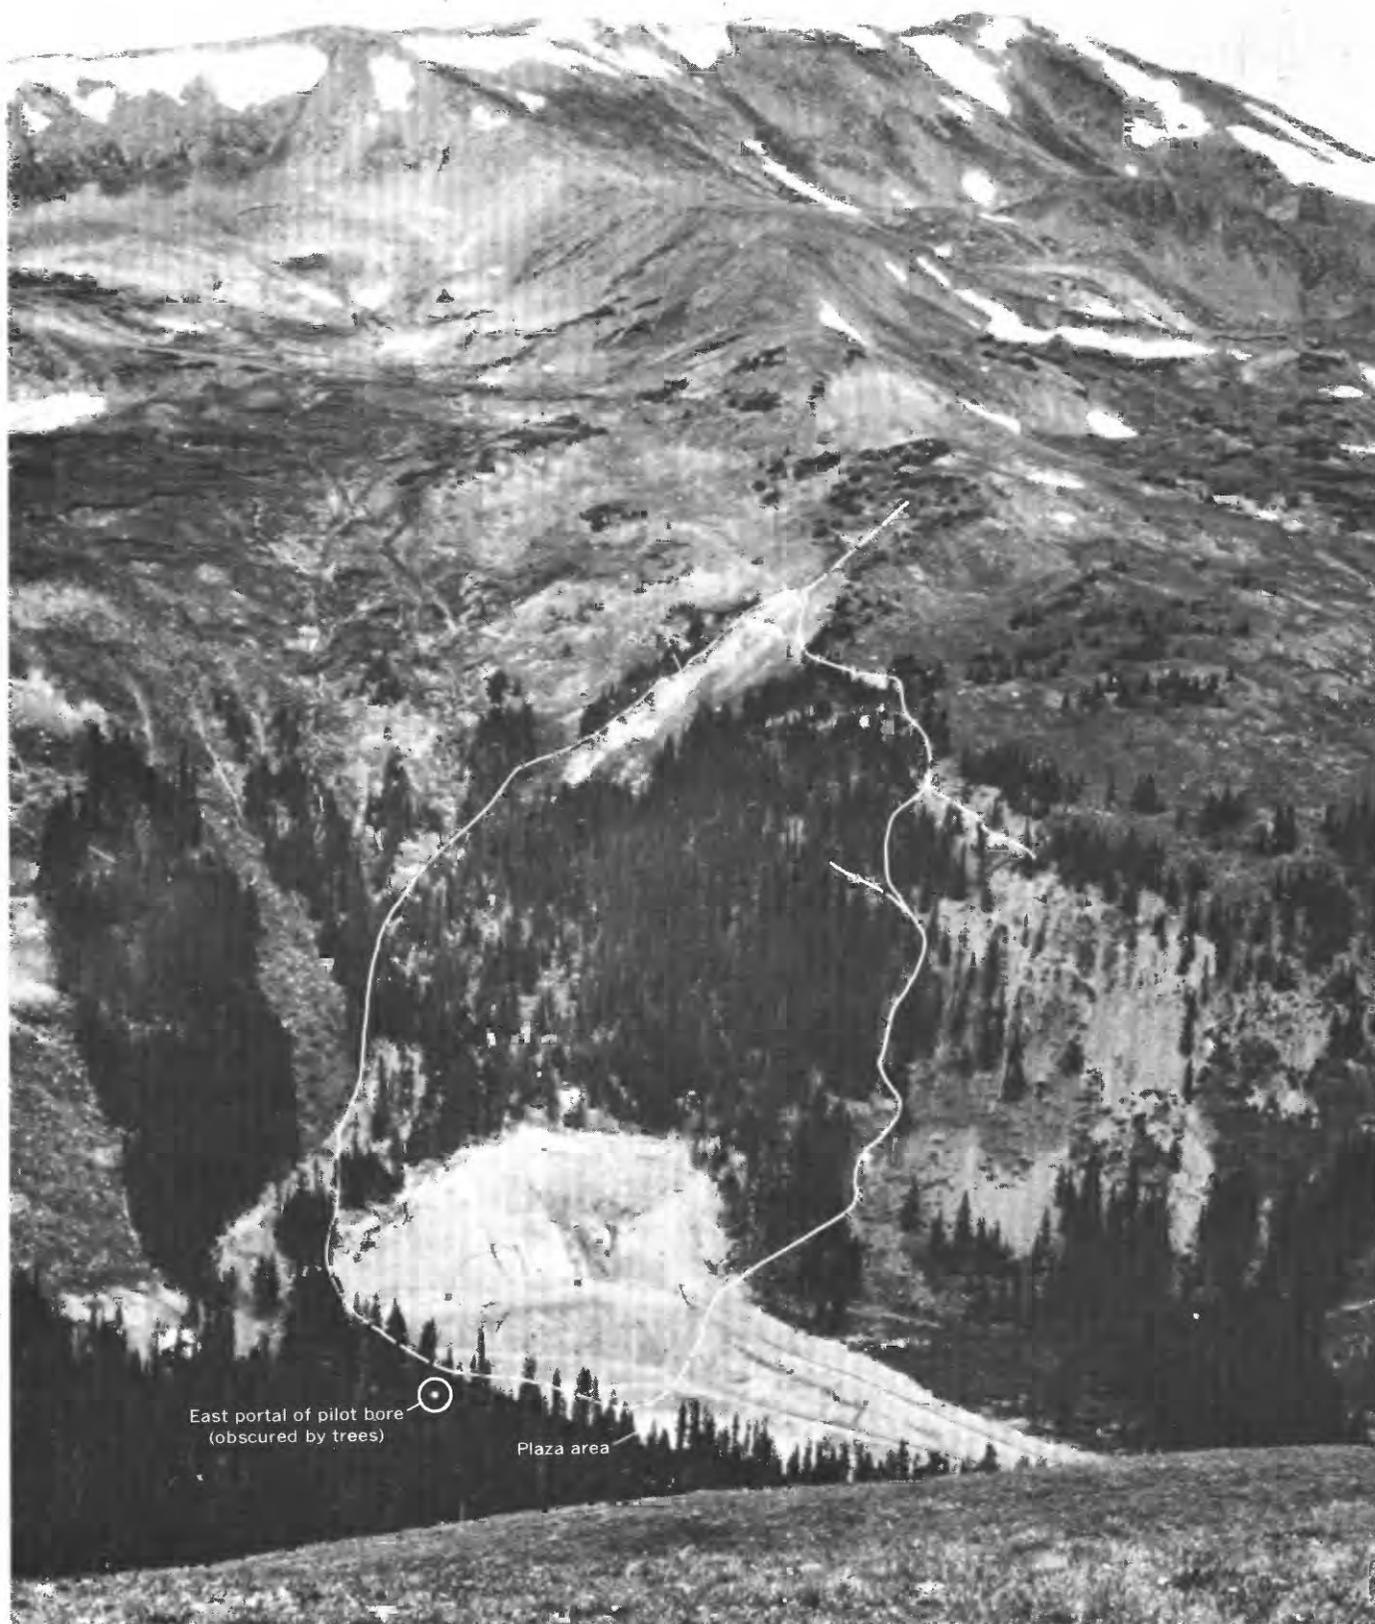
FRONTISPIECE.—Loveland Basin landslide, view northwestward (1965).

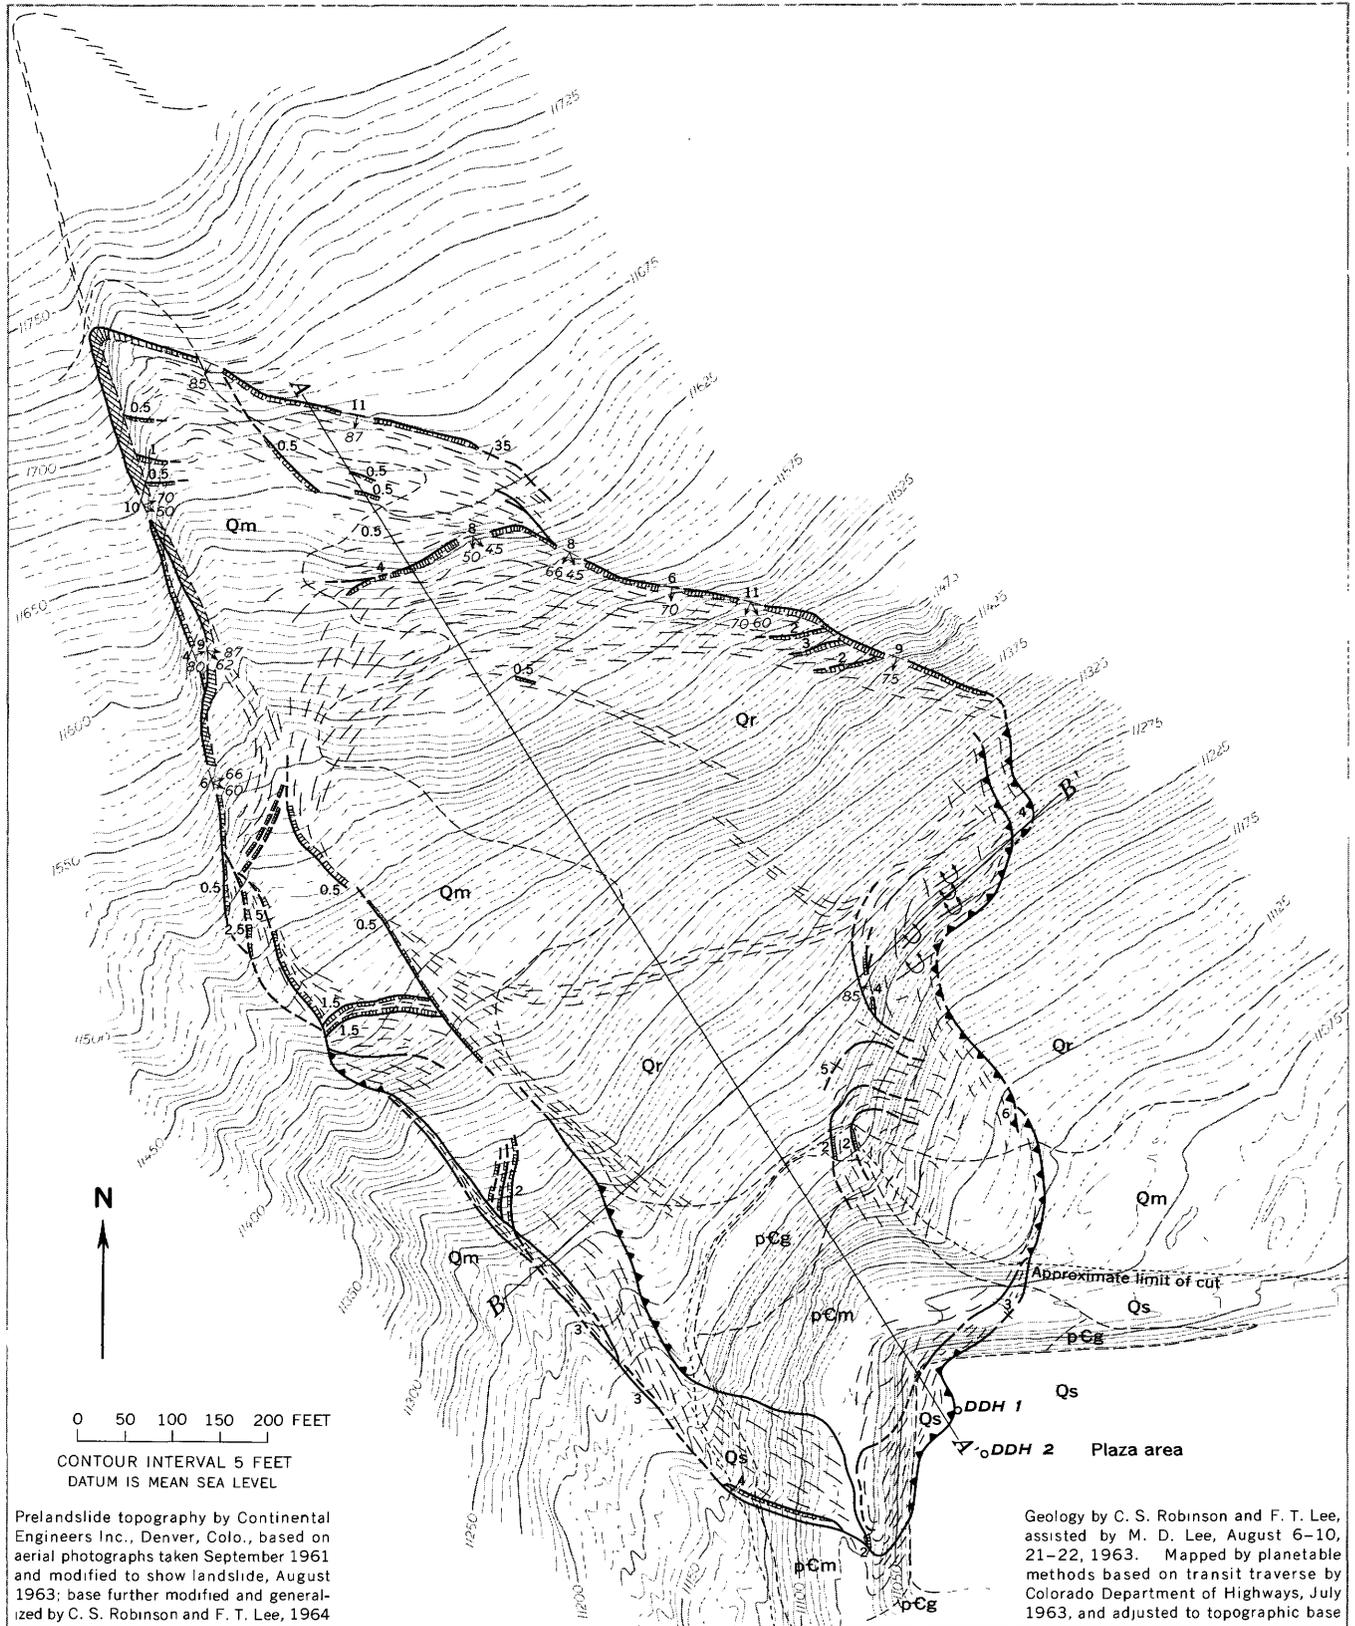
FIGURE 2.—Geologic and topographic map of Loveland Basin landslide, Clear Creek County, Colo.

The geology of the Straight Creek Tunnel site, including the area where the Loveland Basin landslide developed, was mapped at 1:12,000 in 1962 by the authors as part of a research project on the pilot bore for the Straight Creek Tunnel. (See Robinson and Lee, 1962.) After the development of the landslide, the geology of the landslide area was mapped (fig. 2) by planetable methods at 1:1,200.

and Lee (1962) as about 600 feet in width and about 4,000 feet in length. It trends about N. 15° E. and is terminated on the west by the fault that forms the western boundary of the landslide. This fault can be traced for more than half a mile and extends northwest of the northern end of the landslide as it existed in 1965 (fig. 2).

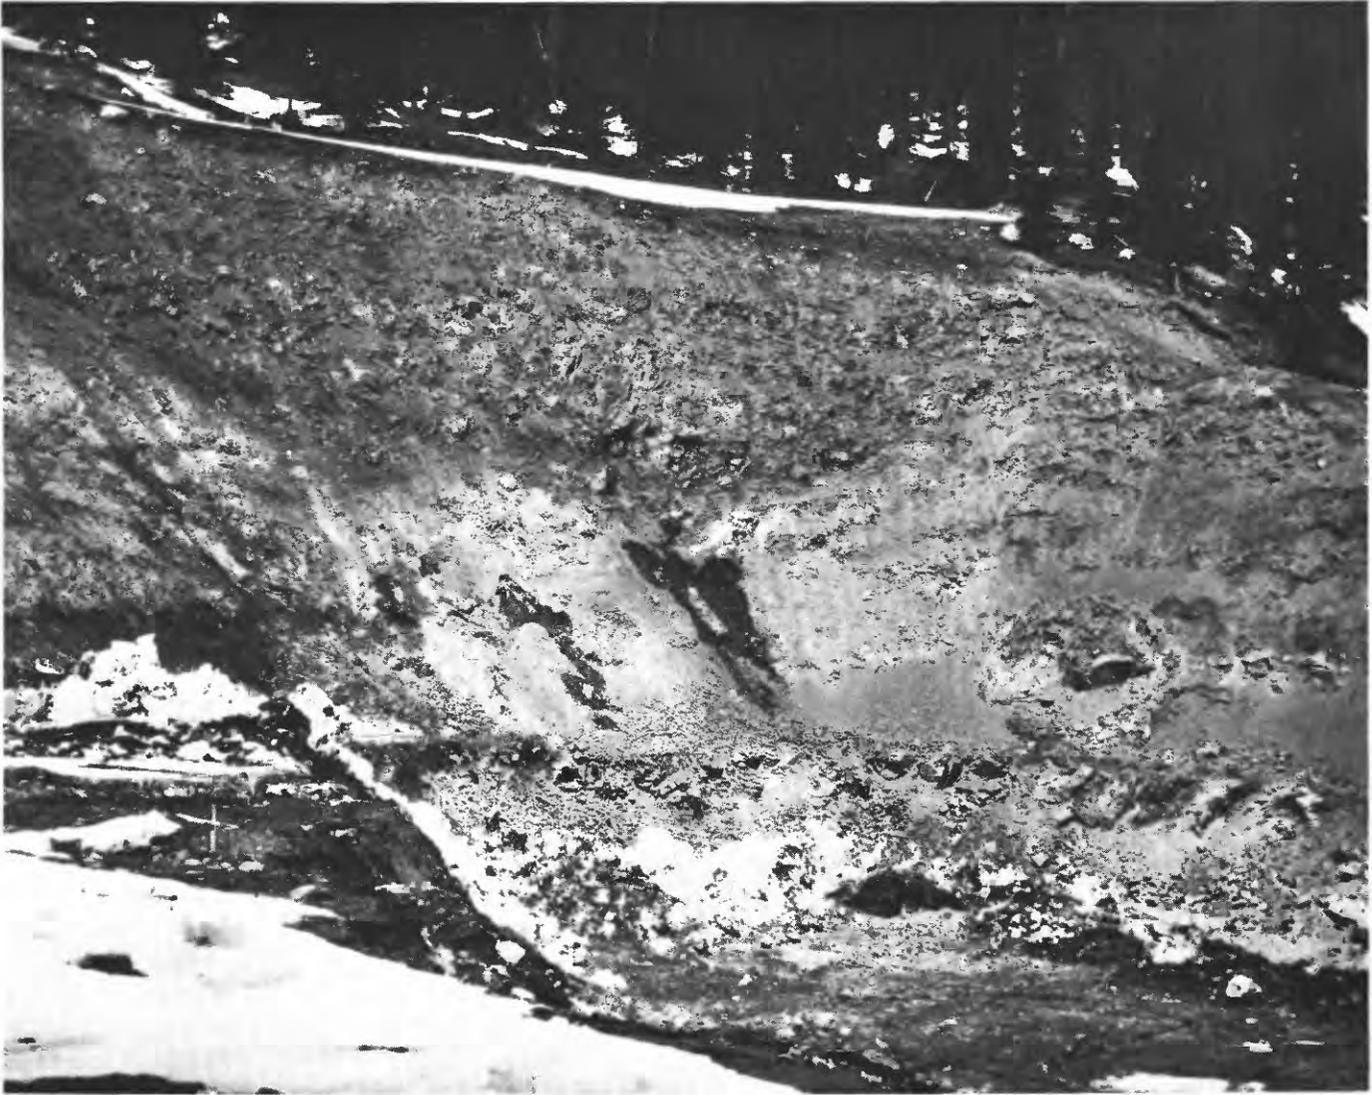
FIGURE 3.—Unfinished cut near east portal of the Straight Creek Tunnel prior to development of landslide. Depth of cut is about 150 feet.

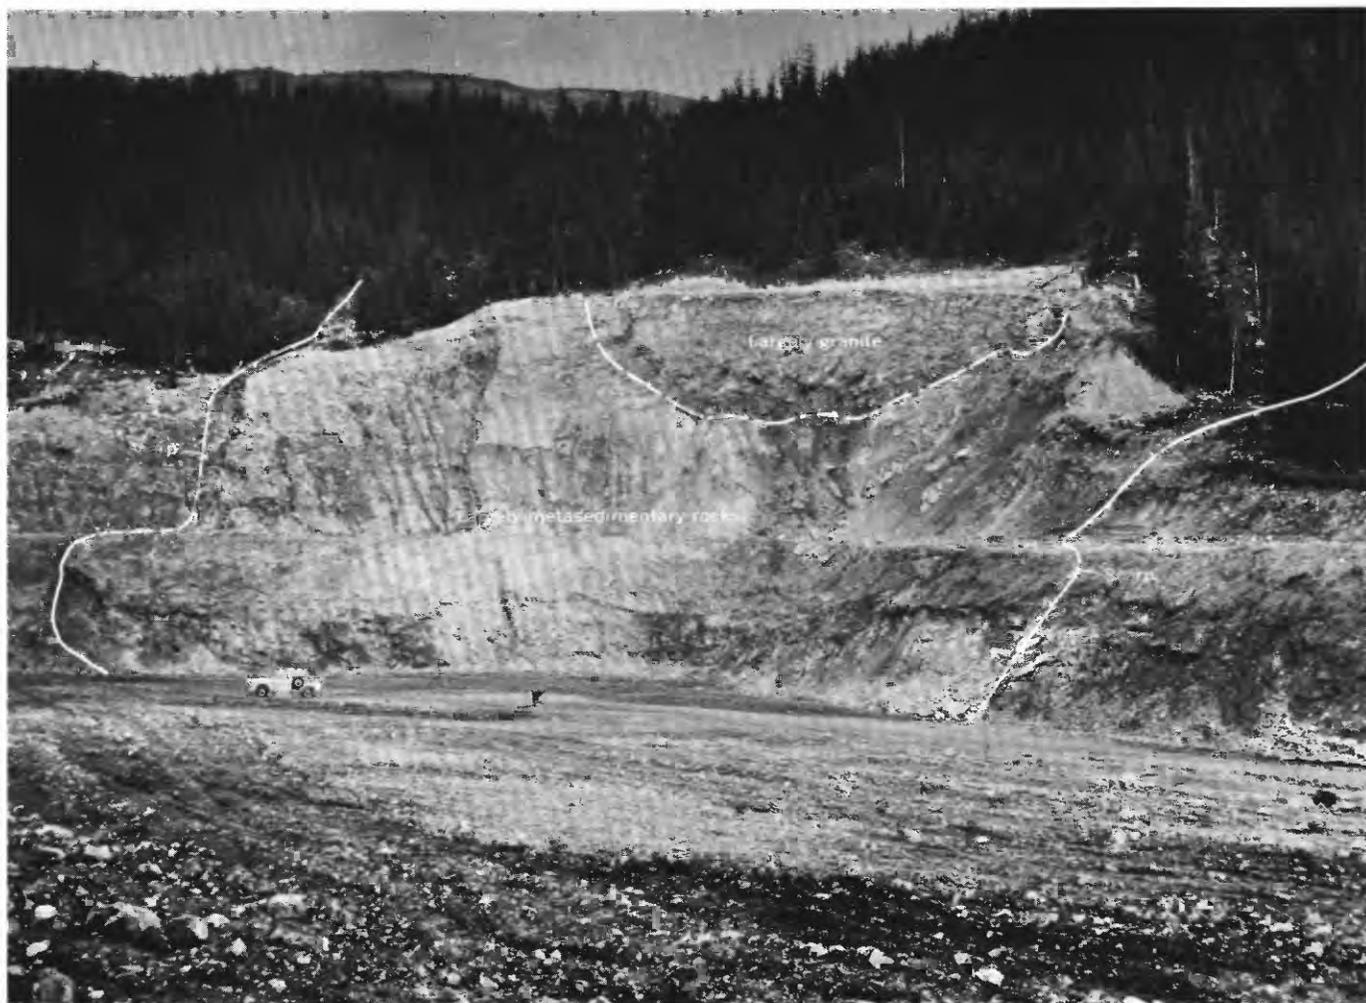
FIGURE 4.—Cut near east portal of Straight Creek Tunnel after start of landslide.

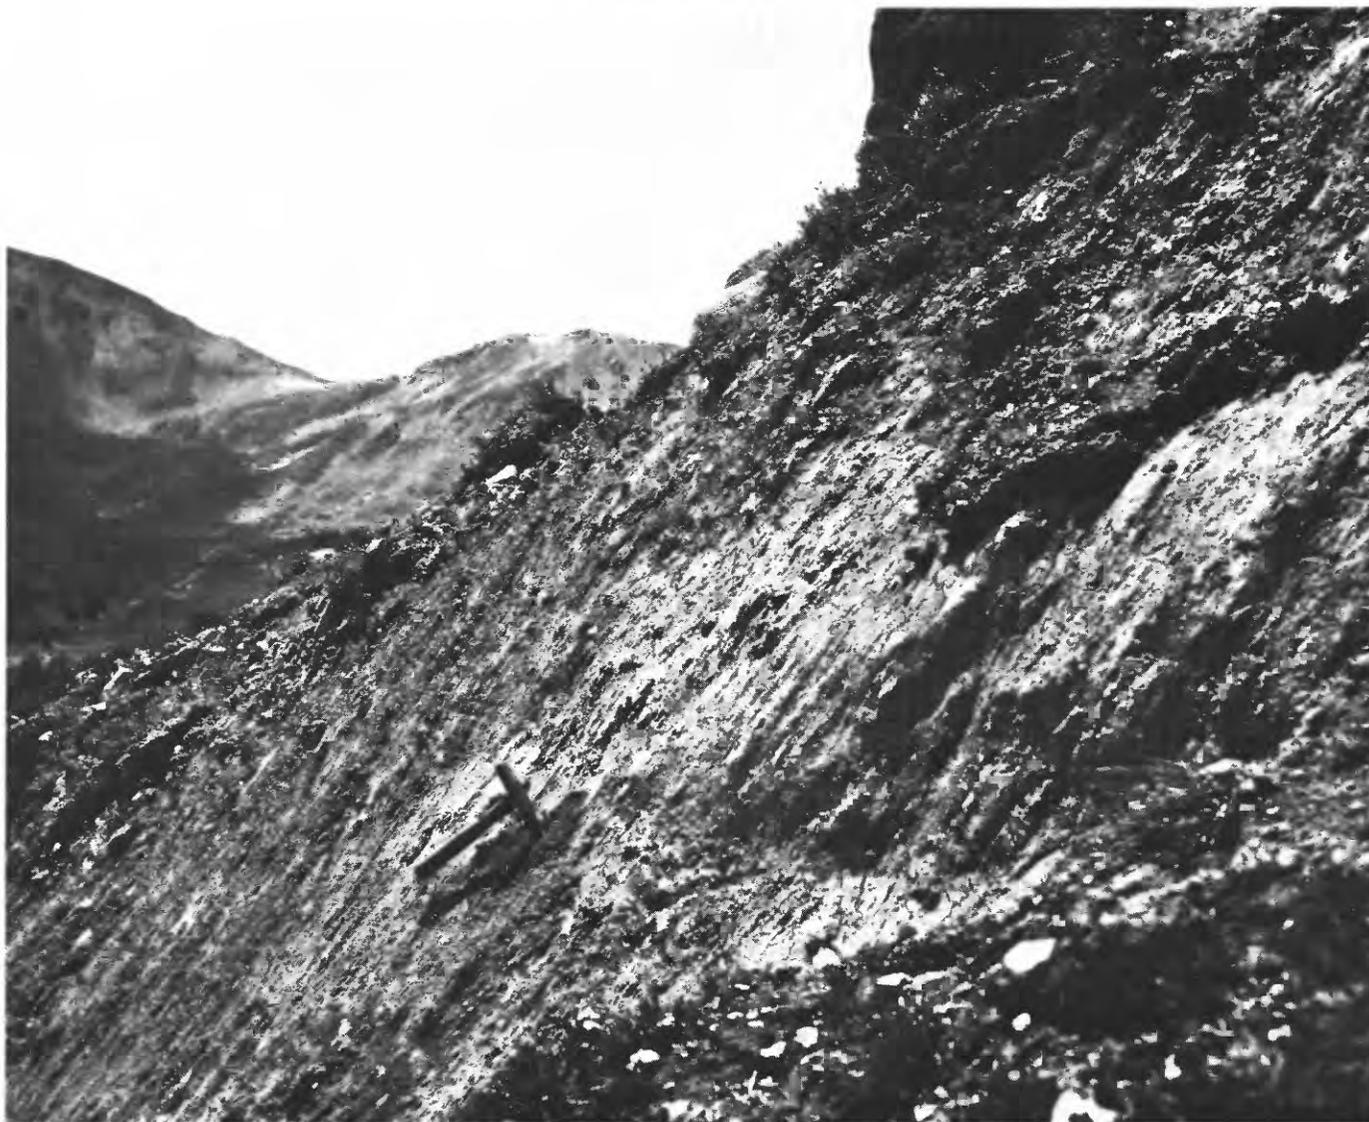
FIGURE 5.—Landslide fault scarp at the northwest border of the landslide. Note striations.

ping was completed in 1963, the heights of the scarps increased, and weathering removed the striations. The striations on the scarp surface near the northwest corner of the landslide (fig. 5) were well formed.

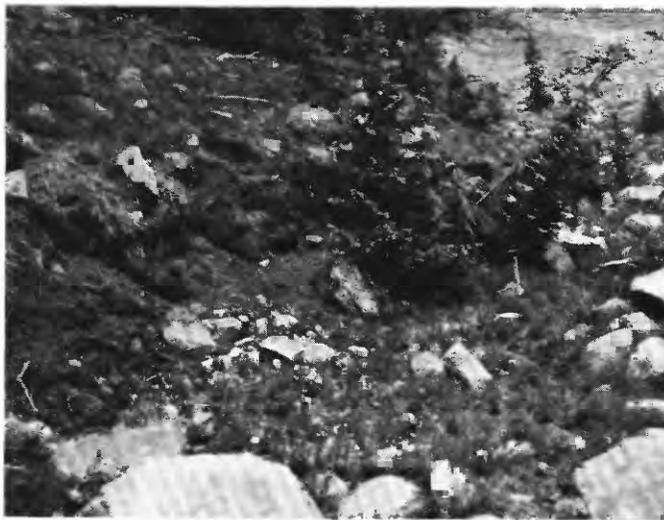
FIGURE 6.—Landslide thrust fault at southeast edge of landslide. Note destruction of plant life as landslide advanced.

The landslide thrust faults occur principally along the southeast margin of the slide and in the interior of the slide near the southwest margin. The heights of the thrusts range from less than 1 foot to about 6 feet (fig. 2). Rolls in the soil with amplitudes of about 1 foot exist in the landslide mass adjacent to the thrusts. During the initial period of landslide movement the thrusts were connected to the scarps by open fractures that had little or no vertical displacement. These thrusts were the most spectacular discernible feature of the landslide during the early days of the investigation. At their margins flowers and small trees could be seen in the process of being overturned and covered by the mass of moving soil and rock of the landslide. A photograph of the thrust sheet near the southeast

corner of the slide (fig. 6) shows a small tree being pushed over by the landslide mass.

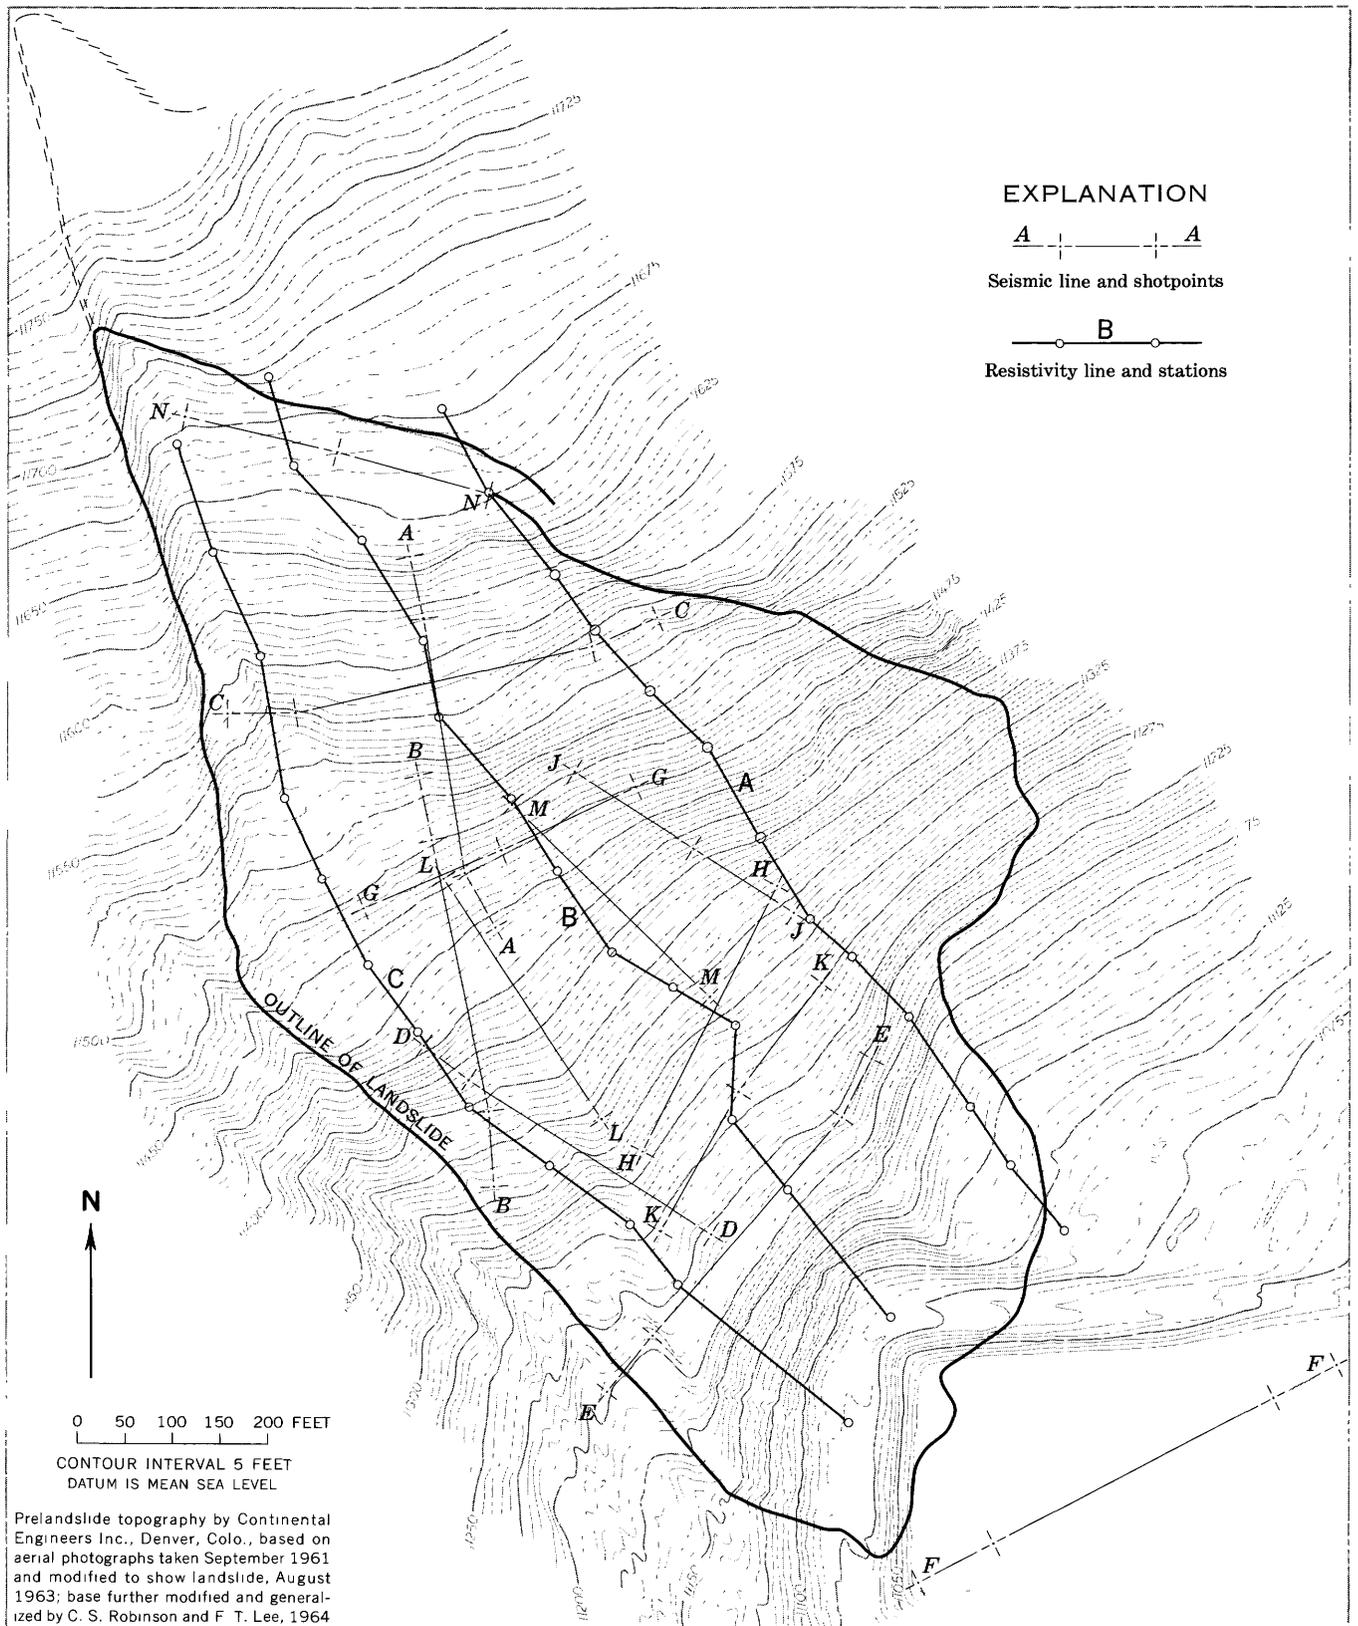
FIGURE 7.—The Loveland Basin landslide showing location of geophysical traverses.

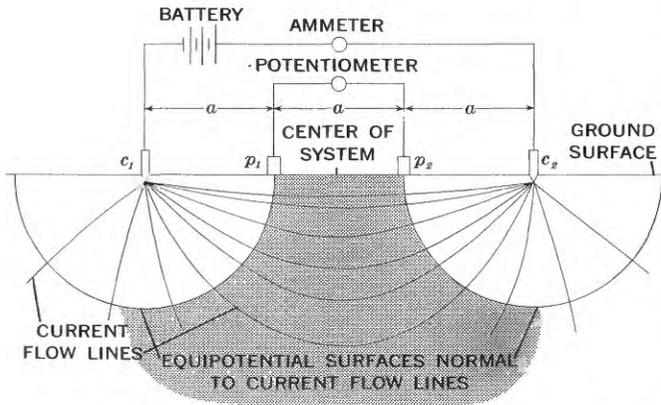
FIGURE 8.—Principle of earth-resistivity measurement using the Wenner configuration c_1 , c_2 , current electrodes; p_1 , p_2 , potential electrodes; a , electrode separation.

As the spacing of the electrodes increases, greater amounts of underlying material are influenced. The average measured (apparent) resistivity will trend toward the resistivity of the underlying layer. The resulting average resistivities are plotted

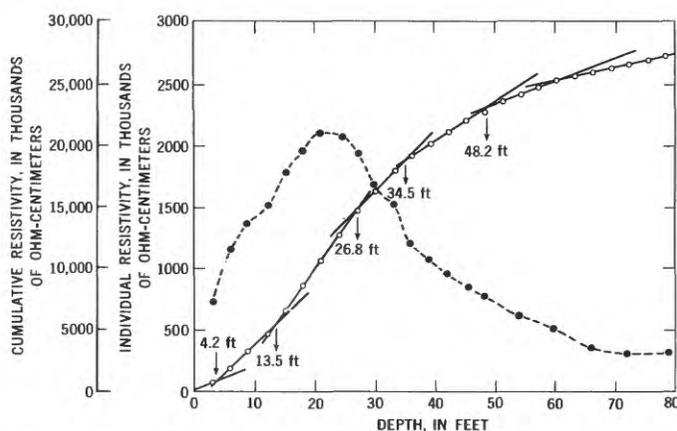
FIGURE 9.—Resistivity-depth curve (dashed line) for talus overlying weathered bedrock and cumulative resistivity curve (solid line) used to empirically determine depths to subsurface layers. Depth, in feet, of effective current penetration is assumed to equal the surface electrode spacing.

against the electrode separations, resulting in a curve. Figure 9 shows a typical resistivity curve which was obtained by expansion of the electrode system to include the depths shown.

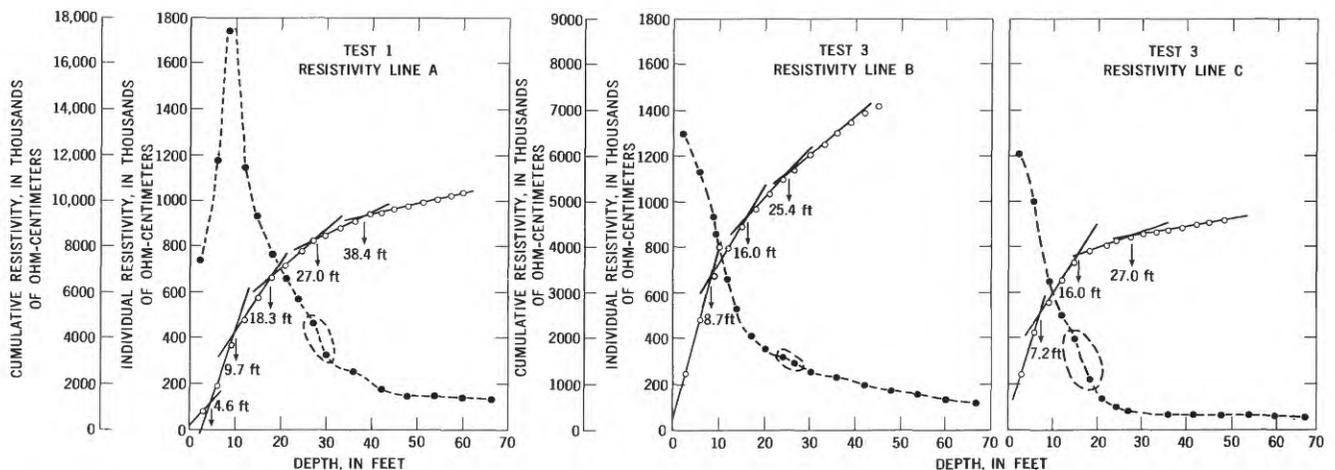
FIGURE 10.—Resistivity-depth curves (dashed lines) and cumulative resistivity curves (solid lines) typical of data obtained on Loveland Basin landslide area. Circled zone is believed to indicate effect of water just above slip surface. Depth, in feet, of effective current penetration is assumed to equal the surface electrode spacing.

Figure 10 shows three resistivity depth curves considered to be rather typical for the 38 depth tests that were made over the slide area. Slope changes are present in each curve at depths believed to coincide with the elevation at the top of the slip zone. Slope changes similar to those appearing in the three curves of figure 10 at depths of about 27, 25, and 16 feet were observed in most of the resistivity-depth curves plotted for the 38 tests.

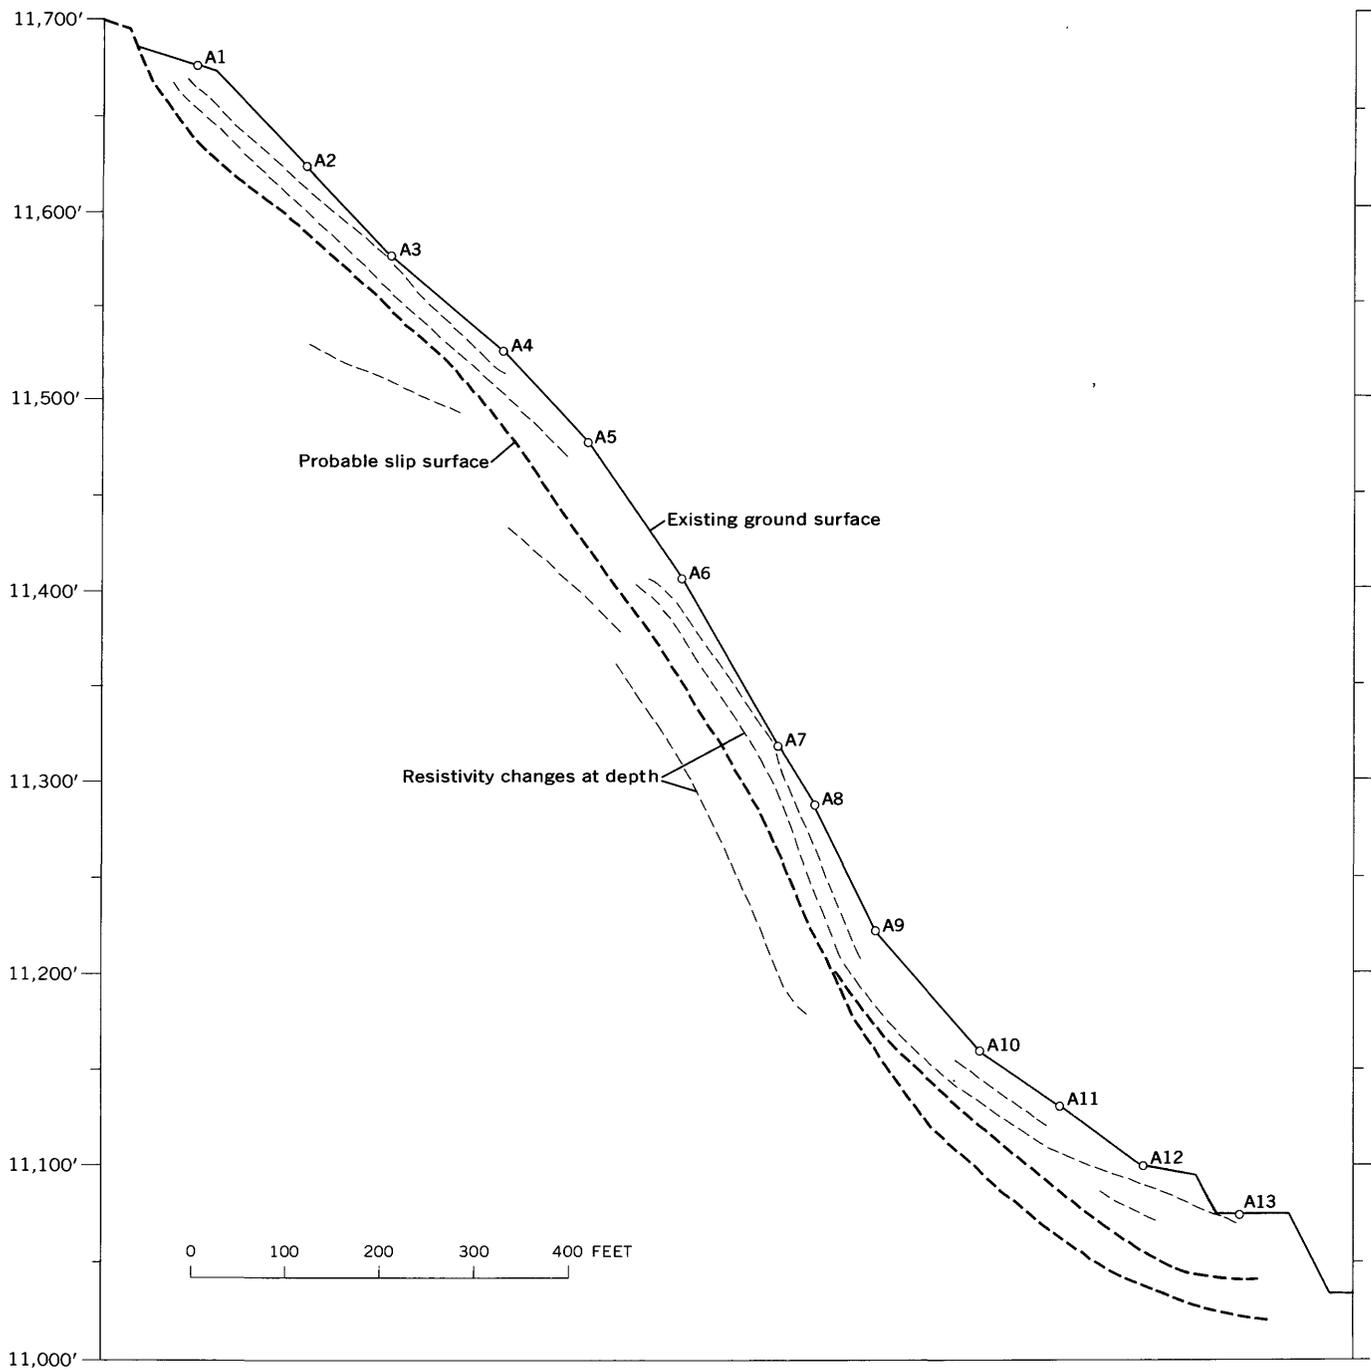
FIGURE 11.—Section through east part of sliding mass (resistivity line A) Loveland Basin landslide. A1–A13, resistivity-depth test locations. Line of section shown in figure 7. (Vertical exaggeration, $\times 2$.)

Figure 11 shows all the significant subsurface resistivity changes along line A. The longer the dashed lines, the more laterally persistent were the resistivity layers. The most significant and the most persistent resistivity layers are shown by the heavier dashed lines. These heavier lines also indicate the location of the probable slip surface. The author believes that the subsurface conditions at the depths indicated by these lines are the weak zones that are the most continuous and therefore the most susceptible to movement. Near the toe of the slide two such zones or surfaces were defined from the resistivity measurements. Therefore, the author believes that probably two separate slip surfaces were present, one above the other, in this part of the slide.

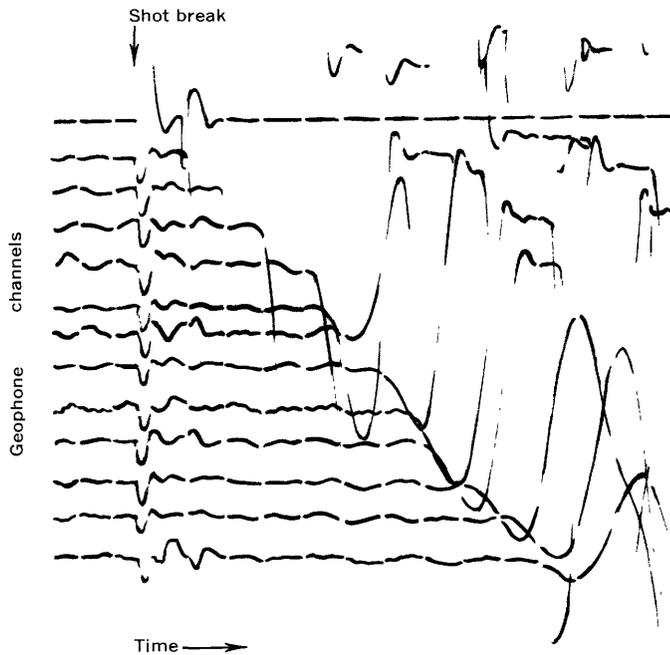
FIGURE 12.—A part of seismic record obtained on seismic line *N*. Charge was five sticks of dynamite at 3-foot depth. Interrupted segments of traces represent time intervals of 10 milliseconds.

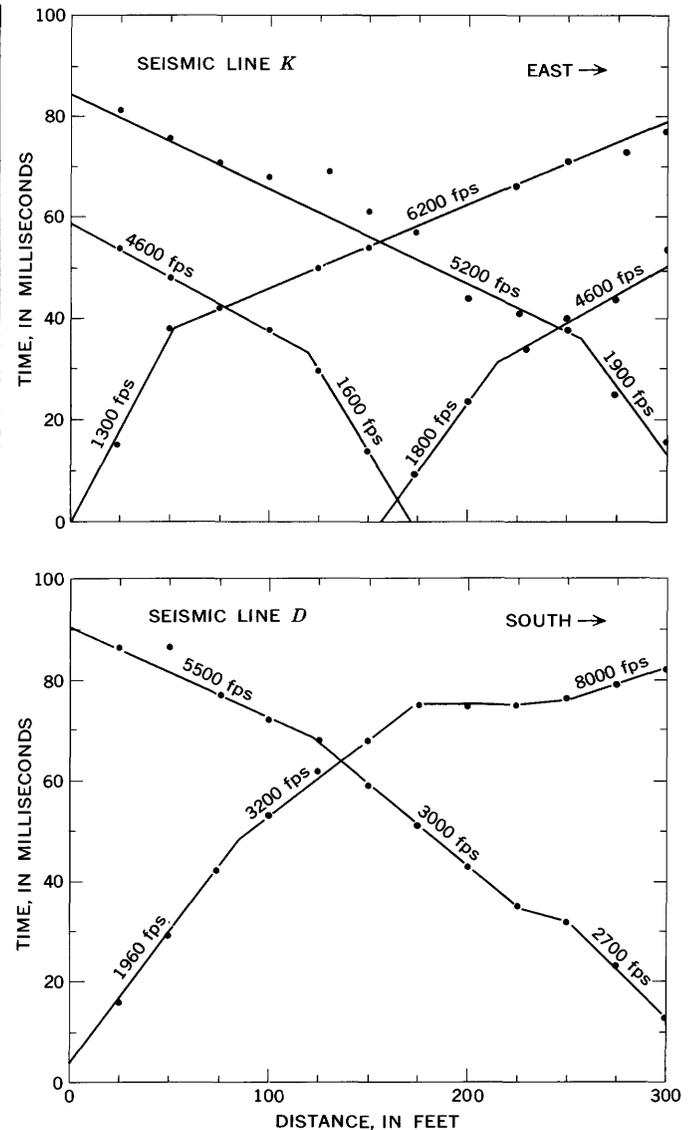
FIGURE 13.—Time-distance graphs obtained on seismic lines *K* and *D*. Location of lines shown in figure 7.

Interpretation of the results obtained on several lines was hampered both by severe attenuation of high-frequency energy and by weak energy in the first arrivals. Interpretation was further complicated by the occasional presence of an irregular refracting surface as well as abrupt velocity variations within the near-surface layer. These two features were sometimes inseparable and caused considerable scatter of points on several travelttime plots. Two examples, typical of the extremes of difference in the travelttime plots, are shown in figure 13.

Travelttime curves for line *K* shown in figure 13 are such that a unique interpretation may be made of the thickness of the low-velocity layer in this area. The travelttime curves for line *D*, on the other hand, exhibit the effects of complex subsurface conditions. On several other lines, especially those parallel with the long axis of the landslide, travelttime curves indicated complex seismic ray paths. One possible explanation for these complex paths is the presence of relatively competent zones of high velocity within the low-velocity layer. These competent zones may possibly act as isolated buttresses within the sliding mass, inhibiting the development and movement of the slide.

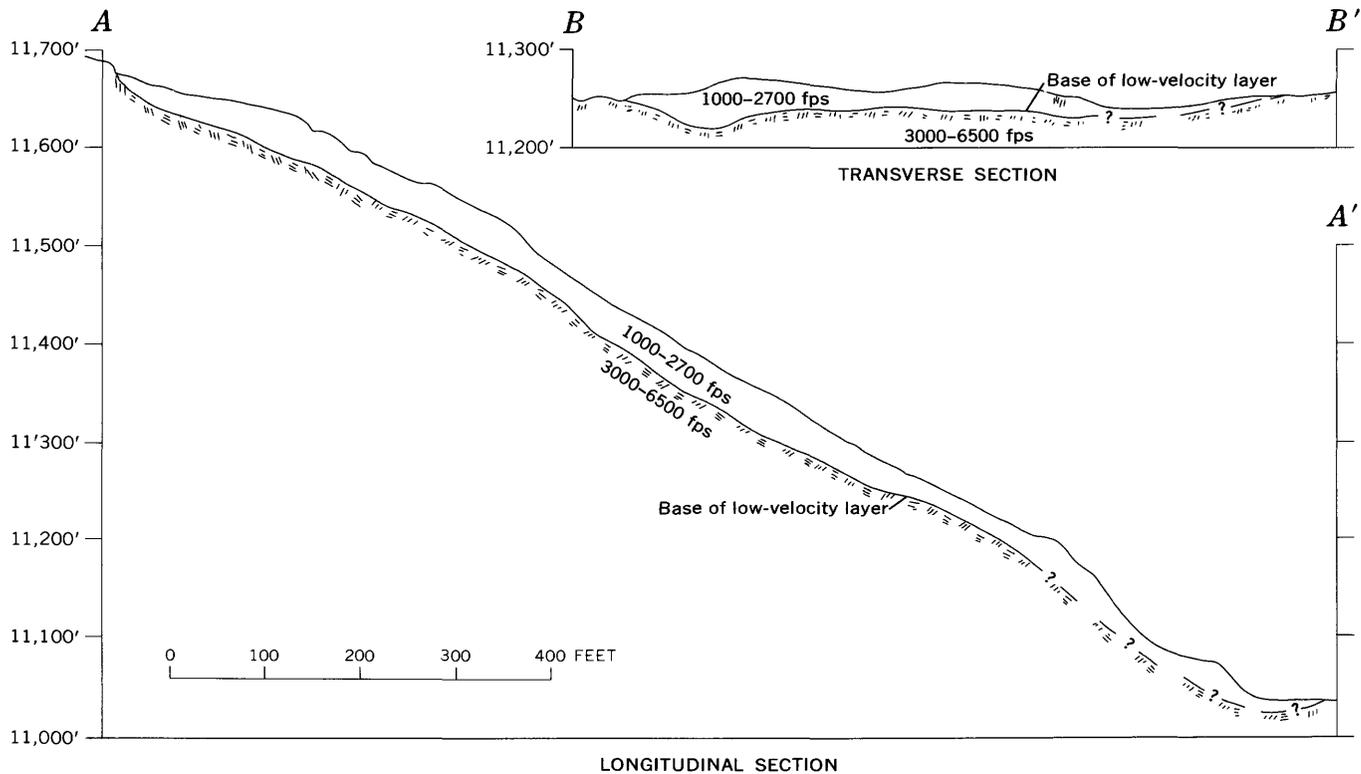
FIGURE 14.—Longitudinal and transverse sections of the Loveland Basin landslide showing thickness of low-velocity layer. Location of sections shown in figure 2.

The volume of this material was calculated to be 440,000 cubic yards. Data from other investigative methods used in the study of the landslide suggest that a greater volume of material may be involved than is indicated by the seismic data. At many locations the seismic data were in general agreement with estimates made by other means.

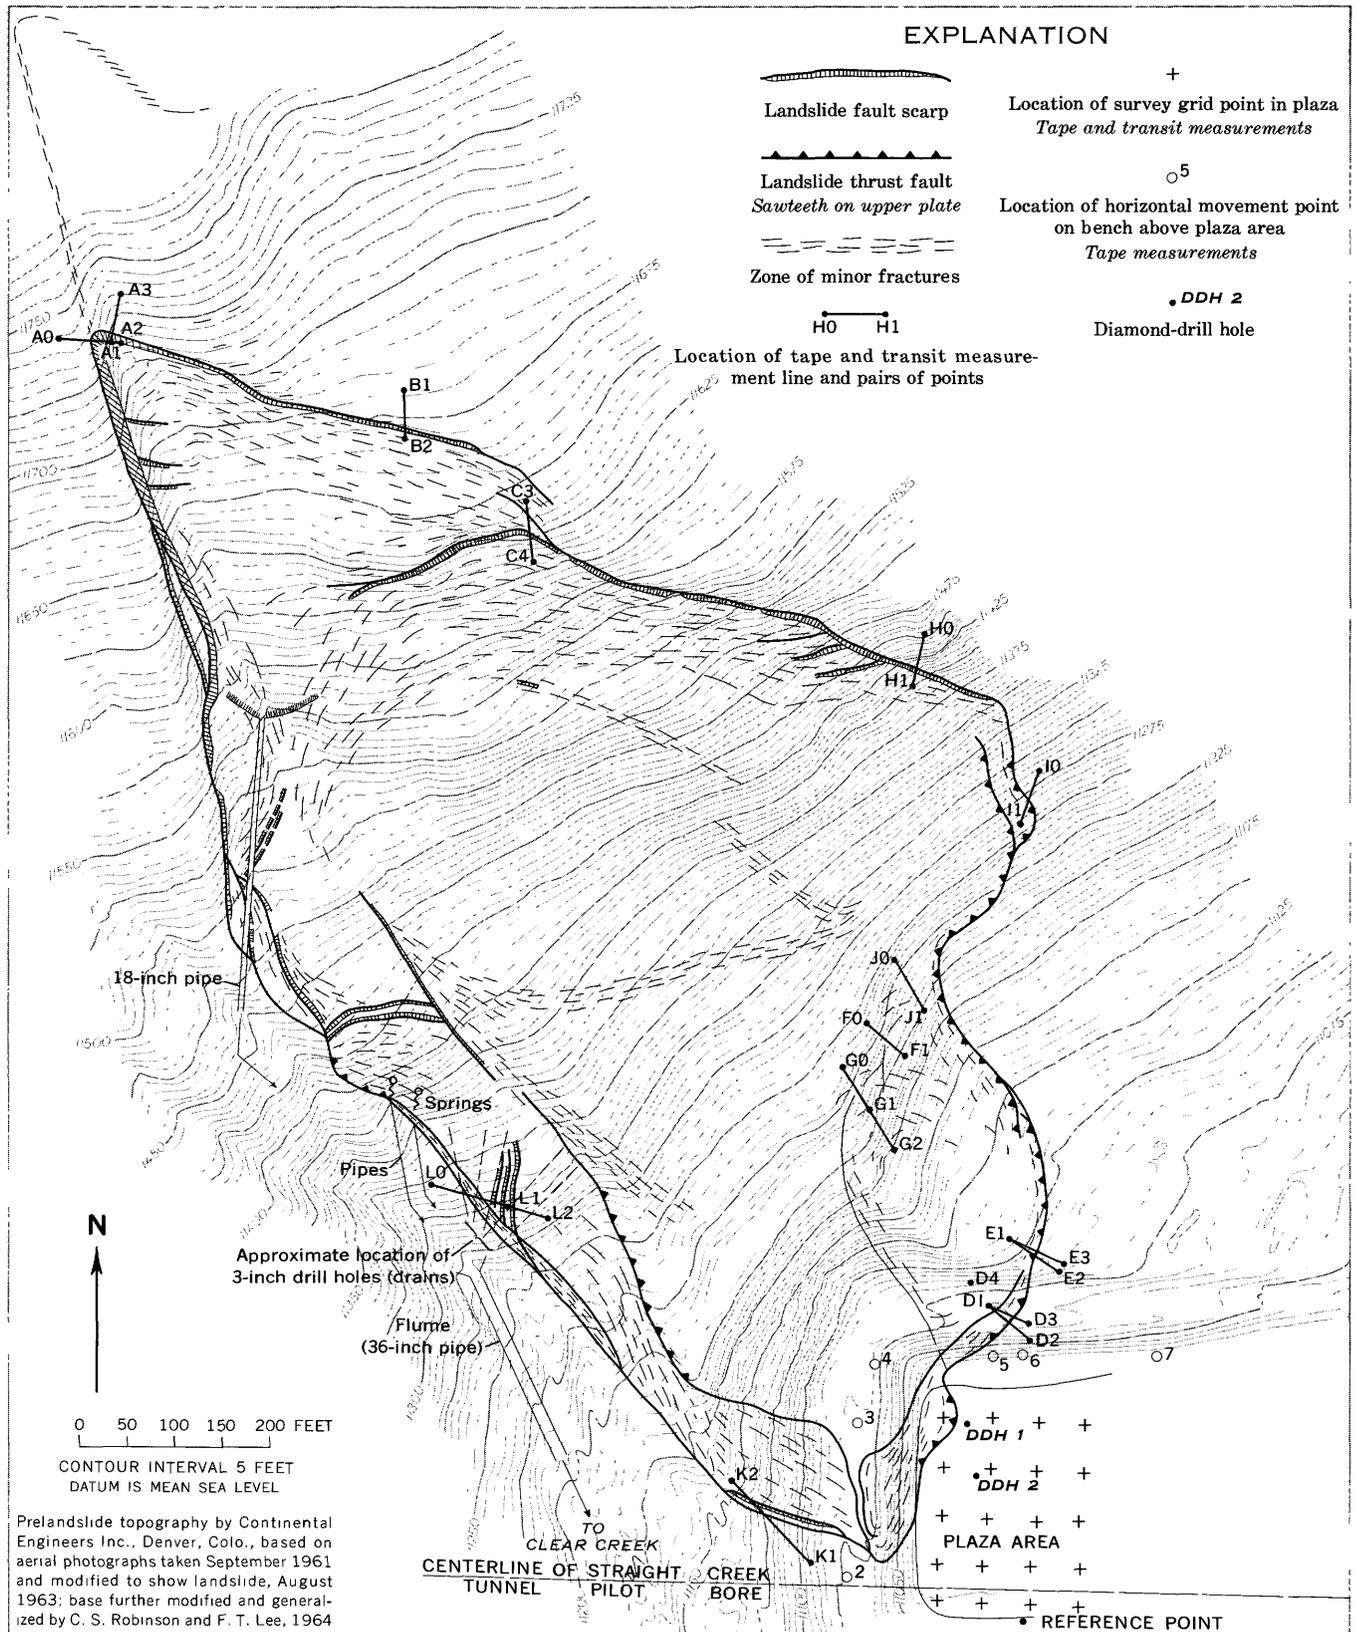
FIGURE 15.—The Loveland Basin landslide; the location of the measurement points at the margins of the landslide and the approximate locations of the surface and subsurface drainage pipes are shown. Prepared by J. E. Gay, Colorado Department of Highways.

Early in July 1963, a transit and chain survey was run around the periphery of the slide. After this survey was run, 15 pairs of transit and tape measurement points were established at or within the slide margin, and 32 other points, to be observed periodically by transit, were established across the slide mass. The locations of some of the pairs of transit and tape measurement points across the breaks in the slide are shown in figure 15. Figure 16 shows records of the relative change in distance between the pairs of points between July 1963 and January 1965.
