Geological, Geophysical, and Engineering Investigations of the Loveland Basin Landslide, Clear Creek County, Colorado, 1963-65

GEOLOGICAL SURVEY PROFESSIONAL PAPER 673-A, B, C, D, E, F, G

*A study using several methods of investigation
to define the geometry and behavior of a
landslide*

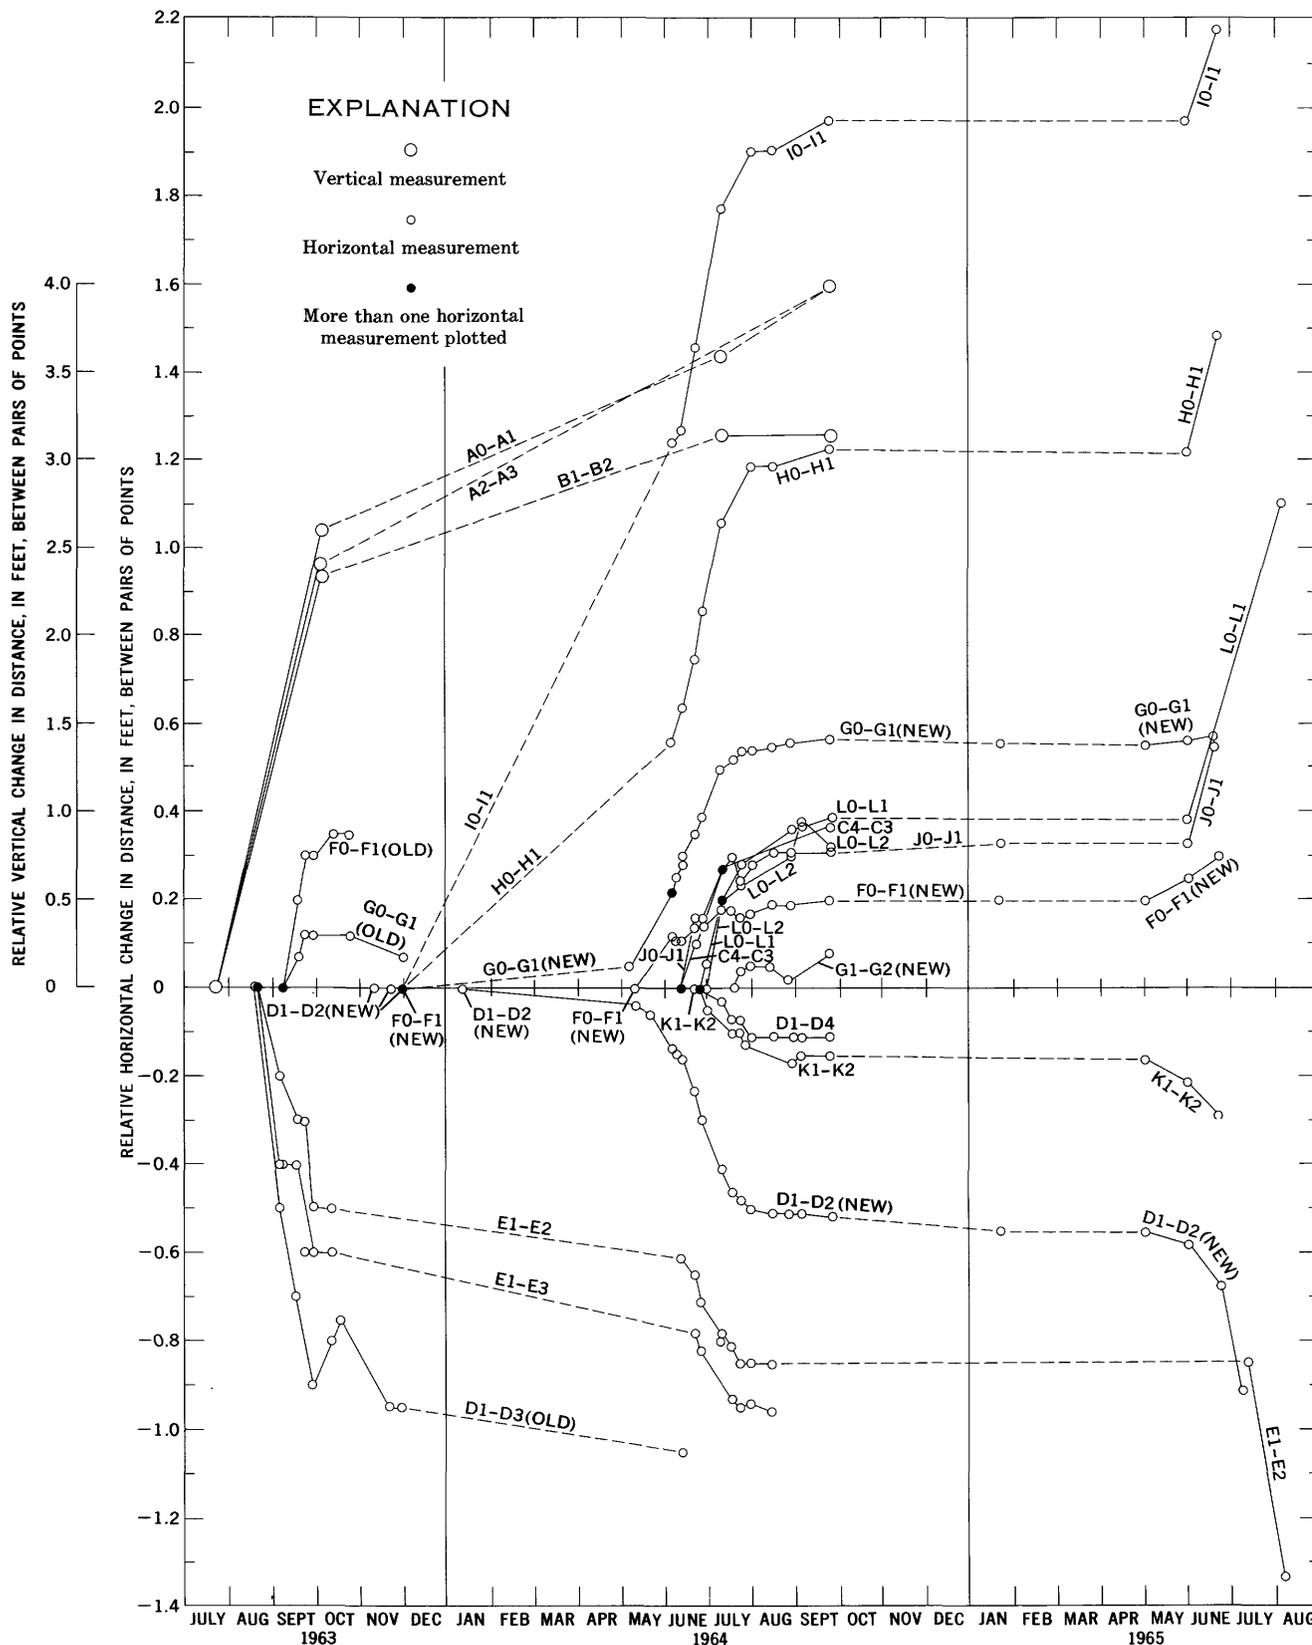
FIGURE 16.—The relative vertical and horizontal changes in distance between pairs of points outside and within the landslide mass. Locations of surveyed lines are shown in figure 15. Dashed lines indicate inferred change.

water table lowered. The central part of the slide did not move as much as the margins—which were deformed more during the original movement.

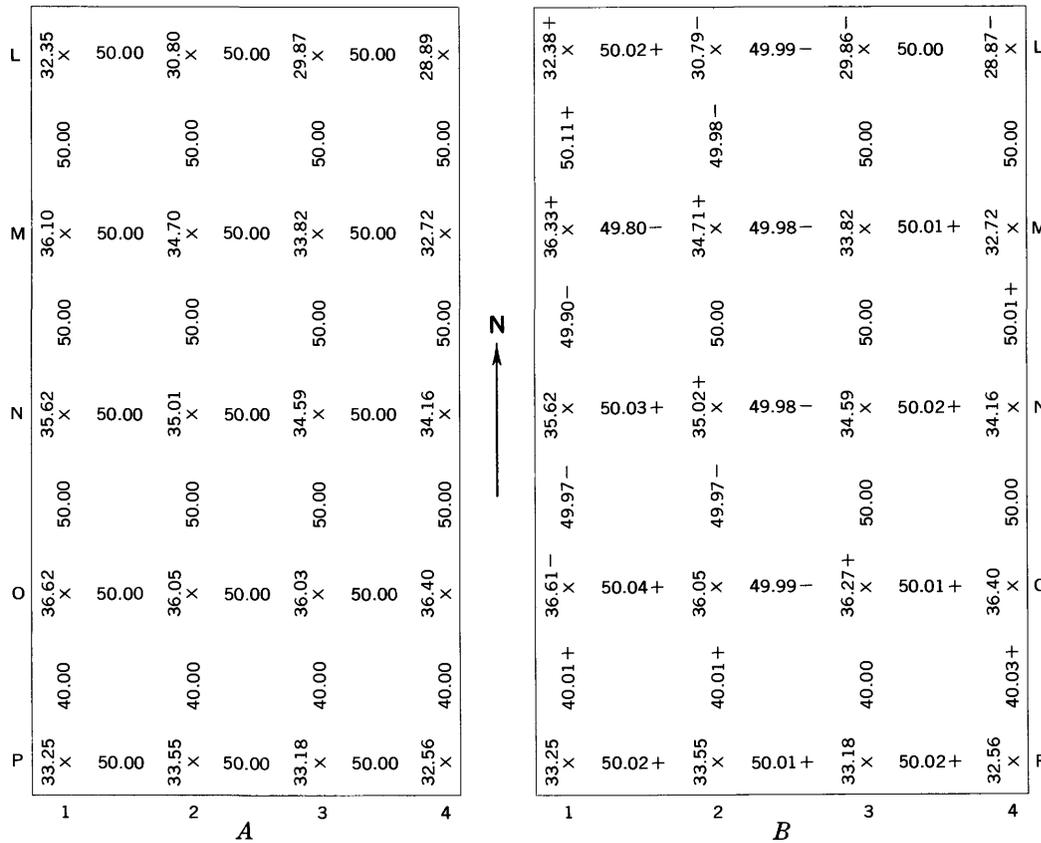
FIGURE 17.—The location and initial (A, Aug. 12, 1963) and final (B, Aug. 23, 1963) dimensions of survey grid established in the plaza area southeast of the landslide mass. Vertical measurements are shown to the left of the reference points (X). Horizontal measurements are shown between reference points. Units are feet. +, lengthened dimension; -, shortened dimension.

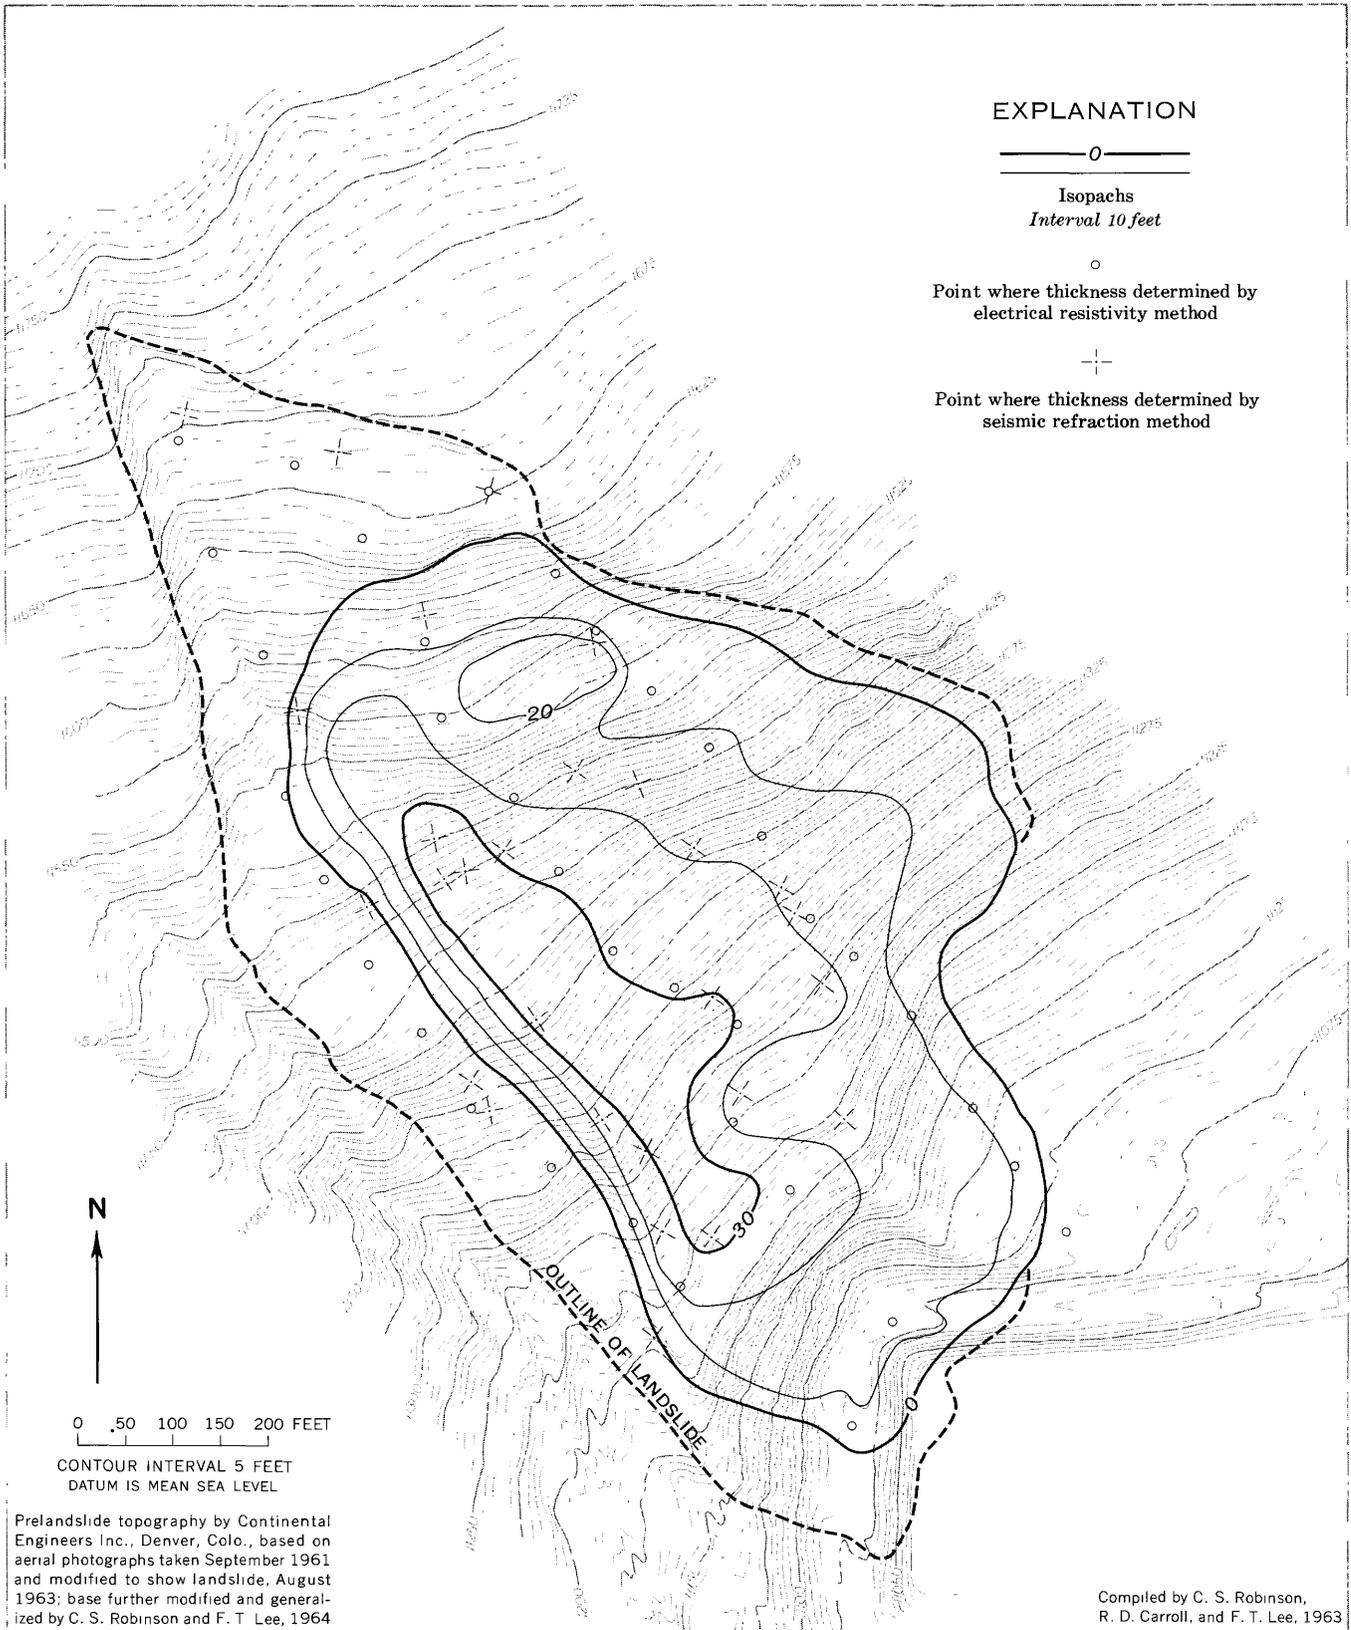
FIGURE 18.—Isopach map of the Loveland Basin landslide to the top of the slip zone.

The volume of the landslide to the top of the slip zone was calculated to be about 470,000 cubic yards weighing about 990,000 tons. The total volume of the landslide to the bottom of the slip zone was calculated to be about 770,000 cubic yards weighing about 1,600,000 tons. The authors believed that, should the landslide fail suddenly, the volume and weight of material involved would be between these two sets of figures.

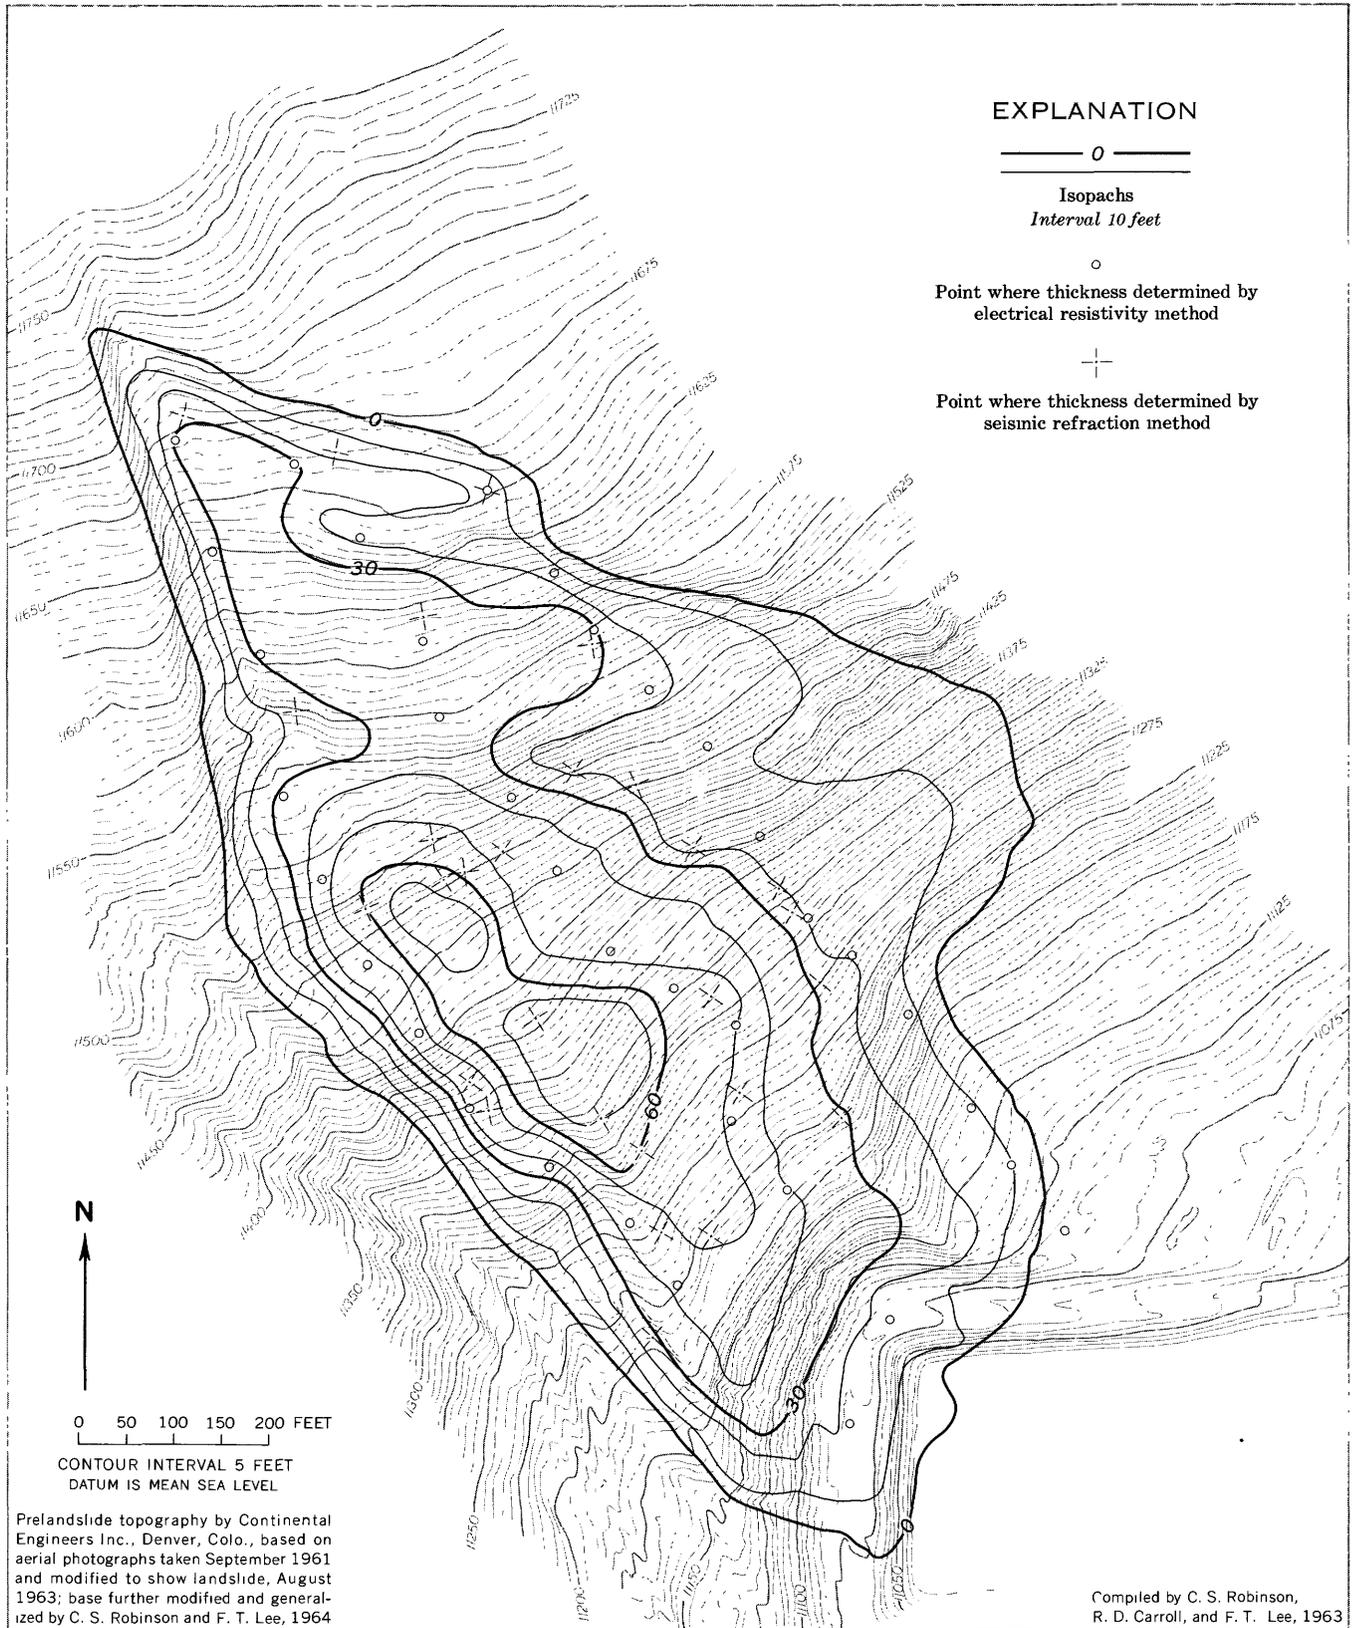
FIGURE 19.—Isopach map of the Loveland Basin landslide to the base of the slip zone.

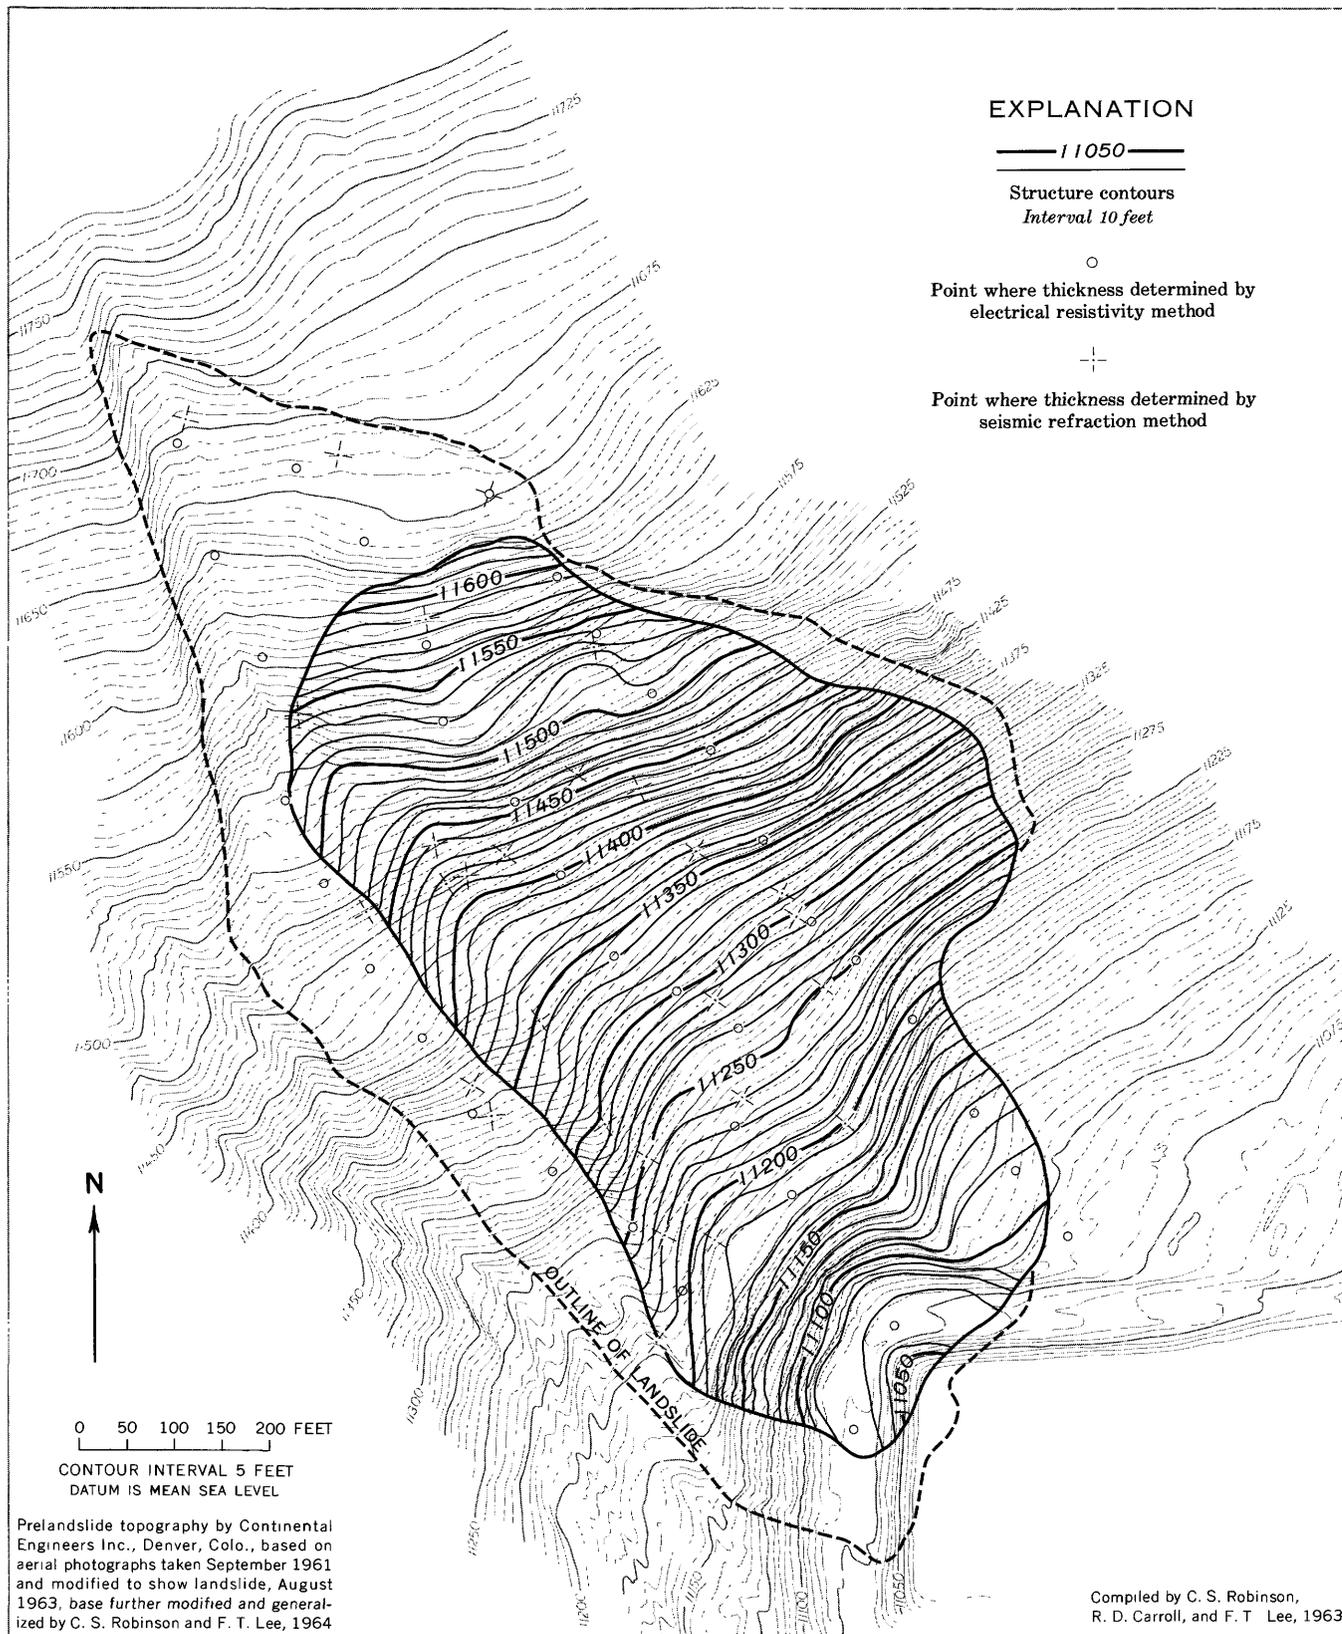
FIGURE 20.—Structure contours drawn on the top of the slip zone of the Loveland Basin landslide.

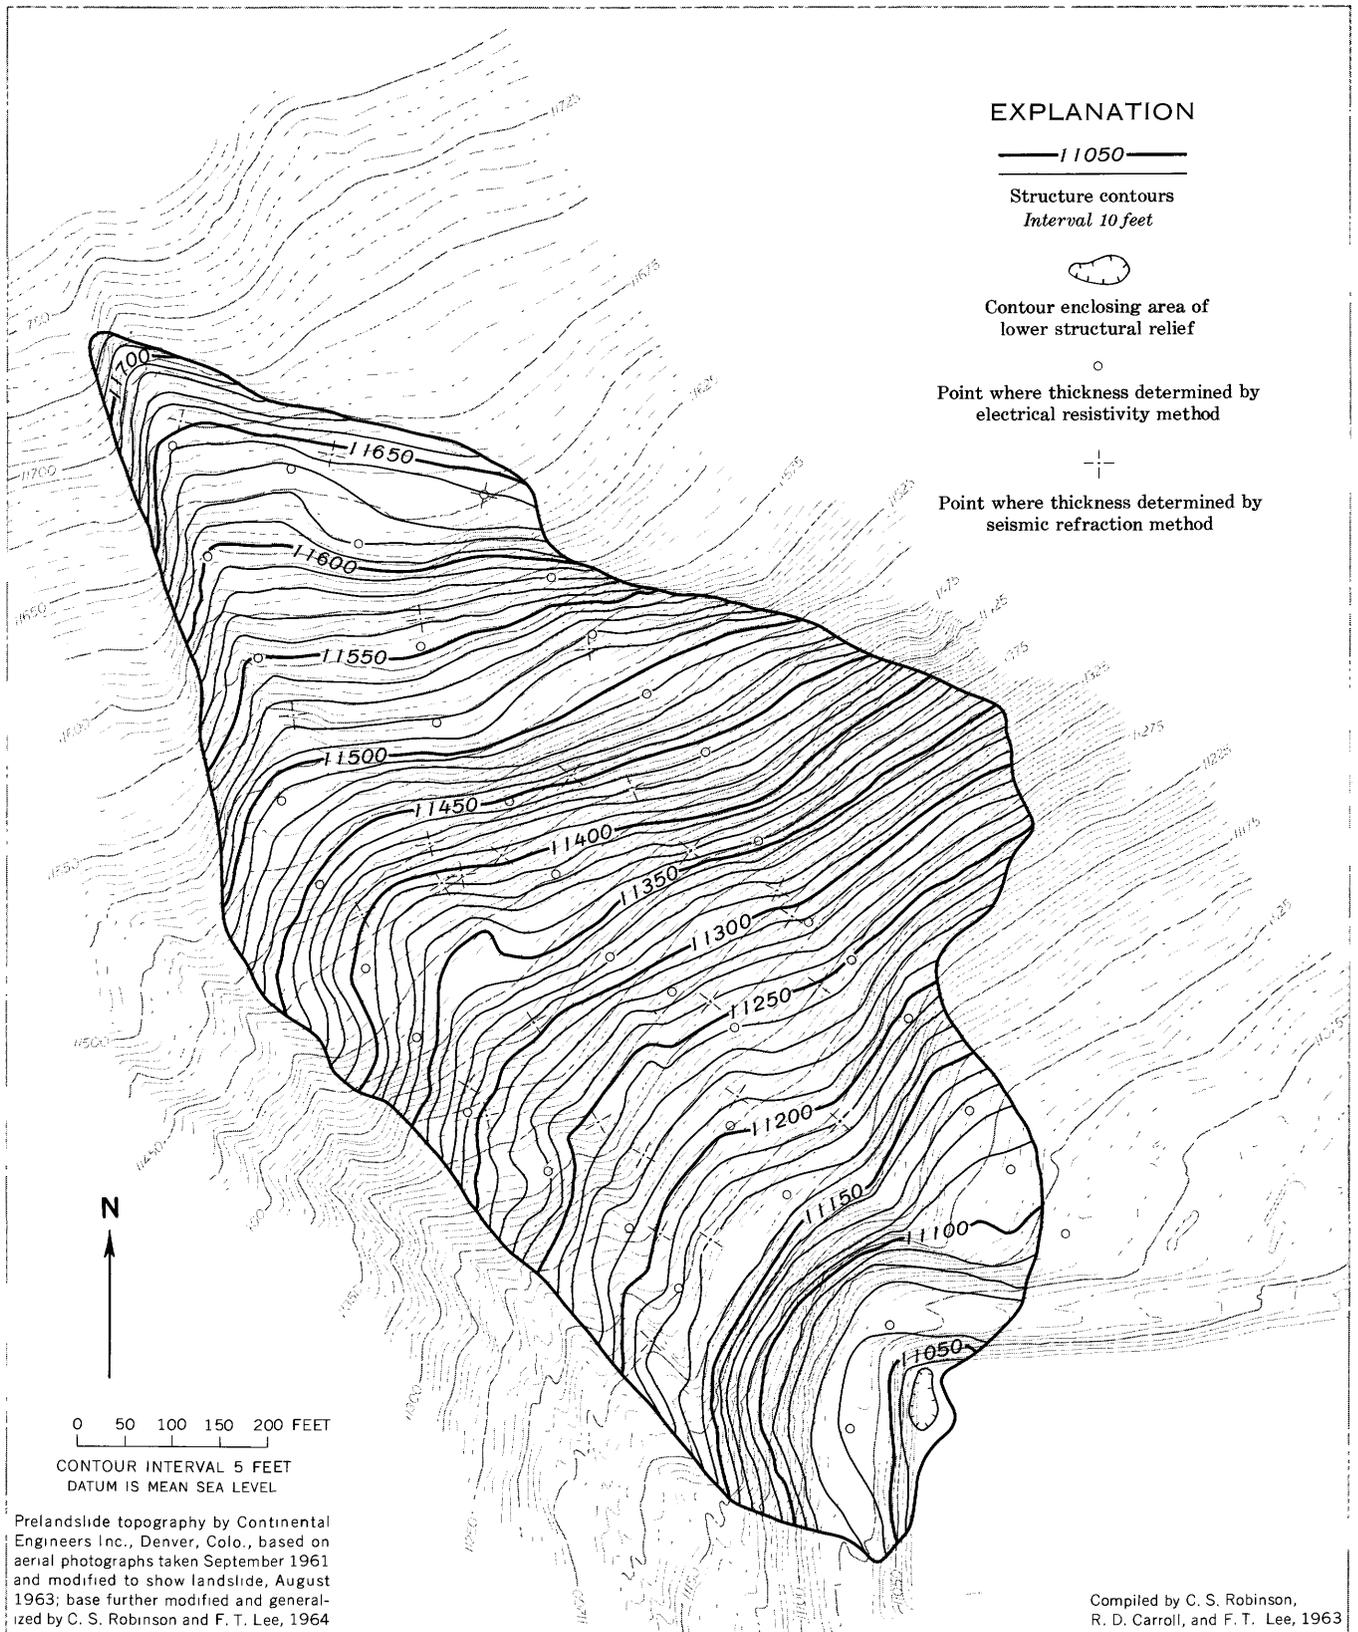
FIGURE 21.—Structure contours drawn on the base of the slip zone of the Loveland Basin landslide.

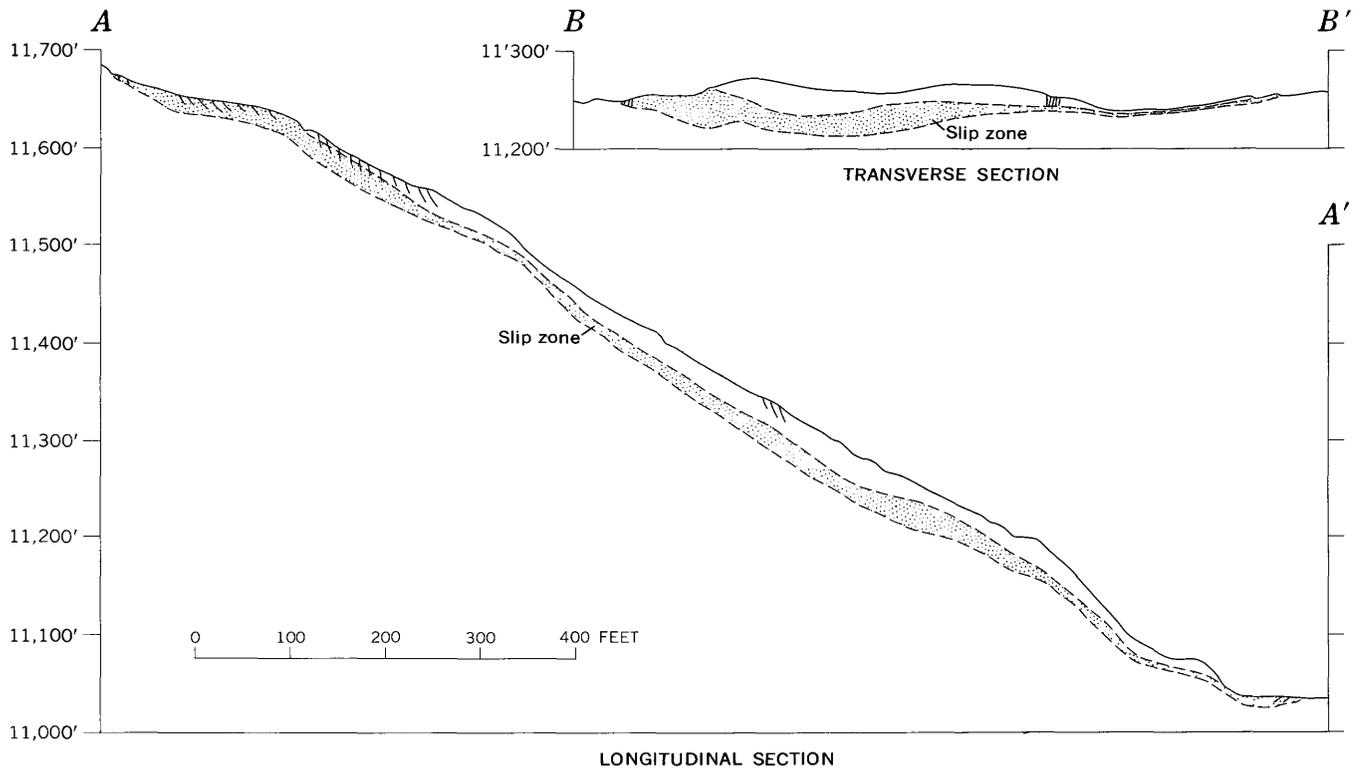
FIGURE 22.—Longitudinal and transverse sections of the Loveland Basin landslide. Lines of sections shown in figure 2.

Longitudinal and transverse sections (fig. 22) were prepared from the structure contour maps to show the configuration of the slip zone and its relation to the entire landslide and the toe load. The central and the western parts of the slide, in general, are deepest. The changes in thickness of the slip zone and the sliding mass and the irregularities along the base of the slip zone are due mainly to variations in surface topography and bedrock competency.

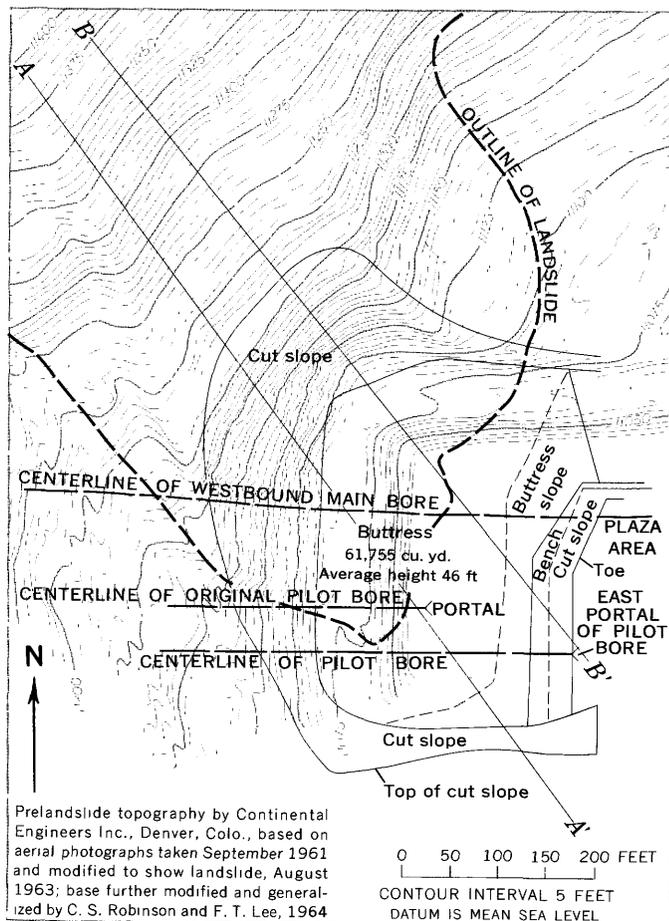
FIGURE 23.—The plaza area and buttness placed on toe of Loveland Basin landslide. A-A' and B-B', sections used to calculate factor of safety against failure at the lower limit of the slip zone; shown in figure 24.

office projections, the decision was made to shift the position of the Straight Creek Tunnel pilot bore to the south, to lower the pilot bore and approach grade, and to shift the portal to the east of the location originally planned. The basic reasons for these changes were to place the portal of the pilot bore as far from the active landslide as possible and to develop all material possible for constructing the recommended buttress. The original plaza area, centerline locations, and other pertinent features are shown in figure 23. Also shown are the changes from the original plan.

The buttress was constructed in September and October 1963 and contains a volume of approximately 61,755 cubic yards of compacted material consisting primarily of shot and ripped rock obtained from the section immediately east of the pilot bore portal where the grade was lowered approximately 16 feet. This amount of material was all that was readily available at the time and was far less than that recommended for the buttress. A second analysis to be based on the actual buttress was considered essential; this analysis was made in 1964 and is presented here.

Assuming the main driving force is generally parallel to the axis of the zone of slippage in a vertical plane, the available factor of safety against failure at the lower limit of the slip zone may be calculated as follows (fig. 24):
