Permafrost and Related Engineering Problems in Alaska

GEOLOGICAL SURVEY PROFESSIONAL PAPER 678

By OSCAR J. FERRIANS, JR., REUBEN KACHADOORIAN, *and*
GORDON W. GREENE

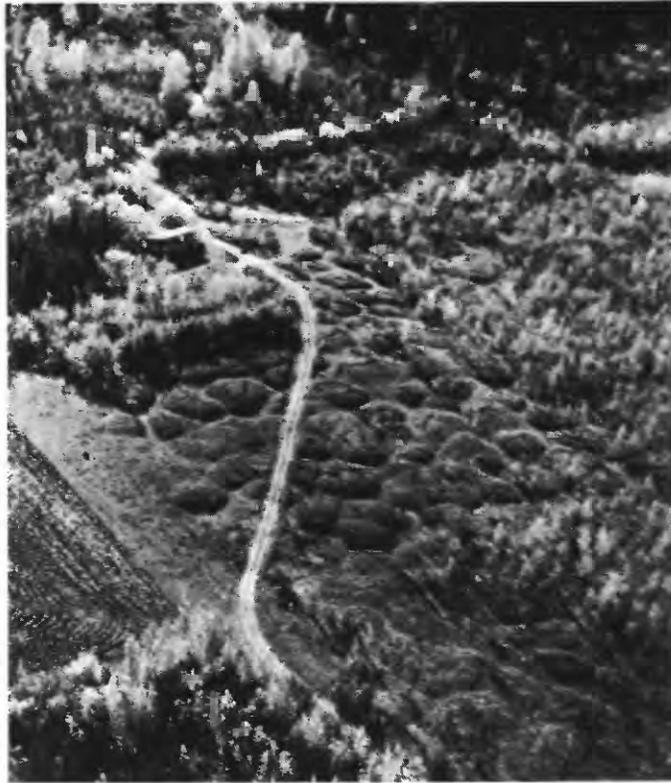
FIGURE 10.—Thermokarst mounds near Fairbanks. Mounds range from 10 to 30 feet in diameter. See figure 11 for ground view of mounds and explanation. Photograph by R. F. Black and T. L. Pévé, September 1948.

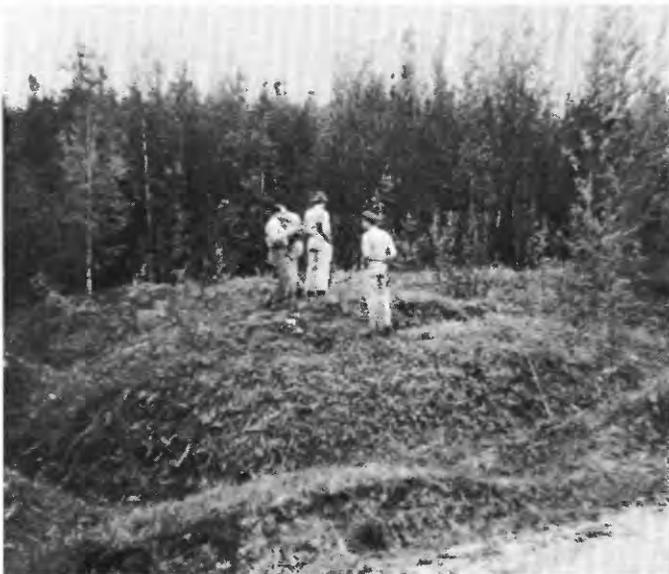
FIGURE 11.—Thermokarst mounds near Fairbanks caused by melting of ice wedges. The resulting ground settlement formed deep trenches in polygonal patterns and left mounds in the intervening areas. The thawing was started after the area was cleared for agricultural purposes. Figure 10 is an aerial view of similar mounds. Photograph taken in June 1955.

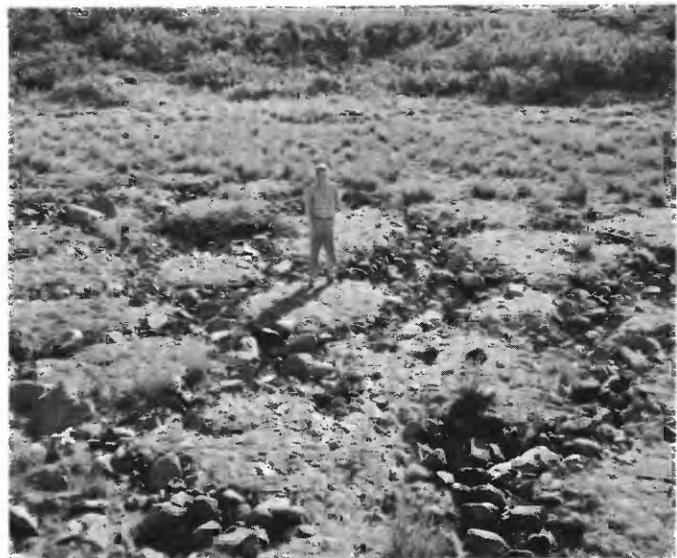
FIGURE 12.—Sorted stone circles caused by frost action, in Alaska Range, south-central Alaska. Photograph by T. L. Pévé, June 1968.

Stone nets, garlands, and stripes are extensive in the arctic. Frost heaving in granular soils produces netlike concentrations of the coarser rocks (fig. 12). If the area is gently sloped, the net is distorted into garlands by downslope movement. If the slope is

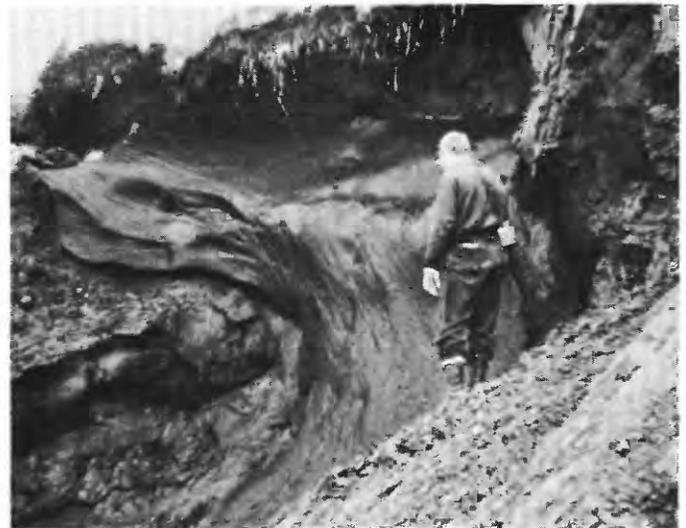
FIGURE 13.—Large mass of ground ice exposed by gold placer mining in silt bluff near Fairbanks. Thawing of a large ice mass causes severe differential settlement of the surface of the ground, as is shown in figure 14. Photograph taken in June 1955.

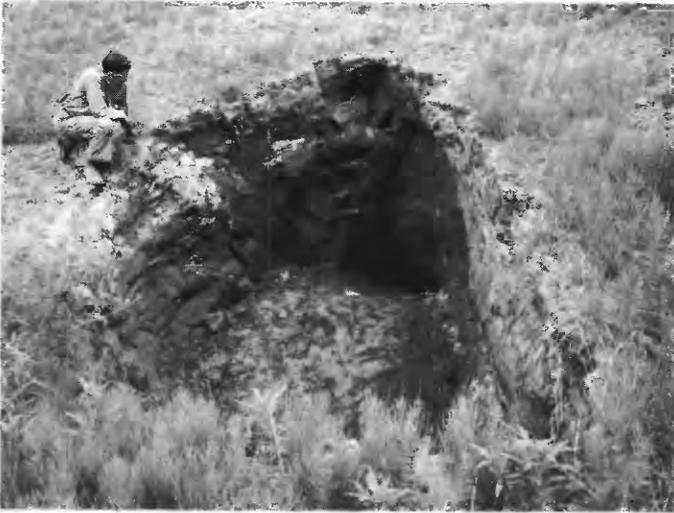
FIGURE 14.—Thaw or thermokarst pit near Fairbanks formed by the thawing of a large ice mass that caused severe differential settlement of the surface of the ground. Photograph by T. L. Péwé, June 1948.

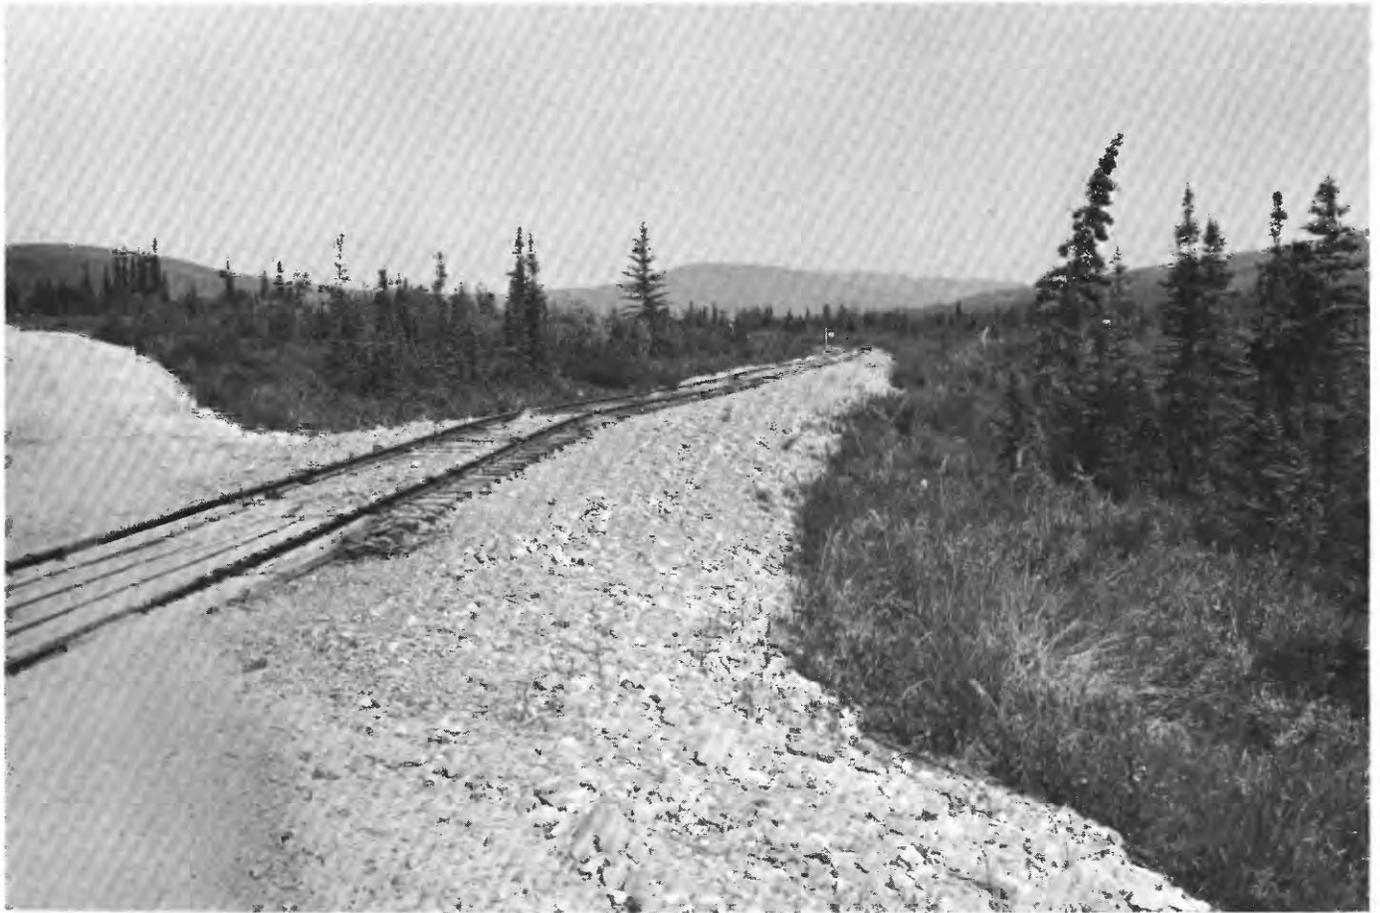
FIGURE 19.—Differential subsidence caused by thawing permafrost along the Murphy Dome Spur of the Alaska Railroad. Roadbed is in Goldstream valley and is underlain by silt. Photograph by T. L. Péwé, June 1954.

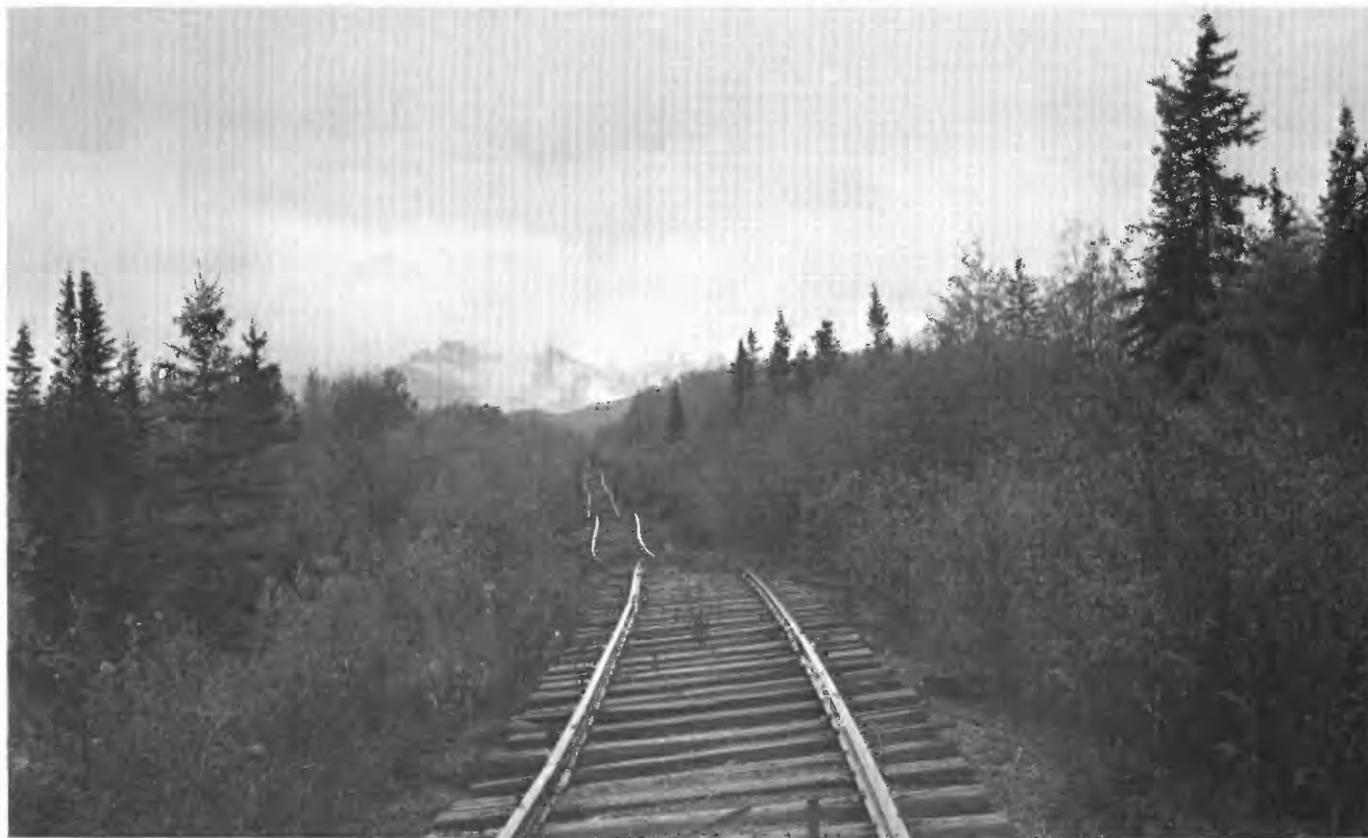
FIGURE 20.—Differential subsidence of roadbed of Copper River and Northwestern Railway near Strelna, 75 miles northeast of Valdez. The thermal equilibrium of the fine-grained sediments underlying the roadbed was disrupted during construction and the permafrost started to thaw. Maintenance and use of the railroad was discontinued in 1938. Subsidence as well as lateral displacement, however, has continued. Photograph by L. A. Yehle, September 1960.

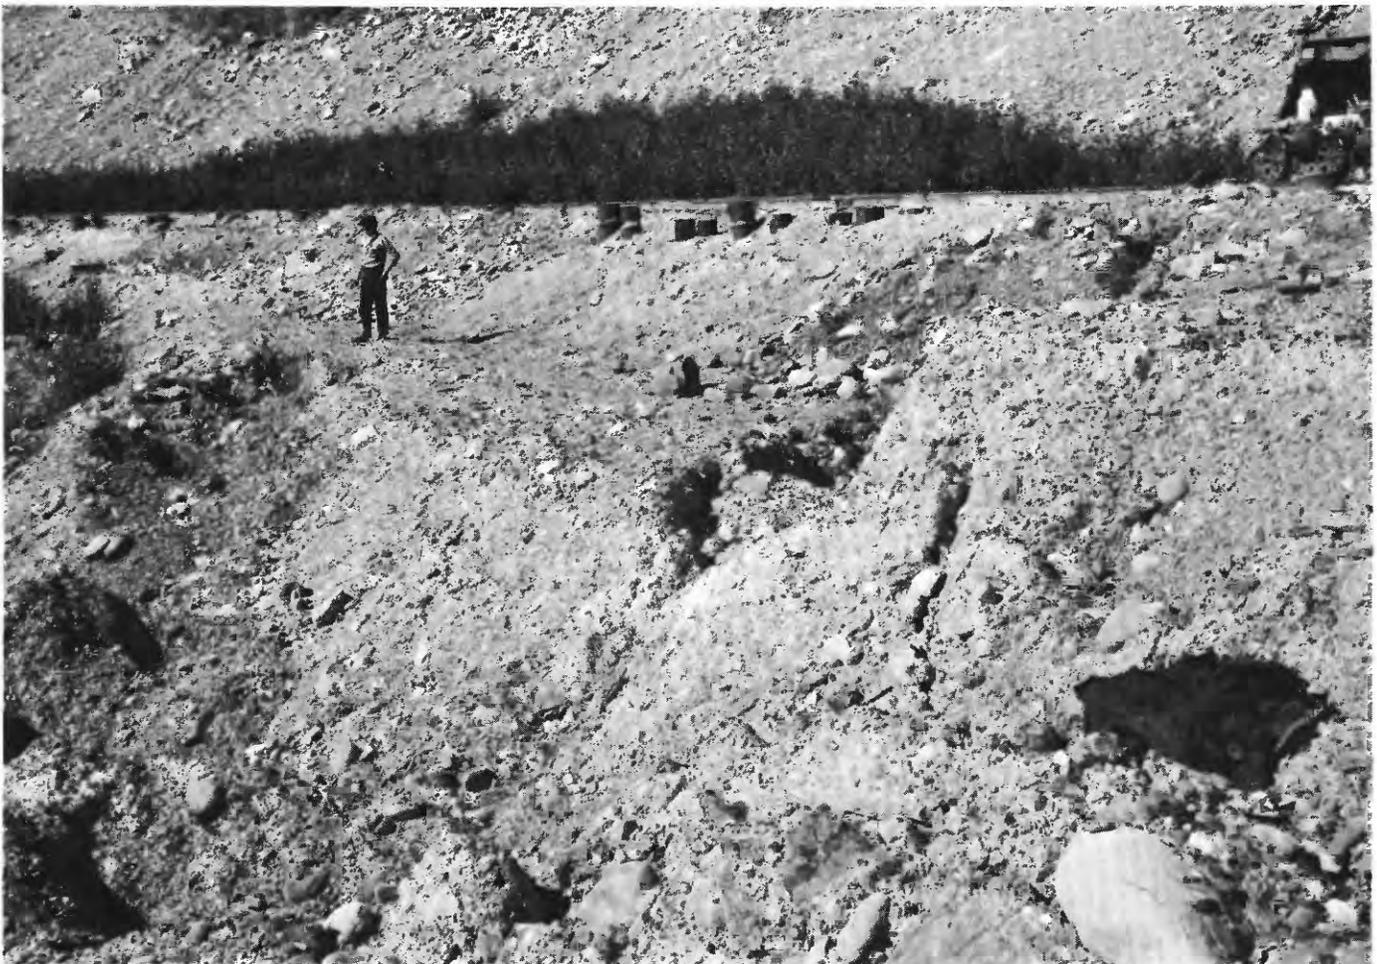
FIGURE 22.—Landslide area at mile 353.5, The Alaska Railroad. Note the tops of piles immediately downslope from the rails to prevent displacement of the tracks.

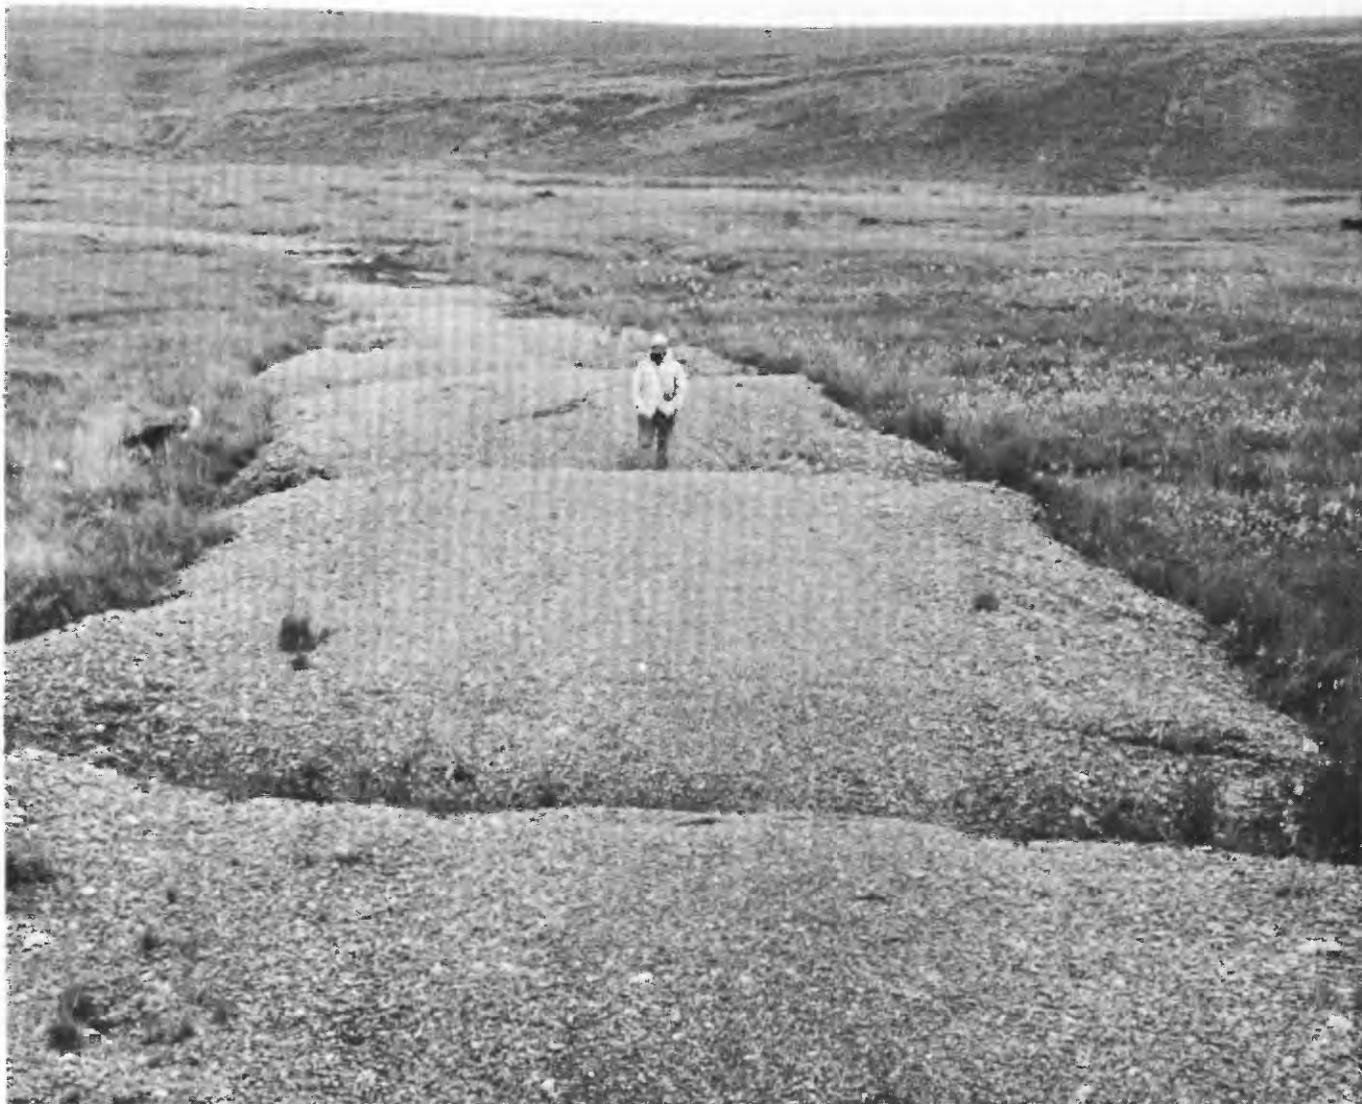
FIGURE 25.—Gravel road near the Umiat showing severe differential subsidence caused by thawing of ice-wedge polygons in permafrost. Photograph taken in August 1958.

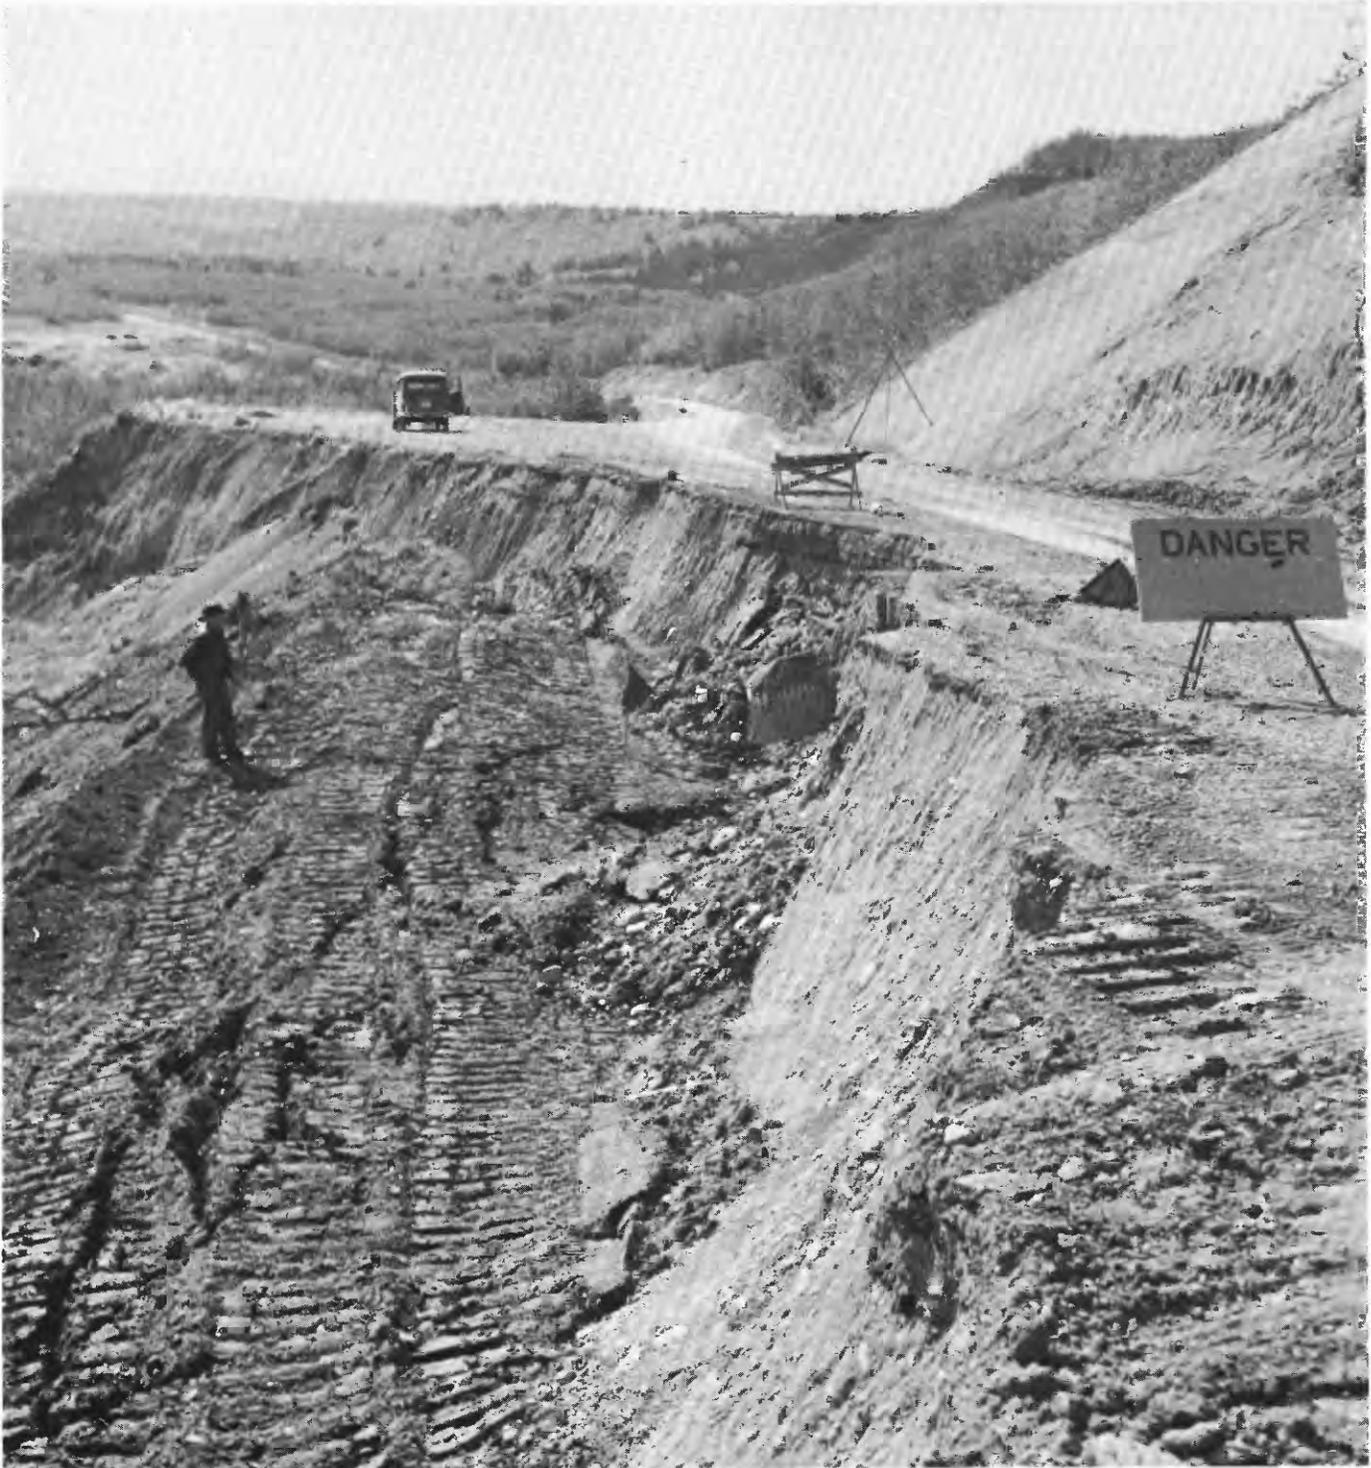
FIGURE 26.—Slump block of fine-grained highway fill material at Simpson Hill, near mile 113 on the Richardson Highway. Centerline of road formerly lay over exposed part of sheared culvert. Note bulldozer tracks on slump block surface, which are a continuation of those at road level on right side of photograph. Photograph by D. R. Nichols, September 1955.

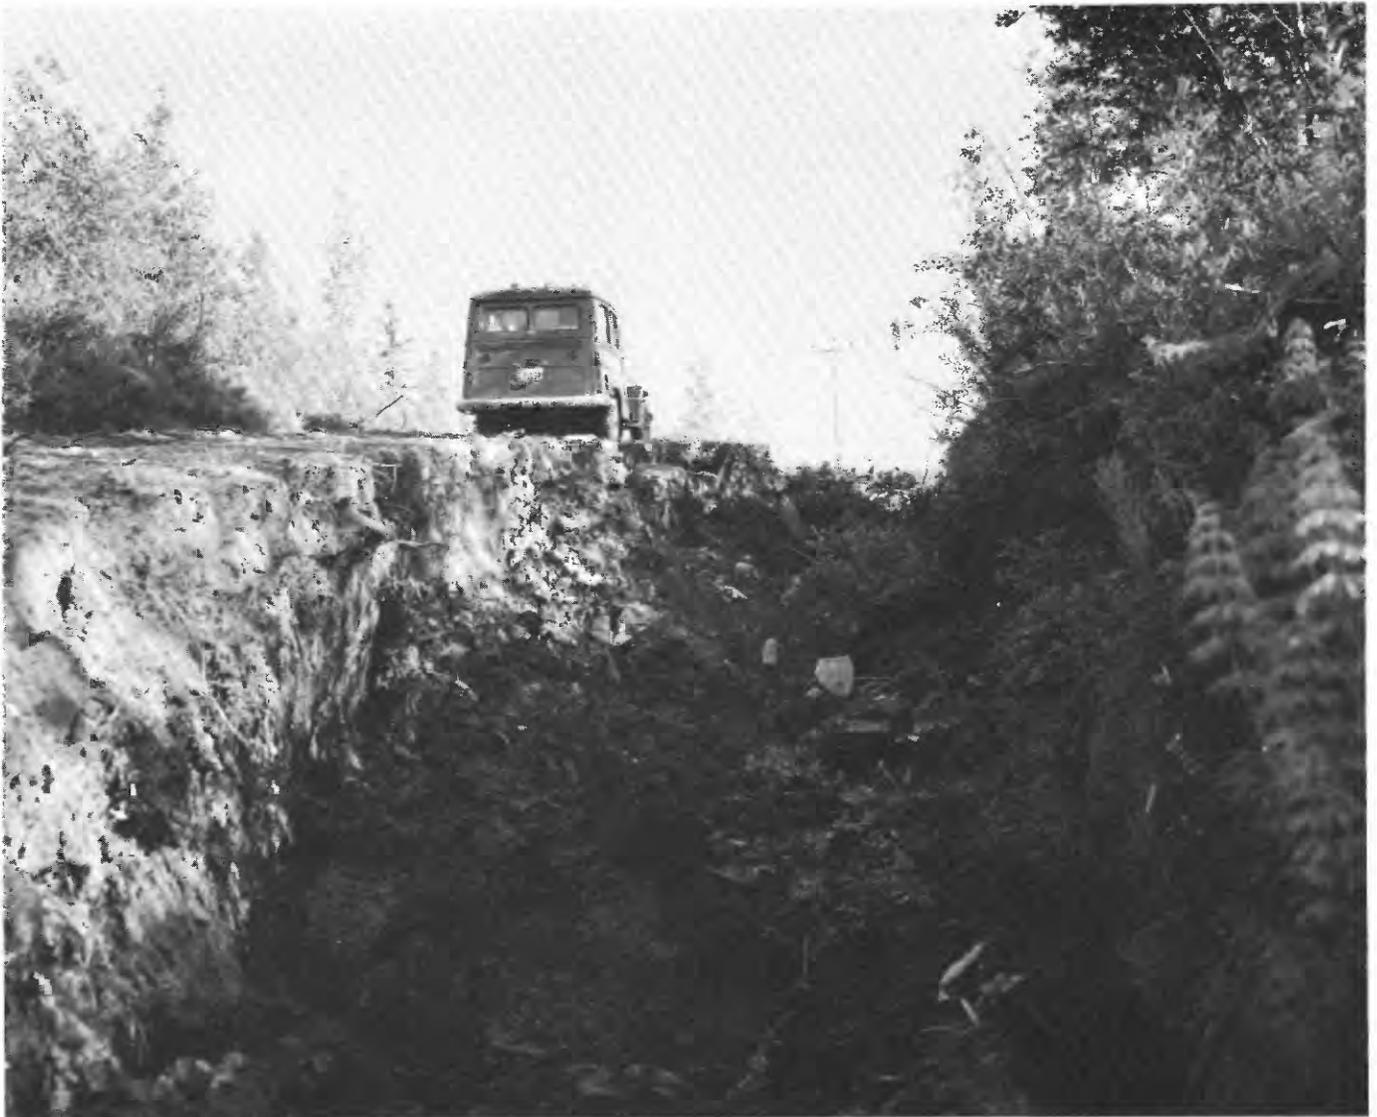
FIGURE 27.—Old Sheep Creek Road northwest of Fairbanks. Gully along edge of road was caused when the surface drainage thawed the permafrost in the underlying loess deposits. Photograph by T. L. Péwé, summer 1955.

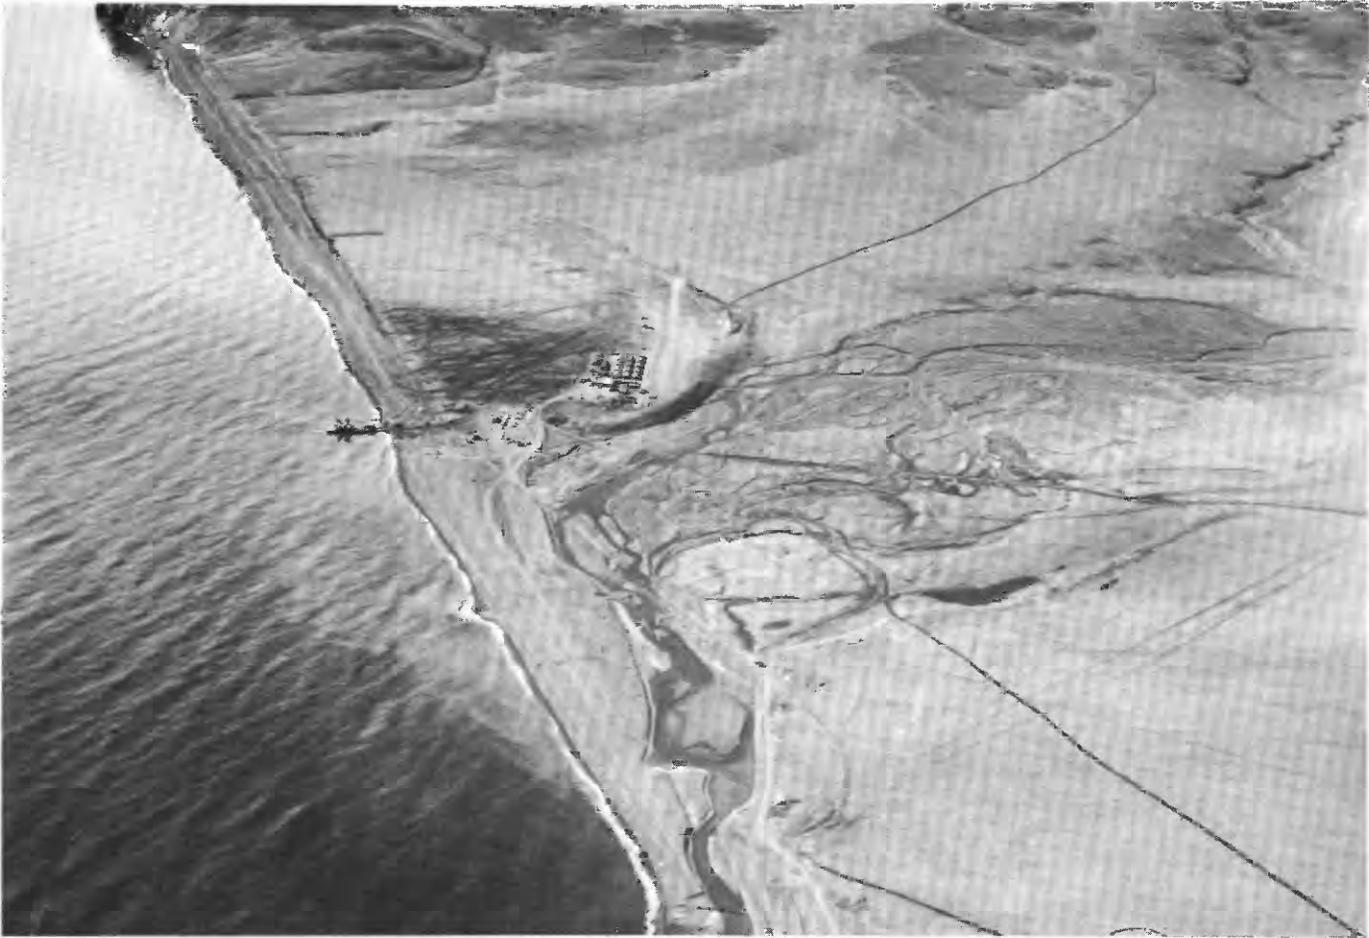
FIGURE 28.—Oblique aerial photograph of Chariot Site, northwestern Alaska. Dark area to the left of camp was caused by the heavy equipment that moved over the terrain while the barges were being unloaded. Trails were caused by tracked vehicles. Photograph by R. H. Campbell, summer 1960.

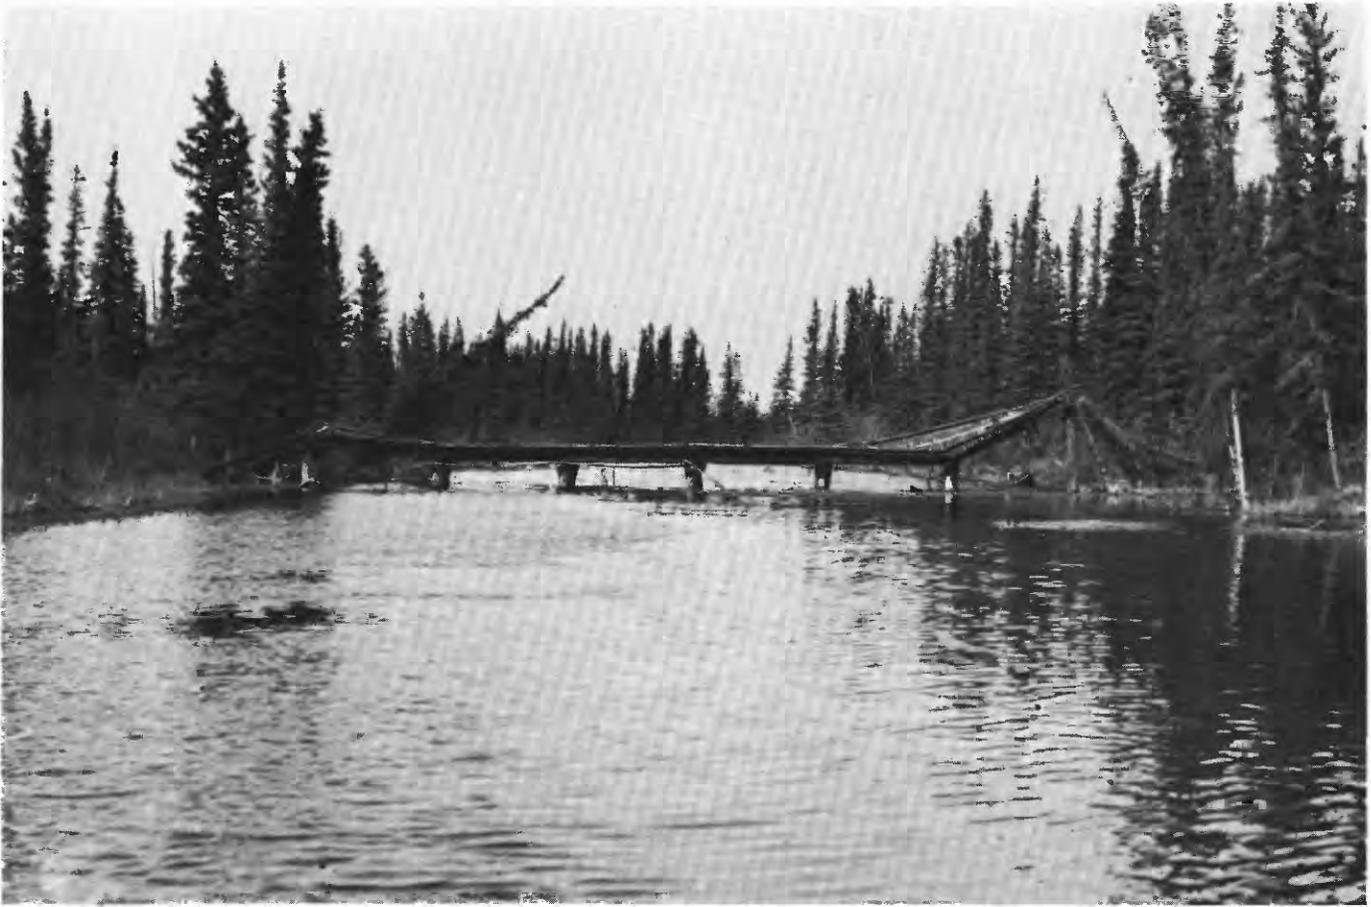
FIGURE 30.—Frost-heaved piling of bridge spanning outlet of Clearwater Lake, 8 miles southeast of Big Delta. Piles are of wood. Photograph by M. F. Meiser, August 1951.

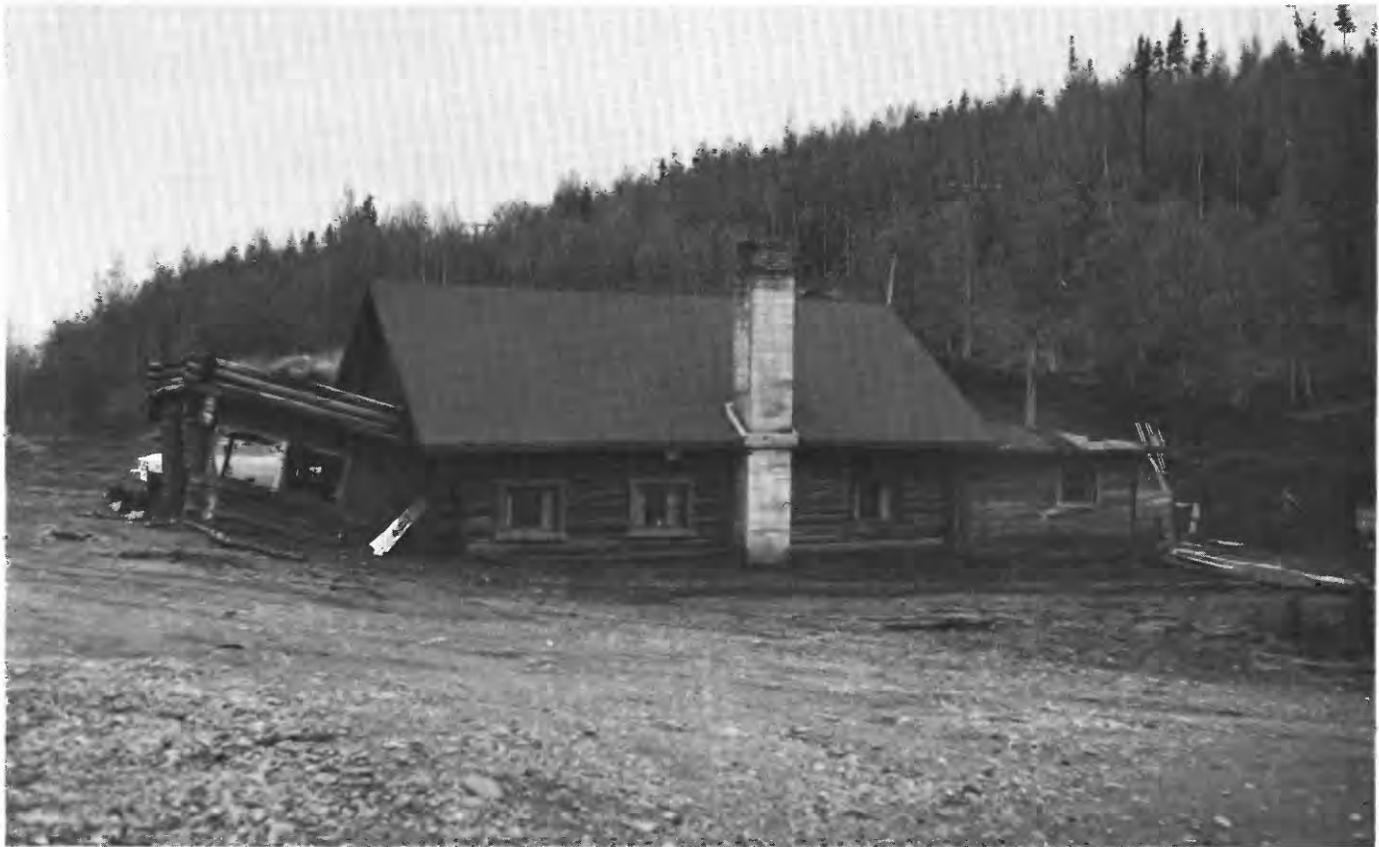
FIGURE 33.—Roadhouse, mile 278.5, Richardson Highway. The structure is distorted because of thawing of the underlying ice-rich permafrost in fine-grained silts and sands. Photograph by T. L. Péwé, May 29, 1962.

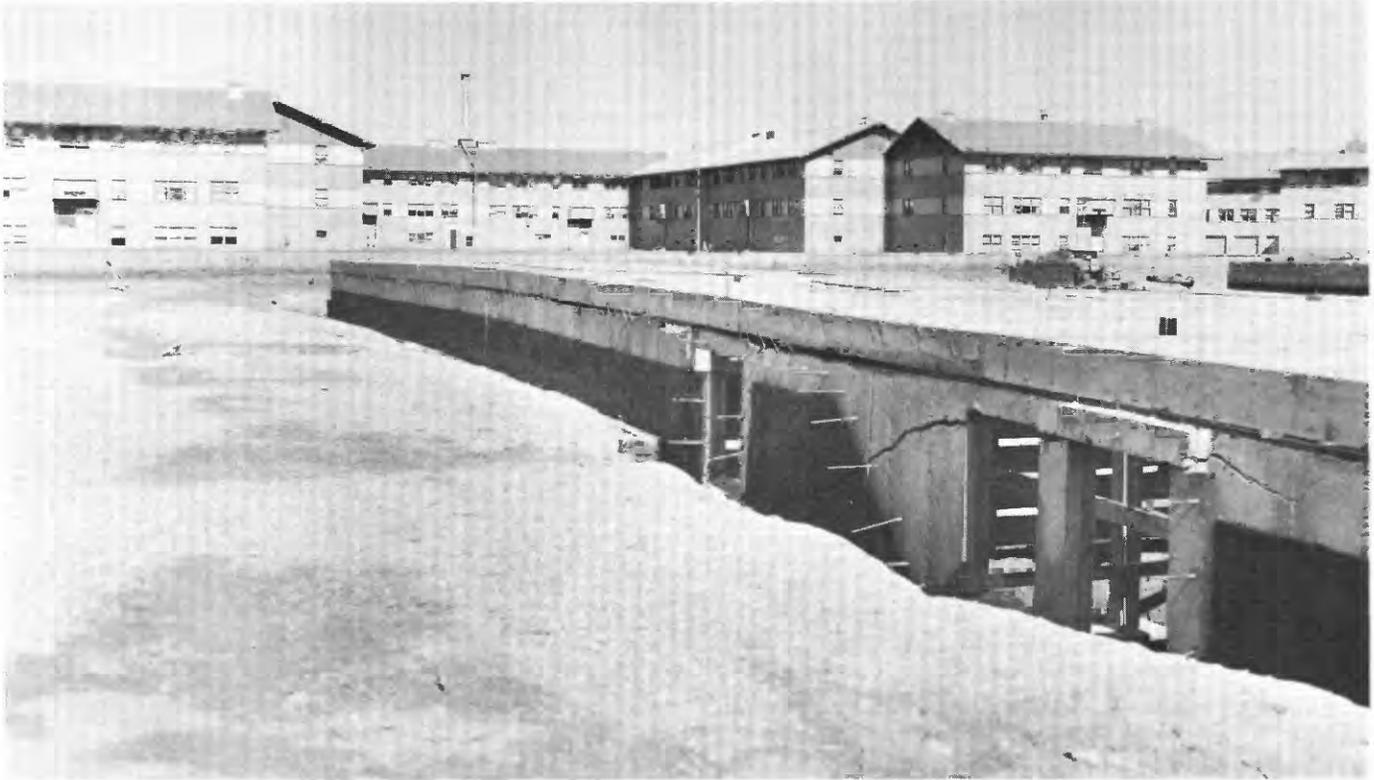
FIGURE 35.—Fracture due to frost heaving of 4-inch concrete foundation of an apartment house in Fairbanks. Photograph by T. L. Péwé, June 1954.

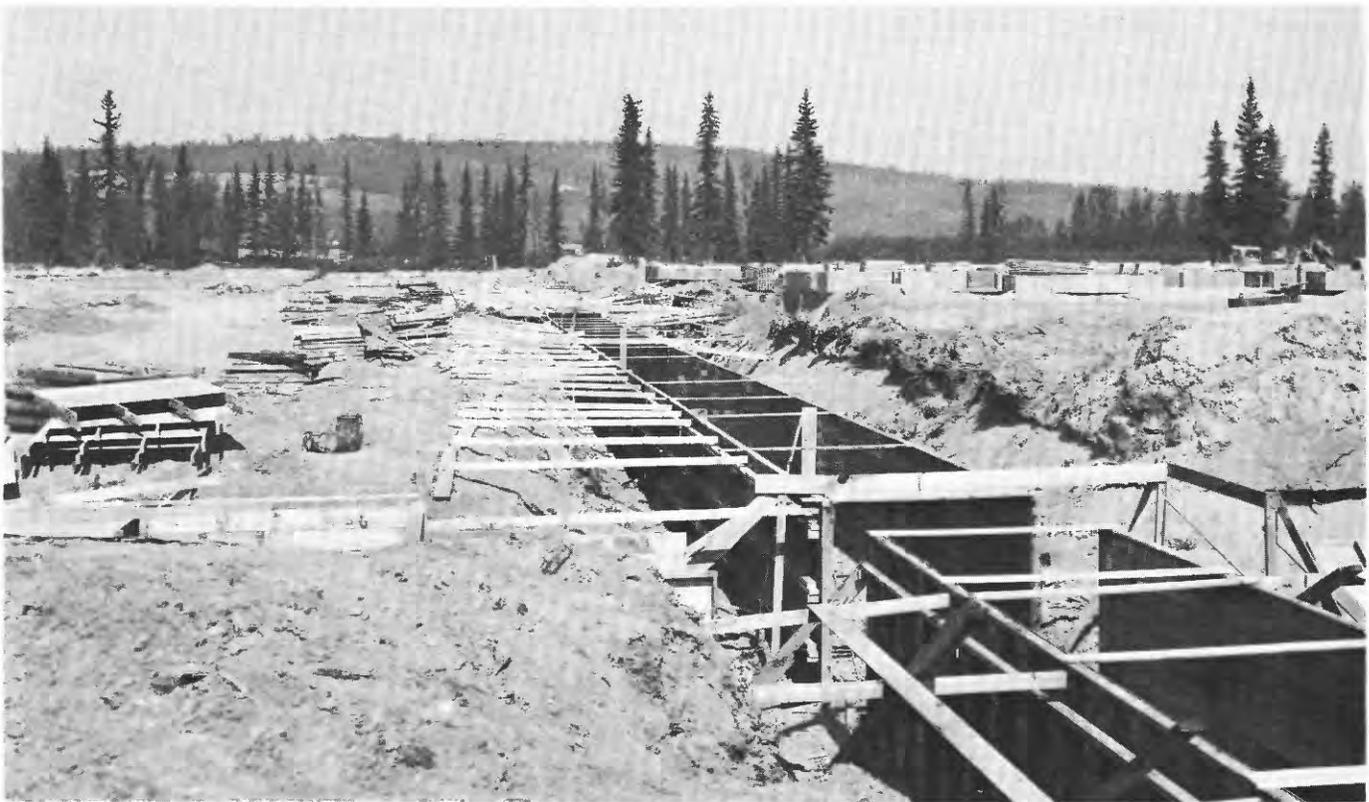
FIGURE 36.—Utilidor under construction at Fort Wainwright near Fairbanks, Alaska. Photograph by T. L. Péwé, July 1947.
