COMPOSITE TUNNEL SECTIONS AND GEOLOGIC PLANS AND SECTIONS OF SELECTED INTERVALS SHOWING RELATION BETWEEN OVERBREAK AND GEOLOGY IN THE ROBERTS TUNNEL BETWEEN STATIONS 84+46 AND 174+66, SUMMIT COUNTY, COLORADO

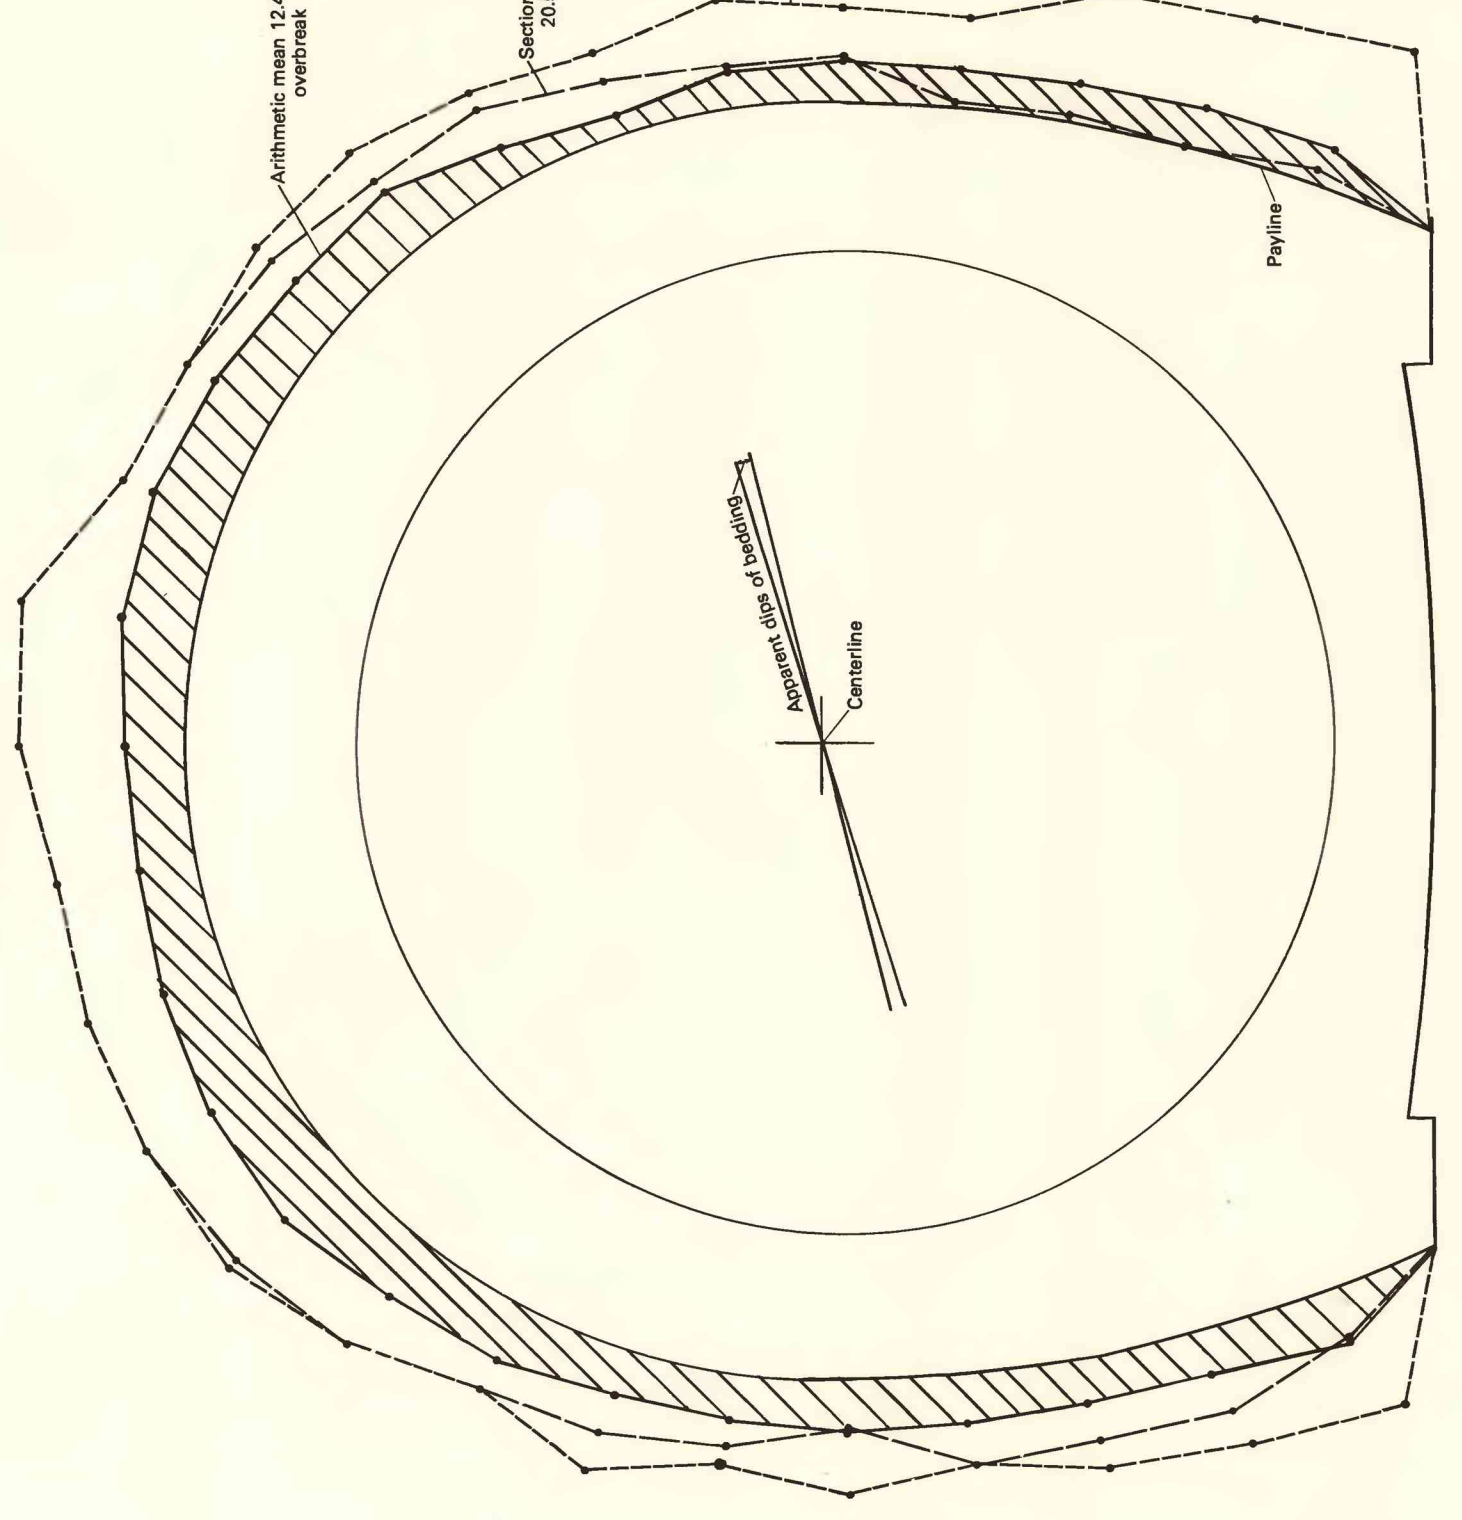
**A—OVERBREAK IN PIERRE SHALE,
STATIONS 84+46 TO 87+66**
15 sections, steel supports on 4-foot centers
