COMPOSITE TUNNEL SECTIONS AND GEOLOGICAL PLANS AND SECTIONS OF SELECTED INTERVALS SHOWING RELATION BETWEEN OVERBREAK AND GEOLOGY IN THE ROBERTS TUNNEL BETWEEN STATIONS 1012+60 AND 1135+00, PARK COUNTY, COLORADO

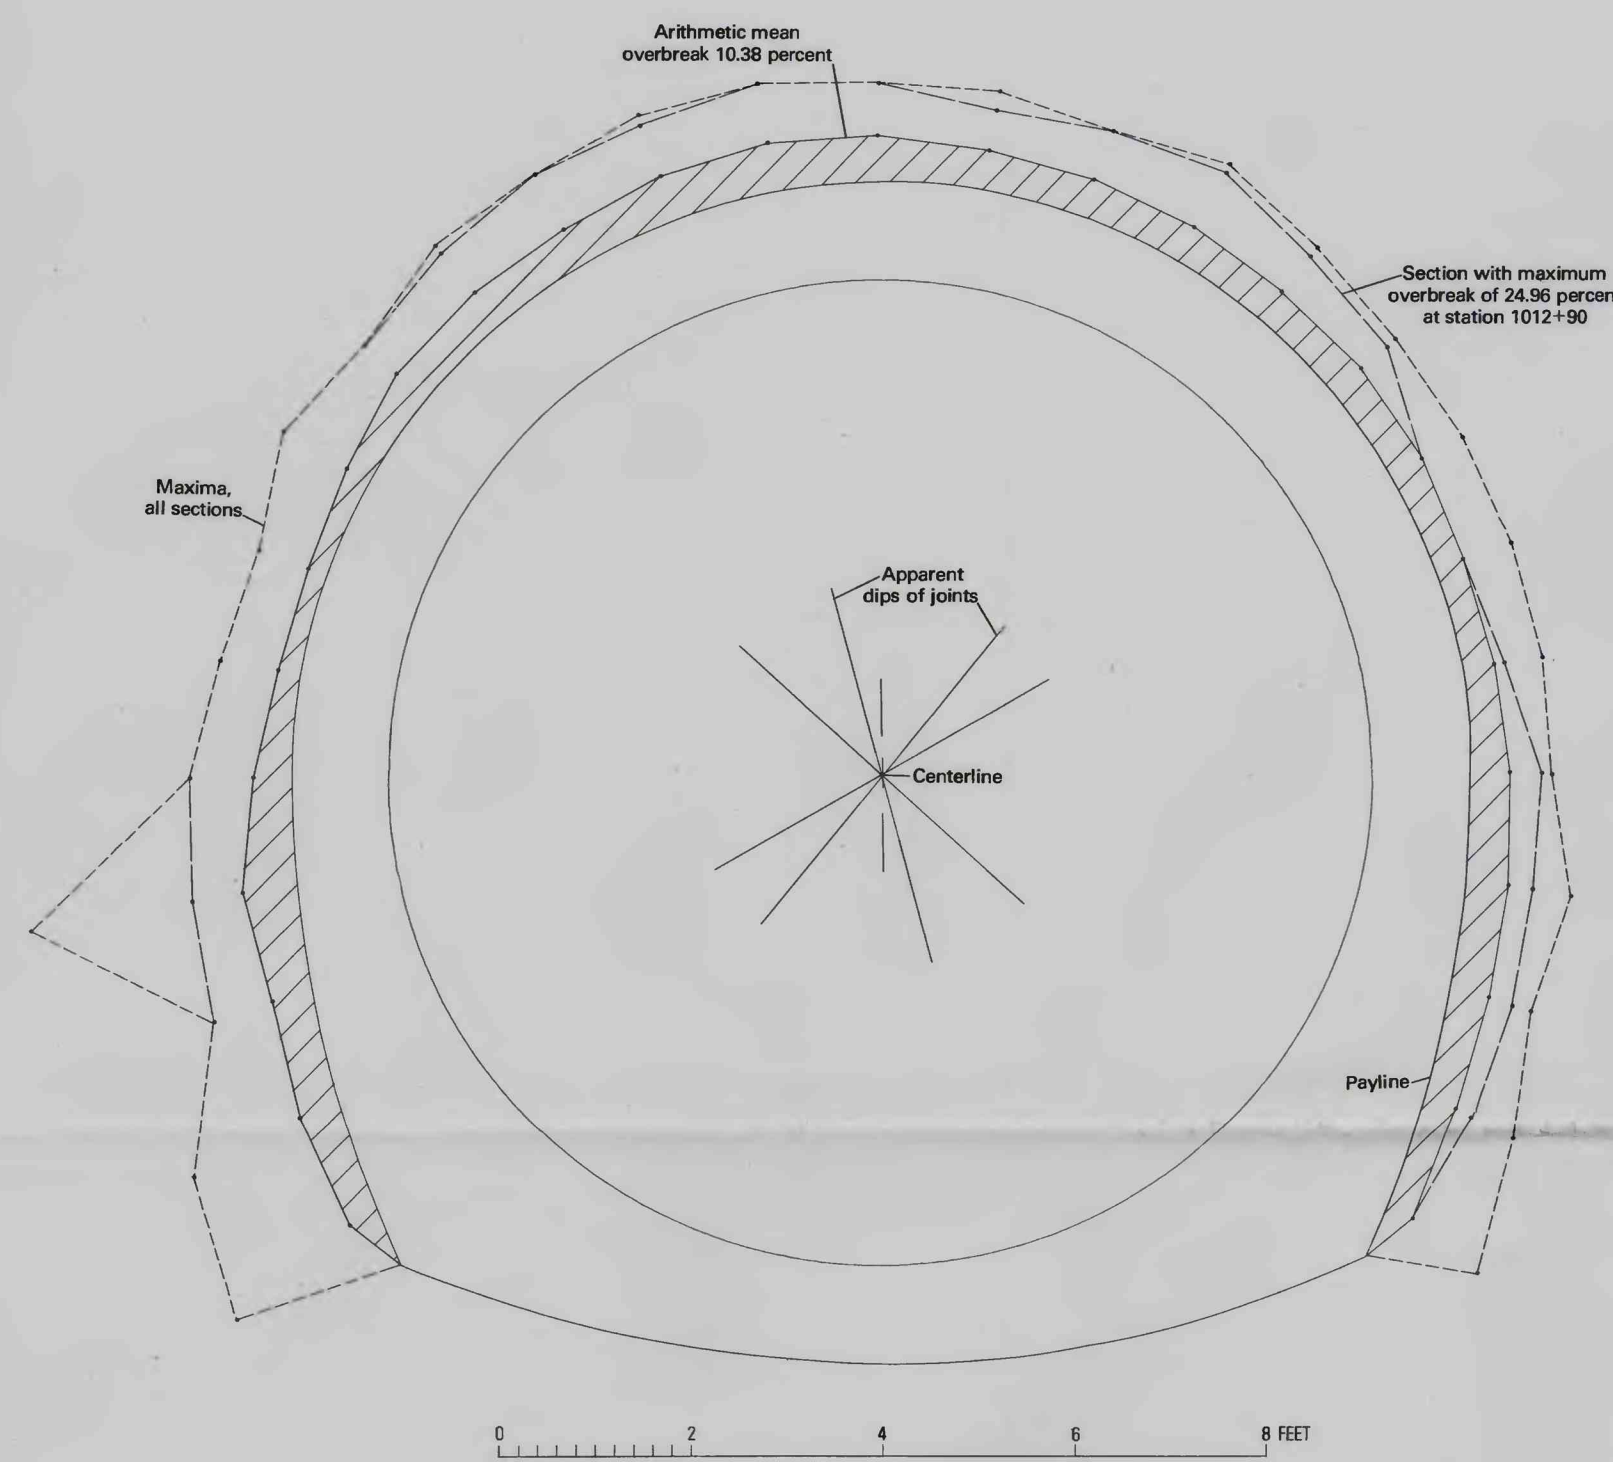
**A.—OVERBREAK IN PEGMATITE,
STATION 1012+60 TO 1014+00**
15 sections, no steel supports
