Slump Blocks in the Atlantic Highlands of New Jersey

GEOLOGICAL SURVEY PROFESSIONAL PAPER 898

By JAMES P. MINARD

*A description of slump blocks and slumping
in the hills of the northeastern
New Jersey Coastal Plain, and a
discussion of their potential
as geologic hazards*

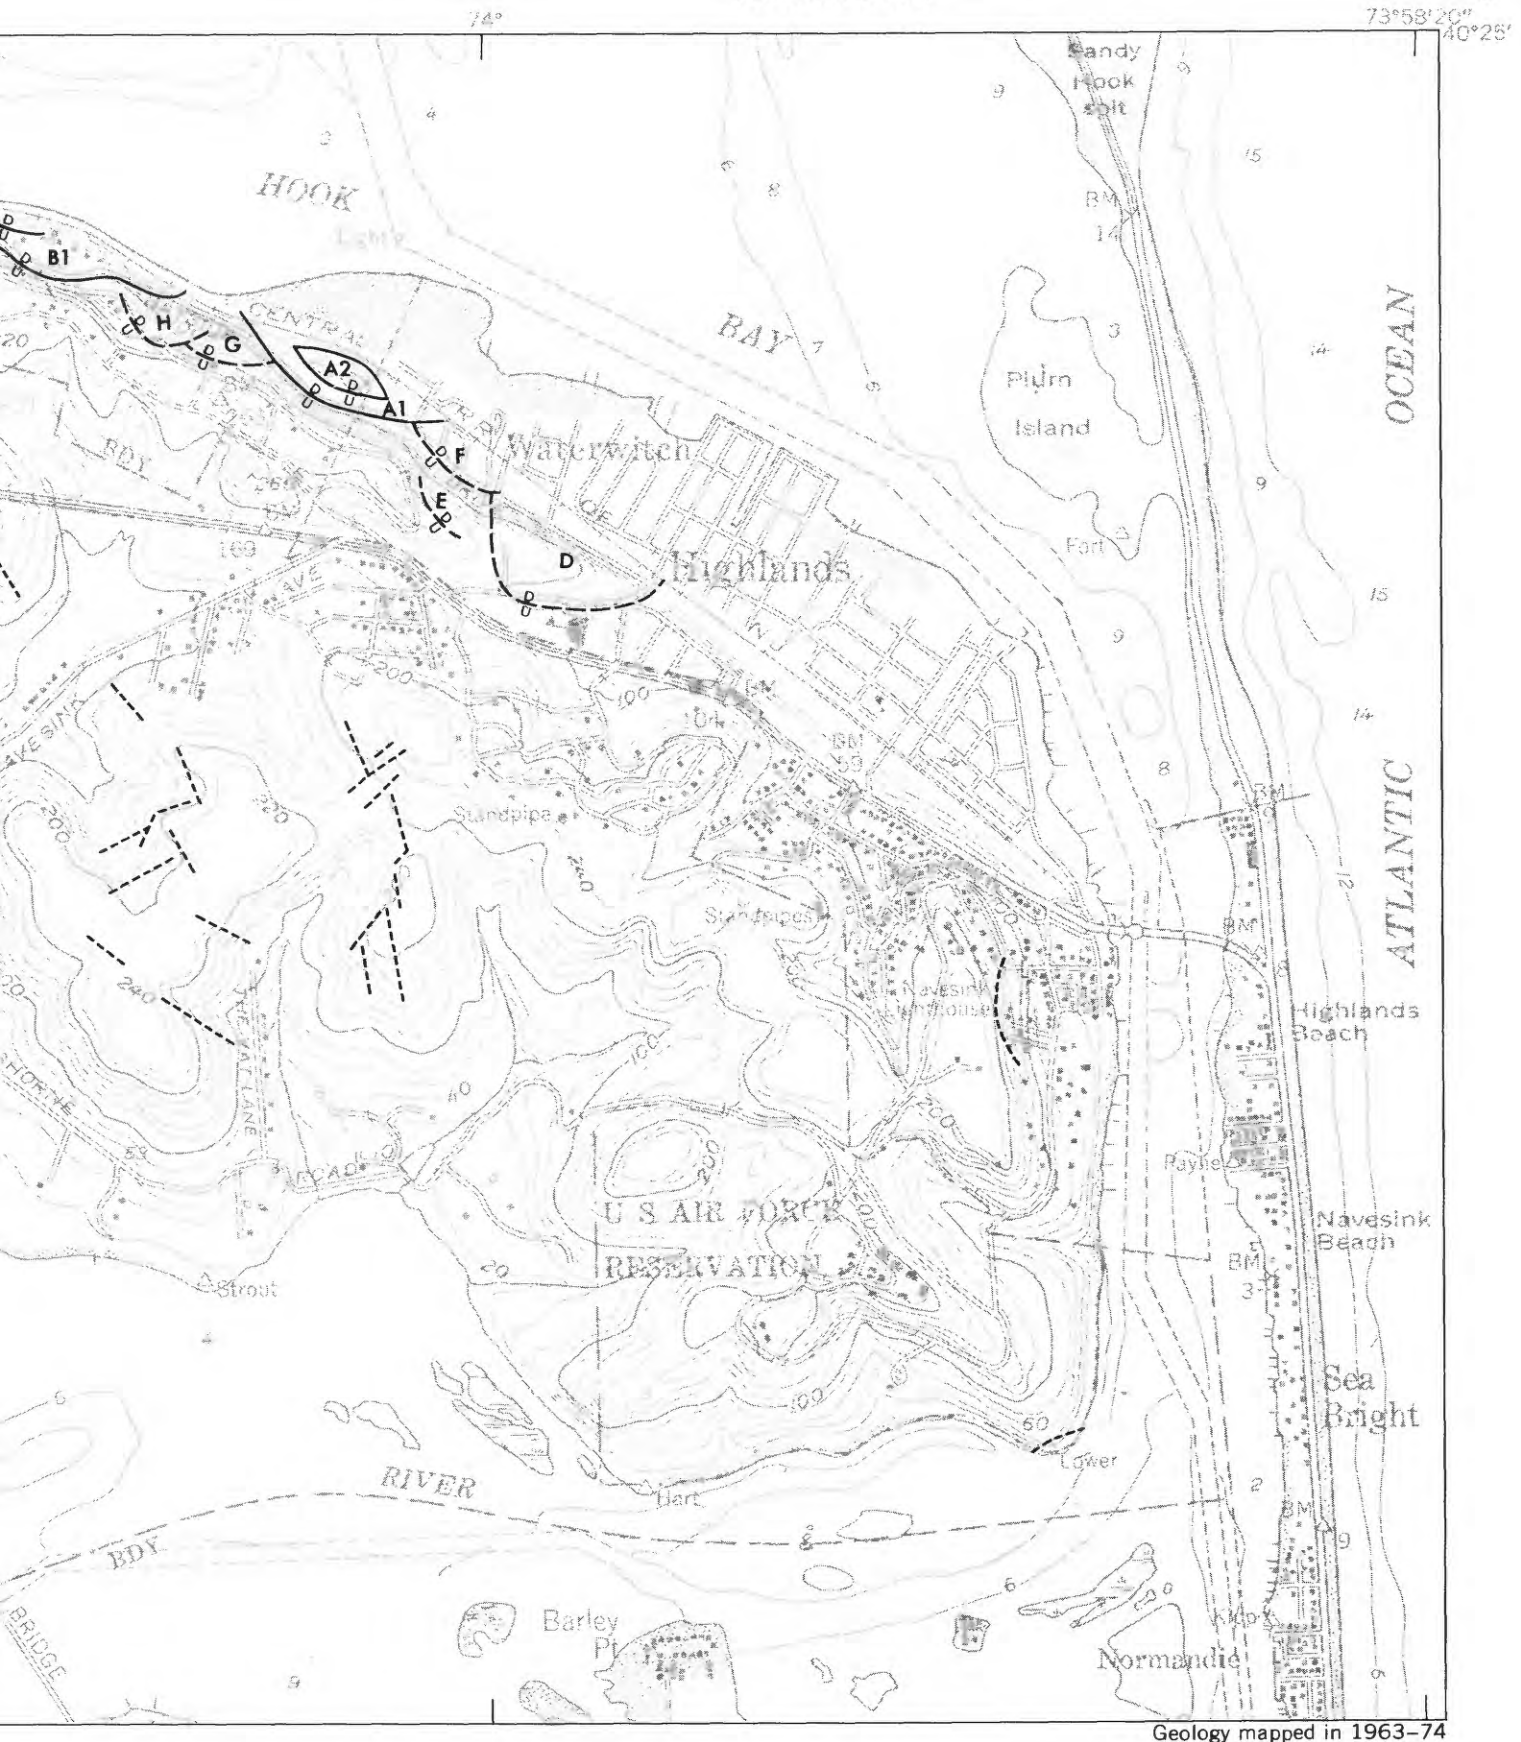
FIGURE 2.—Map of the Atlantic Highlands

showing location of slump blocks and lineaments.

Short dashed line in figure 2 represents linear features apparent on the aerial photographs. A cluster of such features is evident in the wooded hills southeast from Navesink Avenue. A few other lineaments are northwest of Navesink Avenue and south of Locust. These lineaments may be a reflection of joints or fractures, possibly in the iron-oxide-cemented layers in the upper Red Bank, Tinton, and Cohansey Sands. They may indicate zones of relative weakness.

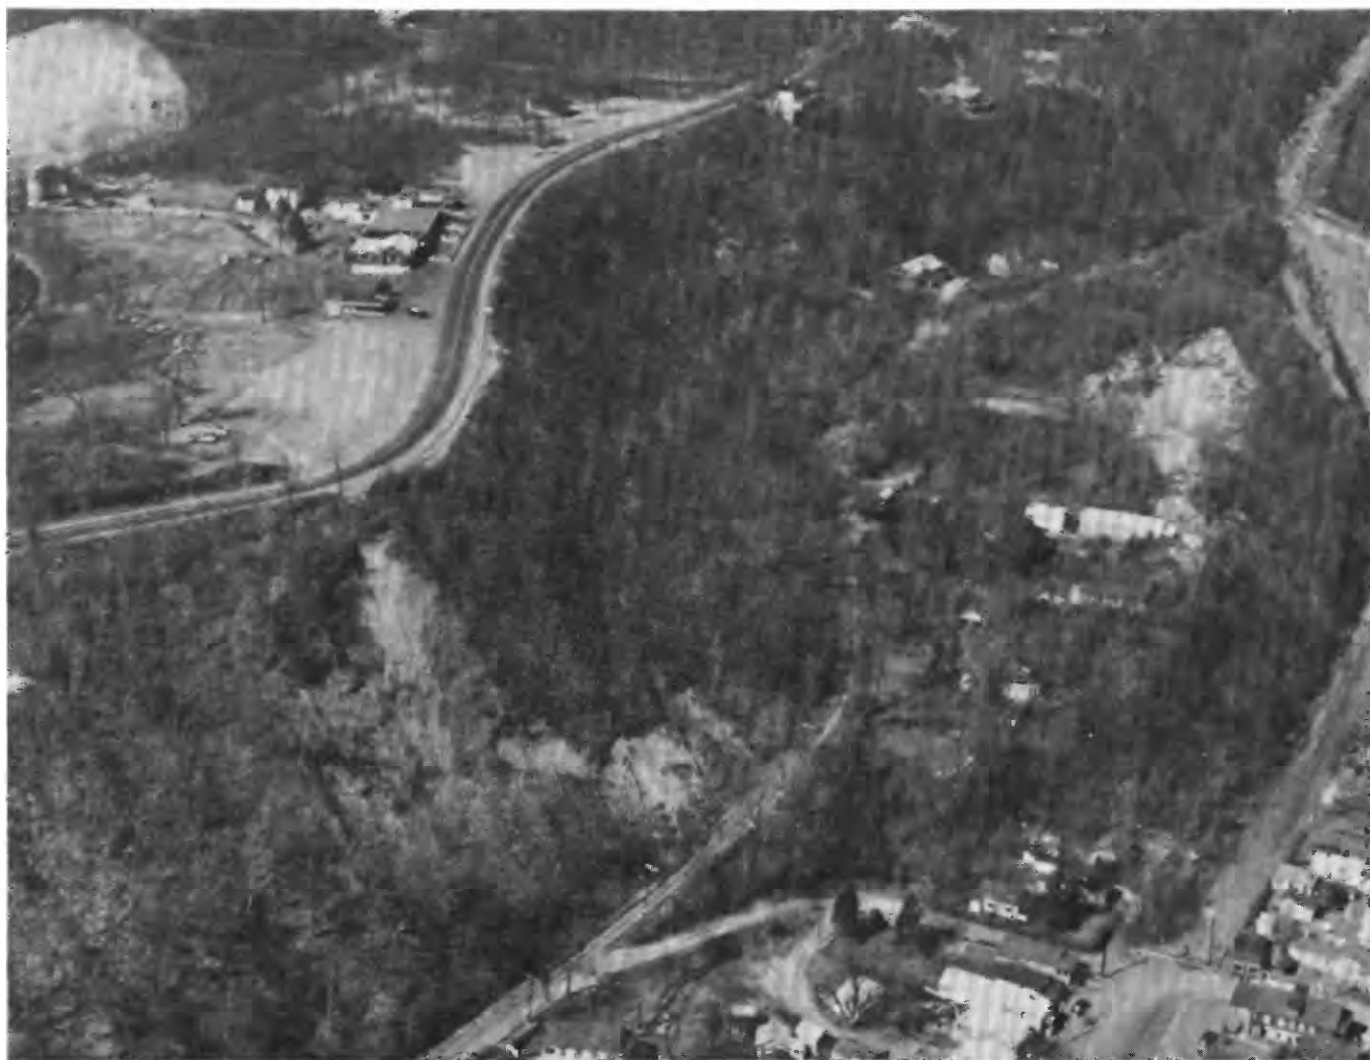
FIGURE 12.—Oblique aerial (helicopter) photograph (looking west) showing extent of surface erosion on the bluff face (center of photograph) on March 16, 1966. Vertical distance from road on top of bluff to road at base of bluff is about 60 m (200 ft). Slump block A is on right part of photograph. Compare extent of slope erosion with that shown in figure 13. The present front of block A lies about 100 m (several hundred feet) bayward (to the right) from its pre-slump position in the bluff.

It is interesting to compare the stages of erosion shown on photographs of different years. Photographs taken after the aerial photographs of 1961 (fig. 11) show that erosion is farther advanced. These differences can be seen on the photograph taken in March 1966 (fig. 12) and that taken in

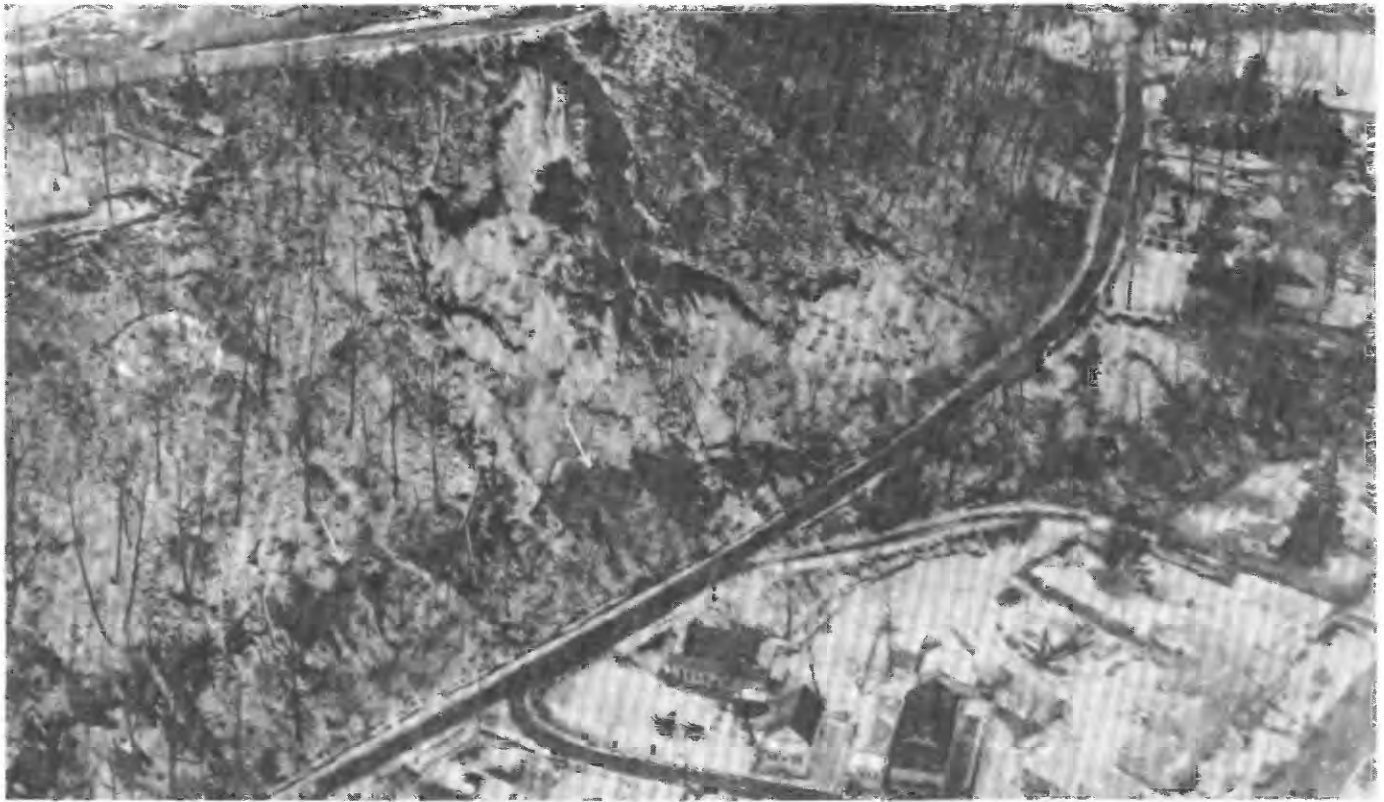
FIGURE 13.—Oblique aerial (helicopter) photograph (looking west) showing extent of surface erosion on the bluff face (center of photograph) on February 13, 1974. Vertical distance from road at top of bluff to road at base of bluff is about 60 m (200 ft). Inner part of slump block A is at far right; scarp is above and left of it. Compare extent of slope erosion with that shown on figure 12, nearly 8 years earlier. Erosion has extended upward, nearly undercutting the road, and laterally. Erosion has cut back into the face of the bluff, as is indicated by the steeper banks bordering the edges of the scar.

February 1974 (fig. 13). The gully in the scarp above and near the west end of block A is much deeper and wider at present than it appeared on the stereoscopic pair of aerial photographs taken in 1961 (fig. 11).

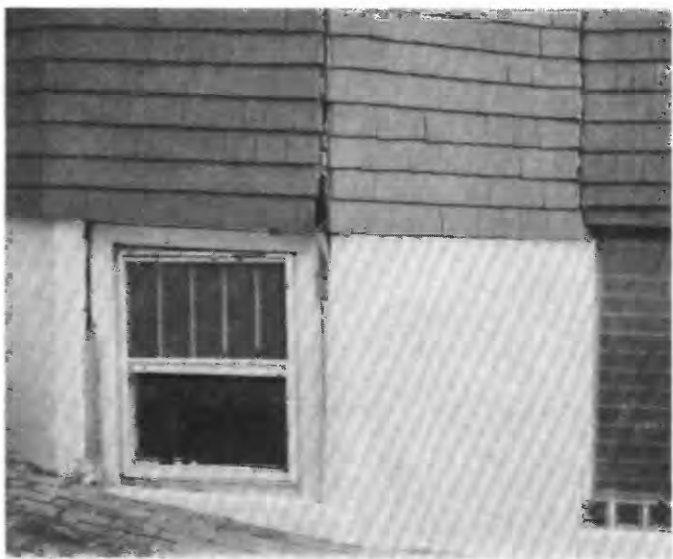
FIGURE 15.—Next house west of one shown in figure 14. Major structural damage to house results from its position astride the line of failure between slump blocks B 1 and B 2. Settlement and breakage goes all the way through the house. Photograph taken June 7, 1973.

dle of this block, several houses and properties are being adversely affected by the slumping. Two houses have been damaged (figs. 14, 15), largely through vertical displacement of as much as 0.3 m (1 ft). An open crack passes in back of two more houses. This crack has been open as much as 20 cm (8 in.) wide and 1 to 1.3 m (3 to 4 ft) deep. At least one stone wall has been cracked completely through. West of here, concrete steps leading down to the shore are conspicuously cracked all the way across; the upper more pronounced crack is shown in figure 16. According to Mr. Edward Weiler (oral commun., January 25, 1974), the steps were not cracked in the fall of 1973.

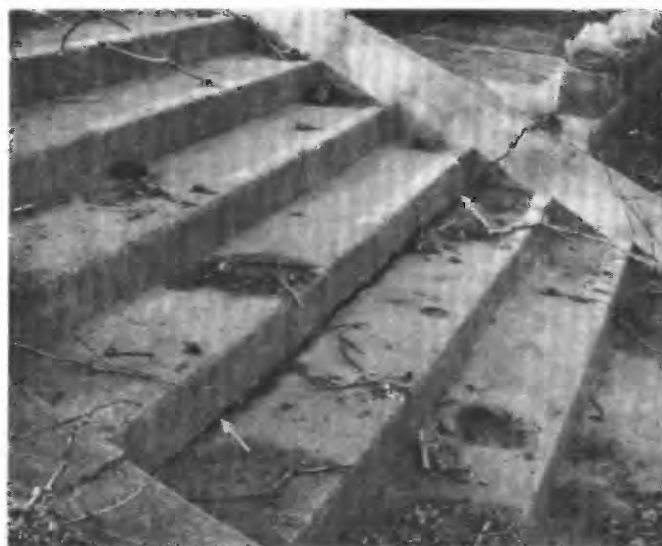
FIGURE 16.—Breakage in concrete steps (see arrows) on the western part of slump blocks B 1 and B 2 (fig. 2). The steps were reported unbroken in late fall 1973. Photograph taken January 25, 1974. First slumping and ground breakage on the blocks were reported during the summer of 1972. This indicates observable movement continuing over a period of 15 or 16 months.

First cracking of the ground and structures seems to have been noticed during the summer of 1972. The concrete steps (fig. 16) were reported to have cracked sometime between late fall 1973 and January 1974. Woodward, Moorhouse, and Associates, who are monitoring lateral movement of the sewerline, have reported continued movement towards the bay (oral commun., June 7, 1974).

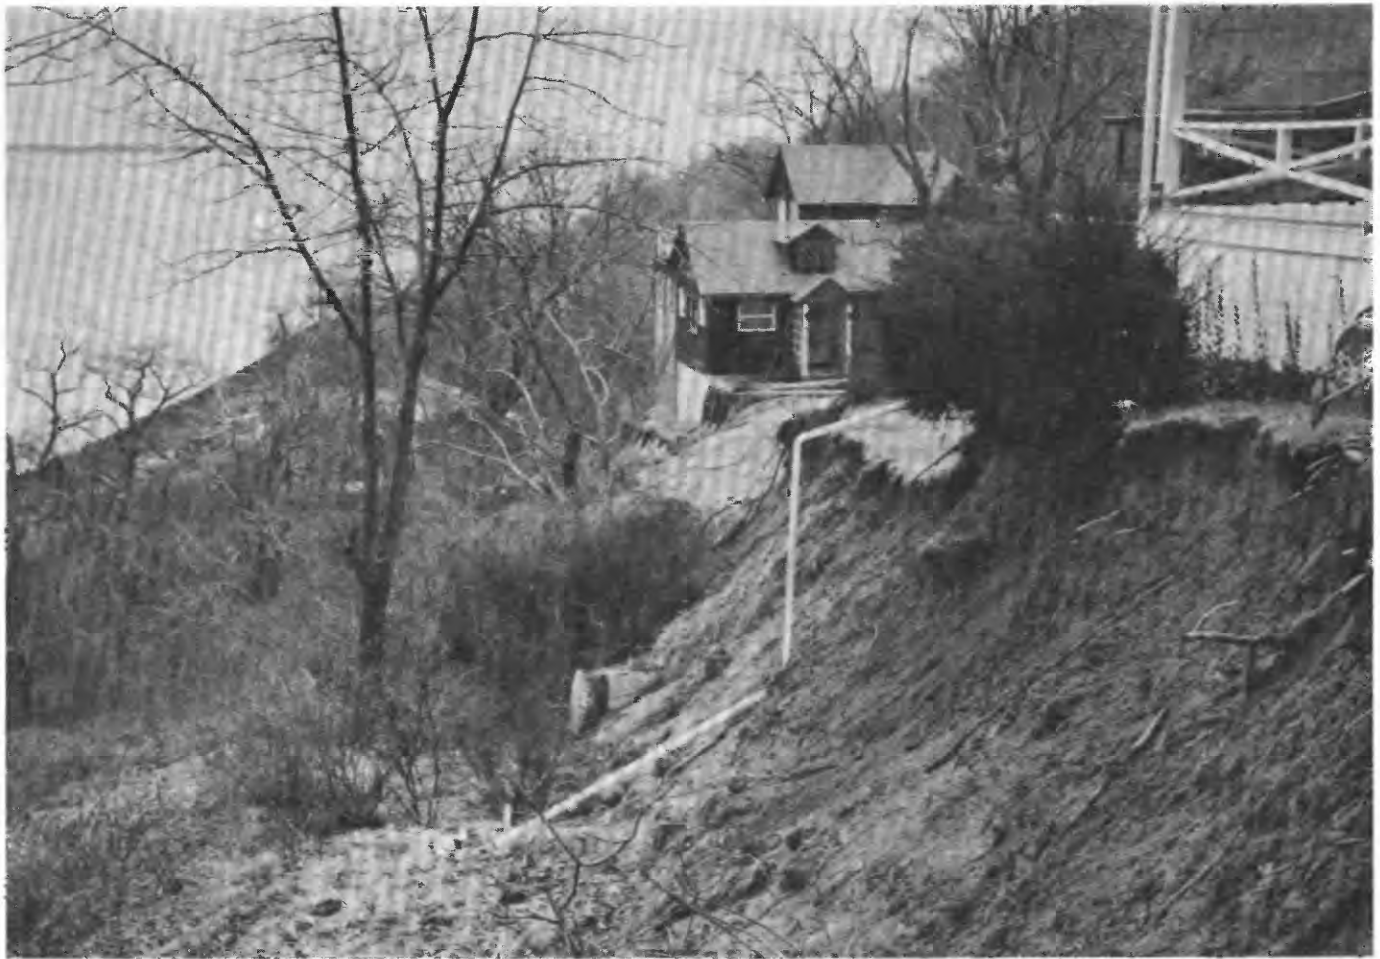
FIGURE 17.—Looking east from the west end of slump block B 3. Scarp on right is rupture zone at top and rear of the block. Total vertical displacement is about 4 to 5 m (13 to 16 ft), most of which is reported to have occurred during a 3-month period in the summer and fall of 1972. The flat grassy area at bottom left was level with the lawn at upper right before failure. Photograph taken January 24, 1974. House in background is shown in figure 18.

Blocks B 3 and B 4 appear to be new blocks. No visible evidence of them appears on the aerial photographs of 1961. The movement on block B was first noticed by the local residents in the summer of 1972 (Mr. Martin Jensen, oral commun., June 7, 1973). A new scarp about 4 to 5 m (13 to 16 ft) high is present at the top of the slumping area immediately in back of the line of houses on top of the bank (fig. 17). One house lost its back porch

It appears that initial movement in blocks B 3 and B 4 probably was in the toe of the slope, possibly as a base failure (at least below the base of the old railroad bed). As material at the toe moved towards the bay, support was removed from material above, which followed in possibly several stages of slope failure before the present uppermost block began the slumping that has produced the 4- to 5-m (13- to 16-ft) scarp behind the houses.

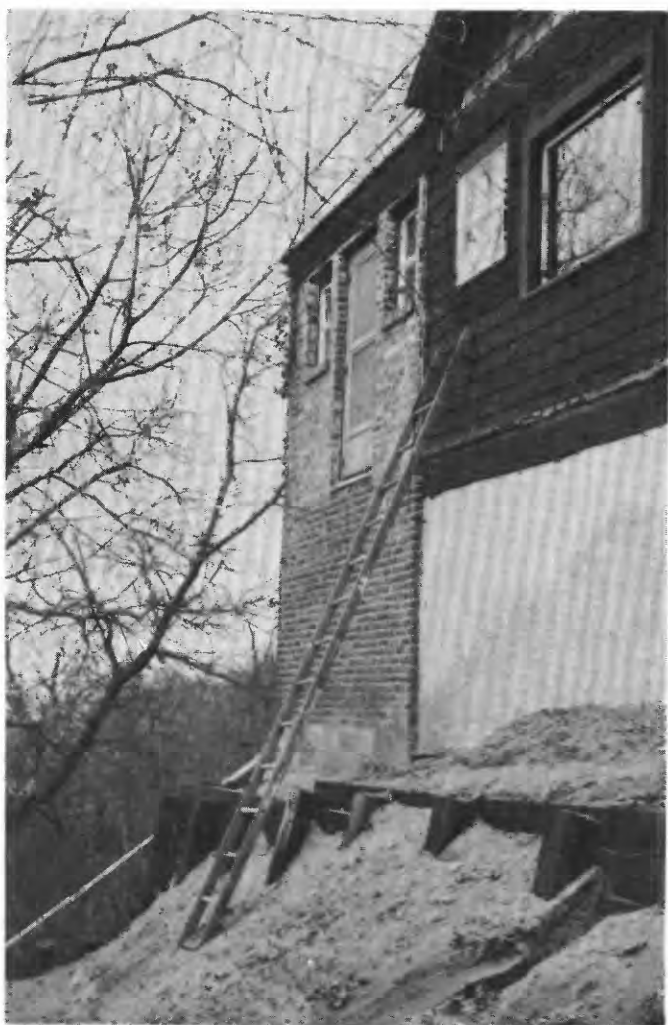
FIGURE 18.—House near east end of bank above block B 3, looking east. This is the house in the background of figure 17. The rear porch, which was attached to the house, collapsed when block B 3 dropped. Note position of door (watch that step!). Photograph taken January 24, 1974.

(fig. 18), one house has been moved back, another has had its foundation footing exposed, and two more are only a metre or two from the line of failure. This line of failure, at least in the upper exposed part, is in the loose-bedded sand of the upper Red Bank Sand. It may be an extension of the line of failure behind slump block B 1, which was mapped by the author in 1963–64 (Minard, 1969, pl. 1) as crossing Bayside Drive near the curve where the road abruptly turns south and uphill. No cracking was visible in the pavement at the time of that mapping. On June 7, 1973, however, cracking was visible in the edge of the road and through the stone wall. By January 25, 1974, this cracking in the pavement had multiplied and extended across

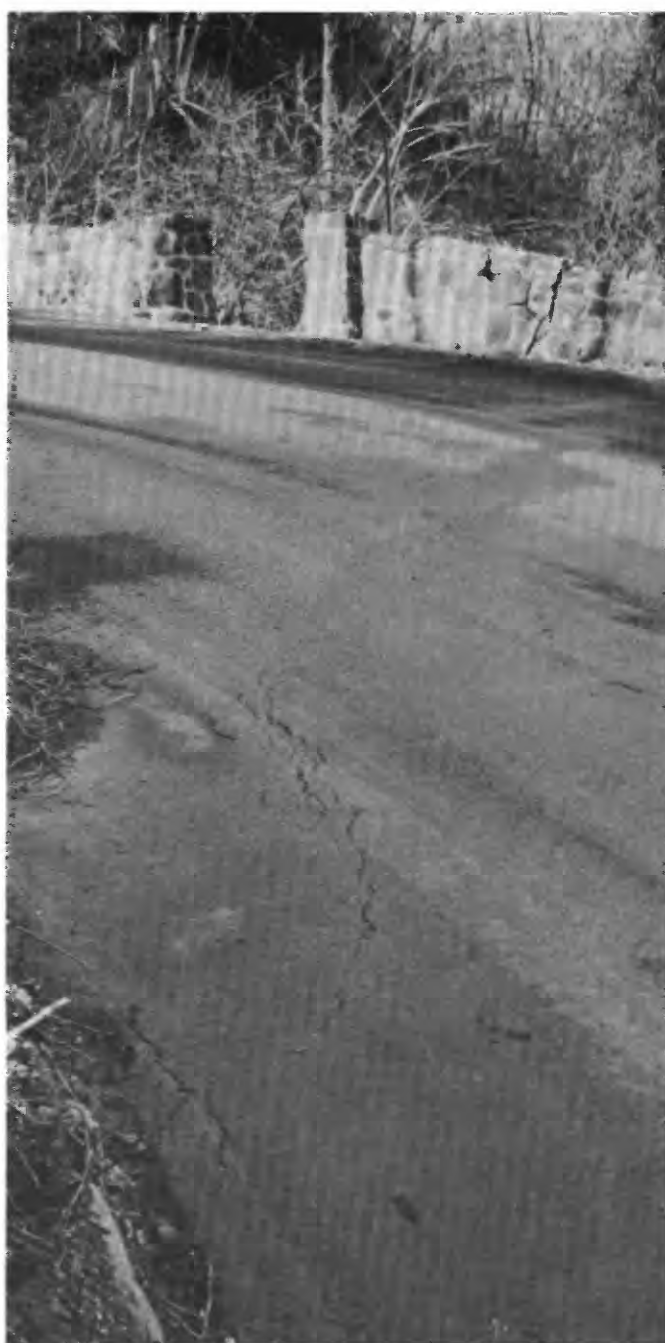
FIGURE 19.—Cracks in pavement of road and in wall at west end of block B 1 (block B as mapped in 1963–64 (Minard, 1969, pl. 1)). No cracking was visible when field mapped. Cracking was visible June 7, 1973, in parts of the pavement and wall. When this photograph was taken on January 25, 1974, cracking had multiplied and extended across the road, and the cracks were wider in the wall. Vertical displacement was as much as 6 to 8 cm (3 in.) in the pavement near the far side of the road.

the road and widened considerably in the stone wall (fig. 19); vertical displacement in the road pavement was 6 to 8 cm (3 in.).

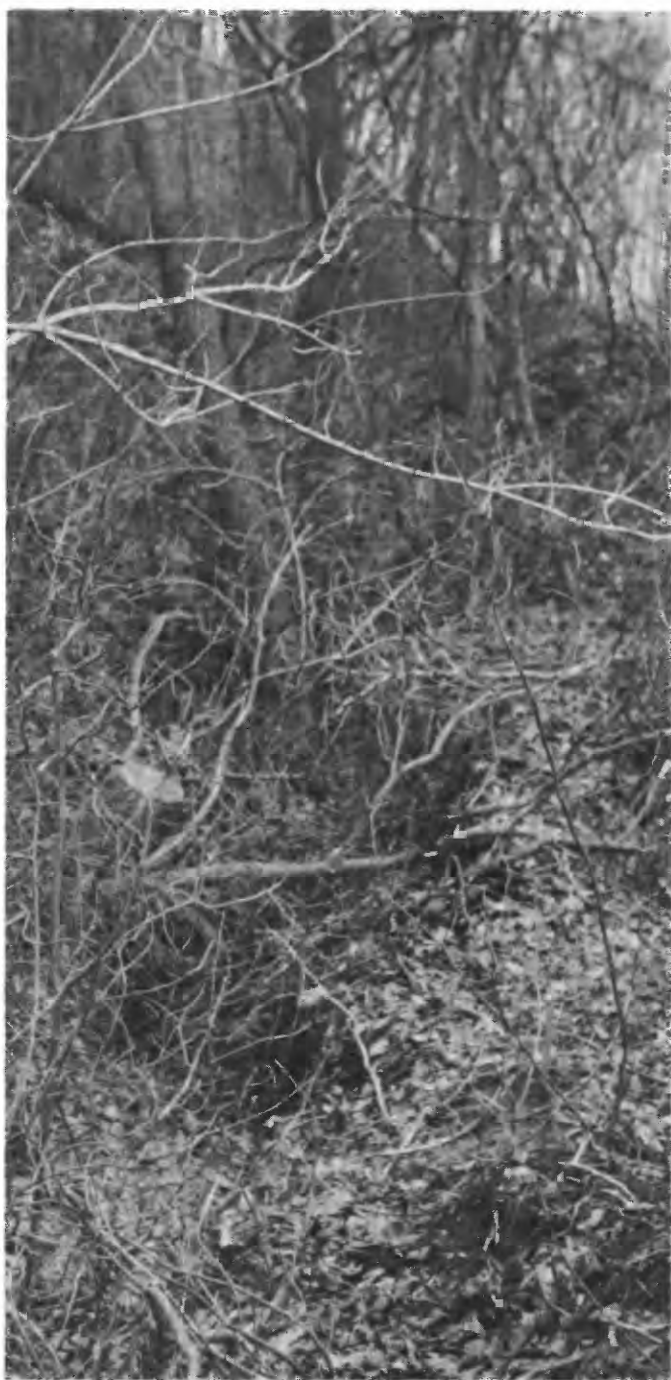
FIGURE 20.—View towards west of a fissure 1 m (several feet) and more deep, separating blocks B 3 and B 4. The fissure is several tens of metres long. Note tilt of tree caused by collapse into fissure.

The surface of the slope on blocks B 3 and B 4 is irregular and unstable, a truly jumbled mass. Actually, more than two blocks are present; several fissures have opened below the main upper scarp at the rear of the houses, dividing the main blocks into smaller blocks (figs. 20, 21). As a result, trees have been tilted at considerable angles from vertical (fig. 22), vines have been stretched taut between blocks. Most movement is down on lower blocks relative to upper blocks, but in some instances upper blocks have slid down and wedged beneath lower blocks so that the upper edges of the lower blocks actually

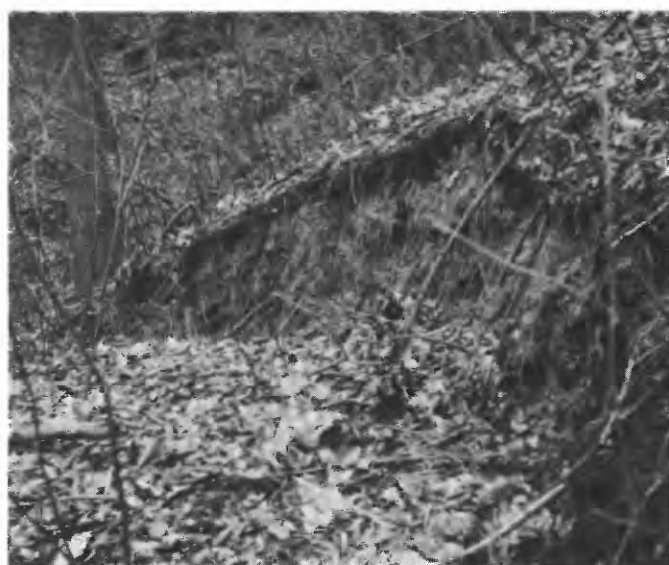
FIGURE 21.—View towards east showing one of the small scarps typical of those on slump blocks B 3 and B 4. Vertical displacement is about 1 m (several feet).

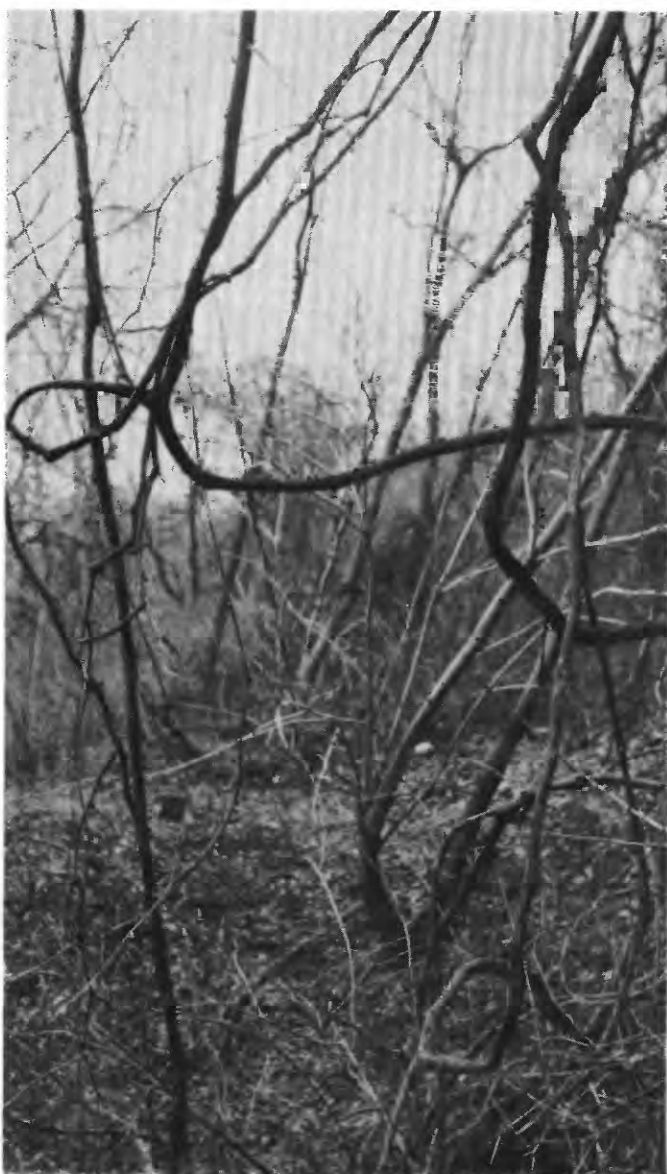
FIGURE 22.—View toward east showing tilted inner surfaces of block B 4 where slumped down from block B 3. (right of photograph). Notice that trees are tilted scarpward, illustrating rotational nature of the block; some vines appear to be stretched taut.
