Effects of the Catastrophic Flood of  
December 1966, North Rim Area,  
Eastern Grand Canyon, Arizona

GEOLOGICAL SURVEY PROFESSIONAL PAPER 980

By M. E. COOLEY, B. N. ALDRIDGE, *and* R. C. EULER

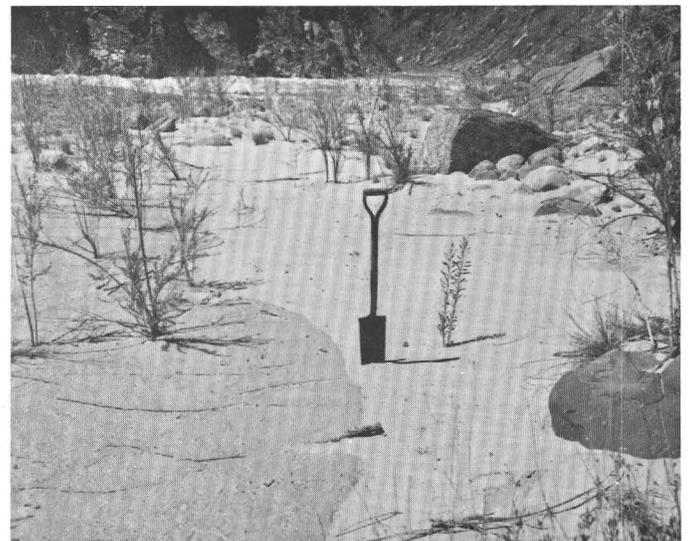
FIGURE 6.—Edge of the mudflow at the mouth of Crystal Creek where a sample was taken to estimate the consistency of the mud during the flood of December 1966. The mud (dark deposits) flowed over the pre-flood deposits (light deposits indicated by spade) of the Colorado River.

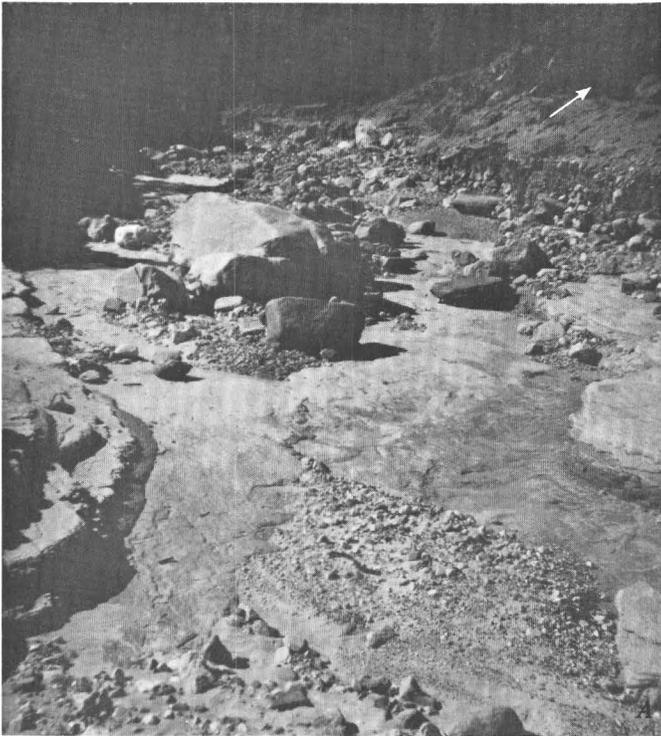
FIGURE 7.—Dragon Creek at site 46. Arrows indicate crest of mudflow. *A*, Looking downstream along the slope-area reach. Note channel scoured to clean bedrock. *B*, Looking across the channel from the east side. The height of the eroded west bank averages about 12 ft (3.7 m).

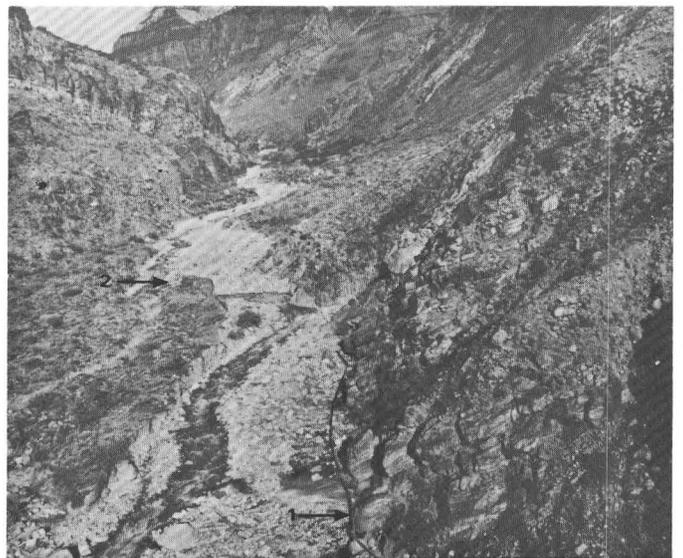
FIGURE 11.—Exposed pipeline (arrow 1) near Ribbon Falls. Prior to the flood, a 40-ft (12-m) bridge crossed Bright Angel Creek in the center of the photograph (arrow 2). The channel is now about 150 ft (46 m) wide and is bordered by a single terrace.

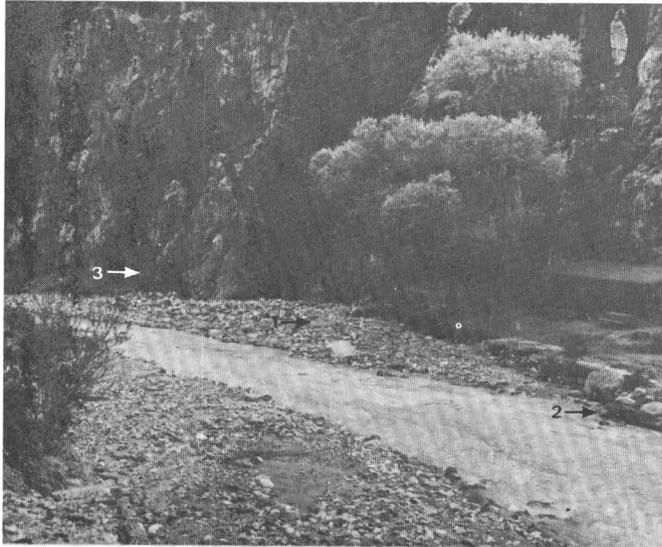
FIGURE 14.—Damage to the Phantom Ranch Campground, flood of December 1966. Prior to the flood, restrooms were located in the area in the center of photograph (arrow 1), and a bridge crossed the creek in the foreground (arrow 2) to provide access to the campground. The fireplace in left center (arrow 3) indicates the former ground level.

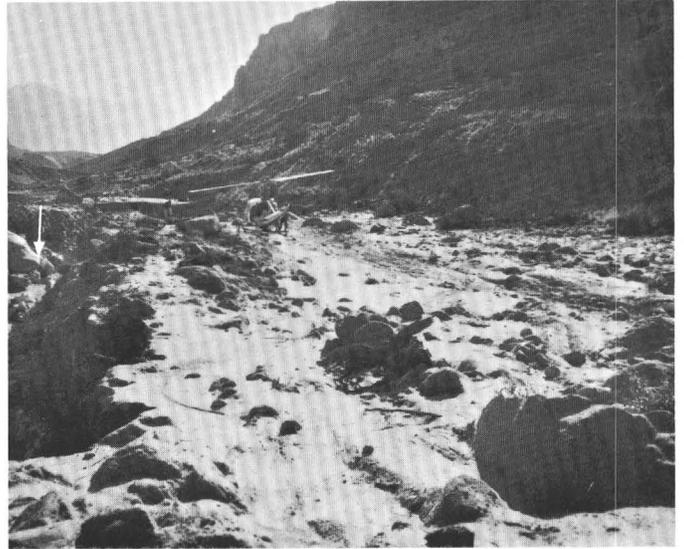
FIGURE 17.—Mudflow debris on the terrace on the right bank of Dragon Creek (arrow). The location of mescal pit (Ariz. B:16:41), which was destroyed by the flood, is near that of the helicopter. Mudflow debris covers this area from canyon wall to canyon wall.

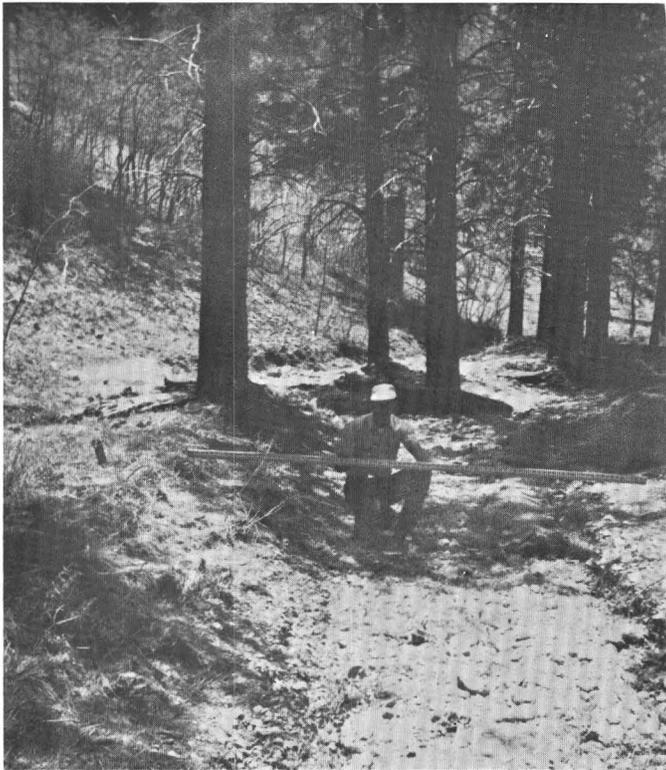
FIGURE 18.—Walhalla Glades at site 26. The flood of December 1966 deepened the channel—renewed arroyo cutting—by  $\frac{1}{2}$ –2 ft (0.2–0.6 m) downstream from site 26; upstream the channel was deepened intermittently by scours. The low bench on the right side of the channel represents the level of the channel prior to the flood. Level rod indicates crest of the flood.

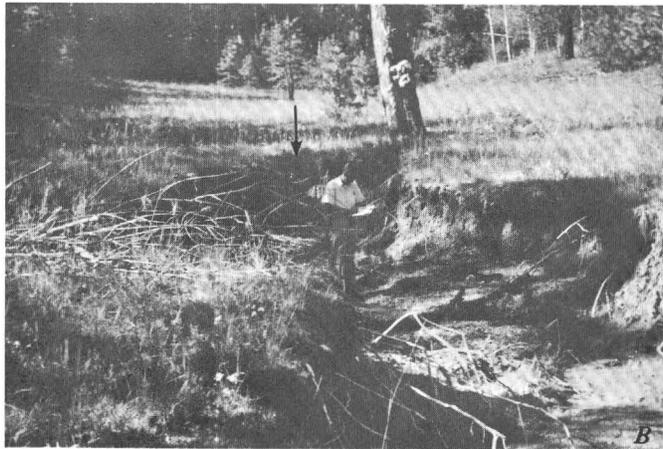
FIGURE 19.—Effects of the flood of December 1966 along Clear Creek tributary 3, Walhalla Plateau. A, Diagrammatic sketch of part of Clear Creek tributary 3 showing scours and bars. B, Head of the 300-ft-long (90-m-long) scour in Clear Creek tributary 3, which probably was being eroded prior to the flood. Upstream from the headcut (arrow), the valley was not eroded during the flood. C, Gravel bar deposited downstream from the 300-ft-long (90-m-long) scour.

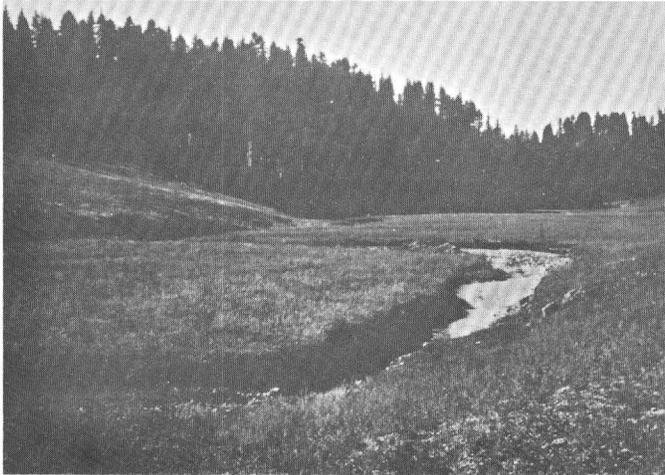
FIGURE 21.—Erosion caused by the flood of December 1966 in Outlet Canyon, Kaibab Plateau. Renewed arroyo cutting in Outlet Canyon between a point about 0.50 mi (0.8 km) downstream from the Point Sublime Trail and the edge of the plateau; the cutting deepened the old channel 1–2 ft (0.3–0.6 m).

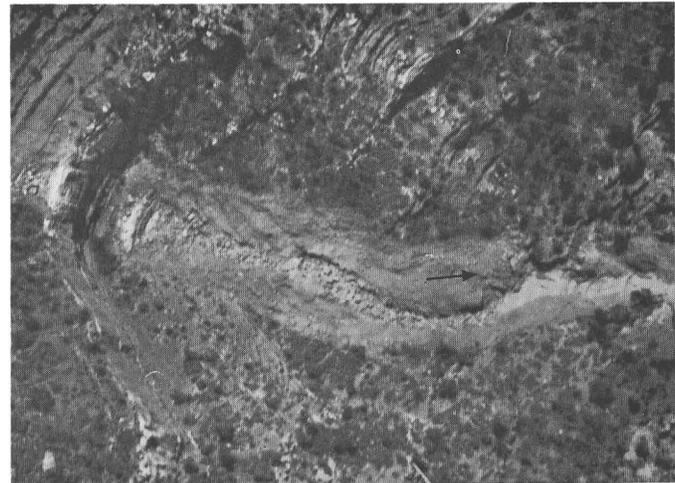
FIGURE 24.—Scar of the main mudflow-debris slide that contributed much debris to the mudflow in Natchi Canyon. Aerial view. Direction of movement (arrow) was from left to right over the almost vertical cliff at left edge of photograph.

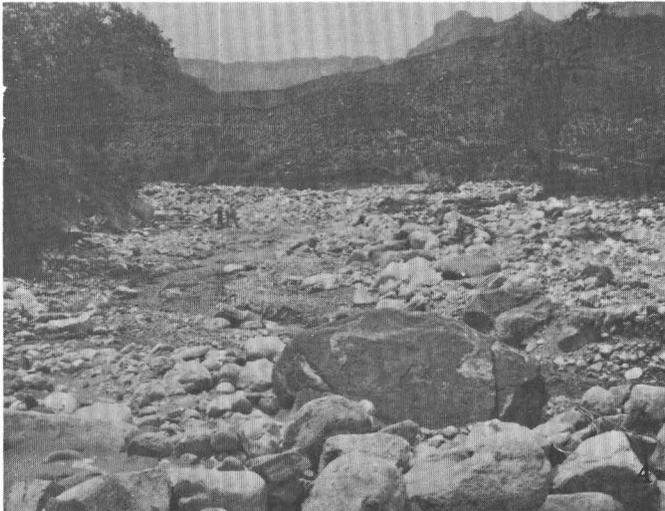
FIGURE 26.—Gravel-floored channel of Nankoweap Creek near site 15 after the flood of December 1966. *A*, Looking upstream along Nankoweap Creek across section *A-A'*. (See fig. 25.) View is from small gravel bar upstream from gravel bar 2 to the lower end of gravel bar 1, where the three men are standing, approximately along section *A-A'*. *B*, Looking downstream along Nankoweap Creek. The narrow channel at section *C-C'* in figure 25 is in the center of the picture and is where the peak of the flood of December 1966 was  $3\frac{1}{2}$ –4 ft (1.1–1.2 m) above the present channel. The low 5-ft-high (1.5-m-high) terrace (arrow) in the left-center of the photograph was not inundated. During the flood peak, the channel at section *C-C'* apparently was deepened and was filled by pebble- to small-cobble-size material during the declining stage of the flood.

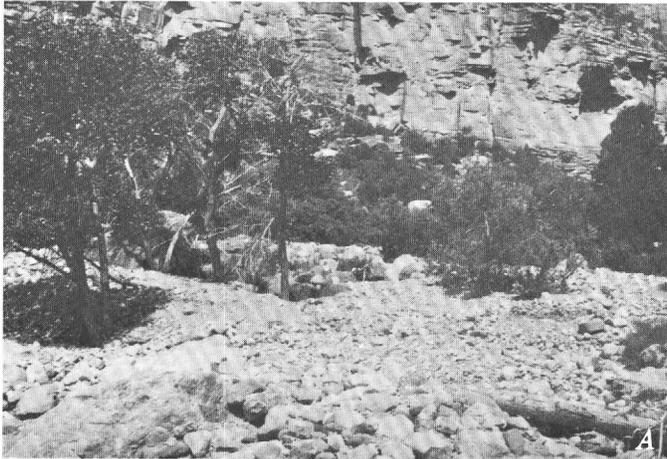
FIGURE 29.—Channels of Lava and Chuar Creeks after the flood of December 1966. *A*, Debris deposited around junipers and cottonwoods in the area where a swamp was present prior to the flood. *B*, Looking downstream along Lava Creek near site 21, where the creek is confined between terraces—few of which were inundated by the mudflow. Approximate height of flood crest is indicated by dashed lines. *C*, Looking upstream along Lava Creek from near its confluence with Chuar Creek. Note boulder bars deposited by the flood of 1966 and by older floods (fig. 27, section *F-F'*). *D*, Looking downstream along Chuar Creek from near its confluence with Lava Creek, which enters from the left. The terrace on the right was not inundated by the flood of 1966. The relation of the root crown of the large cottonwood in the right-center of the photograph (arrow) to the streambed indicates that little change in channel depth has occurred in the last few decades. Bank above cottonwood was eroded by the 1966 flood.

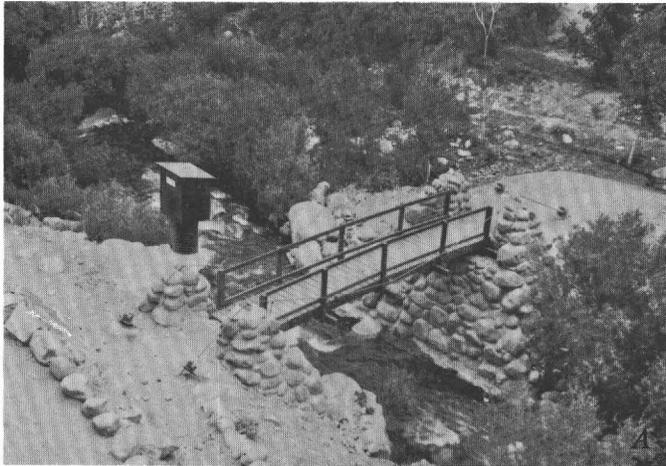
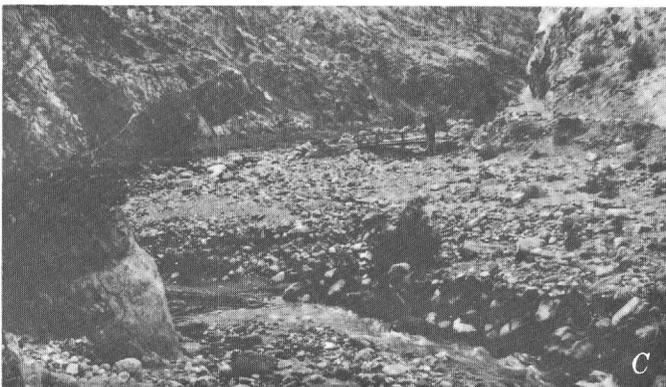
FIGURE 32.—Bright Angel Creek near Phantom Ranch before and after the flood of August 1936 (see figs. 12, 13, 14). *A*, Channel of Bright Angel Creek in May 1936. The trail to Phantom Ranch is bounded by line of rocks in left foreground. *B*, Looking upstream after the flood. Trees in center background are the ones shown near the center of fig. 13. *C*, The preflood channel is indicated by the bridge and gaging station. Looking upstream from a site near the footbridge shown in figure 31.

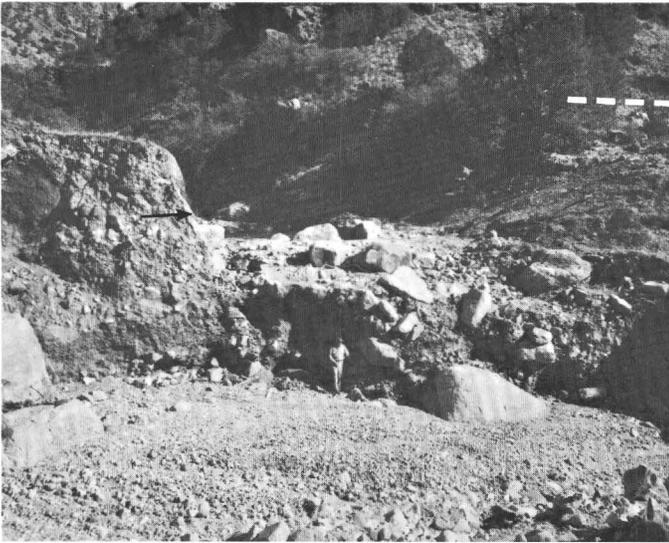
FIGURE 33.—Mudflow in Dragon Creek at the mouth of Dragon Creek tributary 2 in the upper Hindu Amphitheater. The mud flowed from left to right over the terrace at the right side of the photograph and smoothed and rounded the edge of the terrace back as much as 3 ft (0.9 m). Although the crest of the mudflow (dashed line) was 28 ft (8.6 m) above the bed of Dragon Creek, the mudflow did not move laterally into tributary 2. The bed of tributary 2 (arrow) was left "hanging" 12 ft (3.7 m) above the postflood bed of Dragon Creek where the man is standing.

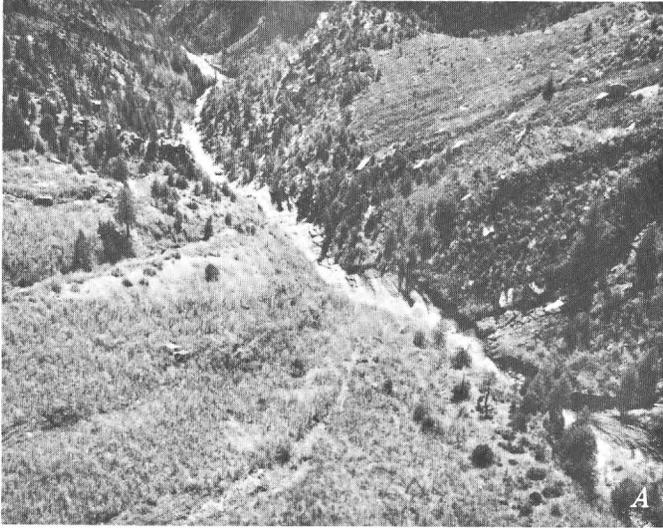
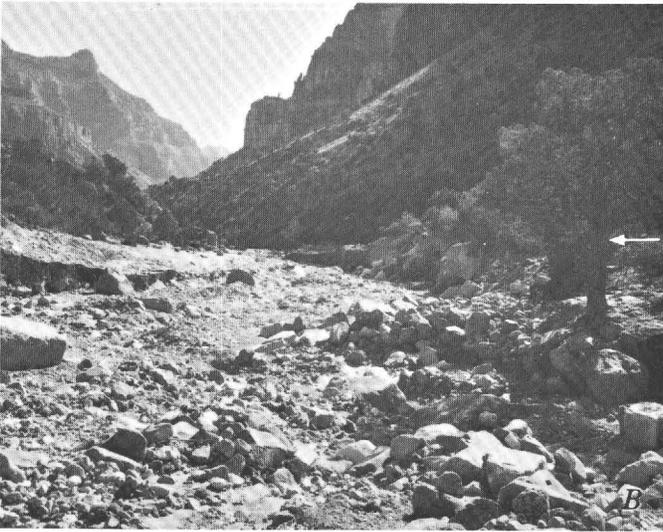
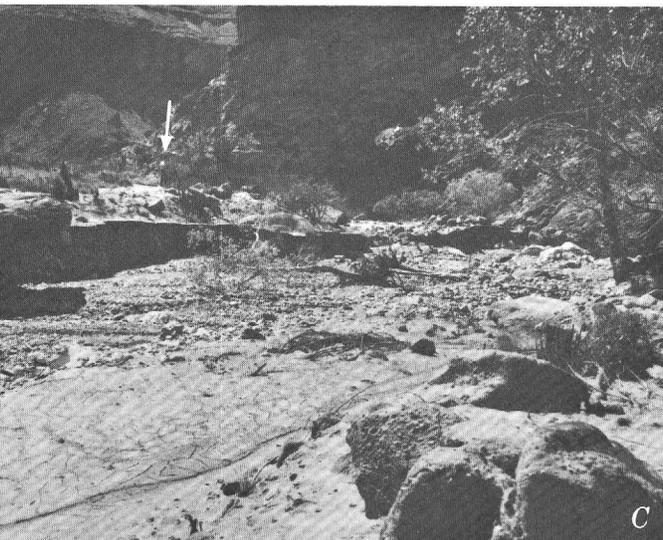
FIGURE 34.—Effects of the flood and mudflow of December 1966 in Milk and Dragon Creeks. *A*, Cleared and smoothed channel of Milk Creek after the mudflow. Note that the mudflow cleared the channel of gravel, loose boulders, and vegetation. *B*, Channel of Dragon Creek looking downstream from section *B-B'* (fig. 35). Terraces along both banks were damaged but not destroyed. The lower 4 ft (1.2 m) of the juniper in the right foreground is plastered with mud. Crest of mudflow is indicated by arrow. *C*, Channel of Dragon Creek looking downstream in the main part of the Hindu Amphitheater toward the mescal pit (Ariz. B:16:42), where the men are standing (arrow). Muddy debris deposited by the mudflow in left foreground extends downward to within 3 ft (0.9 m) of the present streambed. Cutting by the mudflow and streamflow stages of the flood formed a benchlike feature on the left bank 6-7 ft (1.8-2.1 m) above the streambed.

Along Milk Creek upstream from its junction with Dragon Creek, the flood radically changed the characteristics of the channel—more than in any other reach in the Crystal Creek basin—and the mudflow cleared the channel and canyon floor of loose rock and vegetation (fig. 34A; fig. 35, section A-A') by as much as 25 ft (7.6 m) above the present streambed. It is difficult to delineate the multiple-fill terraces in the reach because their edges were rounded and in places were covered by a layer of muddy detritus. Scours that are a few feet deep and large boulders stranded from the mudflow are common on the channel bottom. In contrast with Milk Creek, the channel of Dragon Creek above its confluence with Milk Creek was not modified by a mudflow and shows only the effects of flowing water (fig. 35, section A-A').

Downstream from the knickpoint at section B-B' (fig. 35), the gradient flattens slightly, the channel widens (fig. 34B), and mud is plastered on the channel sides between 6 and 12 ft (1.8-3.7 m) above the streambed. Large boulder bars having as much as 5 ft (1.5 m) of relief suggest that some deposition took place during the flood. Perhaps part of the material removed from the
