Storm and Flood of July 31–August 1, 1976, in the Big Thompson River and Cache la Poudre River Basins, Larimer and Weld Counties, Colorado

GEOLOGICAL SURVEY PROFESSIONAL PAPER 1115

Part A. Meteorology and Hydrology in Big Thompson River and Cache la Poudre River Basins

Part B. Geologic and Geomorphic Effects in the Big Thompson Canyon Area, Larimer County

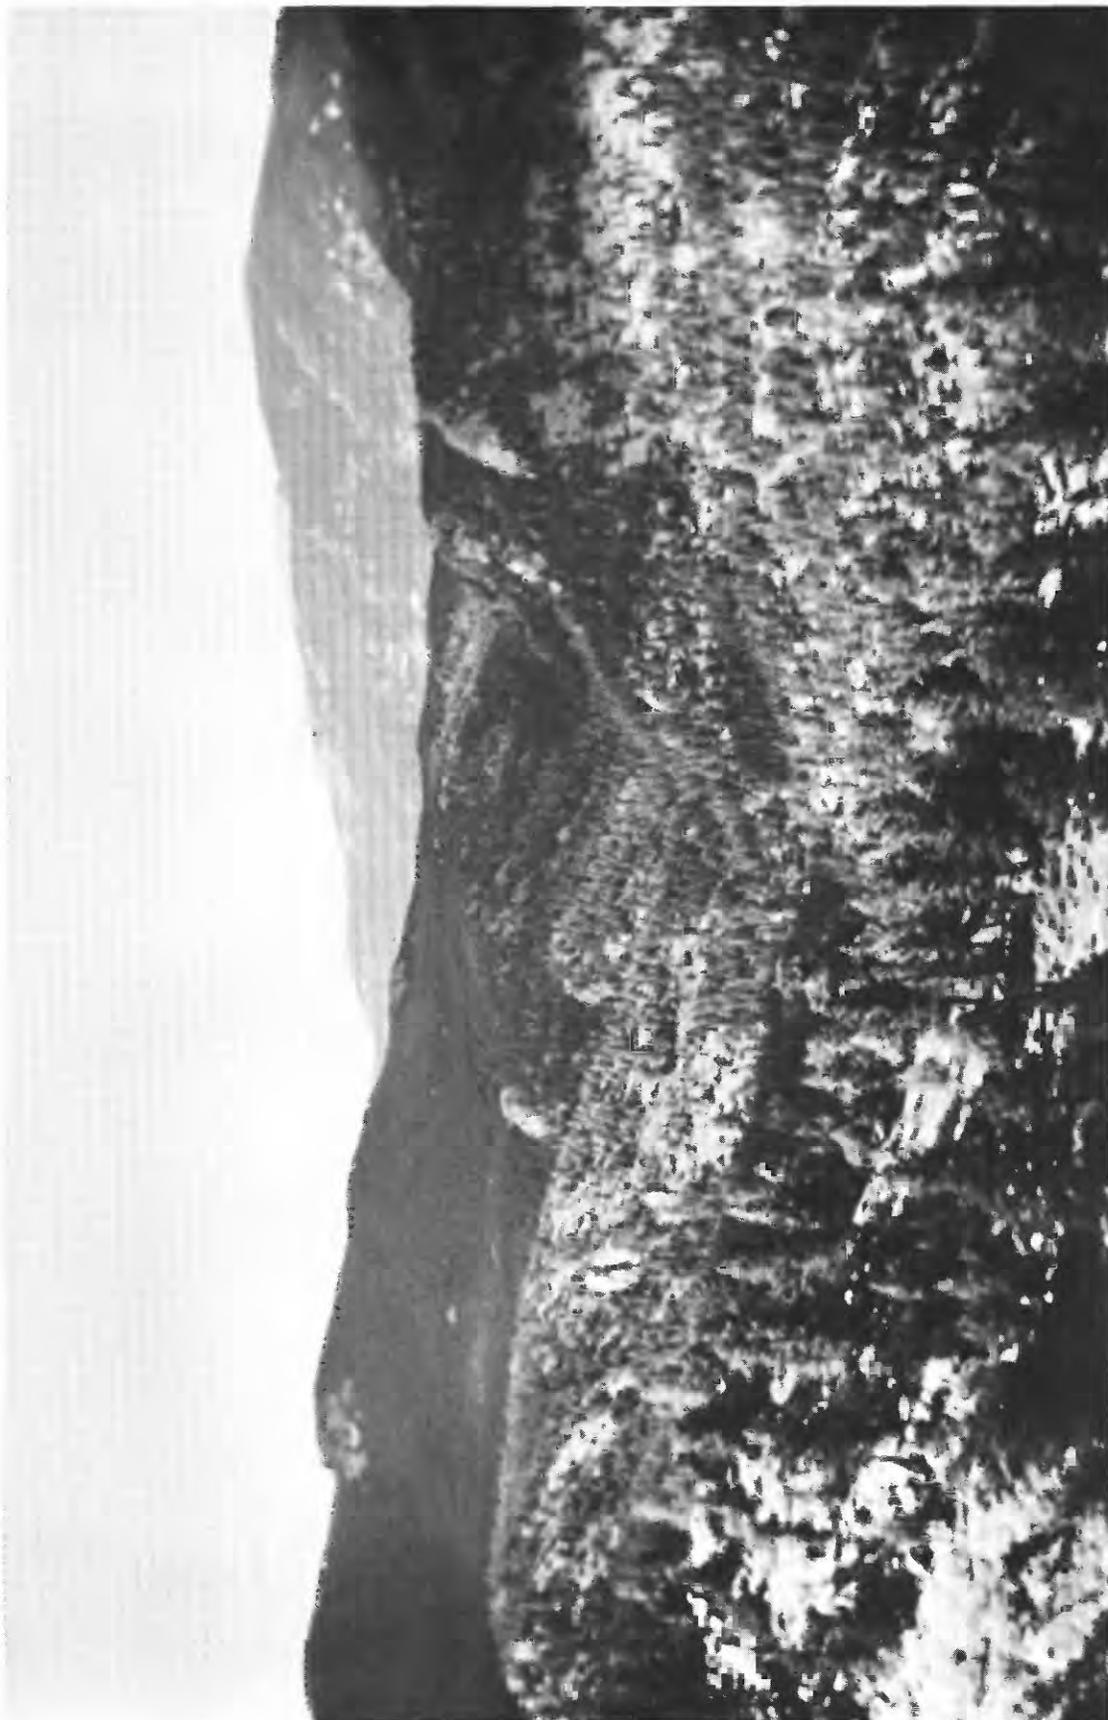
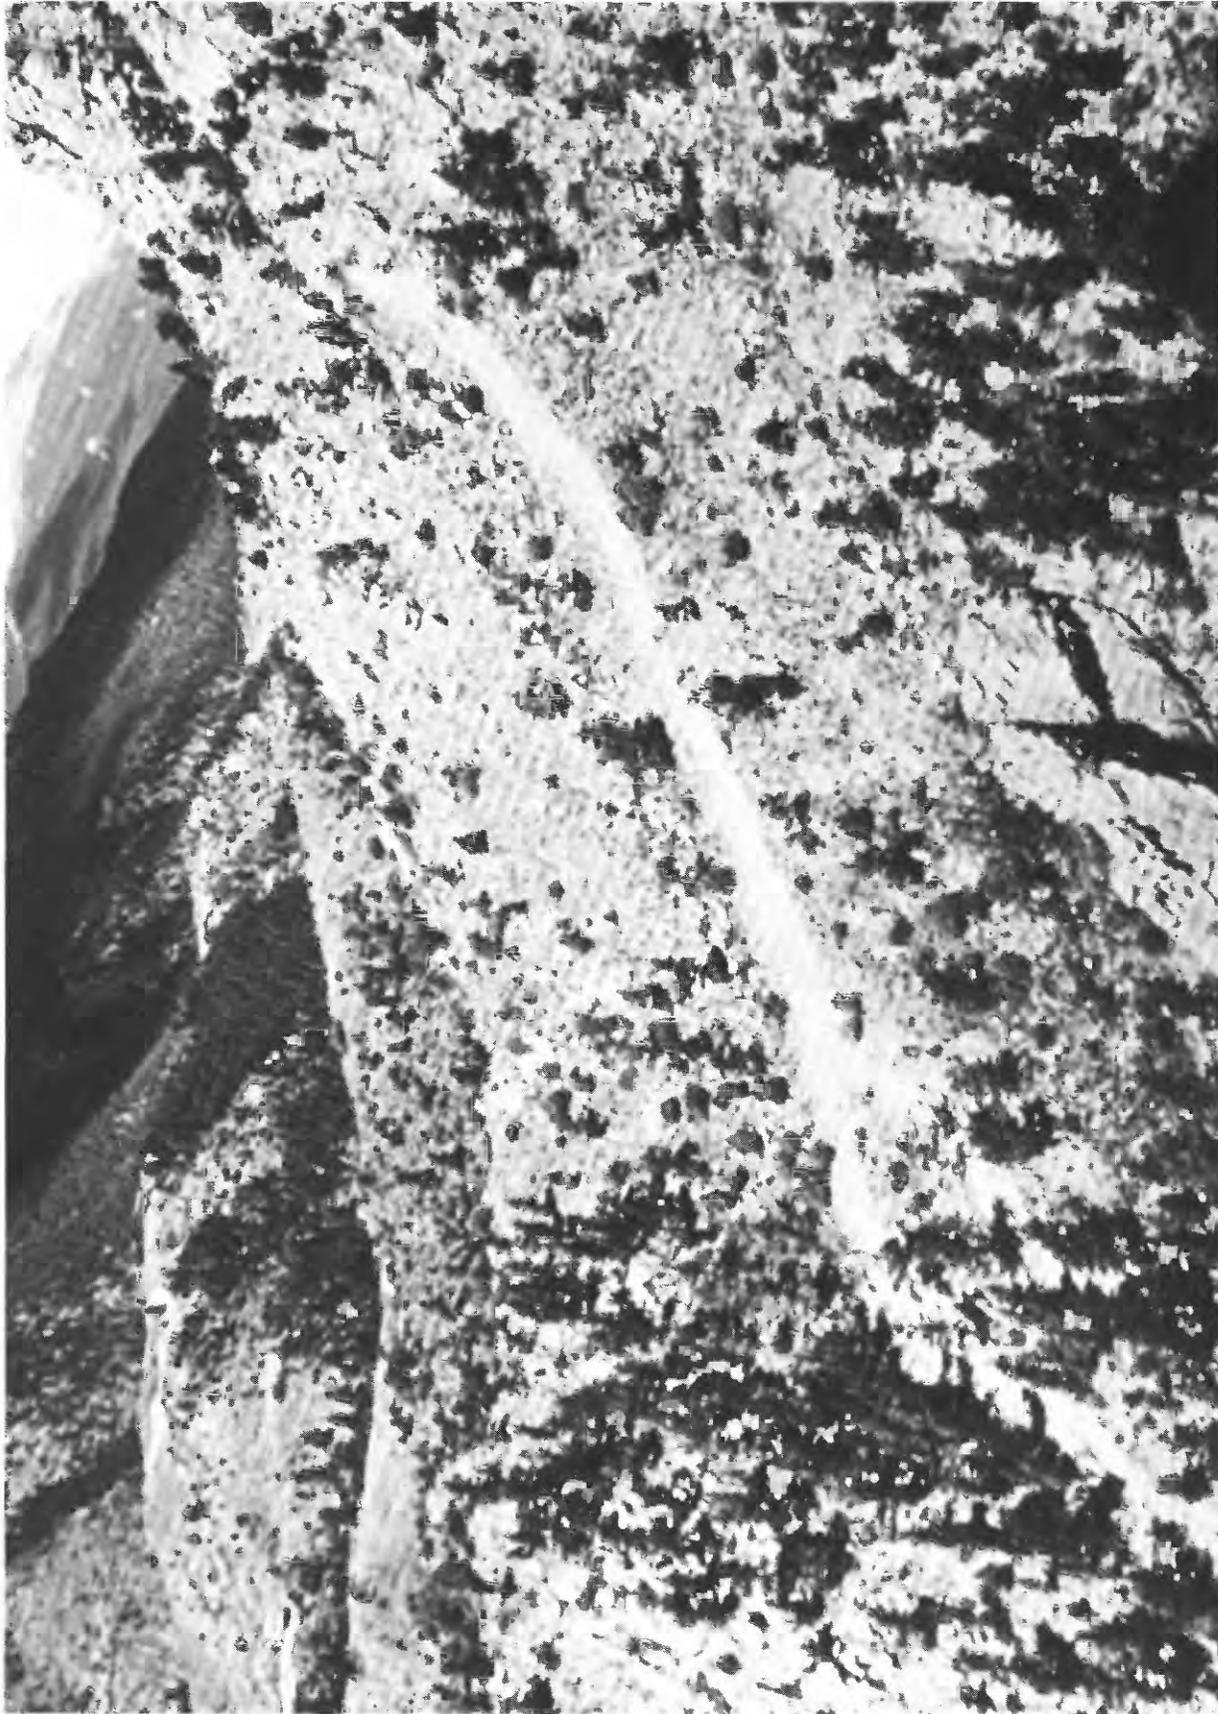
FIGURE 3.—Typical views of terrain in the Big Thompson River basin near the storm center.

FIGURE 3.—Continued.

as 3,000 feet above the valleys (fig. 3). Soils, where present, are shallow, consisting of coarse material derived from both alluvial processes and from slope wash or colluvial processes. Soils generally grade from very gravelly and stoney near the ridges to a sandy to gravelly assortment near stream levels. Permeability of soils is rapid, ranging from 6 to 20 inches per hour with available water capacity generally less than 0.10 inch per inch. Soils are excessively drained with rapid runoff potential and are highly susceptible to severe erosion. North-facing slopes have a much denser forest cover than south-facing slopes, with Ponderosa pine most abundant at lower altitudes and Douglas-fir predominant near the mountain tops. Grasses and shrubs fill the open spaces between trees, being more abundant on south-facing slopes than on the denser forested north-facing slopes. Under the trees, the vegetation is sparse and much of the ground surface is exposed. Abundant growths of cottonwood, willow, and birch occur along the stream valleys where they are highly susceptible to the erosive process of the streams.

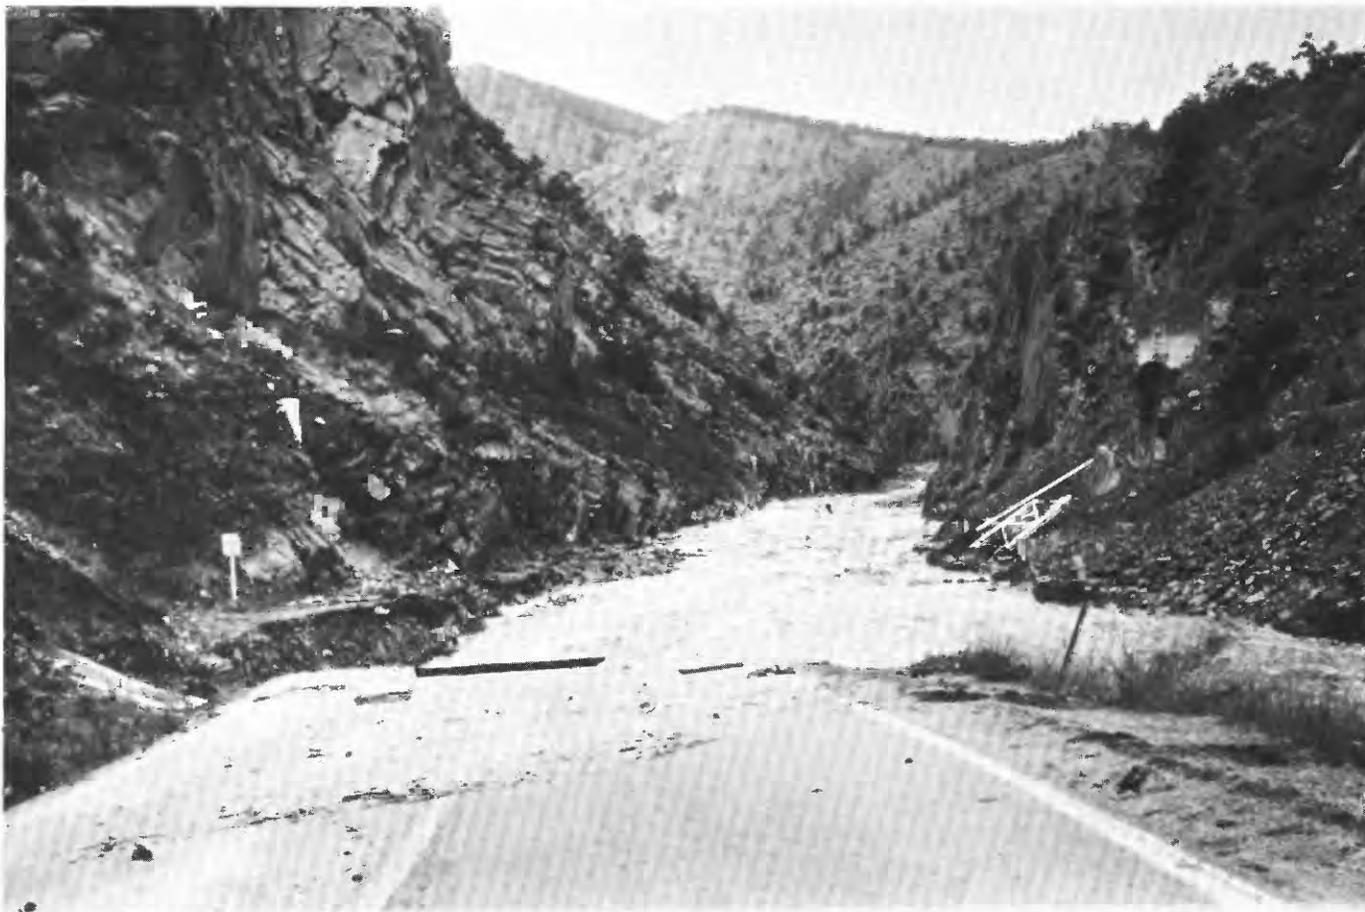
FIGURE 57.—Erosion damage to U.S. Highway 34 and to irrigation siphon at the gaging station on the Big Thompson River at mouth of canyon, near Drake (Site 23).

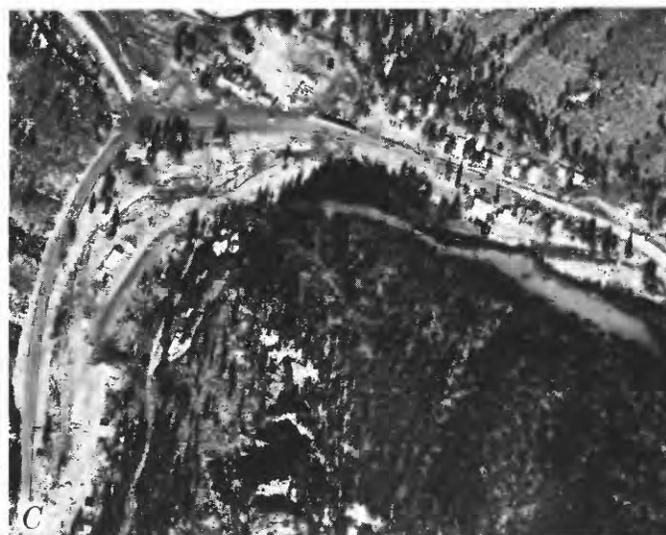
FIGURE 58.—Photographs showing aerial views of Drake: A, pre-flood conditions, August 29, 1973; B, immediately after the flood, August 3, 1976; C, after cleanup operations, October 29, 1976.

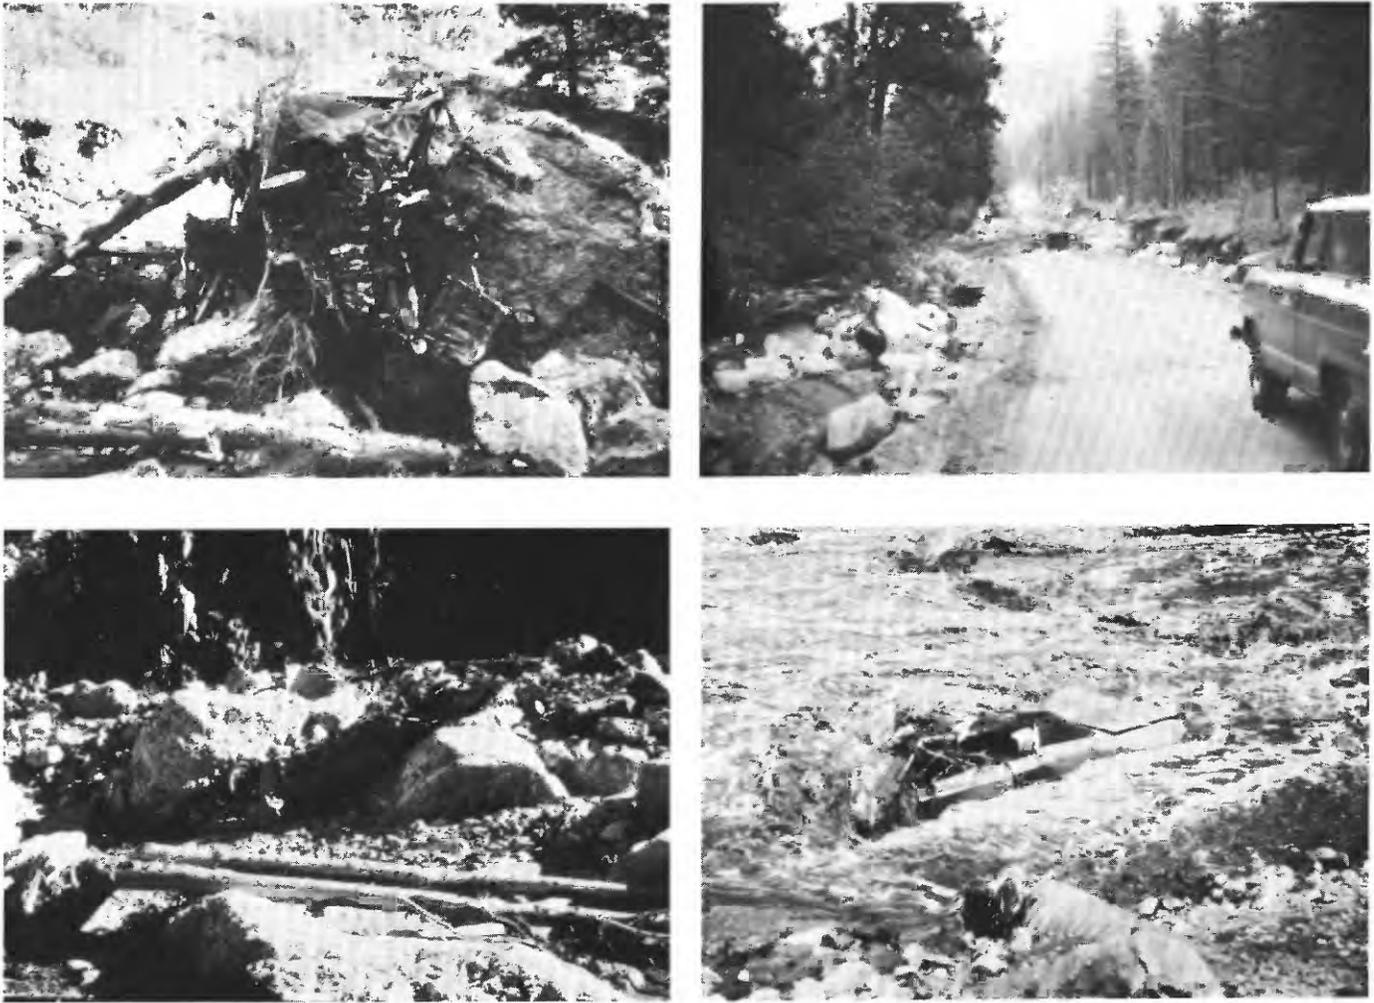
FIGURE 59.—Views of destroyed automobiles.

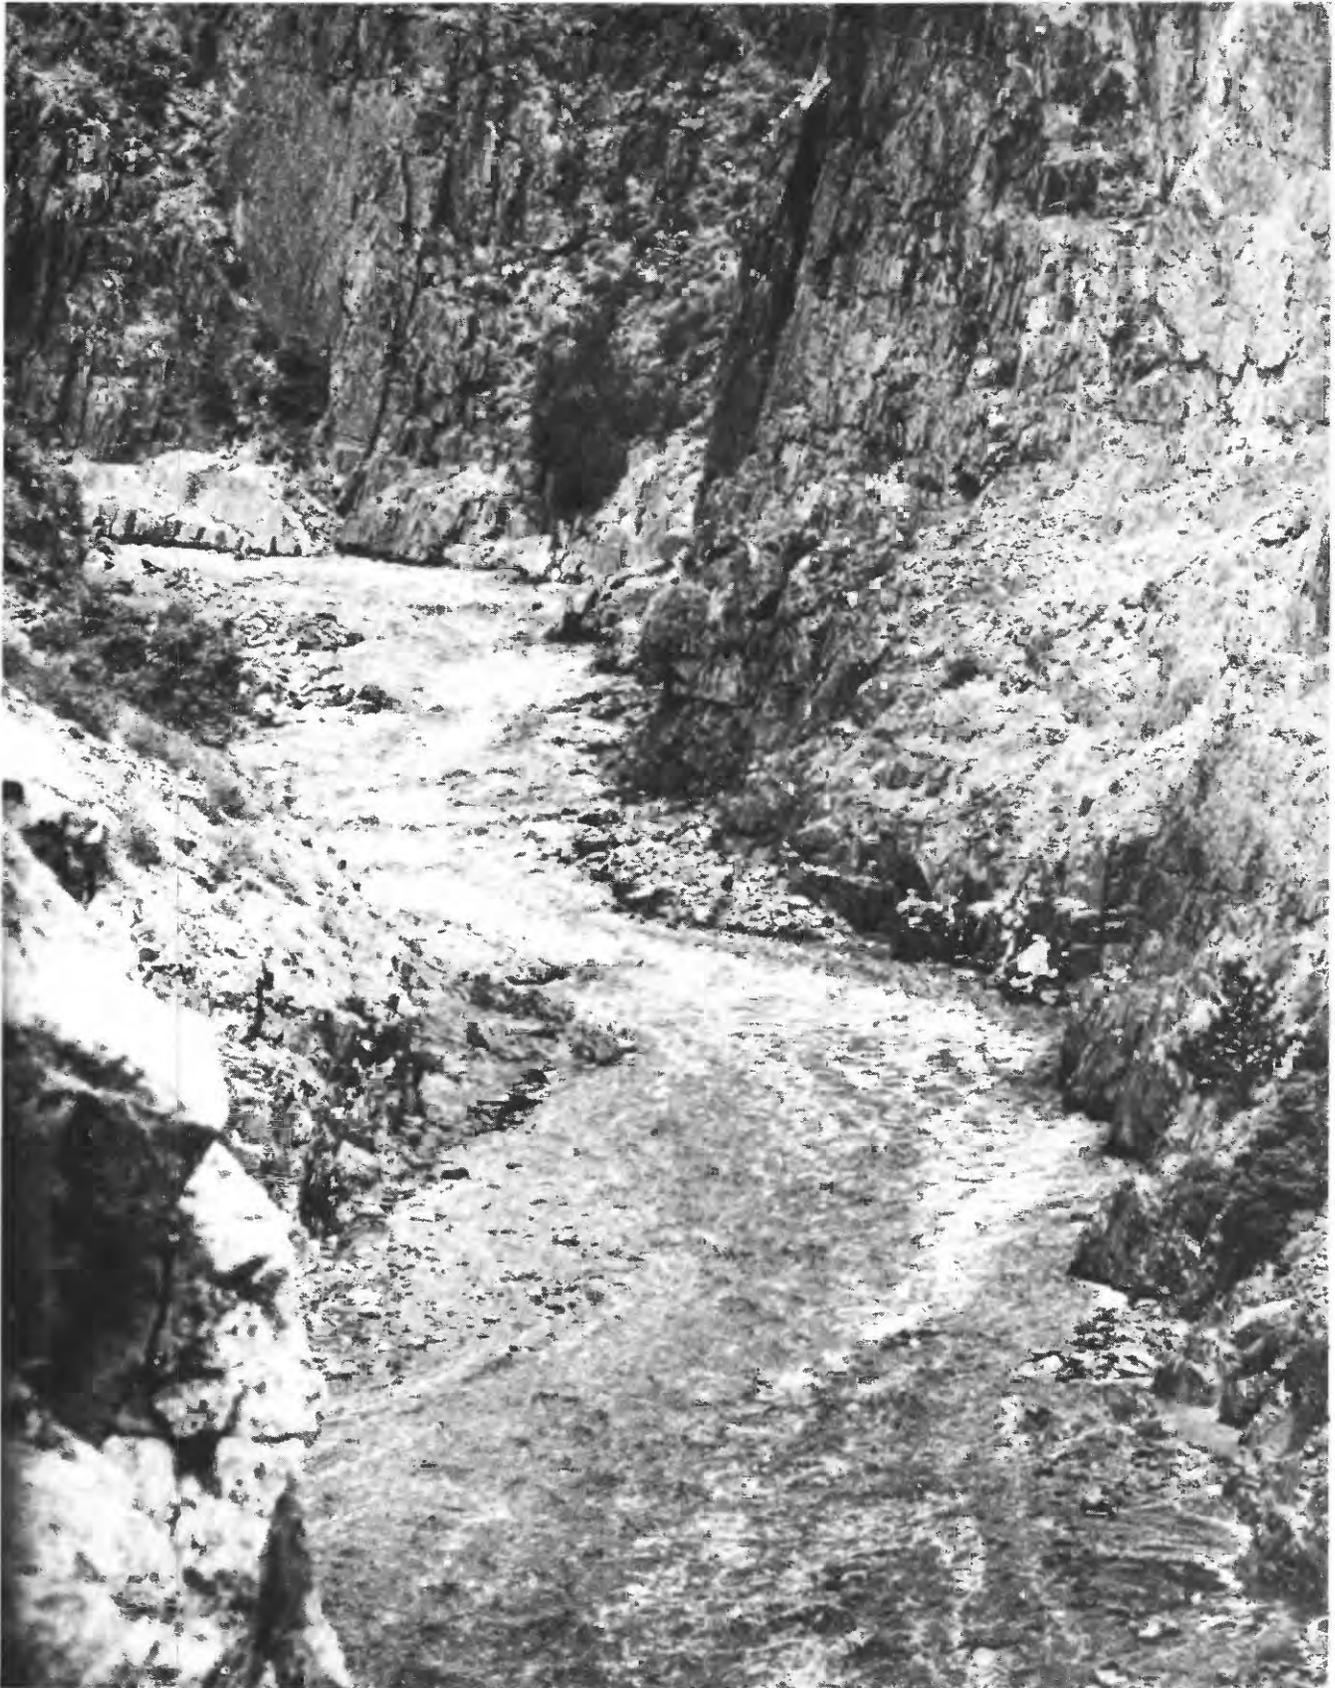
FIGURE 63.—The Narrows of Big Thompson Canyon, August 2, 1976, after the flood had receded. U.S. Highway 34, obliterated in this section of canyon, had followed the left bank in this view looking upstream. Valley floor here is about 80–100 ft wide.

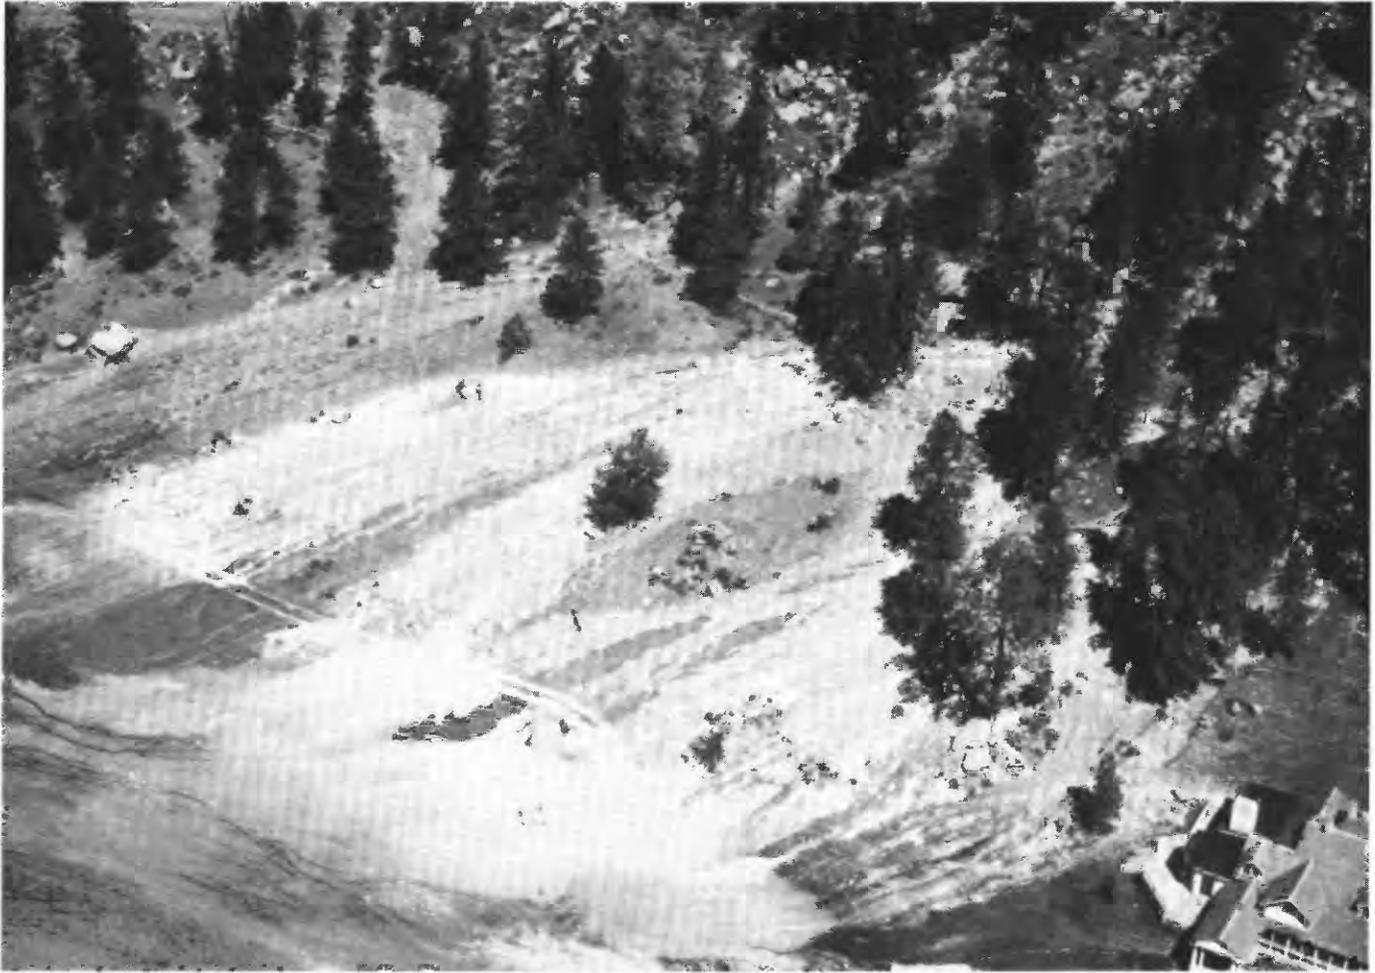
FIGURE 65.—Helicopter view showing effects of sheetflooding along foot of Mount Olympus at Crocker Ranch. Thin layers of sandy sheetwash (light tones). Bouldery gravel (darker tones) at mouth of gully in upper left of photograph. This area received about 10 in. of rain.

deposits of pebble- to boulder-size rock fragments on eroded slopes. Slopes with subtle surface irregularities and a sparse understory of grass were the most susceptible to sheet erosion. Erosion was much reduced by large tree roots, which helped stabilize the substrate and trapped pebbly sheetwash on their upslope sides. Sheetwash deposits also accumulated on the upslope sides of large boulders. Logs and other obstructions together with accumulating sediment deflected the surface flow and concentrated its erosive power in unobstructed areas. Small alluvial fans and thin alluvial aprons formed at the bases of eroded slopes (fig. 65).

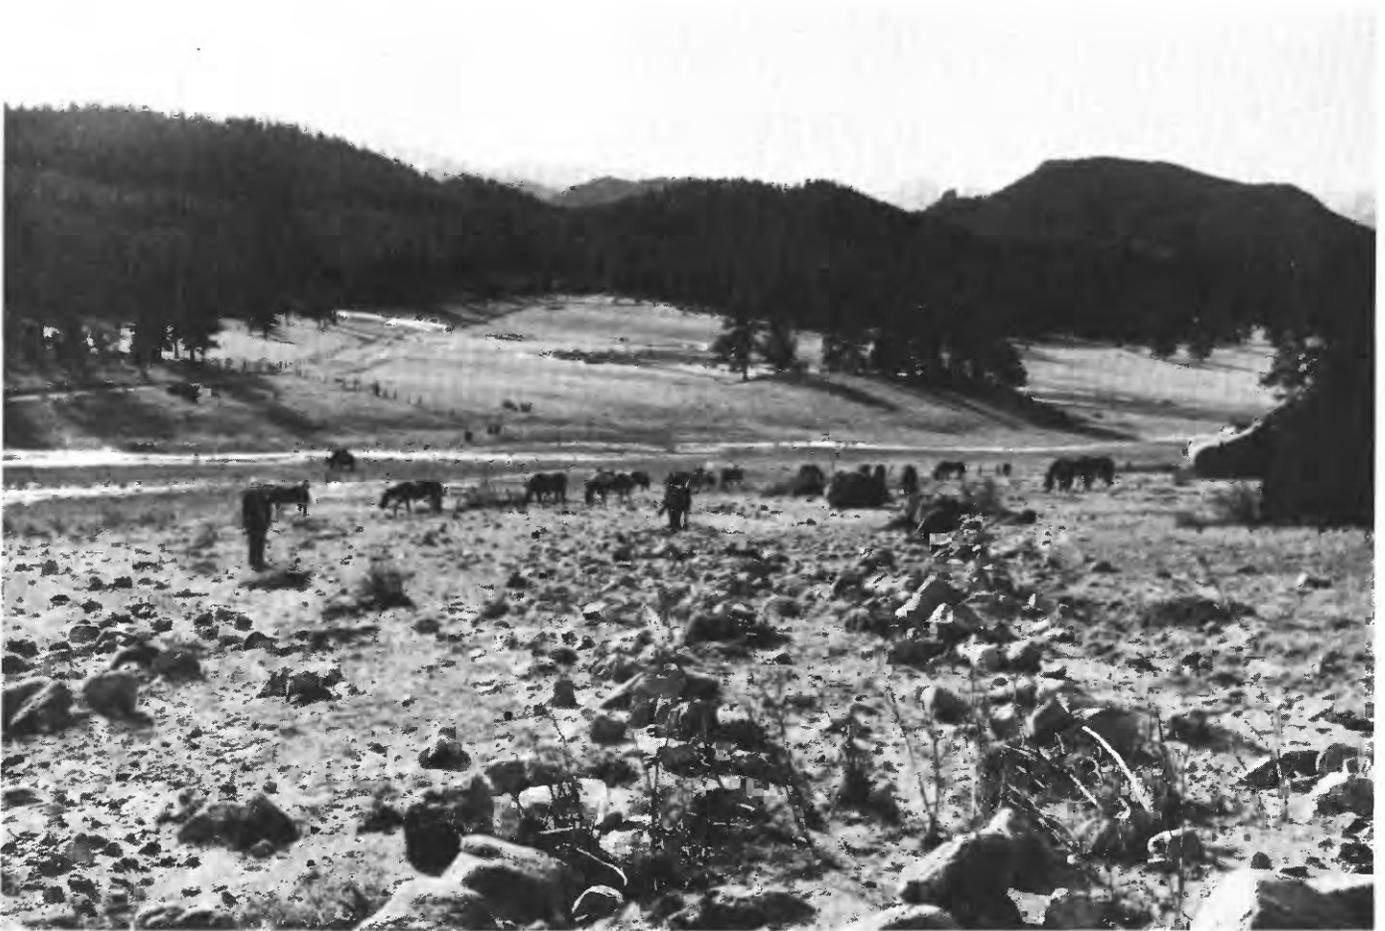
FIGURE 66.—Tongue of bouldery debris deposited by sheetflooding along the base of Mount Olympus at Crocker Ranch. This is a ground view of the area shown in the upper left part of figure 65. The two large boulders on the right in the middle distance were not moved.

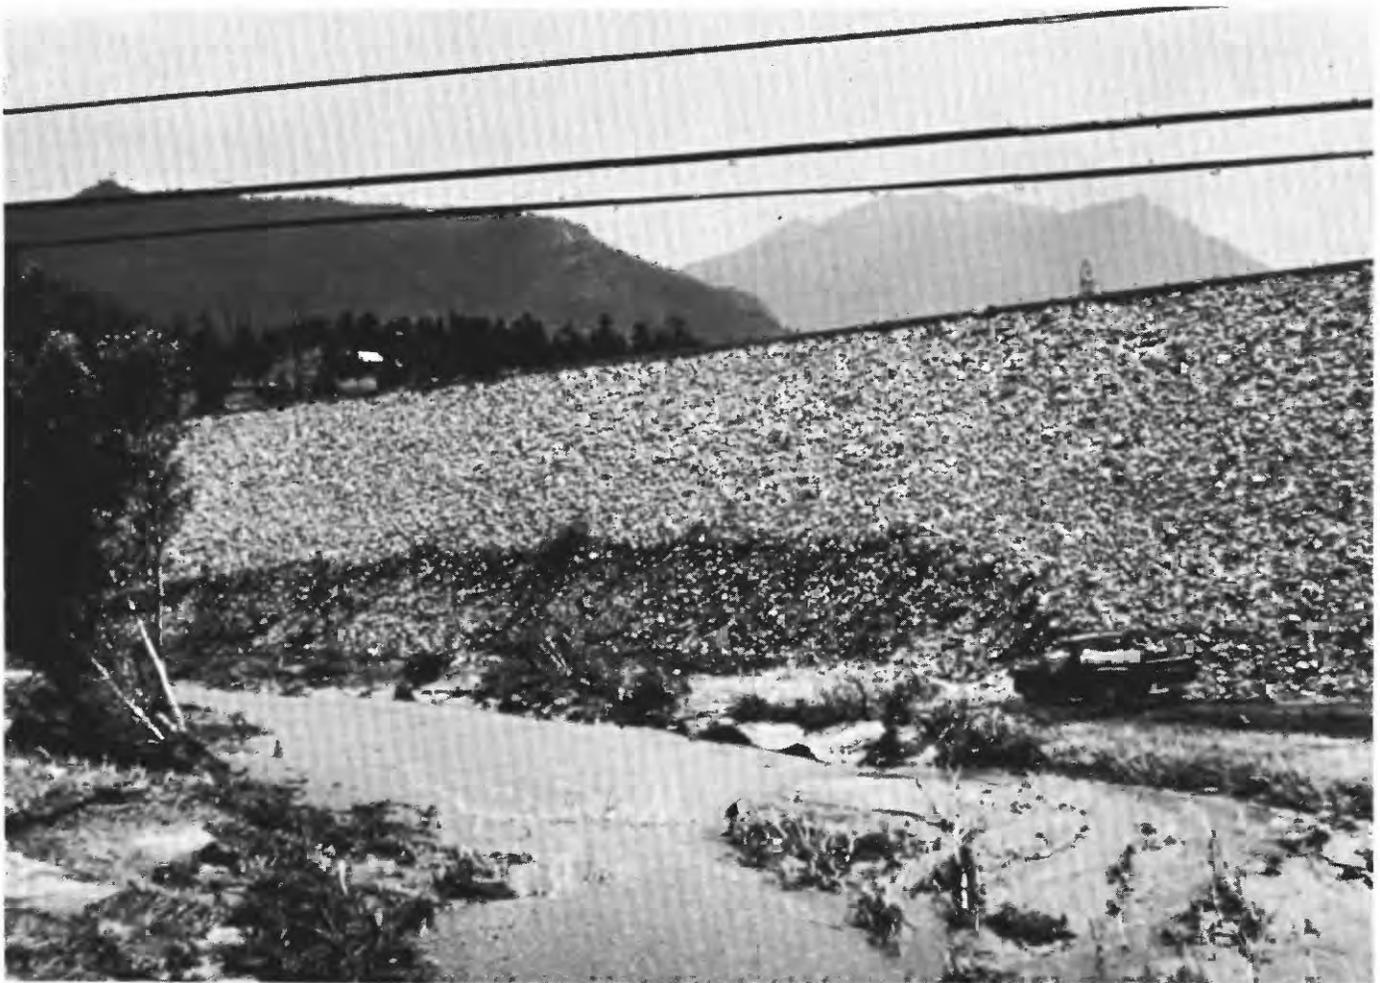
FIGURE 67.—Toe of Olympus Dam, scoured by floodwaters of Dry Gulch, viewed toward the south.

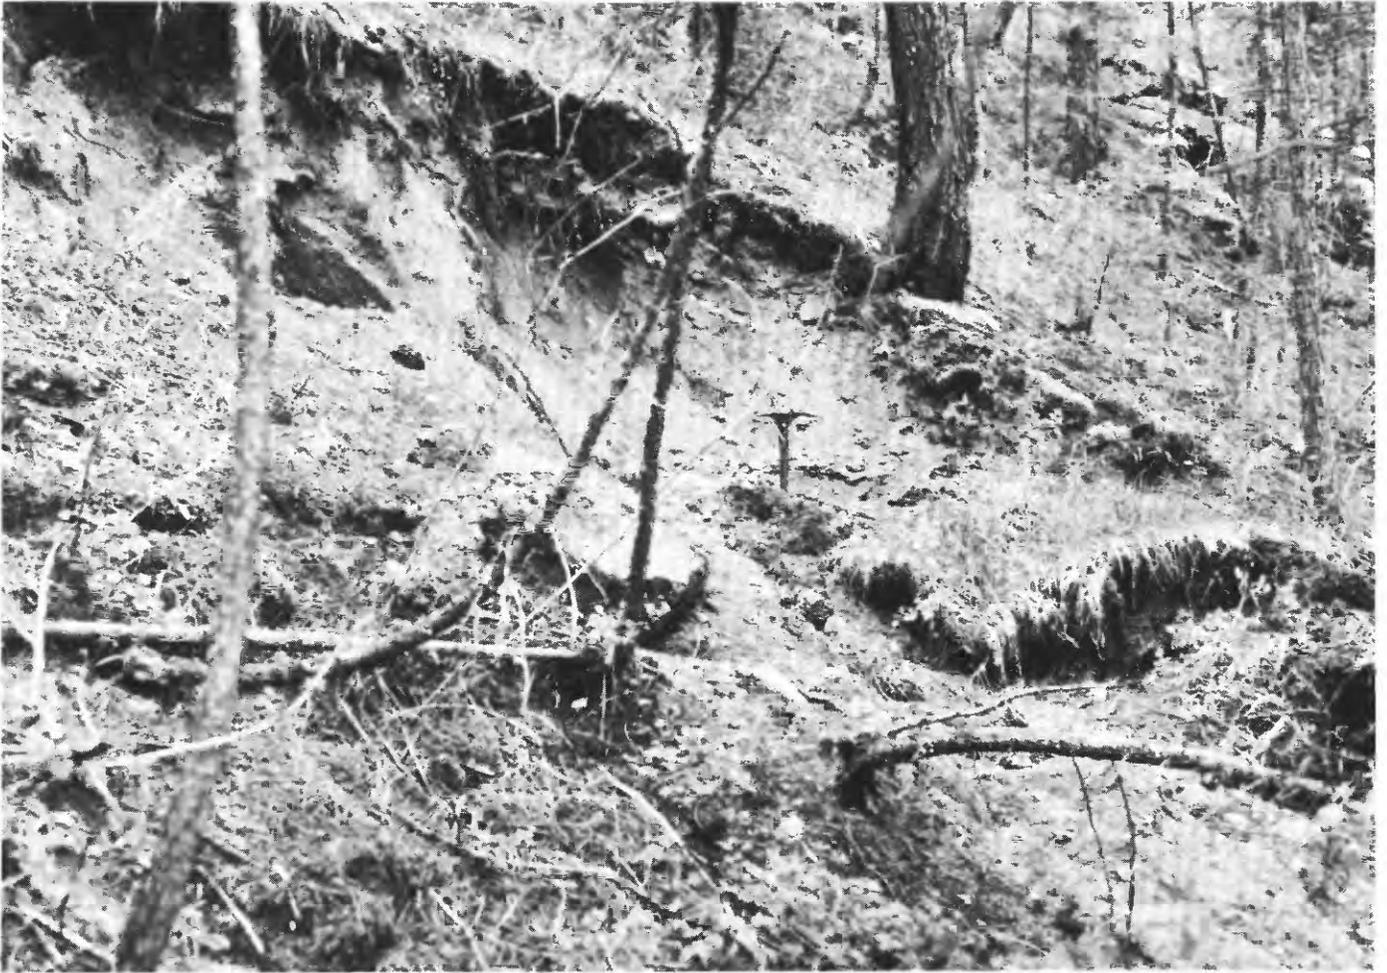
FIGURE 68.—Small debris slide in stony colluvium on 67-percent slope near mile 53.2 This area received about 11.5 in. of rain.

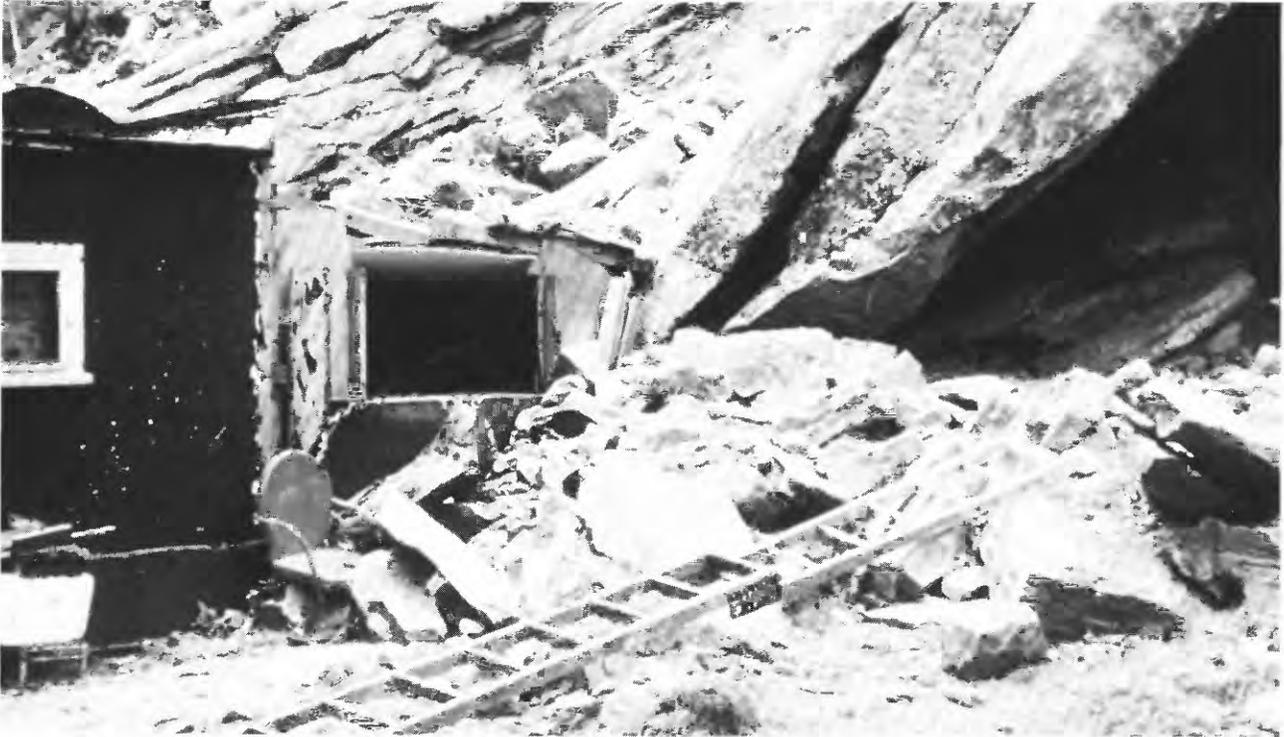
FIGURE 69.—Motel unit damaged by a rockslide on an oversteepened bedrock slope near mile 56.0. Movement was along a sloping joint plane in granite. This area received about 10 in. of rain.

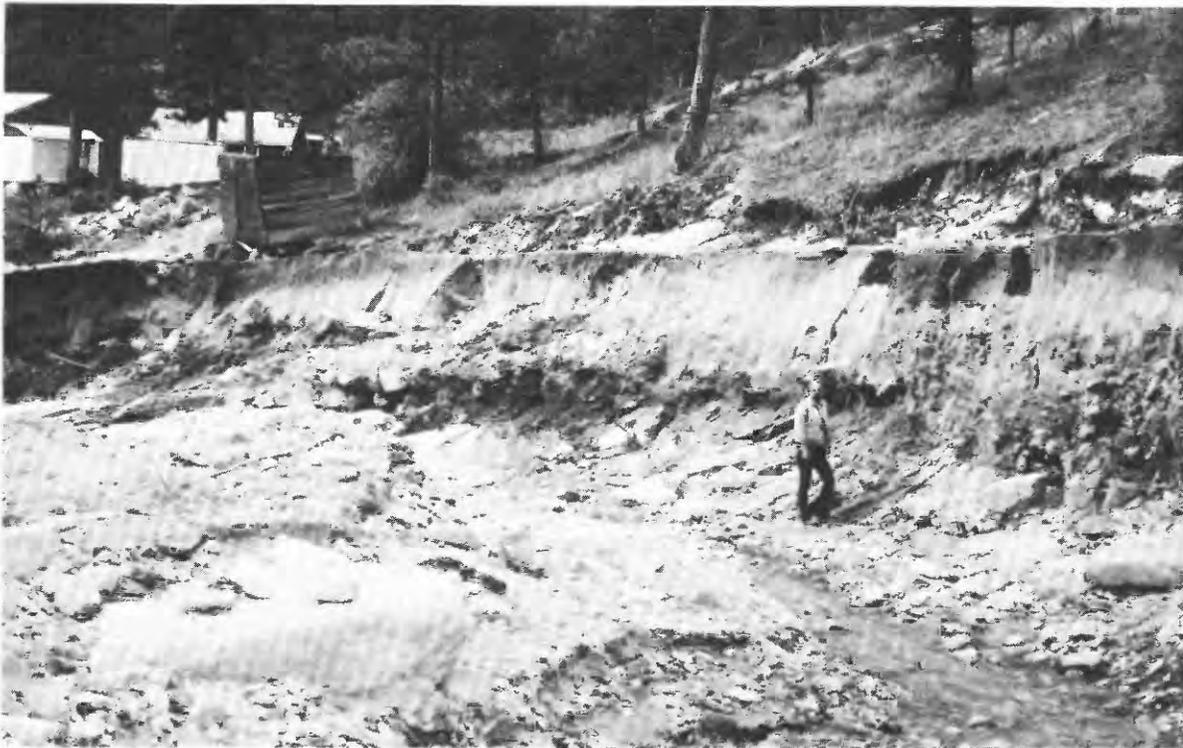
FIGURE 70.—Unnamed gulch, viewed about 100 yd upstream from its confluence with the Big Thompson River, at mile 54.4. Floodwaters with a calculated velocity of 26 ft/s and a peak discharge of 8,700 ft³/s (Part A, table 4) scoured the gulch to bedrock, exposing sandy slope wash and an older bouldery flood deposit. Before the 1976 flood, this part of the gulch was a flat-bottomed grassy meadow without perennial surface drainage.

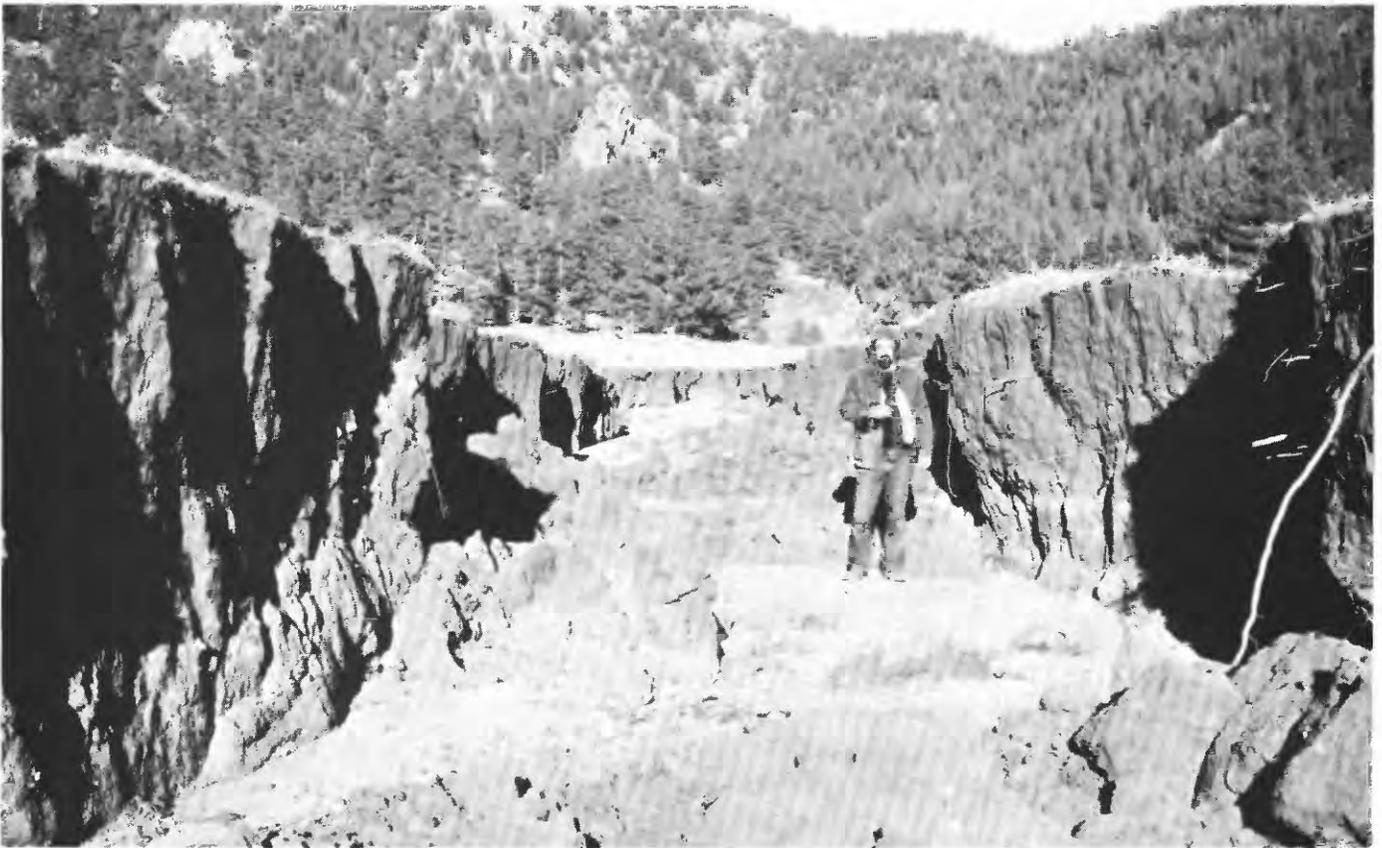
FIGURE 71.—Gully cut by intense runoff channeled along the shallow ruts of a dirt road in a grassy area, upper part of unnamed gulch at mile 54.4 Rainfall here was about 10 in.

Unimproved dirt roads on grassy slopes of about 7 percent along the lower reach of the unnamed gulch at Loveland Heights and in the large meadow in its headwaters were gullied to depths of as much as 5–10 ft (fig. 71). Roads parallel or oblique to the contour of the ground were less deeply gullied than those perpendicular to the contour. Flood debris along the unnamed gulch and Dark Gulch was deposited at heights of about 7–9 ft above the present streambed.

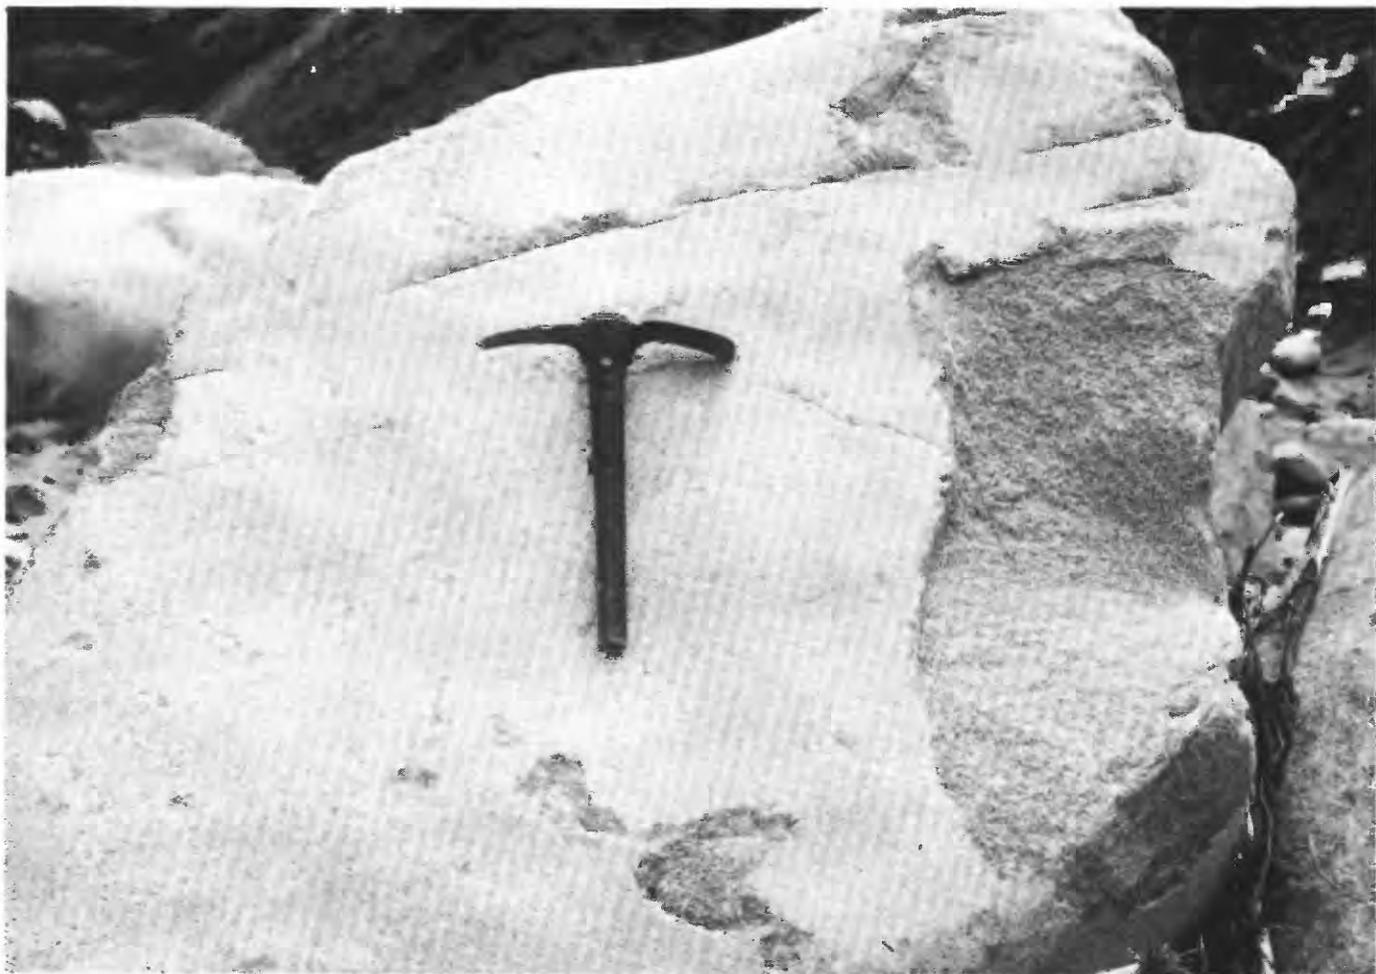
FIGURE 72.—Granite boulder near mile 42.7, showing fresh impact scars. Pick is 17 in. long. Such scars on the downstream sides of boulders indicate movement during the flood.

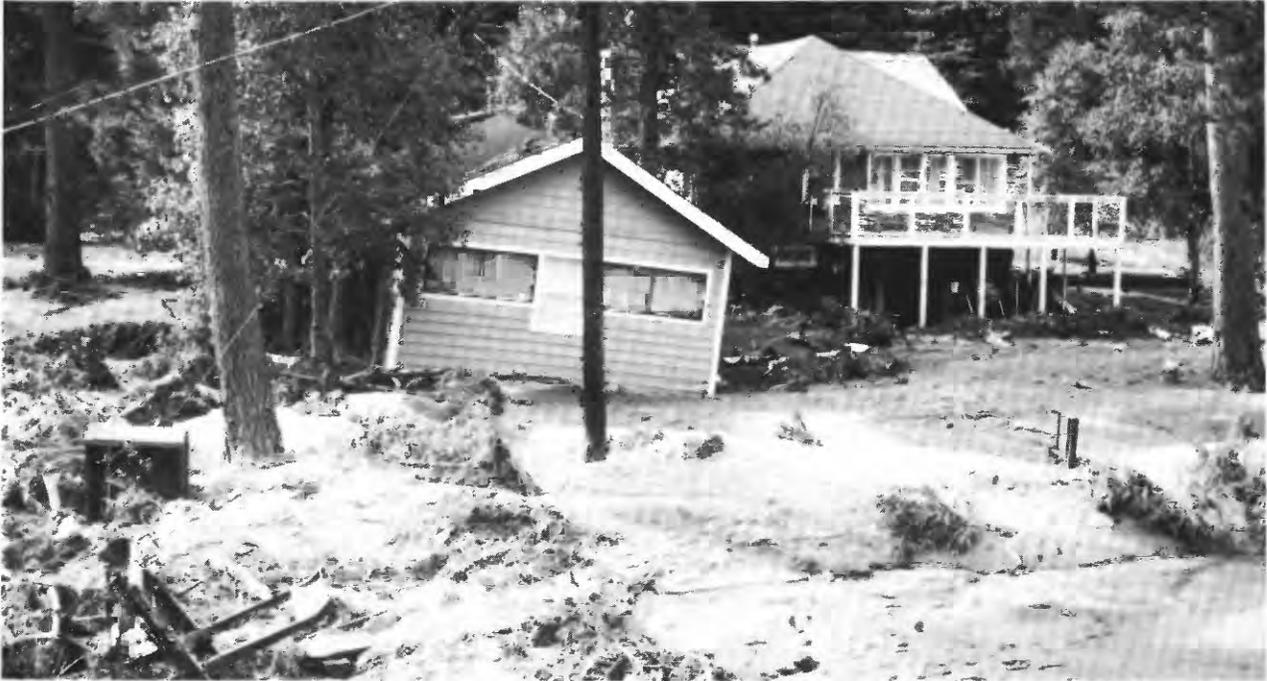
FIGURE 73.—Overbank sand and buoyant debris on the south side of the Big Thompson River at mile 54.4. Frame house in center of photograph was lifted off its foundation and pushed against trees. Much of the damage here was caused by a surge of water from the tributary on the opposite (north) side of the river.

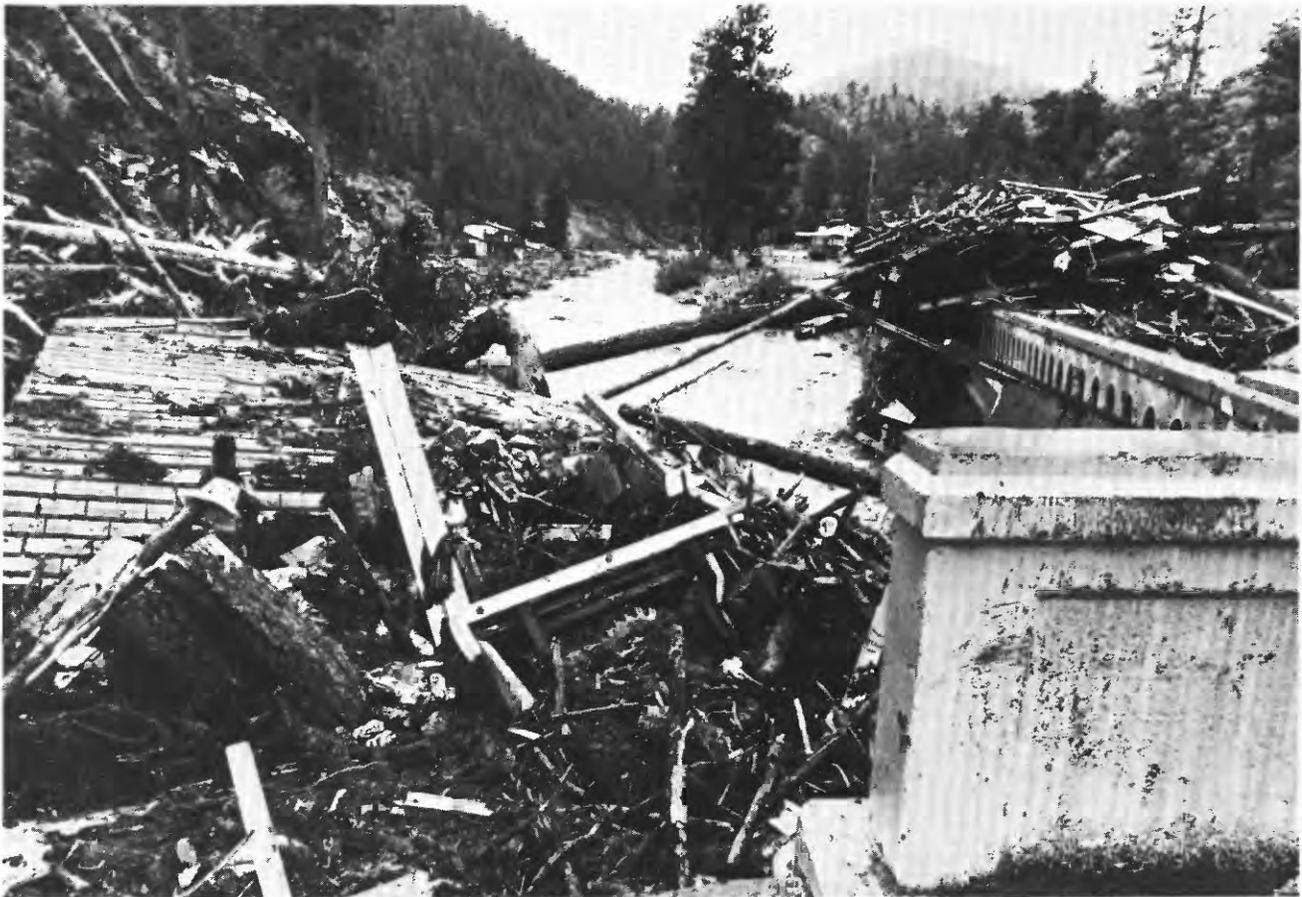
FIGURE 74.—Debris pile on the upstream side of highway bridge at mile 52.2.
