Storm and Flood of July 31–August 1, 1976, in the Big Thompson River and Cache la Poudre River Basins, Larimer and Weld Counties, Colorado

GEOLOGICAL SURVEY PROFESSIONAL PAPER 1115

Part A. Meteorology and Hydrology in Big Thompson River and Cache la Poudre River Basins

Part B. Geologic and Geomorphic Effects in the Big Thompson Canyon Area, Larimer County

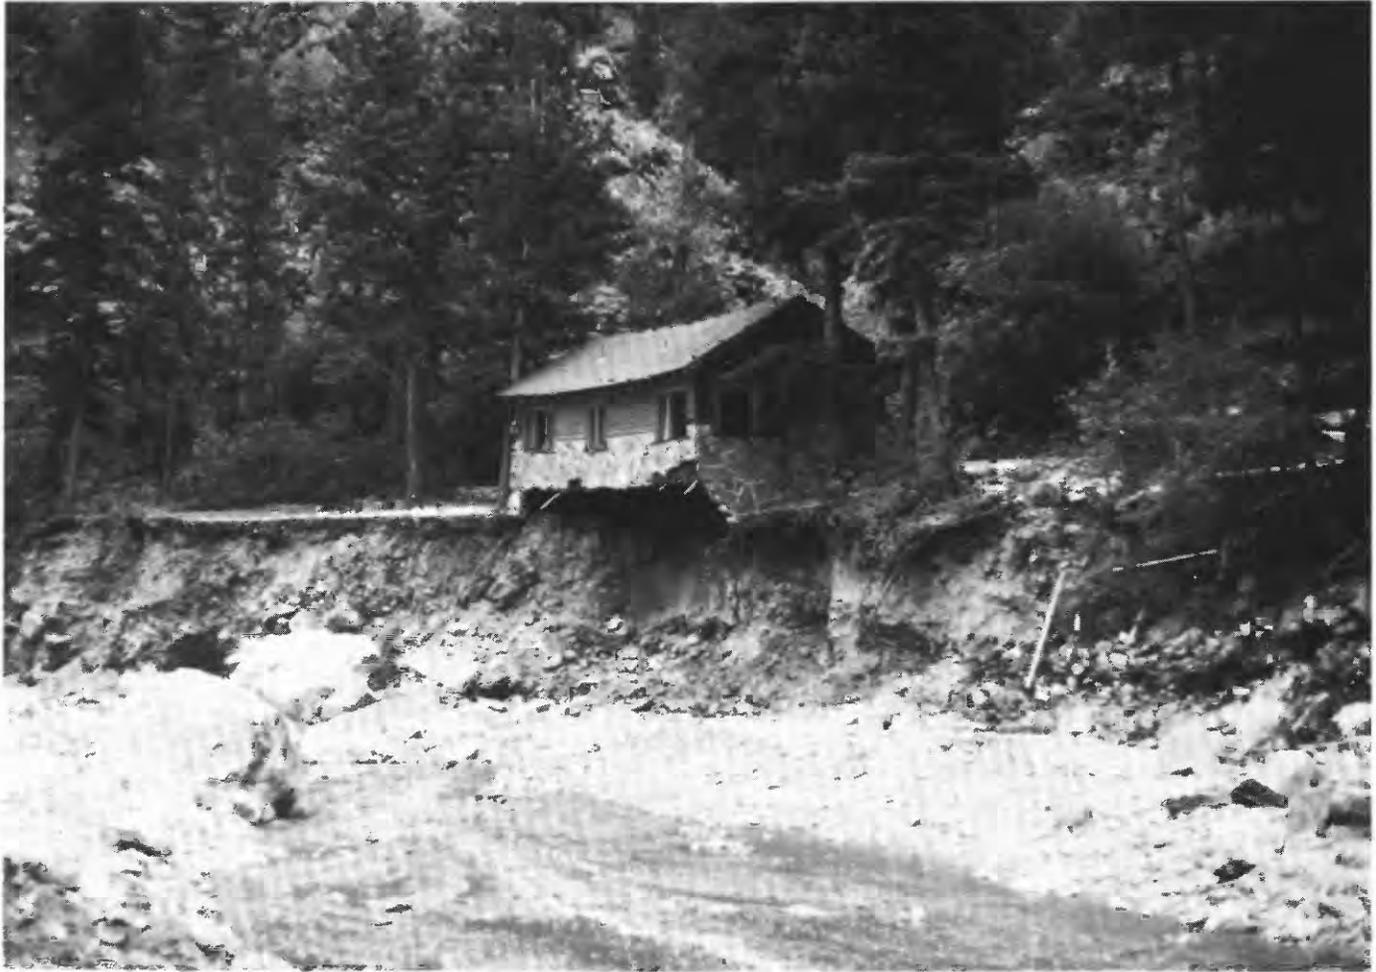
FIGURE 75.—House undercut by Big Thompson River near mile 45.4. House was located on a debris fan at the mouth of the small gulch in background. Rainfall here was relatively light, and the gulch carried no water of any consequence.

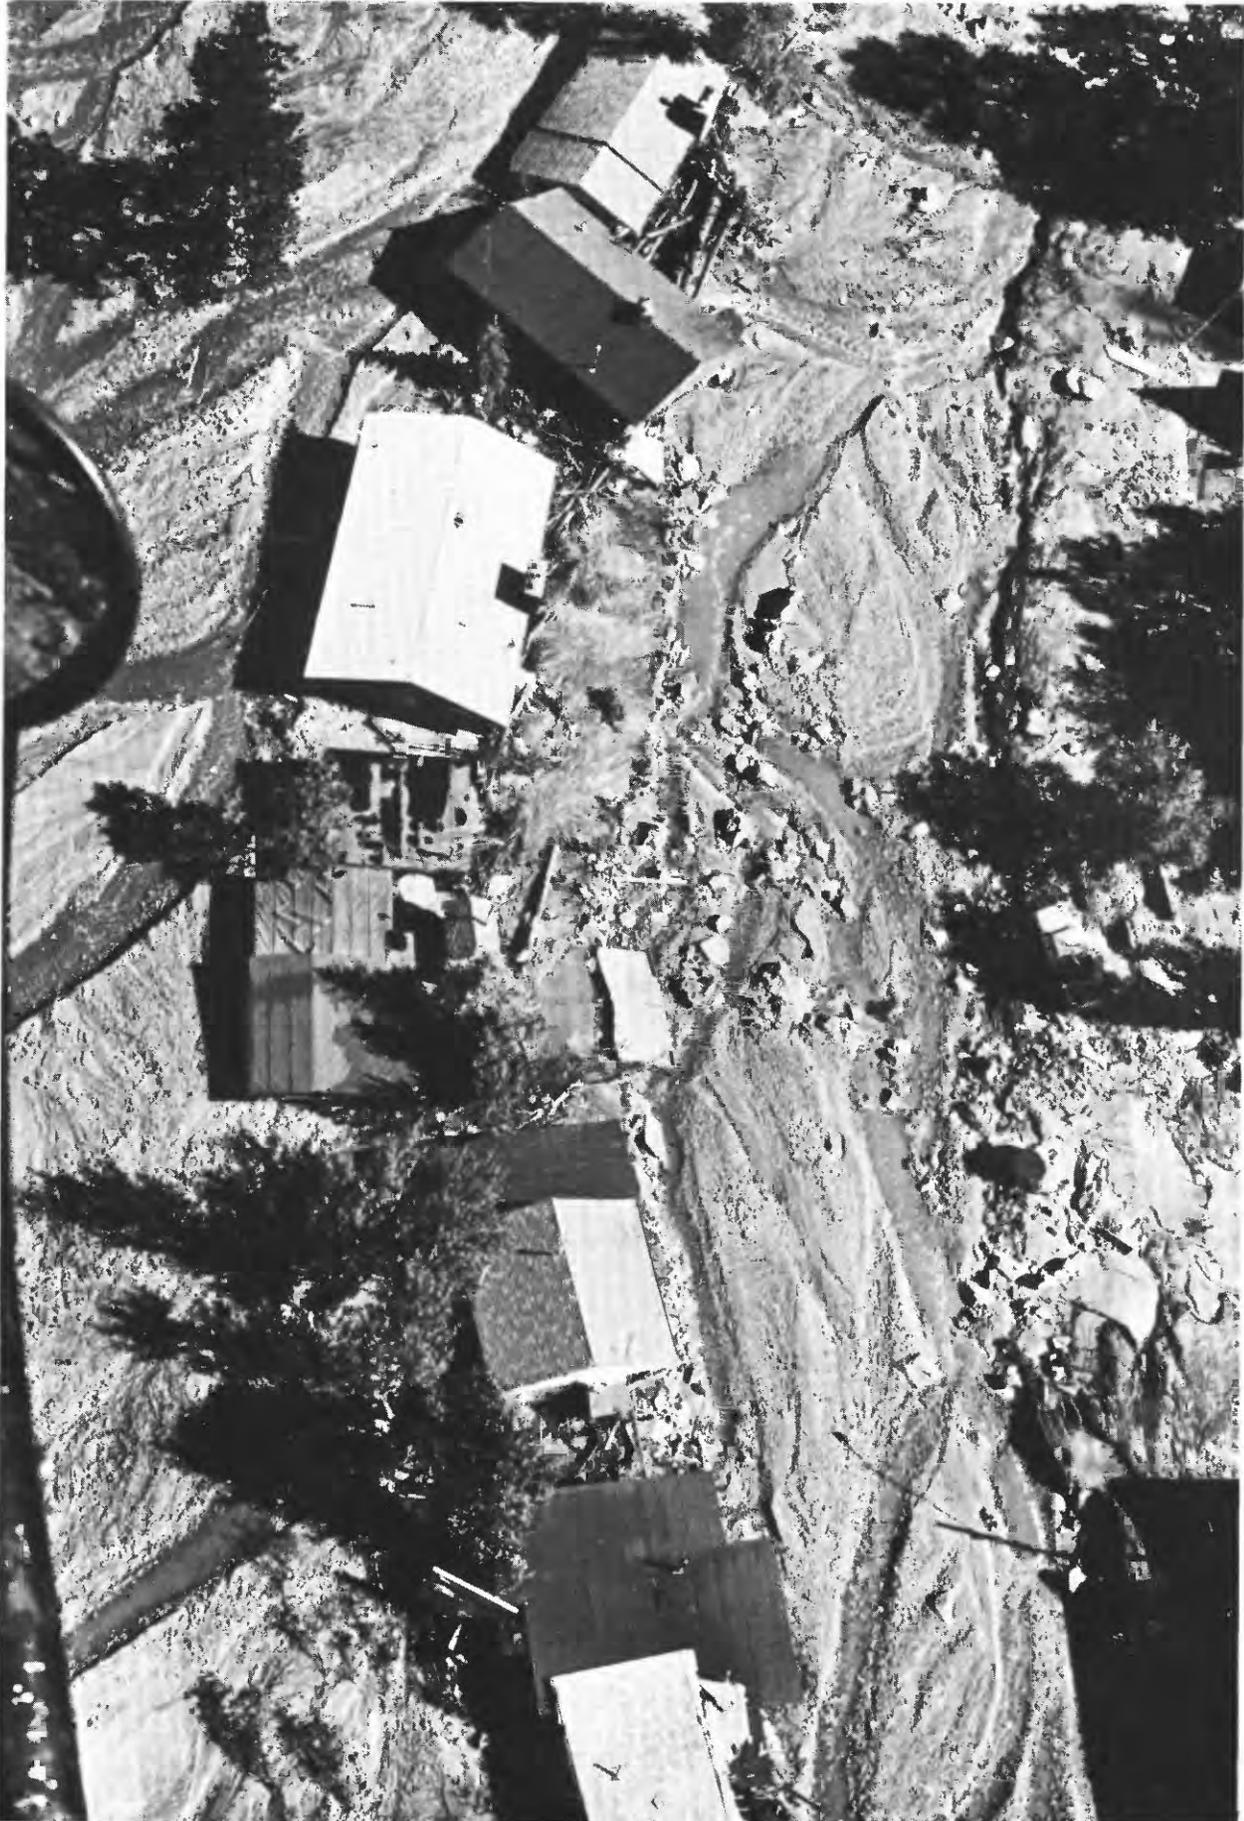
◀ FIGURE 77.—Helicopter view showing flood damage in part of Drake. Downstream (north) is at top of picture. Before the flood the channel of the Big Thompson River was just to the left of the houses, but it shifted widely during the flood and was far to the left outside the picture at the time the photograph was taken. Rainfall here was about 4 in.

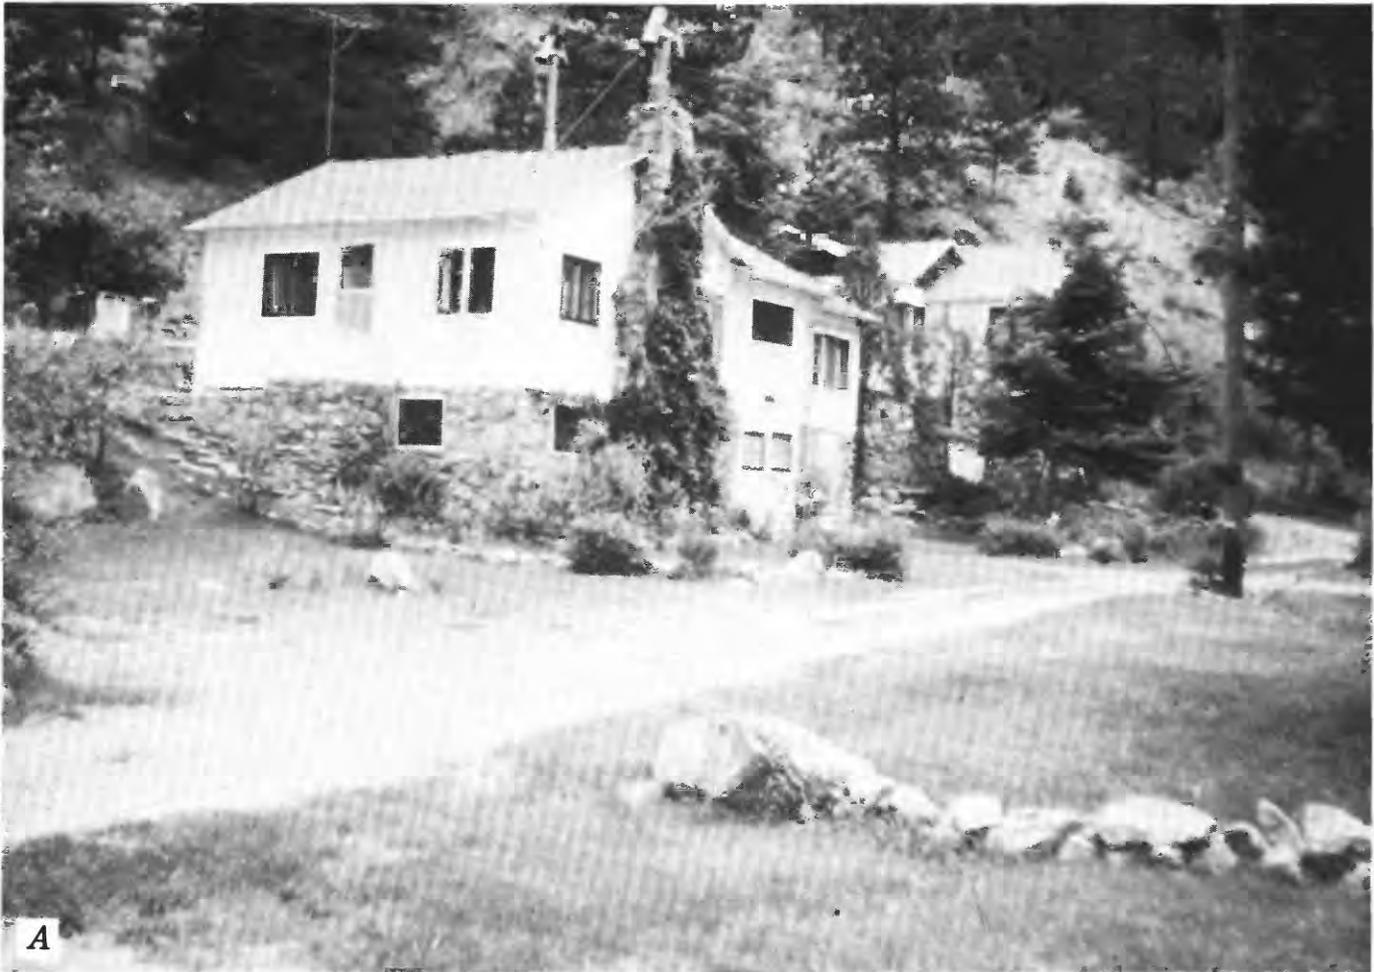
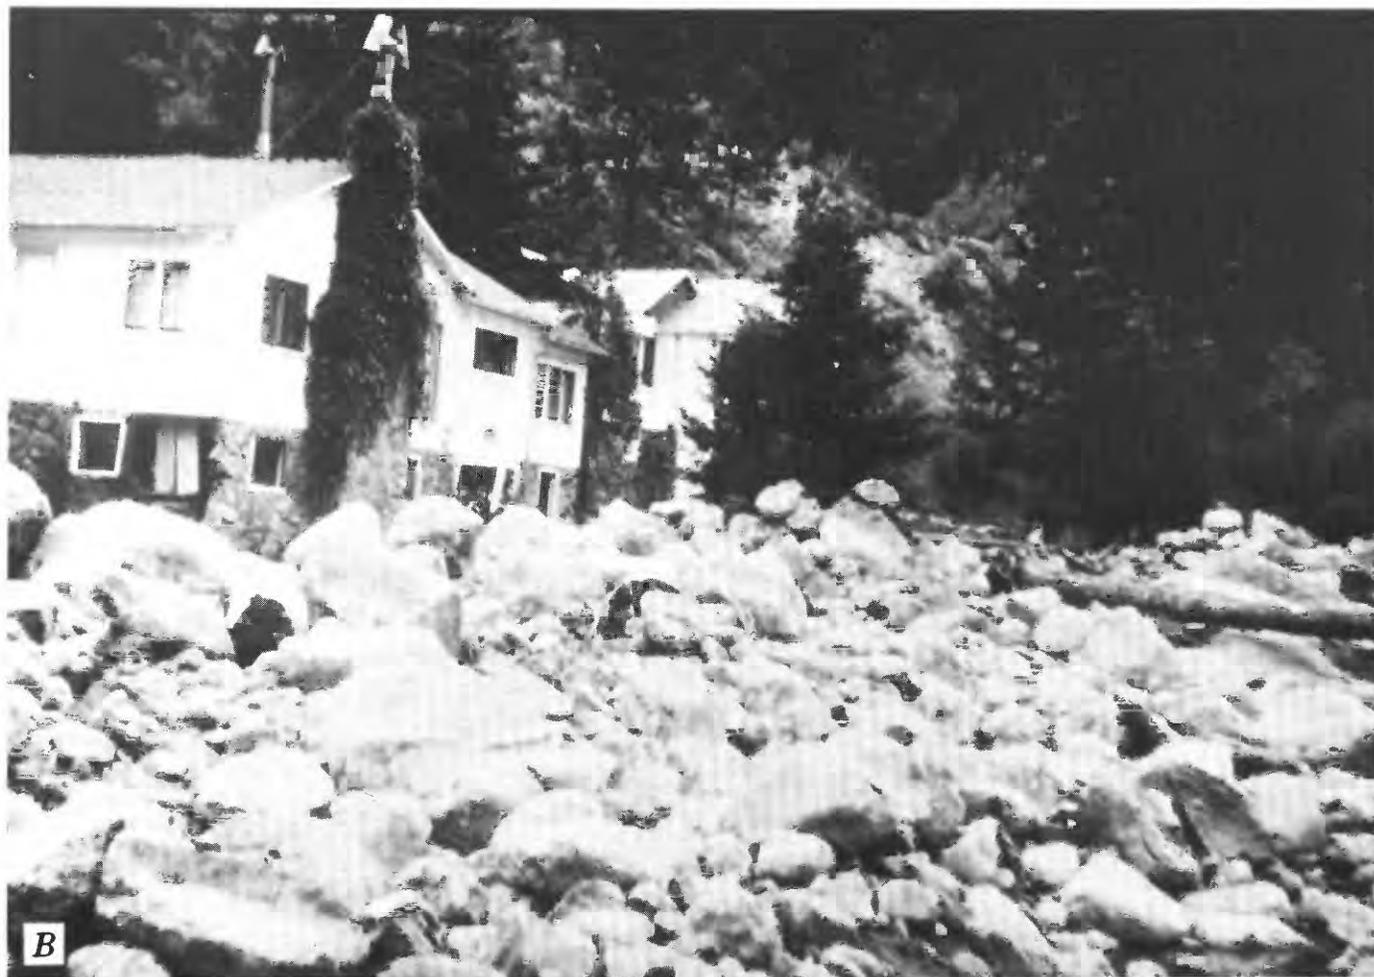
FIGURE 78 (above and facing page).—Preflood (*A*) and postflood (*B*) view taken near south end of Drake showing part of a huge boulder deposit that caused severe damage to part of the community. Houses in background were outside its path and were little damaged. Peak discharge here was about 28,000 ft³/s (Part A, table 3).

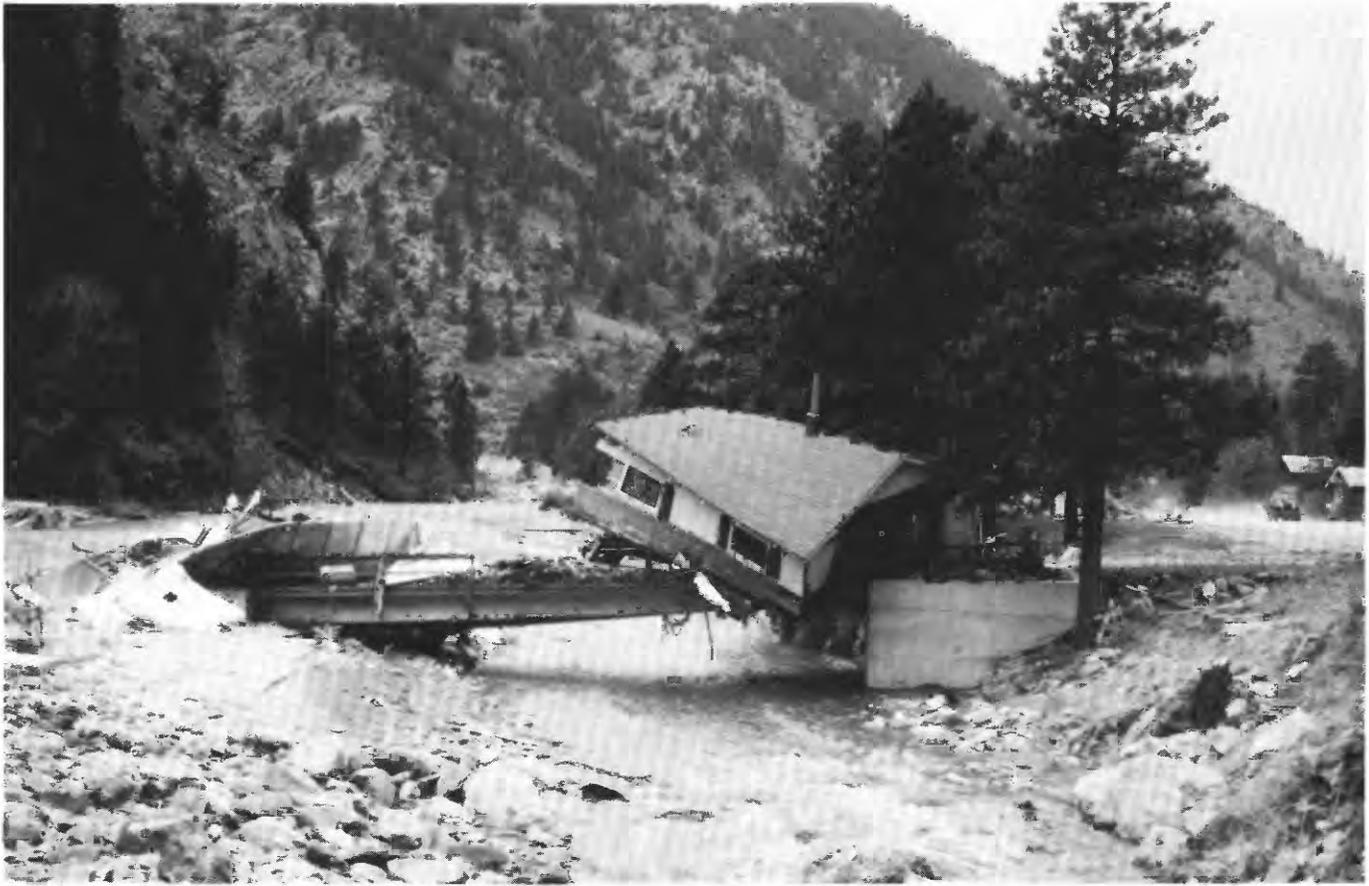
FIGURE 79.—Wrecked house and other debris, including large mobile home, lodged on a damaged private bridge at mile 44.7, 0.5 mi downstream from Drake, looking upstream.

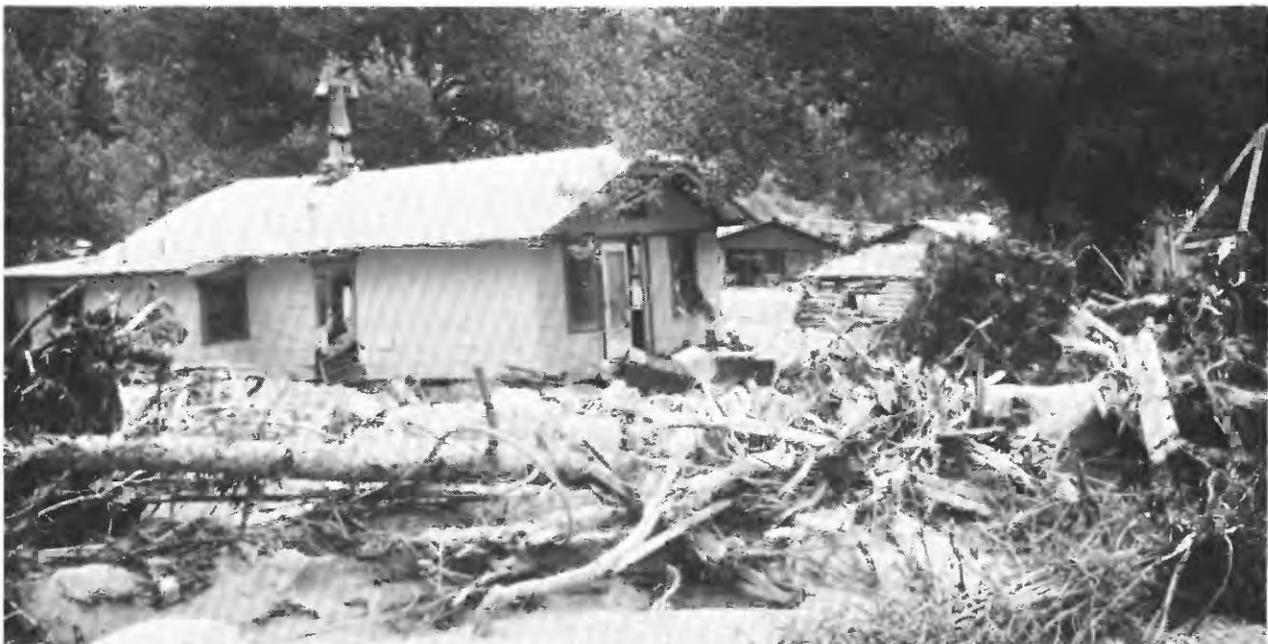
FIGURE 80.—Flood damage along the Big Thompson River near center of Drake, looking upstream. Frame house in foreground was washed off its foundation and damaged beyond repair. Exterior wall on the north side of this house was pushed outward around the window. Side of log cabin in background also was offset in a downstream direction.

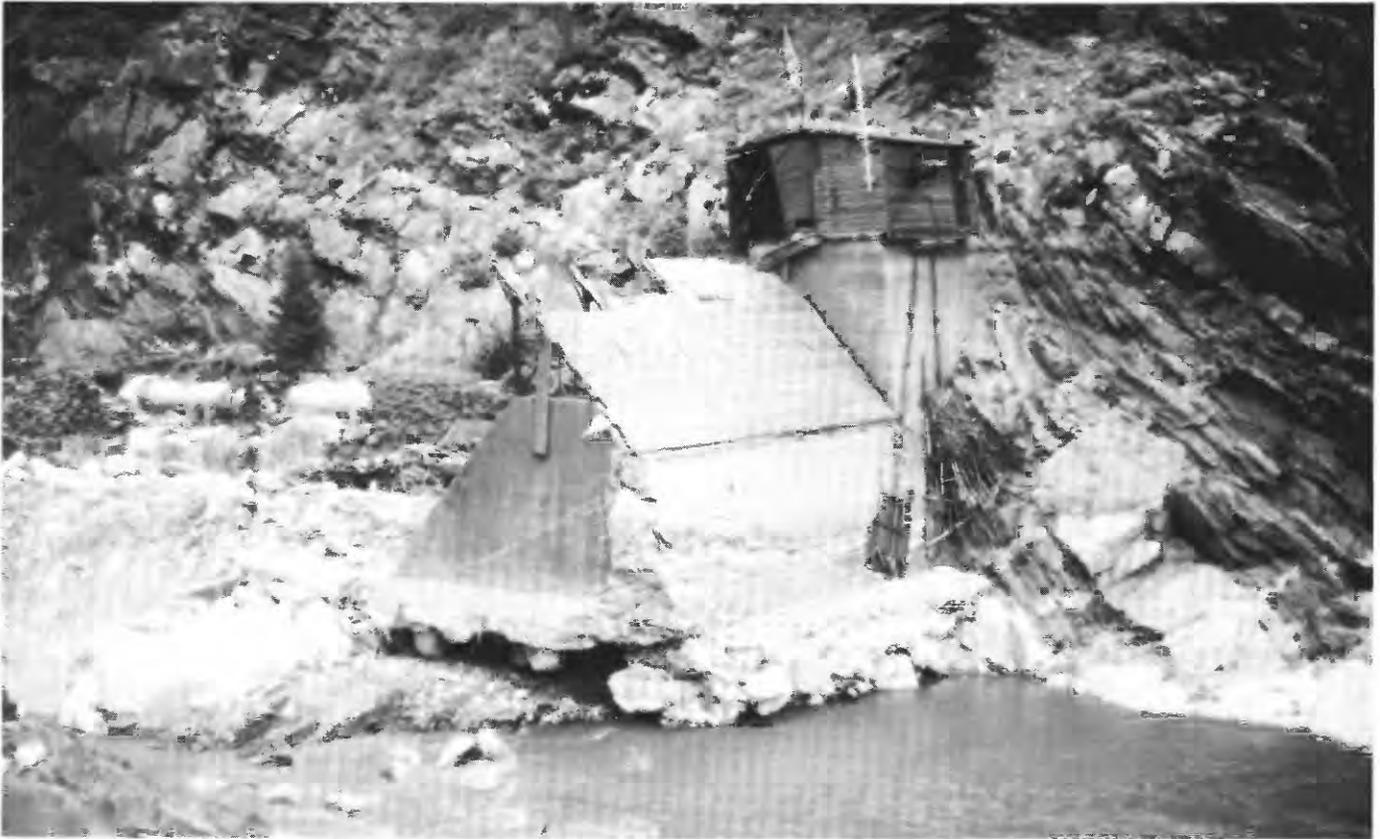
FIGURE 81.—Remains of diversion dam below Midway at mile 43.25. Before breaching the dam, the water rose at least 5 ft above the crest and left a log wedged in the window of the shack on the right abutment.

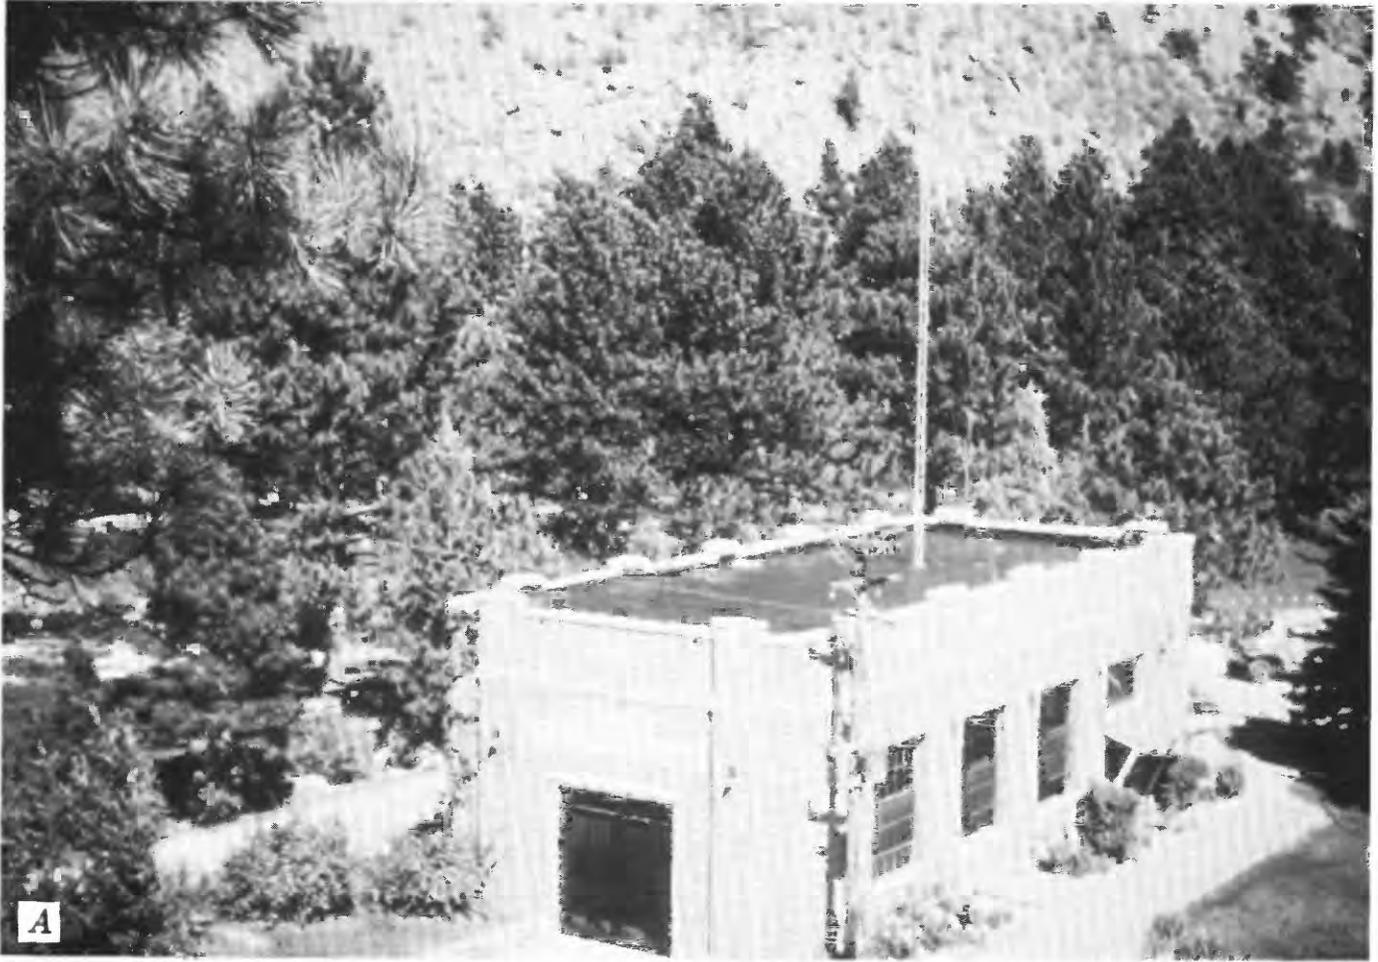
FIGURE 82 (above and facing page).—Site of the Loveland powerplant at mile 41.3. *A*, Before and *B*, after the flood. All but the poured-slab foundation and the bolted-down generators was destroyed. Boulderly flood gravel was about 20 in. thick.

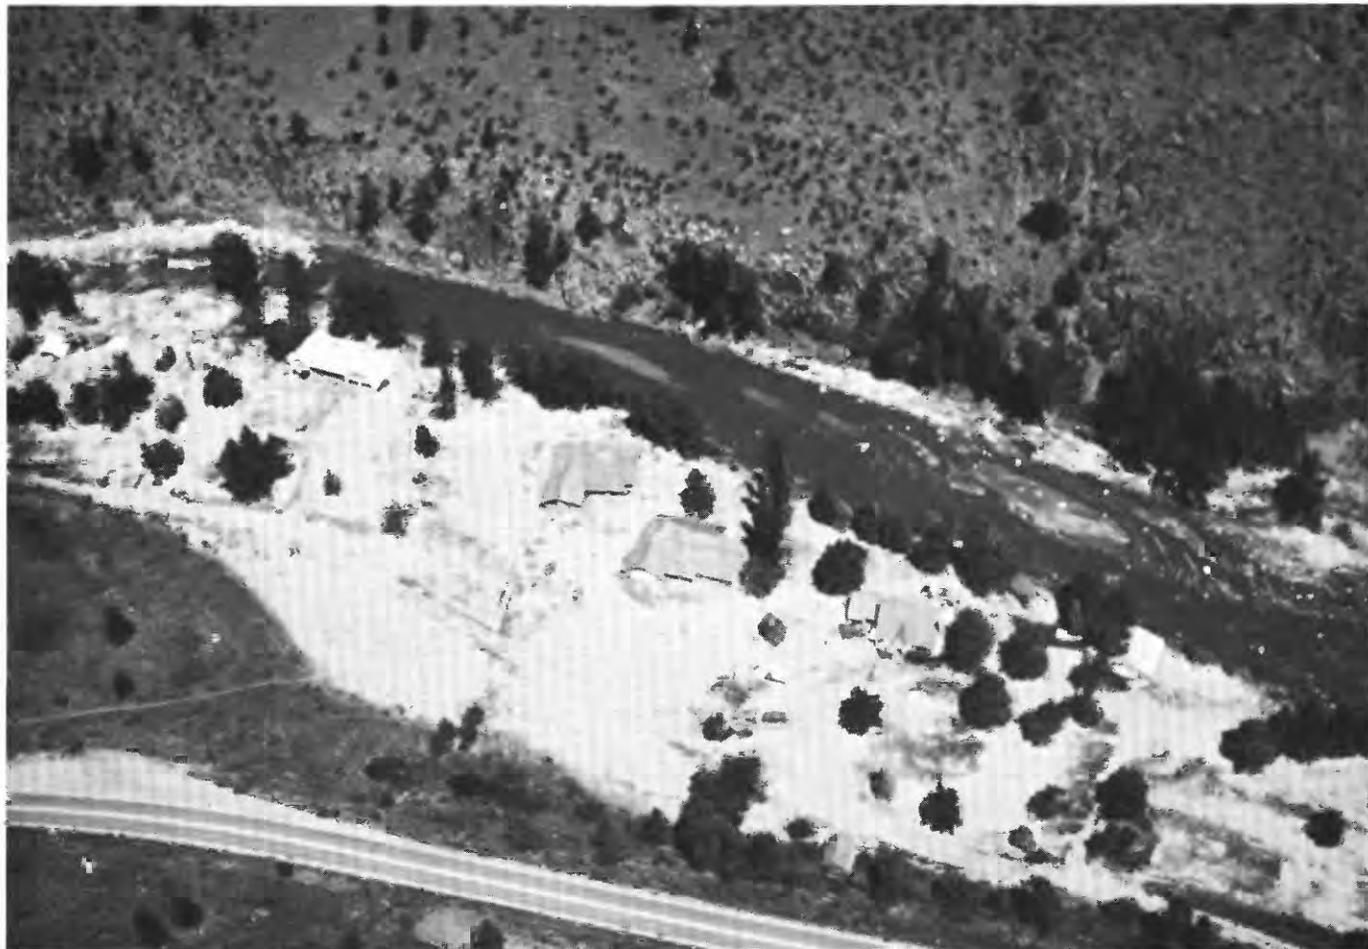
FIGURE 83.—Helicopter view of the Cedar Cove area near mile 39.6. Floodwater deeper than 20 ft above present stream level deposited a blanket of pebbly sand 3 or more ft thick. Boulders in the main channel were locally derived. Boulders on the high terrace remnant above the channel on far bank were deposited by an ancient flood.

front buildings. Buildings on the flood plain were inundated with sediment, and some were carried away. Buildings, fences, debris piles, and trees on the flood plain all retarded the current and intensified deposition (fig. 83). Especially on insides of bends, as near mile 39.5, sand accumulated to depths of more than 3 ft. This sand was horizontally bedded, micaceous, and fine to medium grained. It graded into gravelly sand toward the mainstream channel. Flood alluvium along the main channel was mostly sandy to cobbly gravel, but locally derived boulders were as long as 3.8 ft (table 8, mile 39.5). Below Cedar Cove, the floodwaters entered The Narrows.

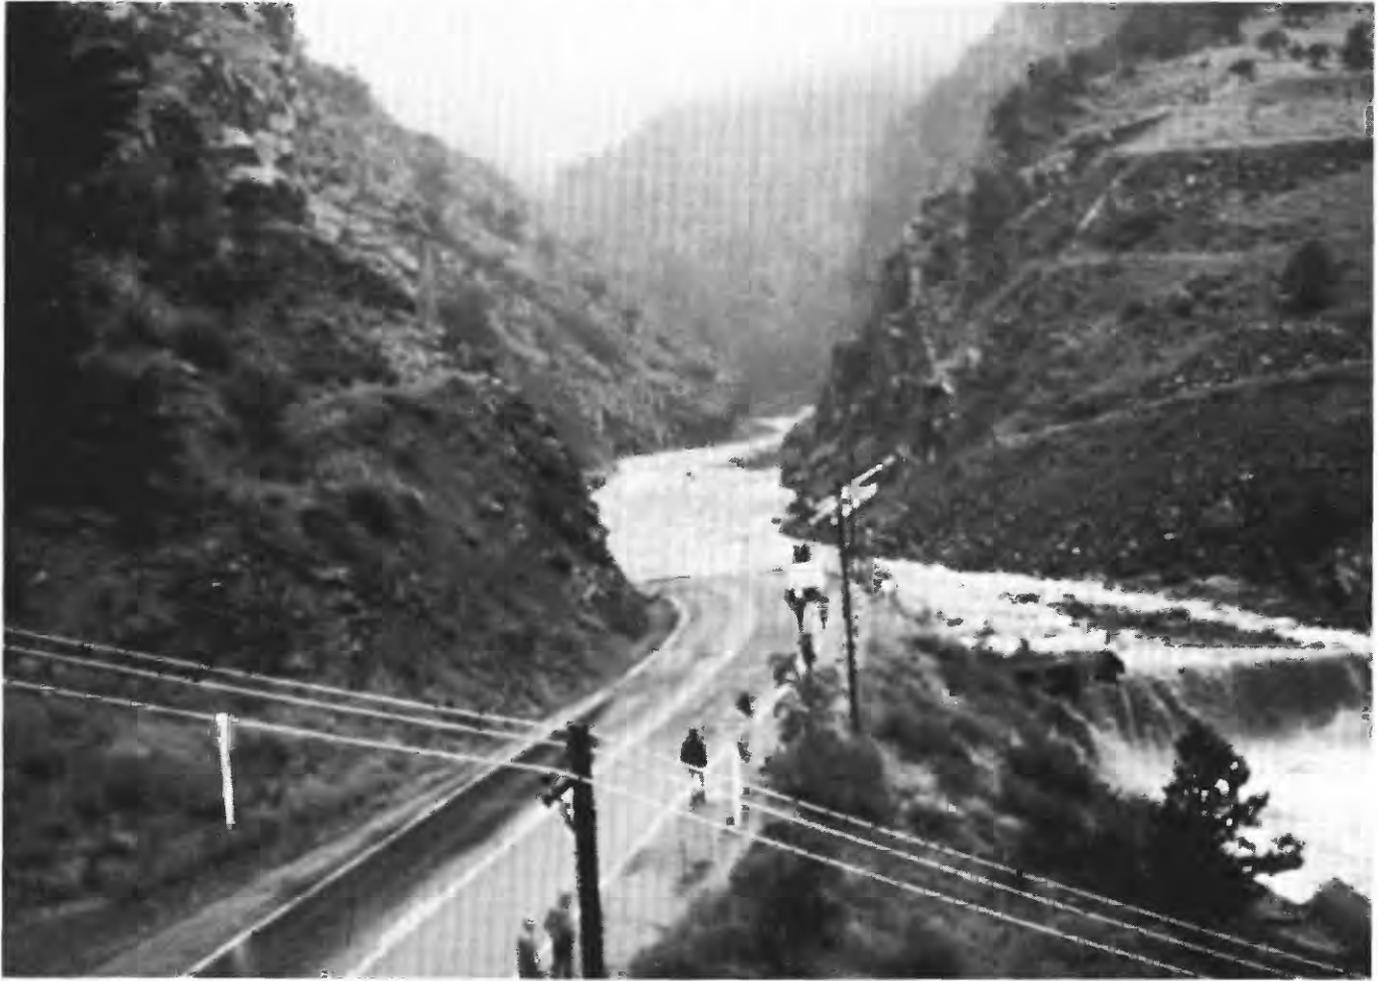
FIGURE 85.—View into The Narrows of Big Thompson Canyon taken from the canyon mouth the afternoon of August 2, 1976, during heavy rainfall. U.S. Highway 34 truncated by scour. Adverse weather and low clouds seriously hampered rescue efforts within the canyon. Crest had fallen but river was still in flood. See also figures 63 and 84.

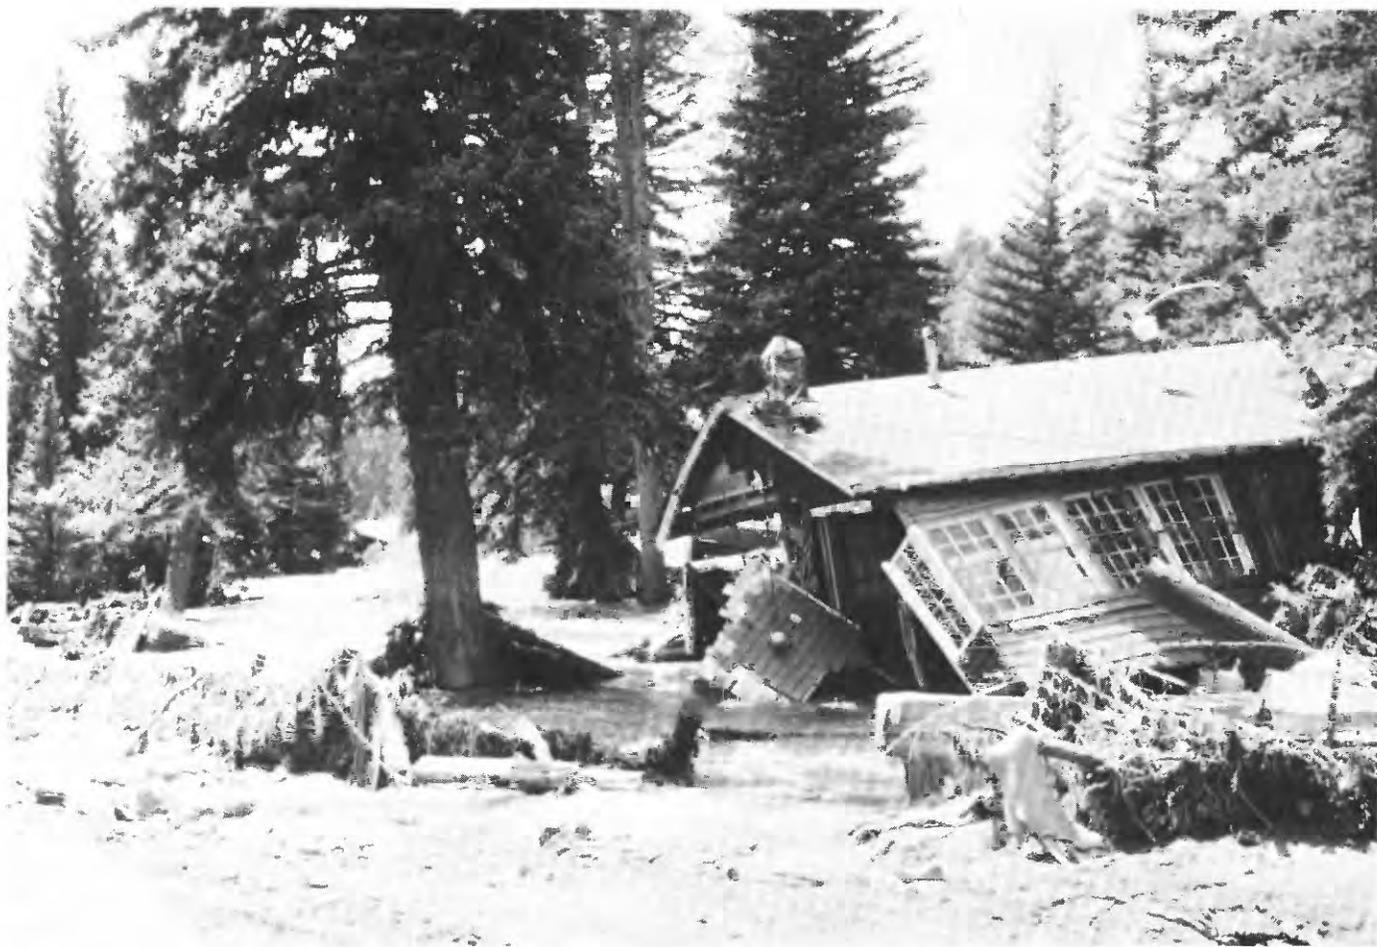
FIGURE 86.—House in the lower end of Devils Gulch, near Glen Haven, demolished by hydraulic forces and impact from floating debris. The upstream side of the house was pushed in and the downstream side was pushed out. Note thick overbank sand and flood debris caught on trees and fences.

Many buildings were damaged or destroyed by floodwater and floating debris. Well-constructed masonry structures fared better than wooden ones, even though many of them lost doors and windows and were partly filled with sediment. Some more lightly constructed frame buildings were destroyed when their upstream sides caved in and their downstream walls were pushed out (fig. 86). On the southeast side of Glen Haven, runoff gullied the hillside, scoured the tributary gulch, and deposited a large sandy fan that spread into Devils Gulch and engulfed buildings and automobiles.

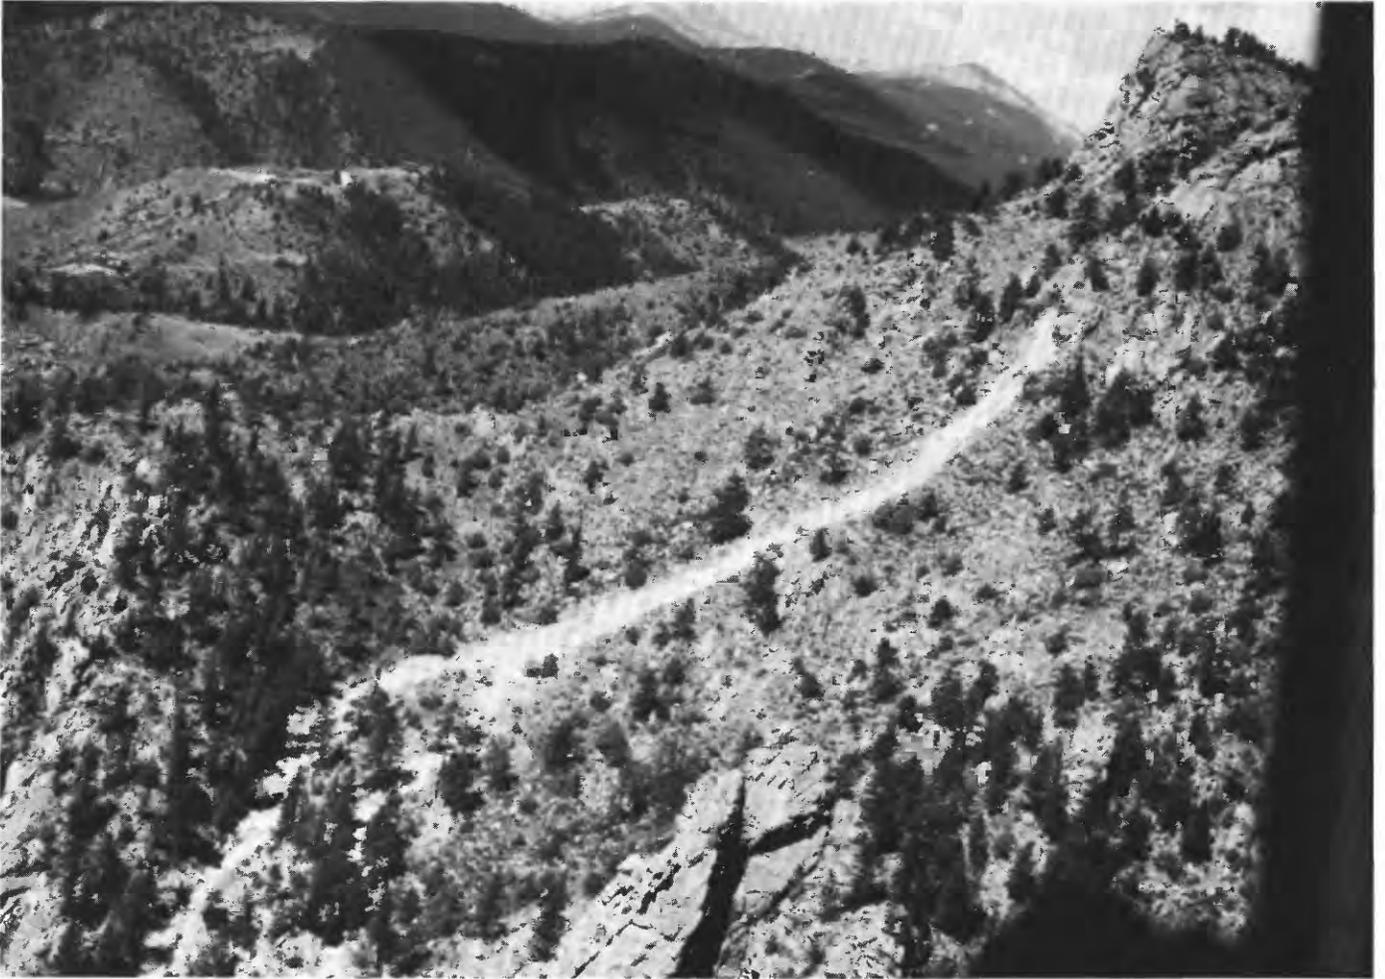
FIGURE 87.—Scar left by debris avalanche that entered the North Fork at mile 5.1. The avalanche originated just below craggy outcrops at right about 520 ft above the North Fork. It cascaded down the 55-percent slope (foreshortened in this view) dumping large boulders and smaller debris onto the canyon floor. Rainfall here was about 7 in.

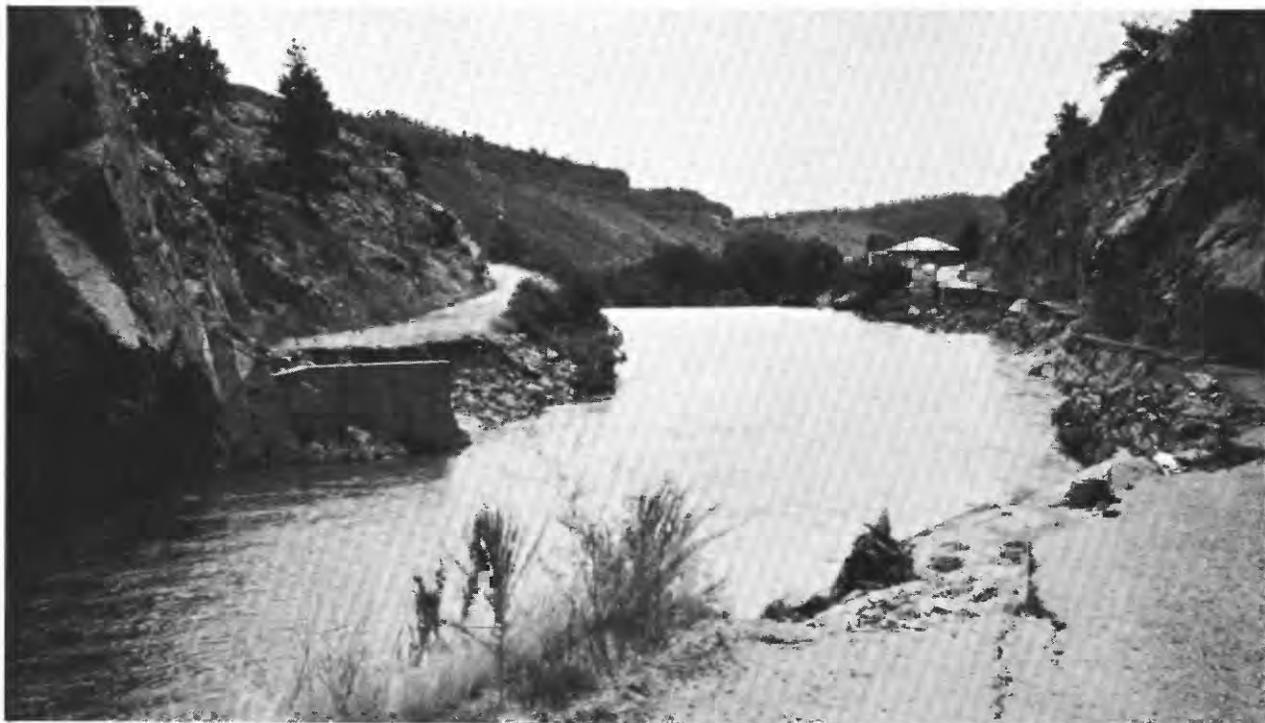
FIGURE 90.—View of damage to road and abutment of steel bridge torn out by Big Thompson River where it crosses first ridge east of Big Thompson Canyon.

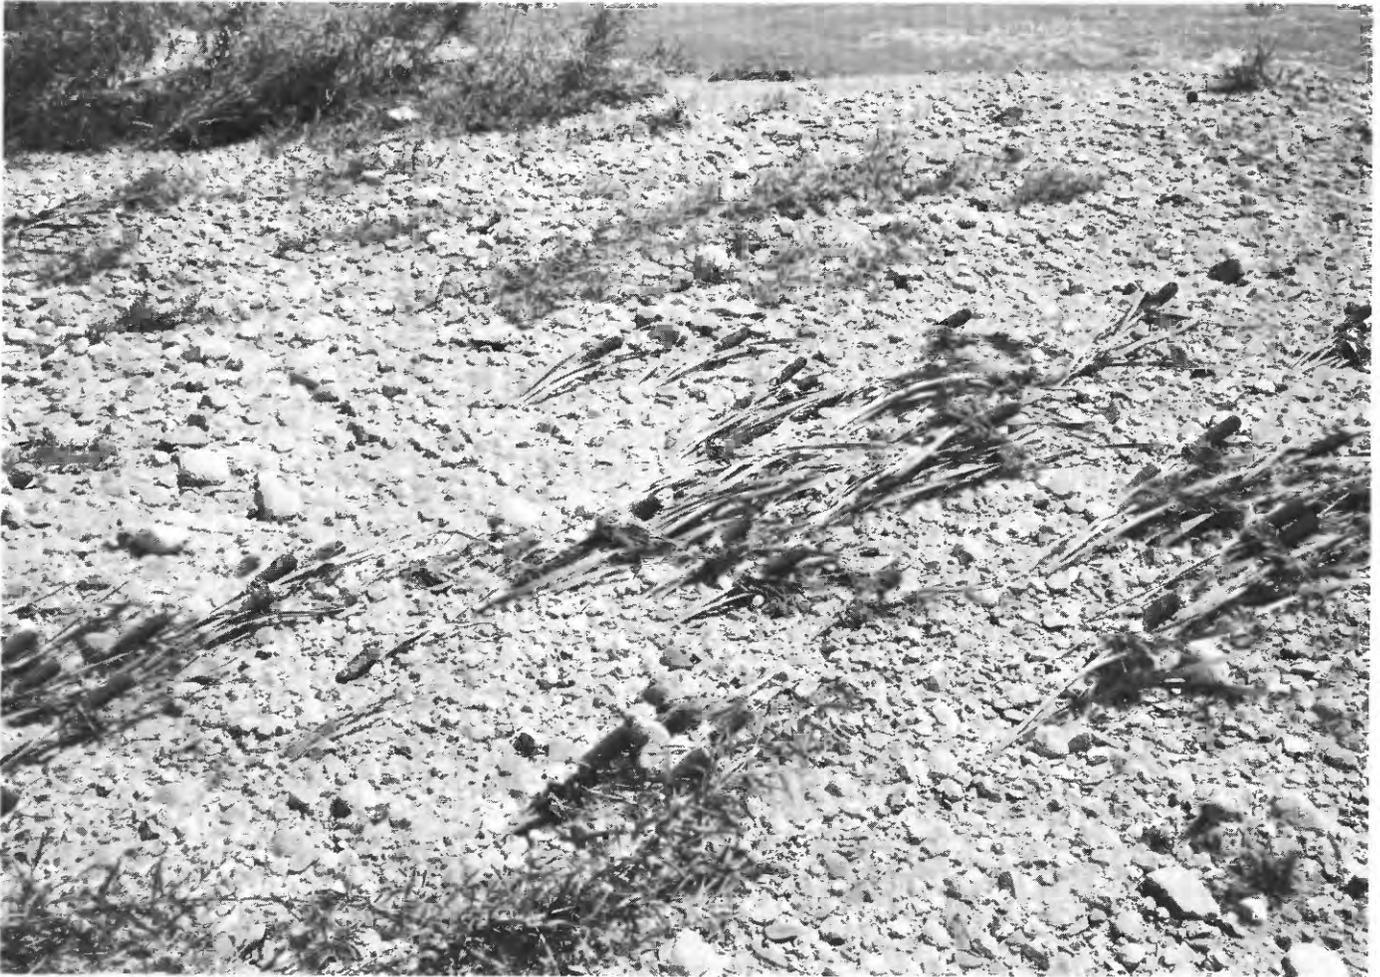
FIGURE 92.—Movement of small cobbles and pebbles on a point bar indicated by partial burial of cattails 2-3 ft tall; about 600 ft east of U.S. Highway 287 south of Loveland.

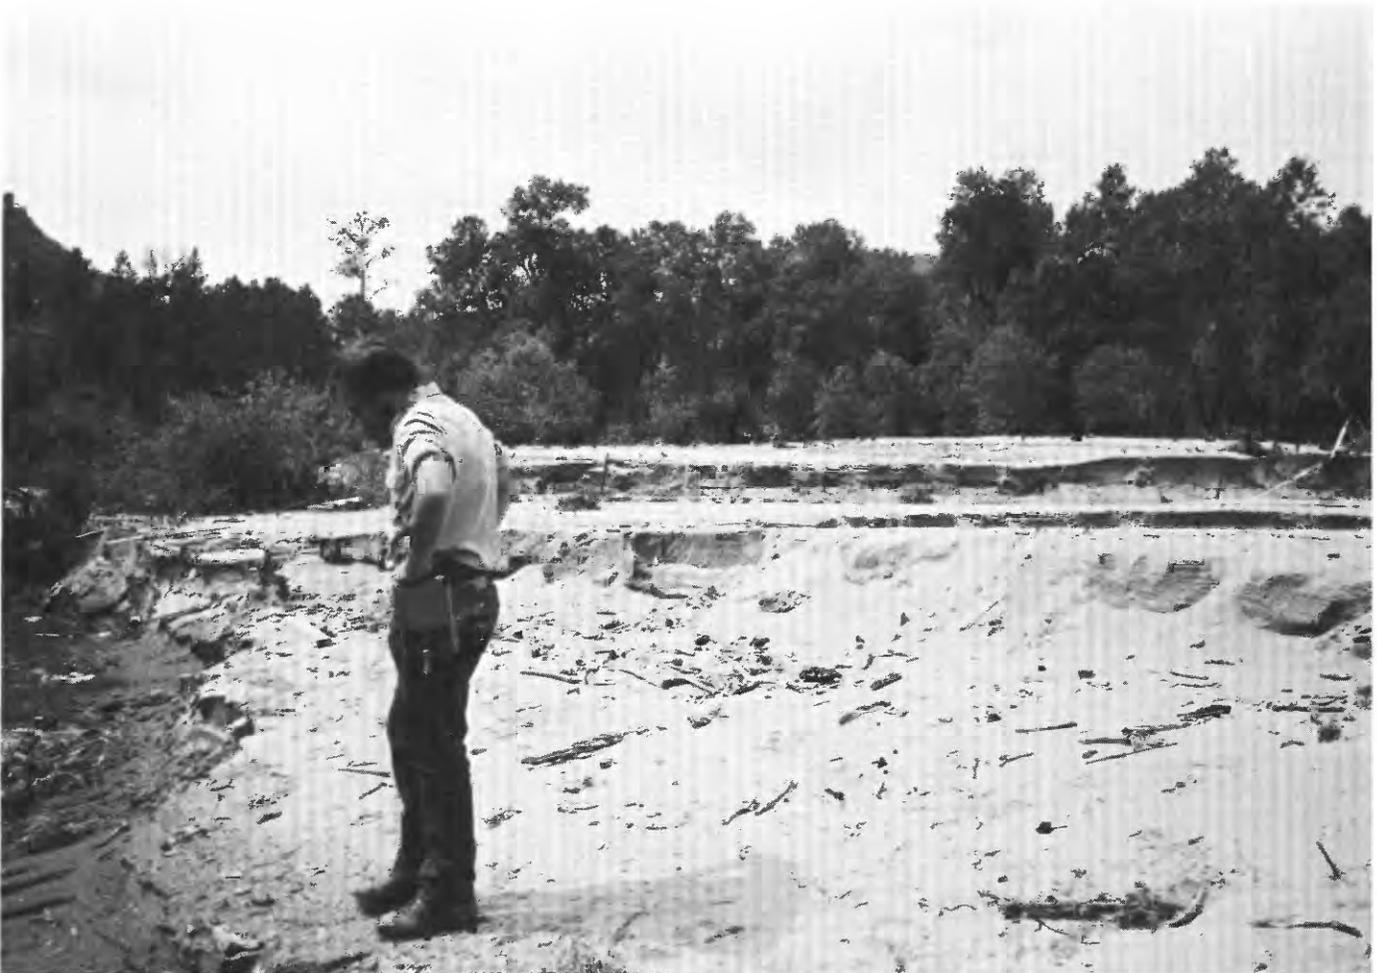
FIGURE 93.—Flood-deposited sand near confluence of Sulzer Gulch and Big Thompson River showing two terraces cut below highest level of deposition.

between terraced mounds of sand as much as 3–6 ft thick made a ragged landscape that probably bore little relation to the preflood surface (fig. 93).

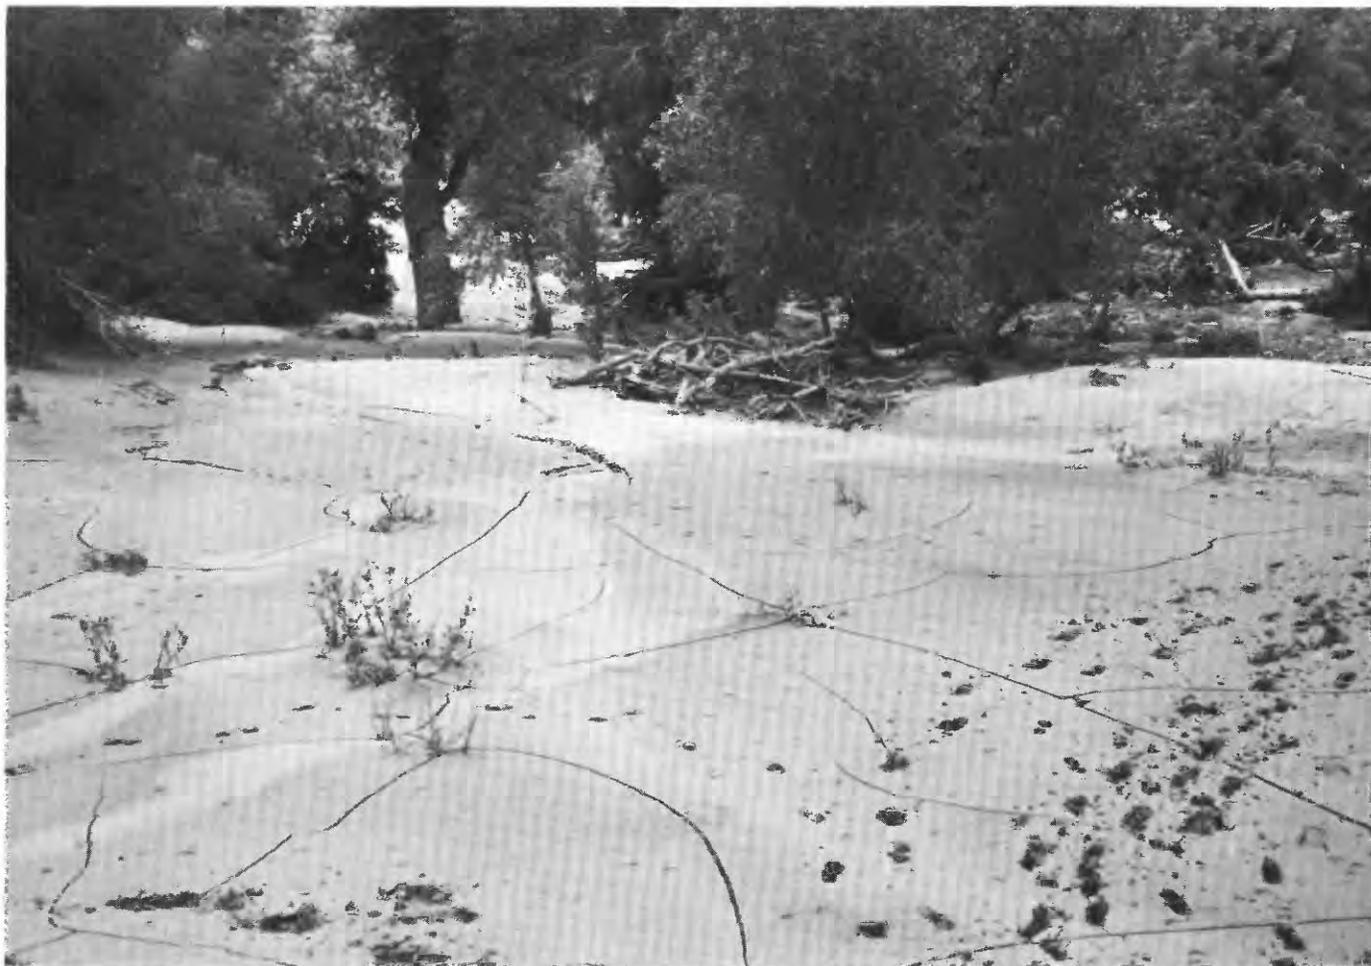
FIGURE 94.—Desiccation cracks in slightly silty very fine sand trapped at mouth of Sulzer Gulch, west of first ridge east of mountain front. Large blocks are 5–8 ft in maximum dimension.
