Storm and Flood of July 31–August 1, 1976, in the Big Thompson River and Cache la Poudre River Basins, Larimer and Weld Counties, Colorado

GEOLOGICAL SURVEY PROFESSIONAL PAPER 1115

Part A. Meteorology and Hydrology in Big Thompson River and Cache la Poudre River Basins

Part B. Geologic and Geomorphic Effects in the Big Thompson Canyon Area, Larimer County

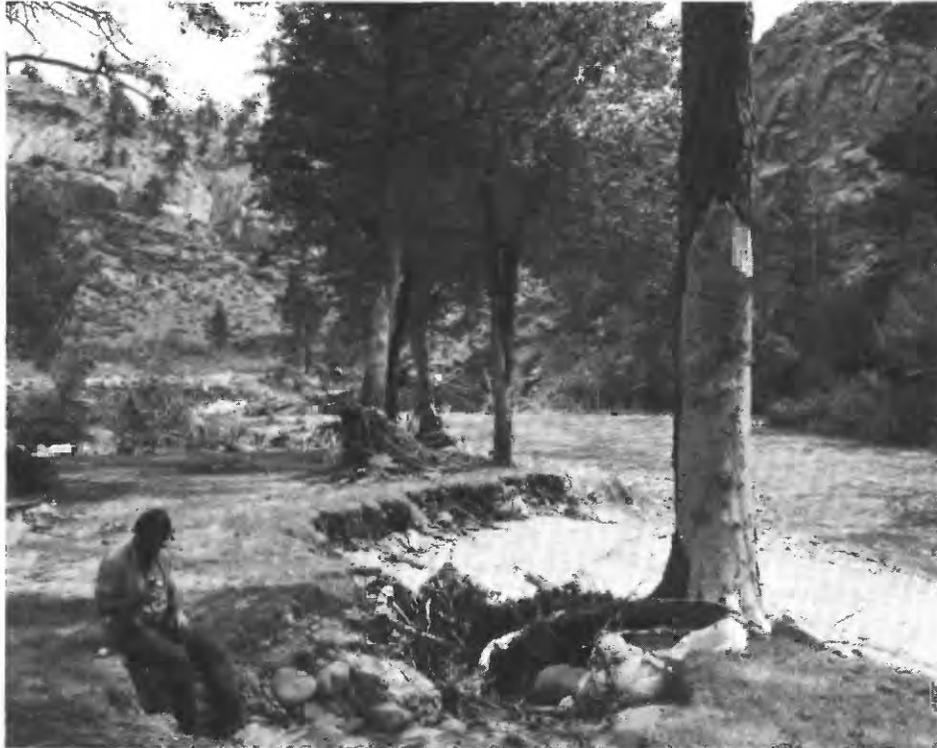
FIGURE 95.—Upstream side of ponderosa pines stripped of bark by impact of flood debris, between dam at mouth of Big Thompson Canyon and first ridge east of canyon; note also, destruction of flood-plain turf.

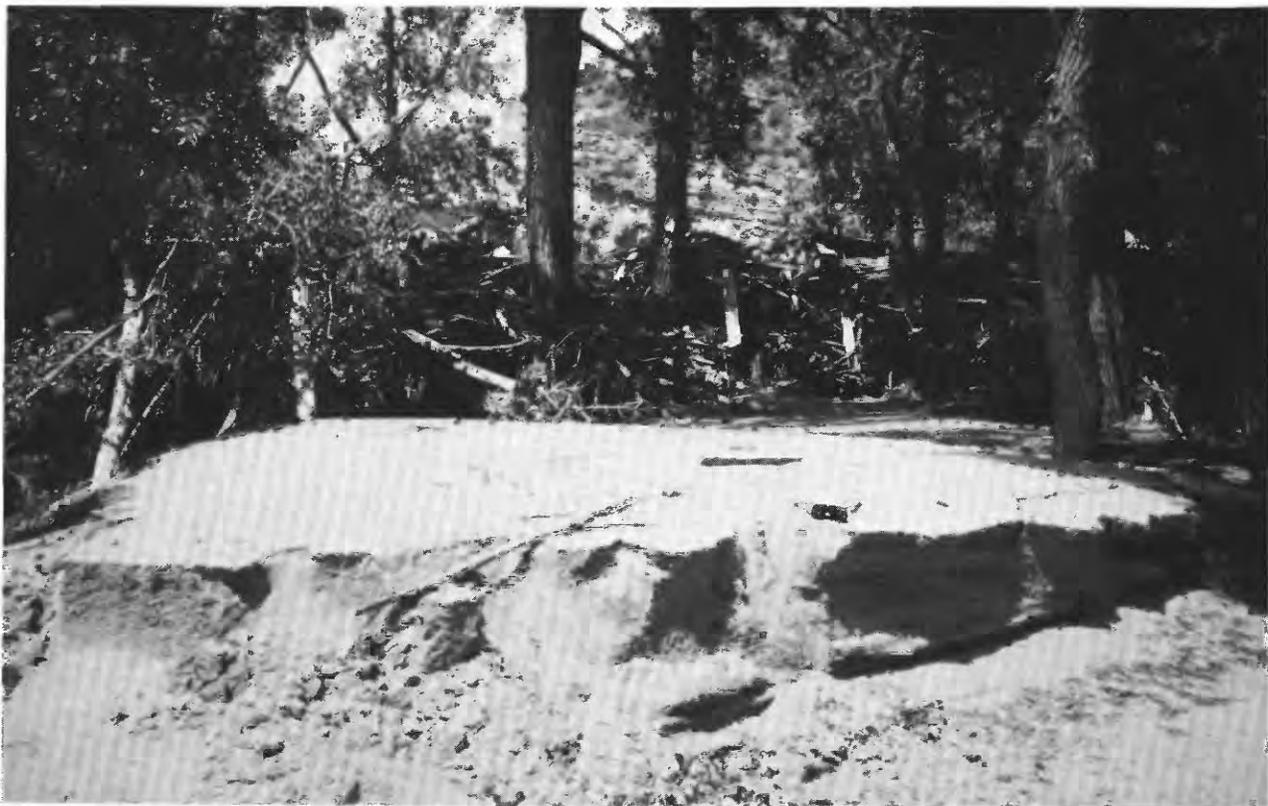
FIGURE 96.—Current-terraced deposit of sand, 3–4 ft thick, on downstream side of debris pile in cottonwood grove about half a mile west of Big Thompson School.

micaceous sand, thinly deposited in open areas but nearly 4 ft thick in the lee of large debris piles in the cottonwood groves north of the Highway 34 bridge (fig. 96). Unobstructed flood currents terraced the thick deposits of sand at one or two levels and left grass exposed in open areas, especially near bank edges. Here, as in other groves farther downstream, massive amounts of broken trees and other buoyant debris were filtered from the flood by standing trees that were able to resist the impact of the flood load. In some places the resulting debris dams provided protection to houses built within several of the groves, but, elsewhere, houses directly exposed to impact were partly destroyed—some beyond reconstruction (fig. 97). Some buildings were rotated on their foundations.

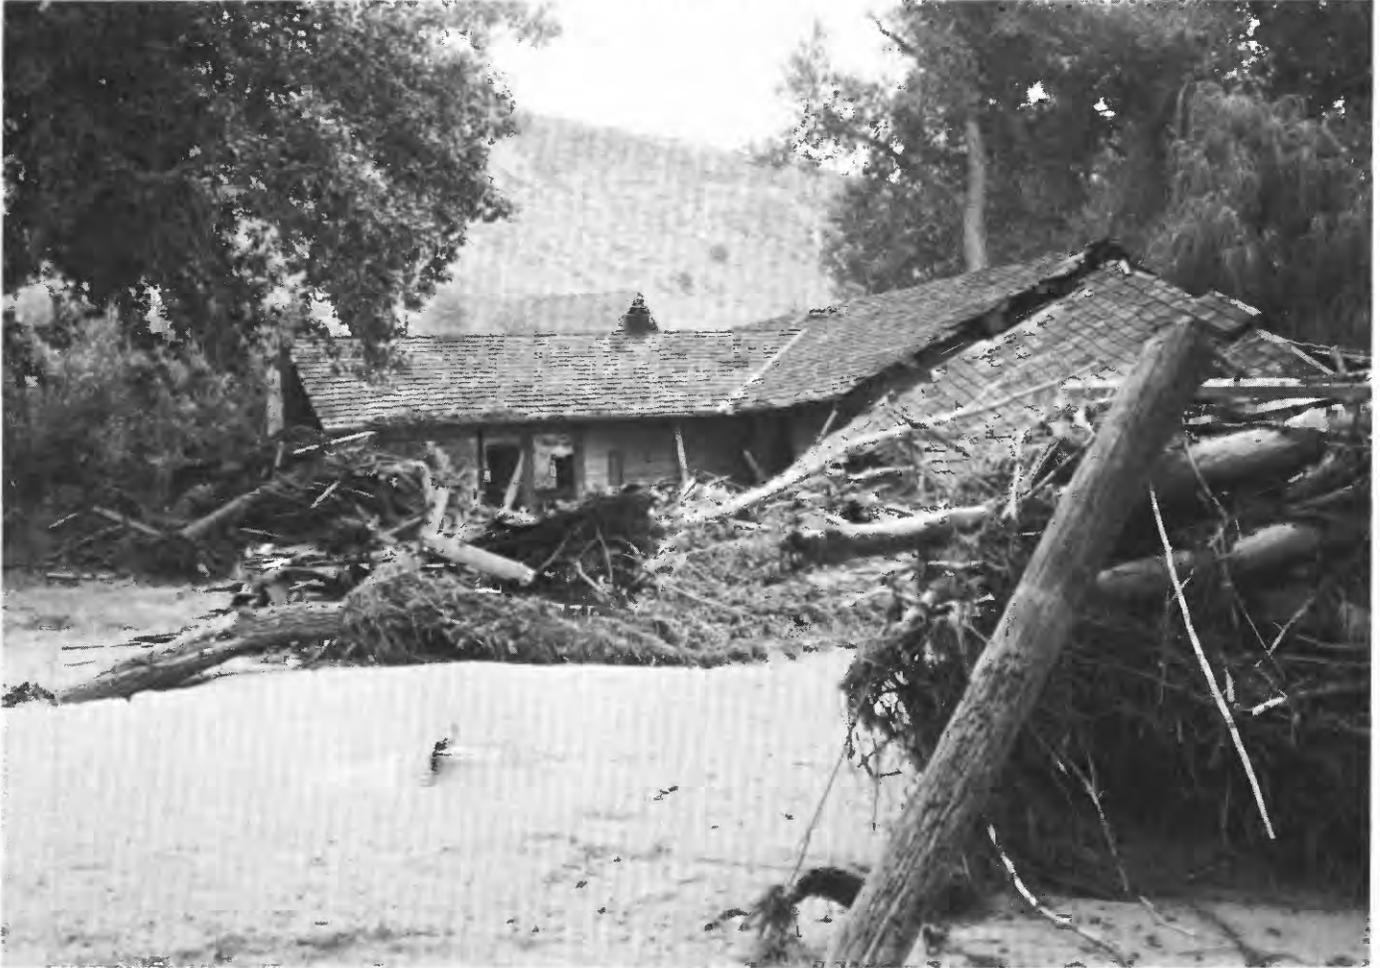
FIGURE 97.—Condemned damaged house and debris pile in cottonwood grove about half a mile west of Big Thompson School.

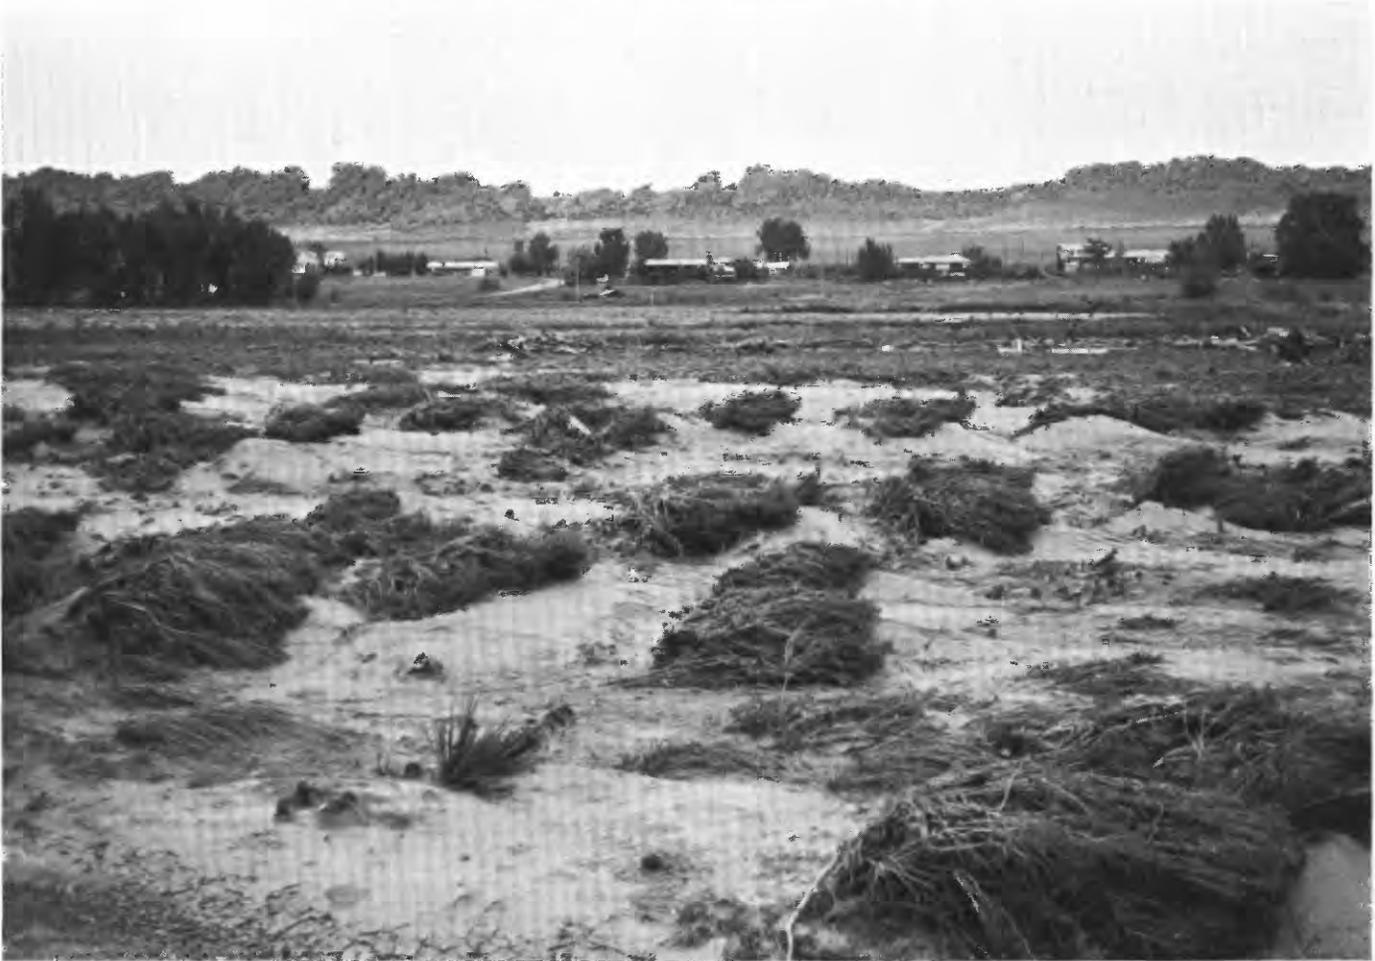
FIGURE 98.—Lee deposits of flood-borne sand on down-current side of bushy weed (3–4 ft original height) east of Glade Road (sec. 7, T. 5 N., R. 69 W.).

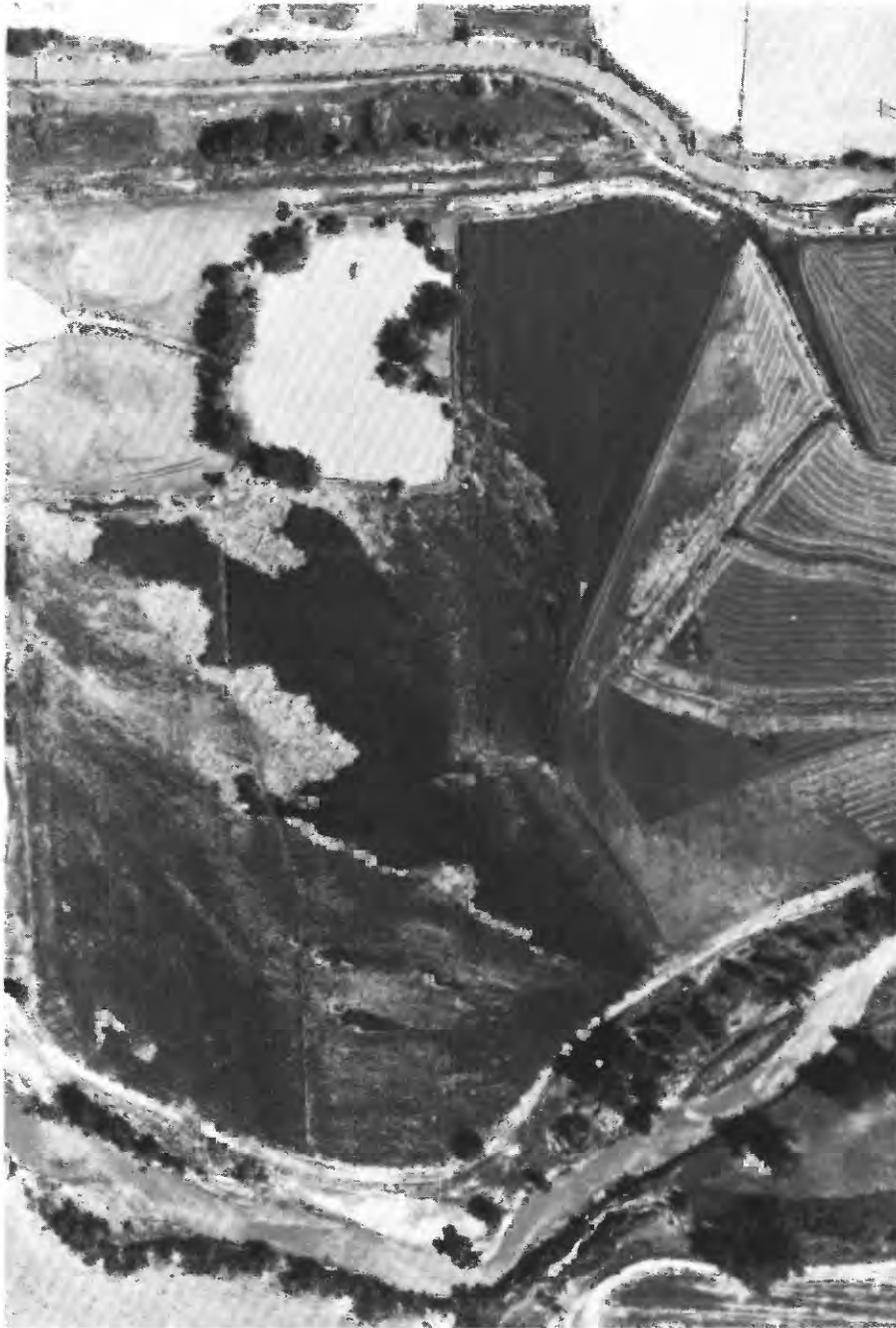
FIGURE 99.—Flood damage in cornfield southwest of Loveland. Debris-laden water, moving from left to right, broke cornstalks in part of the field and drove wedges of broken trees and other debris into corn that remained standing. Approximate scale: 1 in. = 250 ft.

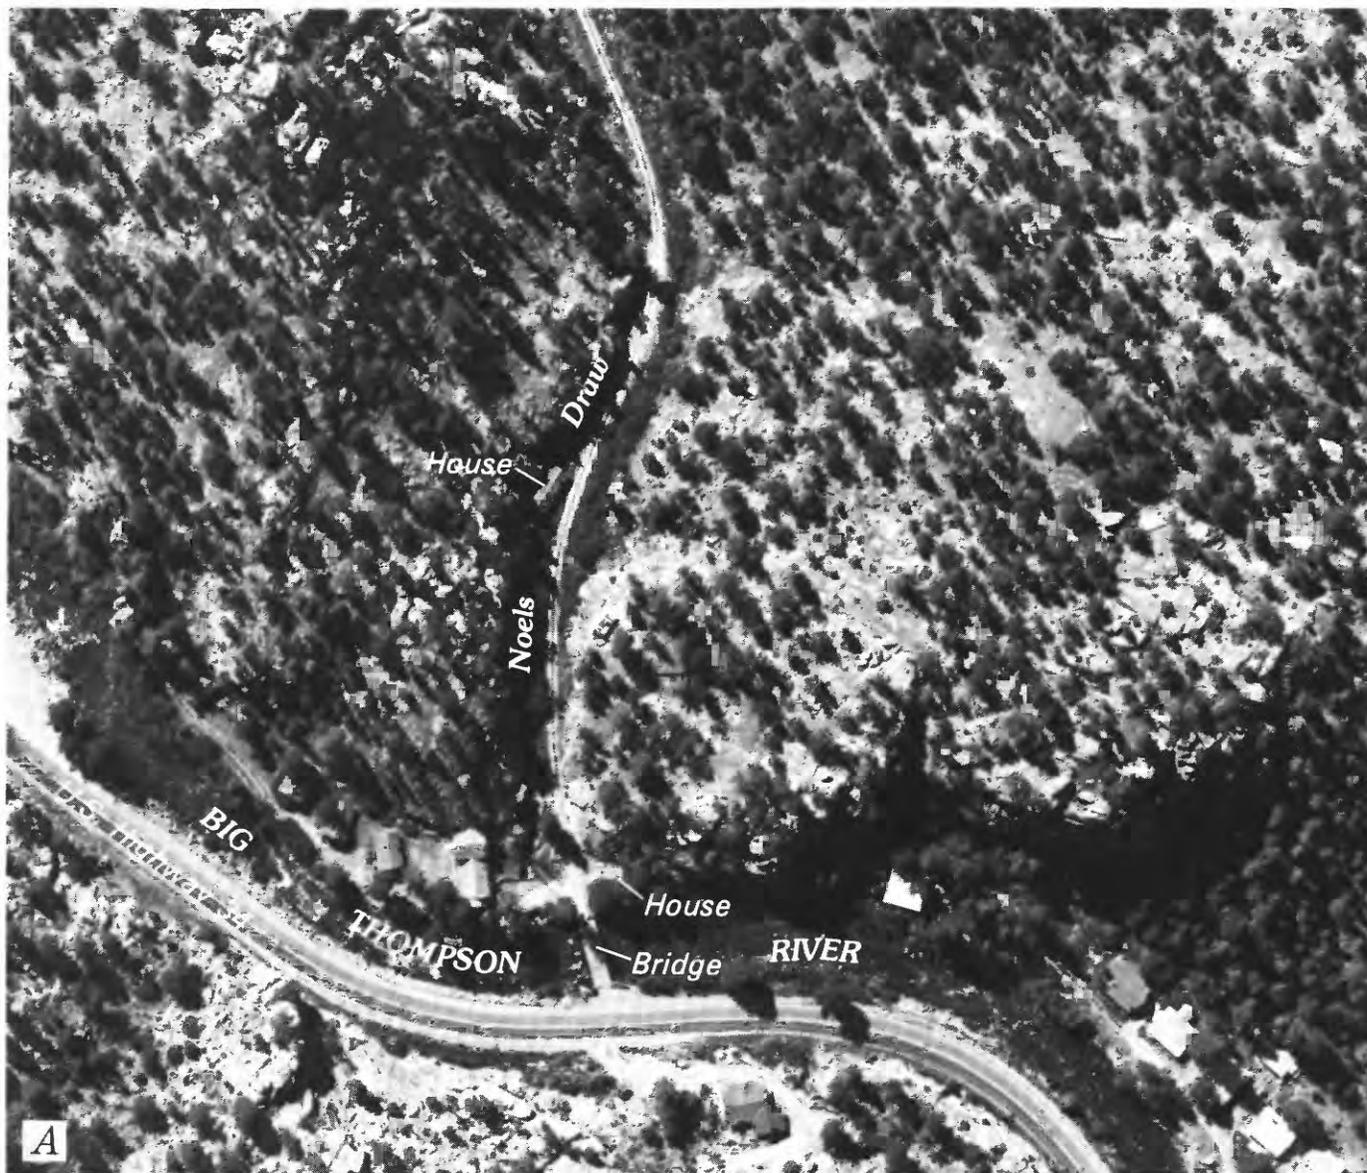
FIGURE 101 (above and facing page).—Aerial views of Noels Draw, mile 52.7 on the Big Thompson River, before and after the 1976 flood. *A*, Preflood view; *B*, postflood view, August 3, 1976. The bedload of Noels Draw had been transported and removed from the draw. This drainageway has a peak discharge of 6,910 ft³/s

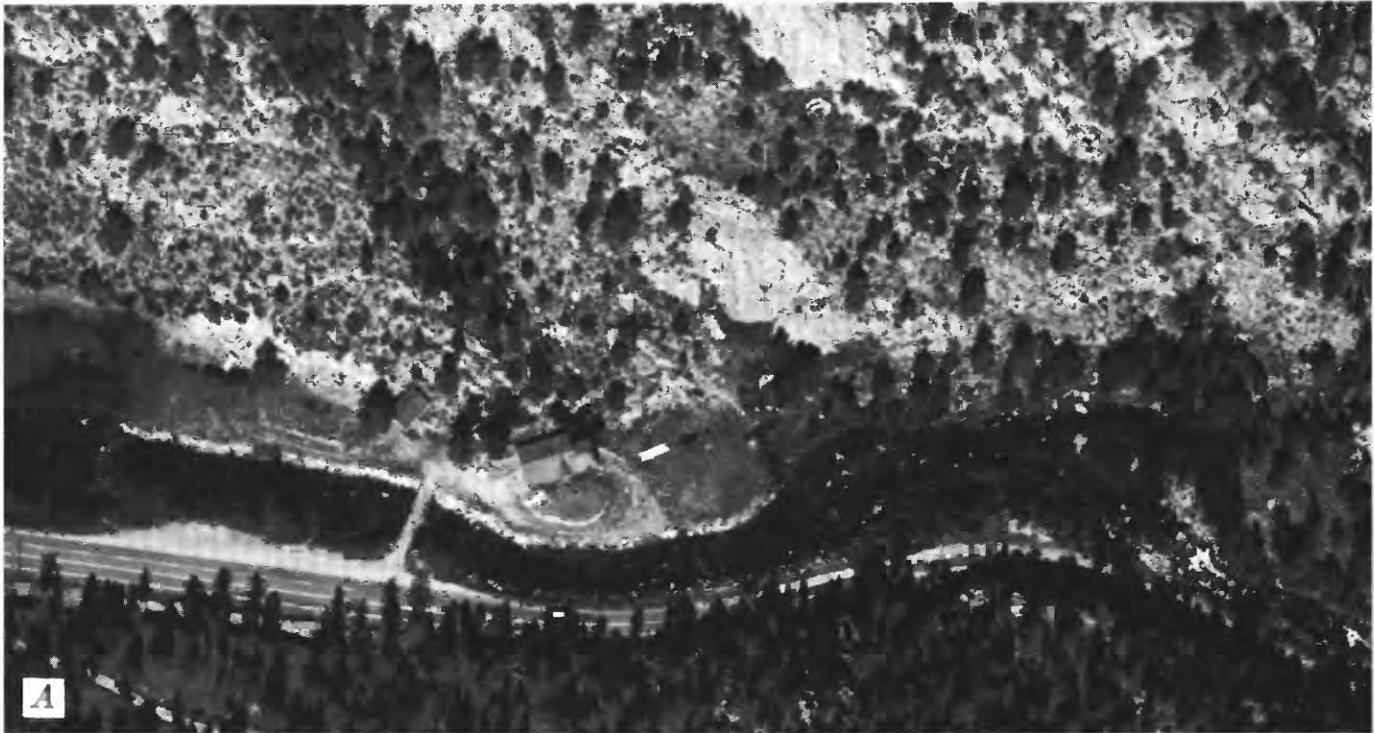
FIGURE 102.—Aerial views of debris fans, mile 51.1 to mile 50.9 on the Big Thompson River, before and after 1976 flood. *A*, Preflood view; *B*, postflood view, August 3, 1976. Note changes in the small debris fans and their associated tributary drainages (outlined); partial destruction of the house shown in figure 103 resulted. A large amount of boulder and vegetation debris is present on the predominantly south facing slopes in these tributary drainages. Approximate scale: 1 in. = 200 ft.

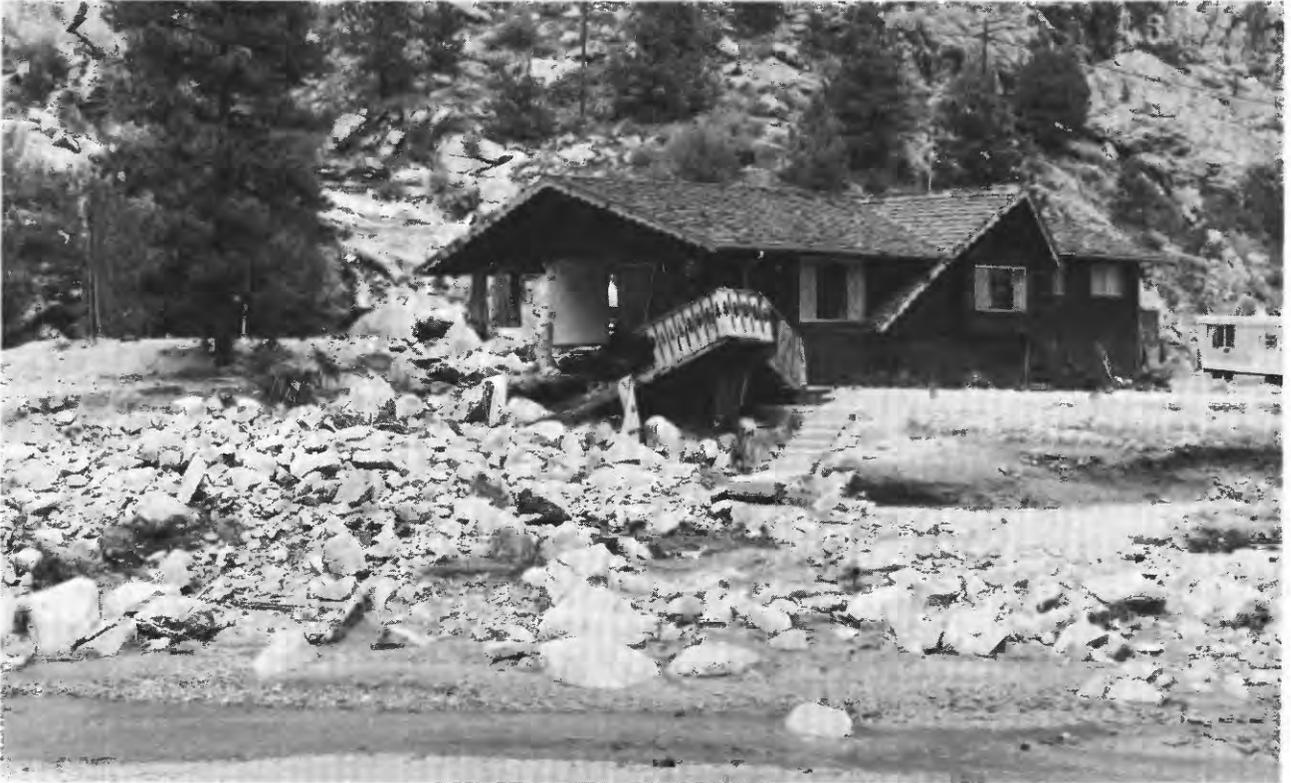
FIGURE 103.—House on debris fan at mile 51.1, Big Thompson River, damaged by boulder debris. Part of the building has been crushed. The house was pushed about 4 ft off its foundation. The mobile home to the right and another home out of view to the left (fig. 102) were virtually undamaged.

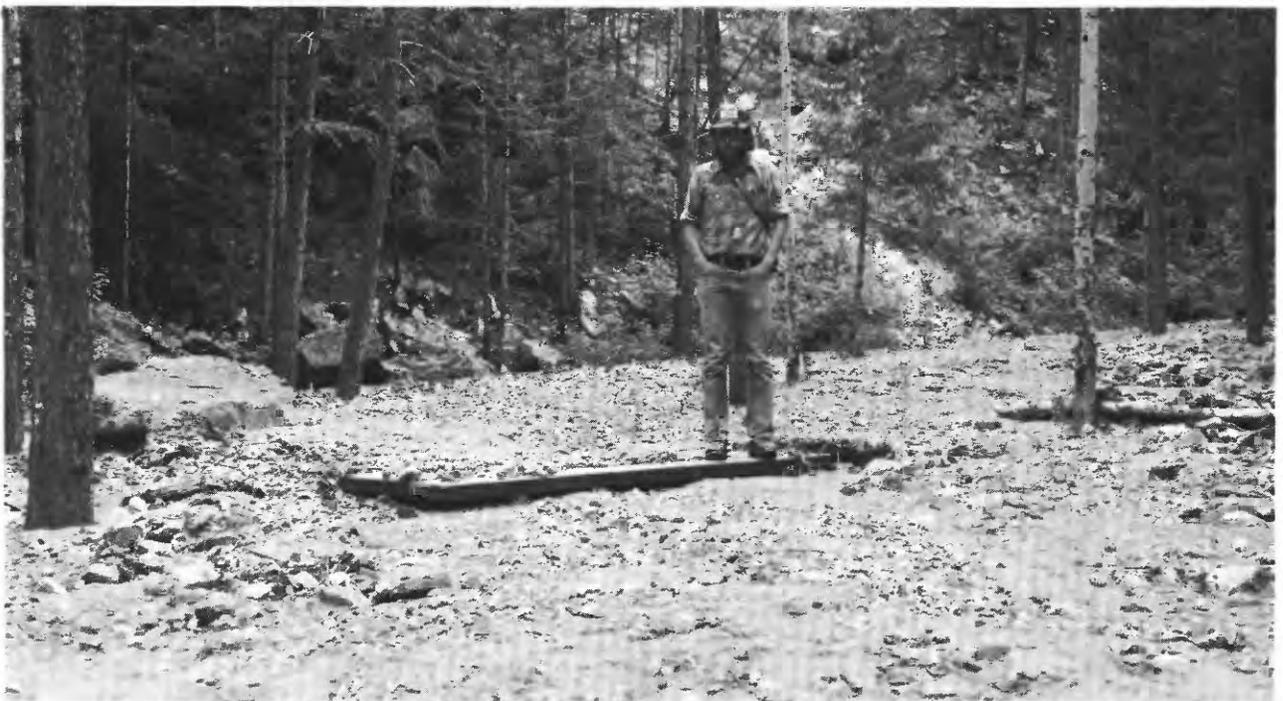
FIGURE 104.—Deposit of sand- to cobble-size material on a debris fan near mile 7.3, North Fork Big Thompson River. Deposit is about 4 ft thick. The man is standing on a picnic table that was engulfed by the deposit.

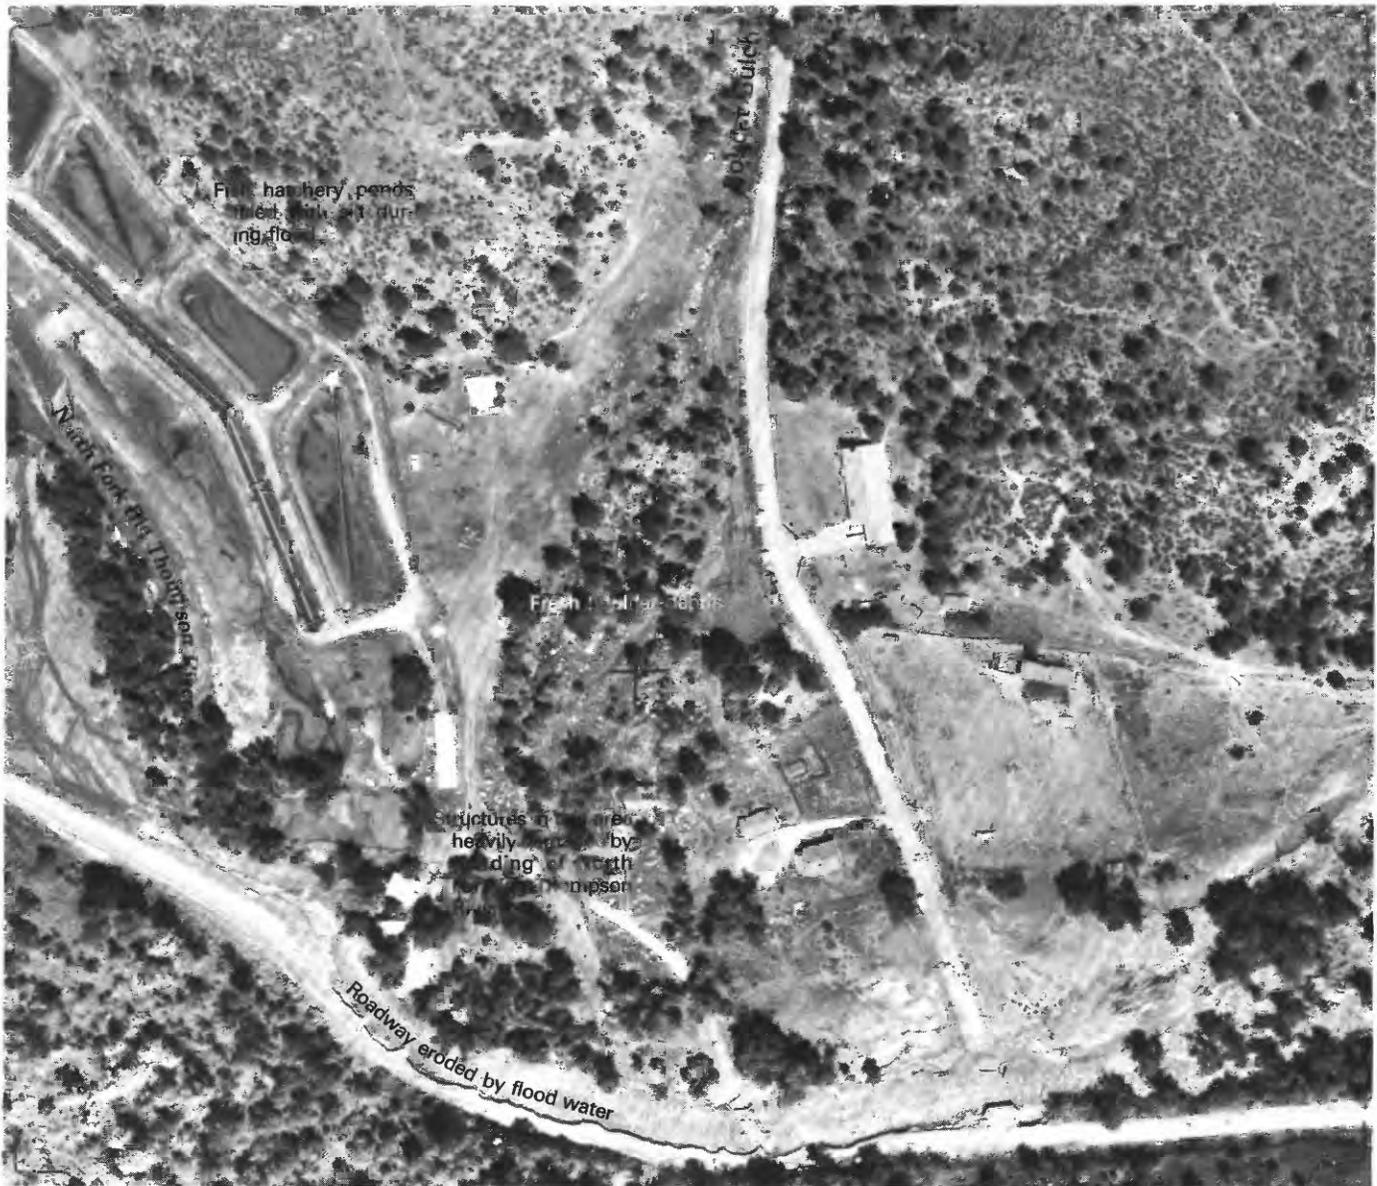
FIGURE 105.—Postflood aerial view of Bobcat Gulch debris fan, mile 0.5 on the North Fork Big Thompson River, August 3, 1976. The many fresh boulders on this debris fan indicate a relatively recent flood, although the water of the 1976 flood was deflected around this debris deposit. Approximate scale: 1 in. = 200 ft.

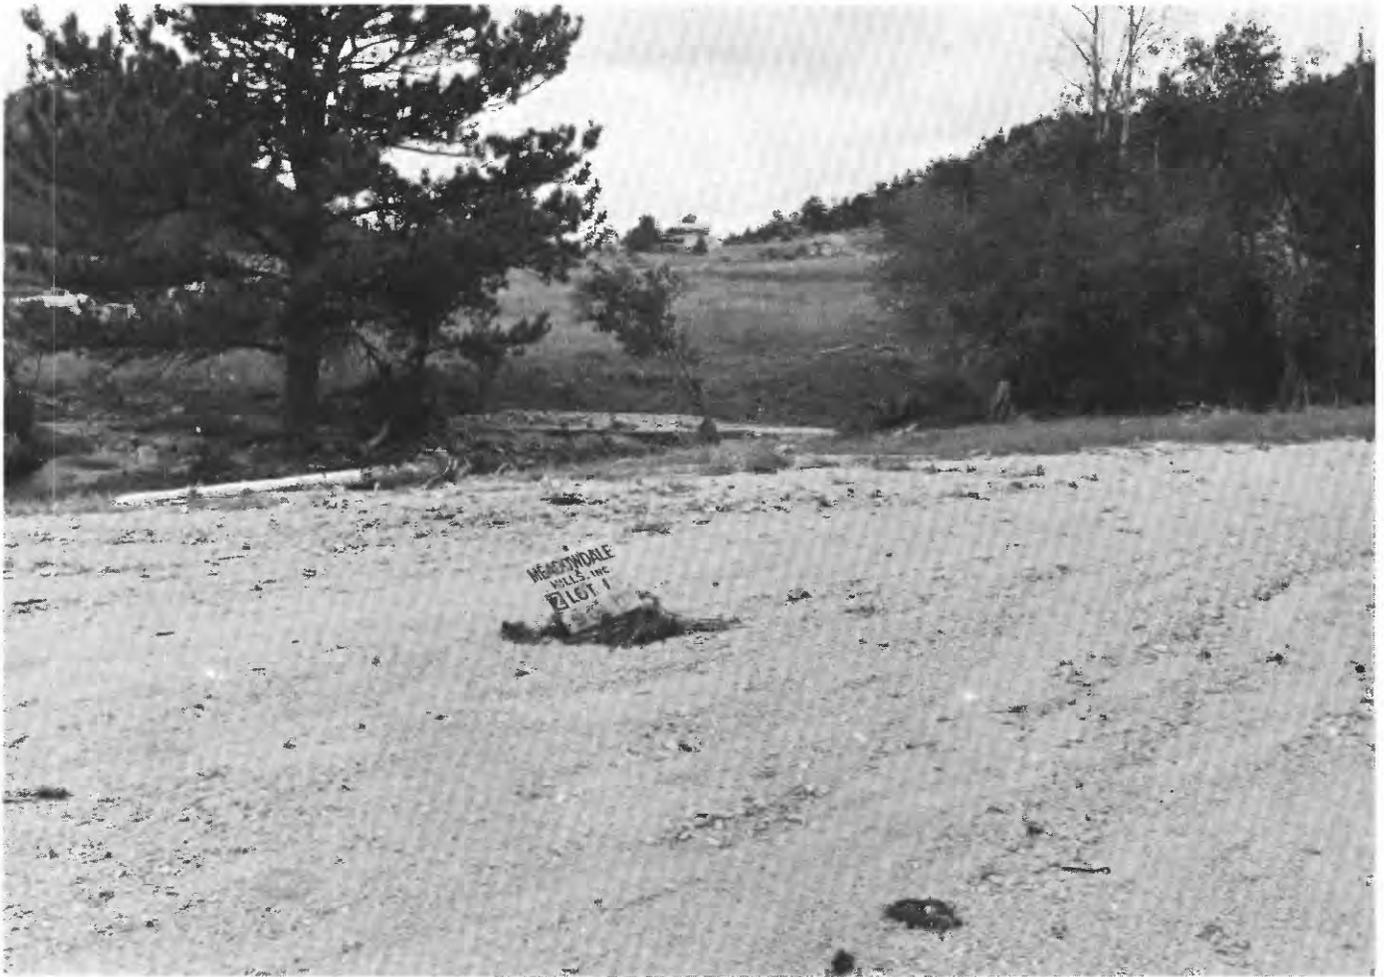
FIGURE 106.—Building lot covered by sediment, in a subdivision where colluvium derived from grus was eroded and redeposited. There was little pre-flood indication of the potential problem. Meadowdale area, near the divide between the Big Thompson and St. Vrain drainages.

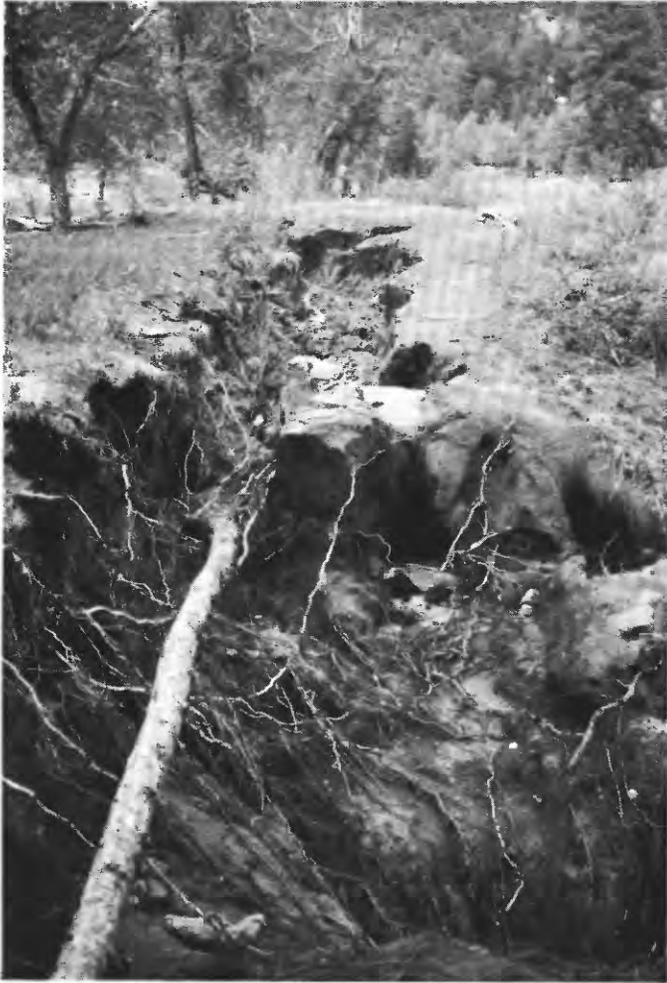
FIGURE 107.—Gully erosion in fine-grained, relatively thick colluvium or residuum derived from granitic rocks. Gully is about 4 ft deep in the foreground. Near mile 54.4 on the Big Thompson River.

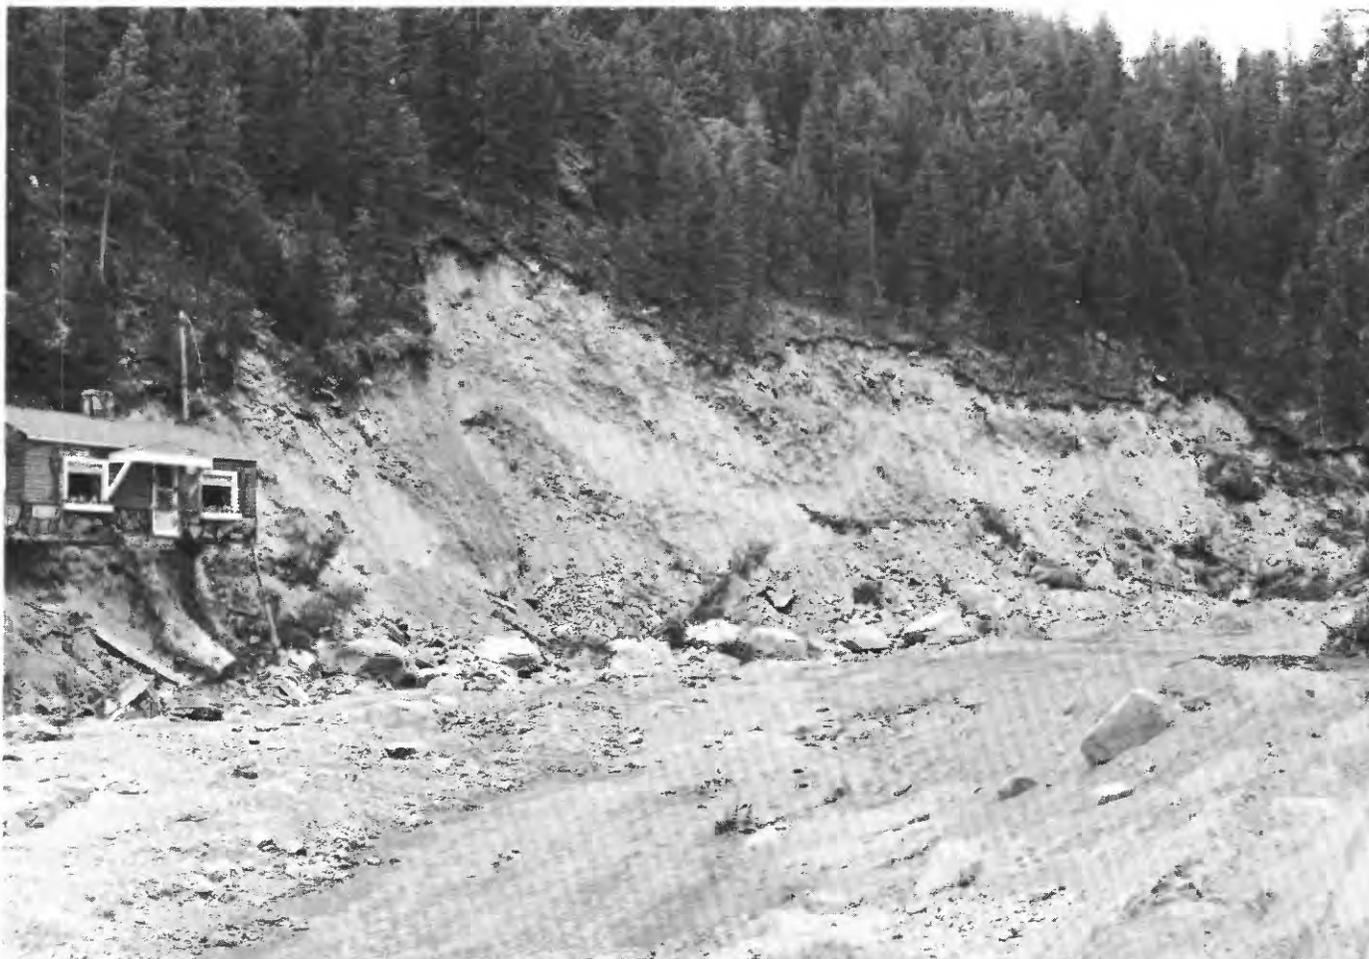
FIGURE 108.—Landslide in Glen Comfort area, mile 52.4 on the Big Thompson River. This landslide was initiated, presumably, before the 1976 flood when a roadcut was made at the base of the slope. During the flood, the road and the house that it served were eroded away and destroyed. Additional erosion into the slope by the Big Thompson River caused further failure of the landslide. Note also the erosion under the house on the left.

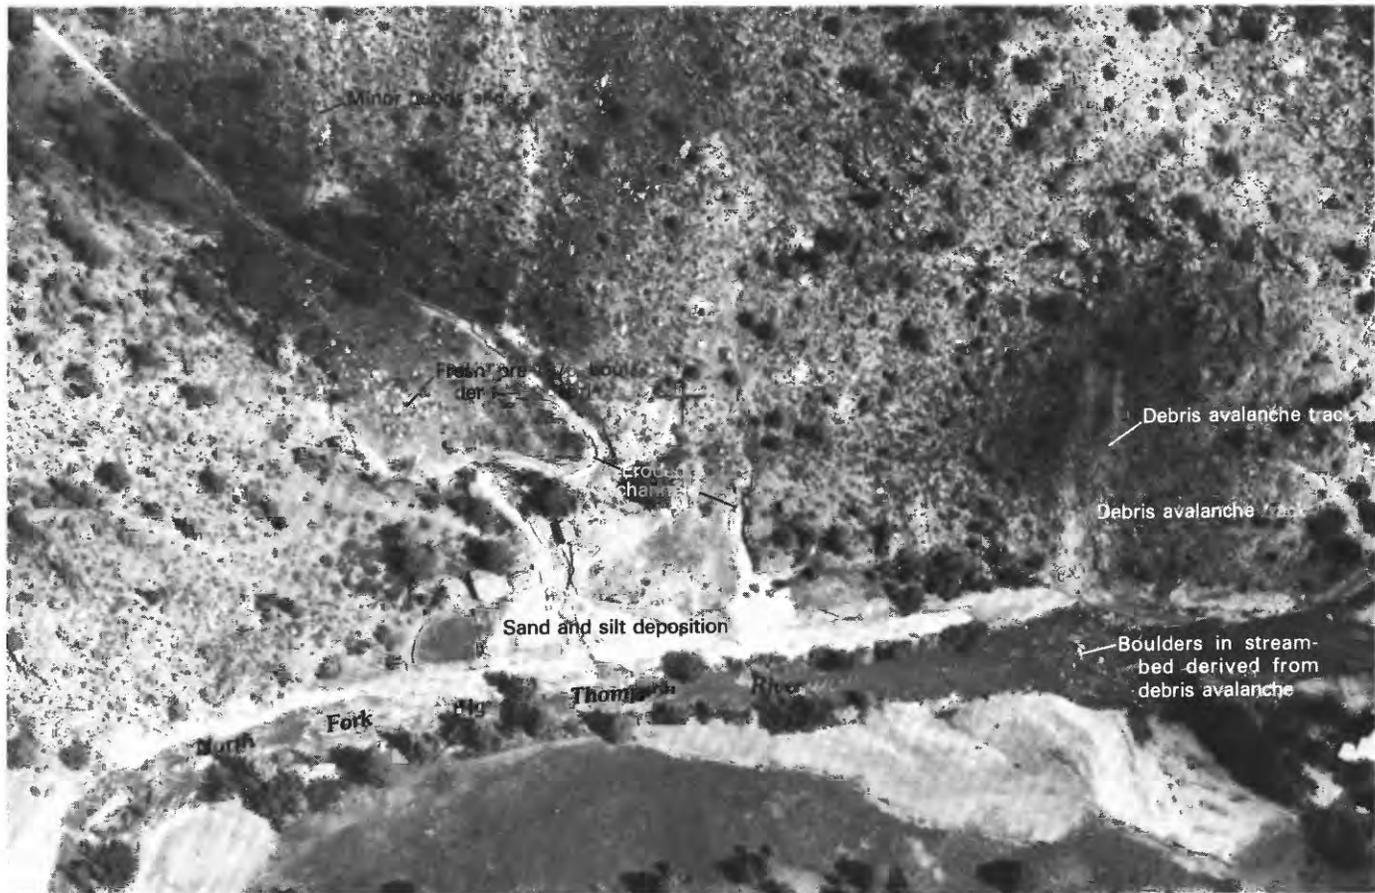
FIGURE 109.—Aerial view of debris avalanches from 1976 storm and flood, between mile 5.2 and mile 5.4 on the North Fork Big Thompson River. Debris avalanches were not common during the July 31, 1976 storm, but places susceptible to them are numerous in the Big Thompson area. The indicated features formed during the storm. Approximate scale: 1 in. = 200 ft.
