Recent Vegetation Changes Along the Colorado River Between Glen Canyon Dam and Lake Mead, Arizona

GEOLOGICAL SURVEY PROFESSIONAL PAPER 1132

By RAYMOND M. TURNER *and* MARTIN M. KARPISCAK

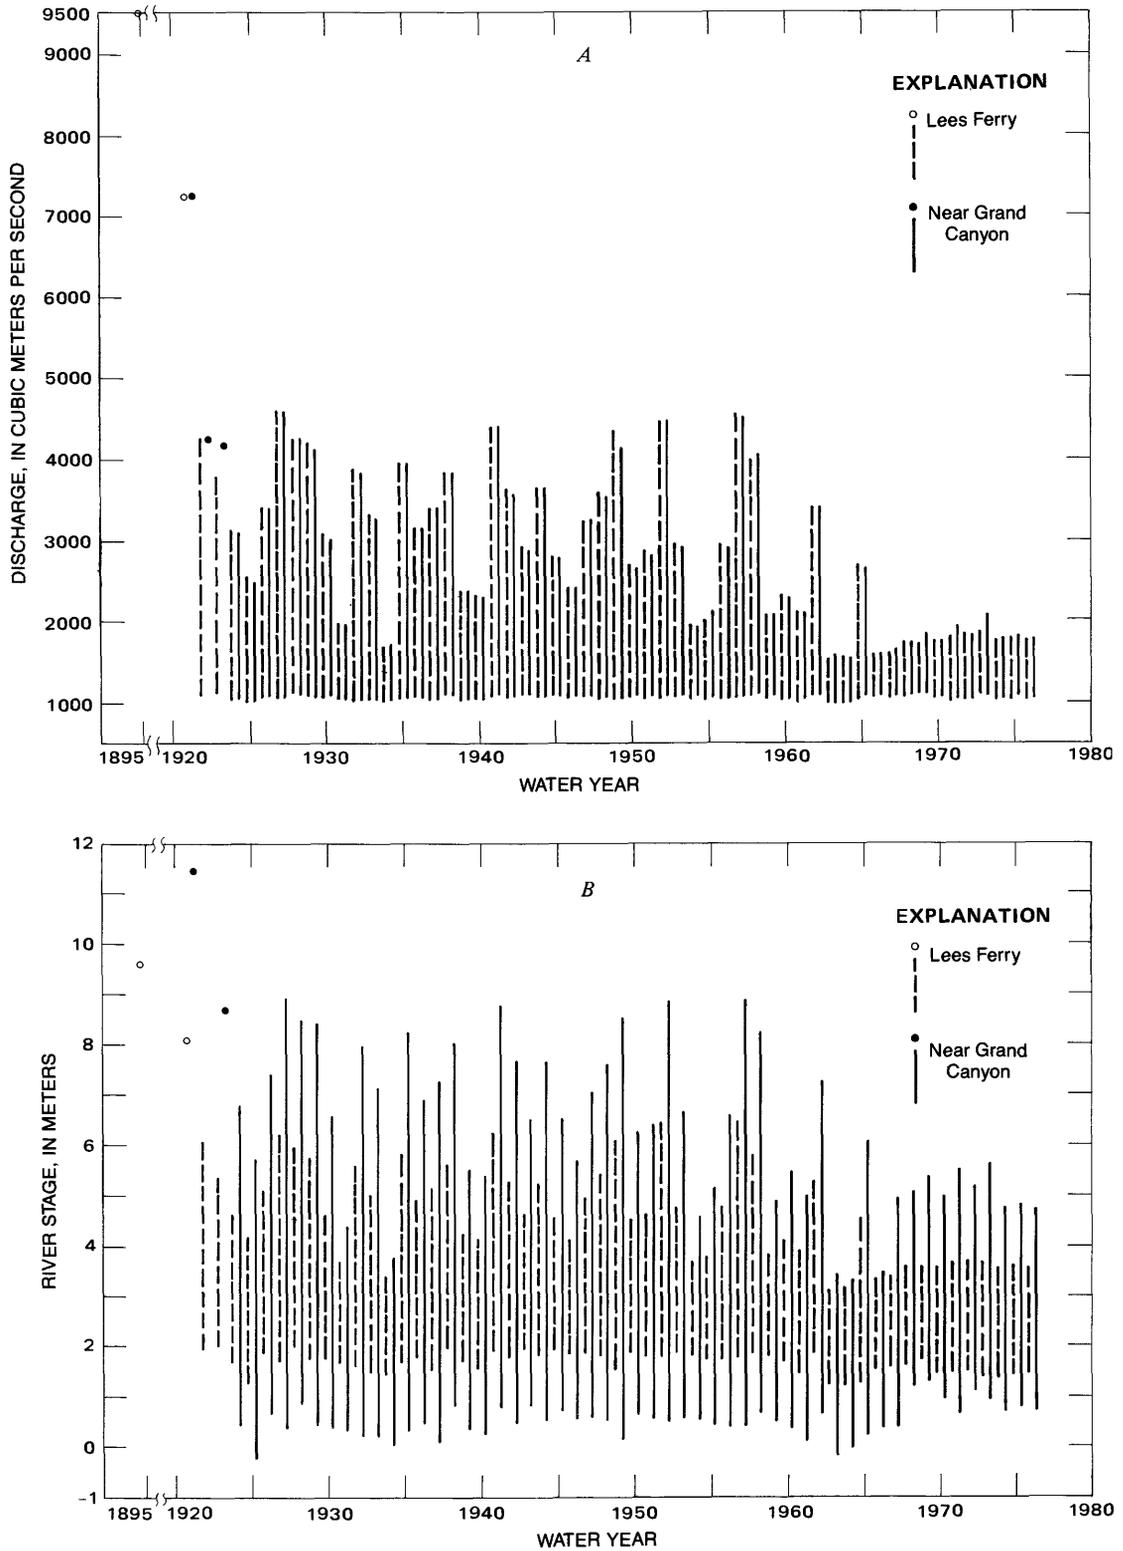
FIGURE 1.—Yearly range between minimum daily and maximum discharge (A) and yearly range between minimum and maximum stage (B) of Colorado River at Lees Ferry and near Grand Canyon.

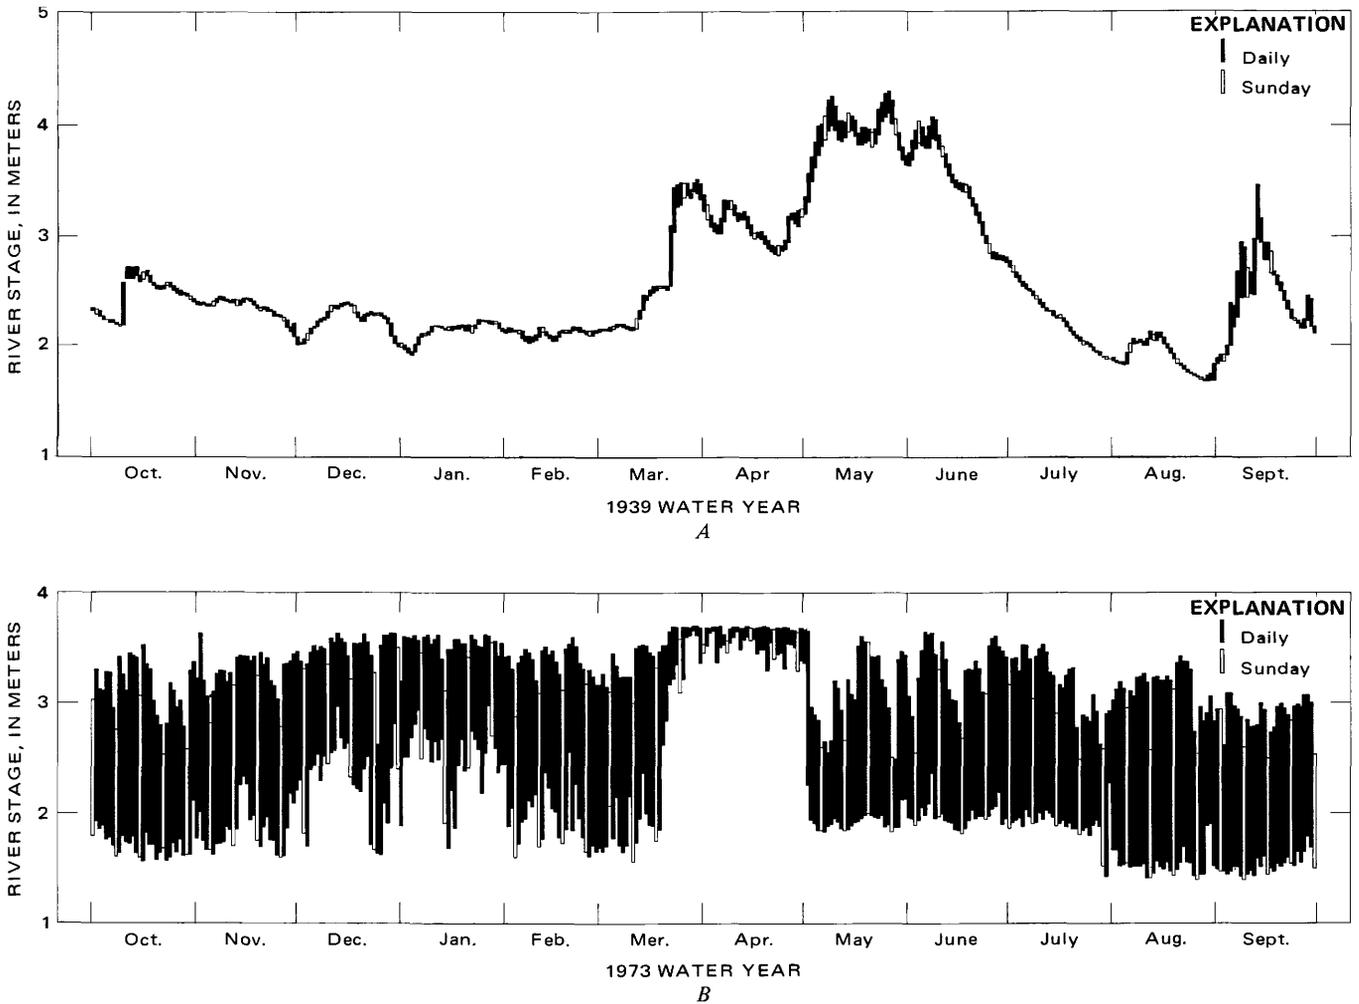
FIGURE 2.—Daily variation in river stage during two selected years, Colorado River at Lees Ferry: (A) water year 1939, before Glen Canyon Dam was built; (B) water year 1973, after Glen Canyon Dam was completed. Bars connect the daily maximum and daily minimum stage.

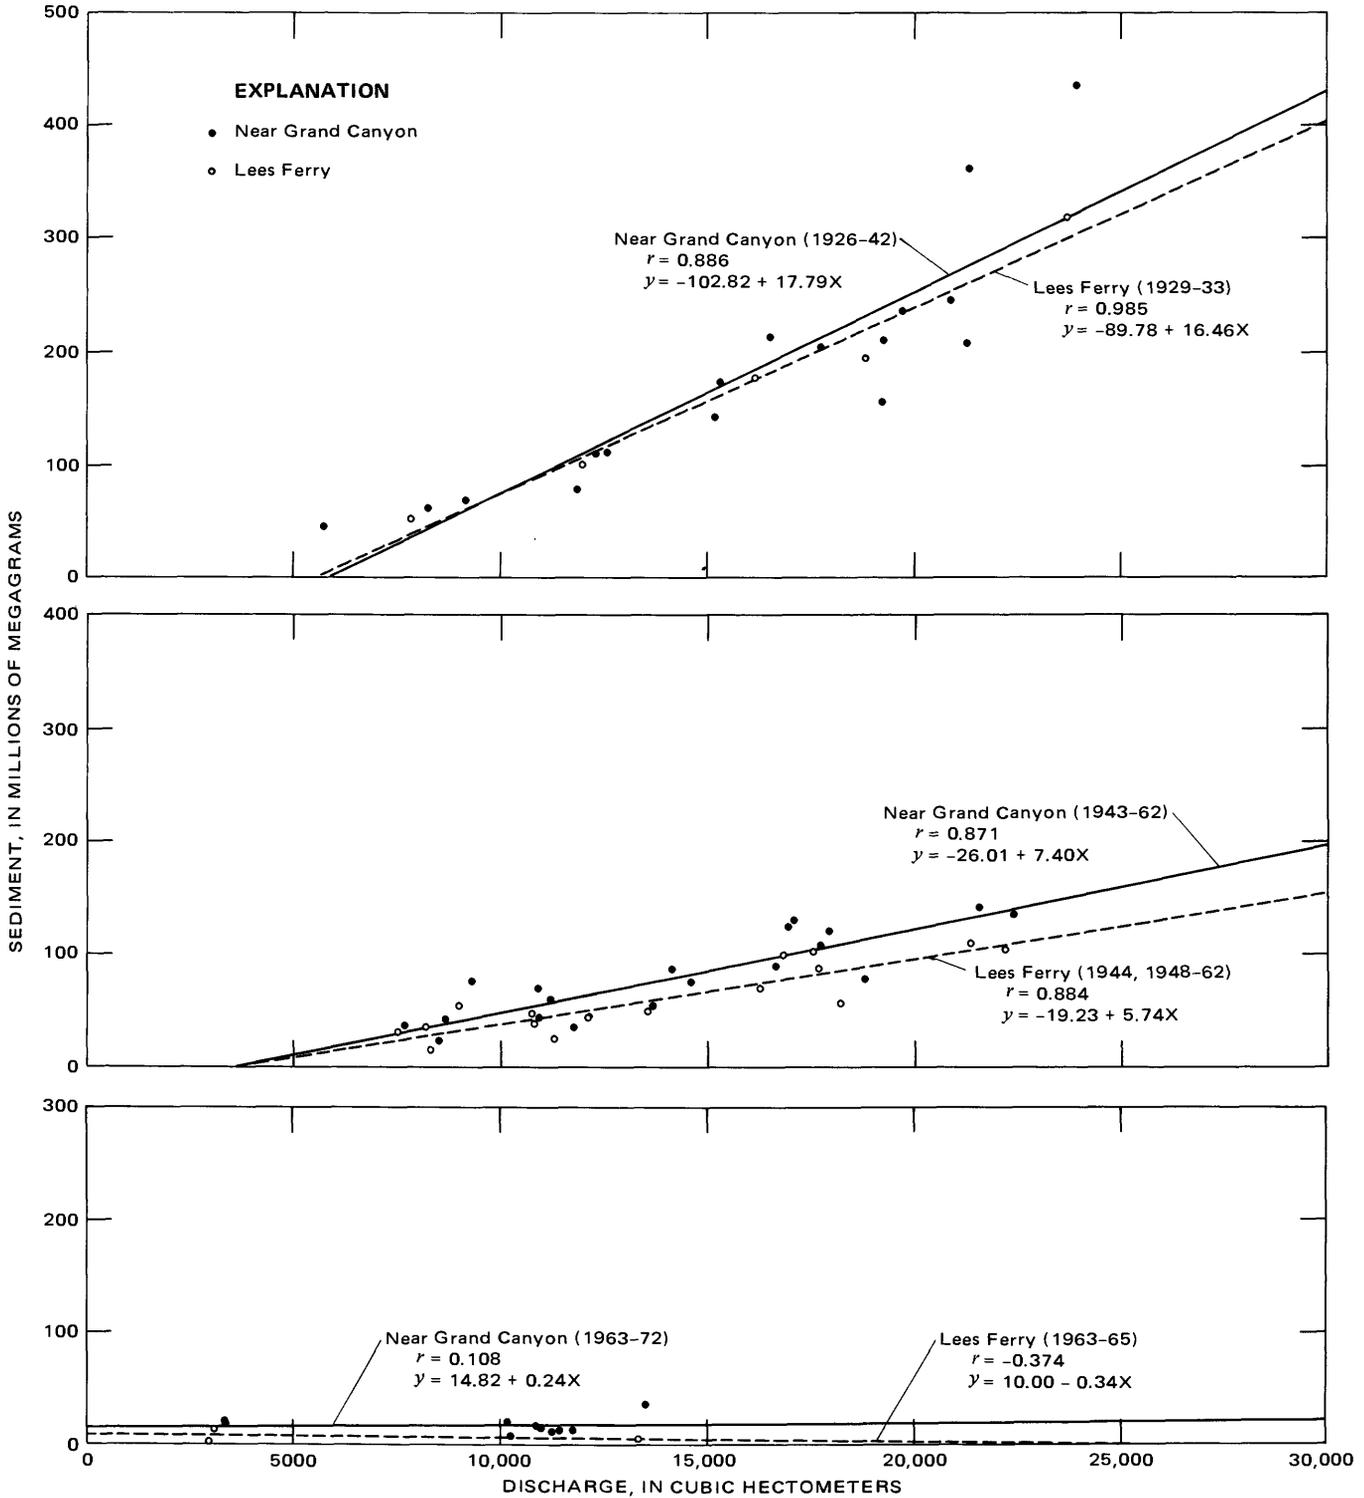
FIGURE 5.—Regression analyses of annual (water year) discharge versus sediment yield as recorded at Lees Ferry and near Grand Canyon.

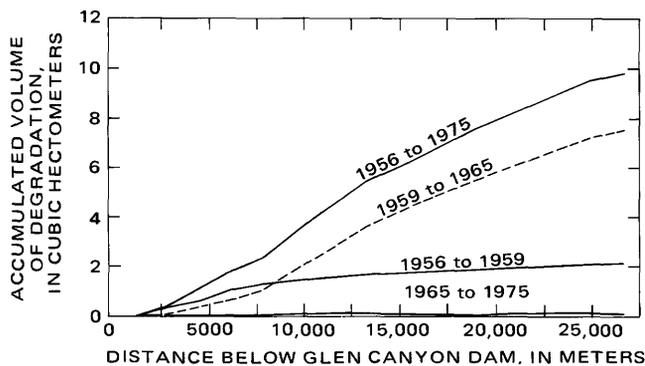
FIGURE 6.—Accumulated volume of degradation below Glen Canyon Dam for various periods between 1956 and 1975 (modified from Pemberton, 1976).

since completion of Glen Canyon Dam, channel degradation had progressed to the vicinity of Lees Ferry and that continuing degradation could be expected downstream through the Grand Canyon. Extrapolating from the known rate of degradation above Lees Ferry, they concluded that somewhat more than 200 years will pass before most of the beaches vanish from the reach below Lees Ferry.

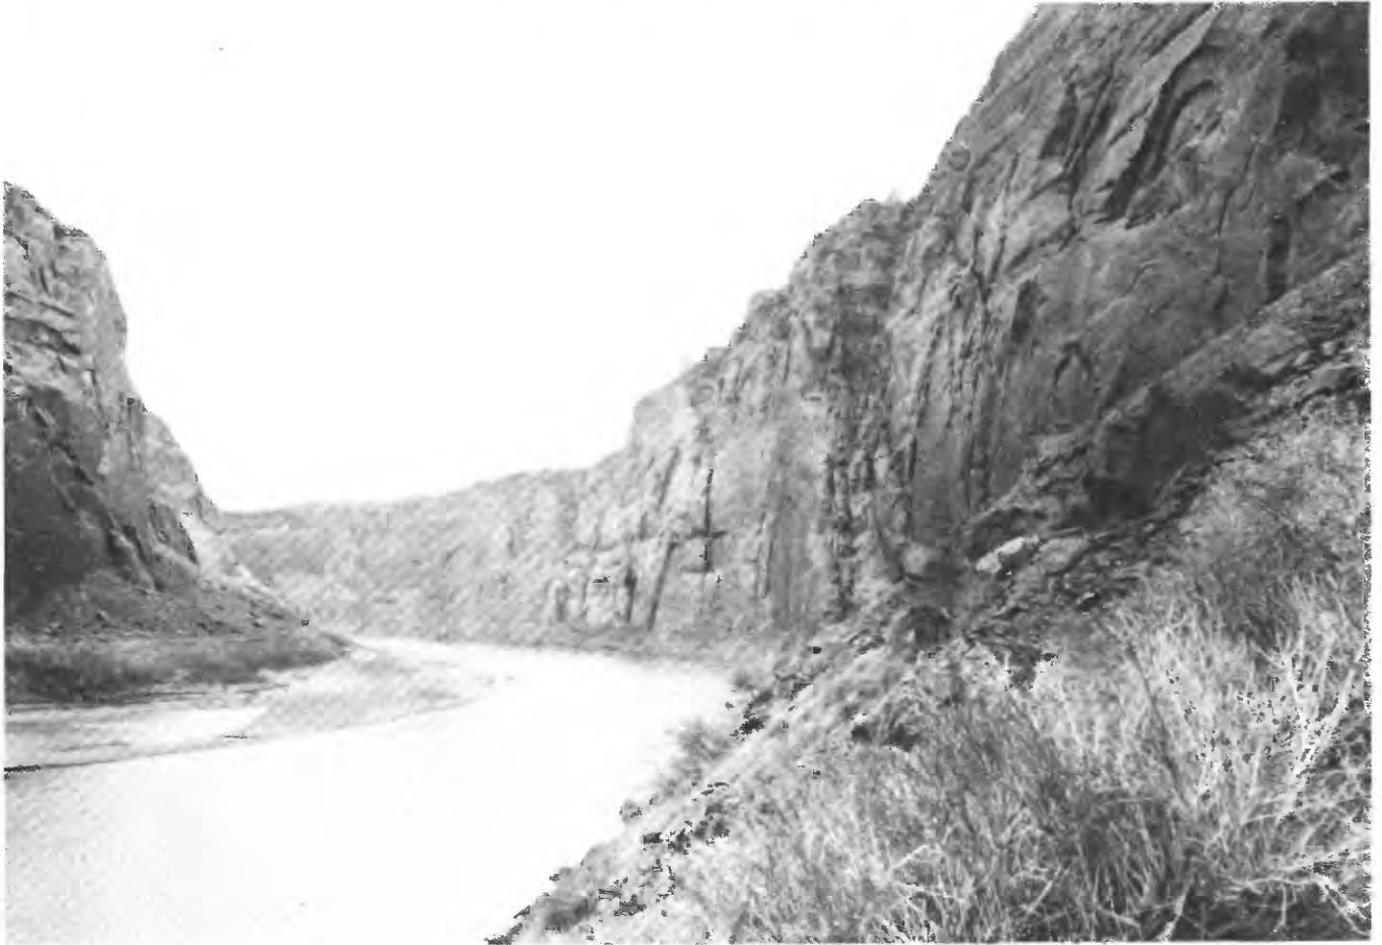
FIGURE 26A.—(1889). F. A. Nims, photographer with the Stanton-Brown railroad survey expeditions, took this photograph looking upstream from a point 1.6 kilometers below the present site of Glen Canyon Dam (24.4 kilometers above Lees Ferry). Woody vegetation on the far bank appears as a dense thicket separated from the water at this river stage by a barren sand bar. The thicket appears to be rabbitbrush. The high sandy terrace supporting the dense growth was a common feature above Lees Ferry but uncommon below. Only in years of extremely high floods would there be overbank flow sufficient to scour out these plants. The sharp lower boundary results from the scouring action of floodwaters. At the base of the distant cliffs above the river in center background are clumps of what appear to be netleaf hackberry. (Altitude 957 meters.)

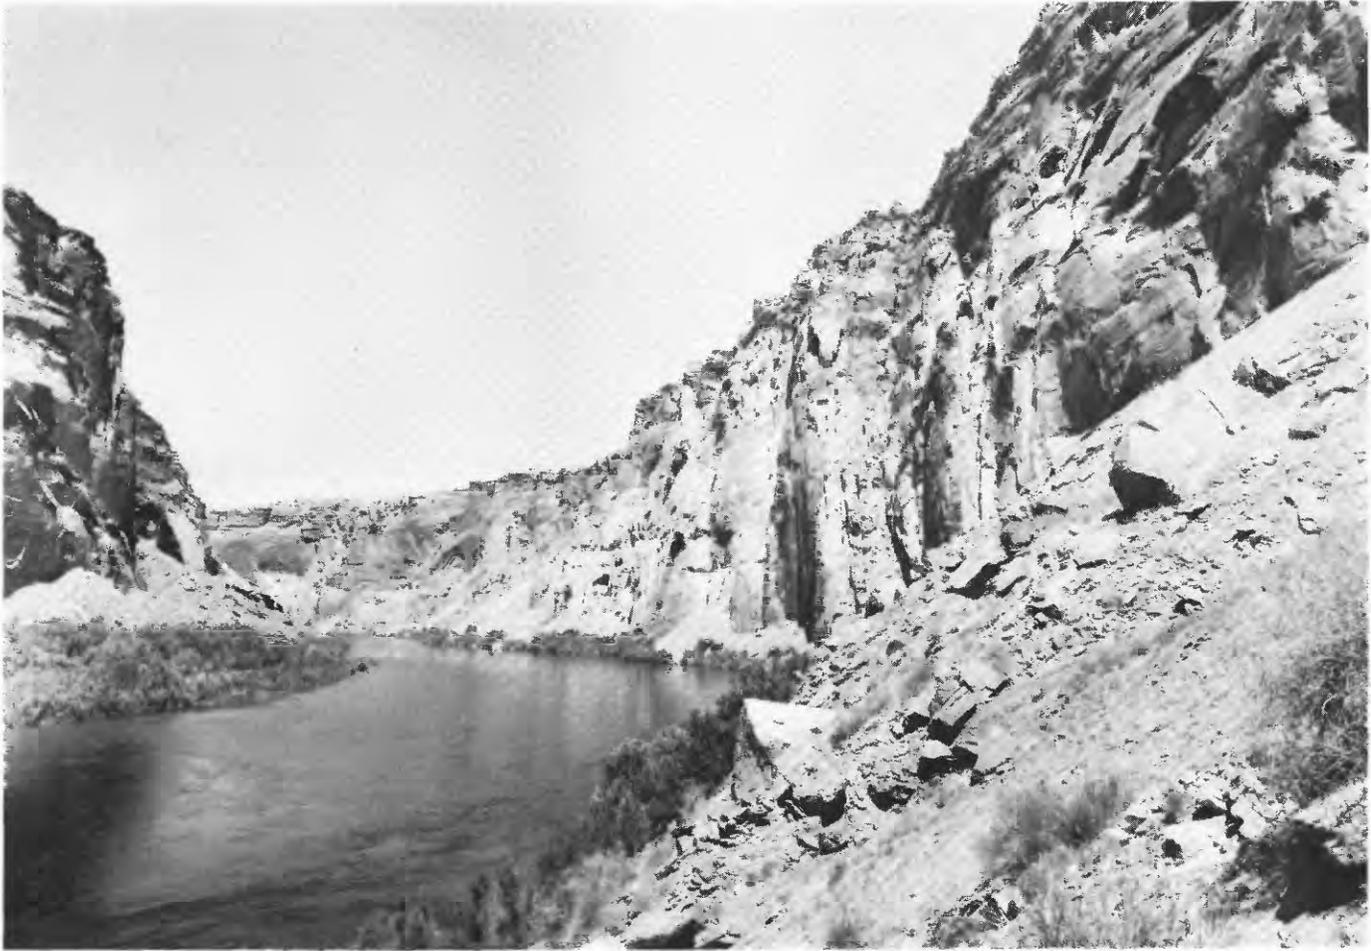
FIGURE 26B.—(1975). Glen Canyon Dam lies just out of view around the bend of the river. Construction activity related to the dam has considerably altered the steep slopes of the left bank. The netleaf hackberry seen in the previous view has been covered by rubble piles below tunnels drilled into the cliffs above. The netleaf hackberry has not reoccupied the niche at the cliff bases, although saltcedar relatively quickly became established along the base of the rubble piles. The foreground has also been altered by rubble from above, although many of the rocks carry over from the older view. The thicket on the opposite bank has enlarged, and its composition has changed—saltcedar dominates today and has spread downward over the barren skirt as far as fluctuations in river level will permit. The photograph was taken at 1330 hours, a time of peak-load demand, and the river is probably at near maximum stage. Large saltcedars dominate on the left bank also, forming a narrow almost continuous streamside band along the base of the steep slopes below the cliffs. Maximum lowering in mean streambed elevation (1.83 meters) occurred during the 1956-59 period at a point near the far bend in the river. Subsequently the channel has been stabilized by gravel and cobble-size armor, eliminating continued degradation (Pemberton, 1976).

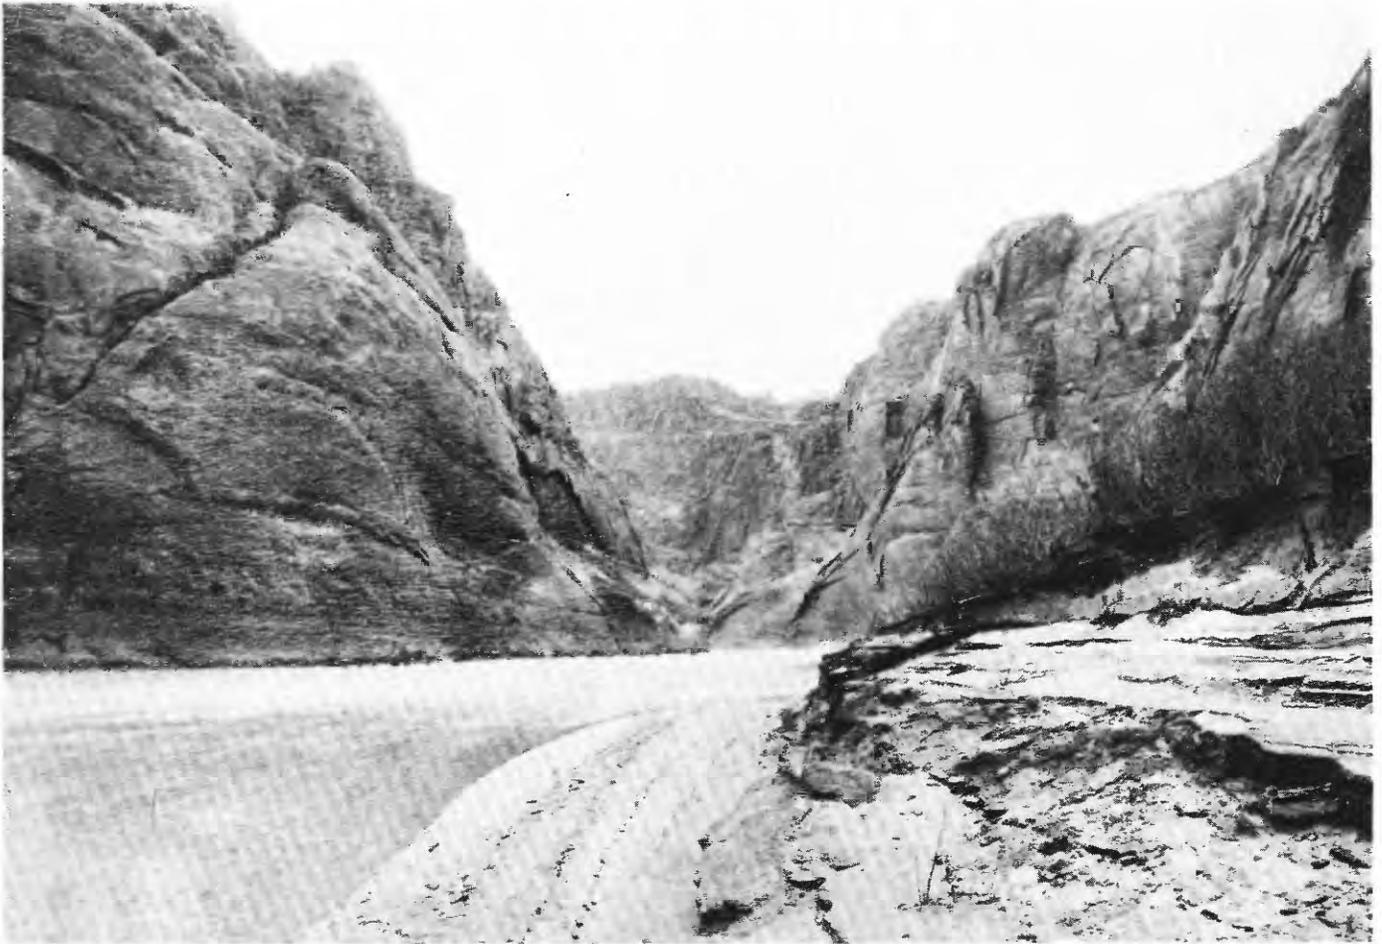
FIGURE 28A.—(1889). This downstream view was taken below the crest of an actively eroding alluvial deposit, 11.3 kilometers above Lees Ferry. Scattered seedlings have become established on the unstable surface marked by horizontal banding. This photograph was taken at a time of low river stage. At the top of the bank can be seen a dense cover of what is probably rabbitbrush. The dense community has been undercut by the river. (Altitude 954 meters.)

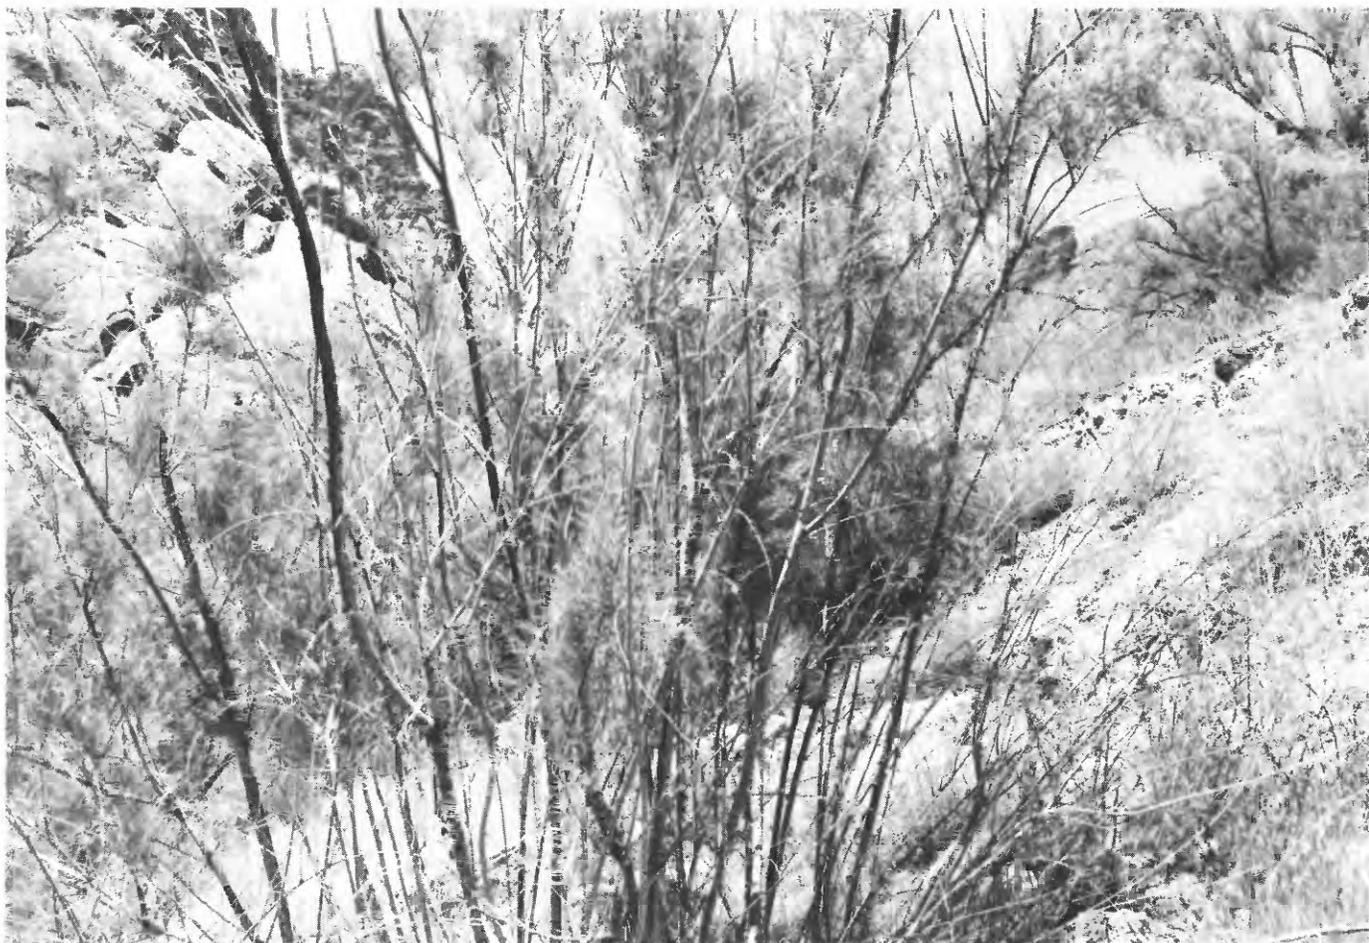
FIGURE 28B.—(1975). The old camera position cannot be exactly located so dense is the vegetation now growing on the alluvial deposit. Saltcedar, arrowweed, and sandbar willow occur from the river's edge up the steep bank, and on to the flat surface above. Rabbitbrush still occurs on top of the terrace where it is mixed with the other riparian species. The dense growth of vegetation providing stability to the steep bank is undoubtedly new since completion of Glen Canyon Dam.

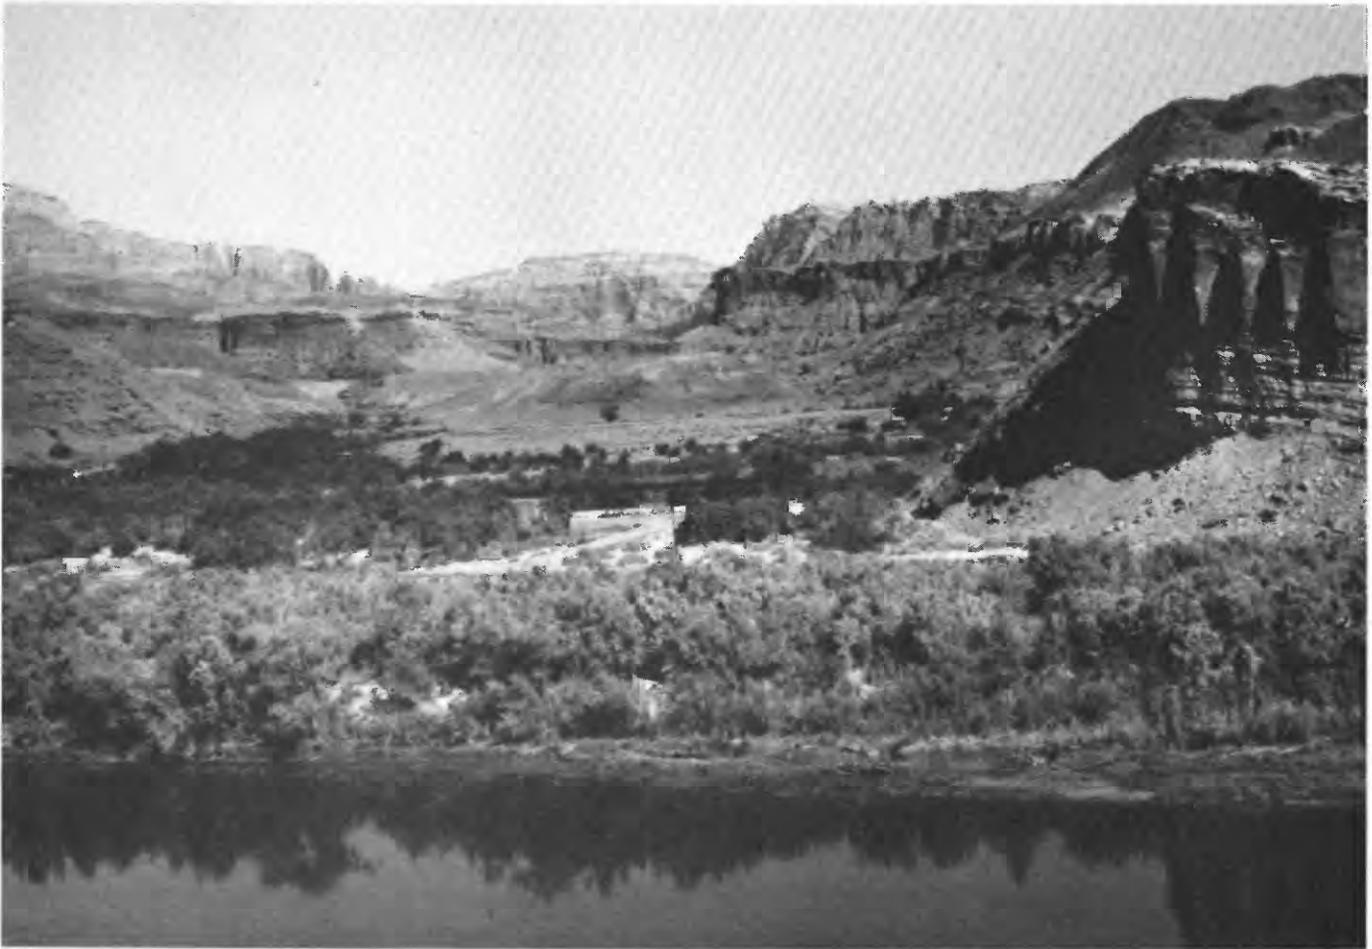
FIGURE 32B.—(1972). Almost a century after the preceding view was taken, many of the rocks on the steep slope below the Echo Monocline are still in place. The Paria has shifted its course, accounting for some of the vegetation changes in that valley. The changes along the Colorado River are marked. The thicket of riparian plants has expanded across the bare shore toward the river. Nearest the water's edge is a low community comprising horsetail and a species of bulrush. Plants at this level are probably inundated daily. Shoreward from this low community is a dense forest of saltcedar and a few sandbar willows. This community is out of reach of the diurnal ebb of the river's fluctuating stage.

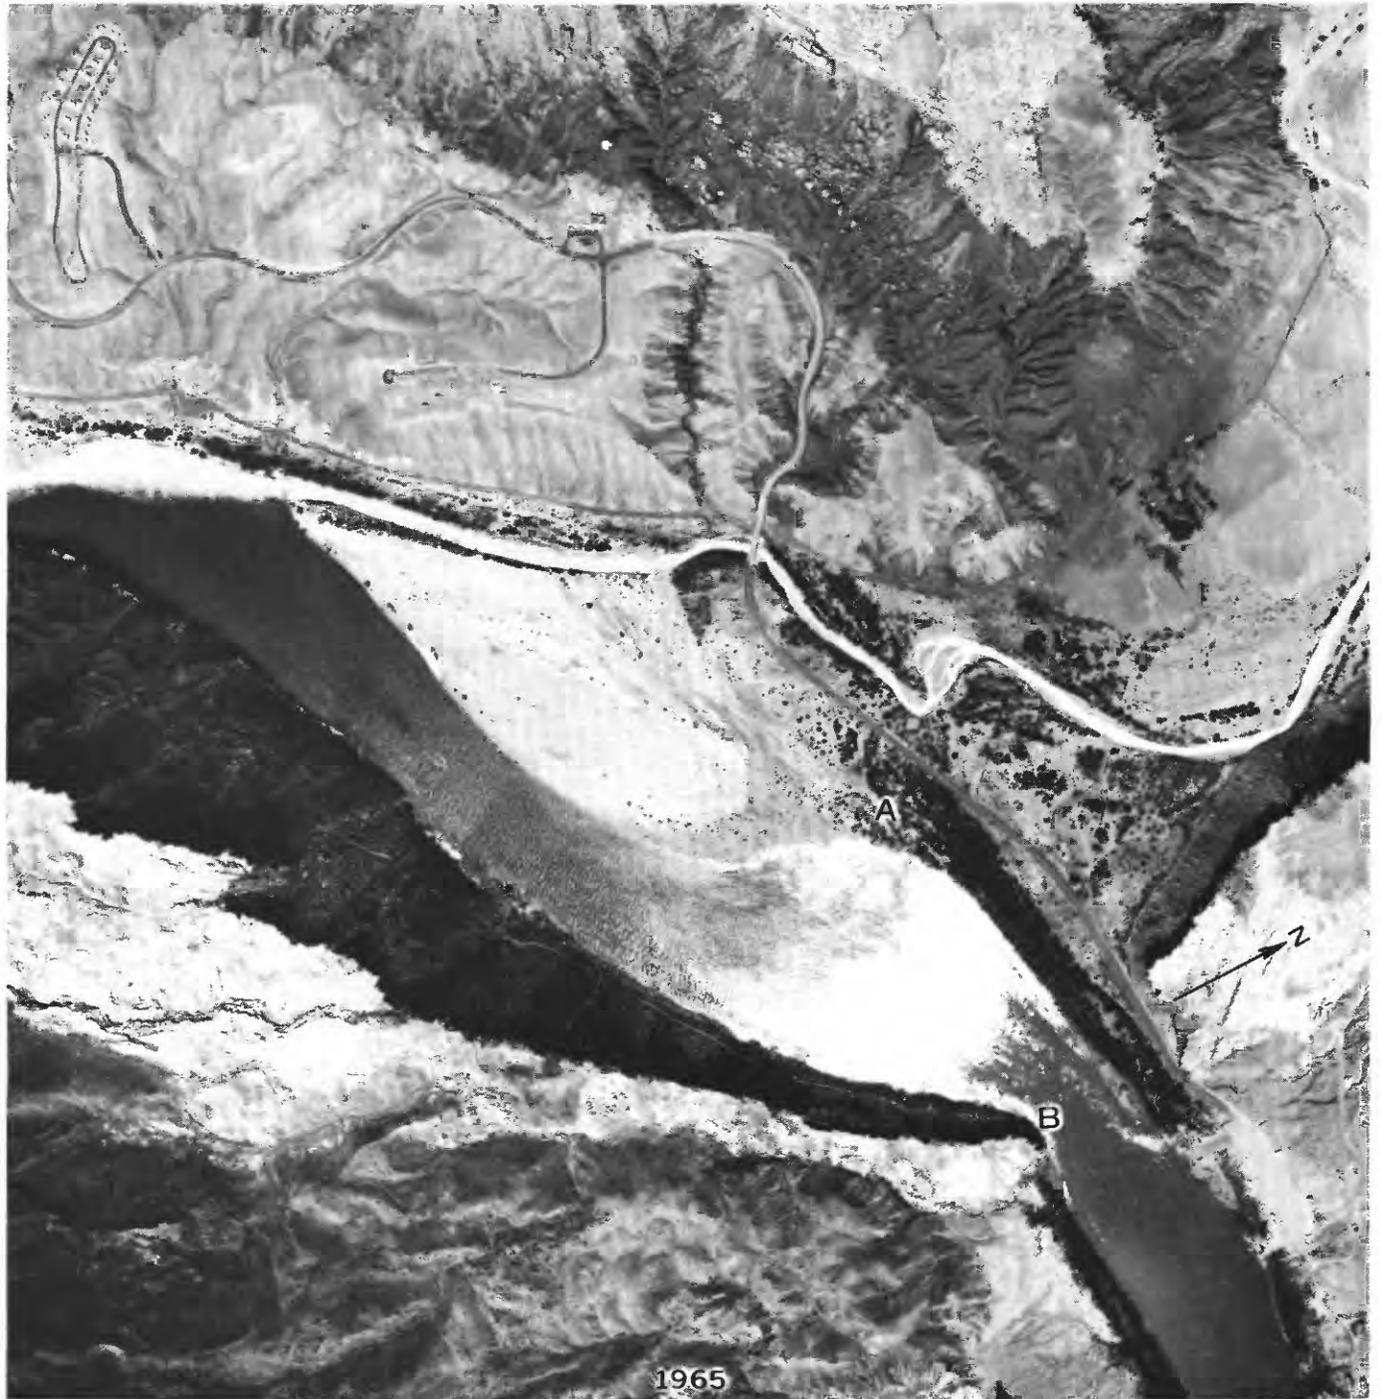
FIGURE 34.—Three aerial photographs, spanning a 21-year period, record conditions at the mouth of the Paria River near Lees Ferry. The photographs were taken on September 24, 1952; May 14, 1965; and June 16, 1973. Many features shown in figures 31 through 33 can be seen in this series of aerial views. The Echo Monocline forms the cliffs to the right of the Paria River which flows toward the Colorado from the upper right of the photographs. The approximate location of the 1873 channel of the Paria (see fig. 33A) is marked with the letter A. The dugway road that was in use until the ferry was abandoned in 1929 can be seen running from point B toward the west above the left bank of the river. The U.S. Geological Survey stream gaging station is located at point B. This is also near the location from which figure 33 was taken.

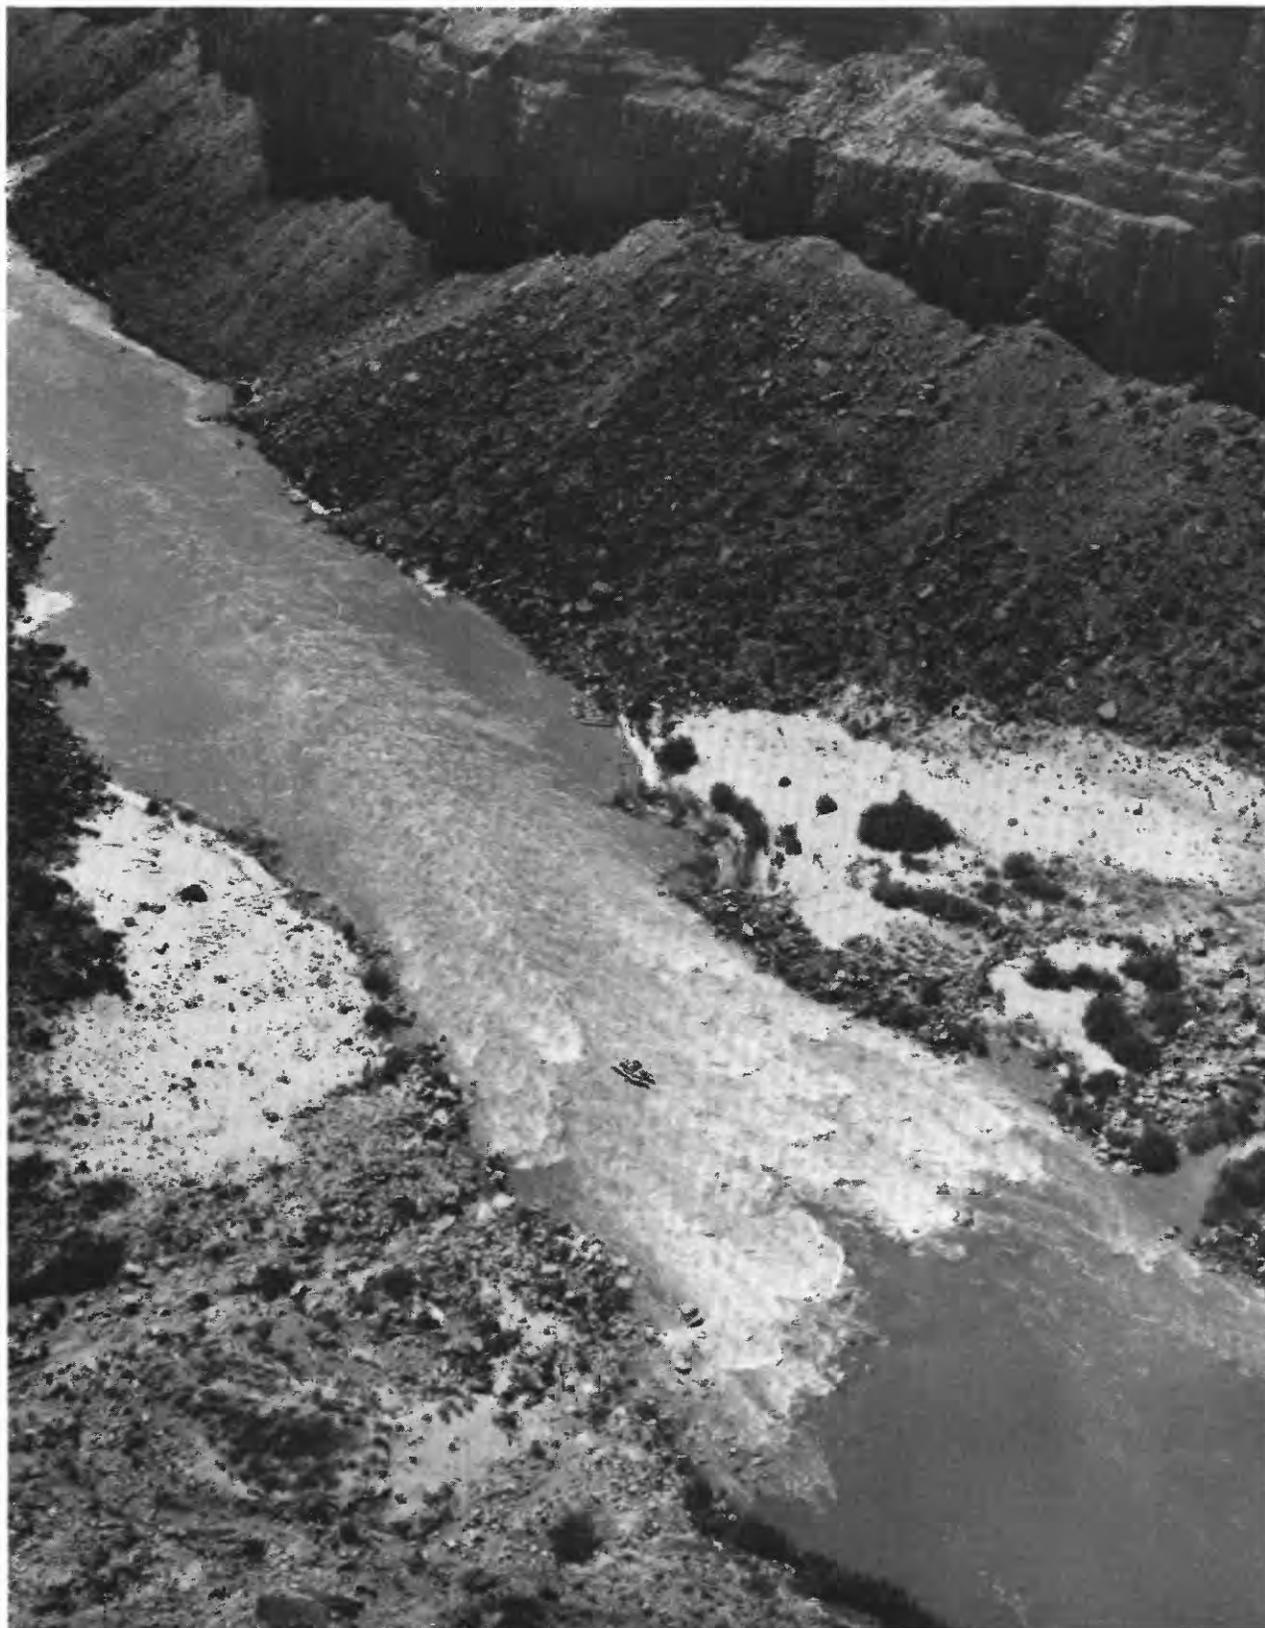
FIGURE 36B.—(1972). The 24-hour discharge at Lees Ferry on the day of this photograph (August 21) was $529.6 \text{ m}^3/\text{s}$, approximately one-fifth the volume for the date of the previous photograph (U.S. Geol. Survey, issued annually). Note the raft passing the Badger Creek rapids and several other rafts near the right bank below the rapids. The water through the rapids is obviously more turbulent at this low stage than at the high stage in the 1952 view. The large shrub of the early view is visible and is saltcedar. This plant was present along the river at many places through the Grand Canyon as early as 1938 (Clover and Jotter, 1944), but it probably grew only at scattered localities at or slightly above the contour of maximum river stage. In this view, saltcedar occurs as an interrupted band along both banks of the river.

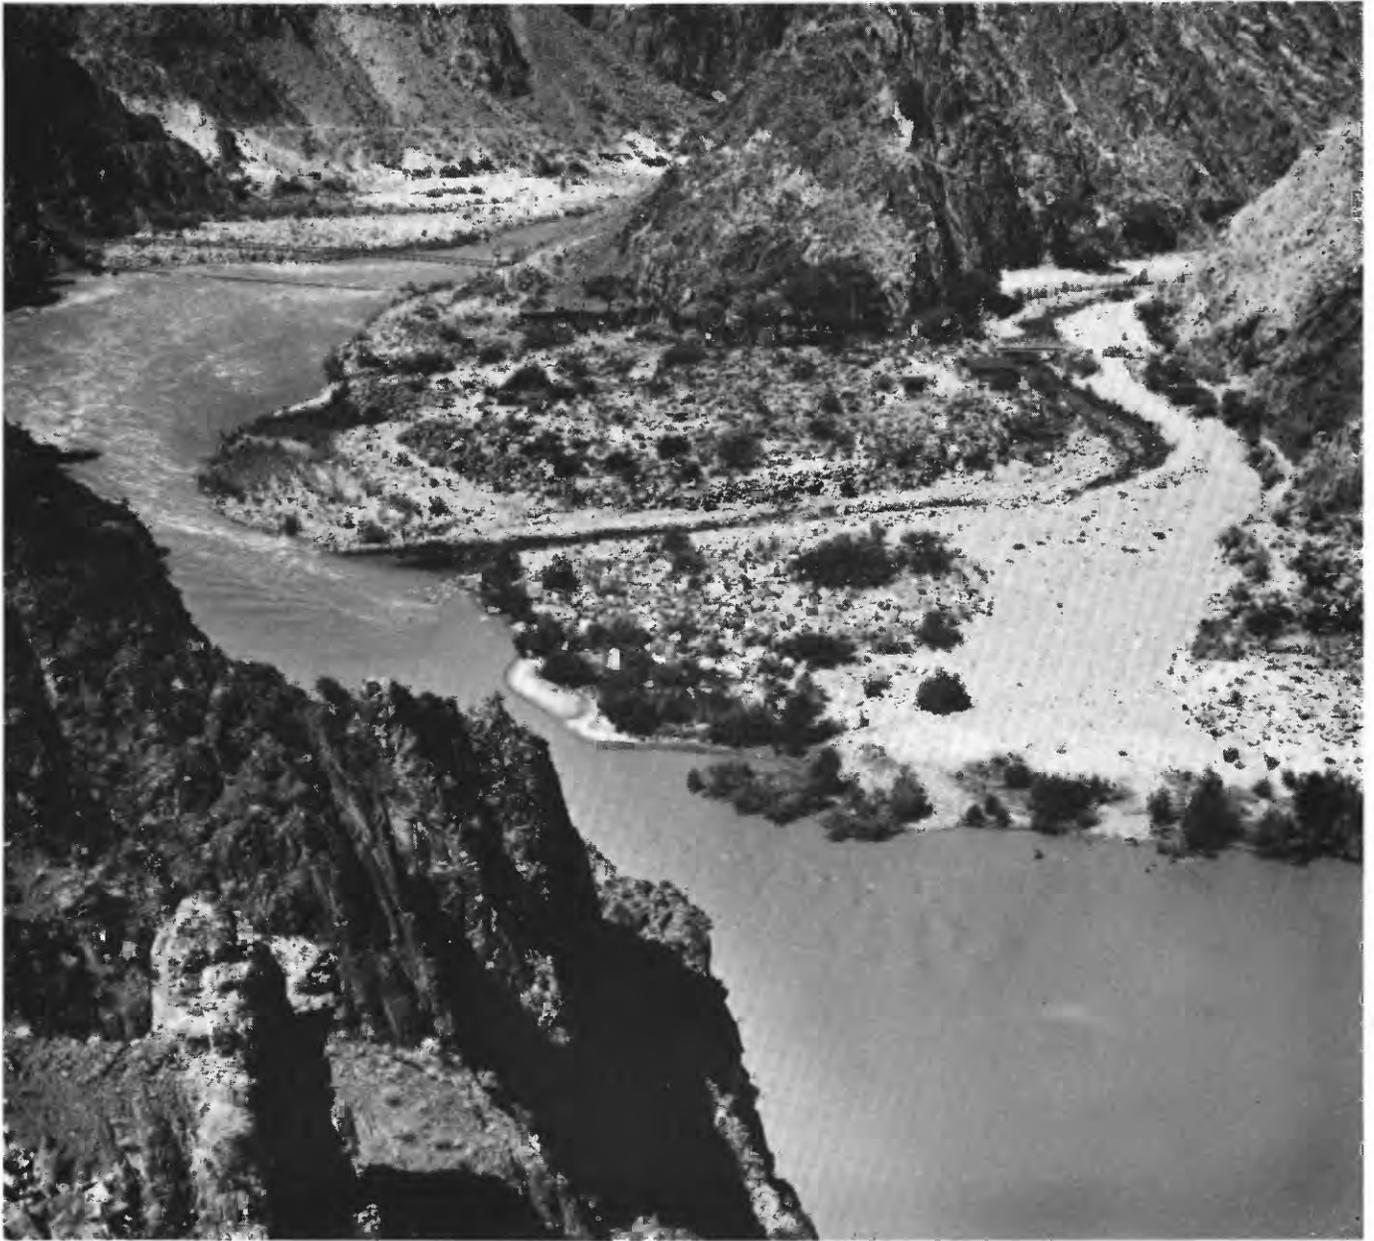
FIGURE 50C.—(1972). In the 9 years since the previous photograph was taken many new features are apparent. In December 1966, record flooding occurred in the Bright Angel watershed and the creek left the old channel, flowing across the debris fan toward the camera point. Boulders in the path of the flood were removed from the fan (or covered?) and finer material was deposited in their place. In the absence of subsequent flooding along the Colorado River, this area has remained free of boulders. The bridge across the Colorado River on the left was built in 1967 and is used as a foot bridge. The bridge also supports a pipeline carrying water from the upper reaches of Bright Angel Creek to the south rim. The cottonwoods at midview have declined as have the mesquites on the right (between the bare fan and the trail above). Plants now occupying the debris fan near the edge of the water include sandbar willow, saltcedar, and several Fremont cottonwood saplings. The fan was visited in May 1978. Beavers had cut the sapling cottonwoods, but the trees had produced multiple basal spouts.

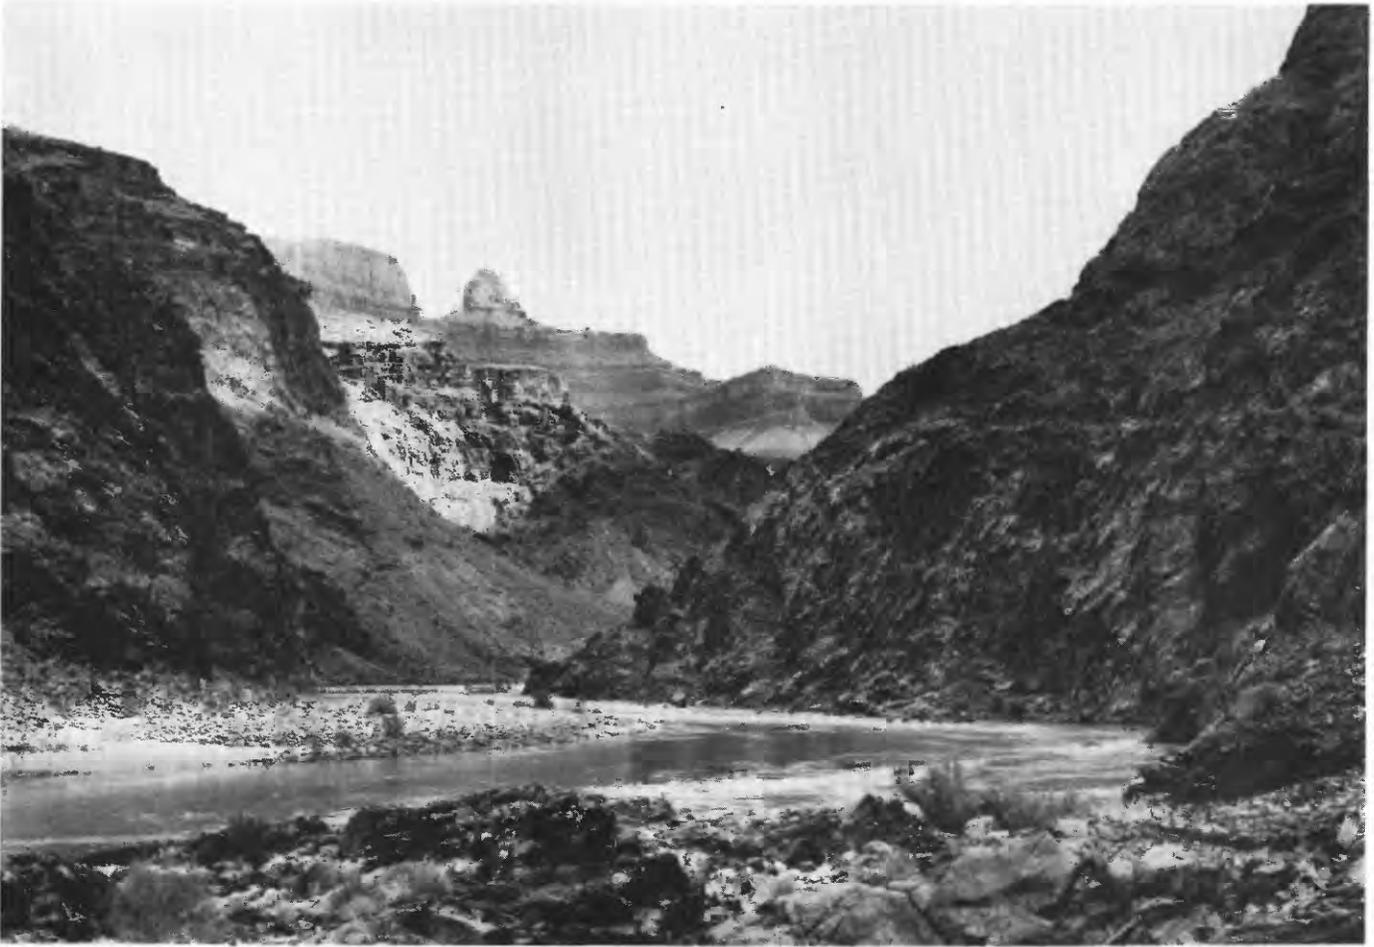
FIGURE 51B.—(1976). The sand deposits seen in the earlier view are largely gone and a few plants have become established along the river banks. The route of a trail cut through the Precambrian Vishnu Schist in 1936 (Hughes, 1967) can be seen above to the right. A large rock block, present in the earlier picture near the river at right, has fallen. It may have been displaced by falling rubble at the time of trail construction. Although not seen in this view, high water levels of predam time are expressed as sand and coarse gravel plastered against the canyon walls 12 to 18 meters above the river (Hamblin and Rigby, 1969).

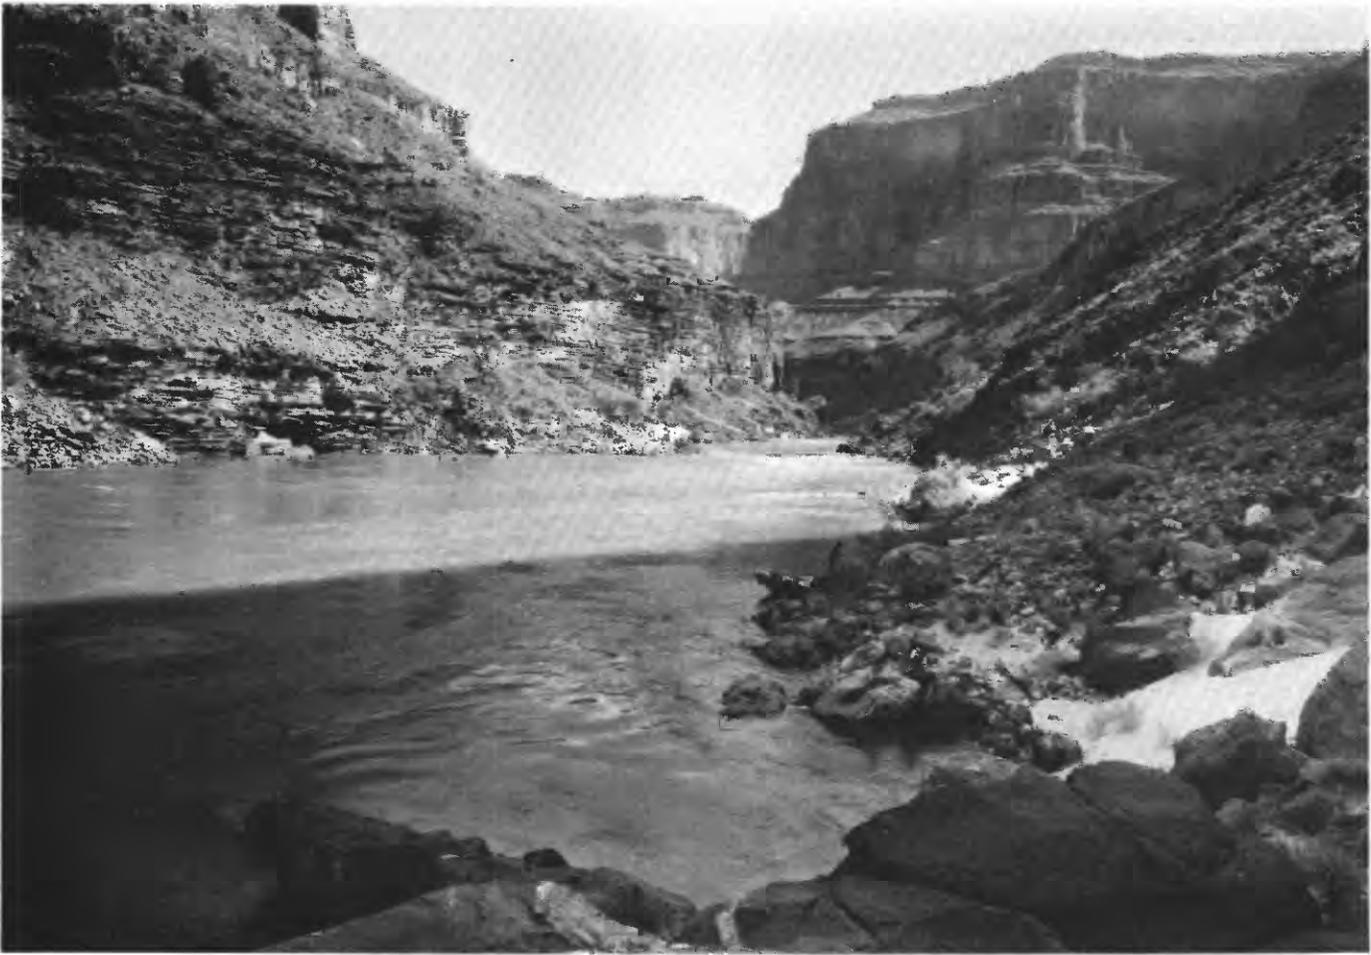
FIGURE 53B.—(1976). The river is at higher stage now than in the earlier view but loss of much of the higher sand deposits is evident. A few plants of *dicoria* occur on the sand. Saltcedar is perhaps 3-4 meters tall where it grows in scattered pockets near the edge of the river.
