Effects of Flooding Upon Woody Vegetation along Parts of the Potomac River Flood Plain

GEOLOGICAL SURVEY PROFESSIONAL PAPER 1206

By THOMAS M. YANOSKY

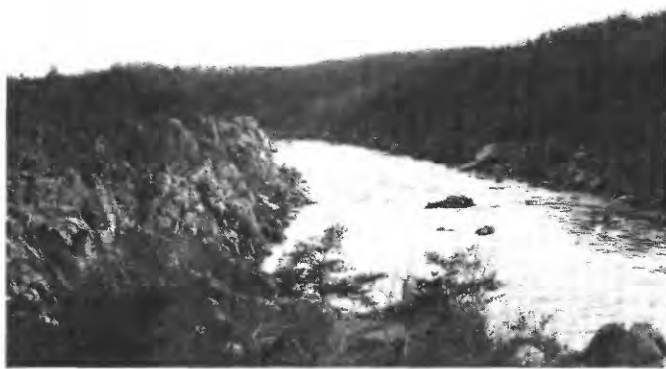
FIGURE 3.—Downstream view of the Potomac River along the upper gorge below Great Falls in November 1968. Discharge is approximately $85 \text{ m}^3/\text{s}$. Floods such as those occurring in 1936, 1937, 1942, and 1972 covered the tops of the gorge.

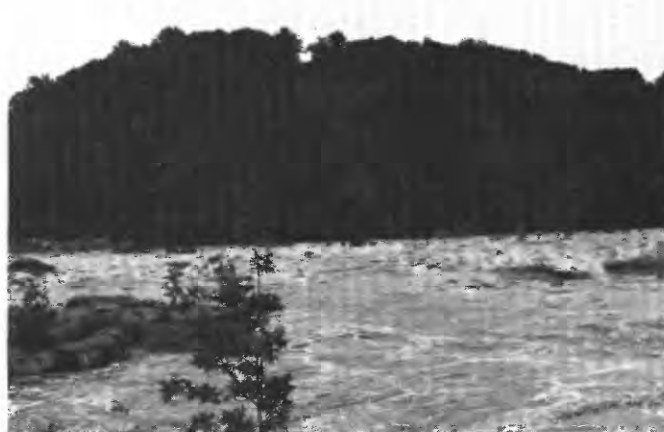
FIGURE 4.—High water (about $4,250 \text{ m}^3/\text{s}$) in lower study area just upstream from Difficult Run. The water is about 6 m above summer levels.

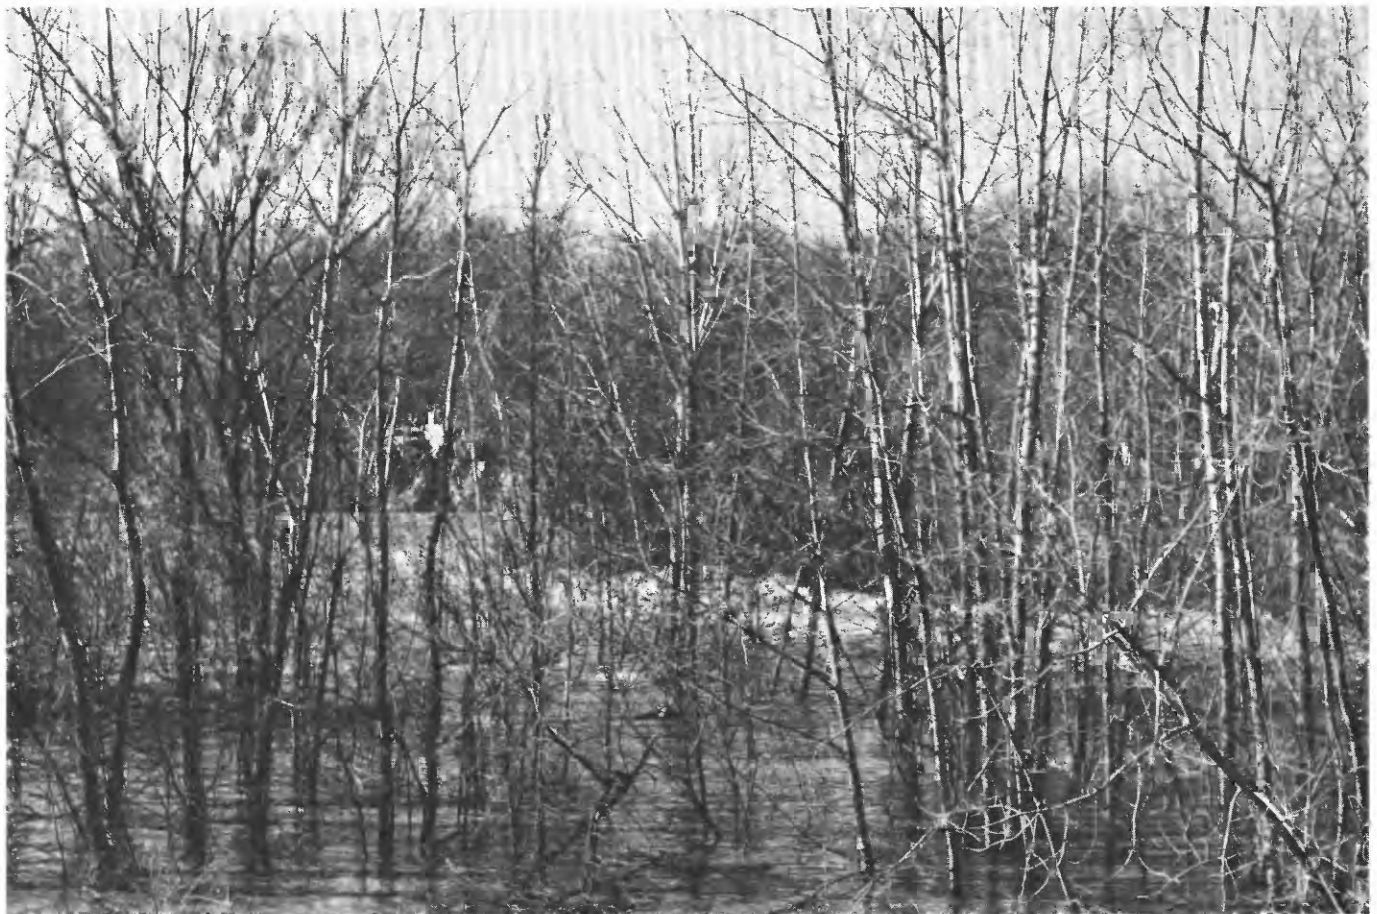
FIGURE 6.—The lower tract of the Yellow Pond flood plain along the Potomac River during the flood of March 9, 1967, peak flow $4,163 \text{ m}^3/\text{s}$. Trees are sheltered from flood currents by a rock wall just upstream. View is from the Virginia shore toward the main channel, which flows from left to right.

little damage was observed (fig. 6). The Hurricane Agnes flood, however, roared through a large gap in the rocks and swept across the downstream half of the tract, destroying all vegetation (fig. 7). In July 1973 a 20-m by 10-m plot on this lower part supported no trees, and in some areas the alluvium had been stripped to bedrock. A plot of identical size on the upstream half of the flood plain supported 20 trees. Tops of the rock walls sheltering this plot remained above the Hurricane Agnes flood, and 8 of 11 trees directly below were still living (fig. 8). Four showed little or no damage. Trees in the remainder of the upstream plot, however, grew just below a smaller wall inundated by about $5,000 \text{ m}^3/\text{s}$, and only 3 of 9 trees survived (table 5).

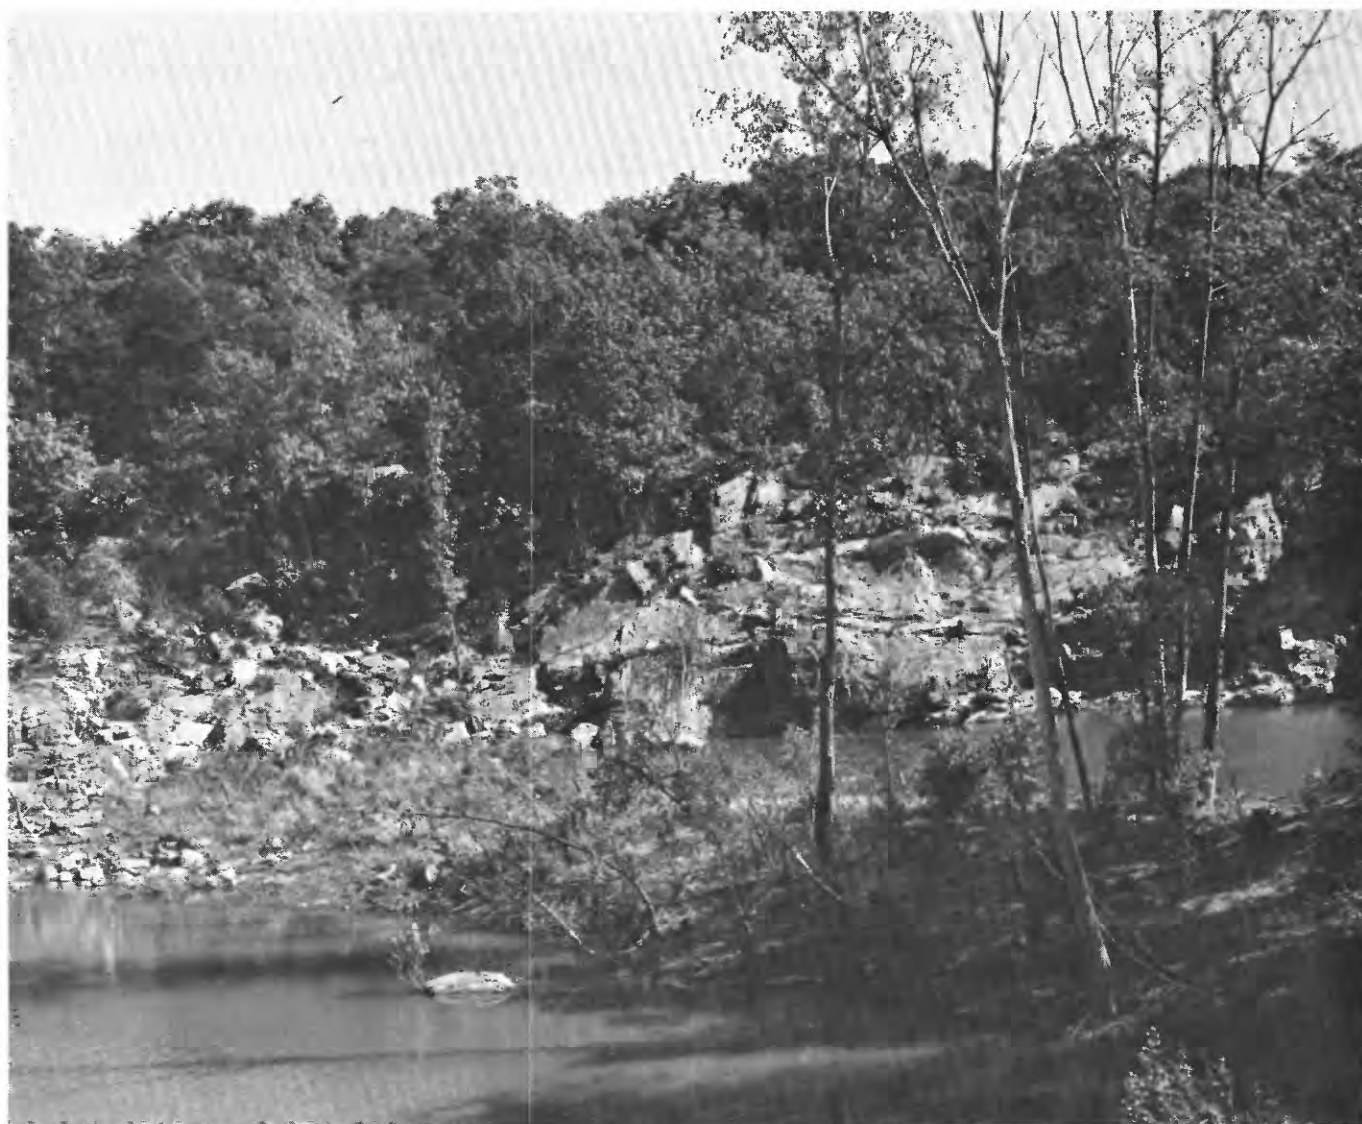
FIGURE 7.—The lower tract of the Yellow Pond flood plain in 1975. View is from the main channel looking toward the Virginia shore.

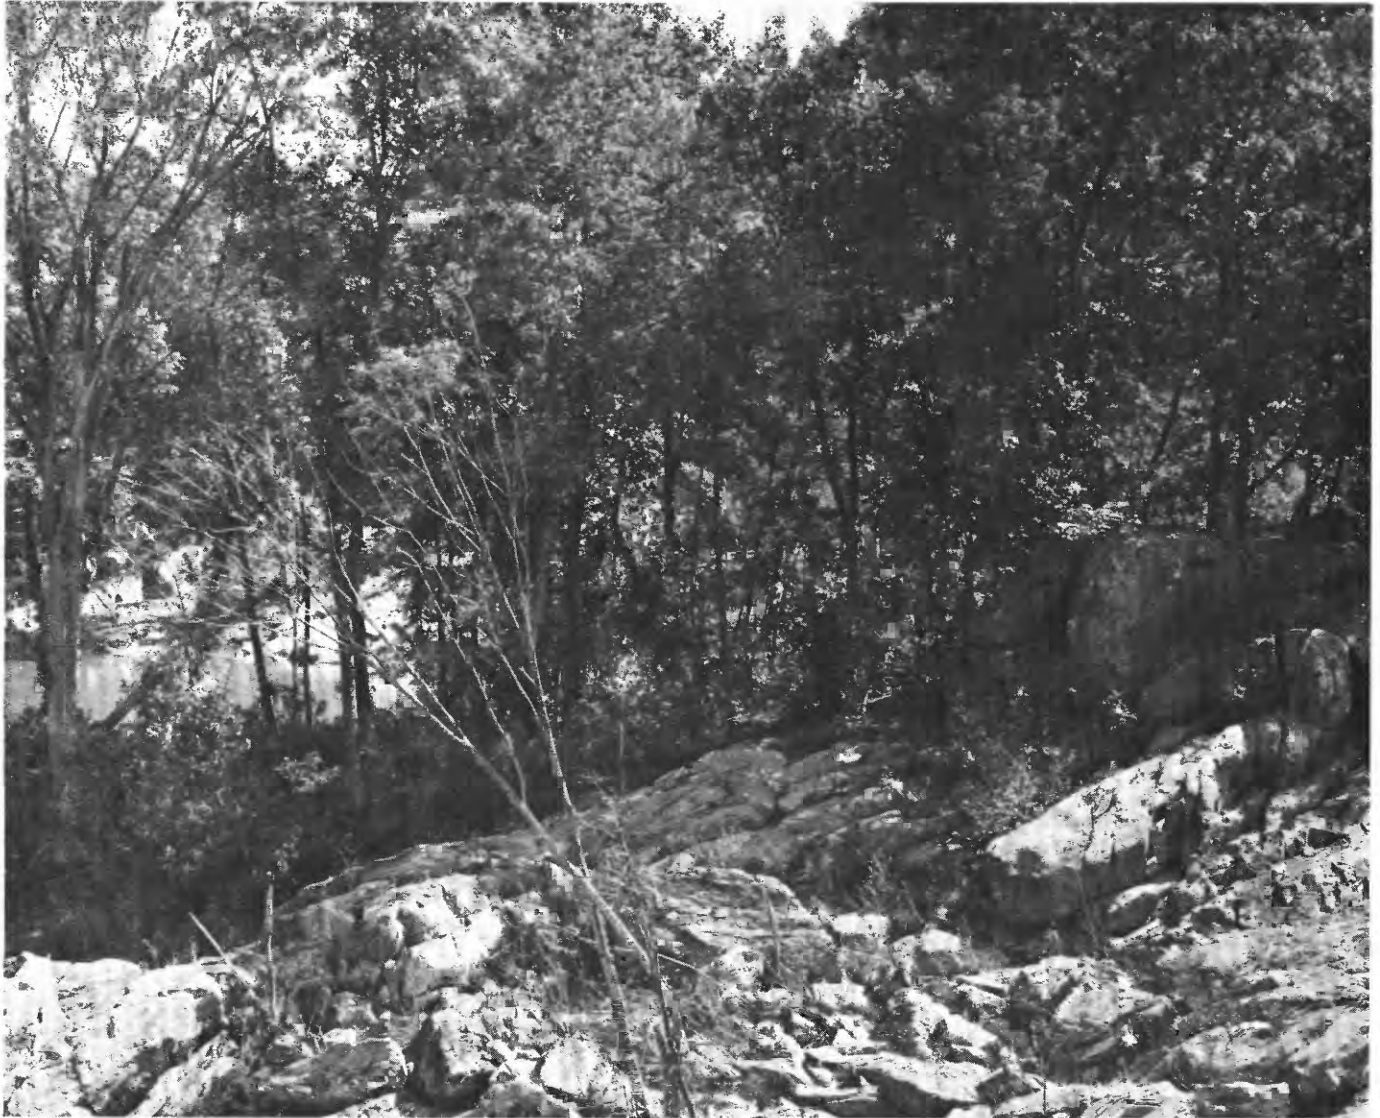
FIGURE 8.—View of the upper tract of the Yellow Pond flood plain in 1975 and part of the rock walls just upstream. A small pond may be seen in the background at left. Note the striking difference between the upper and lower tracts of the flood plain. (See fig. 7.)

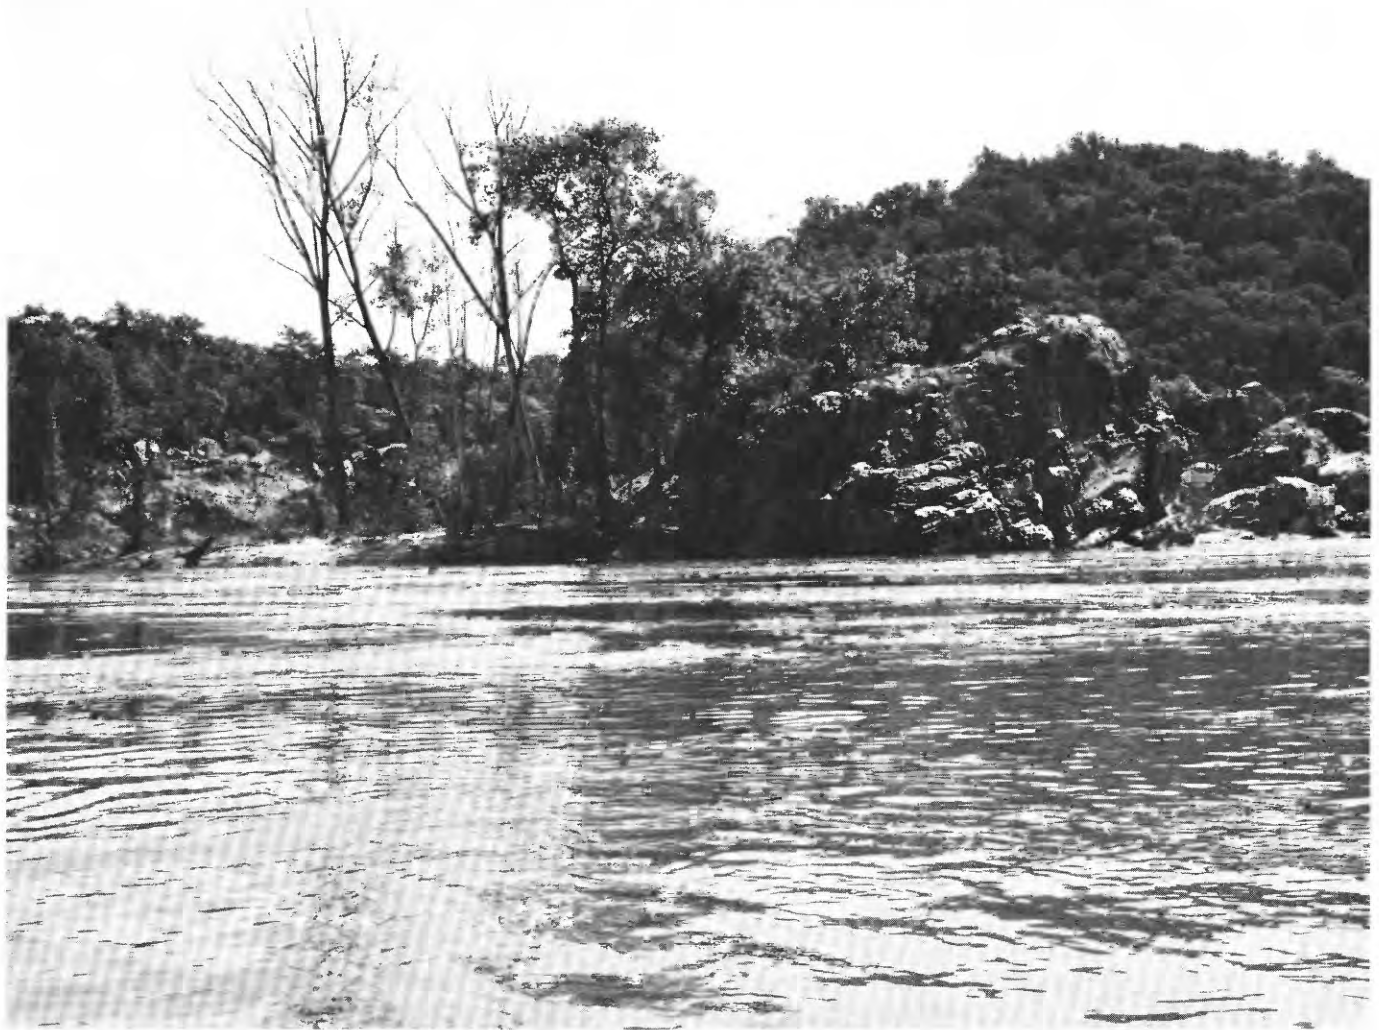
FIGURE 9.—The large rock outcrop adjacent to Yellow Pond as seen from near the Maryland shore in 1975. Note living trees just downstream (to the left) from the rock wall. Several large cottonwood trees damaged by the Hurricane Agnes flood can be seen near the middle of the alluvial island; these trees were living in 1973, but most were dead at the time of the photograph. The alluvial island stretched at least 20 m farther downstream prior to the flood.

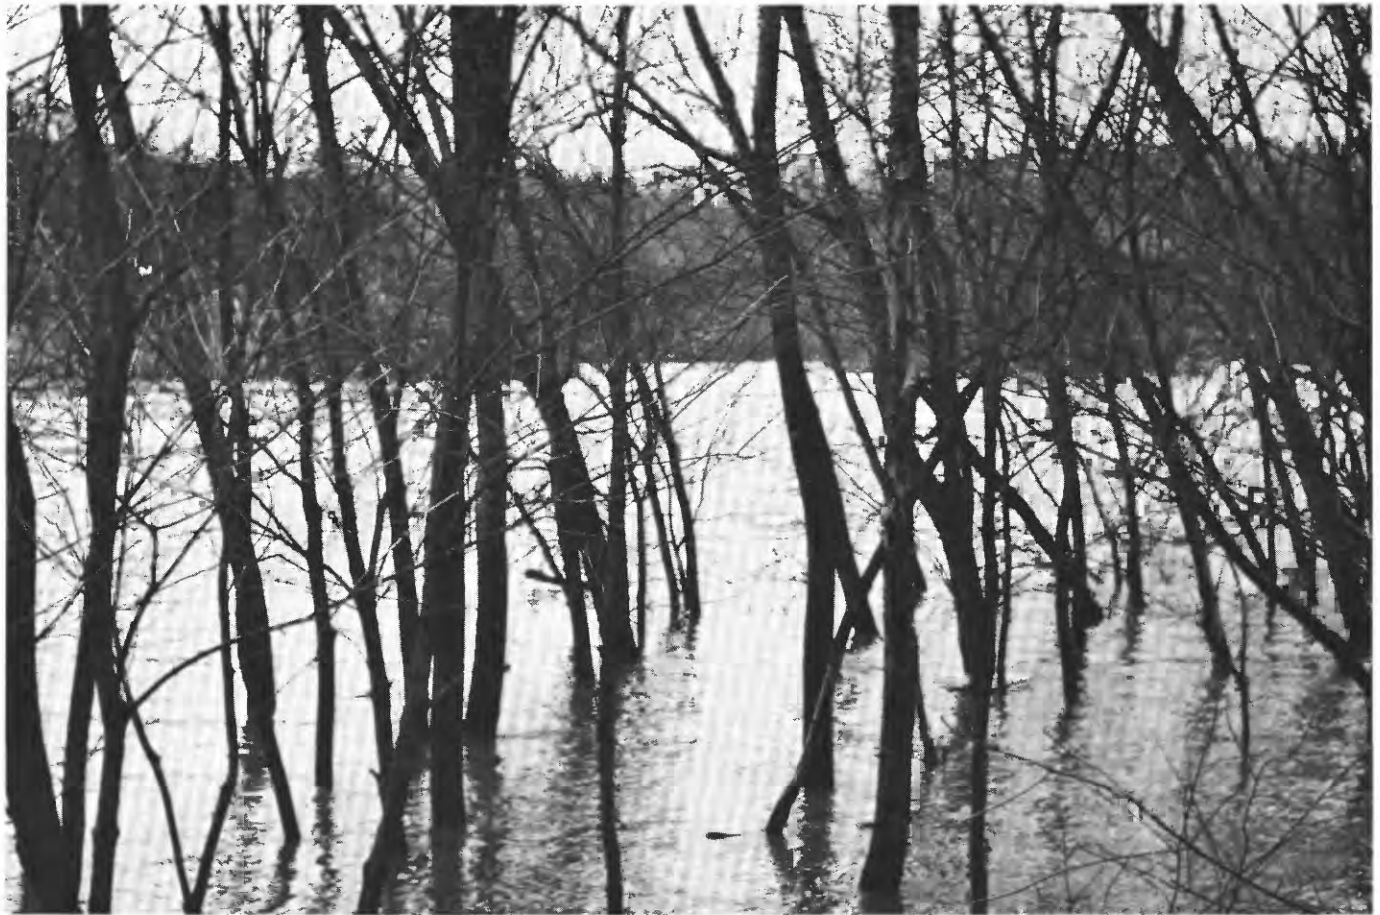
FIGURE 10.—View of the flood plain forest on the upper part of Old Angler flood plain along the Potomac River during the flood of February 15, 1966, peak flow $2,512 \text{ m}^3/\text{s}$. Trees are sheltered from main-channel velocities by a rock wall just upstream.

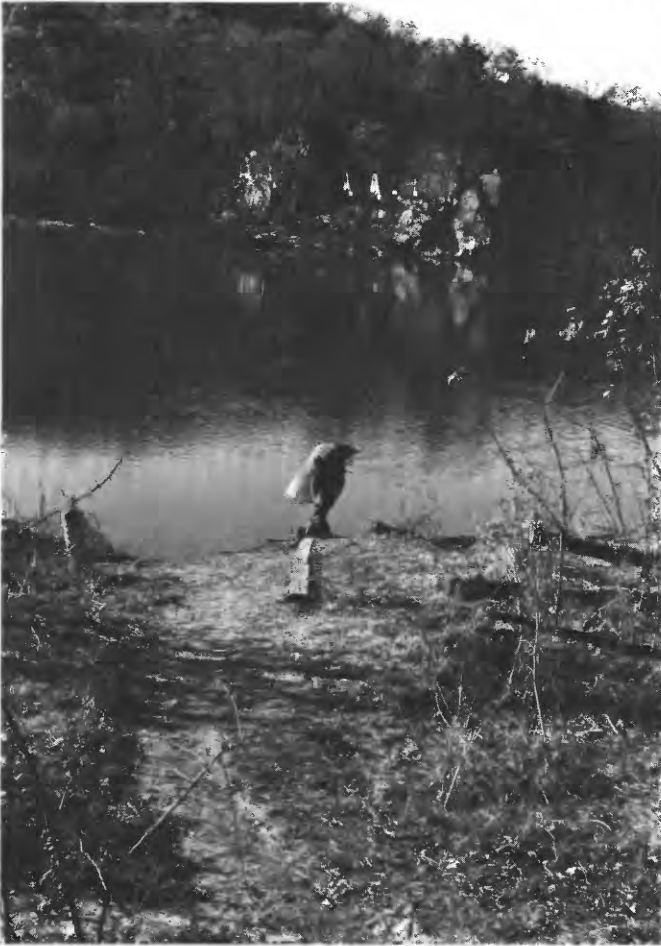
FIGURE 11.—View from the middle of Old Angler flood plain looking toward main channel during low flow in 1975. Note sprouts from inclined boxelder (right) that survived the Hurricane Agnes flood. Much of the flood debris was cleared to make way for a canoe launching site.

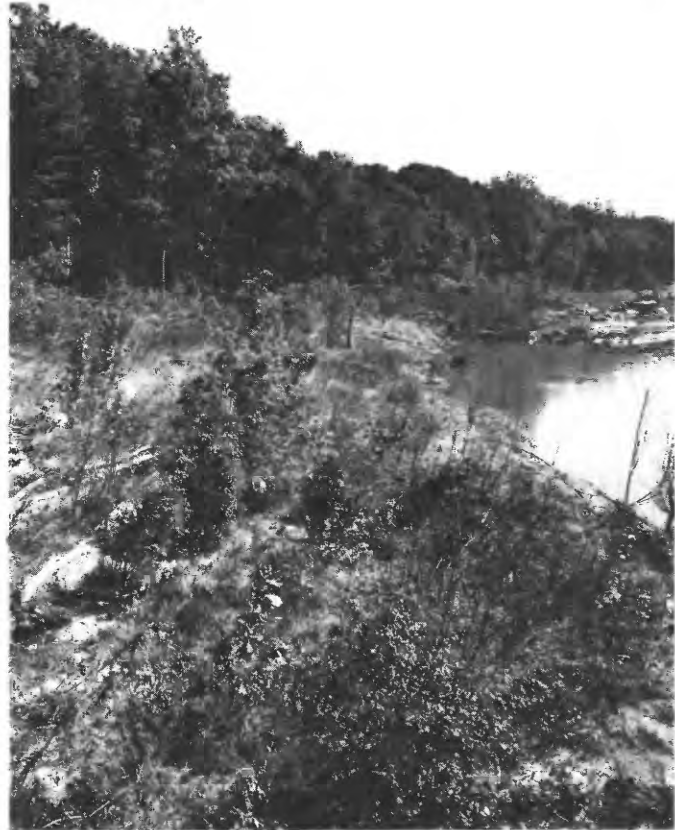
FIGURE 12.—A downstream view in 1975 from the protective wall at the head of Old Angler flood plain. Survival was greatest just below the wall (foreground), where numerous sprouts have grown from buried or severely damaged trunks.

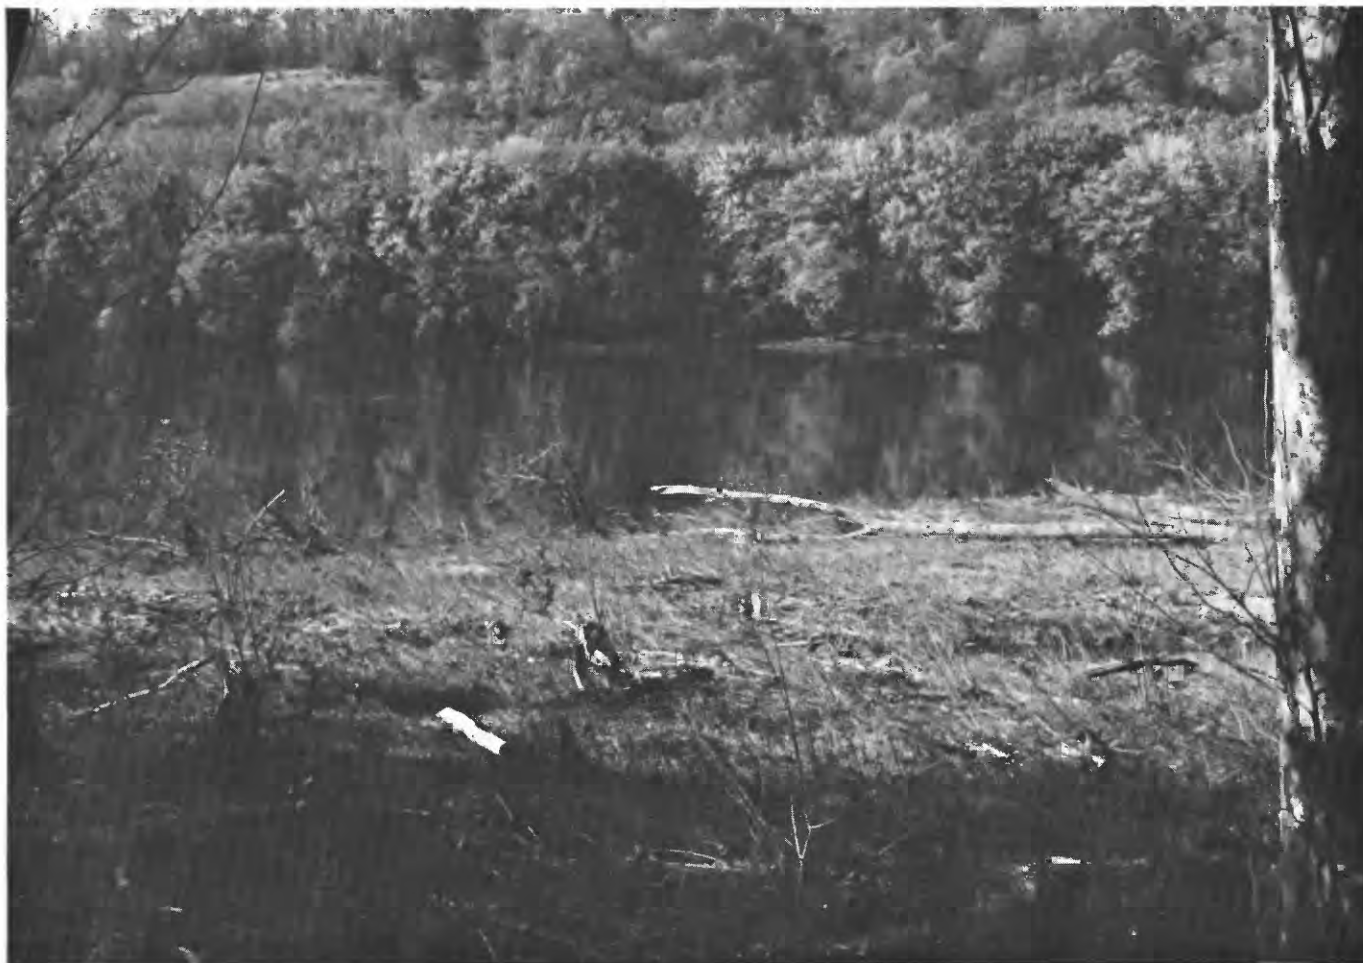
FIGURE 13.—The lower part of Old Angler flood plain 3 years after the Hurricane Agnes flood. Note the contrasting state of the Madeira flood plain on the opposite shore.

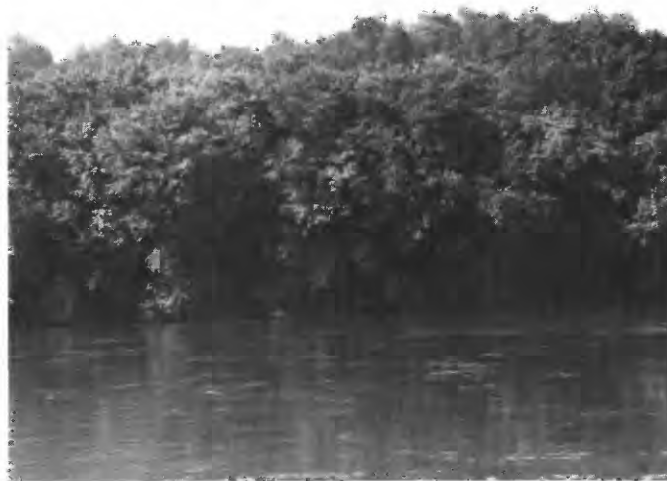
FIGURE 14.—View of the Madeira (Virginia) flood plain opposite the lower portion of Old Angler flood plain. Photograph was taken in 1975 from midstream.

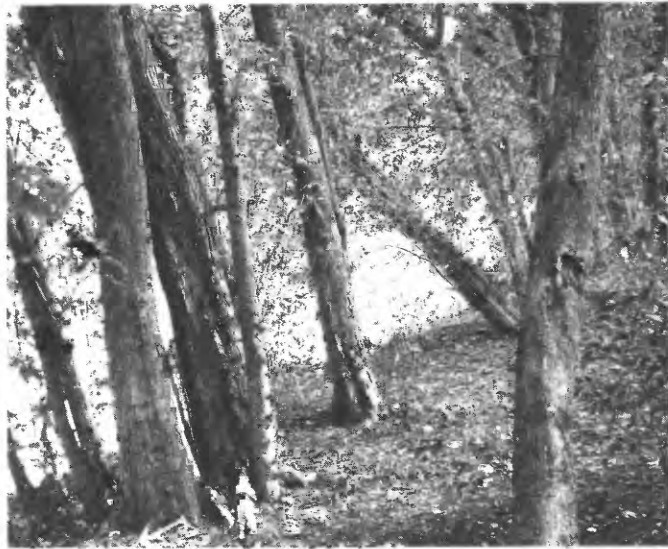
FIGURE 15.—Silver maple forest on Madeira flood plain in 1975. Many trees grow on surfaces flooded by less than $700 \text{ m}^3/\text{s}$.

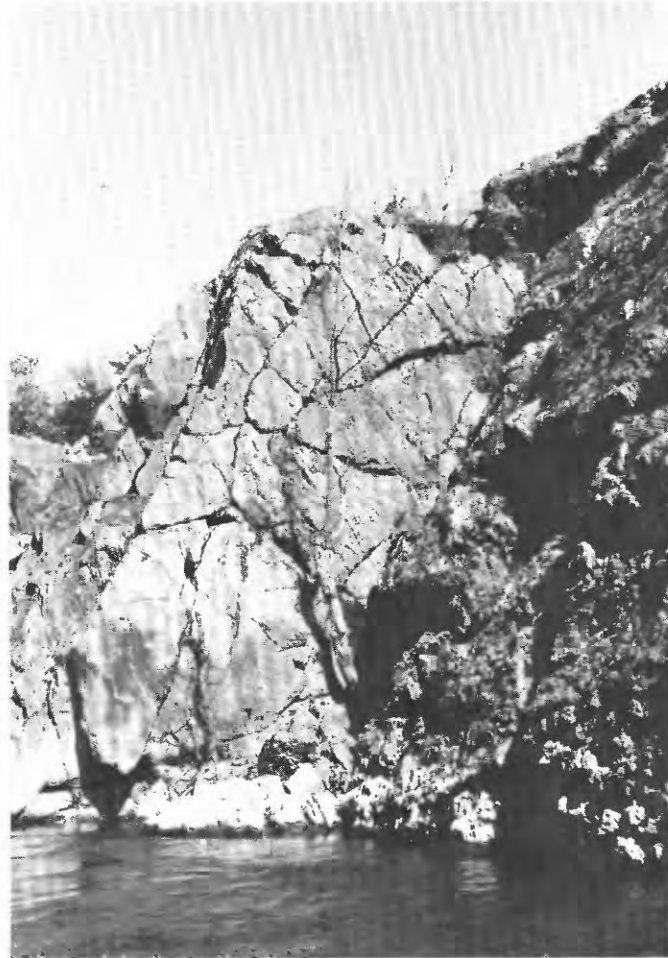
FIGURE 16.—Sycamore growing in a shelter behind a rock wall downstream from Great Falls in 1975. This tree is larger and of different form than trees growing in more exposed locations. Direction of current is from left to right. Discharge is about $255 \text{ m}^3/\text{s}$.

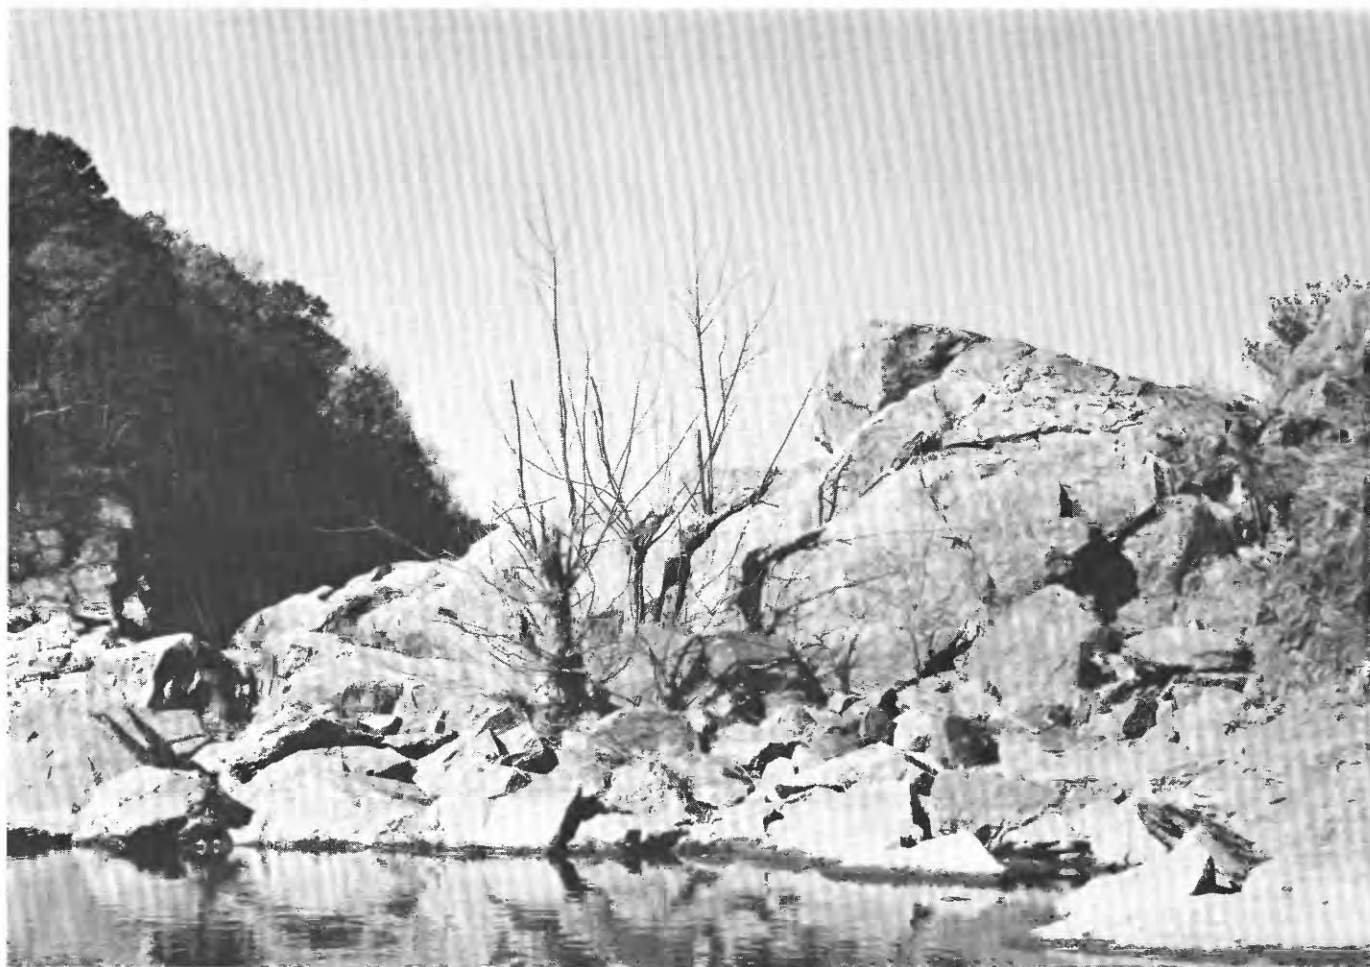
FIGURE 17.—View of several sycamore broken along the trunk during the Hurricane Agnes flood at altitudes corresponding to shelter height. Photograph was taken in 1975 and looks directly upstream from a small cove in the lower study area.

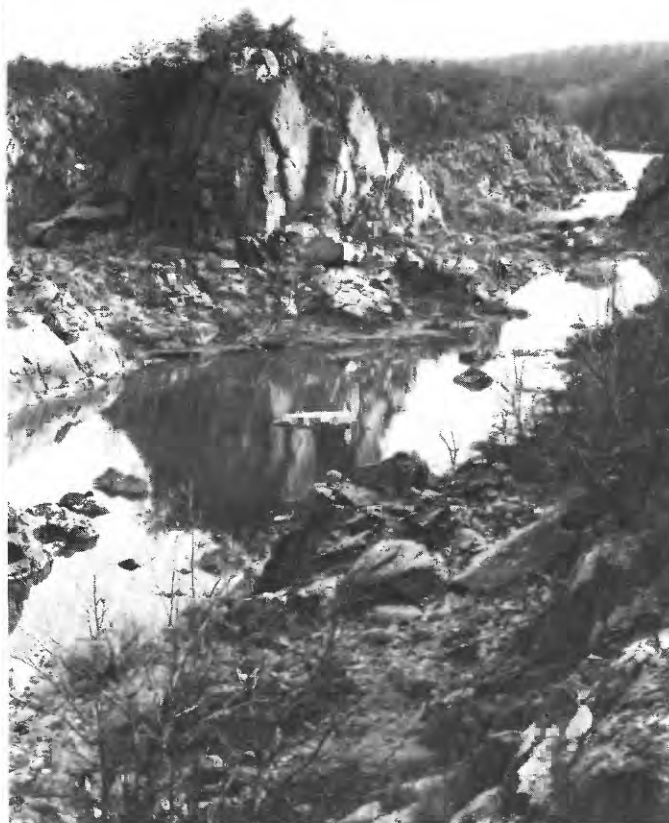
FIGURE 18.—View from Rocky Islands looking downstream along the Potomac River in 1968. Discharge is about 850 m³/s. The main river is in the background. Upland species were tallied on high pinnacles that are rarely flooded.
