# JOHNSTOWN-WESTERN PENNSYLVANIA STORM AND FLOODS OF JULY 19-20, 1977

By L. RAY HOXIT, ROBERT A. MADDOX, CHARLES F. CHAPPELL,  
National Oceanic and Atmospheric Administration, and  
STAN A. BRUA, U.S. Geological Survey

GEOLOGICAL SURVEY PROFESSIONAL PAPER 1211

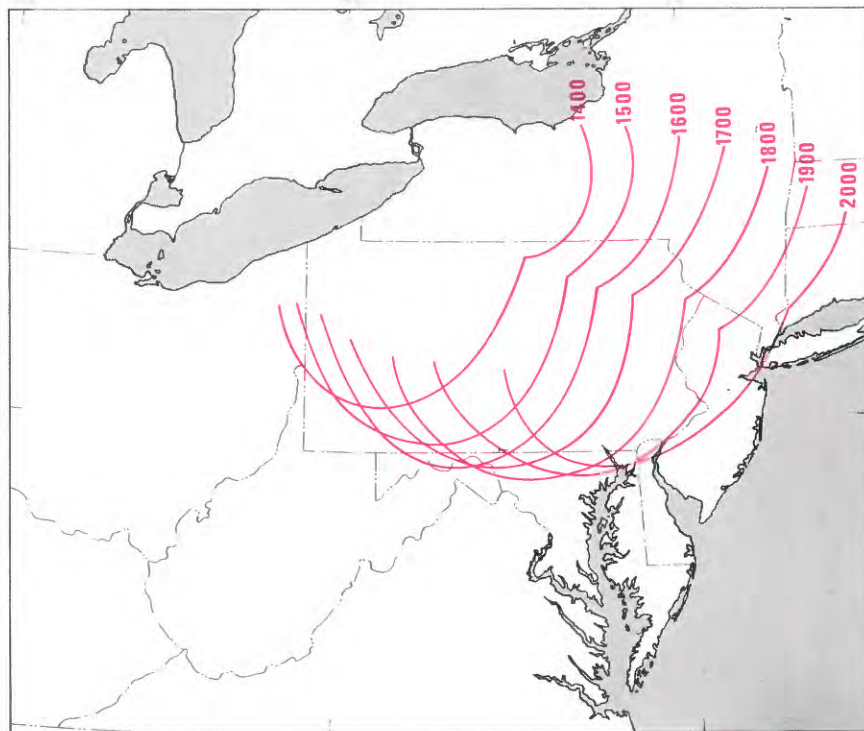
FIGURE 10. - Hourly positions of major thunderstorm outflow boundaries. A, First major boundary: 1400 EDT, July 19, 1977, to 2000 EDT, July 19, 1977. B, Second major boundary: 1600 EDT, July 19, 1977, to 0500 EDT, July 20, 1977; red shading defines region where 24-hr rainfall exceeded 2 in.

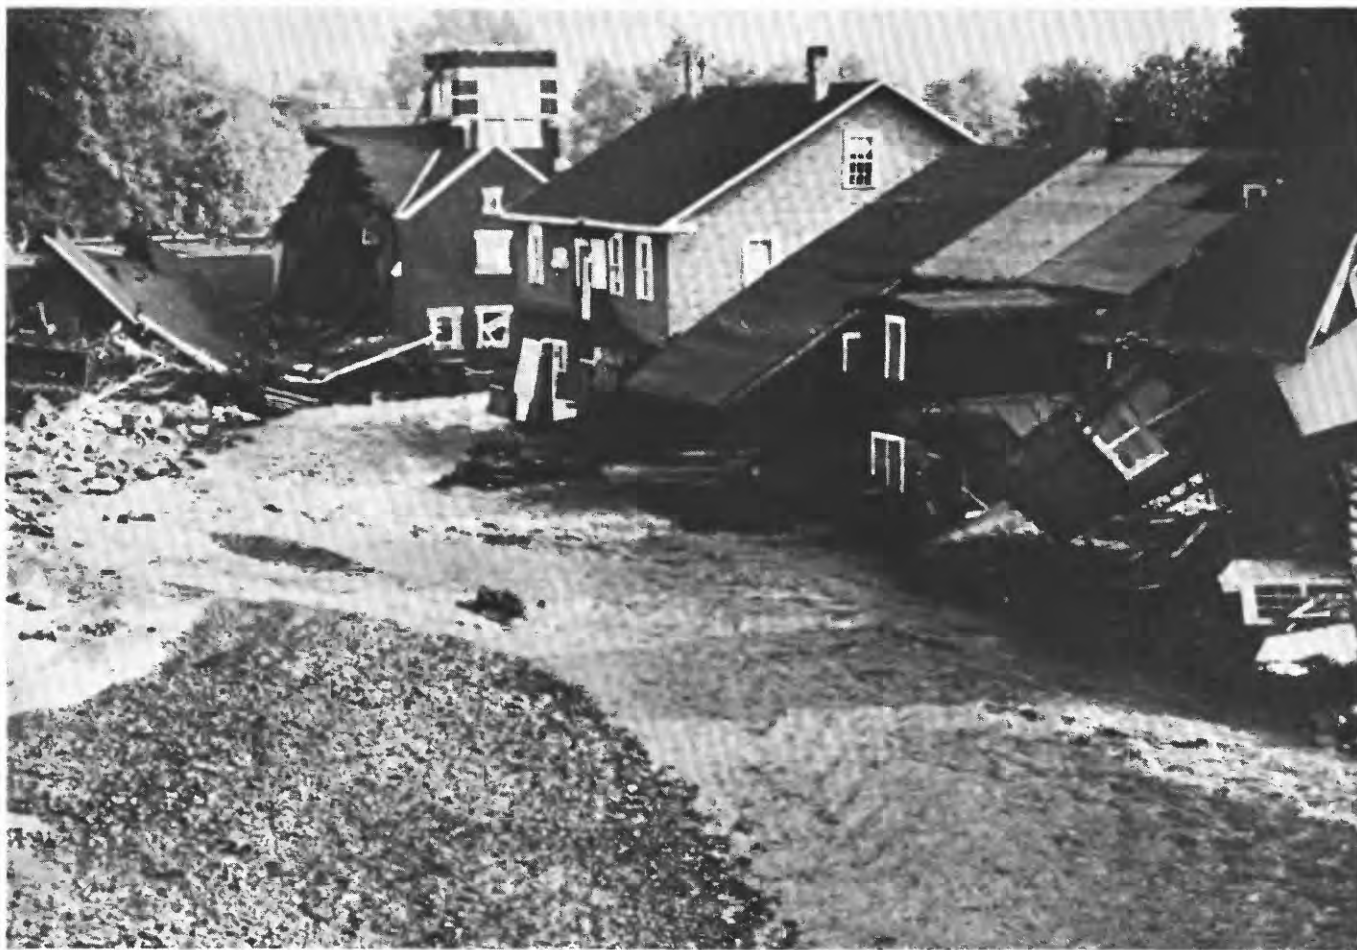
FIGURE 17.—Remains of several homes and a church along Little Paint Creek in Scalp Level. (Johnstown Tribune-Democrat photograph.)

Many deaths and much property damage resulted from flooding in the lower half of the Stony Creek basin. Along Paint Creek and its tributaries, many homes were either destroyed or extensively damaged. (See fig. 17.)

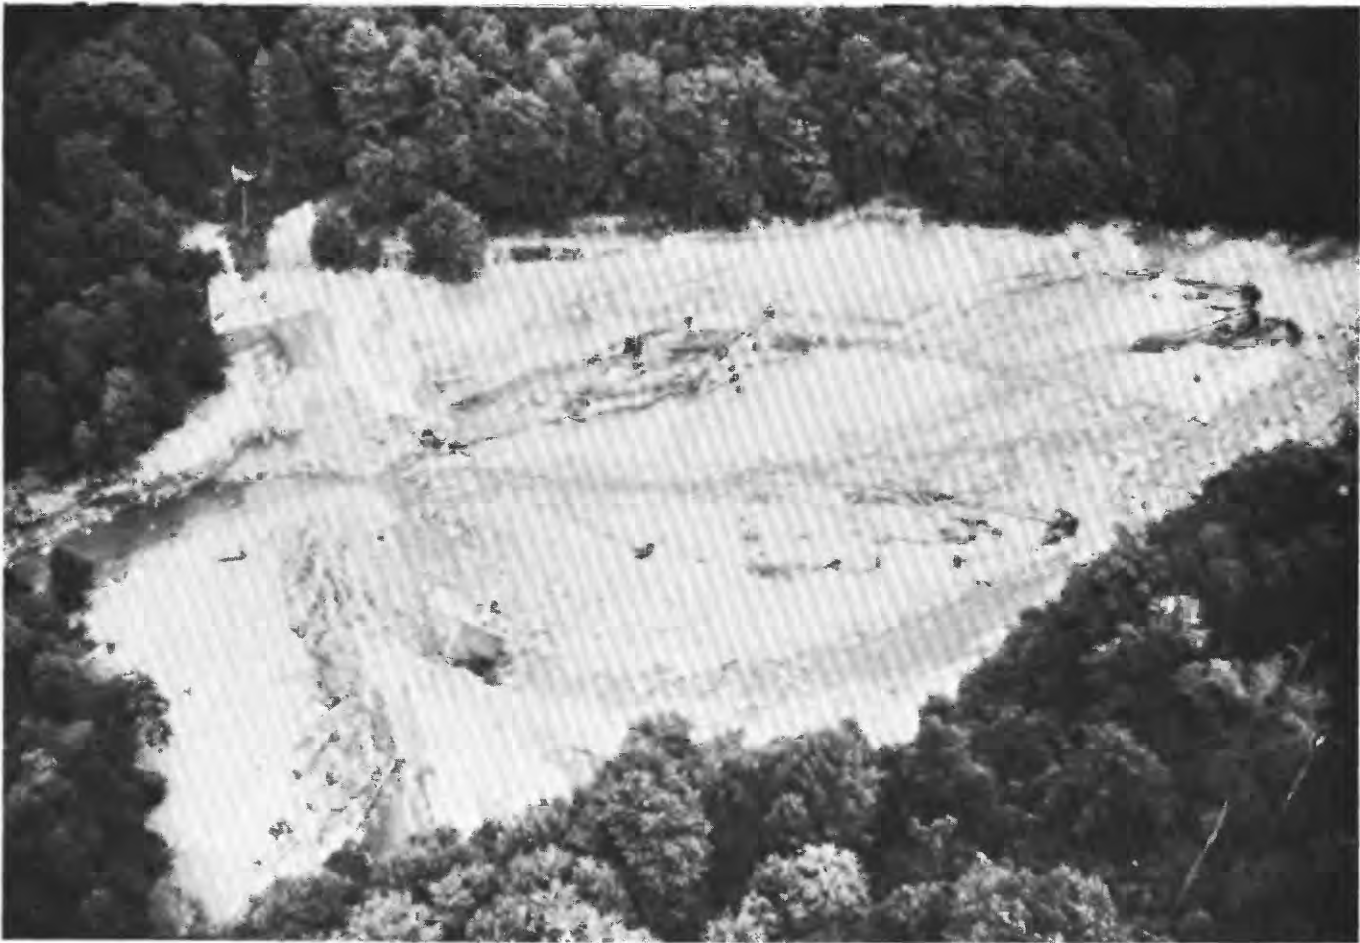
FIGURE 19.—Aerial view of breach in Sandy Run Dam (Pennsylvania Air National Guard photograph.)

Sandy Run, a tributary to the South Fork Little Conemaugh River, had the maximum known natural-runoff rate in the entire flood area— $2,390 \text{ (ft}^3\text{/s)/m}^2$ . This was determined for a site just upstream from a breached water-supply dam (fig. 19). The peak flow at this site (site 21) was  $14,000 \text{ ft}^3\text{/s}$  from a drainage area of  $5.86 \text{ mi}^2$ . The failure of the dam probably caused little modification of the natural peak discharge. One mile downstream from the dam (site 22), the peak flow was  $15,300 \text{ ft}^3\text{/s}$ , or only 10 percent greater than the upstream inflow. Additional information on this and six other dam failures is included in the section Breached Dams.

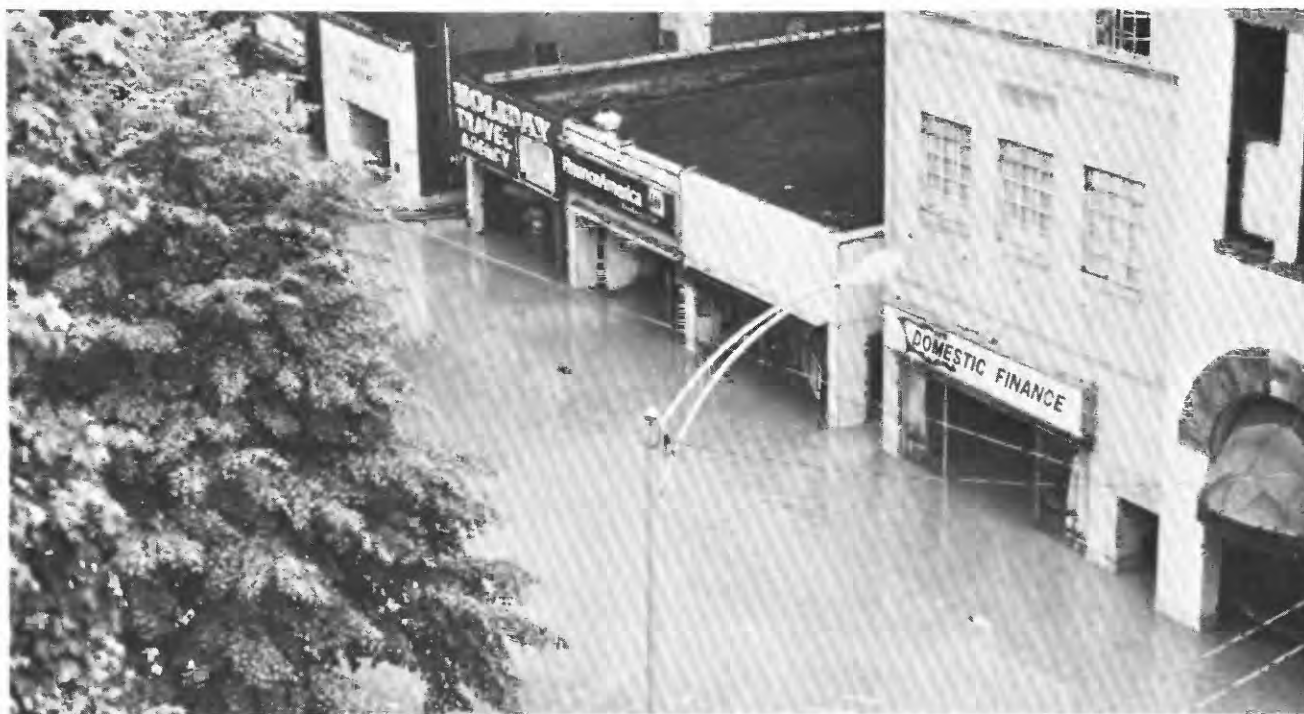
FIGURE 21. – Flooded business establishments in downtown Johnstown at Park Place. The peak stage was about 8 in. higher than the water level shown. (Johnstown Tribune-Democrat photograph.)

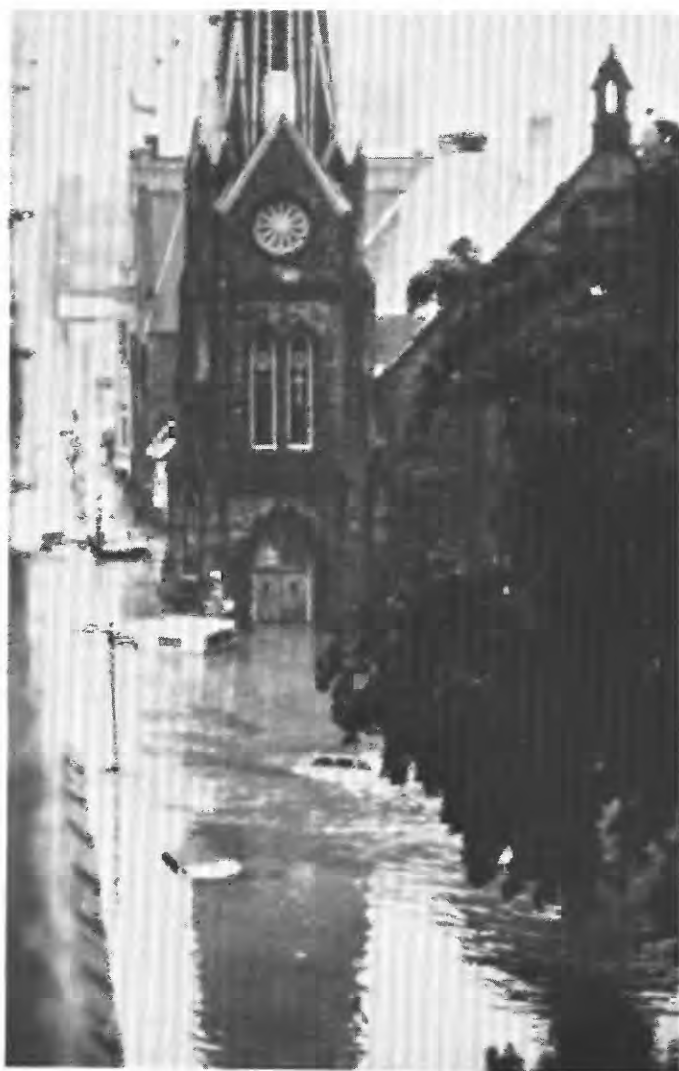
FIGURE 22.—Flooding at Franklin Street United Methodist Church in Johnstown. (Johnstown Tribune-Democrat photograph.)

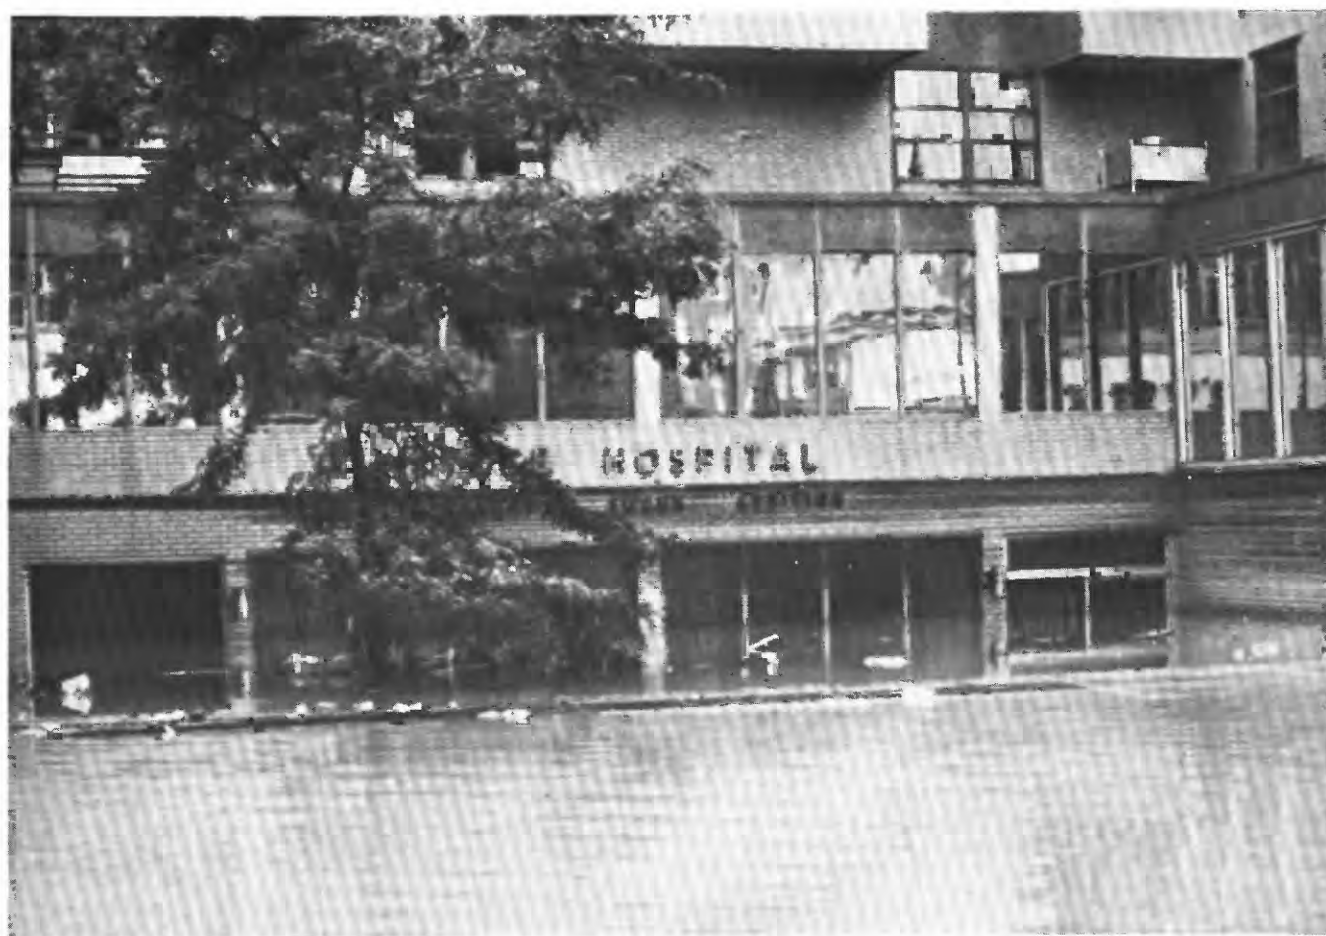
FIGURE 23.—Flooding at Johnstown's Lee Hospital. The dark line across the center of the photograph shows the maximum flood level. (Johnstown Tribune-Democrat photograph.)

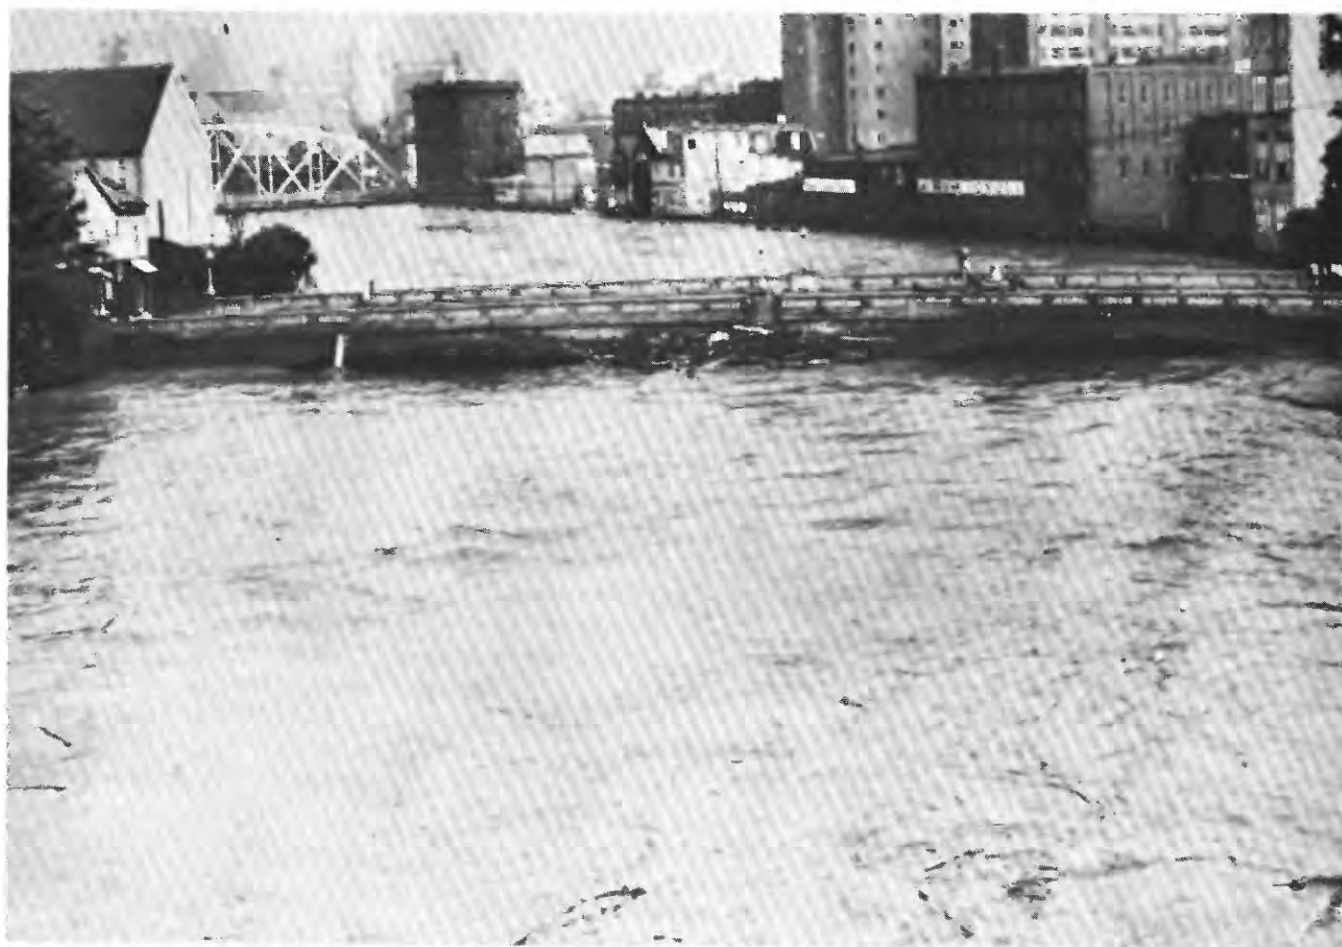
FIGURE 24.—Stony Creek near the height of the flood. View is of Haynes Street bridge looking downstream toward Johnstown's business district. (Johnstown Tribune-Democrat photograph.)

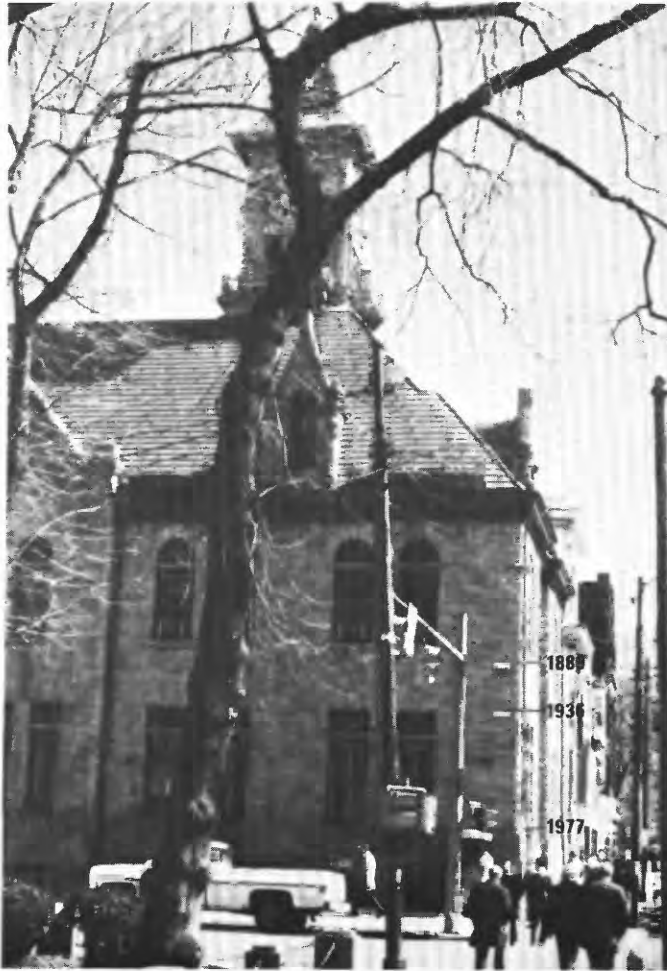
FIGURE 25.—Maximum heights of the 1889, 1936, and 1977 floods at Johnstown's City Hall at northeast corner of Main and Market Streets. (U.S. Geological Survey photograph.)

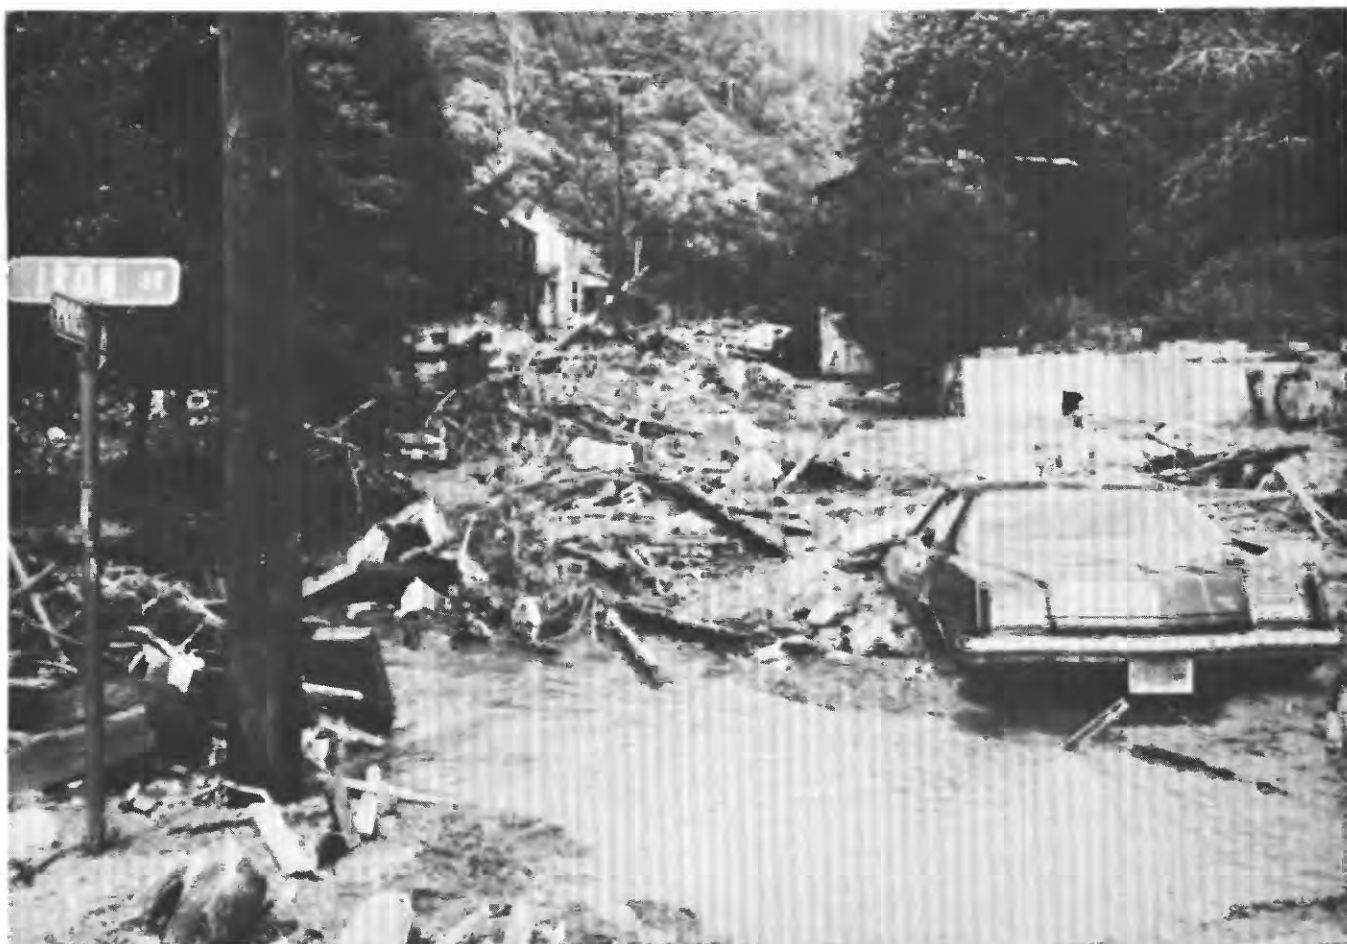
FIGURE 26.—Destruction along an unnamed tributary to the Conemaugh River between the Coopersdale and Minersville sections of Johnstown. The drainage area above this site is about 0.5 mi<sup>2</sup>. (Pennsylvania Air National Guard photograph.)

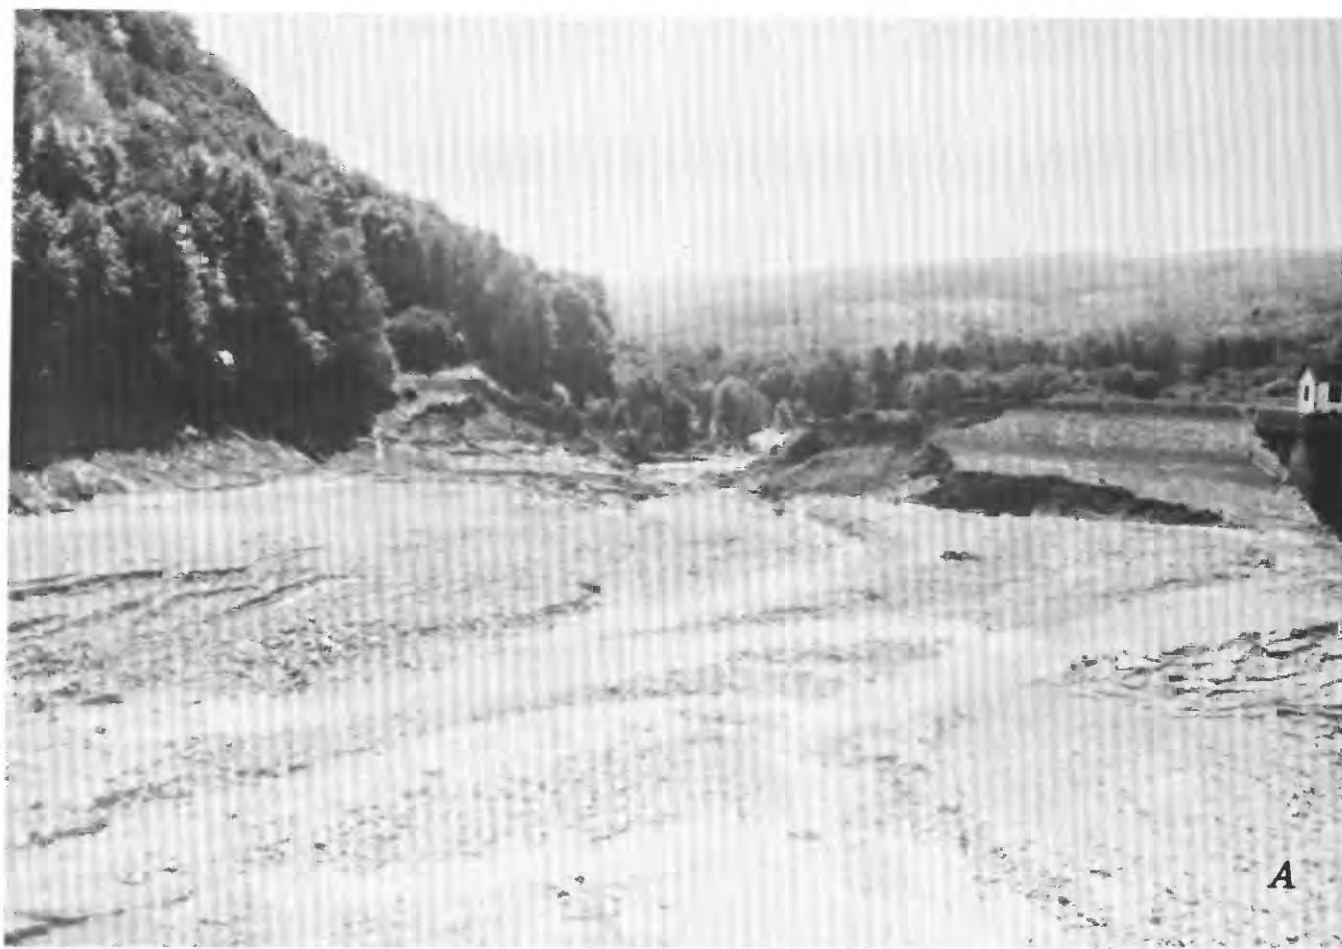
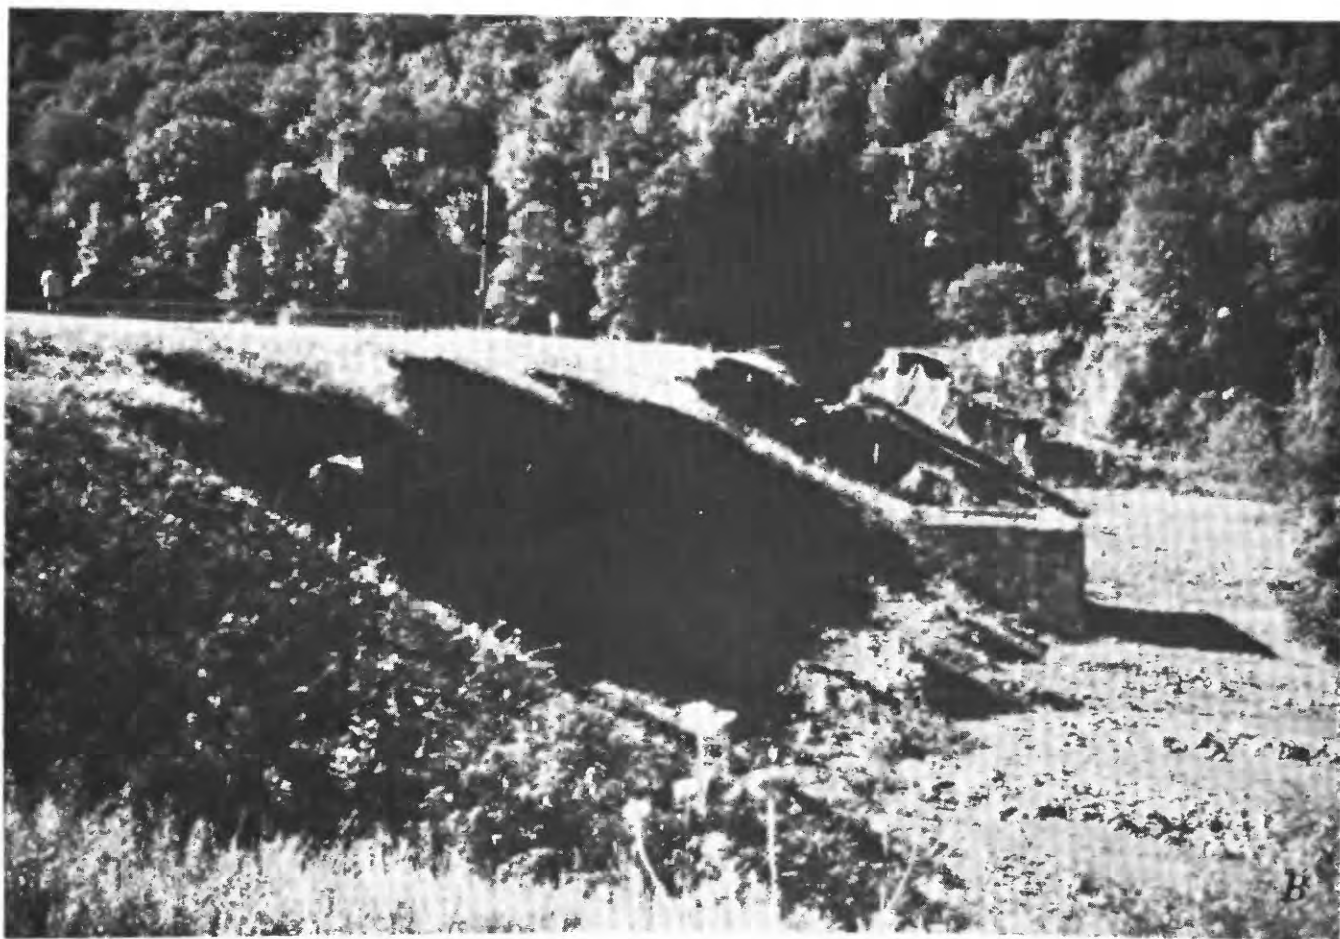
FIGURE 27. —(See caption on facing page.)

FIGURE 27.—Laurel Run Dam. *A*, The left photograph shows the view looking downstream through the breach. (Pennsylvania Air National Guard photograph). *B*, The right photograph shows the eroded downstream face of the dam. The breach is at the far end. (U.S. Geological Survey photograph.)

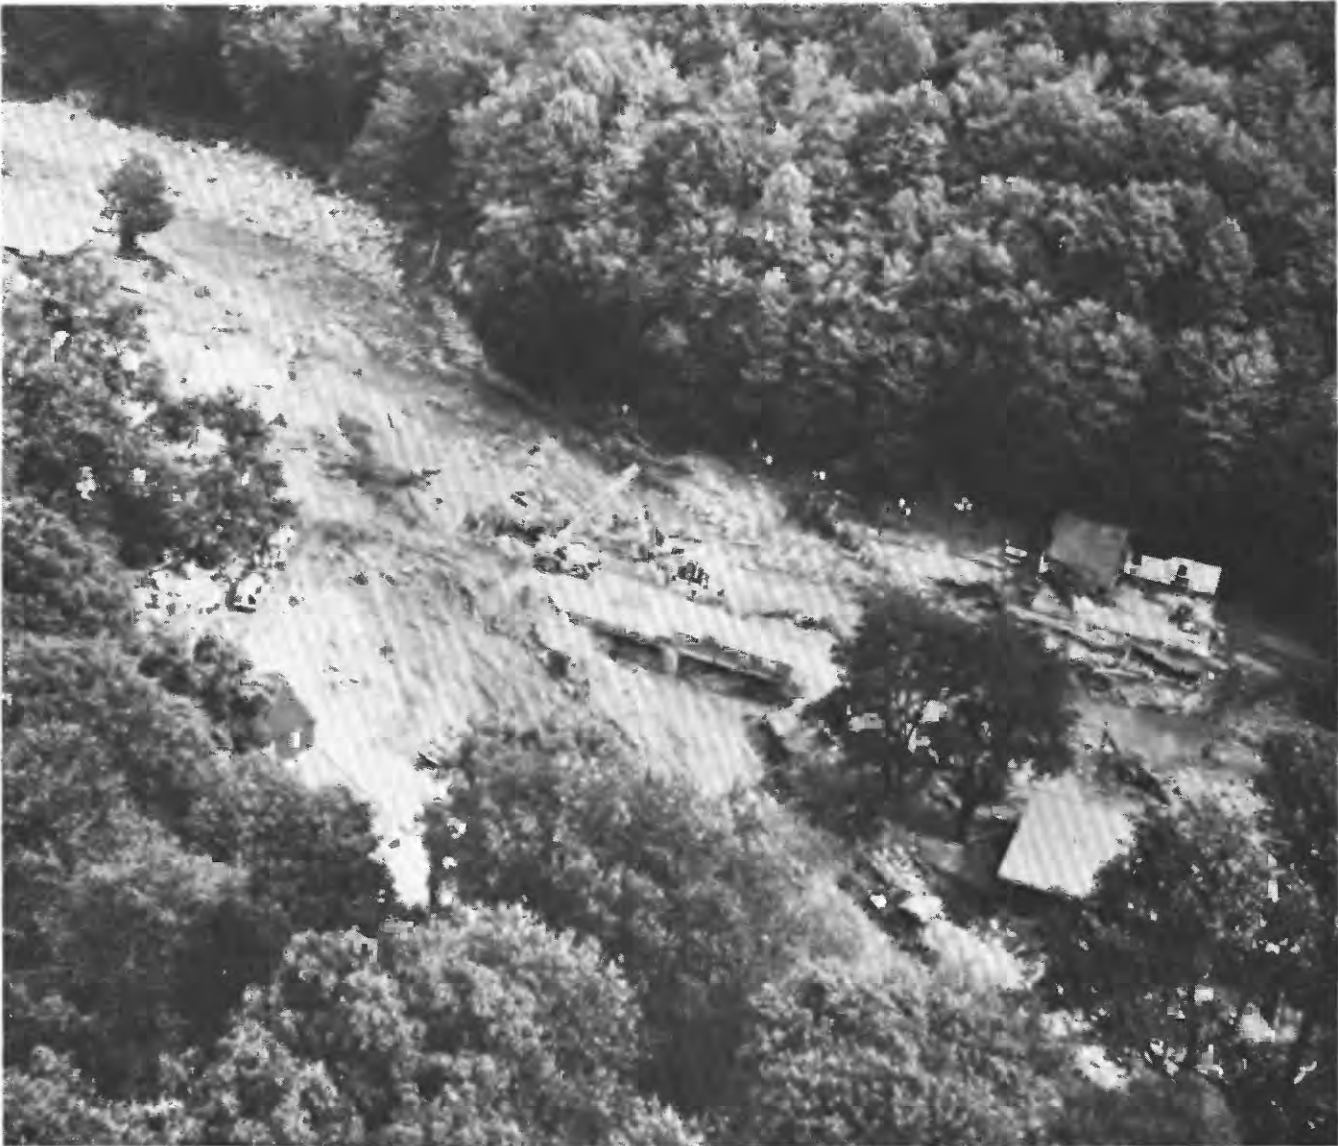
FIGURE 31.—Flood damage downstream from the Laurel Run Dam. The foundations of two homes that were washed away are visible in the upper left corner (Pennsylvania Air National Guard photograph).

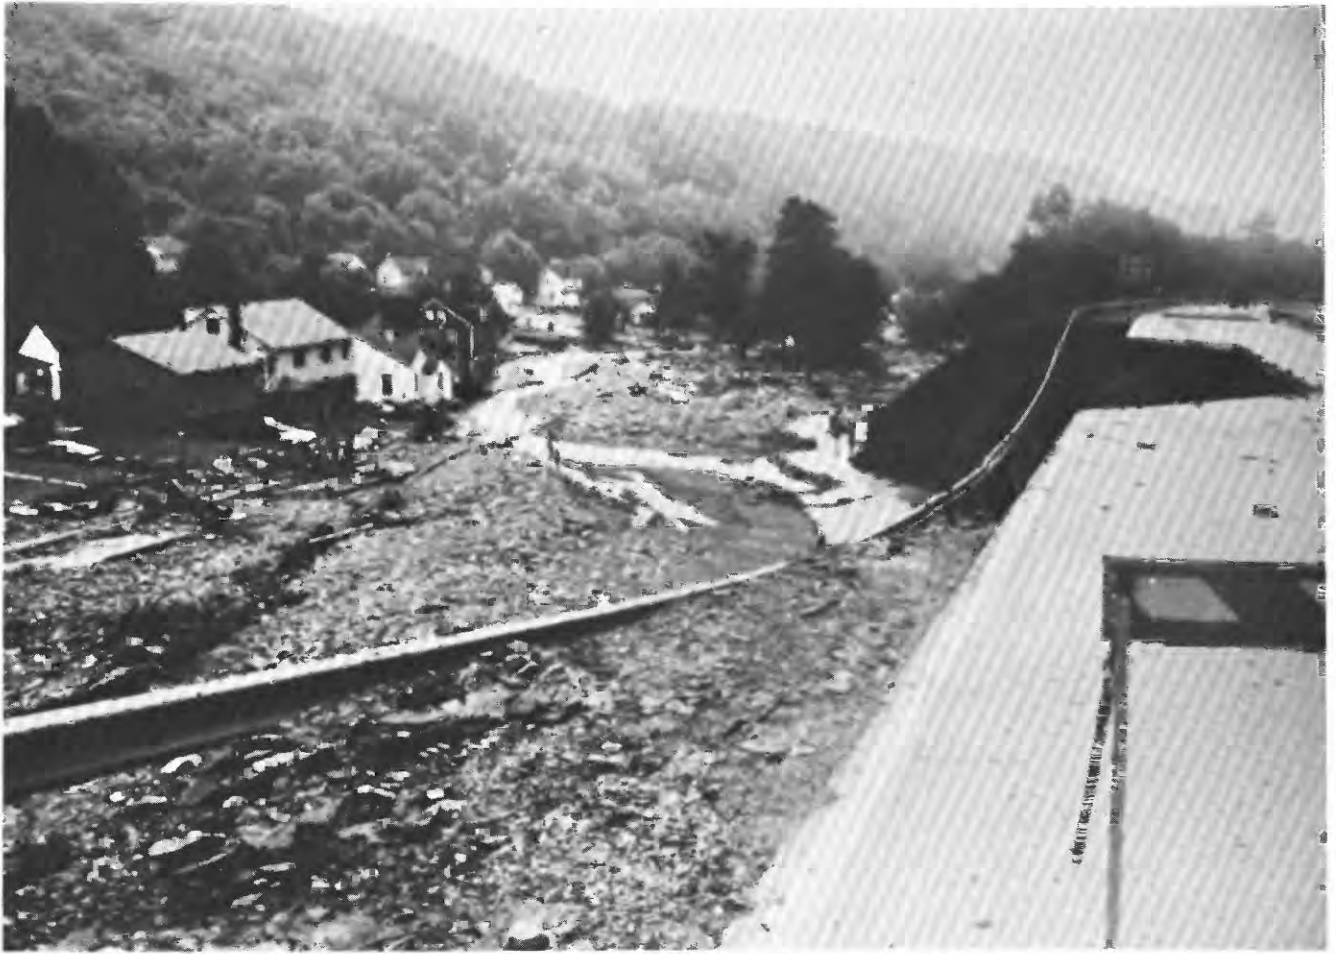
FIGURE 32. – Eastbound lanes of State Highway 56, near Johnstown's eastern corporate boundary, undermined by floodwaters from Solomon Run (Pennsylvania Air National Guard photograph).

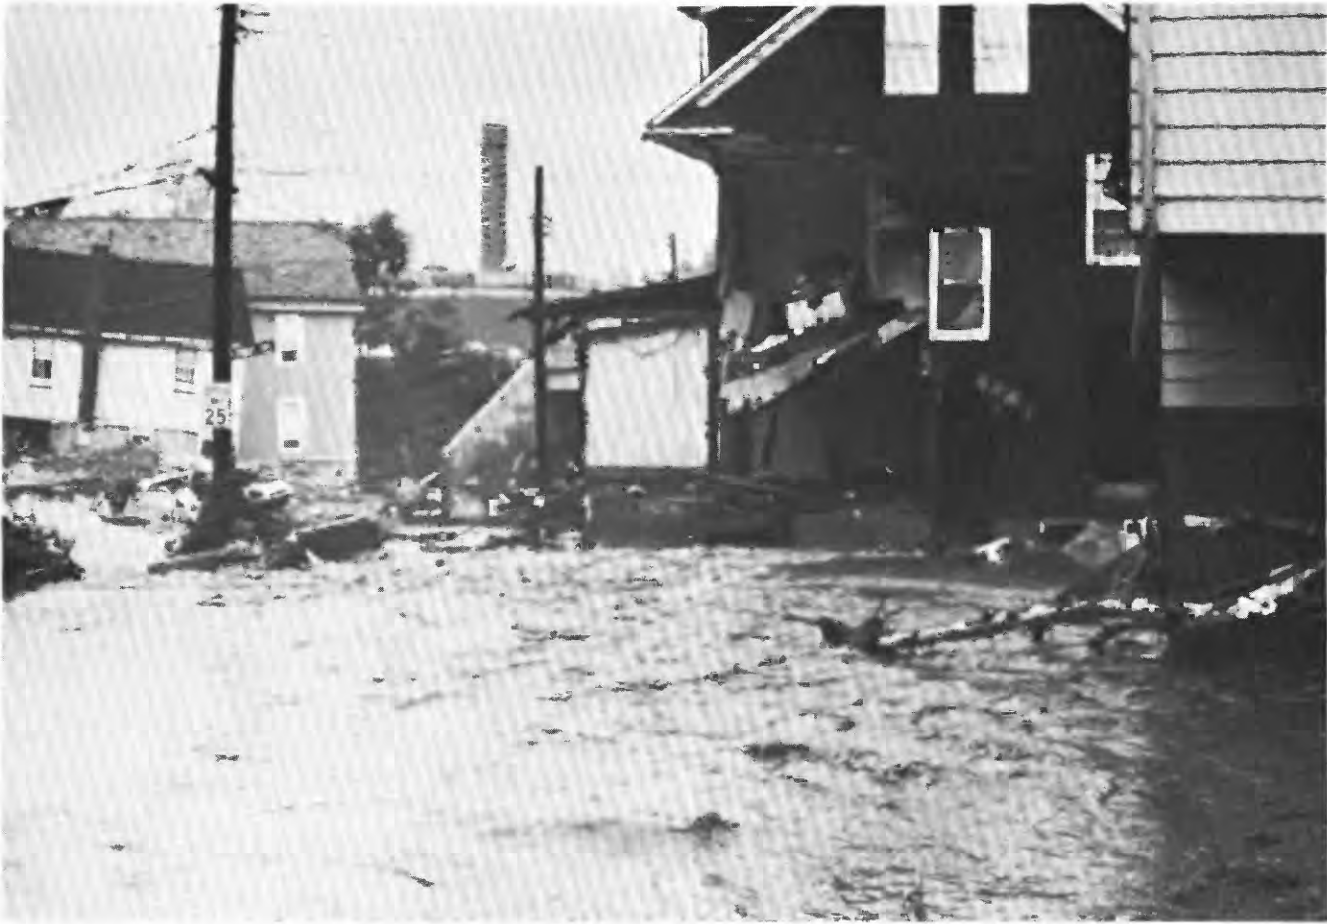
FIGURE 33.—Home damaged by flooding from Solomon Run in the Walnut Grove section of Johnstown (Johnstown Tribune-Democrat photograph.)

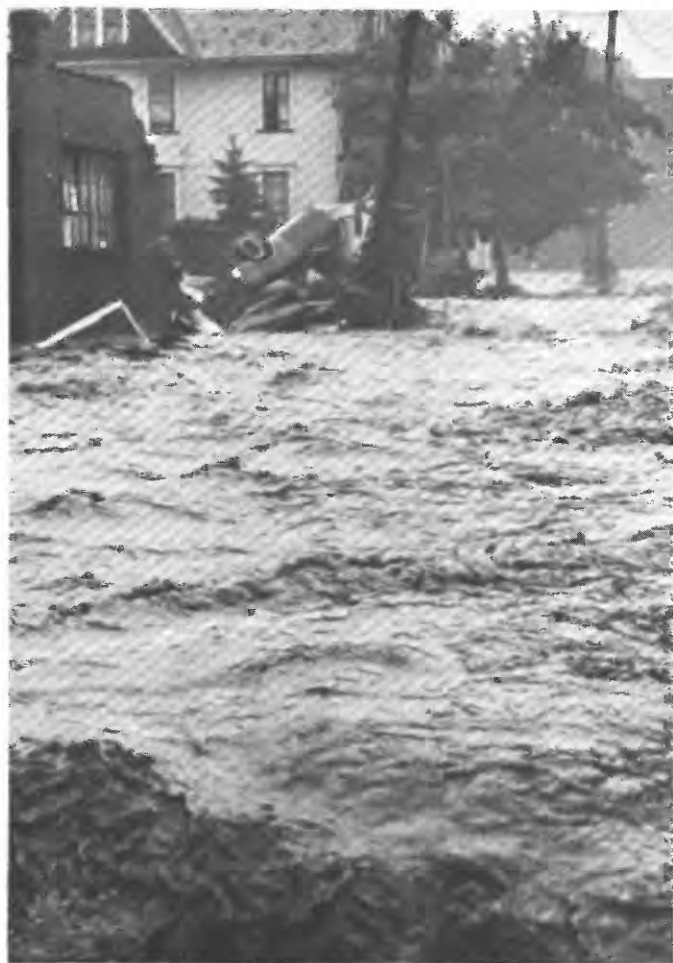
FIGURE 34.—Flooding in the Hornerstown section of Johnstown (Johnstown Tribune-Democrat photograph.)
