# Landslides in the Greater Pittsburgh Region, Pennsylvania

GEOLOGICAL SURVEY PROFESSIONAL PAPER 1229

*Recognition of landslide areas on aerial  
photographs and a study of factors  
affecting slope stability in an urban  
to rural setting*

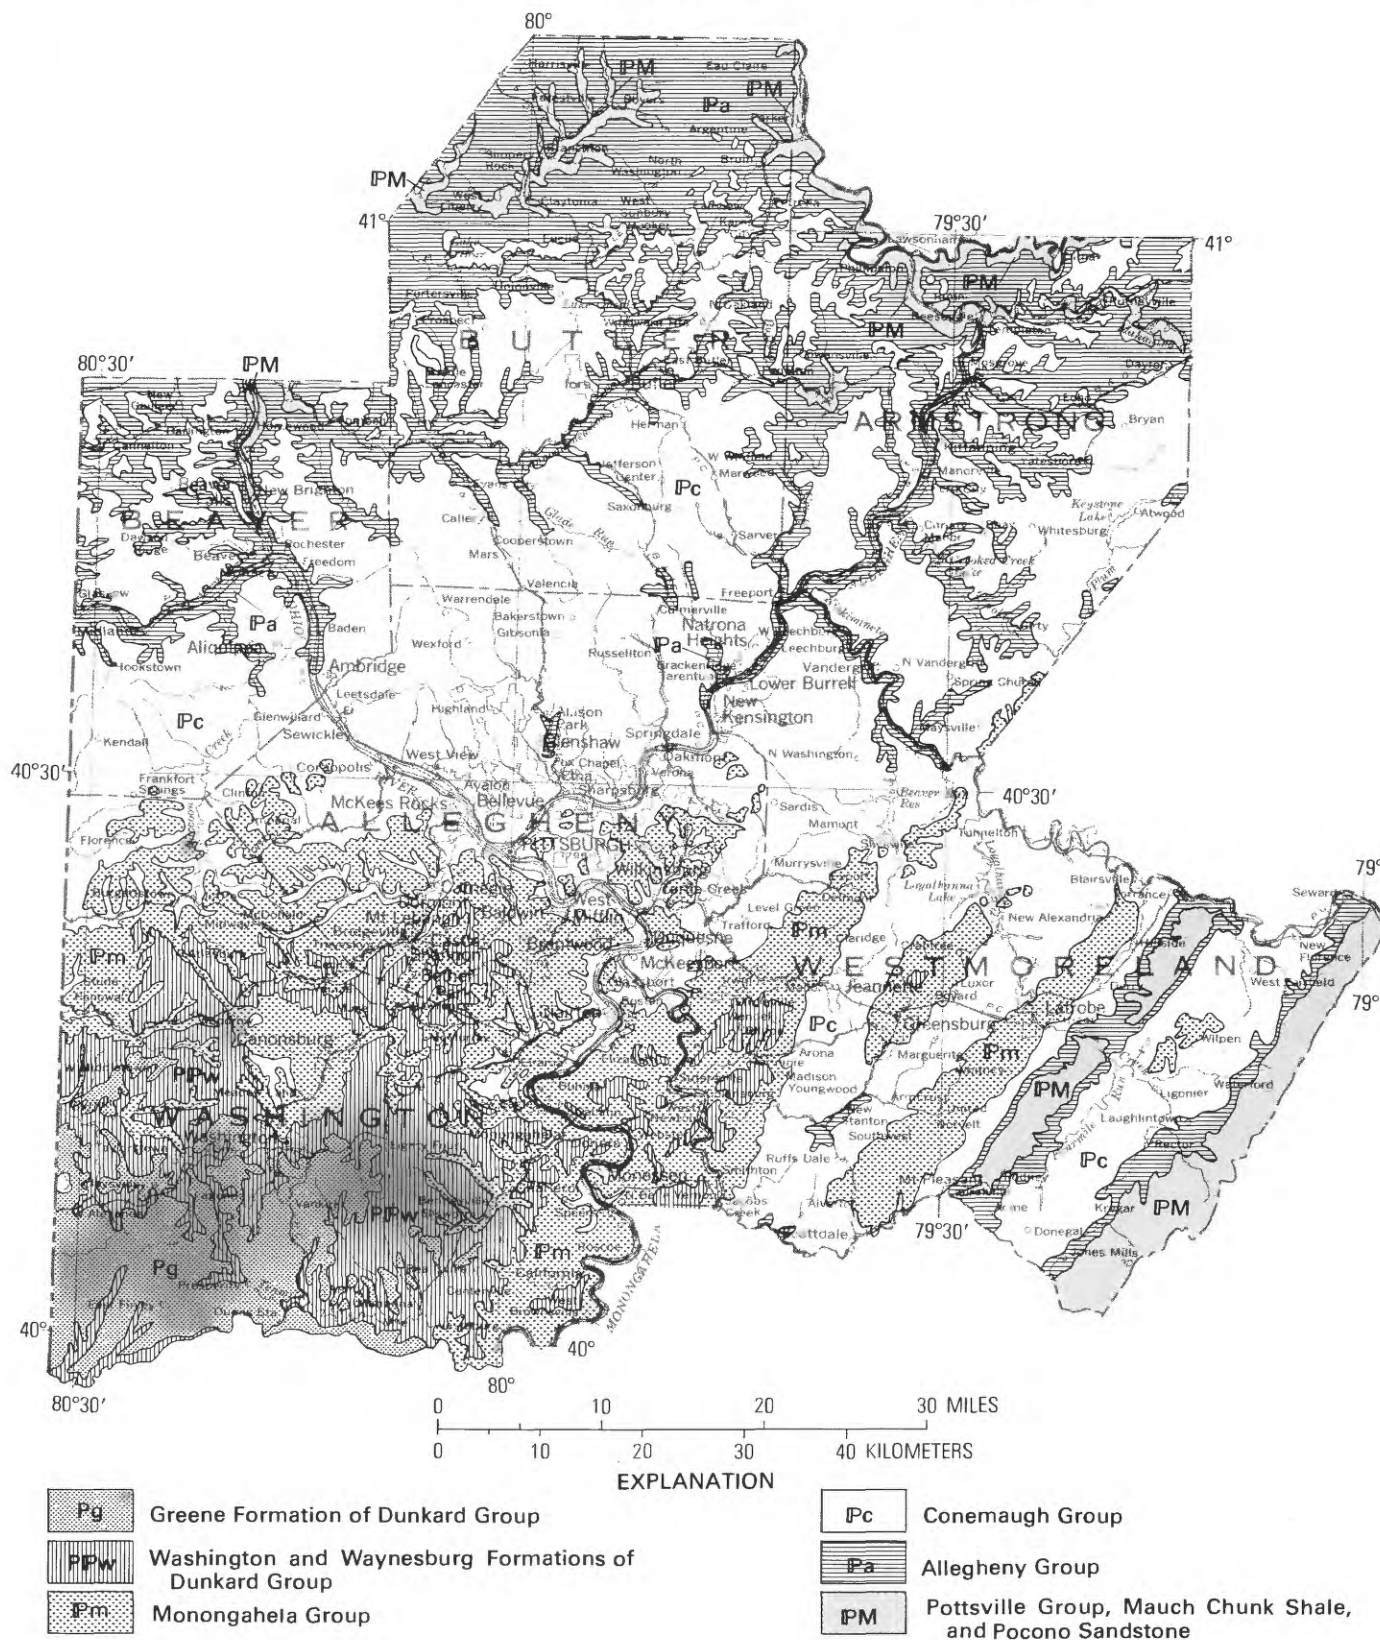
FIGURE 2.—Generalized geologic map of the Greater Pittsburgh region (from Gray and others, 1960).

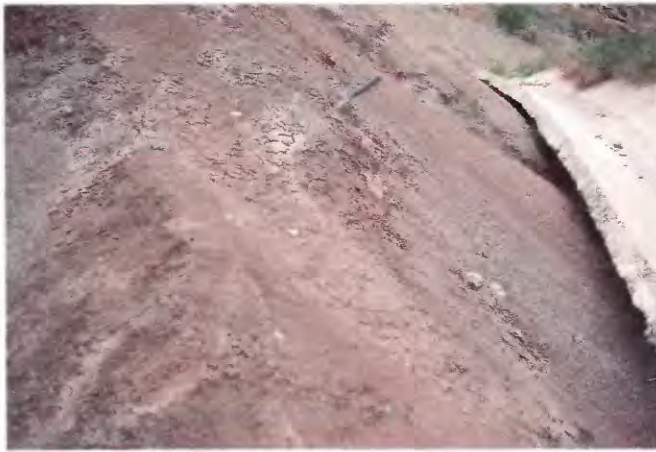
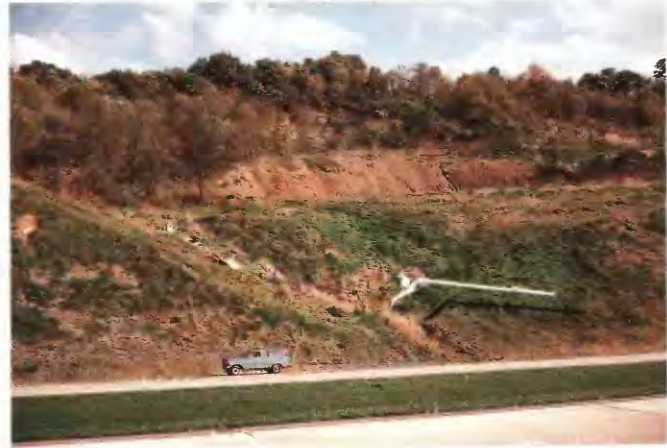
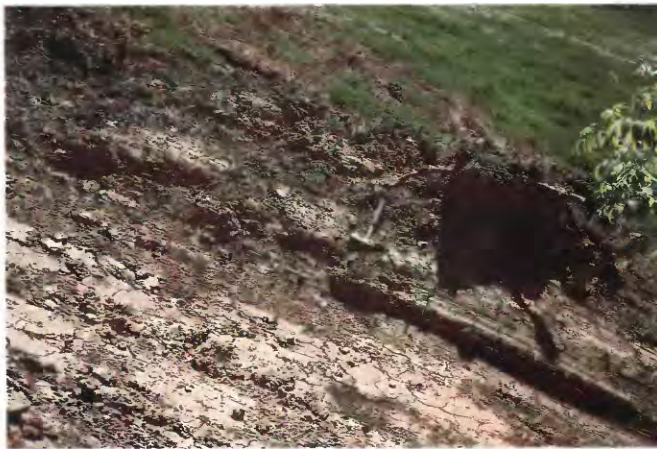
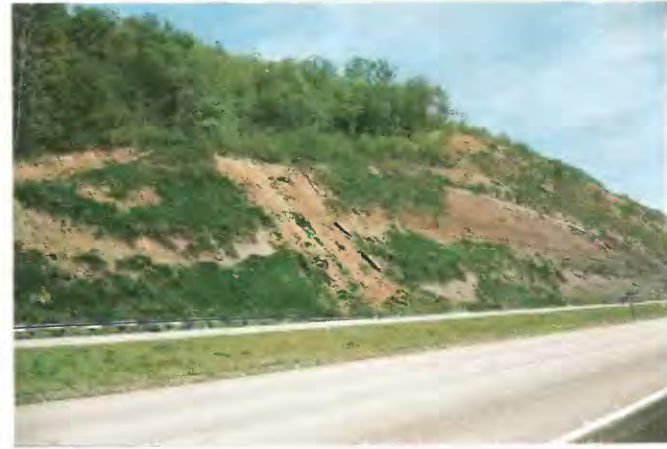
FIGURE 4.—Weathering of the red mudstone outcrop of the Conemaugh Group and mass movement of weathered rock and soils derived from “red beds” of the Conemaugh Group. *A*, Typical nonbedded red mudstone of “Pittsburgh red beds” along I-79 north of Ohio River, Allegheny County. Slaking has left drainage sluice unsupported. Small calcareous nodules are common within unit. *B*, Slickensided surface of sliding plane. Note grooves (striations). Slide involves weathered red mudstone from both Glenshaw and Casselman Formations. Off Wind Gap Road, west Pittsburgh. *C*, Slope failure in colluvium, “Pittsburgh red-beds” interval, I-79 north of Ohio River, Allegheny County. Note broken concrete drainage sluices. *D*, Debris slide along Pennsylvania Rte. 60 south of Aliquippa interchange, Beaver County. “Pittsburgh red beds” below Ames Limestone Member of Glenshaw Formation (thin gray bed at right side).

Road damage due to landslides is high (figs. 4A, C, D, 5A). Remedial action for some slide areas is commonly at a standstill owing to a lack of financial resources at the State, county, township, city, and borough levels. In Allegheny and Beaver Counties, the total cost for contractor and maintenance crews from 1971 to mid-1977 was almost \$7 million (A. J. Gaeta, Pennsylvania Department of Transportation, written commun., 1977), and this amount is for State roads alone. Estimates of costs for utility service disruption (fig. 5B-D) are unavailable.

Debris slides (figs. 4*D*, 12*B*, *C*) consist of incoherent or broken masses of rock and other debris that move

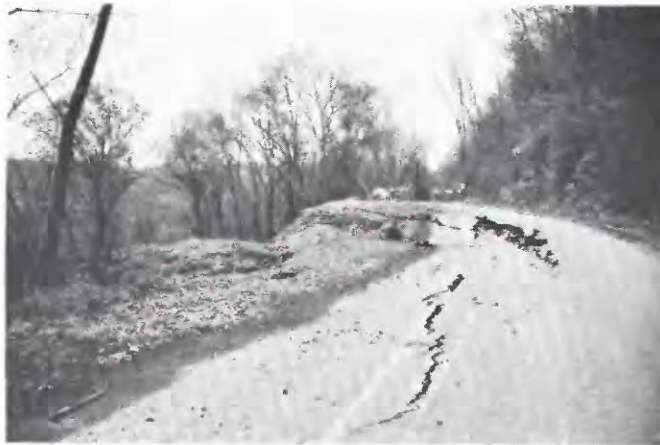
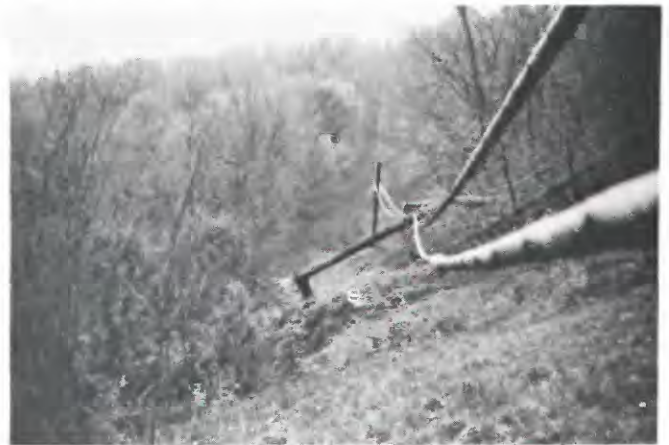
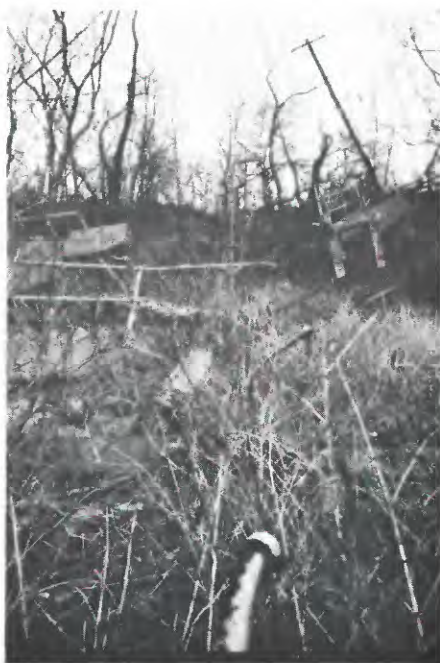
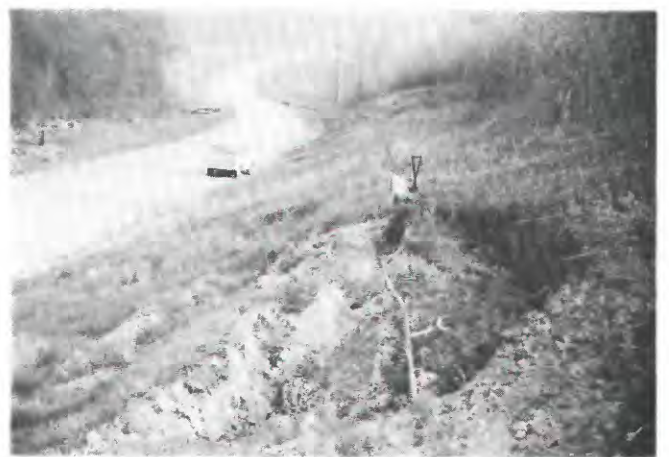
FIGURE 5.—Effects of mass movement on roads and utilities. Note that the stratigraphic unit cited underlies colluvial slope. *A*, Road failure above Raccoon Creek, Independence Township, Beaver County, Glenshaw Formation. *B*, Disrupted stairway and utility line; slide occurs below Sylvan Avenue, Greenfield area, Pittsburgh, Casselman Formation. *C*, Earthflow (e) has shifted telephone-pole alignment; above Buffalo Creek, Donegal Township, Washington County, Dunkard Group. *D*, Buried telephone cable (c) subjected to tensional forces within small slide activated by road-widening activity; Mt. Pleasant Township, Washington County, Monongahela Group.

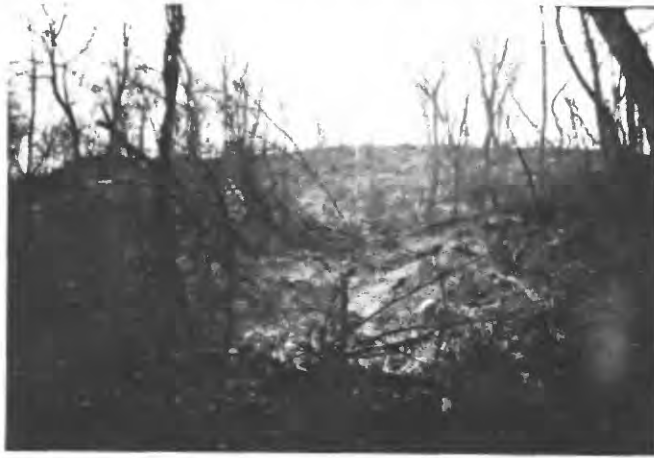
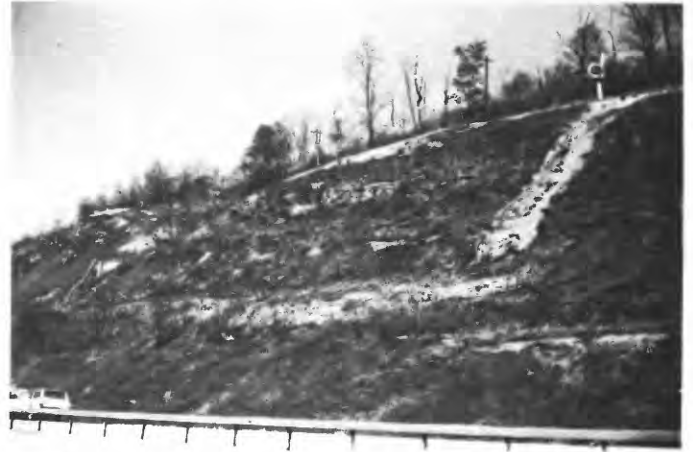
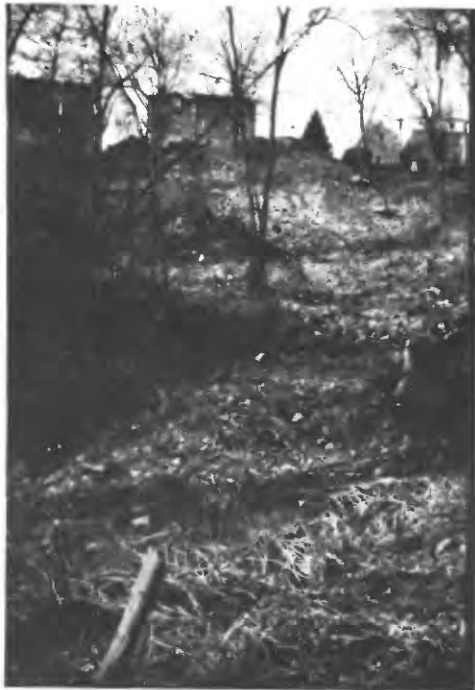
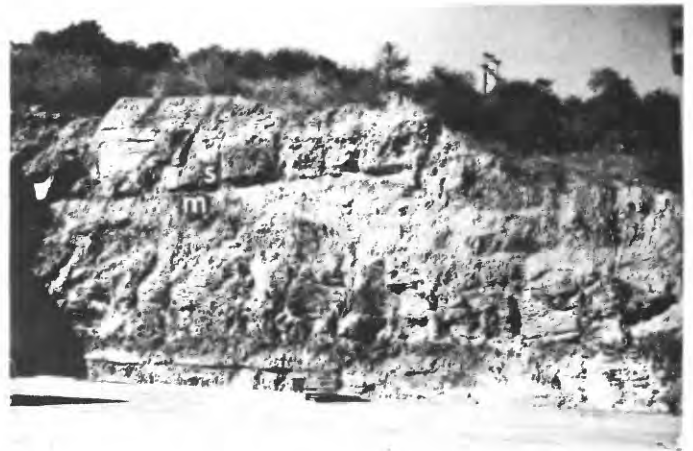
FIGURE 12.—Debris avalanche, debris slides, rockfall. *A*, Debris avalanche, probably caused by heavy precipitation. Above Connoquenessing Creek, Franklin Township, Beaver County. Allegheny Group. *B*, Fill failure behind house reactivated part of an older landslide deposit and caused this debris slide and flow. Harmony Township, Beaver County. Glenshaw and Casselman Formations. *C*, Debris slide (d), bluish-gray clay, exposed at head, served as slippage plane. Pennsylvania Rte. 18 near Rte. 60, Center Township, Beaver County. Glenshaw Formation. *D*, Rockfall hazard at parking lot next to toy store, McKnight Boulevard, Ross Township, Allegheny County. Casselman Formation. Note differential weathering of sandstone (s) and mudstone (m) and potential threat to cars and people.

Debris avalanches (fig. 12A), like debris flows, result from heavy precipitation and are characterized by very rapid to extremely rapid movement of highly saturated material down long narrow paths. The earth material of a debris avalanche usually is more heterogeneous than that of debris flows. Most older debris-avalanche depos-

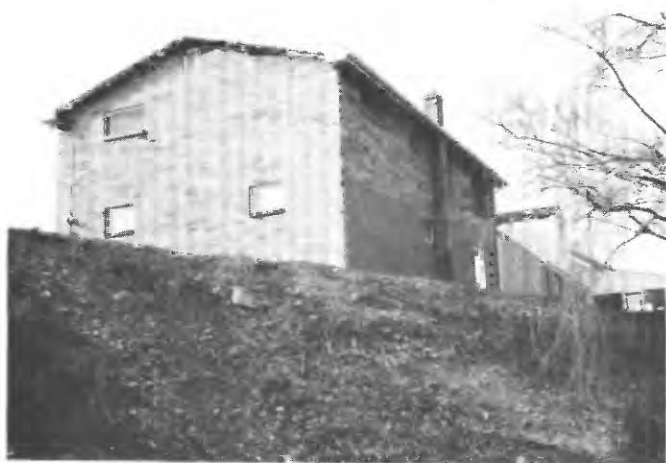
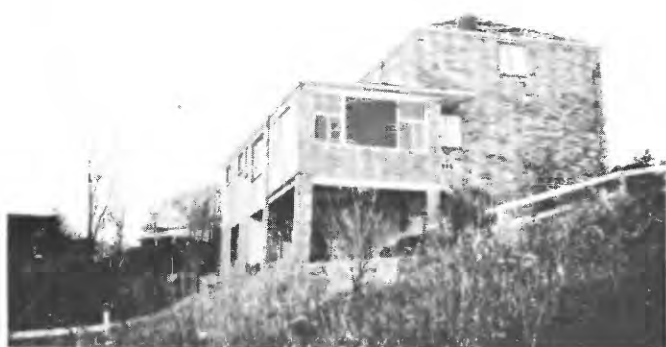
FIGURE 17.—Mass movements along Orchardview Drive and in Edgeworth, Allegheny County. A, B, Orchardview Drive, Scott Township, Allegheny County. Monongahela Group. A, View west from vacant lot formerly occupied by house destroyed by landslide. House in photograph shows partially rebuilt rear wall. (Compare house with unidentified photograph shown by the North Area Environmental Council, Land Use Committee (1972, p. 13).) B, House to east of vacant lot shows out-of-plumb brick porch column affected by soil movement. C, D, Edgeworth, Allegheny County. Glenshaw Formation. C, Head of slide. In November 1973, road was severely cracked; adjacent lower slope showed slanting trees. D, Foot of slide shown in C. Unstable earth material was removed before this January 1974 picture was taken. New fill (granular slag) emplaced afterward.

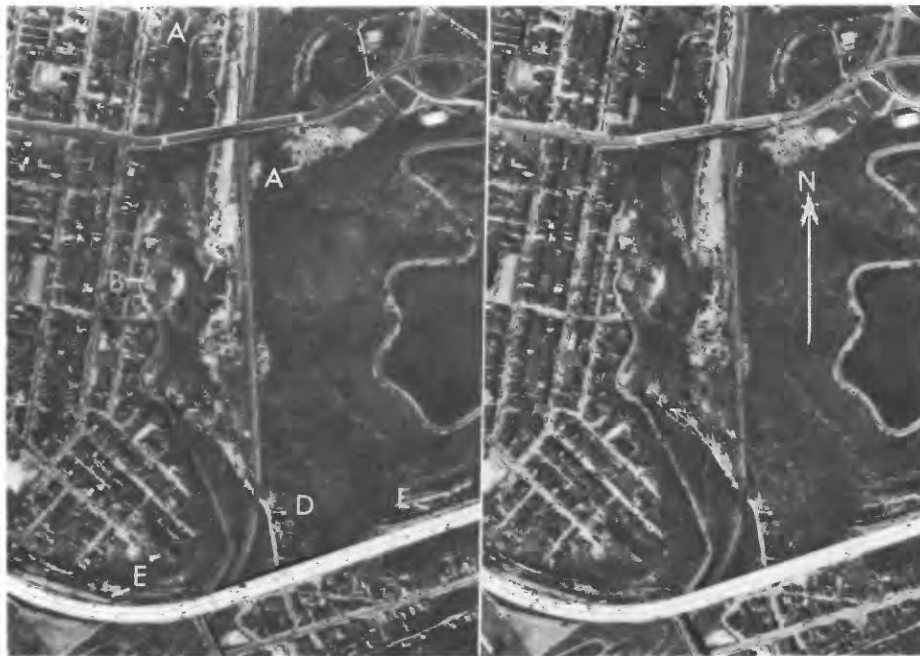
1

Location: Mt. Troy Road area, west of Millvale, Reserve Township, northwest Pittsburgh East 7½-minute quadrangle, Allegheny County.

Aerial photography: April 14, 1973, GS-VDGY, 2-166, 167, scale 1:12,000.

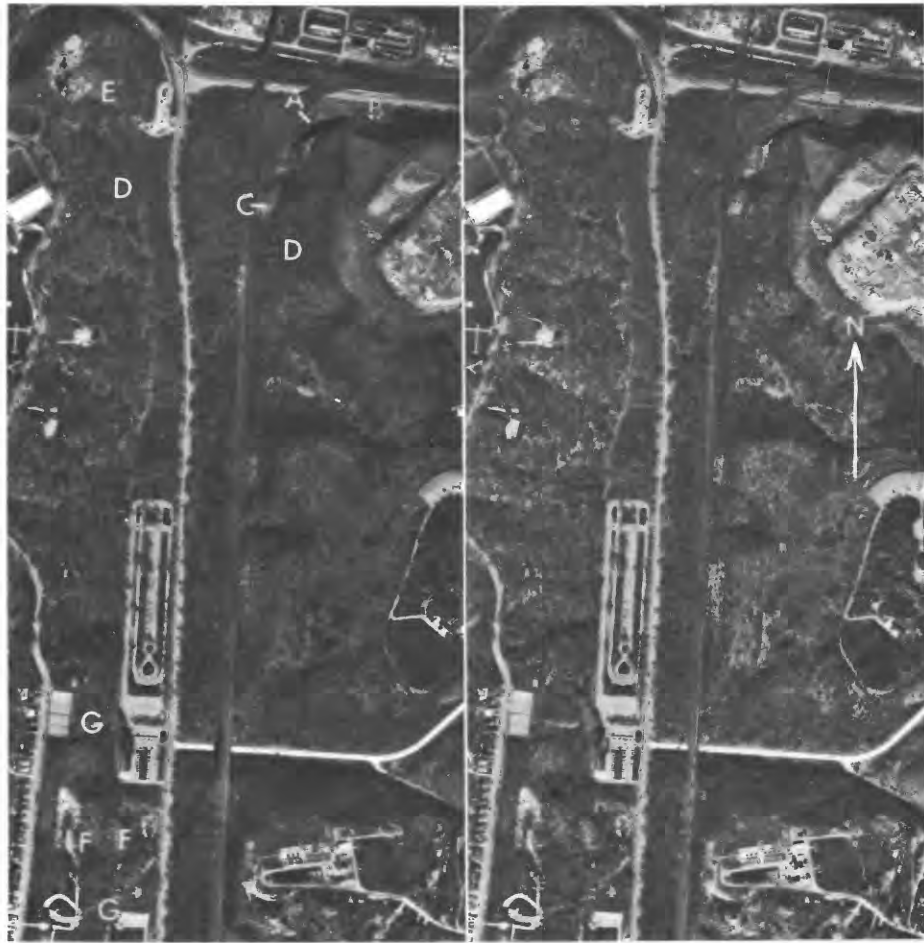
1

Location: U.S. 30 and Pennsylvania Rte. 48 intersection, North Versailles Township, northeast McKeesport 7½-minute quadrangle, Allegheny County.

Aerial photography: April 14, 1973, GS-VDGY, 2-458, 459, scale 1:12,000.

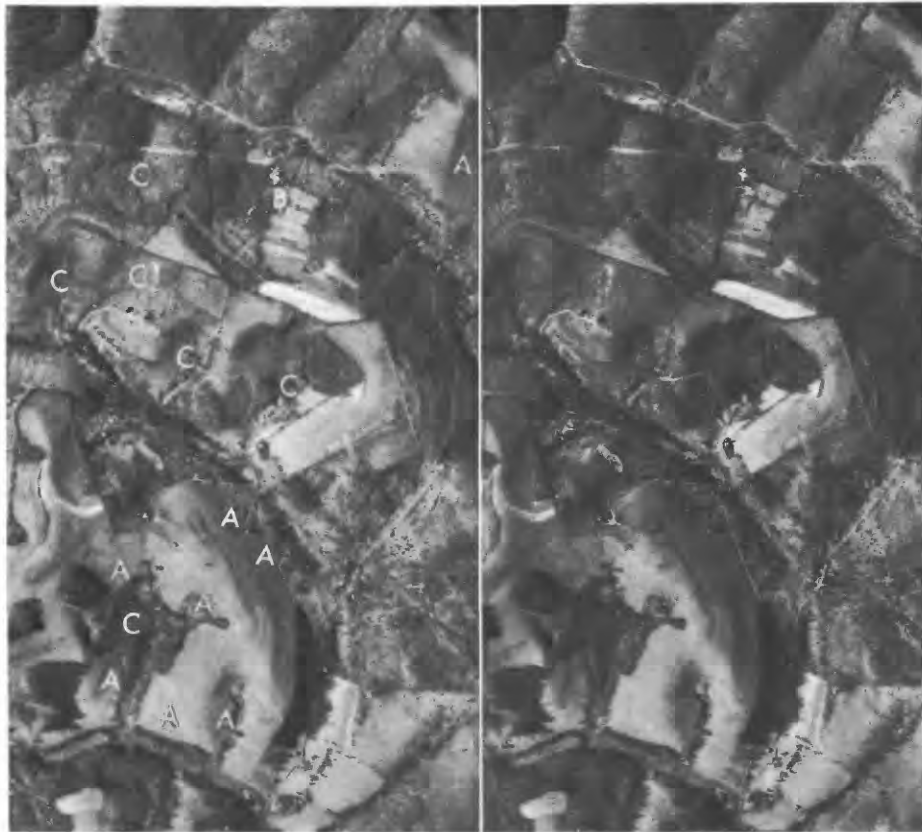
1

Location: Mahoning Creek area south of Distant, Mahoning Township, northwest Distant and northeast Templeton 7½-minute quadrangles, Armstrong County.

Aerial photography: September 24, 1974, USDA-ASCS, 374-5, 6, scale 1:40,000.
