# THE IMPERIAL VALLEY, CALIFORNIA, EARTHQUAKE OF OCTOBER 15, 1979

GEOLOGICAL SURVEY  
PROFESSIONAL PAPER 1254

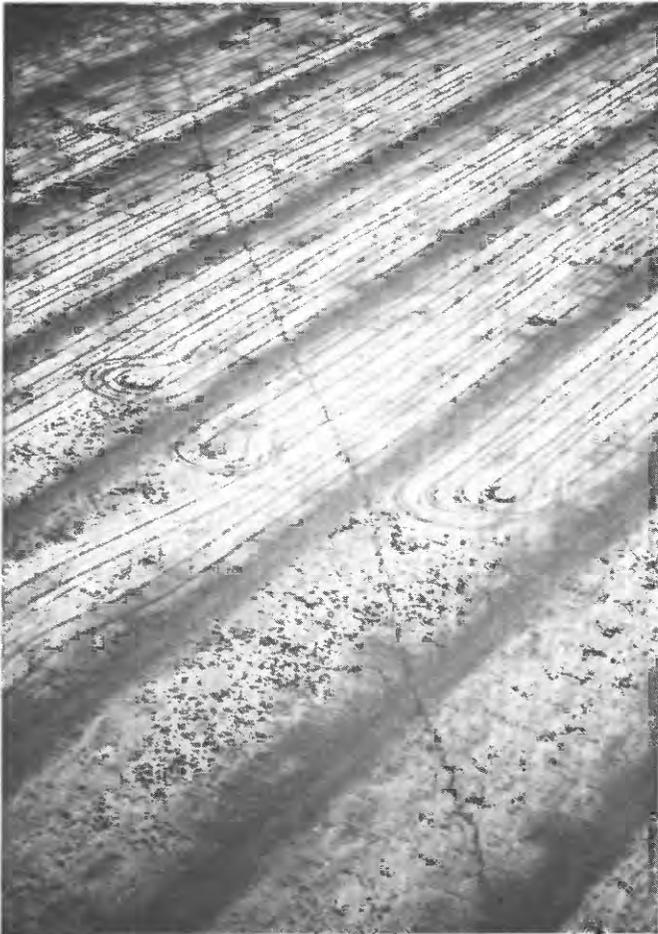
FIGURE 85.—Imperial fault trace 1.0 km south of County Highway S-80 (at 11.3 km). Echelon fissures (vertically oriented in this view) trend N. 20°–50° W.; fault trace trends between N. 30° and 40° W. Compressional features (dark horizontal bands) join ends of separate echelon fractures. Distance between manmade berms (wide dark diagonal bands) is about 9.1 m. Maximum width of obviously deformed zone is about 0.6 m. View southeastward. Photograph by M. J. Rymer, October 23, 1979.

The ground fracturing along much of the Imperial fault (figs. 85, 86) was identical to (or a mirror image of) strike-slip fault ruptures observed from past surface movements in other areas around the world. For that section of the Imperial fault where vertical components of slip were minor, the rupture trace (or "mole track") exhibited the characteristic succession of overlapping echelon fractures. Individual fractures were oriented more northerly than the average northwestward trend of the fault trace, and so the stepover direction from one fracture to the next was to the left—a common rupture pattern for right-lateral strike-slip.

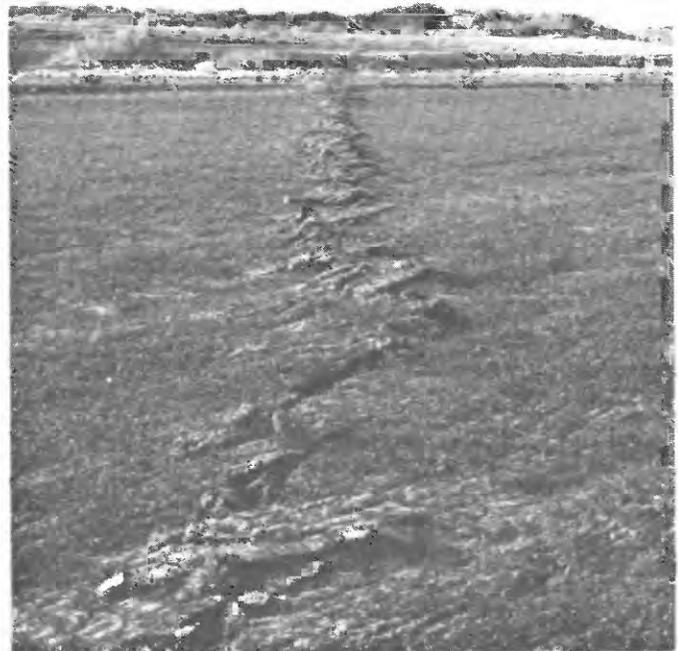
FIGURE 86.—Rupture (or "mole track") on Imperial fault in field south of Heber Road (at 2.4 km). Piled-up soil fragments are compressional mounds that formed between ends of echelon fractures in ground. View northwest. Photograph by J. C. Tinsley, who measured  $45 \pm 3$  cm of dextral displacement on offset crop rows in this field on October 17, 1979.

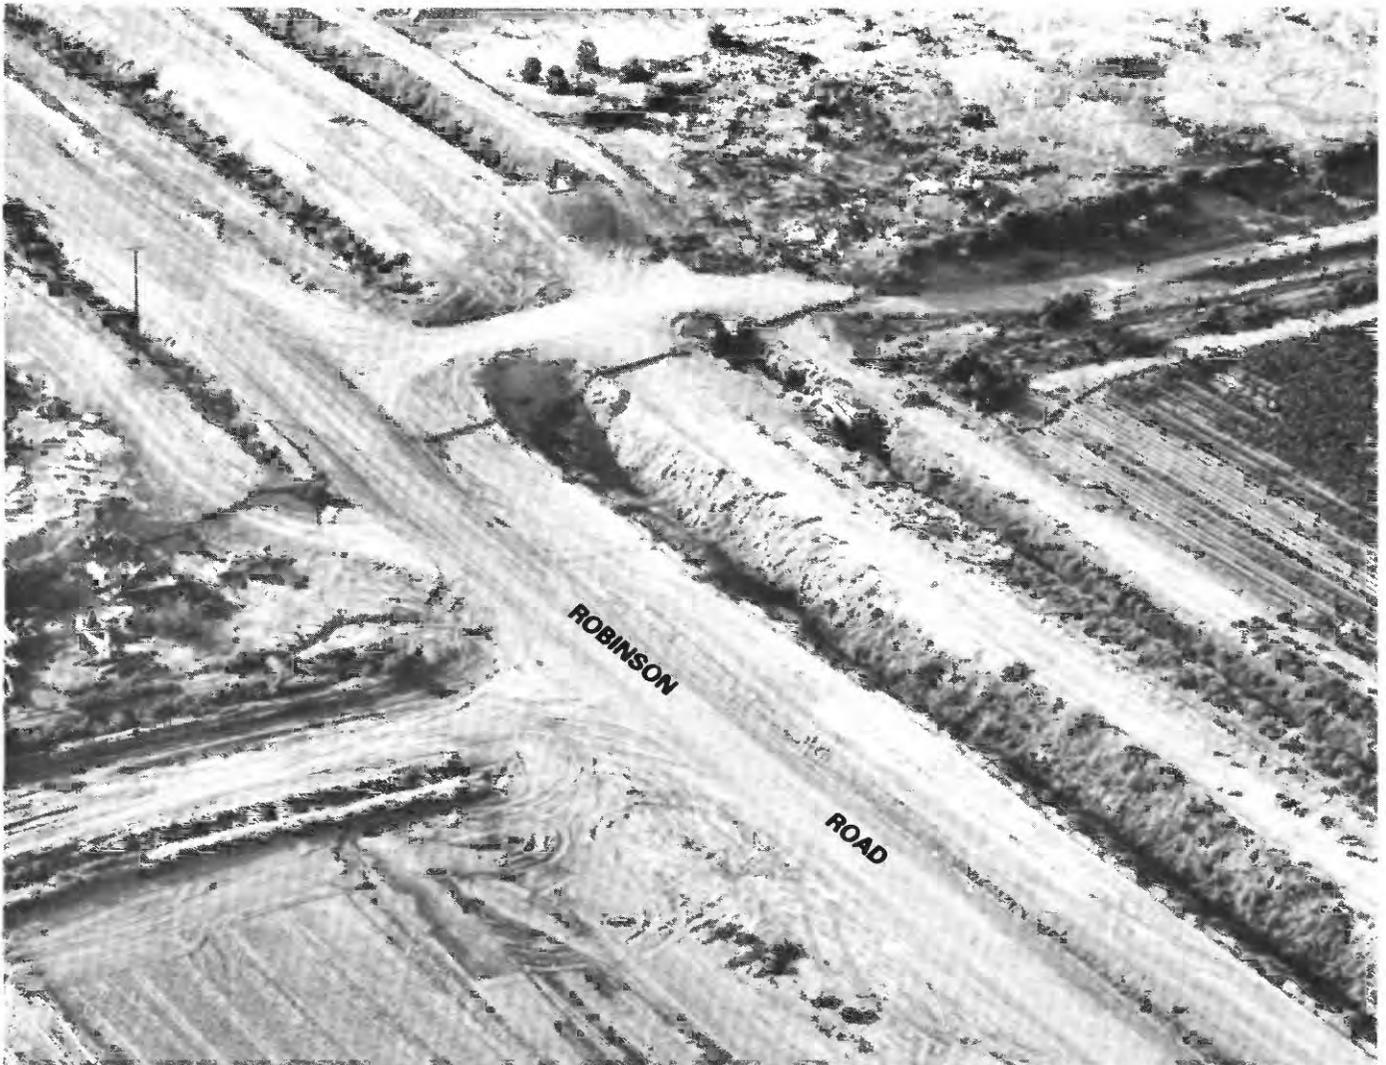
FIGURE 87.—Imperial fault at Robinson Road (at 20.0 km). Vertical component of 1979 slip here created a low scarp (shadowed line) that has been smoothed at road surface by regrading. Vertical displacement at surface rupture is about 28 cm in this view. Surface rupture to right extends along line of bushes that conceal it. Vegetational lineaments of this type commonly mark fault trace along margin of Mesquite basin where some land has not been farmed or otherwise modified. View northwestward. Photograph by M. J. Rymer, October 23, 1979.

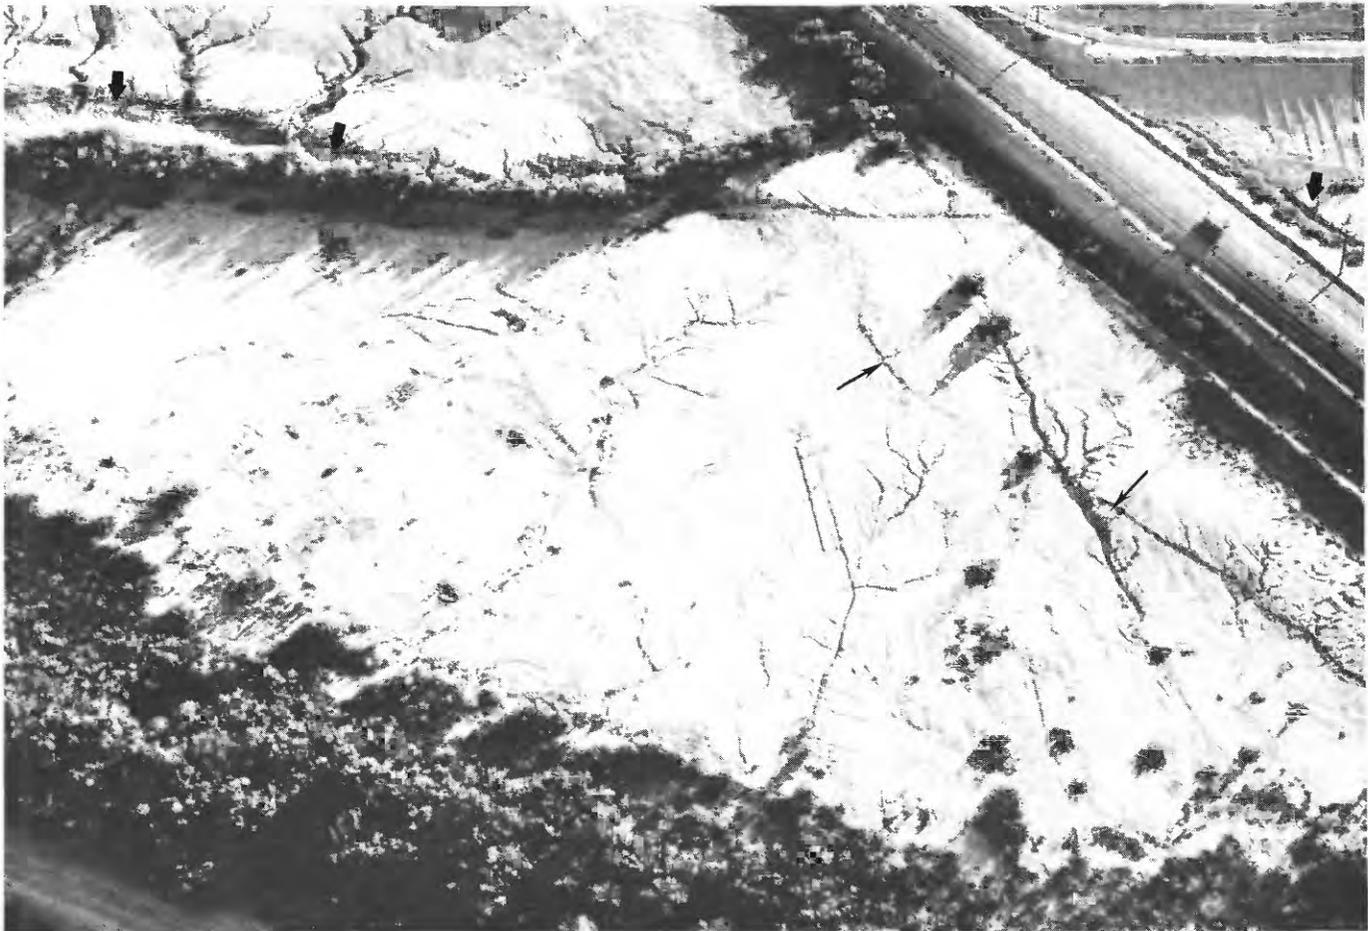
FIGURE 88.—Imperial fault at Dogwood Road (at 23.1 km). Main fault trace crosses top horizontally (short arrows). Gullies are deeply incised on upthrown (southwest) side of fault. Secondary fault (long arrows) branches northward nearly parallel to Dogwood Road and eventually crosses pavement about 170 m north of point where main fracture crosses it. View southwestward. Photograph by D. G. Herd, October 22, 1979.

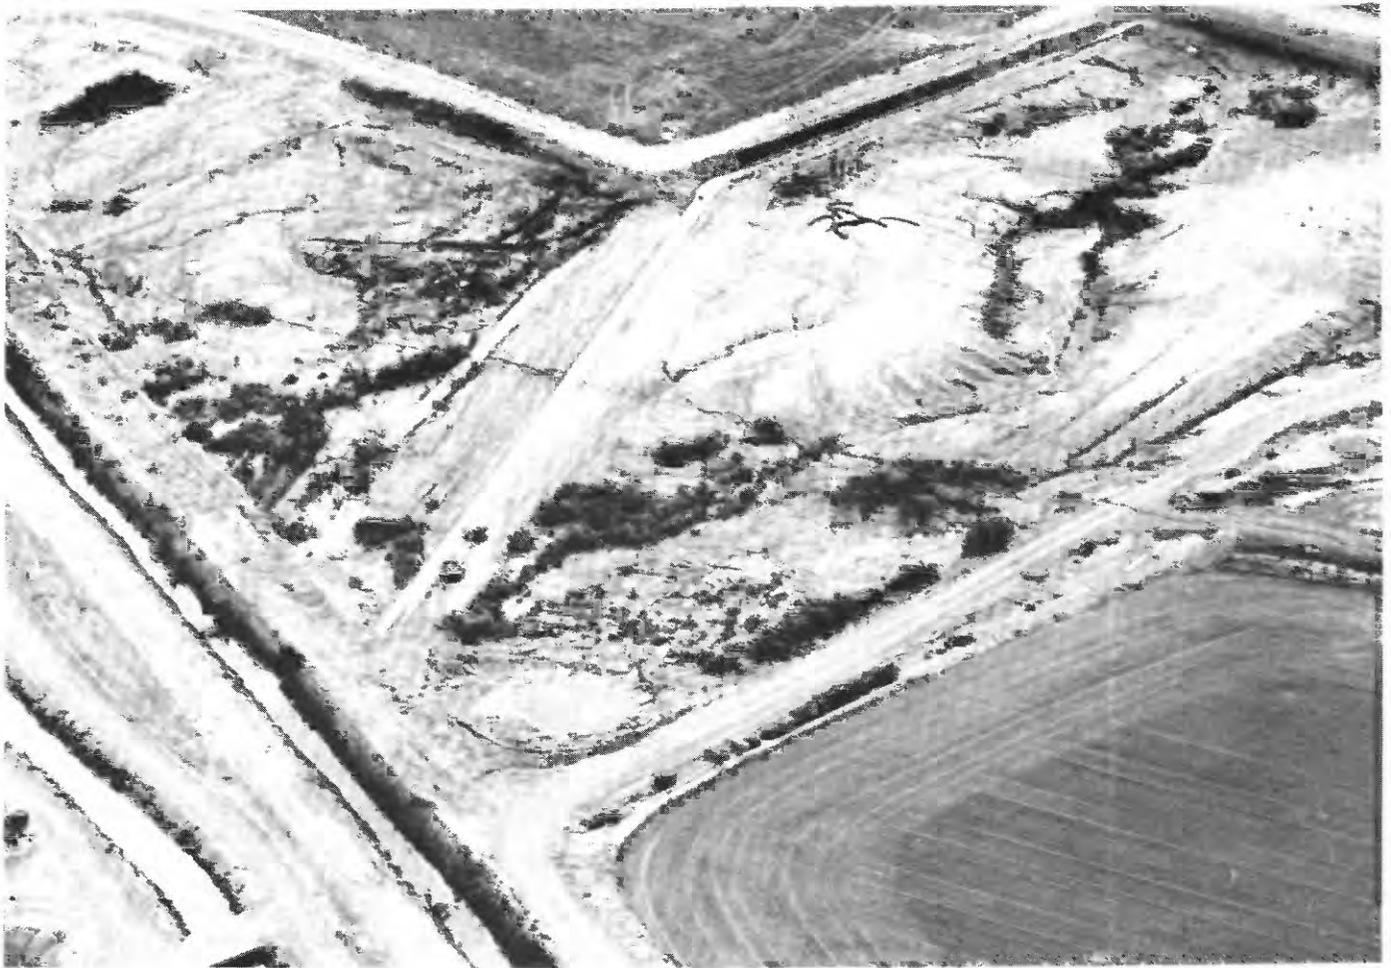
FIGURE 89.—Imperial fault 1.7 km south of Keystone Road (loc. 72). Canal liner near center was one site monitored for data on horizontal and vertical components of afterslip. Plunge of slip here is about  $61^\circ$  in fault surface, which is nearly vertical in a canal-bank exposure beyond left edge. View southwestward. Photograph by M. J. Rymer, October 23, 1979.

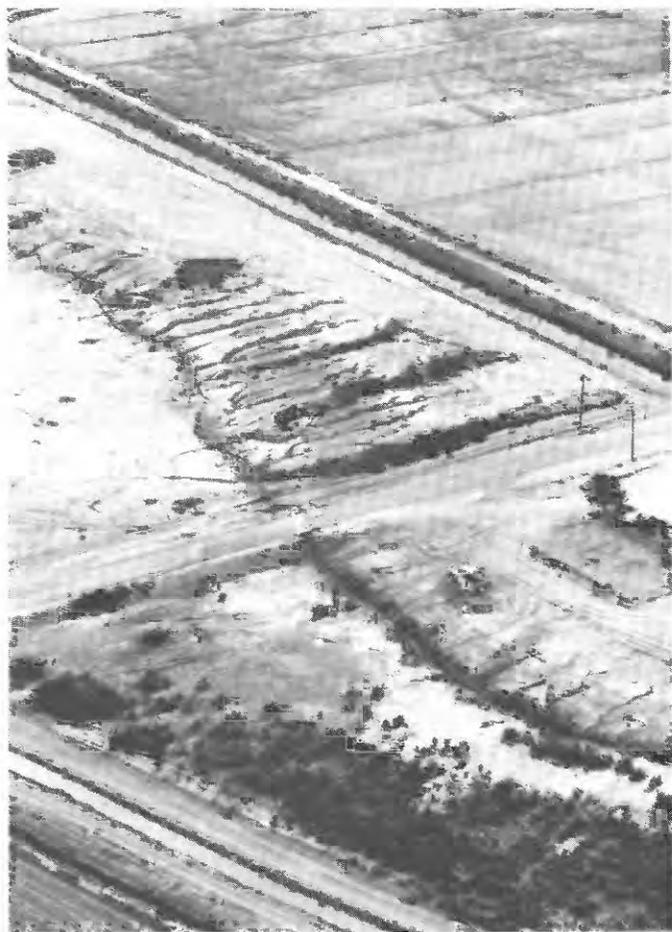
FIGURE 90.—Imperial fault at Harris Road (loc. 67), which passes between utility poles on right. Sinuosity of fault trace is typical of much of northern segment of Imperial fault where vertical component of slip is large. Gullying of upthrown (southwest) side of fault has etched rounded late Holocene scarp. Note general but imperfect congruence of new surface rupture (dark narrow line) with base of older escarpment. View southwestward. Photograph by M. J. Rymer, October 23, 1979.

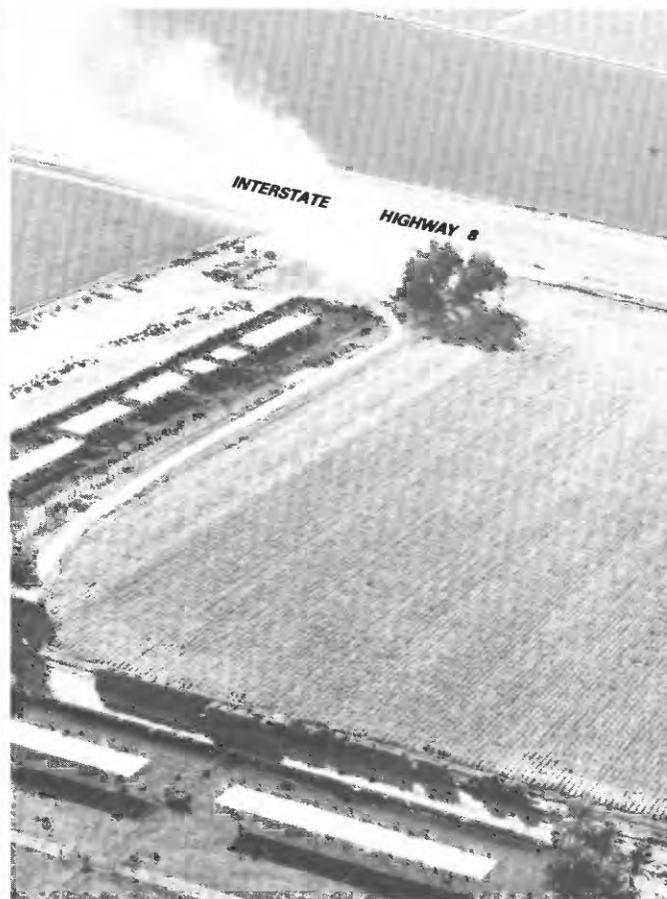
FIGURE 91.—Imperial fault at Interstate Highway 8 (loc. 15). Main fault trace, marked by offset rows of asparagus in foreground, dies out southeastward in field beyond highway. Subsidiary branching fault that crosses this field northwestward to highway probably joins main fault near palms in foreground. View southeastward. Photograph by M. J. Rymer, December 12, 1979.

mole track, complexities involving branching, apparent discontinuity of the main fault strand, and multiple strands also appeared. The most notable of these complexities was near Interstate Highway 8 (loc. 15), where the principal fault strands, as judged by the linearity and amount of displacement, terminated and stepped to the right about 85 m. Subsidiary fractures south of this stepover lay 85 to 175 m southwest of and nearly parallel to the main rupture (fig. 91); these breaks are not connected on the map (pl. 1) between Chick Road (loc. 13) and Barbara Worth Road (at 6.3 km) because dense crops concealed them, although several breaks may have joined to form a second continuous strand. Aerial photographs of this segment of the fault after the 1940 displacement likewise indicated movement of the

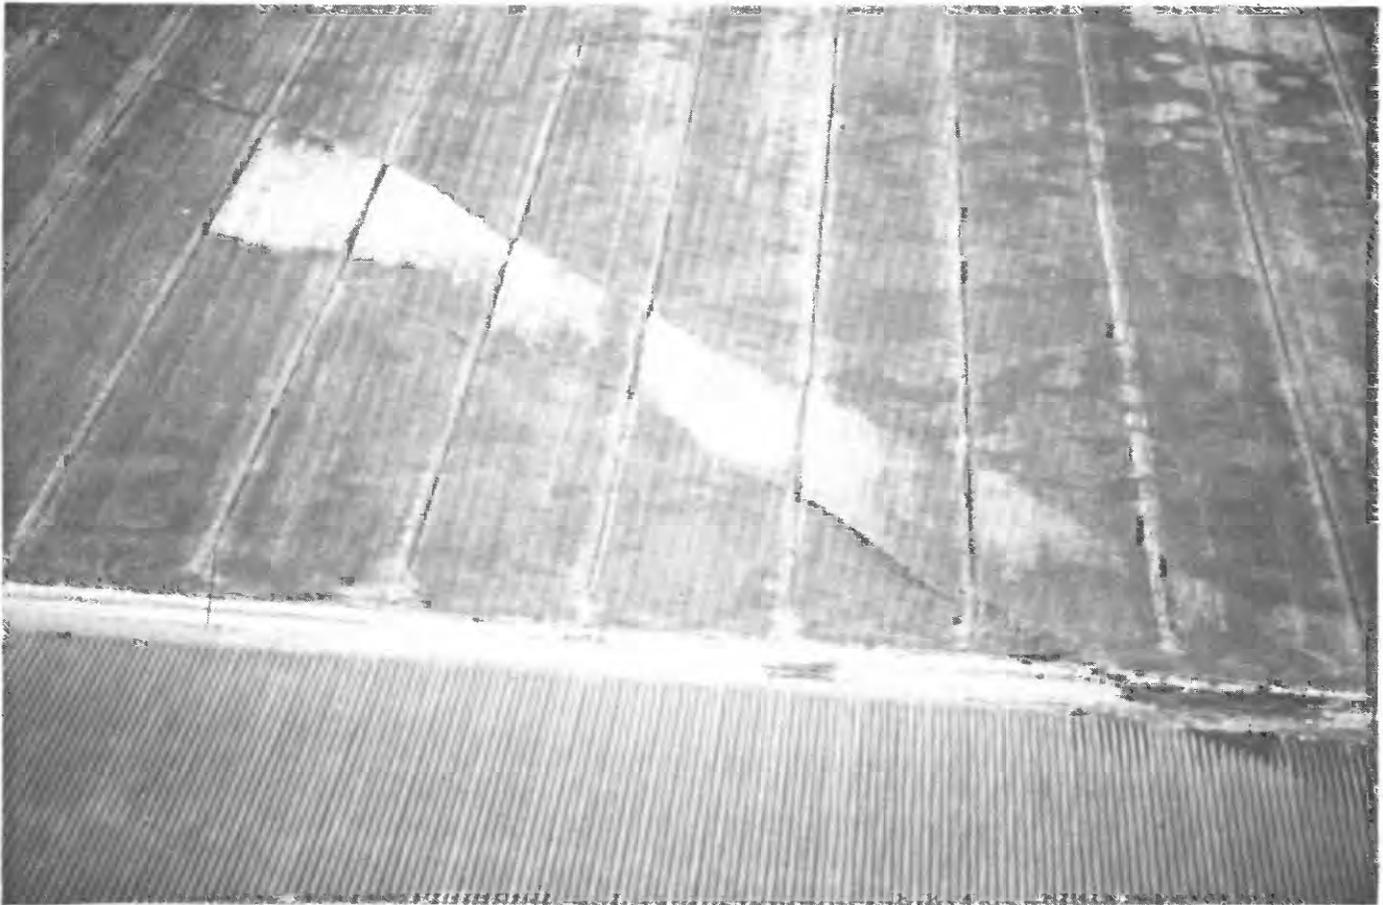
FIGURE 93.—Imperial fault 0.8 km south of McCabe Road (at 4.8 km). Double trace of fault here outlines depression between echelon strands that was flooded by leakage from canal liner (foreground) broken by October 15 displacement. Distance between berms is about 23 m. View northward. Photograph by M. J. Rymer, October 23, 1979.

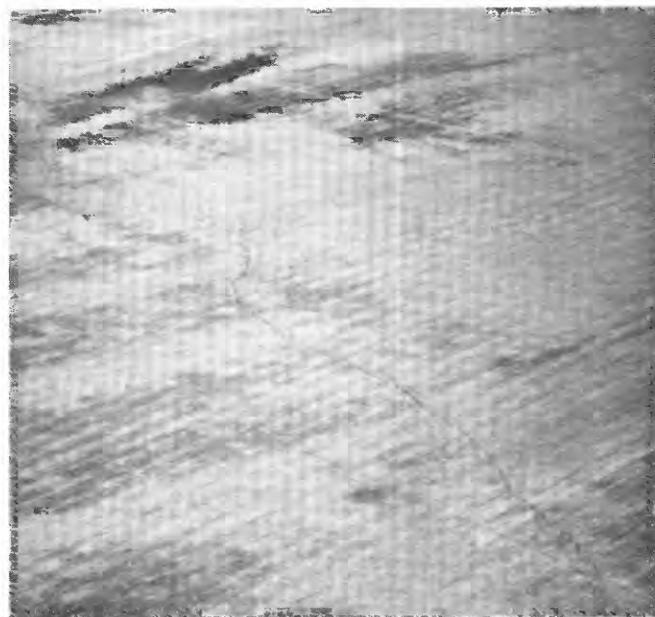
FIGURE 96.—Northern branch of Imperial fault 0.3 km north of Keystone Road (loc. 86). Of three breaks at Keystone Road, this was only strand of Imperial fault that extended away from pavement. Sinuous surface rupture is made up of left-stepping echelon breaks. 3 cm of vertical displacement (far side up) was measured near lower right corner on October 21, 1979. Rupture formed a single line of fractures; two dark bands paralleling trace are postearthquake footpaths worn by curious geologists and other confused visitors. Plowlines in field are spaced at 3.7-m intervals. View southwestward. Photograph by M. J. Rymer, October 23, 1979.

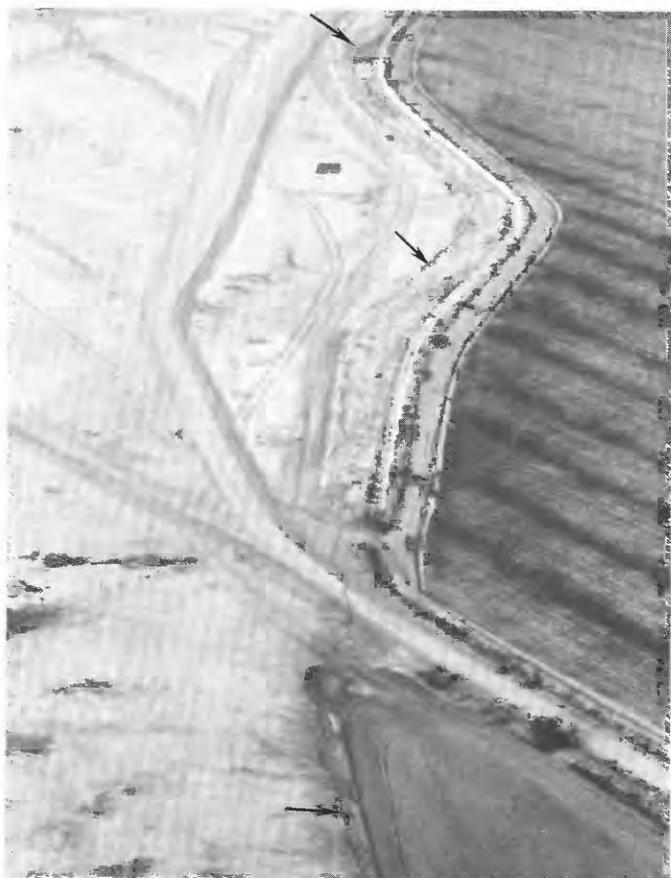
FIGURE 97.—Main branch of Imperial fault (at 29.2 km at bottom) 0.4 to 0.8 km north of Carey Road. Surface break (arrows) is dark line at base of low slightly gullied scarp in foreground. Trace generally follows curved edge of cultivated field in distance and converges with curved concrete canal liner at top. View northeastward.

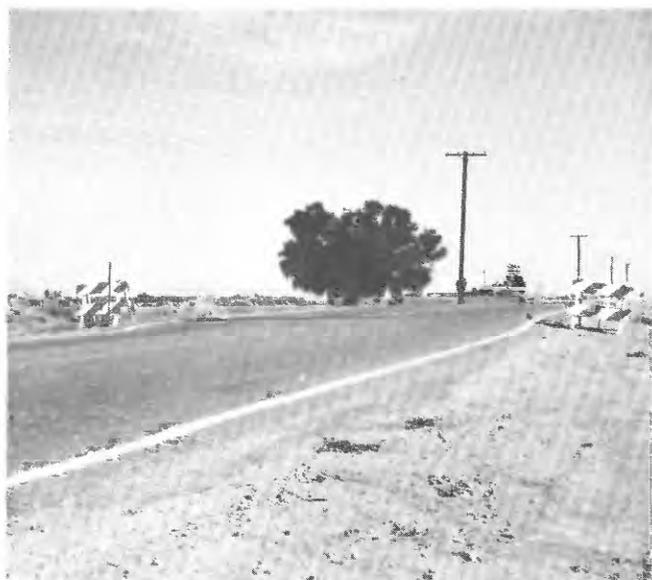
FIGURE 105.—Scarp of Brawley fault zone at Keystone Road (loc. 100). Cracks (dark line) in pavement formed at crest of scarp where flexure of ground is maximum. Base of scarp generally is on west side of cracking for all strands of Brawley fault zone. This position of cracking with respect to base of scarp is generally present in fields as well as at road intercepts. Leveling of profile before and after earthquake indicated that about 9 cm of total relative uplift of about 16 cm at scarp was due to October 15 earthquake. Across an 80-m-wide zone centered on fault scarp, total relative uplift since road was paved in 1960 or 1961 is about 0.5 m. View eastward. Photograph by R. V. Sharp, October 17, 1979.

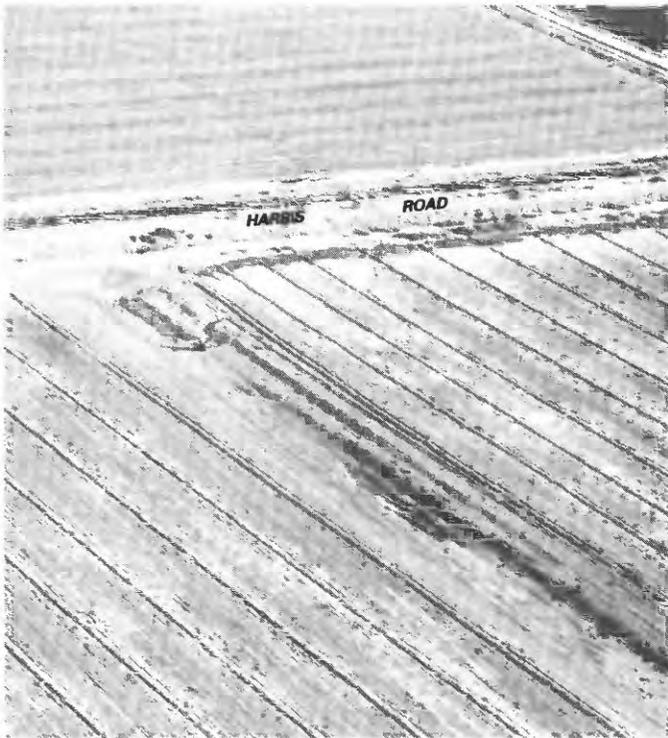
FIGURE 109.—Newly discovered east trace of Brawley fault zone at Harris Road (loc. 107). Sinuous break extends to foreground edge and beyond but is not entirely visible in this view. More nearly linear trace in mown alfalfa field north of Harris Road is marked by line of dark vegetation. View northeastward. Photograph by M. J. Rymer, October 23, 1979.

Continuity of the surface rupture varied widely. At one extreme were echelon cracks in a zone perhaps only a few meters long, at scattered intervals as much as hundreds of meters apart along one strand of the fault. These widely spaced cracks can be assigned to one particular strand on the basis of the location either of the 1975 rupture or of prehistoric fault traces visible on earlier aerial photographs. At the other extreme were several remarkably continuous fault ruptures (figs. 107, 108) that generally formed single cracks with a few echelon stepovers. Within the longest (4 km) nearly continuous rupture in the Brawley fault zone, only a few echelon stepovers and discontinuities were recognized (partly owing to heavy crop cover in one field). This break (fig. 109) formed the easternmost of three ruptures that crossed Harris Road (loc. 107).

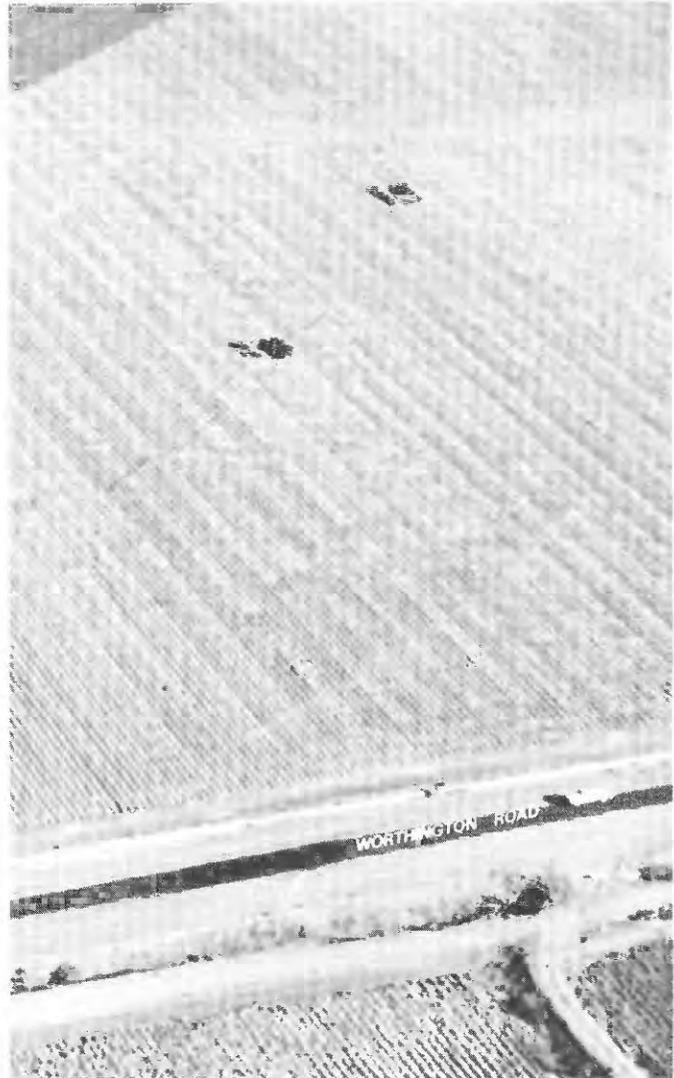
FIGURE 110.—Surface rupture of Brawley fault zone (loc. 114) in field north of Worthington Road (loc. 115). Wide dark spot on pavement (arrow) represents repairs to surface rupture at Worthington Road. Cracks in field, visible as erratic line extending through two excavations (dark areas), mark trace of fault strand. Cracks were traceable only after harvest of dense soybean crop more than a month after earthquake. View northeastward. Photograph by M. J. Rymer, December 12, 1979.

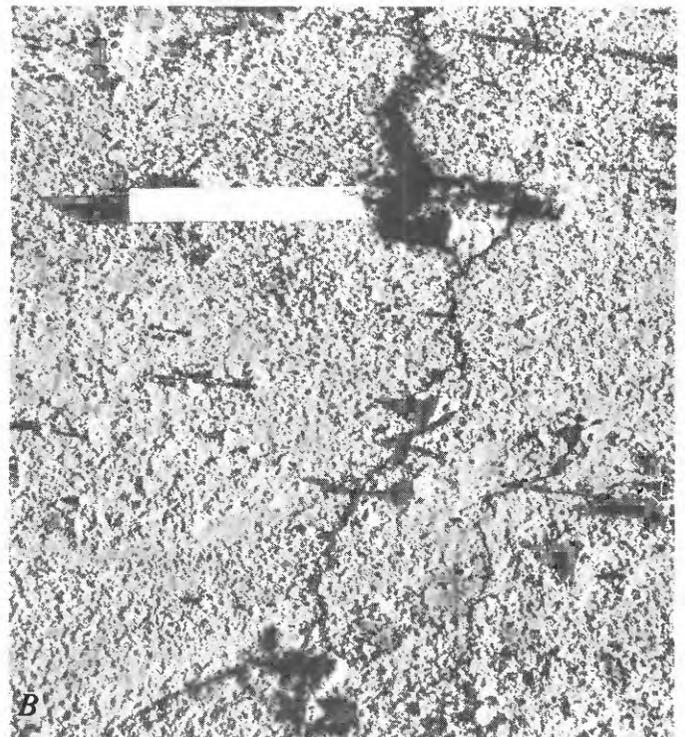
FIGURE 114.—Surface rupturing. *A*, Zigzag break consisting of left-stepping echelon cracks joined by compression ridges. Echelon cracks are about 20 cm long. *B*, Compression ridge connecting two left-stepping echelon cracks. Ridge consists of arched clod of delicately cemented soil a few millimeters thick. Axis of arch parallels ruler (15 cm long).

They occur next to each other along the fault trace and grade into one another. Where left-stepping echelon cracks are connected by crossbreaks in a zigzag pattern (fig. 114A), compressive features are seen; clods of delicately cemented soil are commonly thrust and folded along these crossbreaks (fig. 114B). The axes of these small folds generally trend west. Numerous thrust and folded clods give the appearance of a mole track (see Clark, 1972, fig. 29).

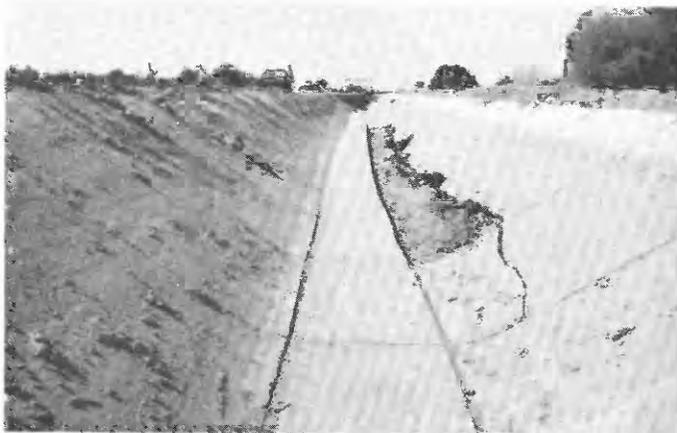
FIGURE 160.—Canal ruptured and offset by lateral spread at site 4. Maximum horizontal displacement is about 20 cm.

*Site 4.*—At a site 1.5 km south of the border and 0.5 km southwest of the Imperial fault, the head of a small lateral spread intersected a concrete-lined canal, ruptured the canal lining, and displaced the floor of the canal about 20 cm laterally to form a gentle curve (fig. 160). Movement on the lateral spread was toward a nearby 1.5-m-deep depression within which several sand boils erupted.

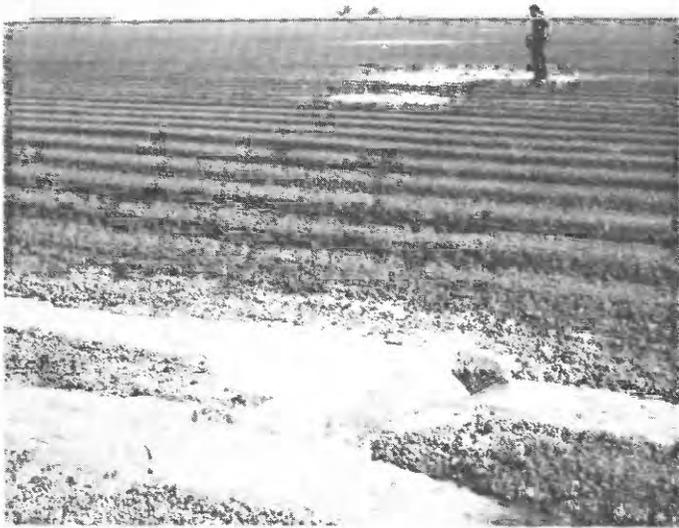
FIGURE 161.—Line of sand boils at site 11 in field about 1 km north of Bonds Corner. Spacing between sand boils is as much as tens of meters. Some small fissures are associated with individual sand boils, but no fissures are throughgoing. View northeastward.

*Site 11.*—About 20 sand boils erupted in an 0.6-km-long northeast trending line about 1 km north of State Highway 98 and about 0.2 km east of Bonds Corner Road (fig. 161). Small cracks appeared near the sand boils, but no continuous cracks formed.

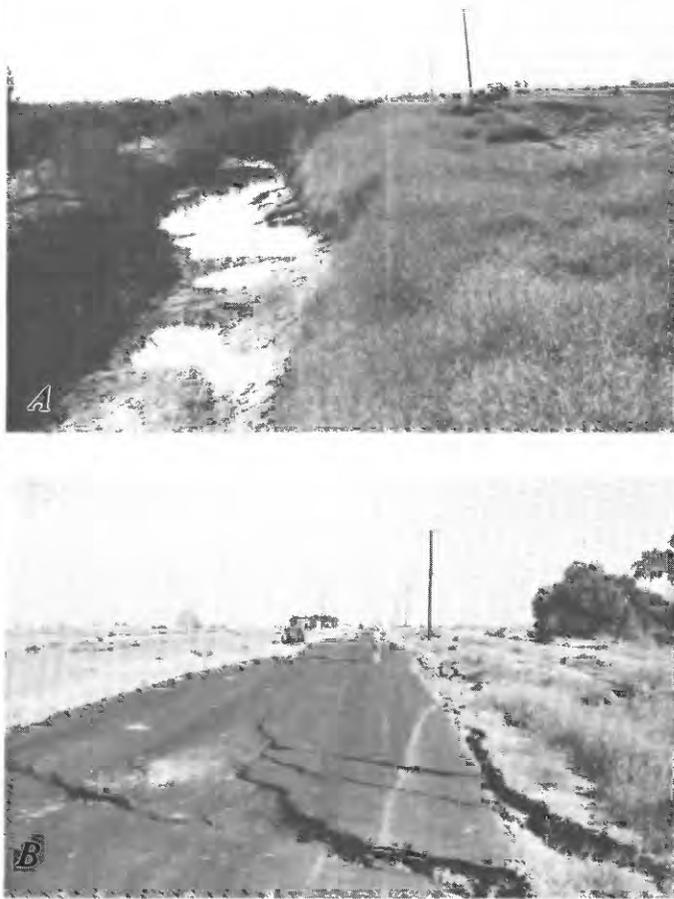
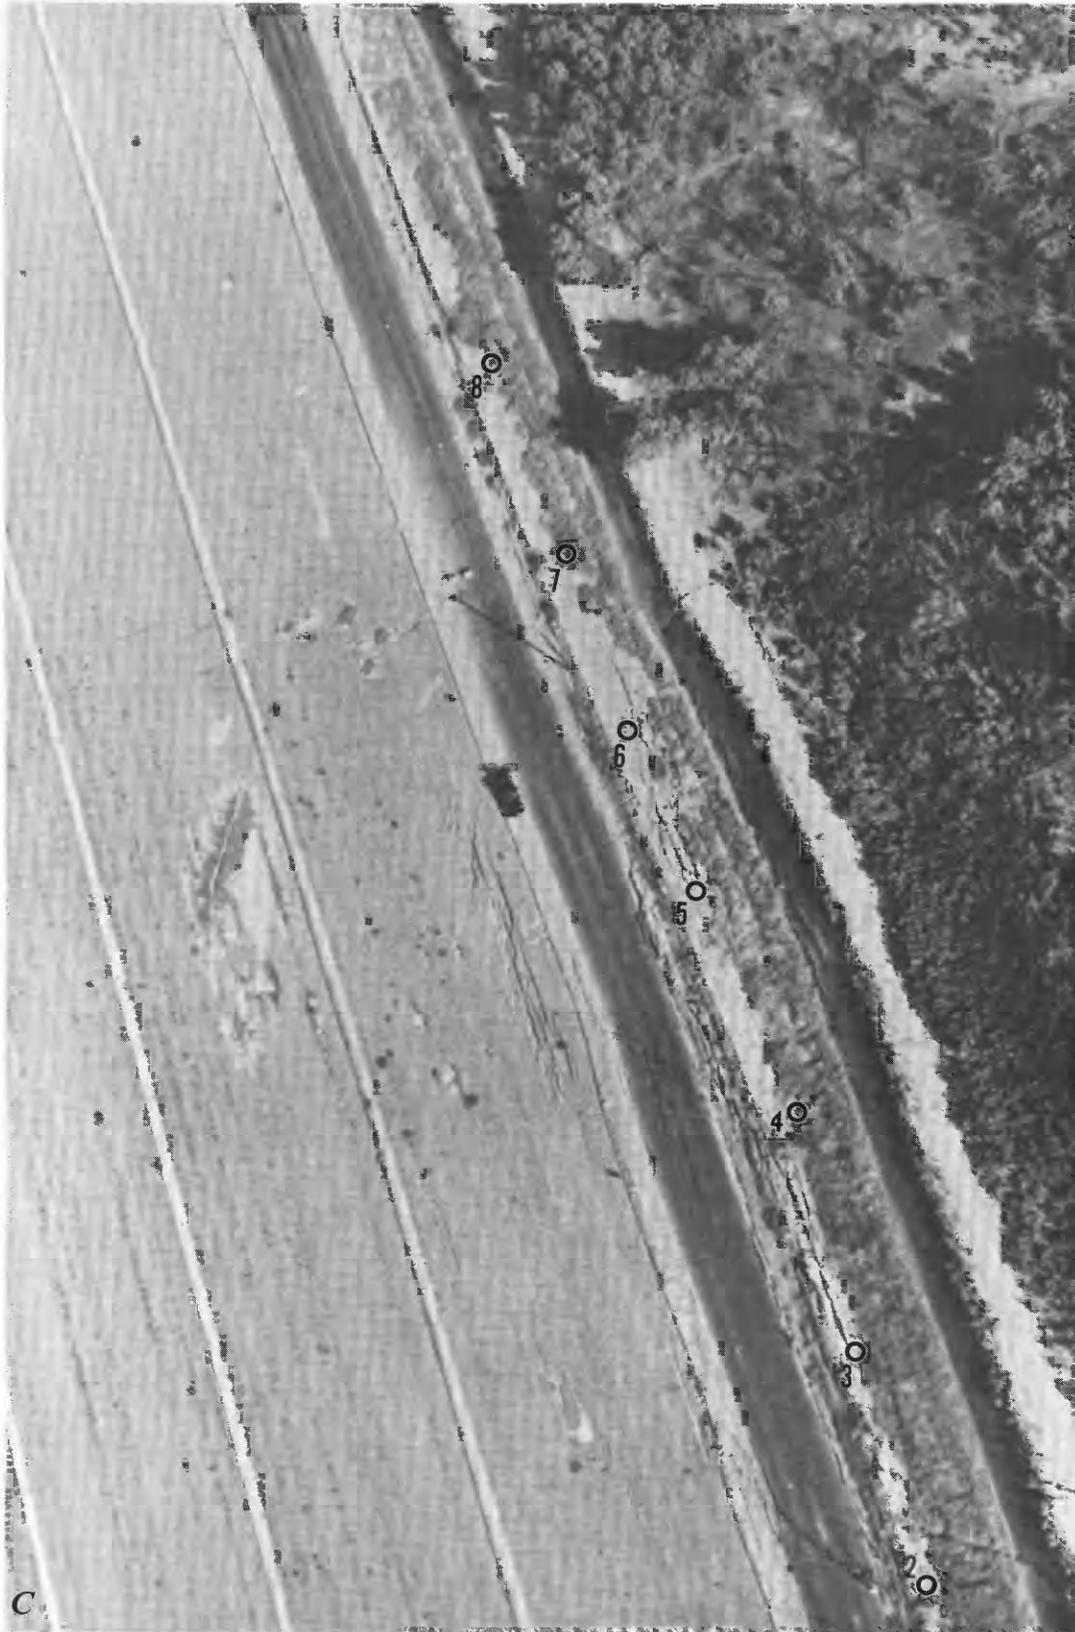
FIGURE 163.—Lateral spread at site 13 on Heber Road, showing associated displacements, fissures, and sand boils (see fig. 162). *A*, Unlined canal, which shifted about 1.2 m to south. View westward. *B*, Pavement on Heber Road, which settled, cracked, and shifted to south by as much as 1.2 m. View eastward. *C*, Sand boils, ground cracks, and displaced road and canal on lateral spread. View eastward. Photograph by Paul Noden.

*Site 13.*—A lateral spread severely disrupted the pavement on Heber Road 1 km east of Mets Road (figs. 162, 163). The spread shifted the road and a parallel unlined canal about 1.2 m southward toward a 2-m-deep depression in Heber Dunes County Park south

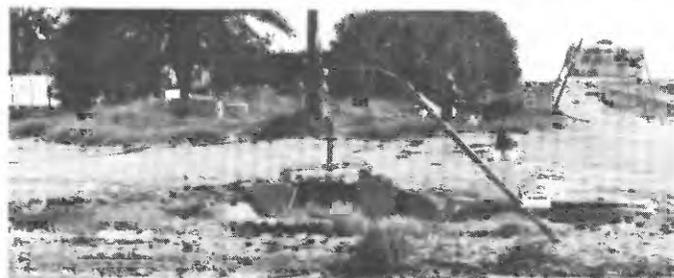
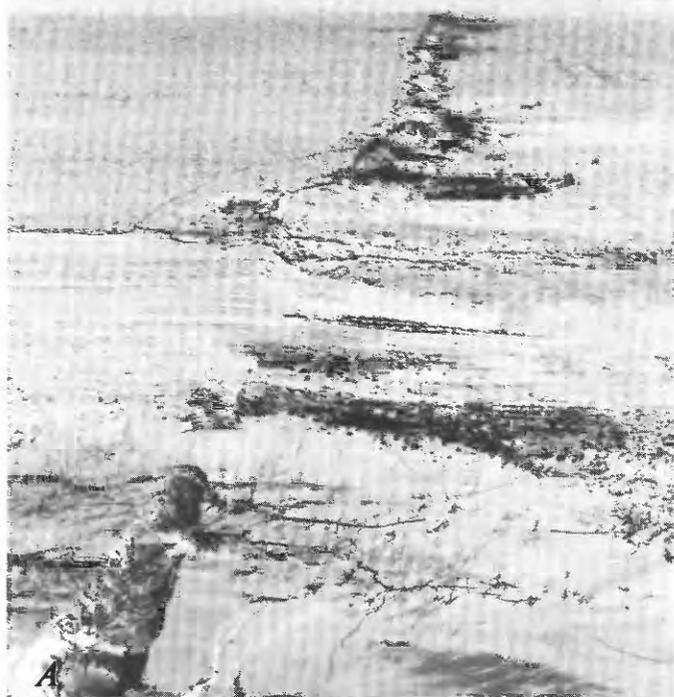
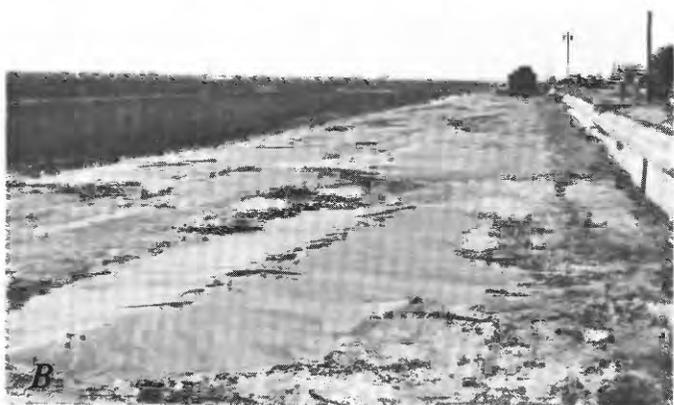
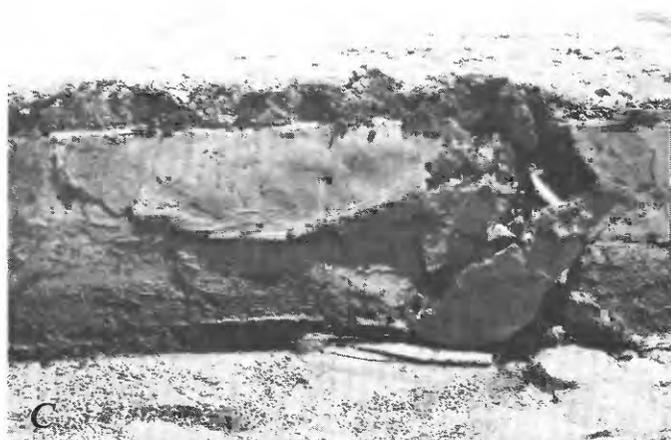
FIGURE 166.—Ground-failure effects at site 17 near intersection of King and Orchard Roads. *A*, Sand boils and scarp in road at east end of disturbed zone. View southward. *B*, Sand boils along canal bank and in field, looking westward from near east end of disturbed zone. *C*, Broken canal lining near west end of disturbed zone. Canal lining is approximately 1 m high. *D*, Overlapped canal lining near east end of disturbed zone. Note sand boil on bottom of canal. Scale in inches.

*Site 17.*—Numerous cracks, scarps, and sand boils disturbed the ground surface in a zone several hundred meters long and about 100 m wide centered on King Road, immediately east of its intersection with Orchard Road (fig. 165). The pavement on King Road was fissured within several places in the zone, and the concrete linings of two irrigation canals paralleling the road were fractured, pulled apart, buckled, or overlapped in various places (fig. 166). At the east margin of the zone, the lining of the canal on the north side of the road was fractured and overlapped by 13 cm (fig. 166D); in other places, the linings were pulled apart. Thus, it appears that both extensional and compressional ground displacements occurred beneath the canal. A local farmer reported that ground cracks and sand boils also formed in this area during the 1940 Imperial Valley earthquake.

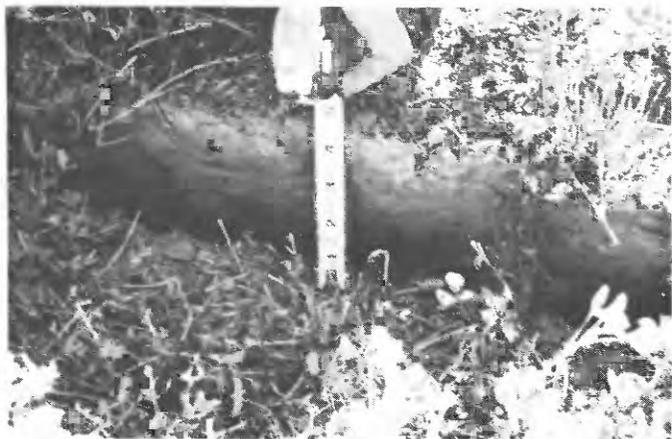
FIGURE 167.—Scarp at boundary of trough feature at site 18 west of Orchard Road, caused by settlement of fill over buried drainline. Scale in inches.

*Site 18.*—A linear trough feature about 5 m wide and 0.13 m deep extended westward from Orchard Road for several hundred meters along a farm lane about 0.8 km north of King Road. Trough boundaries were marked by ground cracks and scarps (fig. 167), and small sand boils

erupted in many places within it. The trough created a dip several centimeters deep in Orchard Road that was hazardous to fast-moving traffic. Inspection of a man-hole near Orchard Road revealed that a drainline about 4 m underground trends westward roughly beneath the centerline of the trough. Compaction and liquefaction of backfill placed over the drainline evidently caused dif-

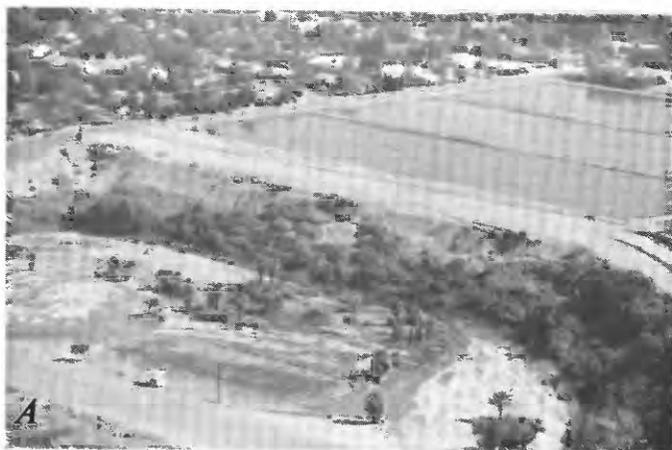
FIGURE 168.—Site 23 near River Park in Brawley, Calif. *A*, Sand boils in graded parking area (below embankment) and flooded area (darker areas). View northwestward. *B*, Sand boils (white patches) in stock pasture between parking area and New River. View southward.

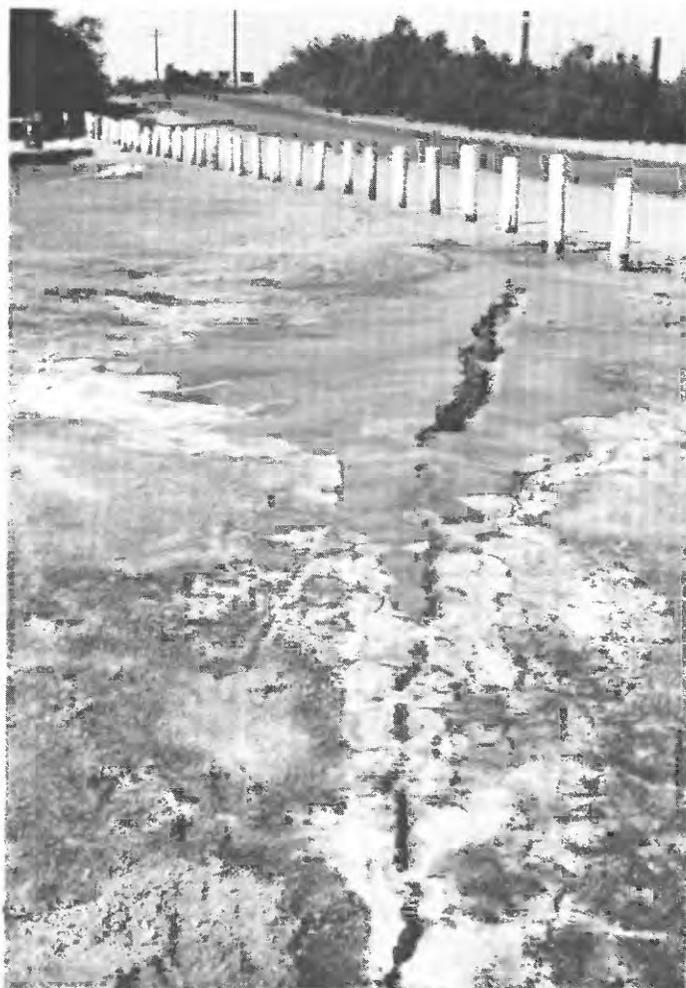
FIGURE 170.—Sand boils and ground cracks in unpaved parking area at site 25 near east shore of Wiest Lake. View northeastward.

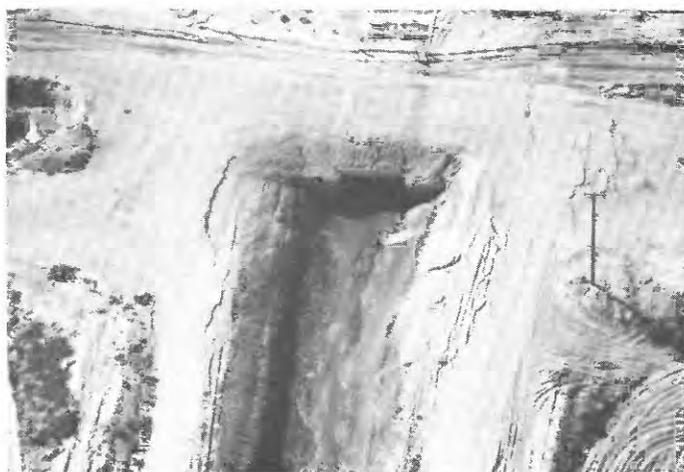
This rapid repair prevented any detailed mapping of the embankment damage. An aerial photograph (fig. 171) shows the concentration of damage along a 1.5-km-long section of the canal near the Alamo River. Several types of ground failures damaged the canal. Rotational earth slumps (fig. 172) that threatened to breach the canal required dredging to restore the original capacity of the channel. Incipient slumps or lateral spreads, as well as many undifferentiated fissures, so cracked the embankment that its ability to hold water was in question. Cracks were also observed in compacted fill around structures (fig. 173).

FIGURE 173.—Differential settlement and incipient slump near box culvert through embankment of All-American Canal at site 26. View southward.

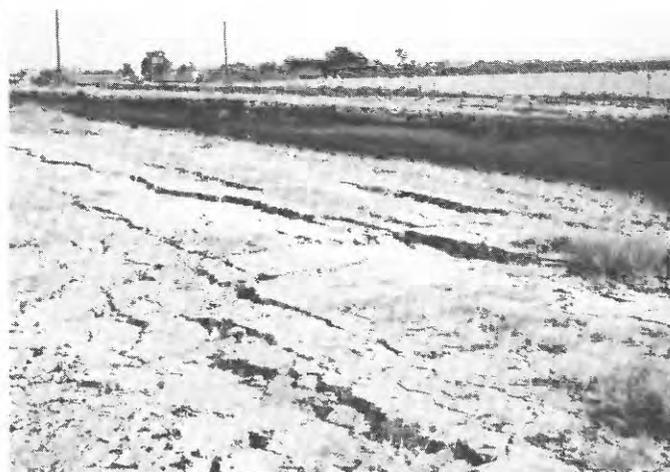
*Site 28.*—Near the intersection of Heber and Keffer Roads, cracks riddled the banks of the South Alamo Canal, which parallels Heber Road on the south (fig. 174). Longitudinal cracks in the banks extended for at least 100 m along both sides of the canal. A badly cracked zone approximately 15 m wide extended from the canal to a barrow pit alongside Heber Road. The cracks, which showed from 5 to 10 cm of vertical separation, displayed little, if any, horizontal displacement. Vertical displacement along cracks on the north side of the canal was consistently downward toward the barrow pit and indicated incipient slumping or incipient lateral spreading toward the pit. In contrast, vertical displacement on cracks along the south side of the canal was consistently downward toward the canal.

FIGURE 174.—Cracks in banks of South Alamo Canal at site 28 west of Keffer Road. Displacements across cracks in near bank are consistently downward away from canal; displacements in far bank are consistently downward toward canal. Light patches in field beyond canal are sand boils at site 14. View southeastward.

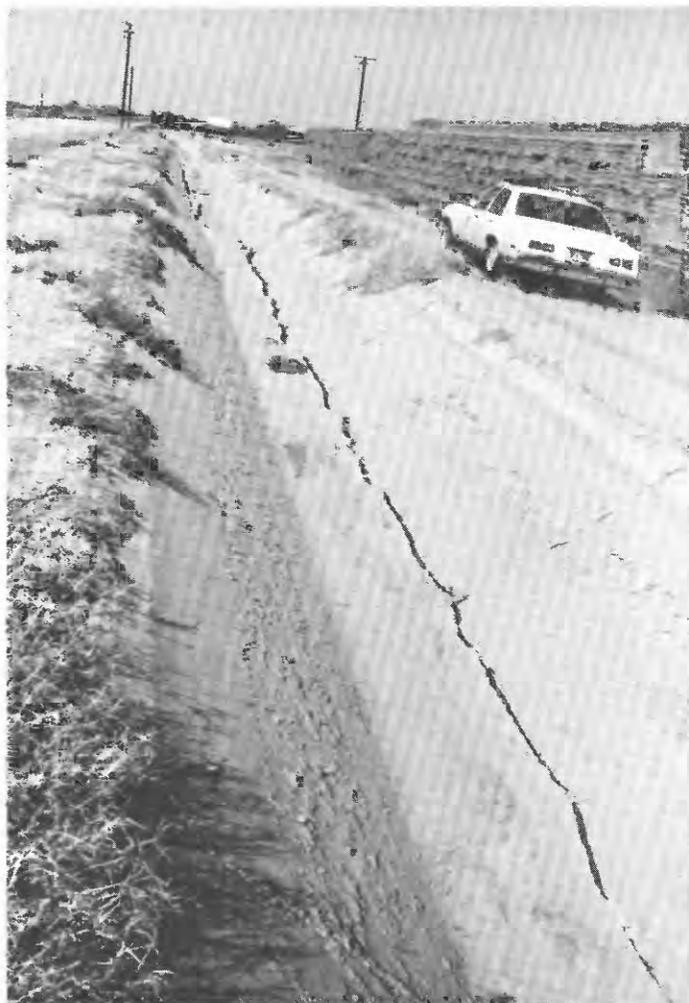
*Site 29.*—The east bank of the South Alamo Canal and an adjacent roadway were fissured for 0.5 km from 1.0 km north of State Highway 98 to the right-angle turn south of the sand dunes. The fissures were caused by incipient slumping or lateral spreading toward the canal. The cracks showed as much as 10 cm of opening and vertical separation. Along a stretch roughly 100 m long the cracks crossed the roadway and intersected a concrete-lined irrigation canal to the east; the lining near the base of the canal was ruptured and displaced westward a few centimeters along part of this segment (fig. 175). The lined canal was taken out of service until the cracks could be repaired.

FIGURE 175.—Ruptured canal lining at site 29, caused by a few centimeters of westward lateral ground displacement of left side of canal. Canal was taken out of service until lining could be repaired. New northward.

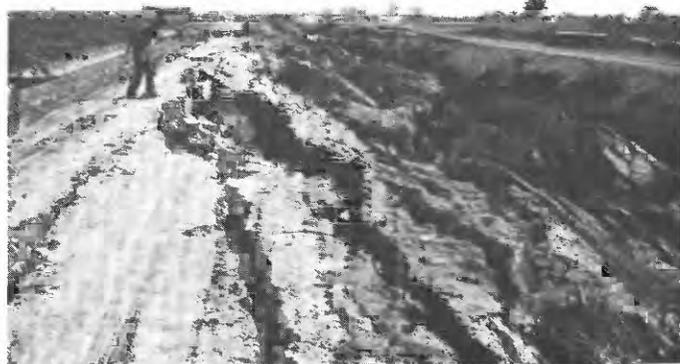
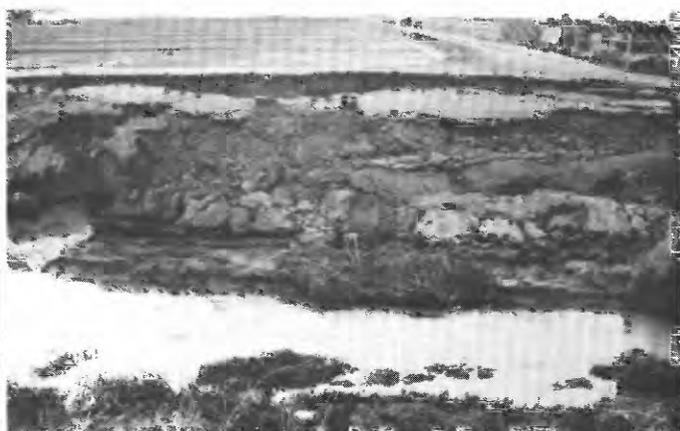
slumps cut several meters into the banks, destroyed unpaved farm lanes on both sides of the drain, and partly dammed the channel. Fissures and scarps showing separations as wide as a few tenths of a meter that formed behind and between the slumps indicate incipient failure in these places. These fissures and scarps broke up the pavement on Zenos Road and impeded traffic. About 10 sand boils that erupted about 50 m east of the largest slumps (site 22) indicate that liquefaction may have contributed to these failures. The drain lies in a lowland area that drains northward into the Alamo River. The lowland was leveled for agricultural purposes, and the drain was cut through after the leveling operation. Thus, the banks that slumped are probably composed of uncompacted fill.

FIGURE 176.—Slumped banks of Barbara Worth Drain at site 30. *A*, Slump in east bank, that destroyed farm lane and blocked drain. View southward. *B*, Slump and scarp in west bank. View westward.
