# THE IMPERIAL VALLEY, CALIFORNIA, EARTHQUAKE OF OCTOBER 15, 1979

GEOLOGICAL SURVEY  
PROFESSIONAL PAPER 1254

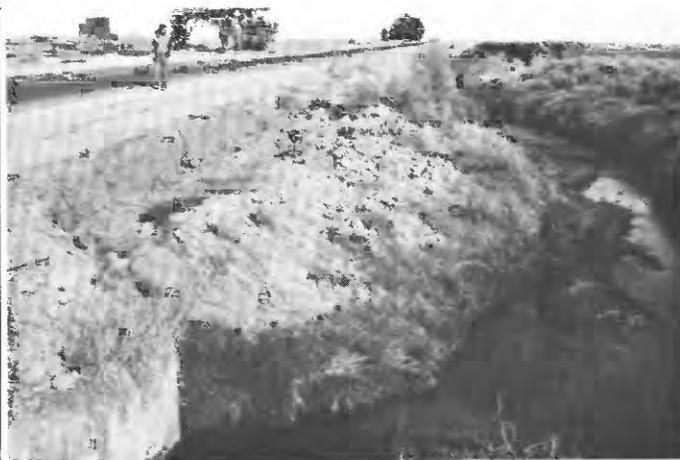
*Site 31.*—About 200 m east of the Alamo River, the banks and part of the shoulder of Worthington Road slumped southward into a drainage ditch paralleling the road (fig. 177). The slump partly blocked the ditch and diverted the flow southward into the opposite bank.

FIGURE 177.—Slumped bank of a drain at site 31 along south side of Worthington Road, about 200 m east of Alamo River. View eastward.

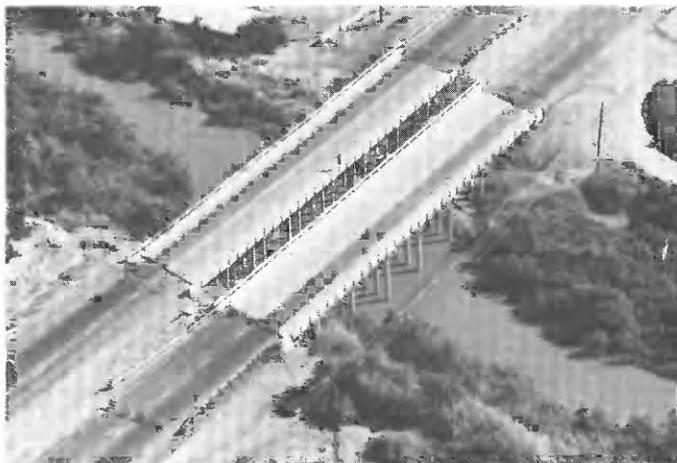
*Site 32.*—The bridge over the New River west of Brawley, Calif., was damaged and had to be closed after the earthquake (fig. 178). The 60-m-long bridge was constructed in 1952 as two parallel concrete structures, each resting on nine sets of cast-in-place concrete piles that extend at least 9 m below the ground surface into fine and very fine sandy soil. A few piles on the west side of the bridge showed some repaired preearthquake damage (cracks), reportedly caused by foundation displacements due to slumping of the west bank. During the earthquake, ground displacements caused by settling and slumping of the approach fill and streambank caused the superstructures of the bridges to rotate counterclockwise in a horizontal plane; this movement cracked and tilted several supporting piles. In spite of these ground and bridge movements, the two decks were virtually undamaged (fig. 178). Repair costs were estimated at \$115,000 to realign the bridge, epoxy the cracked piles, and regrade and repave the approaches (California Department of Transportation, 1979).

The earthquake generated a series of cracks in the riverbanks beneath the bridge, and parts of the banks slumped at least 10 cm toward the river. Relative ground settlements as great as 4 cm occurred around the piles; ground movement toward the river caused soil to compress against the upslope side of the piles and pull away from the downslope side (fig. 179). Inundated vegetation near the cracks on the southeast side of the

Ground displacements toward the river pushed against the spans and caused the bridges to rotate horizontally. The west ends of the span shifted 19 cm southward, and the east ends 9 cm northward, relative to the bridge approaches (fig. 180). The west and east approach fills settled 15 and 7.6 cm, respectively, relative to the

FIGURE 178.—State Highway 86 bridge over New River at site 32 west of Brawley, Calif. Abutment fill settled about 0.15 m, and both ends of bridge and riverbanks slumped about 0.1 m toward stream. Ground displacements caused bridge decks to rotate about 0.3° counterclockwise in a horizontal plane but did not seriously damage structure.

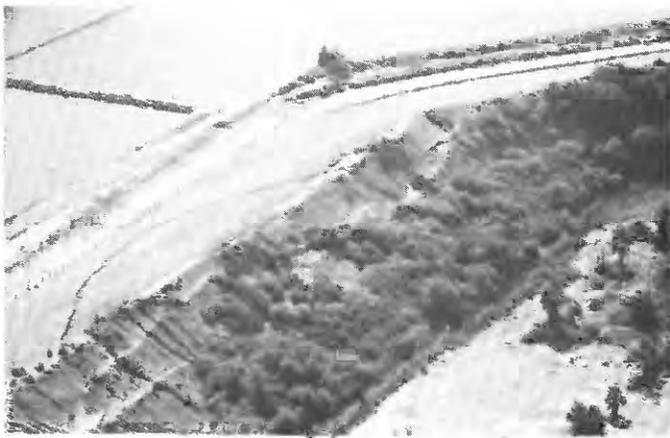
*Site 33.*—An arcuate scarp, approximately 13 cm high and 7 cm wide, outlined a 122-m-long incipient earth slump that formed in a sanitary-landfill embankment in the southwestern part of Brawley, Calif. (fig. 182). The embankment extends north-southward along the bluffs of the New River above River Park. Although the scarp was well marked at the top of the embankment and in the slope, we observed no lower boundary or toe of the slump in the heavy undergrowth at the base of the embankment. A waterpipe buried in the embankment was broken, presumably by the slump movement. A trench excavated to repair the pipe revealed the fill to be dry fine silt.

FIGURE 182.—Arcuate incipient-slump scarp with 13 cm of vertical separation in embankment at site 33 east of River Park in Brawley, Calif. View southeastward.

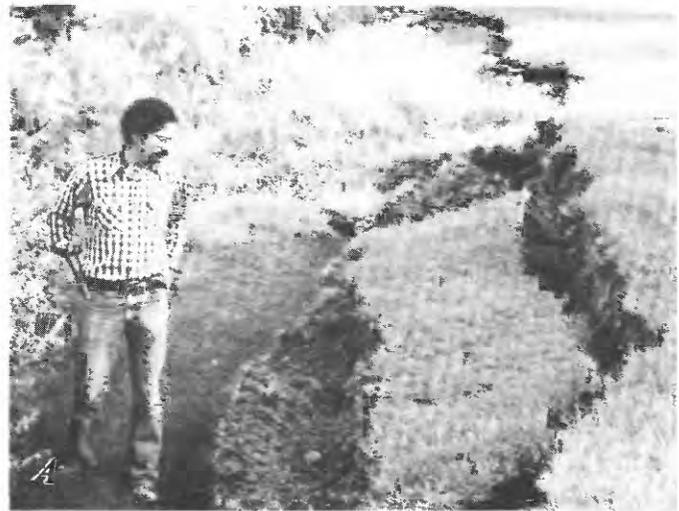
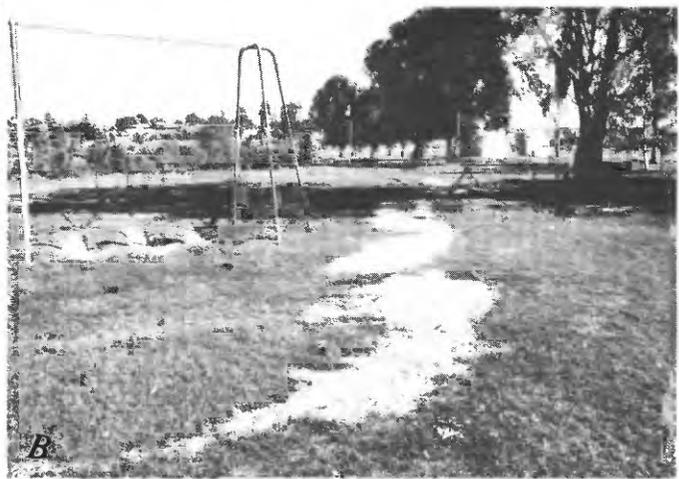
Brawley, Calif. The slump scarp ran 30 m along the river and extended 5 m away from the river's edge (fig. 183A). The height of the scarp ranged from a maximum of 1.2 m at its north end to near zero at its south end, where the scarp merged into incipient slump cracks that were pervasive along the river in that area. The slump disrupted a grassy picnic area and broke several pipes in a sprinkler system; the picnic area is at the west edge of a graded flood plain on which the park is situated.

The soil exposed in the northern part of the slump scarp is a dark moist organic silt. Behind and south of the scarp, sand boils composed of fine white sand that erupted along several cracks (fig. 183B) indicate that liquefaction occurred near the slump. From a subsurface investigation (Bennett and others, 1981), E. L.

FIGURE 183.—Slump and cracks at site 34 in River Park in Brawley, Calif. *A*, Slump near New River, showing 1 m of vertical displacement. View northward. *B*, Sand boils along crack south of slump in figure 183A.

Harp (oral commun., 1980) concluded that liquefaction of a sand layer about 3 m deep was the cause of failure.

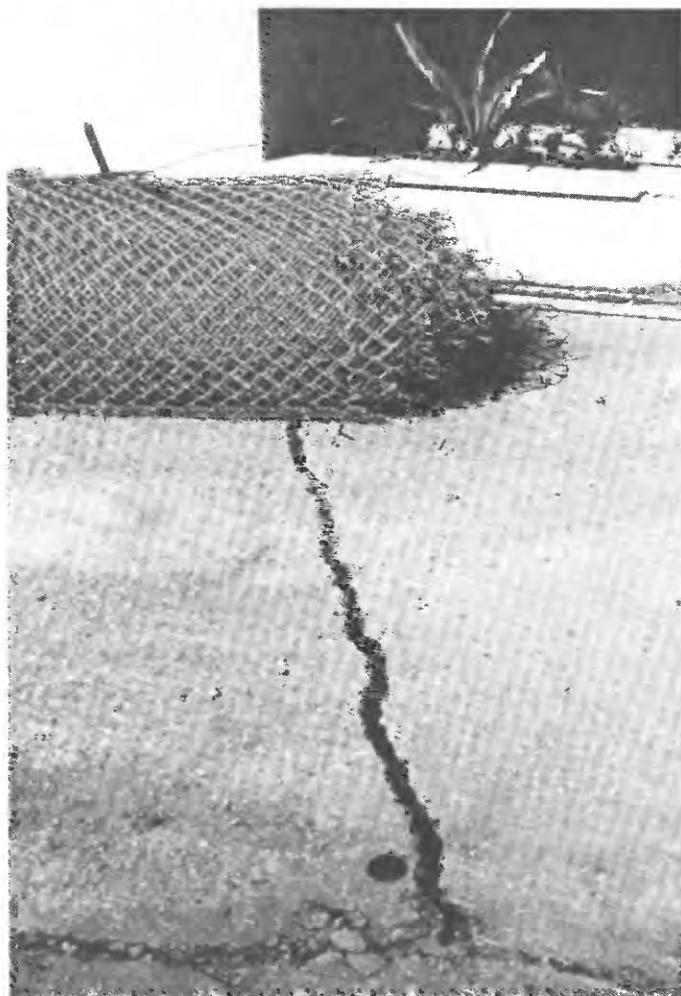
*Site 36.*—Fissures, common along both the New and Alamo Rivers, also transected the grounds of the Brawley sewage-treatment plant east of the New River about 3.5 km north of Brawley, Calif. The fissures opened as wide as 6 cm where they passed beneath a single-story control building. Ground rupture beneath the building caused at most hairline cracks in the concrete-block exterior walls (fig. 184). The cracks also

FIGURE 184.—6-cm-wide crack at site 36 of type common along New and Alamo Rivers. Crack, which passes beneath block building at Brawley sewage-treatment plant, caused no more than hairline cracks in exterior walls of building.

passed beneath cylindrical concrete filtration tanks but did not noticeably disrupt the tanks. One small leak developed in these tanks that may or may not have been due to ground displacement. We noted additional cracks along the base of the bluffs south of the sewage-treatment plant, and T. H. Heaton and others (written commun., 1980) noted cracks, slumps, and sand boils farther south near the KROP radio tower (site 24A).

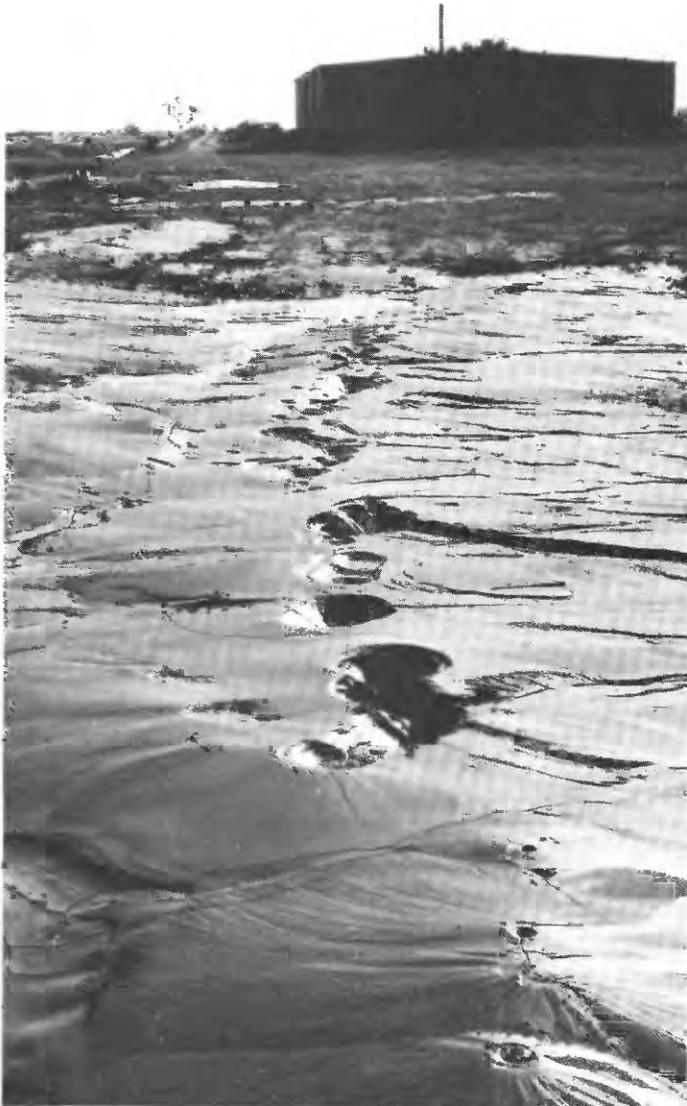
and Wieczorek (this volume, pl. 4). Sandblows composed of very well sorted fine sand formed in east-west-oriented rows of vents spaced 50 to 70 cm apart (fig. 189) and in a few isolated cones. According to local residents, the sandblows formed immediately after the main shock. Residents reported that the same occurrence and distribution of sandblows were observed during the Imperial Valley main shock of May 18, 1940.

faces, and the presence of vents of several ages within the same cone (fig. 189). A series of time-progressive photographs indicates that no significant amounts of sand were deposited during reactivation periods, but instead a slurry of clay and water was ejected onto the cones and eroded pathways on the cone surfaces. Standing water observed within vents and around the base of sandblows during the morning of October 18, 1979, suggests very recent reactivation.

FIGURE 189.—East-west-oriented sandblows, showing collapsed vents, incised drainage patterns on cones, and formation of secondary cones.

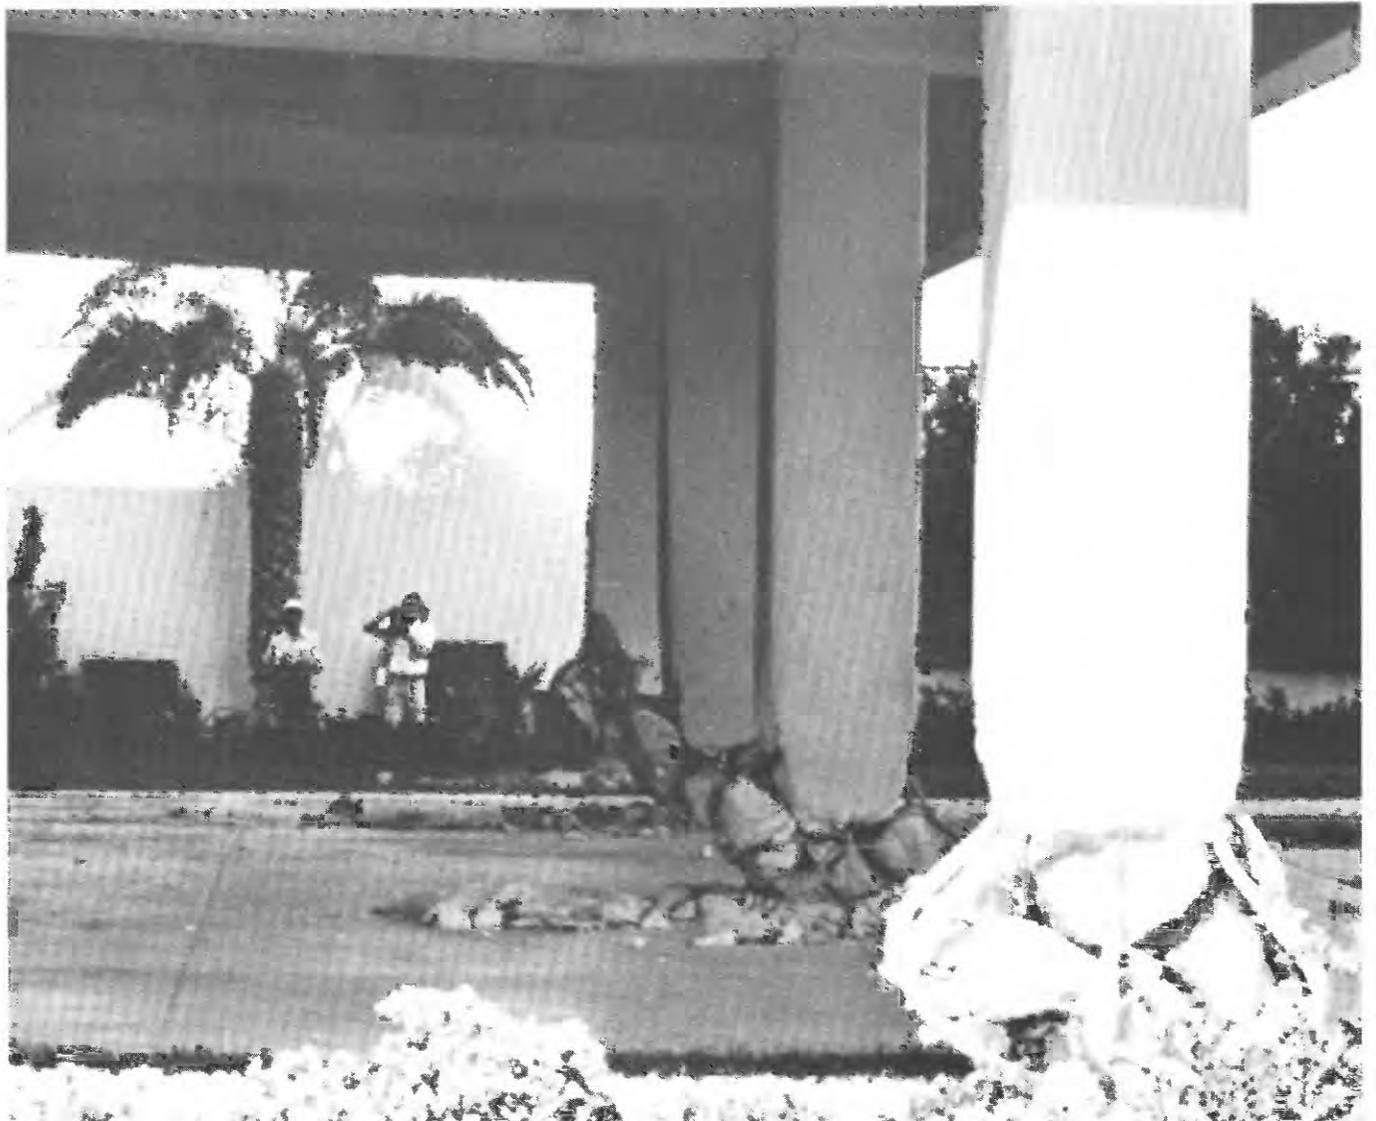
FIGURE 193.—Partial collapse of four columns along east side of Imperial County Services Building. Photograph by Peter Hubiak.

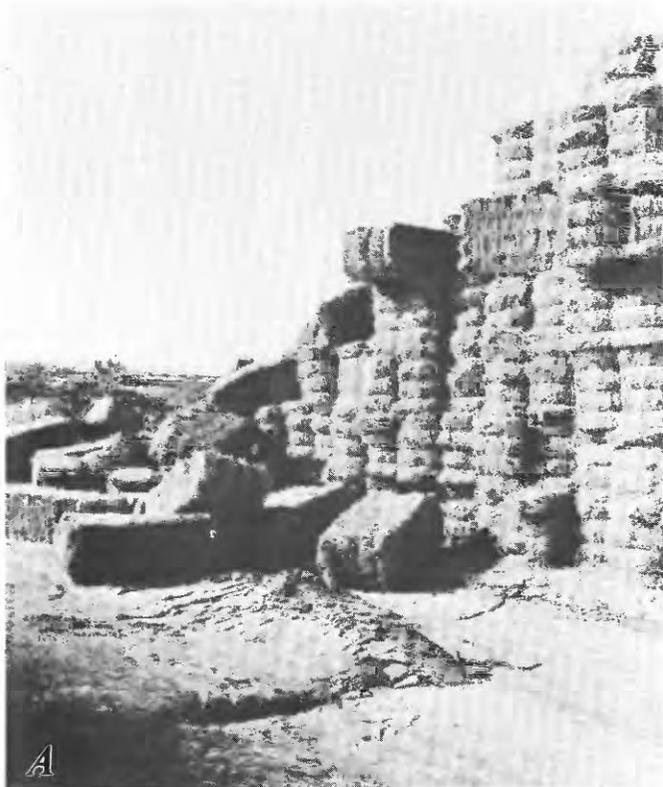
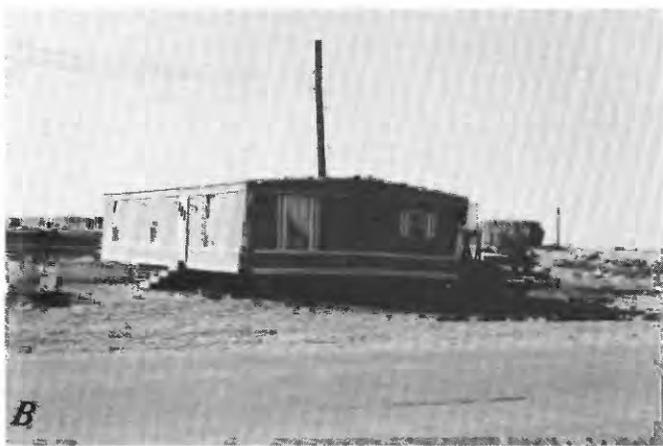
A small water tank resting on a raised platform against the right side of the coach remained standing. Such water tanks, which are common throughout the area, consist of a galvanized-steel tank unfastened to a 4- to 5-ft wooden tower that rests on the ground. Commonly the only lateral support is provided by a ½-in. pipe carrying water into the home.

FIGURE 177.—Site 1. *A*, Imperial fault rupture passing beneath west end of hay-bale stack, oriented east-west. *B*, Mobile home still resting on metal piers, only a few tens of meters from surface rupture of Imperial fault.

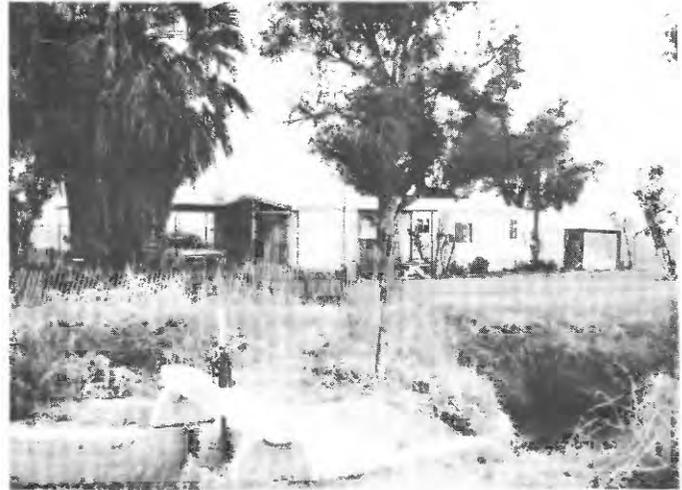
FIGURE 198.—Site 2. Mobile home resting undisturbed on its foundation. Fault rupture passes across foreground within about 15 m of coach. View southwestward.

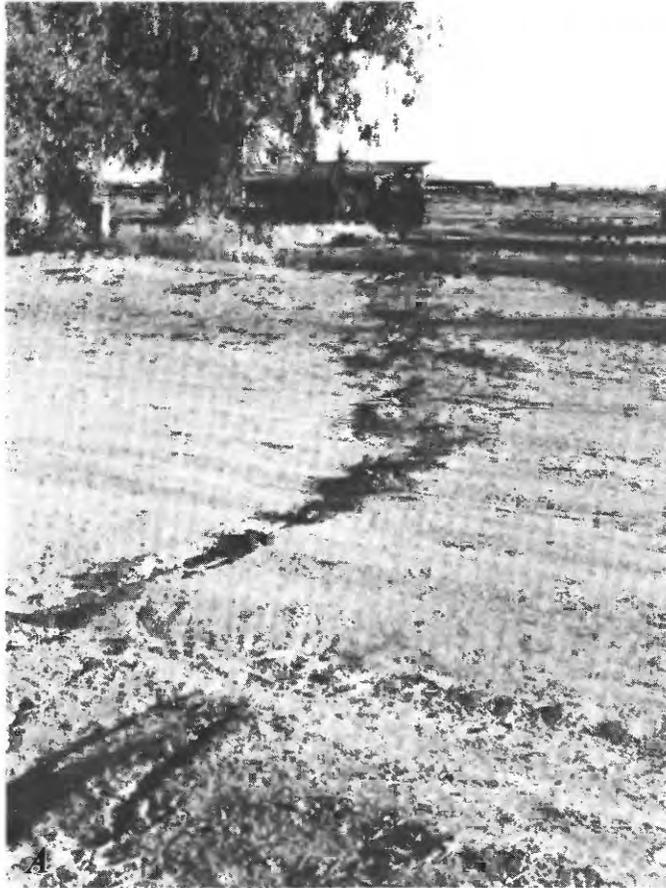
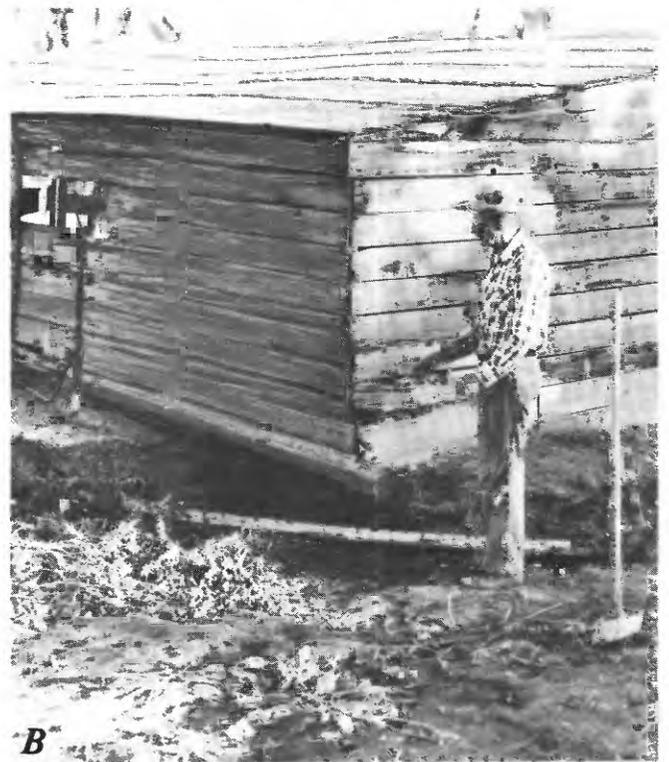
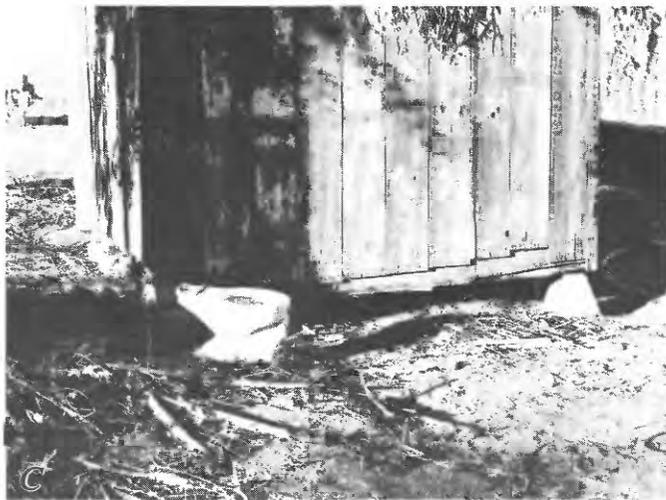
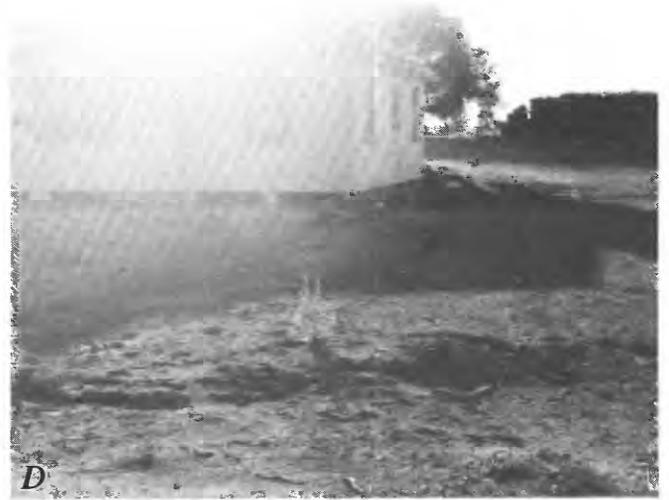
At the home of Mr. and Mrs. Albert Lehmann, about 2 km north of East Evan Hewes Highway and McConnell Road east of El Centro (figs. 196, 199), the surface fault rupture passed directly beneath a wooden chicken coop (fig. 199A, 199B). The coop was undamaged, but a plastic waterpipe broke where the fault trace passed under it (left of corner of shed, fig. 199C). An adjacent shed, about 3 m to the left of the coop (fig. 199B), was still resting, apparently undisturbed, on its concrete supporting piers (fig. 199C), as was the owners' house, which was less than 10 m from the fault trace (fig. 199D). The owners reported no structural damage to the house and no broken windows; a few glass jars fell from a shelf, but large furniture did not shift position.

FIGURE 199.—Site 3. *A*, Surface rupture of Imperial fault passing directly beneath undamaged wooden chicken coop. *B*, Broken plastic water pipe where it crosses fault. Fault rupture trends from lower left corner of photograph through a point beneath corner of coop in center. *C*, Small shed adjacent to coop in figure 199*B*, a few

meters from fault rupture, resting undisturbed on concrete piers. (Location of toilet bowl was not a consequence of the earthquake.) *D*, Surface trace of Imperial fault (foreground) near undamaged house. Orientation of toppled hay-bale stack (background) is north-south.

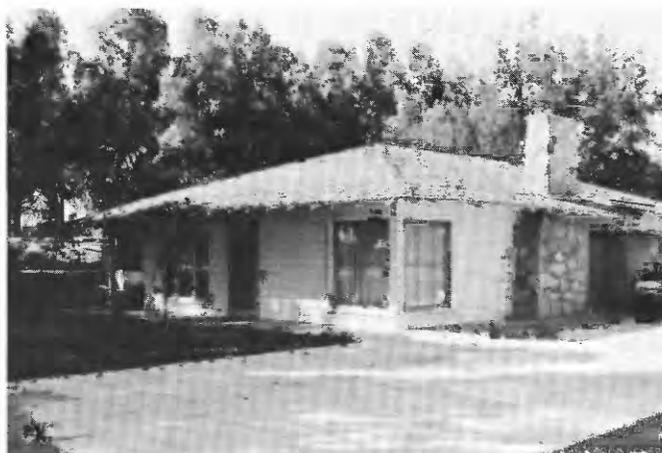
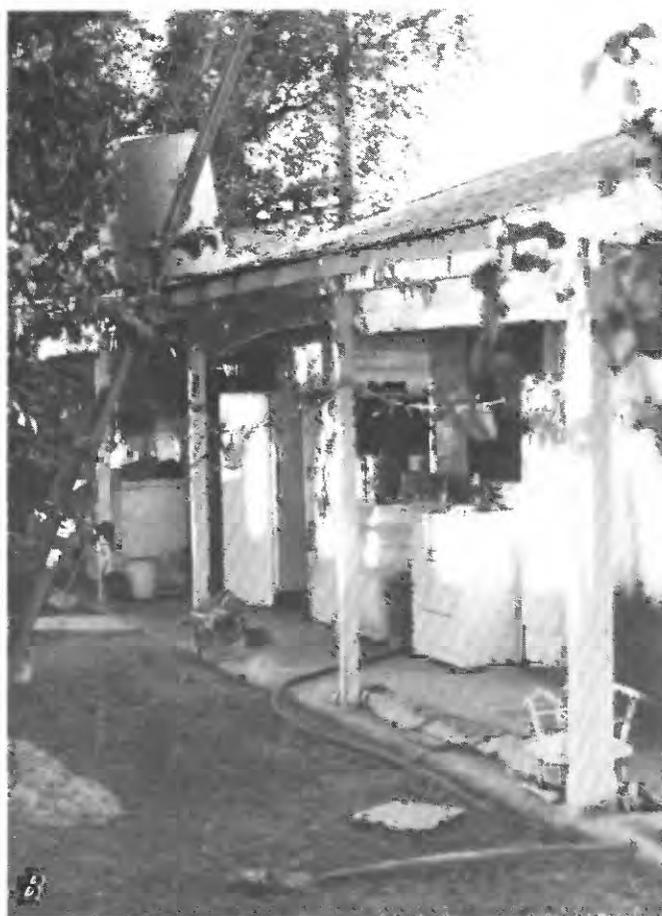
At site 4 is a wood-frame house with wood siding on Huston Road between Dogwood Road and State Highway 111, east of Imperial, Calif. (figs. 196, 200). Although the surface fault rupture passed within 40 m of the house, the house incurred no structural damage; there were no broken windows, and the stone fireplace was completely intact. However, a separation of about 1 cm that occurred beneath the eaves between the house and the fireplace may have been greater, had the roof not enclosed the chimney. None of the heavy appliances in the house shifted position, although a wooden closet (extreme right, fig. 200B) fell over. A ladder leaning against the eaves, and a small water tank resting unfastened on the roof, remained undisturbed throughout the entire series of events. The only noticeable effects of shaking inside the house were that an ironing board fell over and a picture fell from a wall.

FIGURE 200.—Site 4. *A*, Undisturbed residence a few tens of meters from Imperial fault surface rupture. Fault scarp can be seen as a dark line along levee bank through clearing in trees, off left corner of house, just beneath eave. Fault displacement here, as well as at three described sites to north, is predominantly vertical. *B*, Undisturbed wooden ladder, water tank, and large appliances at rear of house in figure 200A.

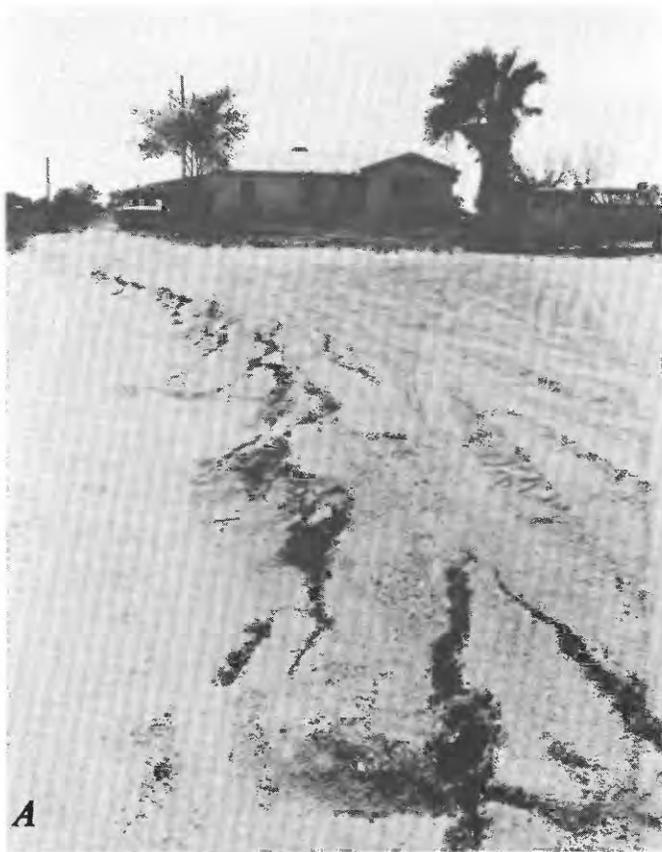
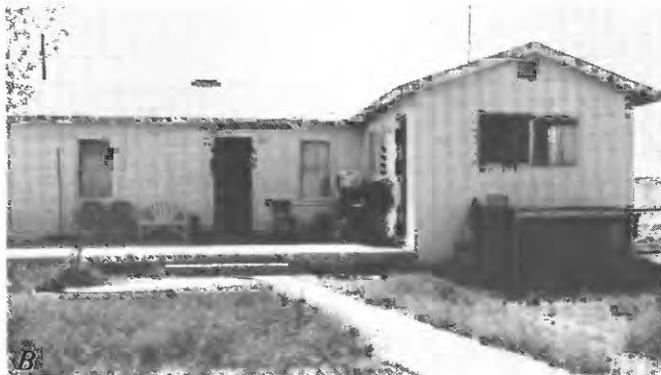
At site 5 is a wood-frame house with wood siding and a stucco addition near the intersection of Worthington Road and State Highway 111, due east of Imperial (figs. 196, 201). The surface trace of the Imperial fault passed within 10 m of the house, but there was no visible structural damage; no windows were broken, and no cracks appeared in the foundation or elsewhere in the stucco parts of the building. The occupants could not be contacted for a description of shaking effects inside the house.

FIGURE 201.—Site 5. *A*, Surface trace of Imperial fault rupture passing within a few meters of wood-and-stucco house that showed no visible signs of damage. *B*, Closeup of house in figure 201A.

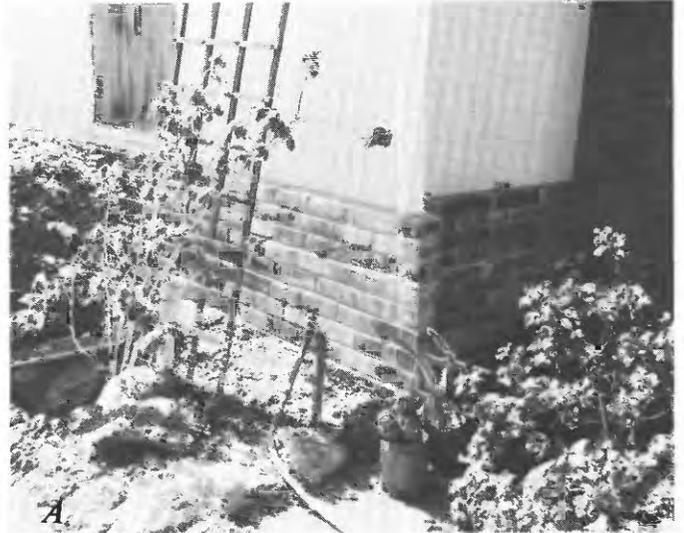
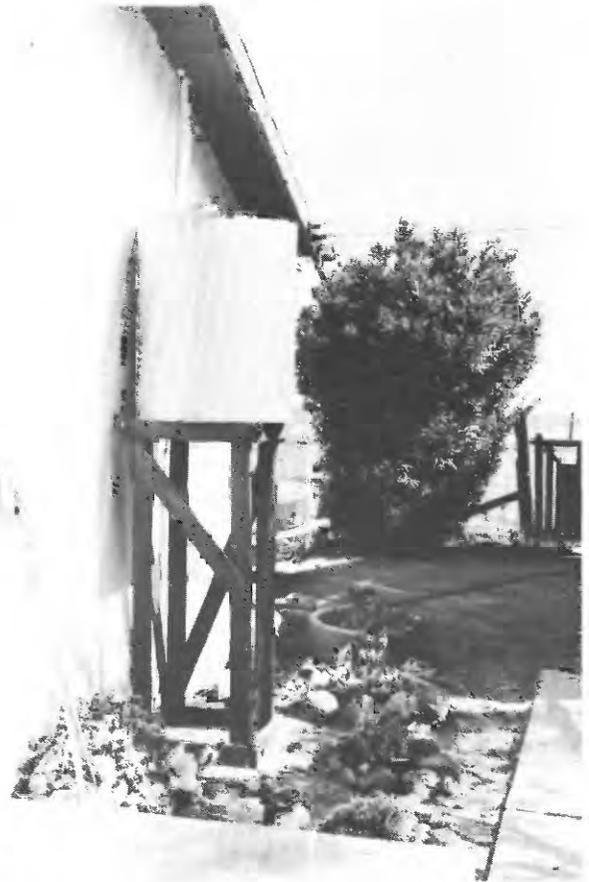
At site 6 is a wood-frame house with stucco exterior and concrete-block foundation on Robinson Road, about 1 km west of its intersection with State Highway 111 (figs. 196, 202). The surface rupture of the Imperial fault passed about 300 m to the east of the site. The home exhibited no visible structural damage; no cracks appeared in the plaster exterior (which had recently been painted before the earthquake), and no windows were

FIGURE 202.—Site 6. *A*, Recently painted plaster walls of house a few hundred meters from surface rupture of Imperial fault, showing no cracks in brick-and-mortar facade. *B*, Undisturbed water tank resting on wooden platform at rear of house in figure 202A.

broken. The foundation has a brick-and-mortar facing that was totally undisturbed. Inside the house, a few pieces of furniture moved about 15 cm, but most were unaffected. Some items toppled off shelves, and in the garage one shelf fell over and several cans of paint were spilled onto the floor. A water tank resting unsecured on a raised platform at the rear of the house remained standing and showed no visible signs of movement (fig. 202B).

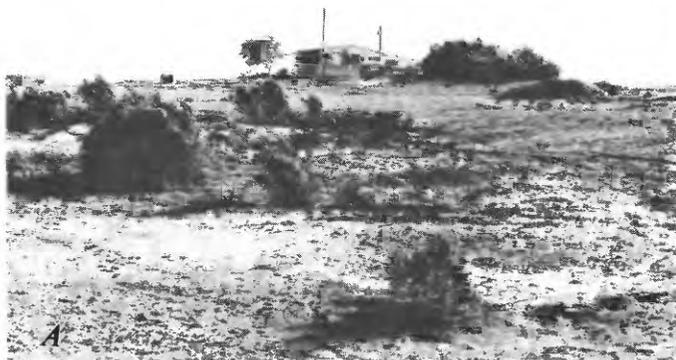
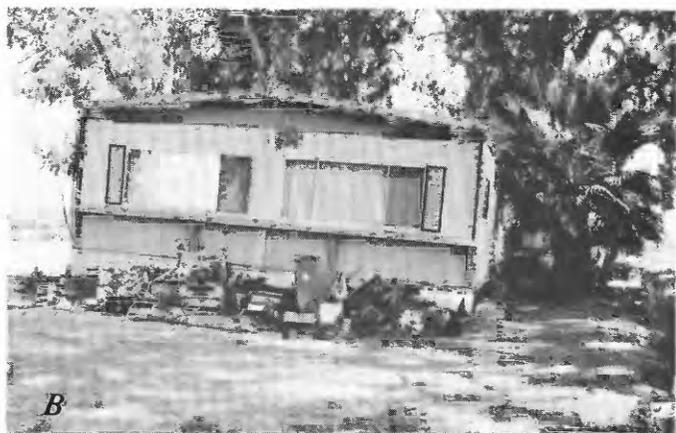
The last and northernmost observation site is about ½ km west of the intersection of Harris and Dogwood Roads, northeast of Imperial (fig. 196). The surface rupture of the Imperial fault passed between two mobile homes that are both within 100 m of the fault trace. The southwestern mobile home on the west side of the fault (fig. 203A) was undamaged; the home is bolted down to a

FIGURE 203.—Site 7. A, Undisturbed mobile home of a few tens of meters from surface trace of Imperial fault (center). B, Mobile home that collapsed on its foundation, situated a few hundred meters from mobile home in figure 203A on opposite side of fault.

concrete foundation, with metal straps spaced at 2-m intervals. The owners stated that the home was erected in 1975, when a local ordinance (later repealed) required that mobile homes be anchored. The occupants reported that heavy furniture did not move, although a television on casters tumbled over. One occupant had difficulty getting up from the ground during the earthquake. A waterline a few meters from the fault rupture broke.

The other mobile home, about ½ km to the northeast on the opposite side of the fault, was thrown off its foundation (fig. 203B). Although the owners could not be contacted, the interior contents of the coach apparently were considerably disrupted by ground shaking. This was the only mobile home of the four observed within a few hundred meters of the Imperial fault where foundation failure occurred.

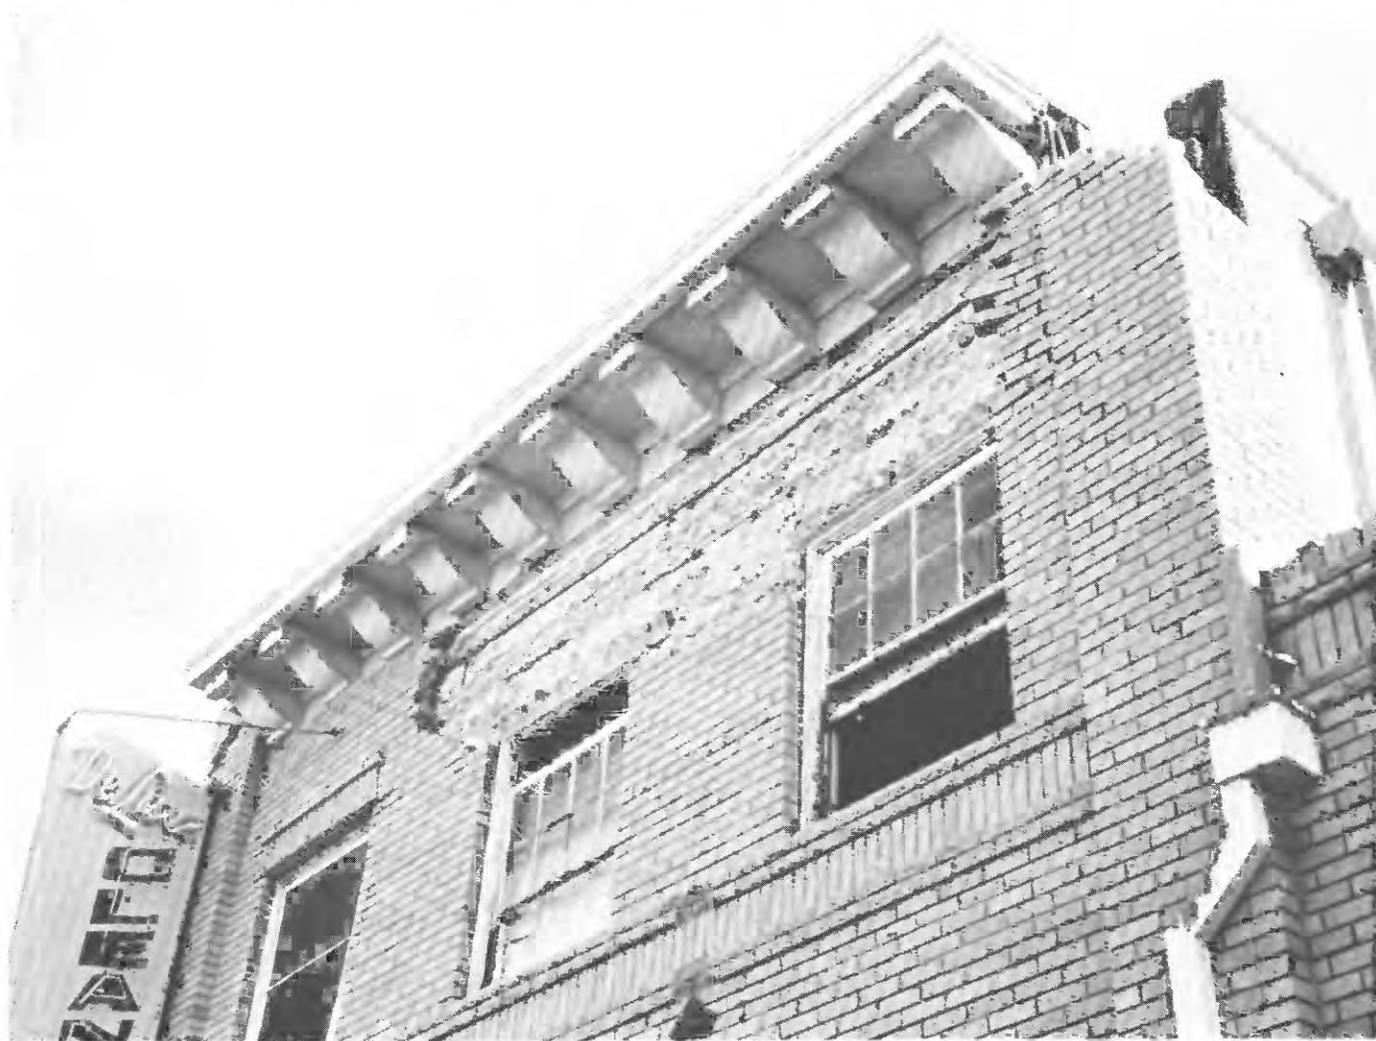
FIGURE 207.—Parapet and veneer damage to older building in El Centro.

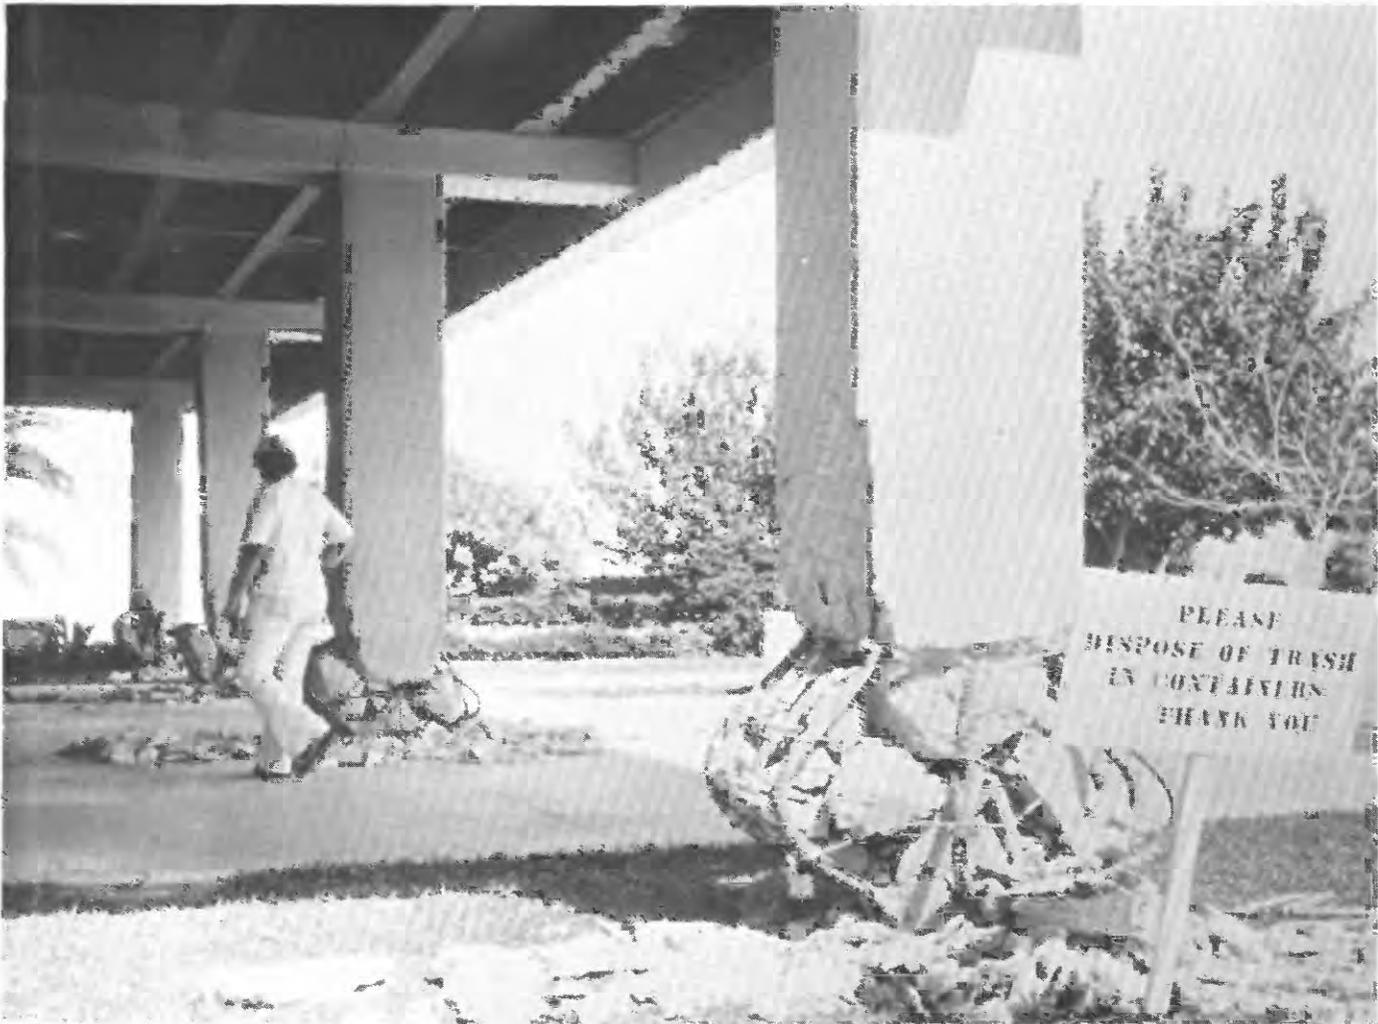
FIGURE 209.—Line of columns that failed at east end of Imperial County Services Building.

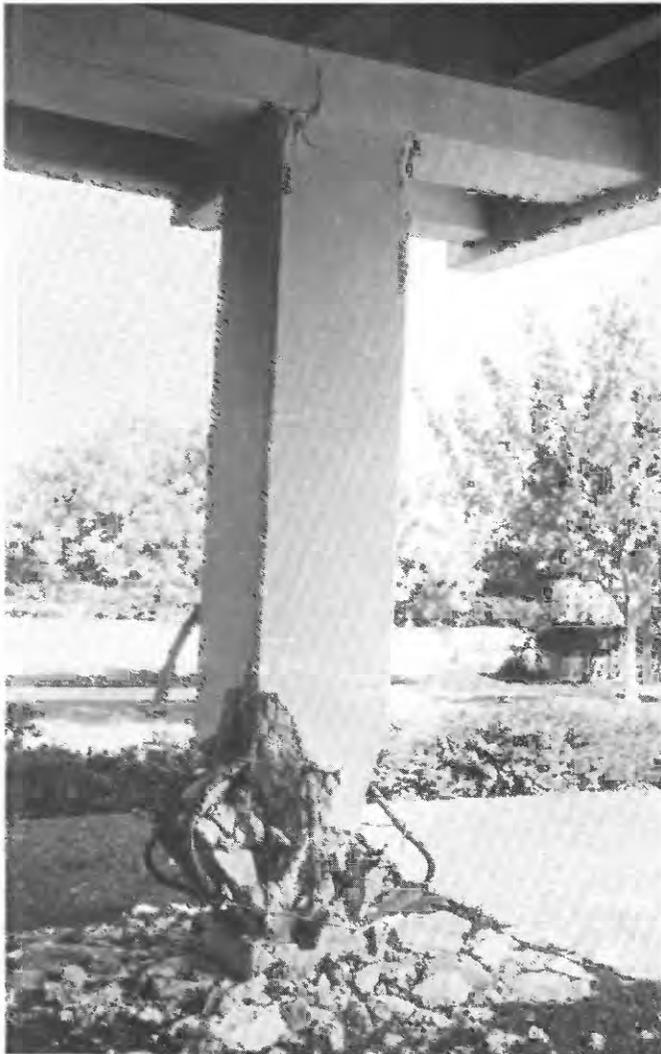
FIGURE 212.—Typical column failure, Imperial County Services Building.

In developing the code requirements for ductile moment-resisting space frames for reinforced concrete, avoidance of hinging columns and forcing of yielding into the girders were considered essential design features; furthermore, the girder design must allow for yielding without any shear failure. These requirements do more than prevent hinging of the columns; they also set an upper limit on the earthquake-induced axial load that can be transmitted to the columns. At each floor level, that increment of the axial load is determined by the yield moments at the ends of the girders framing into the columns. Thus, the maximum ultimate axial load on columns can be reasonably well determined for ductile moment-resisting space frames.

The same cannot be said, however, for systems similar to the transverse-wall system in the Imperial County Services Building, where shear walls are discontinuous and supported on freestanding columns below. In this type of system, no element will yield, and thus no control exists over the axial load that can be imposed on the column due to the overturning effects of earthquake forces—that is, the system has no ductility. The entire philosophy of earthquake-resistant design is based on the recognition that actual forces may greatly exceed the code forces and that the response of structural elements must enable them to resist those forces. Normally, this result is achieved through ductility of the system; where such ductility is impossible, the members must be designed for a substantially higher

factor of safety. This reasoning clearly applies to the columns supporting a stilt-type building.

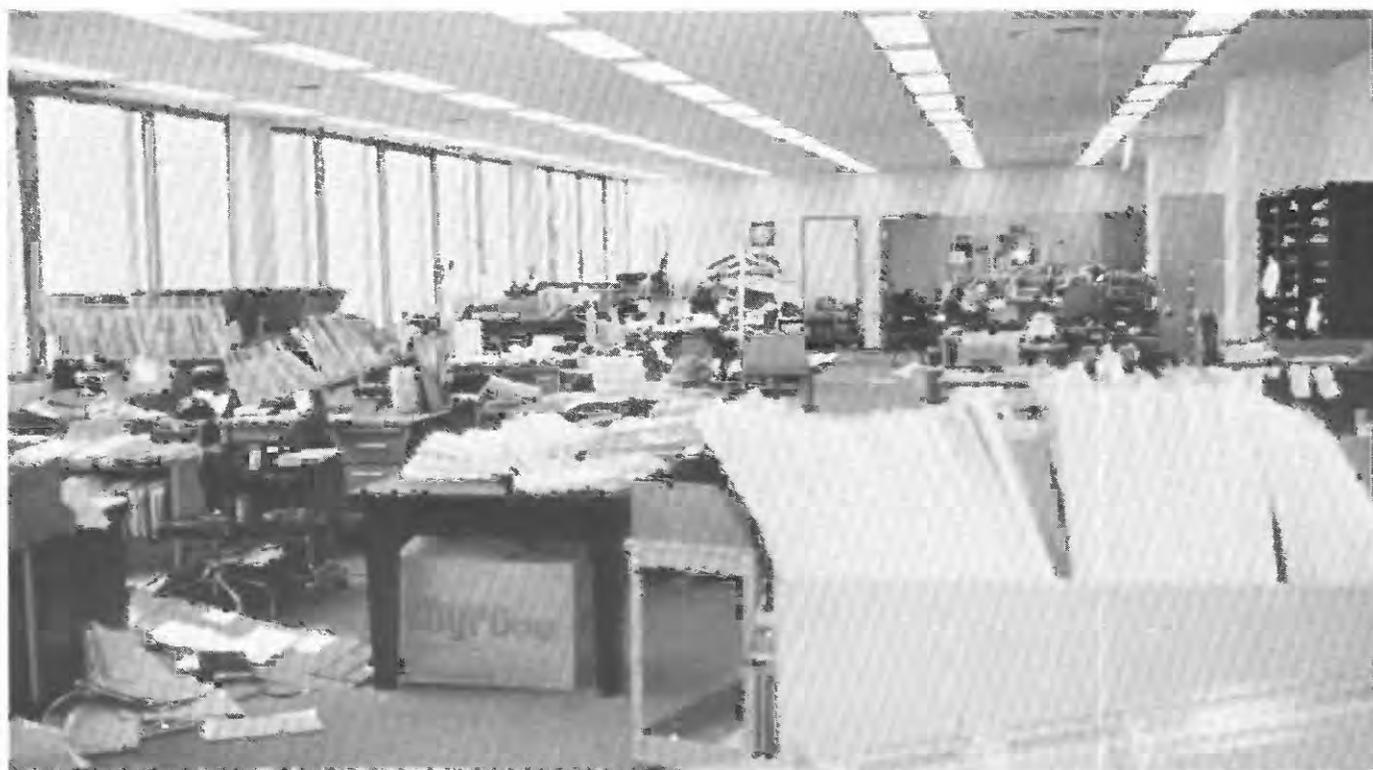
FIGURE 213.—Interior of Imperial County Services Building, showing undamaged ceiling, ceiling light fixtures, and partitions. Such contents as papers, files, and bookshelves, however, were thrown about.

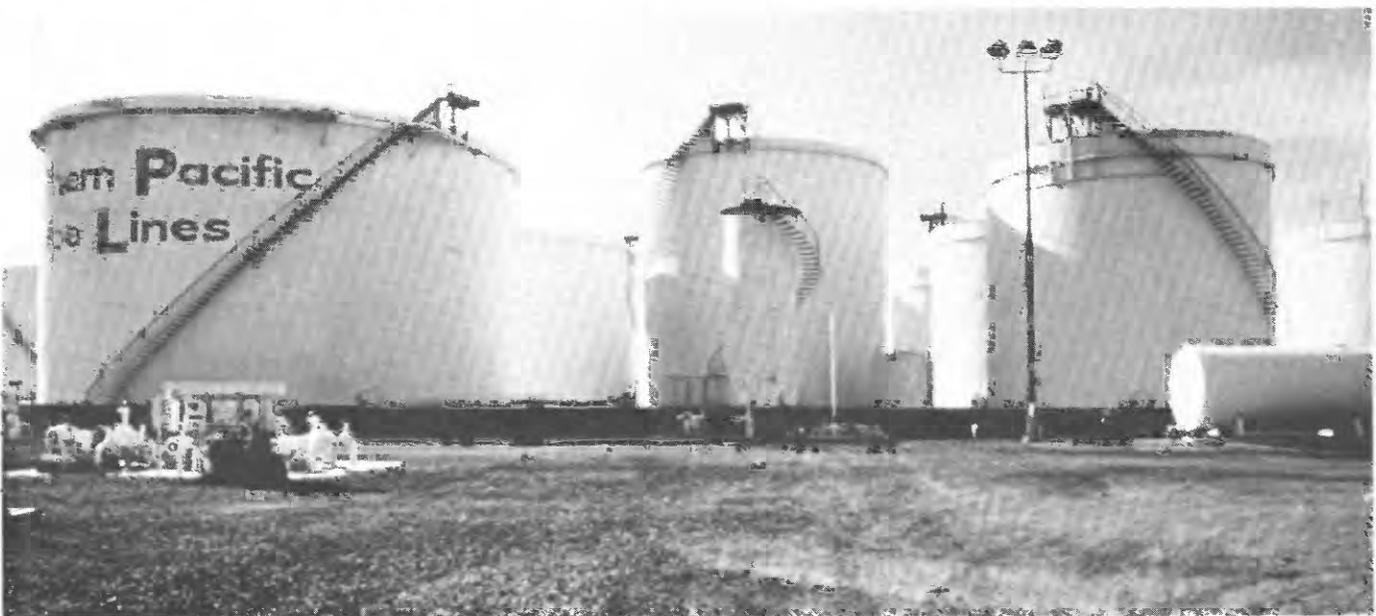
At the Southern Pacific Pipe Lines gasoline storage tank farm (fig. 214), east of the Imperial County Airport, damage in the main shock prompted the evacuation of all persons from within a 1-mi radius of the site. This evacuation was ordered because of a leak from a minor rupture in the most severely damaged tank, IP-13. The 11,000-gal-capacity steel tank measures 41 ft in diameter by 49 ft high. The unit utilizes a Weathermaster roof of rigid steel with a floating steel liner; the tank is supported by a concrete-perimeter ringbeam on compacted fill. No direct attachment exists between the tank and perimeter beam. Tank IP-13, which has the largest ratio of height to diameter of all the tanks on the site, was nearly full at the time of the earthquake, as were all the other tanks.

FIGURE 214.—Southern Pacific Pipe Lines gasoline storage tank farm. View southward.

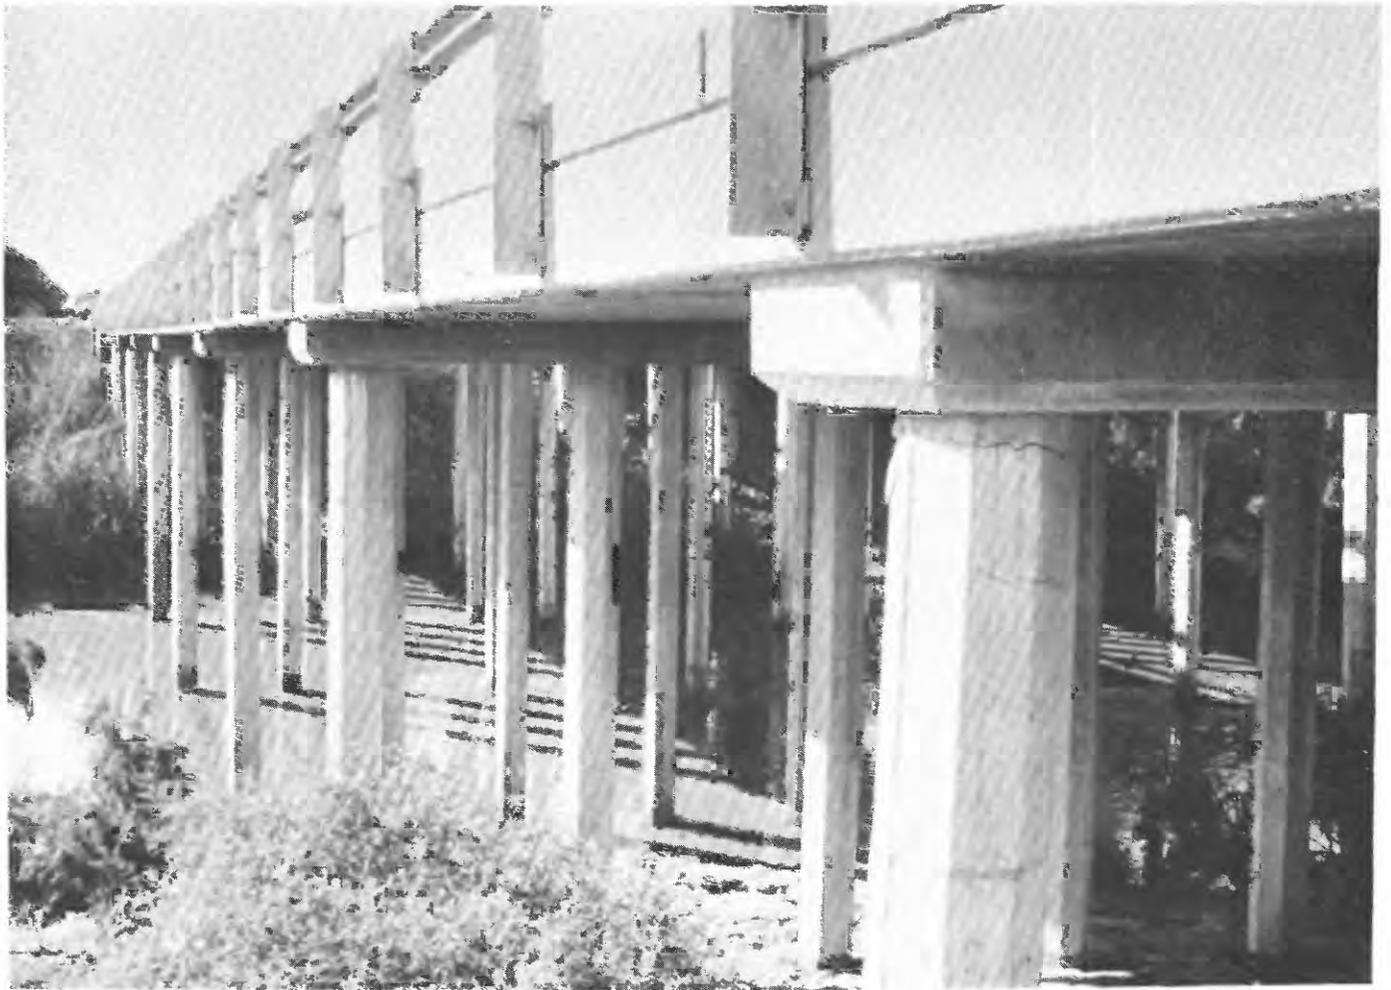
The New River Bridges on State Highway 86 approximately 2 mi west of Brawley, Calif., were the most severely damaged highway structures in the area and had to be closed to traffic until shored. The twin straight parallel two-lane bridges (fig. 216), each supported on

seven interior bents, extend east-westward 198 ft between free-floating abutments; the ends of the bridges are skewed 20°. The bridges are supported on Raymond step-taper piles extending approximately 60 ft below the elevation of the bridge decks. Octagonal concrete columns, each supported on a single pile, extend from 1 ft below grade to a cap at the deck soffit at interior bents.

The earthquake caused the abutments at each end of the bridges to move inward. The total movement at the west abutment of the southern bridge (eastbound lane) was measured by Caltrans to be 14½ in. from its original position. Previous measurements made in 1975 indicated that 7½ in. of movement had taken place by then since construction in 1952. Therefore, approximately 6 in. of additional movement may be attributed to slope movement during the earthquake. Hinging at the tops of the columns on the first interior bents at each end of the bridges, and roadway settlements of 6 to 8 in. behind the abutments, may also be attributed to slope movement.

FIGURE 216.—New River Bridges on State Highway 86, showing southern bridge (eastbound lane). View westward.
