# THE IMPERIAL VALLEY, CALIFORNIA, EARTHQUAKE OF OCTOBER 15, 1979

GEOLOGICAL SURVEY  
PROFESSIONAL PAPER 1254

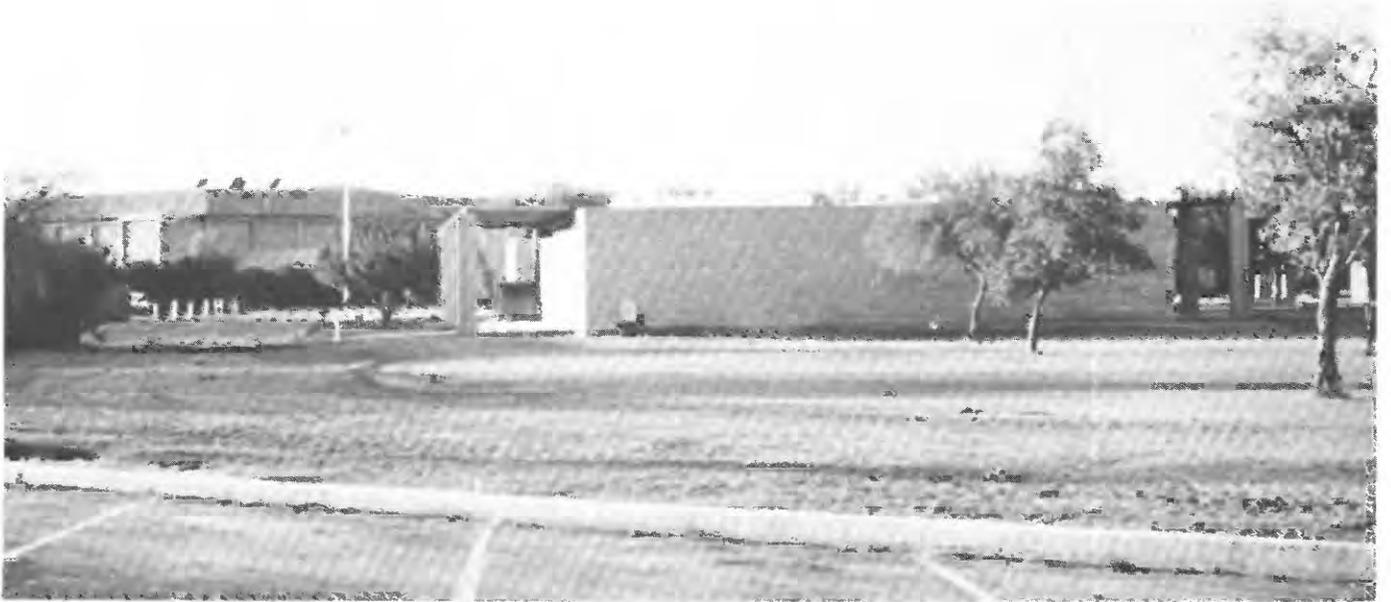
Structural damage to the buildings on the campus was minimal or nonexistent. Neither movement nor damage was apparent in the mechanical equipment examined, much of which was unanchored or only nominally anchored. In the gymnasium a pipe trapeze was damaged and a few fluorescent-light fixtures fell, all of which were supported from the steel truss-roof members

FIGURE 219.—Imperial Valley College. View northwestward.

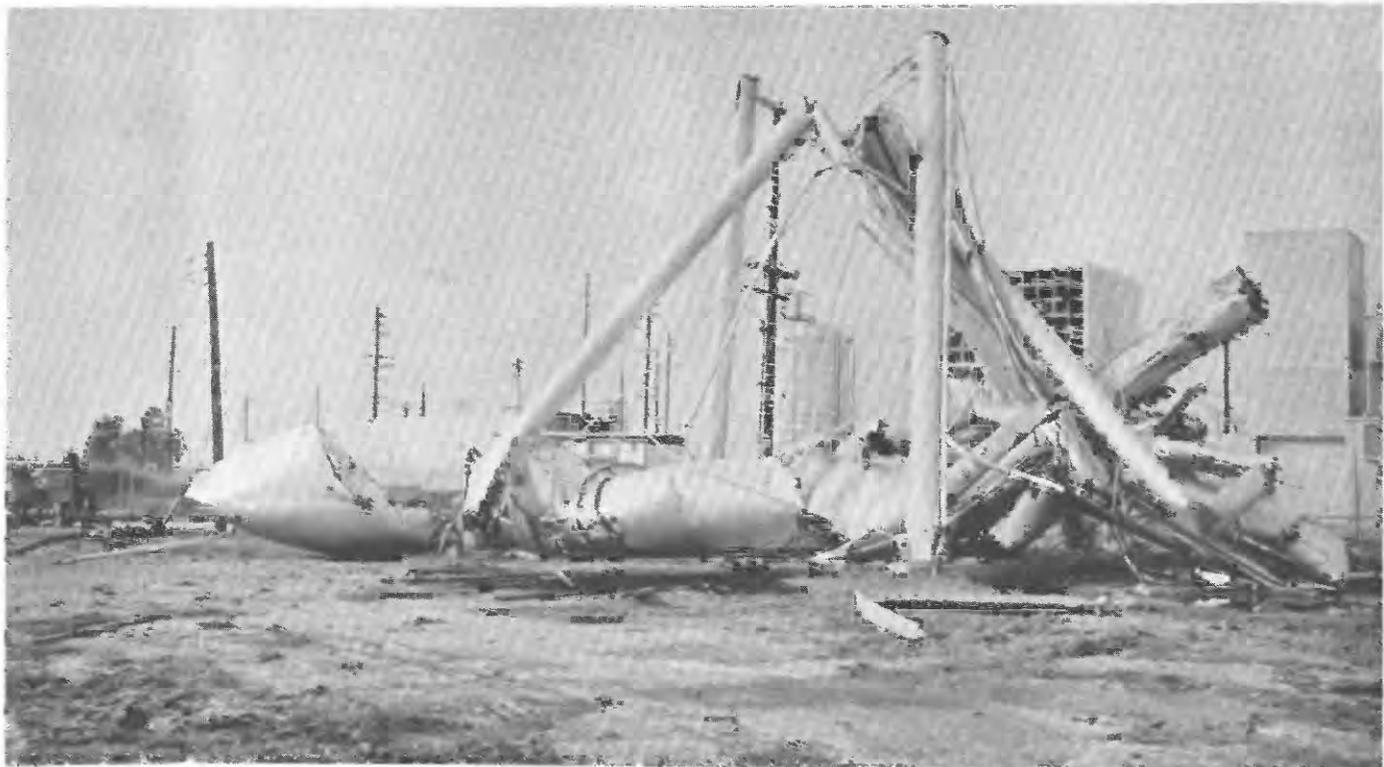
tank just south of Brawley on Dogwood Road that completely collapsed. This collapsed tank (fig. 220), known as the Calcot Water Tank, was estimated to have been 100 ft tall by 30 ft wide at the base. Its four tubular legs, 21 in. round by  $\frac{3}{8}$  in. thick, were braced by three tiers of diagonal rods,  $\frac{2}{4}$  in. round in the bottom tier. Rods had upset threads and turnbuckles at one end, and were welded to two plates at the other to form clevises. Struts were T-shaped 8-in. double channels. Clevises and struts were connected to 1-in. gusset plates welded to the tubular uprights. Diaphragm plates were generally welded into place within the tubes above and below the gusset plates. Some nuts were not fully threaded onto the clevis pins. Welds generally appeared satisfactory.

FIGURE 220.—Collapsed Calcot Water Tank.

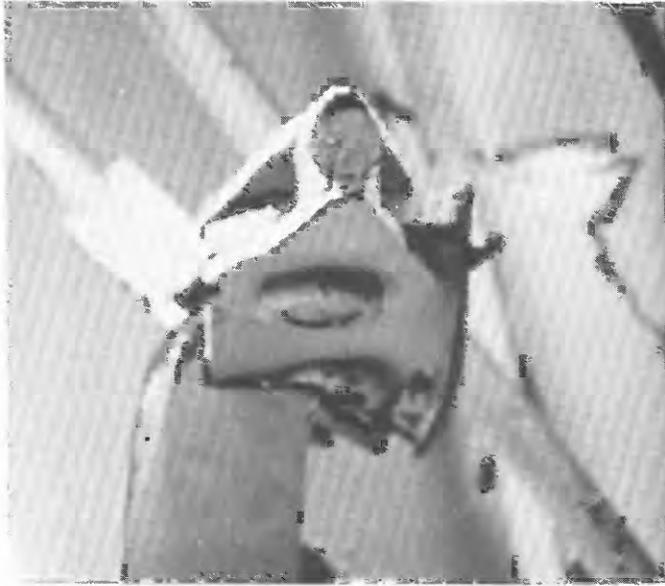
The tank was filled with water at the time of the main shock. Brash failures occurred in the rods where they were welded to the clevis plates, and the gussets tore from the tube walls in some places from the wall and weld (fig. 221).

FIGURE 221.—Calcot Water Tank rod failure.

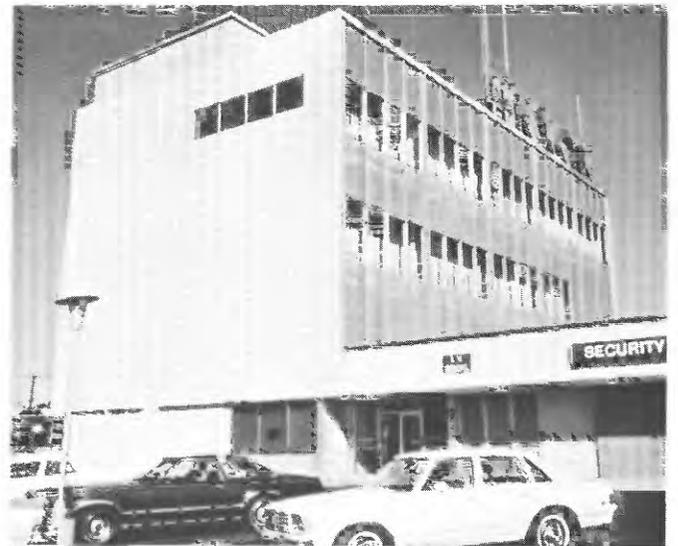
The second tallest building in El Centro is KXO radio station (fig. 223) at the Valley Plaza Shopping Center, three blocks west of the Imperial County Services Building. The structure is a four-story steel frame with lightweight concrete-on-steel deck, 50 by 100 ft in plan, on 50-ft piles, built in 1966. No broken windows were visible. Some horizontal hairline cracks were apparent in the north- and south-facing 50-ft walls, assumed to be nonbearing. No architectural damage was noticeable on the ground floor, although one employee of the radio station stated that some minor tile damage was visible in the third-floor bathrooms. The station was fully functional when power was restored to the building a few hours after the earthquake.

FIGURE 223.—KXO radio station, El Centro. View northwestward.

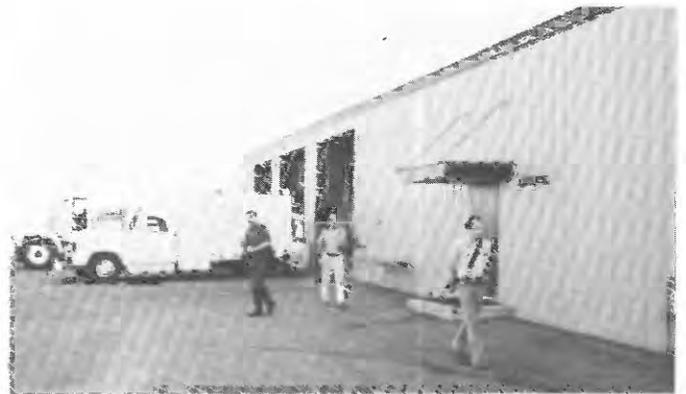
building (fig. 224) divided into three occupancies: garage, office space, and repair shop. No damage to the structure was visible. Many of the lights in the garage and shop, suspended from the frame on small chains, broke after swinging into the ceiling or becoming unhooked. The steel duct system within the shop exhibited considerably less response, according to employees. Sprayed-on-wall insulation in the shop was cracked. Some ceiling tiles and insulation in the office fell. A hairline crack was visible in the garage floor; fire engines were parked in the garage during the earthquake. The office functioned as the County emergency services center after the earthquake.

FIGURE 224.—Imperial County Emergency Services and Fire Department Building, Imperial County Airport. View northeastward.

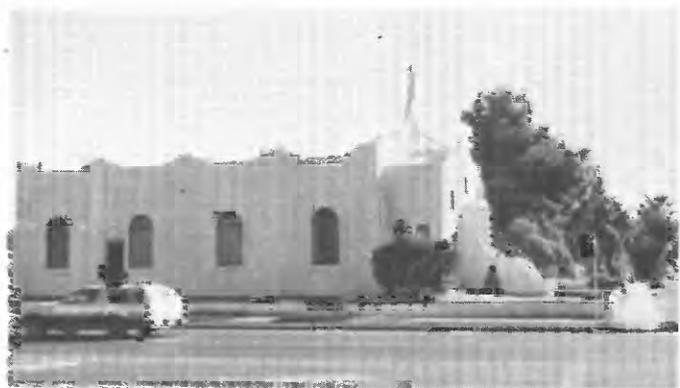
In general, earthquake-related structural damage to these church buildings was minor or nonexistent. No damage was observed at the First Church of the Nazarene, Grace Lutheran Church, or the United Methodist Church. The Church of the Four Square Gospel (fig. 225), an old one-story unreinforced-masonry bearing-wall structure with a wood roof, had some cracking in its entrance stairway, walls, and parapets, and the guy wires for the cross atop the building apparently were elongated owing to the earthquake.

FIGURE 225.—Church of the Four Square Gospel, El Centro. View eastward.

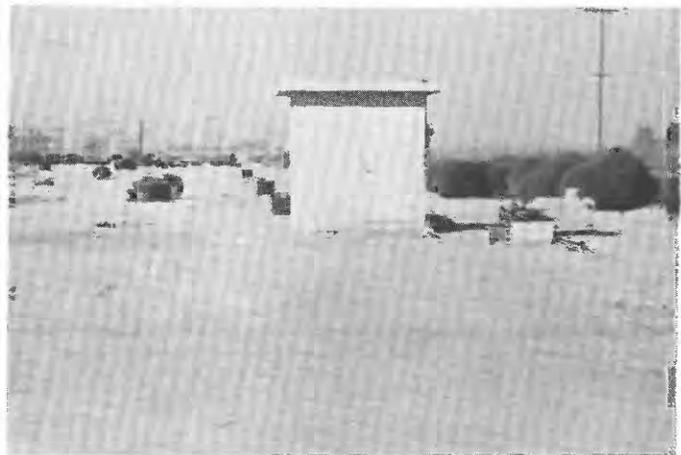
Such an array, funded jointly by the Federal Highway Administration and the U.S. Geological Survey, was recently installed at El Centro, Calif., in time to record the earthquake of October 15, 1979. The Imperial Valley Irrigation District permitted the array to be placed in a large vacant area near El Centro steam station 4 (Matthiesen and Porcella, this volume) that is secured by a cyclone fence and meets the other requirements discussed above. Figure 238 shows the structure, and table 34 the velocity profile, of the region; figure 239 shows the location of the array with respect to local faults. Because faults surround the area, no particular orientation appeared optimal, and so the array was laid south to north along the inside of the fence running along Dogwood Road (fig. 240). This area is remote from the powerplant, and so interactional effects should be negligible. The six instruments were placed at distances of 0, 60, 180, 420, 700, and 1,000 ft and numbered 1 through 6, respectively; these spacings give distances between any two instruments of 60, 120, 180, 240, 280, 300, 360, 420, 520, 580, 640, 700, 820, 940, and 1,000 ft.

FIGURE 240.—El Centro differential ground-motion array site. Recording house is shown in right center. Black box adjacent to house (to left) is station 1; remainder of array extends northward (into background).

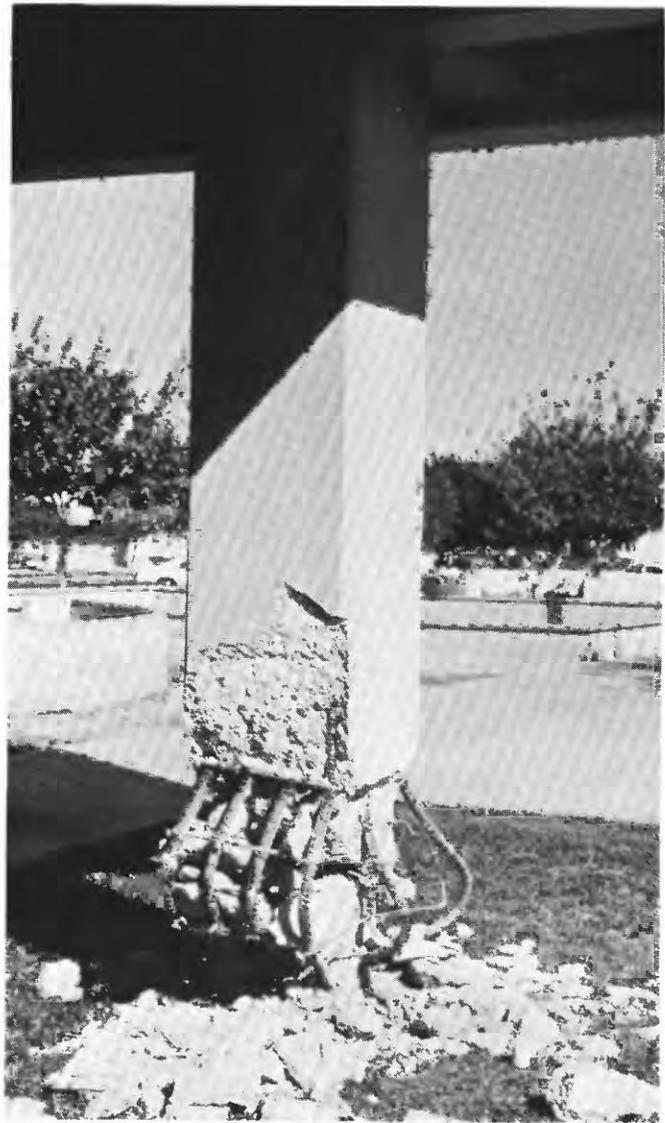
As described in the report by Wosser and others (this volume), the most significant damage to the Imperial County Services Building was the partial collapse just above ground level of the four reinforced-concrete columns along the building's east end (figs. 244, 245). Concrete at the base of each column was badly shattered, vertical reinforcing bars were severely buckled, and horizontal tie bars were widely splayed. On the basis of measurements by the Imperial County Department of Buildings and Grounds, the columns were shortened by approximately 23 cm (9 in.) during the main shock and

FIGURE 245.—One of four damaged reinforced-concrete columns along east end of Imperial County Services Building between ground and second floors. Damage to other three columns was similar.

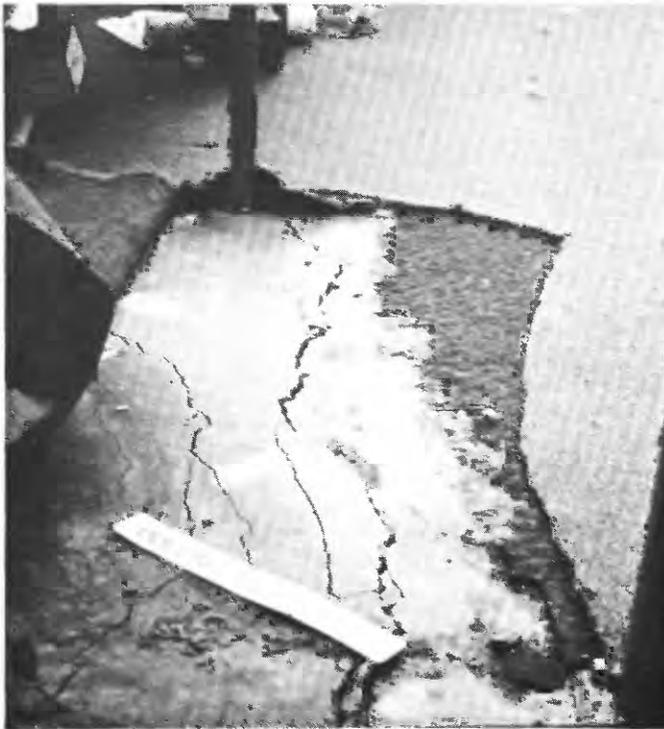
by approximately 7½ cm (3 in.) more during the strongest aftershock (Randy Rister, oral commun., 1979). Less significant damage elsewhere in the building included minor cracking in all columns beneath the second floor (just beneath the beams), minor cracking or spalling at the base of most columns (just above ground level), and a north-south line of severe cracking (fig. 246) in all upper-story floor slabs just to the east of the first interior row of columns (from the east end). The pattern of column damage suggests frame yielding in the longitudinal (east-west) direction and axial-force failure due to north-south overturning of the east-end shear wall; the floor-slab cracks were due to settlement of the structure at the east end.

FIGURE 246.—North-south-trending crack in sixth floor just east of first interior row of columns (from east face).

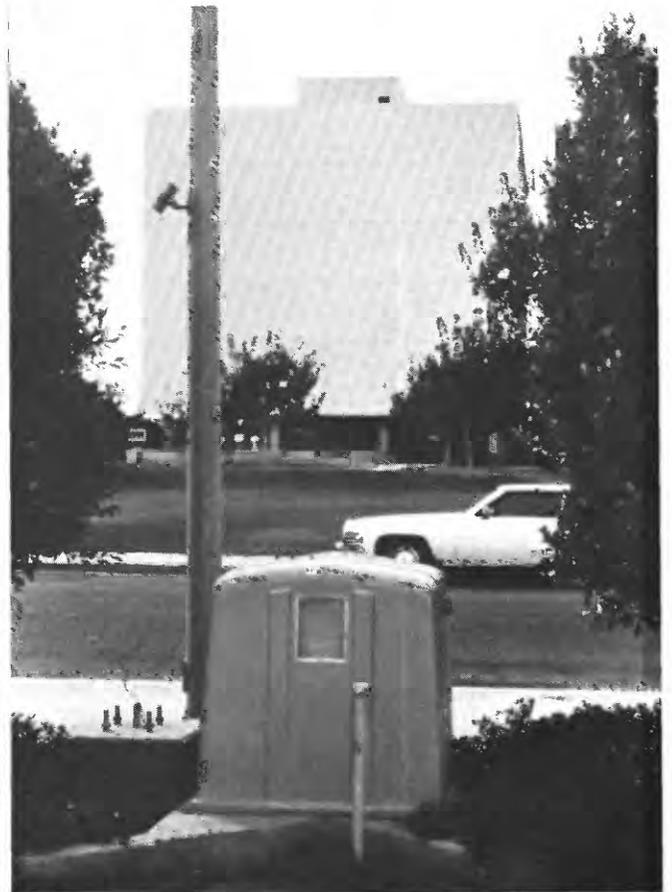
The SMA-1 accelerograph at the ground-level site east of the building (hereafter referred to as the free-field site) is in a standard Fiberglass instrument shelter (fig. 247) founded on a small reinforced-concrete pad. The three-component accelerograph is battery powered, is triggered by vertical motion that equals or exceeds 0.01  $g$ , and records analog signals on 70-mm light-sensitive film. The 1- $g$  accelerometers have a natural frequency of approximately 25 Hz and thus respond to frequency components nominally within the range 0–25 Hz. Real time is provided on each record by a radio

FIGURE 247.—Fiberglass instrument shelter (foreground) housing SMA-1 accelerograph east of Imperial County Services Building (background). Note solar cells mounted on pole adjacent to shelter; these cells provide current for accelerograph's battery charger.

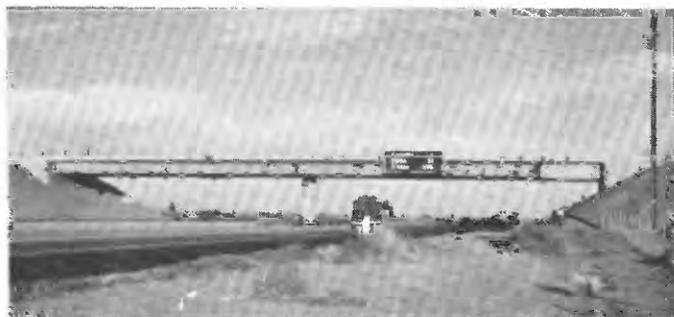
The bridge is a continuous two-span cast-in-place reinforced-concrete box girder with 104-ft spans (fig. 261) carrying two lanes of local traffic over Interstate Highway 8. The bridge superstructure, which weighs

FIGURE 261.—Meloland Road-Interstate Highway 8 overcrossing. View eastward.
